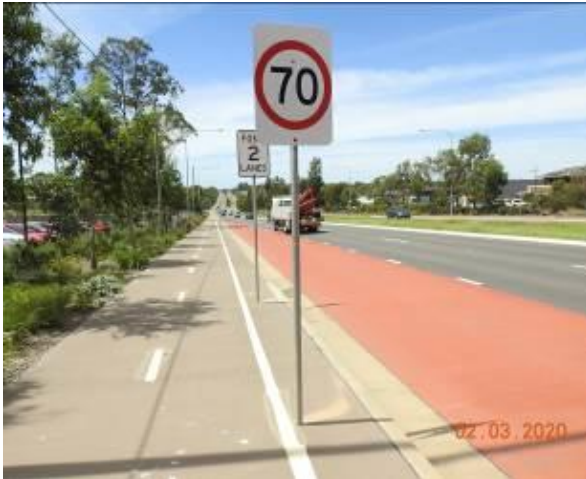
Figure 1852 – General Condition of street sign

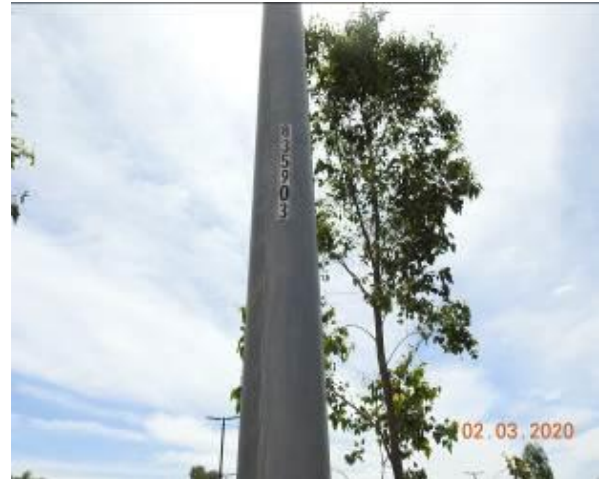
Figure 1853 – General Condition of lamp post
Identification No.835903

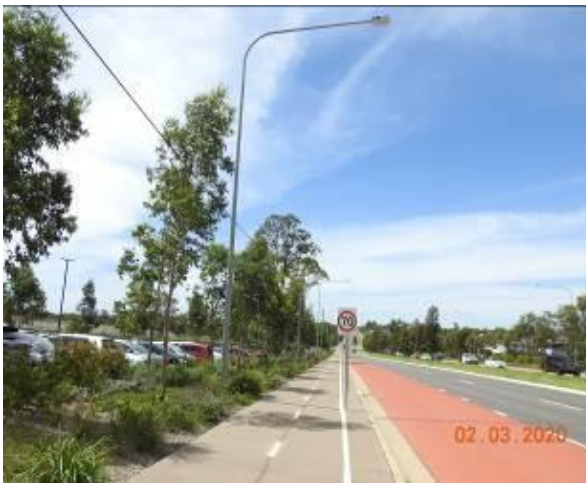
Figure 1854 – General Condition of lamp post

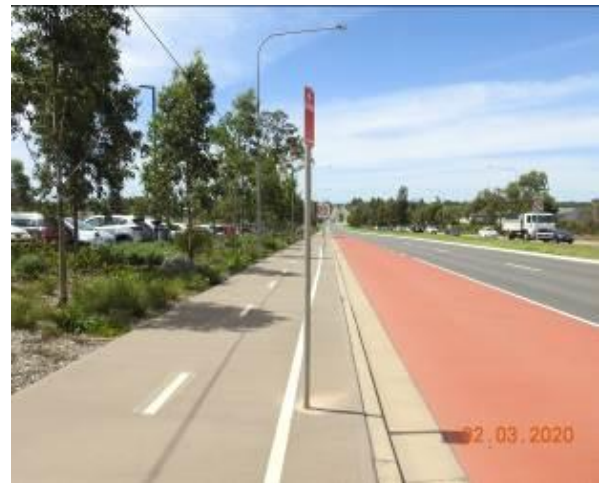
Figure 1855 – General Condition of street sign

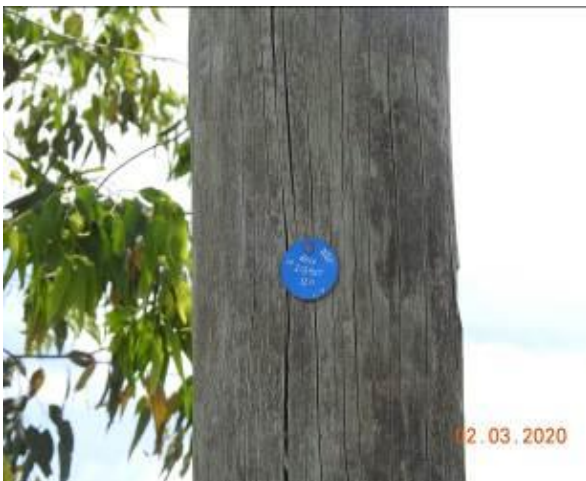
Figure 1856 – General Condition of telegraph pole
Identification No.213955 / 124

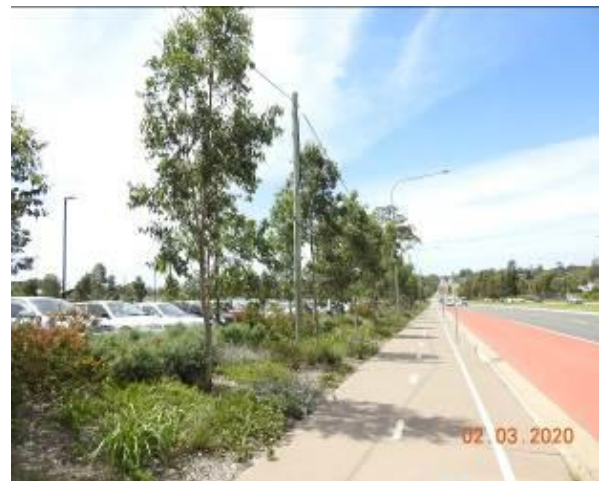
Figure 1857 – General Condition of telegraph pole

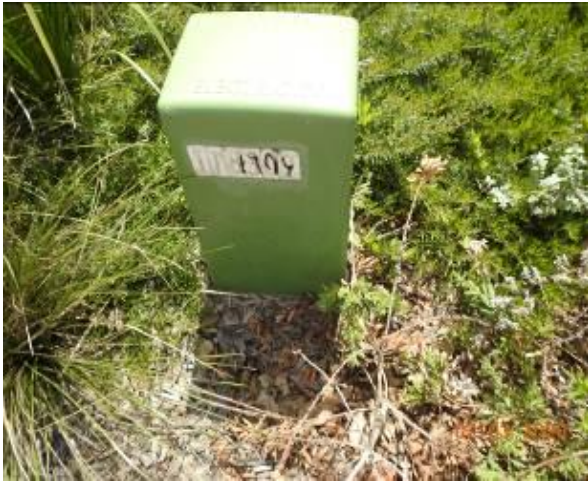
Figure 1858 – General Condition of electricity box
Identification No.118309

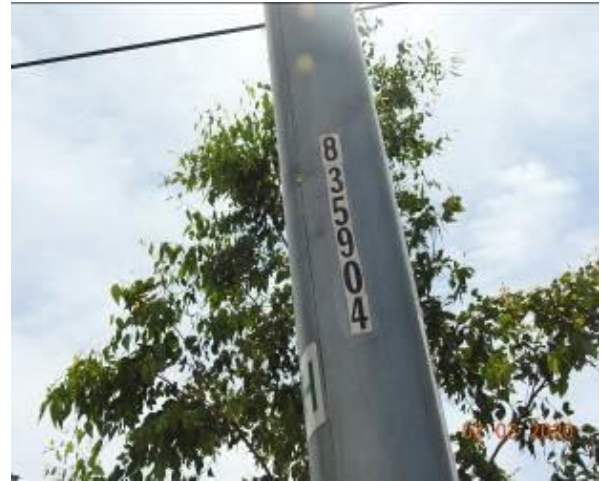
Figure 1859 – General Condition of lamp post
Identification No.835904

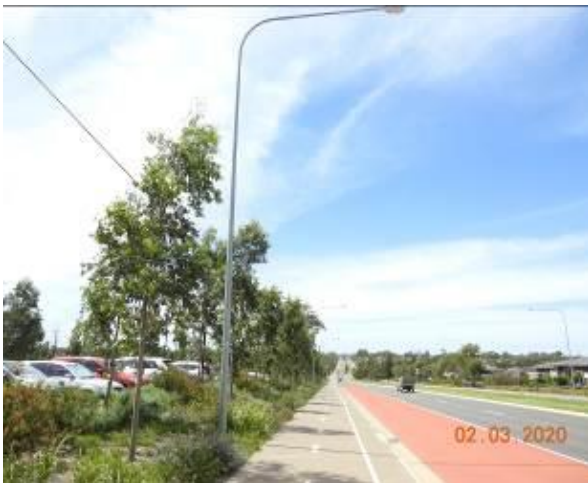
Figure 1860 – General Condition of lamp post

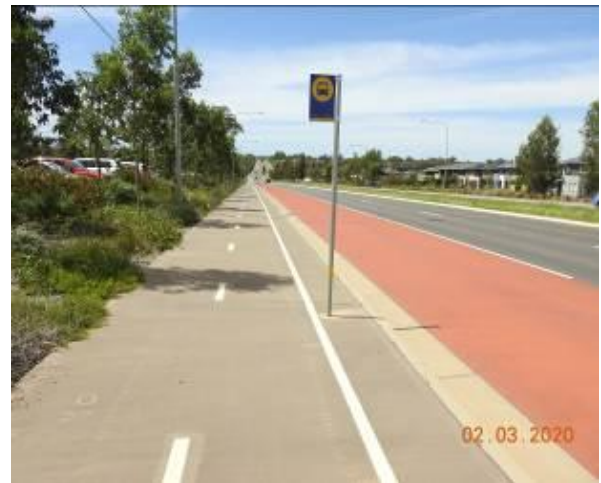
Figure 1861 – General Condition of street sign

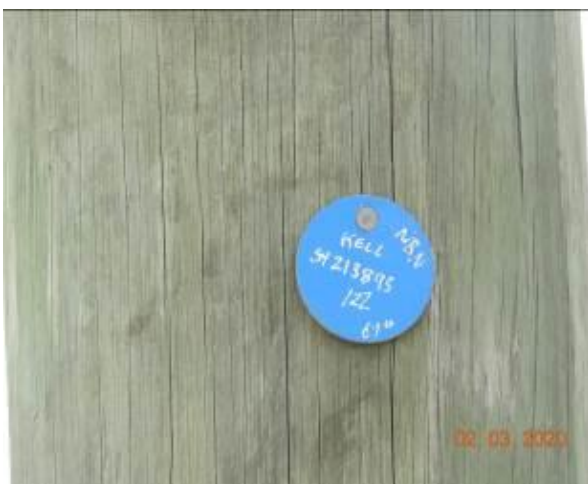
Figure 1862 – General Condition of telegraph pole
Identification No.213893 / 122

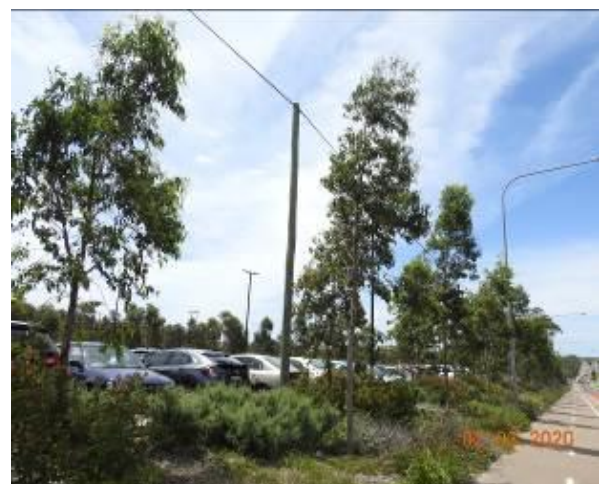
Figure 1863 – General Condition of telegraph pole

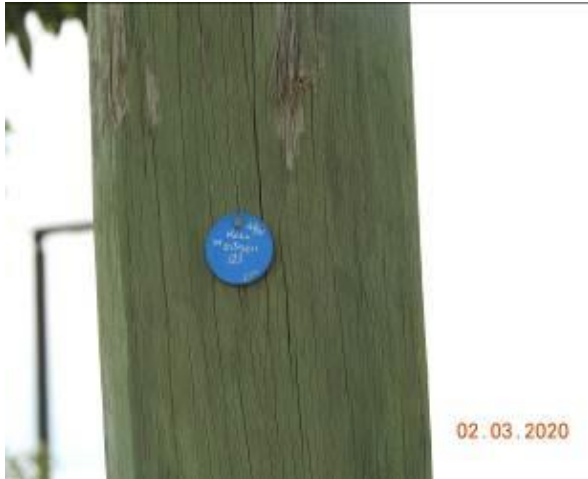
Figure 1864 – General Condition of telegraph pole
Identification No.213984 / 123

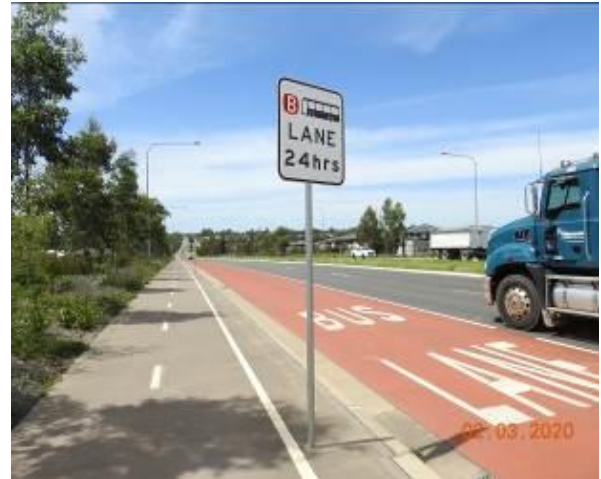
Figure 1865 – General Condition of street sign

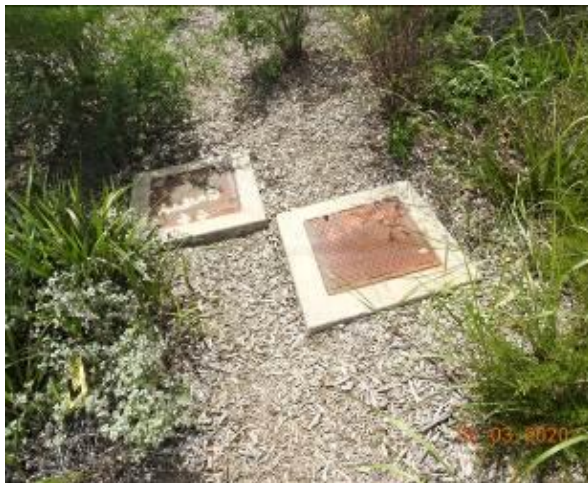
Figure 1866 – General Condition of service pit

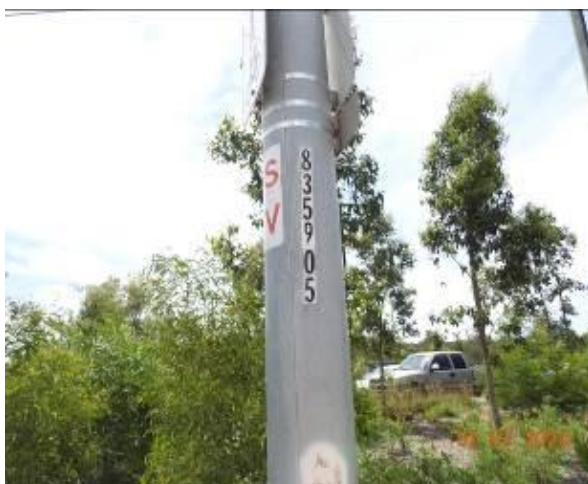
Figure 1868 – General Condition of lamp post
Identification No.835905

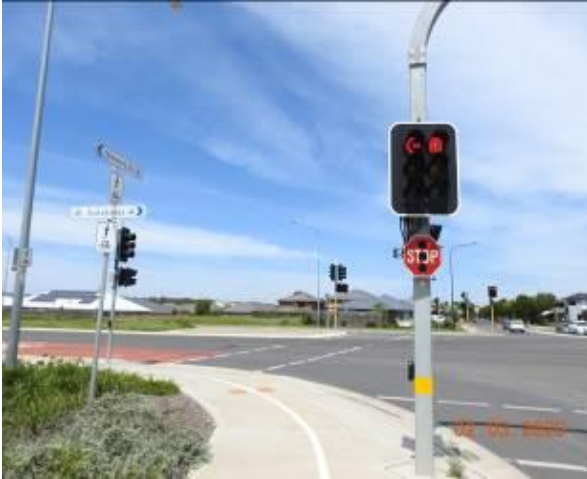
Figure 1870 – General Condition of traffic light / street sign

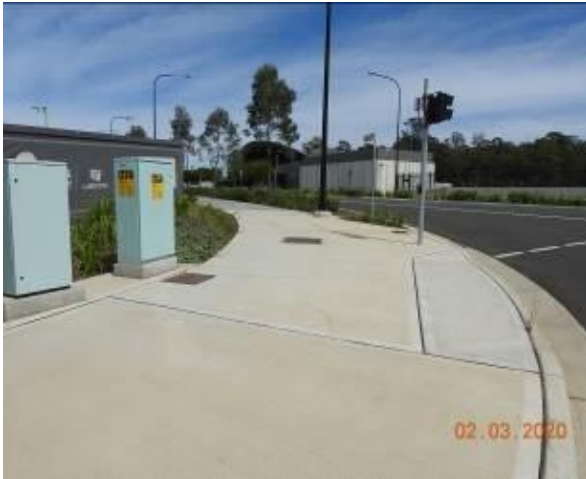
Figure 1871 – General Condition of footpath pavement

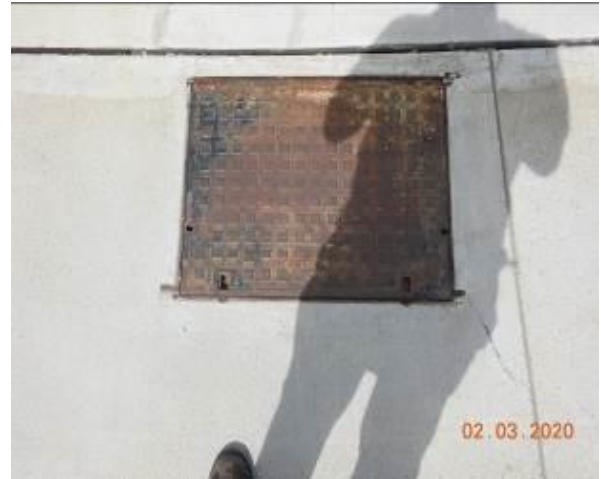
Figure 1872 – General Condition of service pit

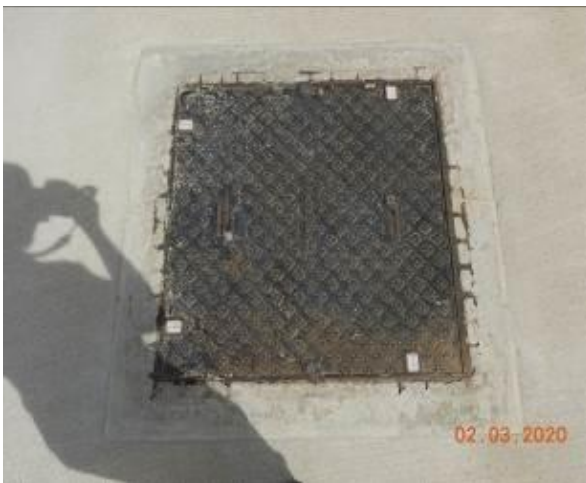
Figure 1873 – General Condition of service pit

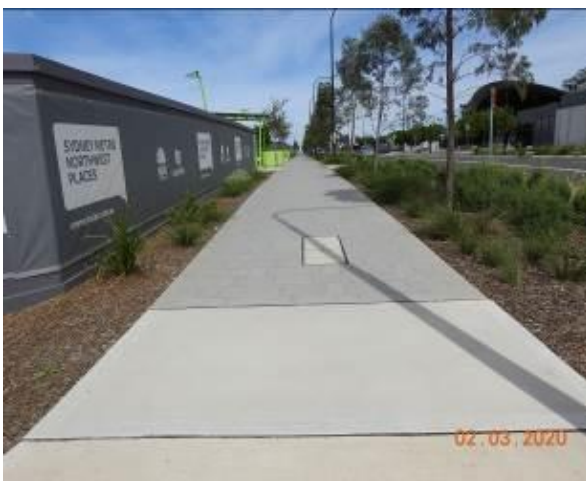
Figure 1875 – General Condition of footpath pavement

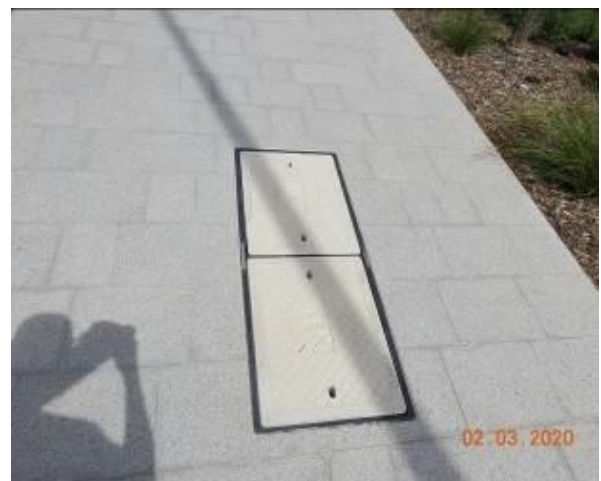
Figure 1876 – General Condition of service pit

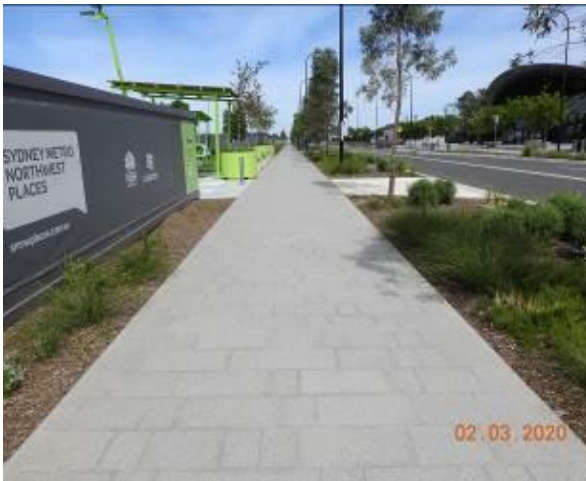
Figure 1877 – General Condition of footpath pavement

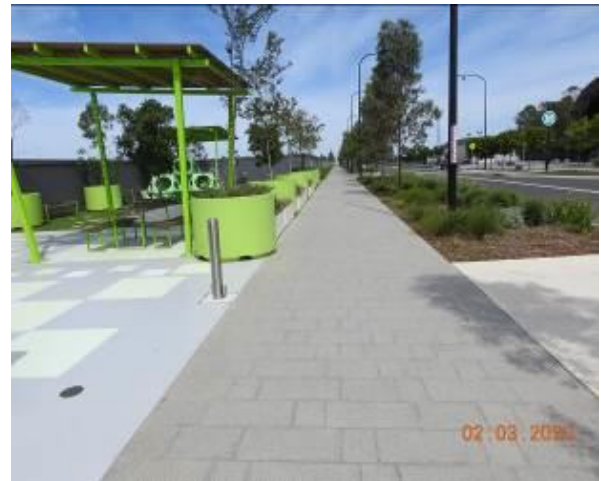
Figure 1878 – General Condition of footpath pavement

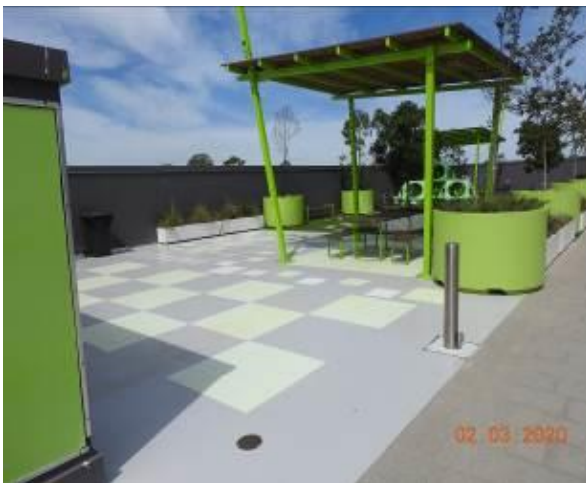
Figure 1879 – General Condition of footpath pavement

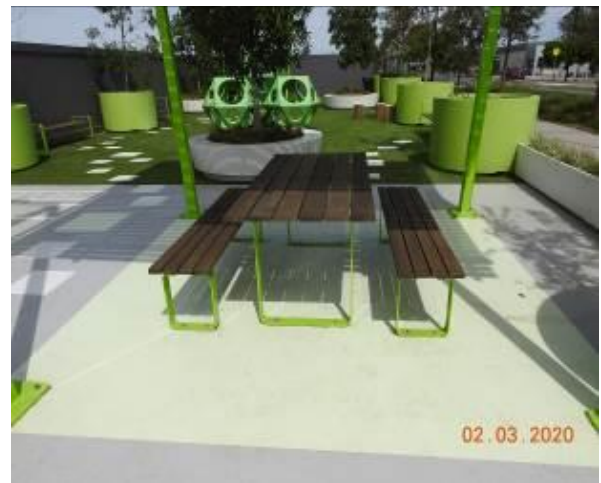
Figure 1880 – General Condition of park bench

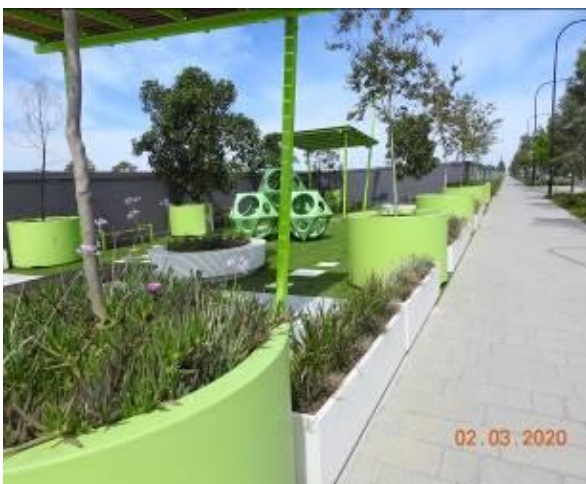
Figure 1881 – General Condition of public park area

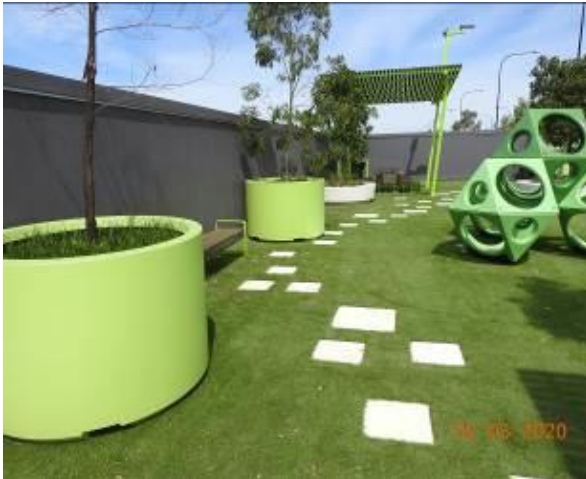
Figure 1883 – General Condition of park grass area

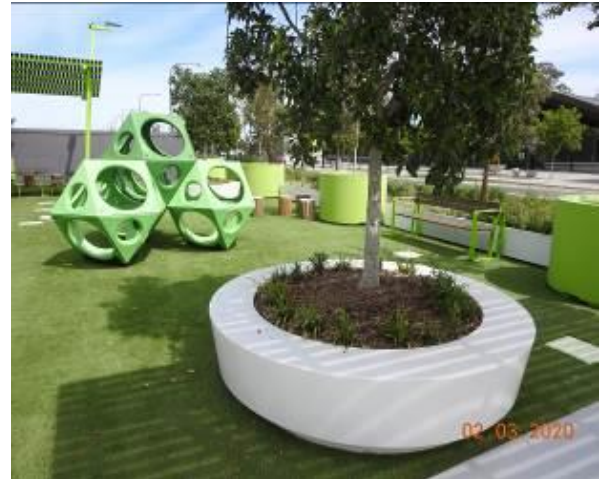
Figure 1884 – General Condition of park plantation

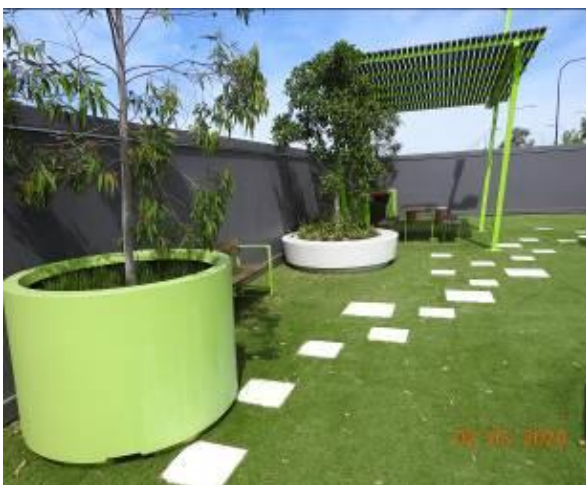
Figure 1885 – General Condition of park plantation

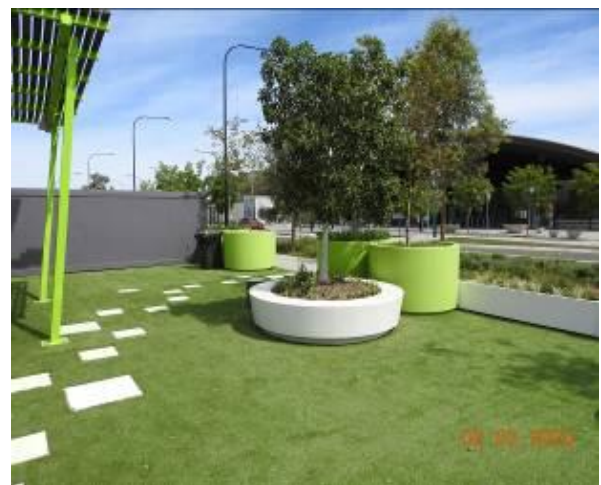
Figure 1886 – General Condition of park plantation

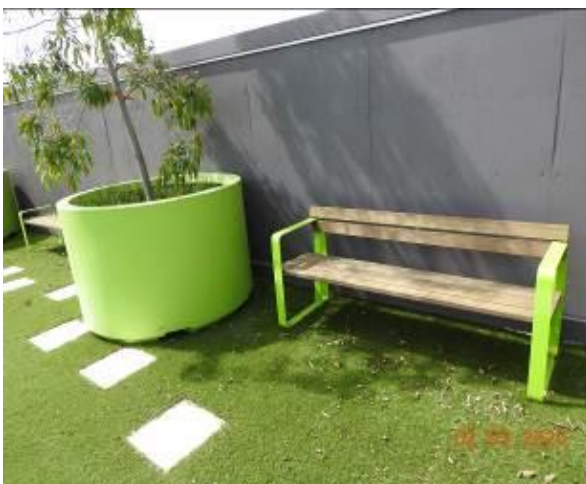
Figure 1887 – General Condition of park public bench

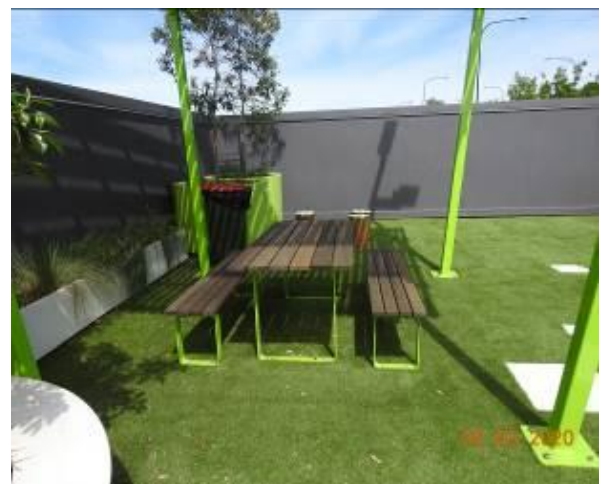
Figure 1888 – General Condition of park bench

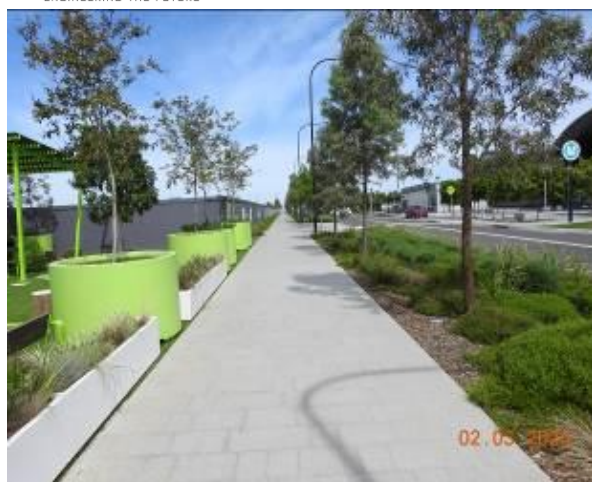
Figure 1889 – General Condition of footpath pavement

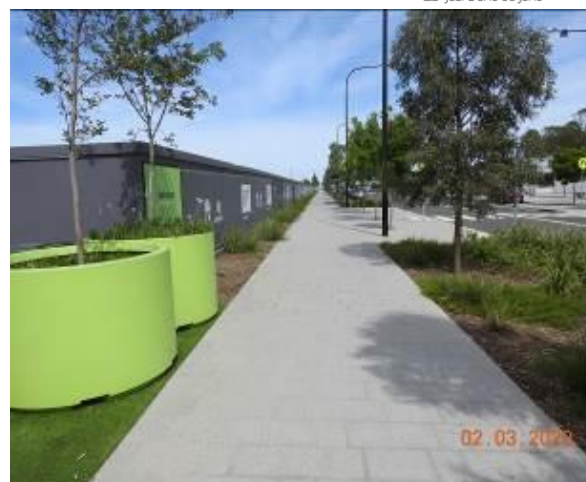
Figure 1890 – General Condition of footpath pavement

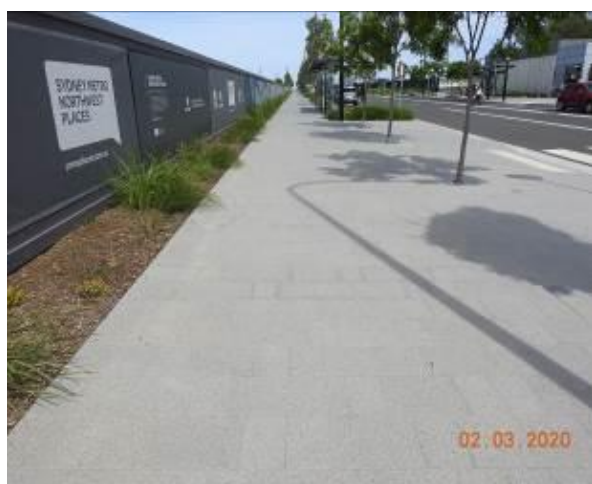
Figure 1891 – General Condition of footpath pavement

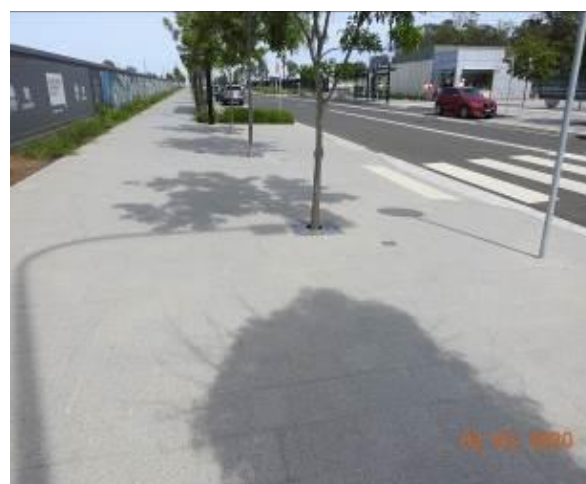
Figure 1892 – General Condition of footpath pavement

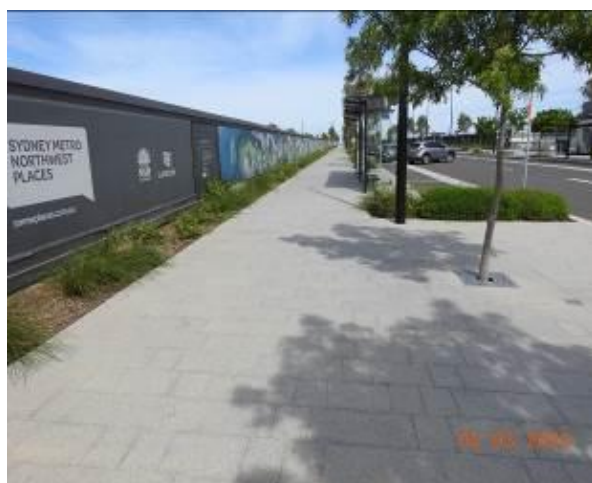
Figure 1893 – General Condition of footpath pavement

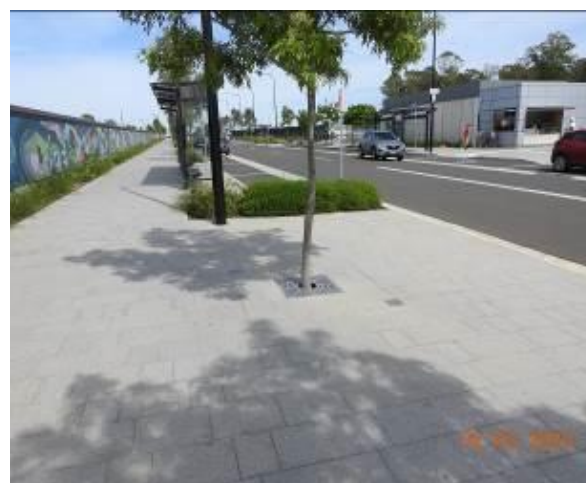
Figure 1894 – General Condition of footpath pavement

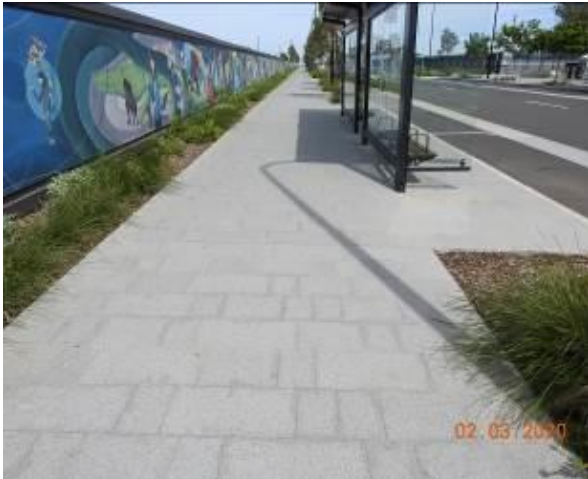
Figure 1895 – General Condition of footpath pavement

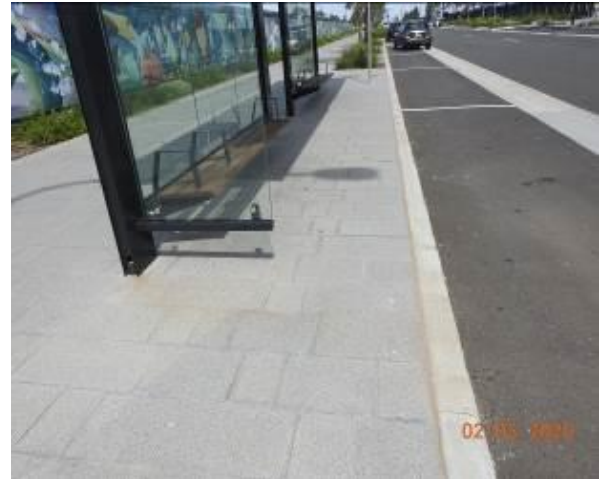
Figure 1896 – General Condition of footpath pavement

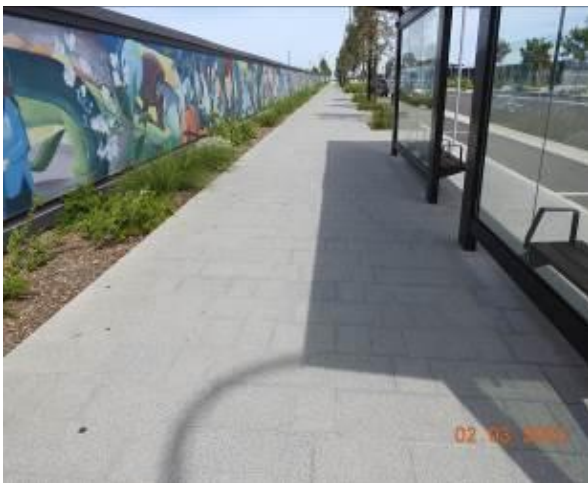
Figure 1897 – General Condition of footpath pavement

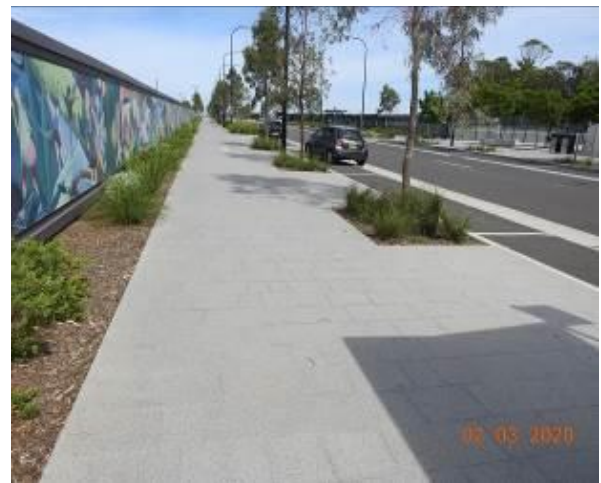
Figure 1898 – General Condition of footpath pavement

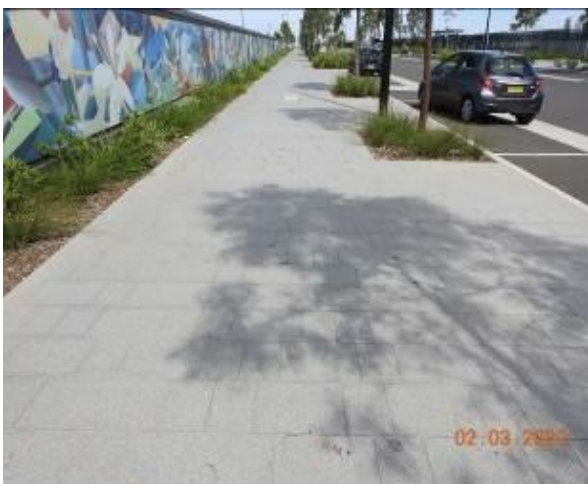
Figure 1899 – General Condition of footpath pavement

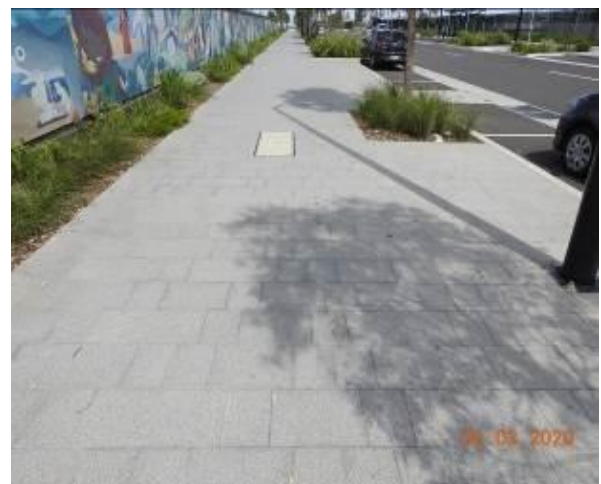
Figure 1900 – General Condition of footpath pavement

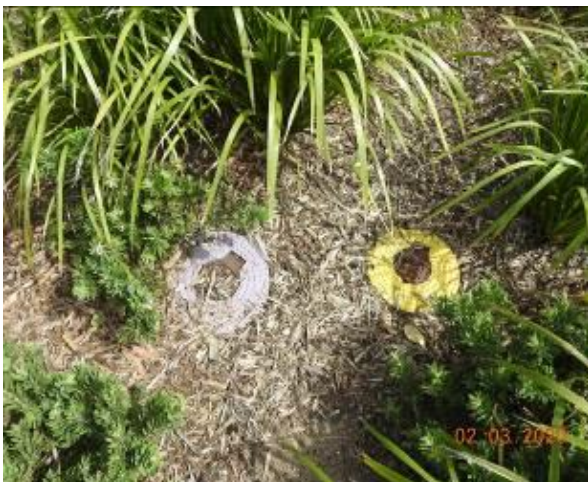
Figure 1905 – General Condition of footpath pavement

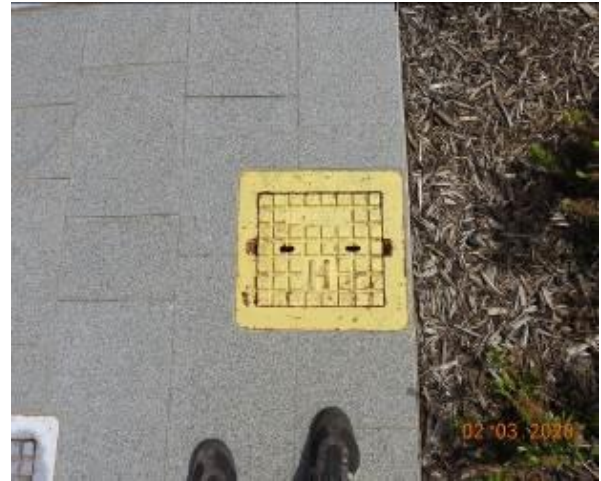
Figure 1908 – General Condition of service pit

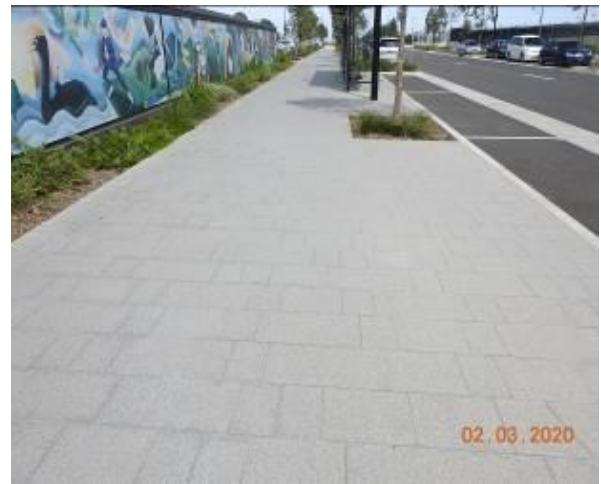
Figure 1910 – General Condition of footpath pavement

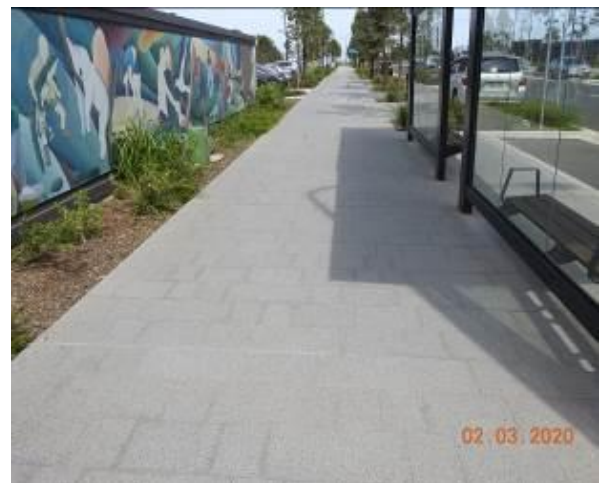
Figure 1912 – General Condition of footpath pavement

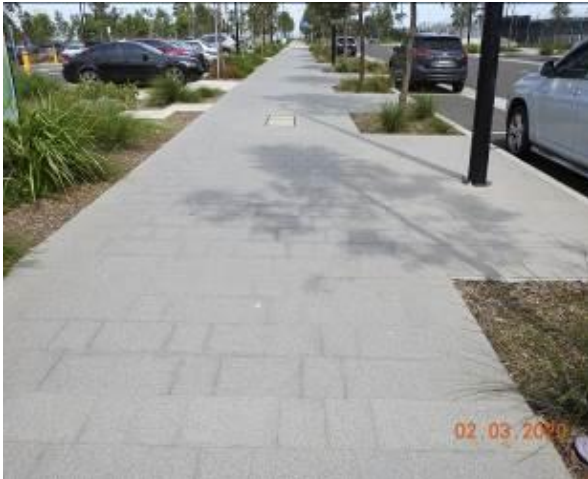
Figure 1913 – General Condition of footpath pavement

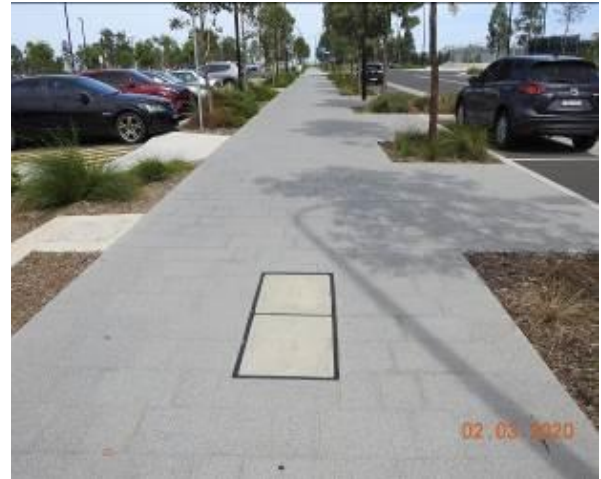
Figure 1914 – General Condition of service pit

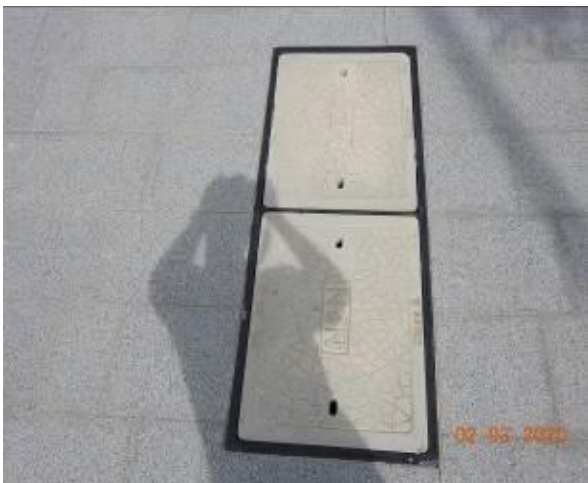
Figure 1915 – General Condition of service pit

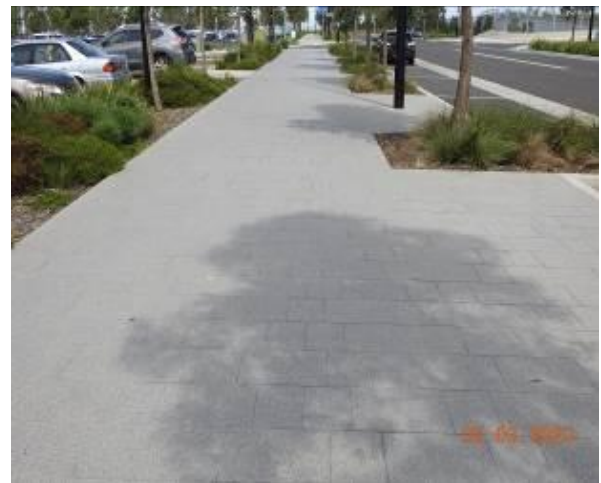
Figure 1916 – General Condition of footpath pavement

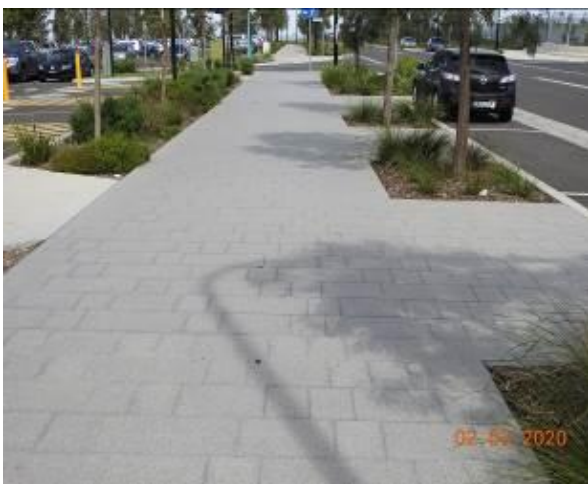
Figure 1917 – General Condition of footpath pavement

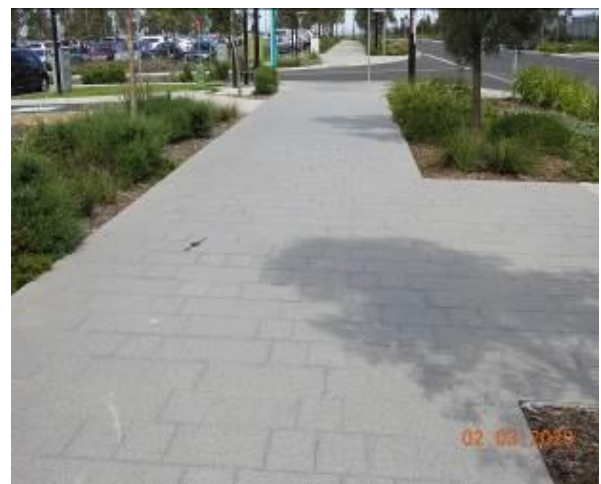
Figure 1918 – General Condition of footpath pavement

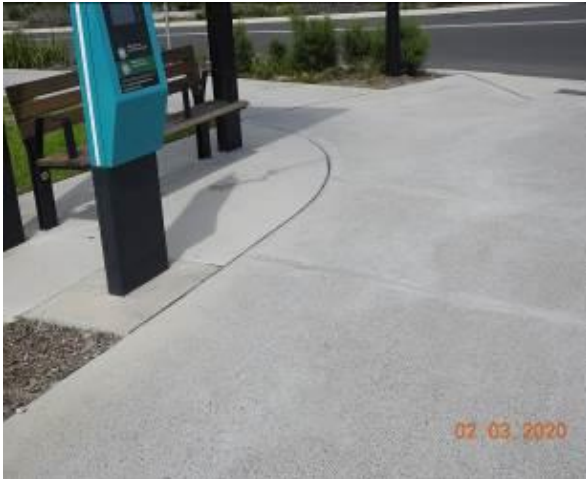
Figure 1919 – General Condition of footpath pavement

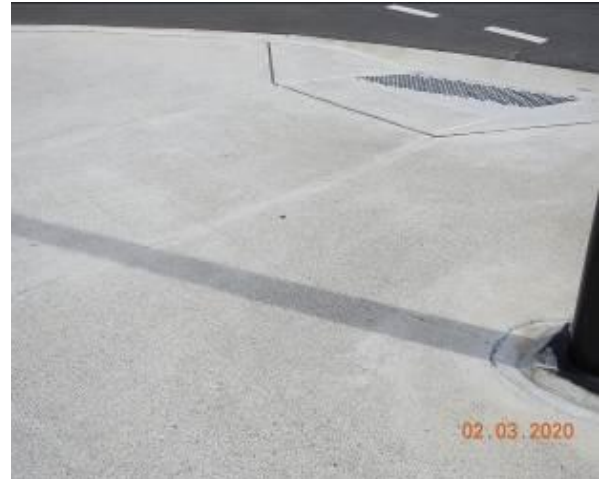
Figure 1920 – Crack propagation through footpath pavement

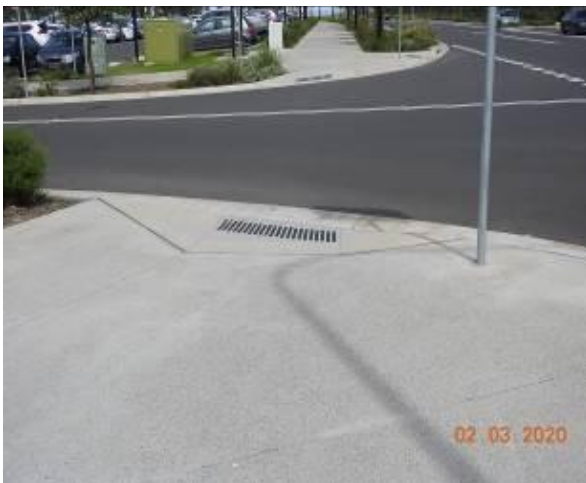
Figure 1921 – General Condition of footpath pavement

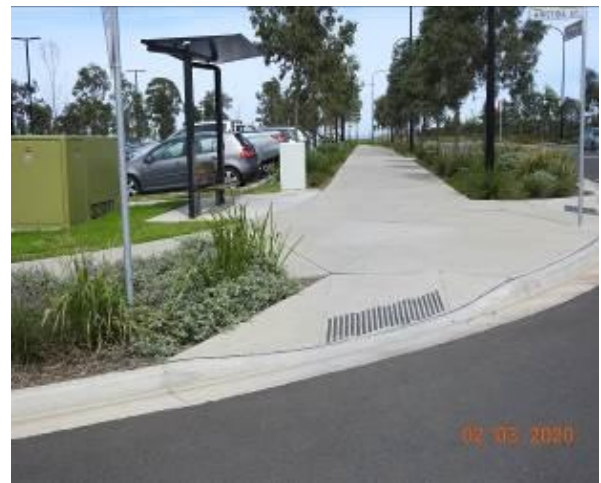
Figure 1922 – General Condition of footpath pavement

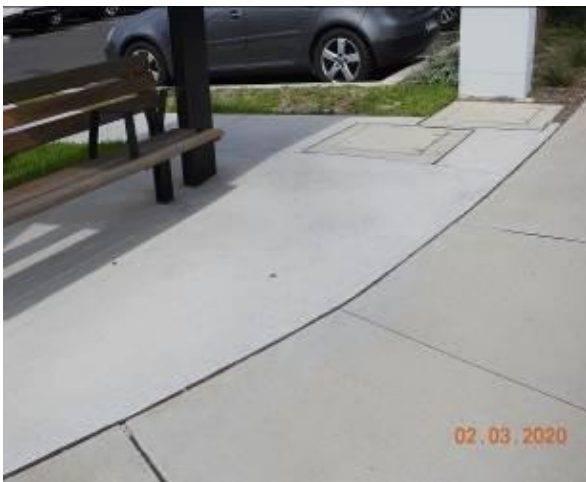
Figure 1923 – General Condition of footpath pavement

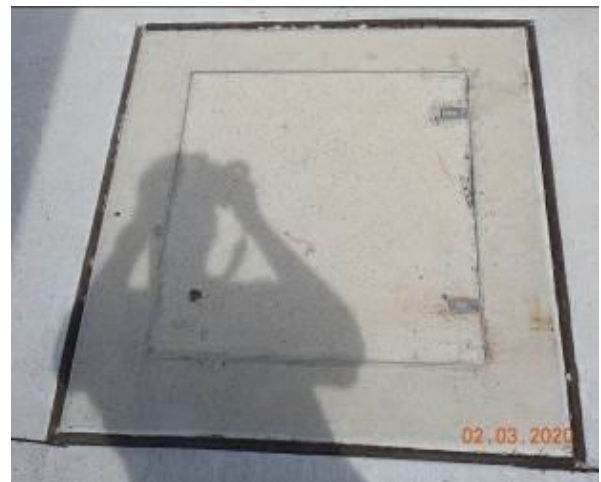
Figure 1924 – Loss of material through service pit

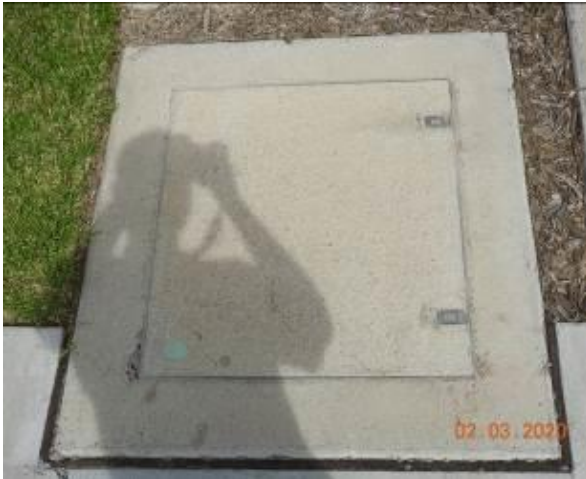
Figure 1925 – Loss of material through service pit

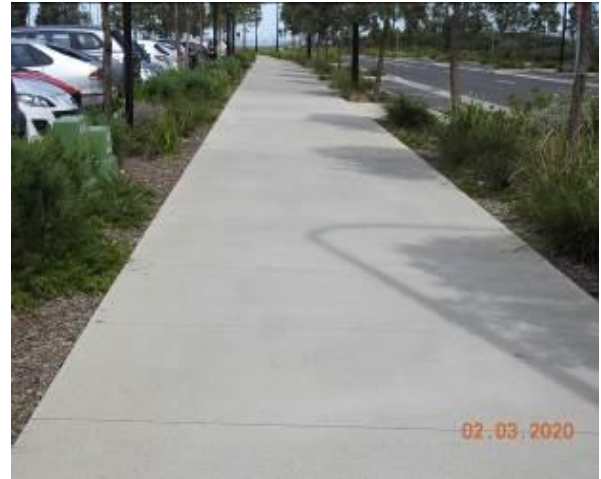
Figure 1926 – General Condition of footpath pavement

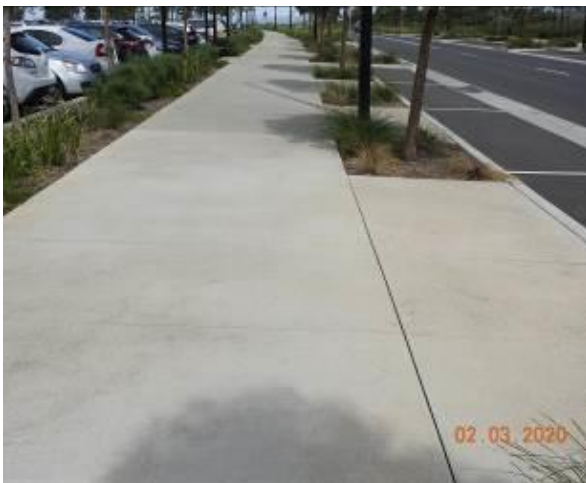
Figure 1927 – General Condition of footpath pavement

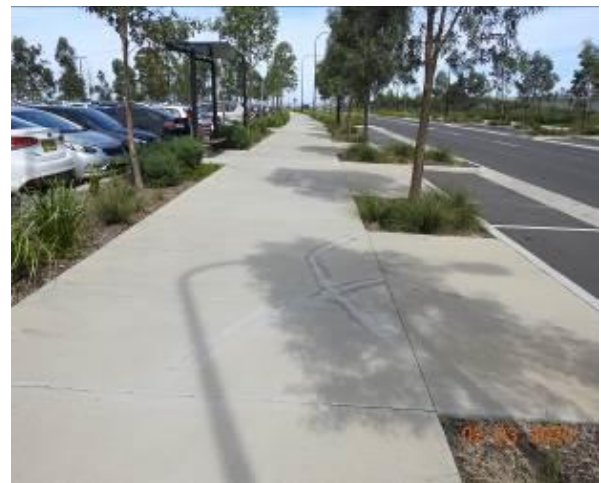
Figure 1928 – General Condition of footpath pavement

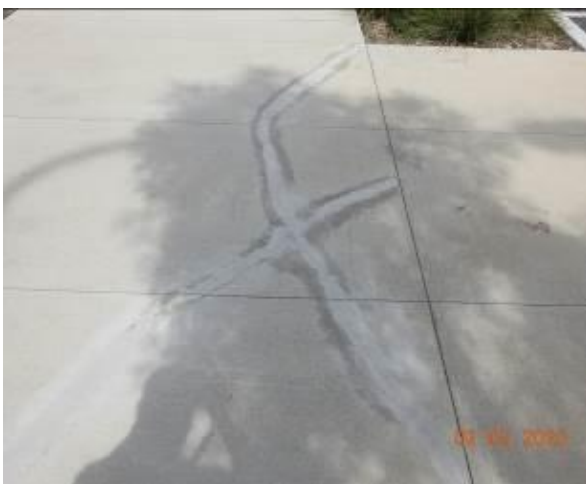
Figure 1929 – Crack propagation through footpath pavement

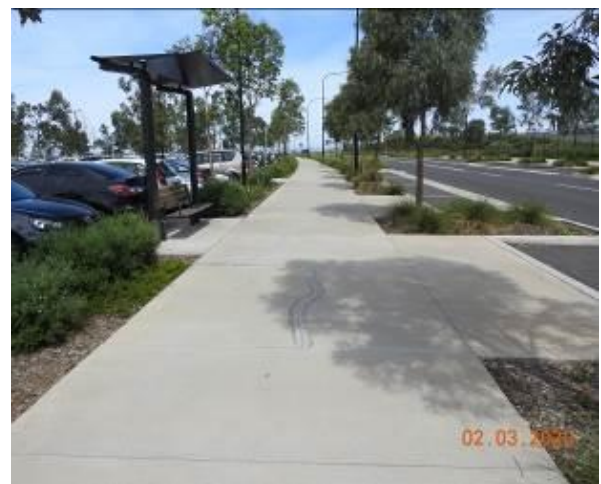
Figure 1930 – General Condition of footpath pavement

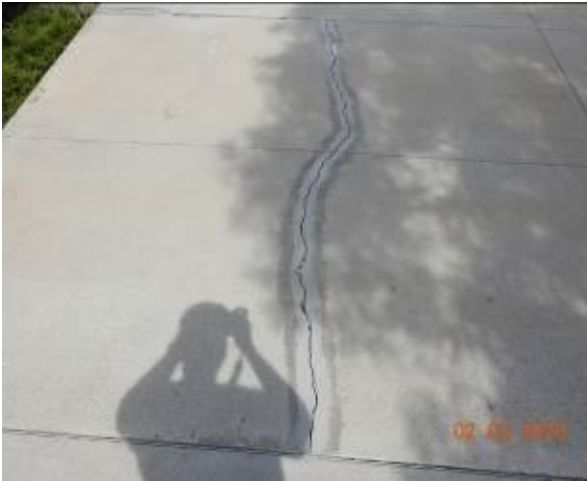
Figure 1931 – Crack propagation and loss of material through footpath pavement

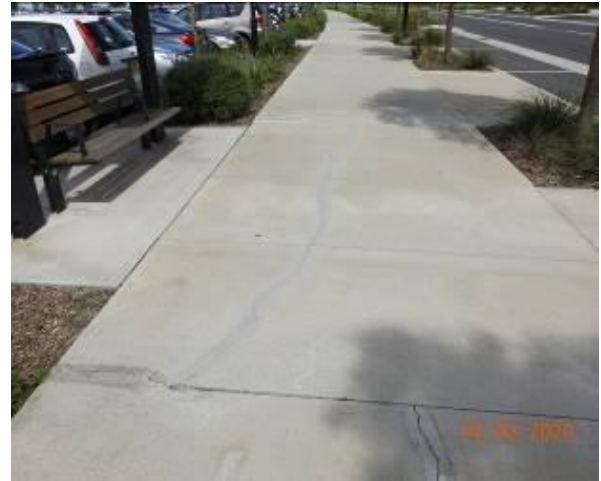
Figure 1932 – General Condition of footpath pavement

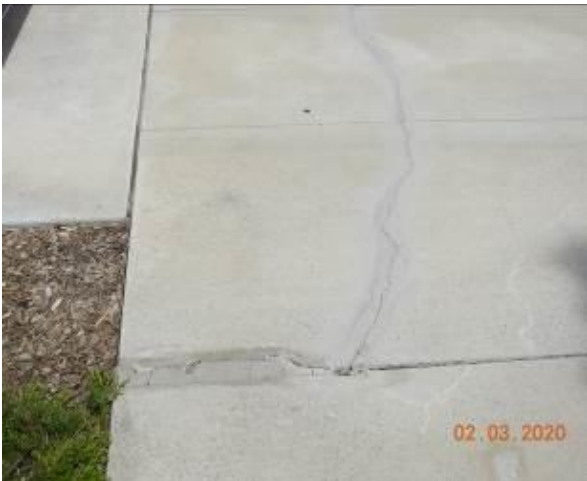
Figure 1933 – Crack propagation and loss of material through footpath pavement

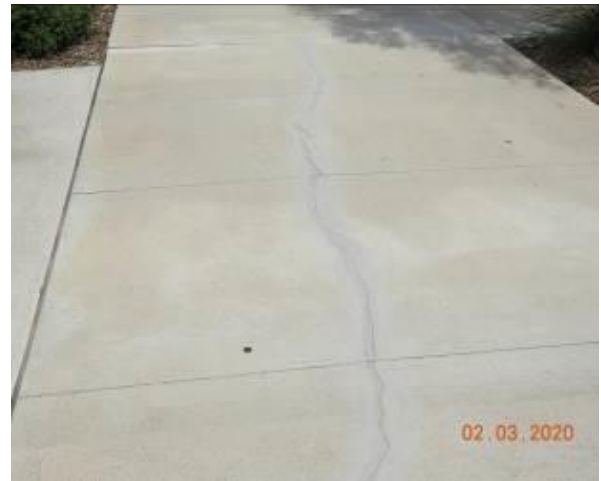
Figure 1934 – Crack propagation through footpath pavement

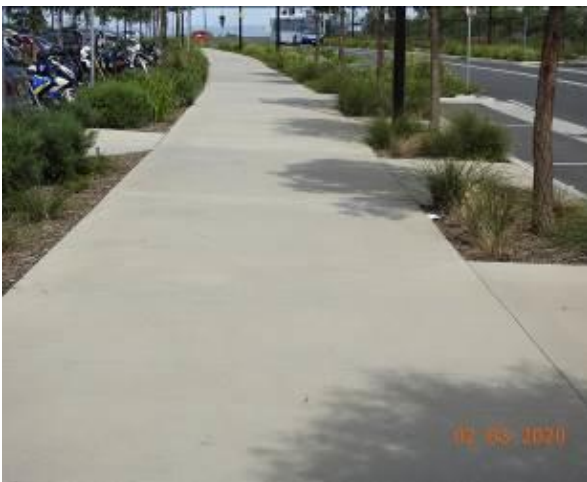
Figure 1935 – General Condition of footpath pavement

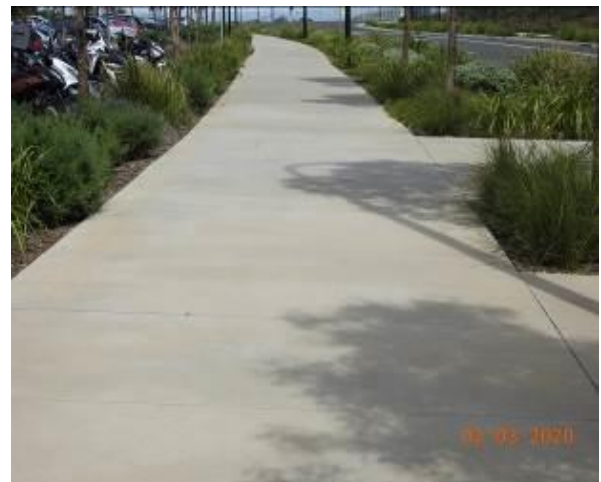
Figure 1936 – General Condition of footpath pavement

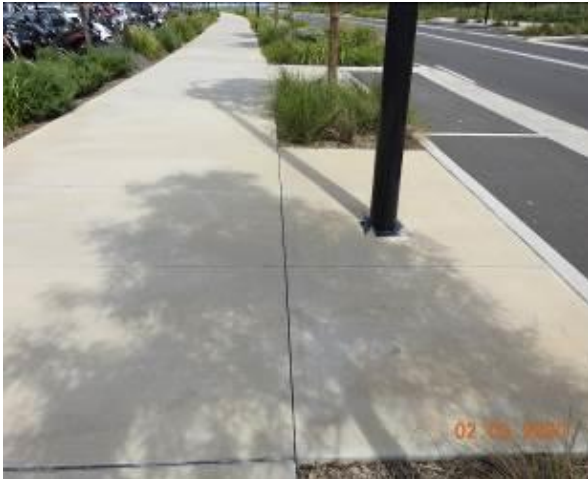
Figure 1937 – General Condition of footpath pavement

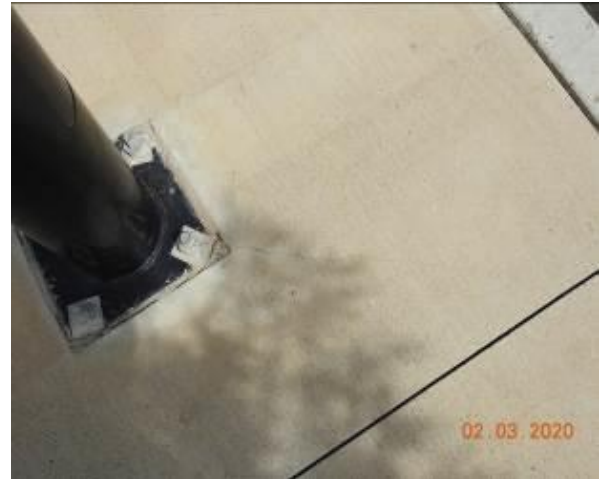
Figure 1938 – Crack propagation through footpath pavement

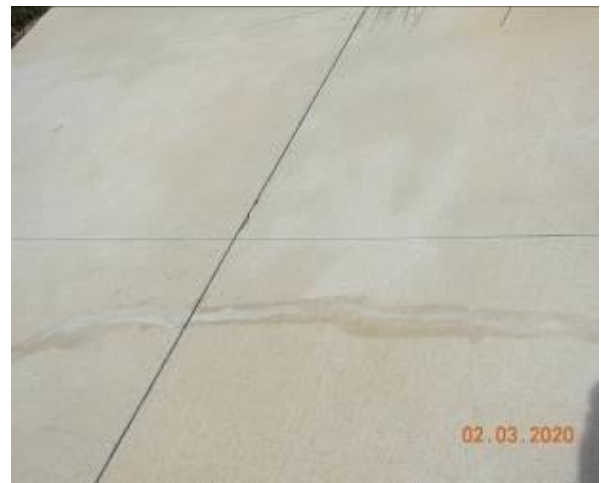
Figure 1940 – Loss of material through footpath pavement

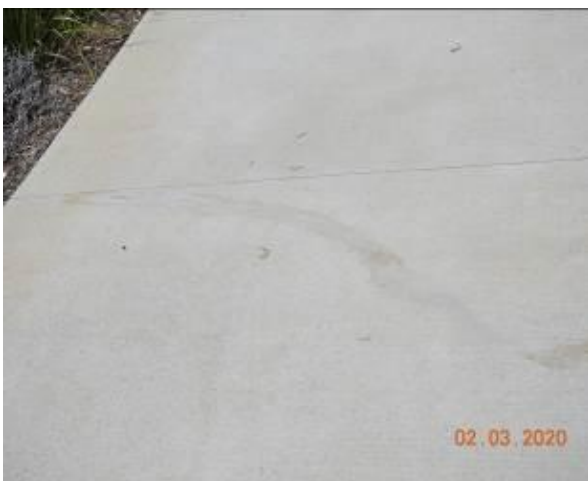
Figure 1941 – Crack propagation through footpath pavement
