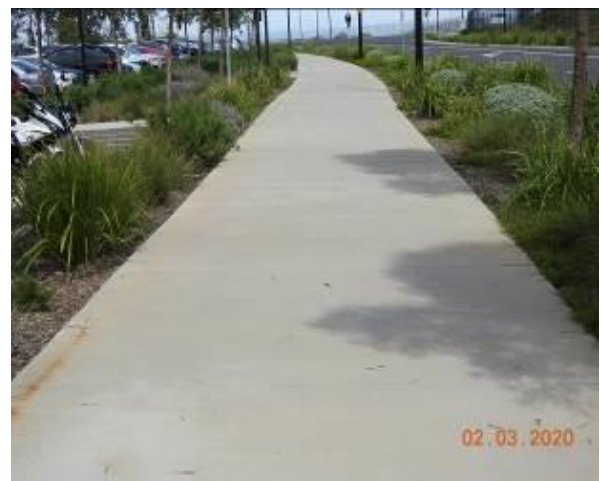
Figure 1942 – General Condition of footpath pavement

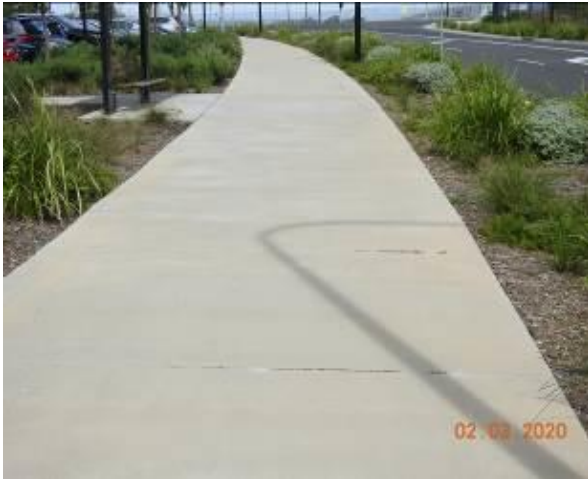
Figure 1943 – General Condition of footpath pavement

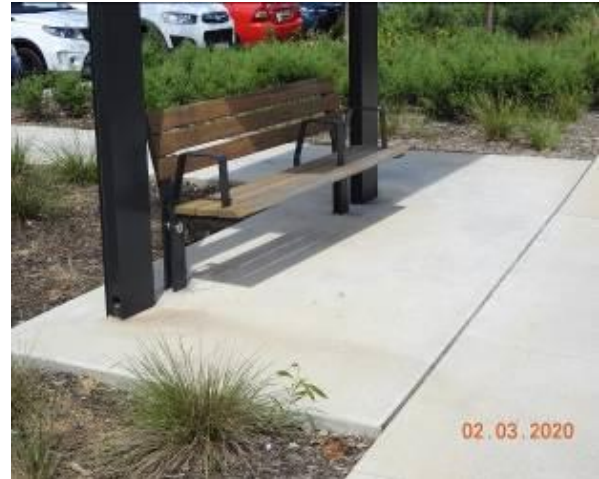
Figure 1944 – General Condition of public bench

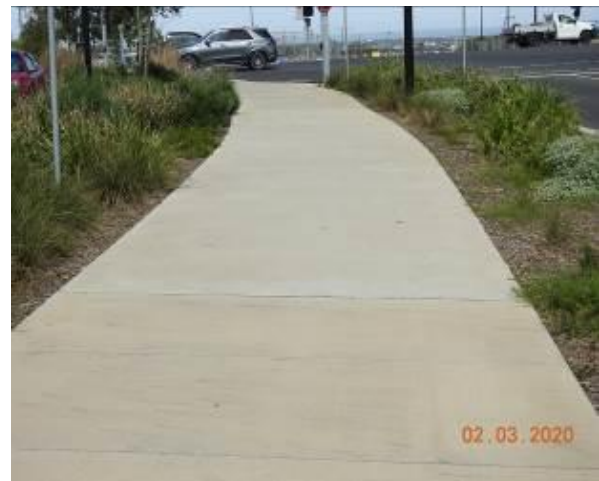
Figure 1946 – General Condition of footpath pavement

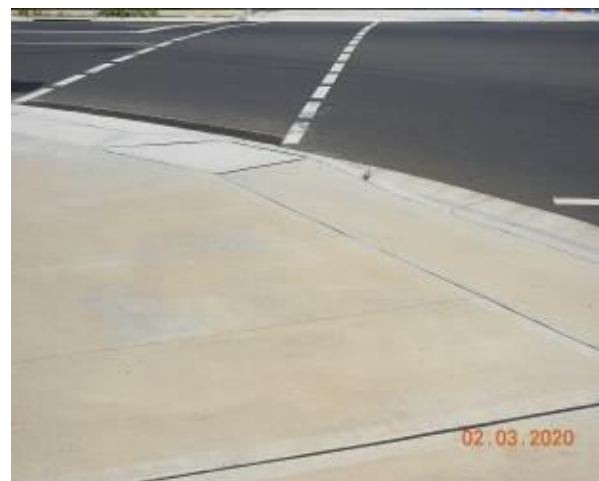
Figure 1948 – General Condition of footpath pavement

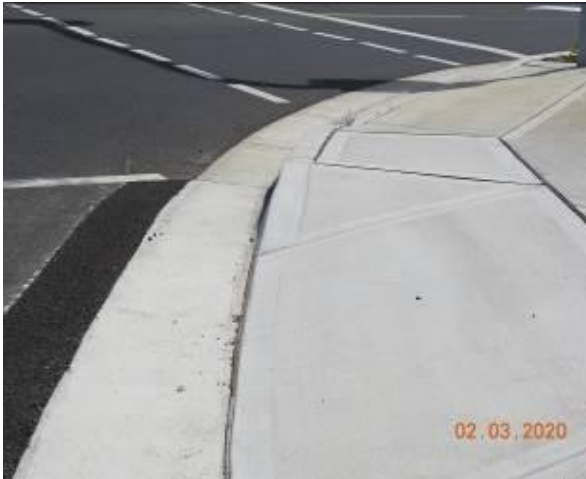
Figure 1949 – General Condition of kerb and gutter

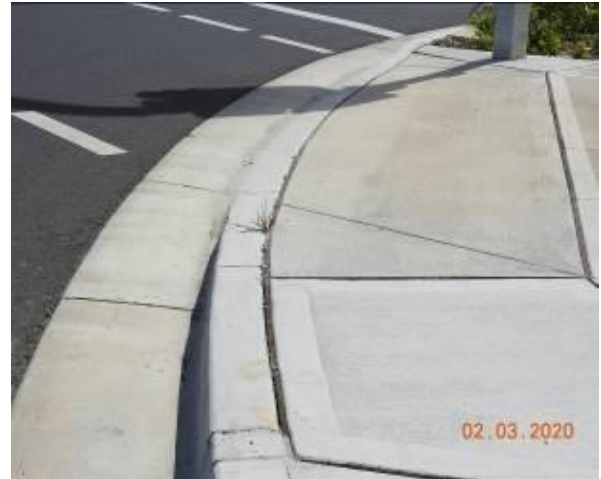
Figure 1950 – General Condition of kerb and gutter

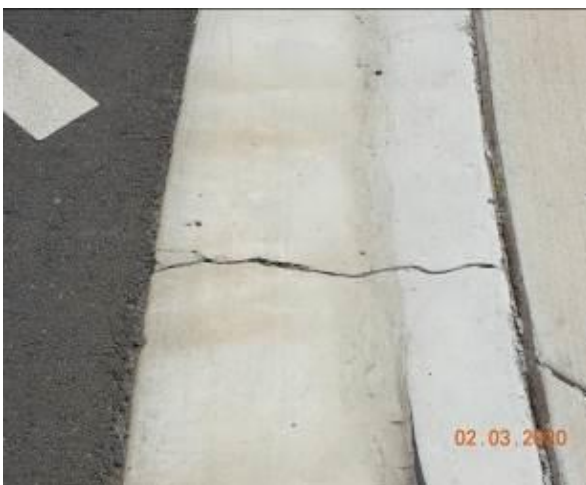
Figure 1951 – Crack propagation through kerb and gutter

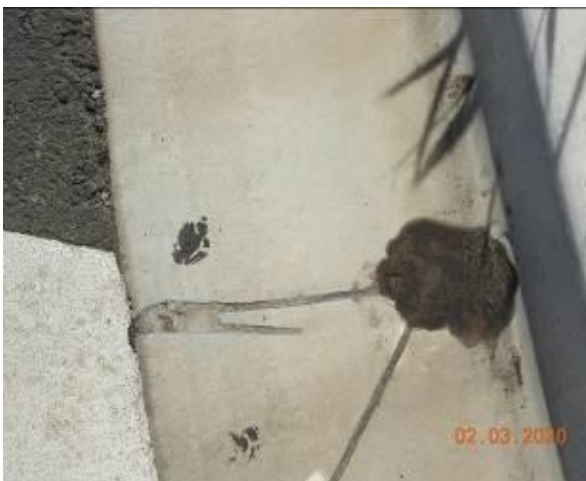
Figure 1953 – Loss of material through gutter

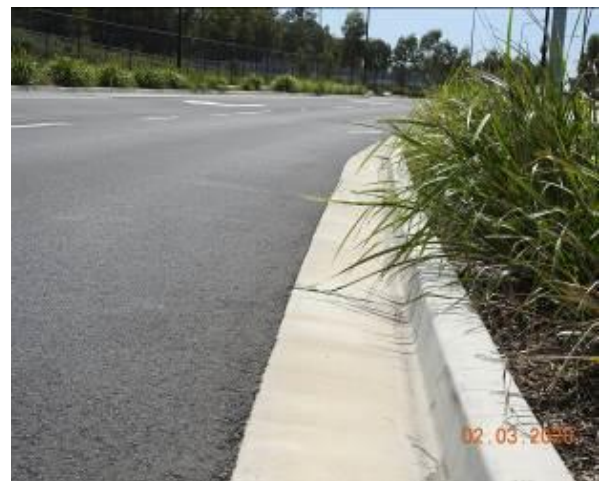
Figure 1954 – General Condition of kerb and gutter

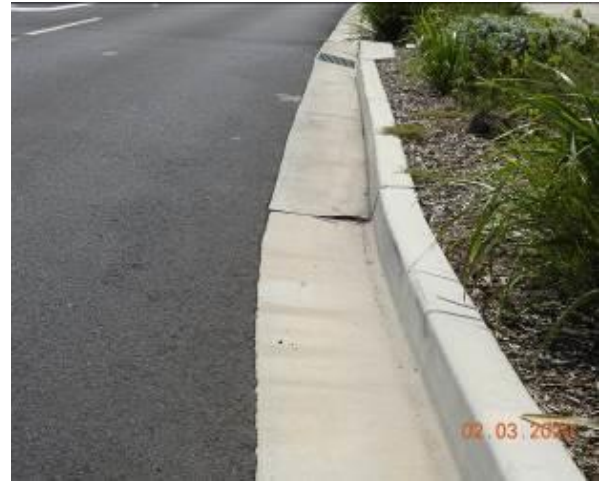
Figure 1956 – General Condition of kerb and gutter

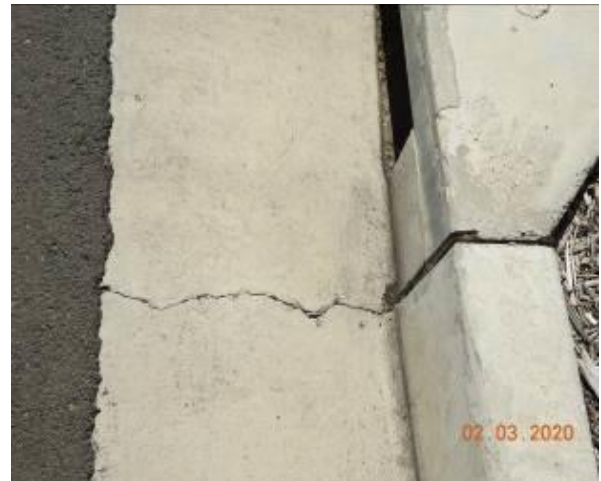
Figure 1958 – Crack propagation through gutter

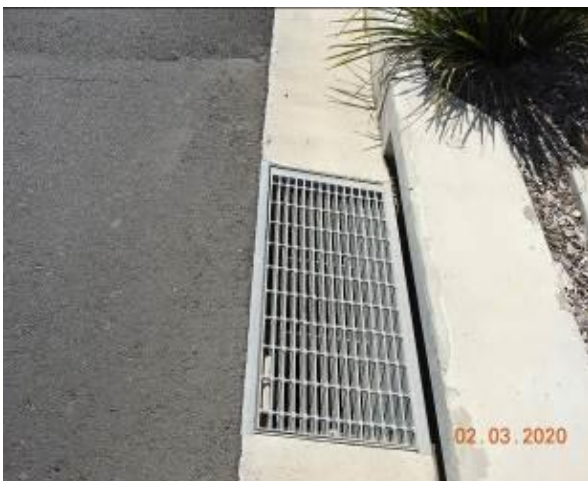
Figure 1959 – General Condition of stormwater inlet pit

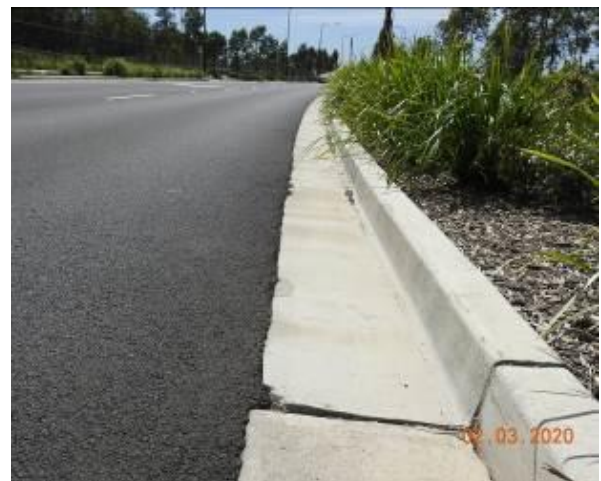
Figure 1960 – General Condition of kerb and gutter

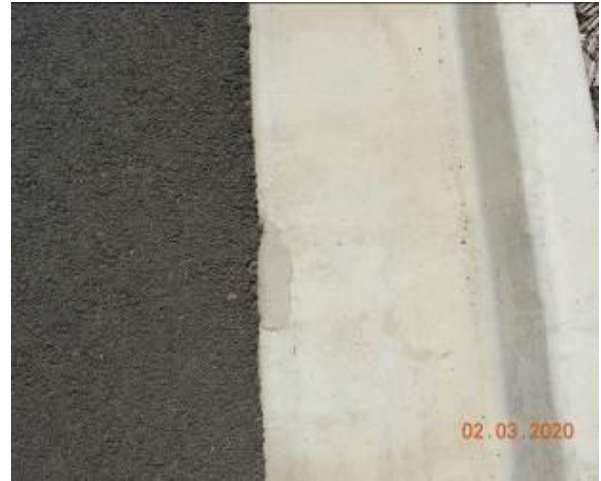
Figure 1962 – Evidence of patchwork through gutter

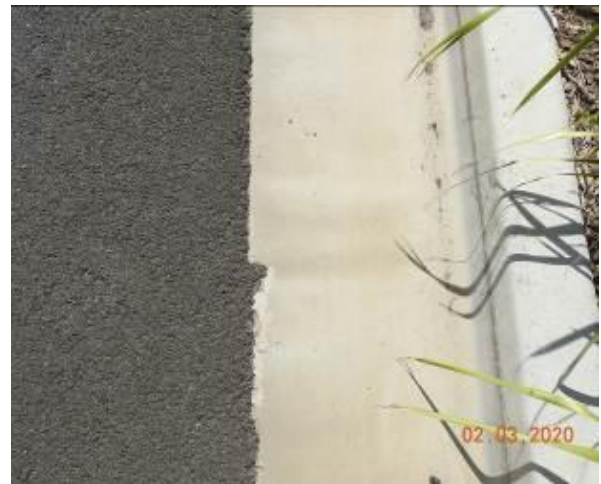
Figure 1964 – Loss of material through gutter

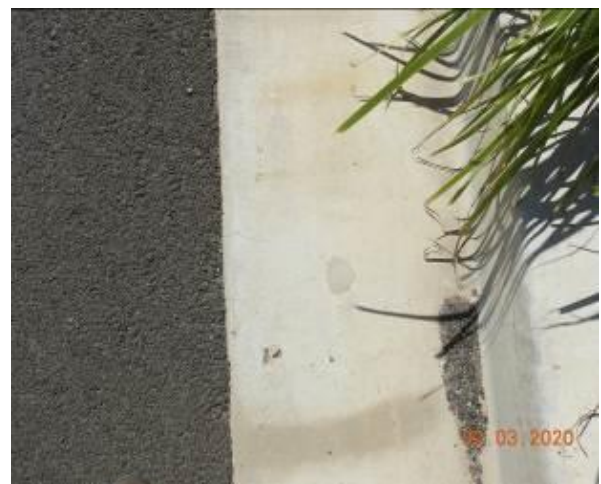
Figure 1966 – Crack propagation and Evidence of patchwork through gutter

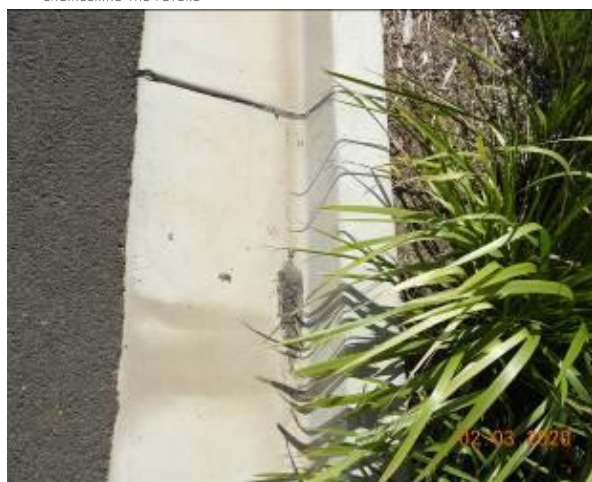
Figure 1967 – General Condition of kerb and gutter

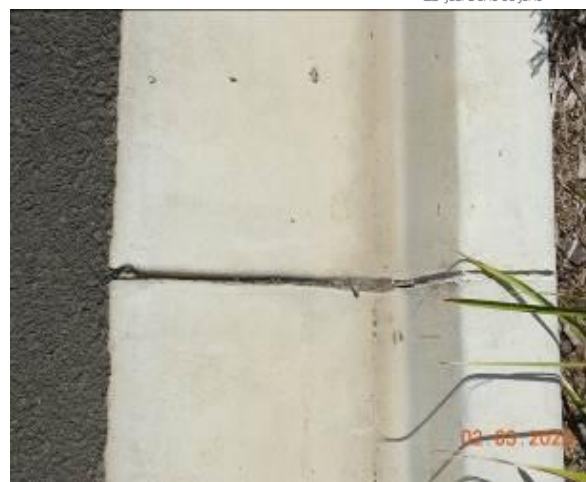
Figure 1968 – Crack propagation and loss of material through kerb and gutter

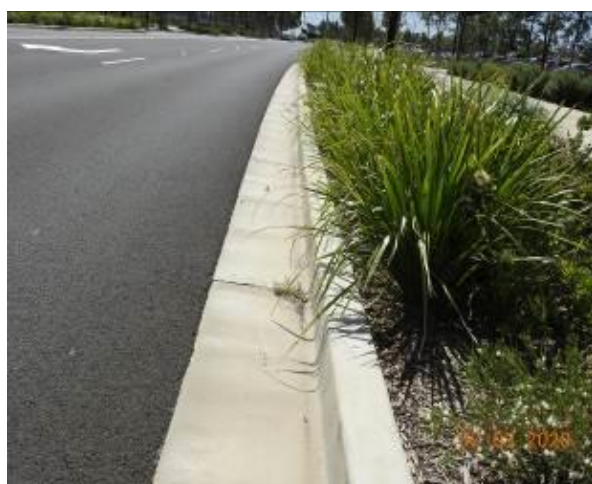
Figure 1969 – General Condition of kerb and gutter

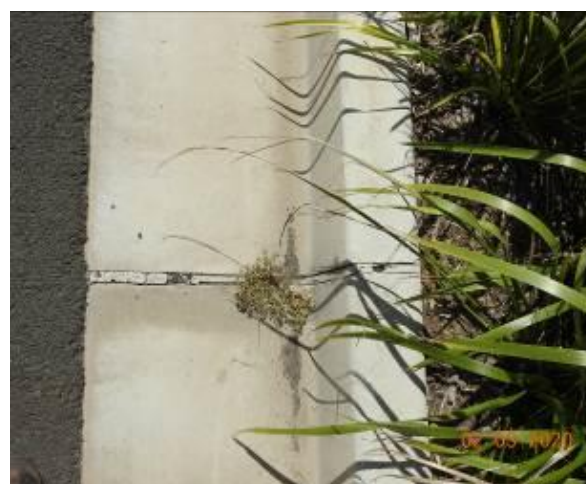
Figure 1970 – Crack propagation through kerb and gutter

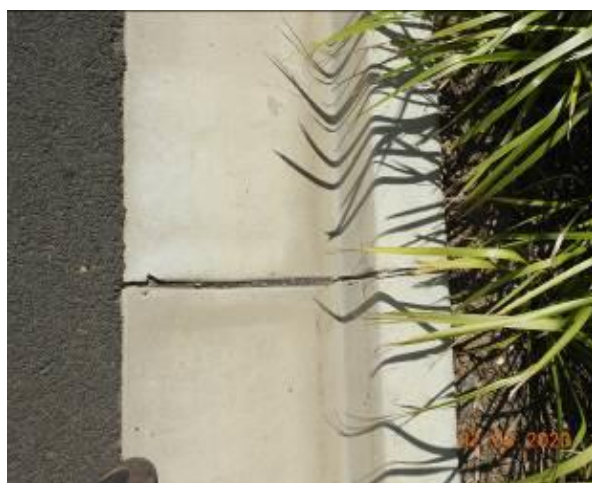
Figure 1971 – Loss of material through gutter

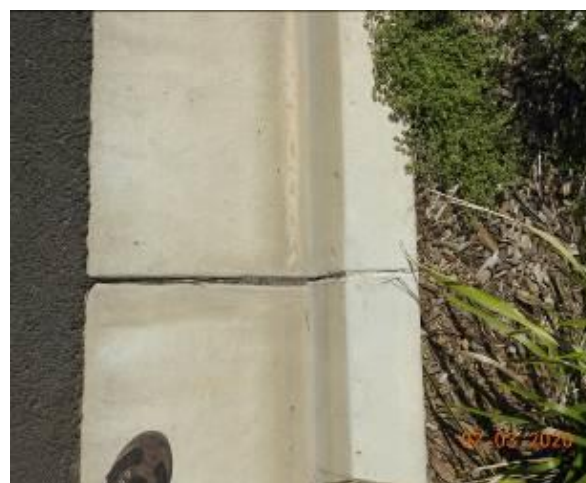
Figure 1972 – Crack propagation and loss of material through kerb and gutter

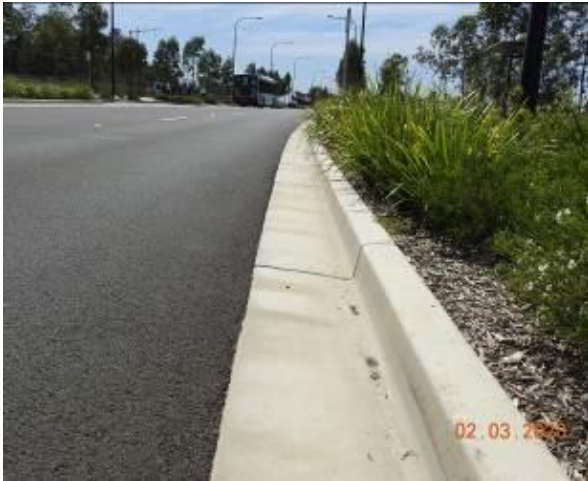
Figure 1973 – General Condition of kerb and gutter

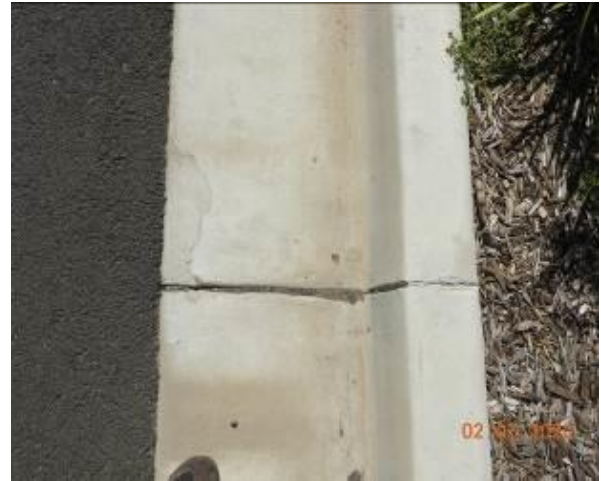
Figure 1974 – Crack propagation through kerb and gutter

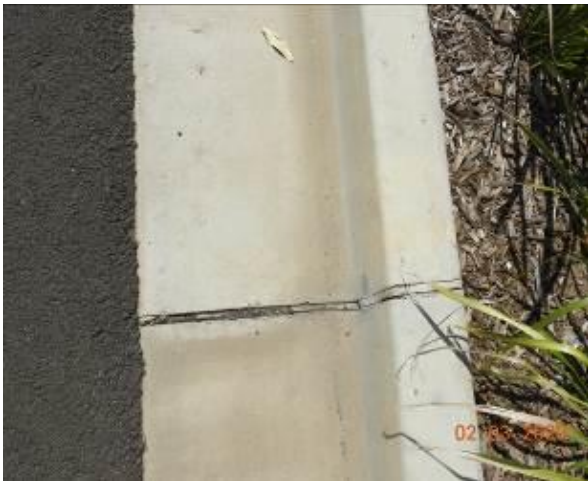
Figure 1975 – Crack propagation through kerb and gutter

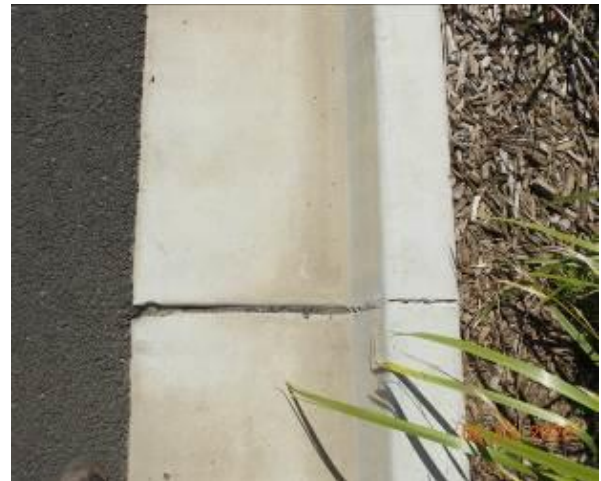
Figure 1976 – Crack propagation through kerb and gutter

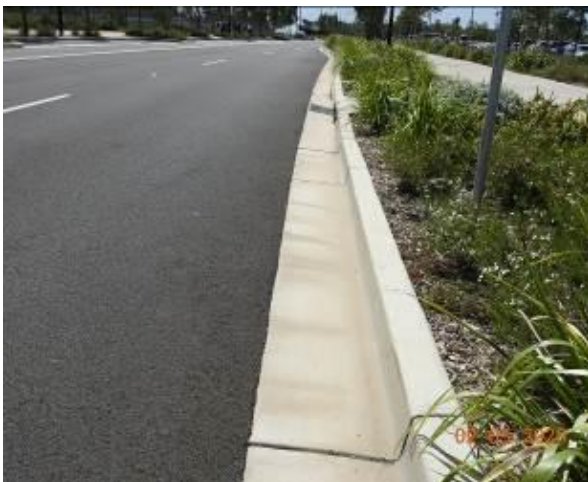
Figure 1977 – General Condition of kerb and gutter

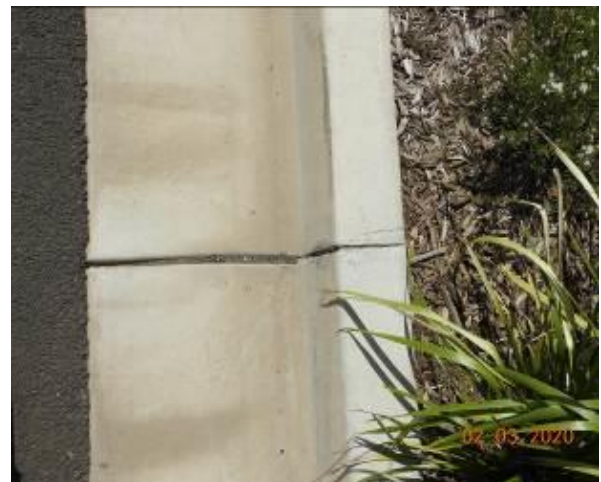
Figure 1978 – Crack propagation through kerb

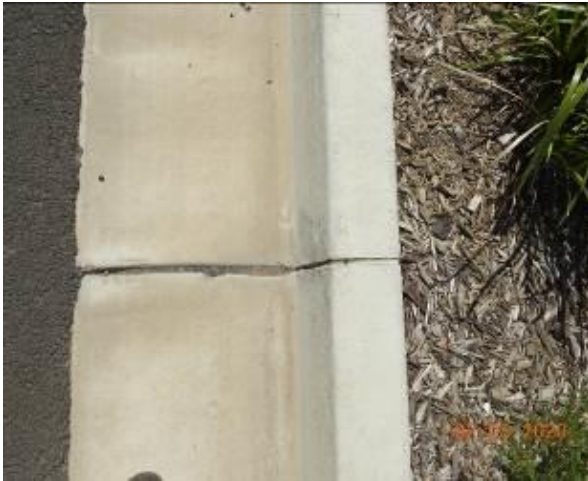
Figure 1979 – Loss of material through kerb and gutter

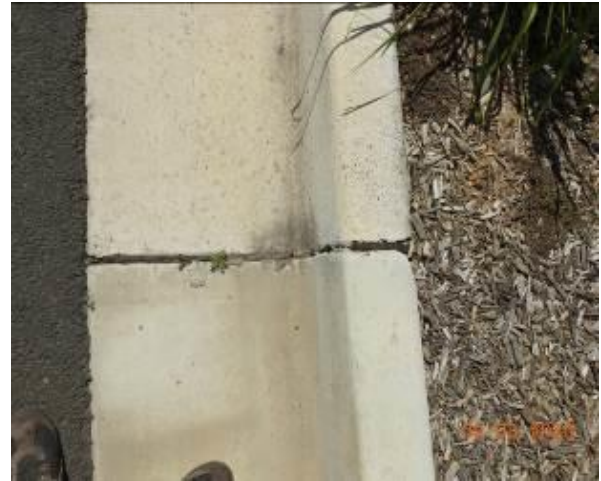
Figure 1980 – Loss of material through kerb and gutter

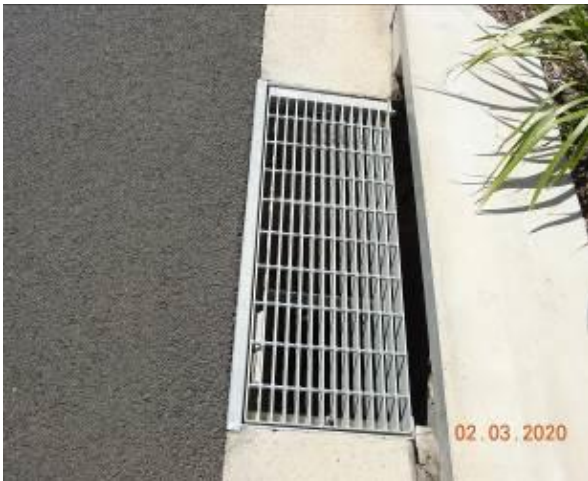
Figure 1981 – General Condition of stormwater inlet pit

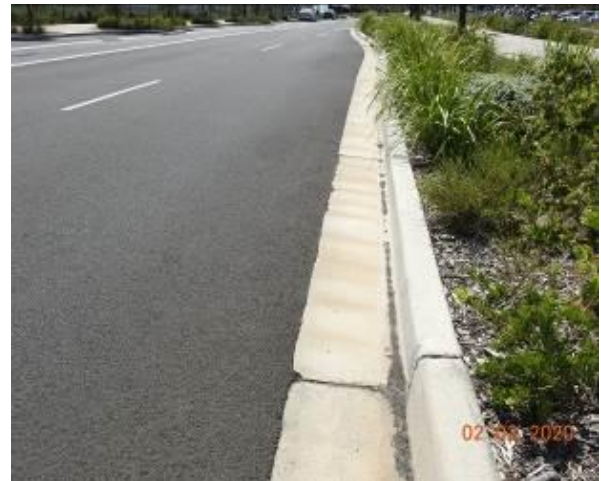
Figure 1982 – General Condition of kerb and gutter

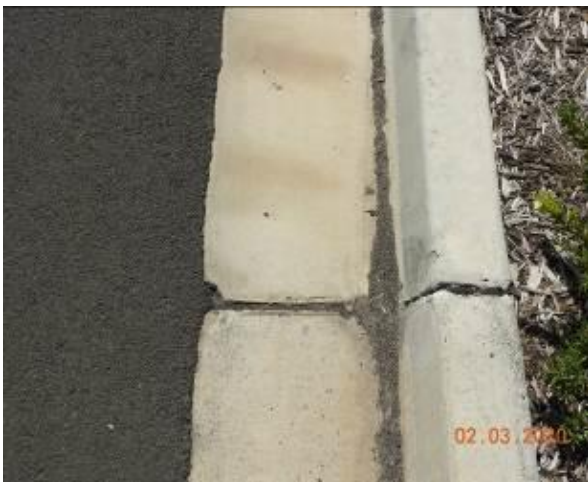
Figure 1983 – Loss of material through kerb and gutter

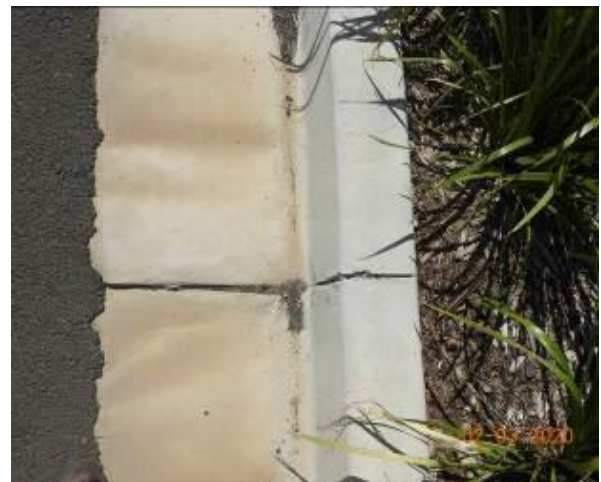
Figure 1984 – Crack propagation through kerb

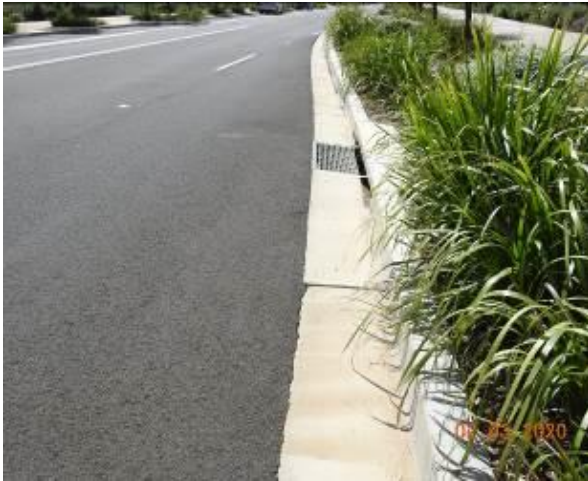
Figure 1991 – General Condition of kerb and gutter

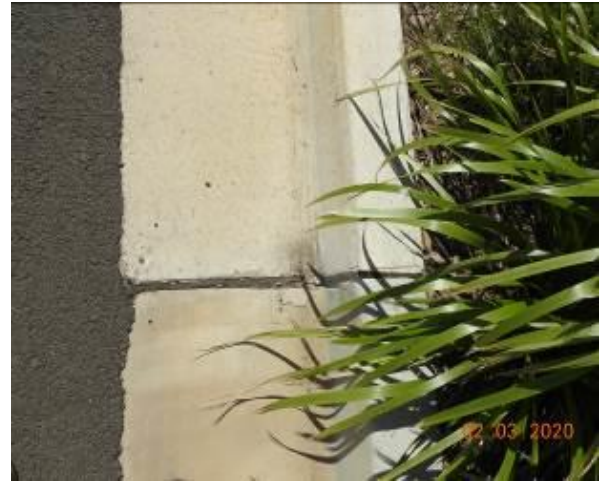
Figure 1992 – Loss of material through gutter

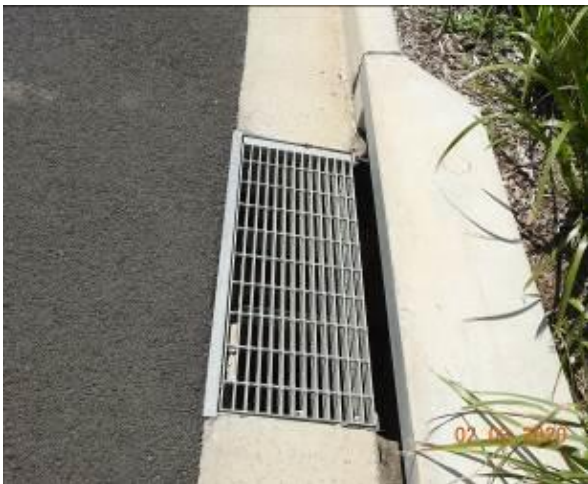
Figure 1993 – General Condition of stormwater inlet pit

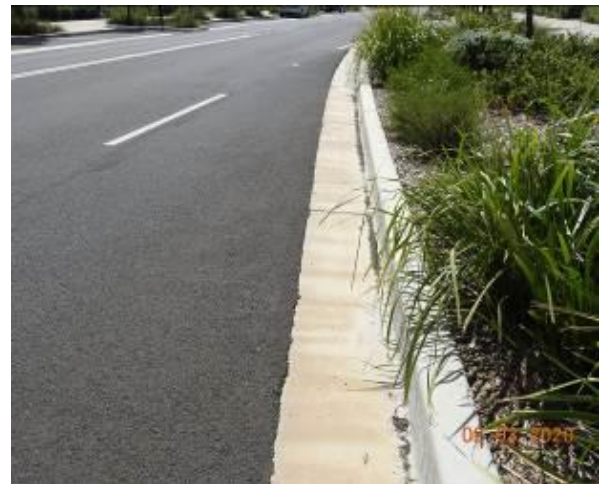
Figure 1994 – General Condition of kerb and gutter

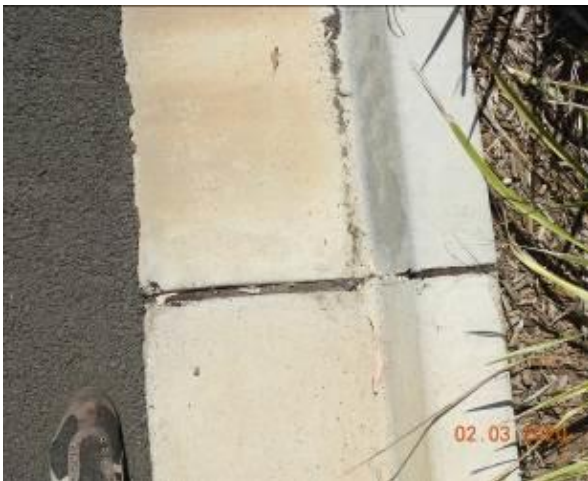
Figure 1995 – Loss of material through kerb and gutter

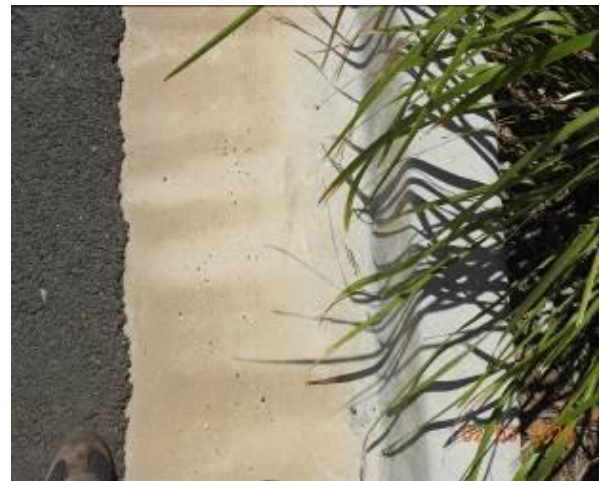
Figure 1996 – General Condition of kerb and gutter

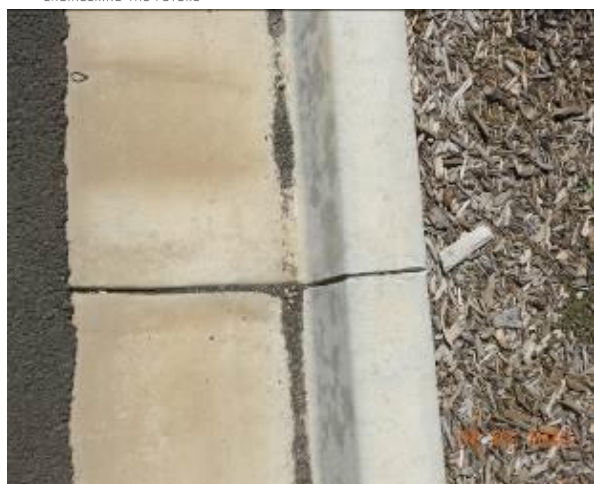
Figure 1997 – Loss of material through kerb and gutter

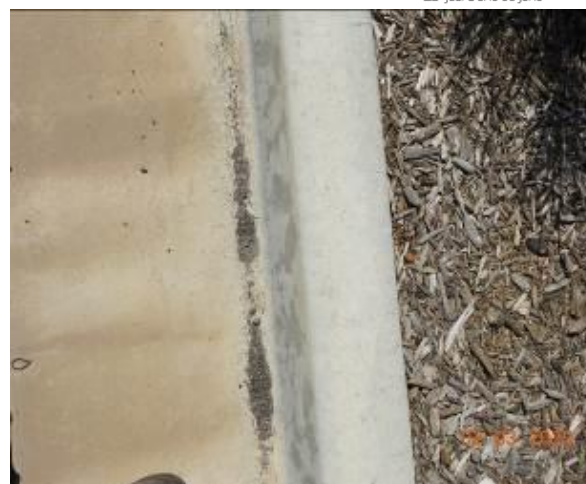
Figure 1998 – Crack propagation through kerb and gutter

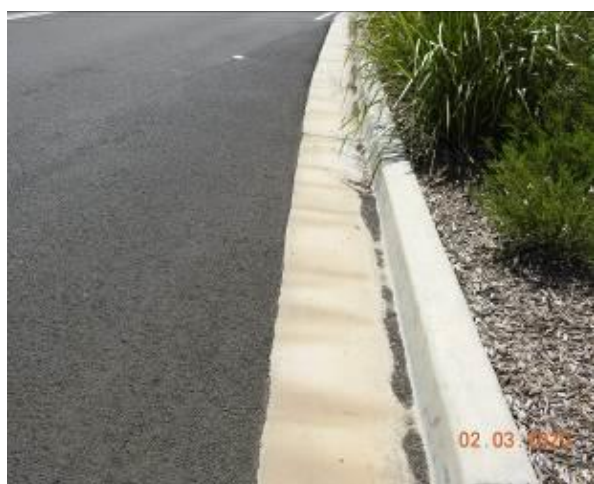
Figure 1999 – General Condition of kerb and gutter

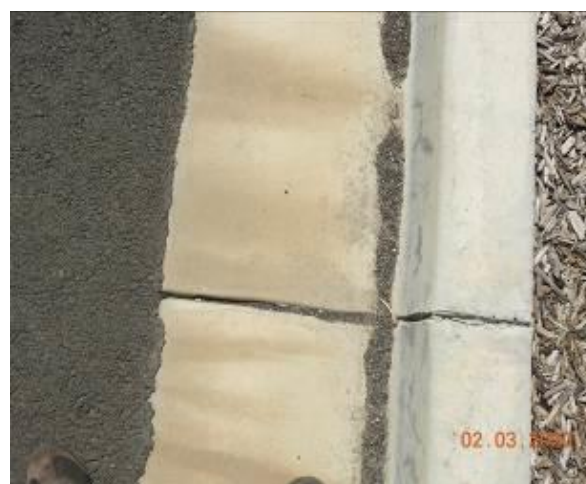
Figure 2000 – Crack propagation through kerb and gutter

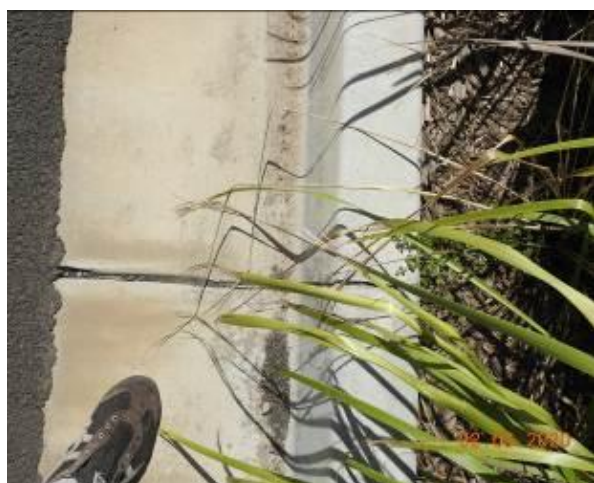
Figure 2001 – Crack propagation through kerb and gutter

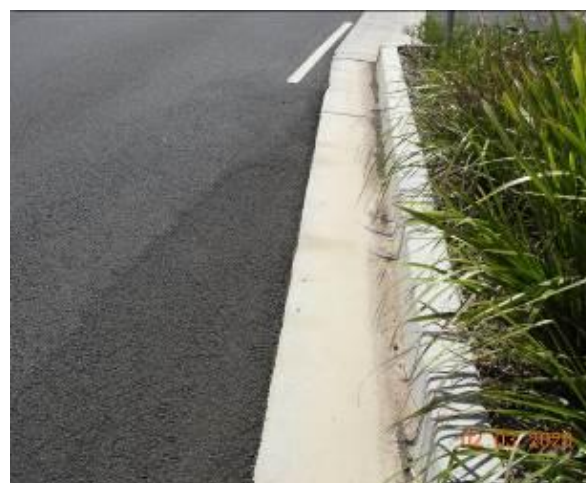
Figure 2002 – General Condition of kerb and gutter

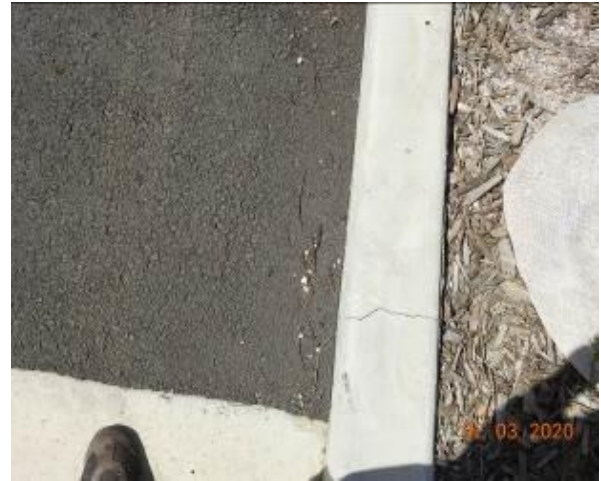
Figure 2004 – Crack propagation through curb

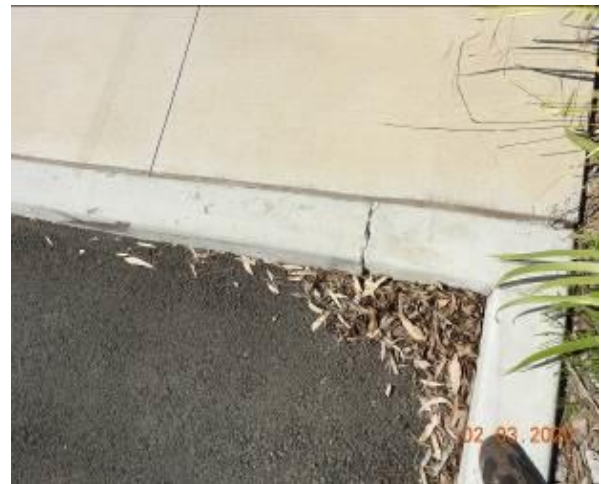
Figure 2006 – Crack propagation through curb

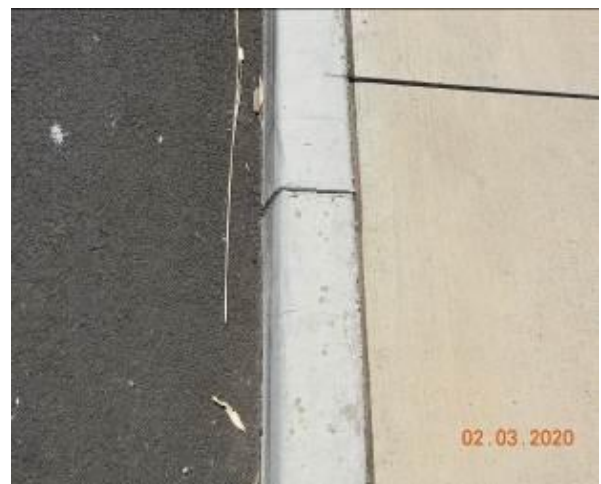
Figure 2008 – Crack propagation through curb

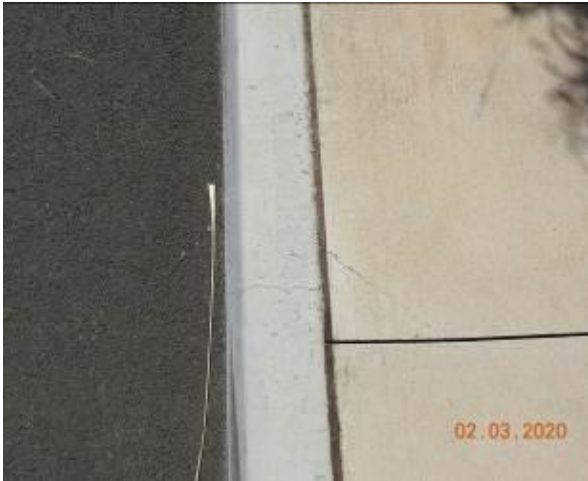
Figure 2009 – Crack propagation through kerb

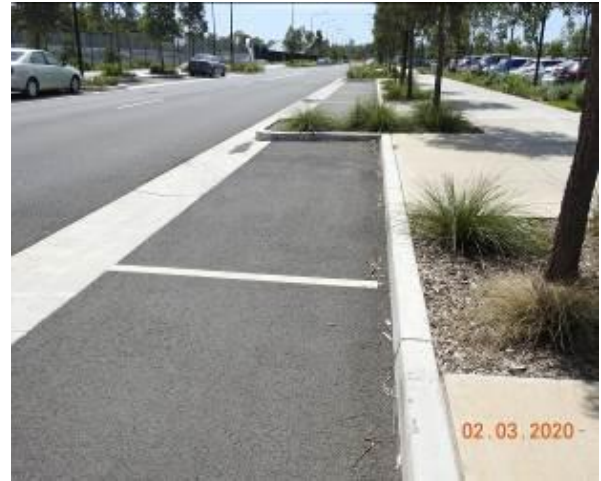
Figure 2010 – General Condition of kerb

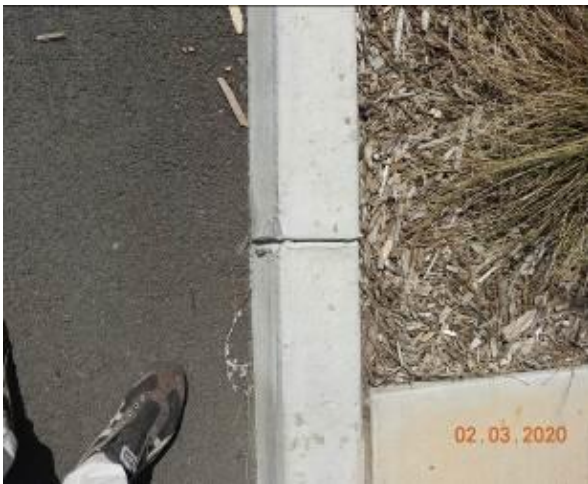
Figure 2011 – Crack propagation through kerb

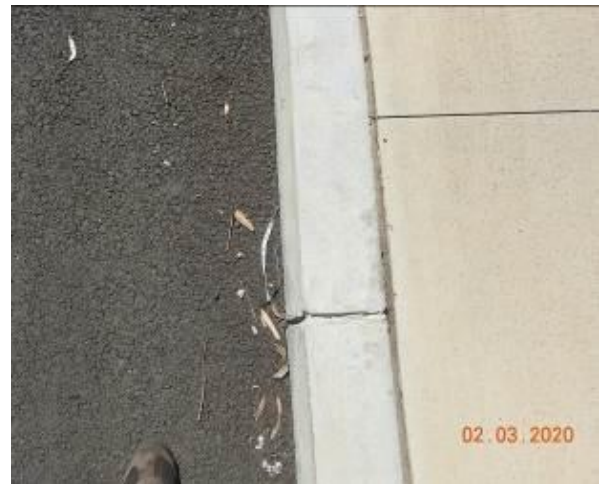
Figure 2012 – Loss of material through kerb

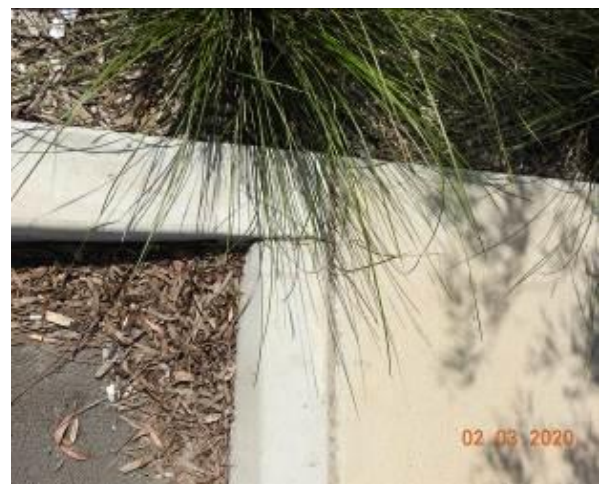
Figure 2014 – Crack propagation through kerb

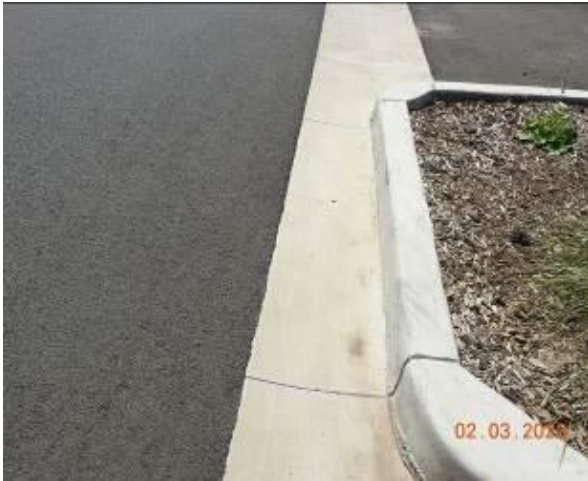
Figure 2015 – General Condition of kerb and gutter

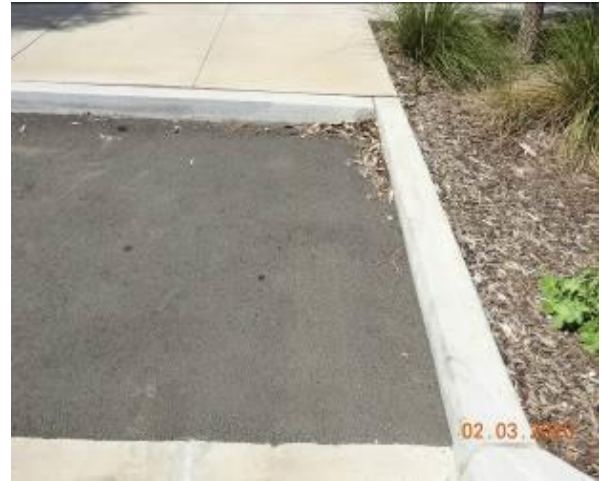
Figure 2016 – General Condition of kerb

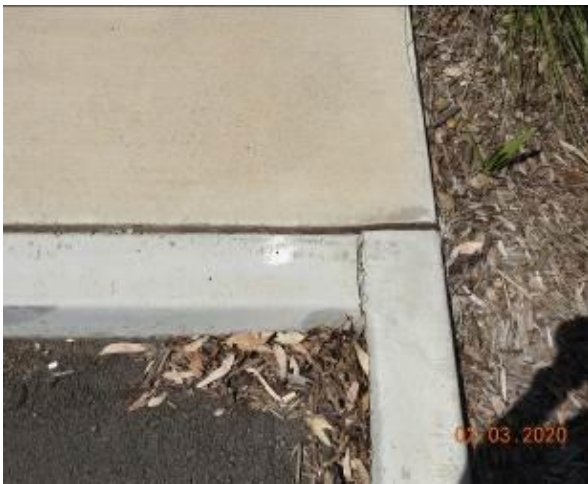
Figure 2017 – Crack propagation and loss of material through kerb

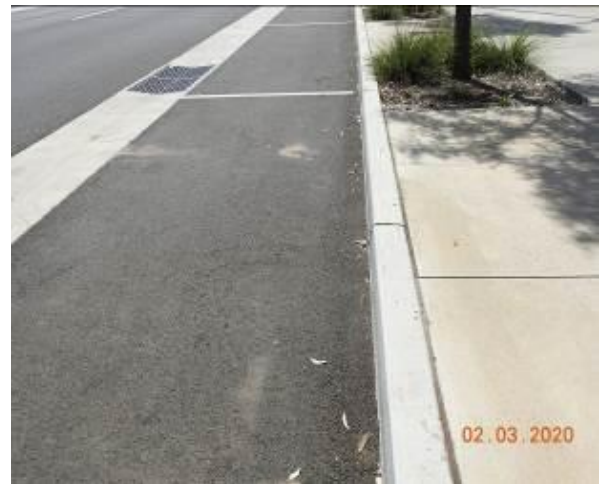
Figure 2018 – General Condition of kerb

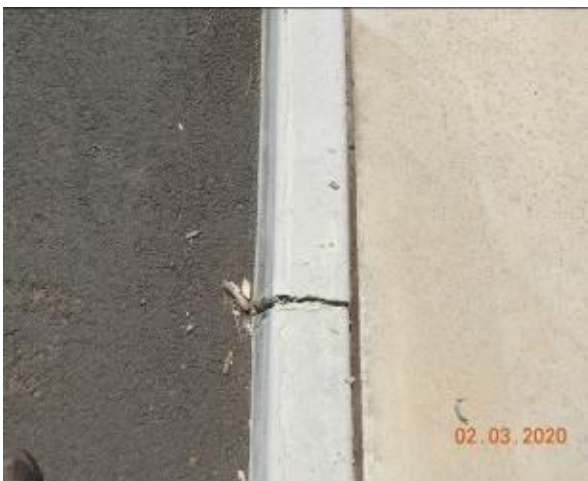
Figure 2019 – Loss of material through kerb

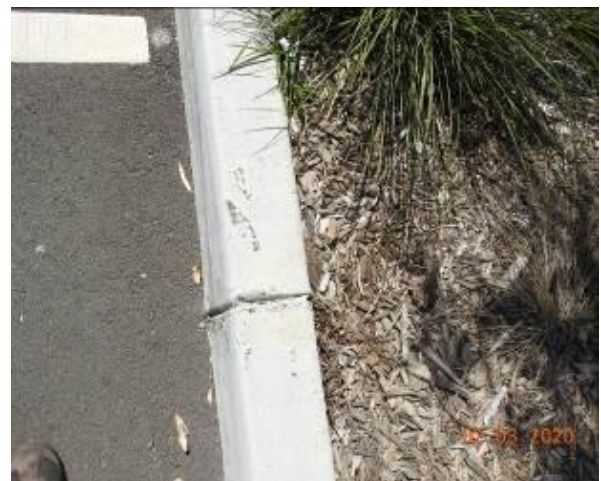
Figure 2020 – Loss of material through kerb

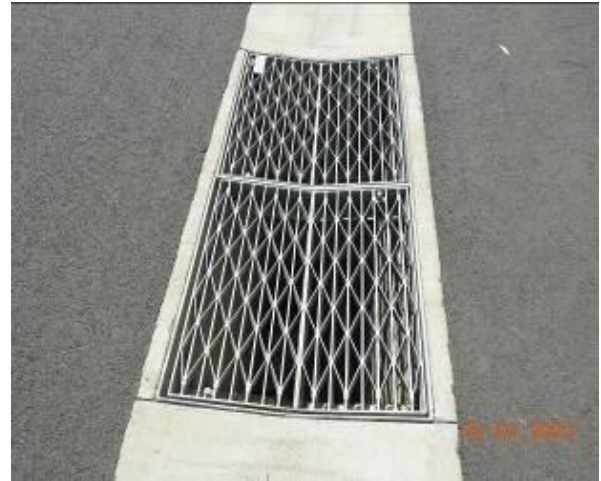
Figure 2022 – General Condition of stormwater inlet pit

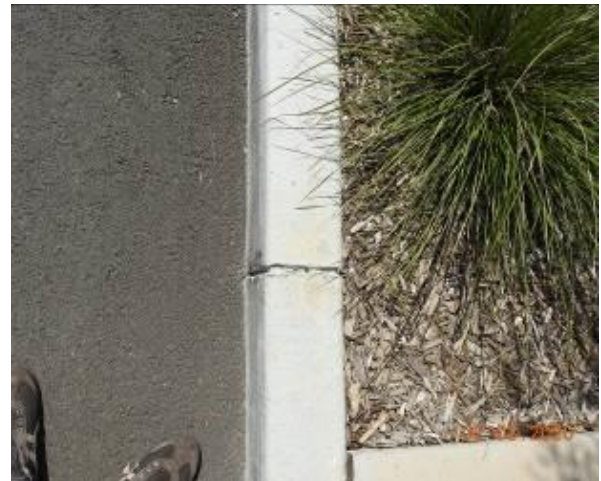
Figure 2024 – Crack propagation through kerb

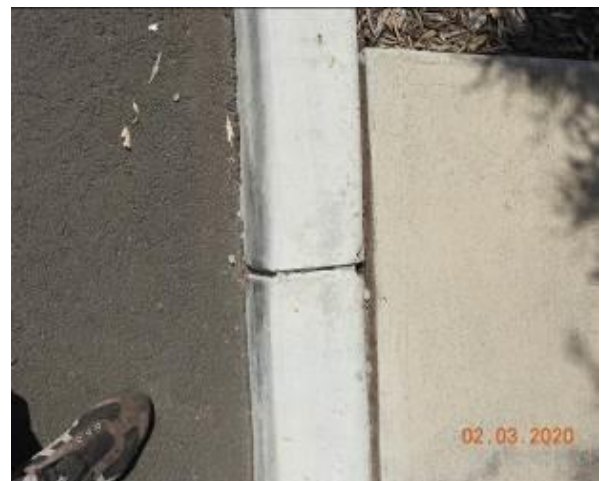
Figure 2026 – Crack propagation through kerb

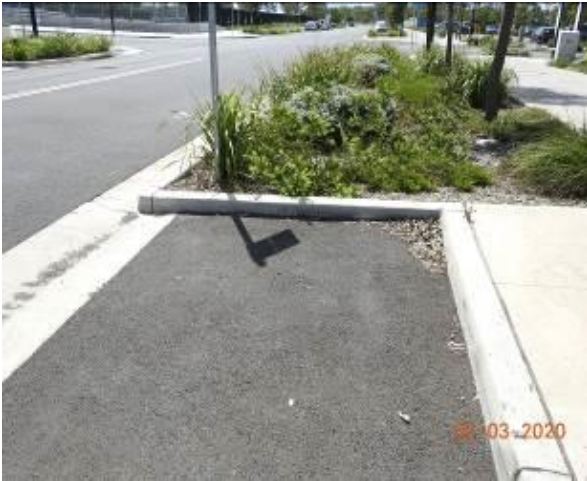
Figure 2027 – General Condition of kerb

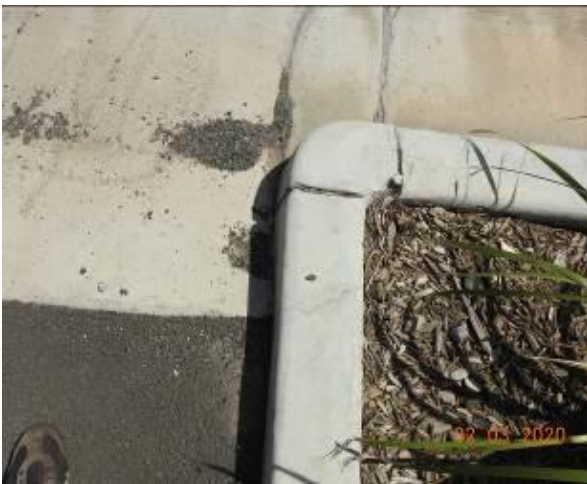
Figure 2029 – Crack propagation through kerb

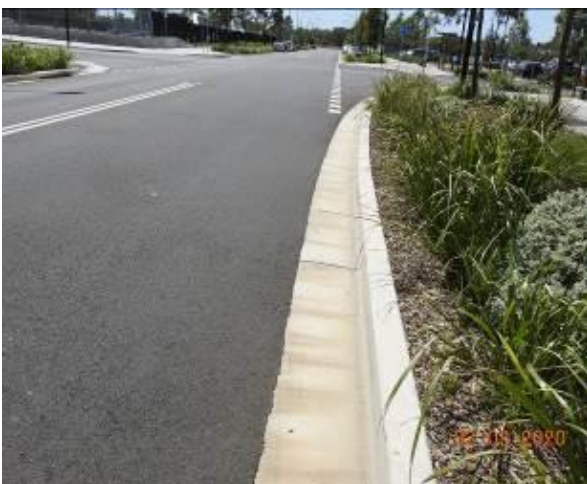
Figure 2031 – General Condition of kerb and gutter

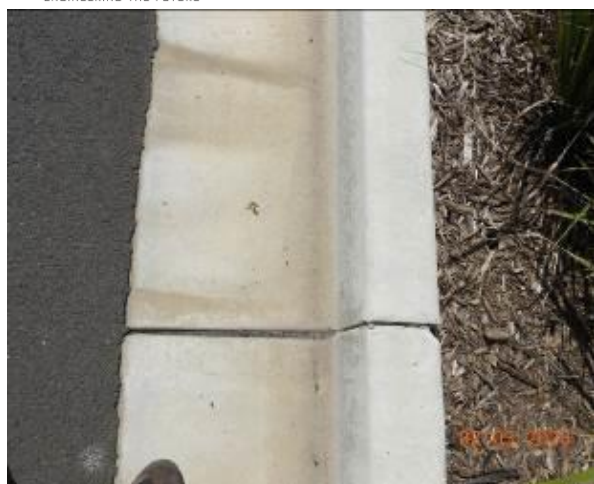
Figure 2033 – Crack propagation through kerb

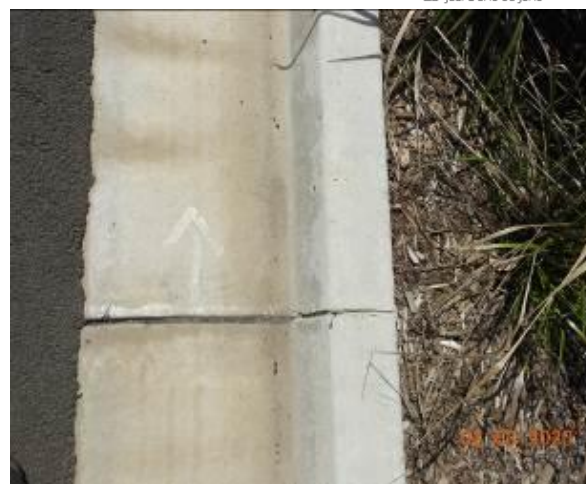
Figure 2034 – Crack propagation through kerb

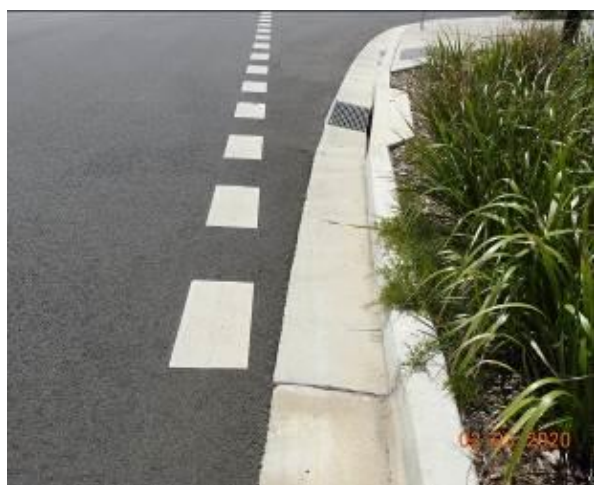
Figure 2035 – General Condition of kerb and gutter

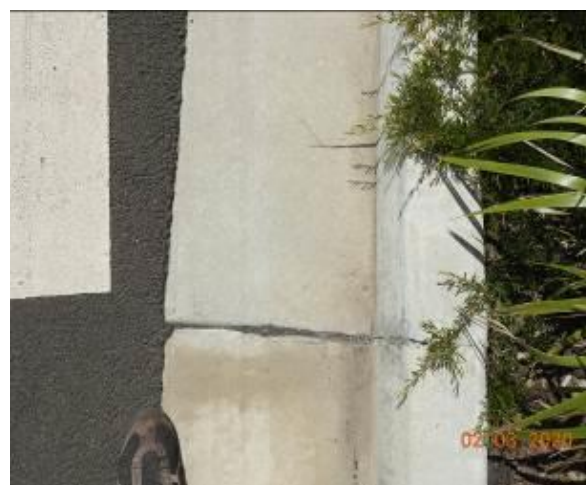
Figure 2036 – Crack propagation and loss of material through kerb and gutter

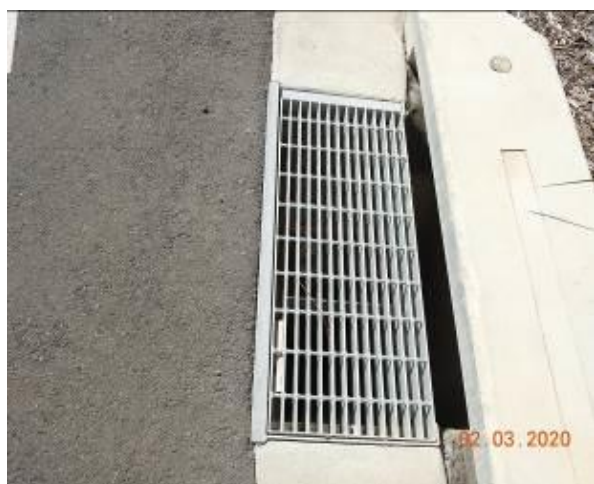
Figure 2037 – General Condition of stormwater inlet pit

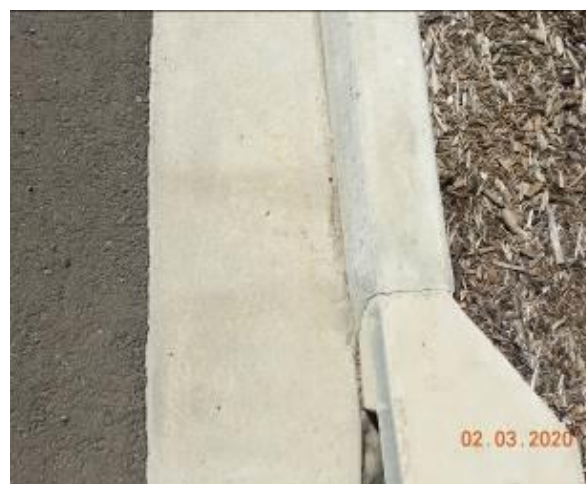
Figure 2038 – Crack propagation through stormwater inlet pit

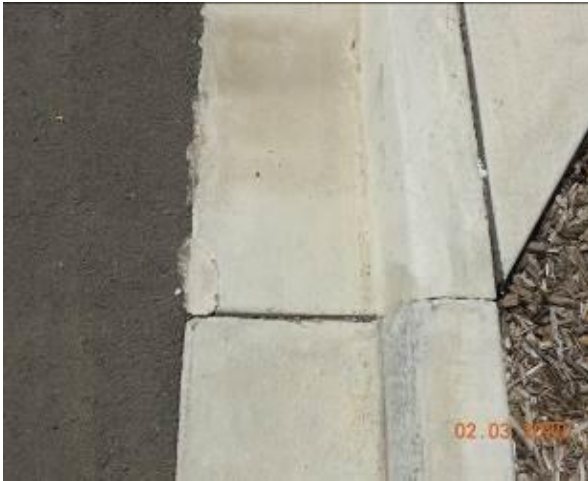
Figure 2039 – Crack propagation through gutter

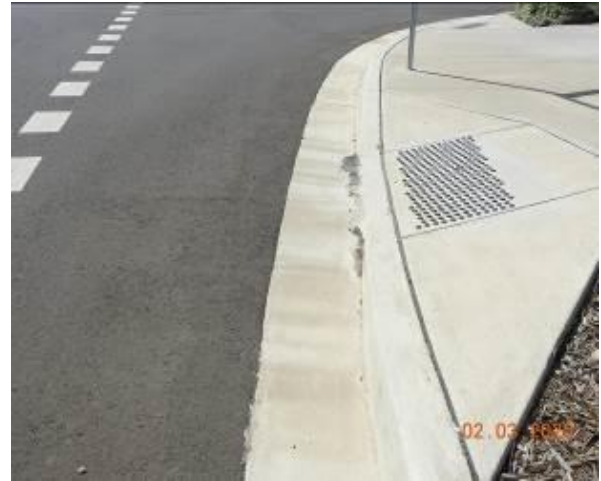
Figure 2040 – General Condition of layback and gutter

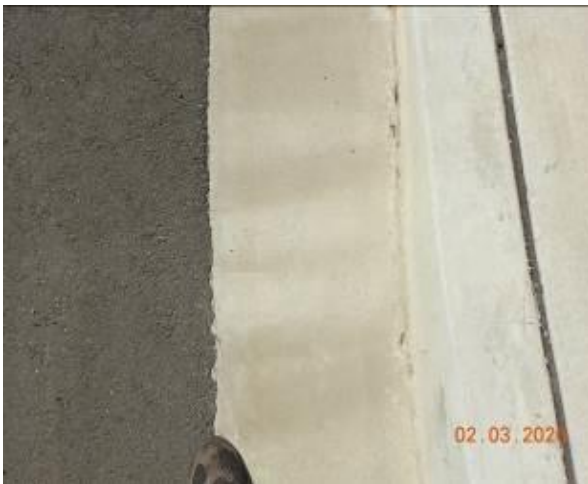
Figure 2041 – Crack propagation through layback and gutter

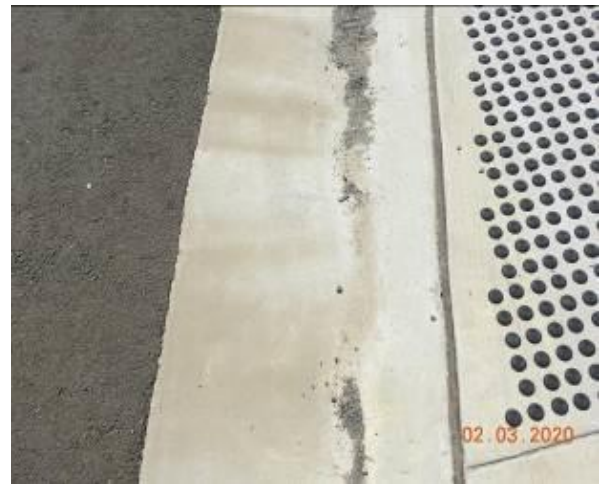
Figure 2042 – General Condition of layback and gutter
