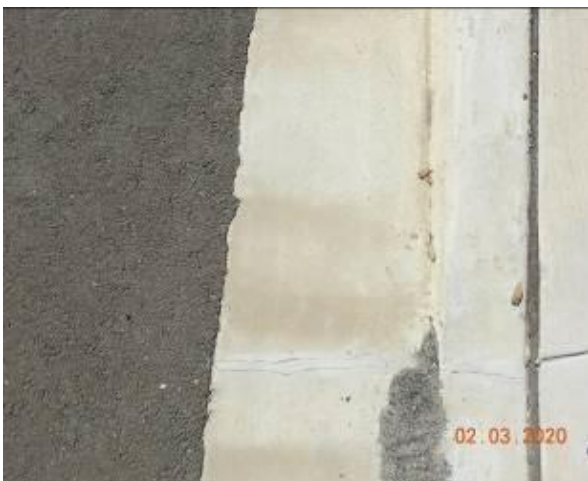
Figure 2043 – Evidence of patchwork through layback and gutter

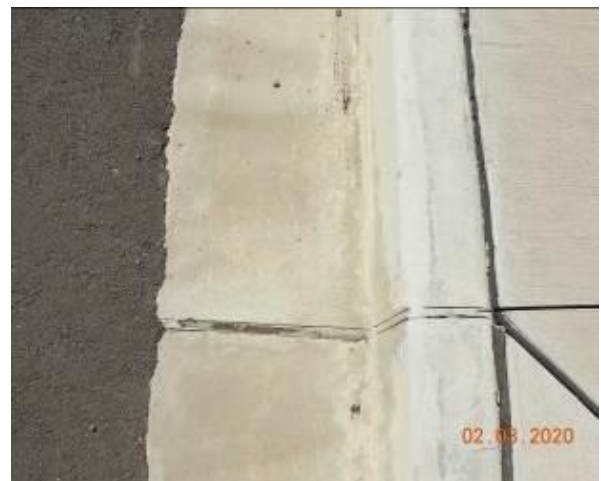
Figure 2044 – Loss of material through gutter

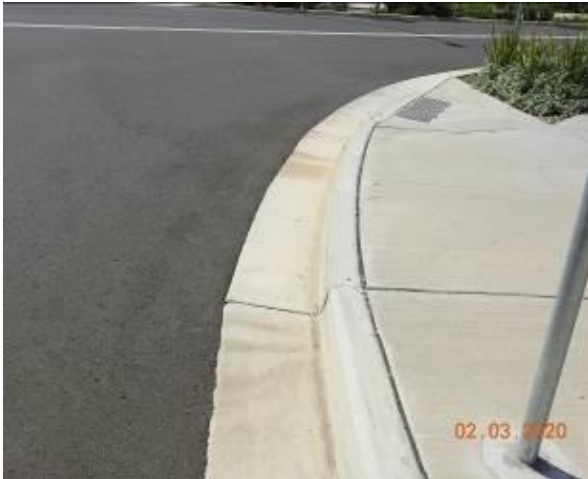
Figure 2045 – General Condition of kerb and gutter

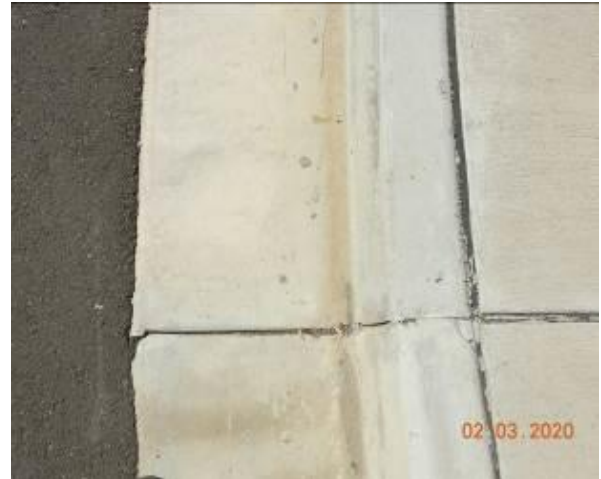
Figure 2046 – Loss of material through kerb and gutter

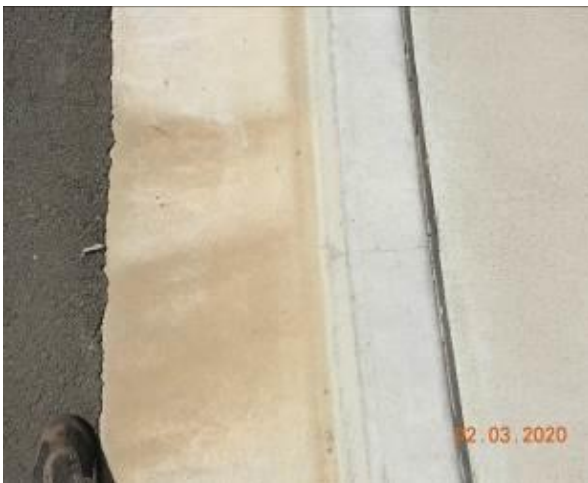
Figure 2047 – Crack propagation through kerb and gutter

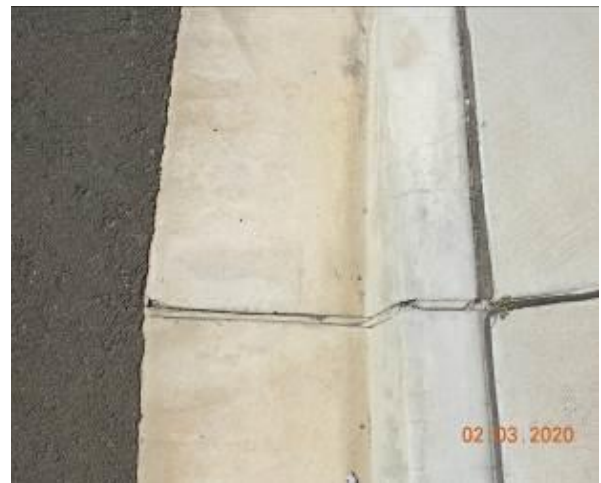
Figure 2048 – Loss of material through kerb and gutter

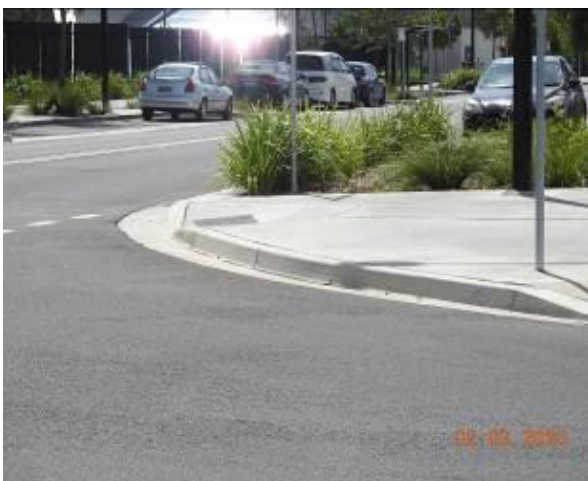
Figure 2049 – General Condition of kerb and gutter

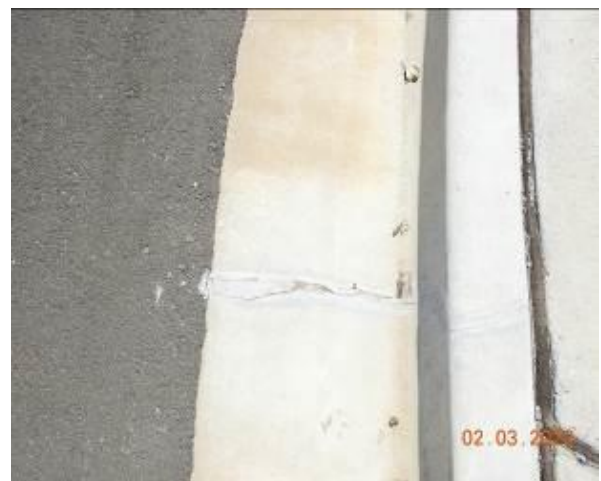
Figure 2050 – Crack propagation through kerb and gutter

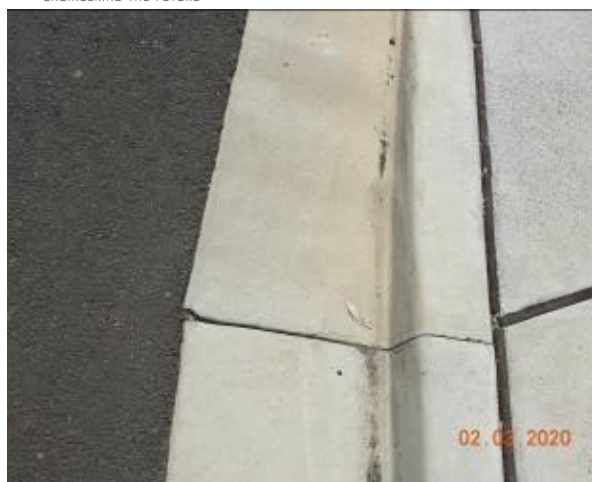
Figure 2051 – Loss of material through gutter

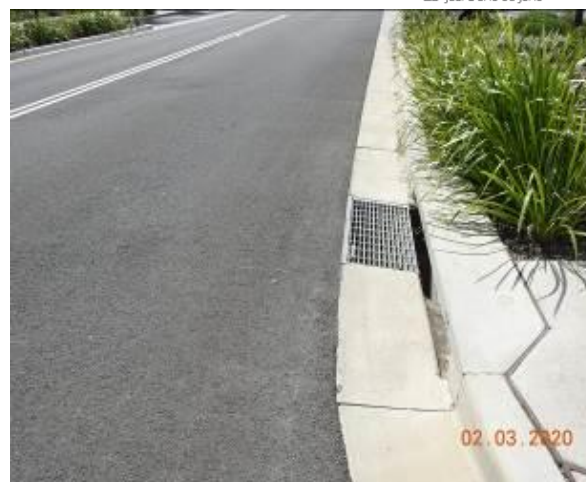
Figure 2052 – General Condition of kerb and gutter

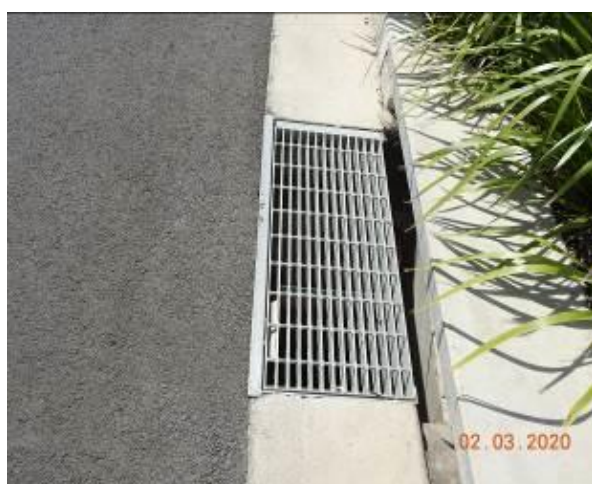
Figure 2053 – General Condition of stormwater inlet pit

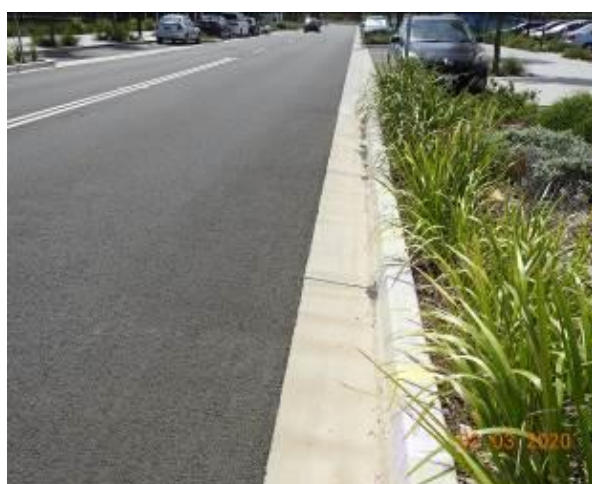
Figure 2055 – General Condition of kerb and gutter

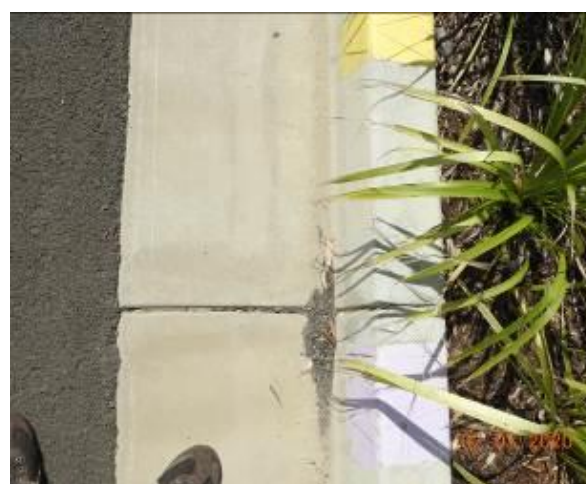
Figure 2056 – Crack propagation through kerb and gutter

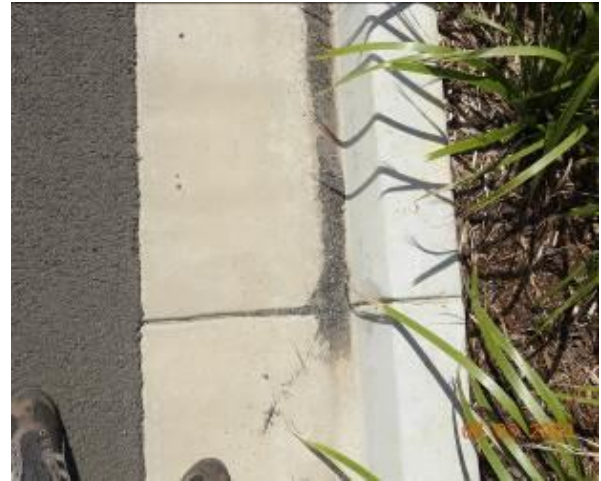
Figure 2058 – Crack propagation through kerb and gutter

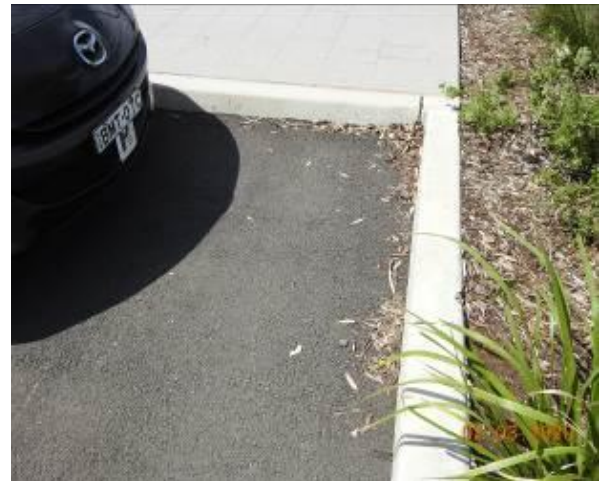
Figure 2060 – General Condition of kerb

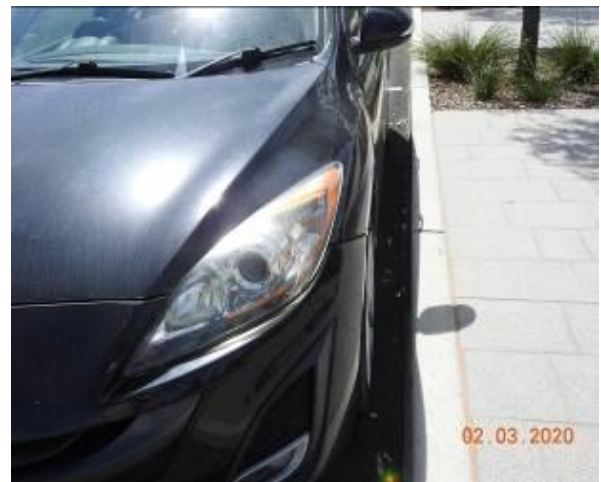
Figure 2062 – General Condition of kerb

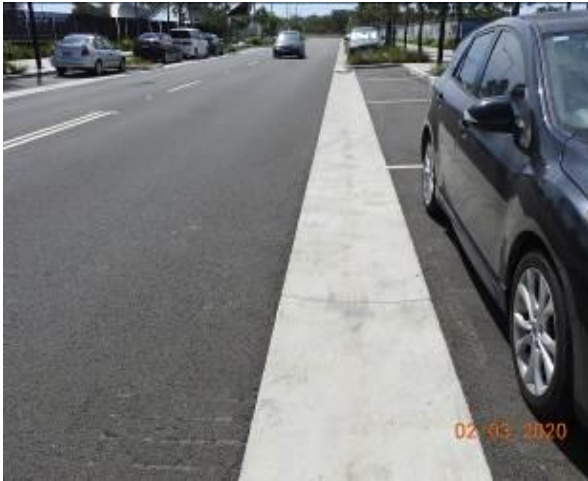
Figure 2063 – General Condition of gutter

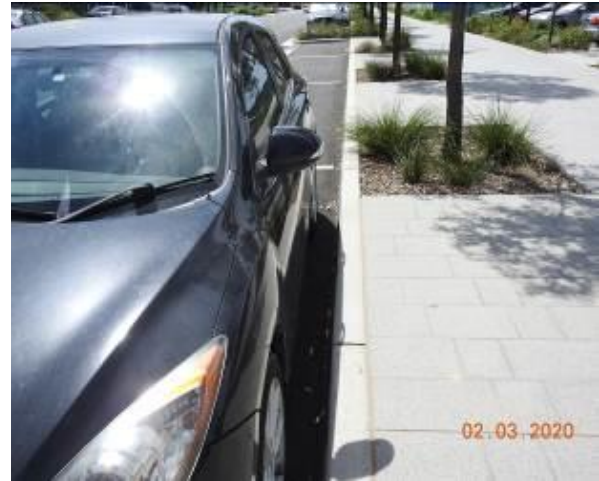
Figure 2064 – General Condition of kerb

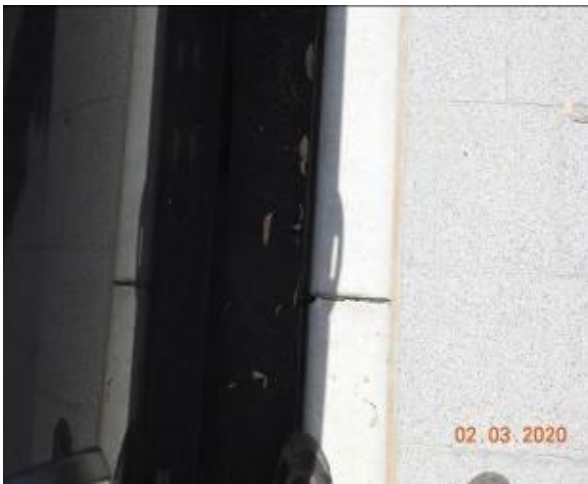
Figure 2065 – Crack propagation through kerb

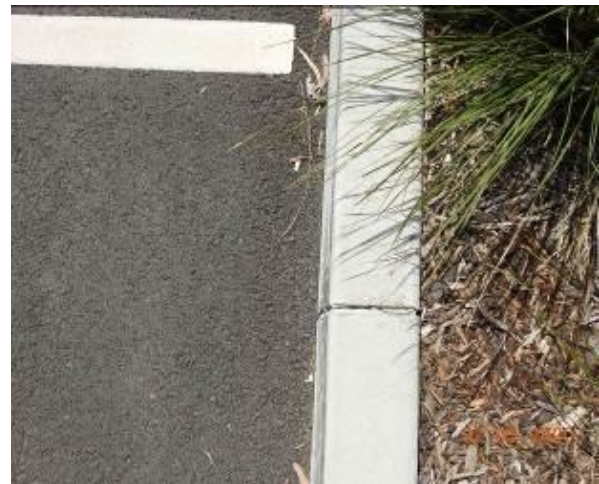
Figure 2066 – Crack propagation through kerb

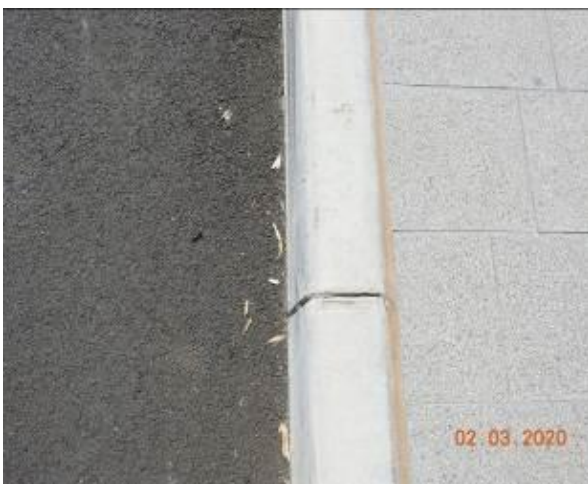
Figure 2067 – Crack propagation through kerb

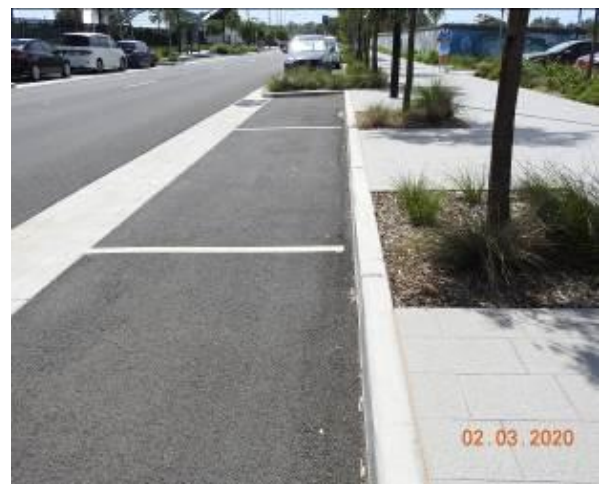
Figure 2068 – General Condition of kerb

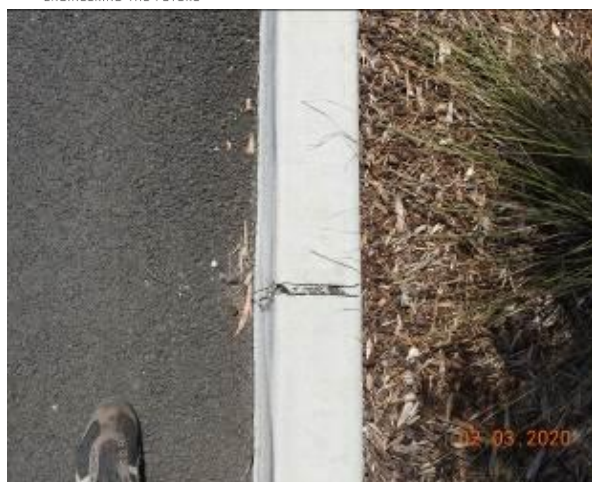
Figure 2069 – Crack propagation and loss of material through kerb

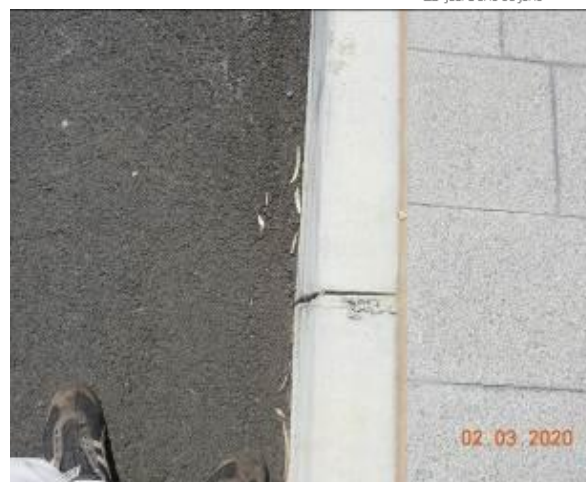
Figure 2070 – Crack propagation and loss of material through kerb

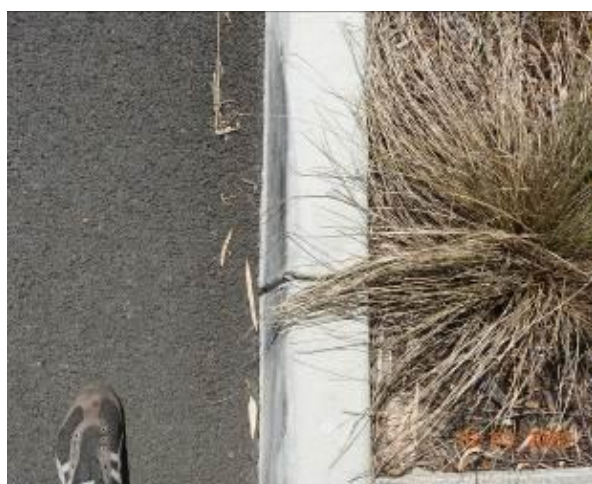
Figure 2071 – Loss of material through kerb

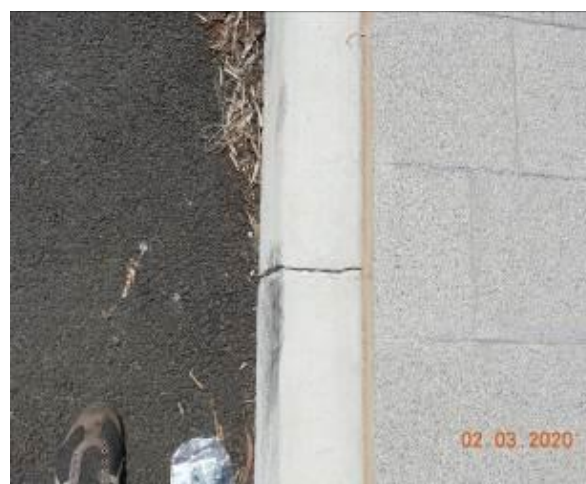
Figure 2072 – Crack propagation through kerb

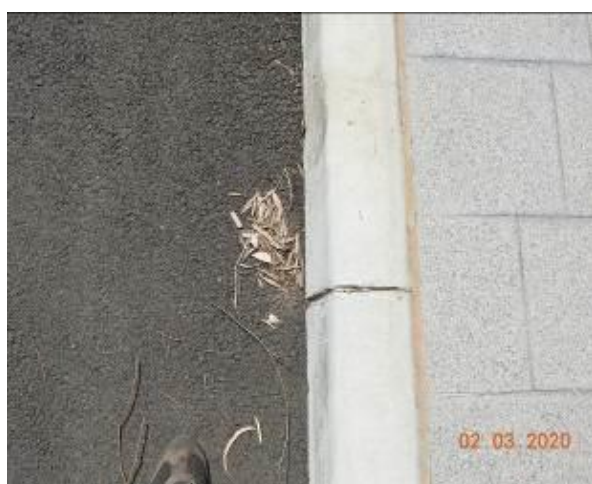
Figure 2073 – Crack propagation through kerb

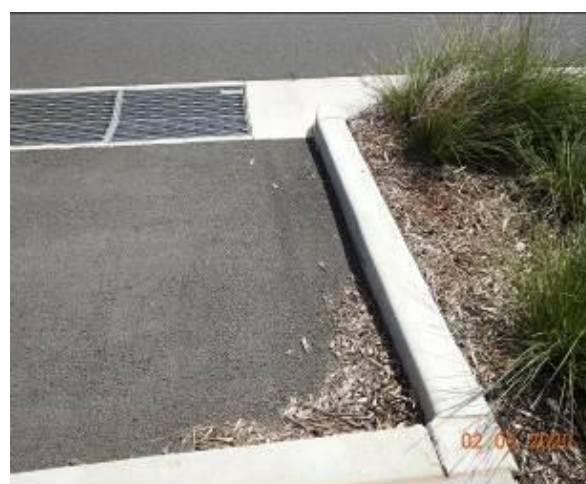
Figure 2074 – General Condition of kerb

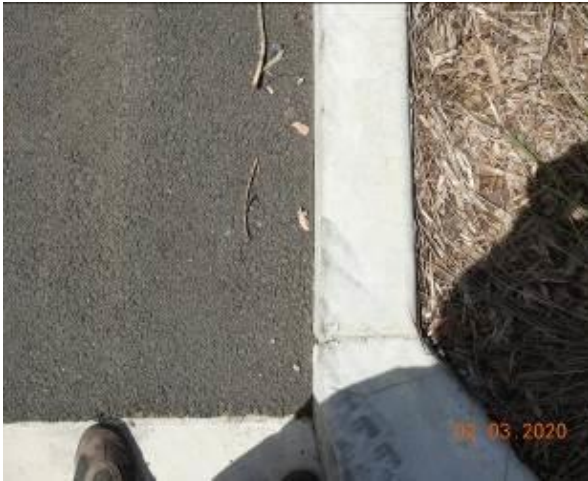
Figure 2081 – Loss of material through kerb

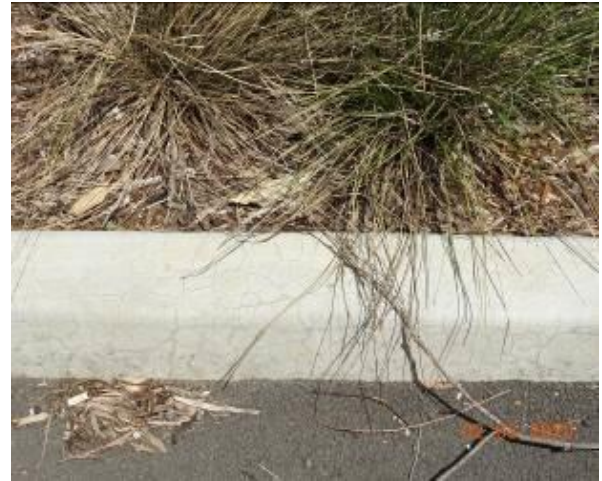
Figure 2082 – Crack propagation through kerb

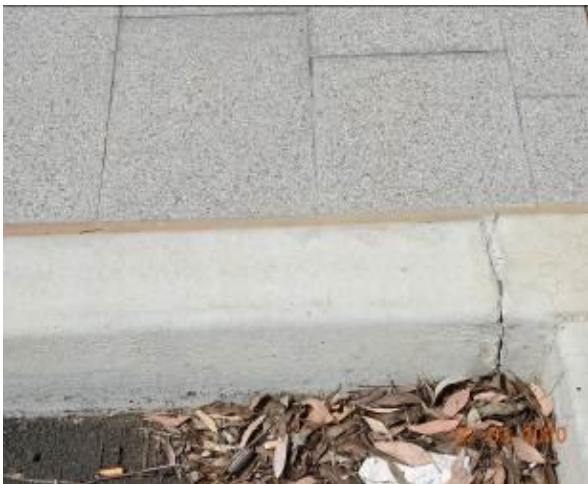
Figure 2083 – Separation through kerb

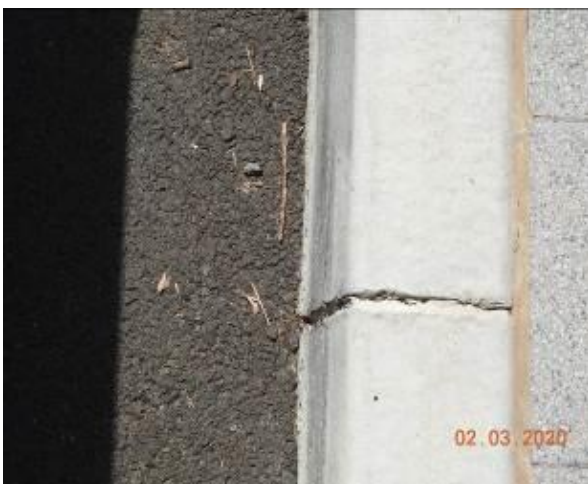
Figure 2085 – Crack propagation through kerb

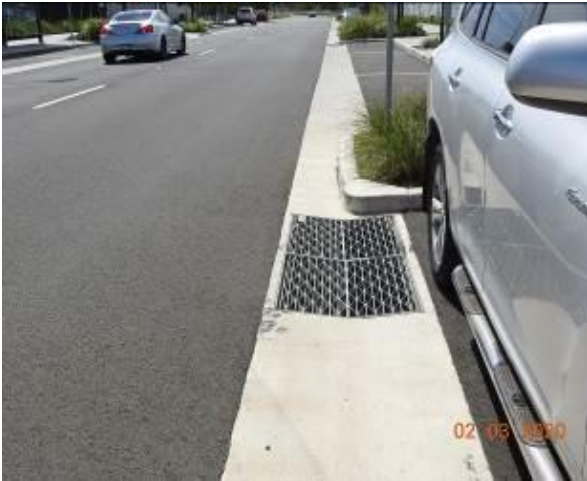
Figure 2093 – General Condition of gutter

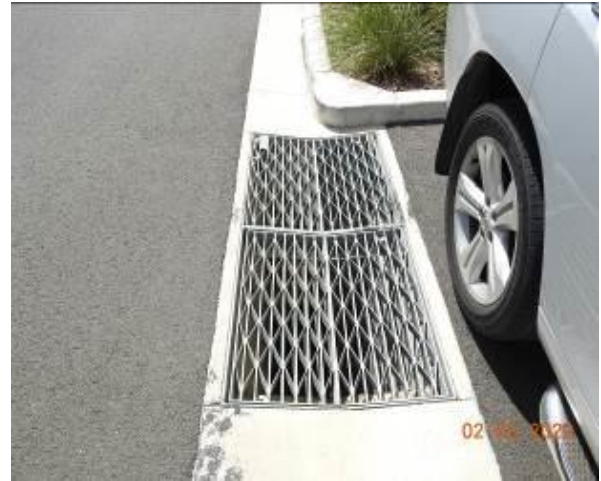
Figure 2094 – General Condition of stormwater inlet pit

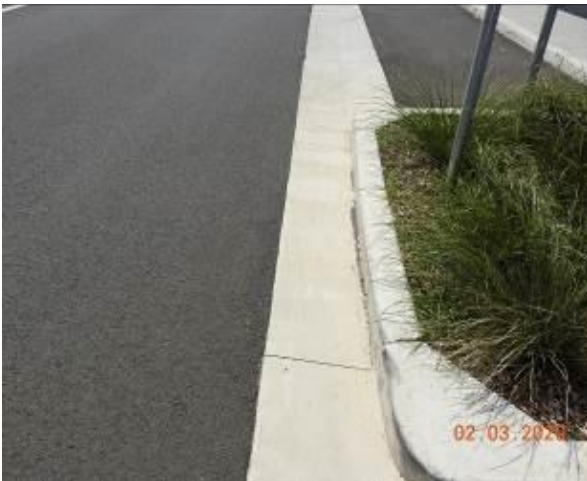
Figure 2095 – General Condition of kerb and gutter

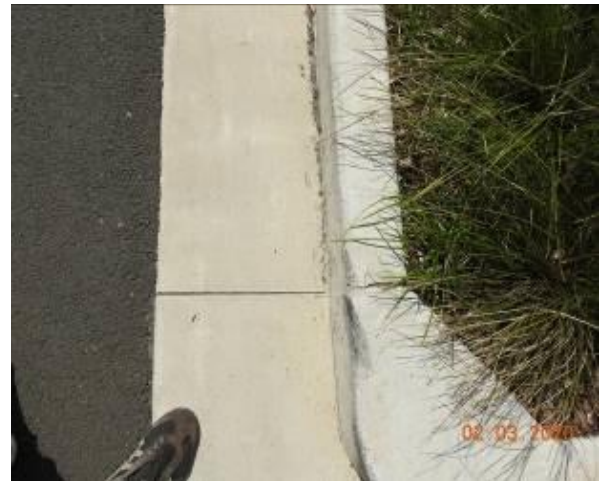
Figure 2096 – Crack propagation through kerb

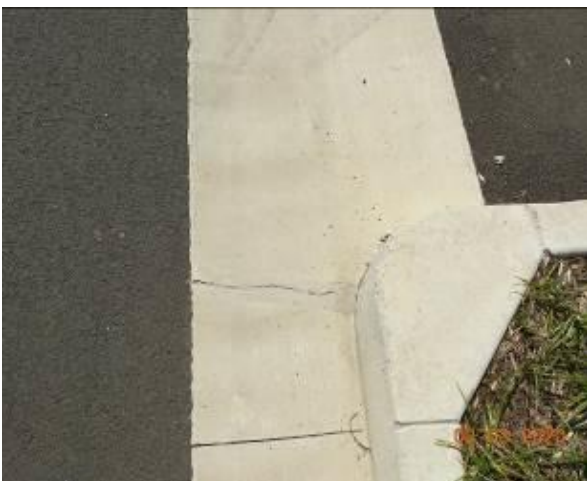
Figure 2097 – Crack propagation through gutter

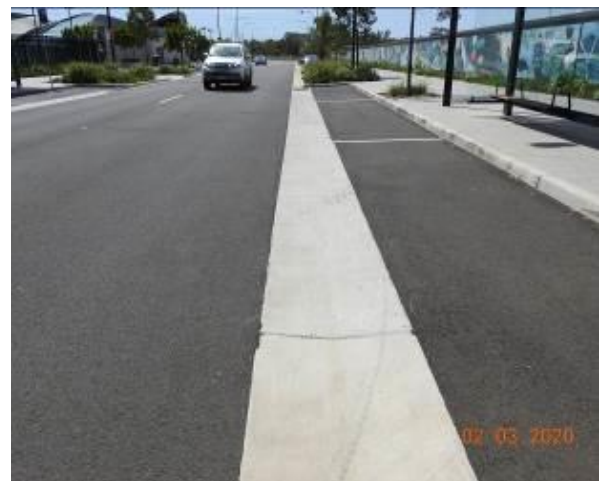
Figure 2098 – General Condition of gutter

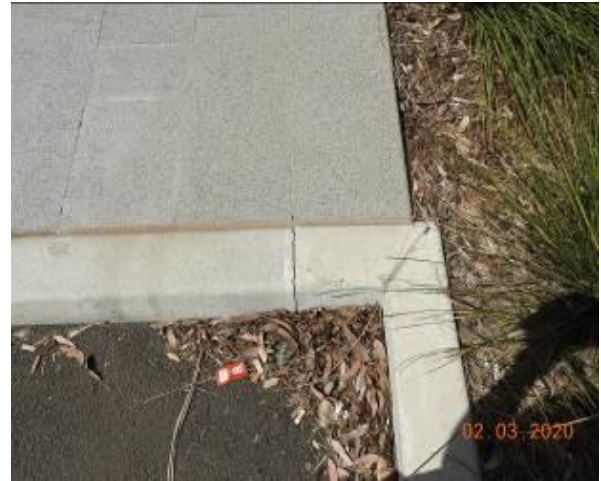
Figure 2100 – Separation through kerb

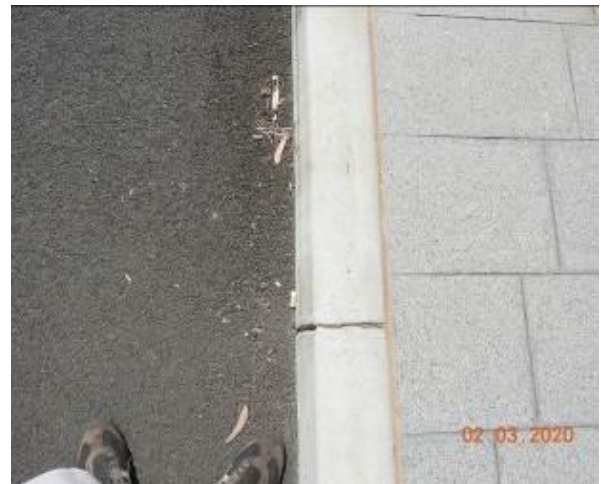
Figure 2102 – Crack propagation through kerb

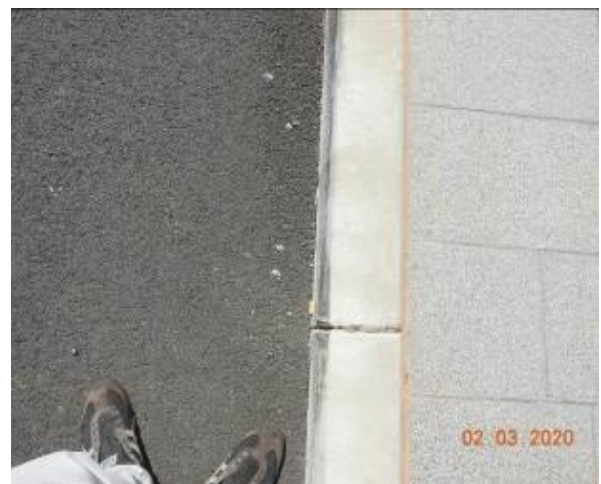
Figure 2104 – Crack propagation through kerb

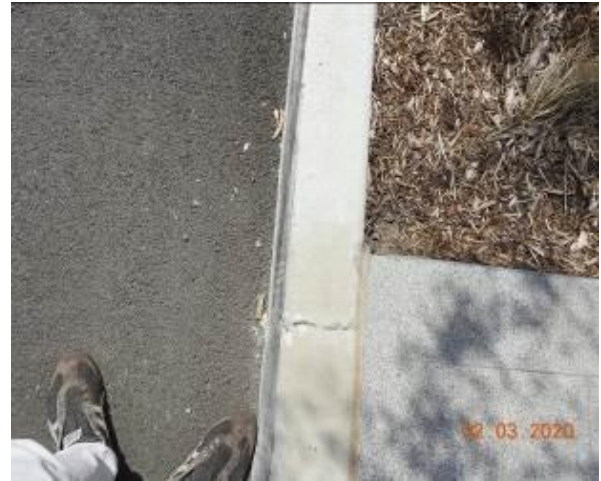
Figure 2106 – Crack propagation through kerb

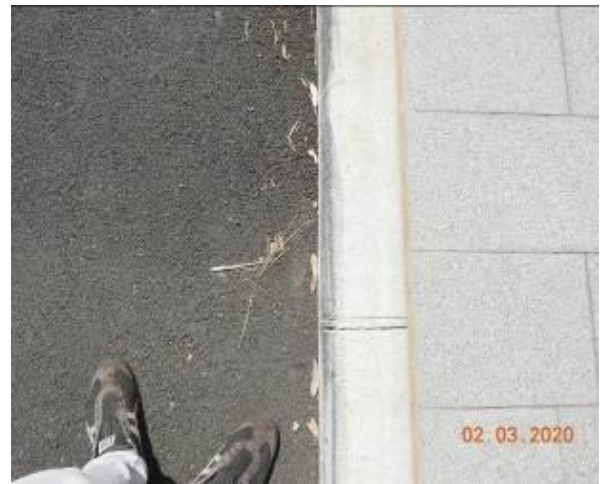
Figure 2108 – Crack propagation through kerb

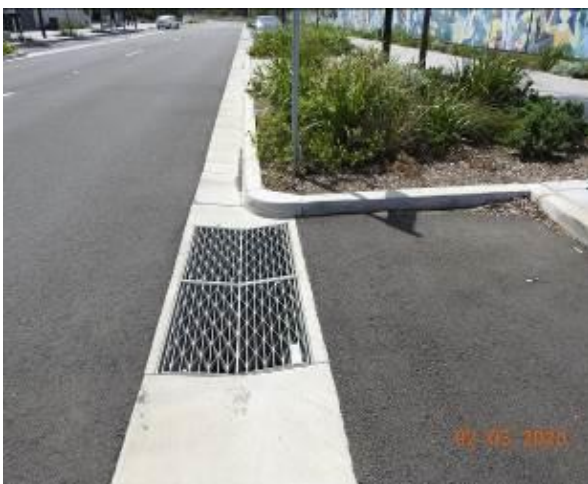
Figure 2109 – General Condition of gutter

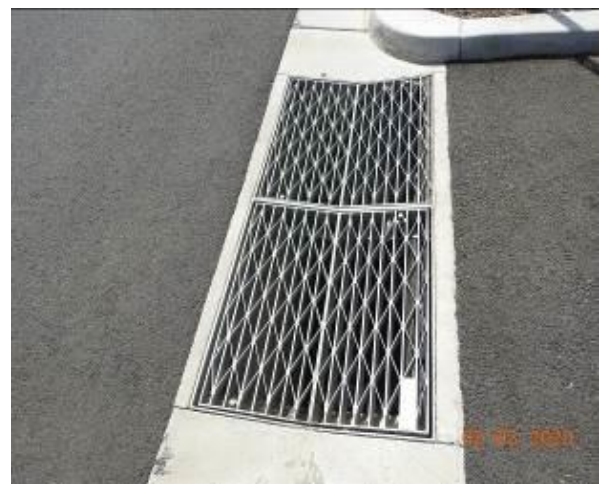
Figure 2110 – General Condition of stormwater inlet pit

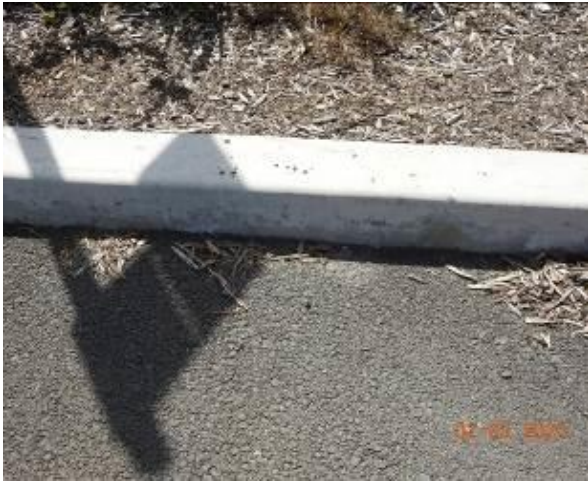
Figure 2111 – Crack propagation through kerb

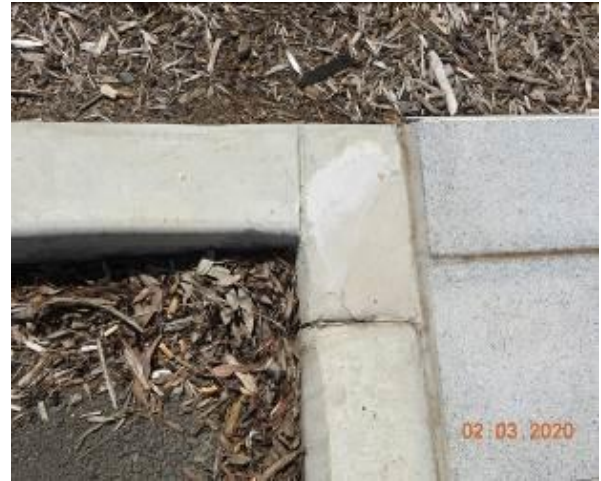
Figure 2112 – Crack propagation through kerb

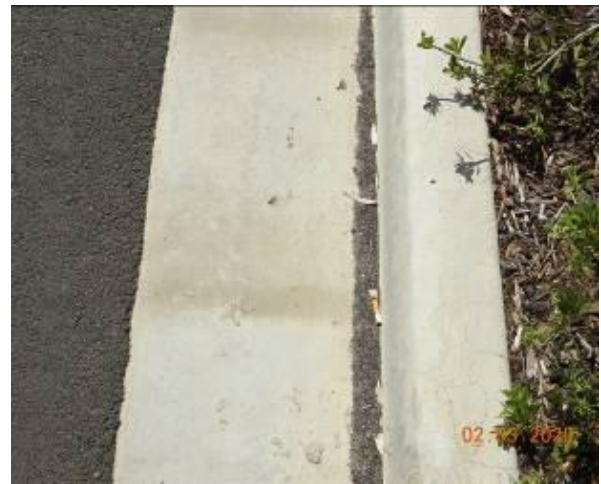
Figure 2114 – Crack propagation through kerb

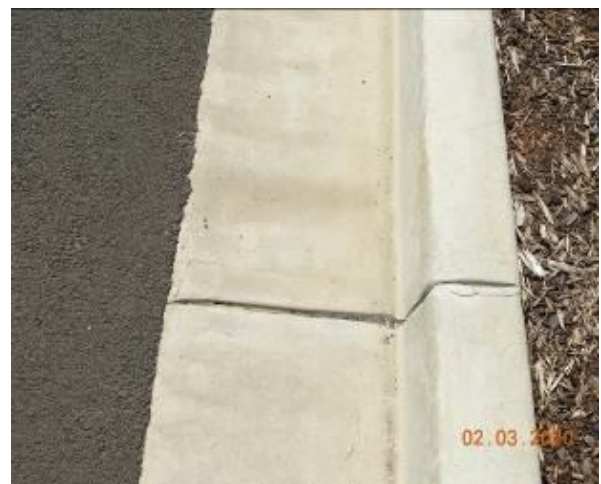
Figure 2116 – Crack propagation through kerb and gutter

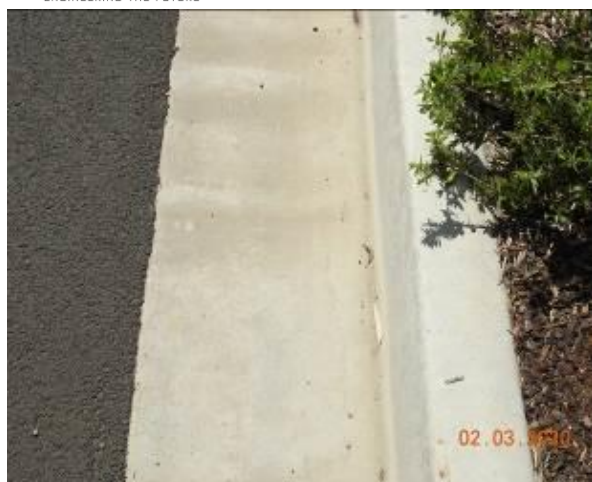
Figure 2117 – General Condition of kerb and gutter

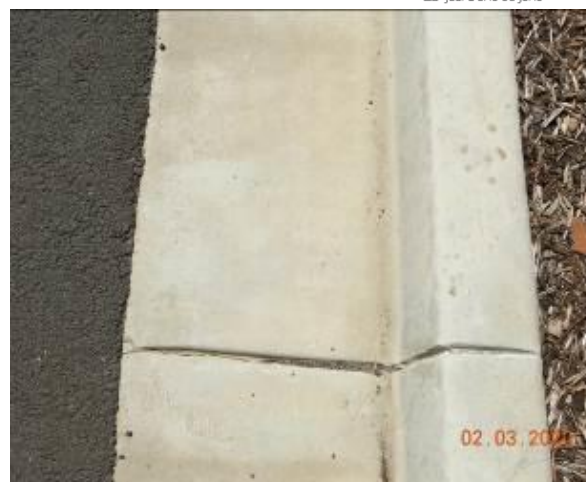
Figure 2118 – Crack propagation through kerb and gutter

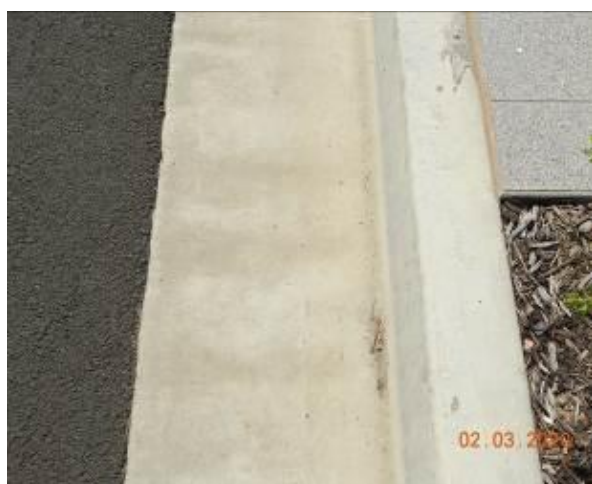
Figure 2119 – General Condition of kerb and gutter

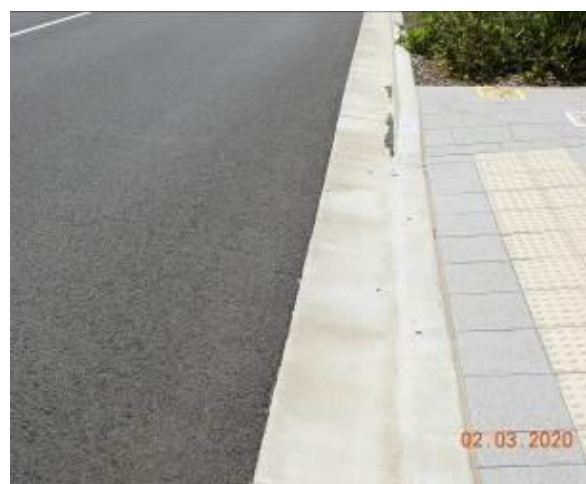
Figure 2120 – General Condition of layback and gutter

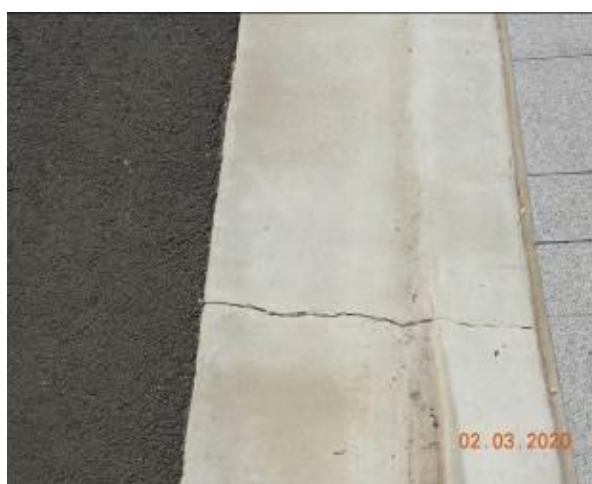
Figure 2121 – Crack propagation through layback and gutter

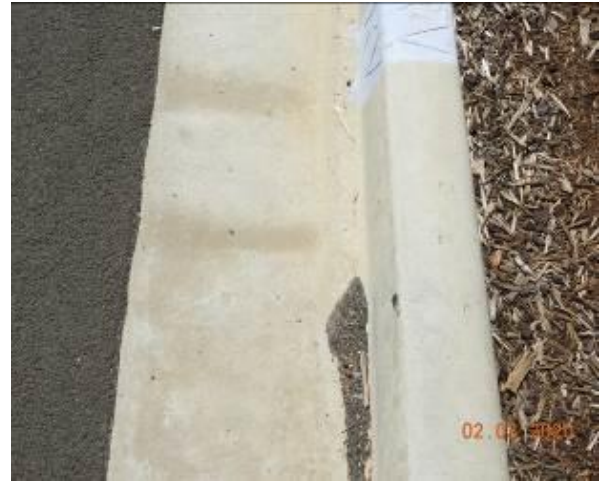
Figure 2124 – Crack propagation through kerb and gutter

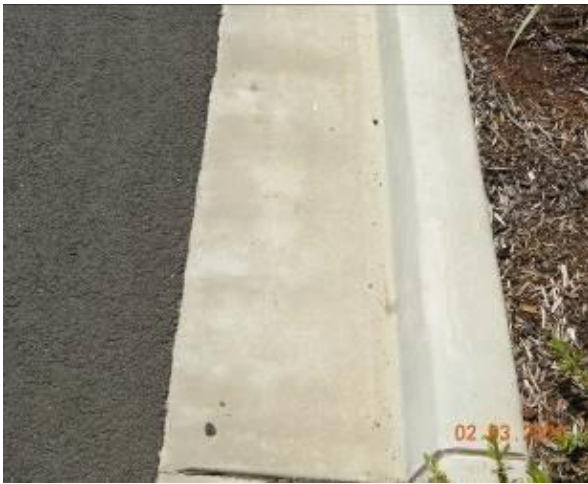
Figure 2125 – General Condition of kerb and gutter

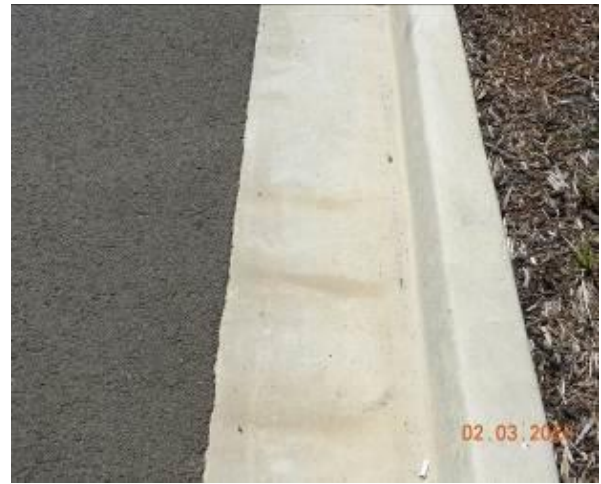
Figure 2126 – General Condition of kerb and gutter

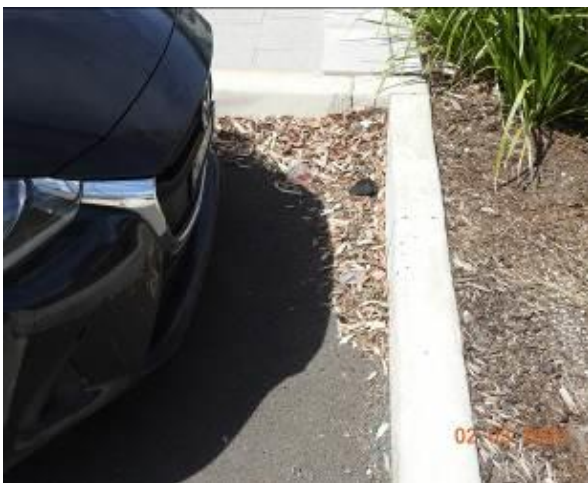
Figure 2127 – General Condition of kerb

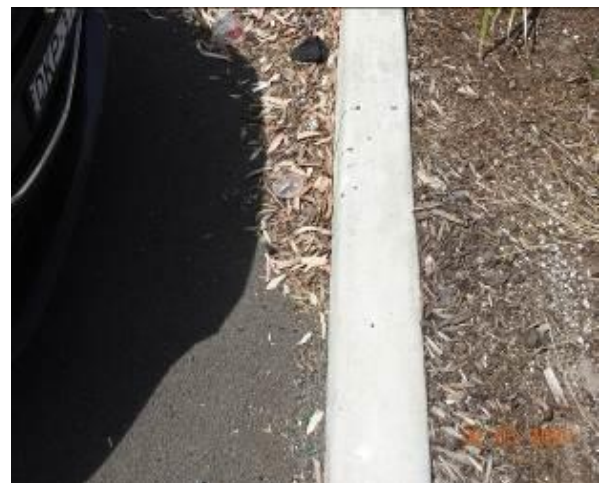
Figure 2128 – General Condition of kerb

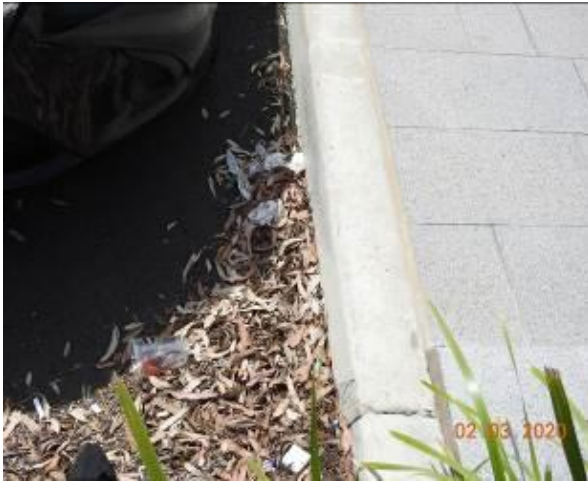
Figure 2129 – Crack propagation through kerb

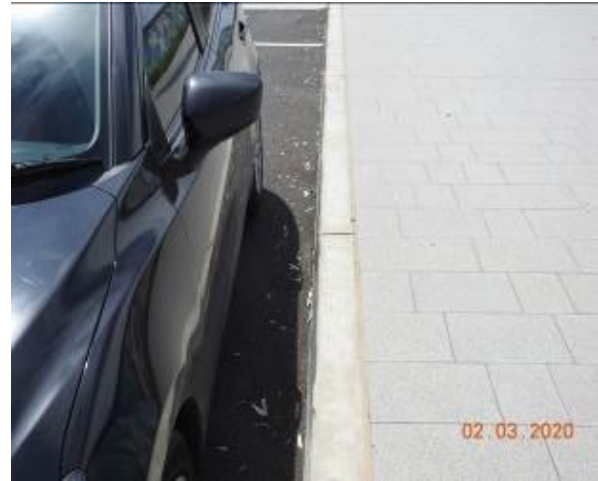
Figure 2130 – General Condition of kerb

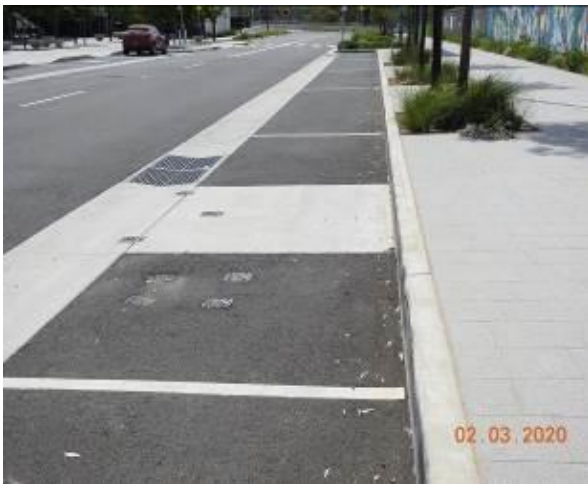
Figure 2131 – General Condition of kerb

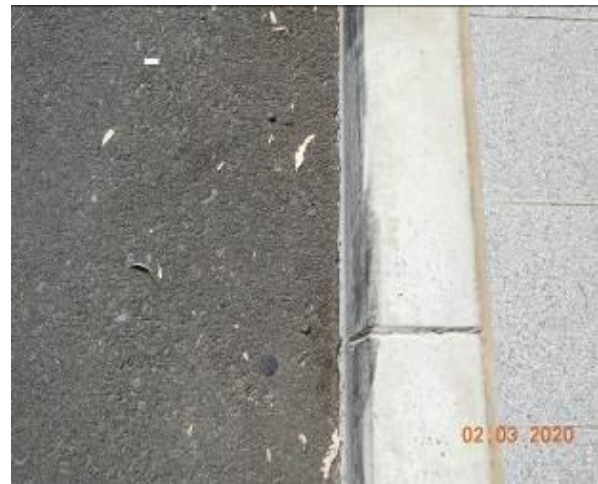
Figure 2132 – Crack propagation through kerb

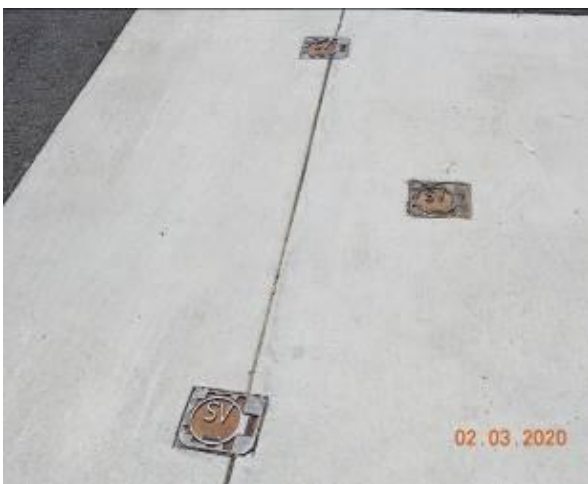
Figure 2133 – General Condition of service pit

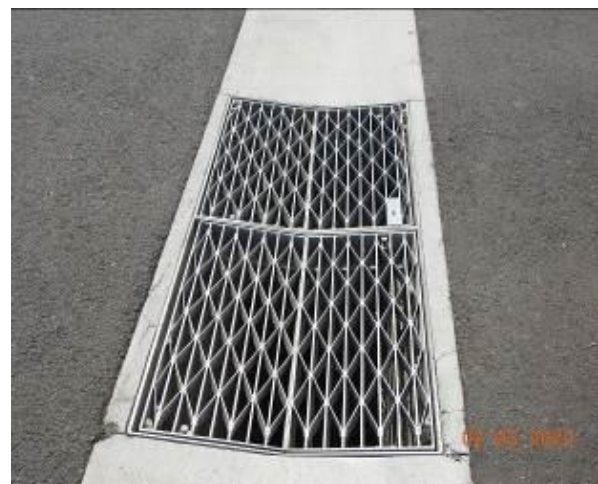
Figure 2134 – General Condition of stormwater inlet pit

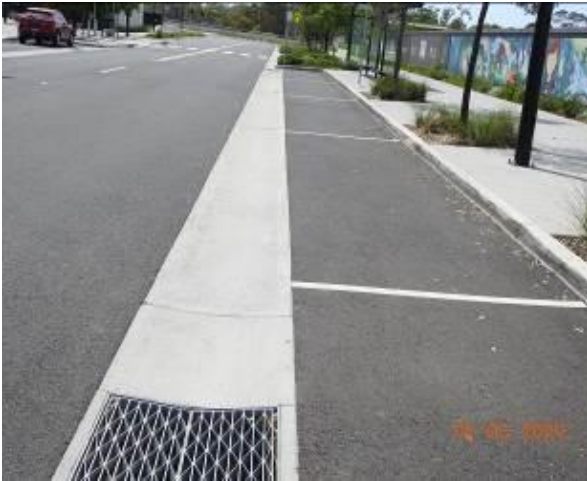
Figure 2135 – General Condition of gutter

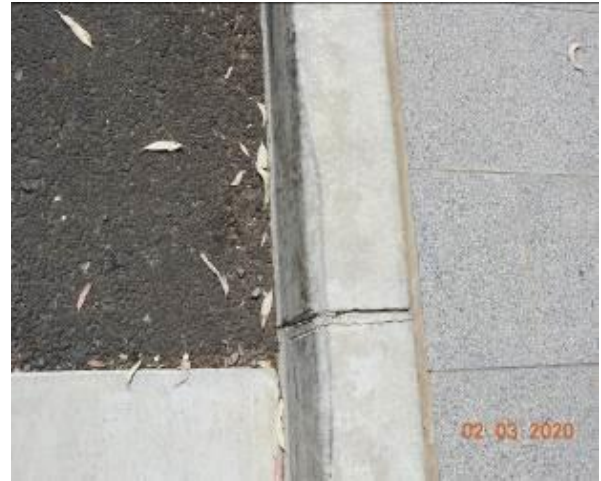
Figure 2136 – Crack propagation through kerb

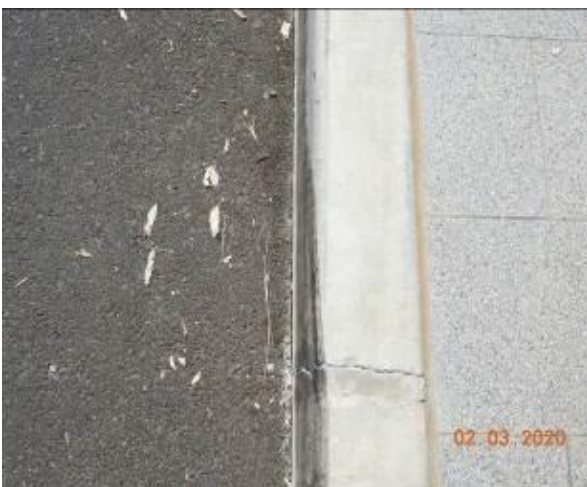
Figure 2137 – Crack propagation through kerb

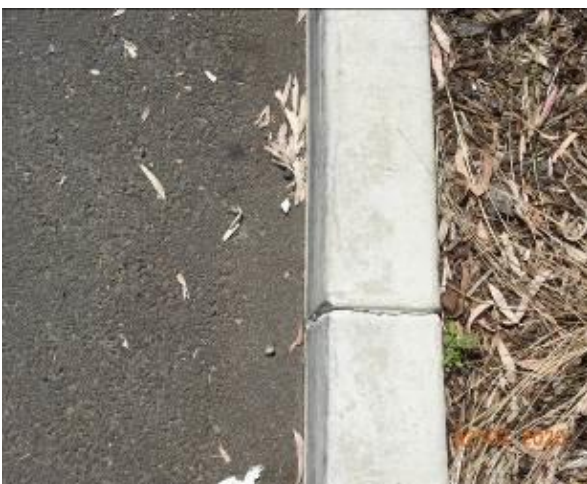
Figure 2139 – Crack propagation through kerb

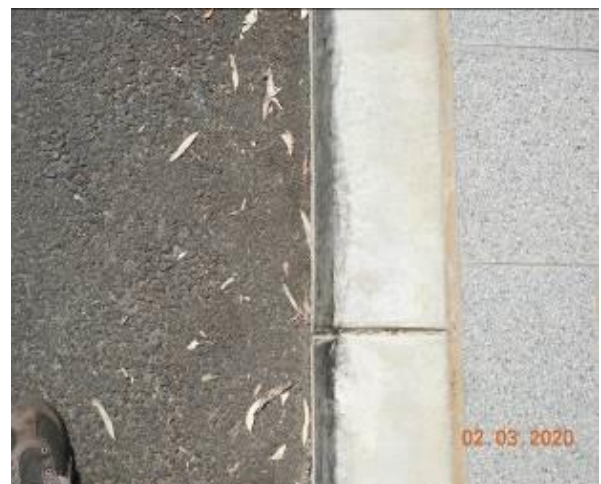
Figure 2140 – Crack propagation through kerb

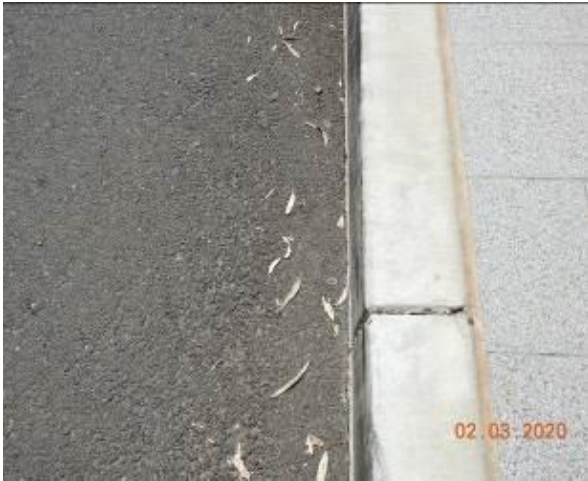
Figure 2141 – Crack propagation through kerb

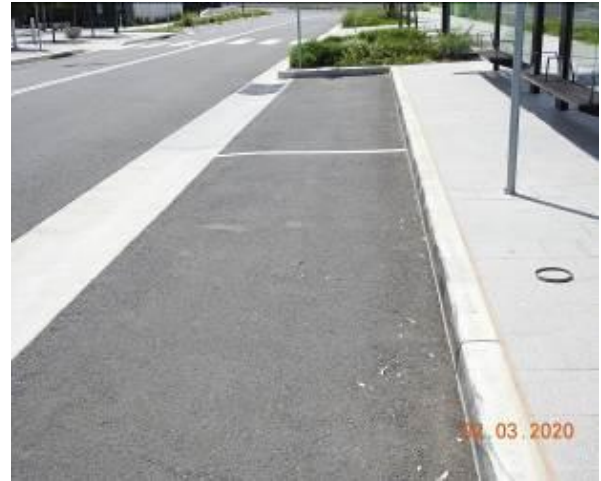
Figure 2142 – General Condition of kerb

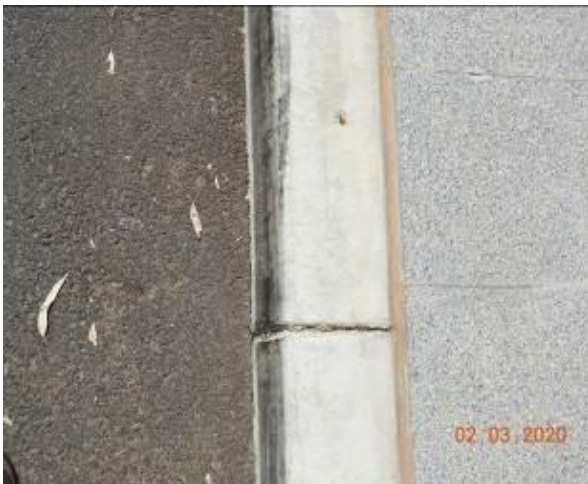
Figure 2143 – Crack propagation through kerb

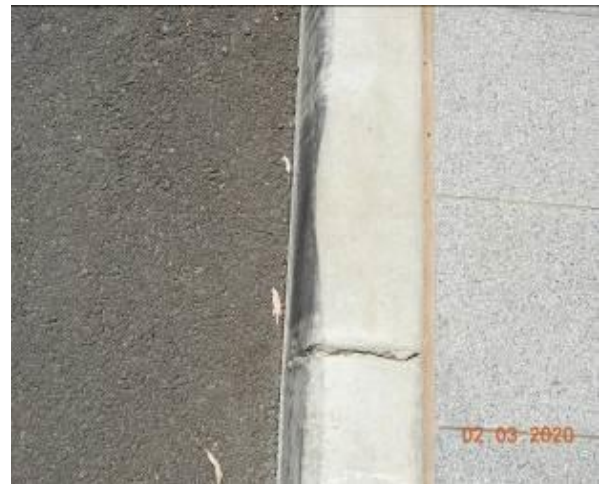
Figure 2144 – Crack propagation through kerb

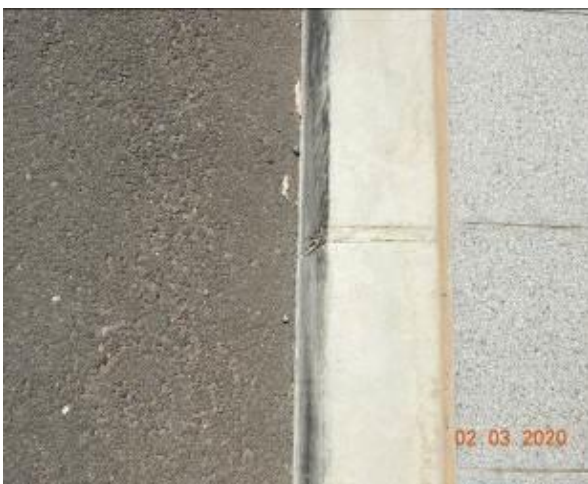
Figure 2145 – Crack propagation through kerb

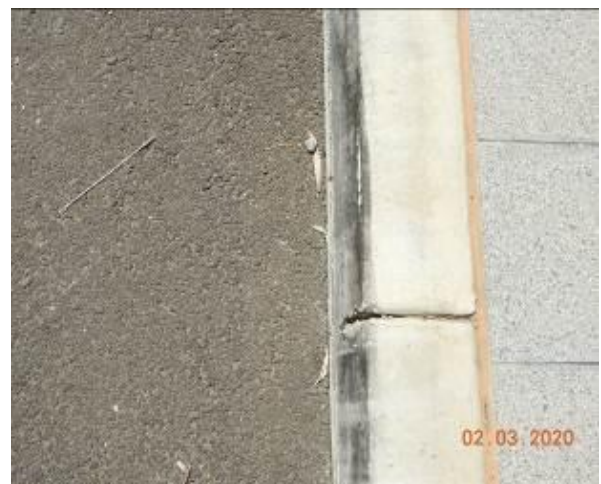
Figure 2146 – Crack propagation and loss of material through kerb

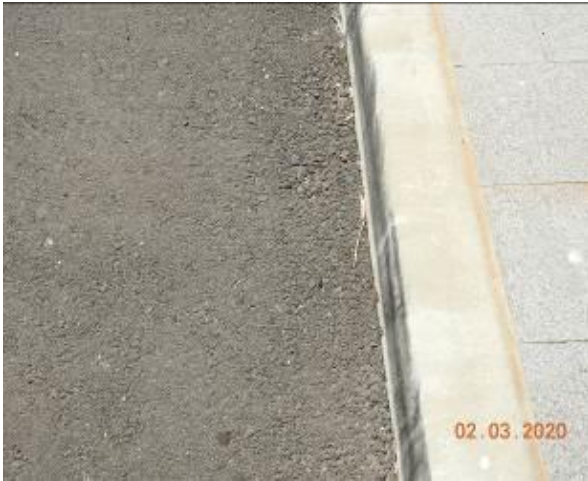
Figure 2147 – Crack propagation through kerb
