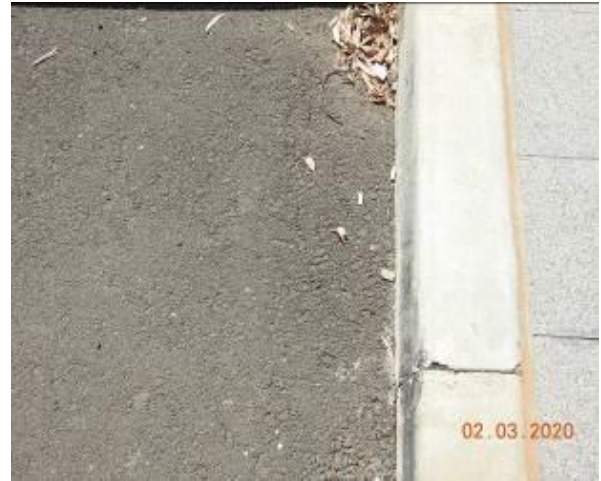
Figure 2148 – Crack propagation through kerb

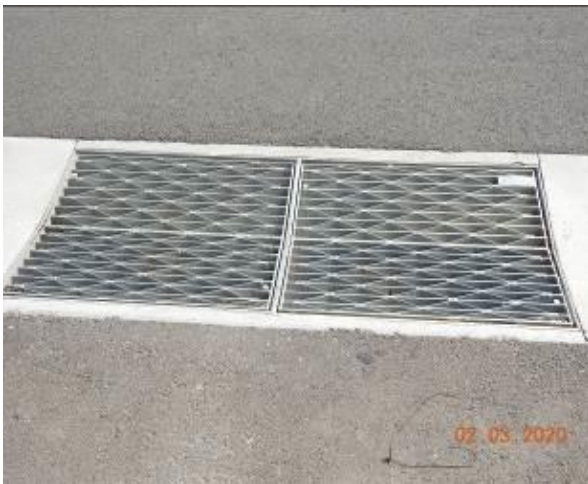
Figure 2149 – General Condition of stormwater inlet pit

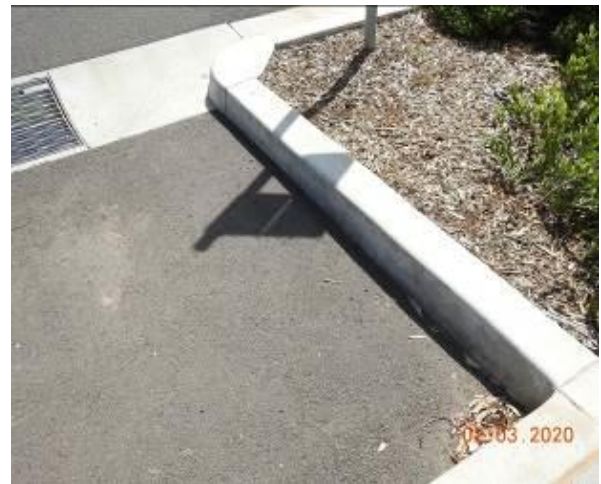
Figure 2150 – General Condition of kerb

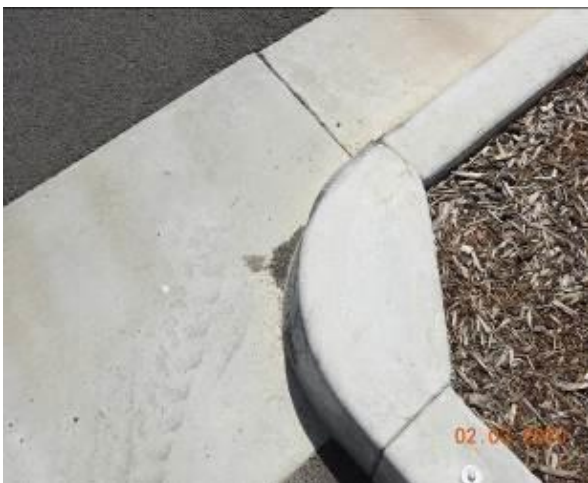
Figure 2151 – Crack propagation through kerb

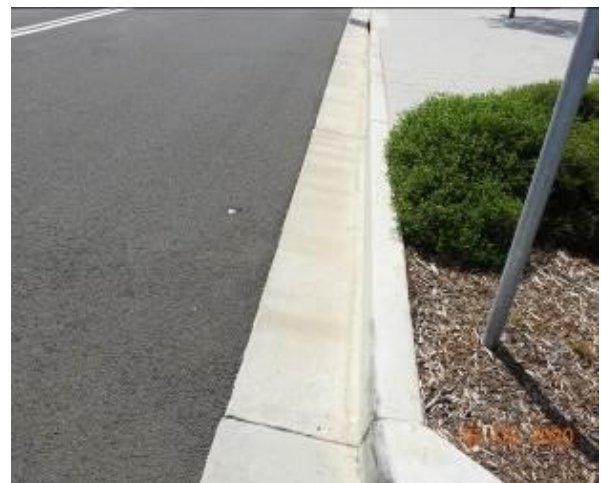
Figure 2152 – General Condition of kerb and gutter

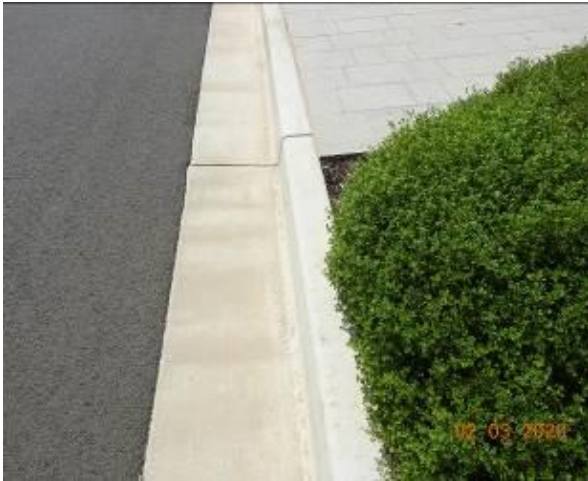
Figure 2153 – General Condition of kerb and gutter

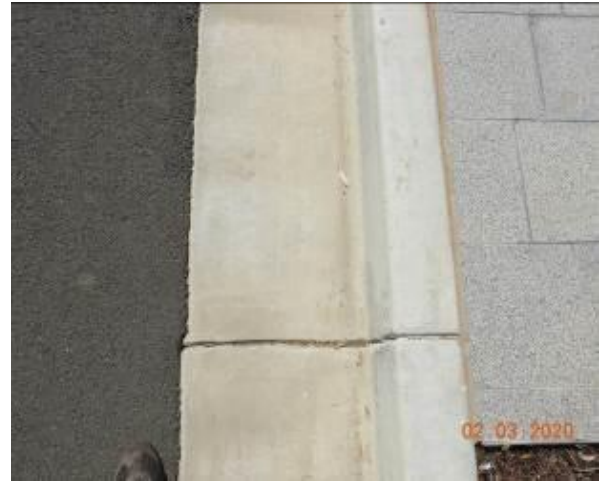
Figure 2154 – Crack propagation through kerb and gutter

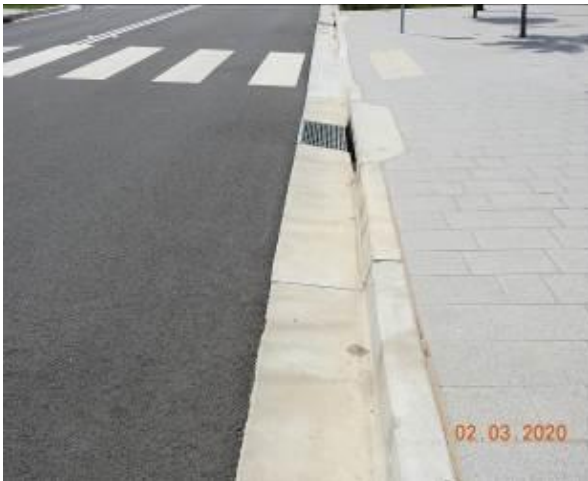
Figure 2155 – General Condition of kerb and gutter

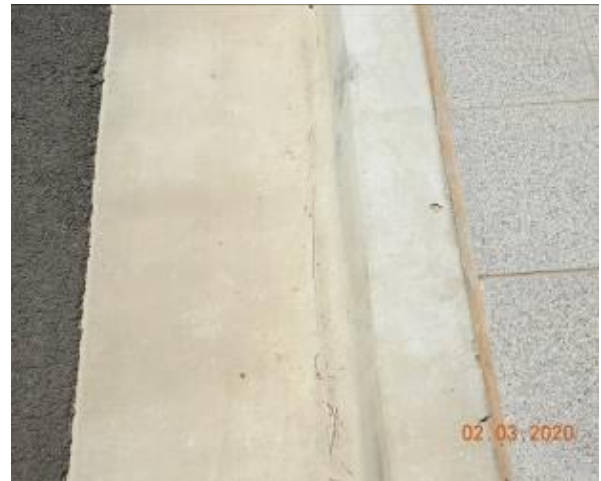
Figure 2156 – Crack propagation through kerb

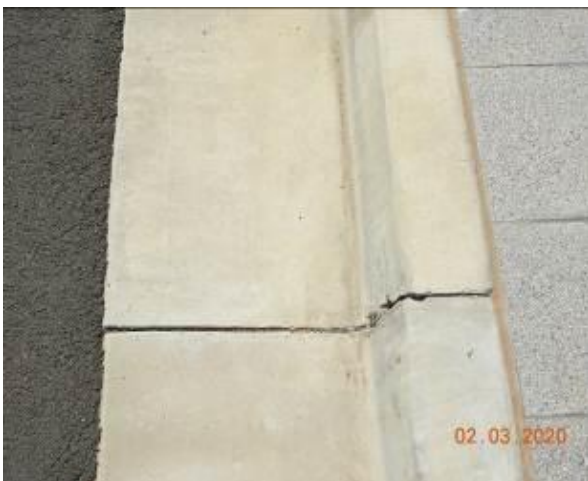
Figure 2157 – Loss of material through kerb and gutter

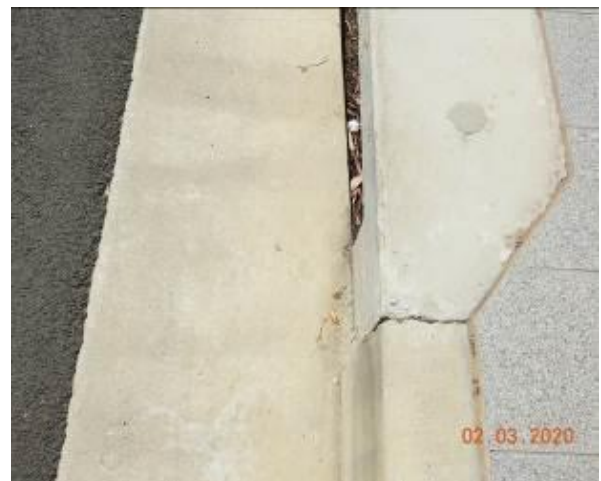
Figure 2158 – Crack propagation through kerb

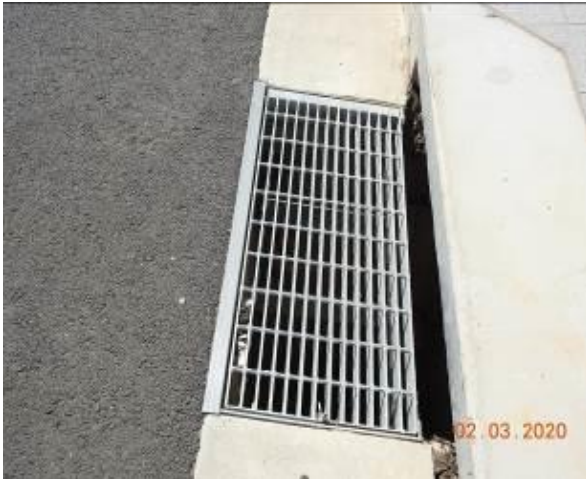
Figure 2159 – General Condition of stormwater inlet pit

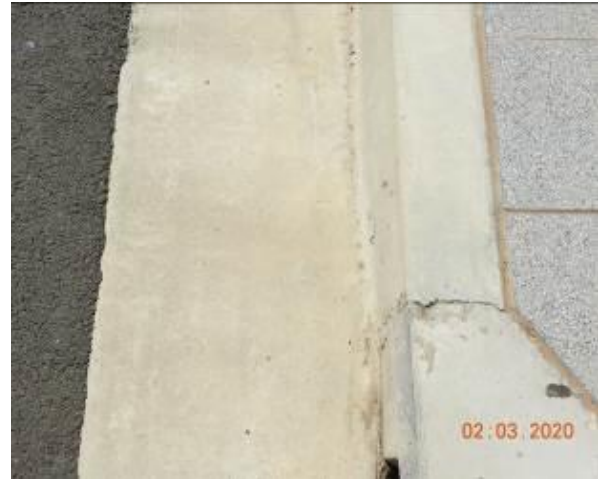
Figure 2160 – Crack propagation through kerb

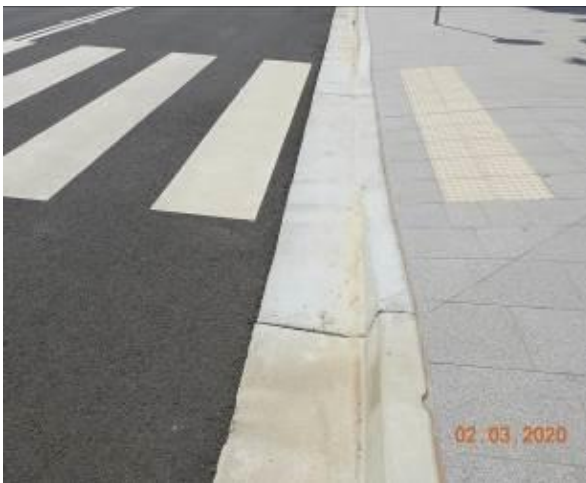
Figure 2161 – General Condition of layback and gutter

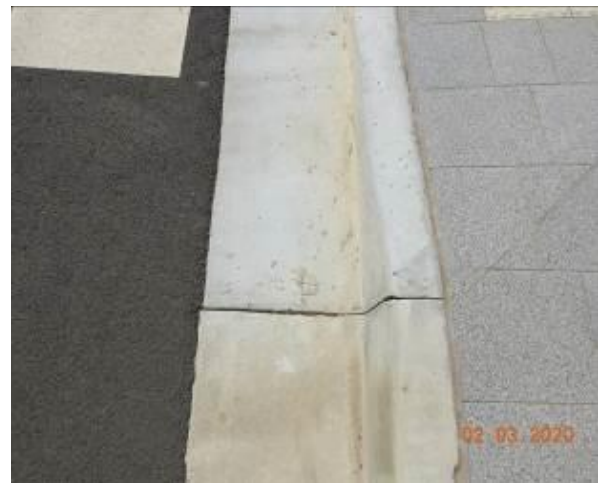
Figure 2162 – General Condition of kerb and gutter

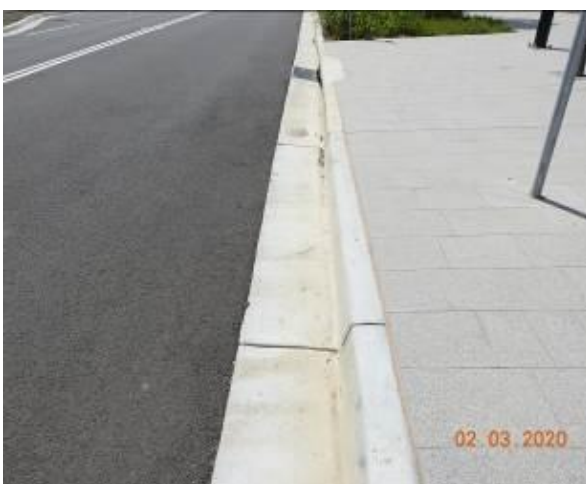
Figure 2163 – General Condition of kerb and gutter

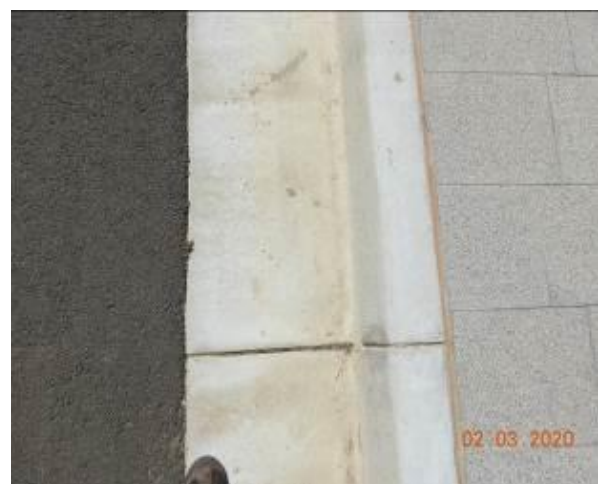
Figure 2164 – Crack propagation through kerb and gutter

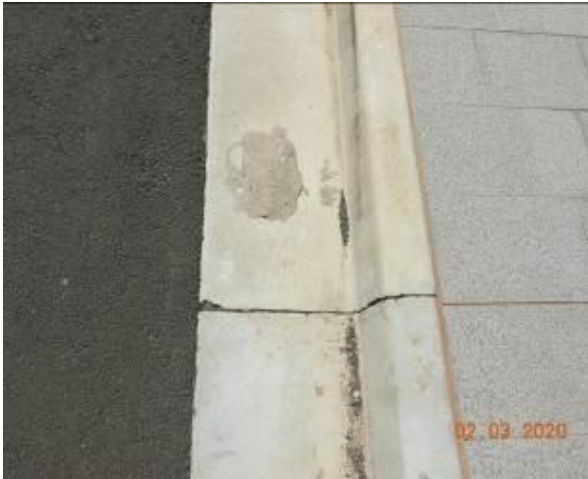
Figure 2165 – Crack propagation and loss of material through kerb and gutter

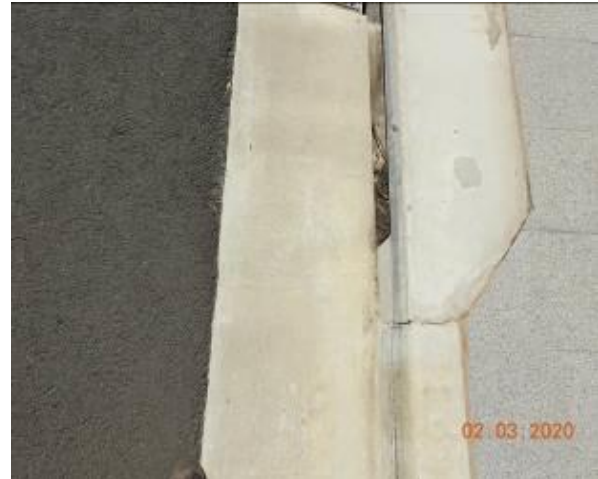
Figure 2166 – Crack propagation through kerb and gutter

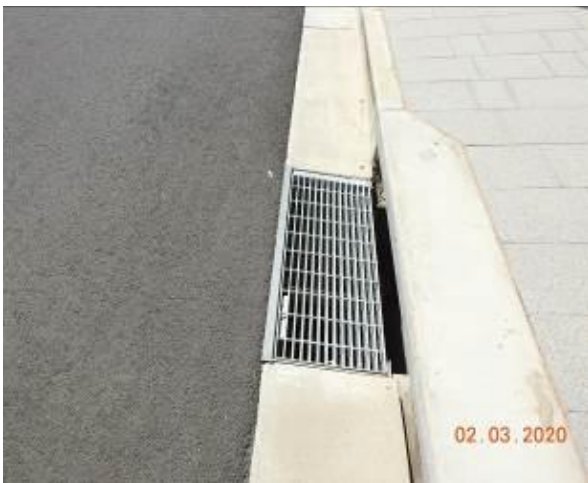
Figure 2167 – General Condition of stormwater inlet pit

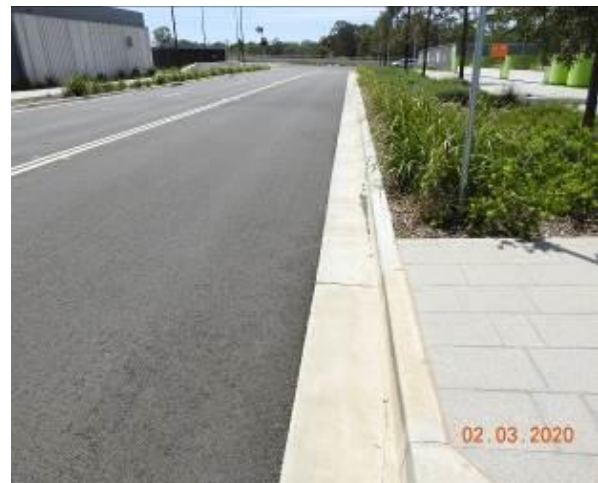
Figure 2168 – General Condition of kerb and gutter

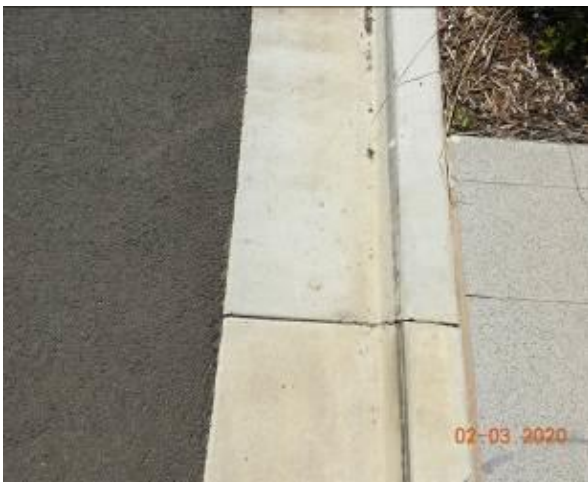
Figure 2169 – General Condition of kerb and gutter

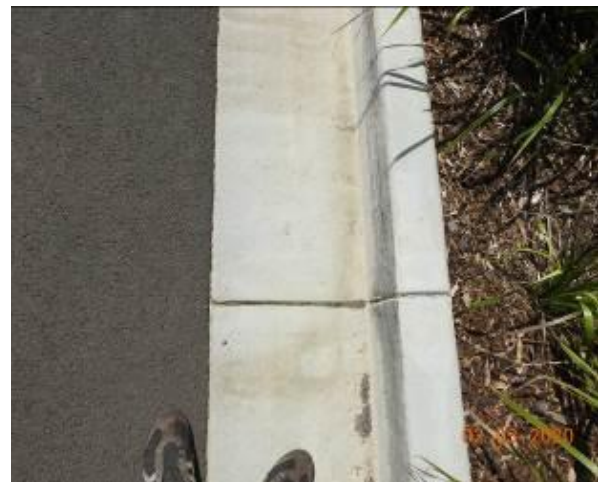
Figure 2170 – Crack propagation through kerb

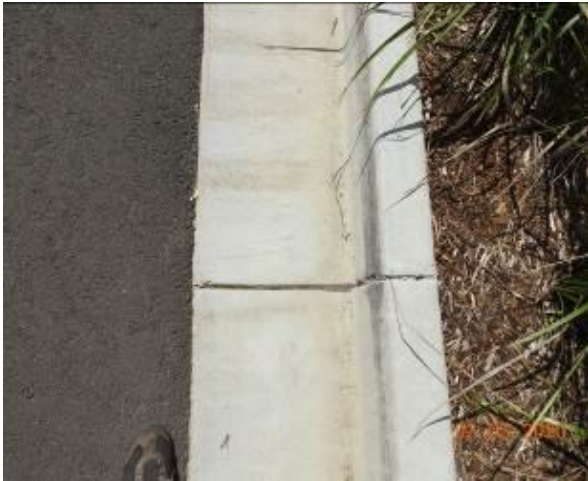
Figure 2171 – Crack propagation through kerb

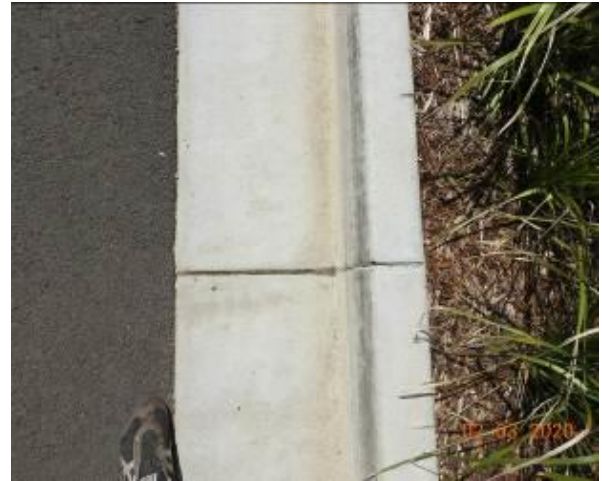
Figure 2172 – Crack propagation through kerb and gutter

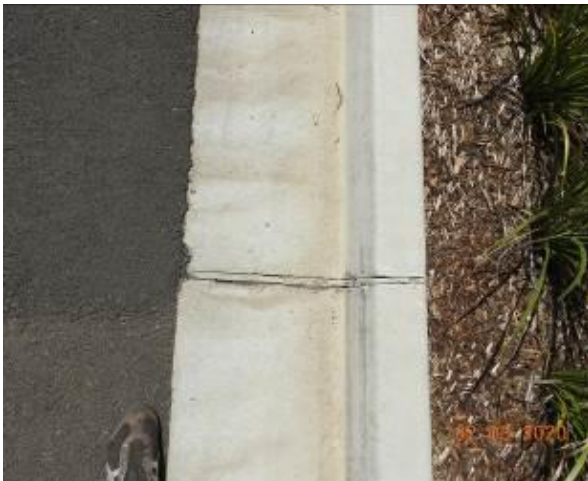
Figure 2173 – Crack propagation through kerb and gutter

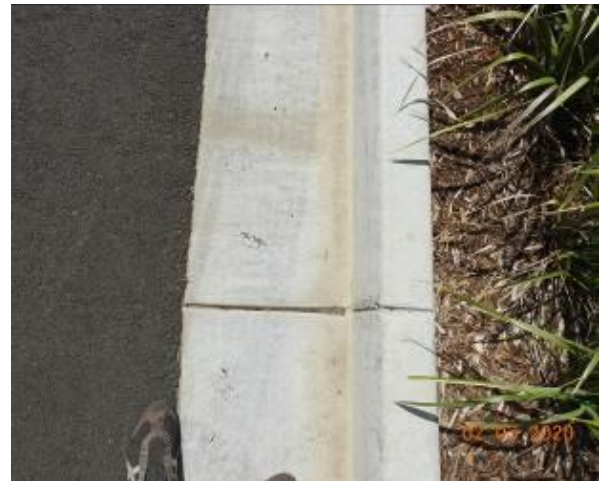
Figure 2174 – Crack propagation through kerb and gutter

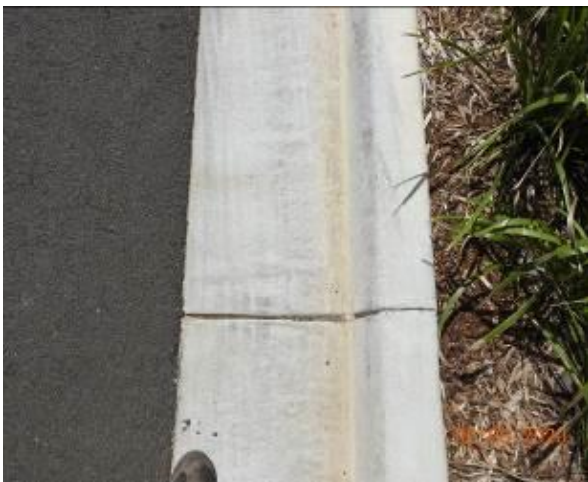
Figure 2175 – Crack propagation through kerb and gutter

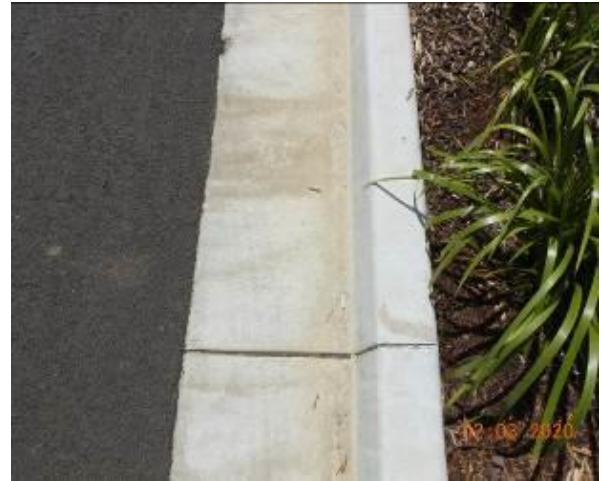
Figure 2178 – Crack propagation through kerb and gutter

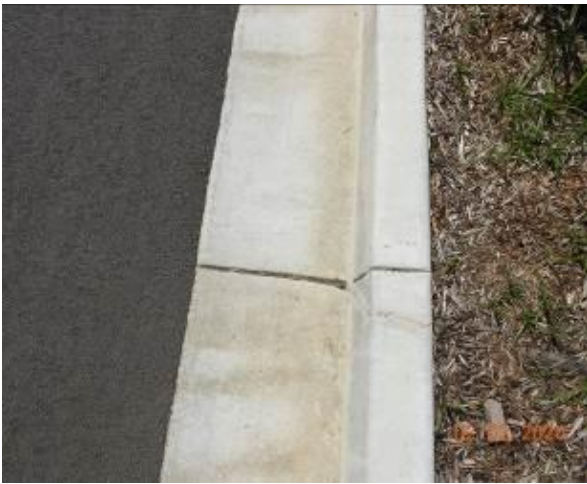
Figure 2179 – Crack propagation through kerb

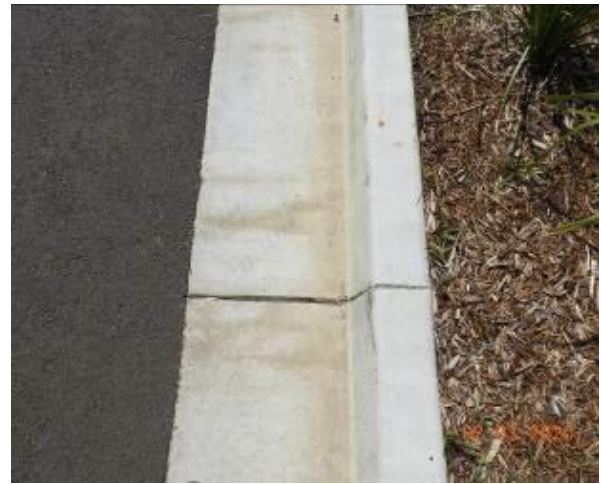
Figure 2180 – Crack propagation through kerb and gutter

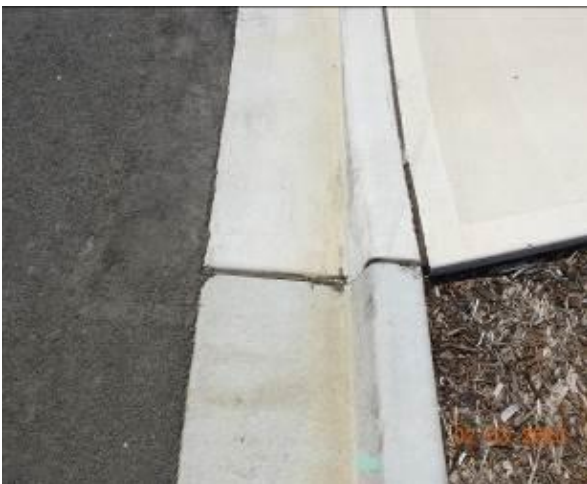
Figure 2181 – Crack propagation and loss of material through kerb and gutter

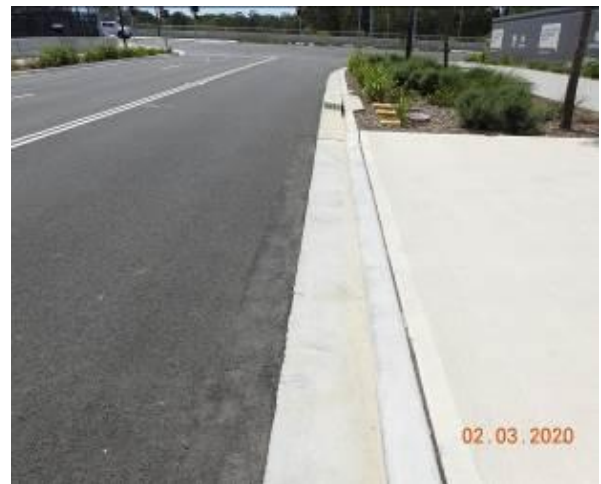
Figure 2182 – General Condition of layback and gutter

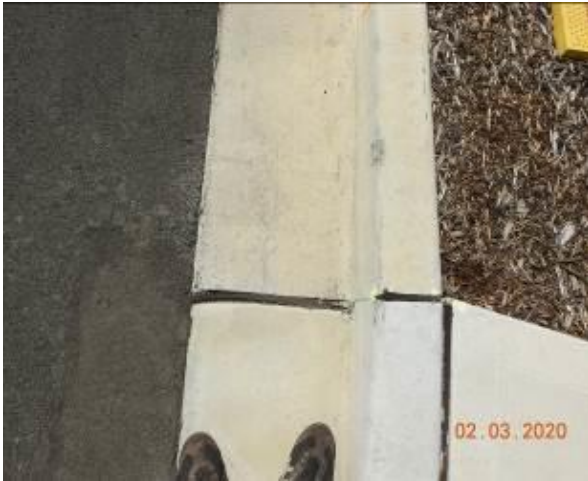
Figure 2183 – Crack propagation through kerb

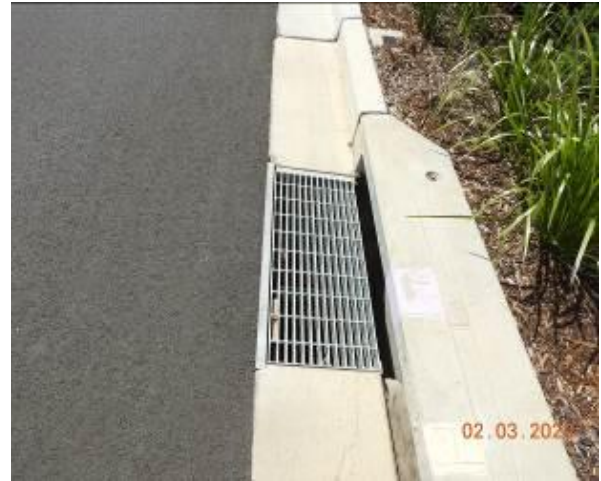
Figure 2184 – General Condition of stormwater inlet pit

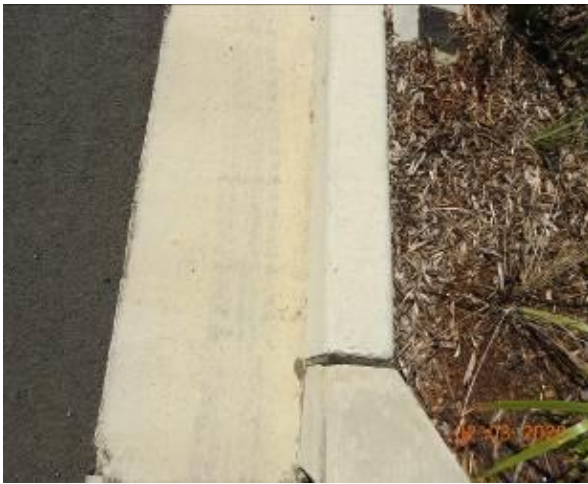
Figure 2185 – Crack propagation through kerb

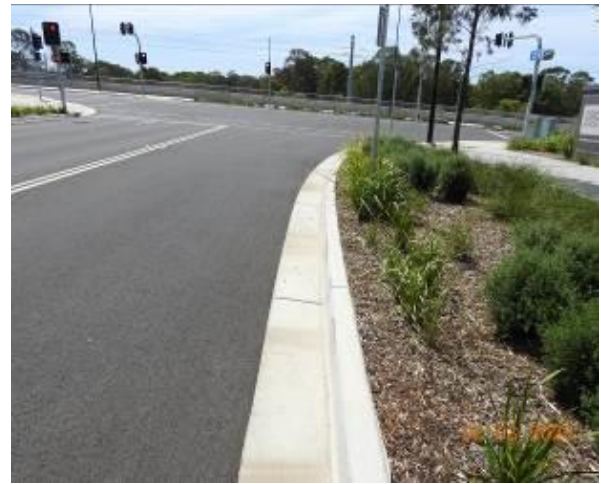
Figure 2186 – General Condition of kerb and gutter

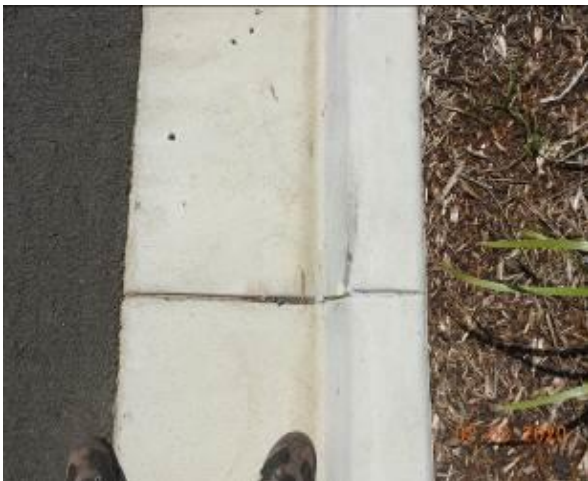
Figure 2187 – Crack propagation through kerb and gutter

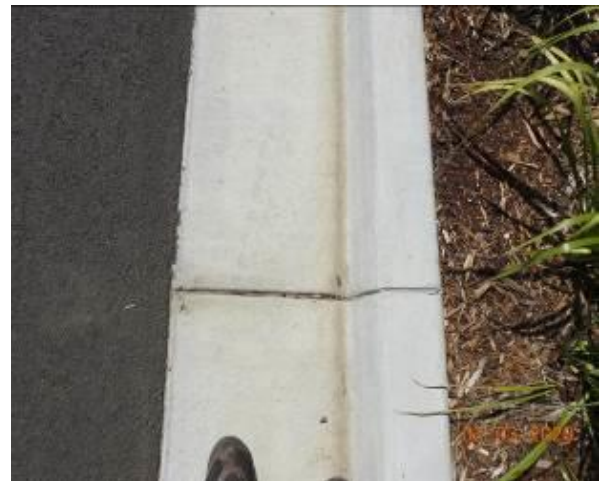
Figure 2188 – Crack propagation through kerb and gutter

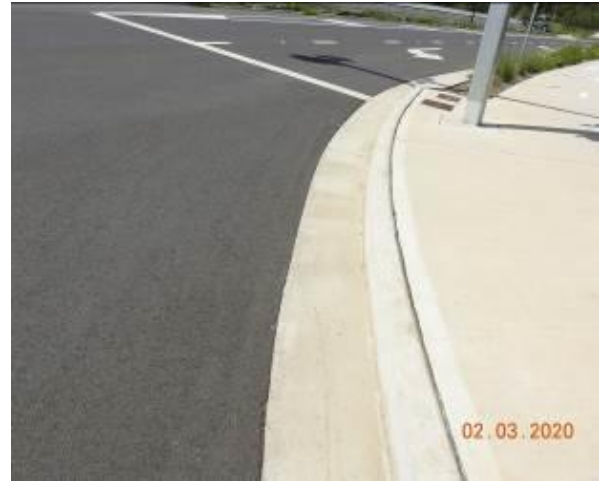
Figure 2196 – General Condition of layback and gutter

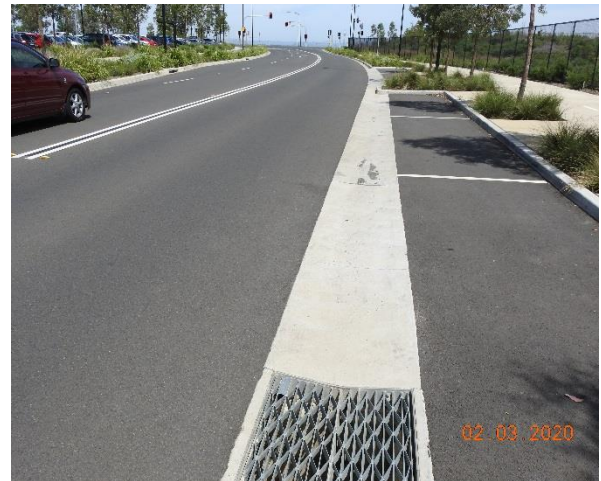
Figure 2198 – General Condition of gutter

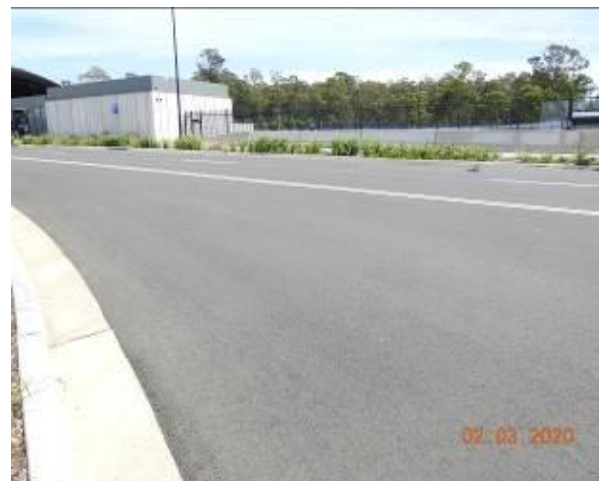
Figure 2200 – General Condition of road surface

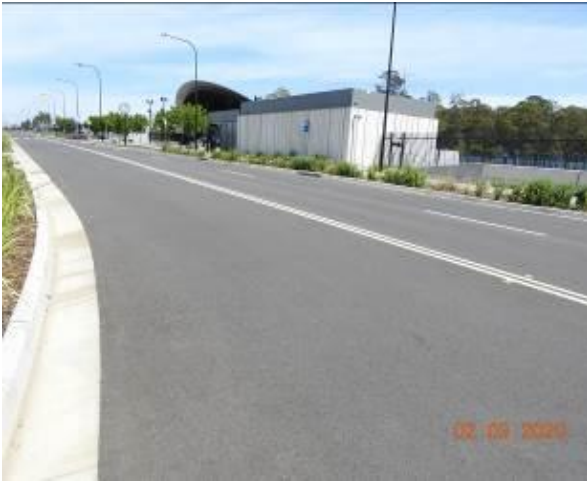
Figure 2201 – General Condition of road surface

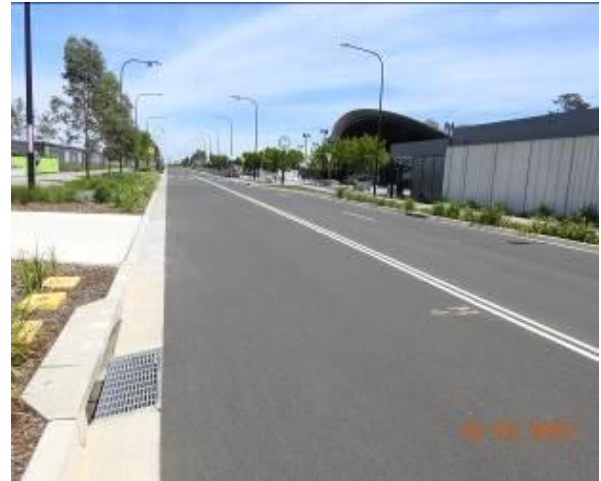
Figure 2202 – General Condition of road surface

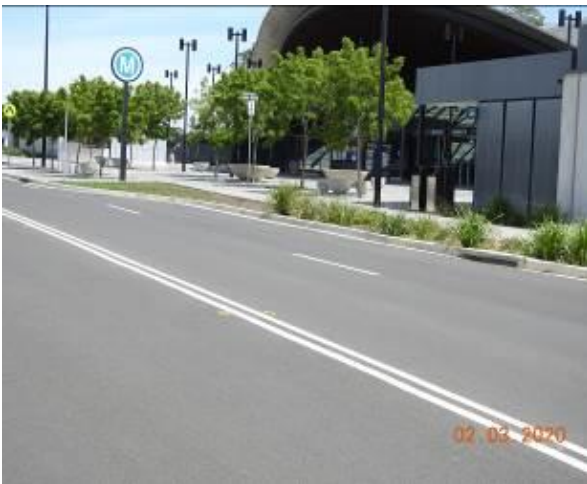
Figure 2203 – General Condition of road surface

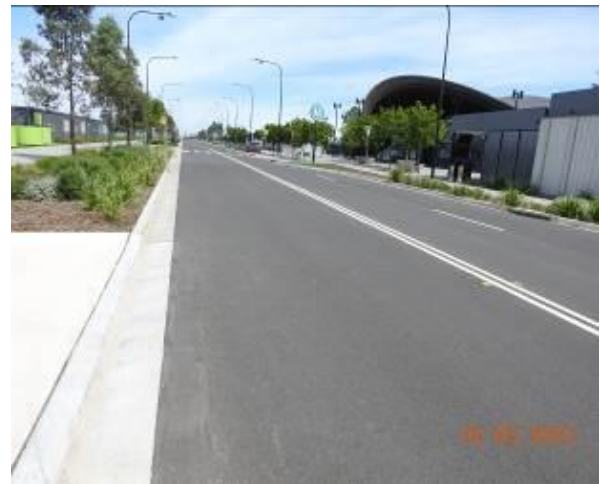
Figure 2204 – General Condition of road surface

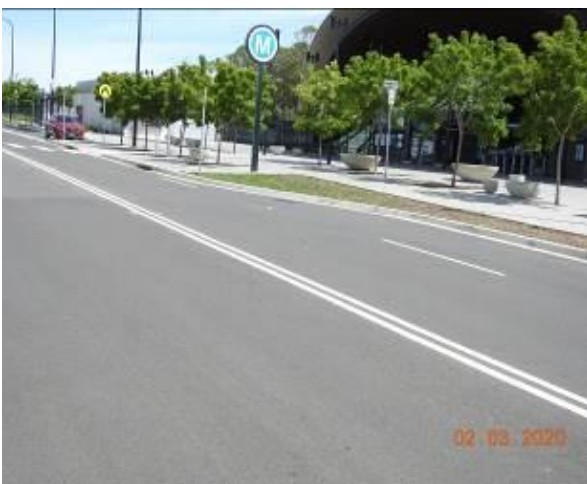
Figure 2205 – General Condition of road surface

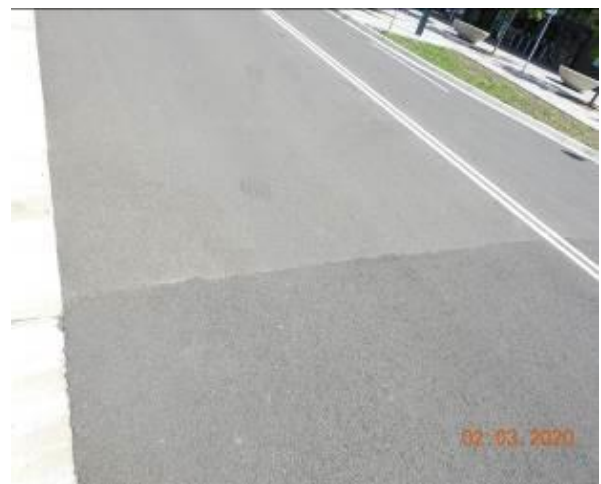
Figure 2206 – General Condition of road surface

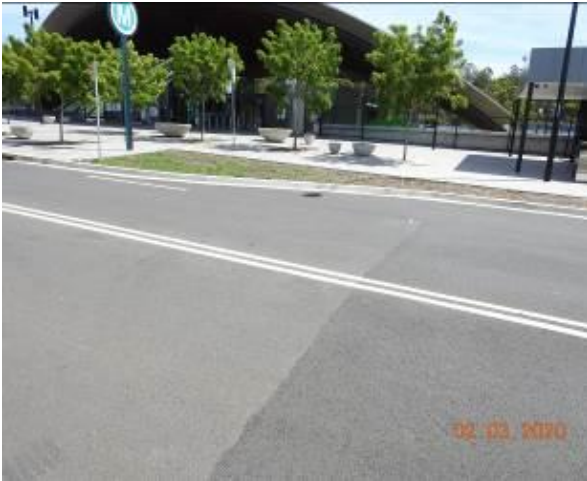
Figure 2207 – General Condition of road surface

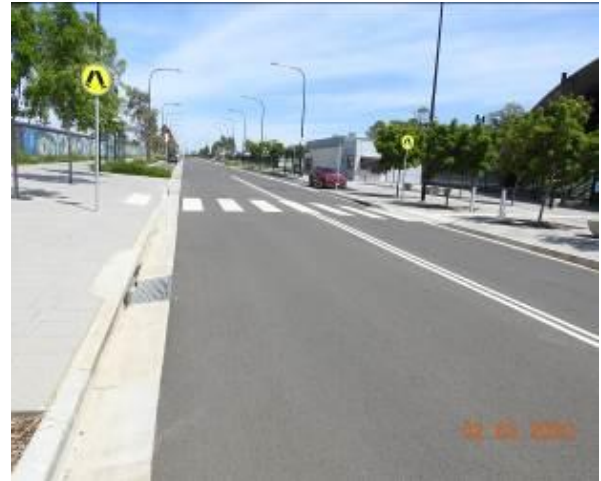
Figure 2208 – General Condition of road surface

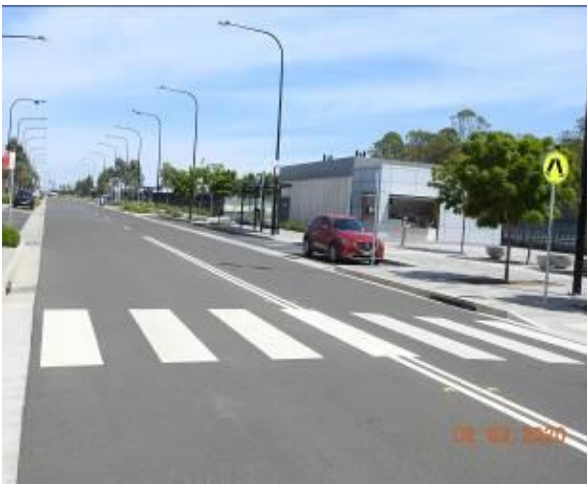
Figure 2209 – General Condition of road surface

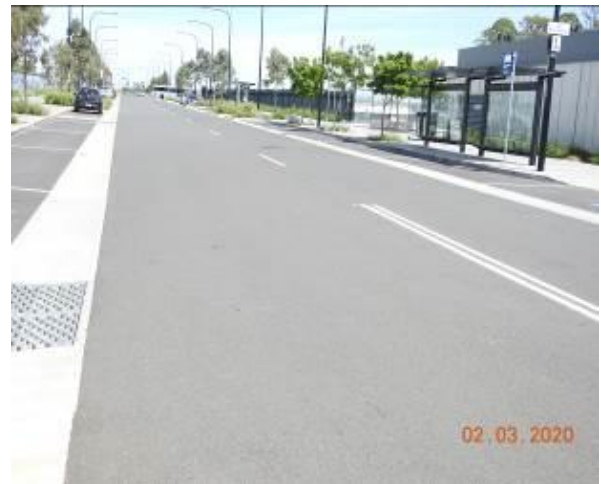
Figure 2210 – General Condition of road surface

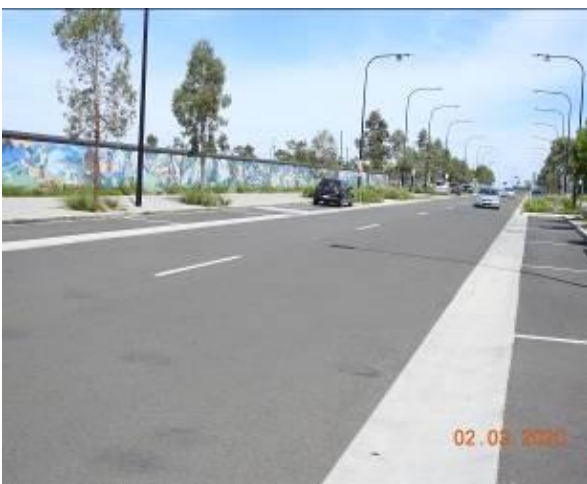
Figure 2211 – General Condition of road surface

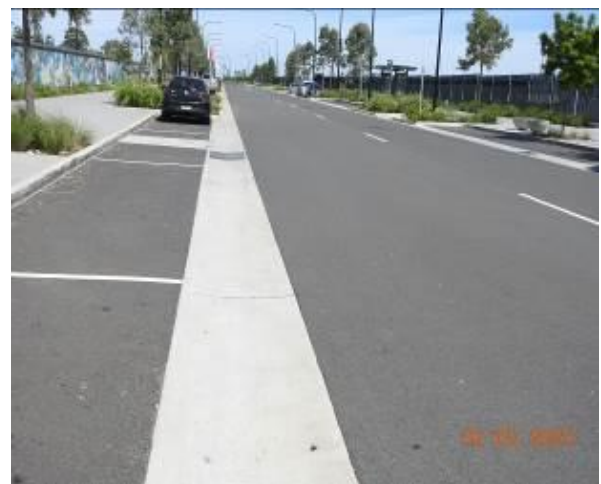
Figure 2212 – General Condition of road surface

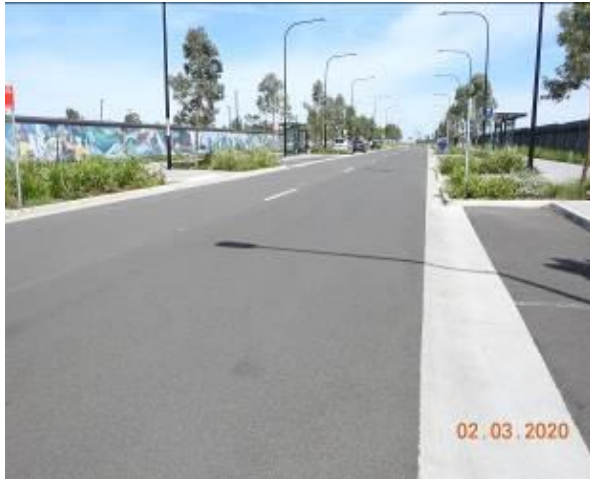
Figure 2213 – General Condition of road surface

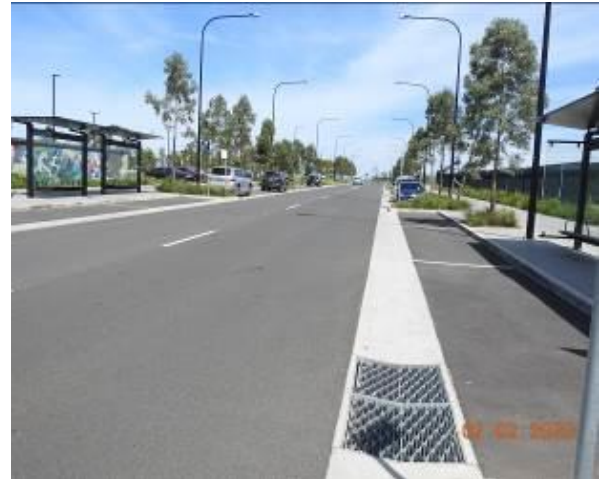
Figure 2214 – General Condition of road surface

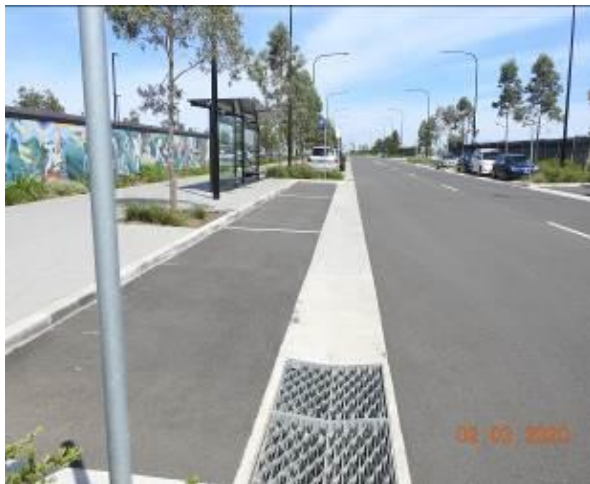
Figure 2215 – General Condition of road surface

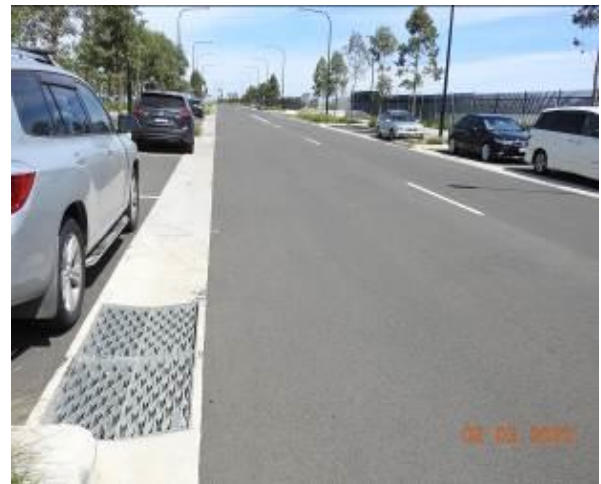
Figure 2216 – General Condition of road surface

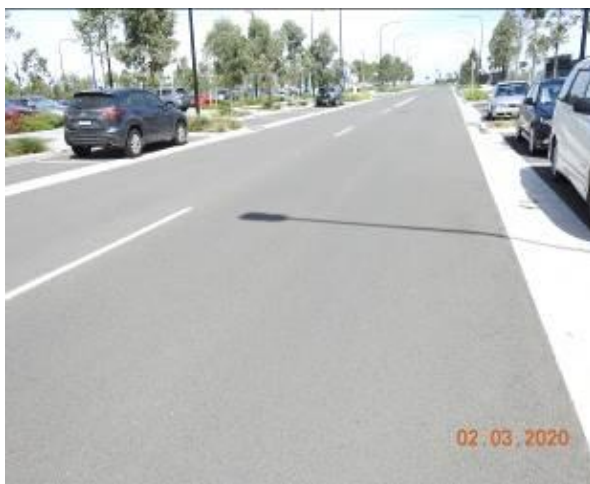
Figure 2217 – General Condition of road surface

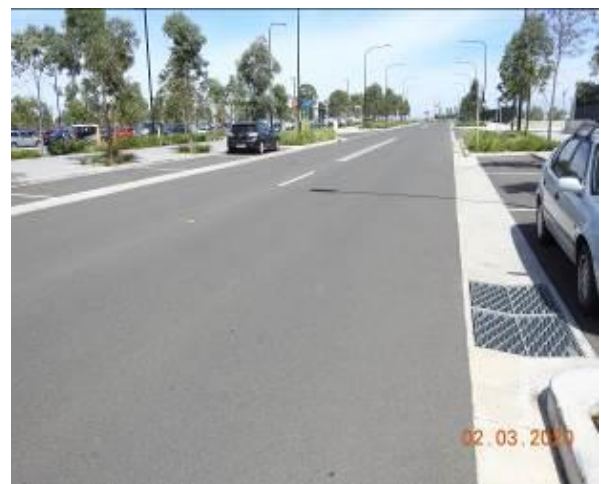
Figure 2218 – General Condition of road surface

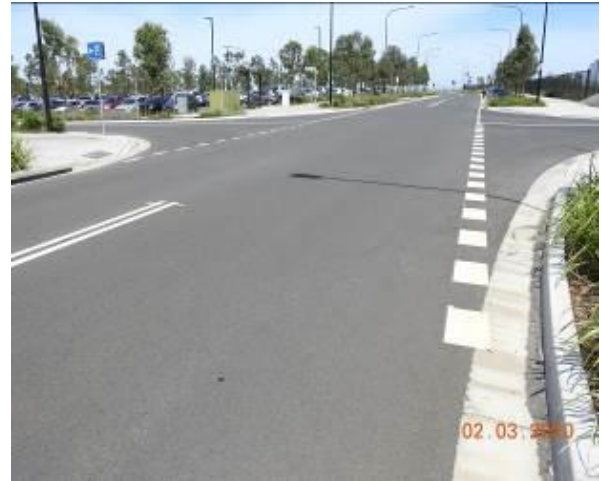
Figure 2220 – General Condition of road surface

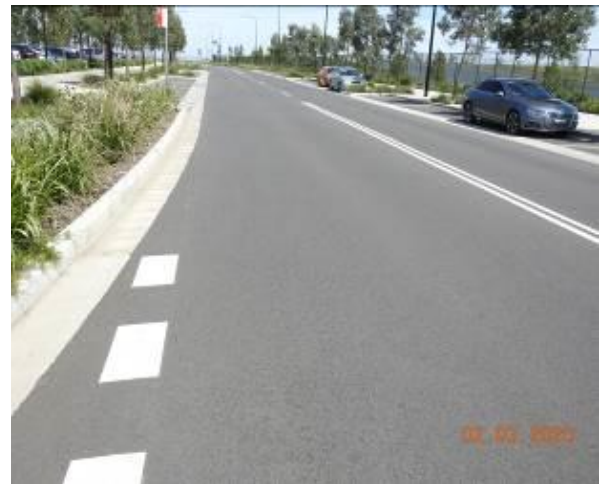
Figure 2222 – General Condition of road surface

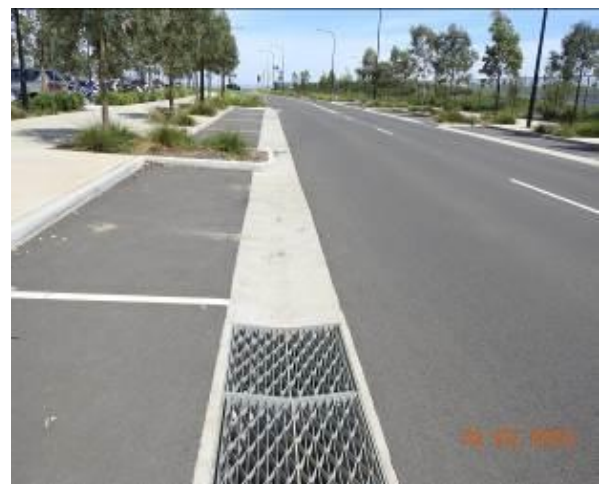
Figure 2224 – General Condition of road surface

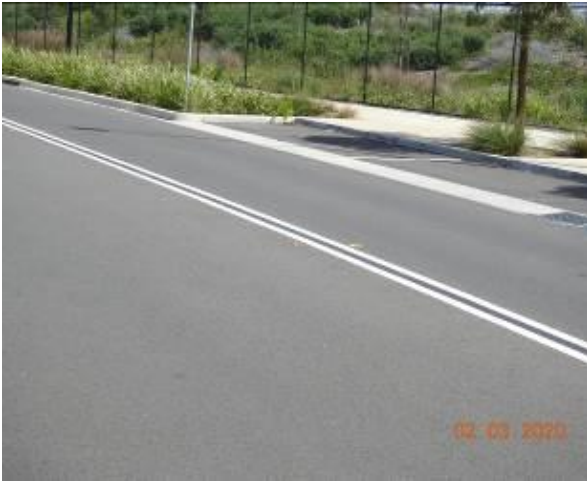
Figure 2231 – General Condition of road surface

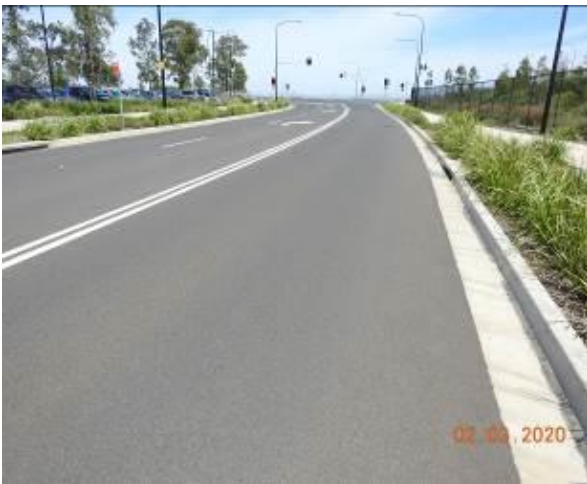
Figure 2233 – General Condition of road surface

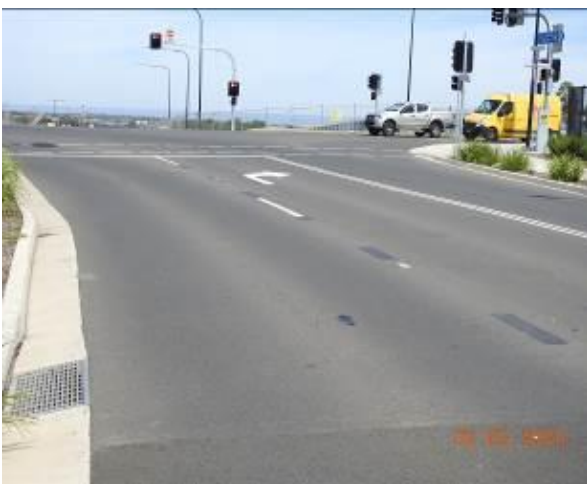
Figure 2235 – General Condition of road surface

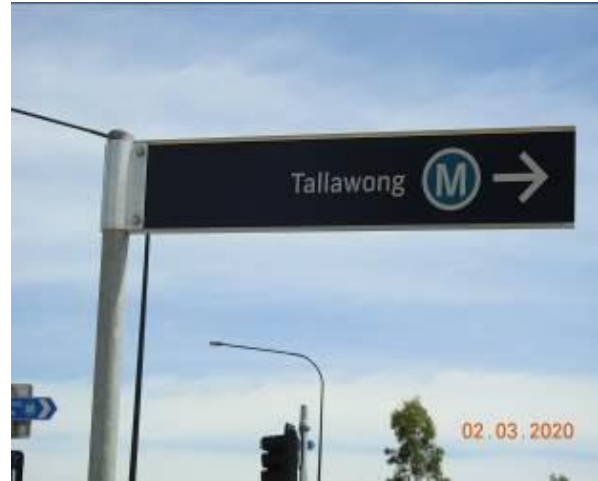
Figure 2238 – General Condition of street sign

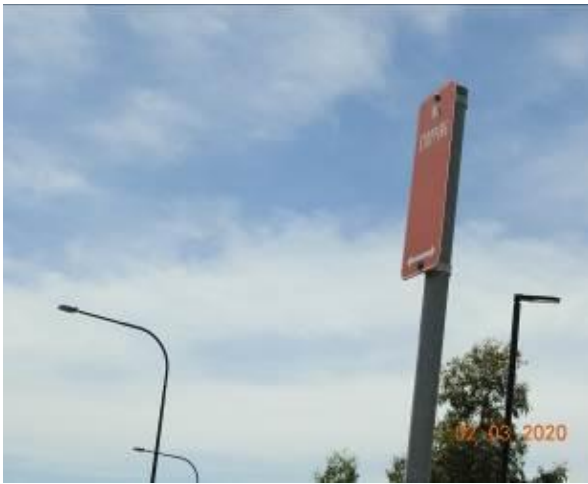
Figure 2239 – General Condition of street sign

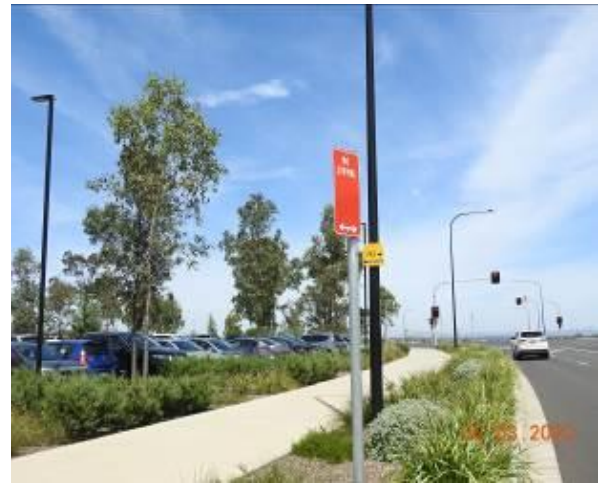
Figure 2240 – General Condition of street sign

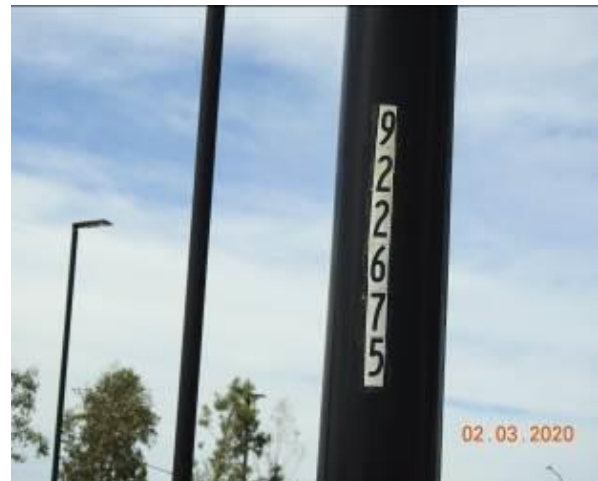
Figure 2242 – General Condition of lamp post
Identification No.922675

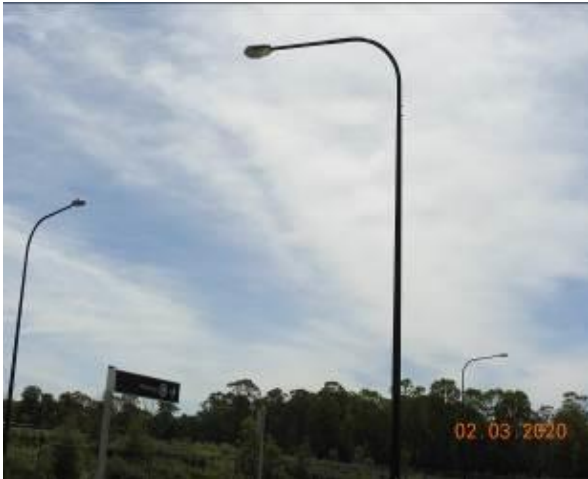
Figure 2243 – General Condition of lamp post

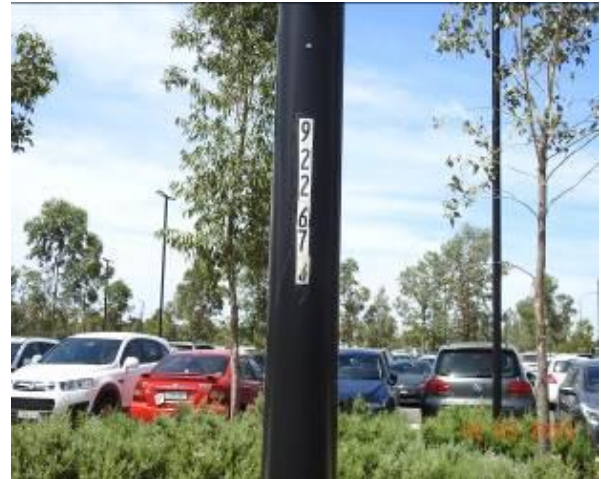
Figure 2244 – General Condition of lamp post
Identification No.922678

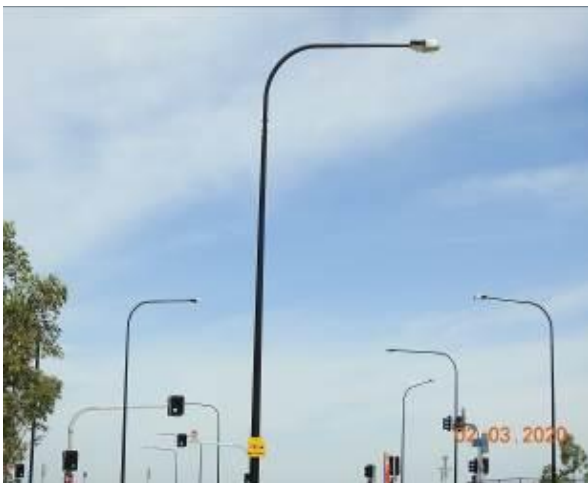
Figure 2245 – General Condition of lamp post

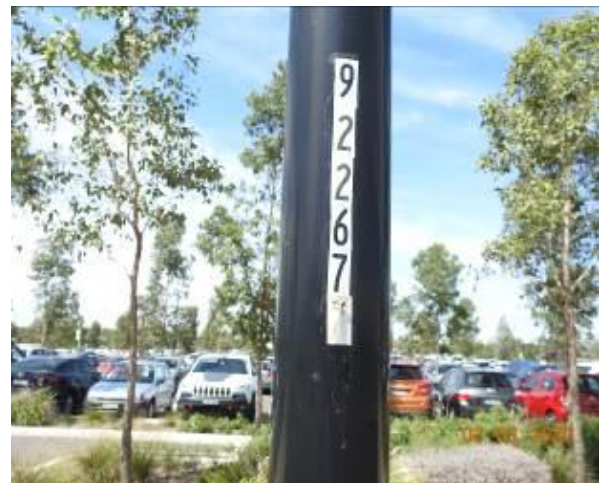
Figure 2246 – General Condition of lamp post
Identification No.922677

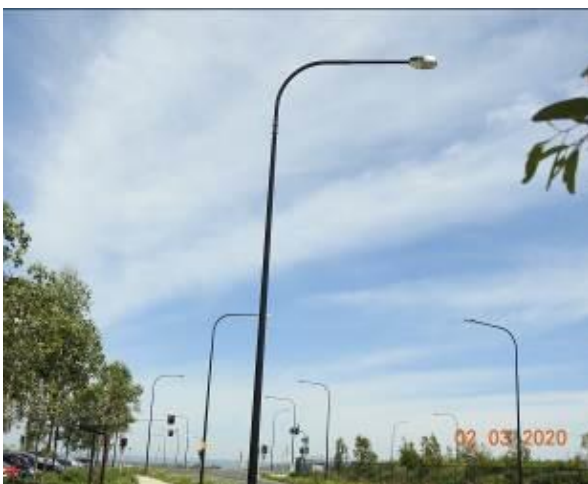
Figure 2247 – General Condition of lamp post

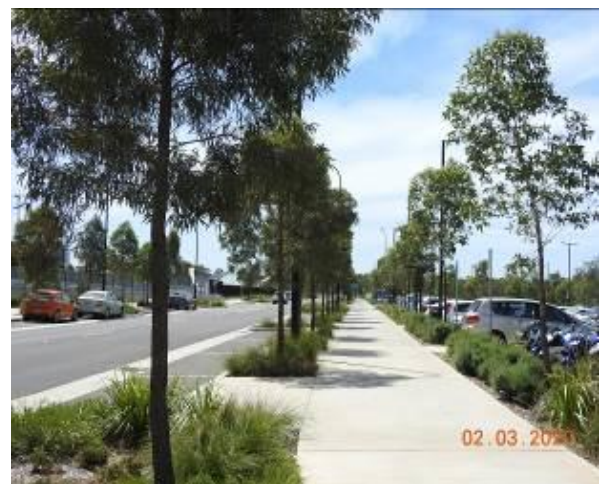
Figure 2248 – General Condition of plantation

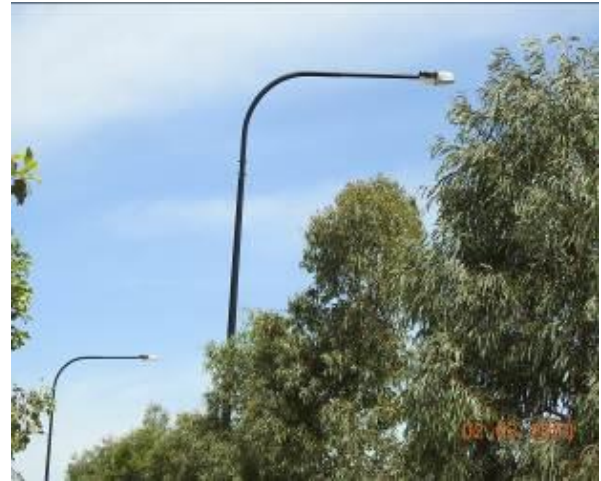
Figure 2250 – General Condition of lamp post
