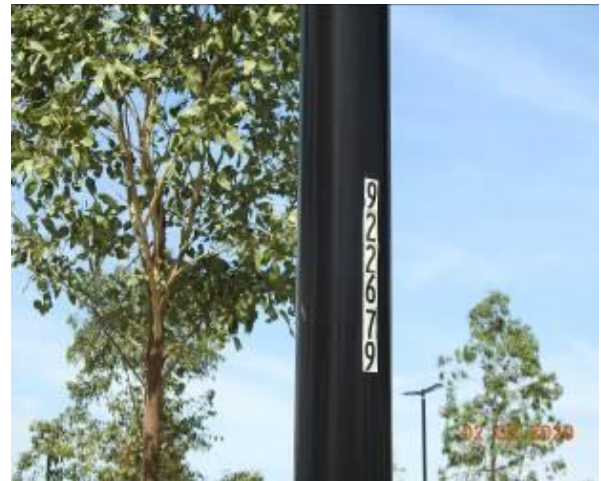
Figure 2252 – General Condition of lamp post
Identification No.922679

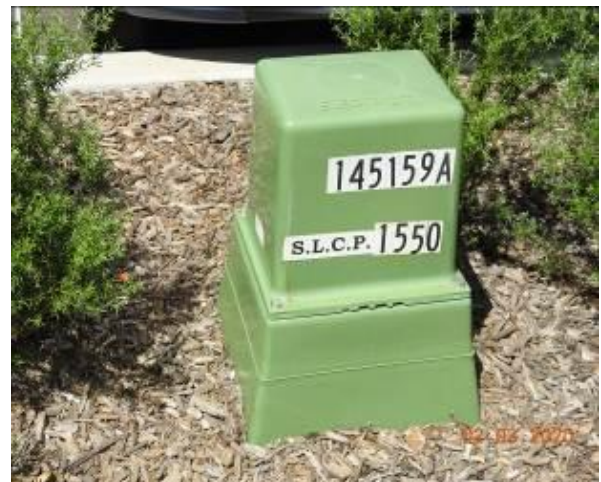
Figure 2254 – General Condition of electricity box
Identification No.145159A / S.L.C.P.1550

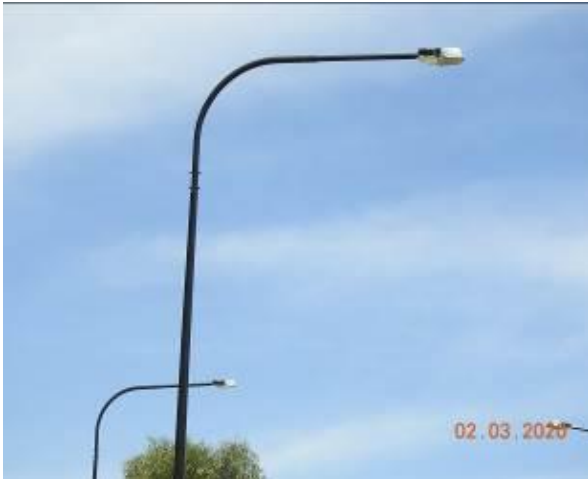
Figure 2261 – General Condition of lamp post

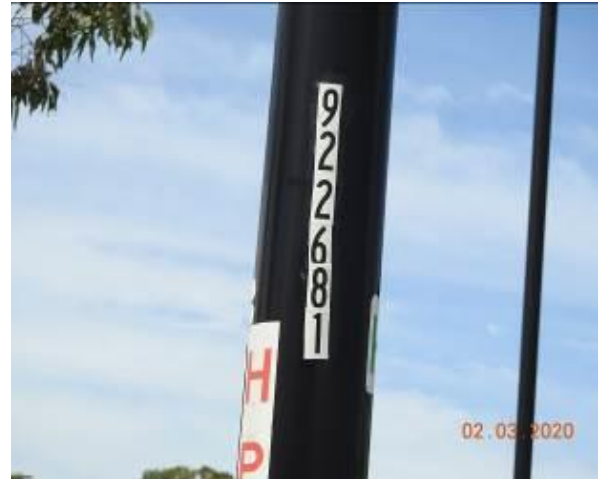
Figure 2262 – General Condition of lamp post
Identification No. 922681

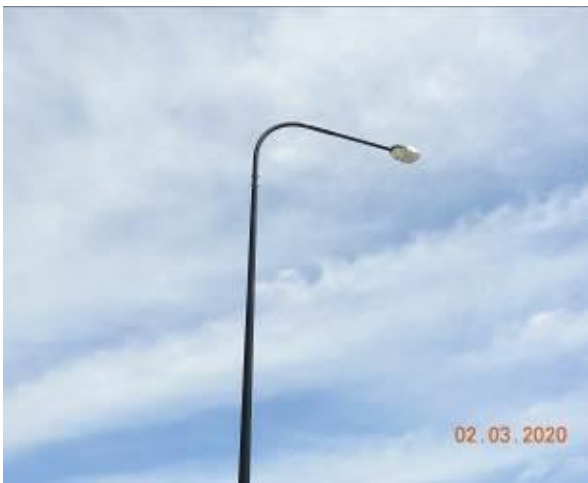
Figure 2263 – General Condition of lamp post

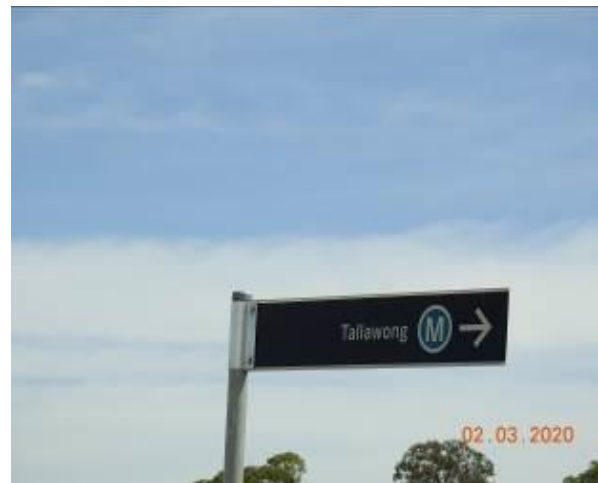
Figure 2264 – General Condition of street sign

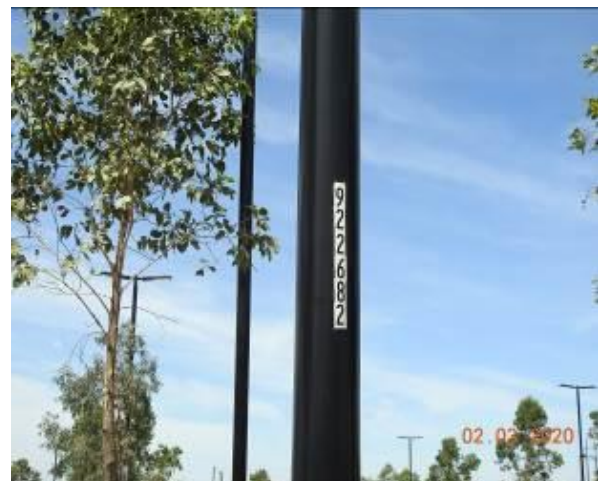
Figure 2266 – General Condition of lamp post
Identification No. 922682

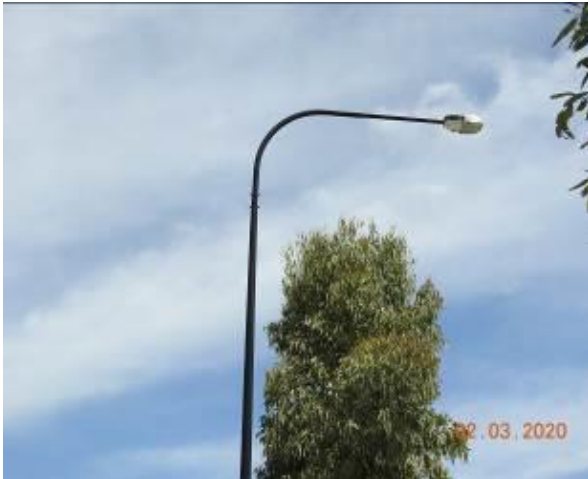
Figure 2267 – General Condition of lamp post

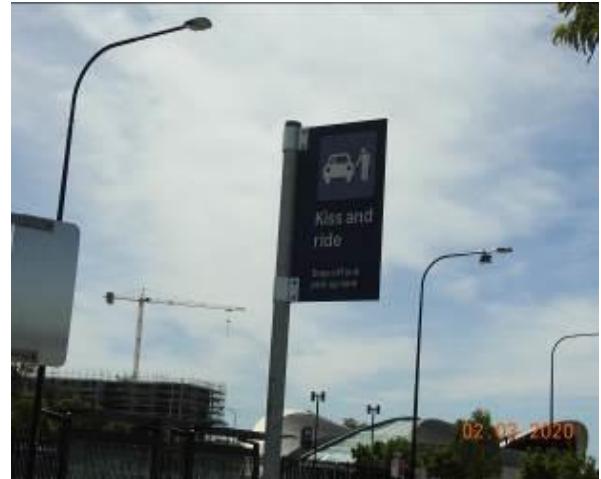
Figure 2268 – General Condition of street sign

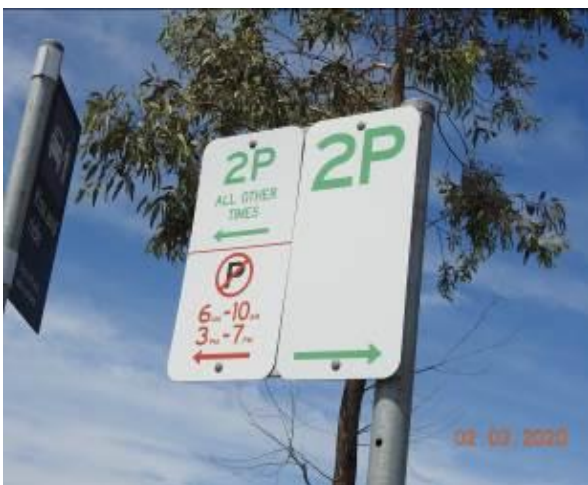
Figure 2269 – General Condition of street sign

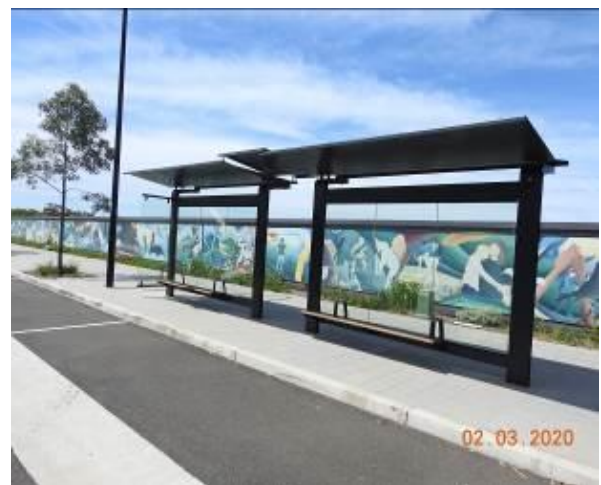
Figure 2270 – General Condition of bus stop public bench

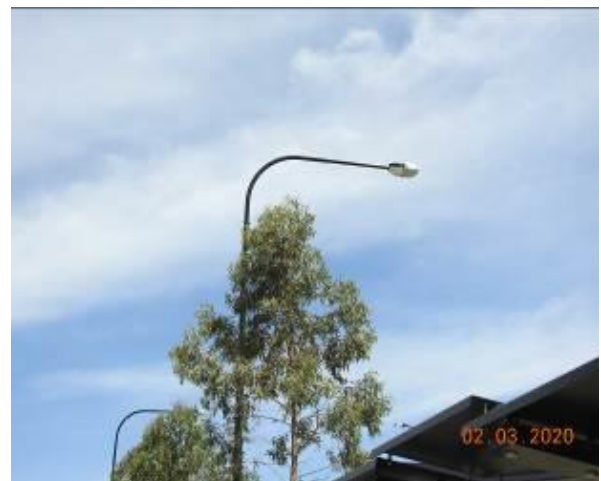
Figure 2272 – General Condition of lamp post

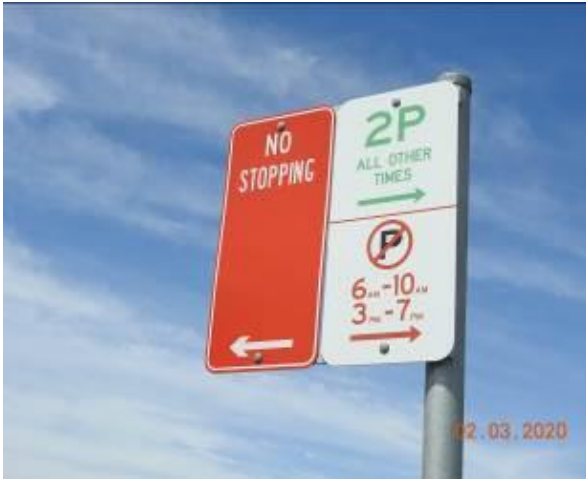
Figure 2273 – General Condition of street sign

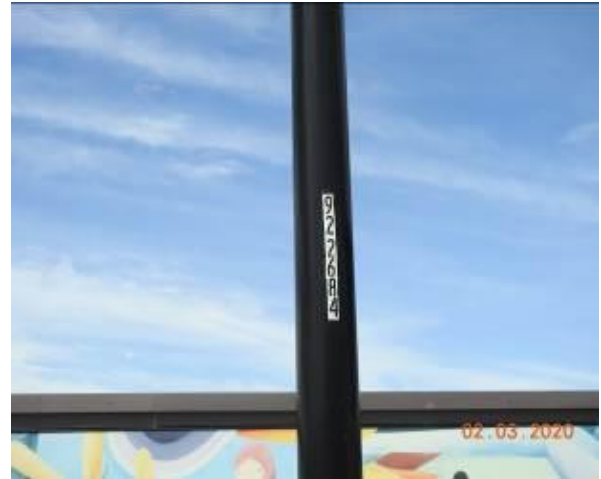
Figure 2274 – General Condition of lamp post
Identification No. 922684

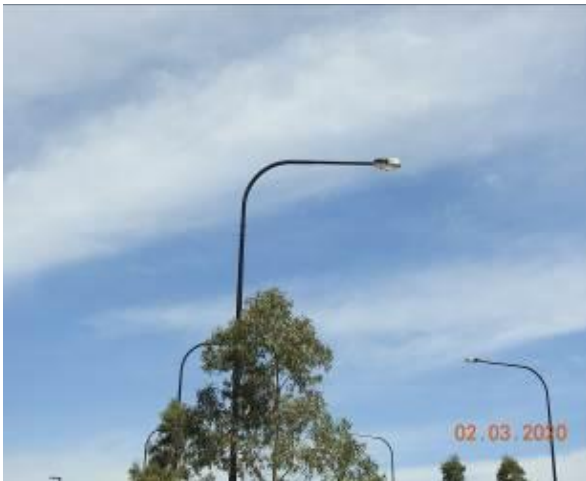
Figure 2275 – General Condition of lamp post

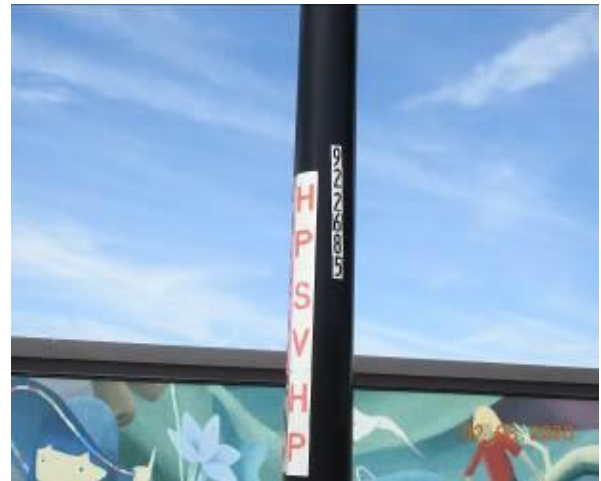
Figure 2276 – General Condition of lamp post
Identification No. 922685

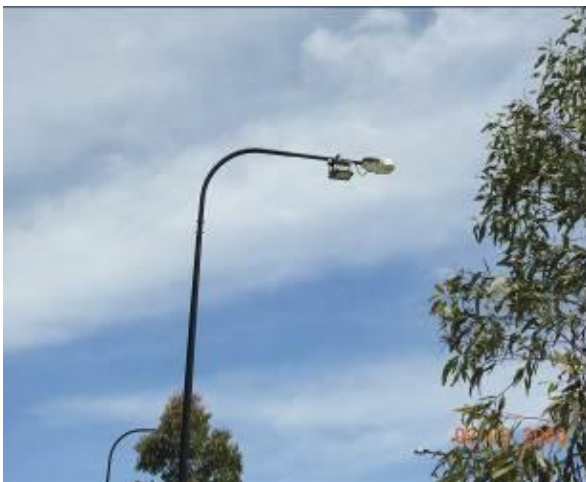
Figure 2277 – General Condition of lamp post

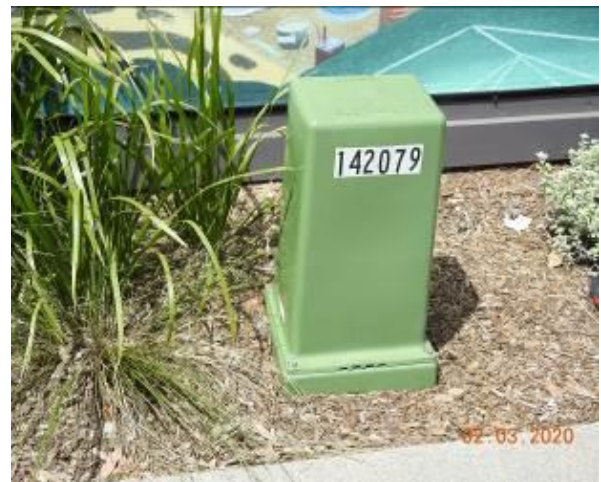
Figure 2278 – General Condition of electricity box
Identification No. 142079

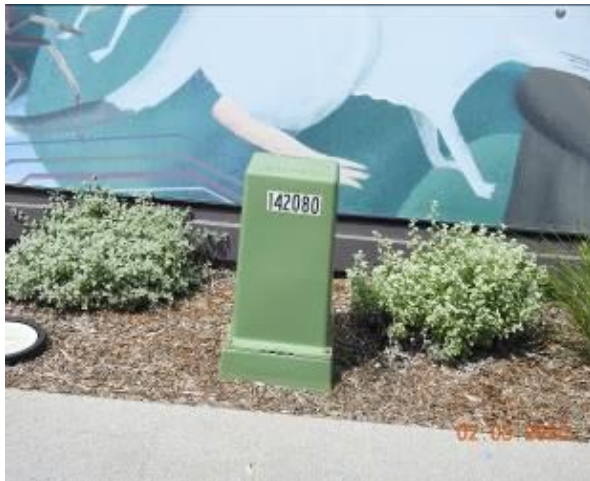
Figure 2279 – General Condition of electricity box
Identification No. 142079

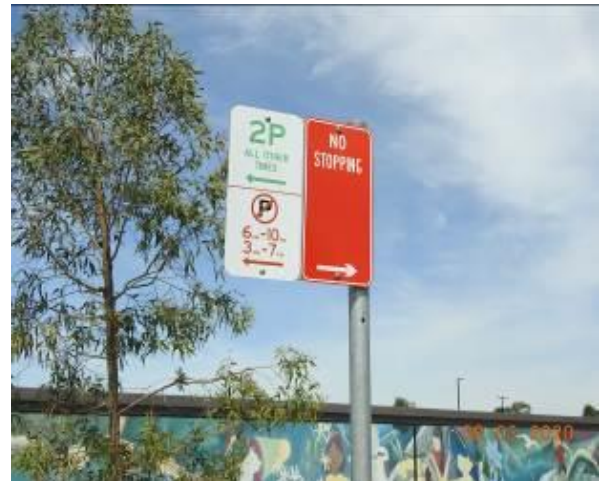
Figure 2280 – General Condition of street sign

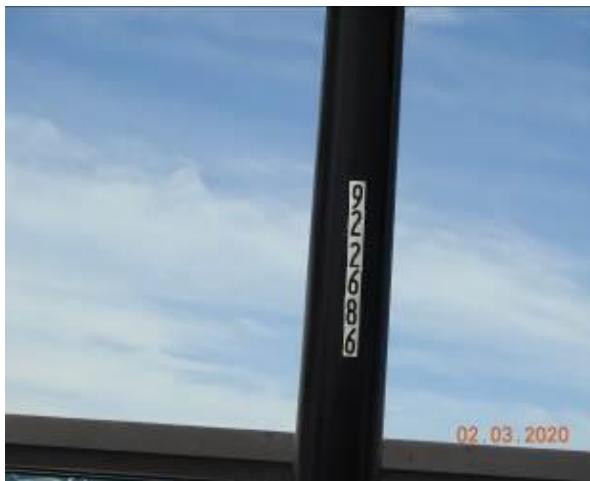
Figure 2281 – General Condition of lamp post
Identification No. 922686

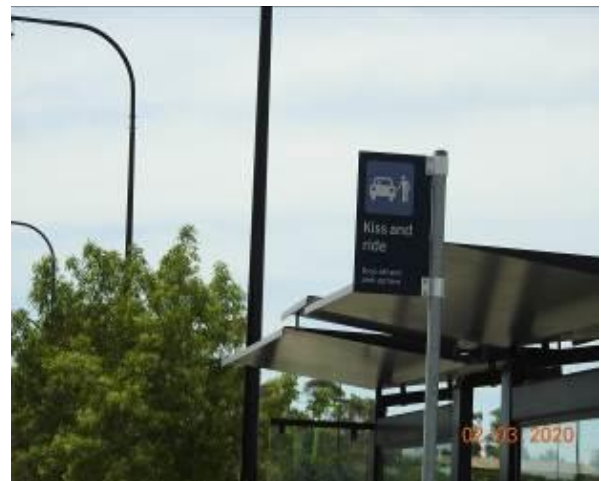
Figure 2282 – General Condition of street sign

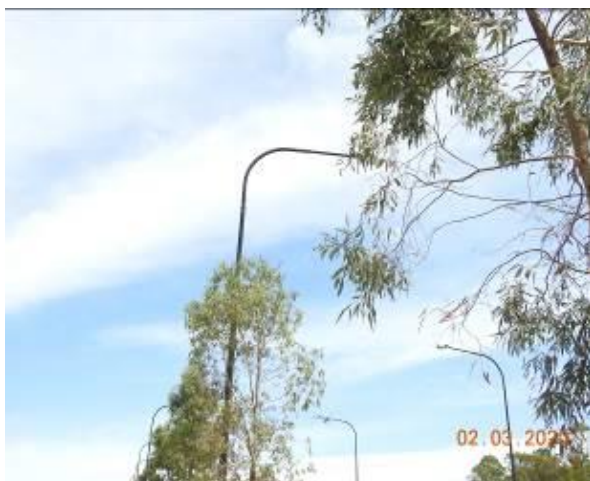
Figure 2283 – General Condition of lamp post

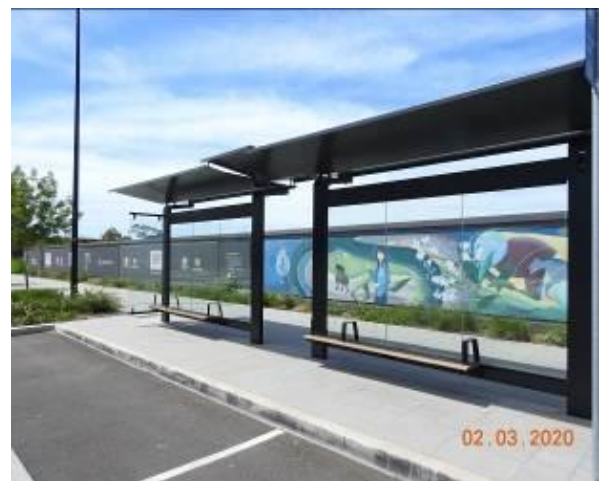
Figure 2284 – General Condition of bus stop public bench

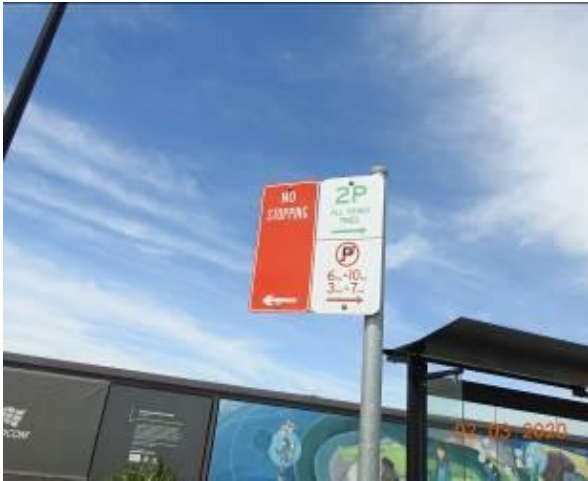
Figure 2285 – General Condition of street sign

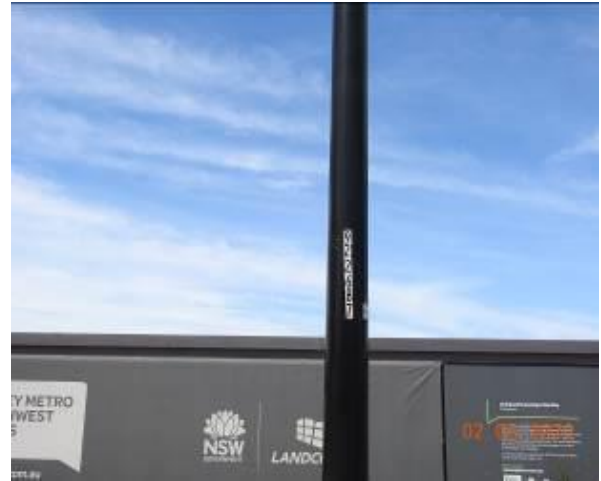
Figure 2286 – General Condition of lamp post
Identification No. 922687

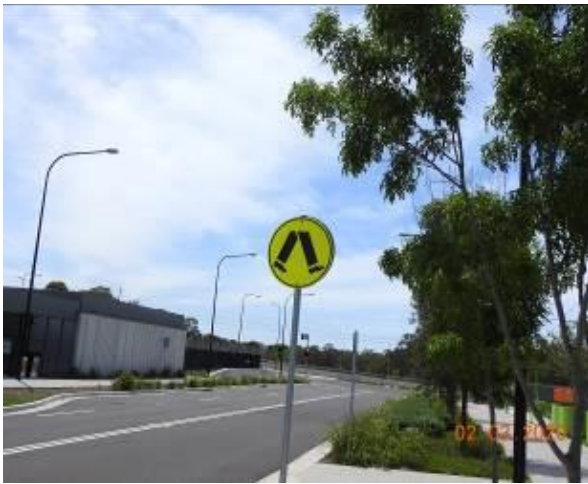
Figure 2287 – General Condition of street sign

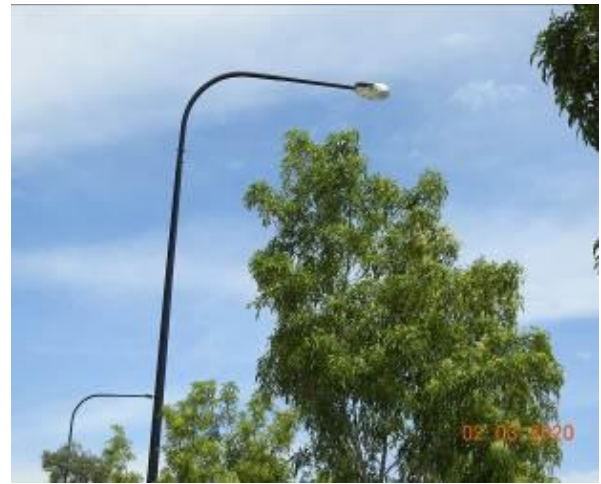
Figure 2288 – General Condition of lamp post

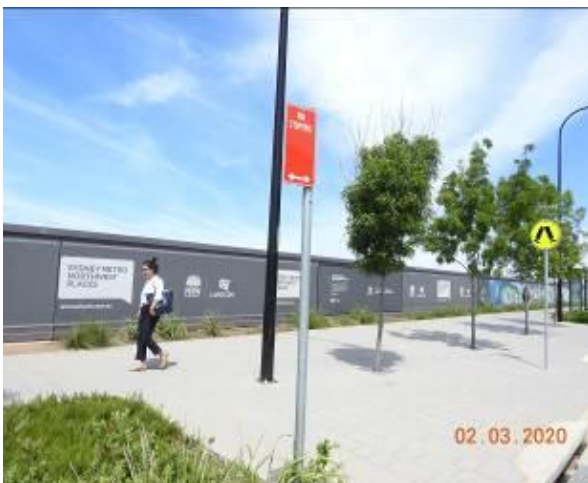
Figure 2289 – General Condition of street sign

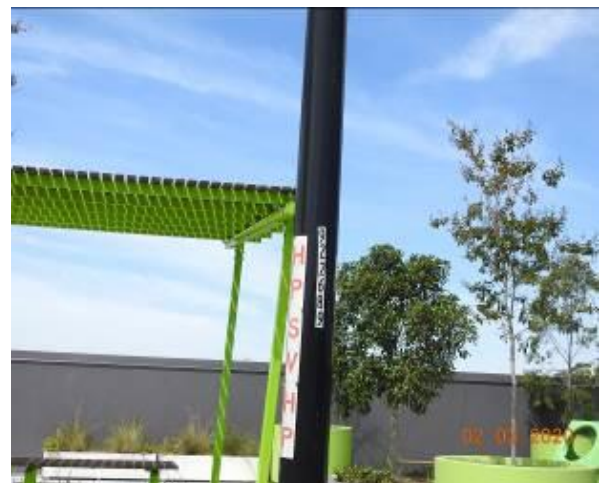
Figure 2290 – General Condition of lamp post
Identification No. 922689

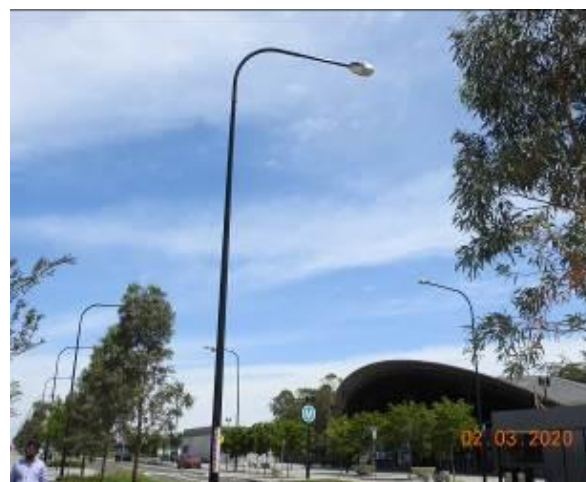
Figure 2292 – General Condition of lamp post

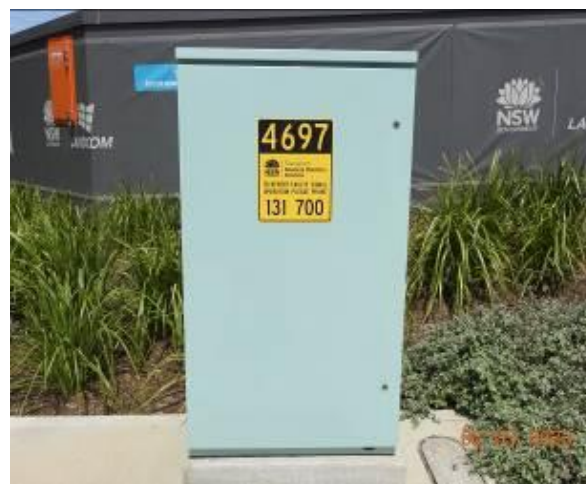
Figure 2294 – General Condition of electricity box
Identification No. 4697

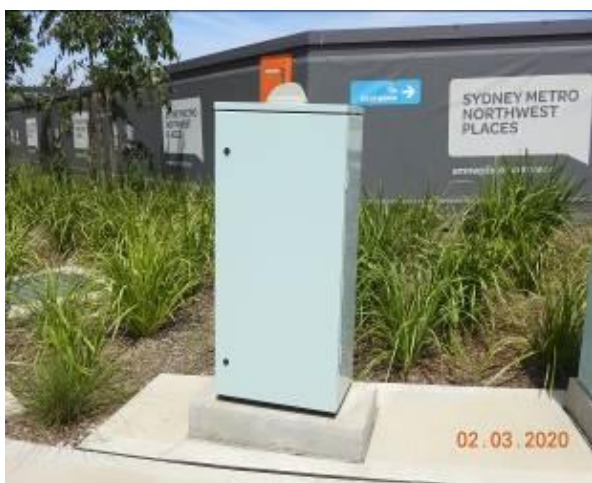
Figure 2295 – General Condition of electricity box

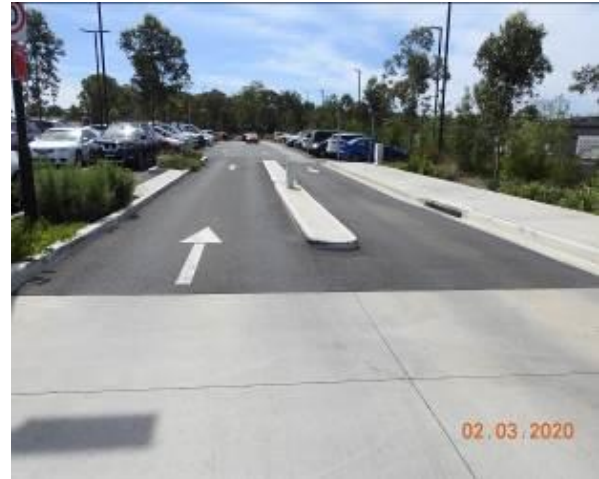
Figure 2297 – General Condition of driveway pavement

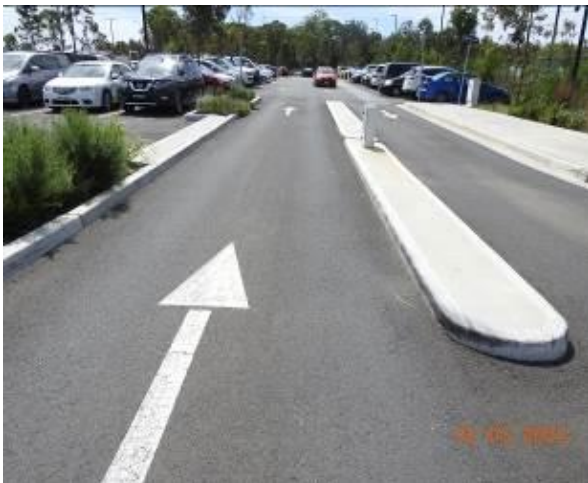
Figure 2298 – General Condition of carpark pavement

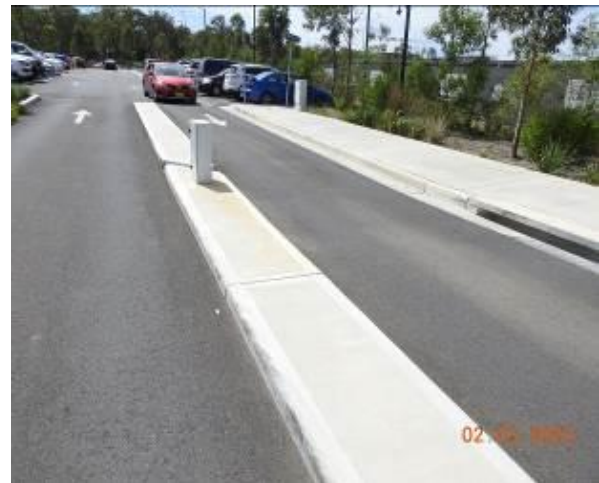
Figure 2299 – General Condition of carpark pavement

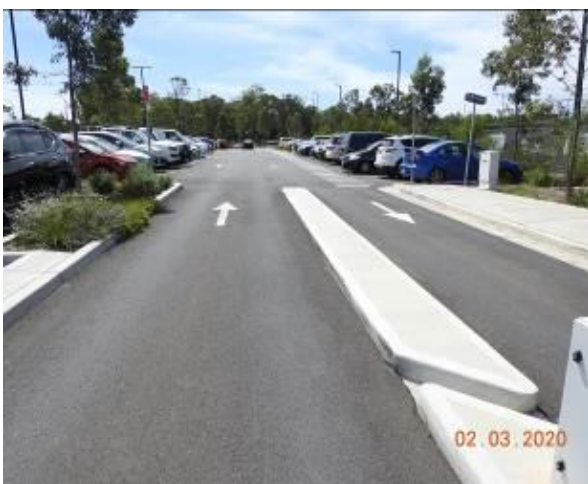
Figure 2300 – General Condition of carpark pavement

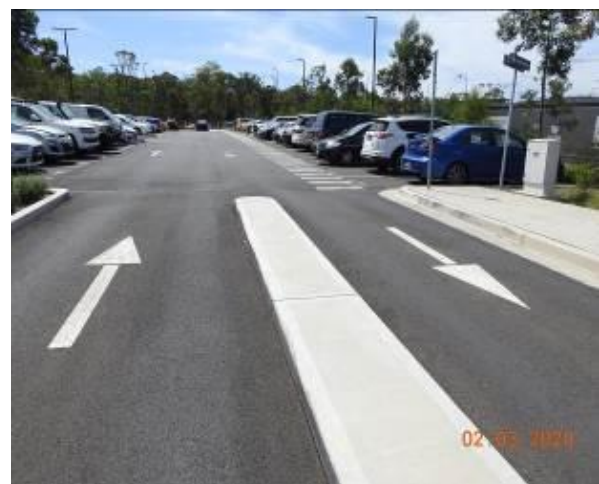
Figure 2301 – General Condition of carpark pavement

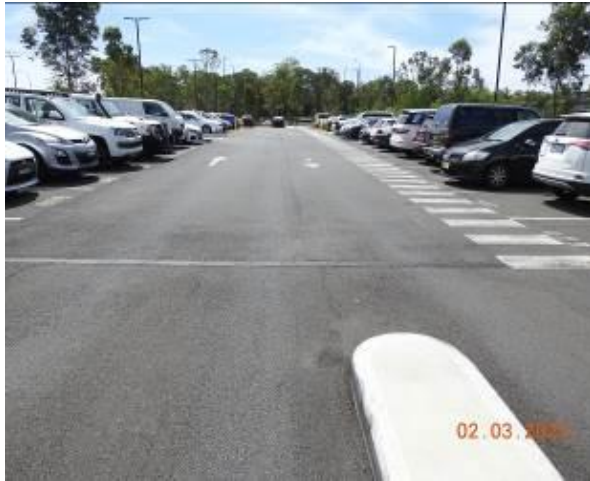
Figure 2302 – General Condition of carpark pavement

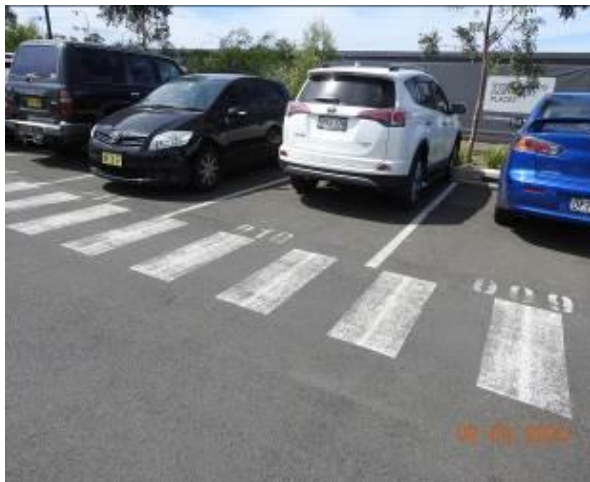
Figure 2304 – General Condition of carpark pavement

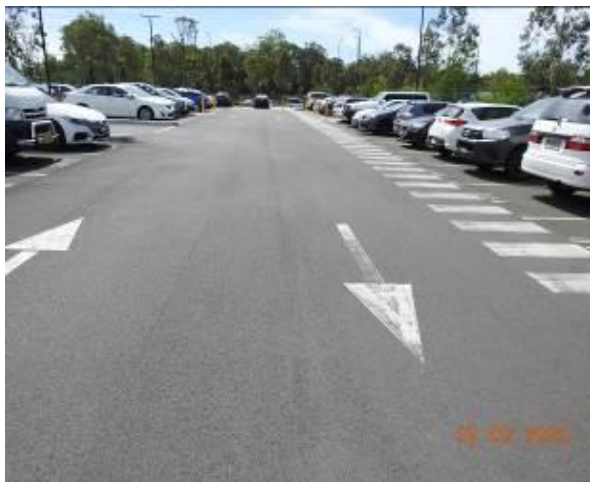
Figure 2306 – General Condition of carpark pavement

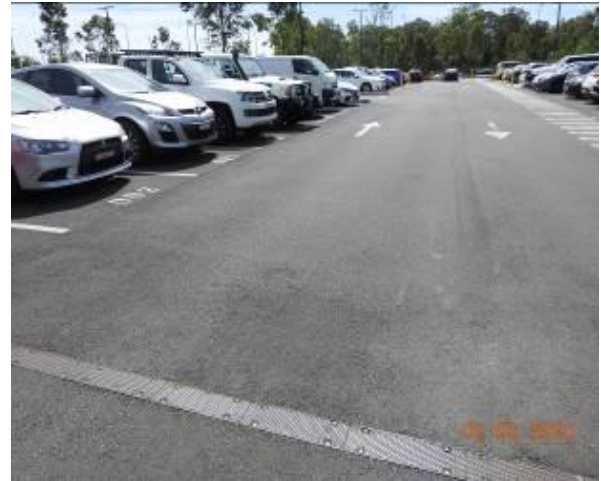
Figure 2303 – General Condition of carpark pavement

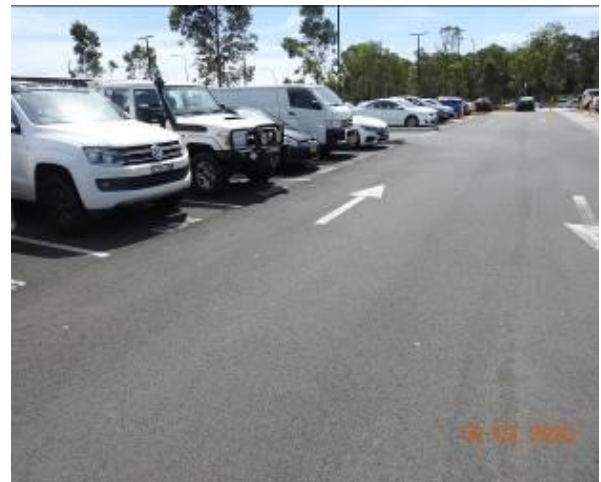
Figure 2305 – General Condition of carpark pavement

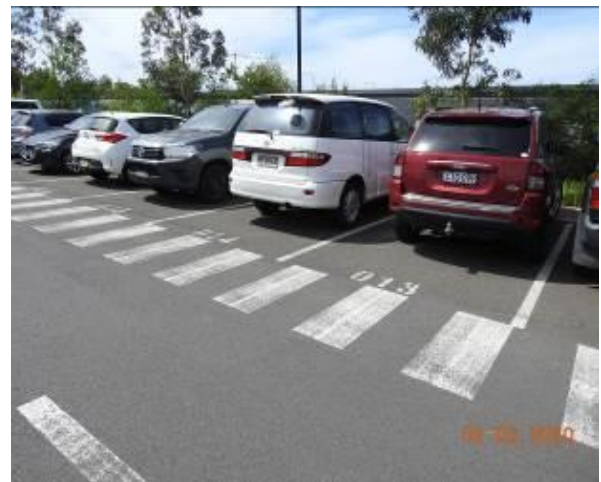
Figure 2307 – General Condition of carpark pavement

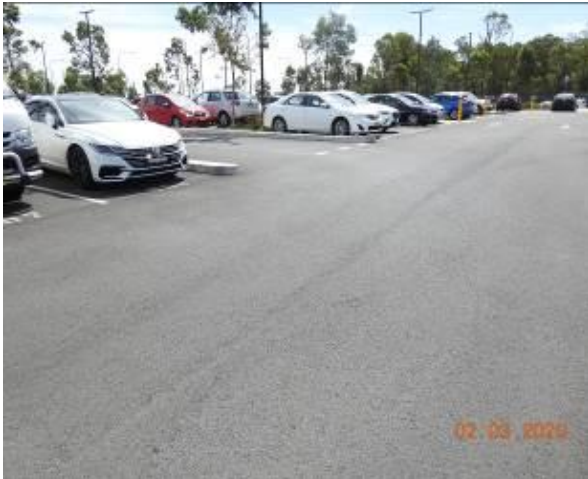
Figure 2308 – General Condition of carpark pavement

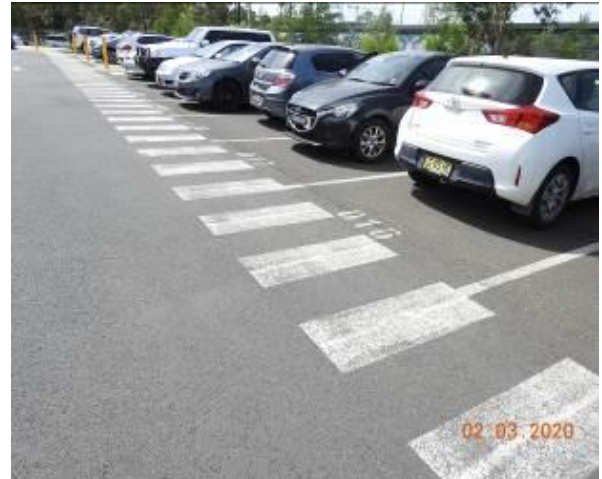
Figure 2309 – General Condition of carpark pavement

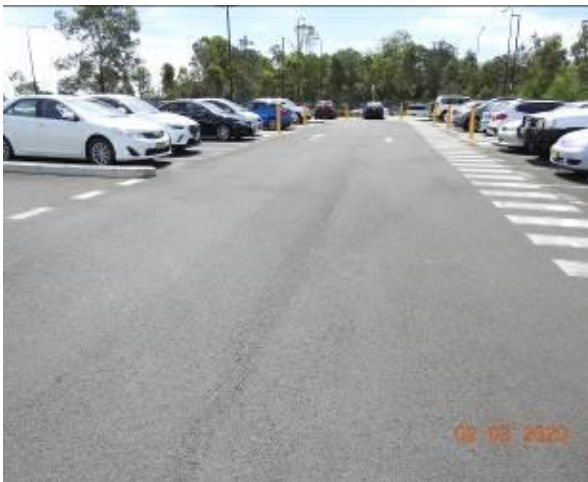
Figure 2310 – General Condition of carpark pavement

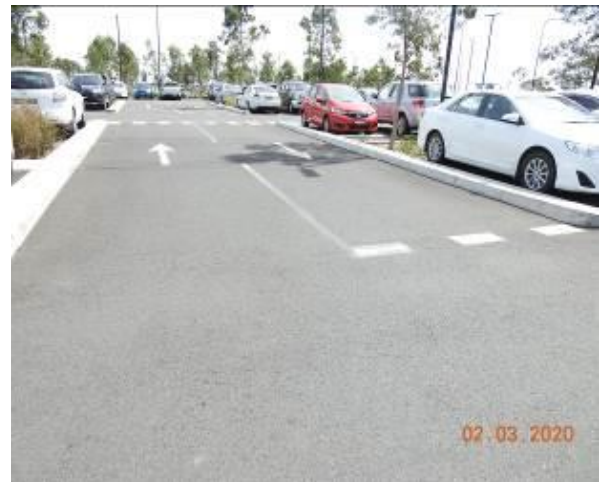
Figure 2311 – General Condition of carpark pavement

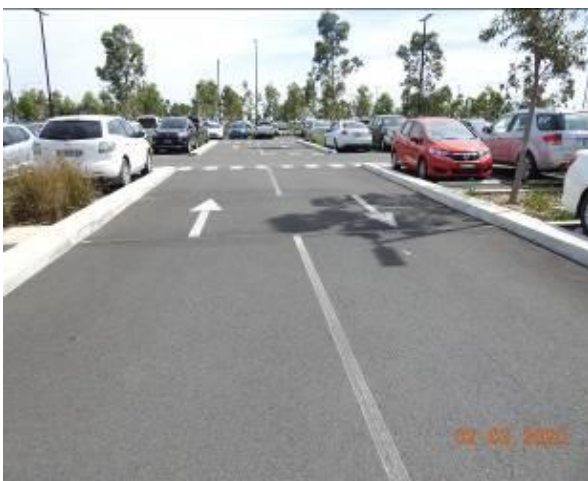
Figure 2312 – General Condition of carpark pavement

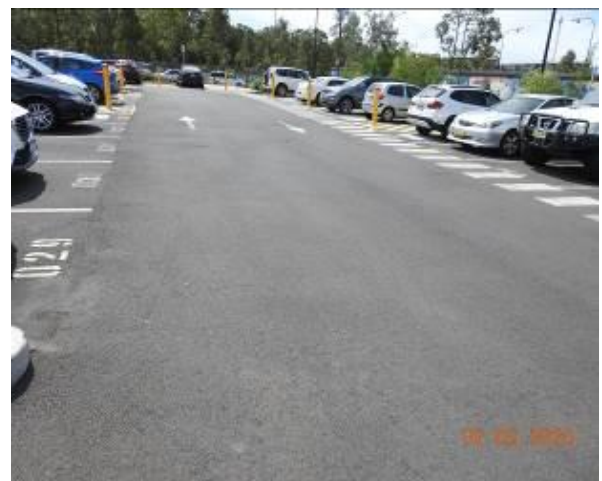
Figure 2313 – General Condition of carpark pavement

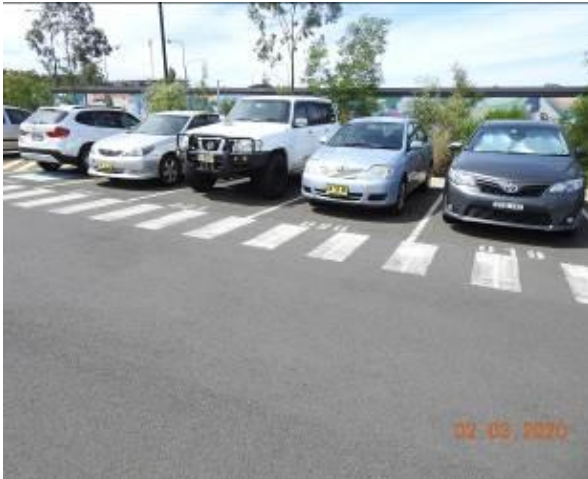
Figure 2314 – General Condition of carpark pavement

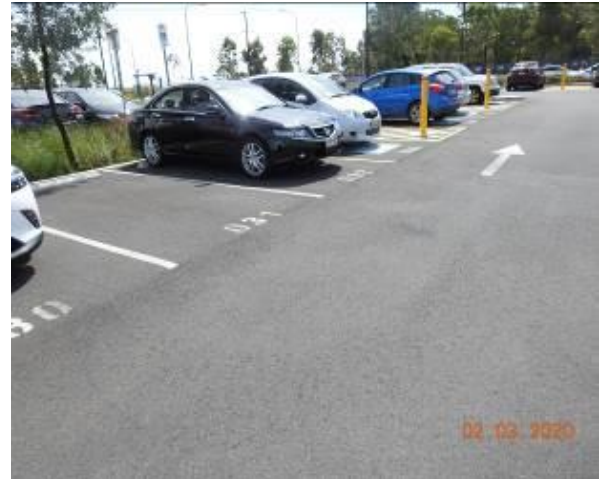
Figure 2315 – General Condition of carpark pavement

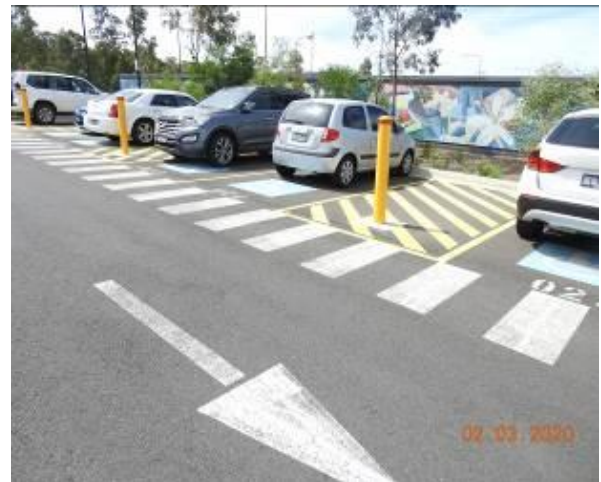
Figure 2317 – General Condition of carpark pavement

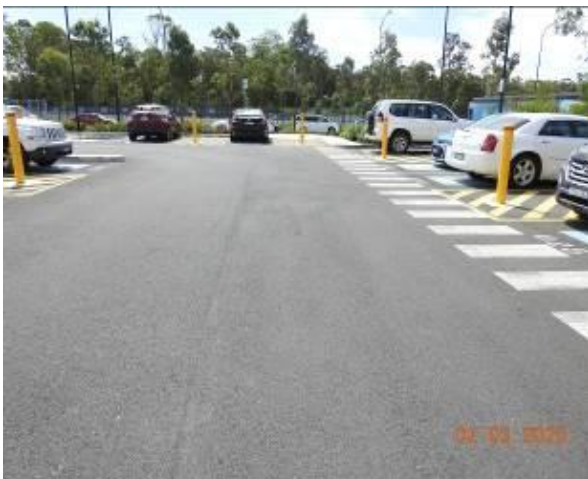
Figure 2318 – General Condition of carpark pavement

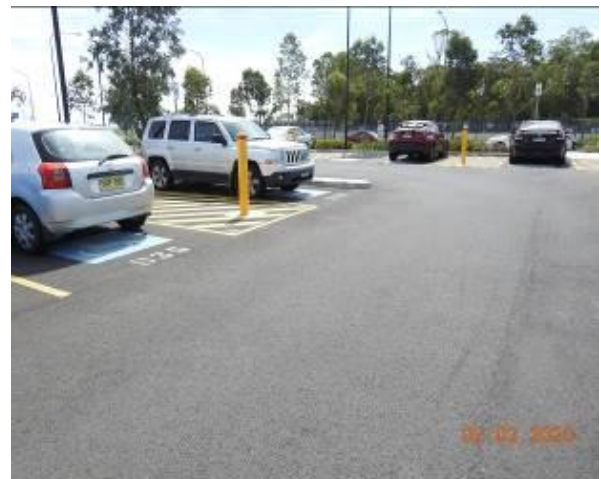
Figure 2319 – General Condition of carpark pavement

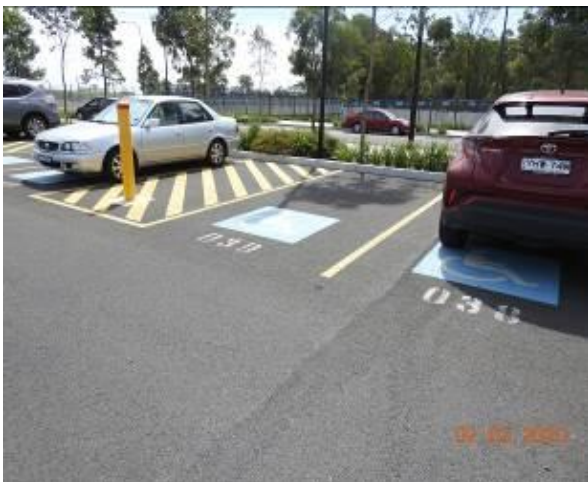
Figure 2324 – General Condition of carpark pavement

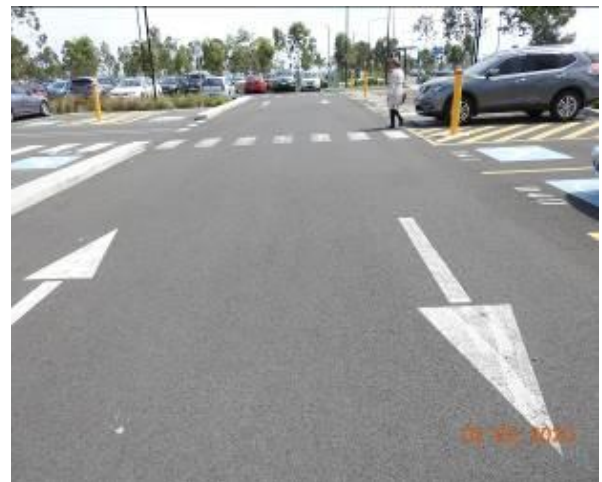
Figure 2325 – General Condition of carpark pavement

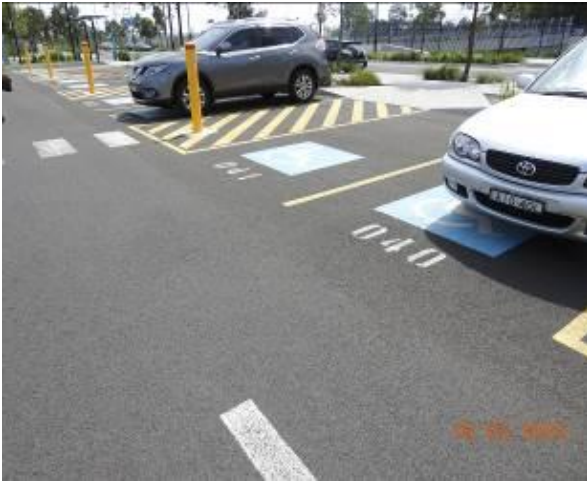
Figure 2326 – General Condition of carpark pavement

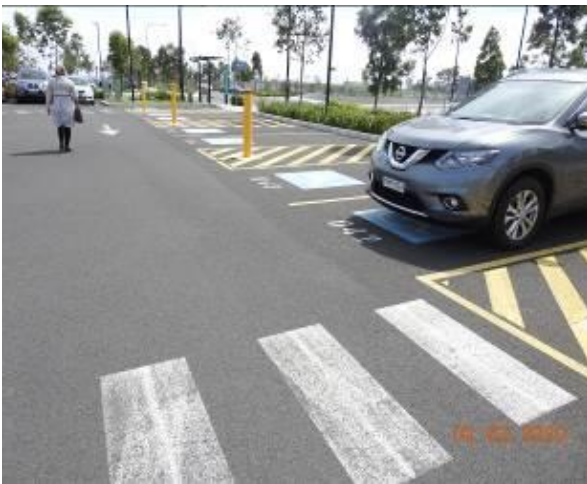
Figure 2328 – General Condition of carpark pavement

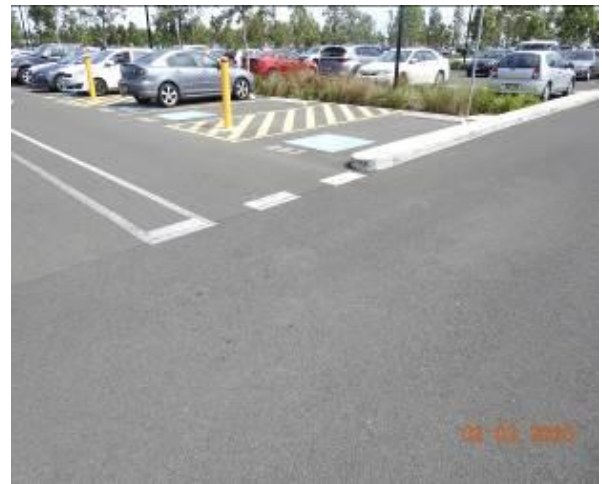
Figure 2329 – General Condition of carpark pavement

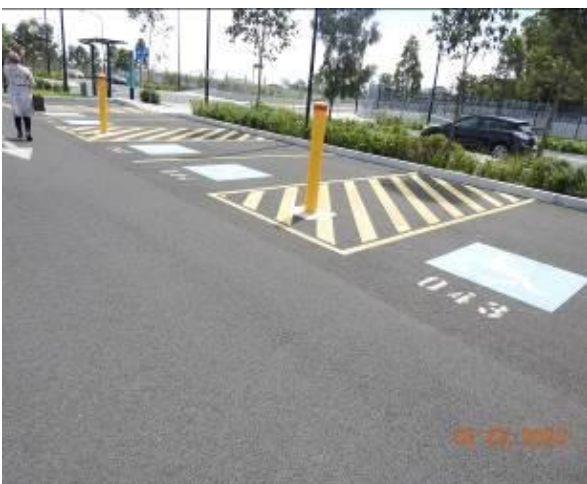
Figure 2330 – General Condition of carpark pavement

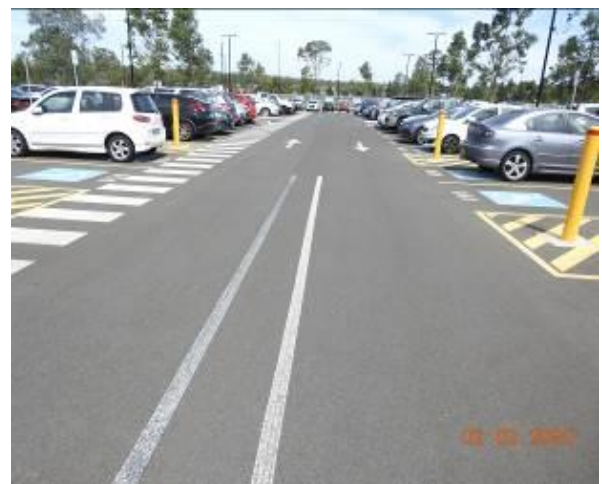
Figure 2331 – General Condition of carpark pavement

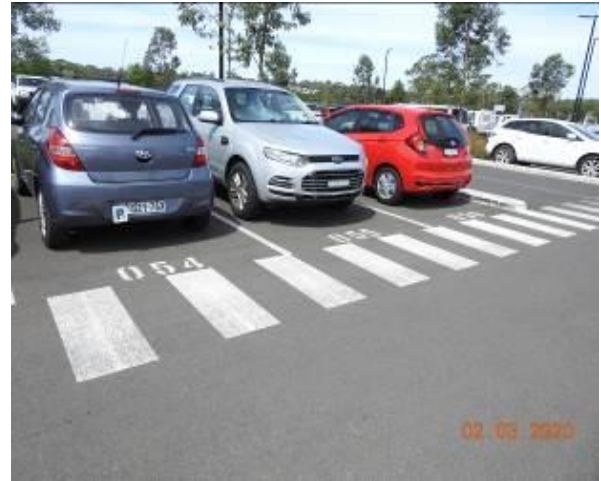
Figure 2339 – General Condition of carpark pavement

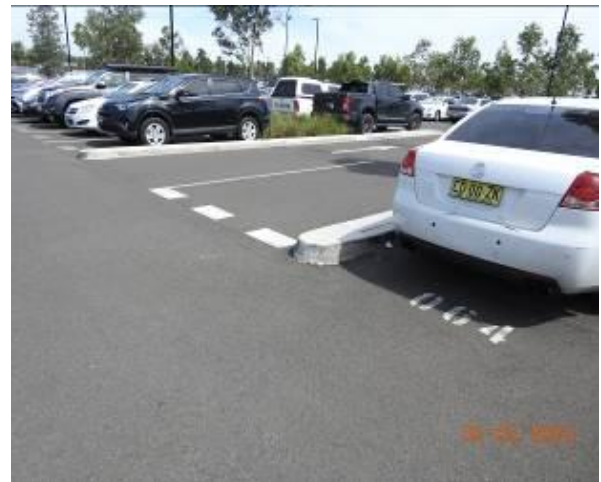
Figure 2341 – General Condition of carpark pavement

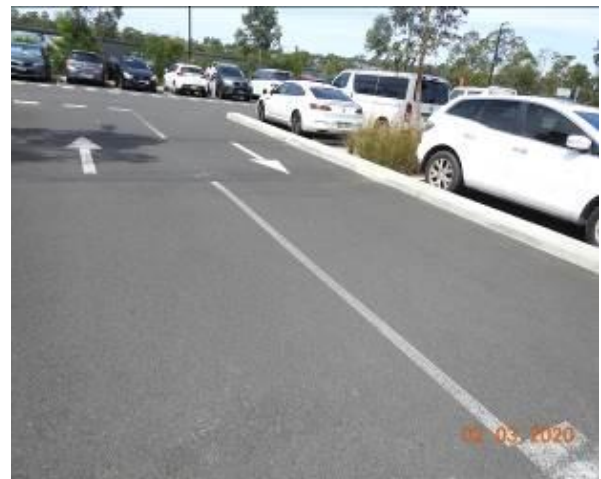
Figure 2343 – General Condition of carpark pavement

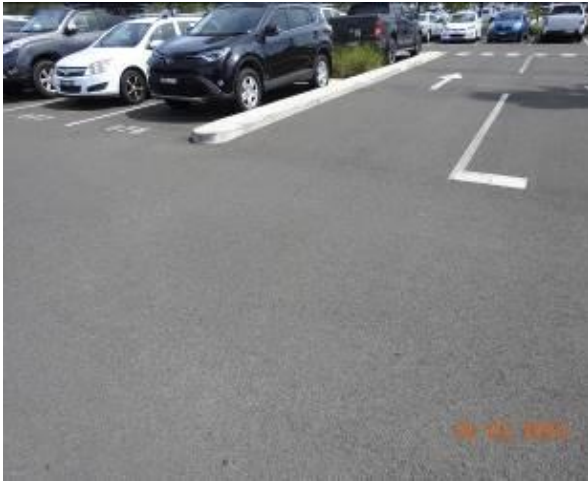
Figure 2344 – General Condition of carpark pavement

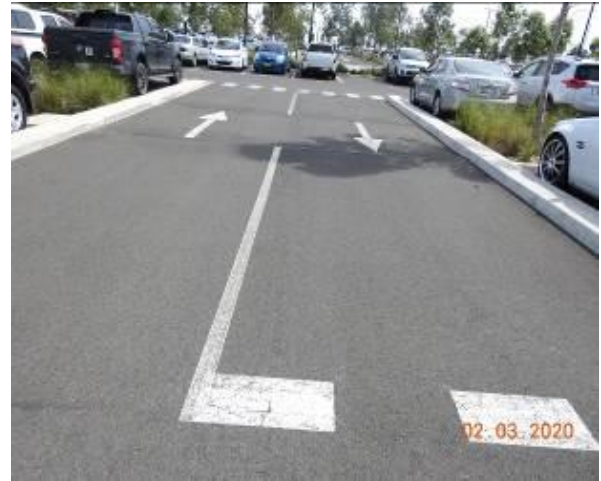
Figure 2345 – General Condition of carpark pavement

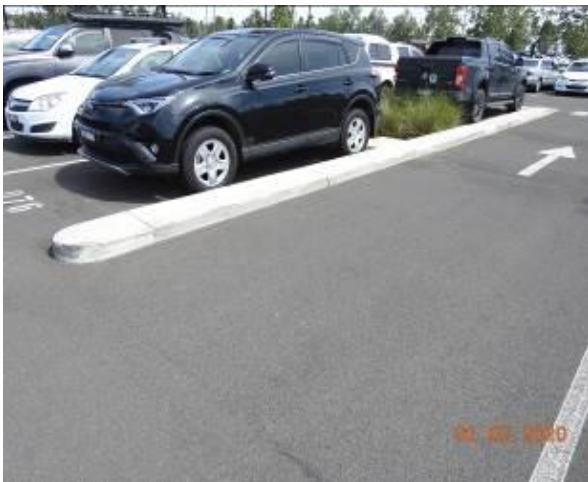
Figure 2346 – General Condition of carpark pavement

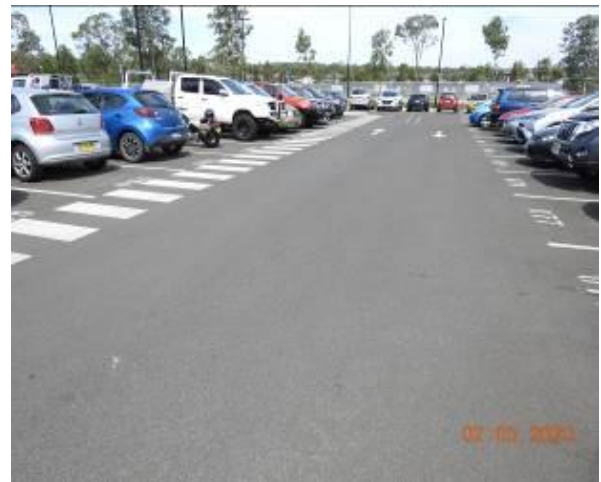
Figure 2347 – General Condition of carpark pavement

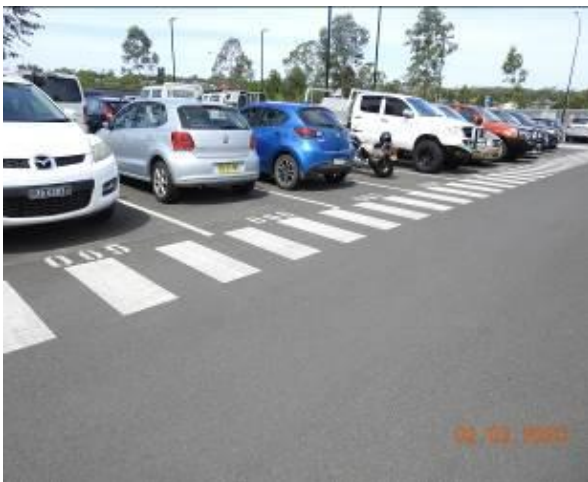
Figure 2348 – General Condition of carpark pavement

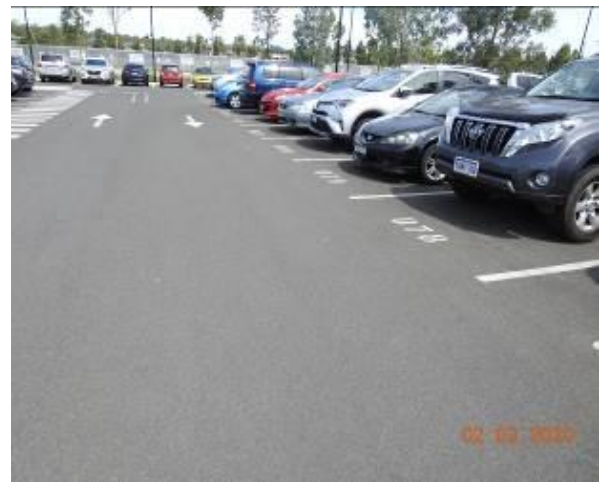
Figure 2349 – General Condition of carpark pavement

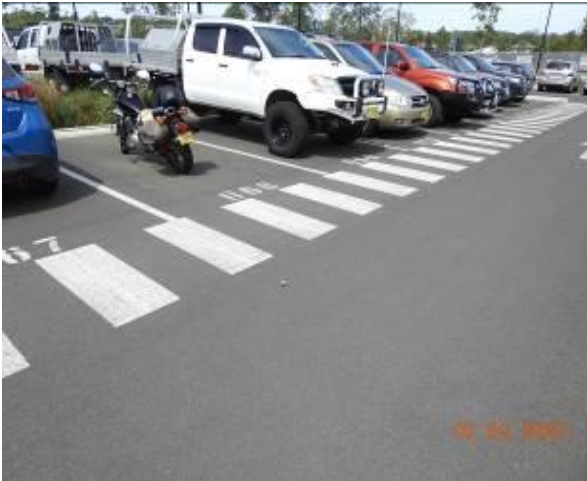
Figure 2350 – General Condition of carpark pavement

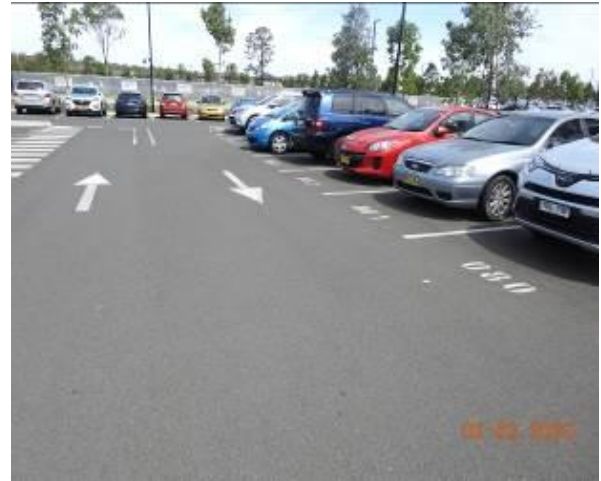
Figure 2351 – General Condition of carpark pavement

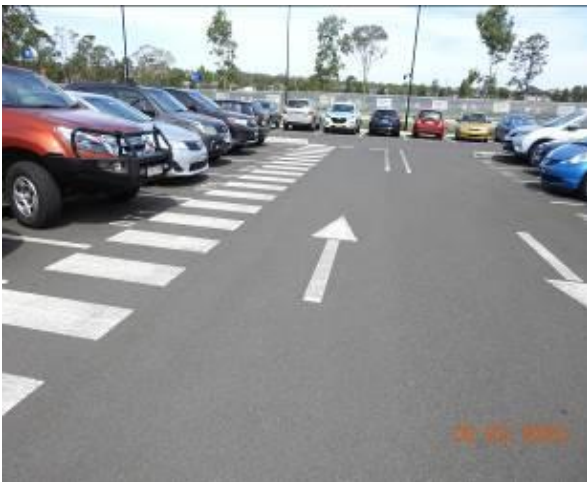
Figure 2352 – General Condition of carpark pavement

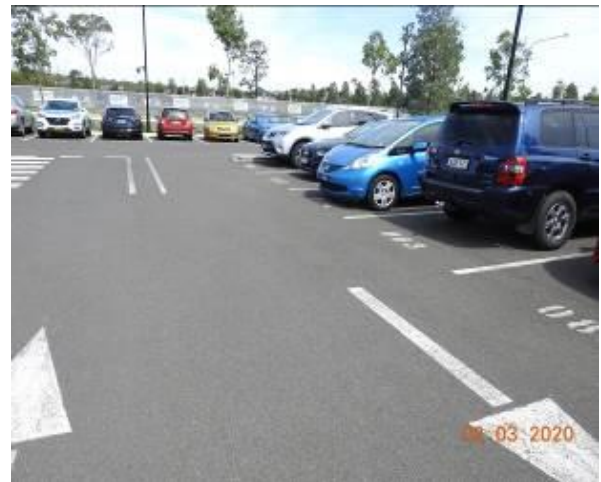
Figure 2353 – General Condition of carpark pavement

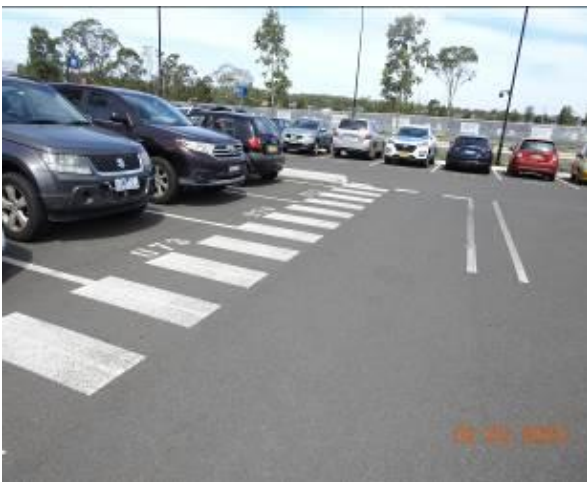
Figure 2354 – General Condition of carpark pavement

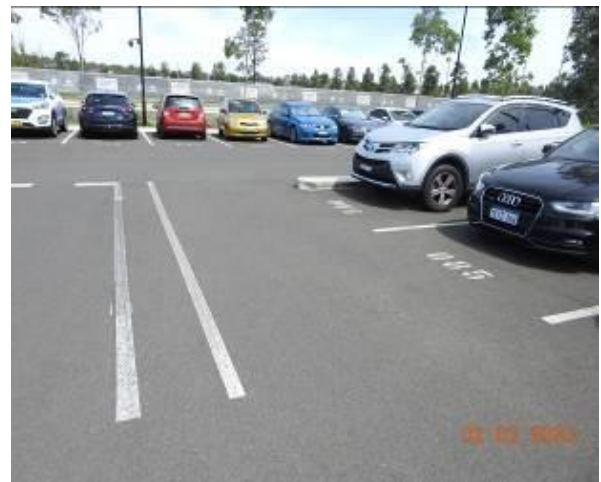
Figure 2355 – General Condition of carpark pavement
