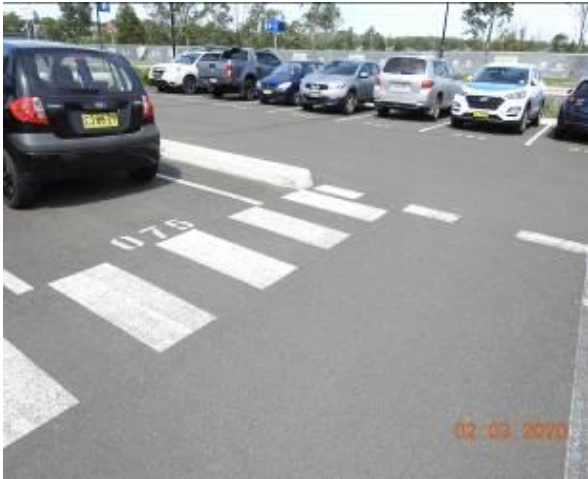
Figure 2356 – General Condition of carpark pavement

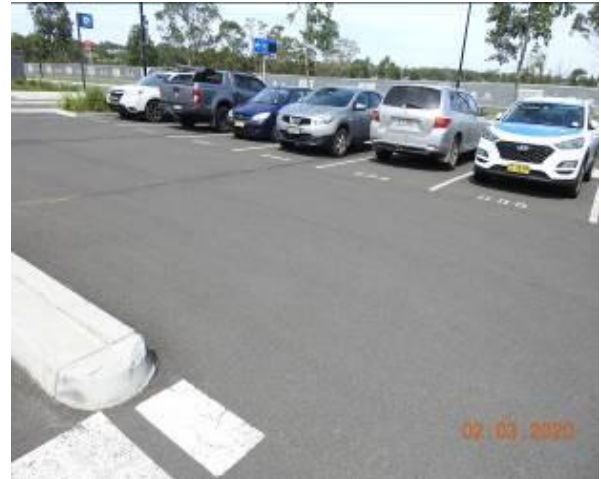
Figure 2357 – General Condition of carpark pavement

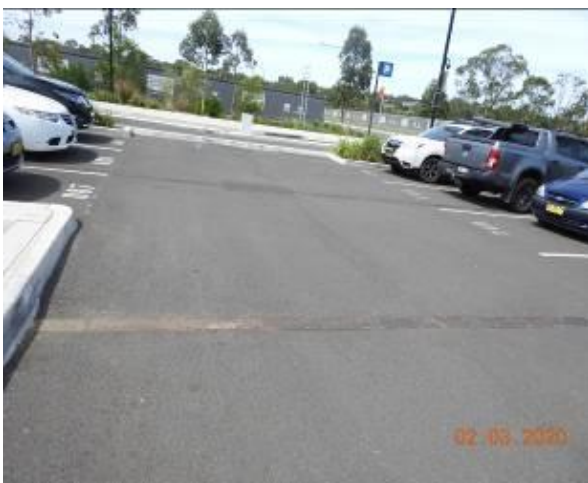
Figure 2358 – General Condition of carpark pavement

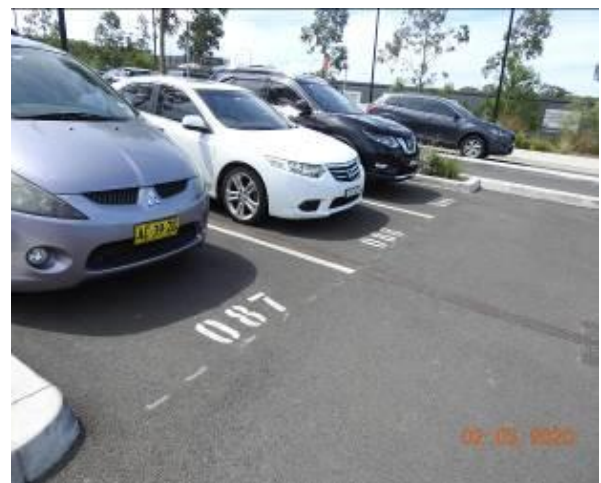
Figure 2359 – General Condition of carpark pavement

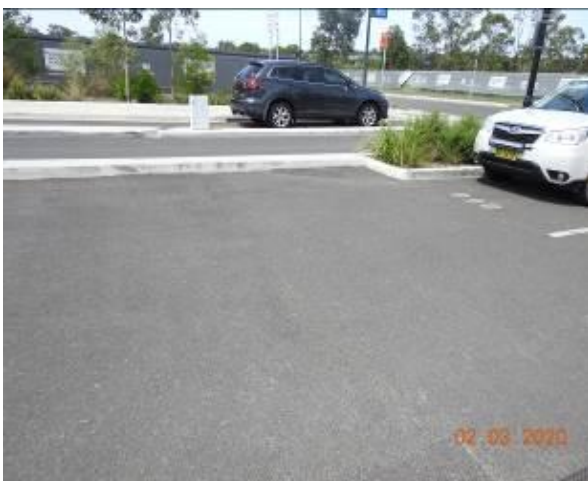
Figure 2360 – General Condition of carpark pavement

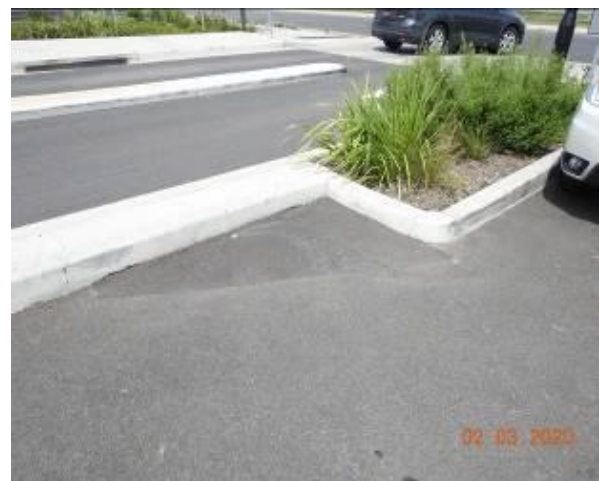
Figure 2361 – Crack propagation through carpark pavement

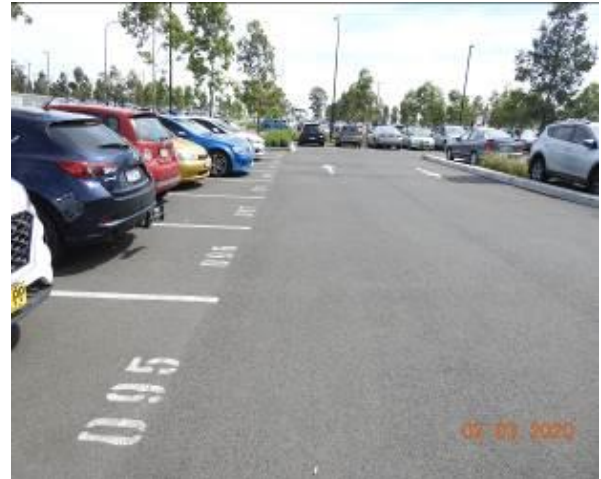
Figure 2363 – General Condition of carpark pavement

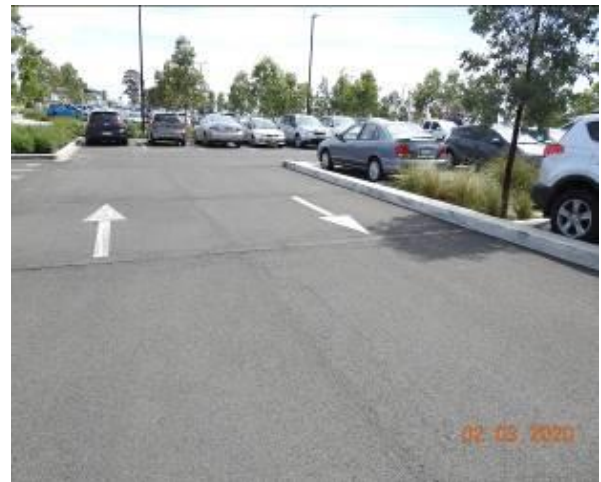
Figure 2365 – General Condition of carpark pavement

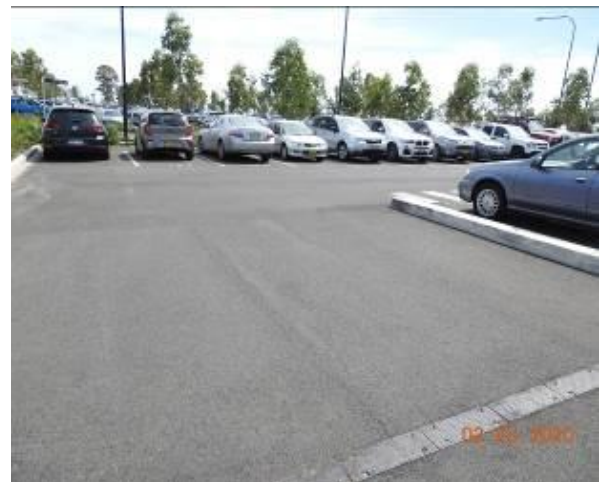
Figure 2367 – General Condition of carpark pavement

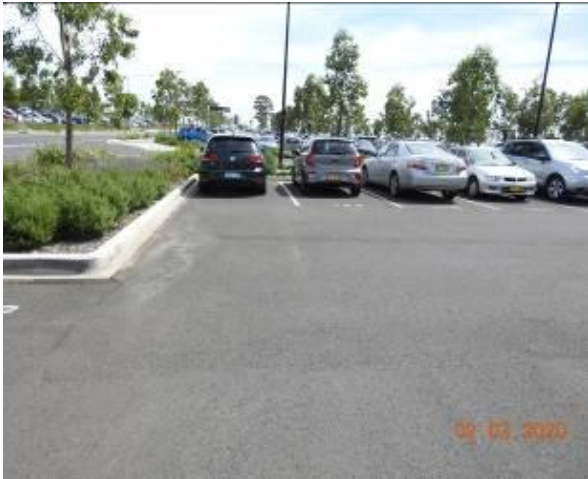
Figure 2368 – General Condition of carpark pavement

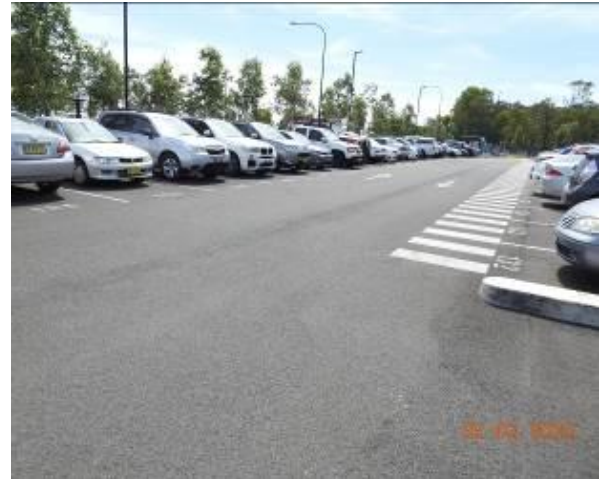
Figure 2369 – General Condition of carpark pavement

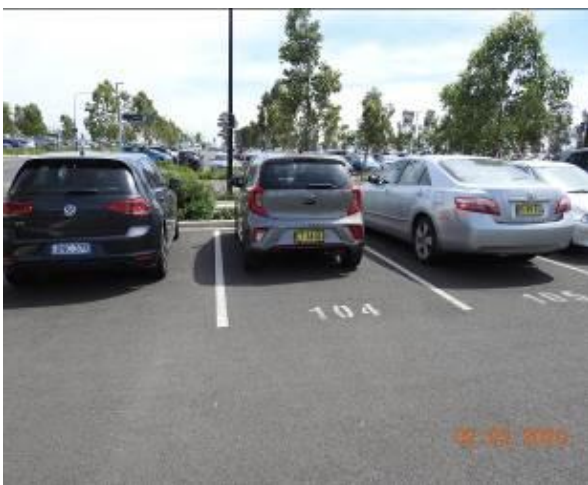
Figure 2370 – General Condition of carpark pavement

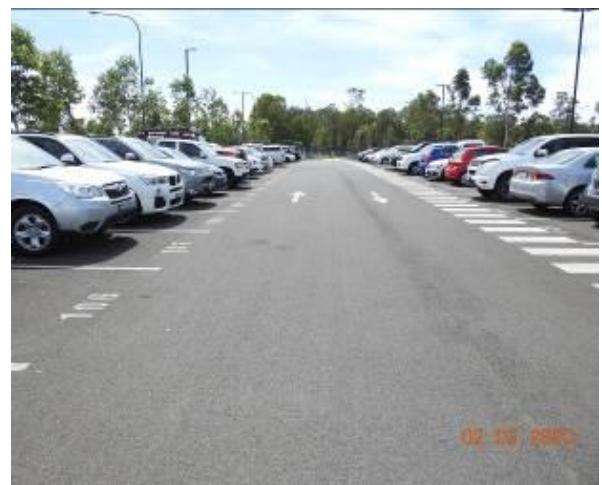
Figure 2371 – General Condition of carpark pavement

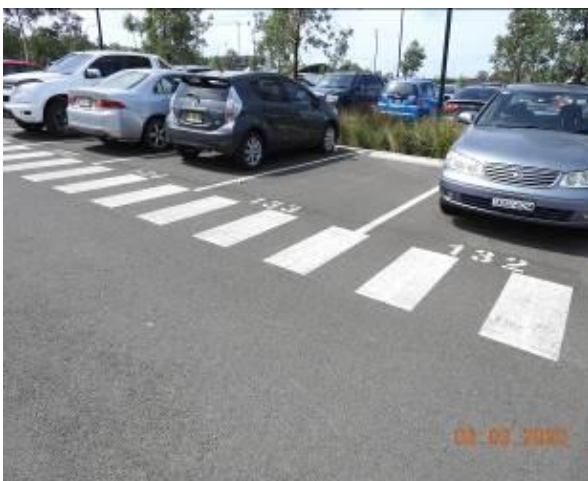
Figure 2372 – General Condition of carpark pavement

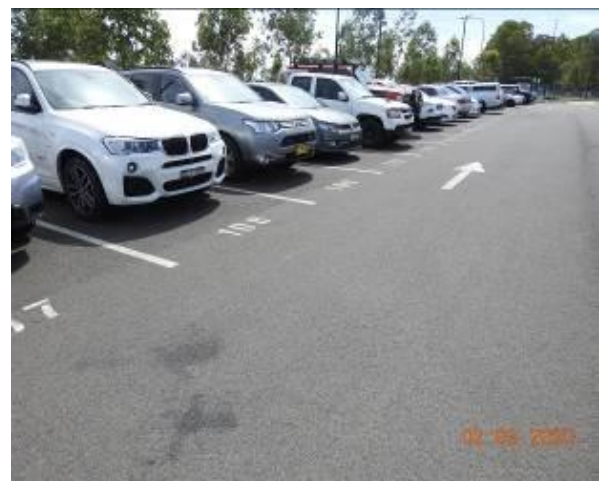
Figure 2373 – General Condition of carpark pavement

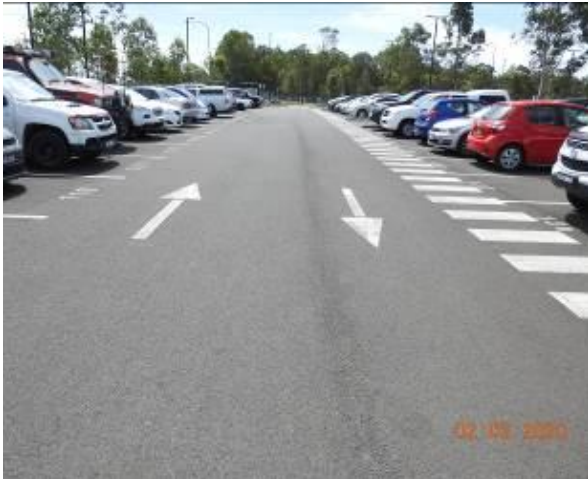
Figure 2374 – General Condition of carpark pavement

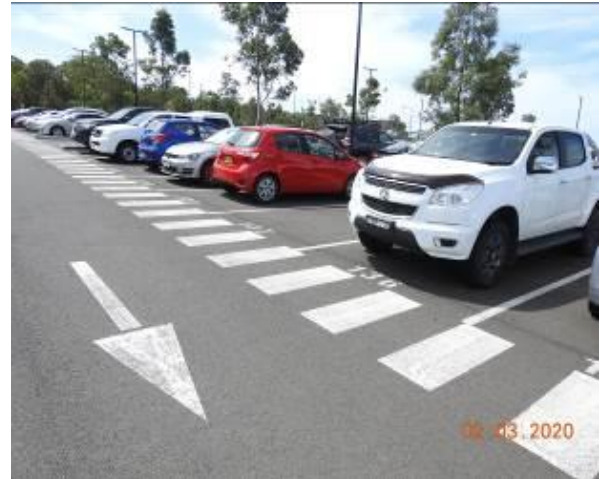
Figure 2375 – General Condition of carpark pavement

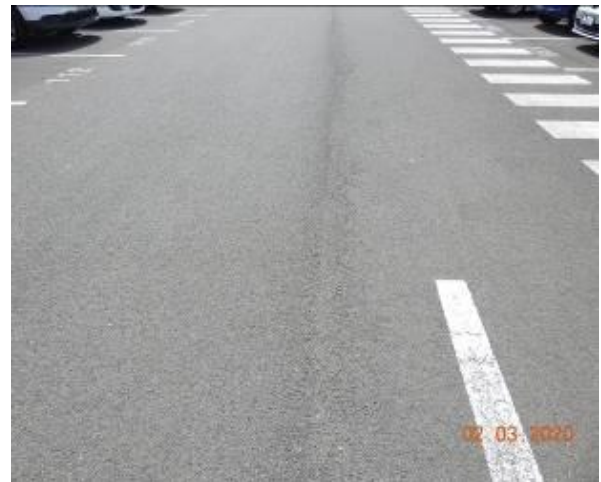
Figure 2377 – Loss of material through carpark pavement

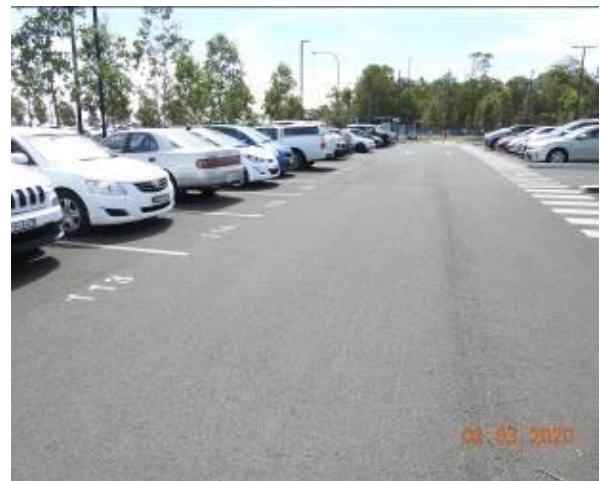
Figure 2379 – General Condition of carpark pavement

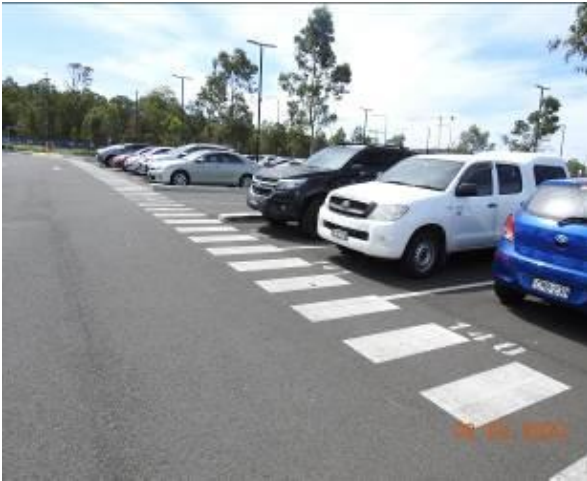
Figure 2380 – General Condition of carpark pavement

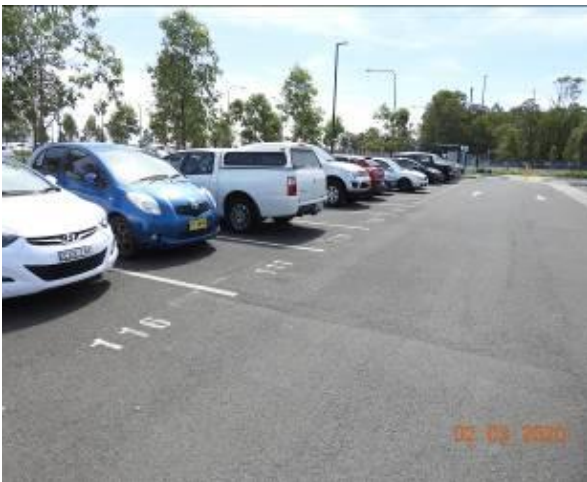
Figure 2382 – General Condition of carpark pavement

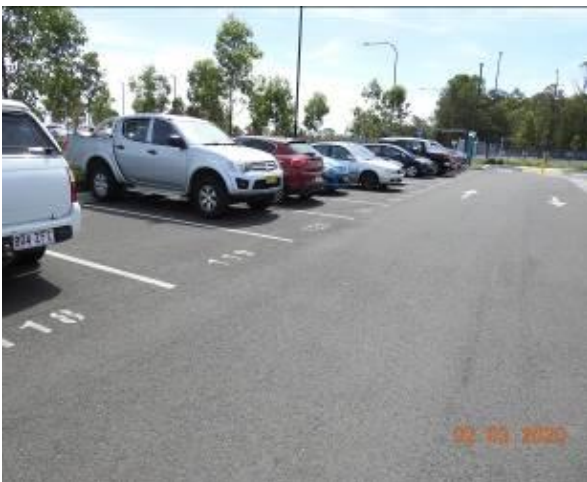
Figure 2384 – General Condition of carpark pavement

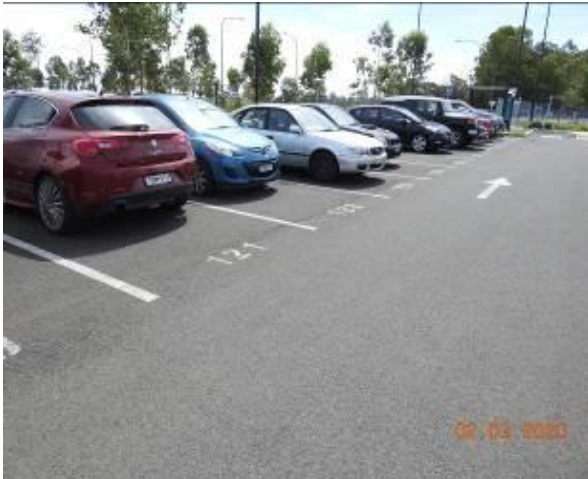
Figure 2386 – General Condition of carpark pavement

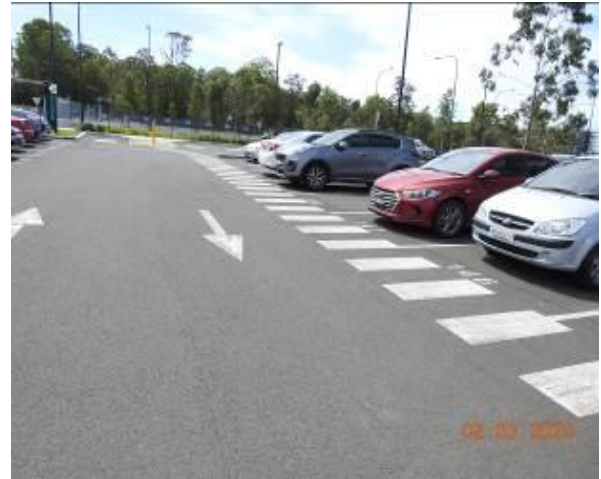
Figure 2387 – General Condition of carpark pavement

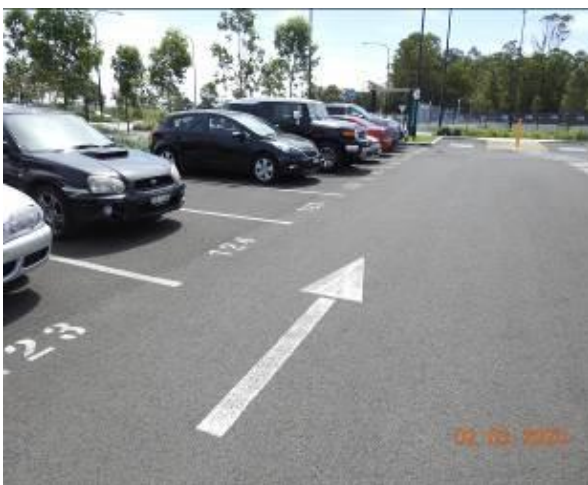
Figure 2388 – General Condition of carpark pavement

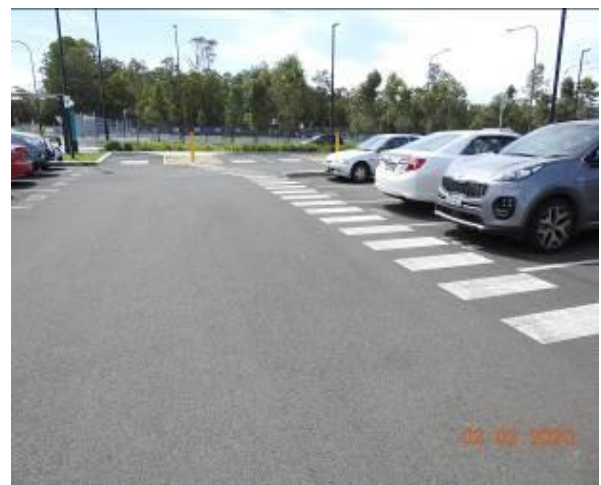
Figure 2389 – General Condition of carpark pavement

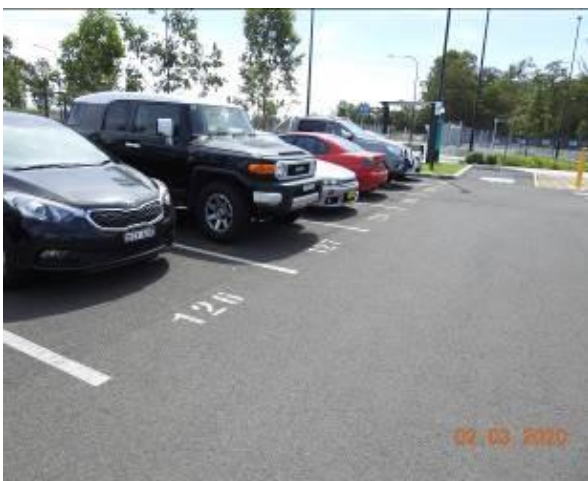
Figure 2390 – General Condition of carpark pavement

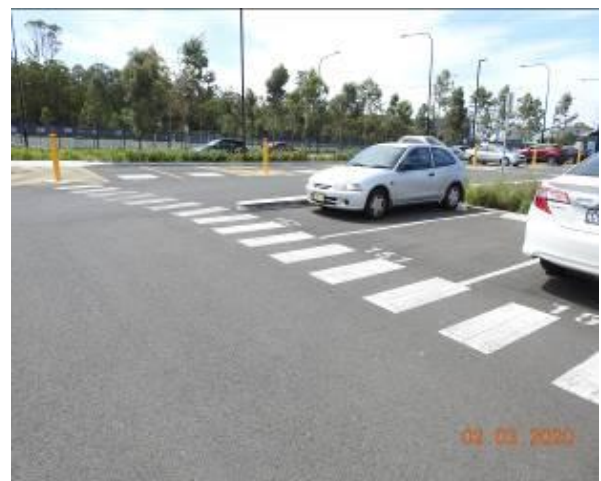
Figure 2391 – General Condition of carpark pavement

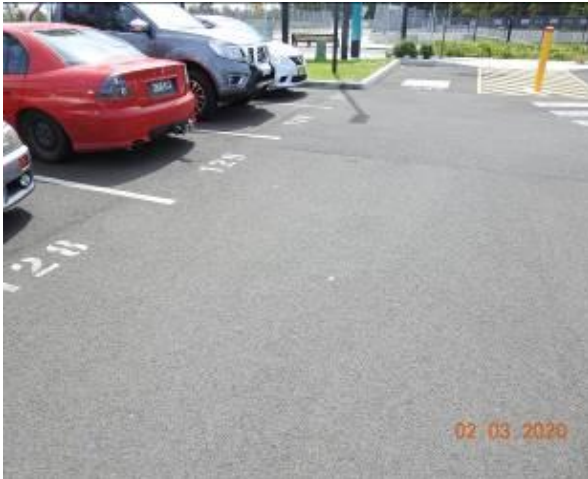
Figure 2392 – General Condition of carpark pavement

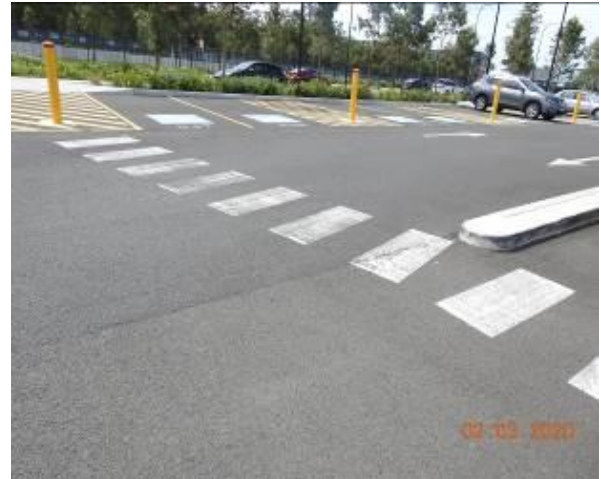
Figure 2393 – General Condition of carpark pavement

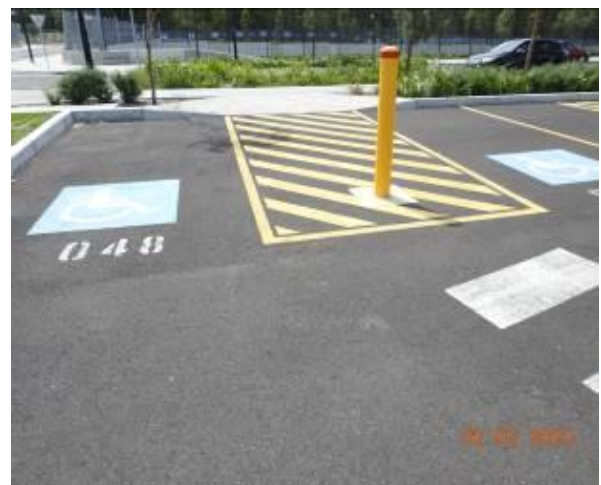
Figure 2395 – General Condition of carpark pavement

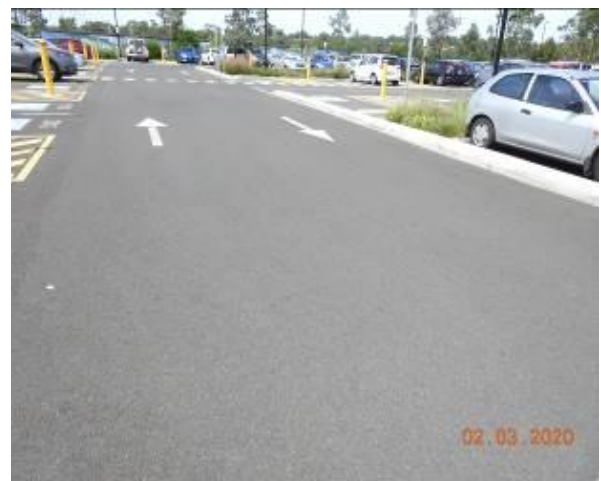
Figure 2397 – General Condition of carpark pavement

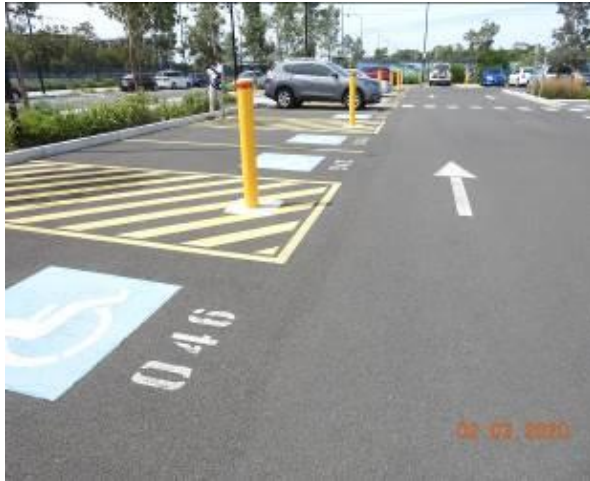
Figure 2398 – General Condition of carpark pavement

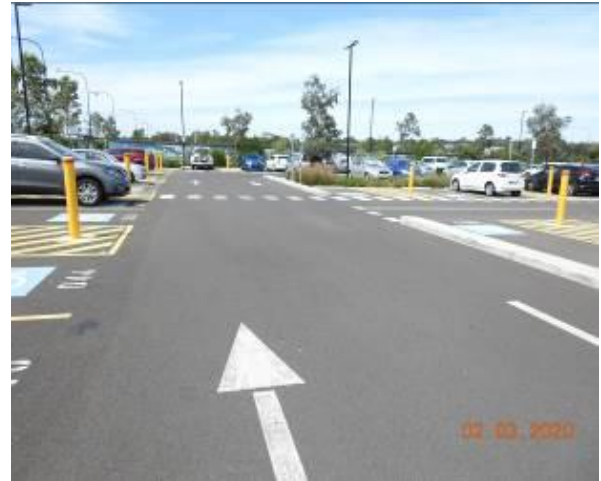
Figure 2399 – General Condition of carpark pavement

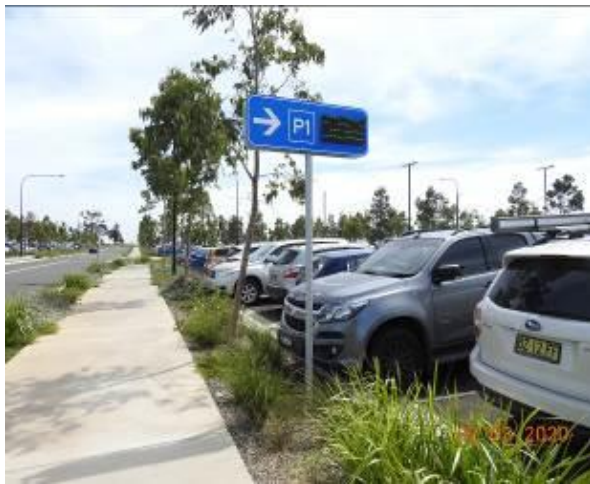
Figure 2400 – General Condition of street sign

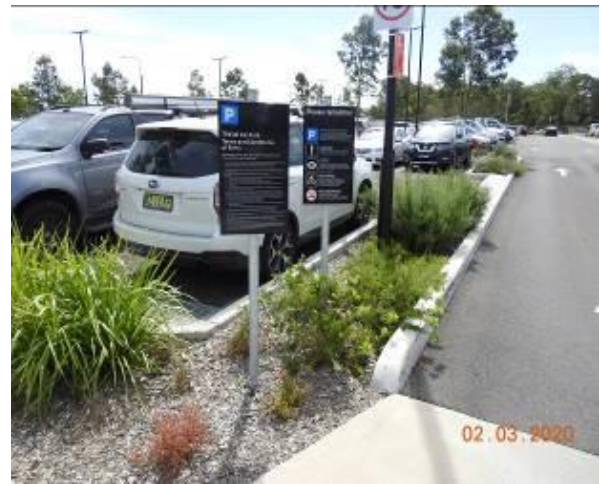
Figure 2401 – General Condition of street sign

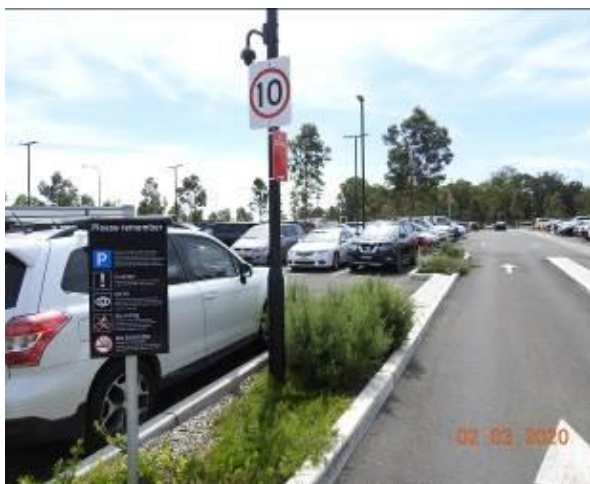
Figure 2402 – General Condition of street sign

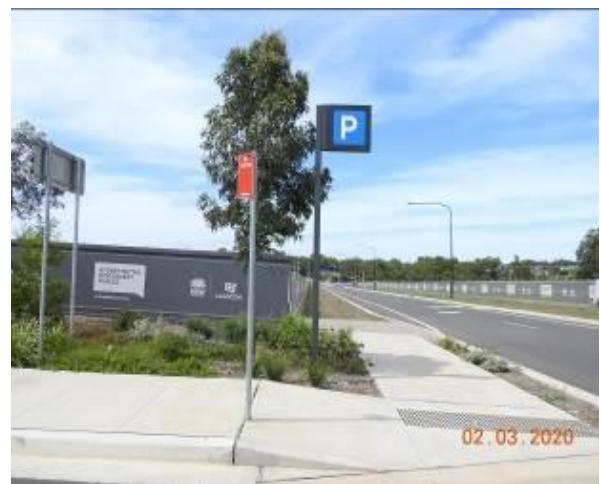
Figure 2403 – General Condition of street sign

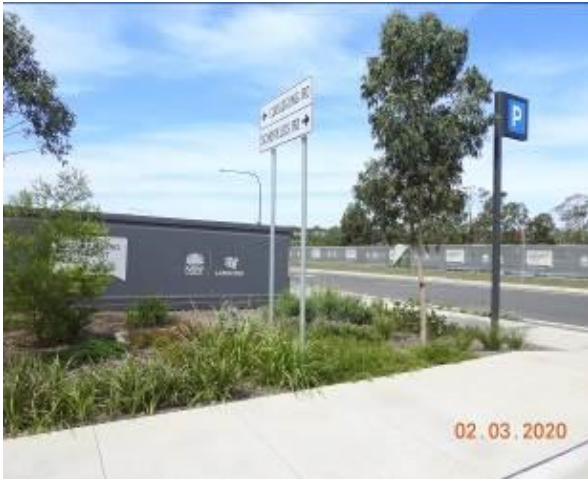
Figure 2404 – General Condition of street sign

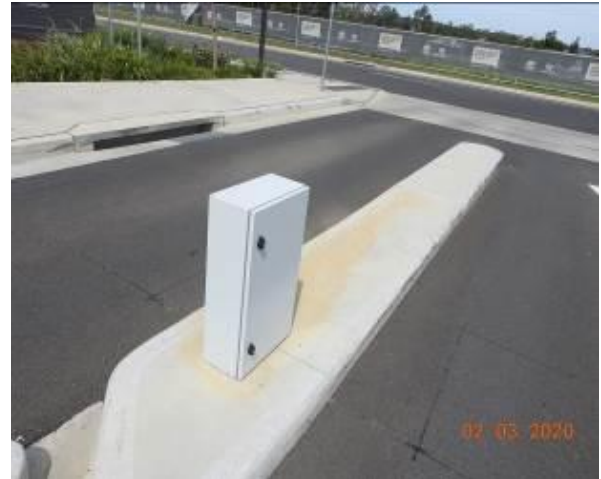
Figure 2405 – General Condition of electricity box

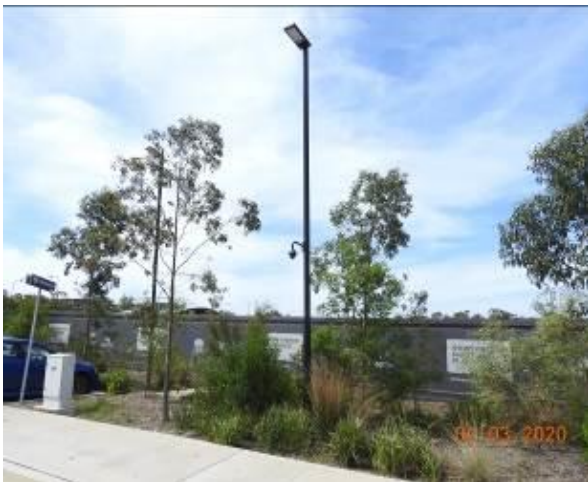
Figure 2406 – General Condition of lamp post

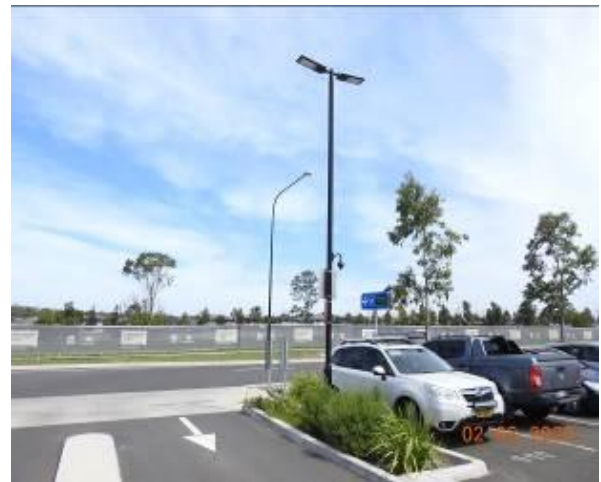
Figure 2407 – General Condition of lamp post

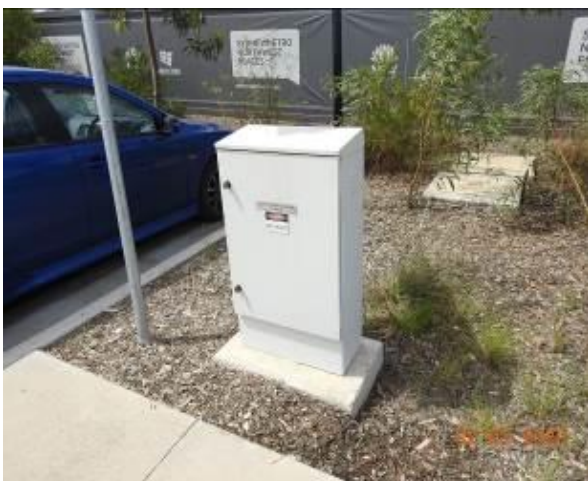
Figure 2408 – General Condition of electricity box

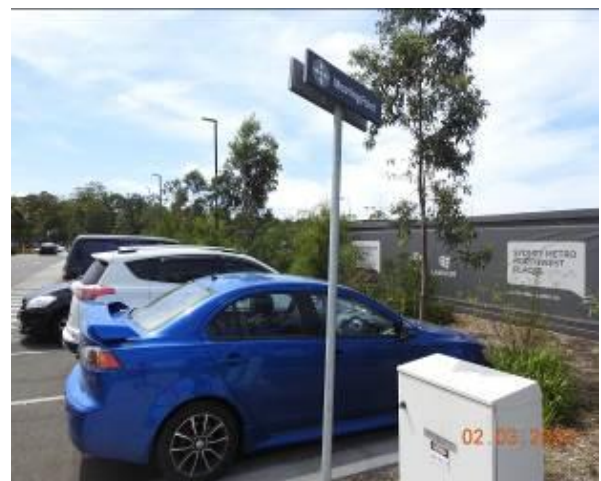
Figure 2409 – General Condition of street sign

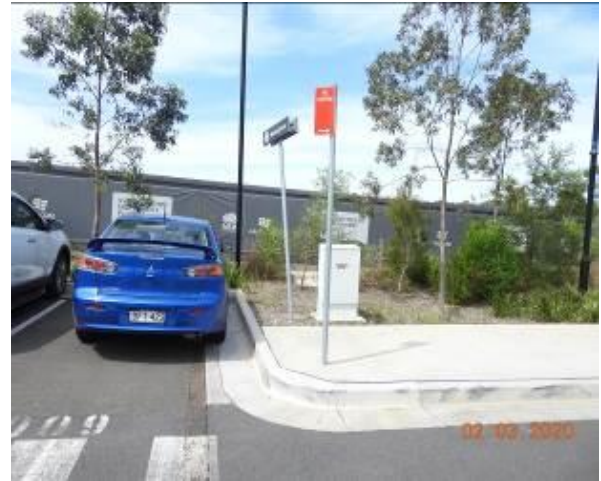
Figure 2411 – General Condition of street sign

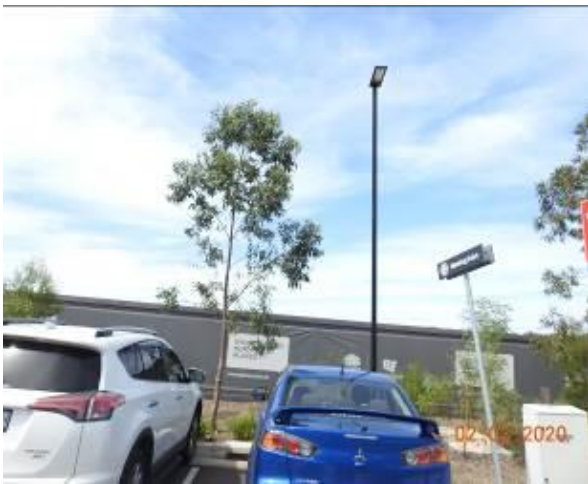
Figure 2412 – General Condition of lamp post

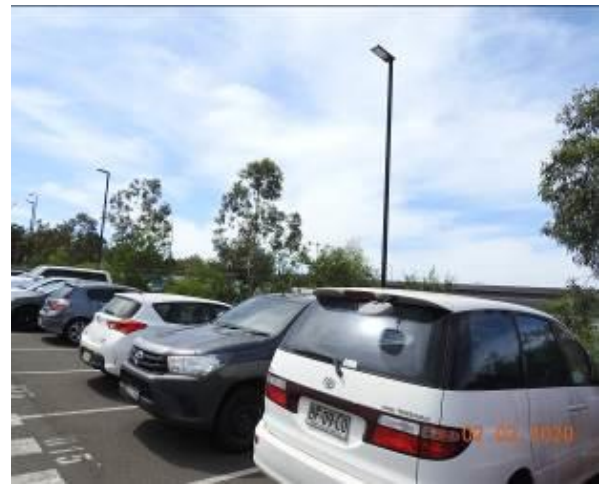
Figure 2413 – General Condition of lamp post

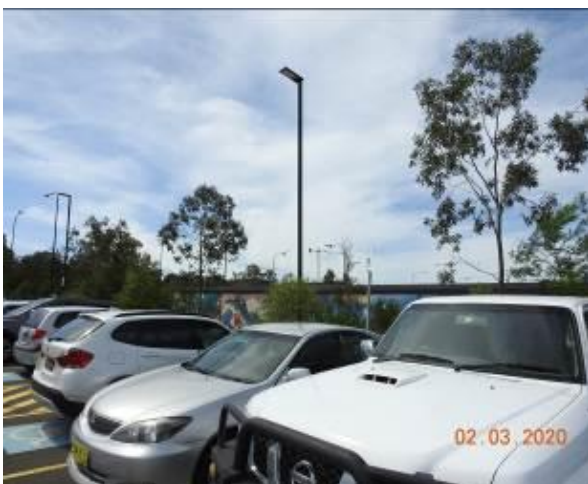
Figure 2414 – General Condition of lamp post

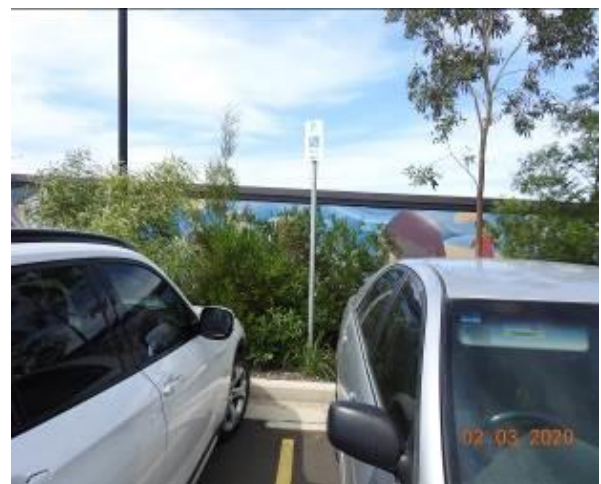
Figure 2415 – General Condition of street sign

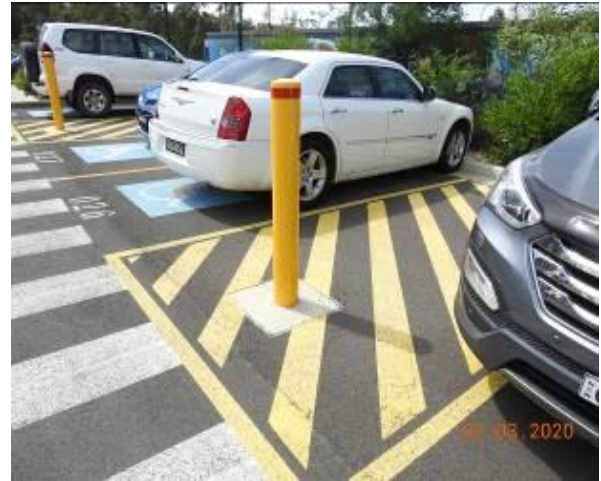
Figure 2417 – General Condition of traffic bollard

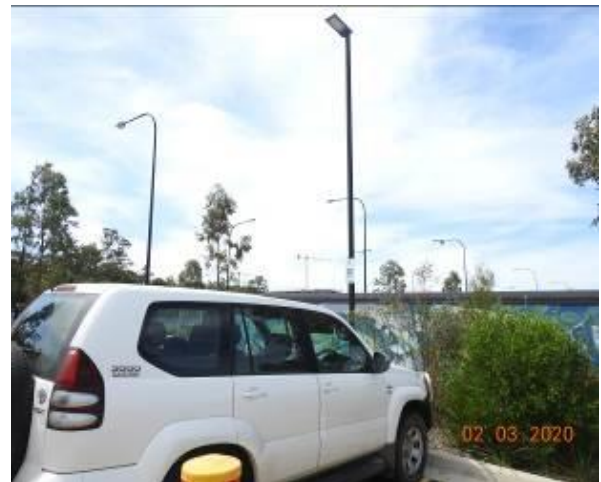
Figure 2419 – General Condition of lamp post

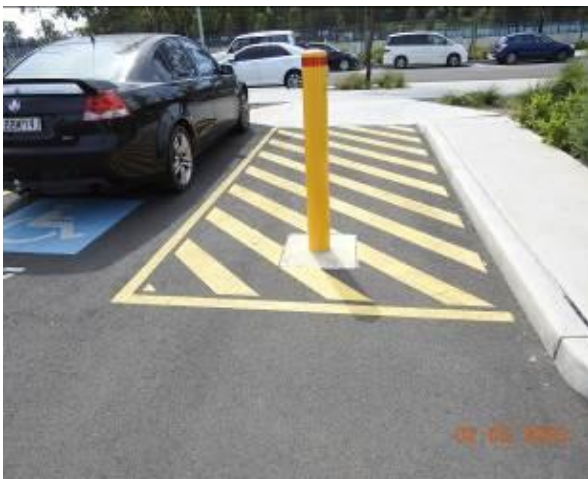
Figure 2420 – General Condition of traffic bollard

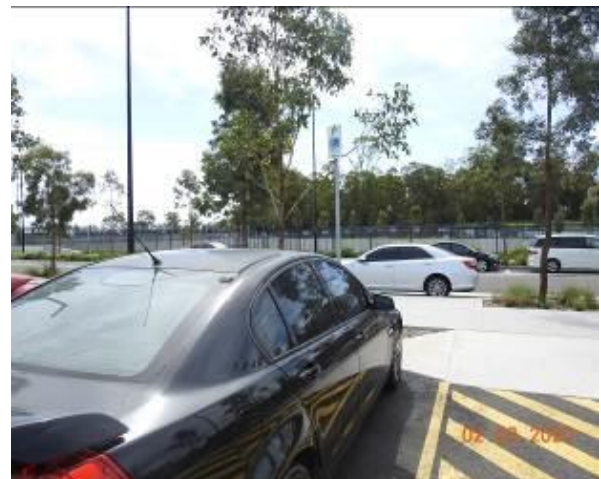
Figure 2421 – General Condition of street sign

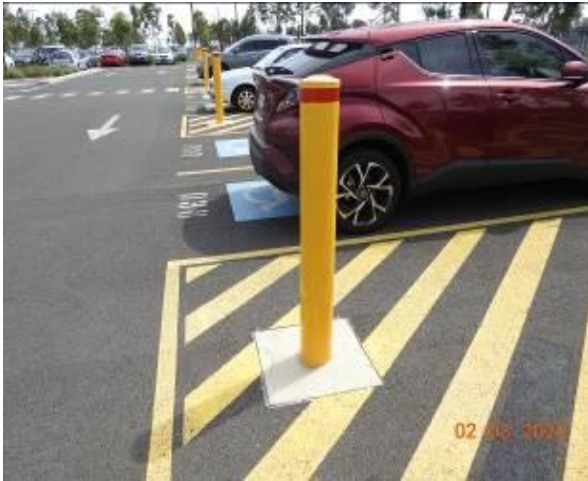
Figure 2422 – General Condition of traffic bollard

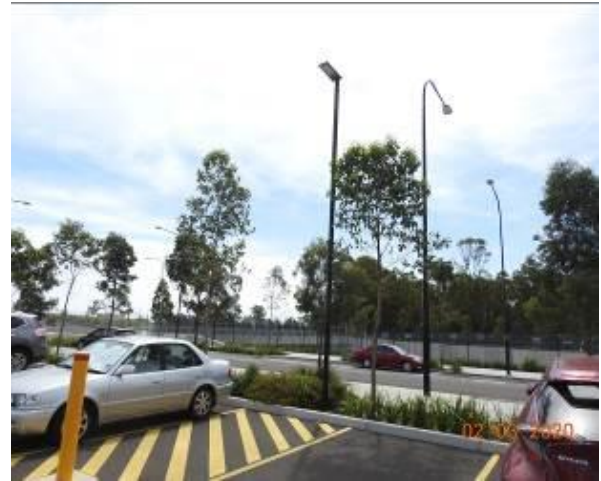
Figure 2423 – General Condition of lamp post

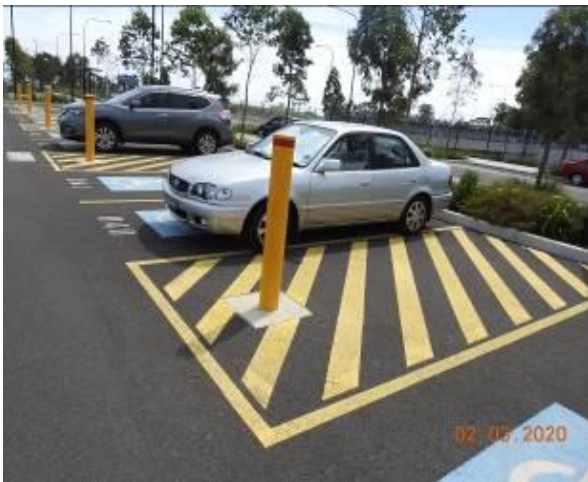
Figure 2424 – General Condition of traffic bollard

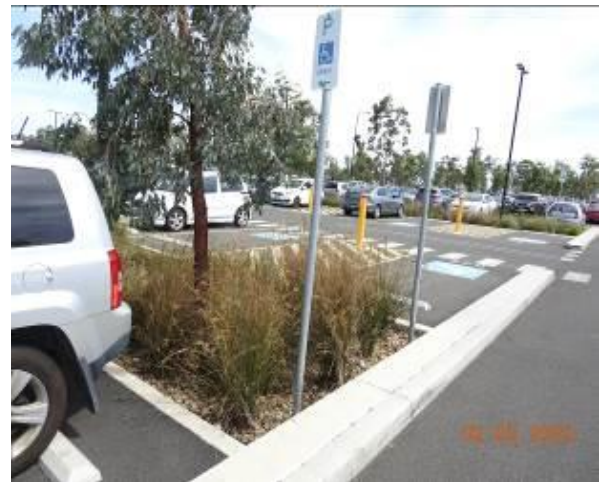
Figure 2425 – General Condition of street sign

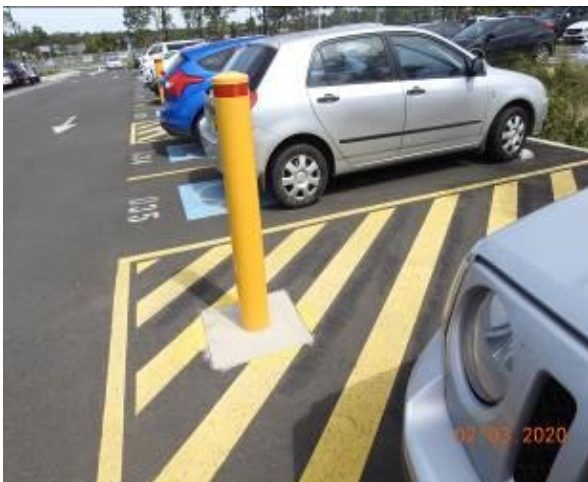
Figure 2426 – General Condition of traffic bollard

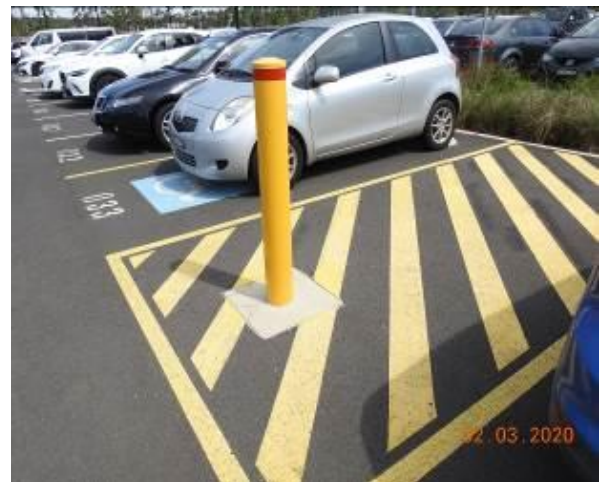
Figure 2427 – General Condition of traffic bollard

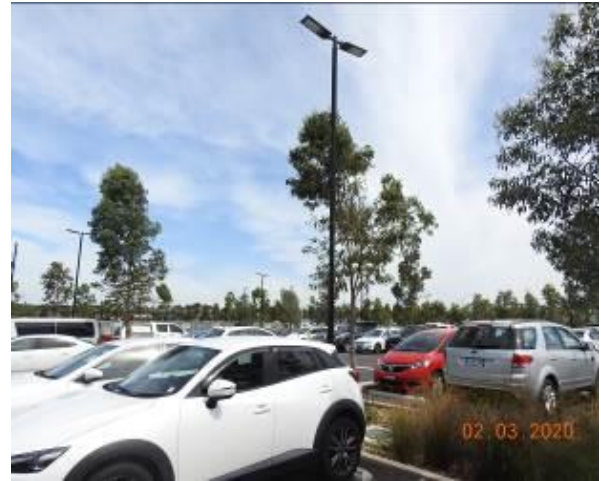
Figure 2429 – General Condition of lamp post

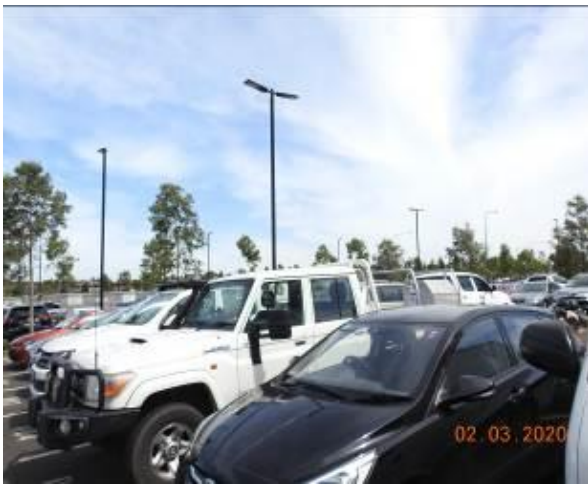
Figure 2430 – General Condition of lamp post

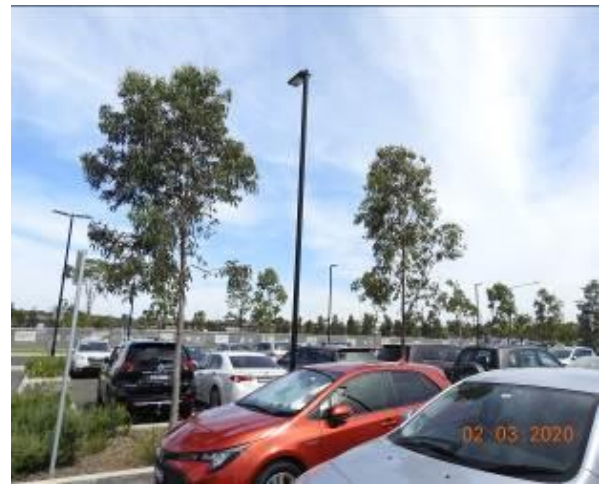
Figure 2431 – General Condition of lamp post

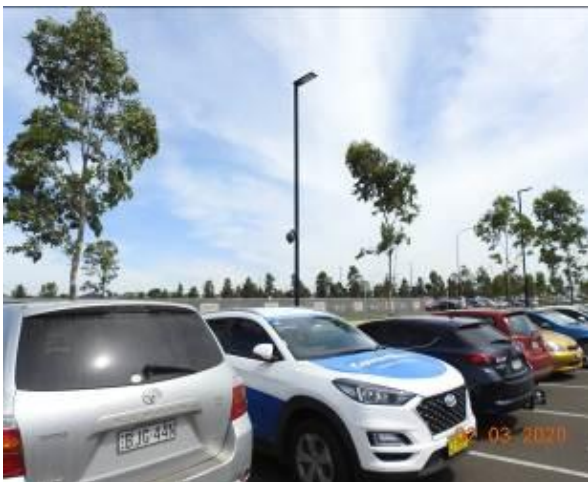
Figure 2432 – General Condition of lamp post

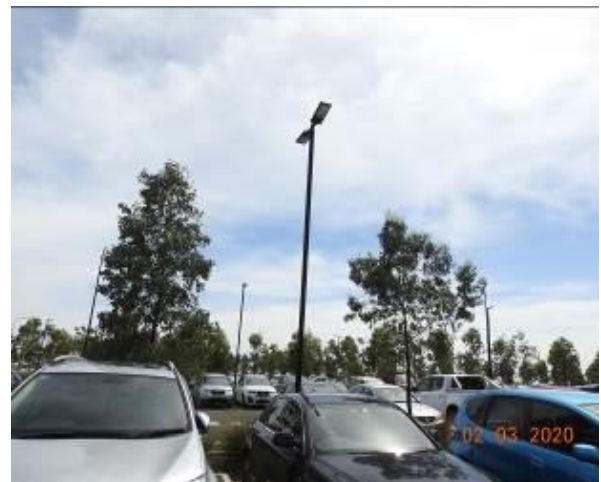
Figure 2433 – General Condition of lamp post

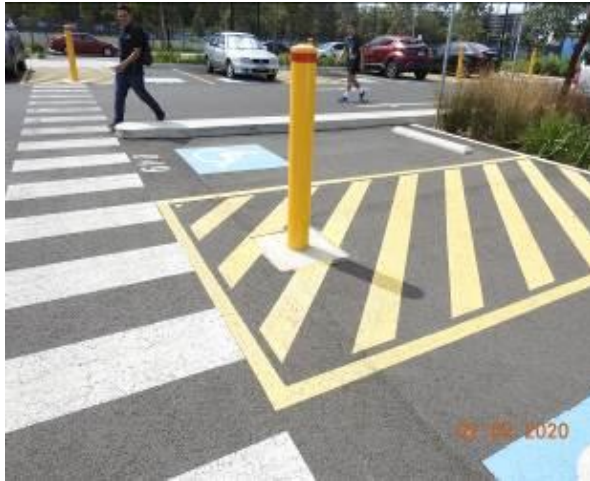
Figure 2440 – General Condition of traffic bollard

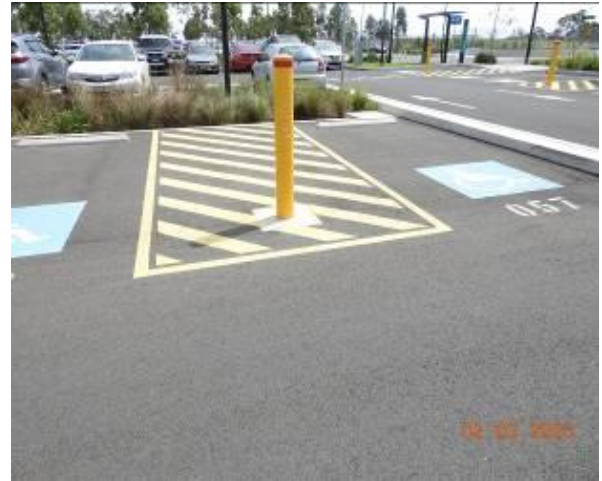
Figure 2441 – General Condition of traffic bollard

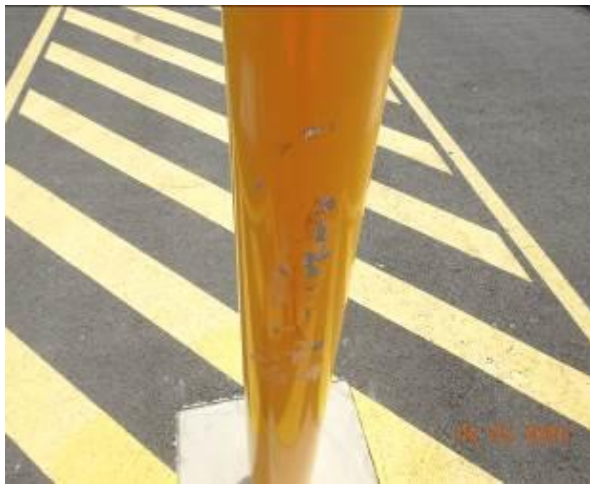
Figure 2442 – Physical damage traffic bollard

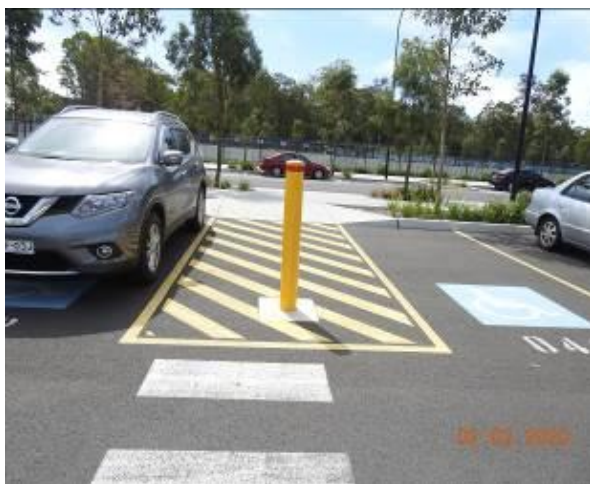
Figure 2444 – General Condition of traffic bollard

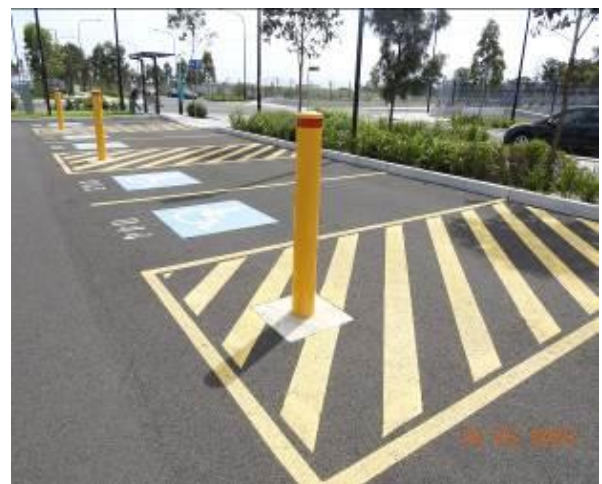
Figure 2445 – General Condition of traffic bollard

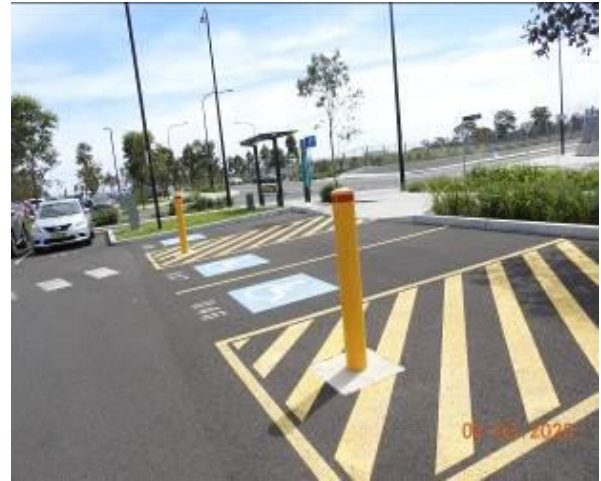
Figure 2447 – General Condition of traffic bollard

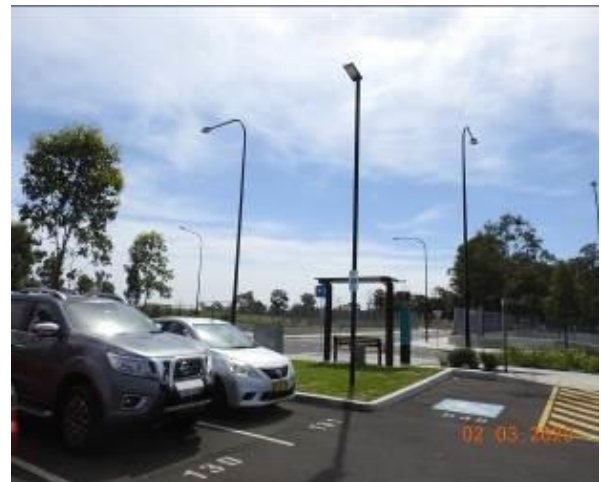
Figure 2449 – General Condition of lamp post

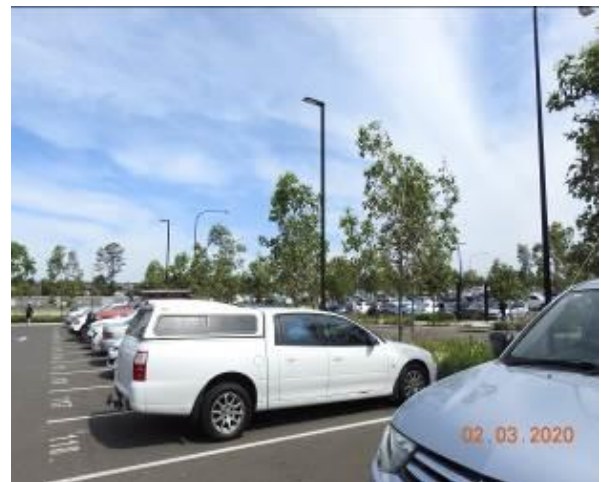
Figure 2451 – General Condition of lamp post

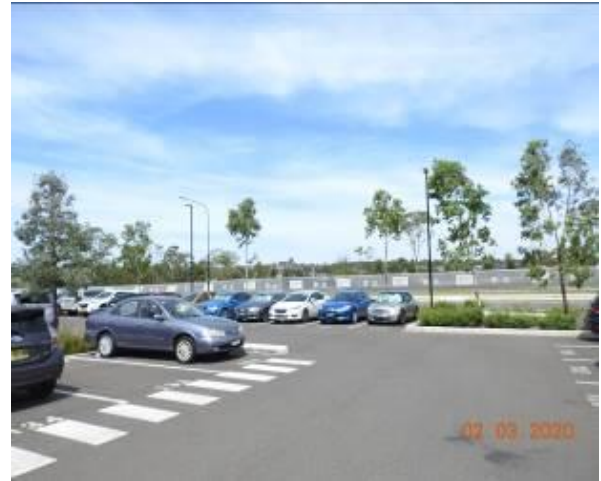
Figure 2453 – General Condition of lamp post

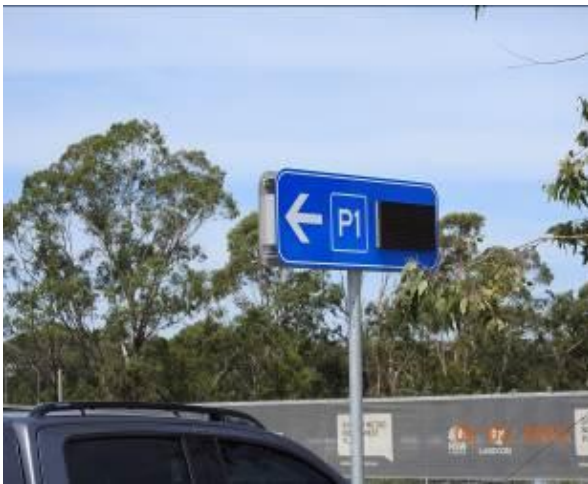
Figure 2454 – General Condition of street sign

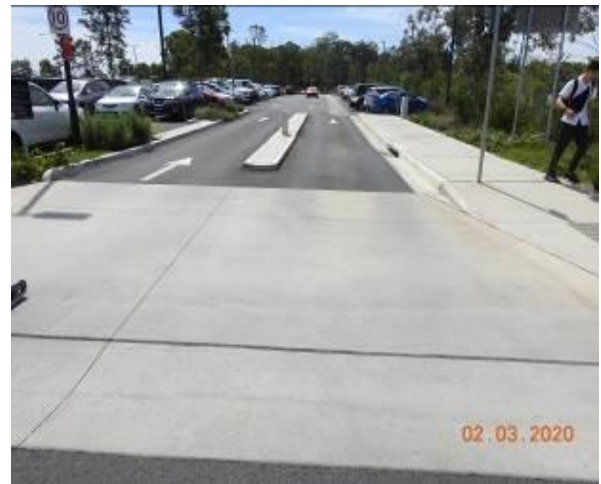
Figure 2455 – General Condition of layback

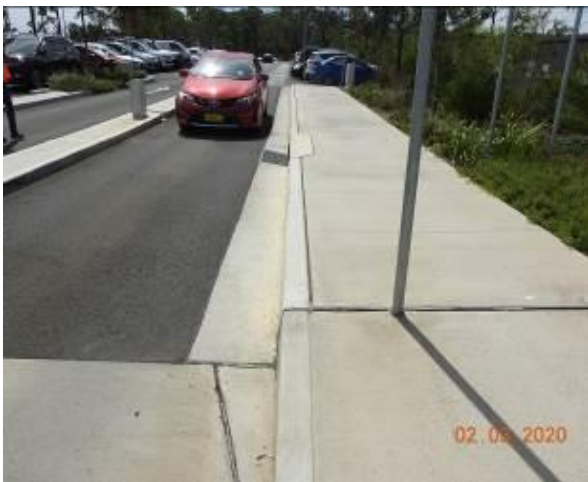
Figure 2456 – General Condition of kerb and gutter

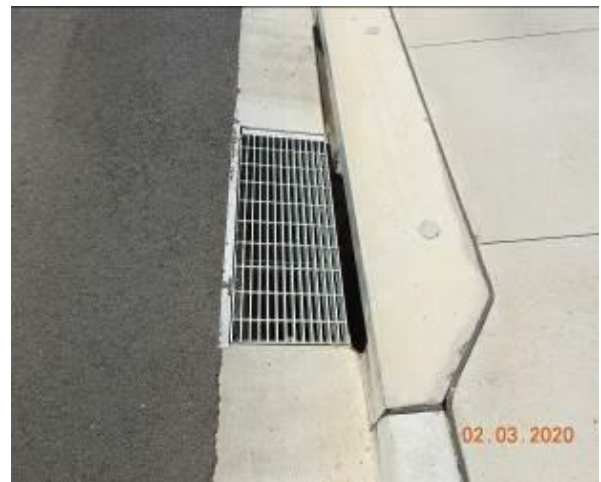
Figure 2457 – General Condition of stormwater inlet pit
