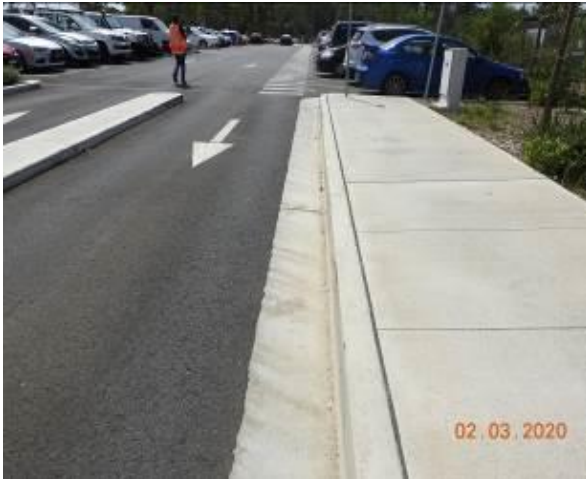
Figure 2458 – General Condition of kerb, gutter and footpath pavement

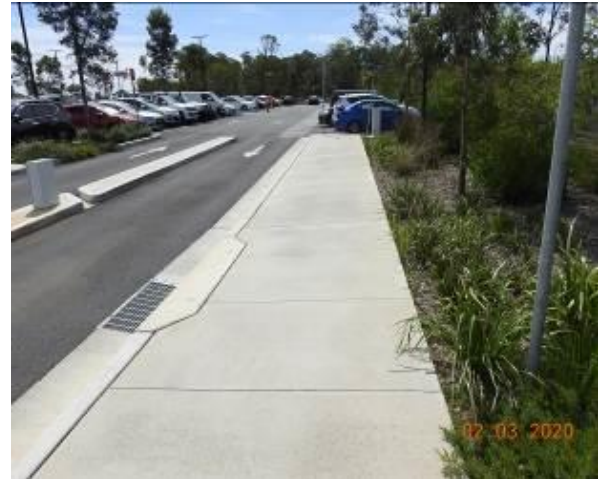
Figure 2459 – General Condition of footpath pavement

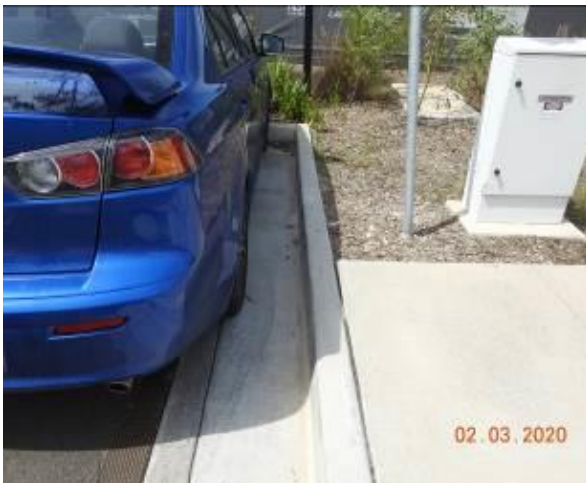
Figure 2460 – General Condition of kerb and gutter

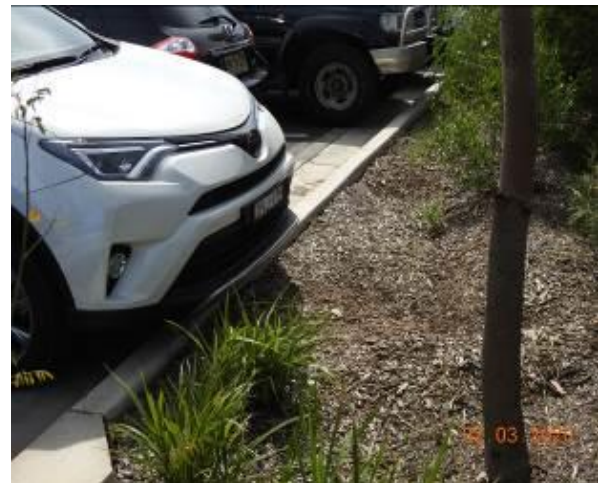
Figure 2461 – General Condition of kerb

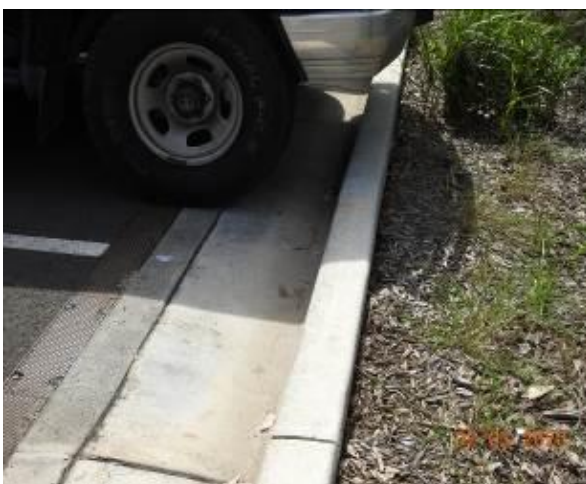
Figure 2462 – General Condition of kerb and gutter

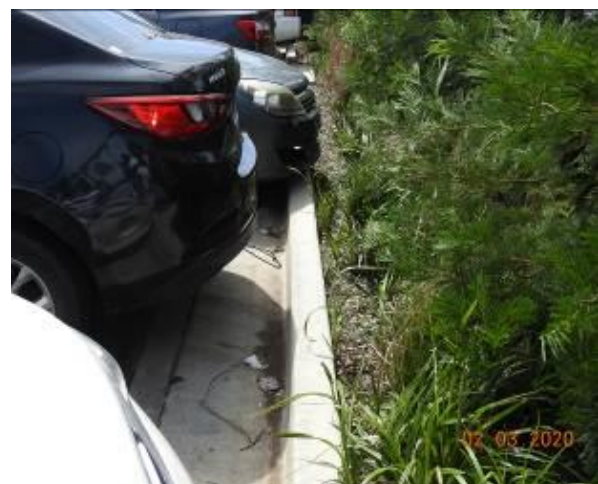
Figure 2463 – General Condition of kerb and gutter

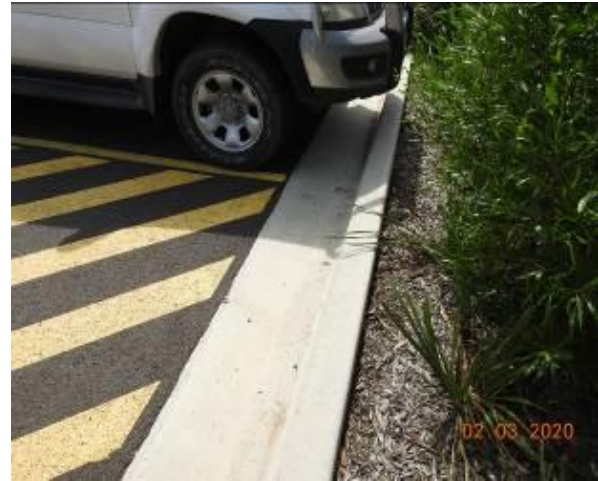
Figure 2465 – General Condition of kerb and gutter

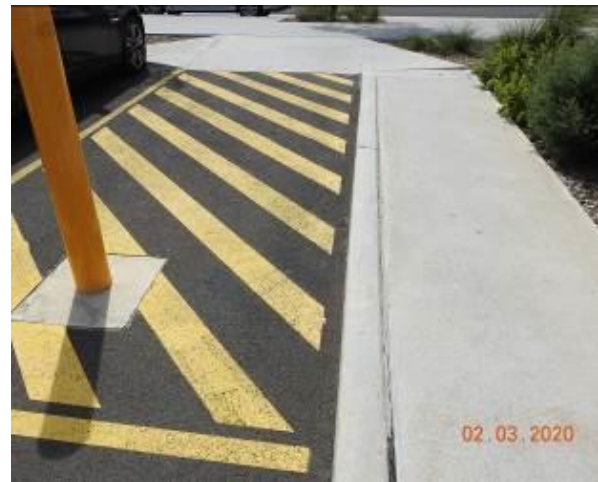
Figure 2467 – Crack propagation through footpath pavement

The road pavement of the car park was in a reasonable condition with evidence of cracking and material loss. The kerb, gutter and footpath in the car park were also inspected, they were in a reasonable condition with evidence of cracking through the footpath pavement. As well as evidence of material loss through kerb and gutter.

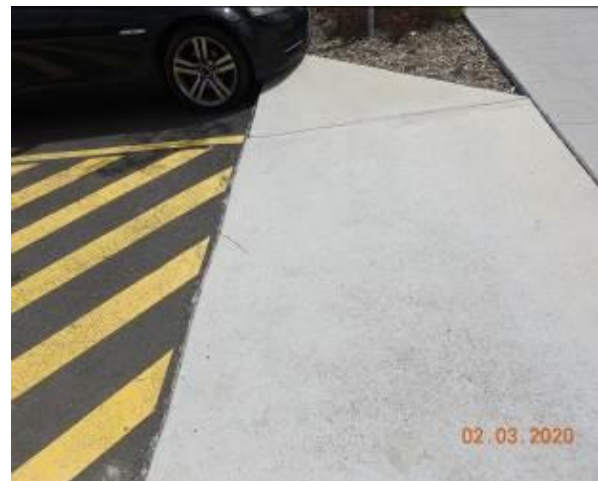
Figure 2469 – General Condition of footpath pavement

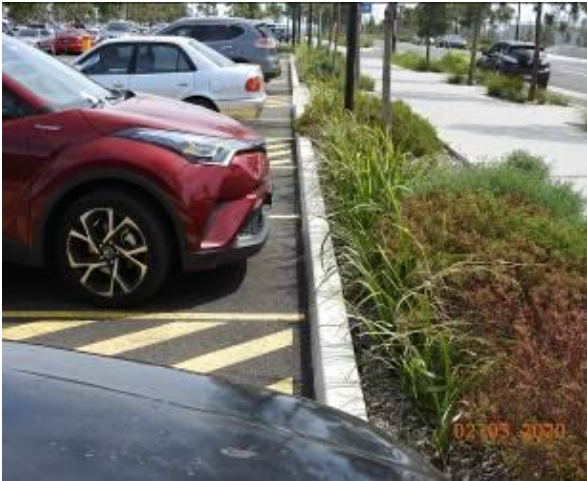
Figure 2470 – General Condition of kerb and gutter

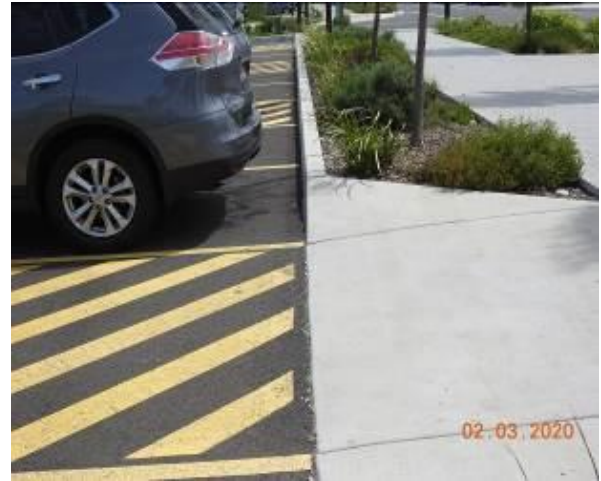
Figure 2471 – General Condition of layback and gutter

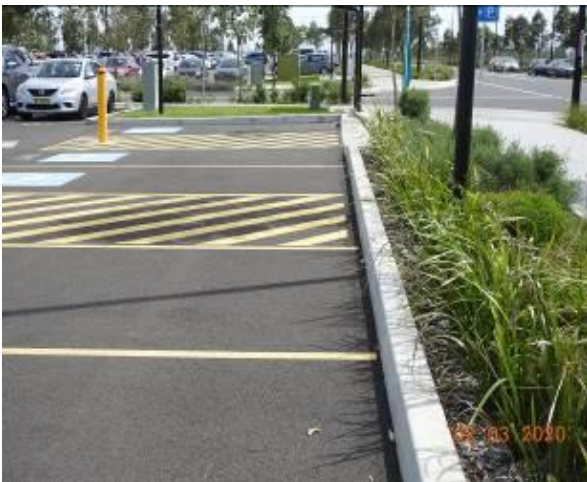
Figure 2472 – General Condition of kerb

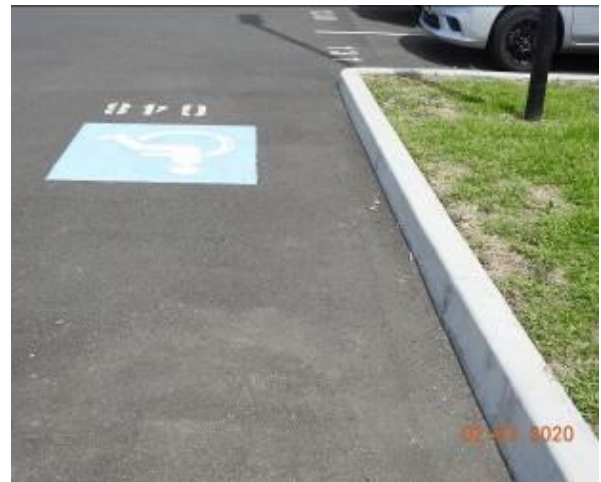
Figure 2473 – General Condition of kerb

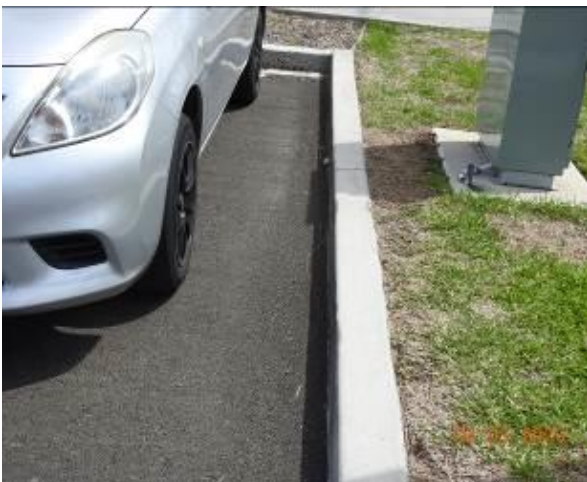
Figure 2474 – General Condition of kerb

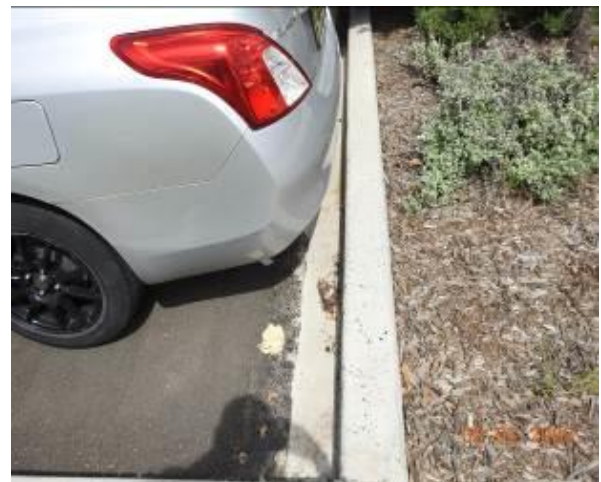
Figure 2475 – General Condition of kerb and gutter

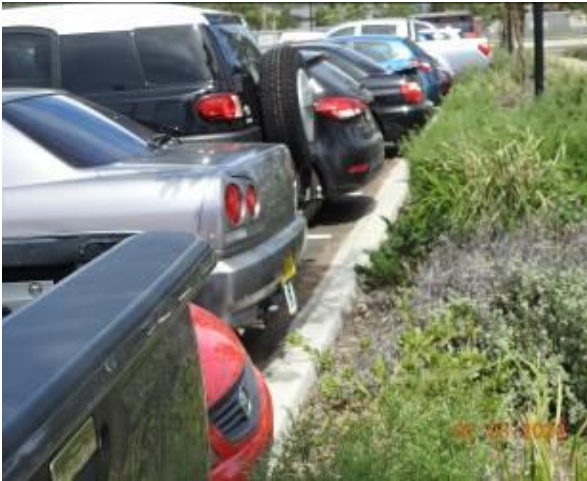
Figure 2476 – General Condition of kerb

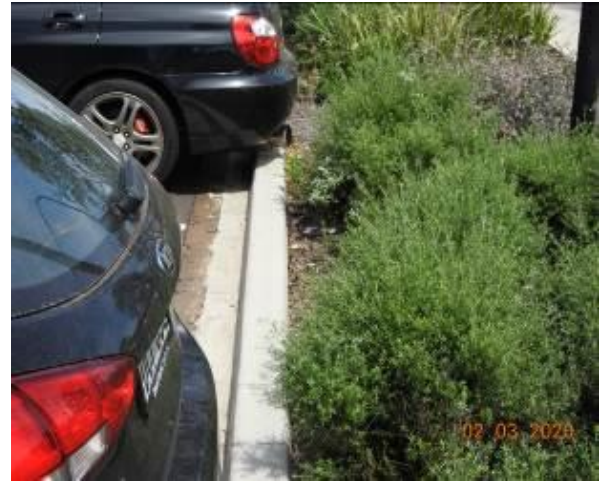
Figure 2477 – General Condition of kerb and gutter

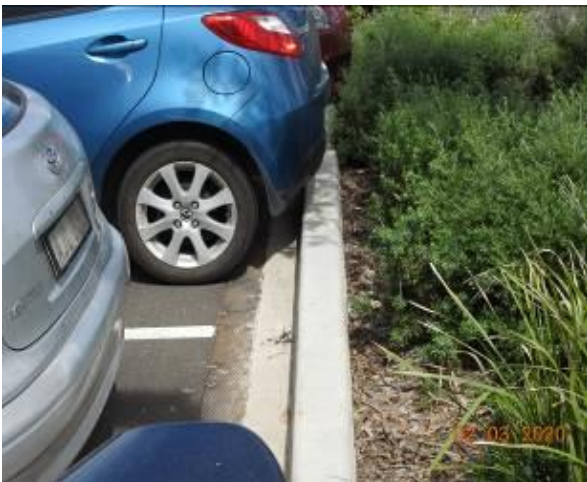
Figure 2478 – General Condition of kerb and gutter

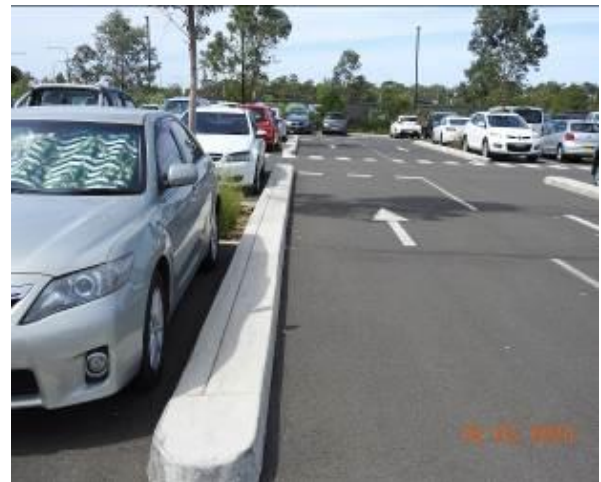
Figure 2479 – General Condition of traffic island kerb

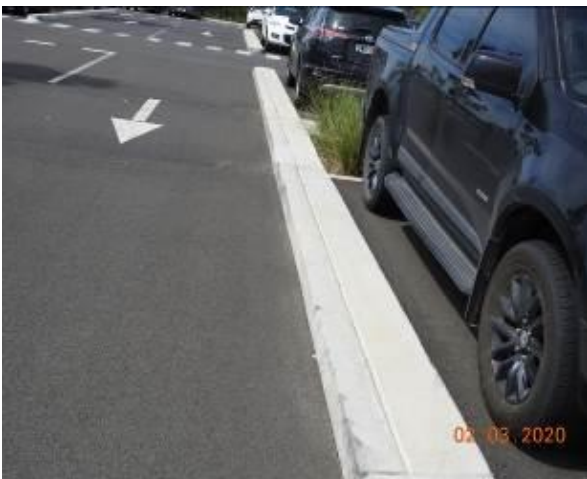
Figure 2480 – General Condition of traffic island kerb

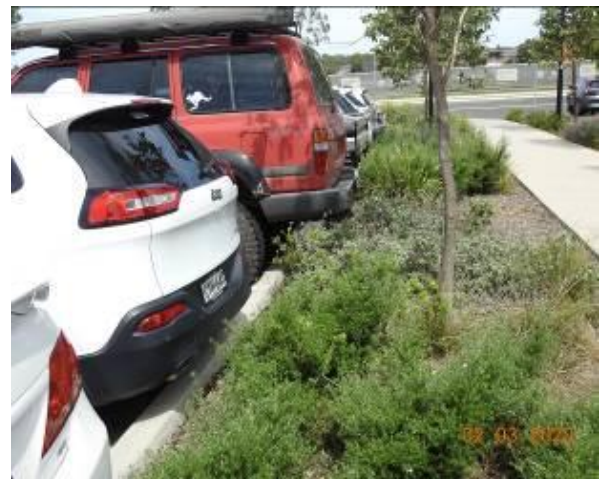
Figure 2481 – General Condition of kerb

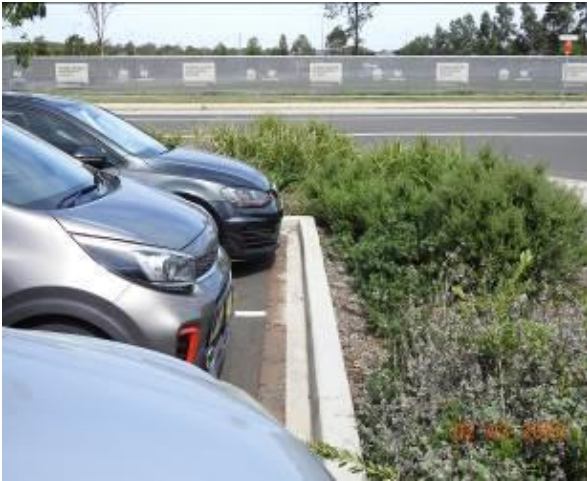
Figure 2482 – General Condition of kerb and gutter

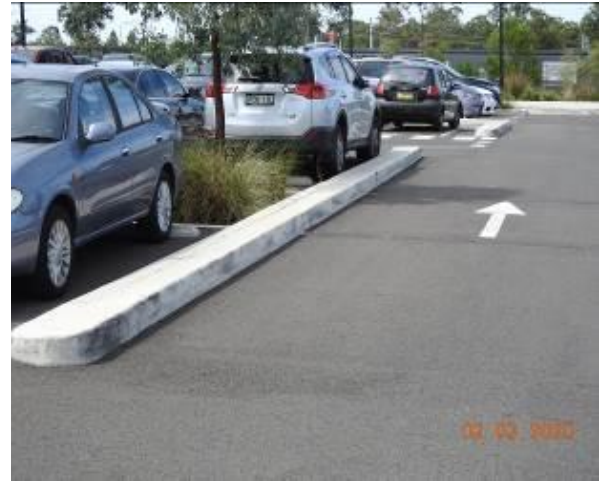
Figure 2483 – General Condition of traffic island kerb

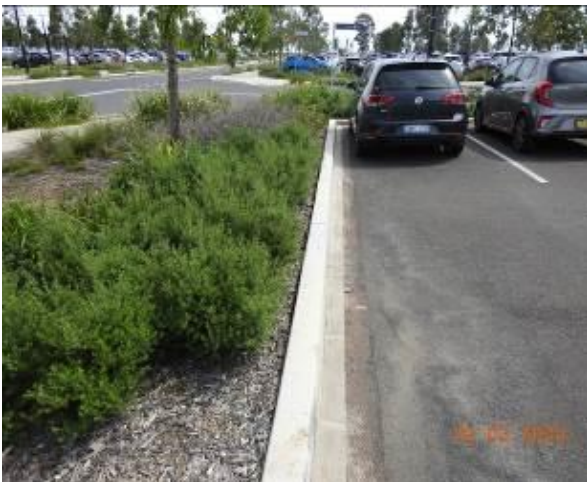
Figure 2484 – General Condition of kerb and gutter

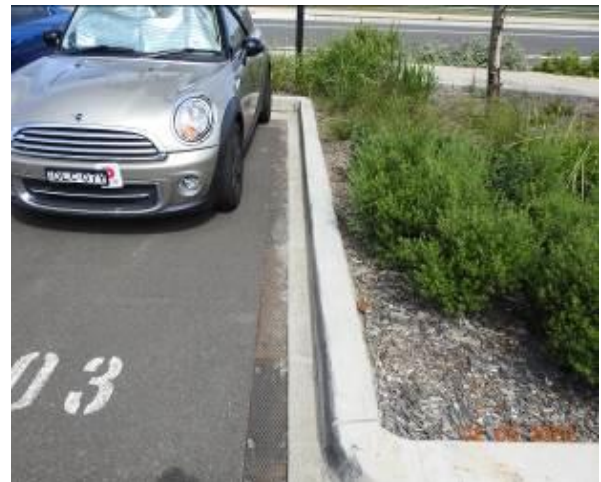
Figure 2485 – General Condition of kerb and gutter

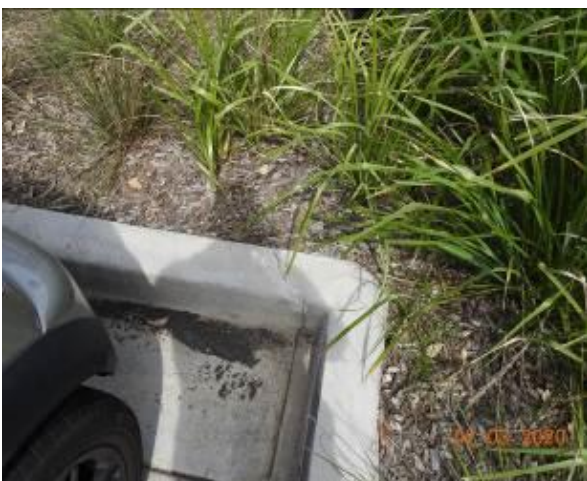
Figure 2486 – Crack propagation through kerb

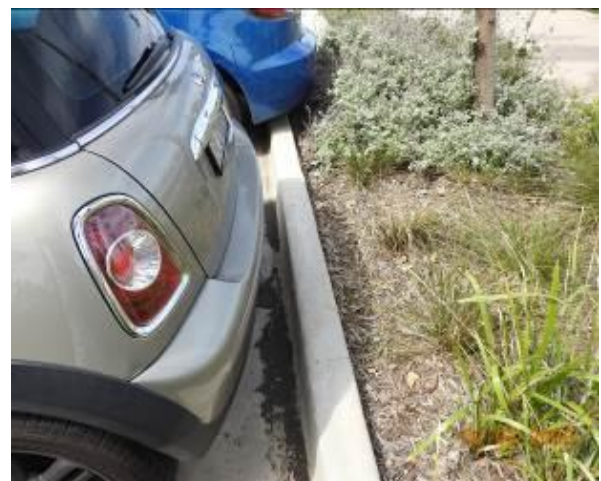
Figure 2487 – General Condition of kerb and gutter

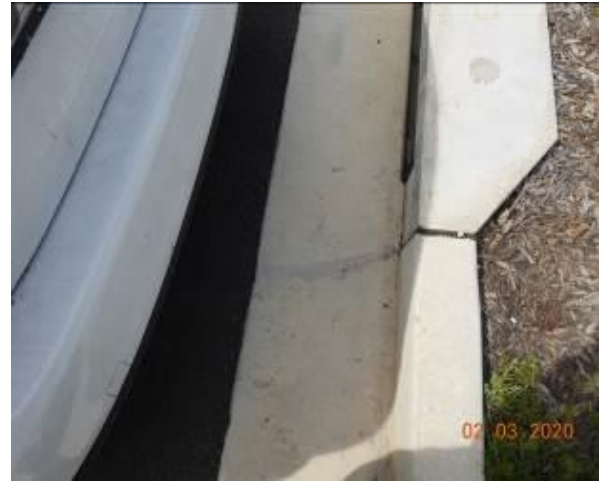
Figure 2489 – Crack propagation through gutter

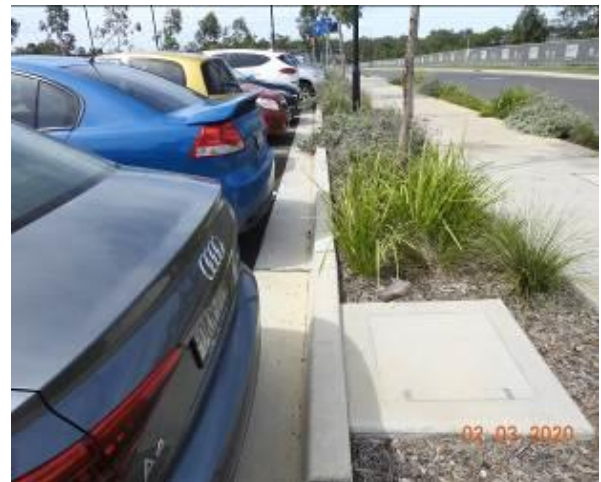
Figure 2491 – General Condition of kerb and gutter

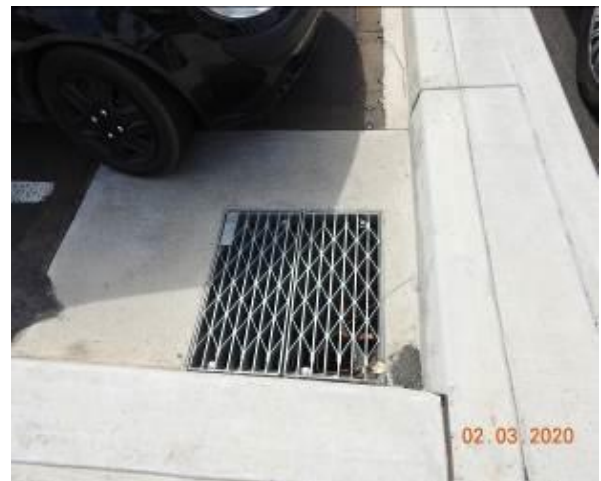
Figure 2493 – General Condition of stormwater inlet pit

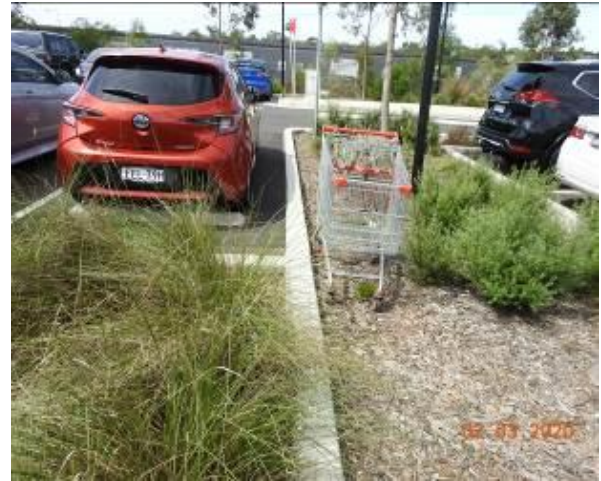
Figure 2495 – General Condition of kerb

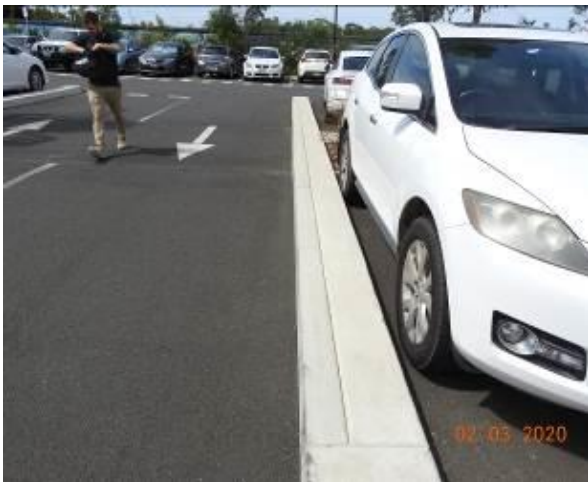
Figure 2496 – General Condition of traffic island kerb

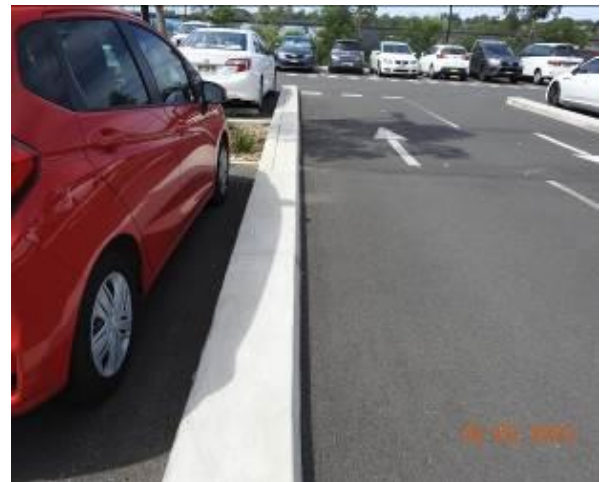
Figure 2497 – General Condition of traffic island kerb

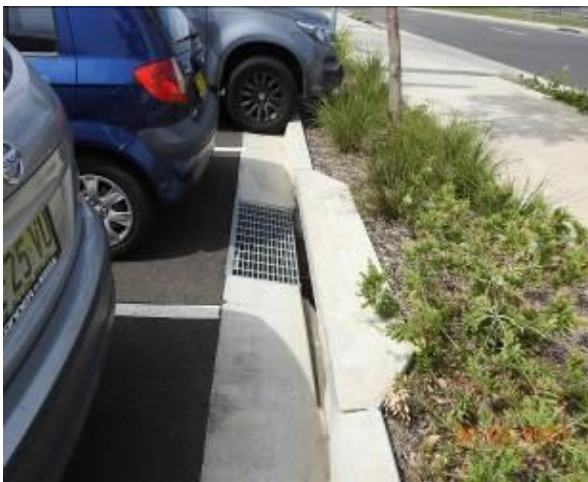
Figure 2498 – General Condition of kerb and gutter

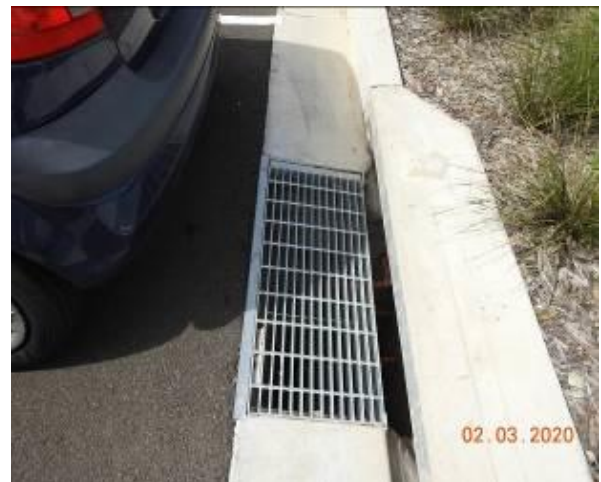
Figure 2499 – General Condition of stormwater inlet pit

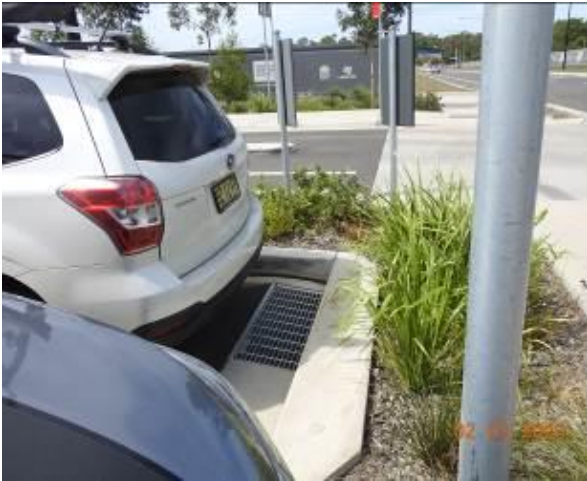
Figure 2500 – General Condition of kerb and gutter

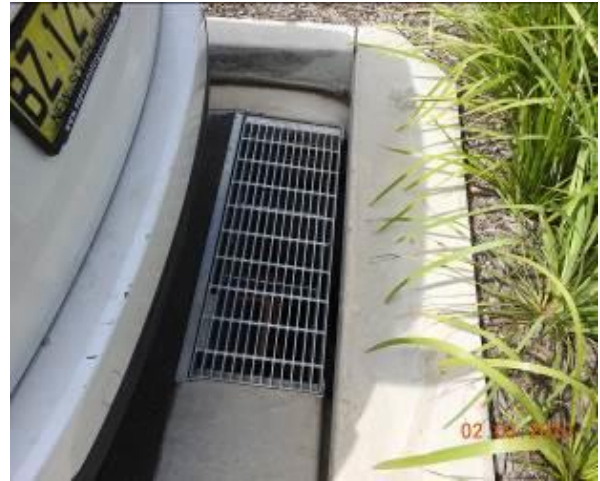
Figure 2501 – General Condition of stormwater inlet pit

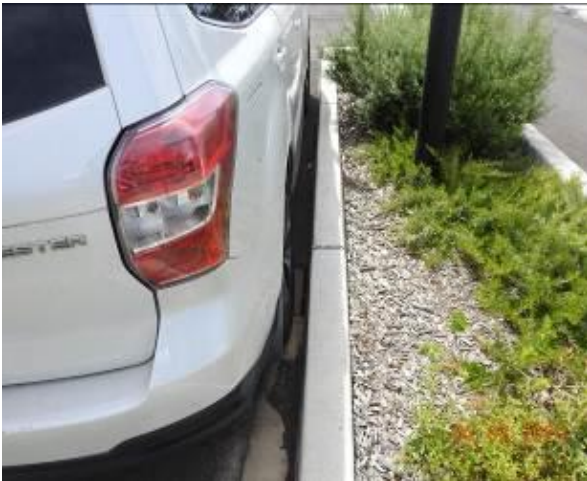
Figure 2502 – General Condition of kerb

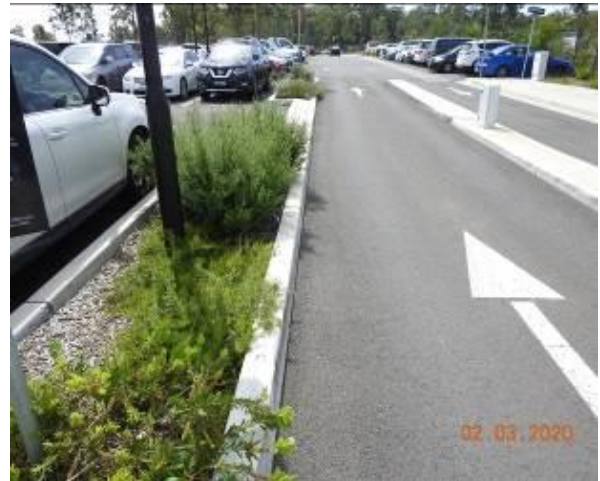
Figure 2503 – General Condition of kerb

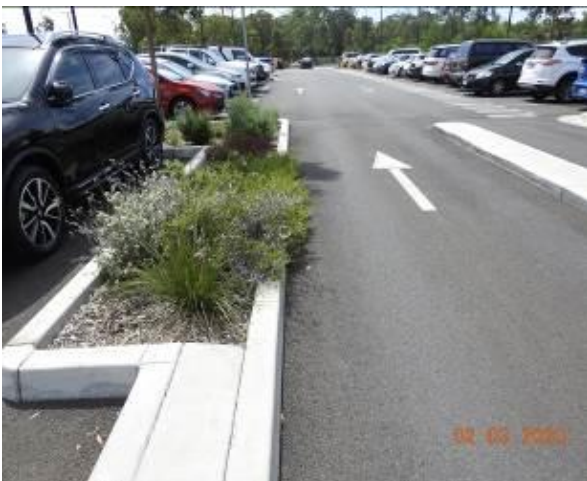
Figure 2504 – General Condition of traffic island kerb

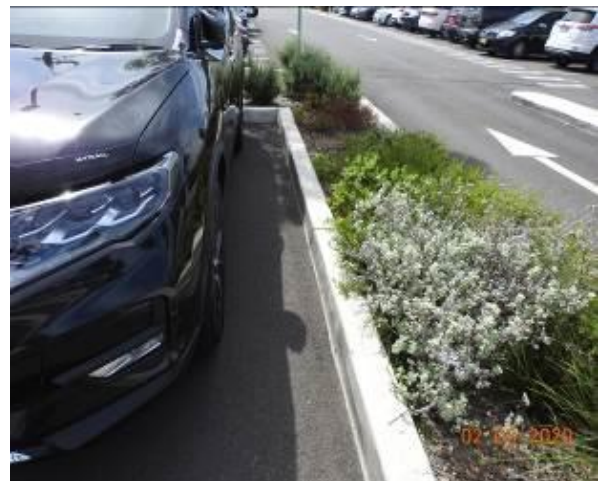
Figure 2505 – General Condition of kerb

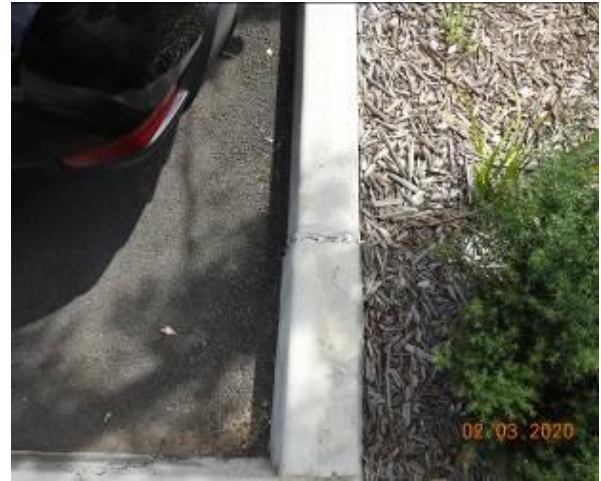
Figure 2507 – Crack propagation and loss of material through kerb

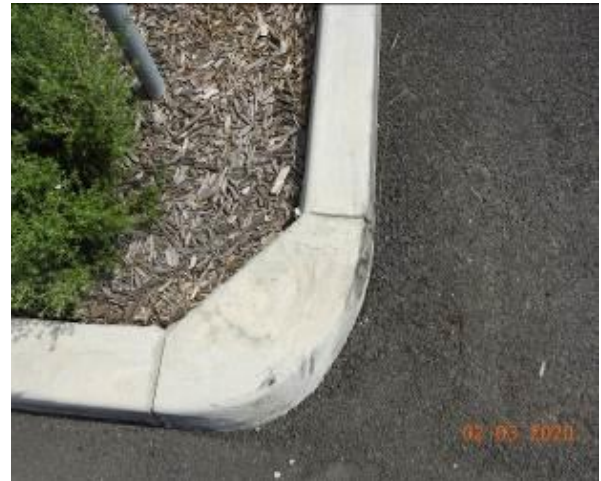
Figure 2509 – Crack propagation through kerb

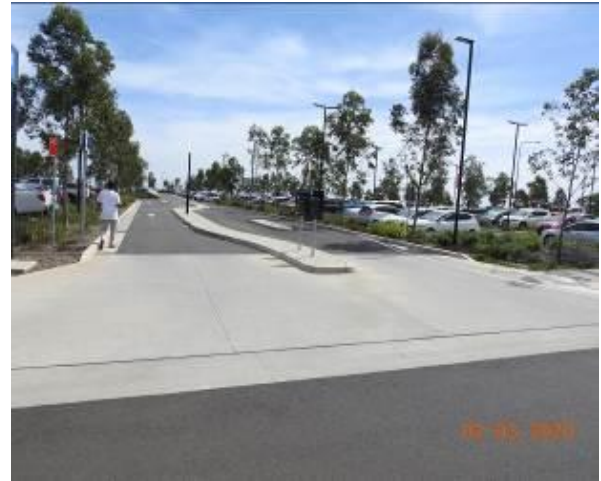
Figure 2511 – General Condition of driveway pavement

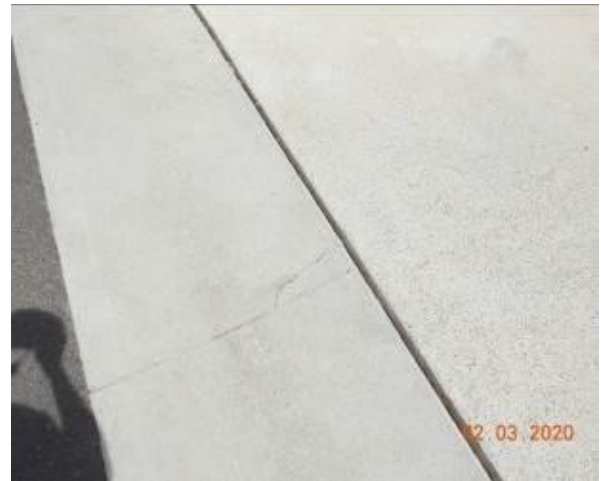
Figure 2513 – Crack propagation through layback and gutter

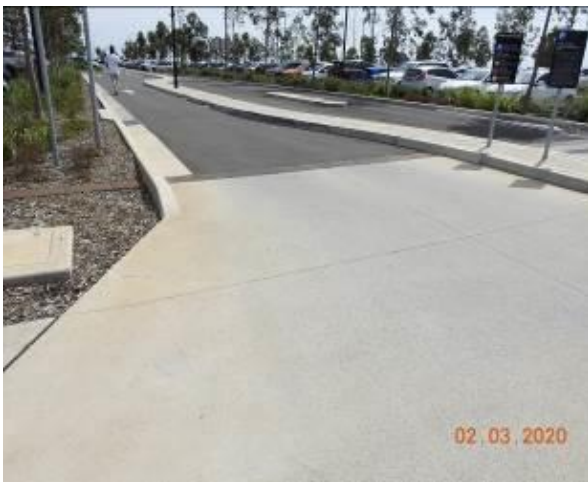
Figure 2514 – General Condition of driveway pavement

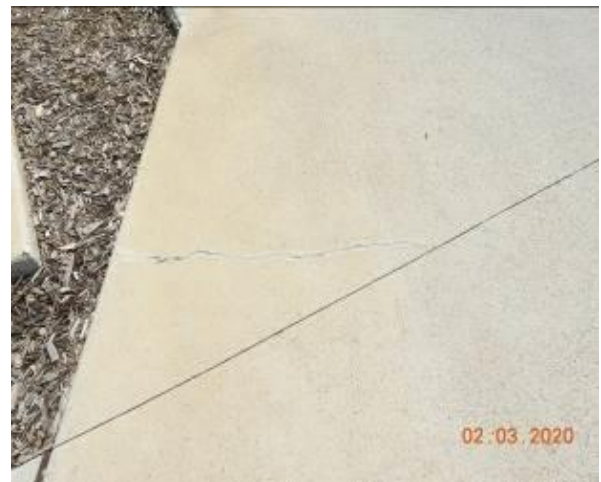
Figure 2515 – Crack propagation through driveway pavement

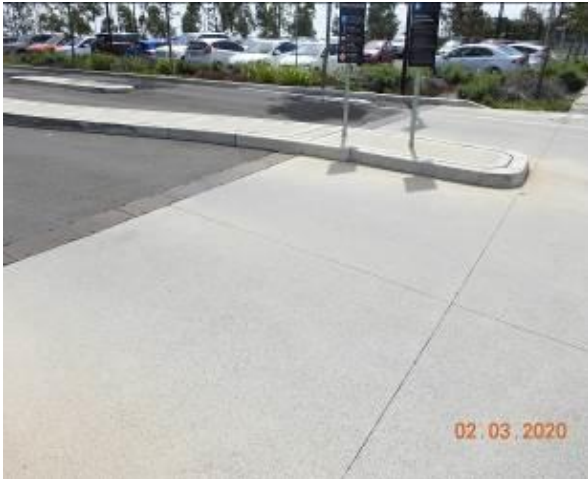
Figure 2516 – General Condition of driveway pavement

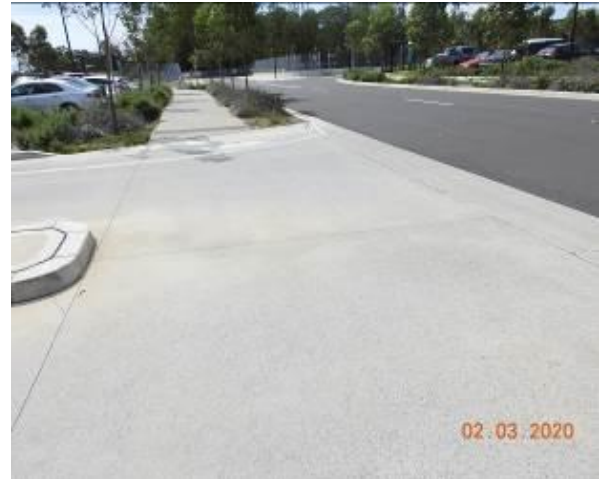
Figure 2517 – General Condition of driveway pavement

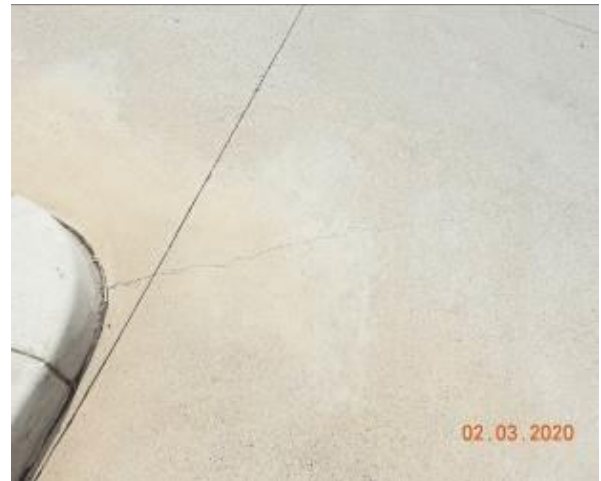
Figure 2519 – Crack propagation through driveway pavement

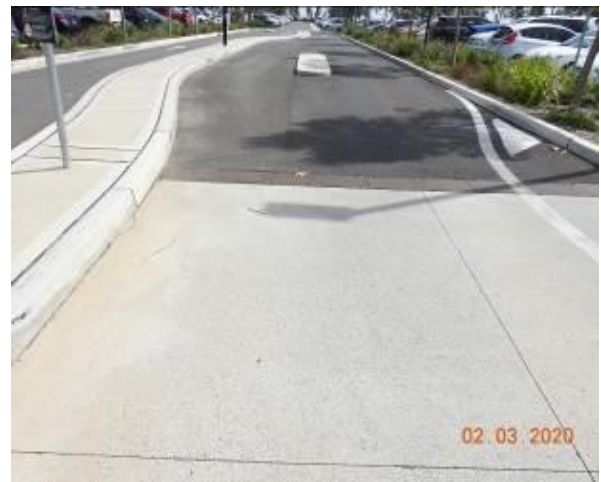
Figure 2521 – General Condition of driveway pavement

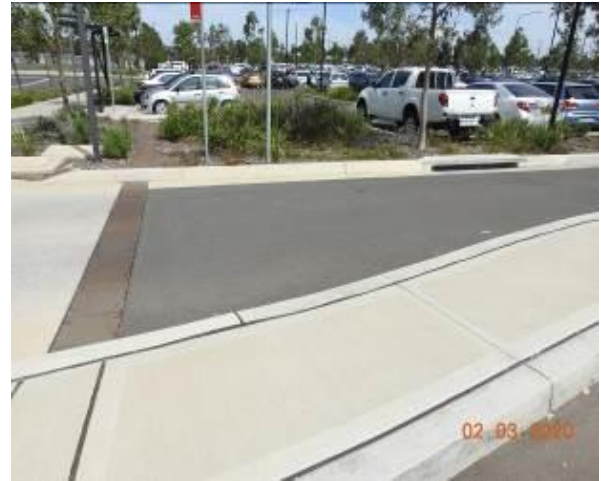
Figure 2523 – General Condition of carpark pavement

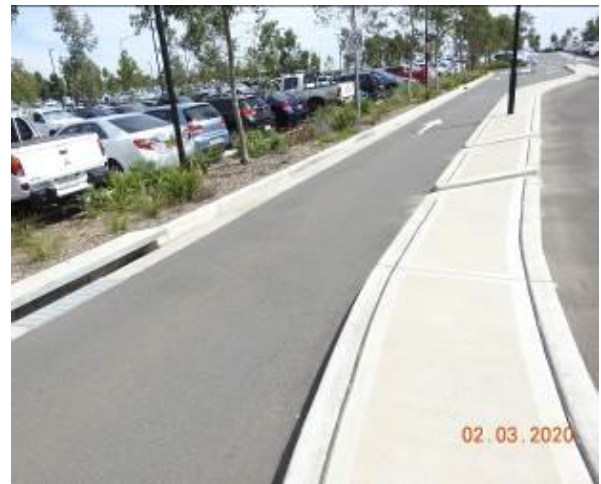
Figure 2525 – General Condition of carpark pavement

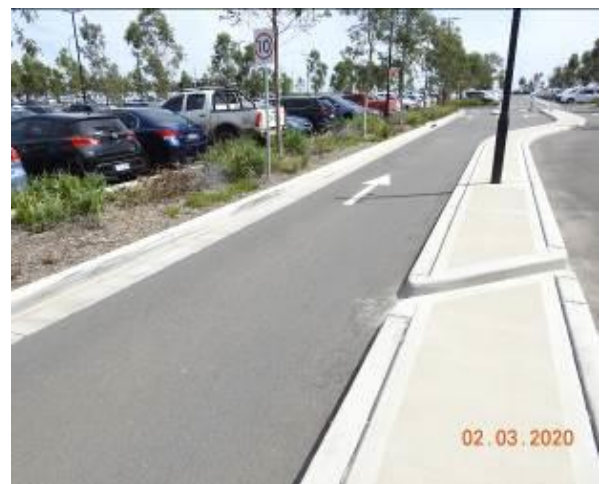
Figure 2527 – General Condition of carpark pavement

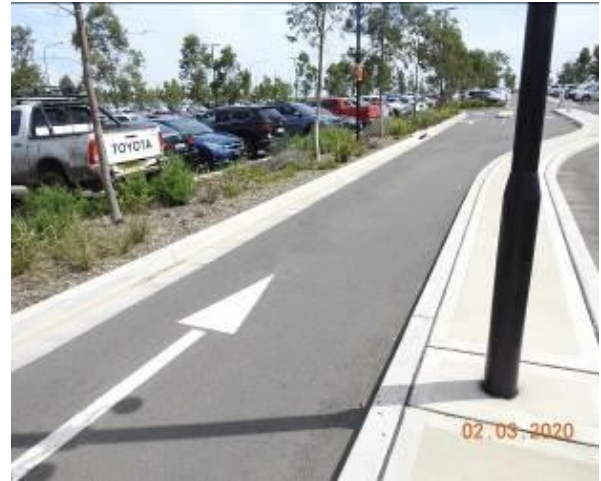
Figure 2529 – General Condition of carpark pavement

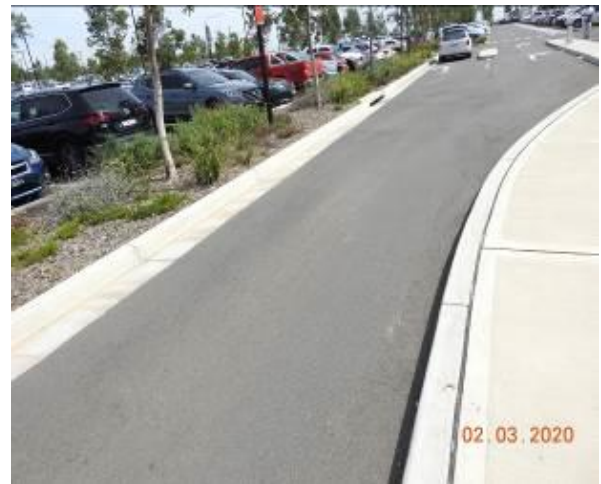
Figure 2531 – General Condition of carpark pavement

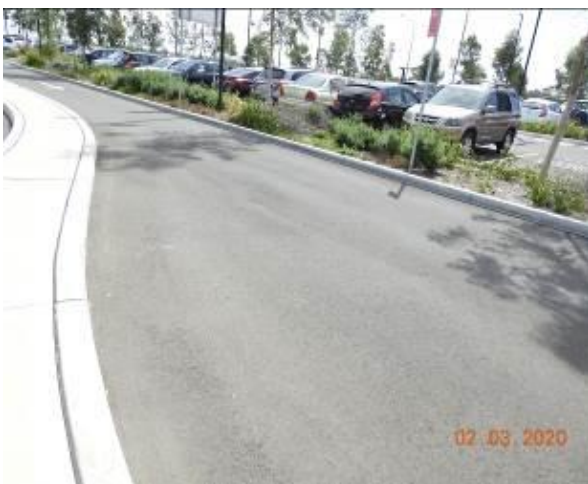
Figure 2532 – General Condition of carpark pavement

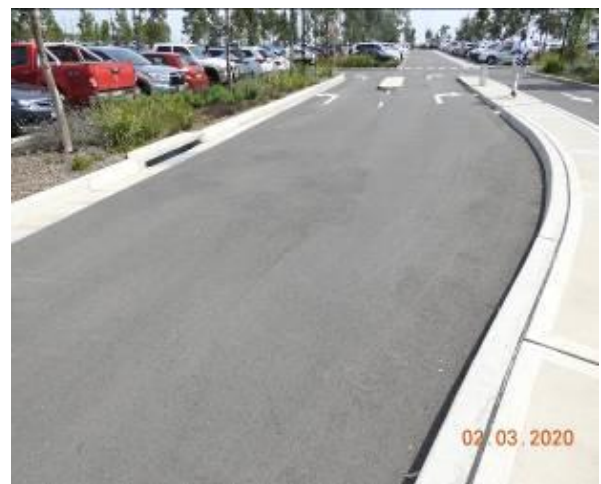
Figure 2533 – General Condition of carpark pavement

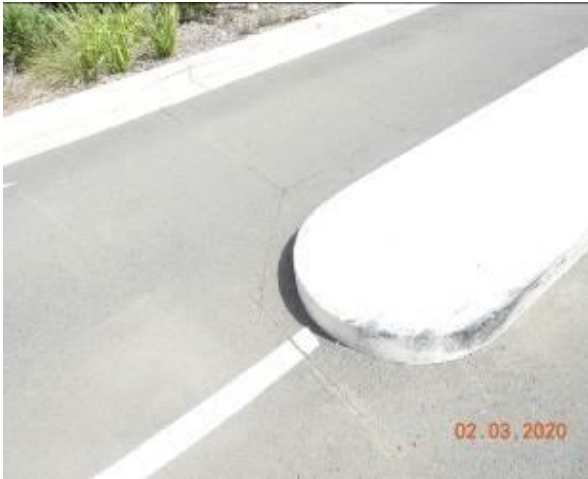
Figure 2540 – General Condition of carpark pavement

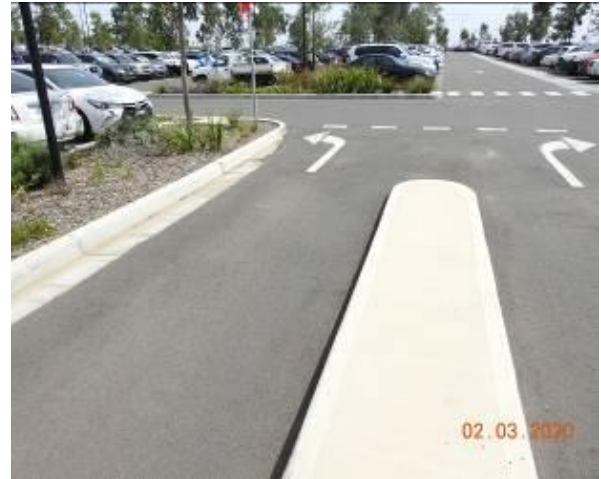
Figure 2541 – General Condition of carpark pavement

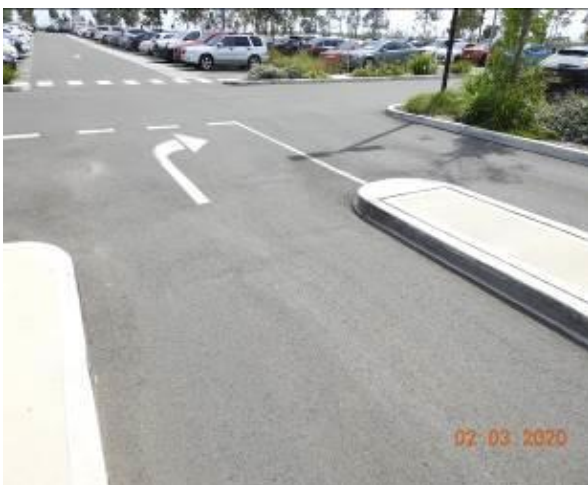
Figure 2542 – General Condition of carpark pavement

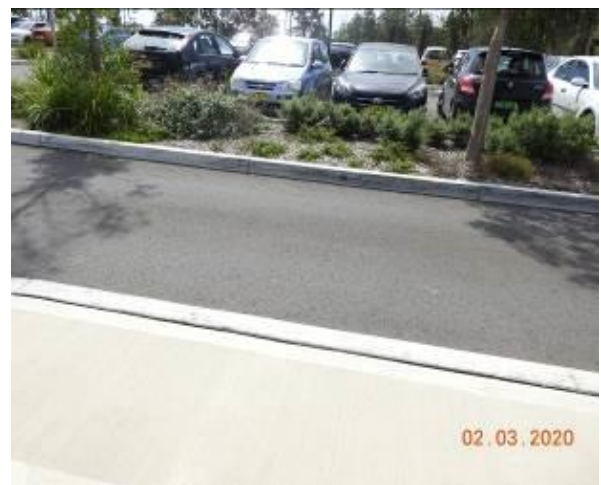
Figure 2543 – General Condition of carpark pavement

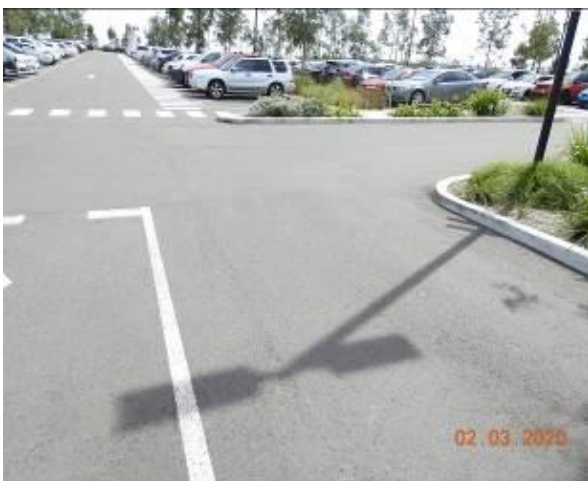
Figure 2544 – General Condition of carpark pavement

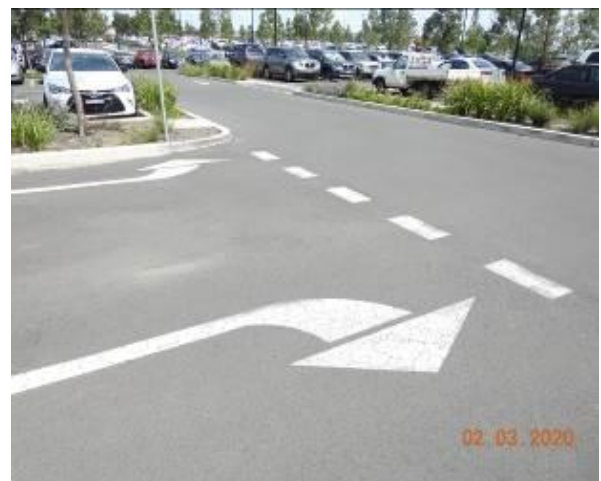
Figure 2545 – General Condition of carpark pavement

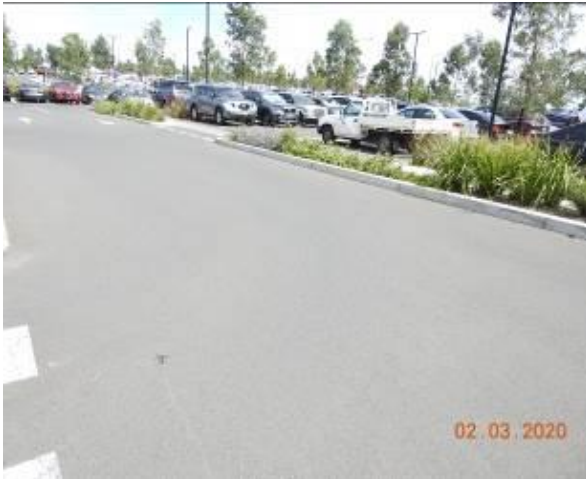
Figure 2546 – General Condition of carpark pavement

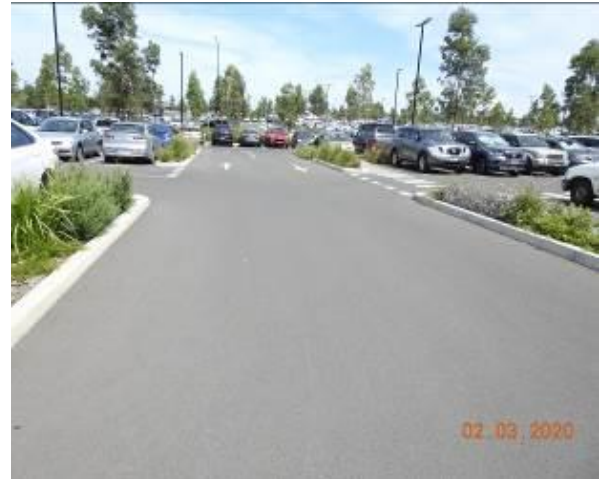
Figure 2547 – General Condition of carpark pavement

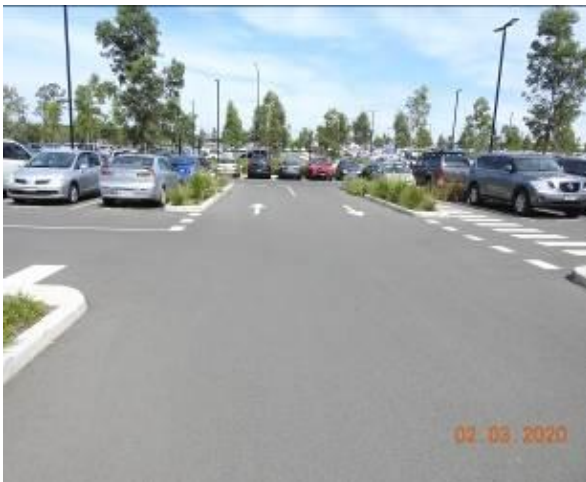
Figure 2548 – General Condition of carpark pavement

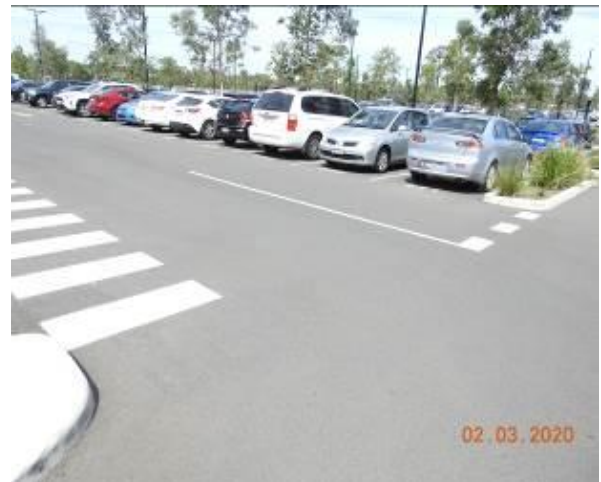
Figure 2549 – General Condition of carpark pavement

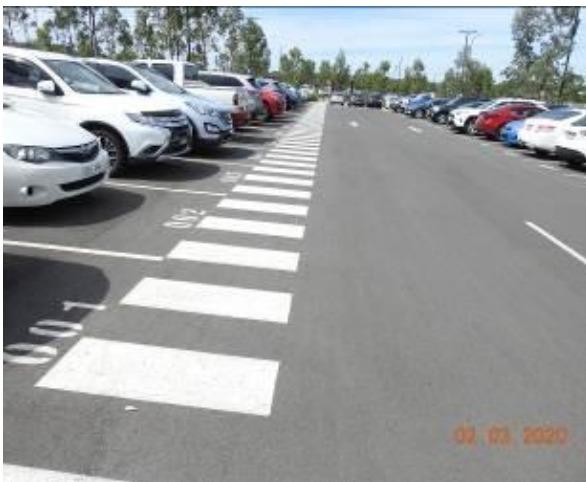
Figure 2550 – General Condition of carpark pavement

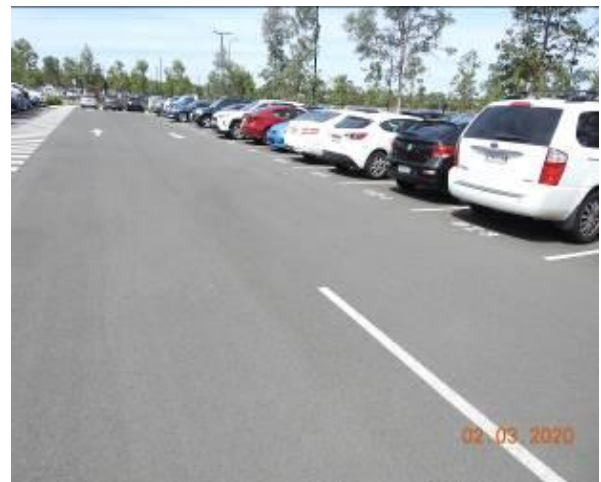
Figure 2551 – General Condition of carpark pavement

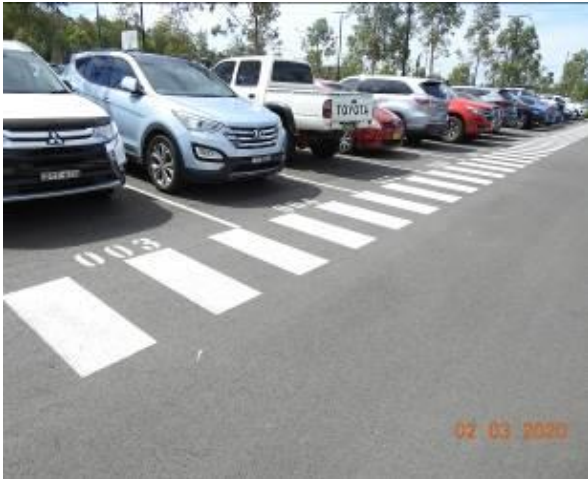
Figure 2552 – General Condition of carpark pavement

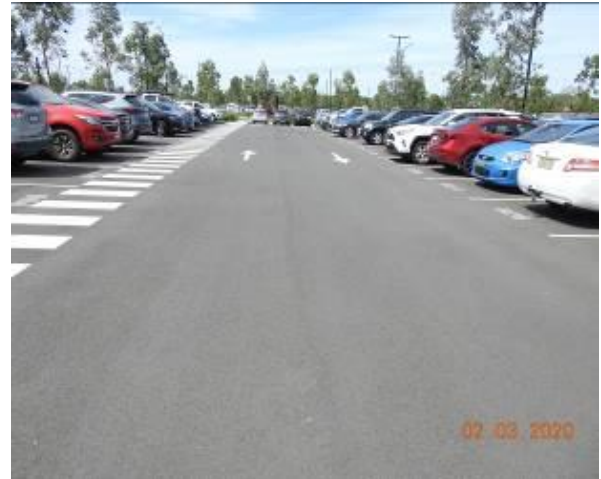
Figure 2553 – General Condition of carpark pavement

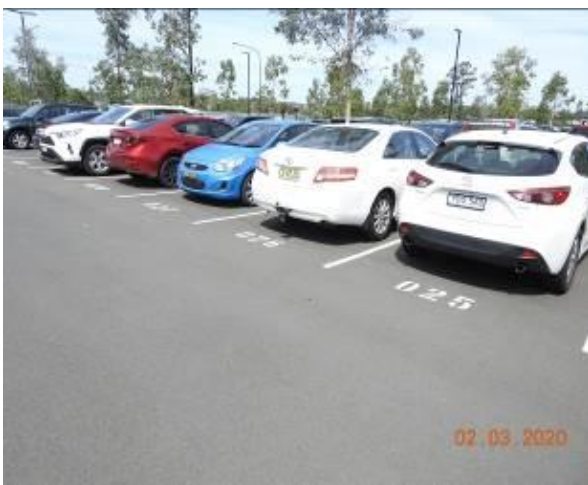
Figure 2554 – General Condition of carpark pavement

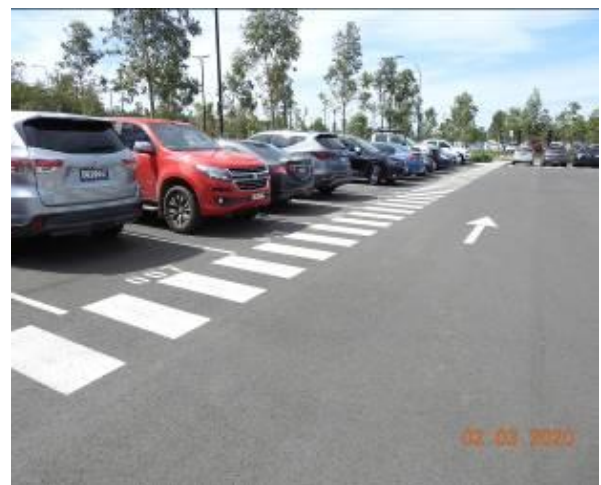
Figure 2555 – General Condition of carpark pavement

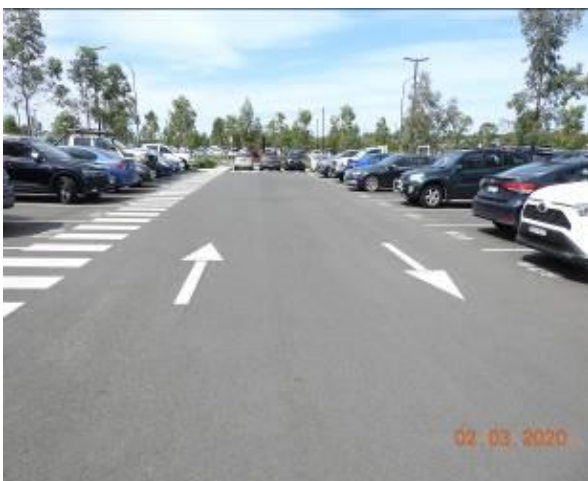
Figure 2556 – General Condition of carpark pavement

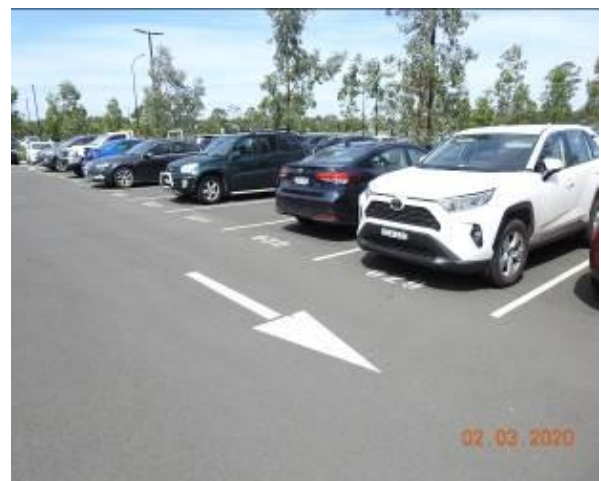
Figure 2557 – General Condition of carpark pavement

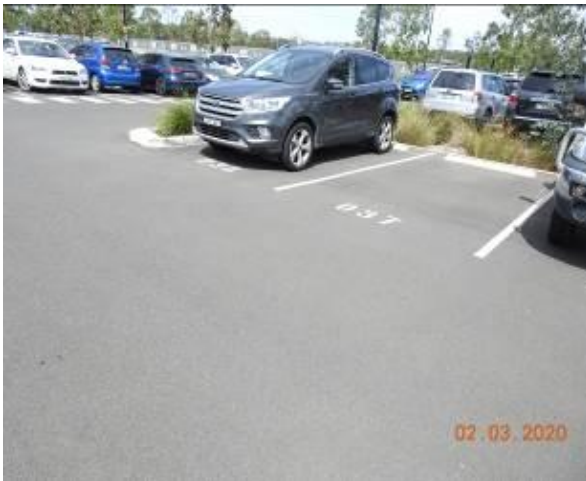
Figure 2564 – General Condition of carpark pavement
