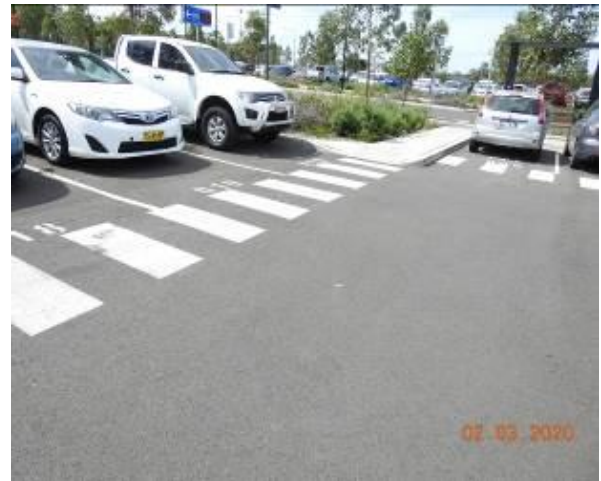
Figure 2565 – General Condition of carpark pavement

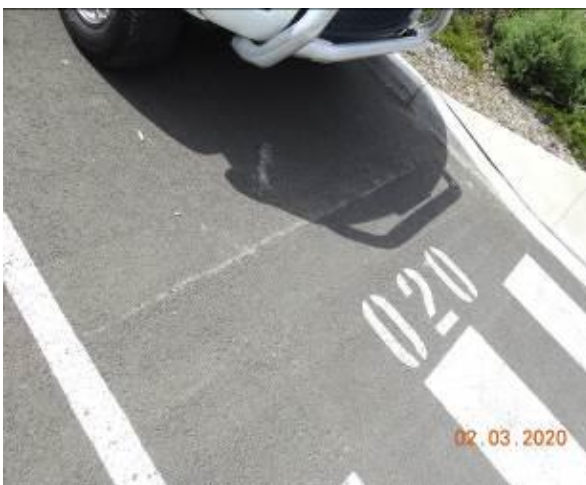
Figure 2566 – Crack propagation through carpark pavement

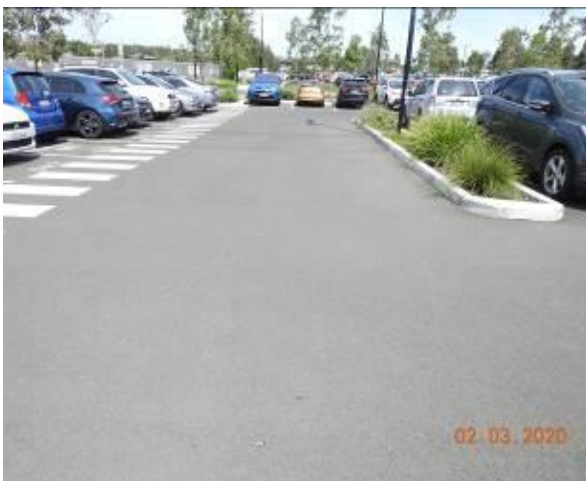
Figure 2568 – General Condition of carpark pavement

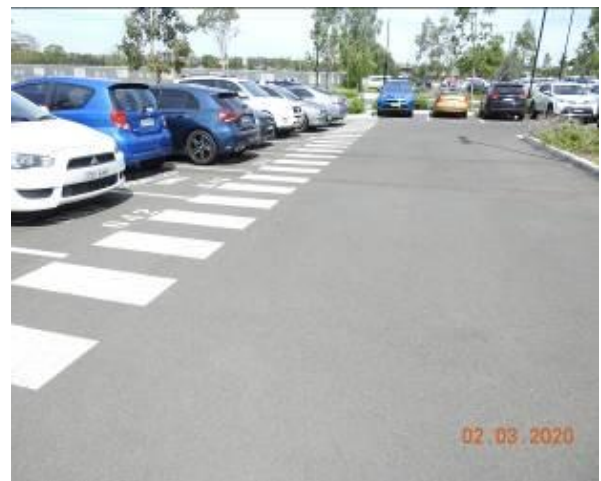
Figure 2569 – General Condition of carpark pavement

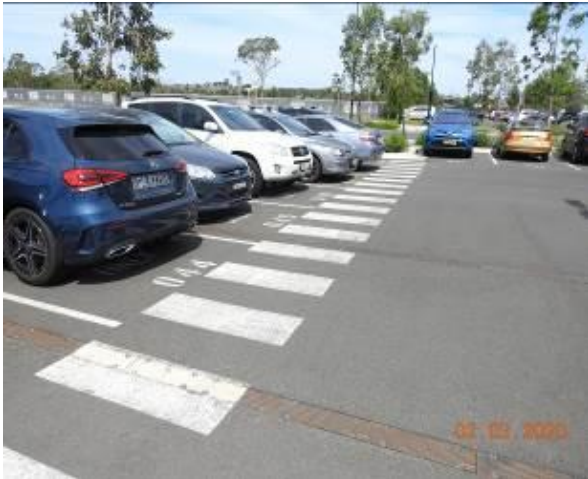
Figure 2570 – General Condition of carpark pavement

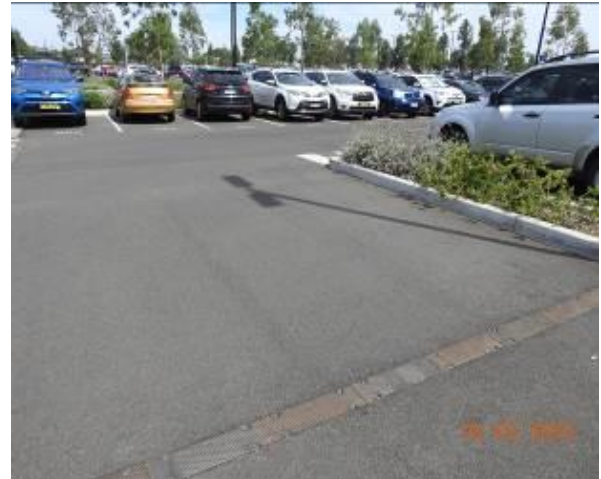
Figure 2571 – General Condition of carpark pavement

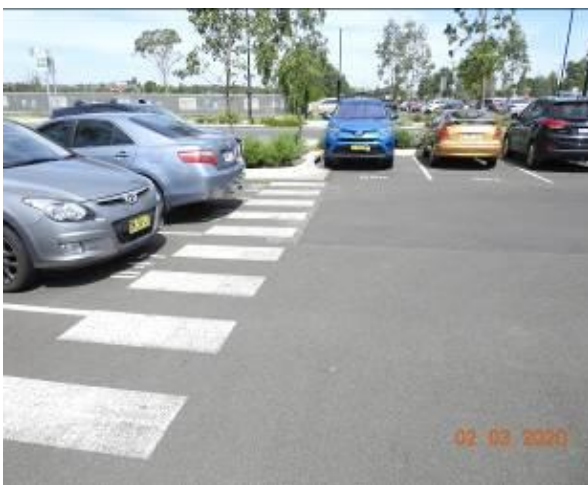
Figure 2572 – General Condition of carpark pavement

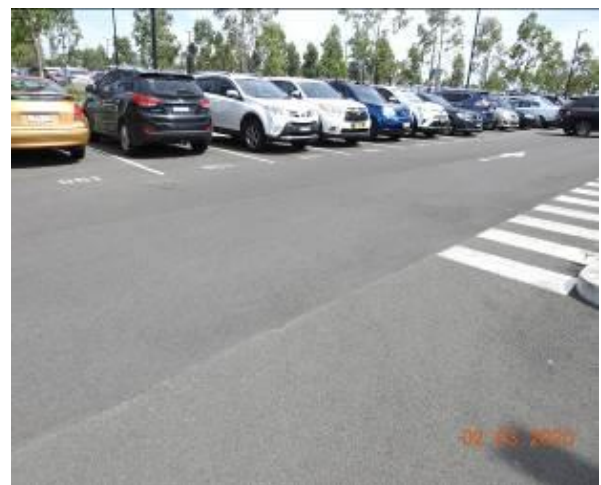
Figure 2573 – General Condition of carpark pavement

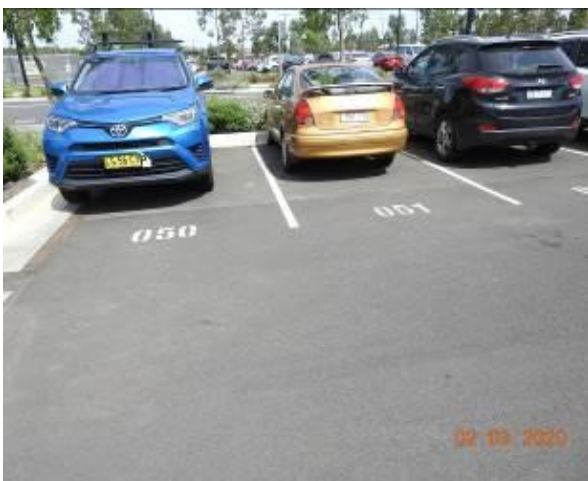
Figure 2574 – General Condition of carpark pavement

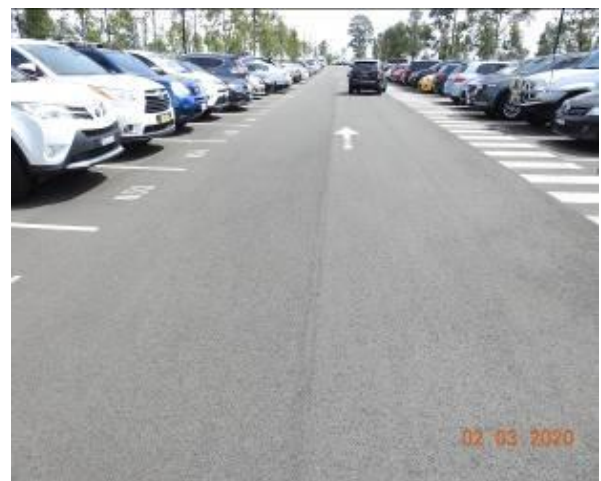
Figure 2575 – General Condition of carpark pavement

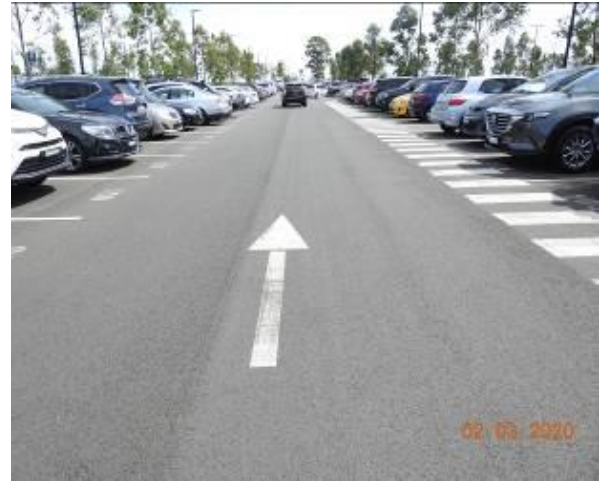
Figure 2577 – General Condition of carpark pavement

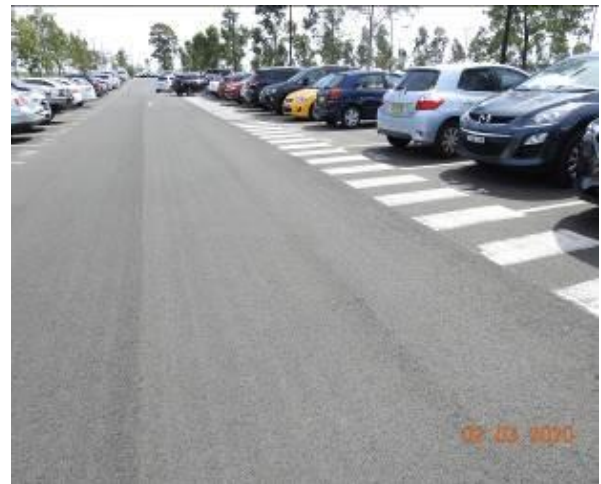
Figure 2579 – General Condition of carpark pavement

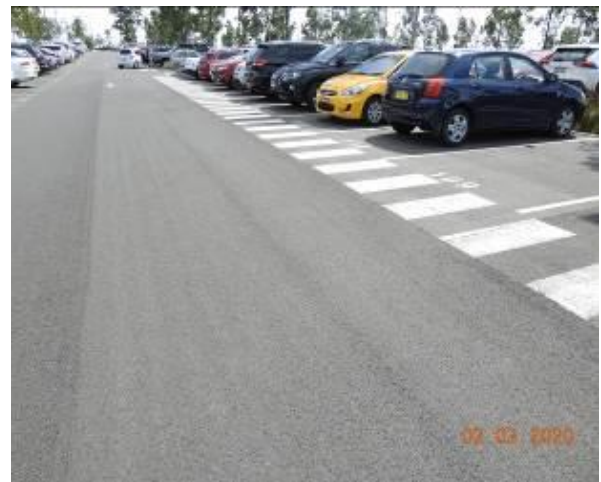
Figure 2581 – General Condition of carpark pavement

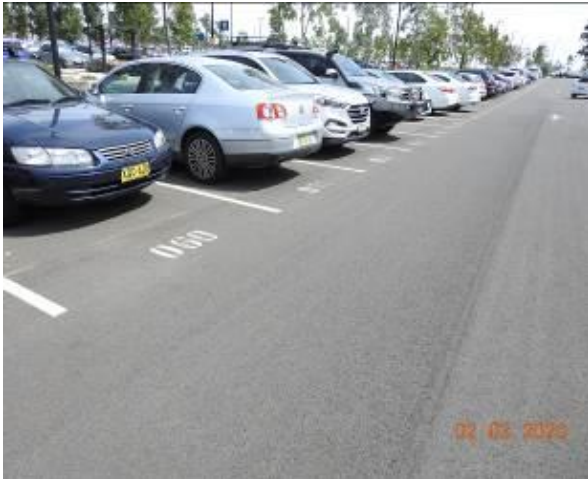
Figure 2582 – General Condition of carpark pavement

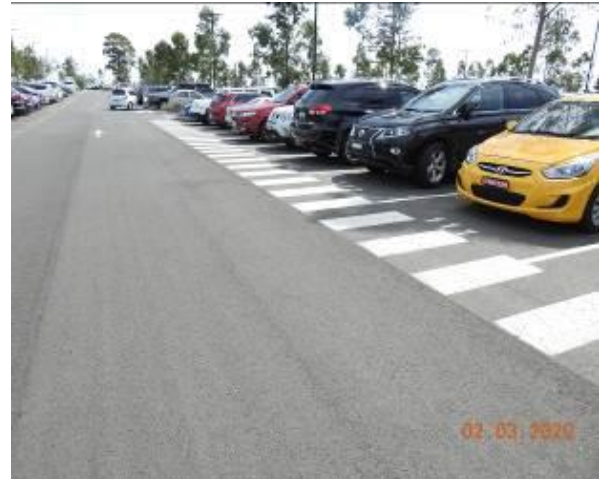
Figure 2583 – General Condition of carpark pavement

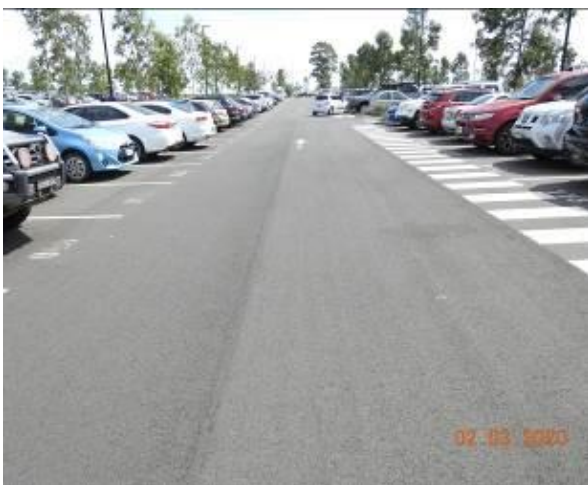
Figure 2584 – General Condition of carpark pavement

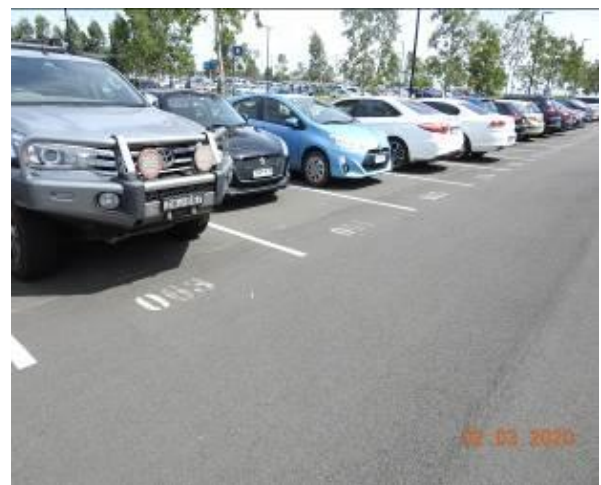
Figure 2585 – General Condition of carpark pavement

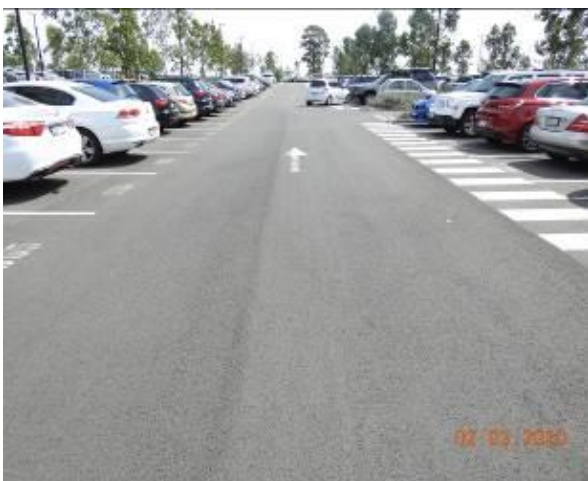
Figure 2586 – General Condition of carpark pavement

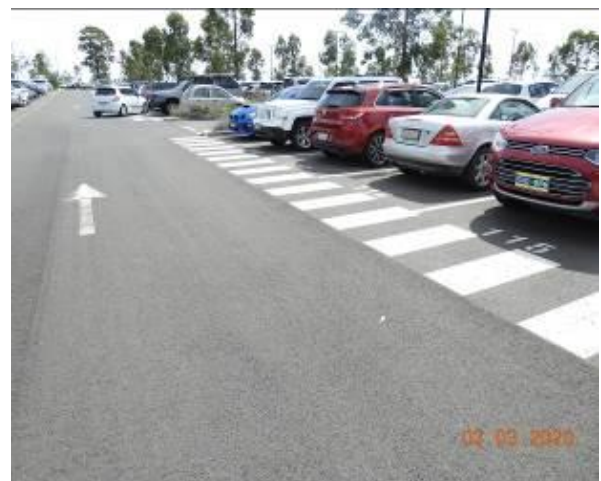
Figure 2587 – General Condition of carpark pavement

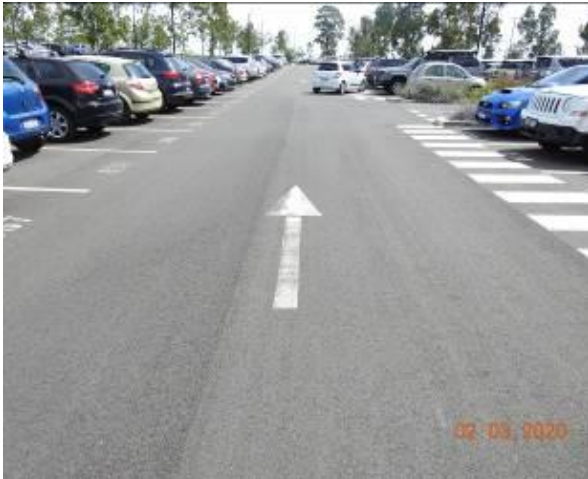
Figure 2588 – General Condition of carpark pavement

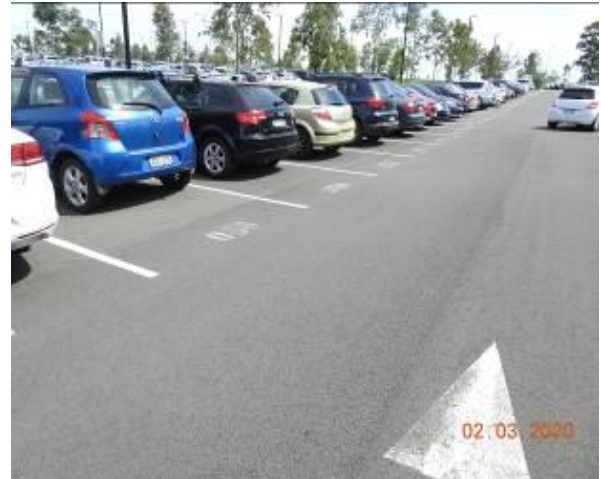
Figure 2589 – General Condition of carpark pavement

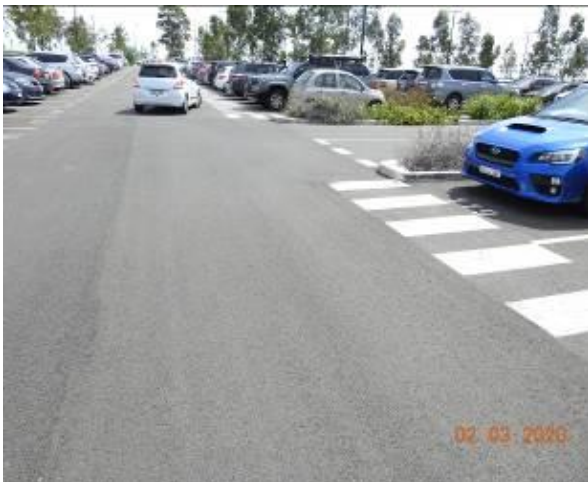
Figure 2590 – General Condition of carpark pavement

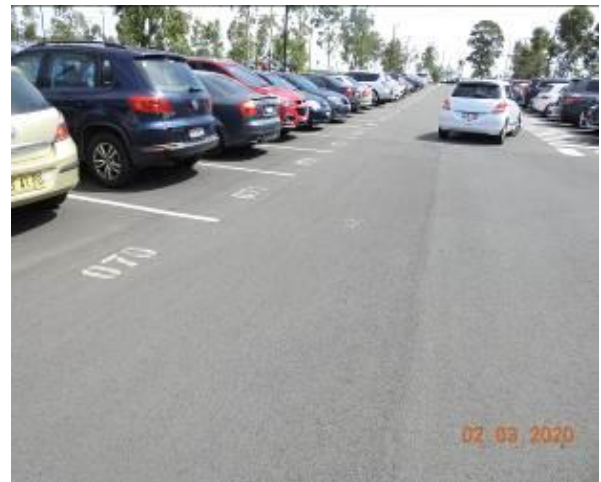
Figure 2591 – General Condition of carpark pavement

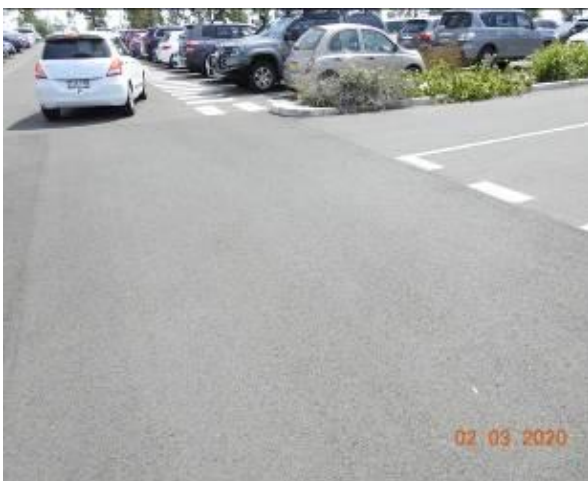
Figure 2592 – General Condition of carpark pavement

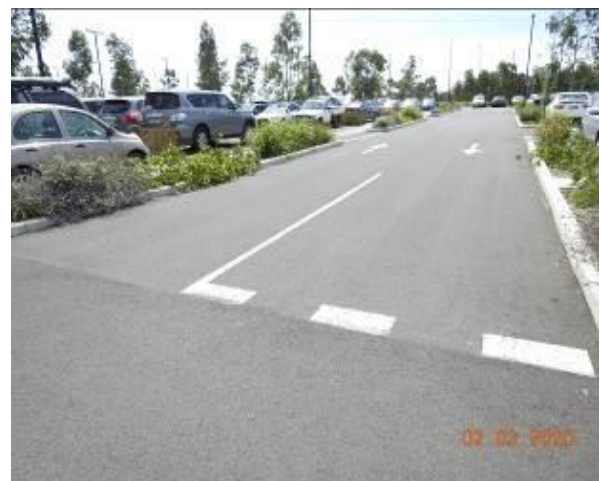
Figure 2593 – General Condition of carpark pavement

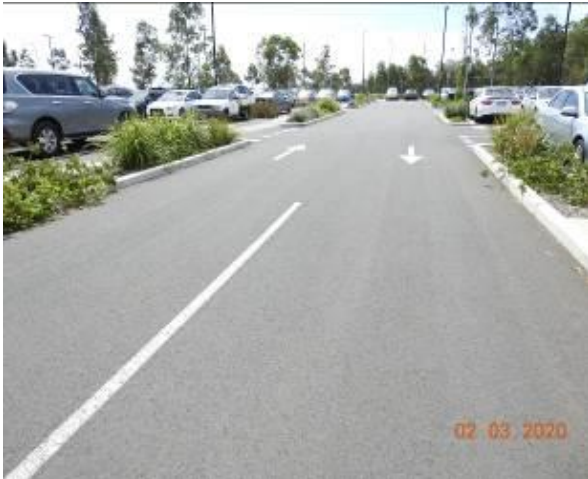
Figure 2594 – General Condition of carpark pavement

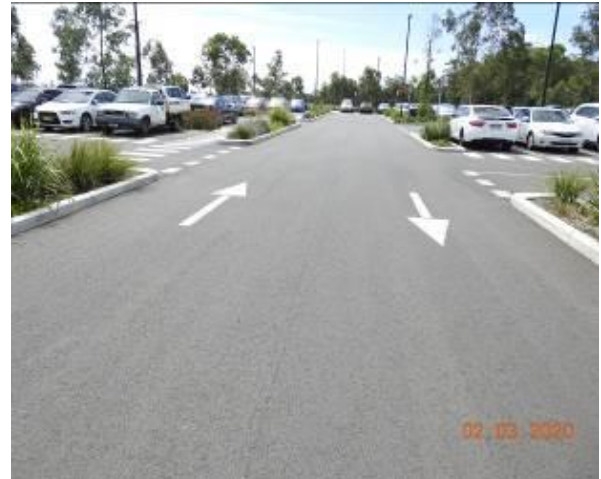
Figure 2595 – General Condition of carpark pavement

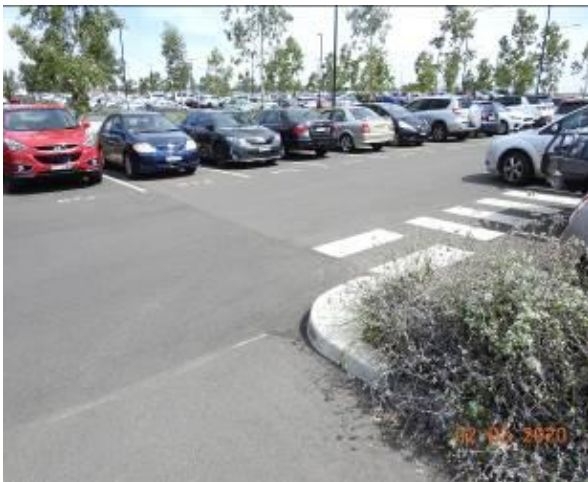
Figure 2596 – General Condition of carpark pavement

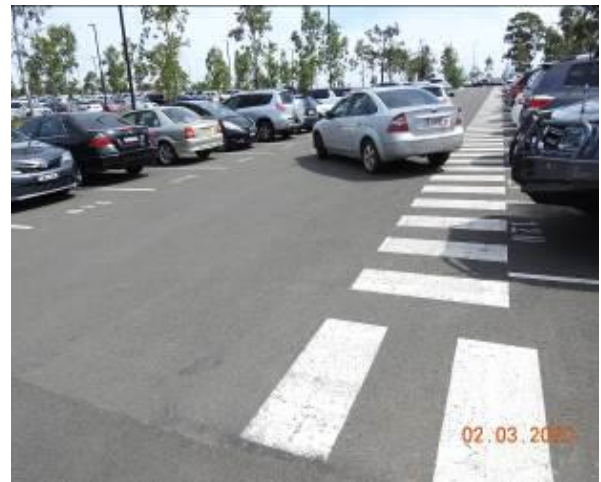
Figure 2597 – General Condition of carpark pavement

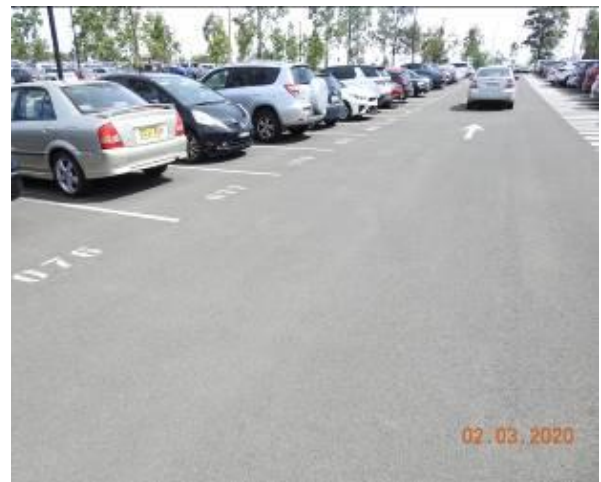
Figure 2599 – General Condition of carpark pavement

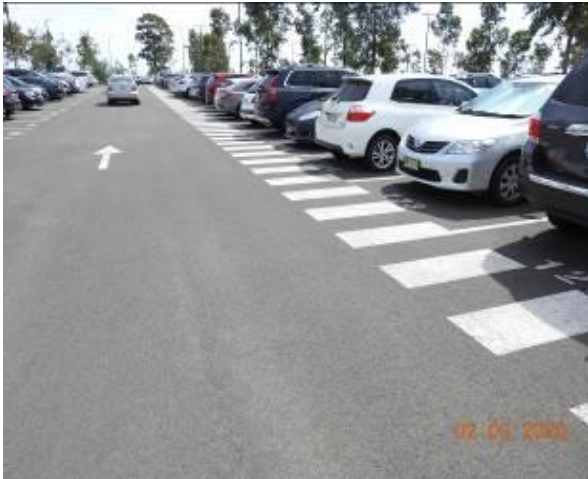
Figure 2600 – General Condition of carpark pavement

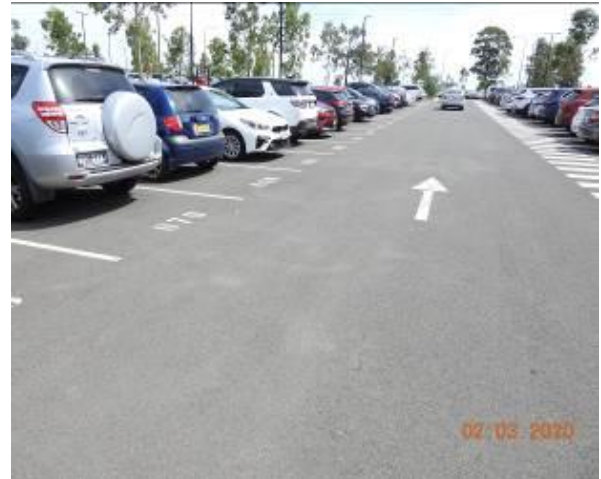
Figure 2601 – General Condition of carpark pavement

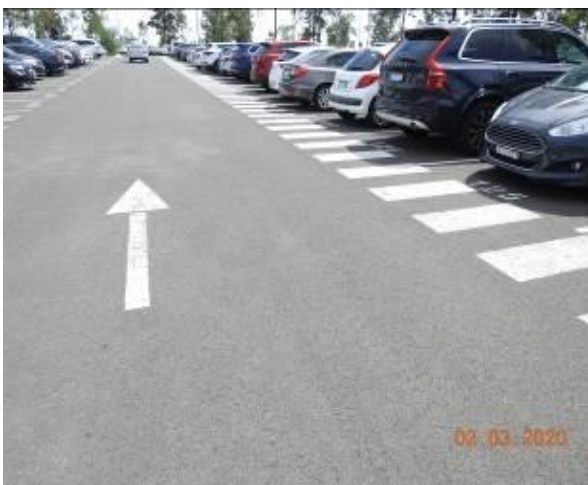
Figure 2602 – General Condition of carpark pavement

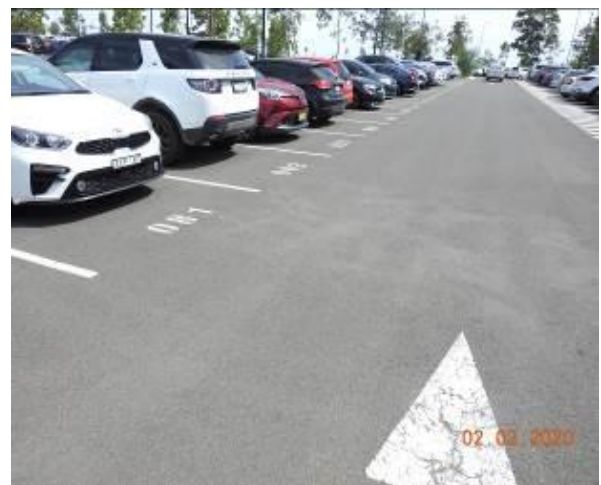
Figure 2603 – General Condition of carpark pavement

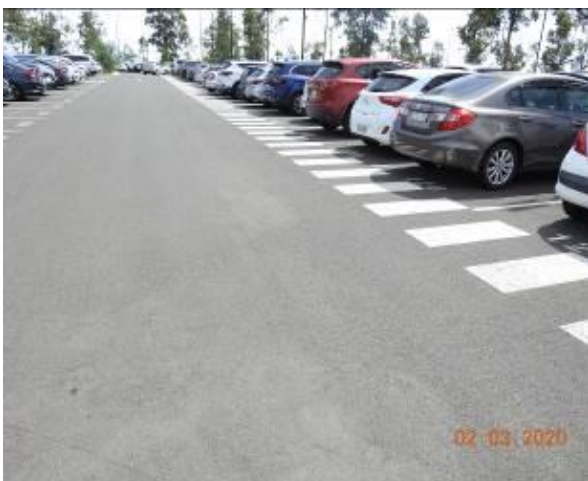
Figure 2604 – General Condition of carpark pavement

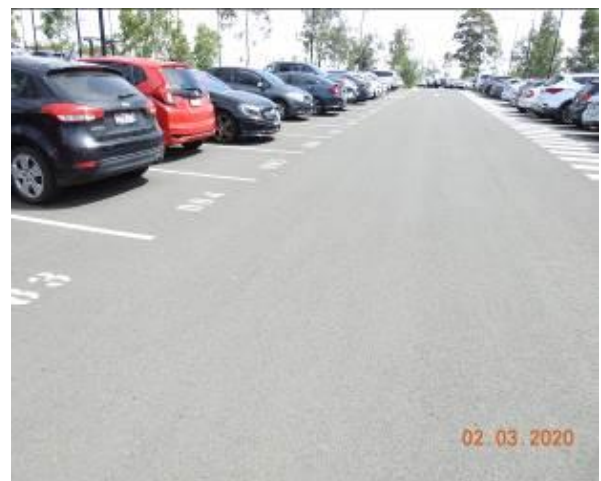
Figure 2605 – General Condition of carpark pavement

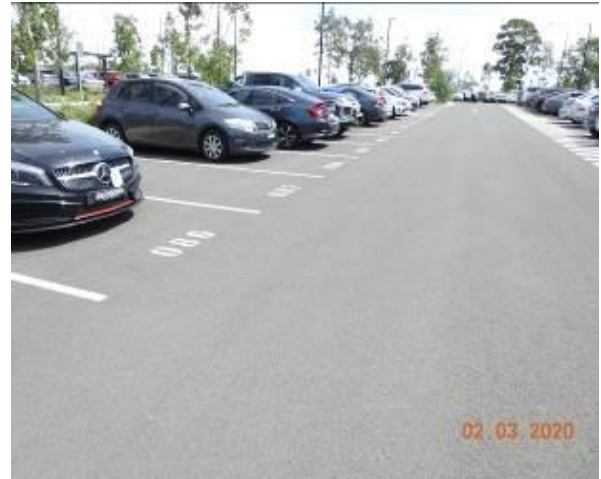
Figure 2607 – General Condition of carpark pavement

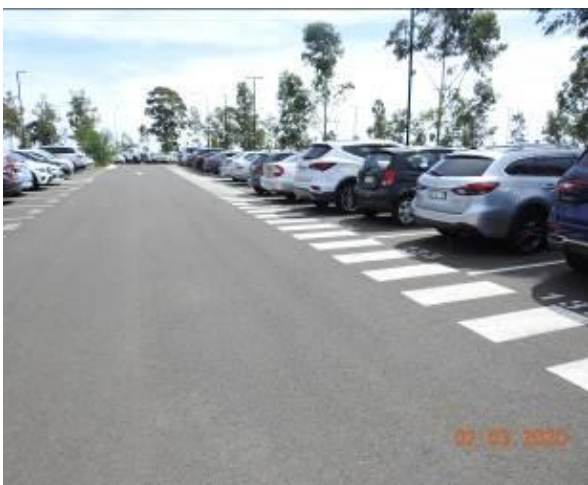
Figure 2608 – General Condition of carpark pavement

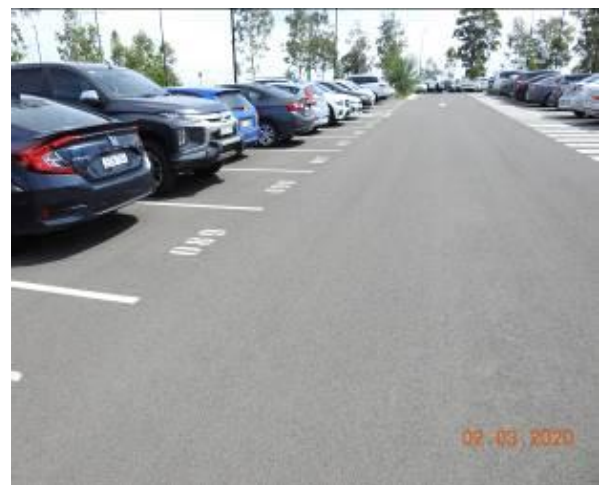
Figure 2609 – General Condition of carpark pavement

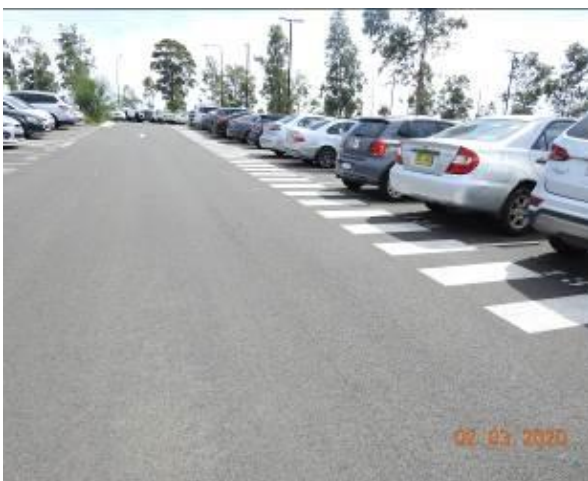
Figure 2610 – General Condition of carpark pavement

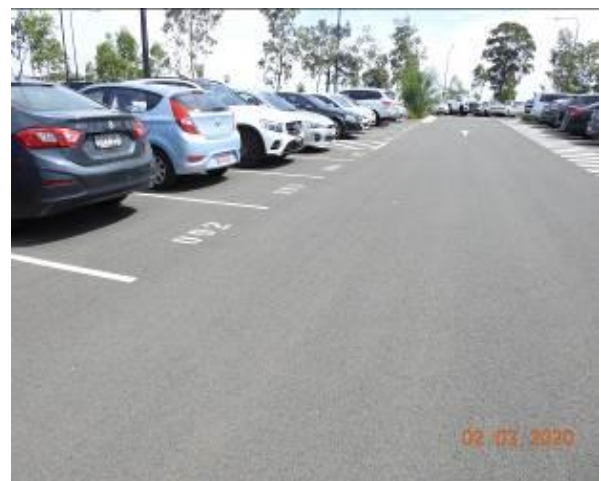
Figure 2611 – General Condition of carpark pavement

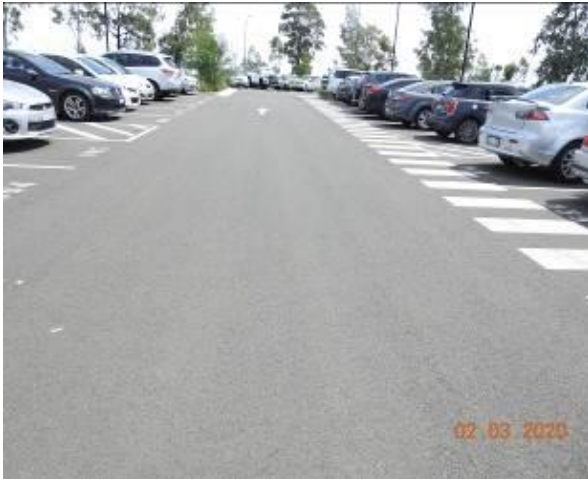
Figure 2612 – General Condition of carpark pavement

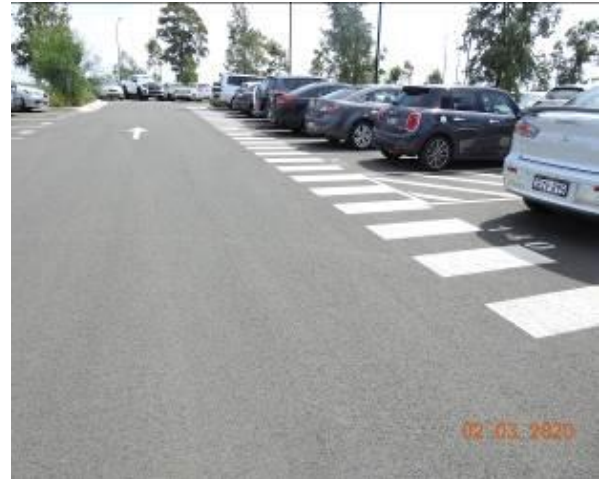
Figure 2613 – General Condition of carpark pavement

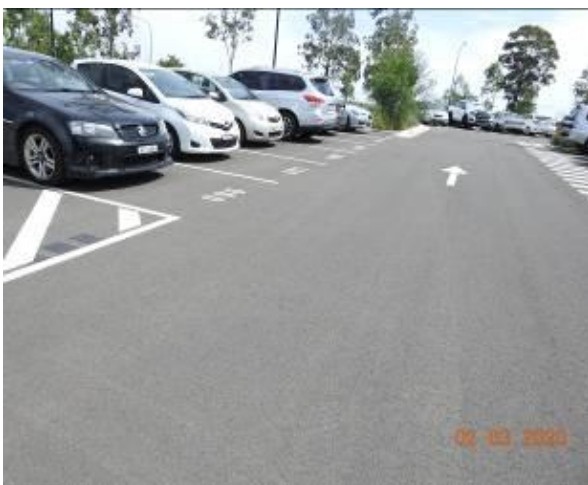
Figure 2614 – General Condition of carpark pavement

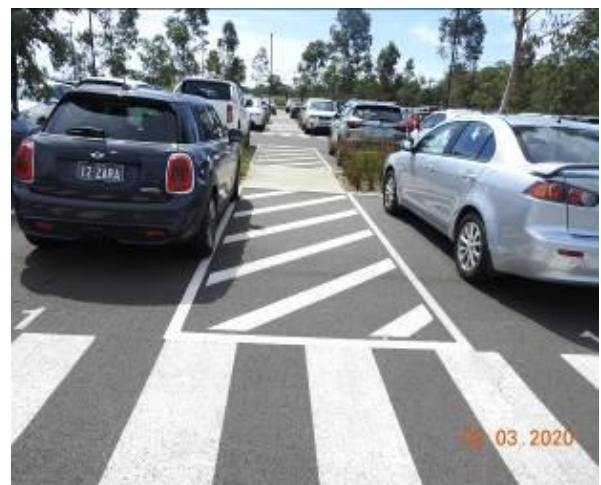
Figure 2615 – General Condition of carpark pavement

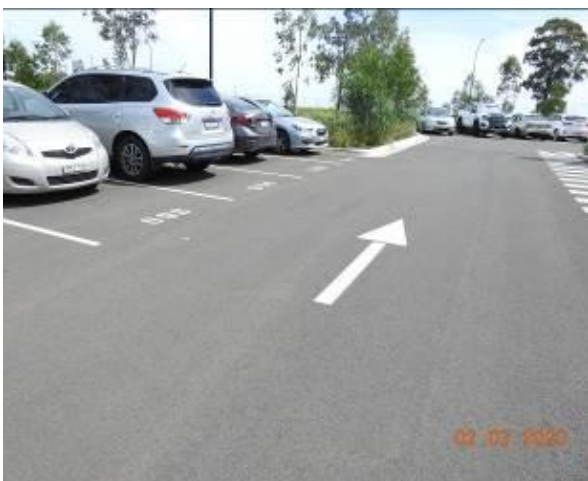
Figure 2616 – General Condition of carpark pavement

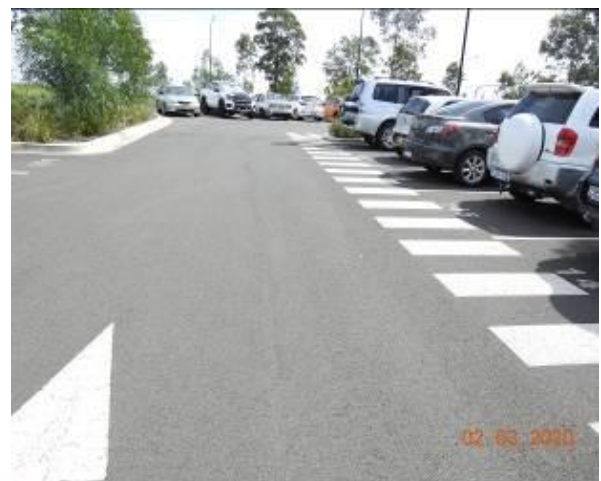
Figure 2617 – General Condition of carpark pavement

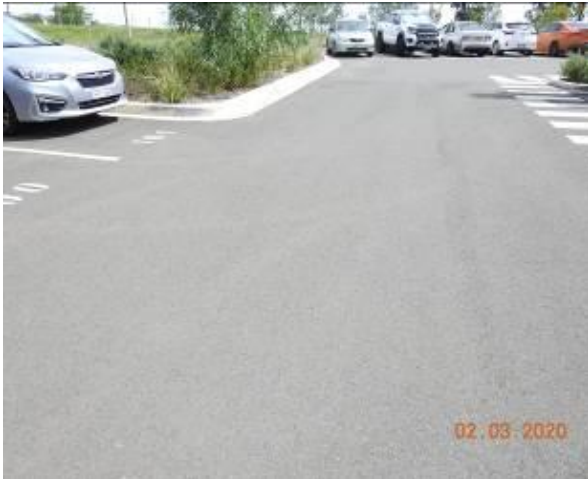
Figure 2618 – General Condition of carpark pavement

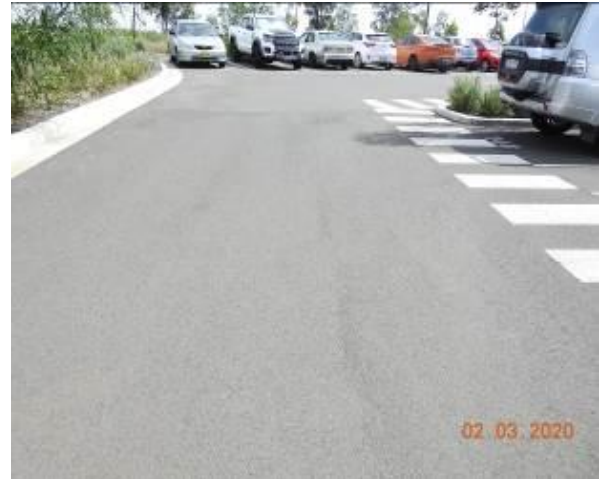
Figure 2619 – General Condition of carpark pavement

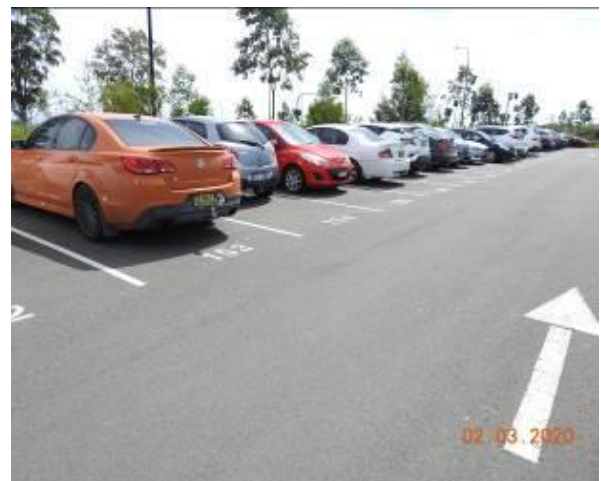
Figure 2623 – General Condition of carpark pavement

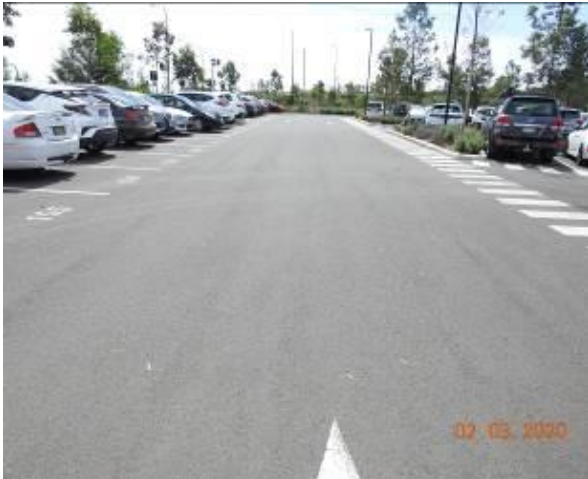
Figure 2624 – General Condition of carpark pavement

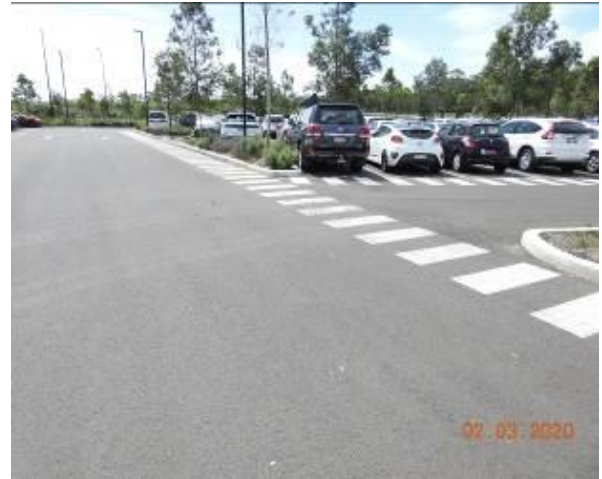
Figure 2625 – General Condition of carpark pavement

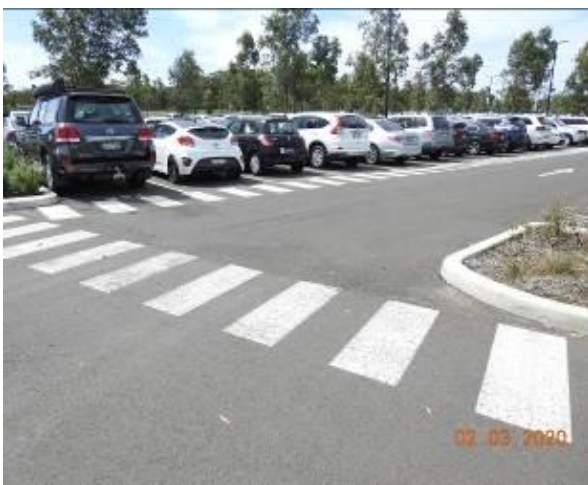
Figure 2626 – General Condition of carpark pavement

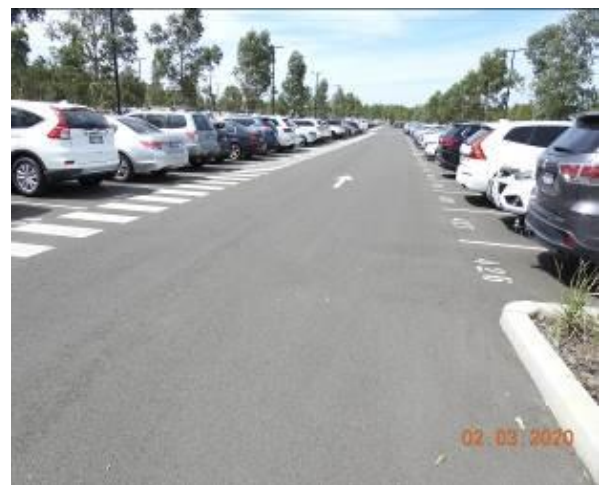
Figure 2627 – General Condition of carpark pavement

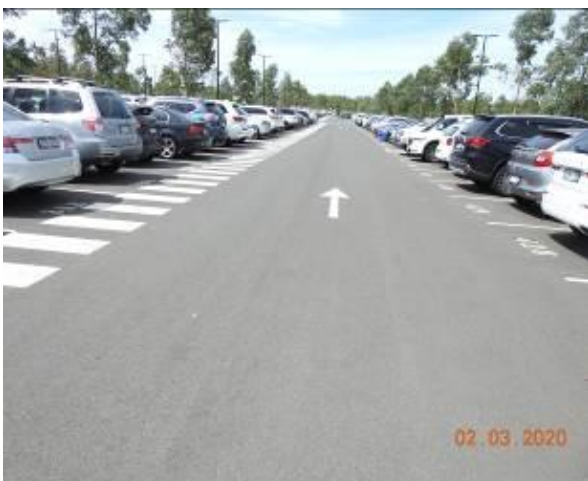
Figure 2628 – General Condition of carpark pavement

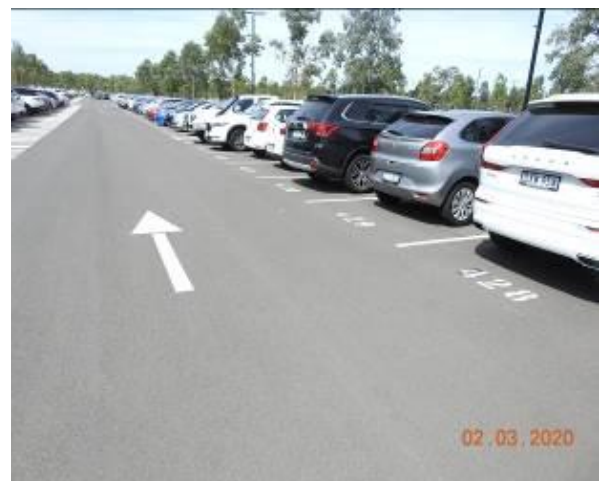
Figure 2629 – General Condition of carpark pavement

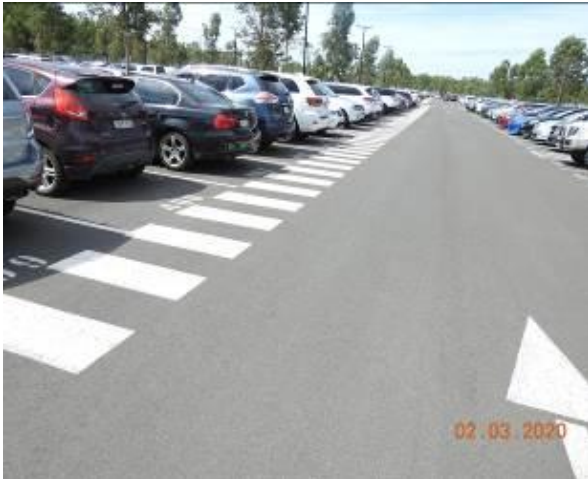
Figure 2630 – General Condition of carpark pavement

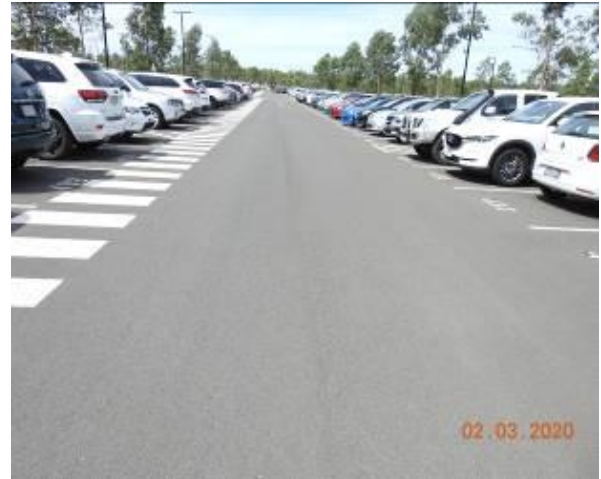
Figure 2631 – General Condition of carpark pavement

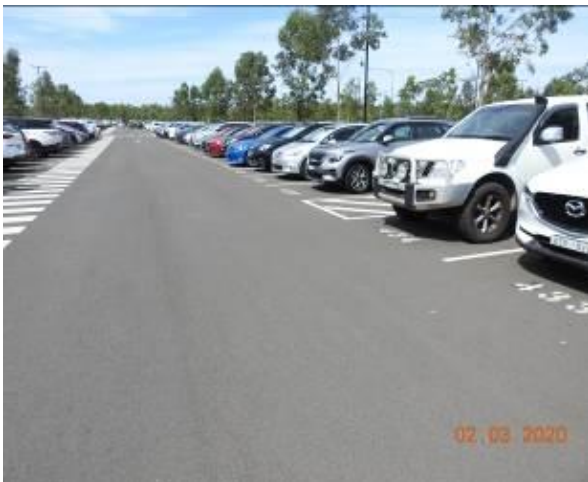
Figure 2632 – General Condition of carpark pavement

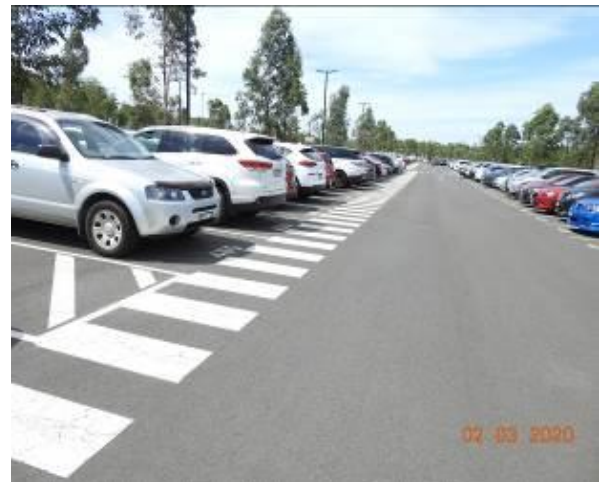
Figure 2633 – General Condition of carpark pavement

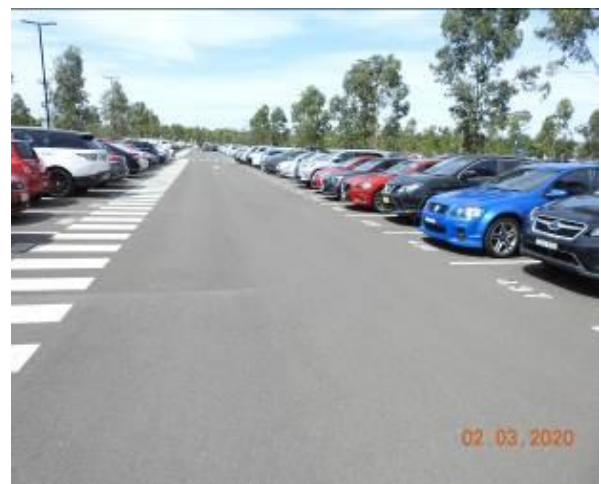
Figure 2635 – General Condition of carpark pavement

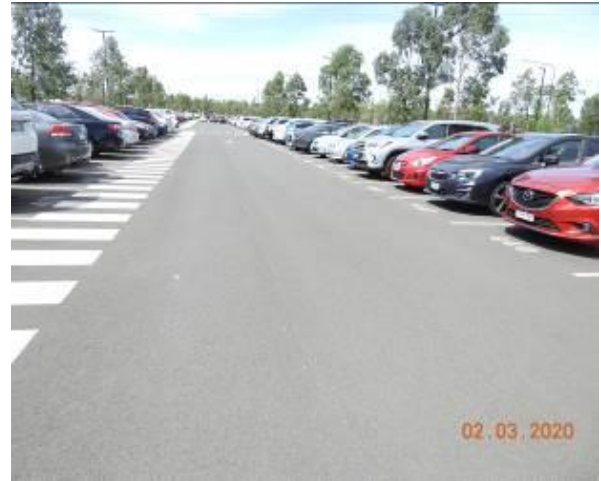
Figure 2637 – General Condition of carpark pavement

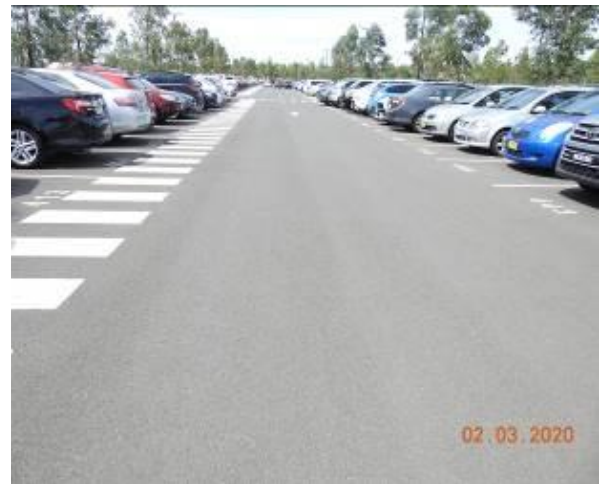
Figure 2639 – General Condition of carpark pavement

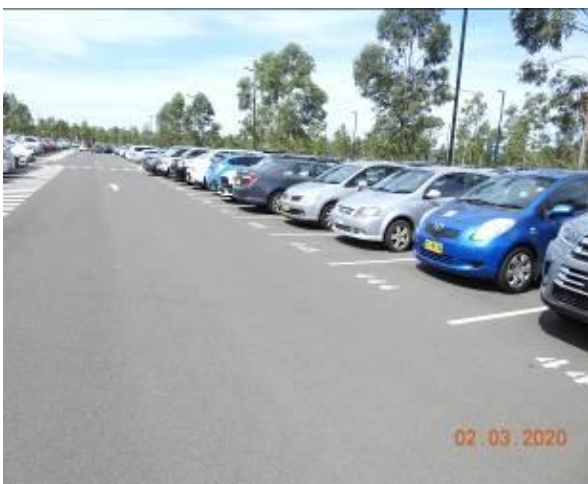
Figure 2640 – General Condition of carpark pavement

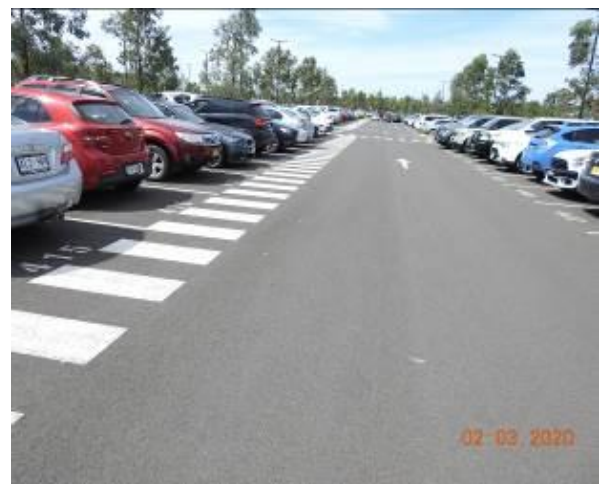
Figure 2641 – General Condition of carpark pavement

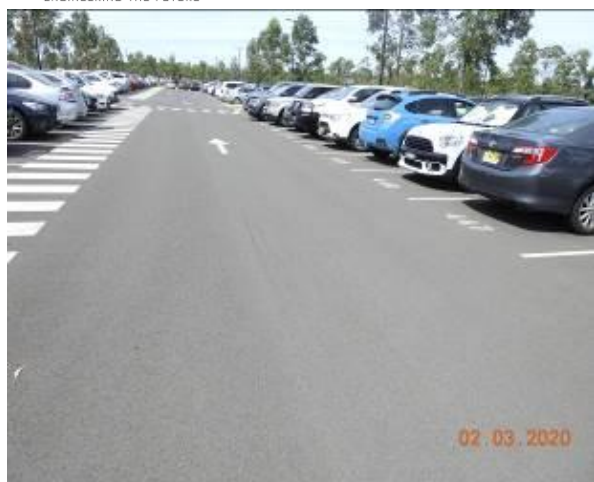
Figure 2642 – General Condition of carpark pavement

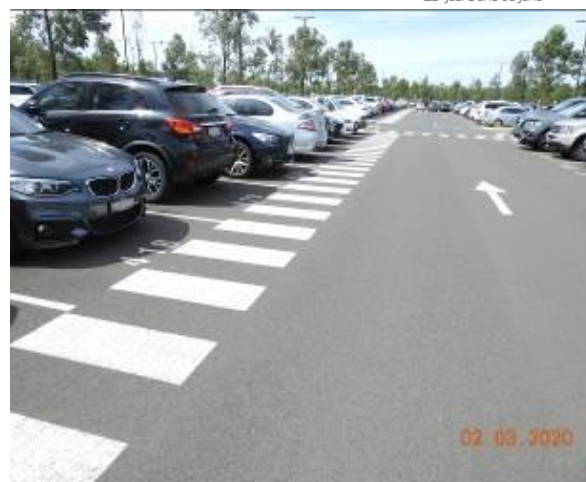
Figure 2643 – General Condition of carpark pavement

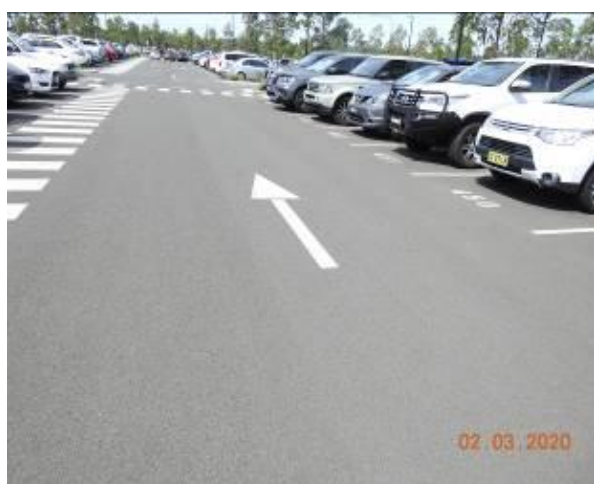
Figure 2644 – General Condition of carpark pavement

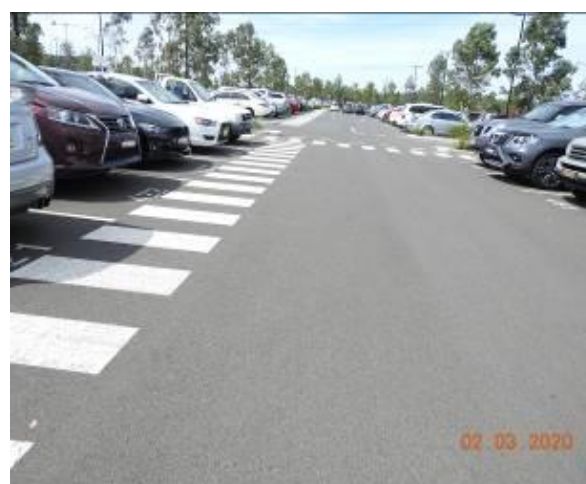
Figure 2645 – General Condition of carpark pavement

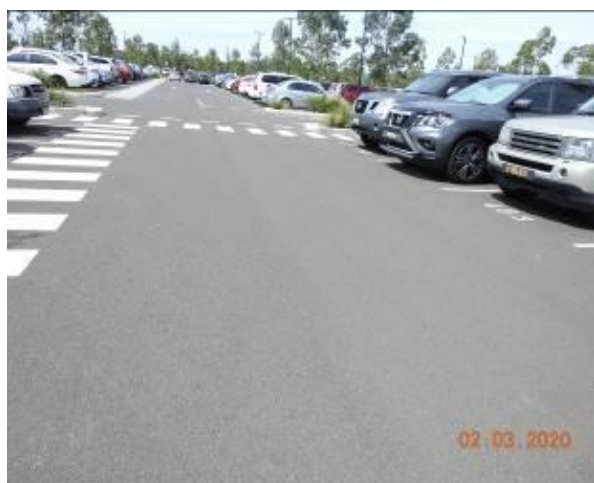
Figure 2646 – General Condition of carpark pavement

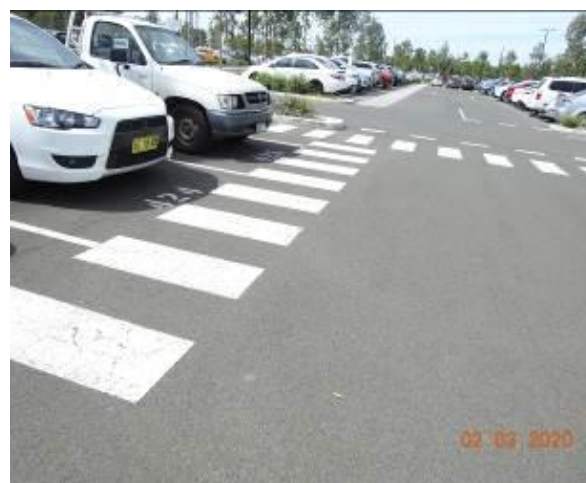
Figure 2647 – Crack propagation through carpark pavement

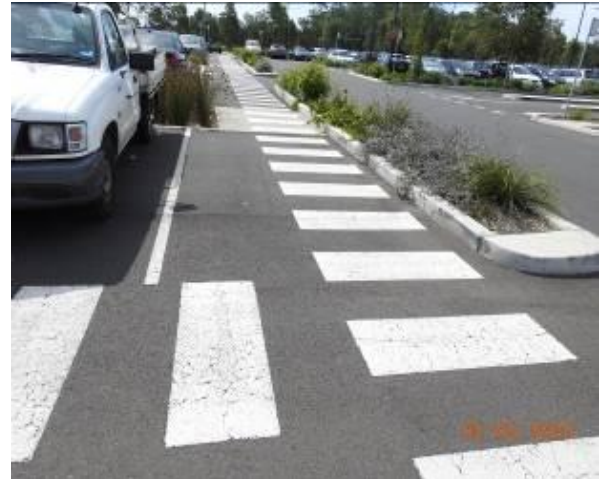
Figure 2649 – Crack propagation through carpark pavement

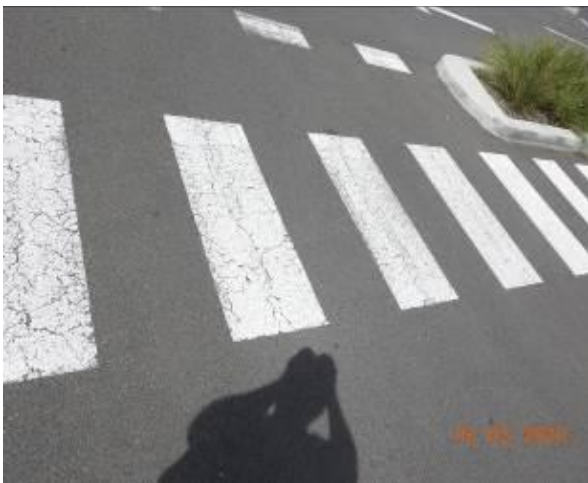
Figure 2650 – Crack propagation through carpark pavement

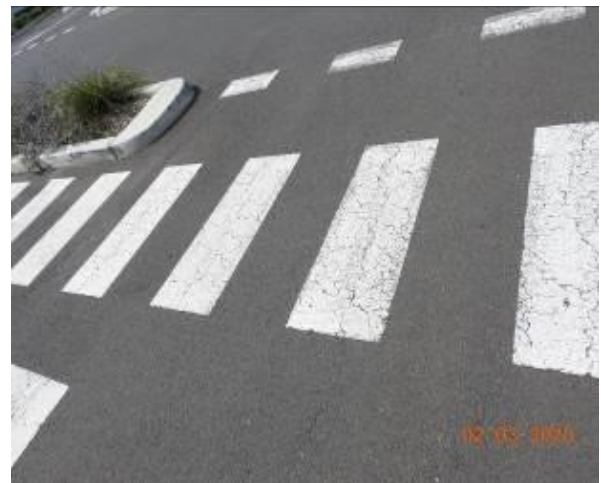
Figure 2651 – Crack propagation through carpark pavement

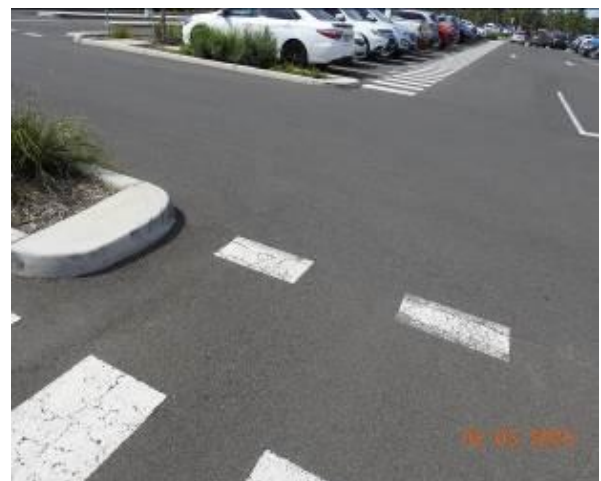
Figure 2653 – Crack propagation through carpark pavement

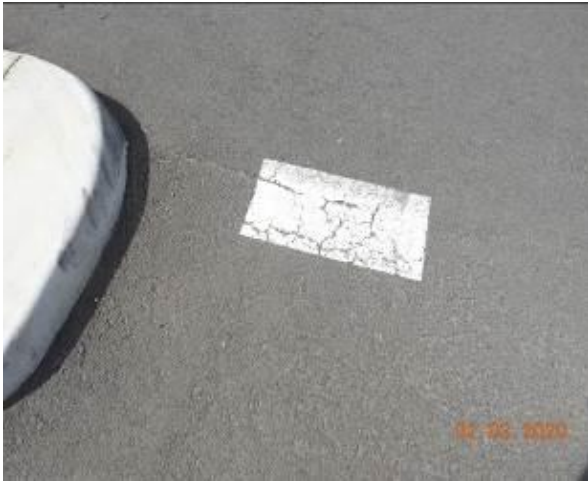
Figure 2654 – Crack propagation through carpark pavement

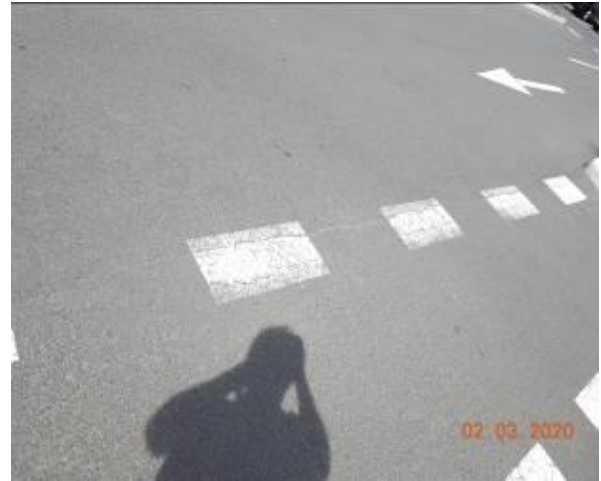
Figure 2655 – Crack propagation through carpark pavement
