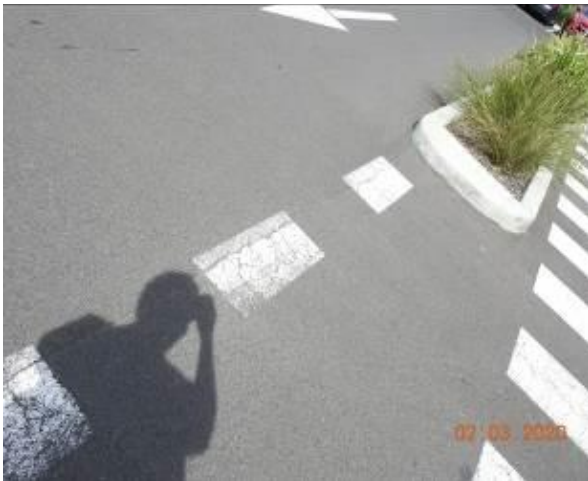
Figure 2656 – Crack propagation through carpark pavement

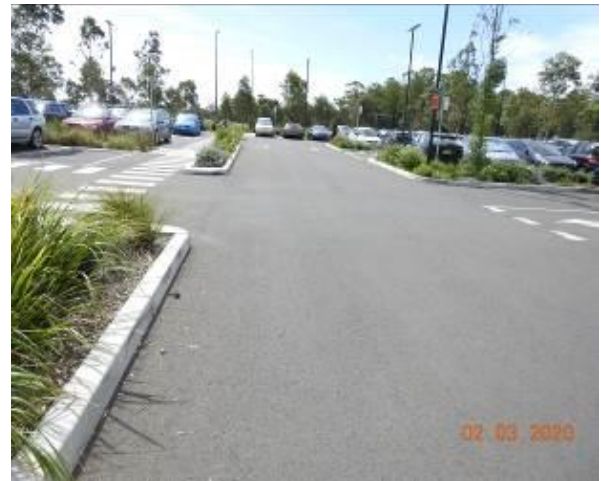
Figure 2657 – General Condition of carpark pavement

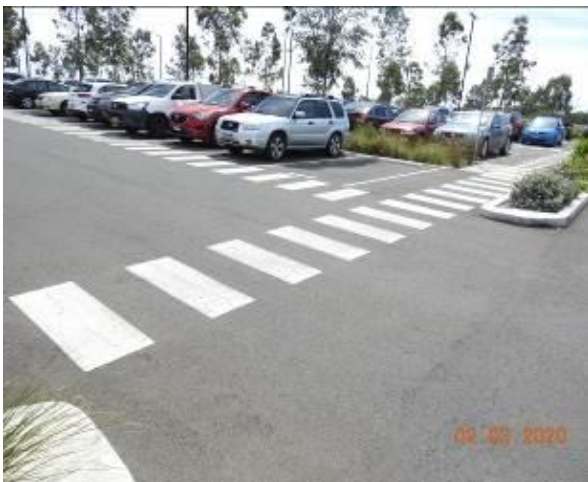
Figure 2658 – General Condition of carpark pavement

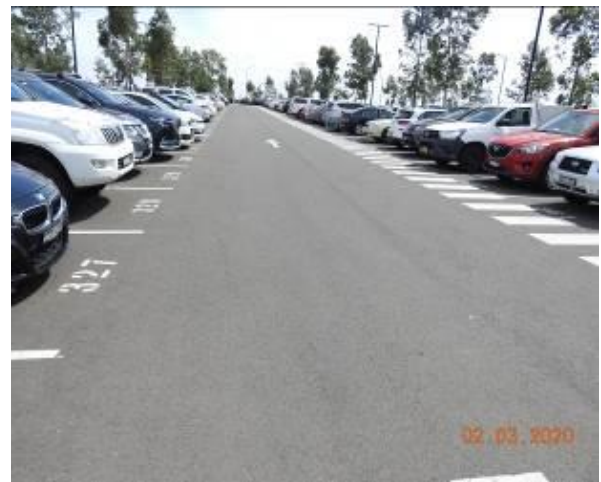
Figure 2659 – General Condition of carpark pavement

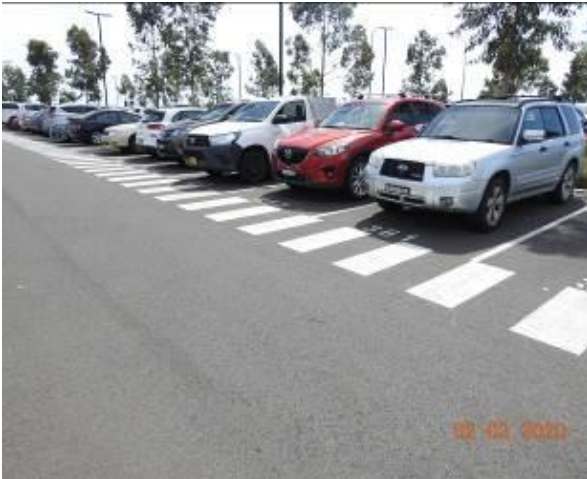
Figure 2660 – General Condition of carpark pavement

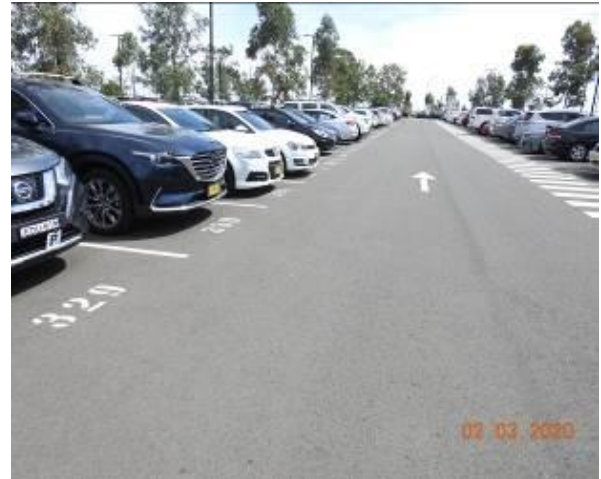
Figure 2661 – General Condition of carpark pavement

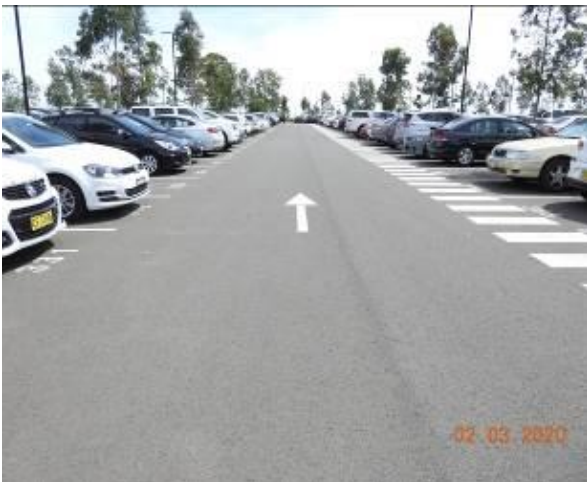
Figure 2662 – General Condition of carpark pavement

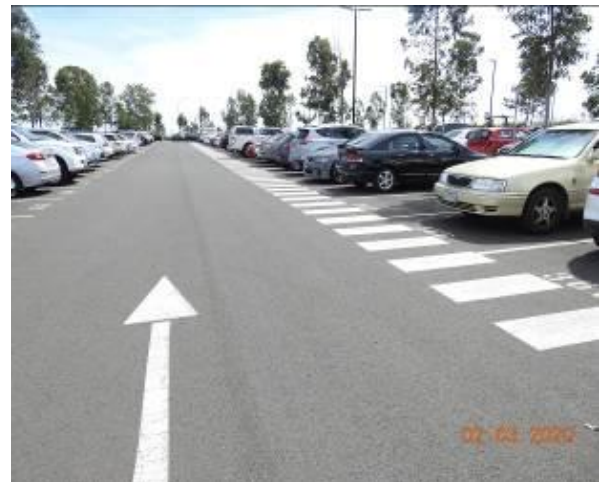
Figure 2663 – General Condition of carpark pavement

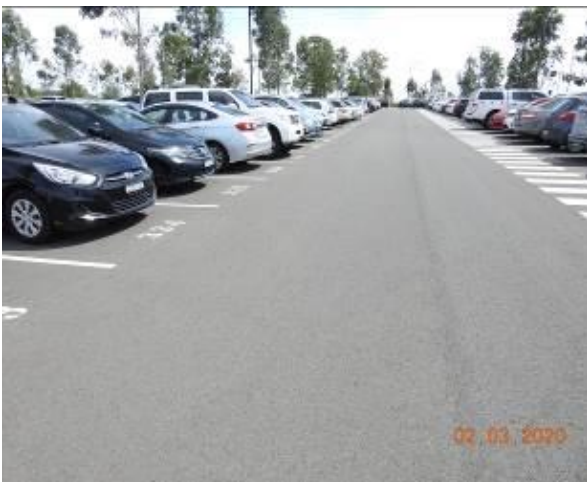
Figure 2664 – General Condition of carpark pavement

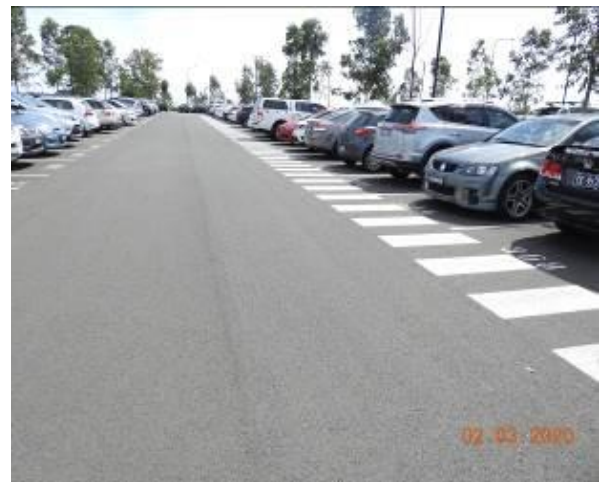
Figure 2665 – General Condition of carpark pavement

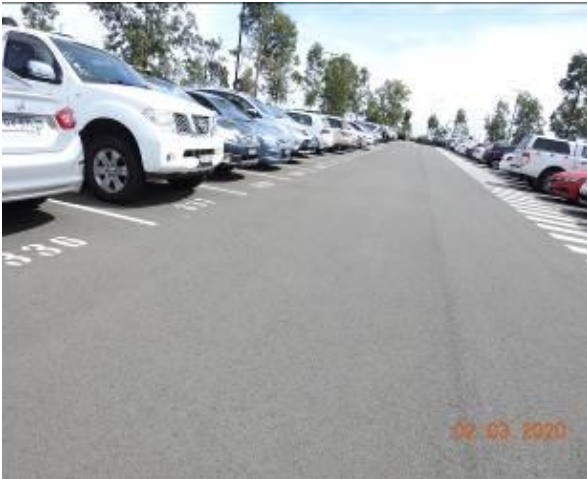
Figure 2666 – General Condition of carpark pavement

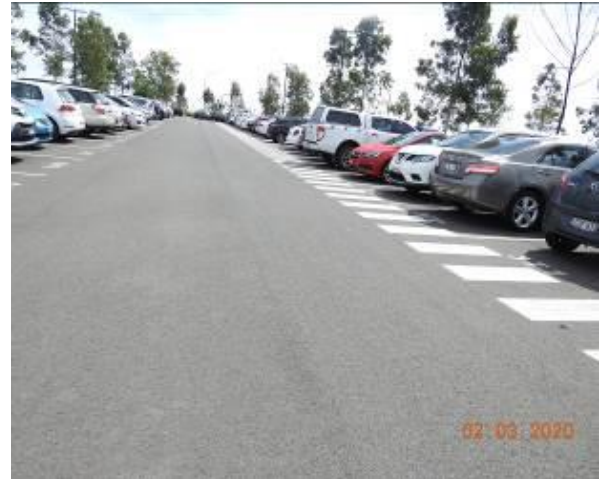
Figure 2667 – General Condition of carpark pavement

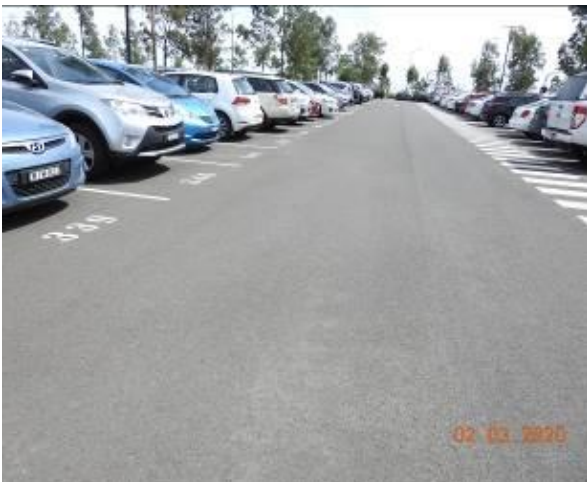
Figure 2668 – General Condition of carpark pavement

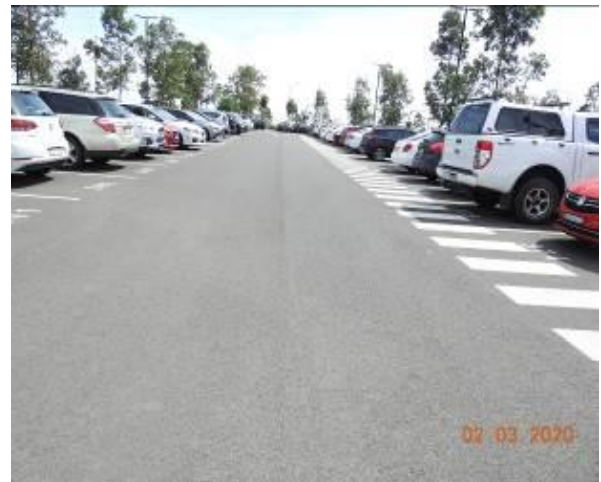
Figure 2669 – General Condition of carpark pavement

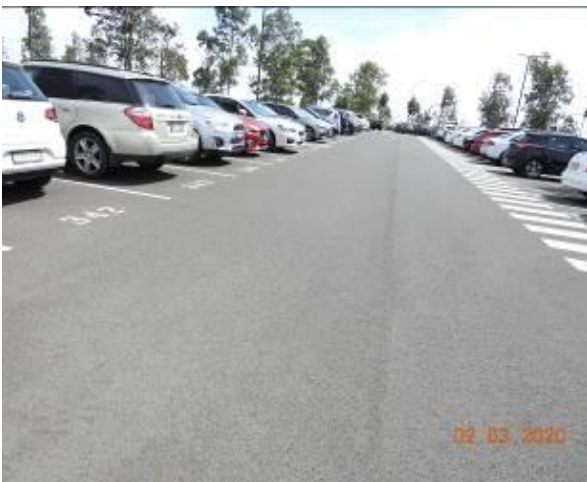
Figure 2670 – General Condition of carpark pavement

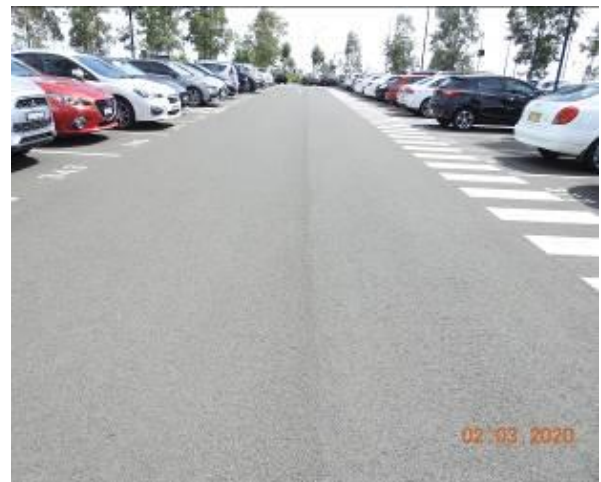
Figure 2671 – General Condition of carpark pavement

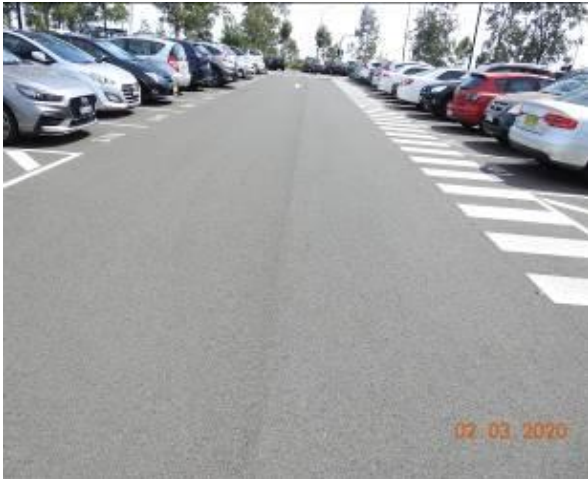
Figure 2672 – General Condition of carpark pavement

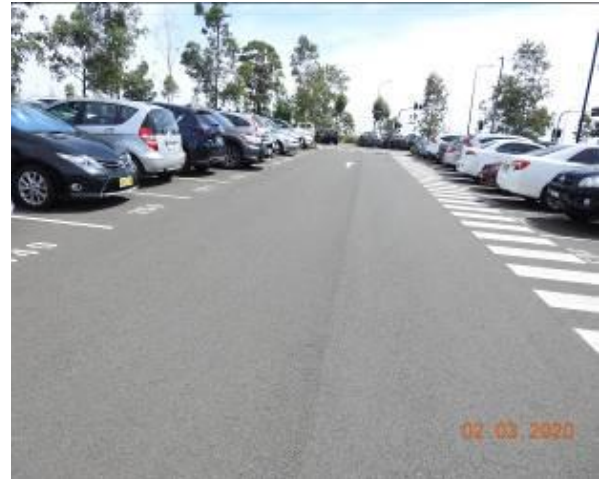
Figure 2673 – General Condition of carpark pavement

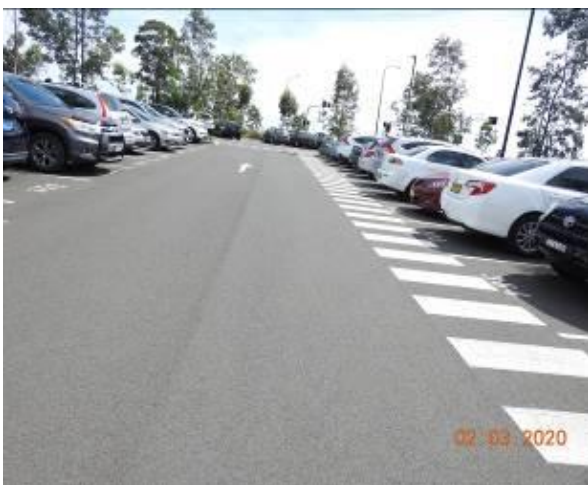
Figure 2674 – General Condition of carpark pavement

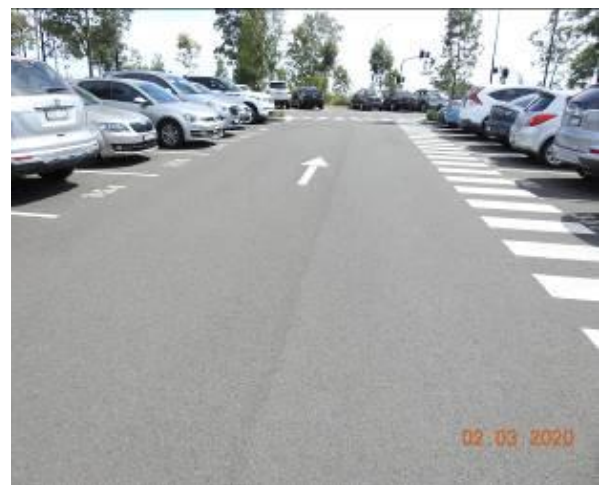
Figure 2675 – General Condition of carpark pavement

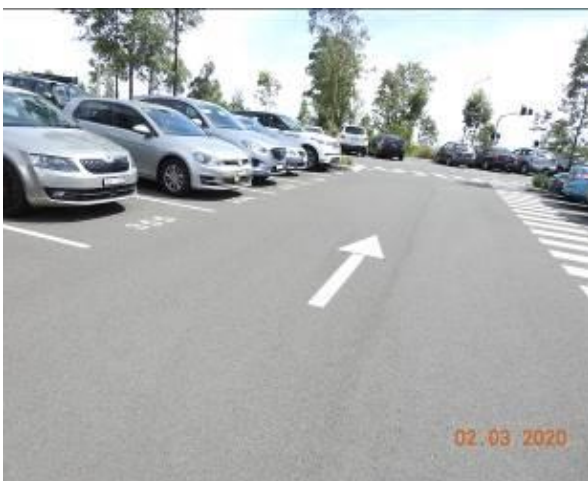
Figure 2676 – General Condition of carpark pavement

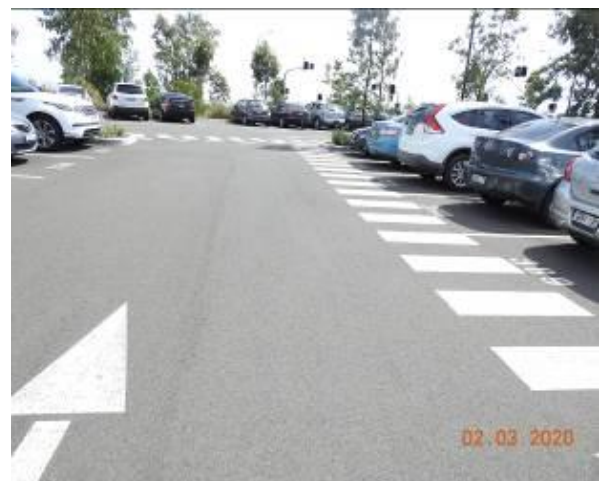
Figure 2677 – General Condition of carpark pavement

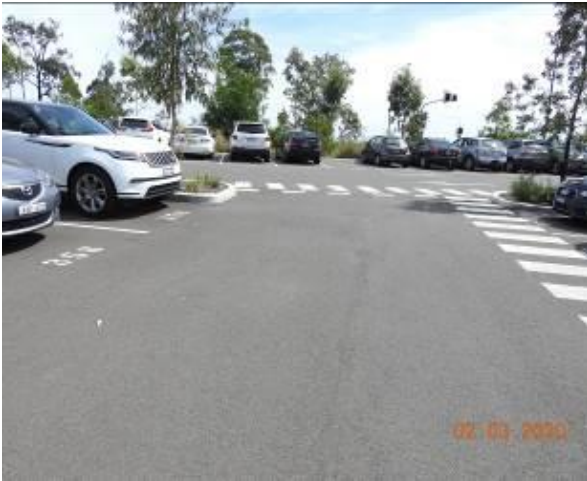
Figure 2678 – General Condition of carpark pavement

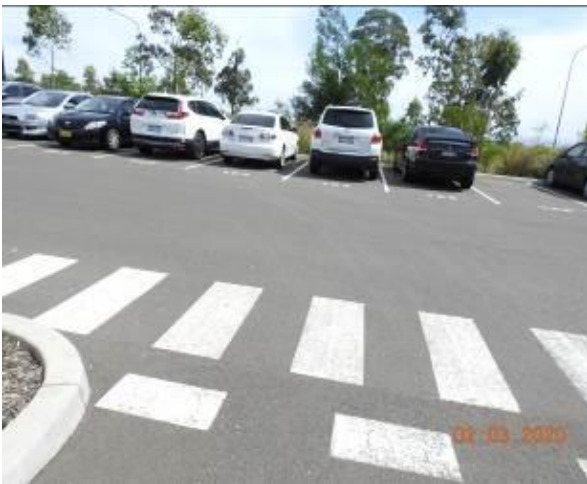
Figure 2680 – General Condition of carpark pavement

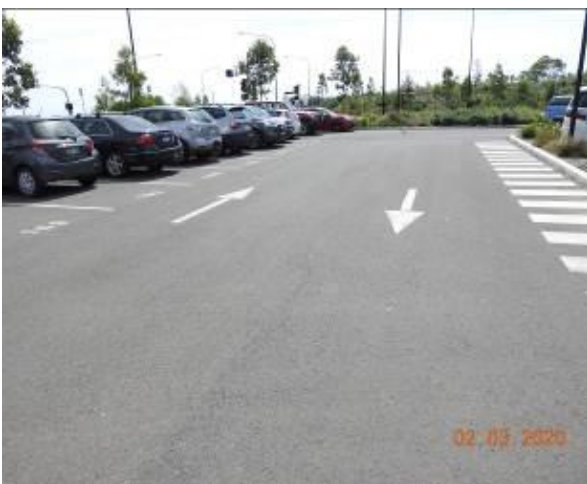
Figure 2682 – General Condition of carpark pavement

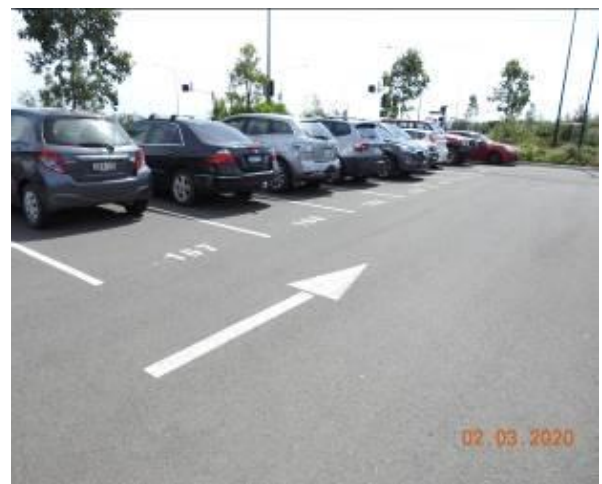
Figure 2683 – General Condition of carpark pavement

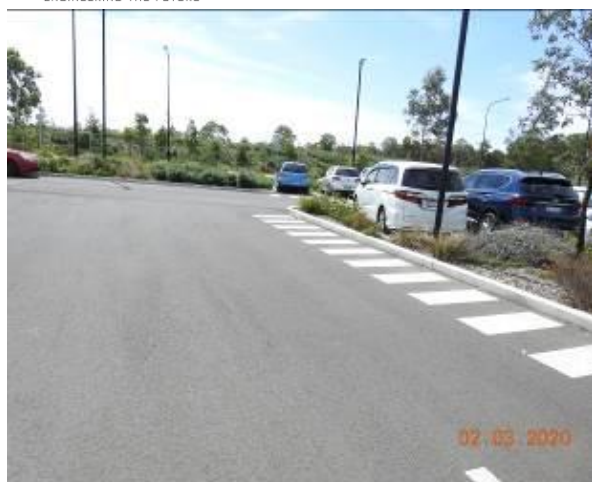
Figure 2684 – General Condition of carpark pavement

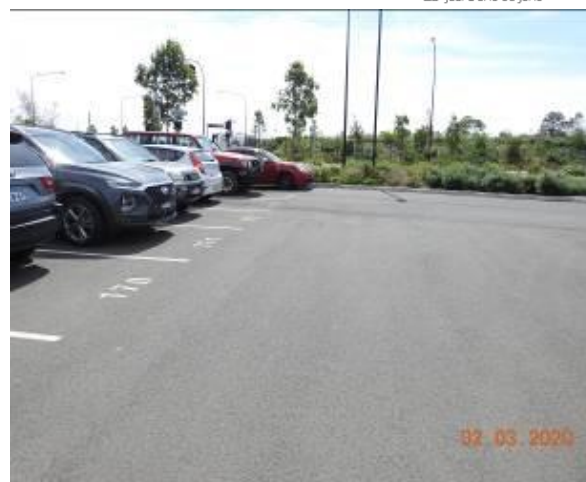
Figure 2685 – General Condition of carpark pavement

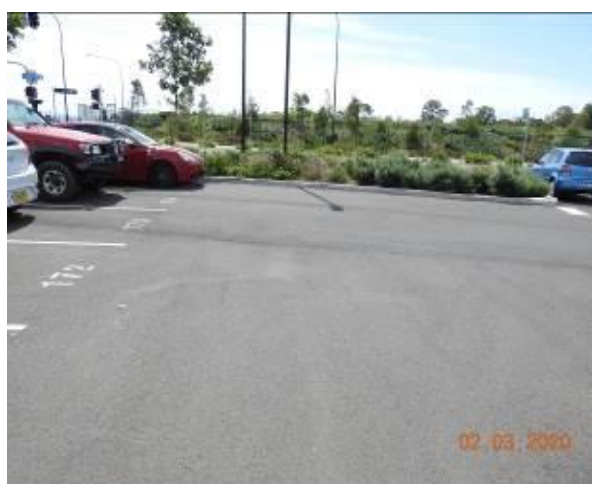
Figure 2686 – General Condition of carpark pavement

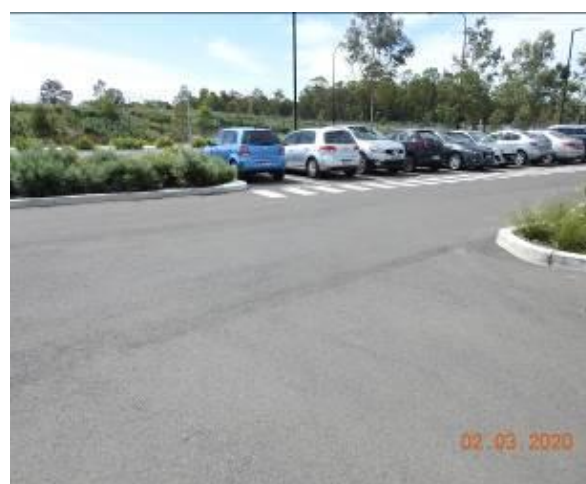
Figure 2687 – General Condition of carpark pavement

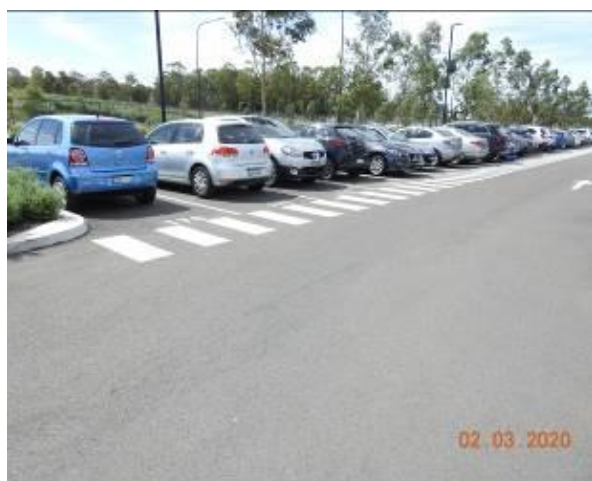
Figure 2688 – General Condition of carpark pavement

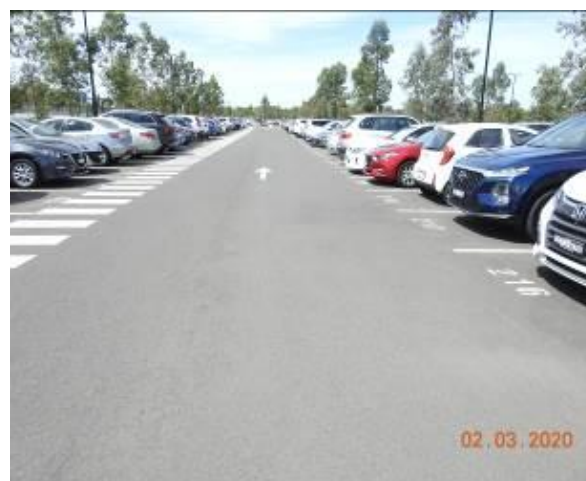
Figure 2689 – General Condition of carpark pavement

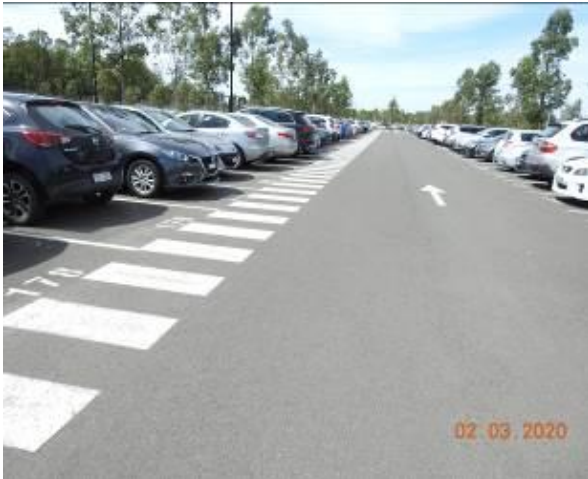
Figure 2690 – General Condition of carpark pavement

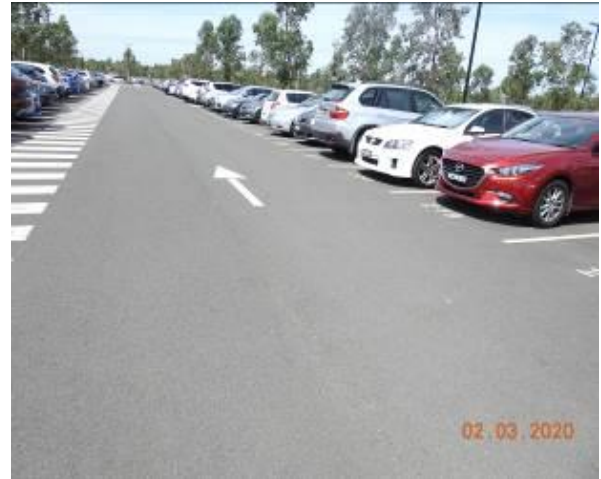
Figure 2691 – General Condition of carpark pavement

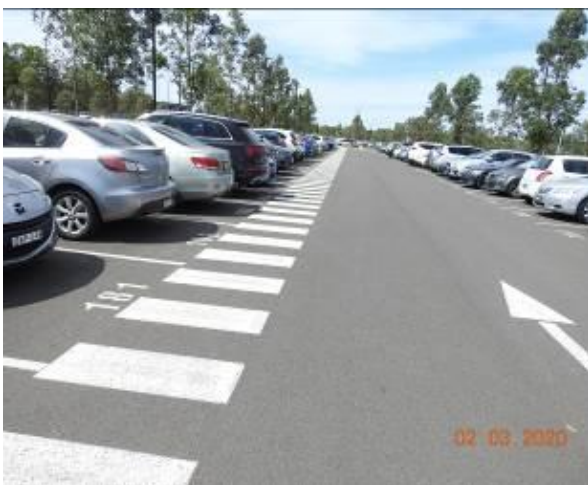
Figure 2692 – General Condition of carpark pavement

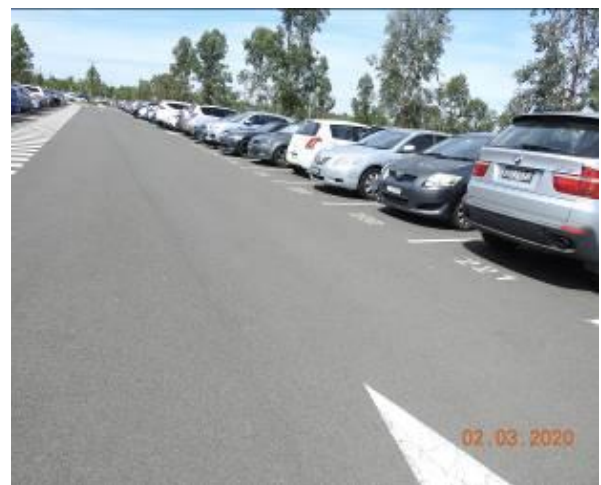
Figure 2693 – General Condition of carpark pavement

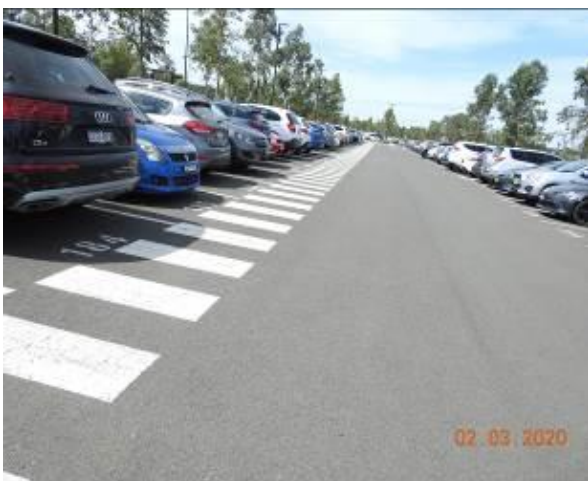
Figure 2694 – General Condition of carpark pavement

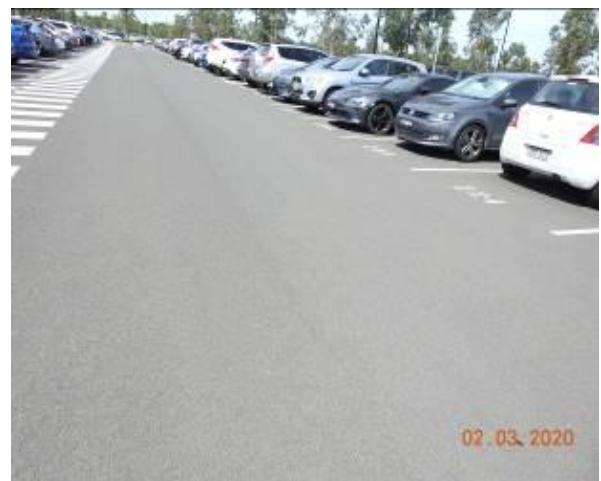
Figure 2695 – General Condition of carpark pavement

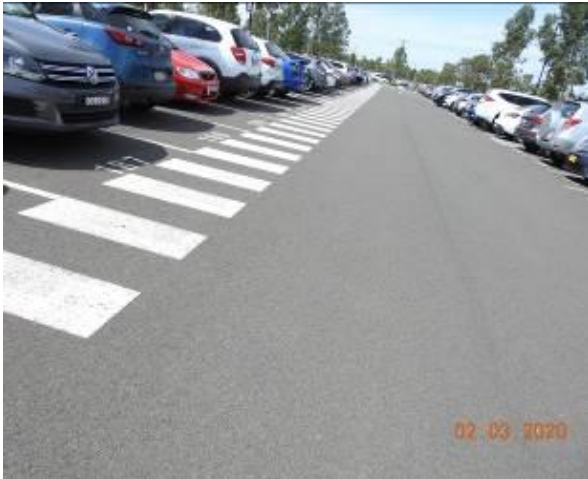
Figure 2696 – General Condition of carpark pavement

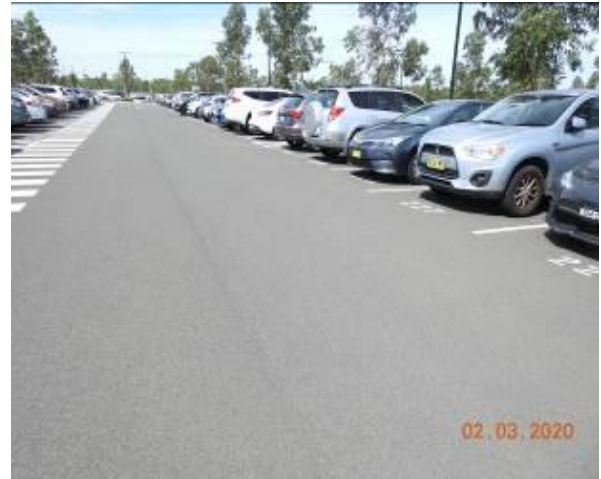
Figure 2697 – General Condition of carpark pavement

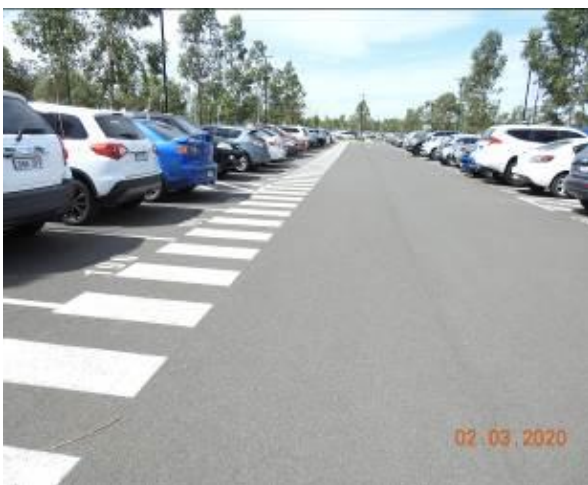
Figure 2698 – General Condition of carpark pavement

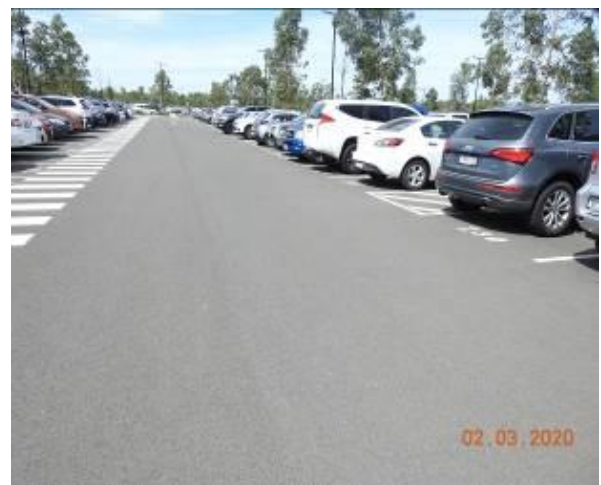
Figure 2699 – General Condition of carpark pavement

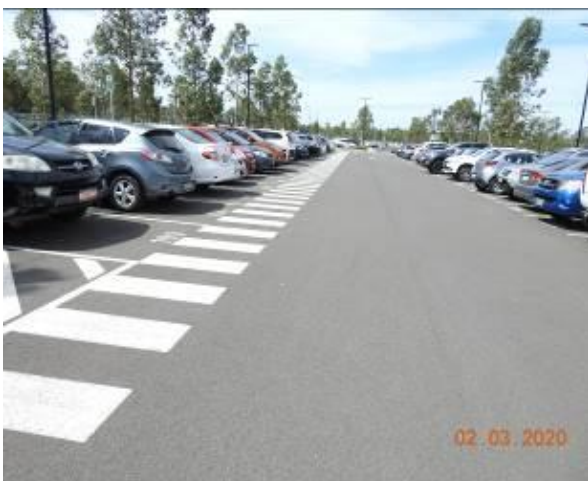
Figure 2700 – General Condition of carpark pavement

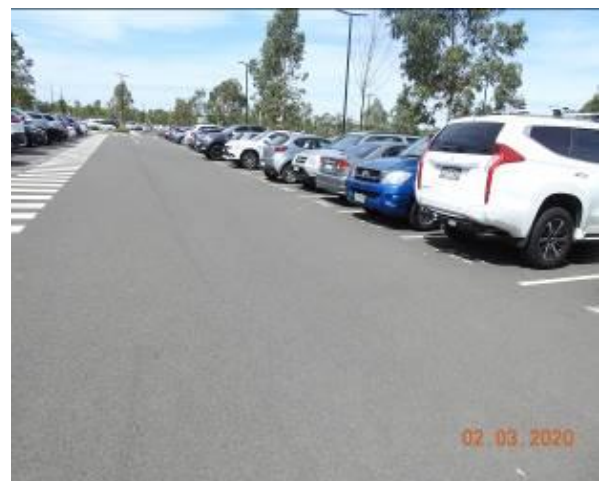
Figure 2701 – General Condition of carpark pavement

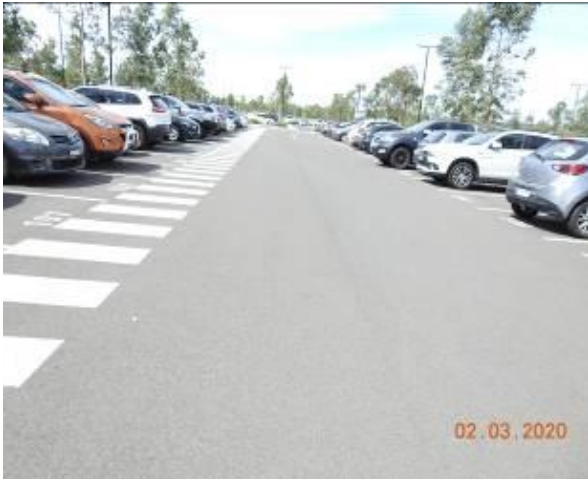
Figure 2702 – General Condition of carpark pavement

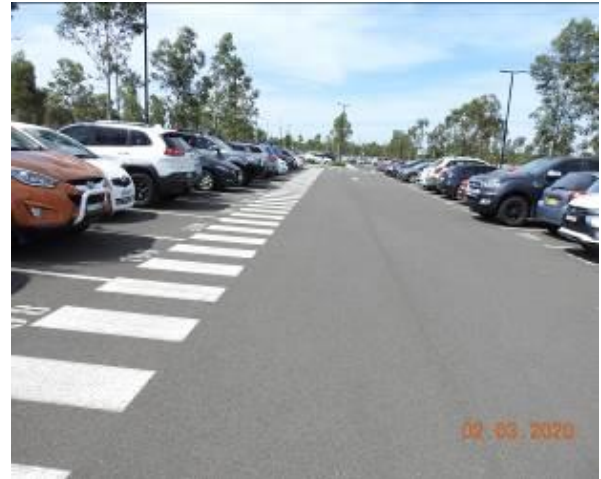
Figure 2703 – General Condition of carpark pavement

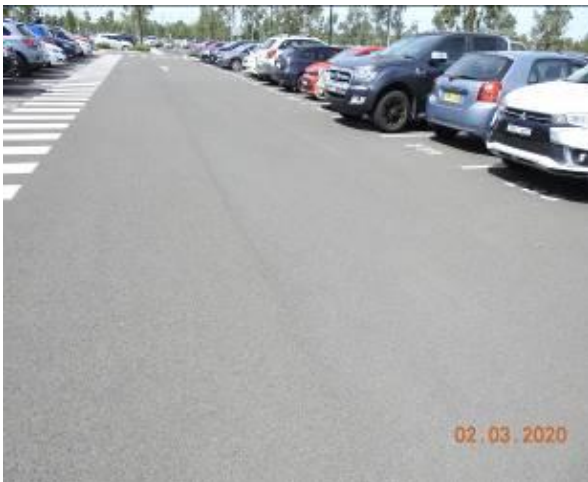
Figure 2704 – General Condition of carpark pavement

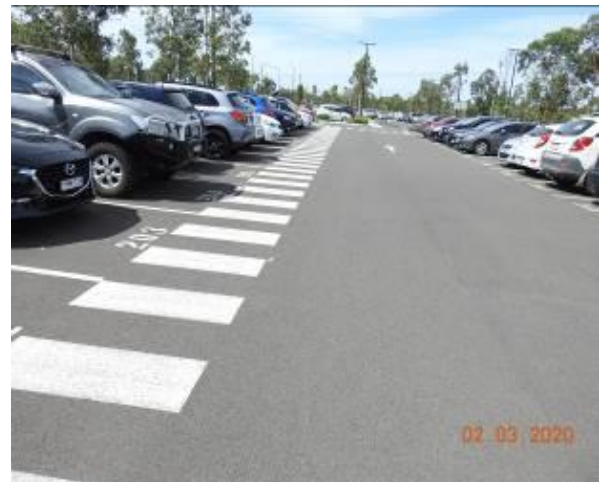
Figure 2705 – General Condition of carpark pavement

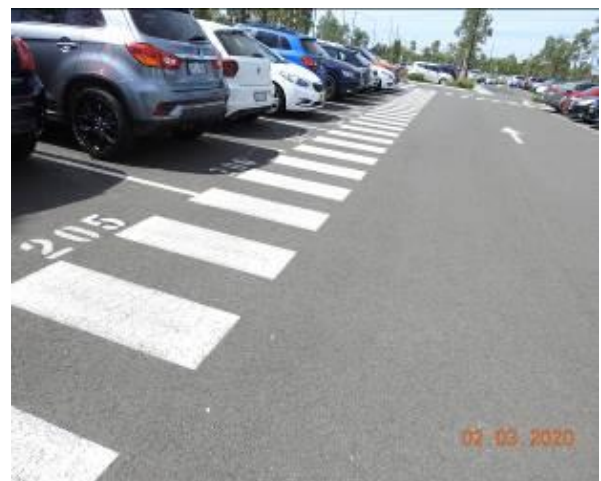
Figure 2707 – General Condition of carpark pavement

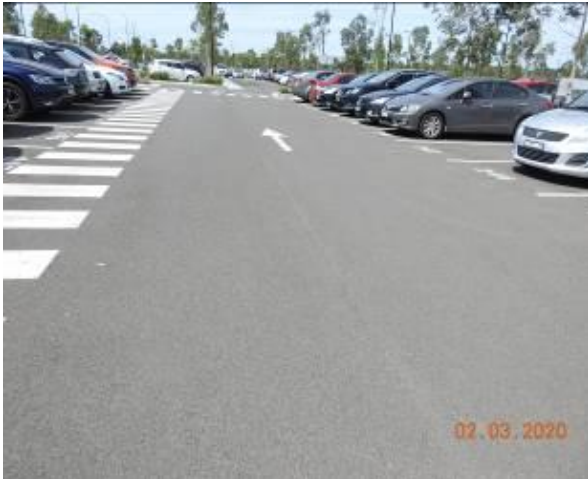
Figure 2708 – General Condition of carpark pavement

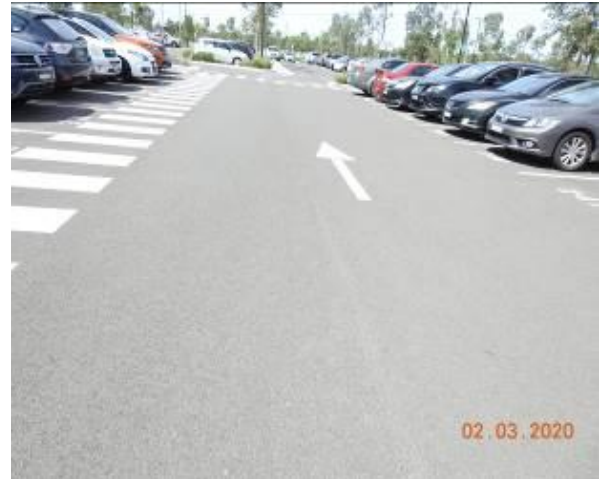
Figure 2709 – General Condition of carpark pavement

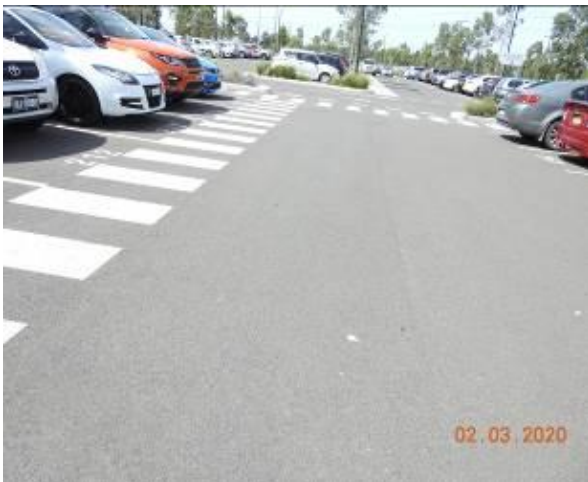
Figure 2710 – General Condition of carpark pavement

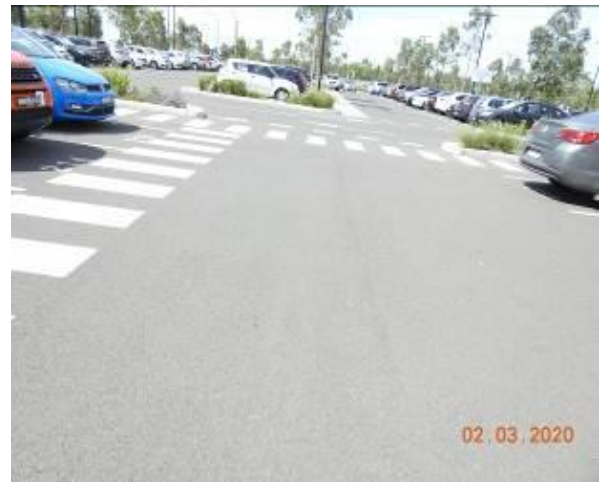
Figure 2711 – General Condition of carpark pavement

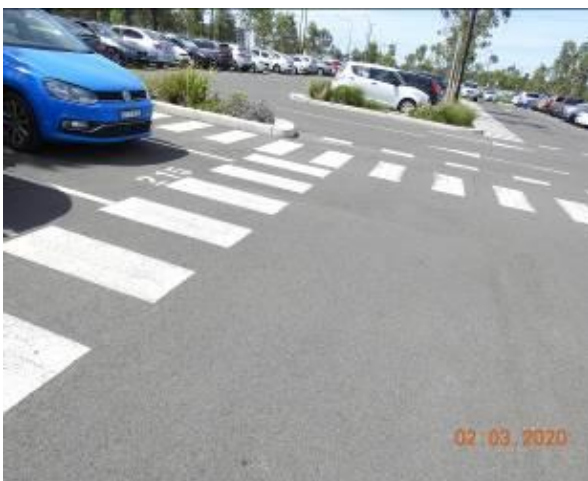
Figure 2712 – General Condition of carpark pavement

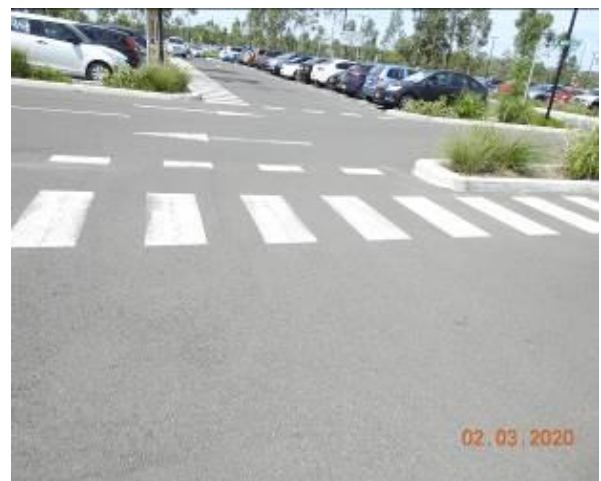
Figure 2713 – General Condition of carpark pavement

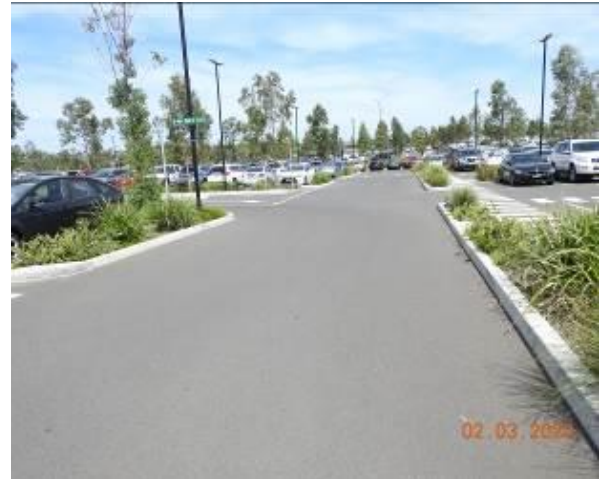
Figure 2715 – General Condition of carpark pavement

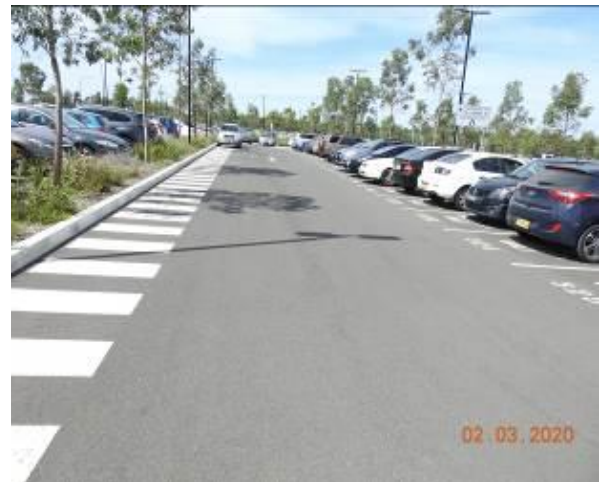
Figure 2717 – General Condition of carpark pavement

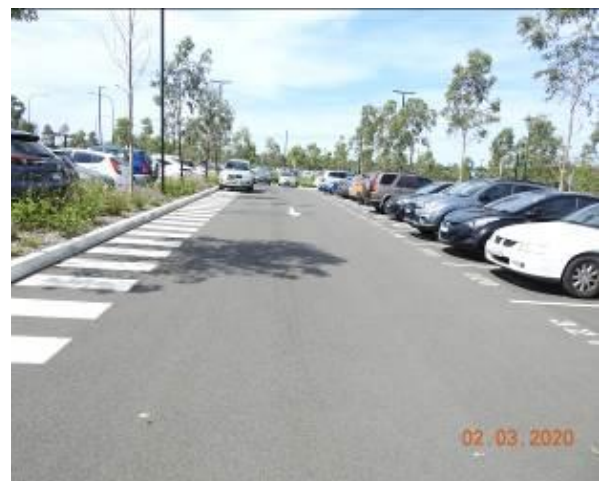
Figure 2719 – General Condition of carpark pavement

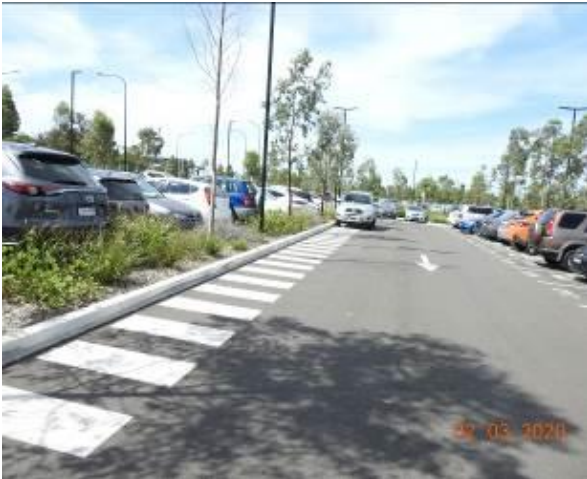
Figure 2720 – General Condition of carpark pavement

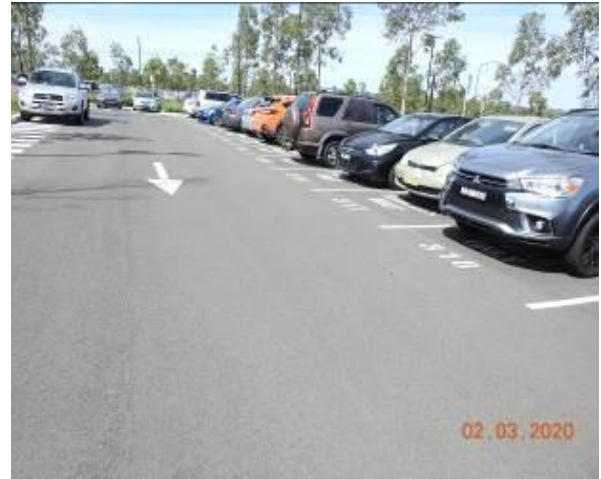
Figure 2721 – General Condition of carpark pavement

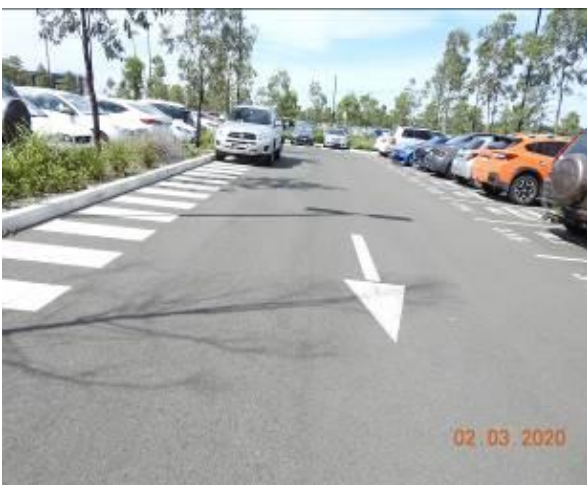
Figure 2722 – General Condition of carpark pavement

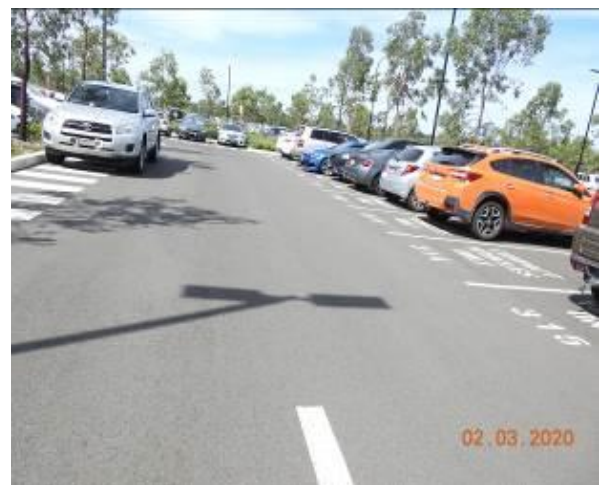
Figure 2723 – General Condition of carpark pavement

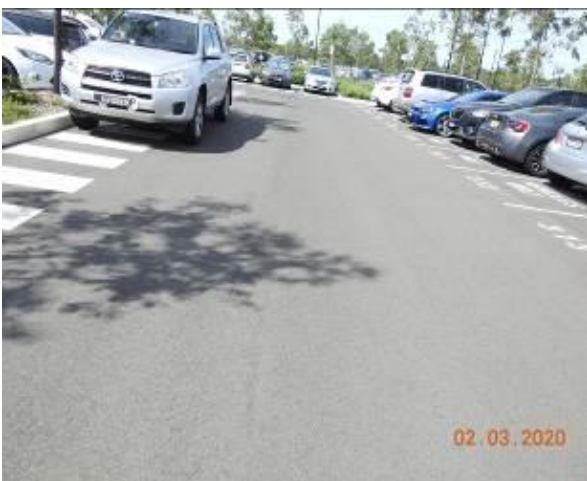
Figure 2724 – General Condition of carpark pavement

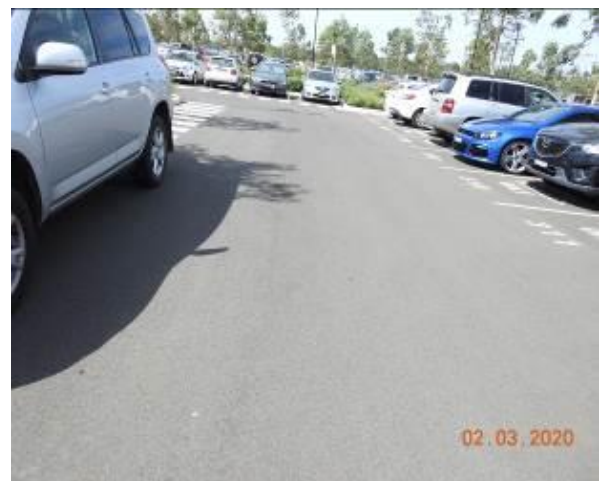
Figure 2725 – General Condition of carpark pavement

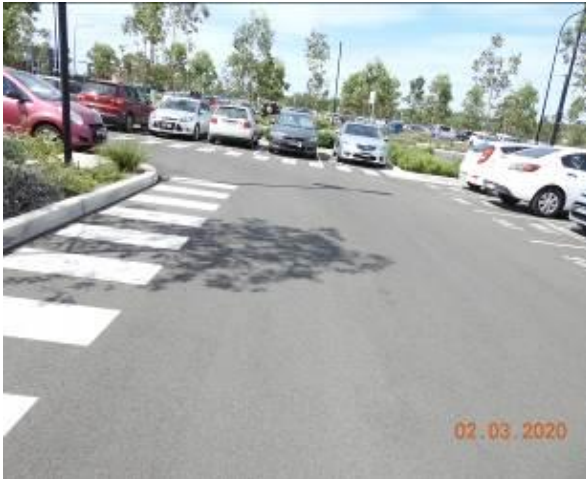
Figure 2726 – General Condition of carpark pavement

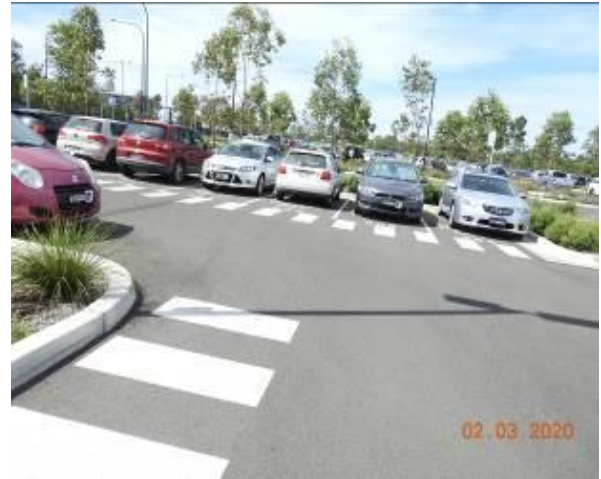
Figure 2727 – General Condition of carpark pavement

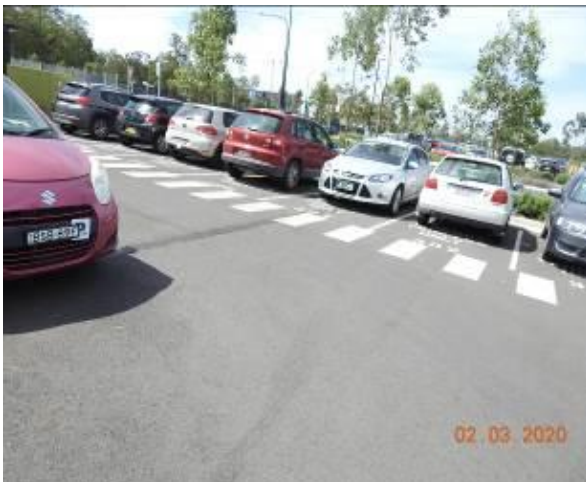
Figure 2728 – General Condition of carpark pavement

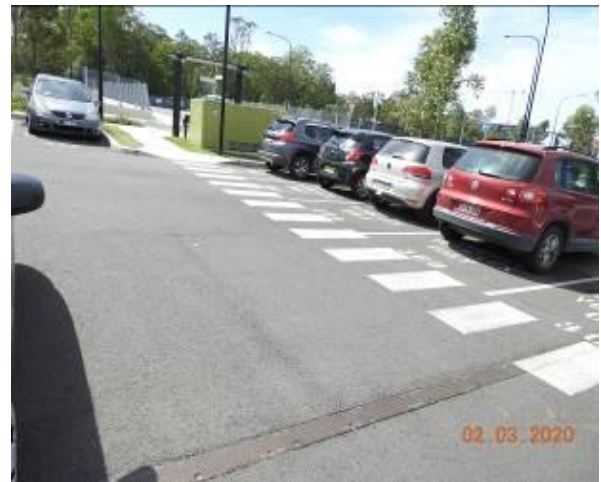
Figure 2729 – General Condition of carpark pavement

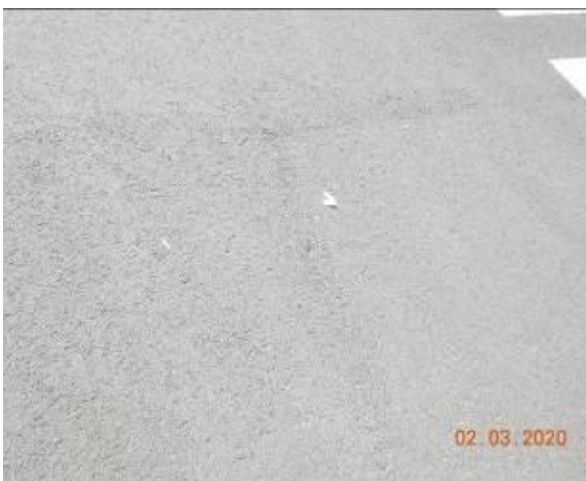
Figure 2730 – Crack propagation through carpark pavement

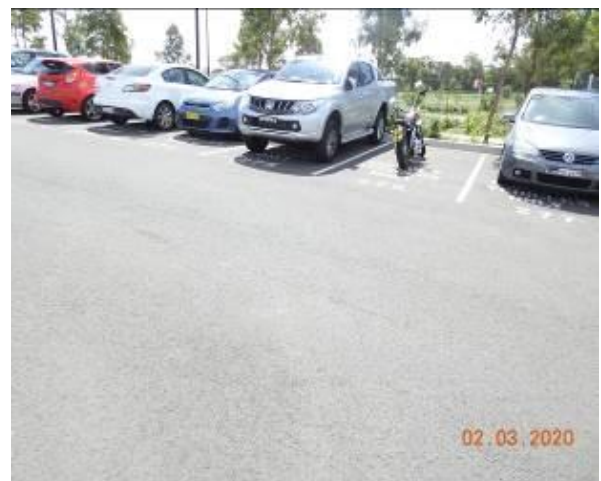
Figure 2731 – General Condition of carpark pavement

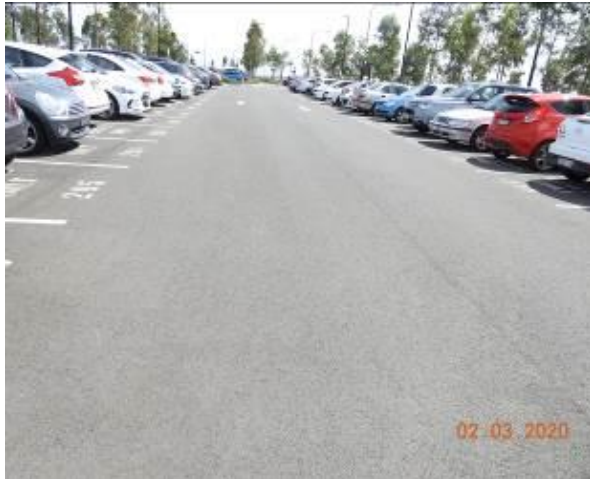
Figure 2732 – General Condition of carpark pavement

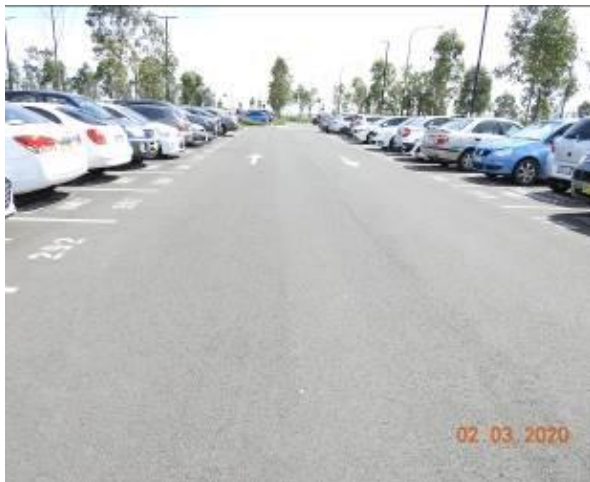
Figure 2734 – General Condition of carpark pavement

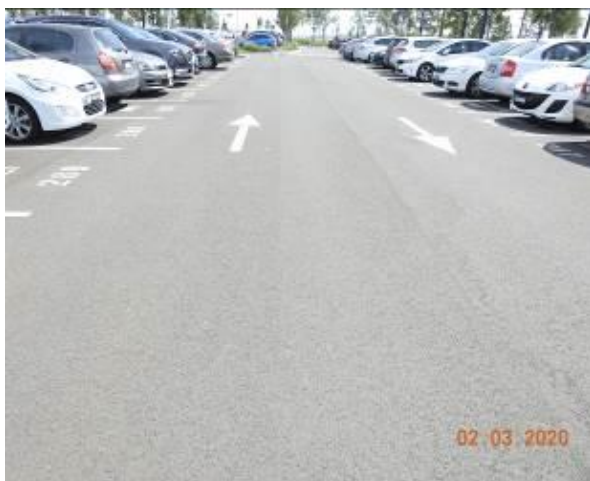
Figure 2736 – General Condition of carpark pavement

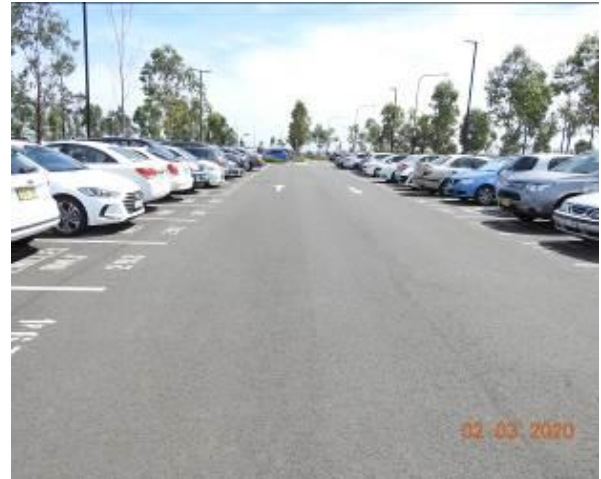
Figure 2733 – General Condition of carpark pavement

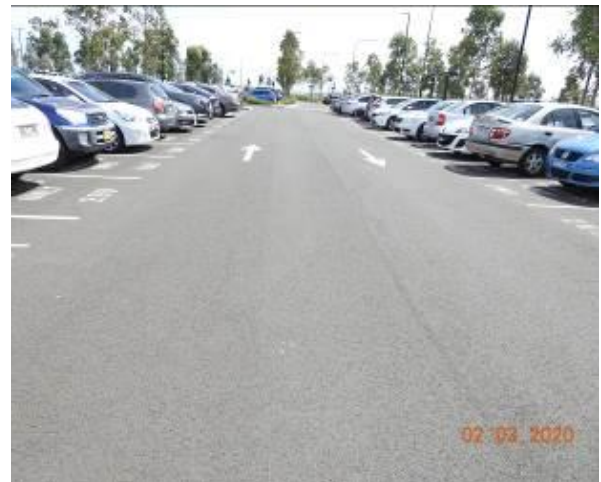
Figure 2735 – General Condition of carpark pavement

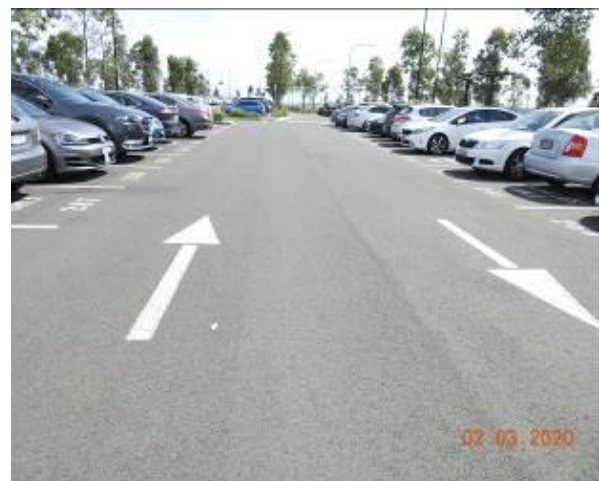
Figure 2737 – General Condition of carpark pavement

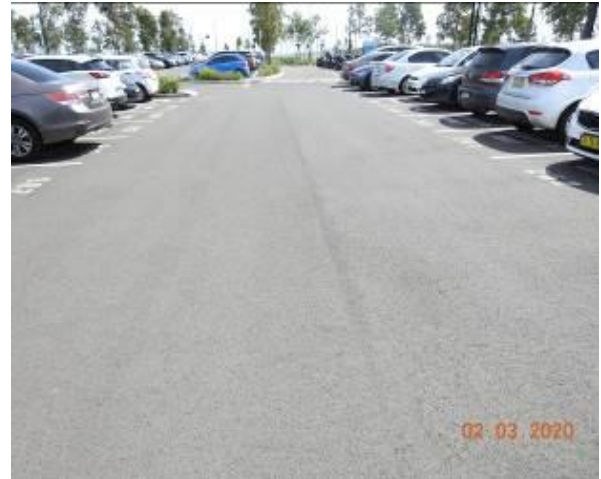
Figure 2739 – General Condition of carpark pavement
