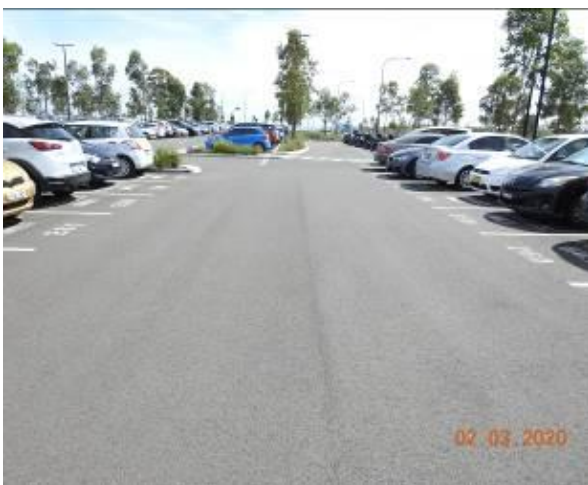
Figure 2740 – General Condition of carpark pavement

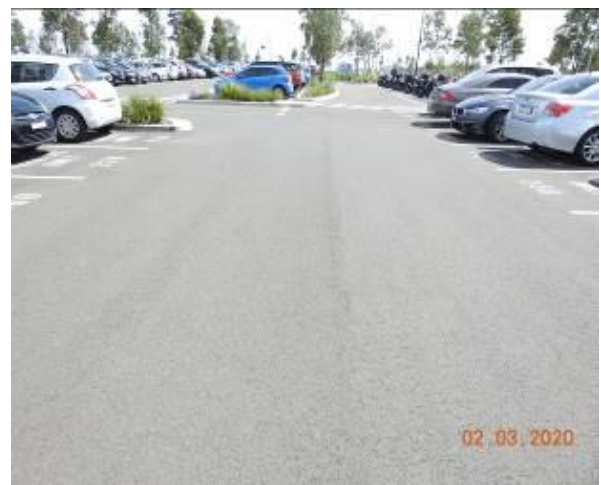
Figure 2741 – General Condition of carpark pavement

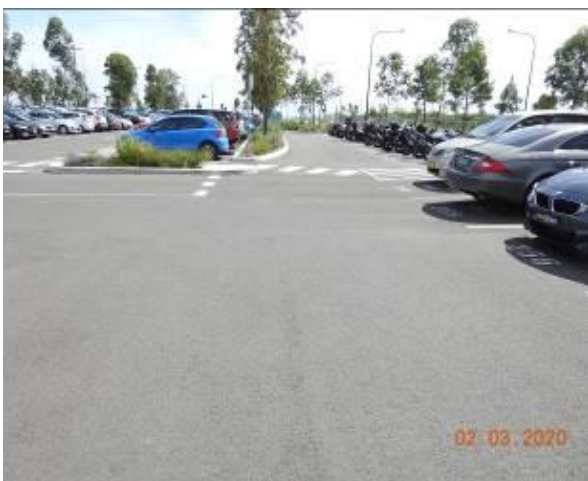
Figure 2742 – General Condition of carpark pavement

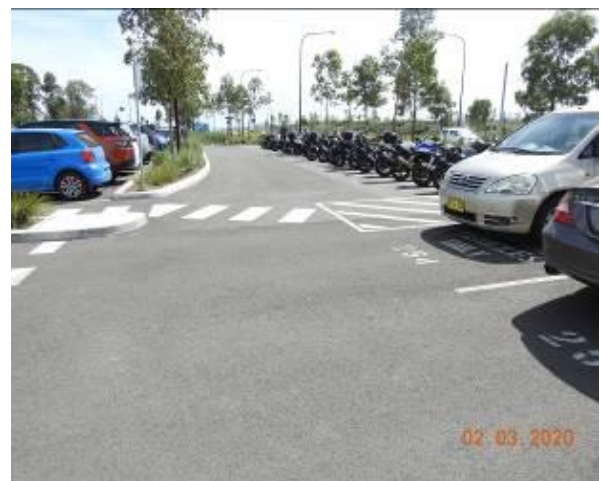
Figure 2743 – General Condition of carpark pavement

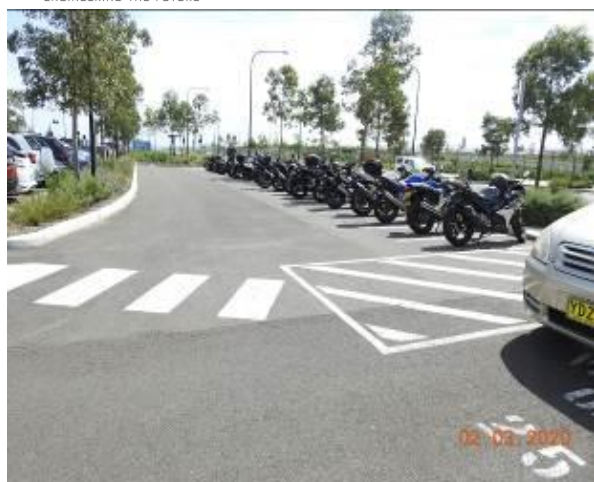
Figure 2744 – General Condition of carpark pavement

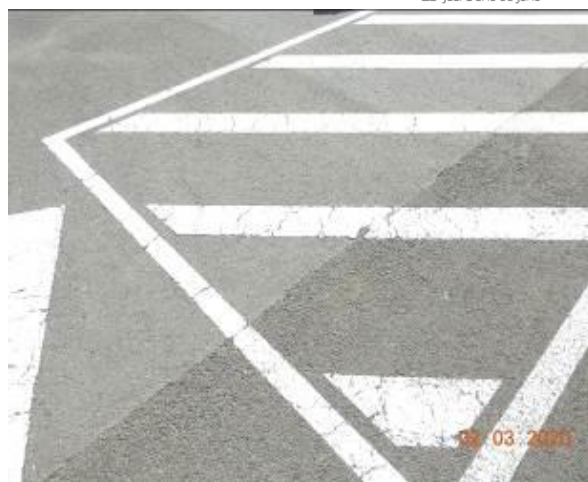
Figure 2745 – Crack propagation through carpark pavement

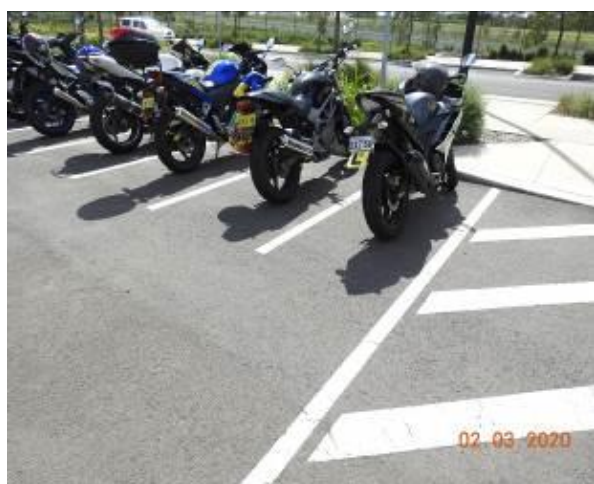
Figure 2746 – General Condition of carpark pavement

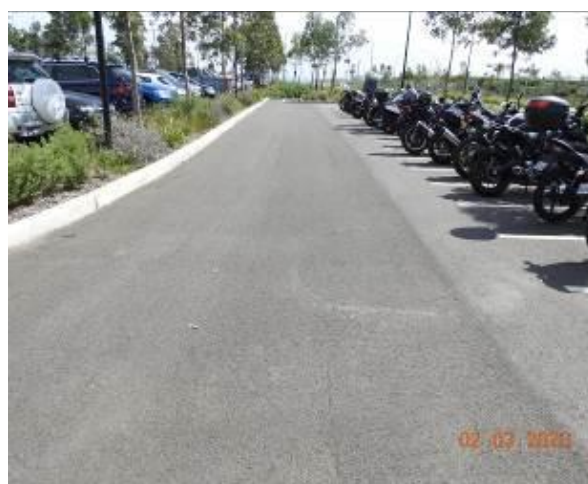
Figure 2747 – Crack propagation through carpark pavement

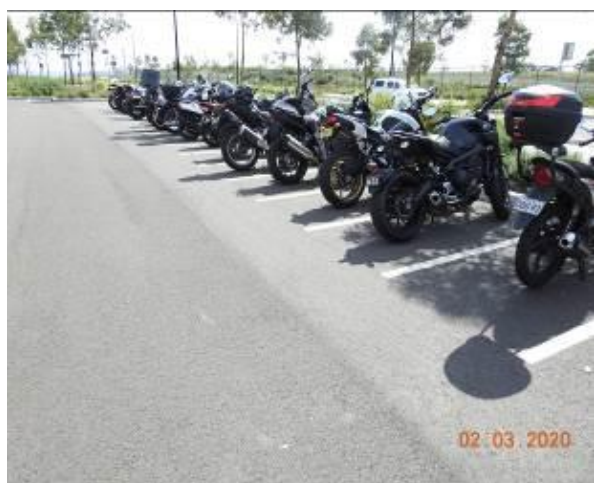
Figure 2748 – General Condition of carpark pavement

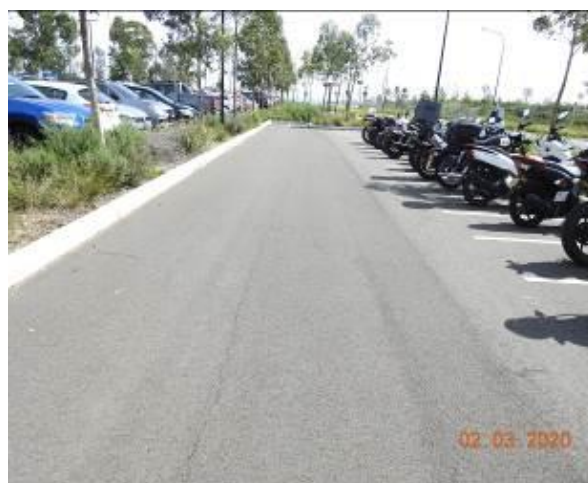
Figure 2749 – Crack propagation through carpark pavement

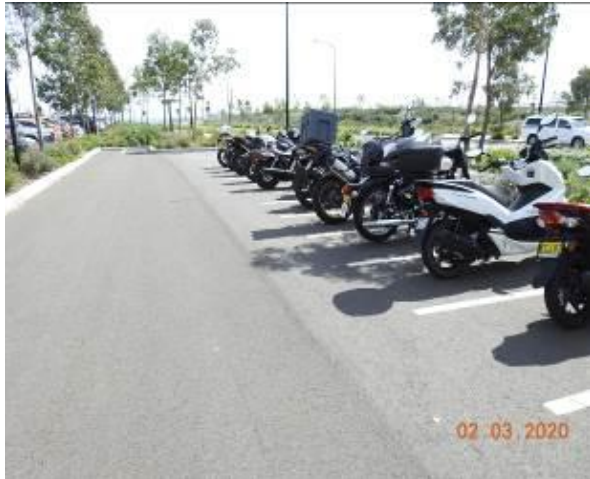
Figure 2750 – General Condition of carpark pavement

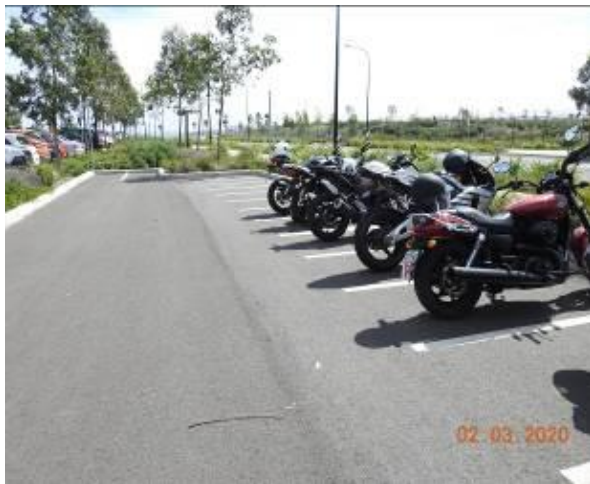
Figure 2752 – General Condition of carpark pavement

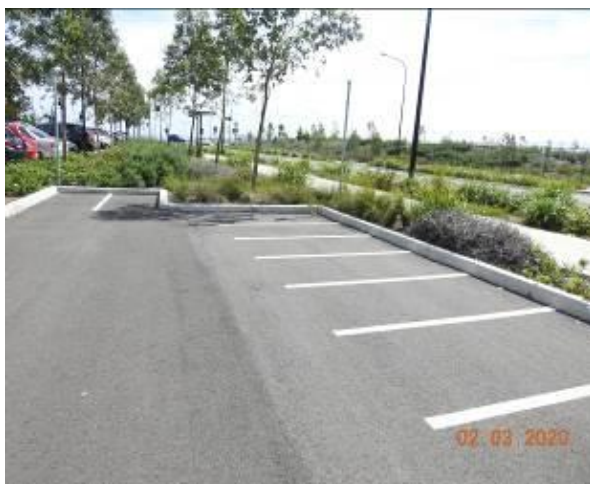
Figure 2754 – General Condition of carpark pavement

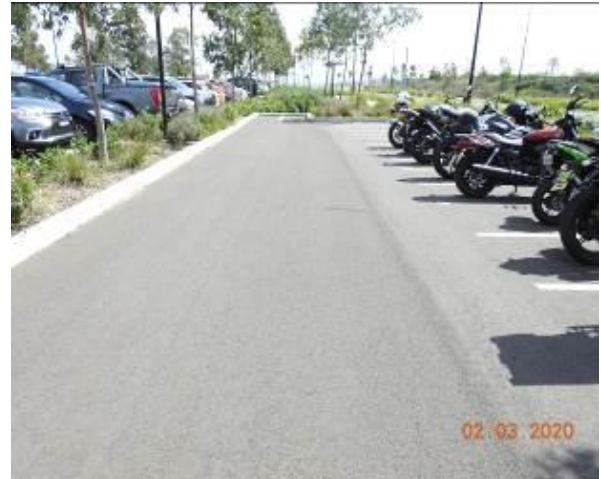
Figure 2751 – General Condition of carpark pavement

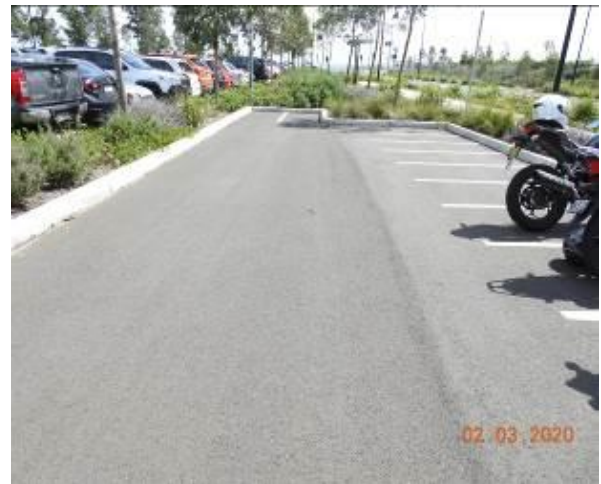
Figure 2753 – General Condition of carpark pavement

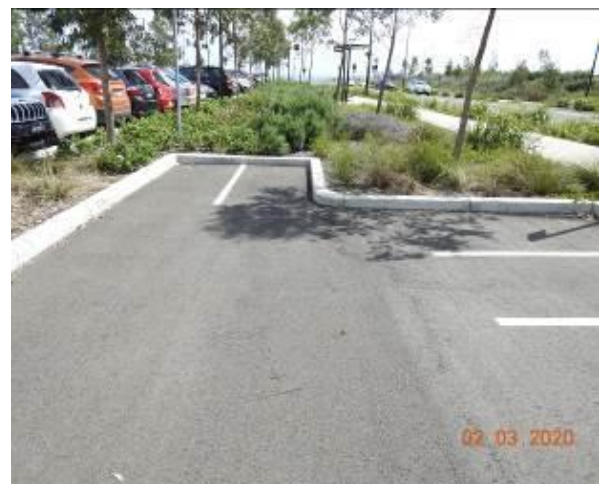
Figure 2755 – General Condition of carpark pavement

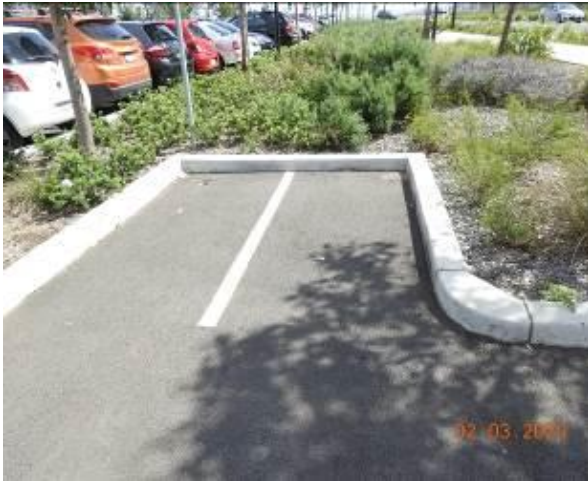
Figure 2756 – General Condition of carpark pavement

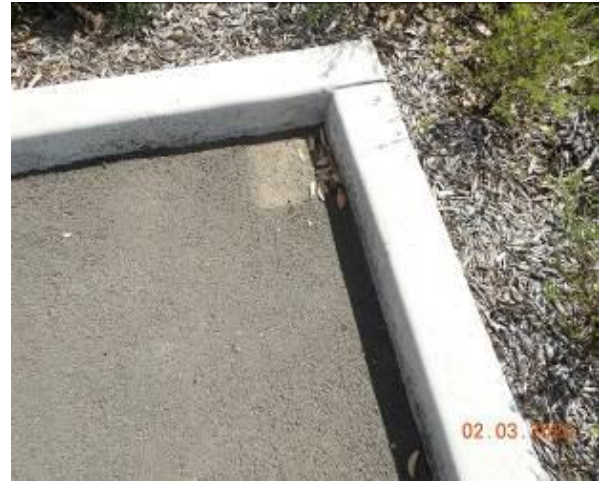
Figure 2757 – Loss of material through carpark pavement

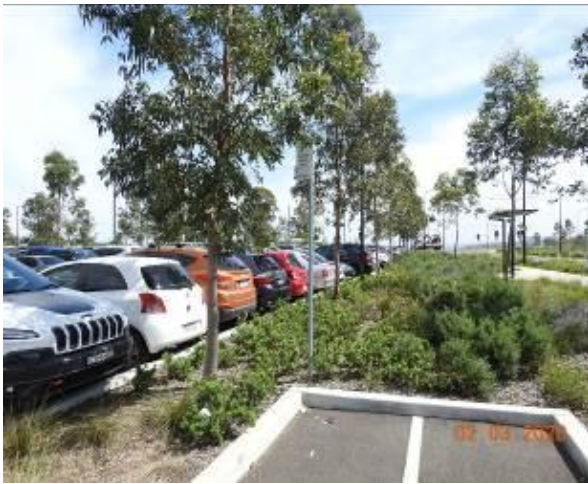
Figure 2758 – General Condition of street sign

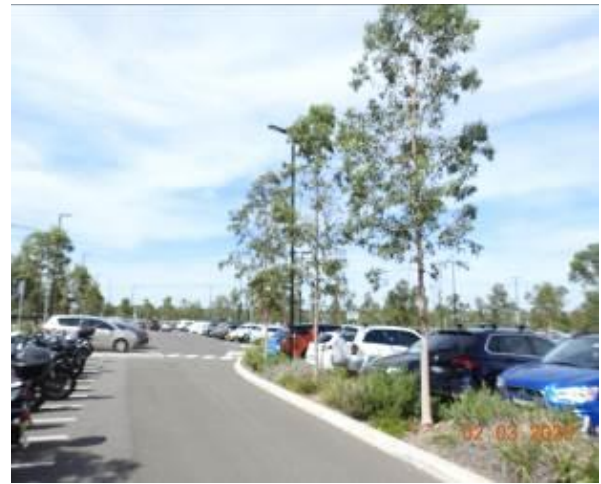
Figure 2759 – General Condition of lamp post

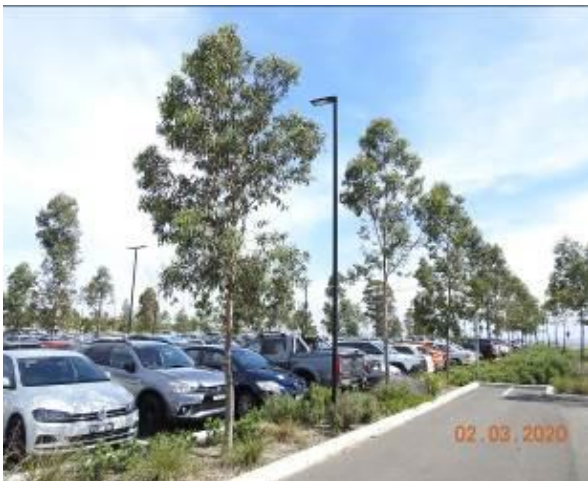
Figure 2760 – General Condition of lamp post

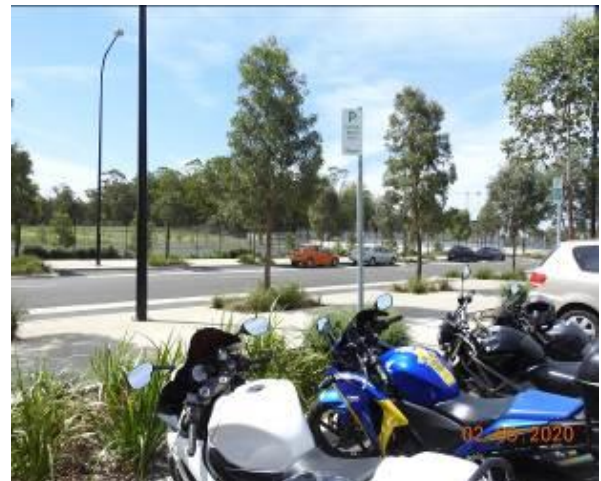
Figure 2761 – General Condition of street sign

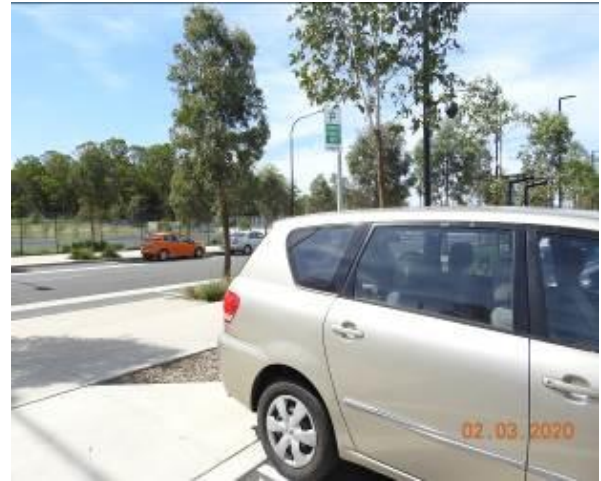
Figure 2763 – General Condition of street sign

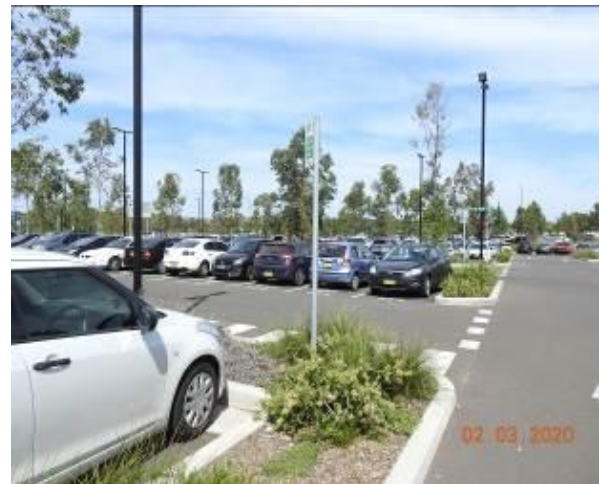
Figure 2765 – General Condition of street sign

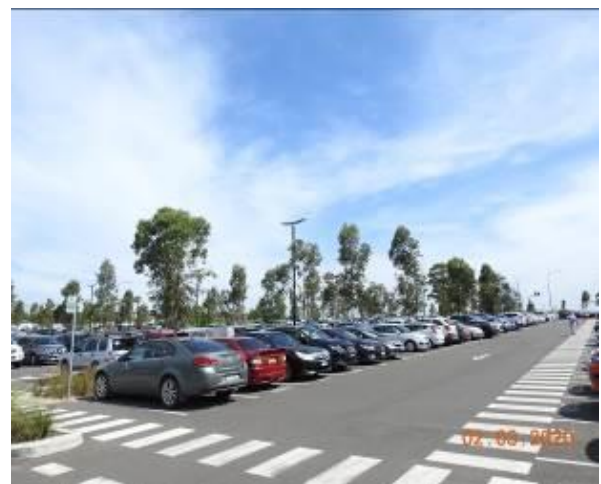
Figure 2767 – General Condition of lamp post

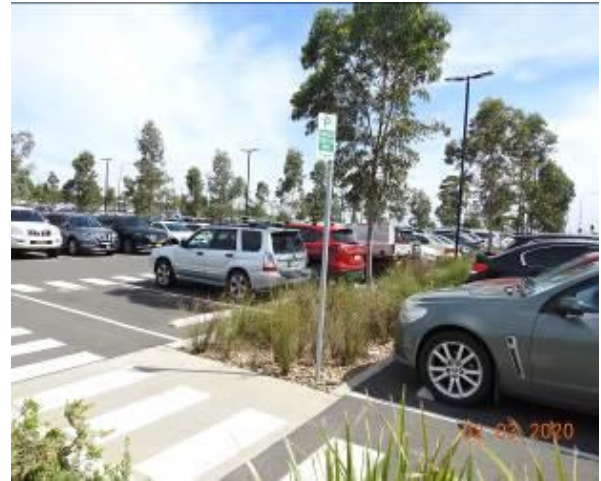
Figure 2769 – General Condition of street sign

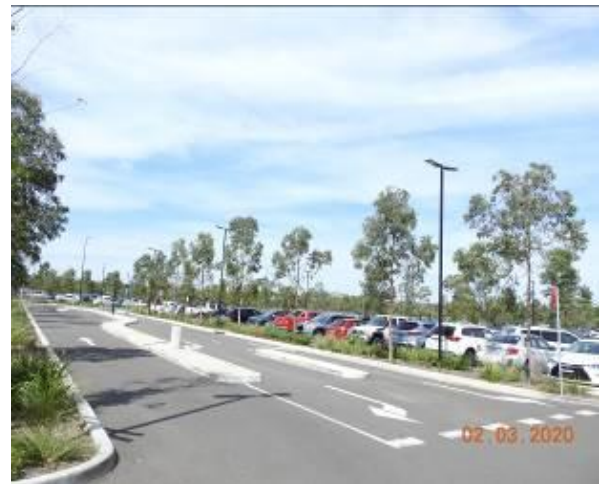
Figure 2771 – General Condition of lamp post

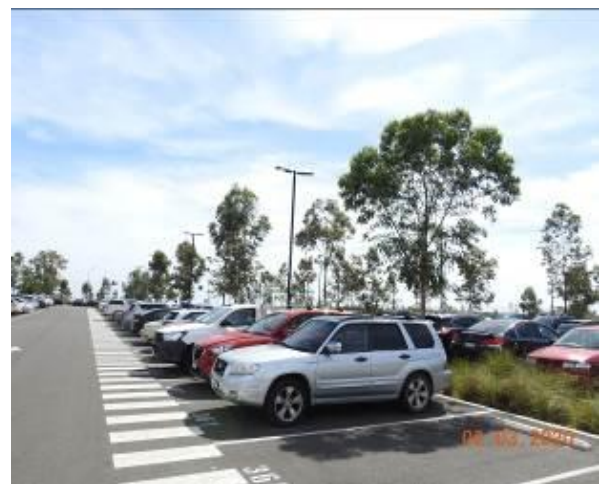
Figure 2773 – General Condition of lamp post

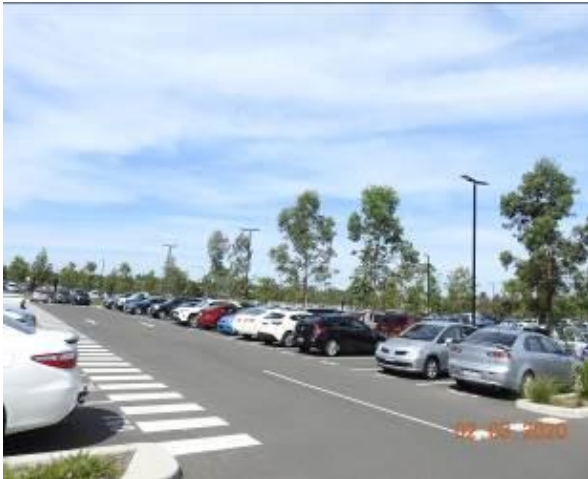
Figure 2774 – General Condition of lamp post

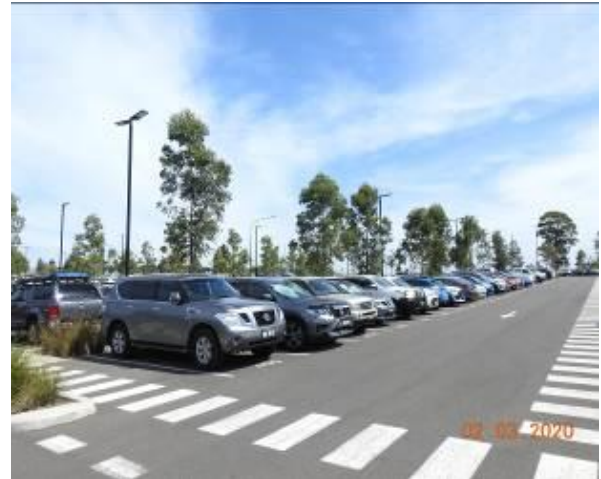
Figure 2775 – General Condition of lamp post / plantation

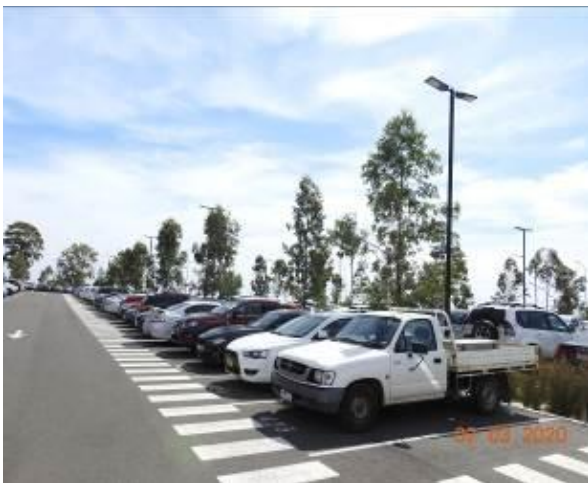
Figure 2776 – General Condition of lamp post / plantation

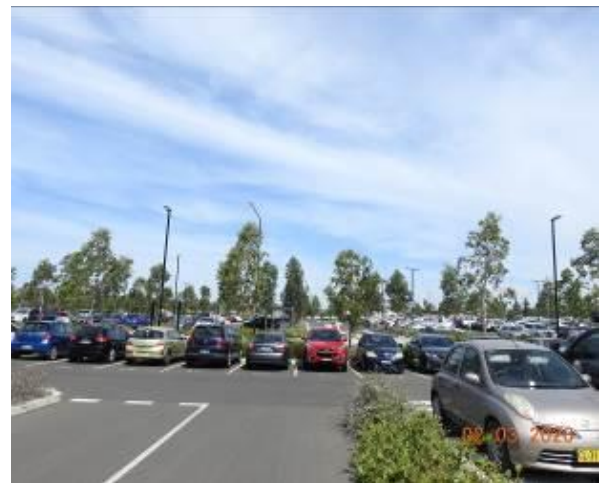
Figure 2777 – General Condition of lamp post / plantation

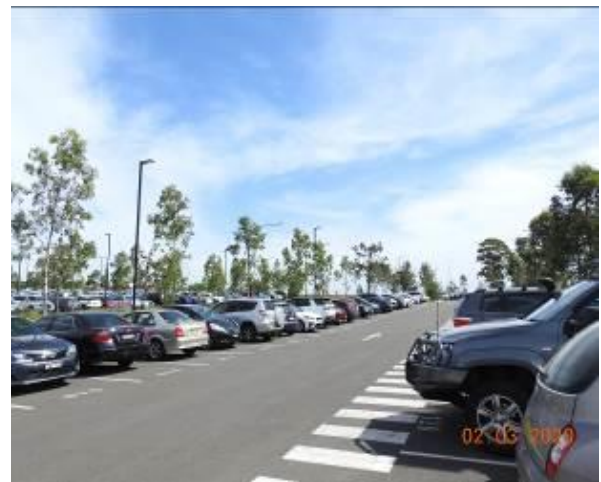
Figure 2779 – General Condition of lamp post / plantation

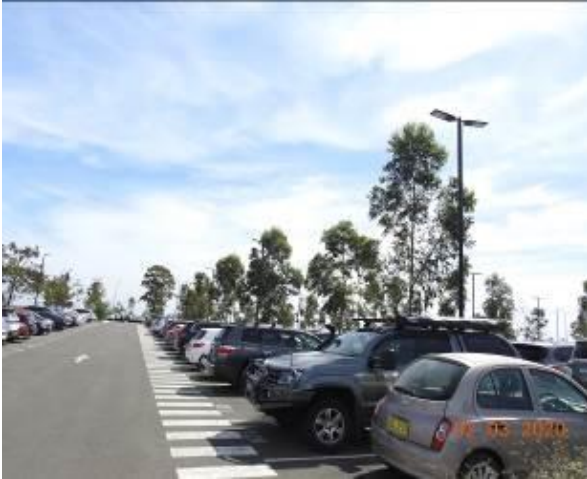
Figure 2780 – General Condition of lamp post / plantation

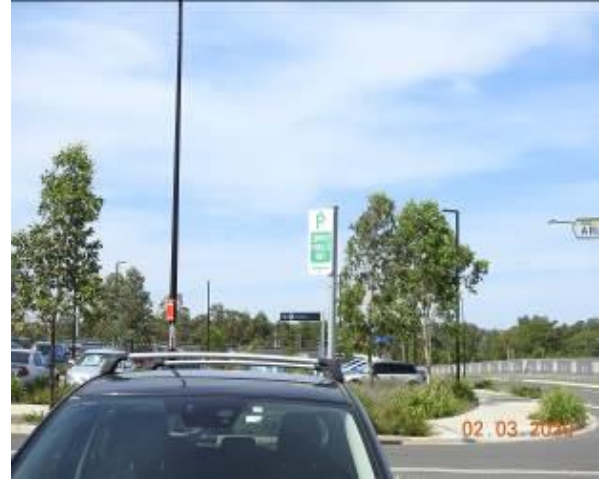
Figure 2781 – General Condition of street sign

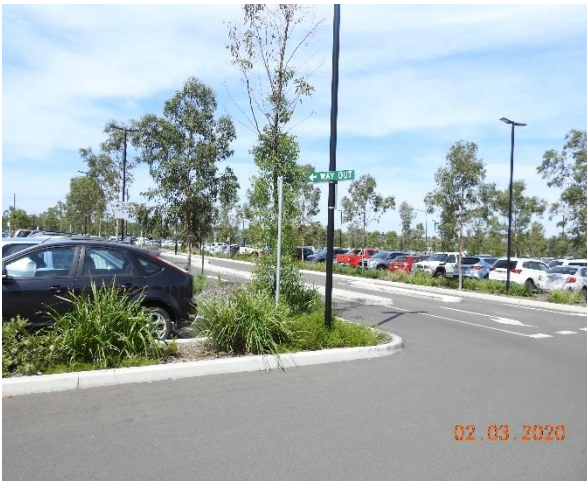
Figure 2782 – General Condition of lamp post / plantation

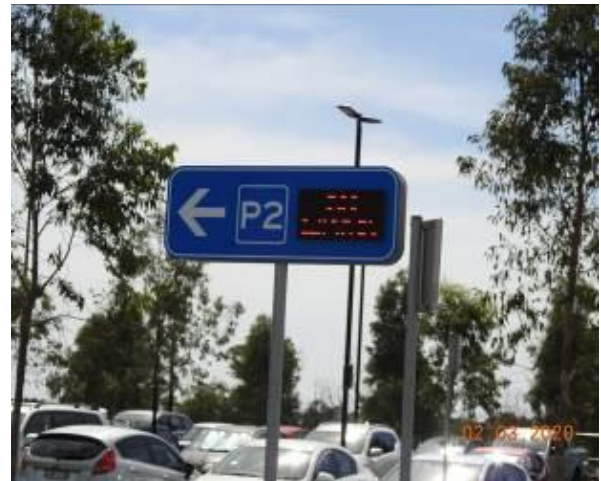
Figure 2783 – General Condition of street sign

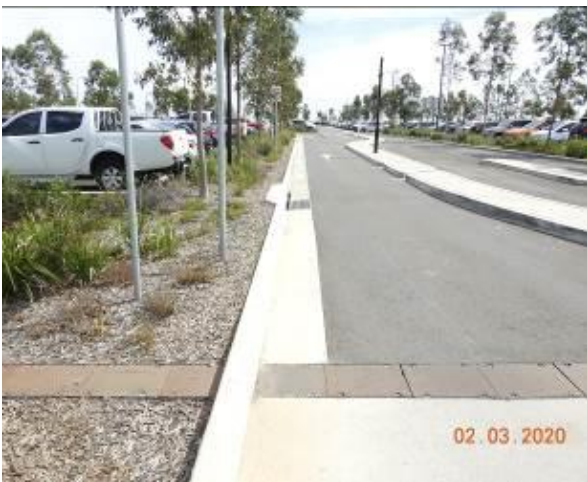
Figure 2784 – General Condition of kerb and gutter

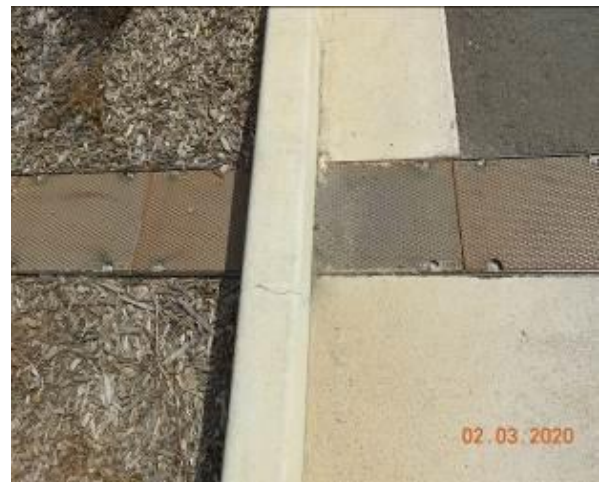
Figure 2785 – Crack propagation through kerb

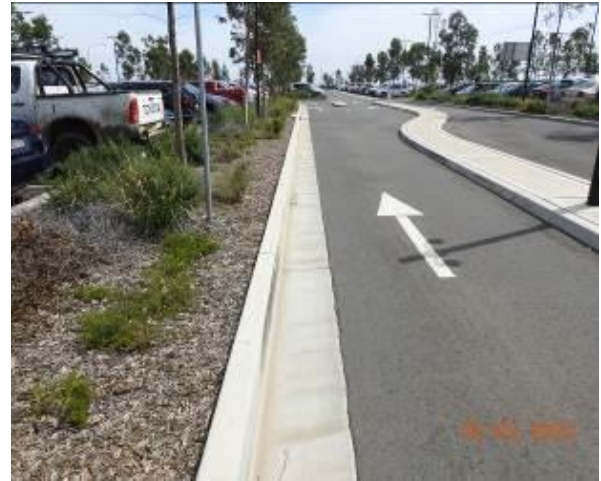
Figure 2787 – General Condition of kerb and gutter

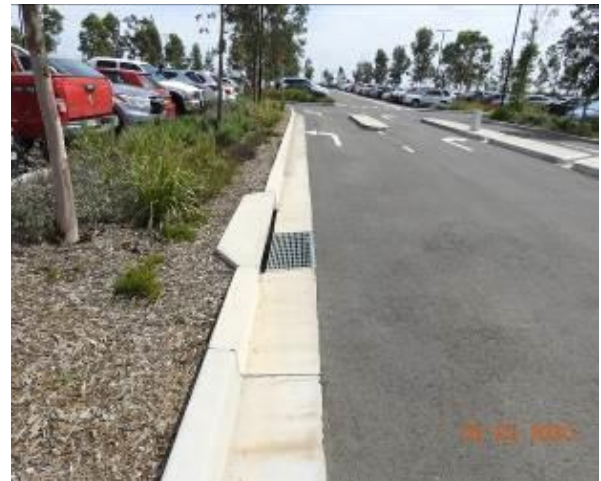
Figure 2789 – General Condition of kerb and gutter

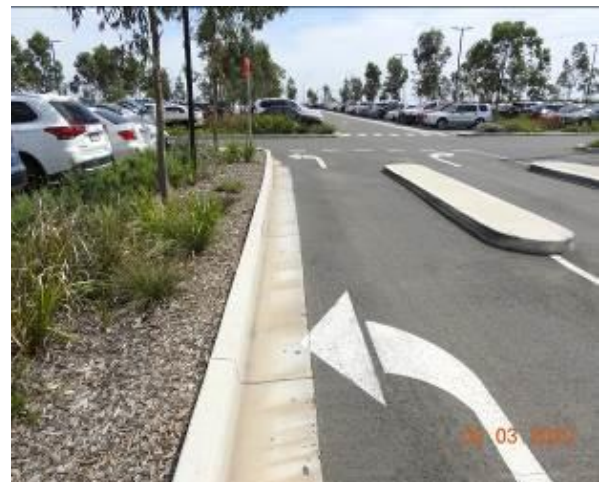
Figure 2791 – General Condition of kerb and gutter

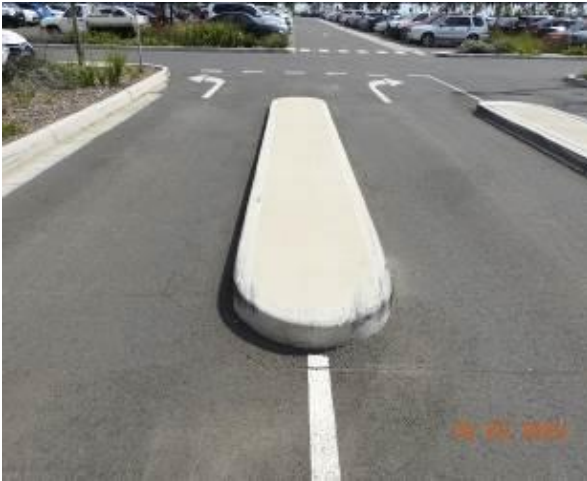
Figure 2792 – General Condition of traffic island kerb

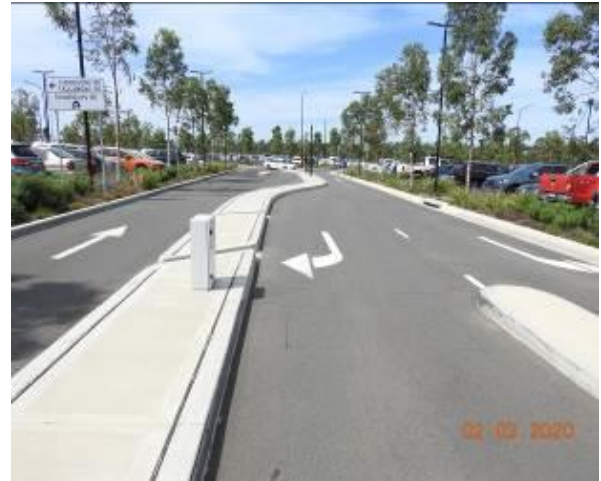
Figure 2793 – General Condition of traffic island kerb and footpath pavement

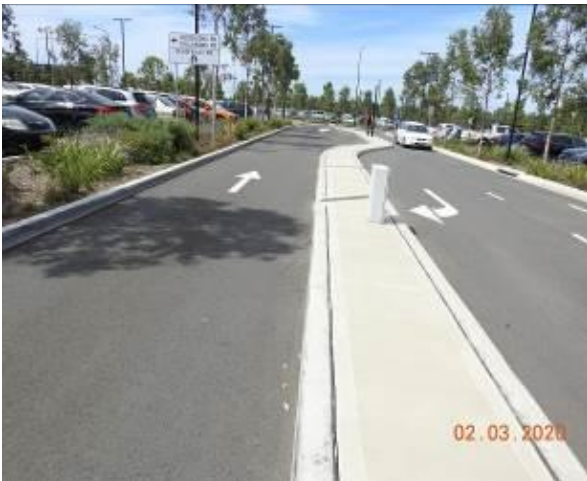
Figure 2794 – General Condition of traffic island kerb and footpath pavement

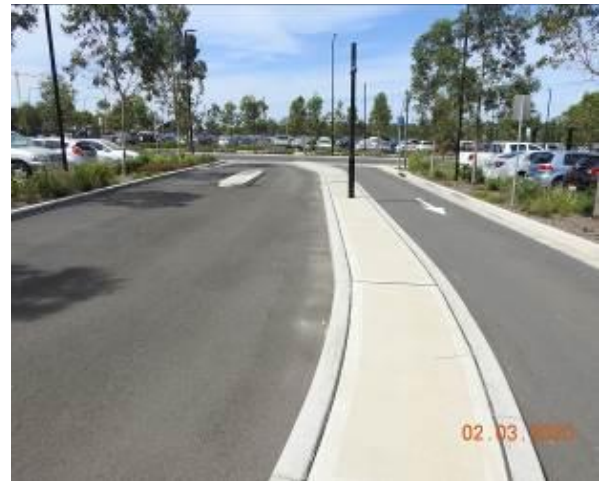
Figure 2795 – General Condition of traffic island kerb and footpath pavement

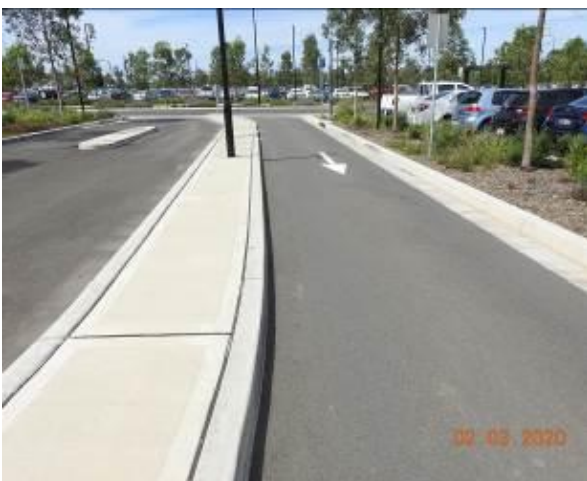
Figure 2796 – General Condition of traffic island kerb and footpath pavement

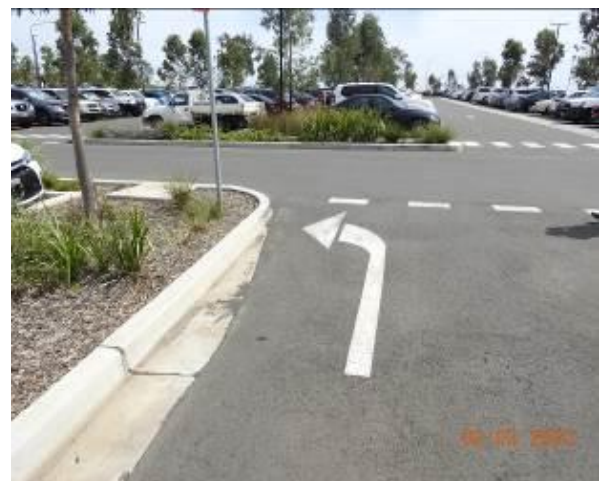
Figure 2797 – General Condition of kerb and gutter

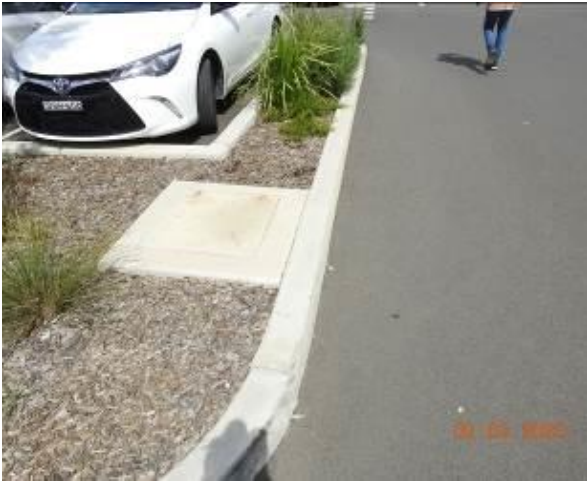
Figure 2798 – General Condition of kerb

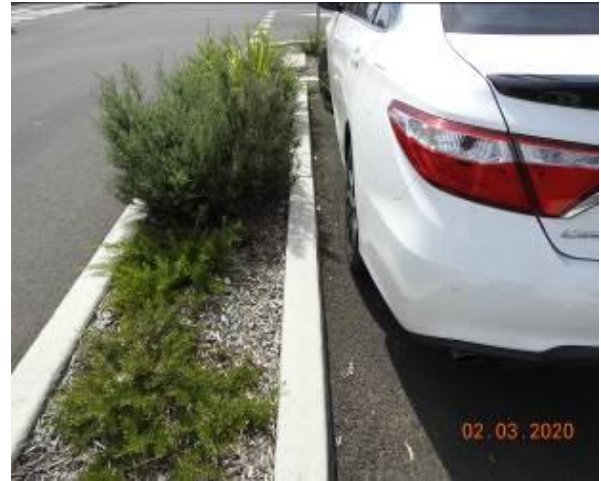
Figure 2799 – General Condition of kerb

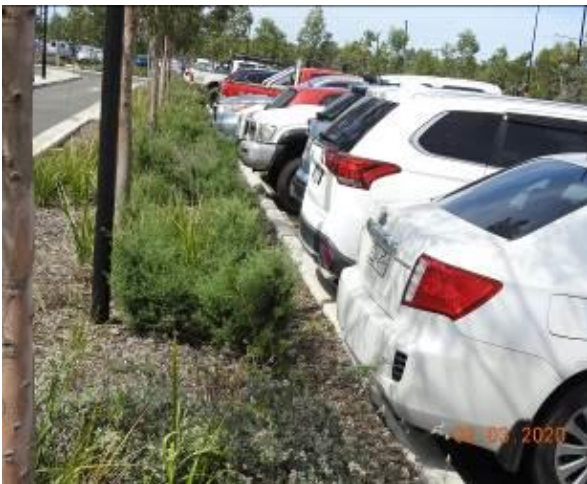
Figure 2800 – General Condition of kerb

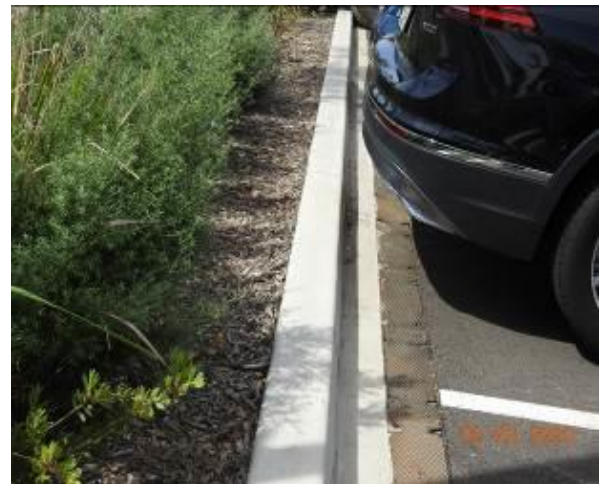
Figure 2801 – General Condition of kerb and gutter

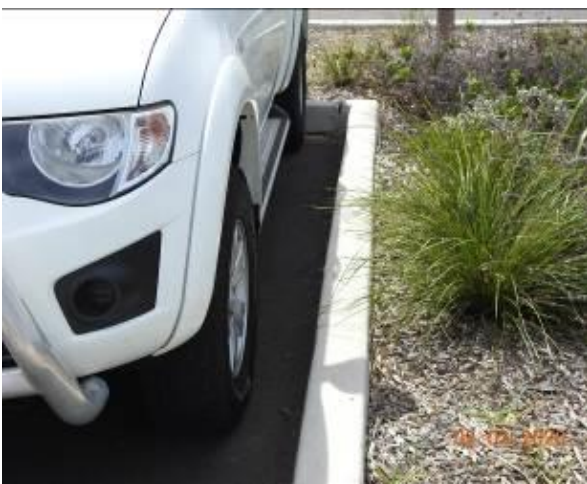
Figure 2802 – General Condition of kerb

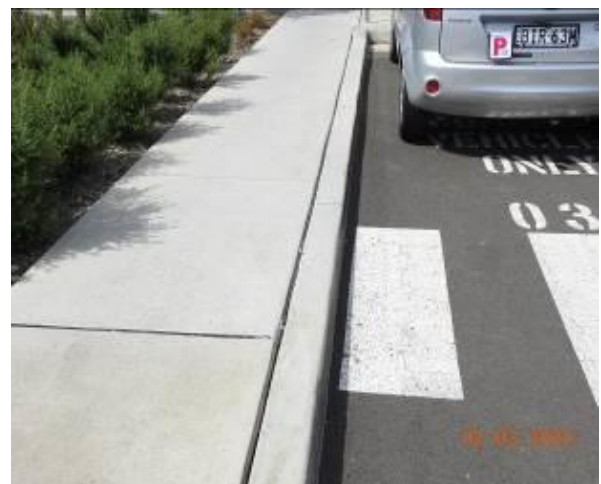
Figure 2803 – General Condition of kerb and footpath pavement

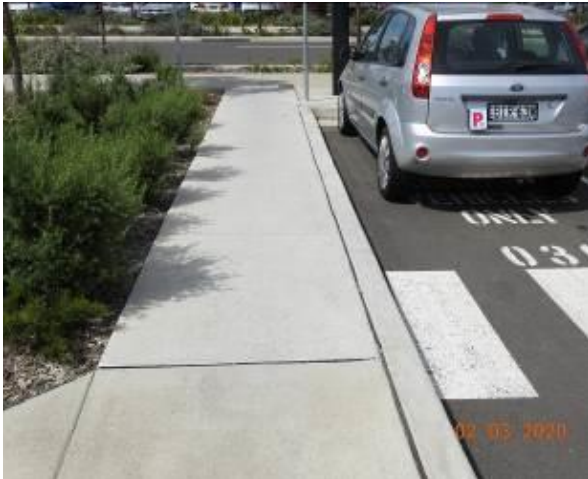
Figure 2804 – General Condition of kerb and footpath pavement

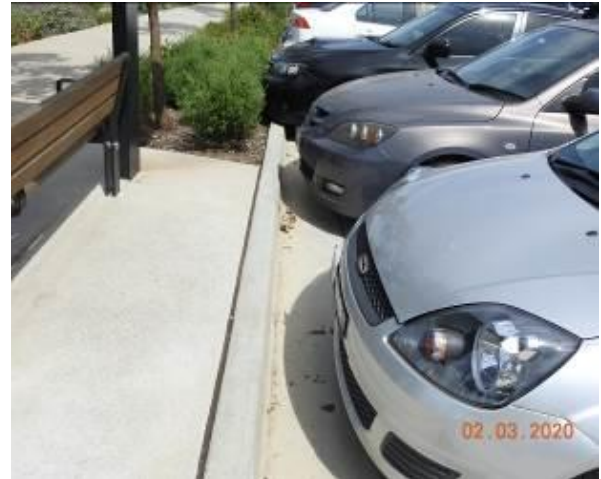
Figure 2805 – General Condition of kerb, gutter and footpath pavement

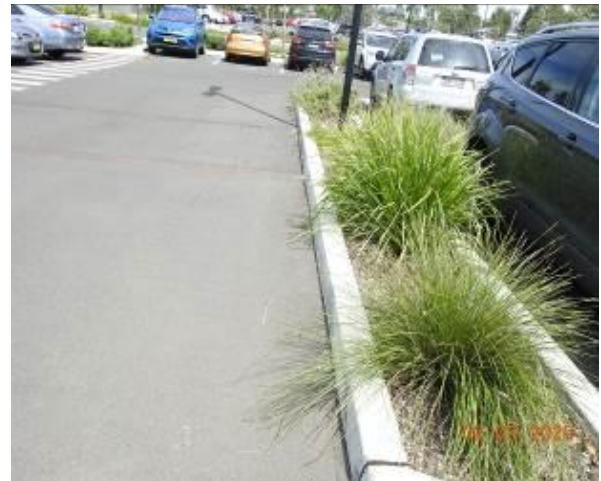
Figure 2807 – General Condition of kerb

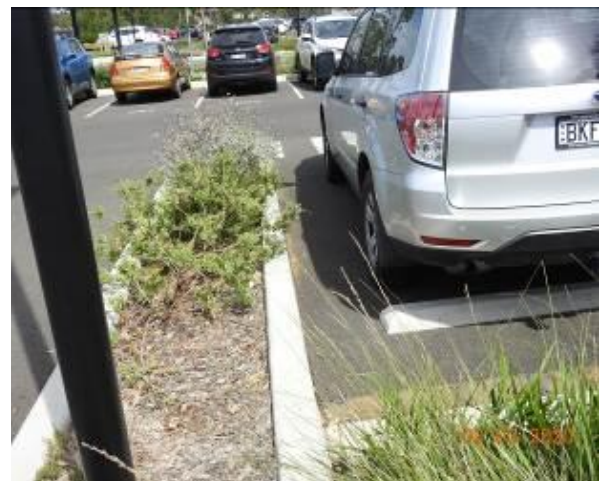
Figure 2809 – General Condition of kerb

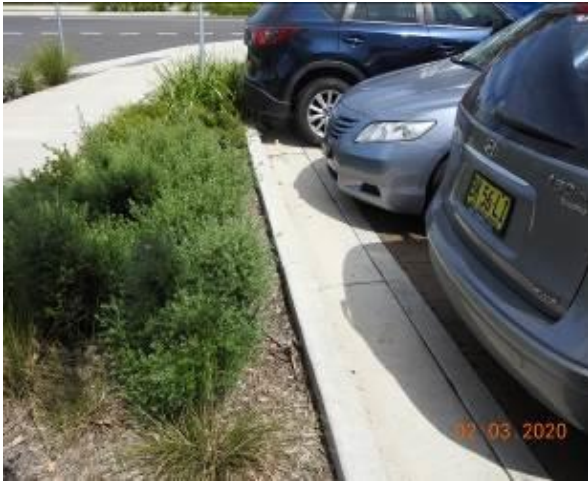
Figure 2810 – General Condition of kerb and footpath pavement

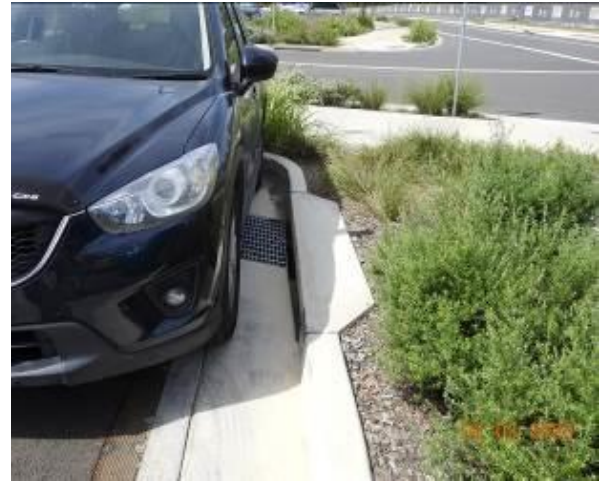
Figure 2811 – General Condition of kerb and gutter

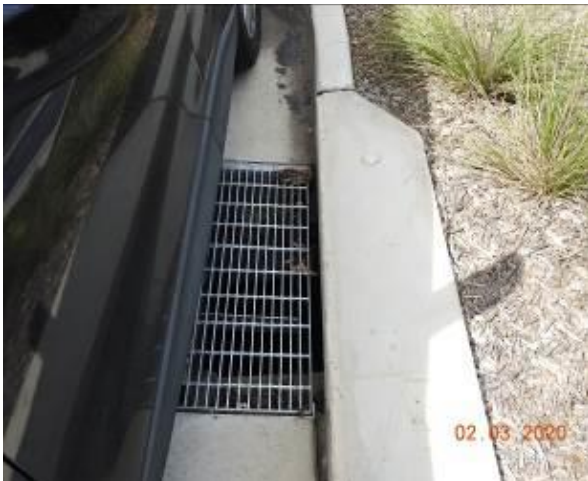
Figure 2812 – General Condition of stormwater inlet pit

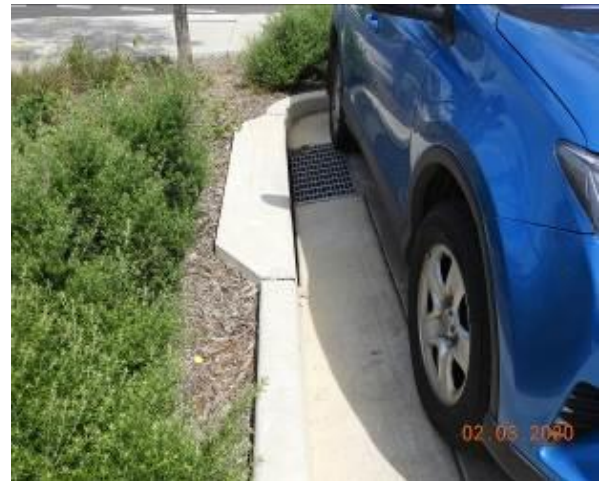
Figure 2813 – General Condition of kerb and gutter

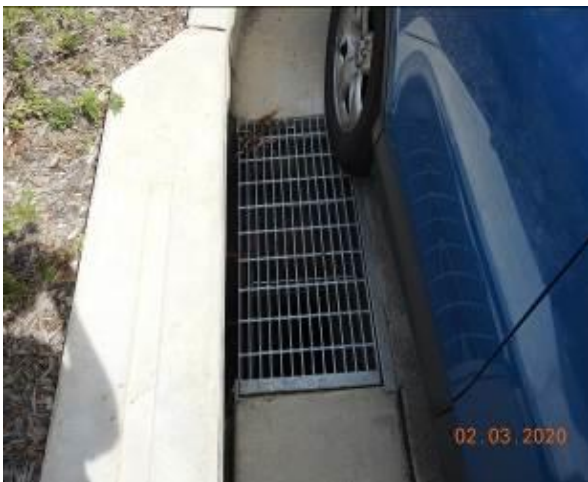
Figure 2814 – General Condition of stormwater inlet pit

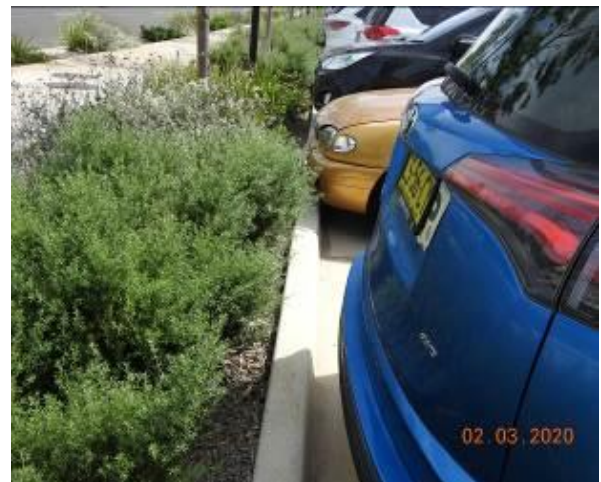
Figure 2815 – General Condition of kerb and gutter

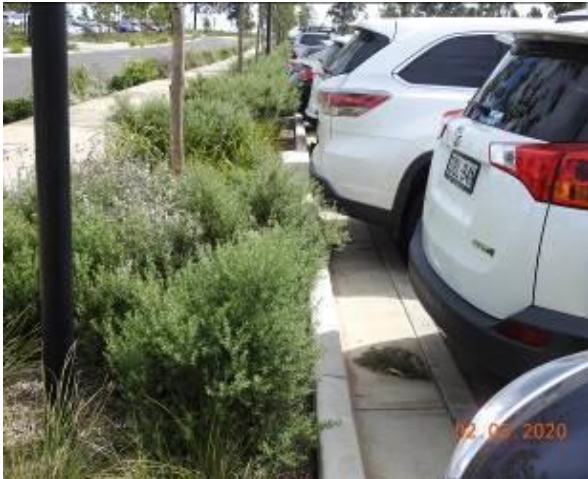
Figure 2816 – General Condition of kerb and gutter

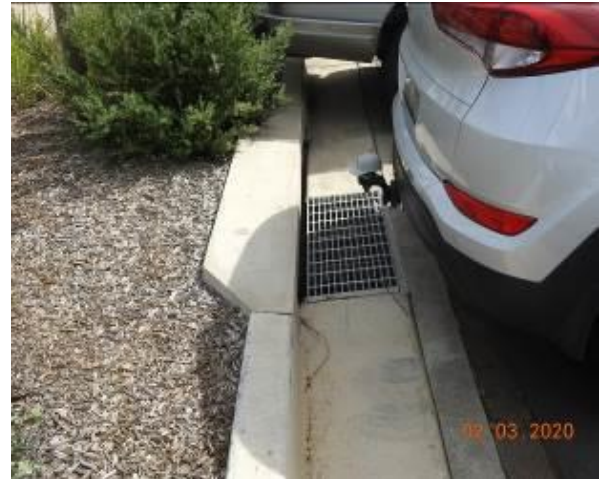
Figure 2817 – General Condition of kerb and gutter

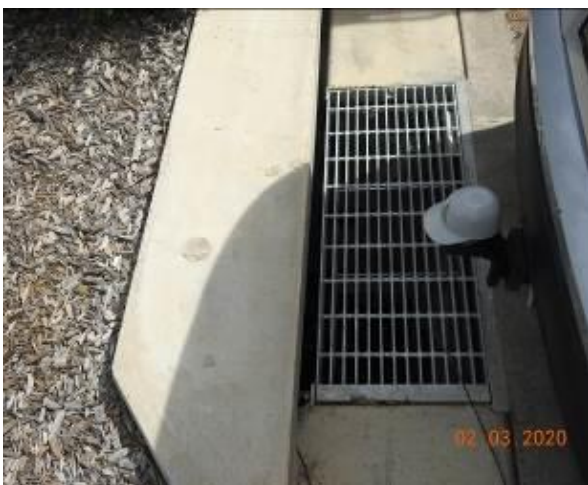
Figure 2818 – General Condition of stormwater inlet pit

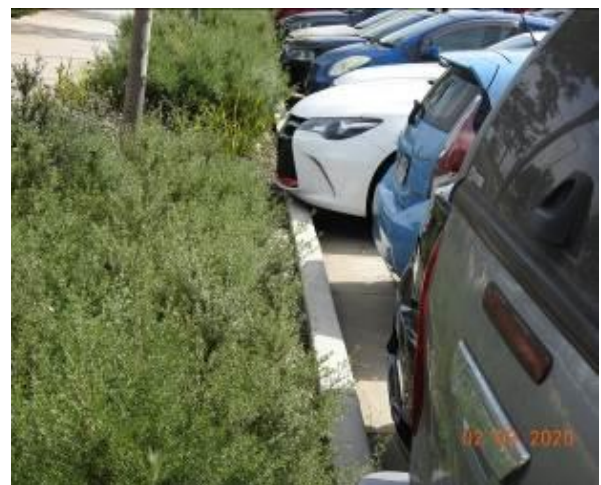
Figure 2819 – General Condition of kerb

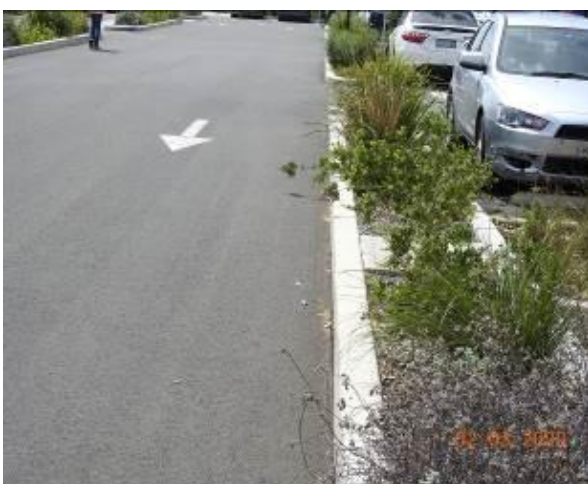
Figure 2820 – General Condition of kerb

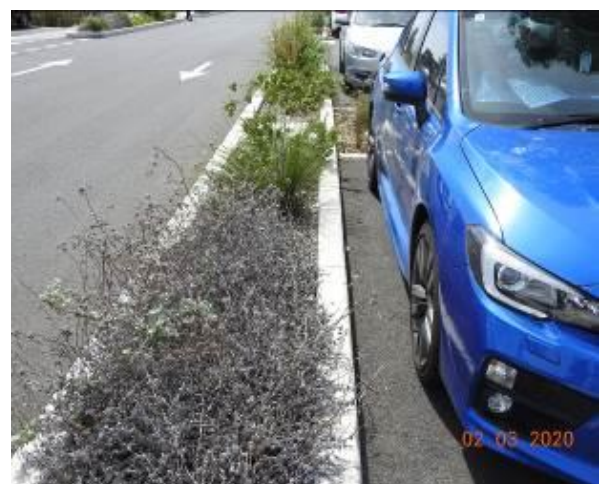
Figure 2821 – General Condition of kerb

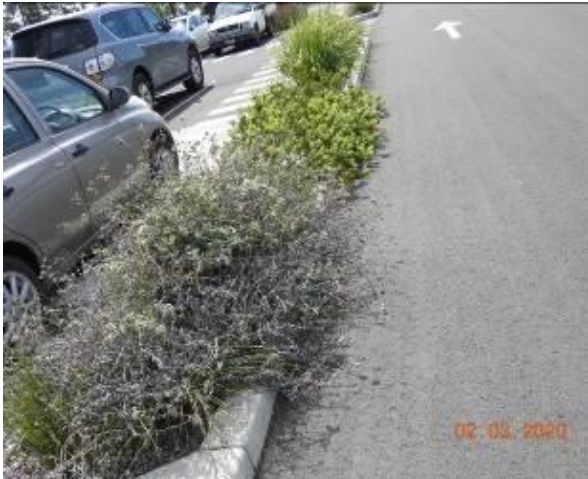
Figure 2822 – General Condition of kerb

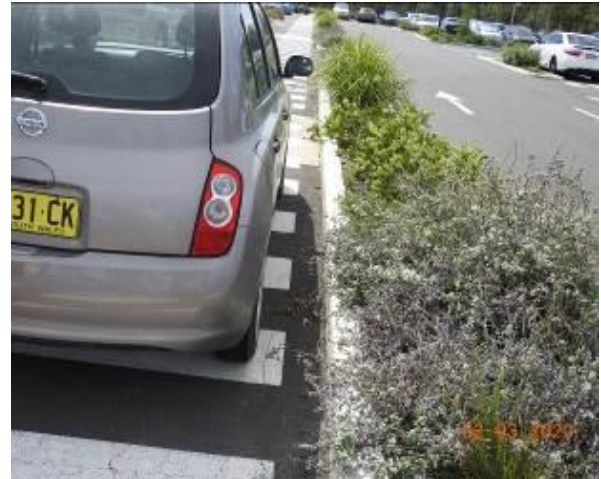
Figure 2823 – General Condition of kerb

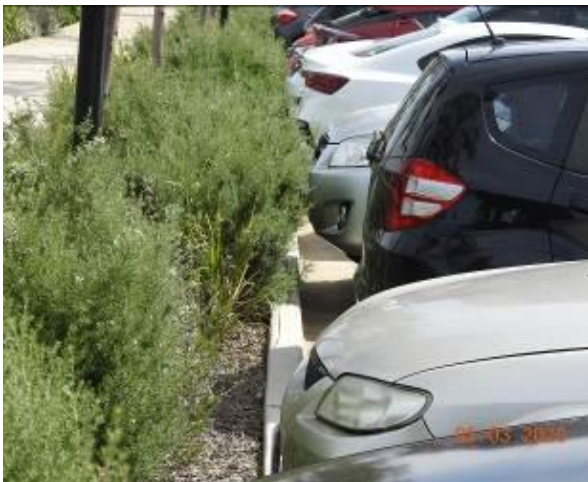
Figure 2824 – General Condition of kerb and gutter

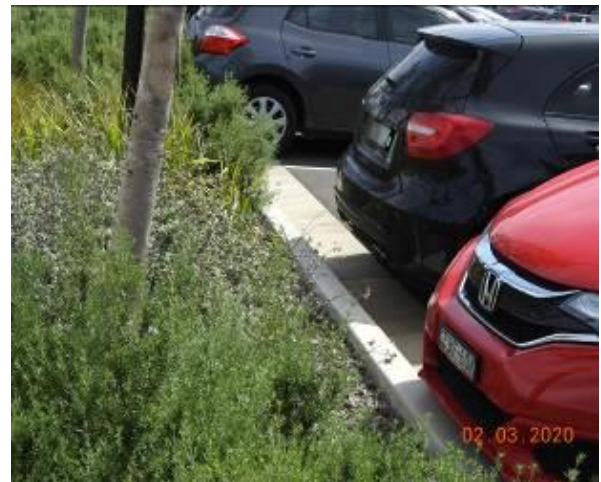
Figure 2825 – General Condition of kerb and gutter

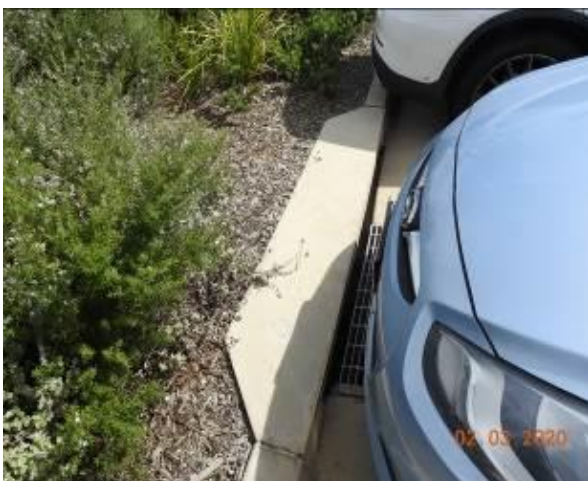
Figure 2826 – General Condition of kerb and gutter

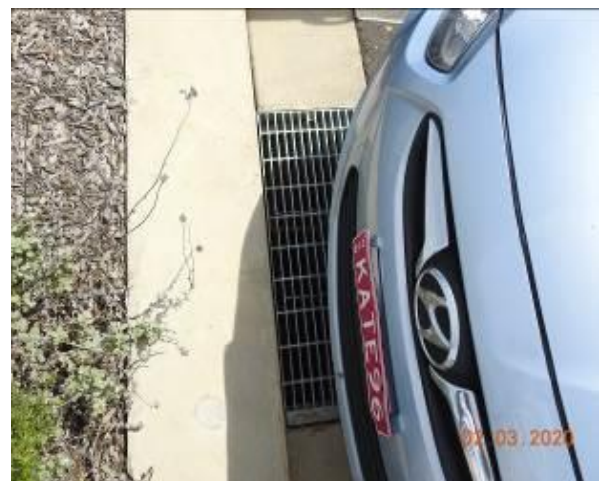
Figure 2827 – General Condition of stormwater inlet pit

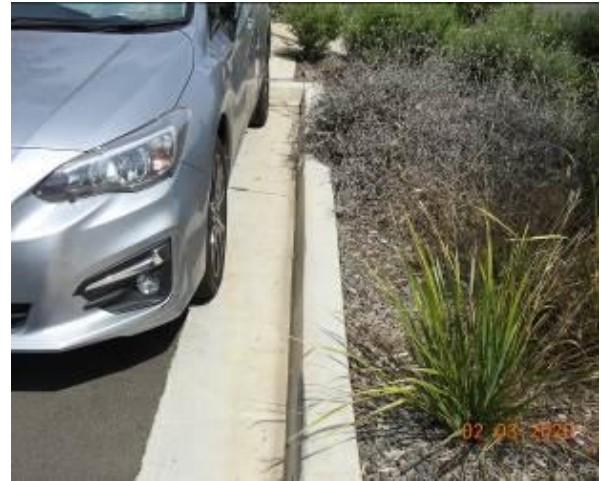
Figure 2829 – General Condition of kerb and gutter
