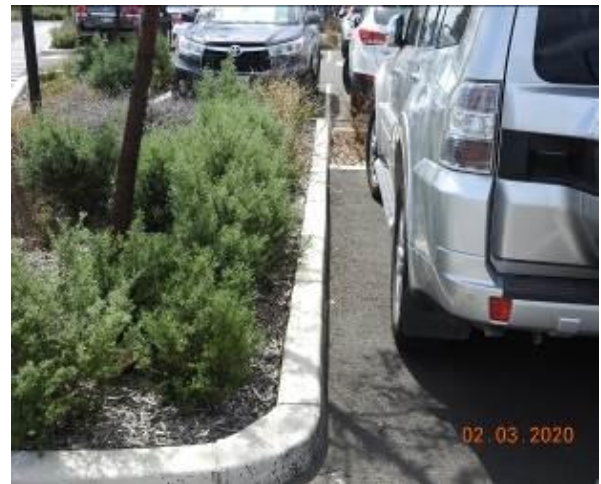
Figure 2831 – General Condition of kerb

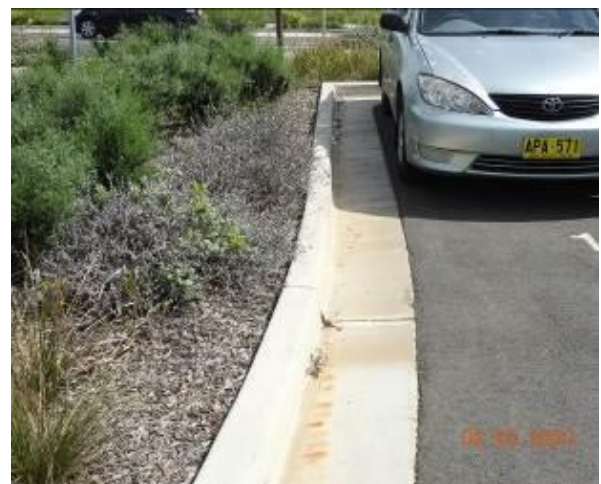
Figure 2833 – General Condition of kerb and gutter

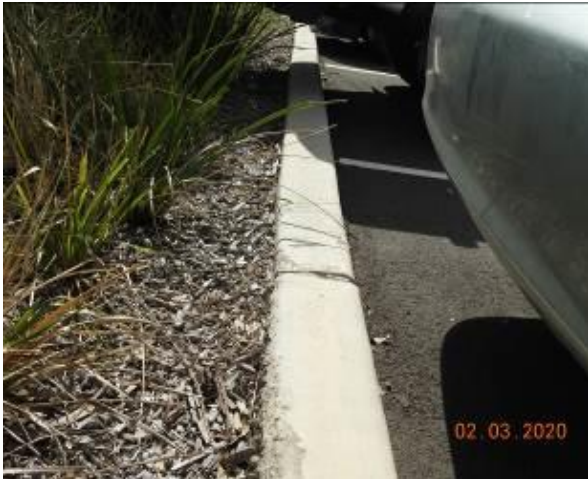
Figure 2834 – Loss of material through kerb

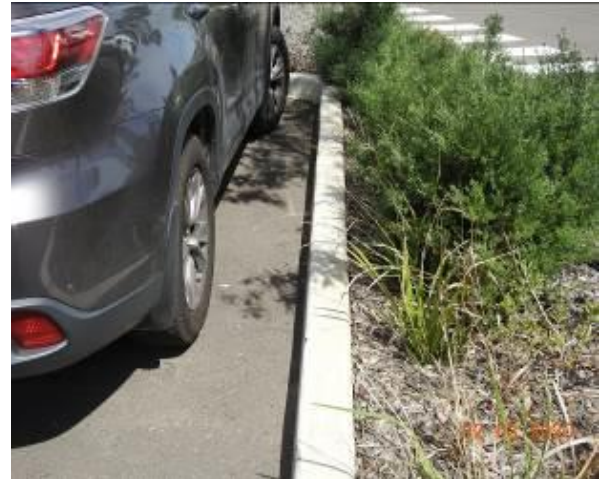
Figure 2835 – General Condition of kerb

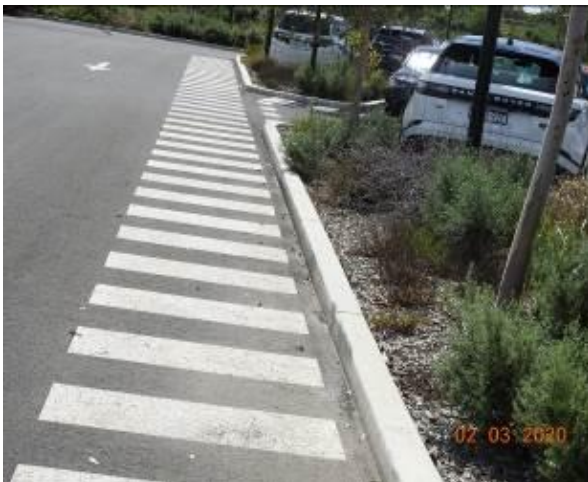
Figure 2836 – General Condition of kerb

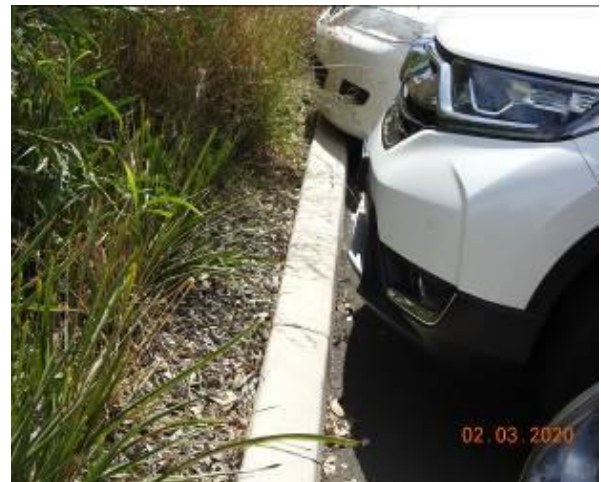
Figure 2837 – General Condition of kerb

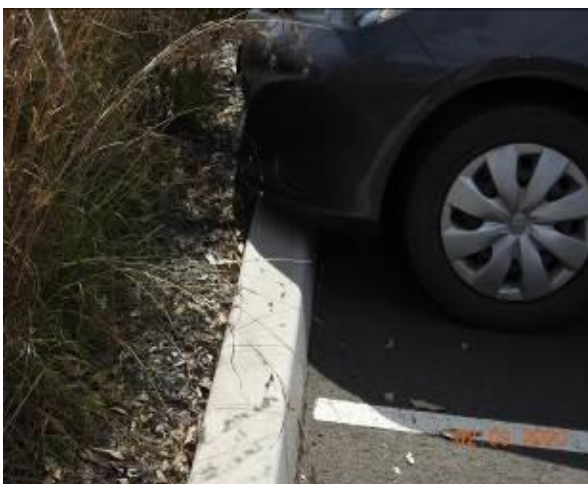
Figure 2838 – General Condition of kerb

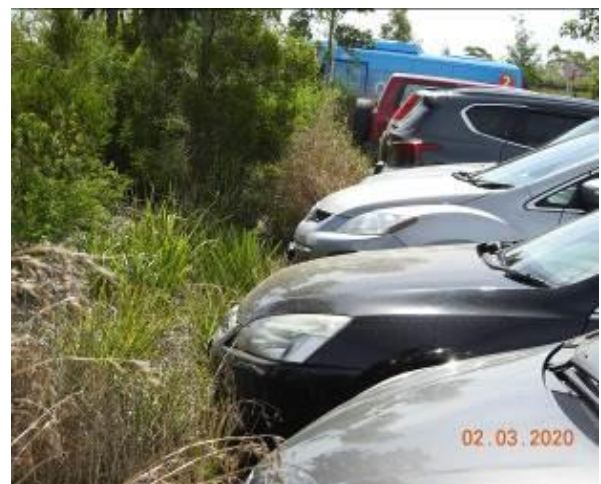
Figure 2839 – General Condition of kerb

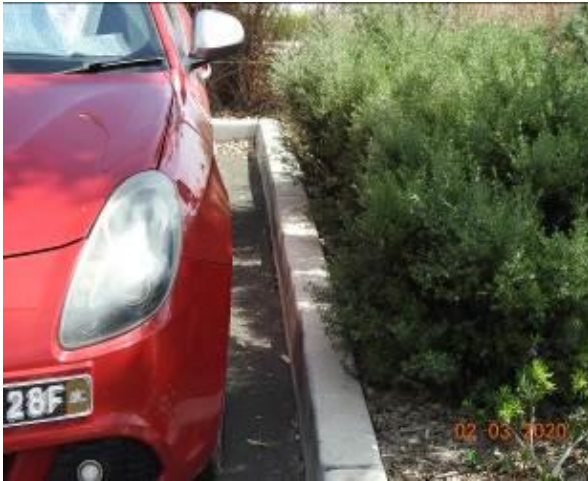
Figure 2840 – General Condition of kerb

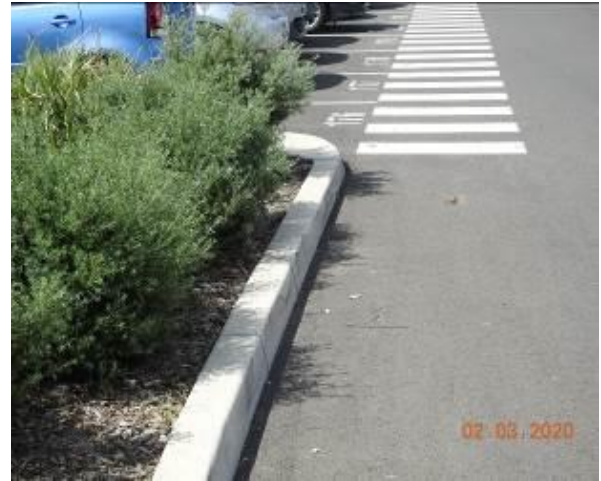
Figure 2841 – General Condition of kerb

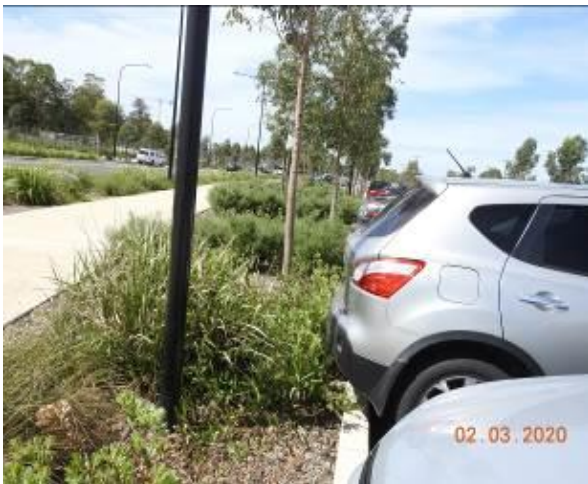
Figure 2842 – General Condition of kerb

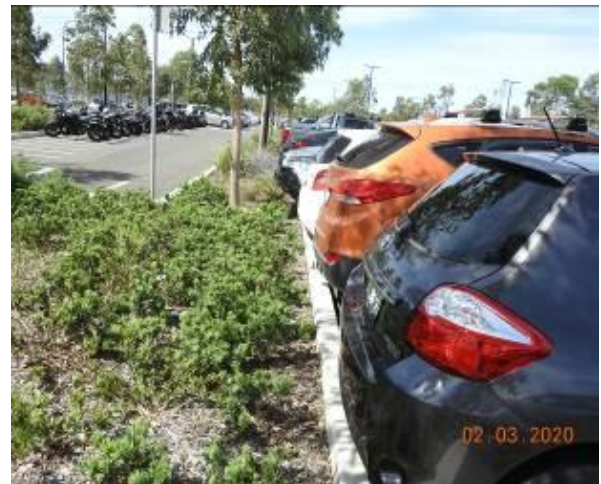
Figure 2843 – General Condition of kerb

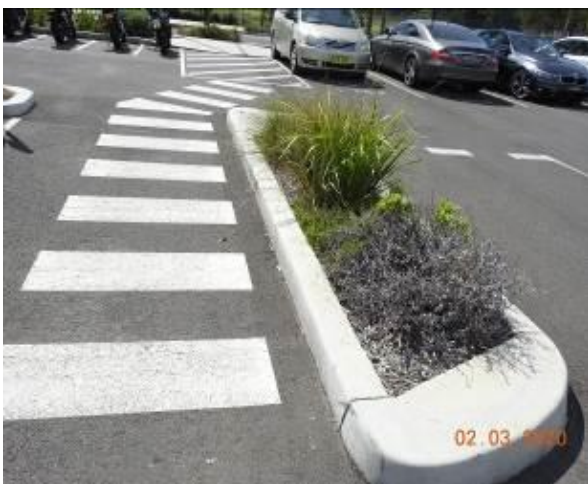
Figure 2844 – General Condition of traffic island kerb

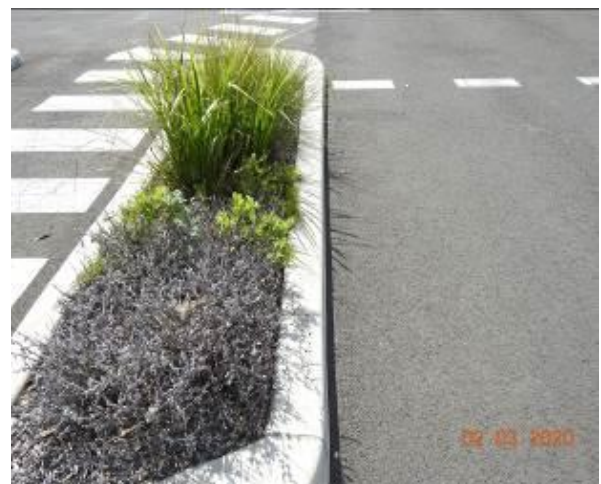
Figure 2845 – General Condition of traffic island kerb

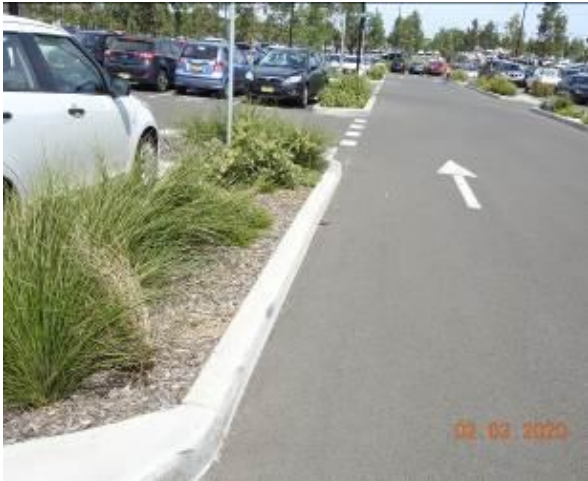
Figure 2846 – General Condition of traffic island kerb

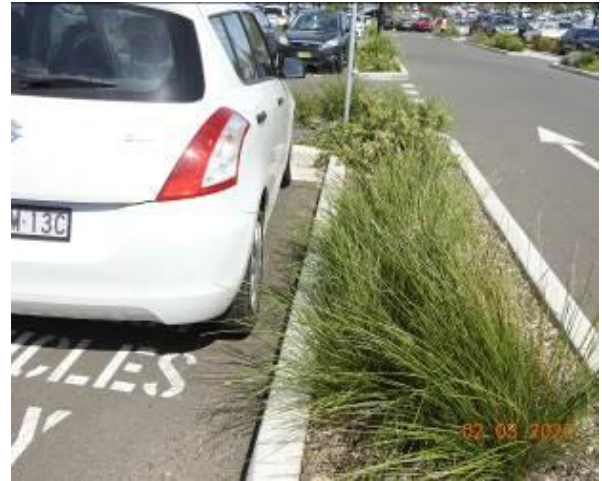
Figure 2847 – General Condition of traffic island kerb

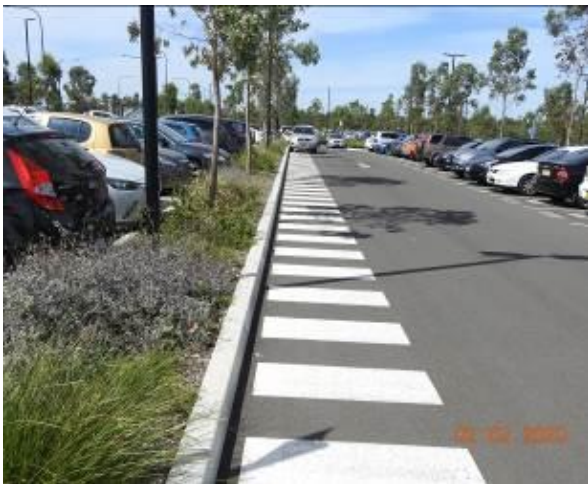
Figure 2848 – General Condition of kerb

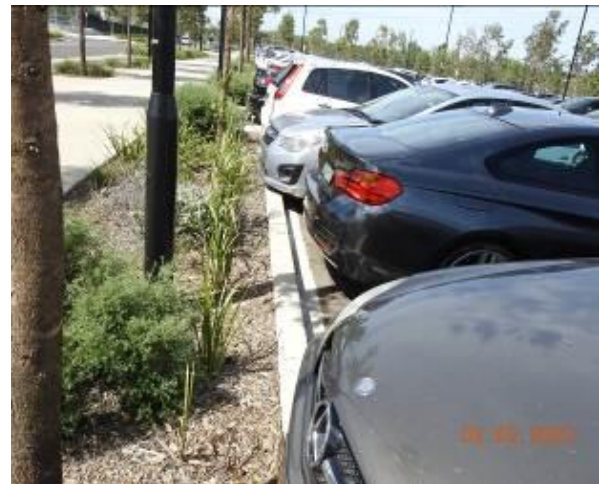
Figure 2849 – General Condition of kerb

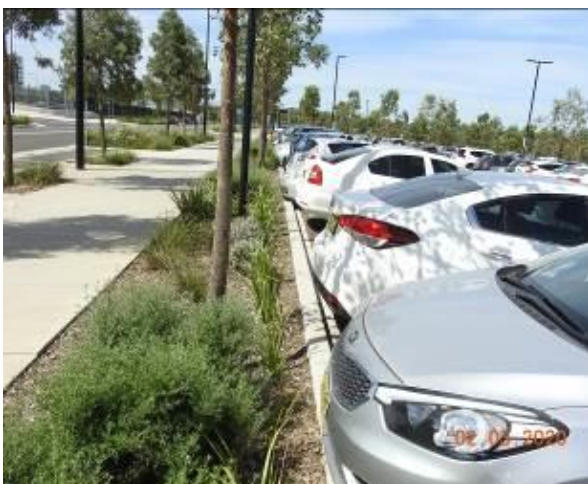
Figure 2850 – General Condition of kerb

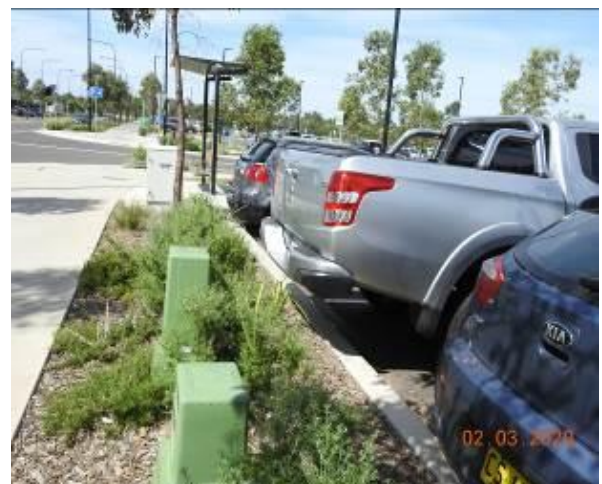
Figure 2851 – General Condition of kerb

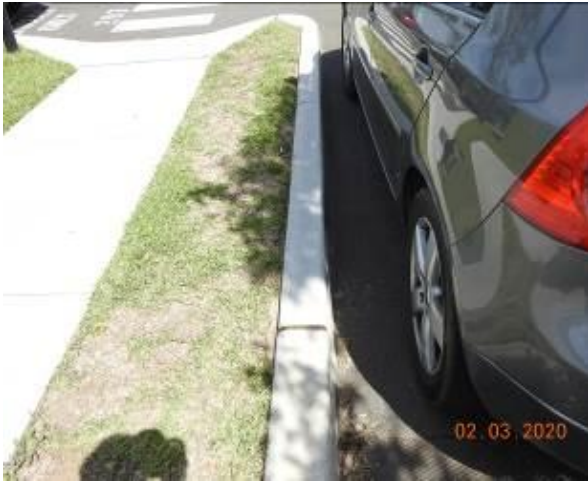
Figure 2852 – General Condition of kerb

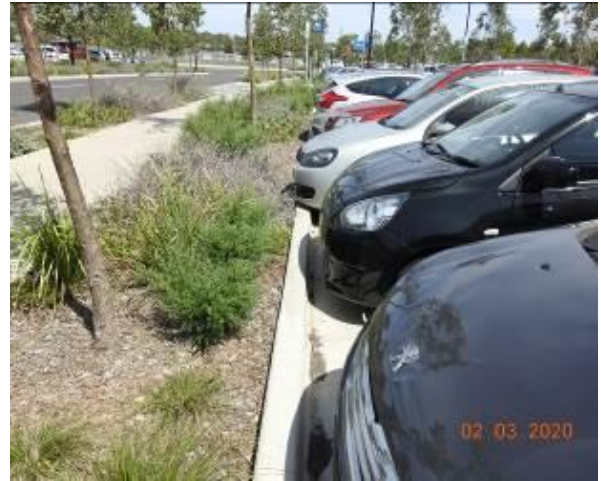
Figure 2853 – General Condition of kerb

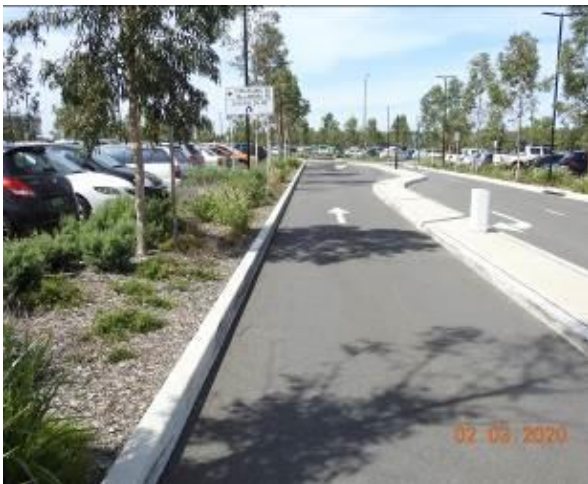
Figure 2854 – General Condition of kerb

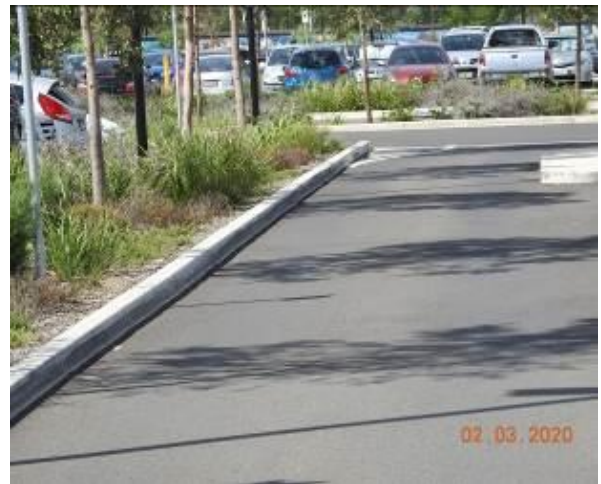
Figure 2855 – General Condition of kerb

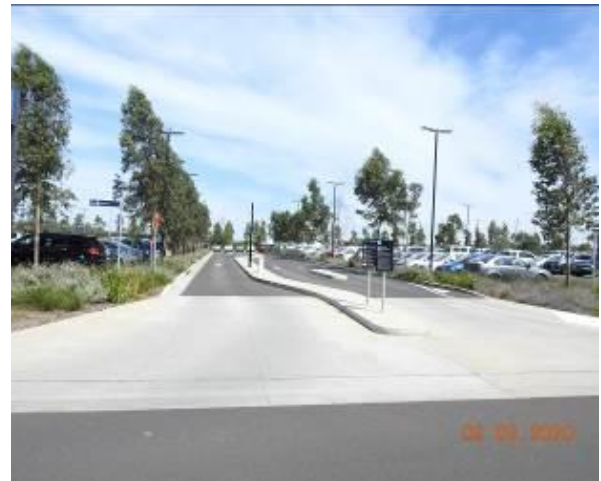
Figure 2857 – General Condition of driveway pavement

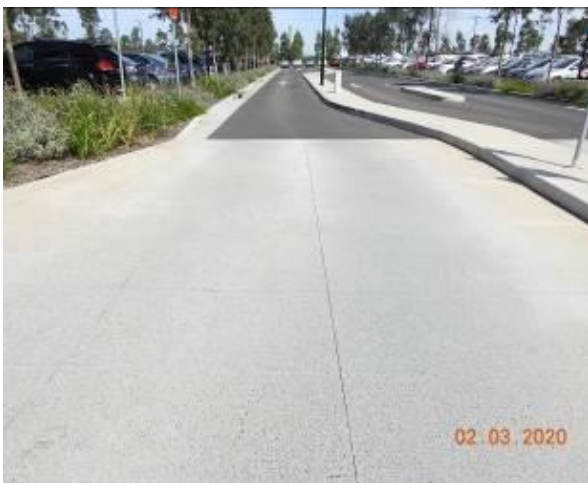
Figure 2858 – General Condition of driveway pavement

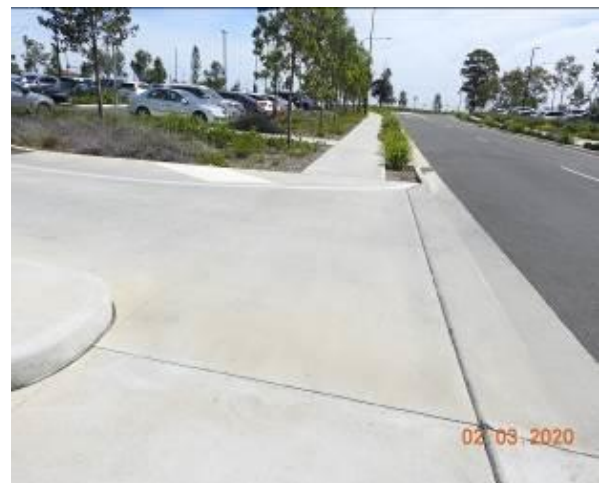
Figure 2859 – General Condition of driveway pavement

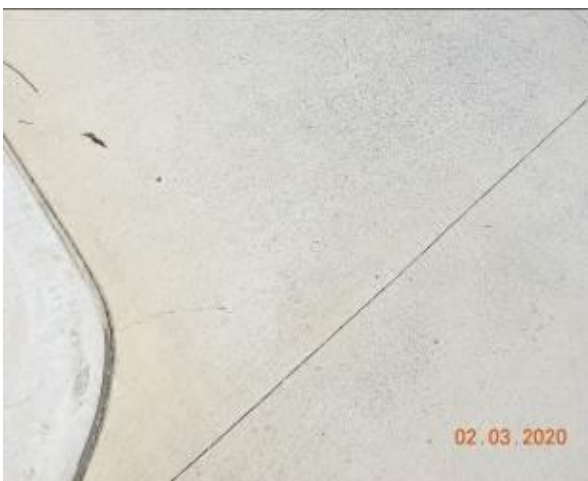
Figure 2860 – Crack propagation through driveway pavement

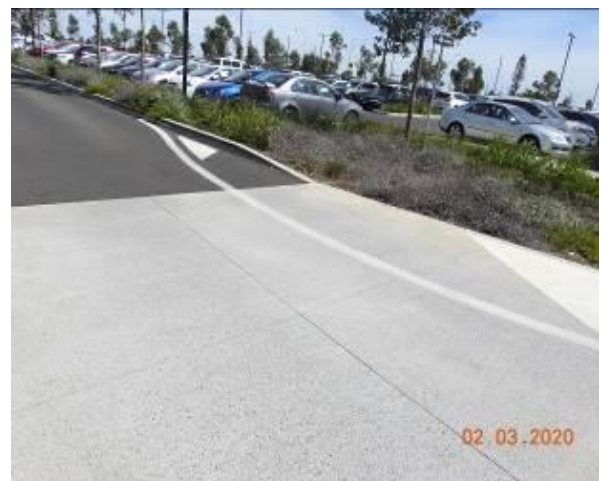
Figure 2861 – General Condition of driveway pavement

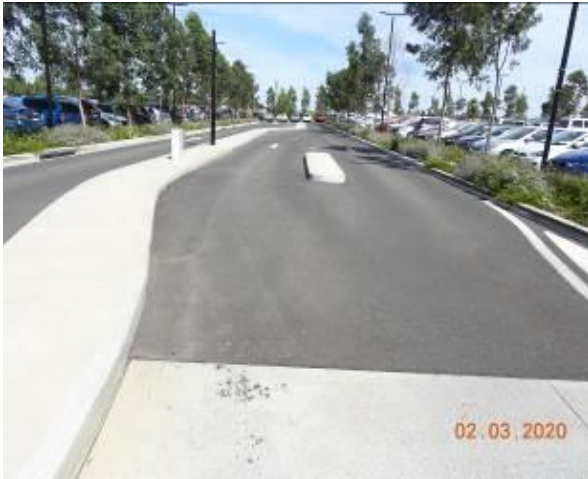
Figure 2862 – General Condition of carpark pavement

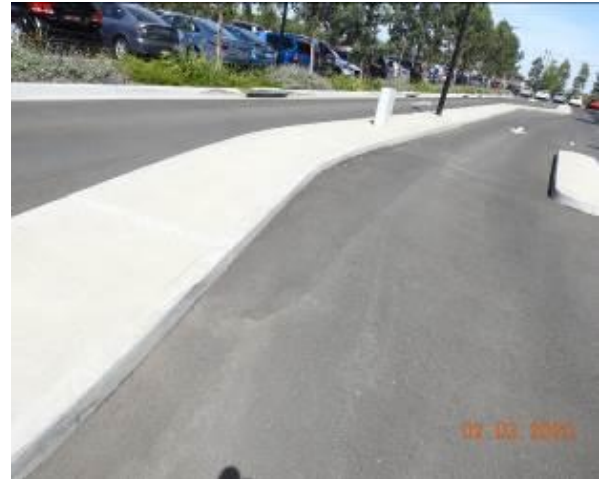
Figure 2863 – Evidence of patchwork through carpark pavement

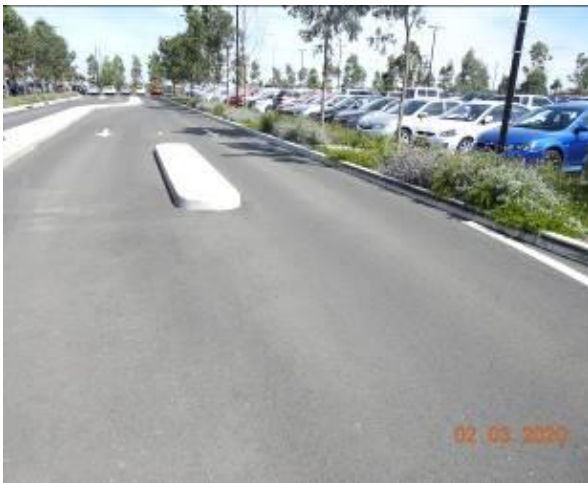
Figure 2864 – General Condition of carpark pavement

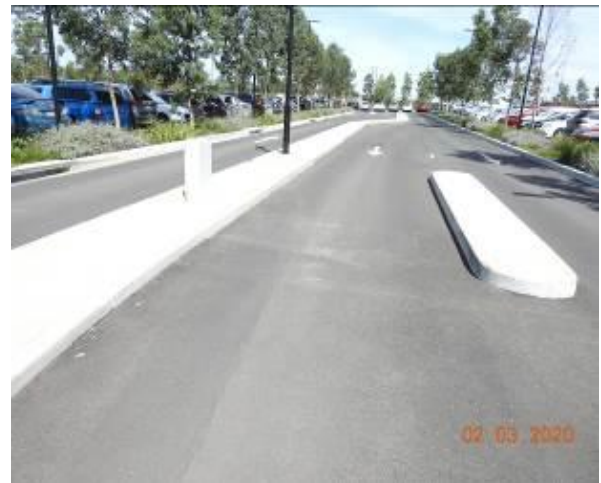
Figure 2865 – General Condition of carpark pavement

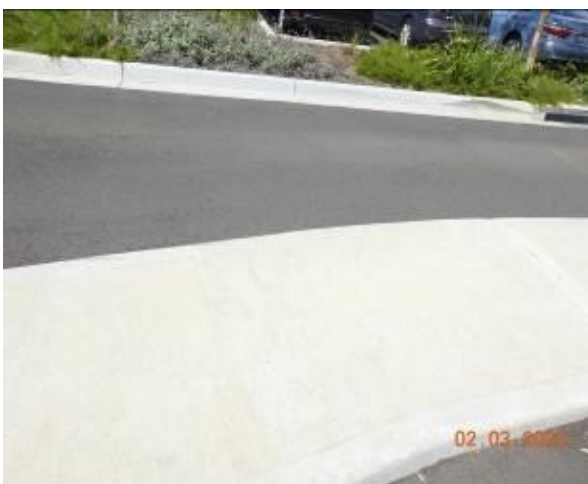
Figure 2866 – General Condition of carpark pavement

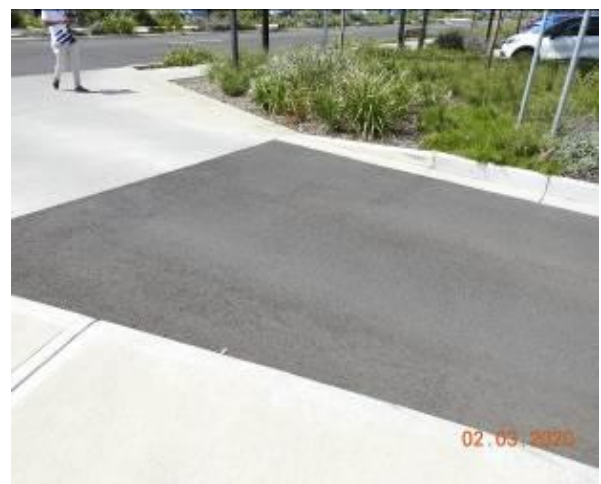
Figure 2867 – General Condition of carpark pavement

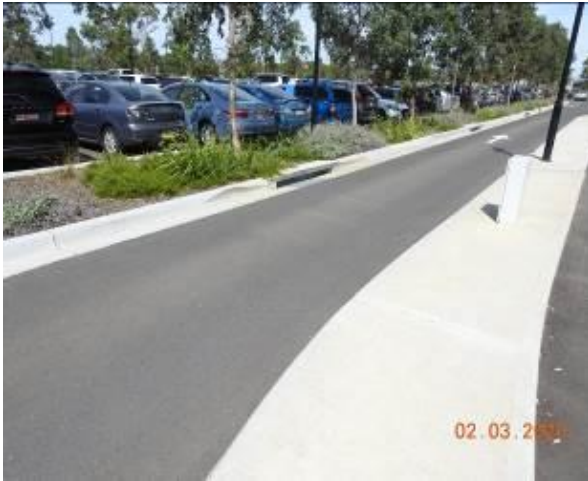
Figure 2868 – General Condition of carpark pavement

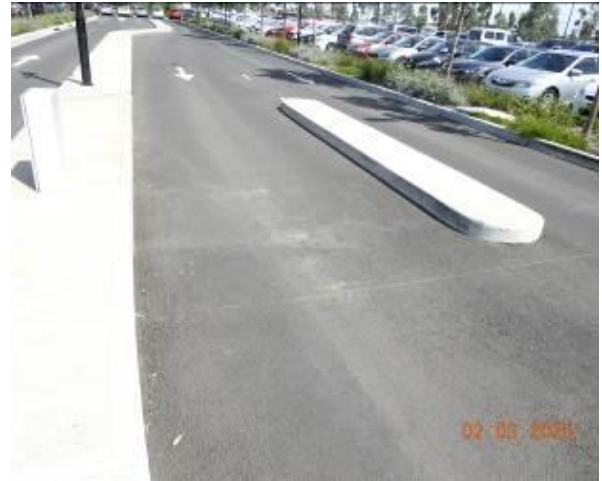
Figure 2869 – General Condition of carpark pavement

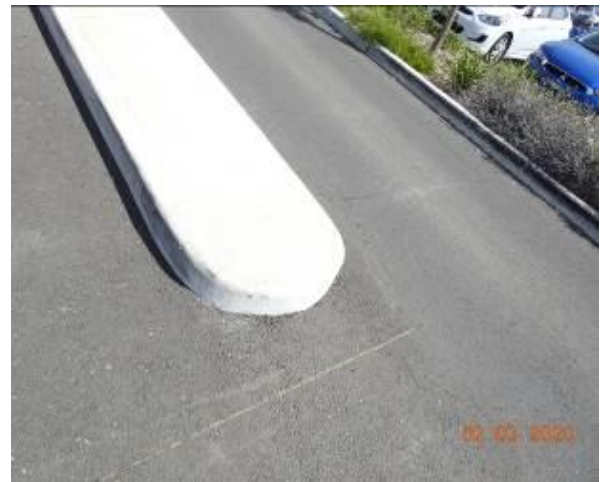
Figure 2871 – General Condition of carpark pavement

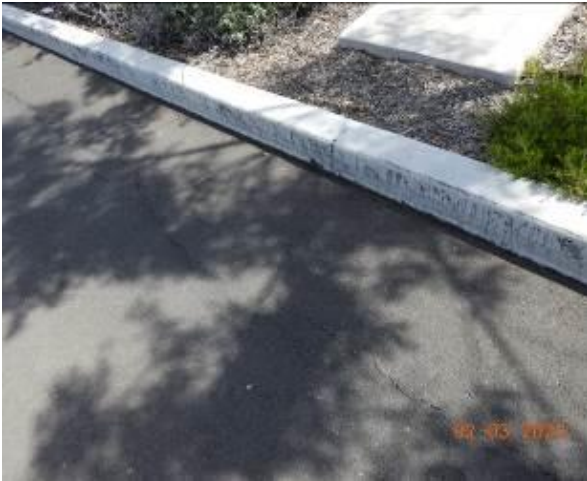
Figure 2874 – Crack propagation through carpark pavement

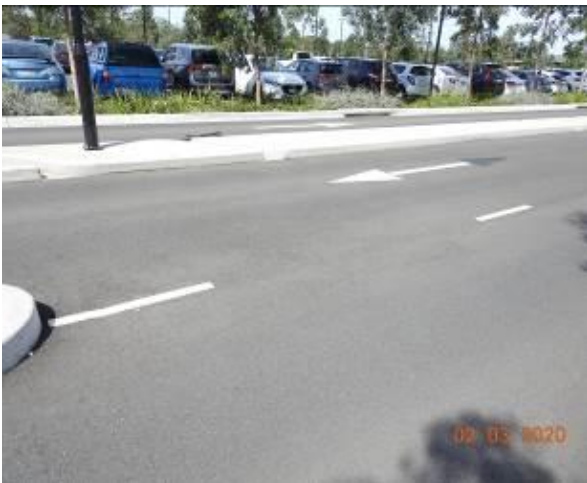
Figure 2876 – General Condition of carpark pavement

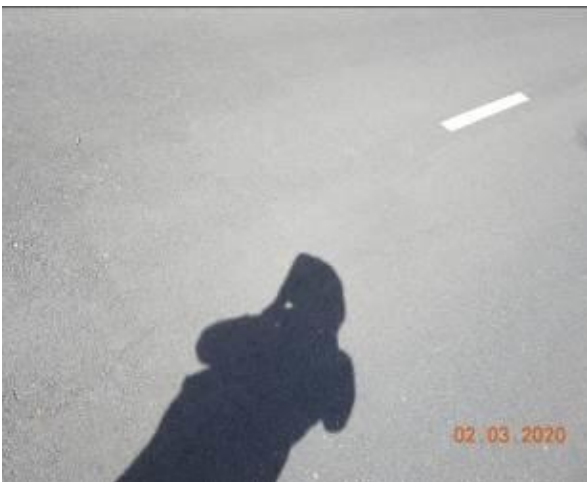
Figure 2878 – Crack propagation through carpark pavement

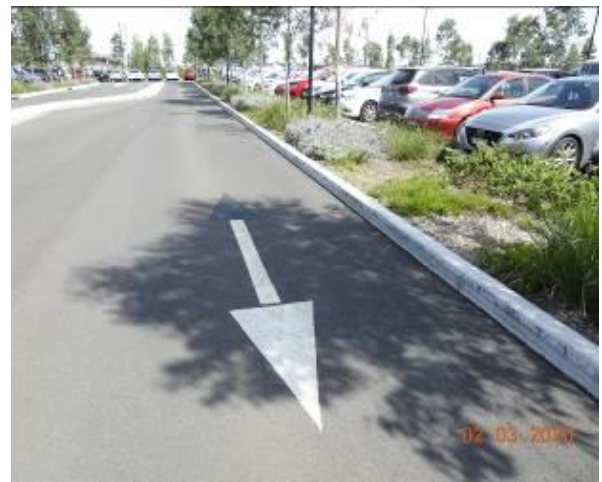
Figure 2879 – General Condition of carpark pavement

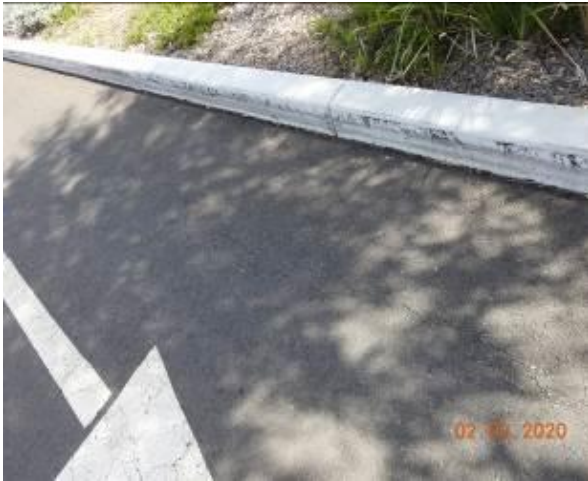
Figure 2880 – Crack propagation through carpark pavement

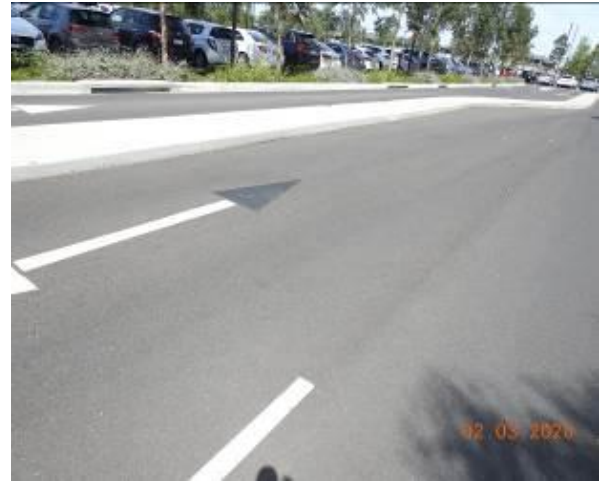
Figure 2881 – General Condition of carpark pavement

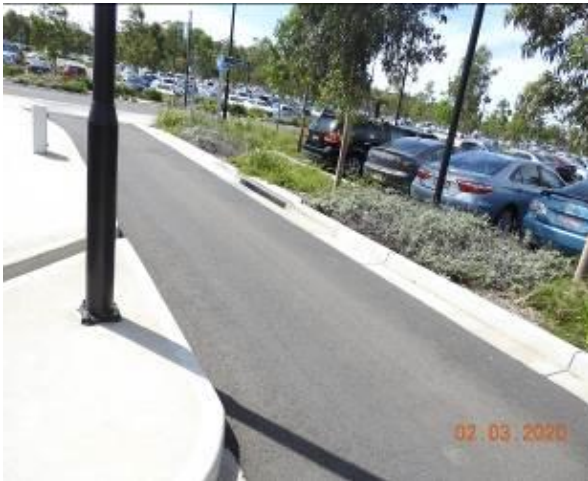
Figure 2882 – Crack propagation through carpark pavement

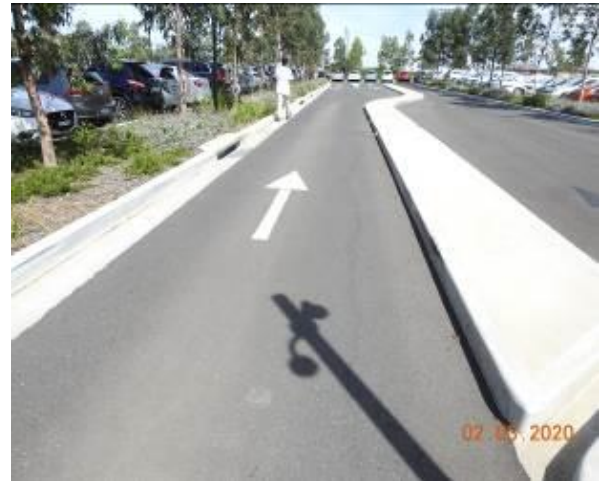
Figure 2883 – Crack propagation through carpark pavement

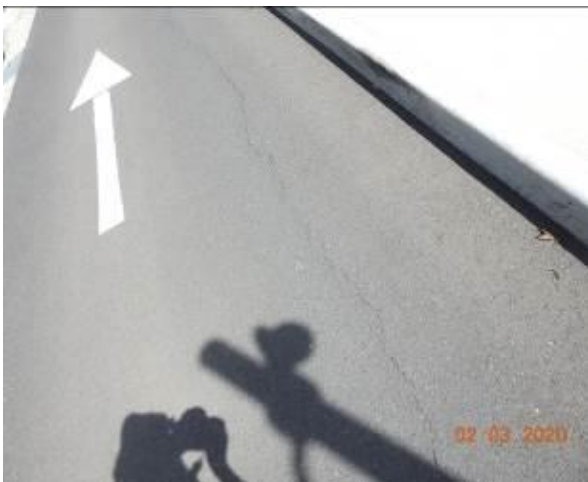
Figure 2884 – Crack propagation through carpark pavement

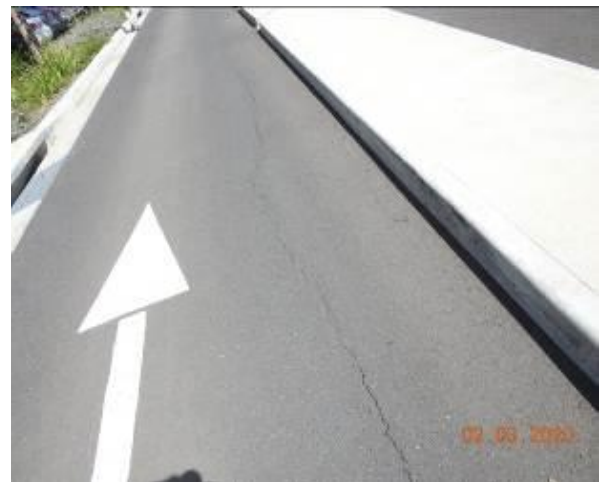
Figure 2885 – Crack propagation through carpark pavement

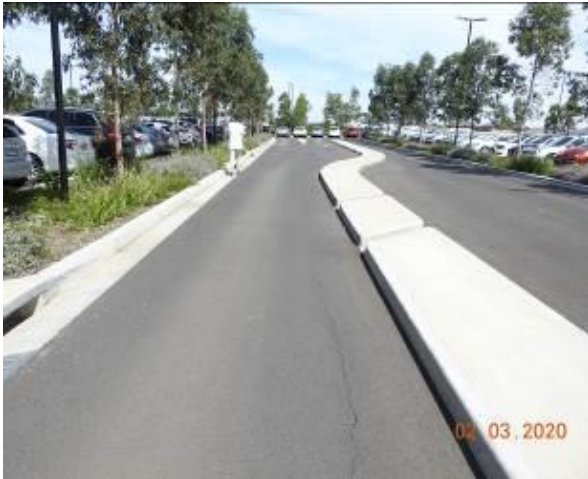
Figure 2886 – Crack propagation through carpark pavement

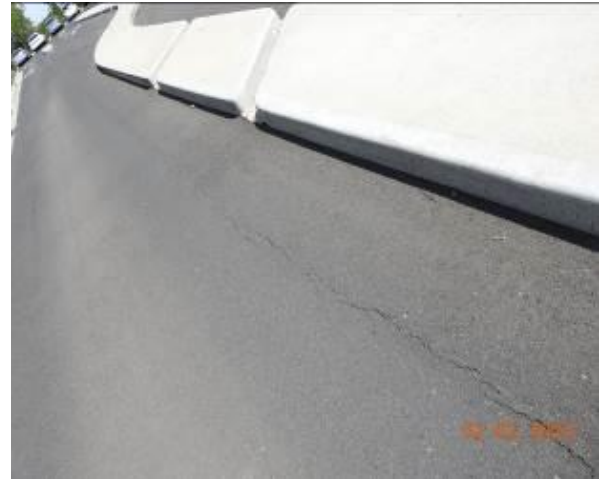
Figure 2887 – Crack propagation through carpark pavement

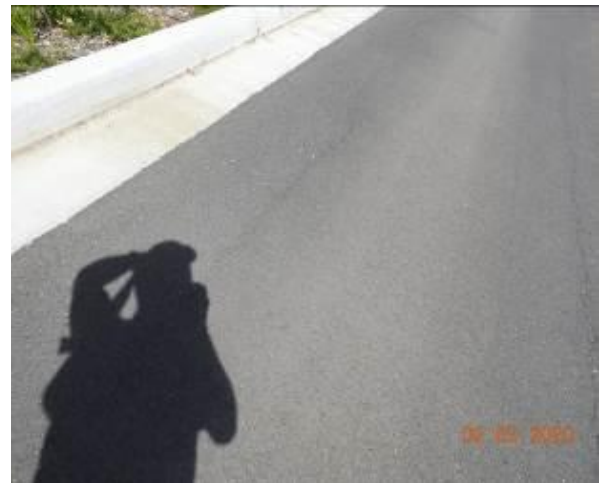
Figure 2889 – Crack propagation through carpark pavement

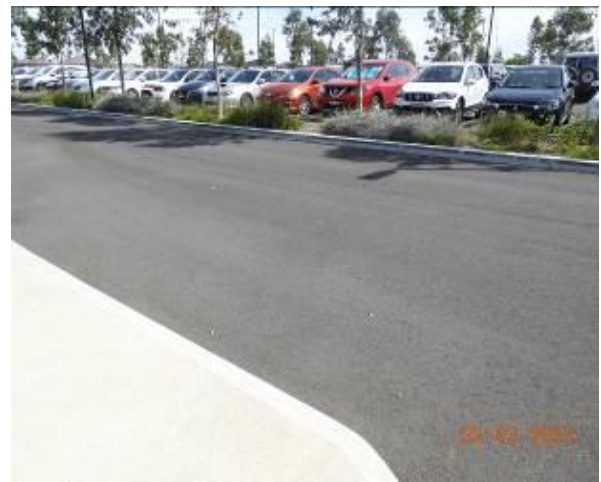
Figure 2891 – General Condition of carpark pavement

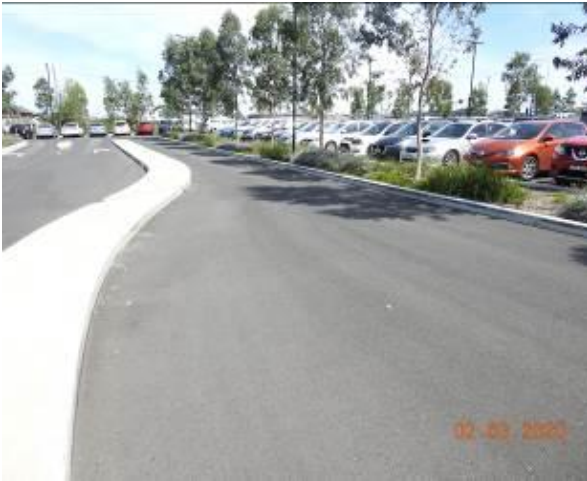
Figure 2892 – General Condition of carpark pavement

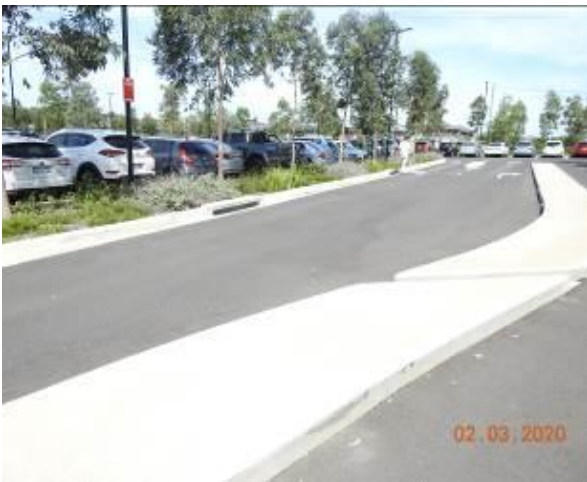
Figure 2894 – General Condition of carpark pavement

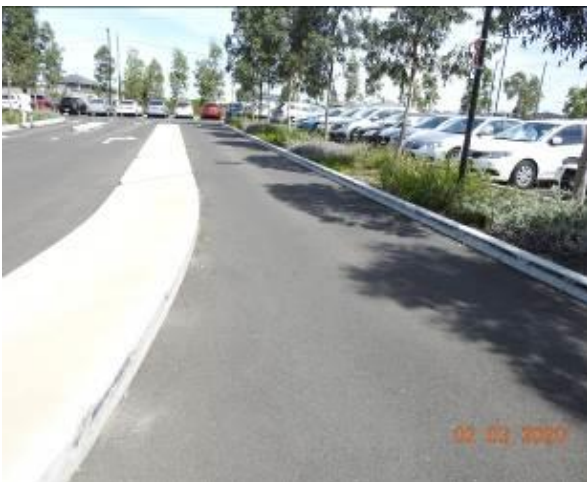
Figure 2896 – General Condition of carpark pavement

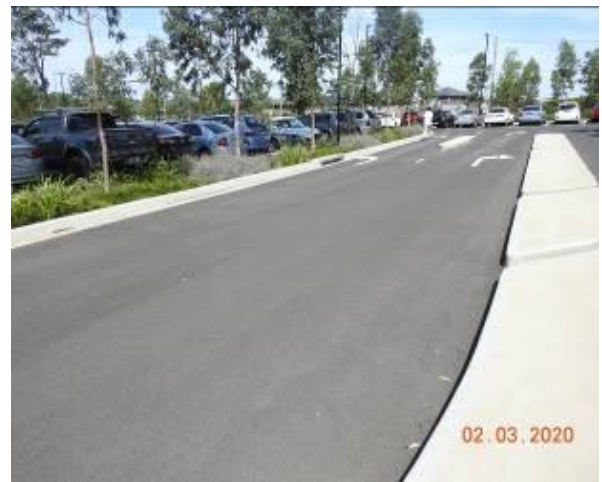
Figure 2897 – General Condition of carpark pavement

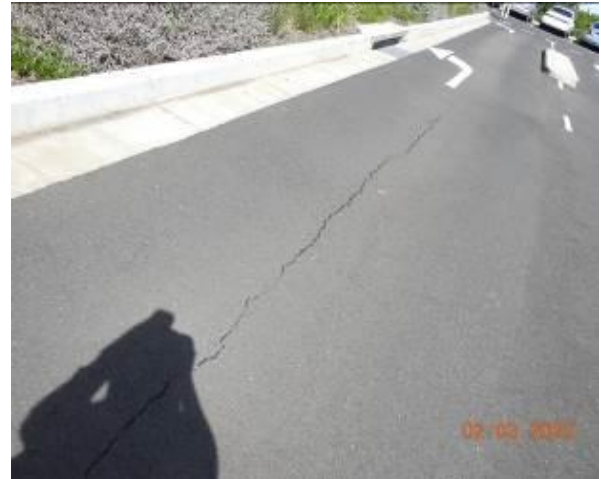
Figure 2899 – Crack propagation through carpark pavement

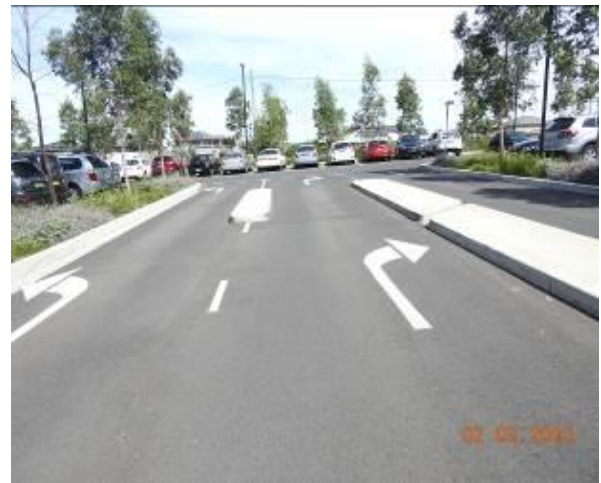
Figure 2901 – General Condition of carpark pavement

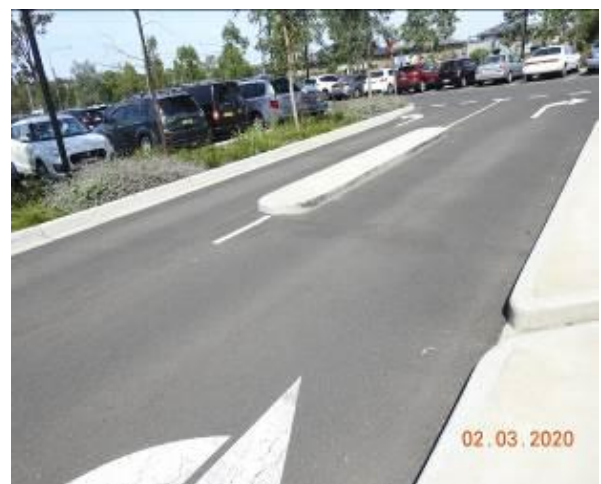
Figure 2903 – General Condition of carpark pavement

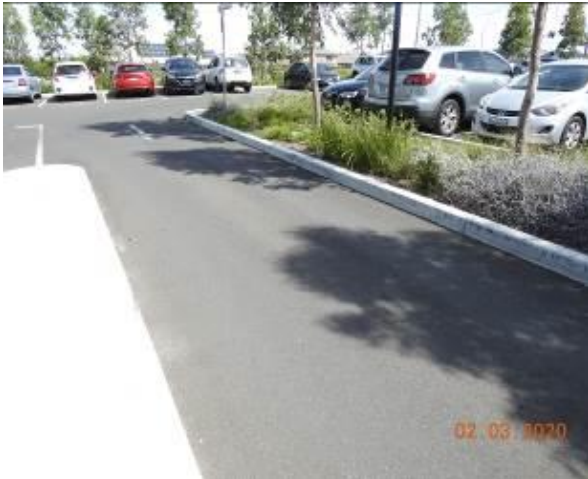
Figure 2904 – General Condition of carpark pavement

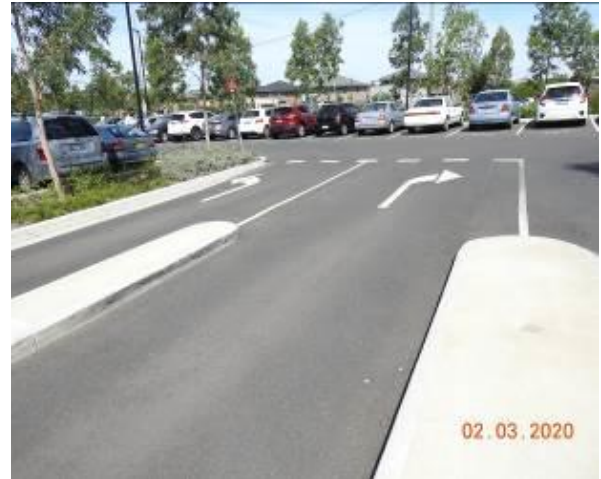
Figure 2905 – General Condition of carpark pavement

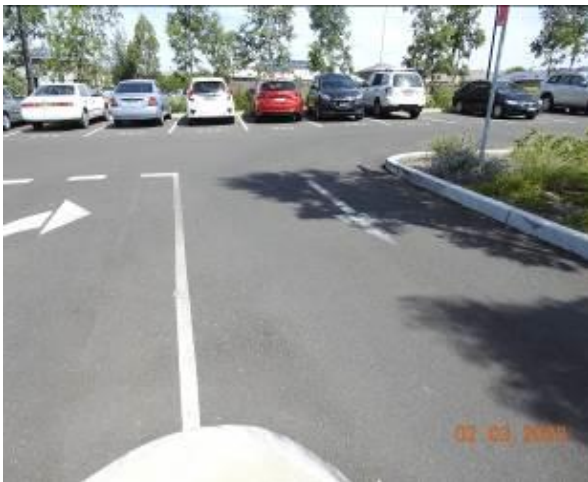
Figure 2906 – General Condition of carpark pavement

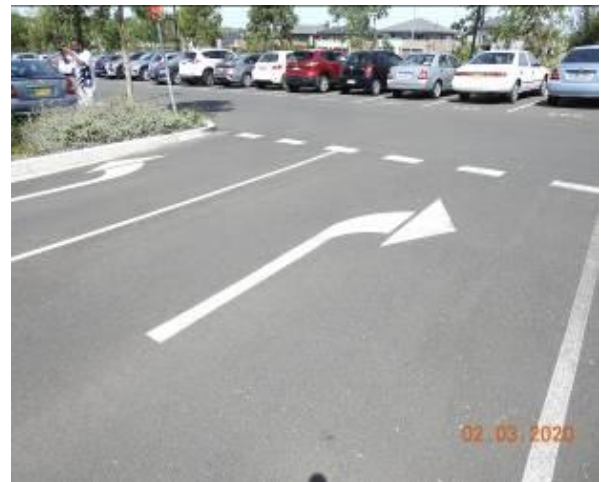
Figure 2907 – General Condition of carpark pavement

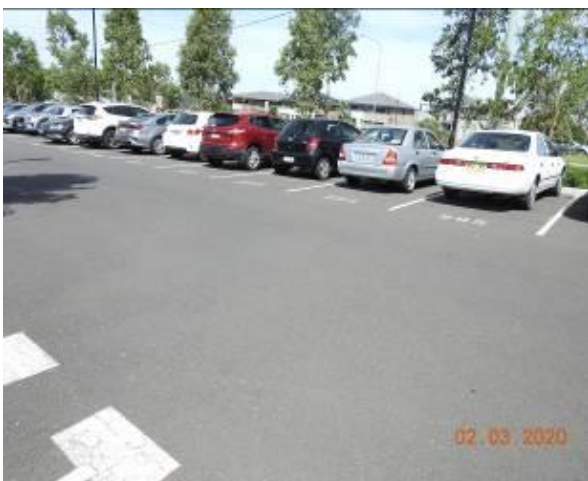
Figure 2908 – General Condition of carpark pavement

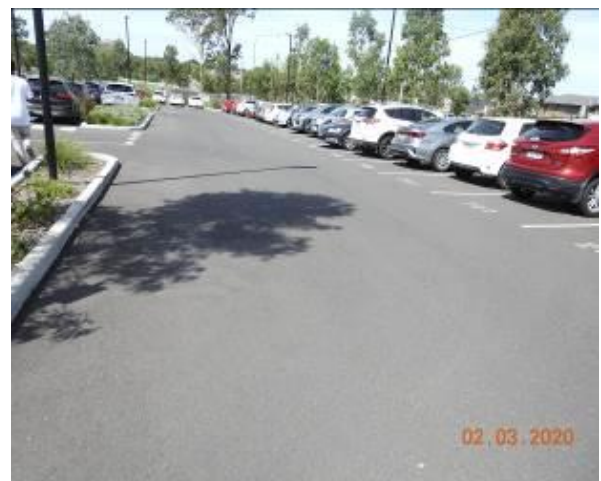
Figure 2909 – General Condition of carpark pavement

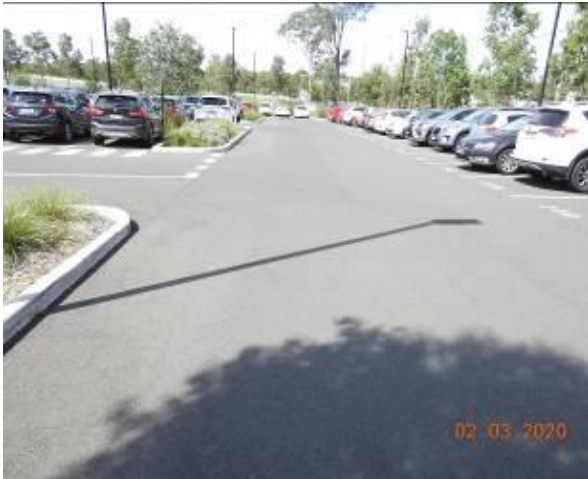
Figure 2910 – General Condition of carpark pavement

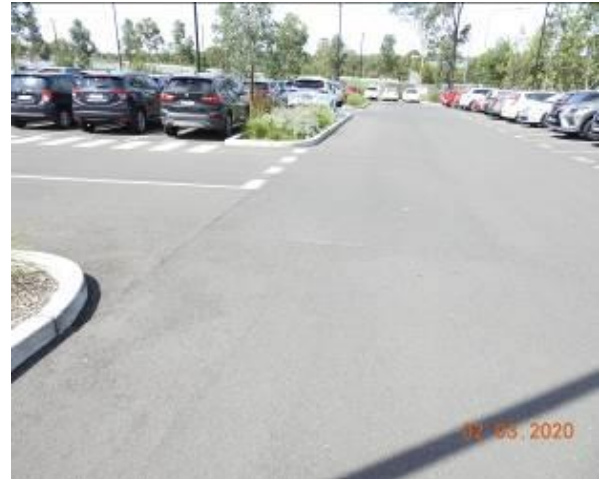
Figure 2911 – General Condition of carpark pavement

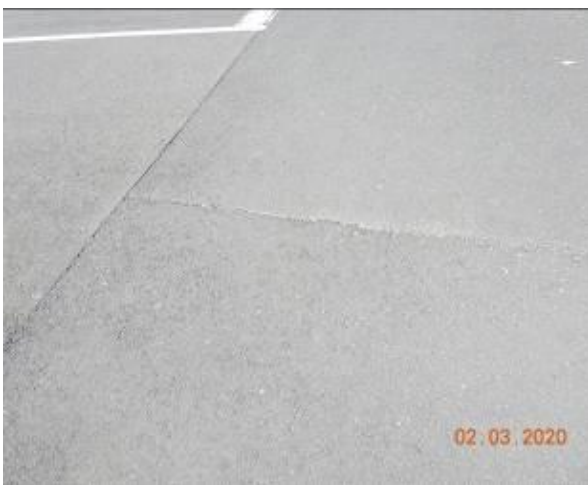
Figure 2912 – Crack propagation through carpark pavement

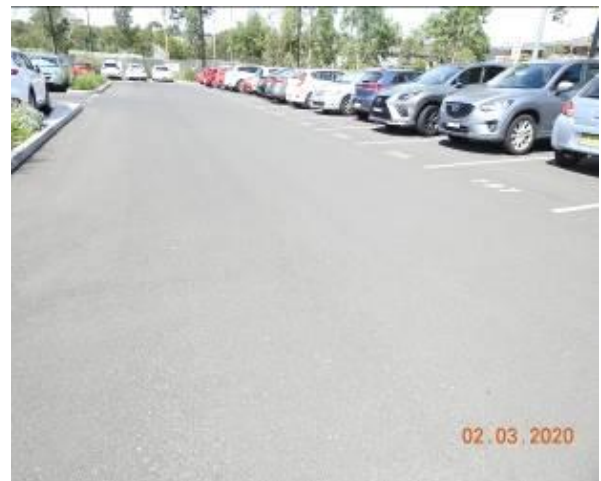
Figure 2915 – General Condition of carpark pavement

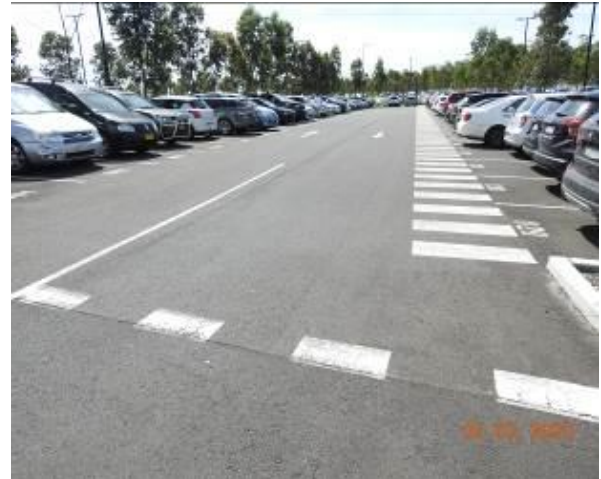
Figure 2917 – General Condition of carpark pavement

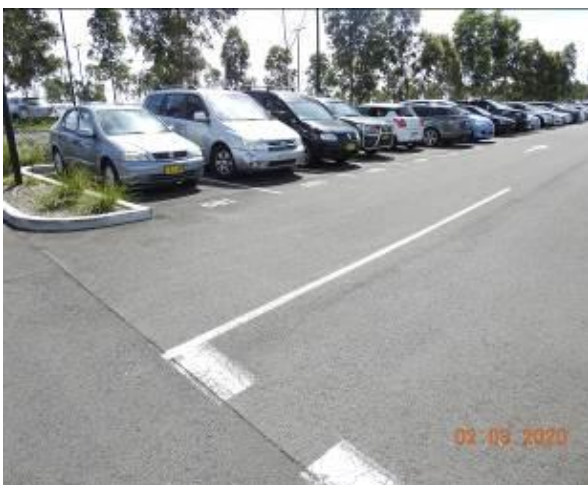
Figure 2918 – General Condition of carpark pavement

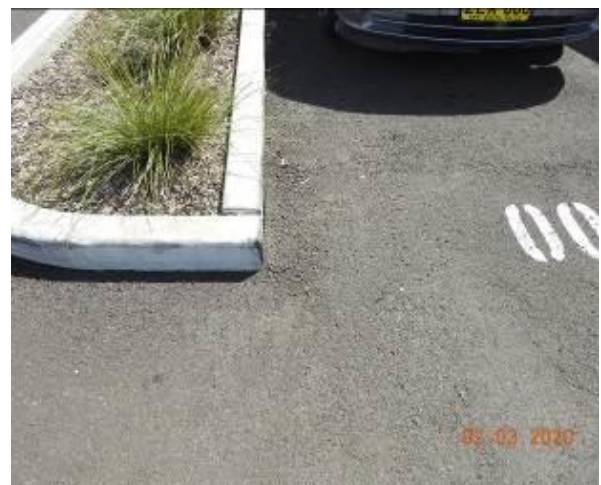
Figure 2919 – Loss of material through carpark pavement

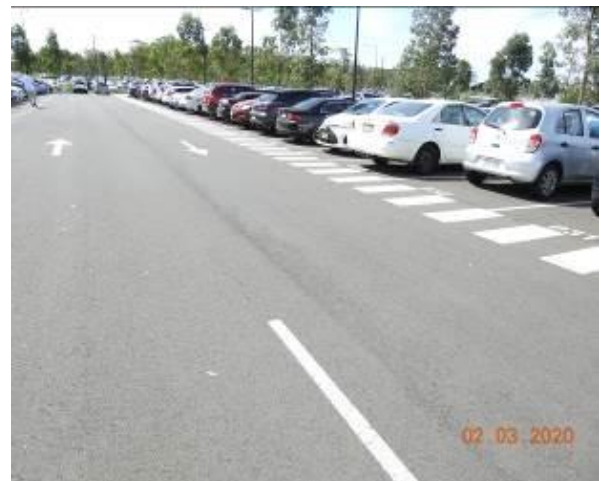
Figure 2921 – General Condition of carpark pavement

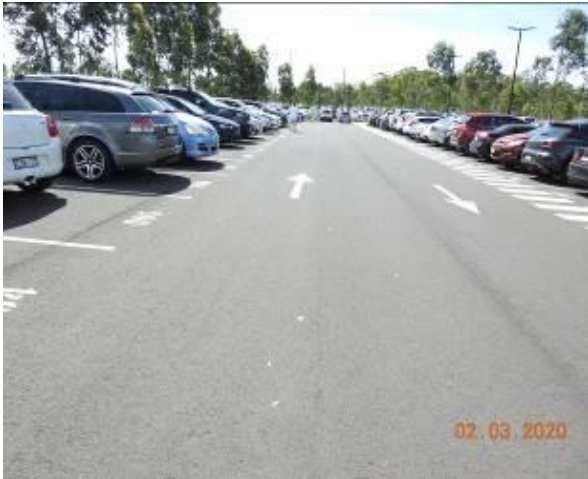
Figure 2922 – General Condition of carpark pavement

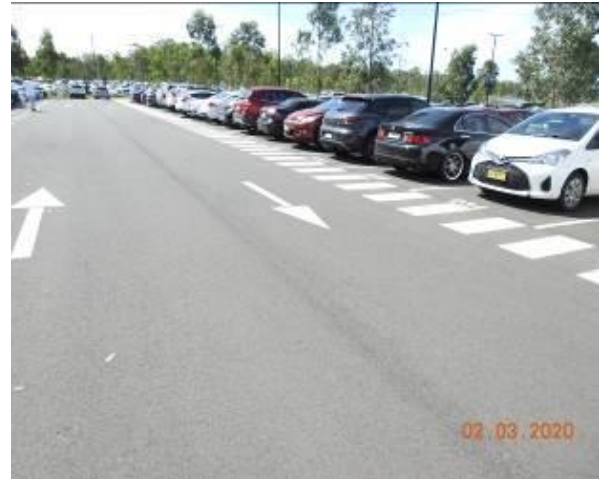
Figure 2923 – General Condition of carpark pavement

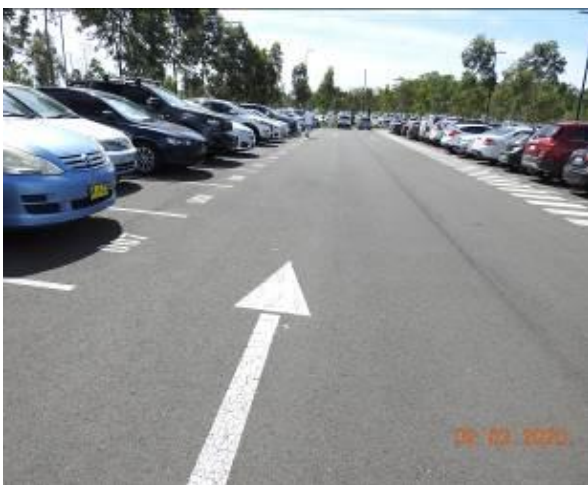
Figure 2924 – General Condition of carpark pavement

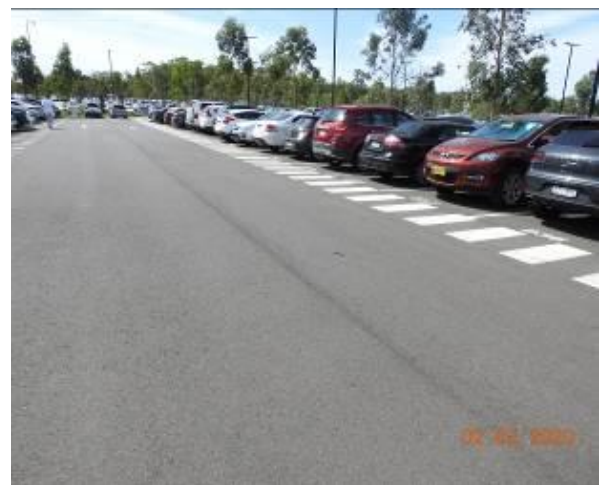
Figure 2925 – General Condition of carpark pavement
