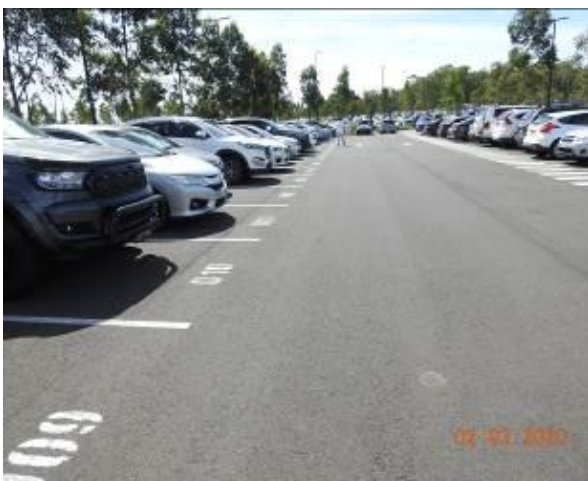
Figure 2926 – General Condition of carpark pavement

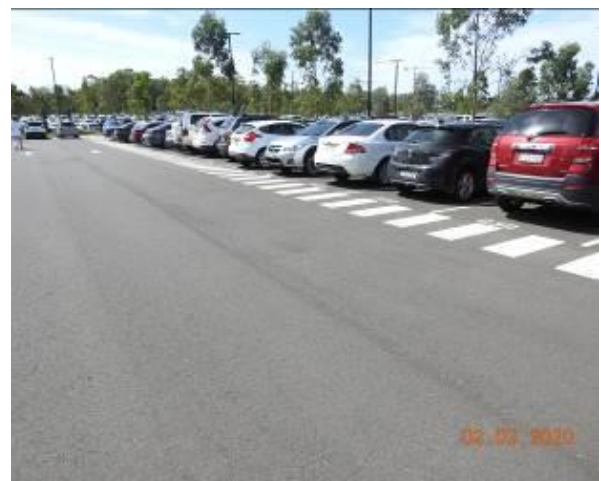
Figure 2927 – General Condition of carpark pavement

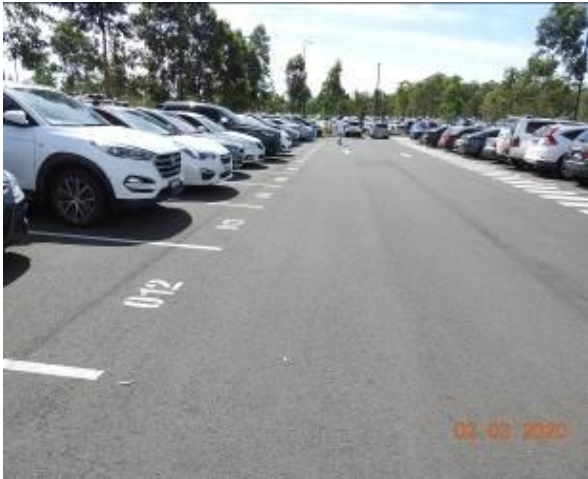
Figure 2928 – General Condition of carpark pavement

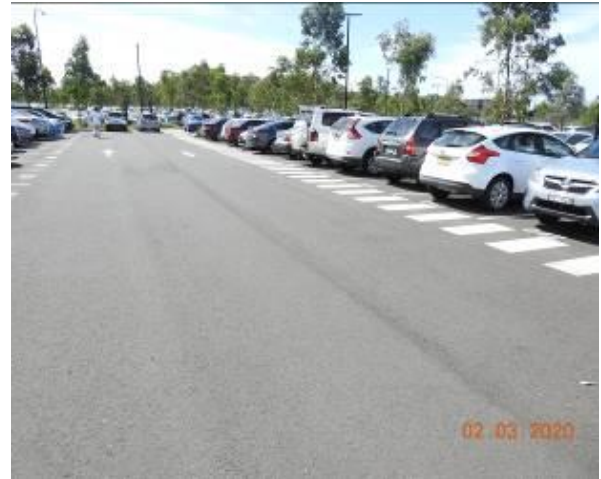
Figure 2929 – General Condition of carpark pavement

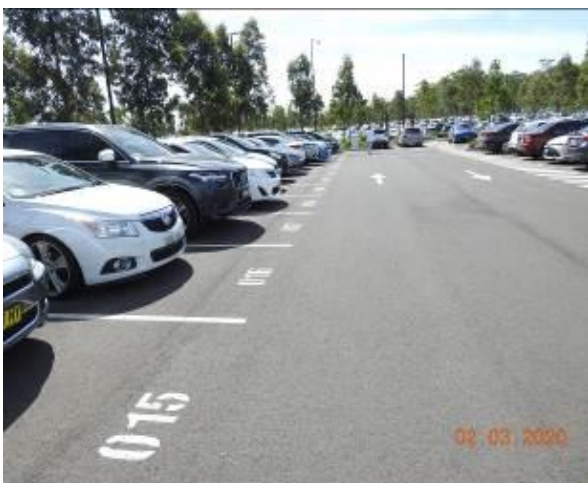
Figure 2930 – General Condition of carpark pavement

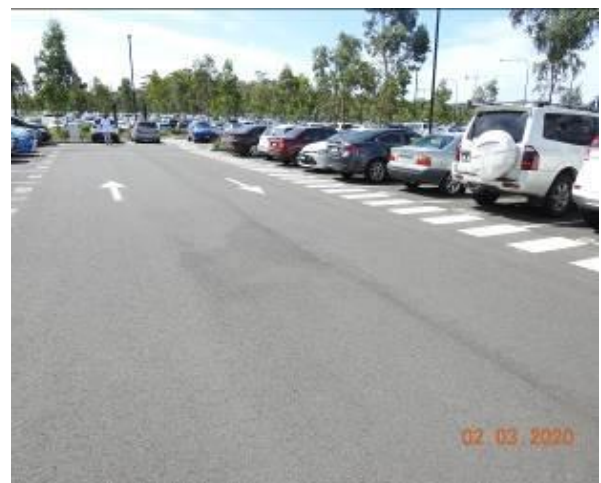
Figure 2931 – General Condition of carpark pavement

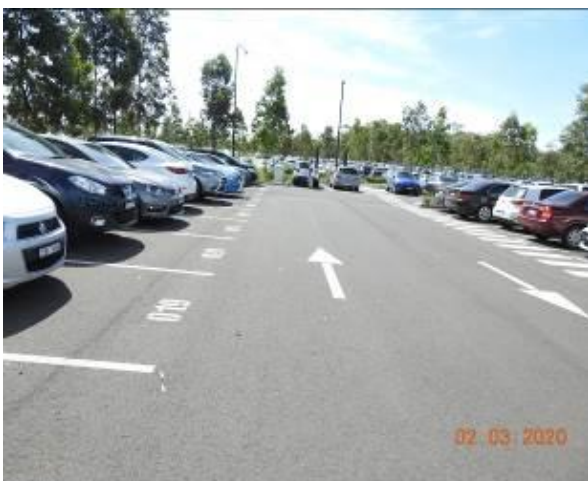
Figure 2932 – General Condition of carpark pavement

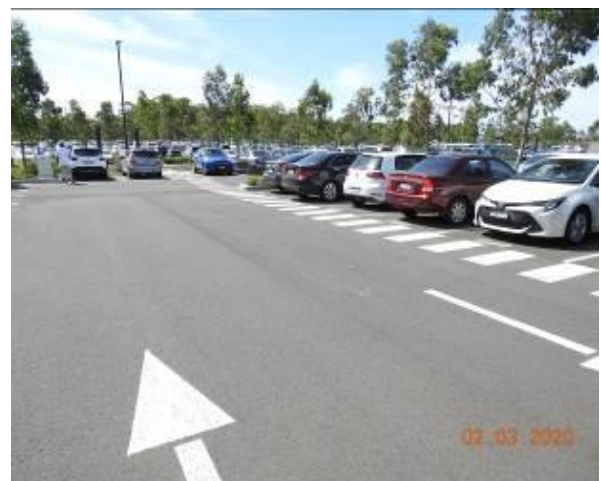
Figure 2933 – General Condition of carpark pavement

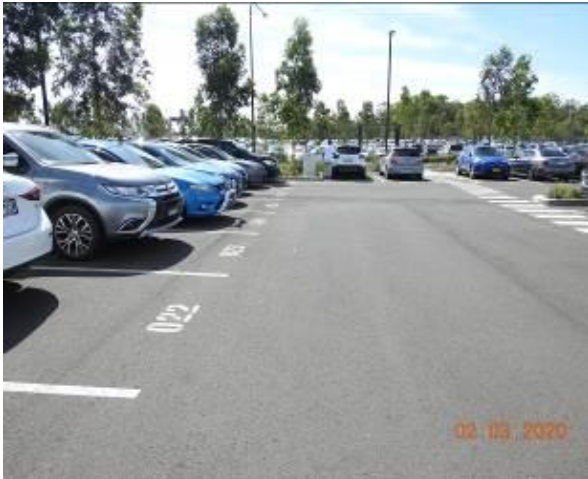
Figure 2934 – General Condition of carpark pavement

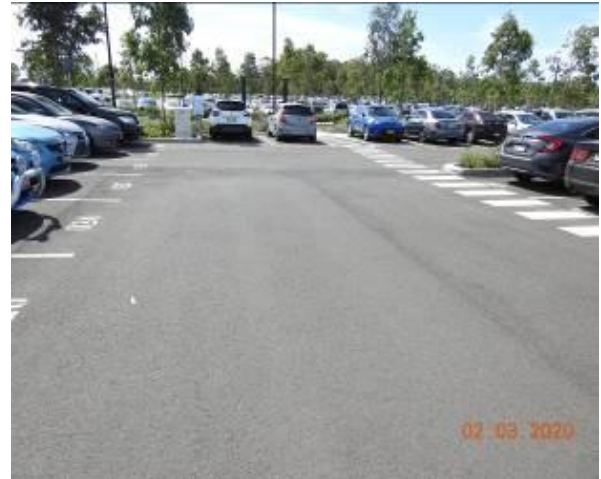
Figure 2935 – General Condition of carpark pavement

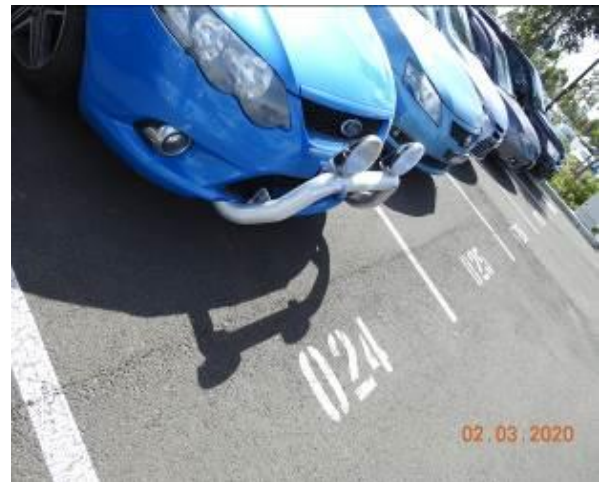
Figure 2937 – Crack propagation through carpark pavement

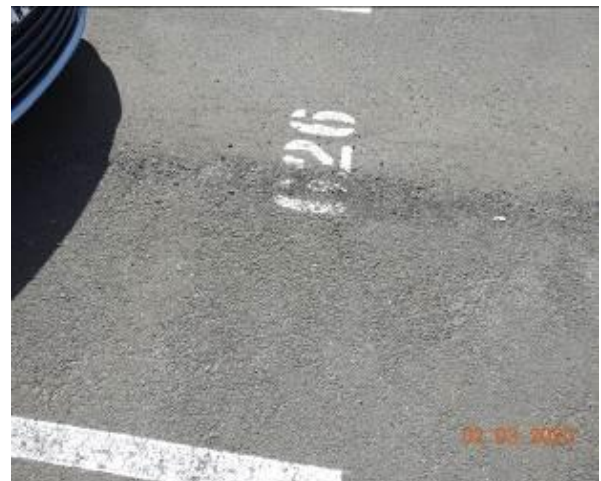
Figure 2939 – Loss of material through carpark pavement

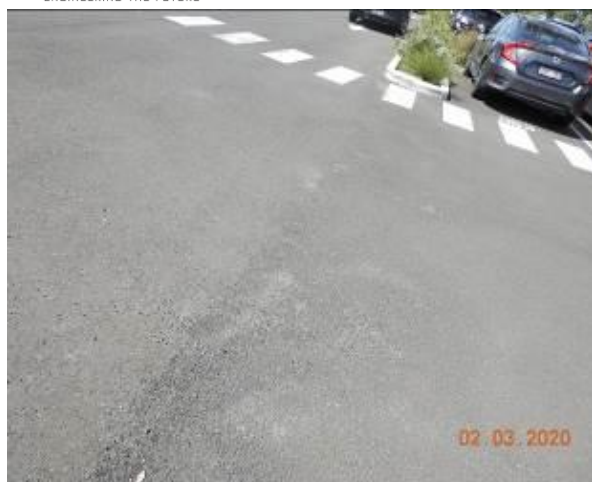
Figure 2940 – General Condition of carpark pavement

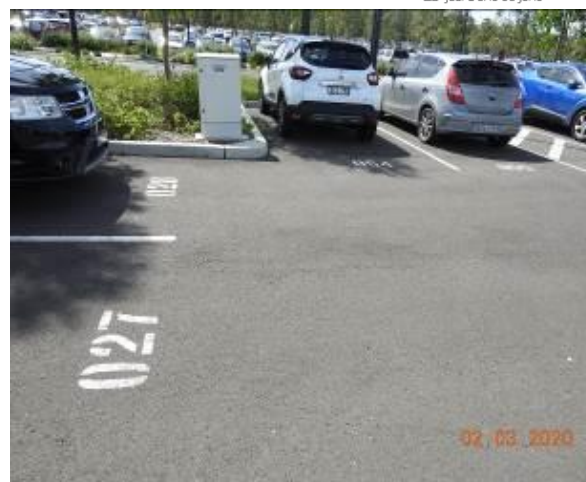
Figure 2941 – General Condition of carpark pavement

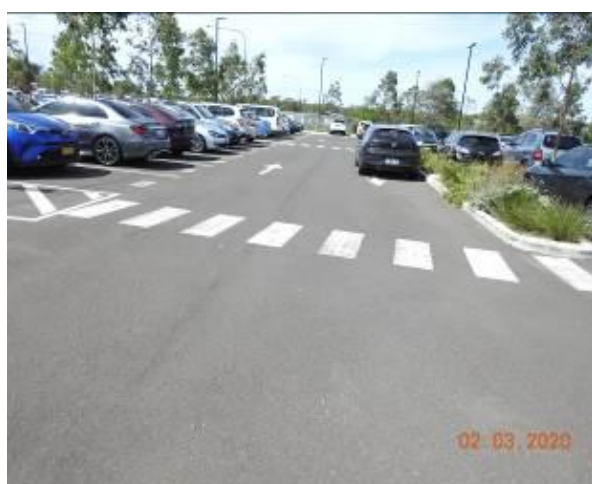
Figure 2942 – General Condition of carpark pavement

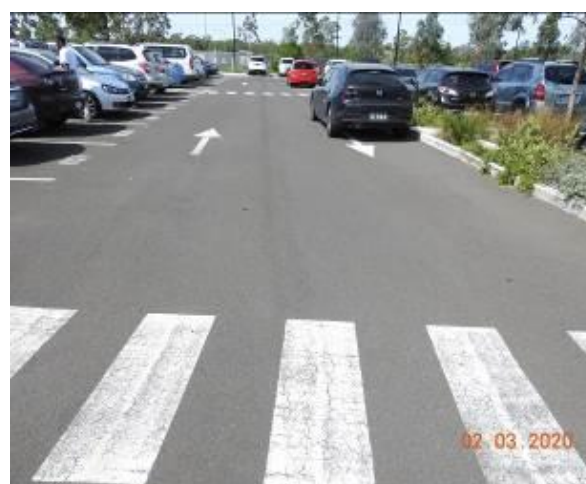
Figure 2943 – General Condition of carpark pavement

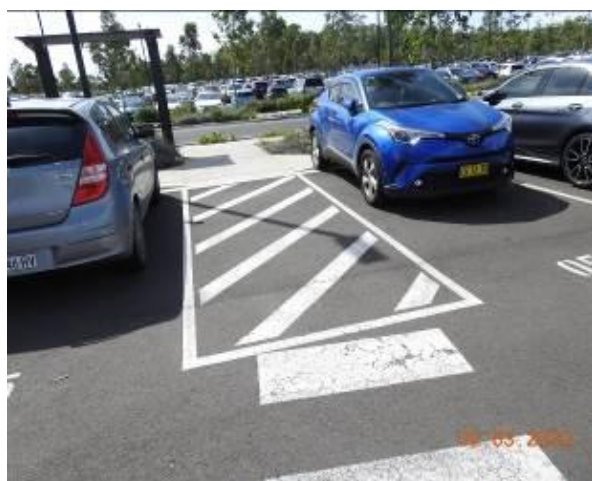
Figure 2944 – General Condition of carpark pavement

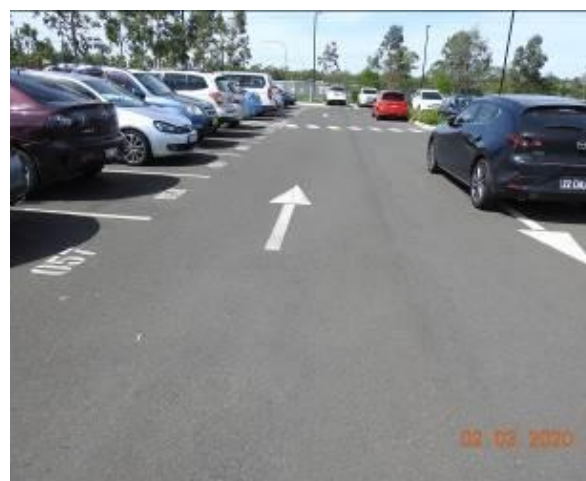
Figure 2945 – General Condition of carpark pavement

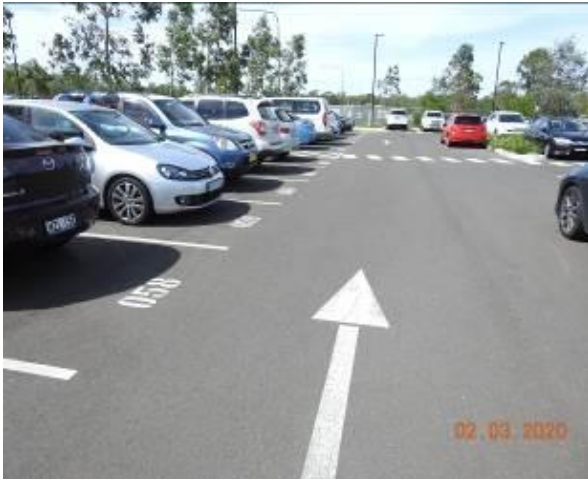
Figure 2946 – General Condition of carpark pavement

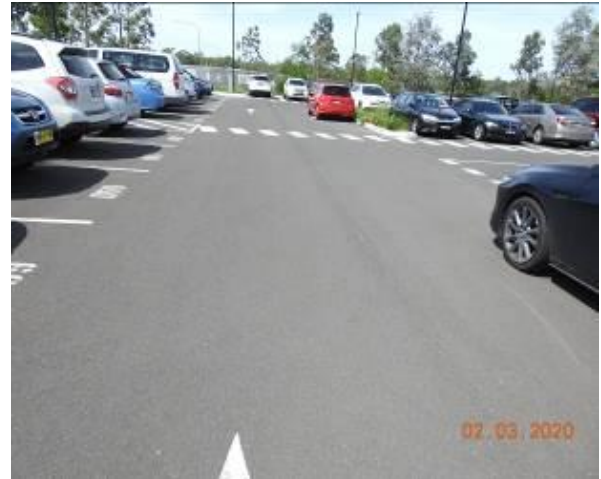
Figure 2947 – General Condition of carpark pavement

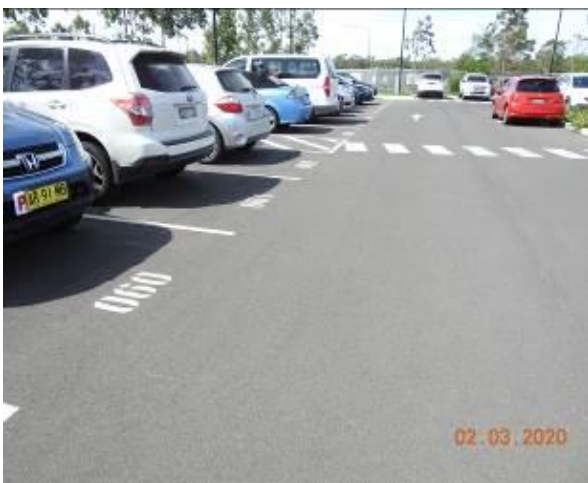
Figure 2948 – General Condition of carpark pavement

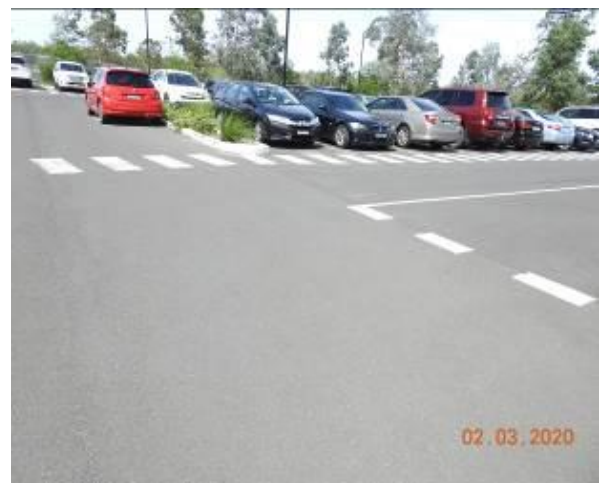
Figure 2949 – General Condition of carpark pavement

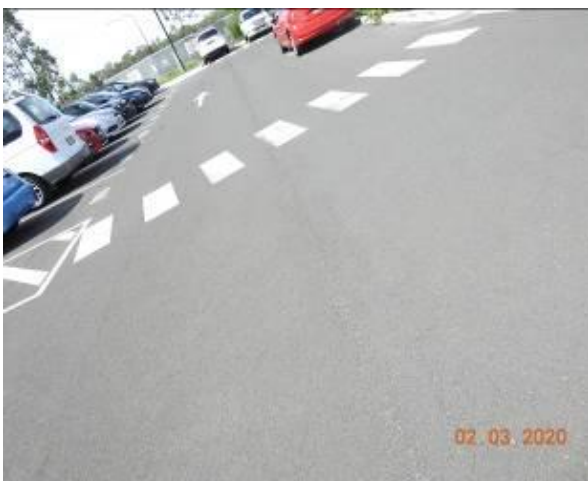
Figure 2950 – Crack propagation through carpark pavement

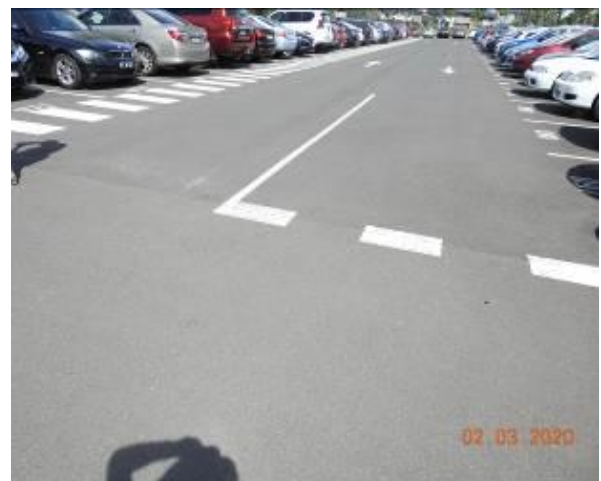
Figure 2951 – General Condition of carpark pavement

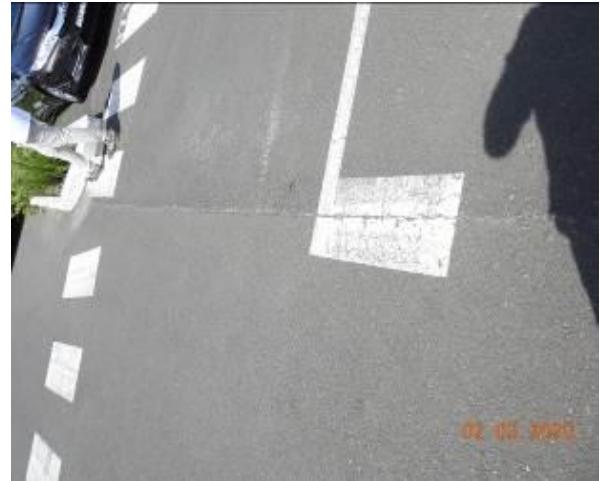
Figure 2953 – Crack propagation through carpark pavement

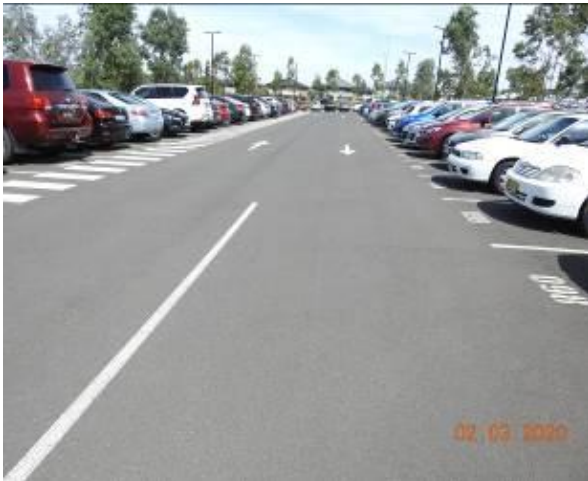
Figure 2954 – General Condition of carpark pavement

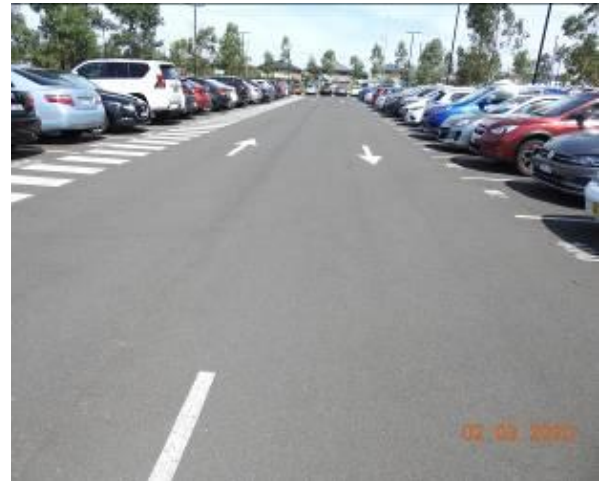
Figure 2955 – General Condition of carpark pavement

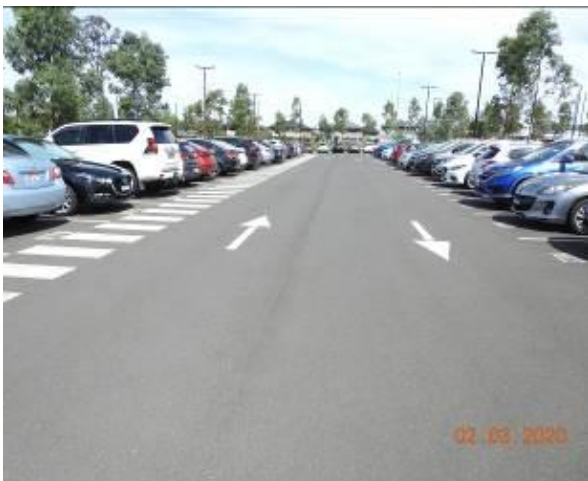
Figure 2956 – General Condition of carpark pavement

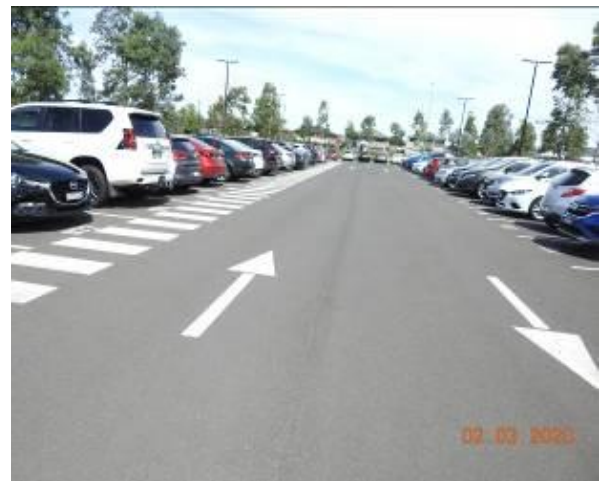
Figure 2957 – General Condition of carpark pavement

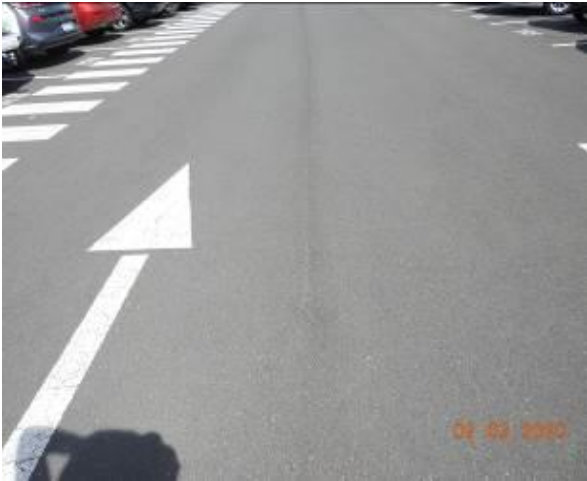
Figure 2958 – Crack propagation through carpark pavement

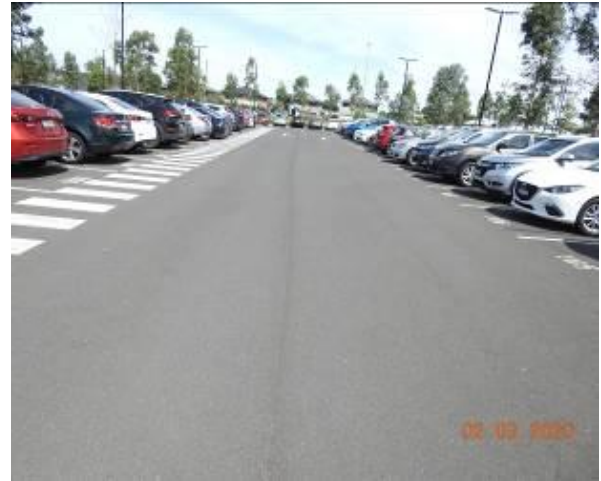
Figure 2959 – Crack propagation through carpark pavement

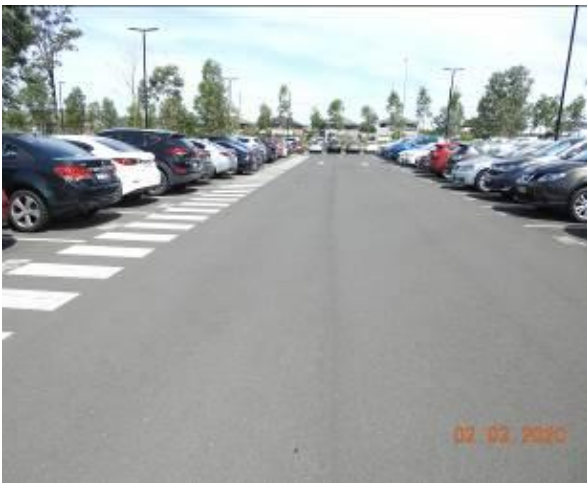
Figure 2960 – General Condition of carpark pavement

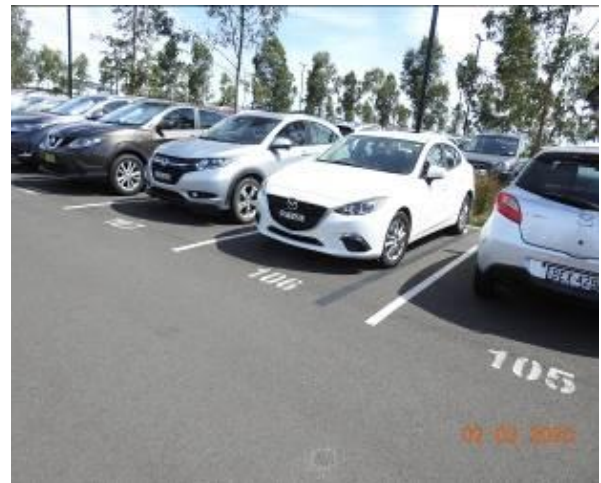
Figure 2961 – General Condition of carpark pavement

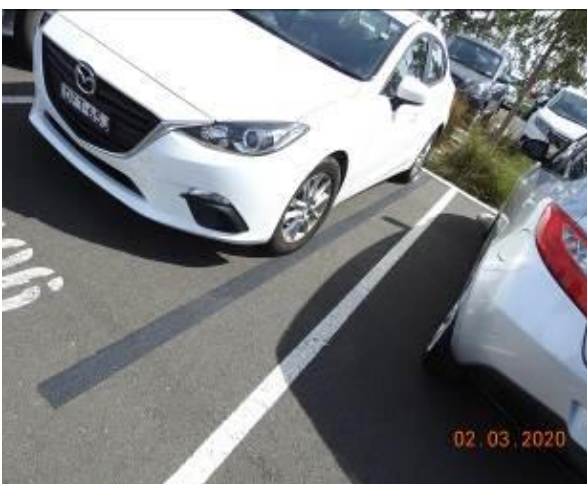
Figure 2962 – General Condition of carpark pavement

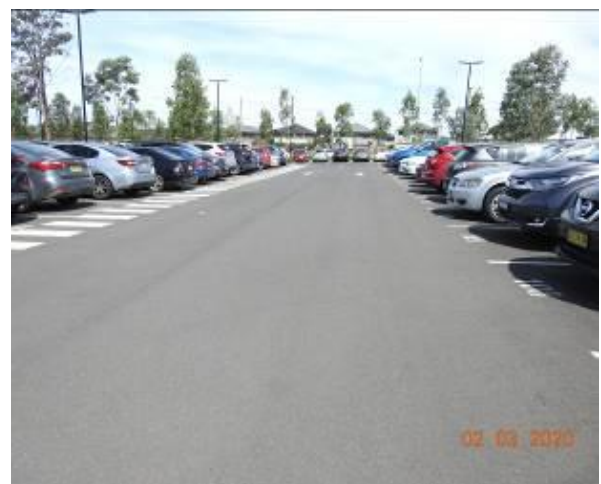
Figure 2963 – General Condition of carpark pavement

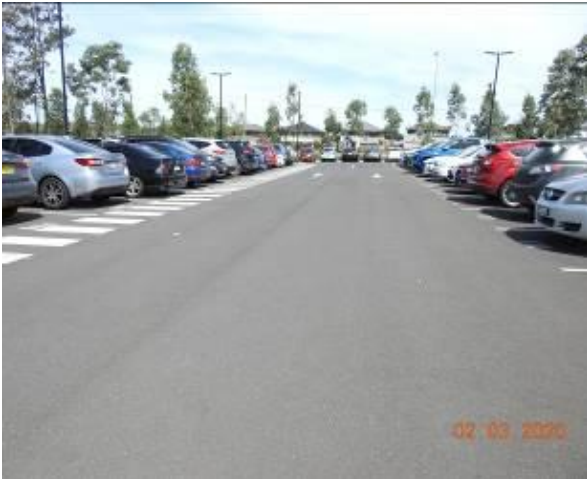
Figure 2964 – General Condition of carpark pavement

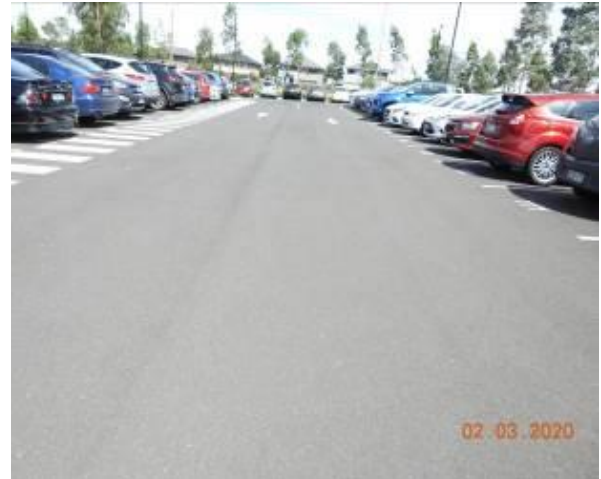
Figure 2965 – General Condition of carpark pavement

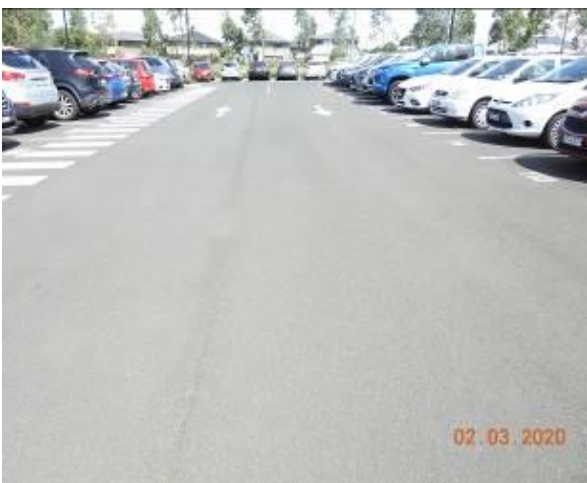
Figure 2966 – General Condition of carpark pavement

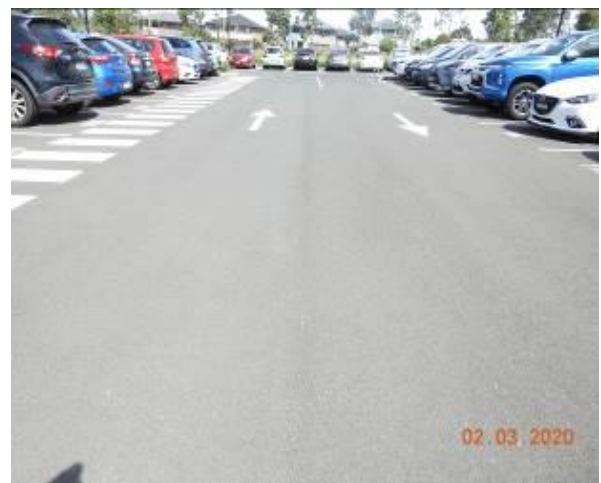
Figure 2967 – General Condition of carpark pavement

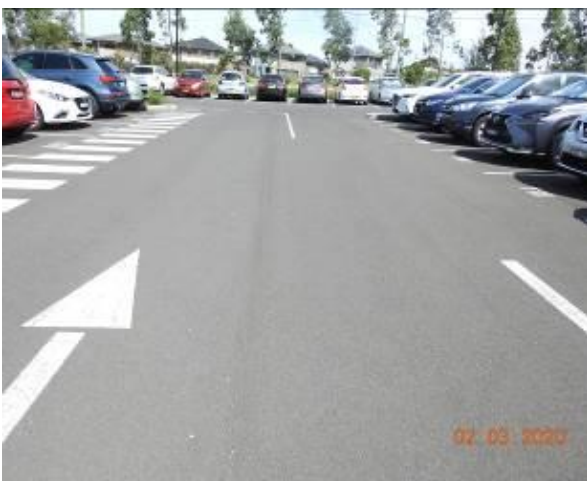
Figure 2968 – General Condition of carpark pavement

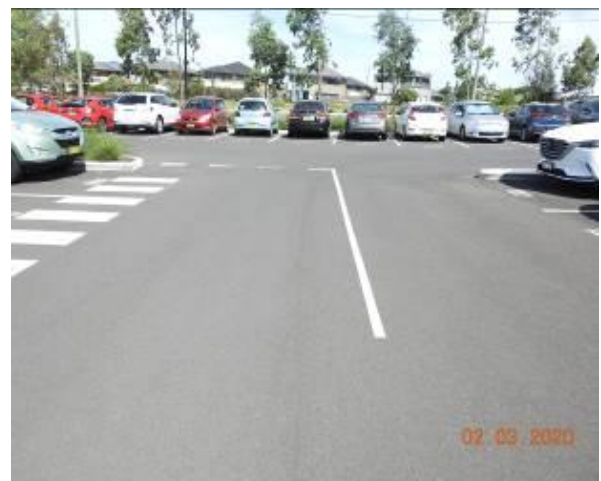
Figure 2969 – General Condition of carpark pavement

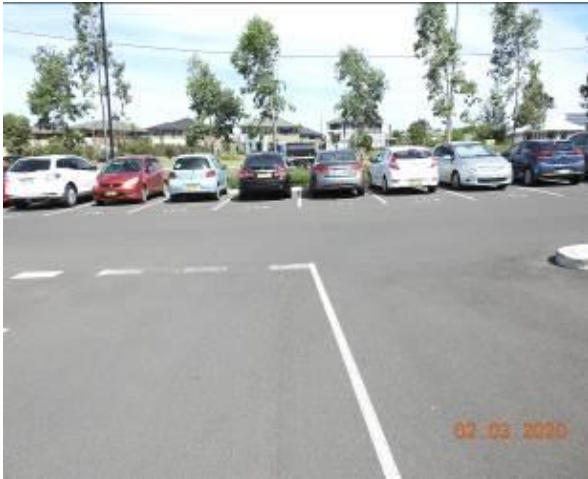
Figure 2970 – General Condition of carpark pavement

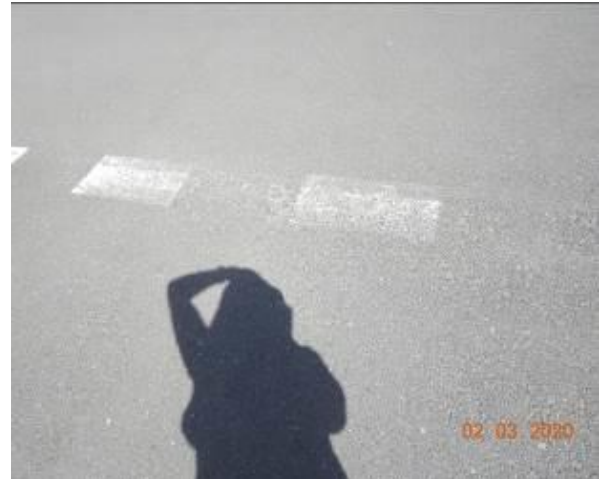
Figure 2971 – Crack propagation through carpark pavement

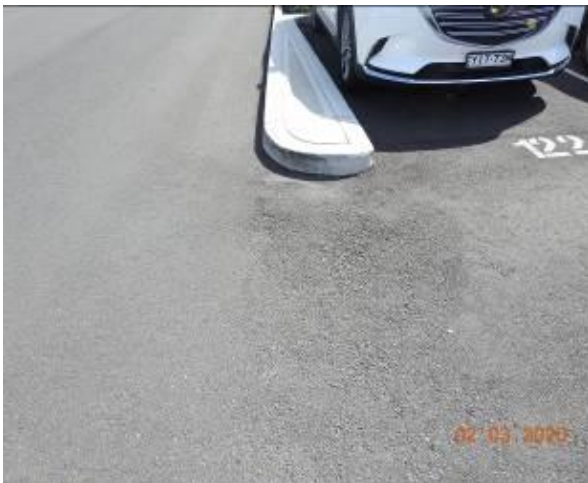
Figure 2972 – General Condition of carpark pavement

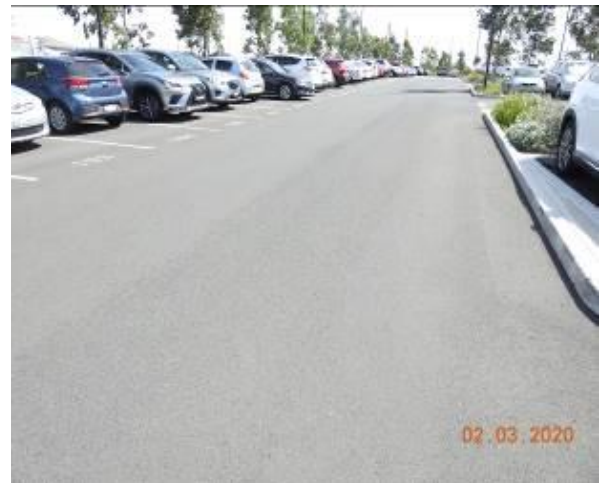
Figure 2973 – General Condition of carpark pavement

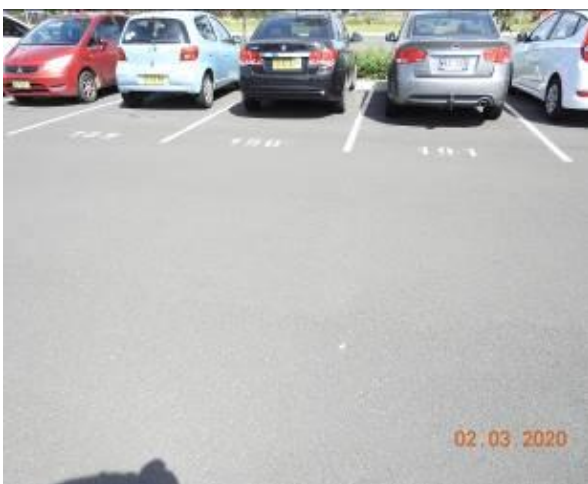
Figure 2974 – General Condition of carpark pavement

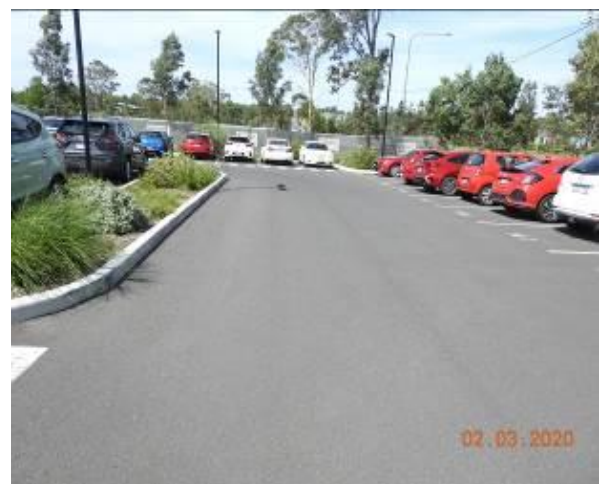
Figure 2975 – General Condition of carpark pavement

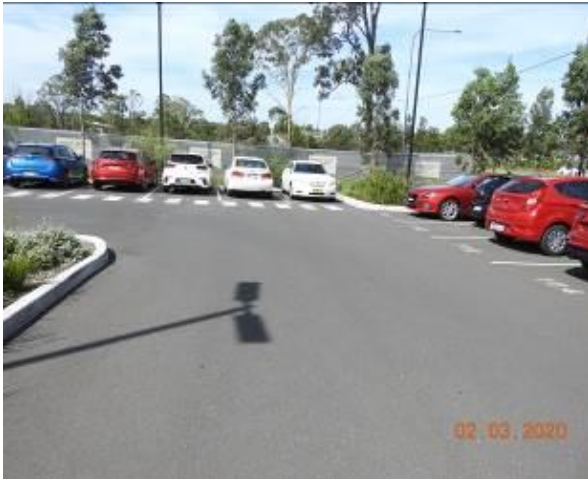
Figure 2976 – General Condition of carpark pavement

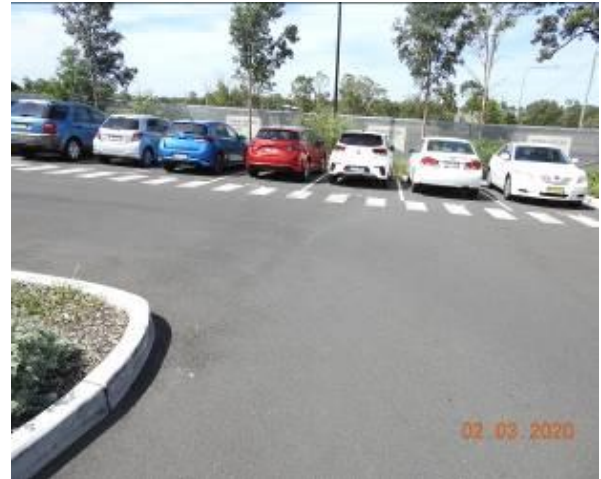
Figure 2977 – General Condition of carpark pavement

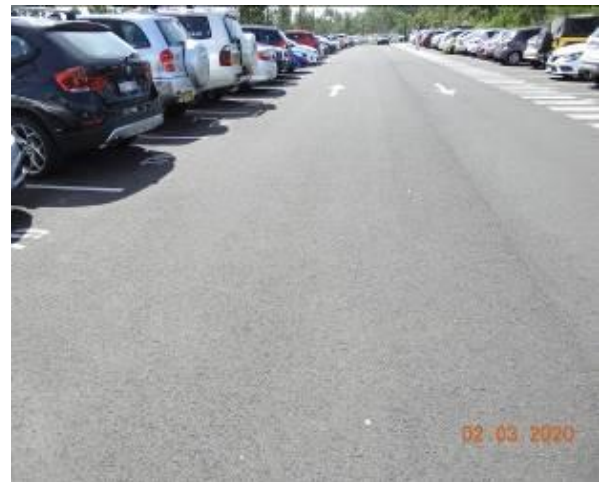
Figure 2979 – General Condition of carpark pavement

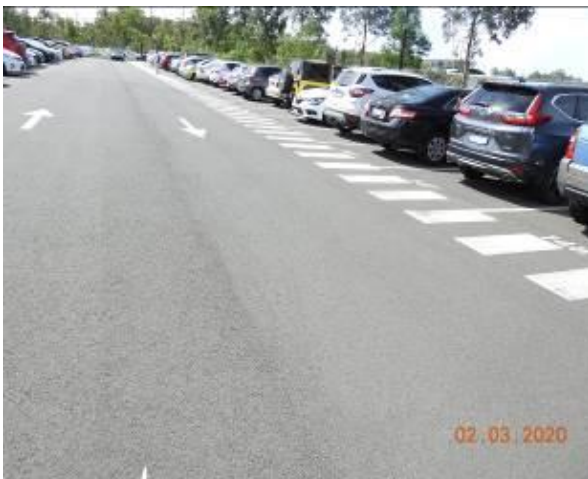
Figure 2980 – General Condition of carpark pavement

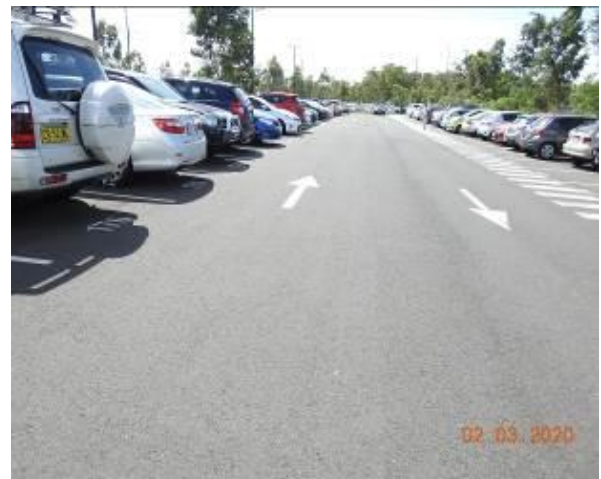
Figure 2981 – General Condition of carpark pavement

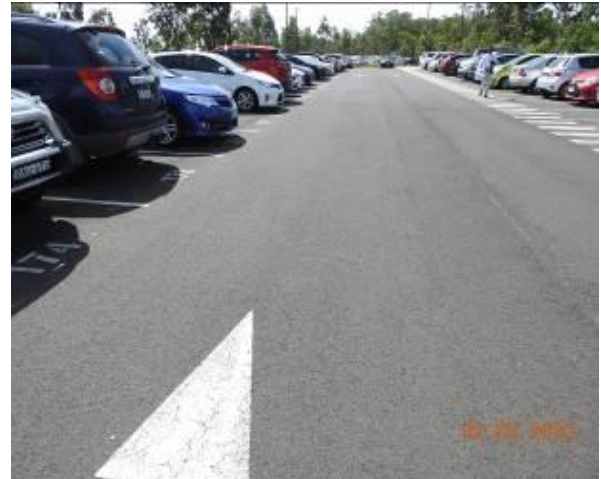
Figure 2983 – General Condition of carpark pavement

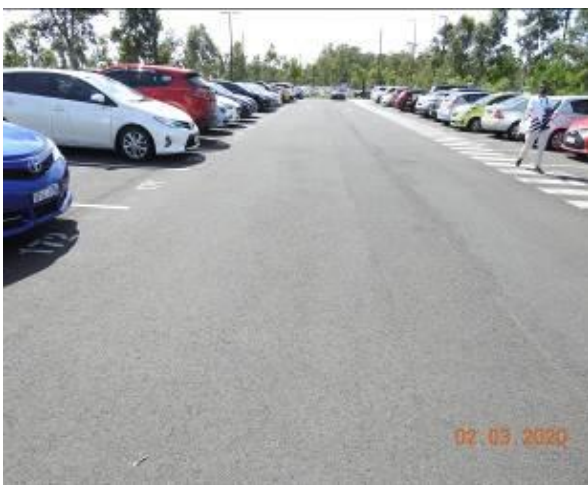
Figure 2984 – General Condition of carpark pavement

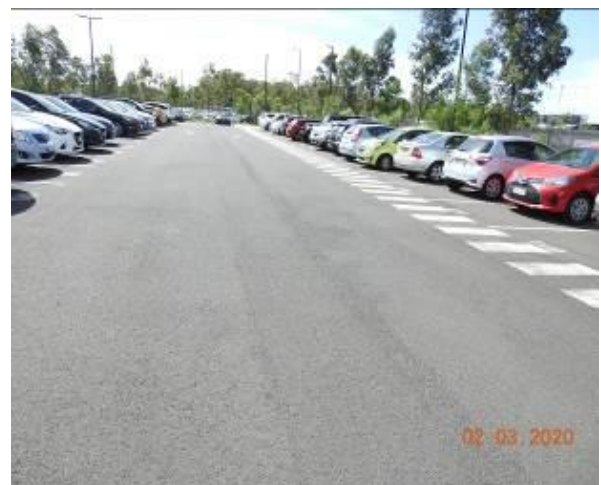
Figure 2985 – General Condition of carpark pavement

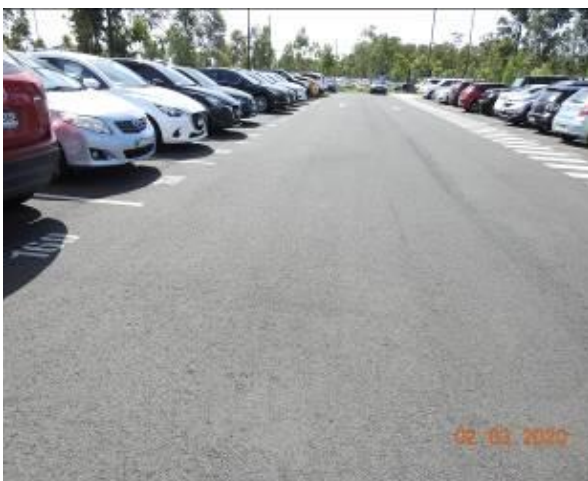
Figure 2986 – General Condition of carpark pavement

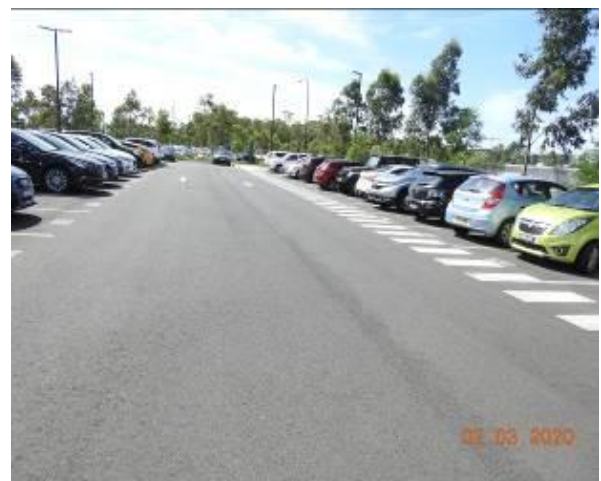
Figure 2987 – General Condition of carpark pavement

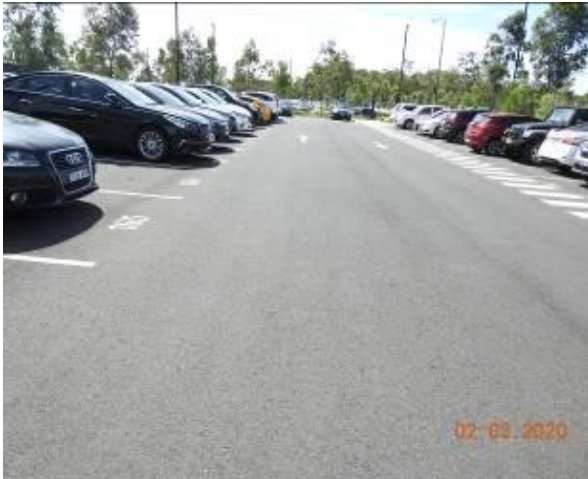
Figure 2988 – General Condition of carpark pavement

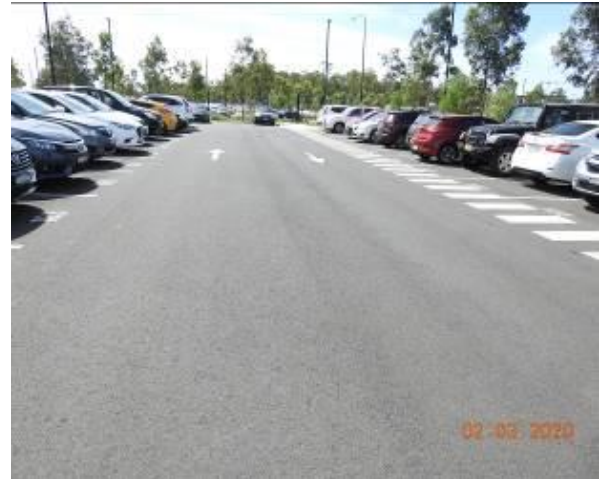
Figure 2989 – General Condition of carpark pavement

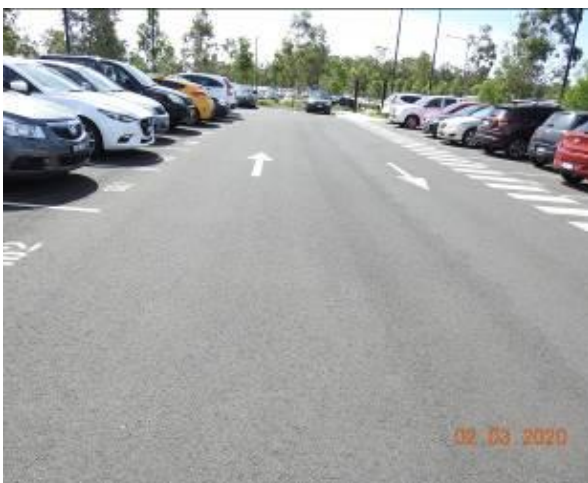
Figure 2990 – General Condition of carpark pavement

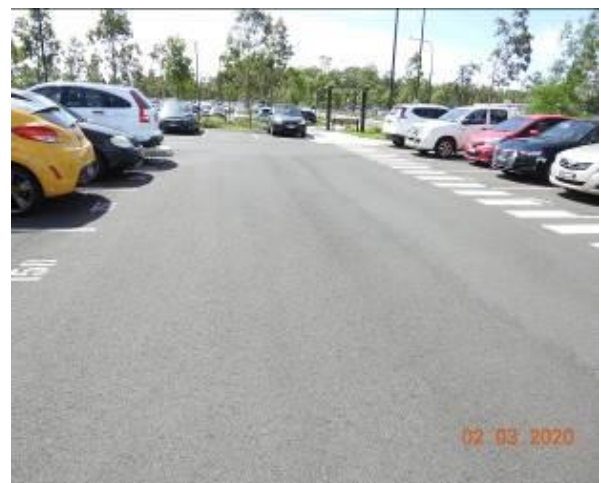
Figure 2991 – General Condition of carpark pavement

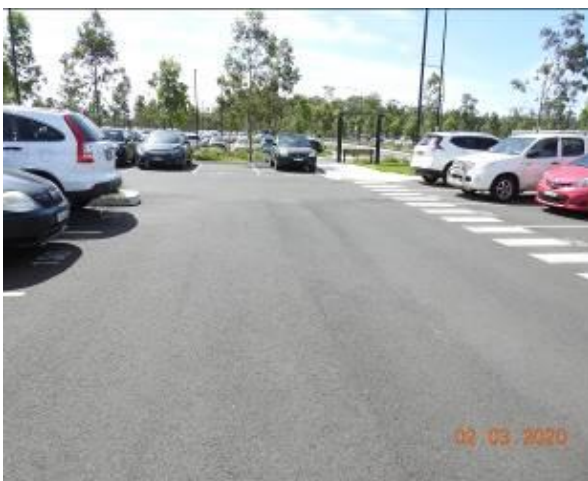
Figure 2992 – General Condition of carpark pavement

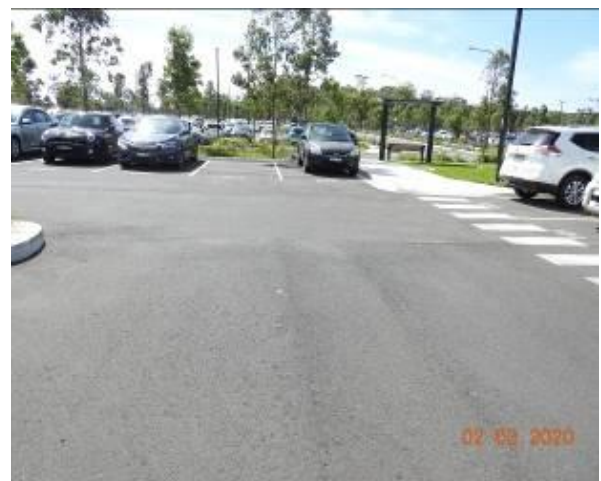
Figure 2993 – General Condition of carpark pavement

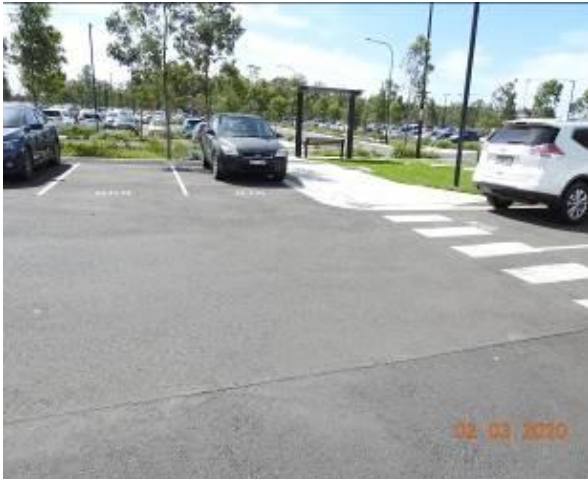
Figure 2994 – General Condition of carpark pavement

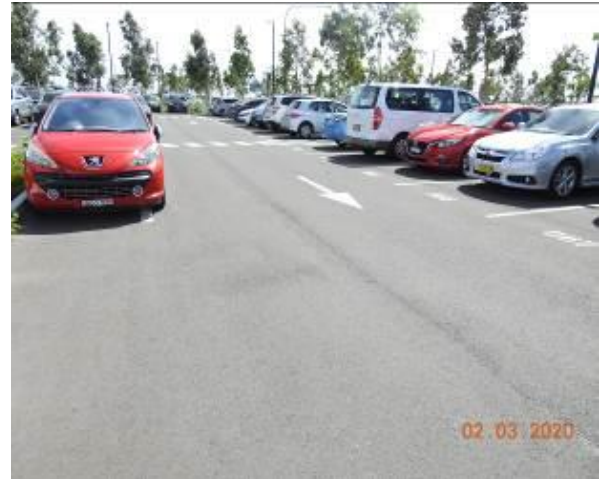
Figure 2995 – General Condition of carpark pavement

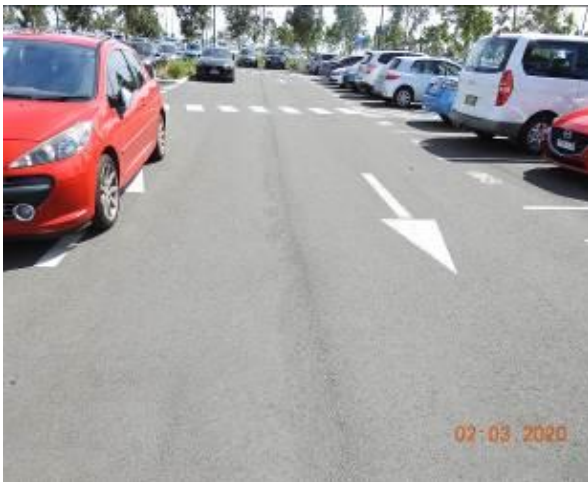
Figure 2996 – Loss of material through carpark pavement

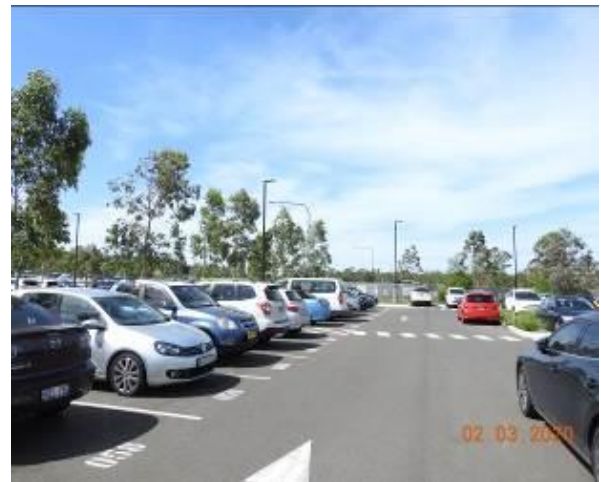
Figure 2997 – General Condition of lamp post / plantation

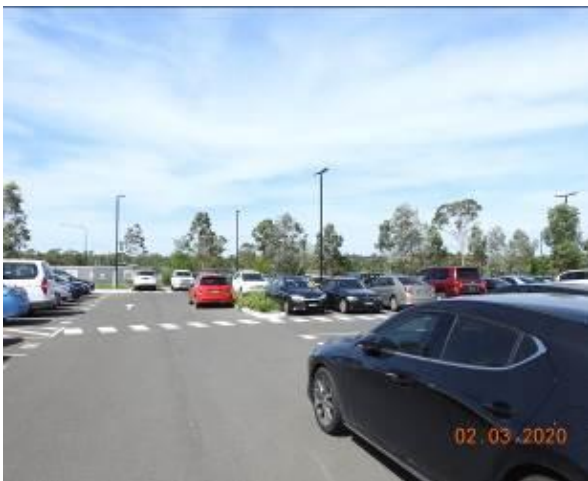
Figure 2998 – General Condition of lamp post / plantation

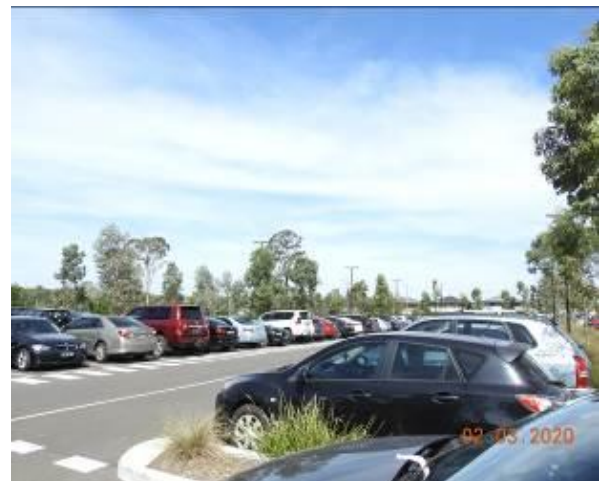
Figure 2999 – General Condition of lamp post / plantation

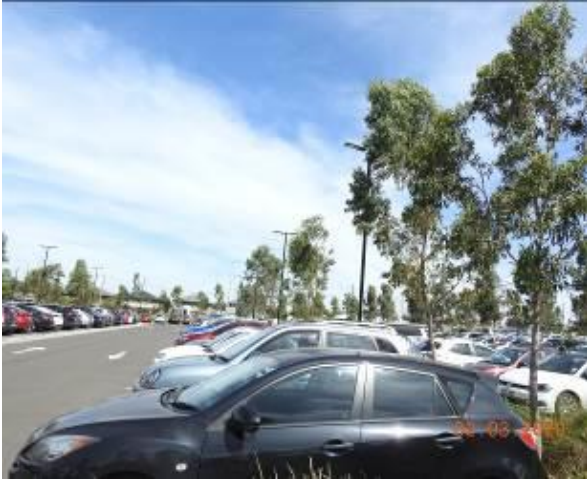
Figure 3000 – General Condition of lamp post / plantation

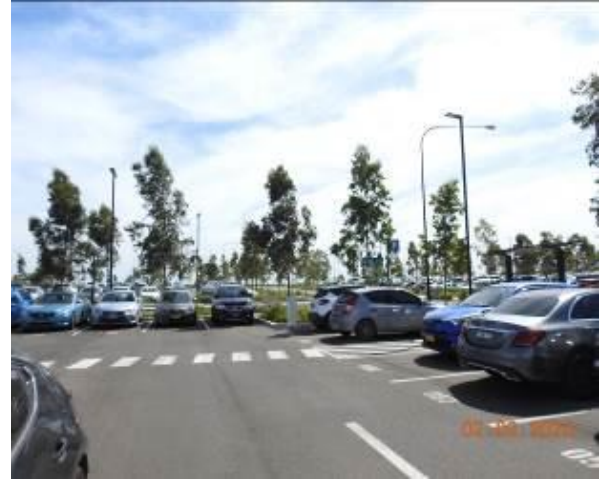
Figure 3001 – General Condition of lamp post / plantation

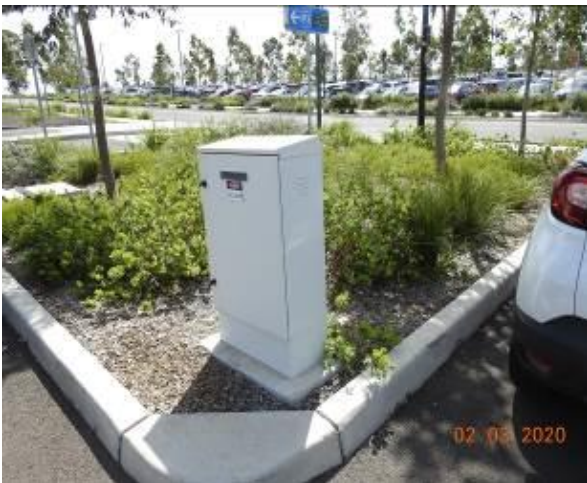
Figure 3002 – General Condition of electricity box

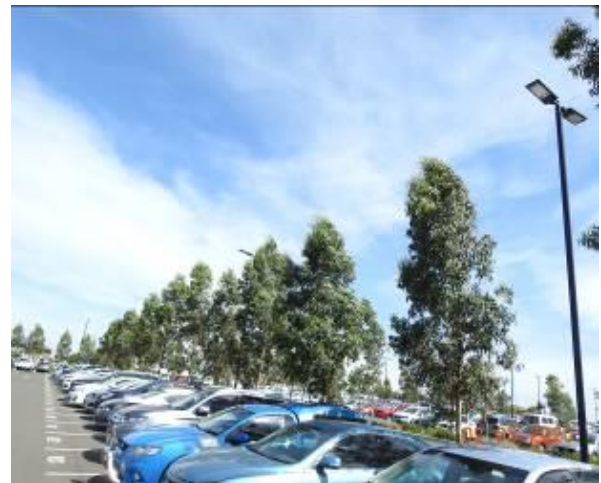
Figure 3003 – General Condition of lamp post / plantation

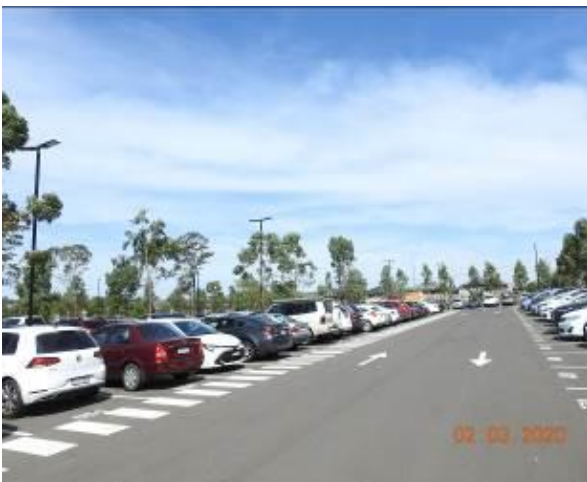
Figure 3004 – General Condition of lamp post / plantation

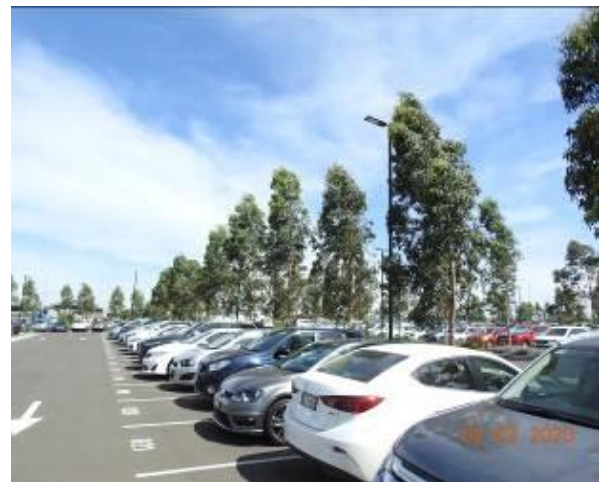
Figure 3005 – General Condition of lamp post / plantation

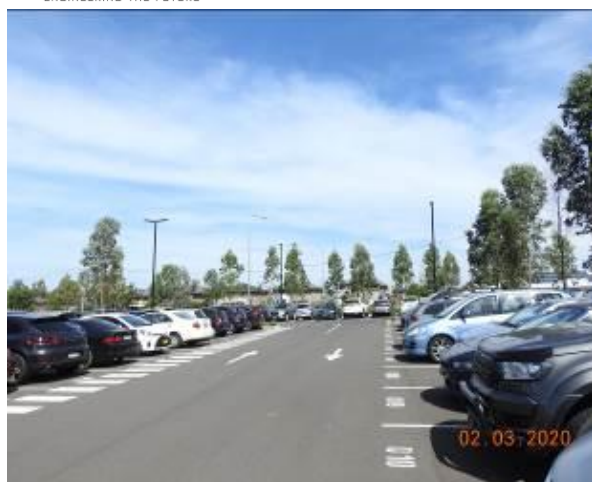
Figure 3006 – General Condition of lamp post / plantation

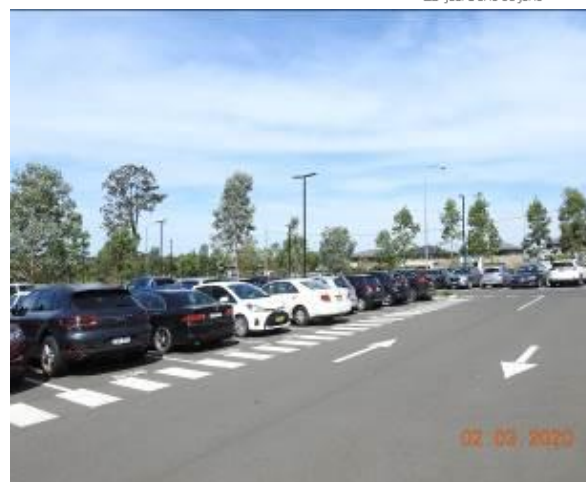
Figure 3007 – General Condition of lamp post / plantation
