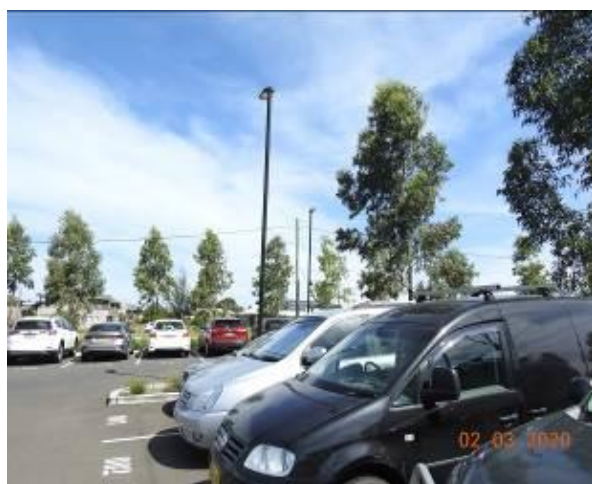
Figure 3008 – General Condition of lamp post / plantation

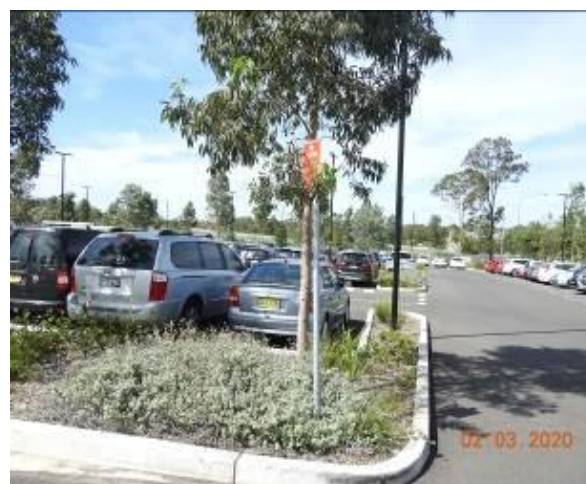
Figure 3009 – General Condition of street sign

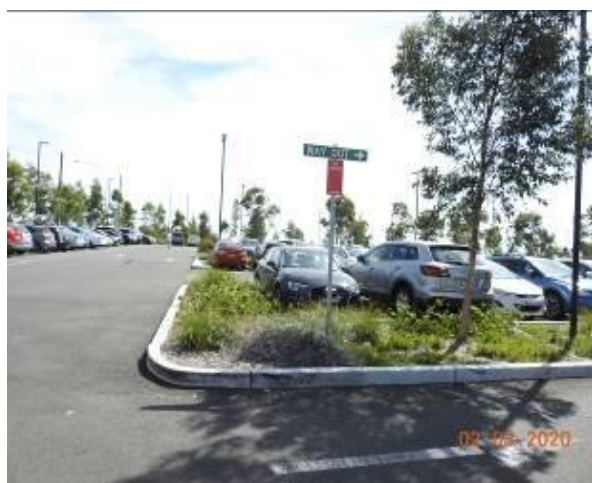
Figure 3010 – General Condition of street sign

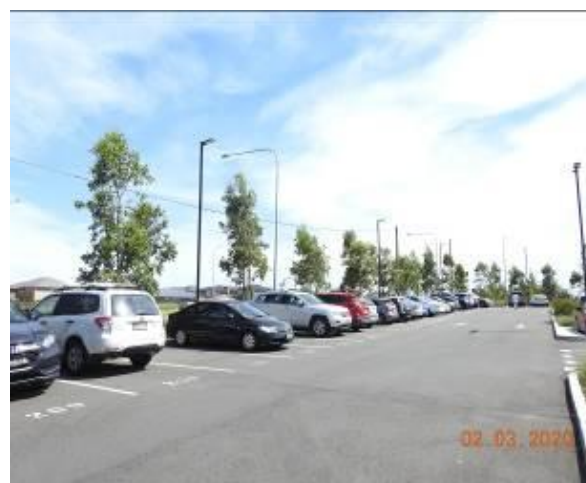
Figure 3011 – General Condition of lamp post / plantation

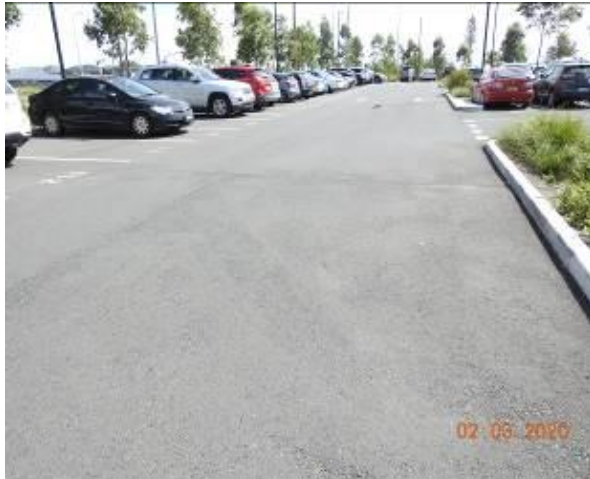
Figure 3012 – General Condition of carpark pavement

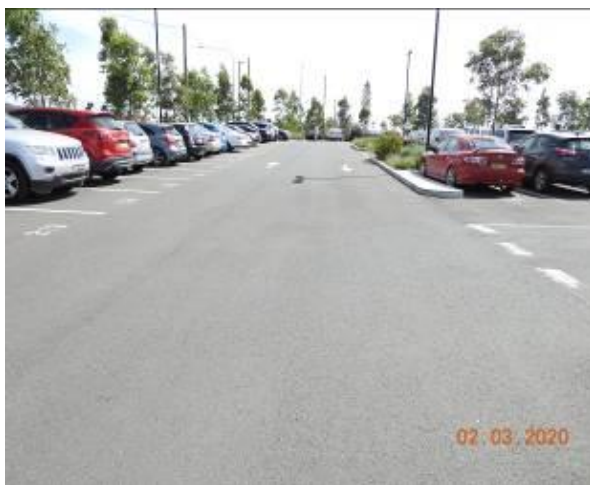
Figure 3014 – General Condition of carpark pavement

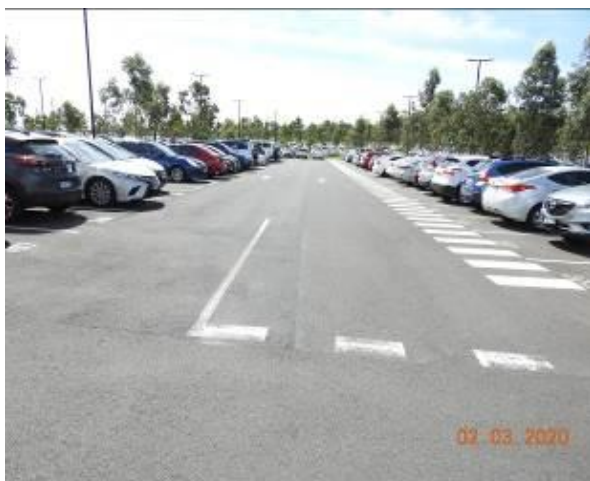
Figure 3016 – General Condition of carpark pavement

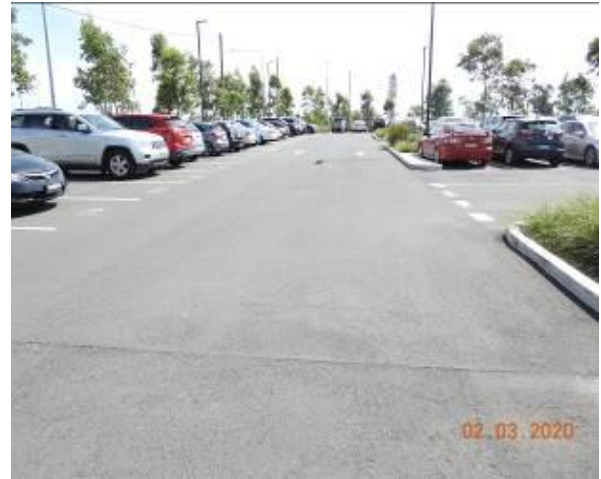
Figure 3013 – General Condition of carpark pavement

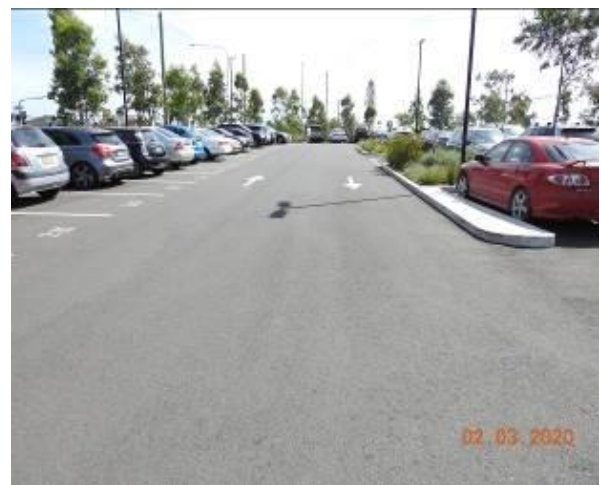
Figure 3015 – General Condition of carpark pavement

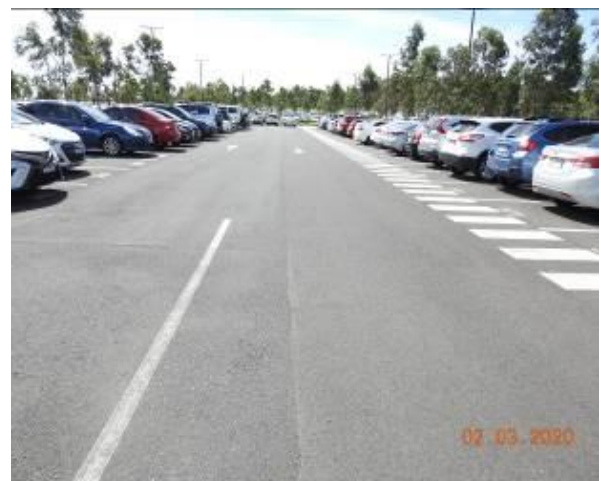
Figure 3017 – Crack propagation through carpark pavement

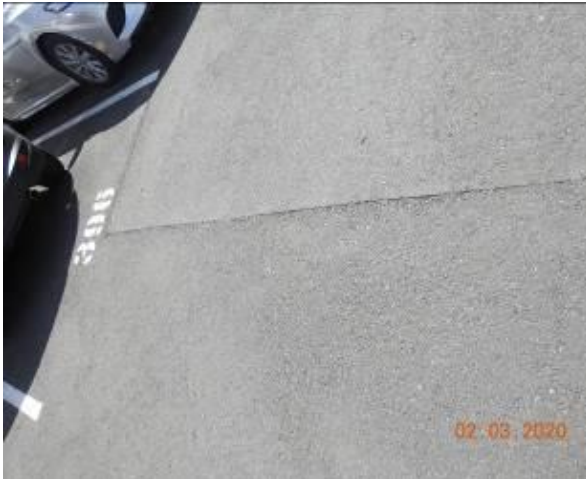
Figure 3018 – Crack propagation through carpark pavement

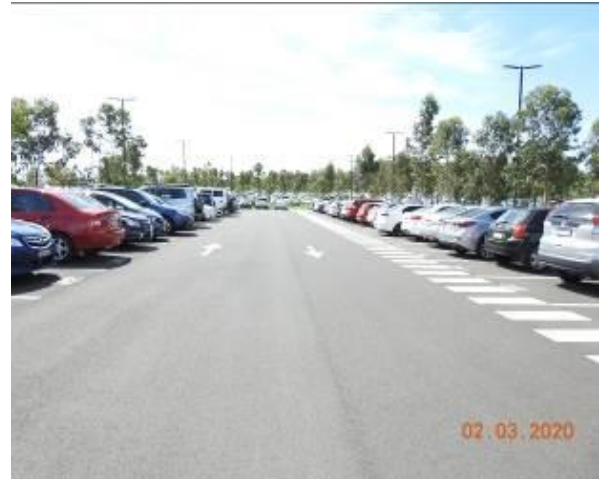
Figure 3019 – General Condition of carpark pavement

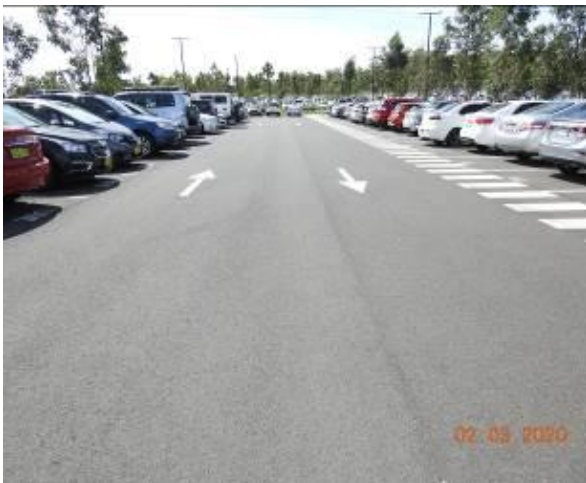
Figure 3020 – General Condition of carpark pavement

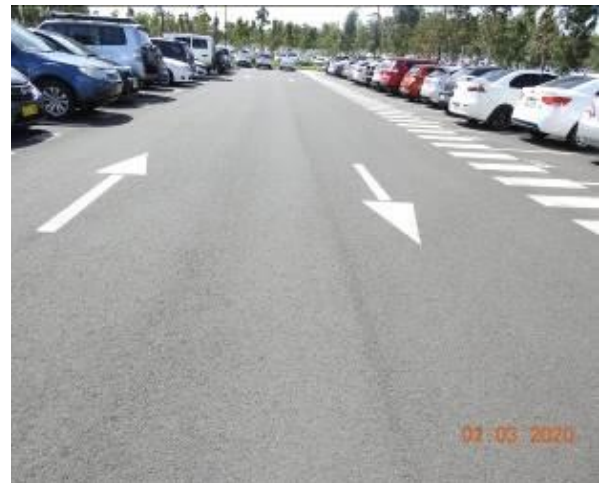
Figure 3021 – General Condition of carpark pavement

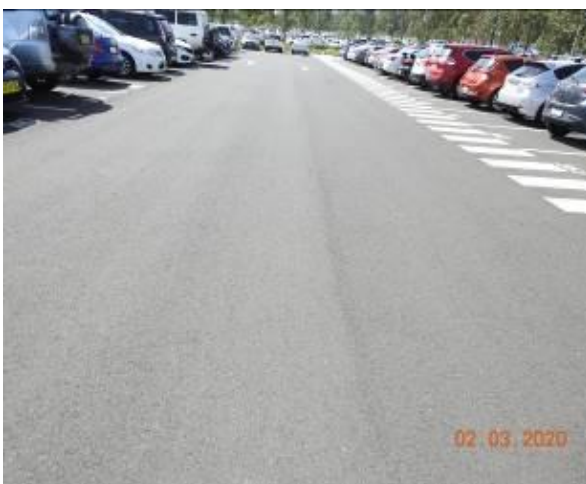
Figure 3022 – General Condition of carpark pavement

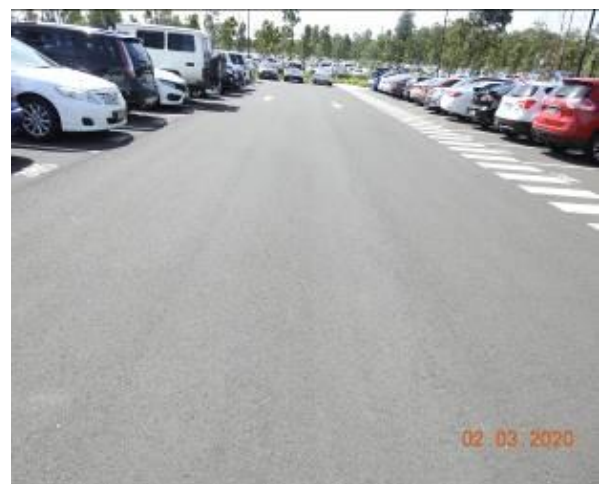
Figure 3023 – General Condition of carpark pavement

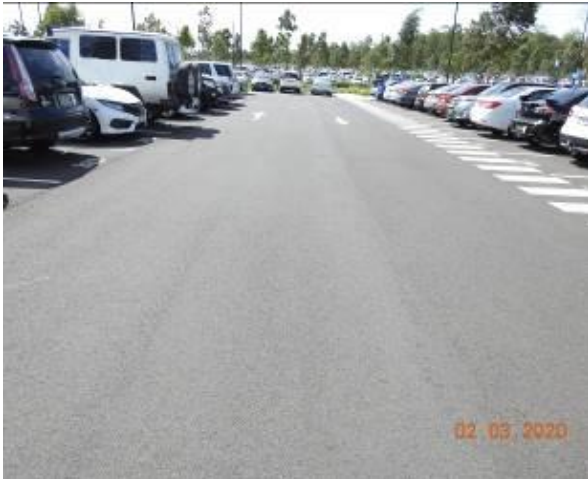
Figure 3024 – General Condition of carpark pavement

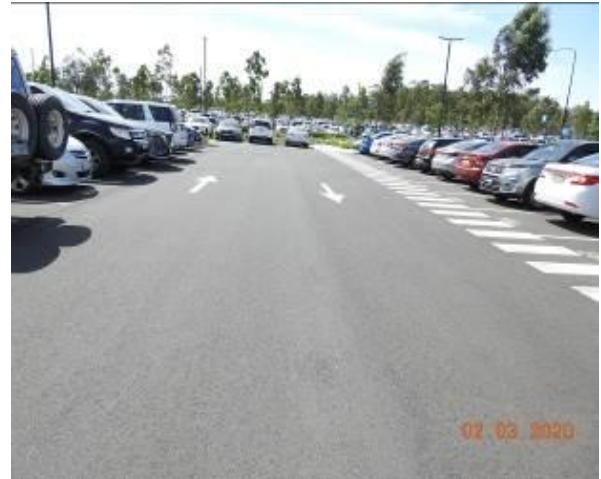
Figure 3025 – General Condition of carpark pavement

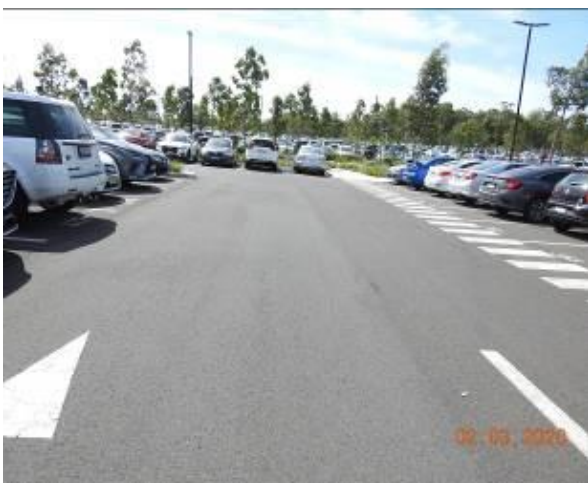
Figure 3026 – General Condition of carpark pavement

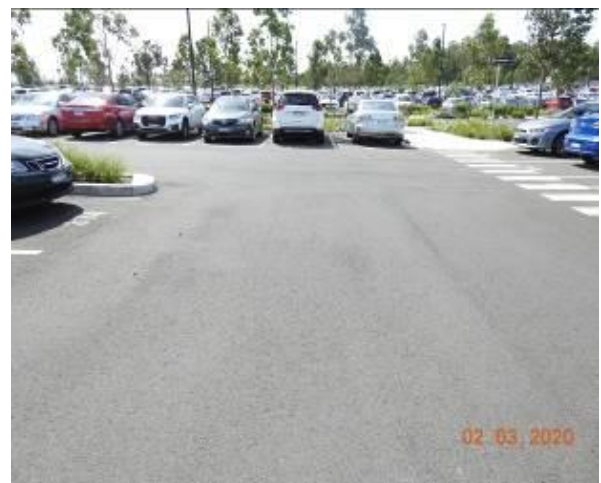
Figure 3027 – General Condition of carpark pavement

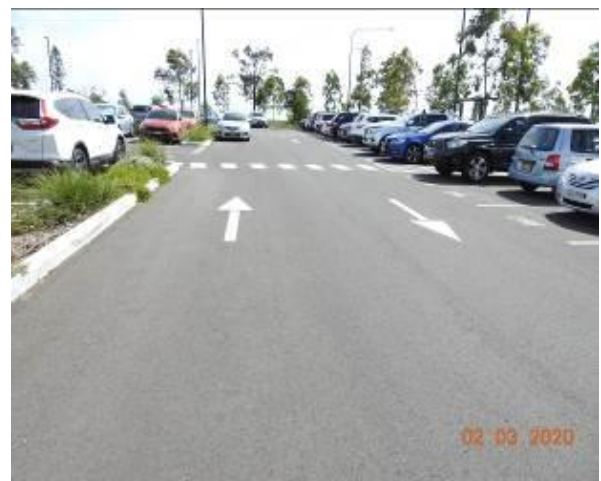
Figure 3029 – General Condition of carpark pavement

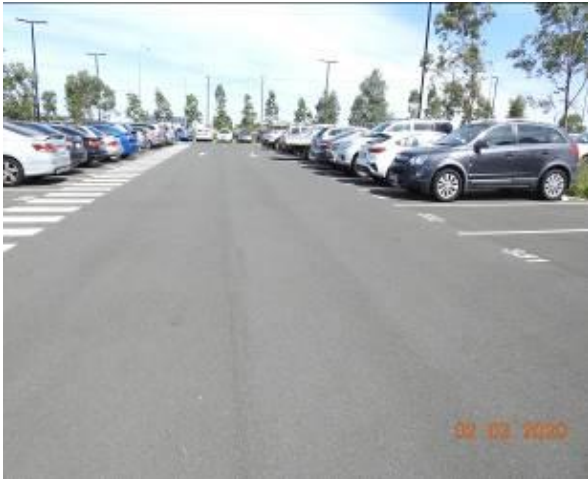
Figure 3036 – General Condition of carpark pavement

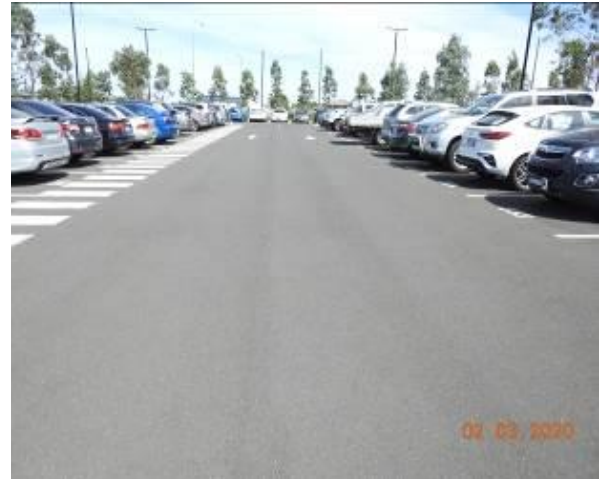
Figure 3037 – General Condition of carpark pavement

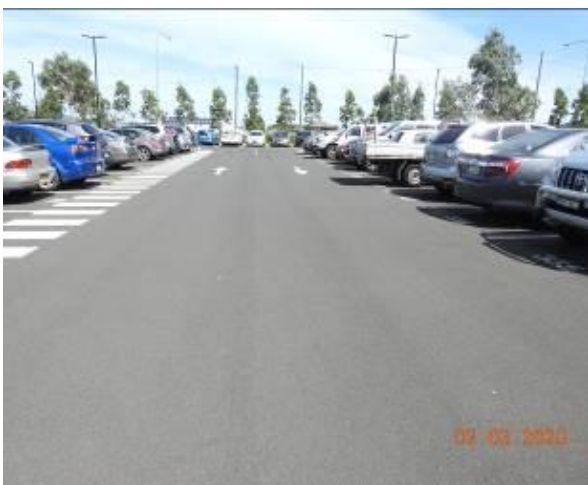
Figure 3038 – General Condition of carpark pavement

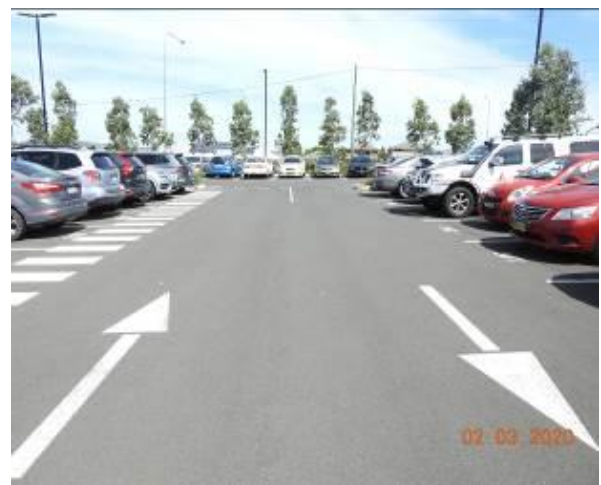
Figure 3039 – General Condition of carpark pavement

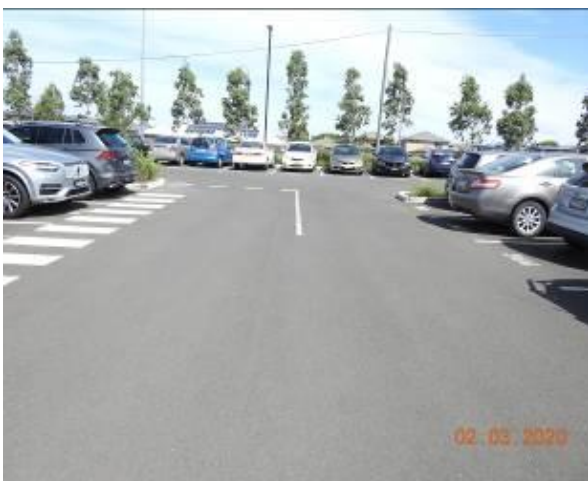
Figure 3040 – General Condition of carpark pavement

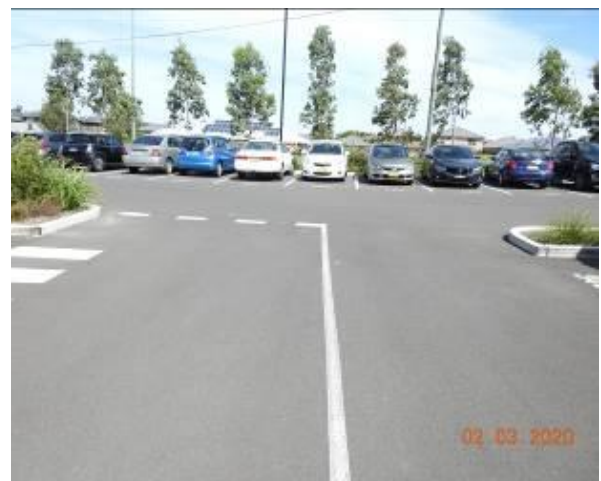
Figure 3041 – General Condition of carpark pavement

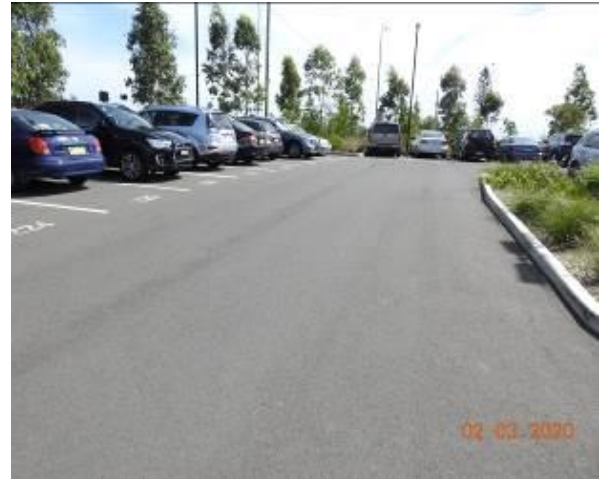
Figure 3043 – General Condition of carpark pavement

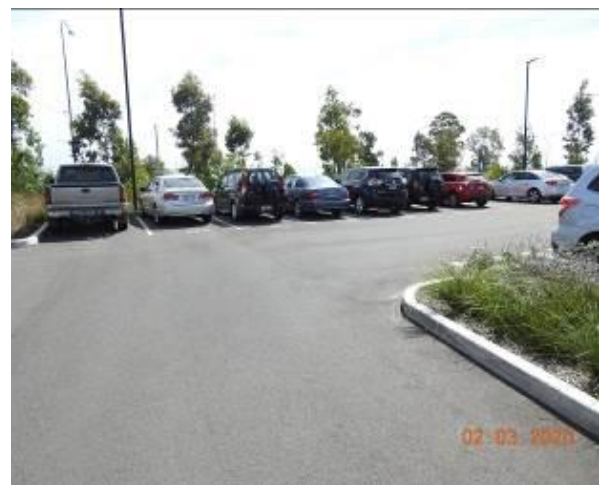
Figure 3045 – General Condition of carpark pavement

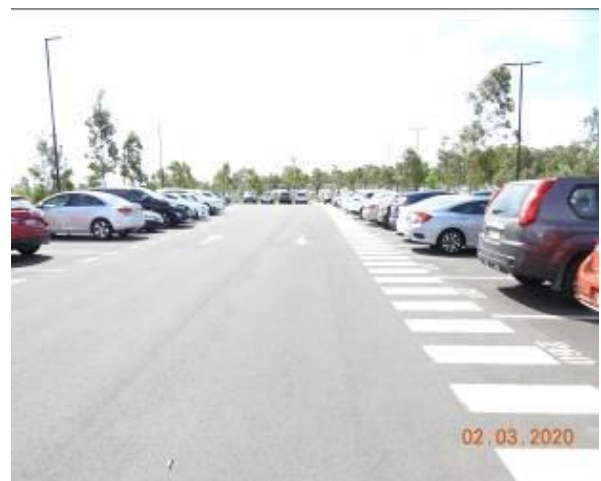
Figure 3047 – General Condition of carpark pavement

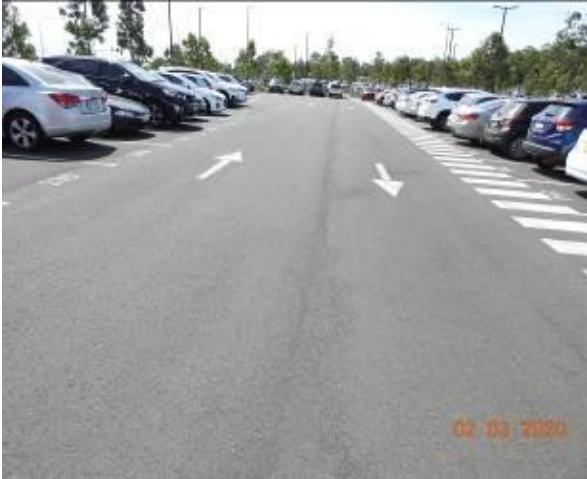
Figure 3048 – Loss of material through carpark pavement

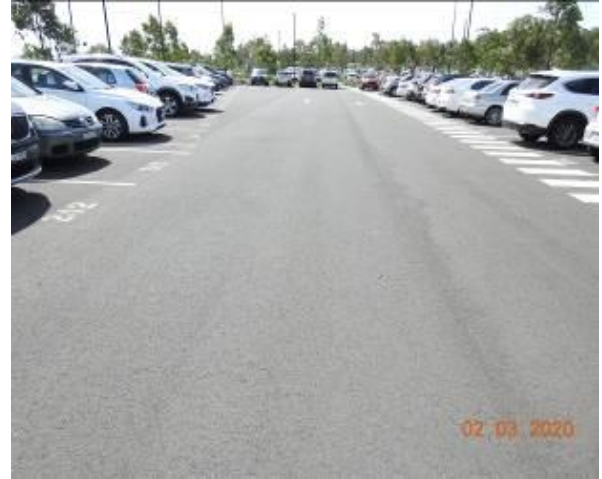
Figure 3049 – General Condition of carpark pavement

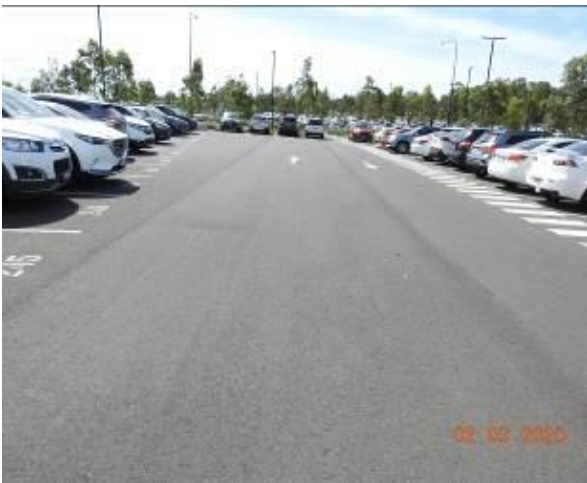
Figure 3050 – General Condition of carpark pavement

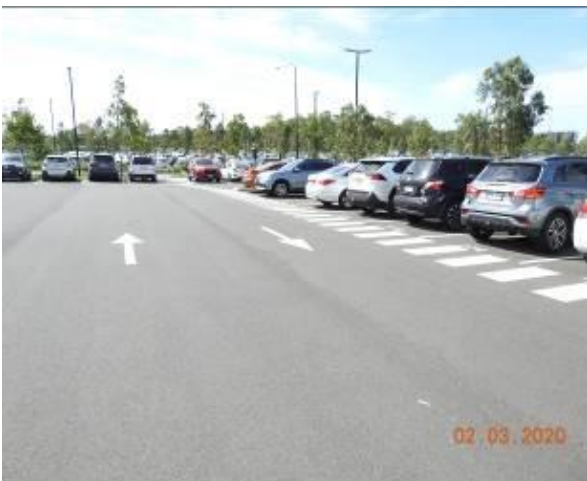
Figure 3052 – General Condition of carpark pavement

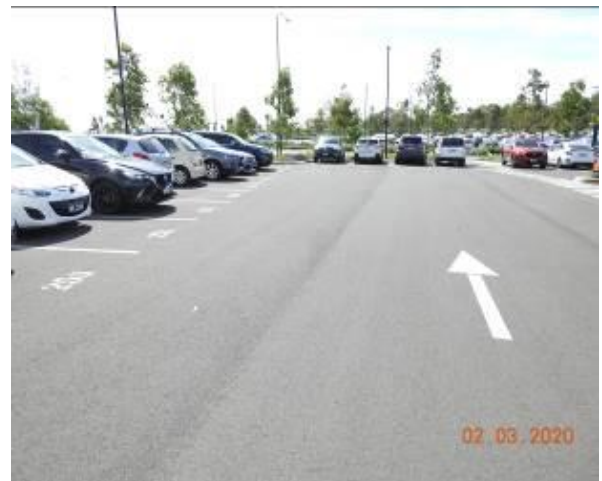
Figure 3053 – General Condition of carpark pavement

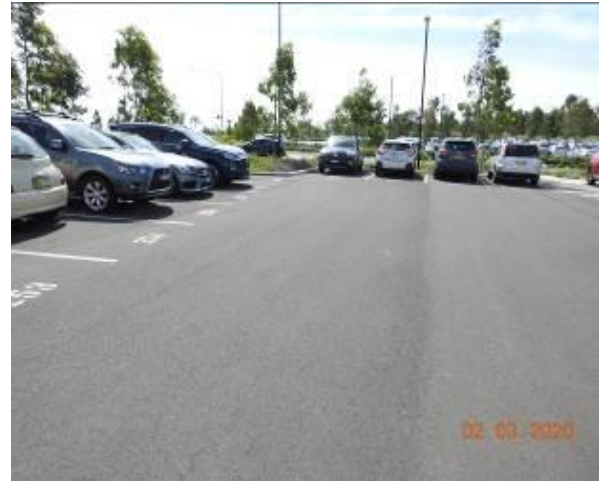
Figure 3055 – General Condition of carpark pavement

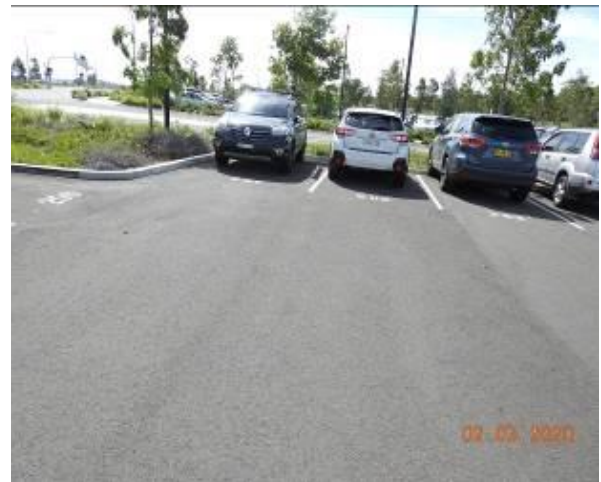
Figure 3057 – General Condition of carpark pavement

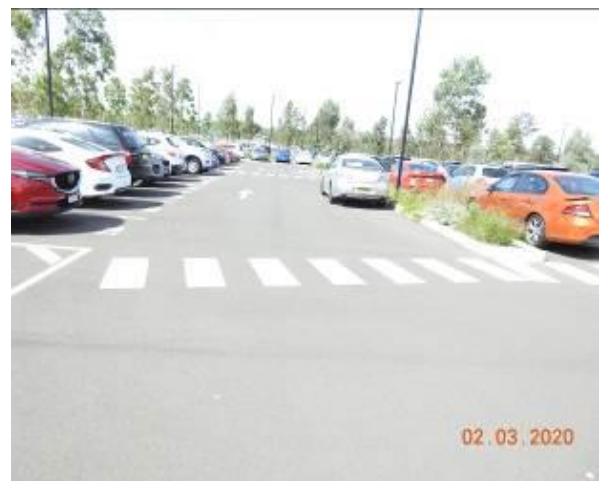
Figure 3059 – General Condition of carpark pavement

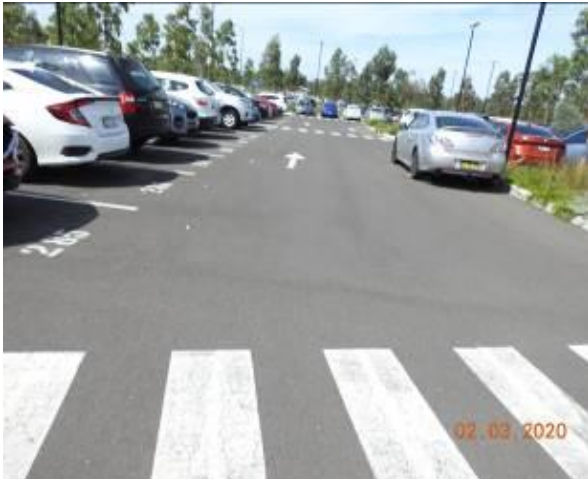
Figure 3060 – General Condition of carpark pavement

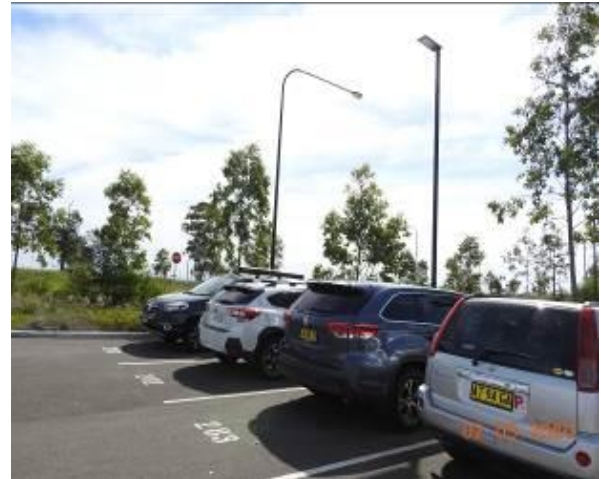
Figure 3061 – General Condition of lamp post / plantation

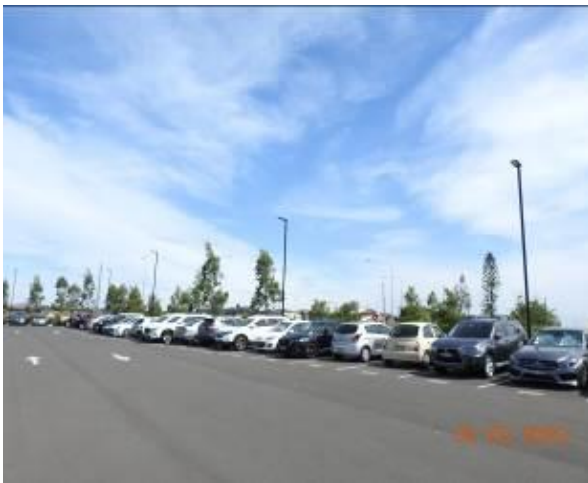
Figure 3062 – General Condition of lamp post / plantation

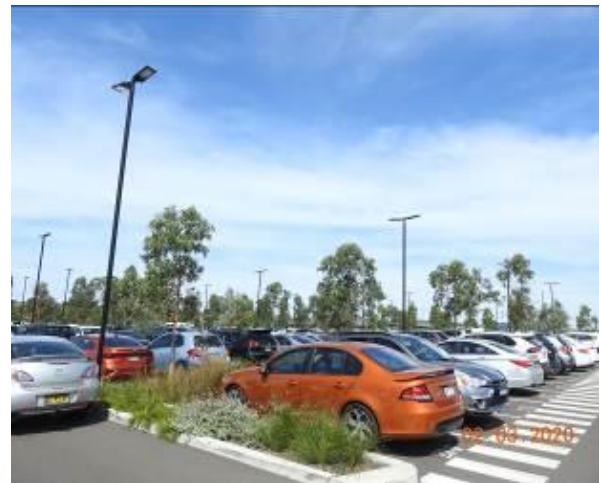
Figure 3063 – General Condition of lamp post / plantation

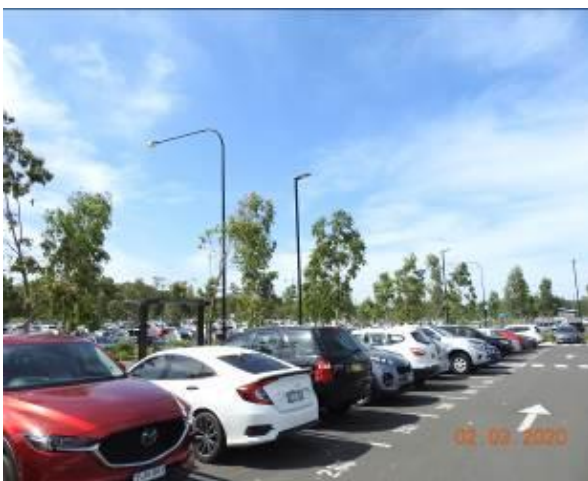
Figure 3064 – General Condition of lamp post / plantation

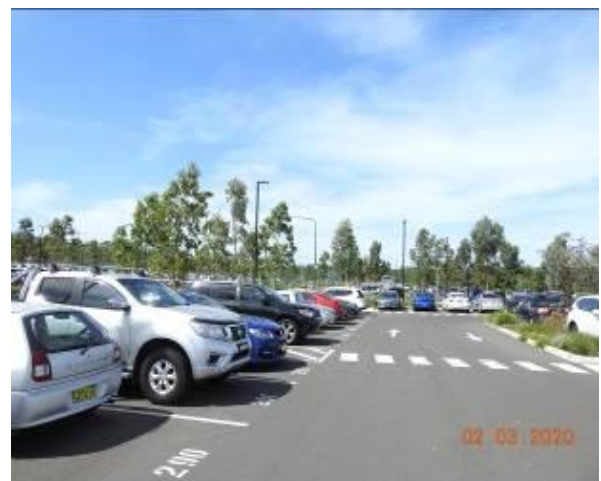
Figure 3065 – General Condition of lamp post / plantation

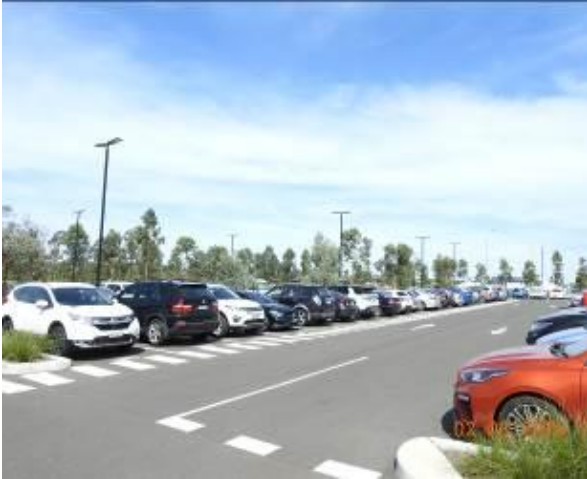
Figure 3066 – General Condition of lamp post / plantation

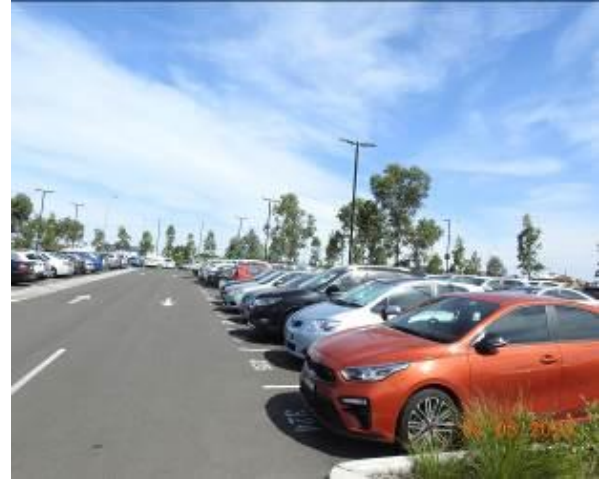
Figure 3067 – General Condition of lamp post / plantation

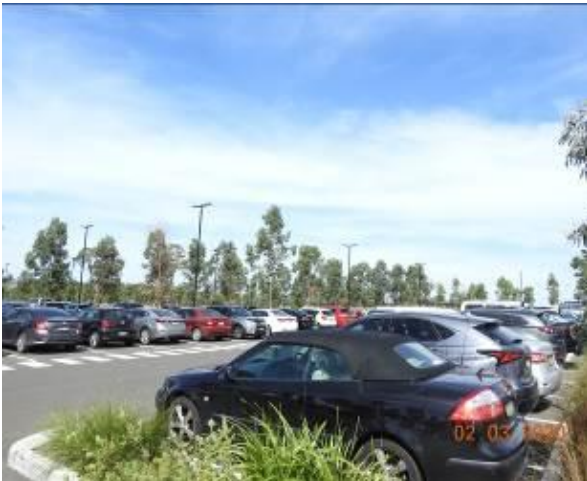
Figure 3068 – General Condition of lamp post / plantation

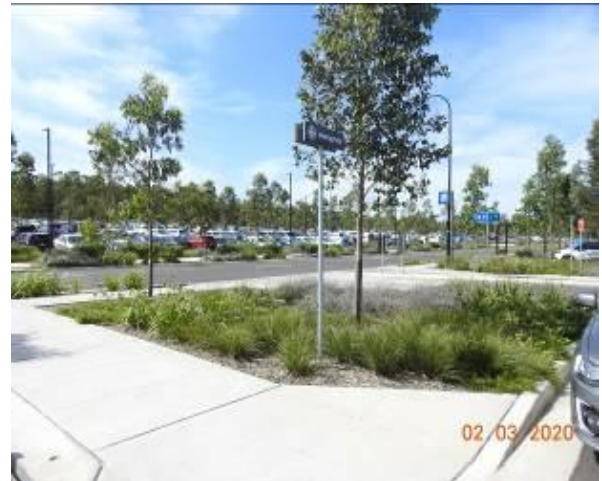
Figure 3069 – General Condition of street sign

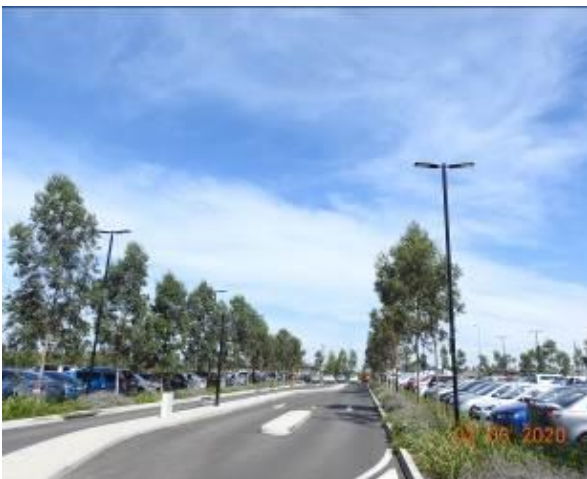
Figure 3070 – General Condition of lamp post / plantation

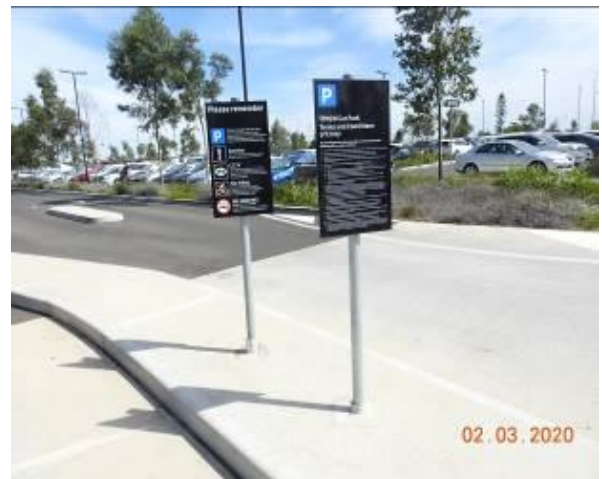
Figure 3071 – General Condition of street sign

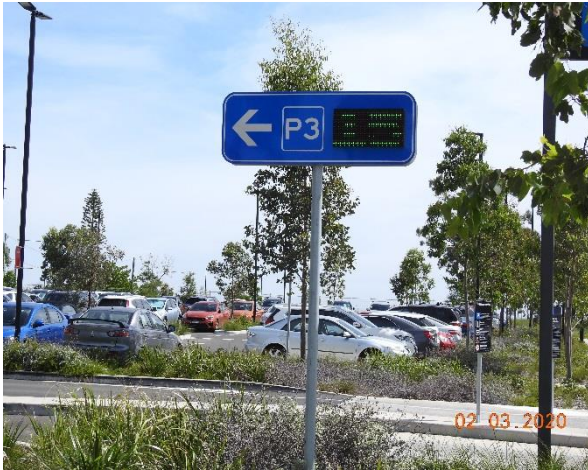
Figure 3072 – The following images display condition of carpark 3

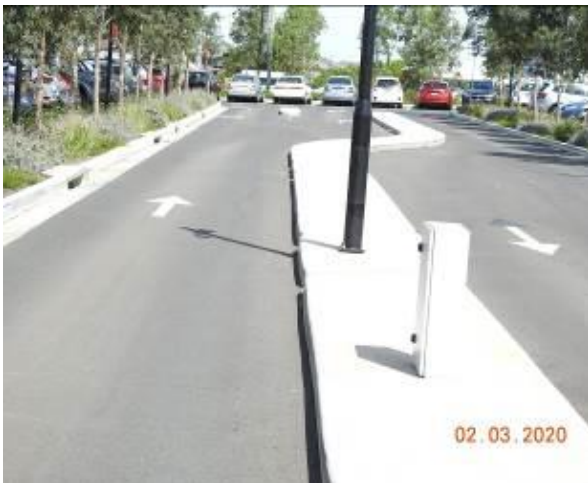
Figure 3074 – General Condition of traffic island kerb

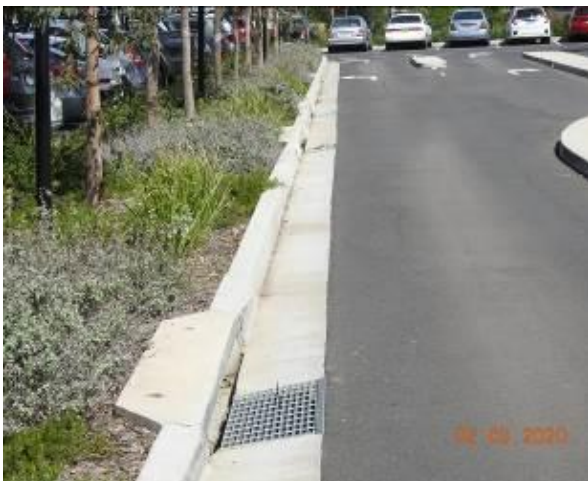
Figure 3076 – General Condition of kerb and gutter

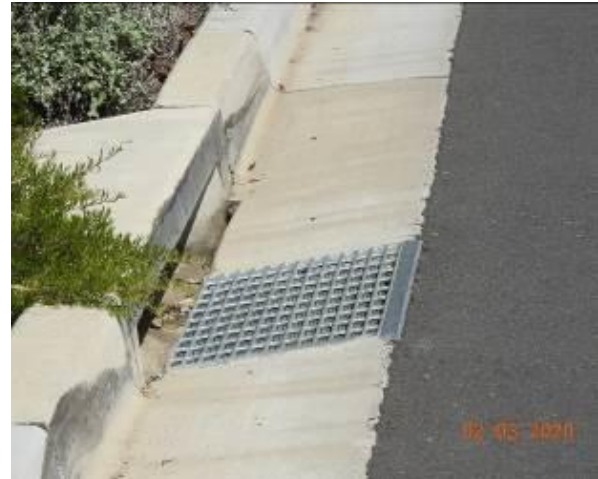
Figure 3073 – General Condition of stormwater inlet pit

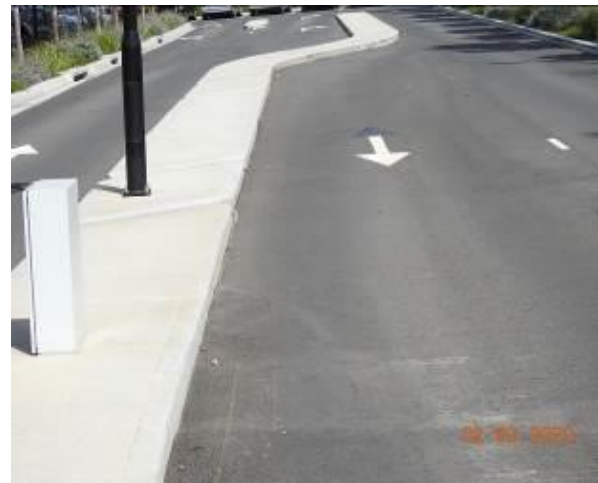
Figure 3075 – General Condition of traffic island kerb

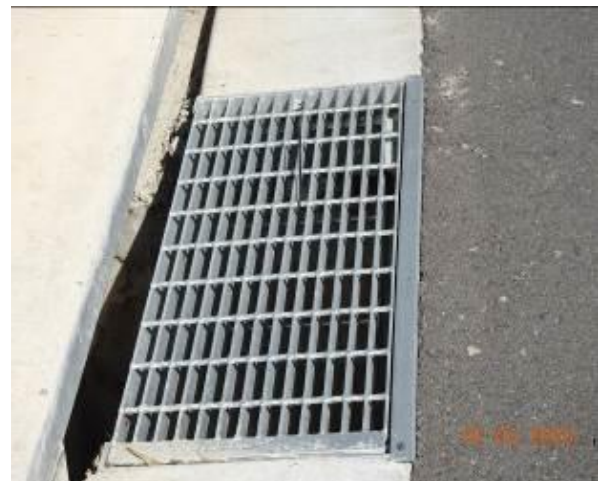
Figure 3077 – General Condition of stormwater inlet pit

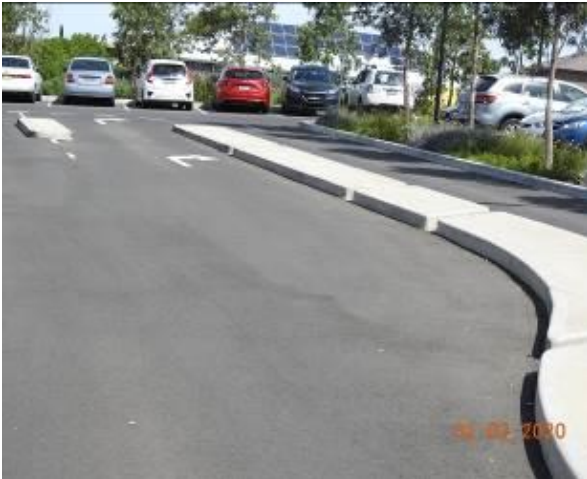
Figure 3078 – General Condition of traffic island kerb

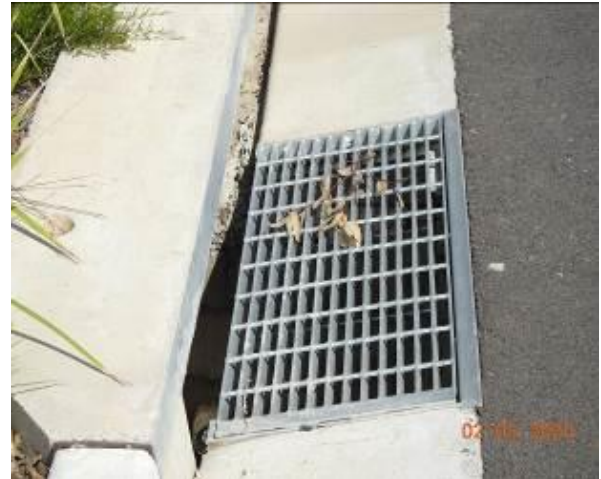
Figure 3079 – General Condition of stormwater inlet pit

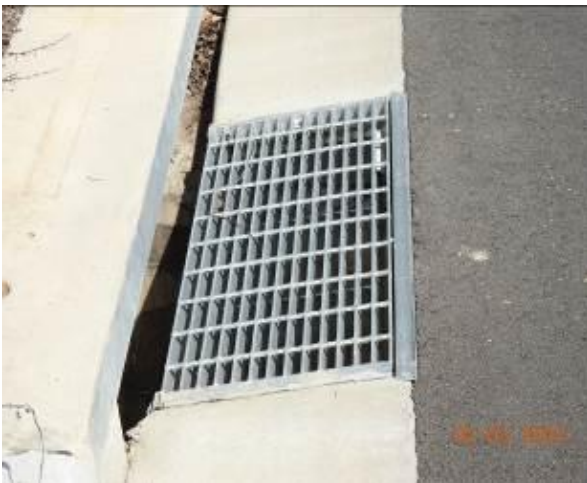
Figure 3080 – Crack propagation through stormwater inlet pit

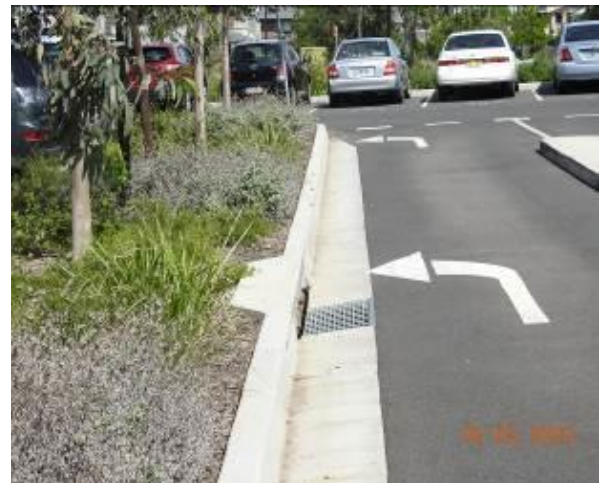
Figure 3081 – General Condition of kerb and gutter

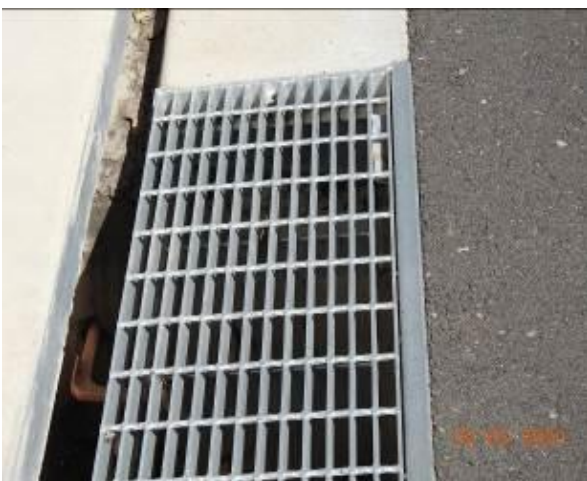
Figure 3082 – General Condition of stormwater inlet pit

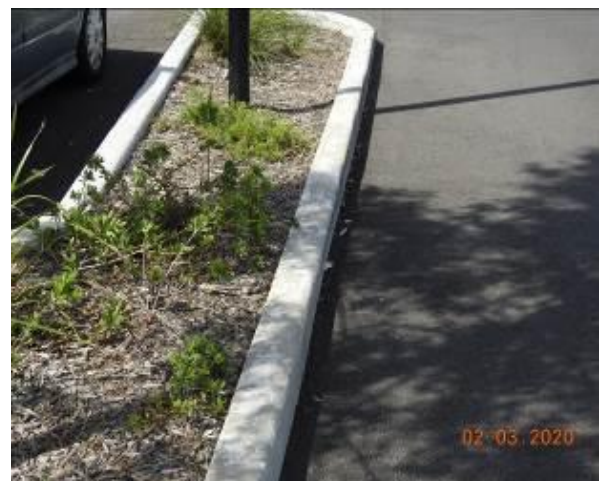
Figure 3083 – General Condition of kerb

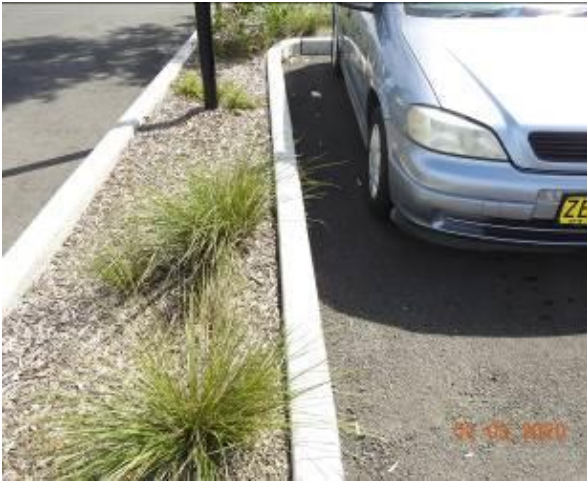
Figure 3084 – General Condition of kerb

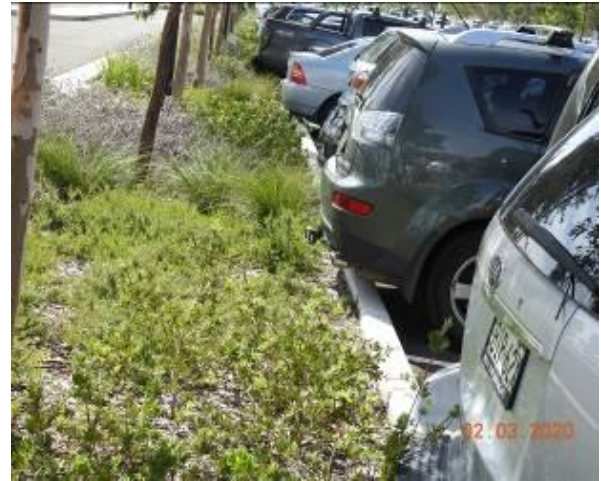
Figure 3085 – General Condition of kerb

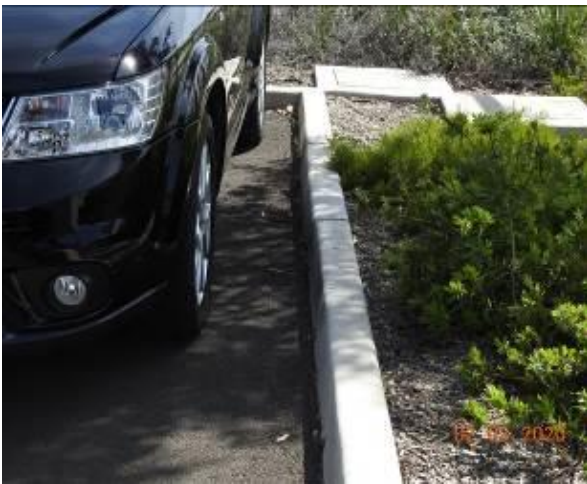
Figure 3086 – General Condition of kerb

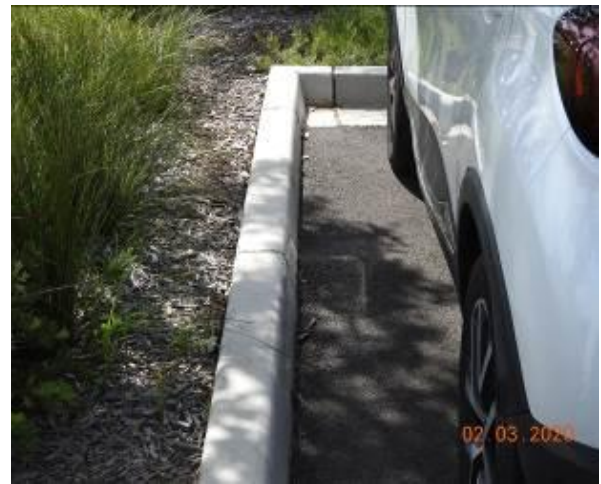
Figure 3087 – General Condition of kerb

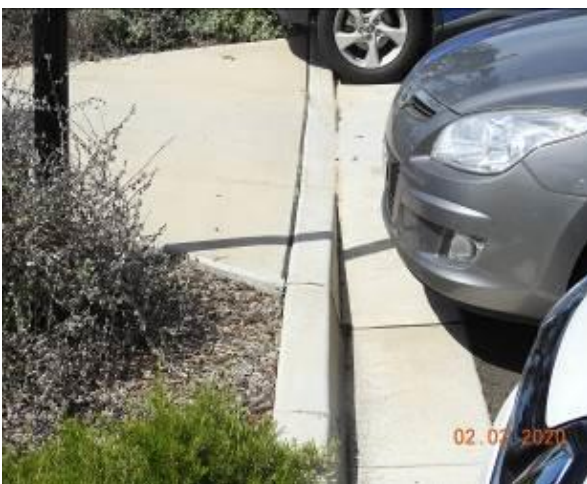
Figure 3088 – General Condition of kerb and gutter

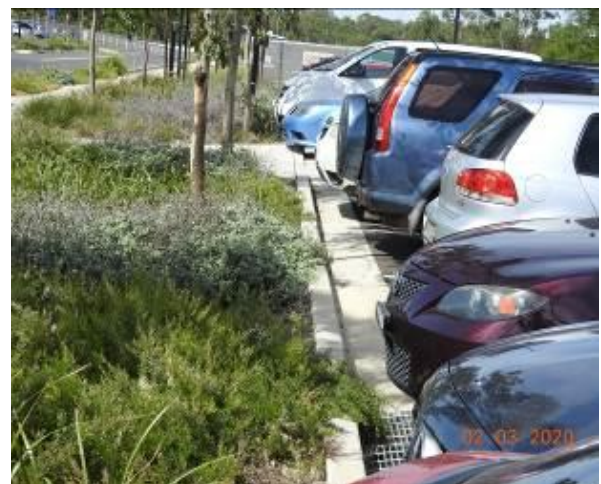
Figure 3089 – General Condition of kerb and gutter

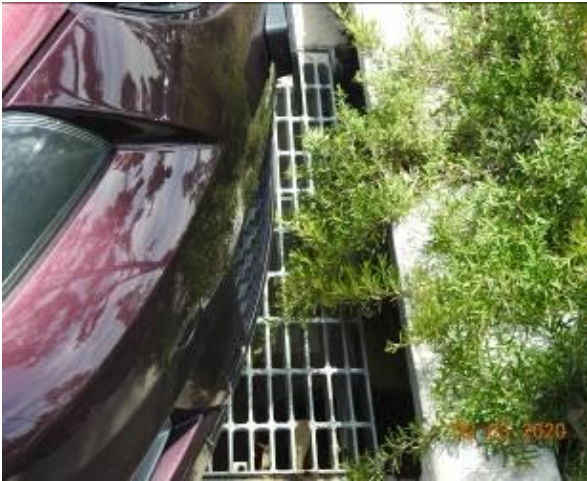
Figure 3090 – General Condition of stormwater inlet pit

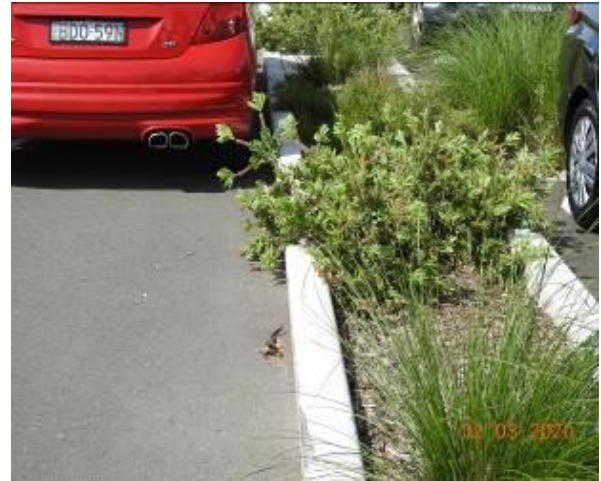
Figure 3091 – General Condition of kerb

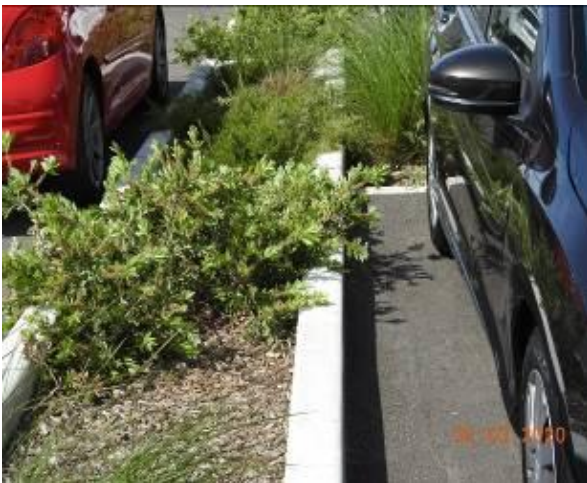
Figure 3092 – General Condition of kerb

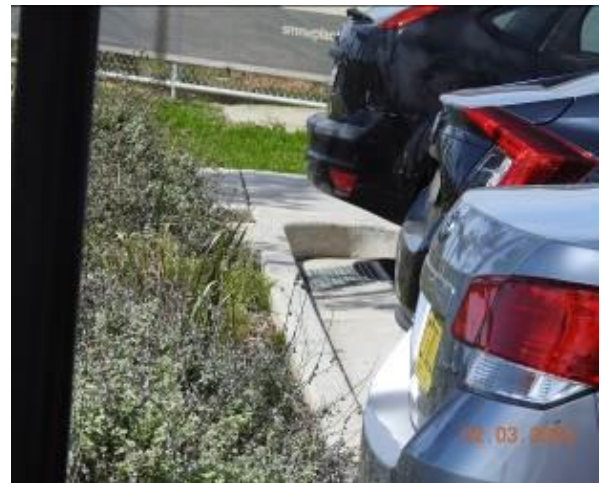
Figure 3093 – General Condition of kerb and gutter

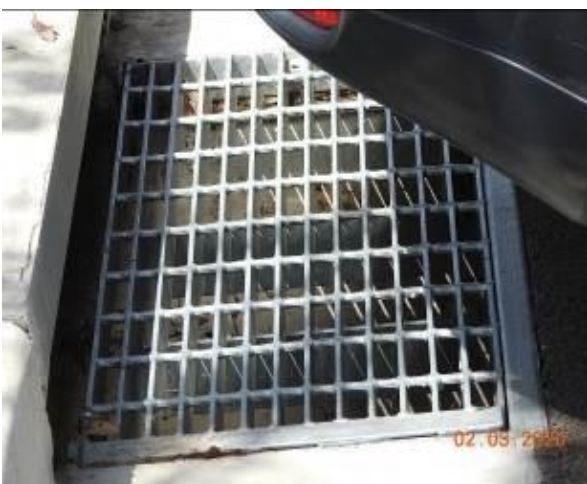
Figure 3094 – Crack propagation through stormwater inlet pit

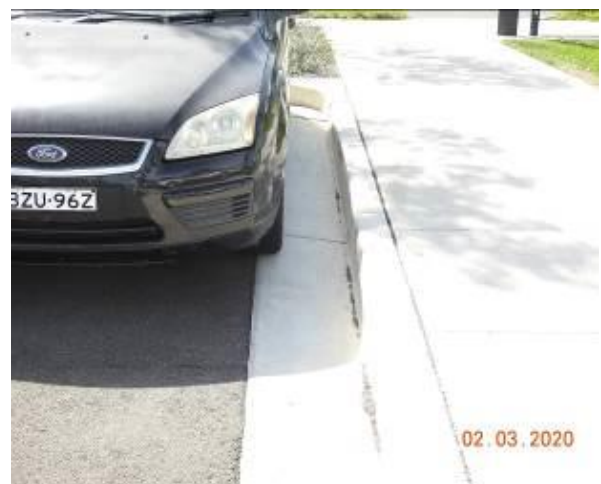
Figure 3095 – General Condition of kerb and gutter

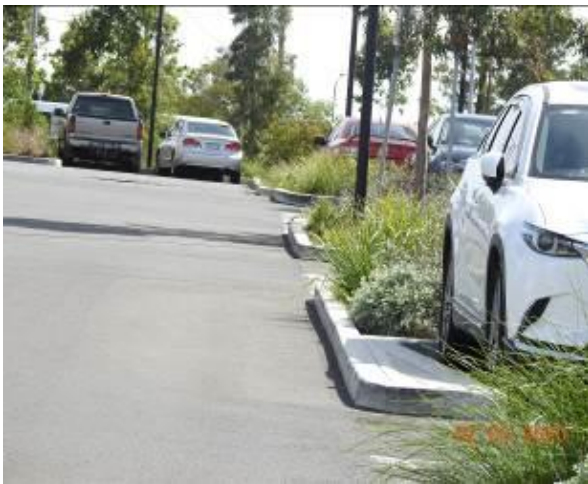
Figure 3098 – General Condition of kerb

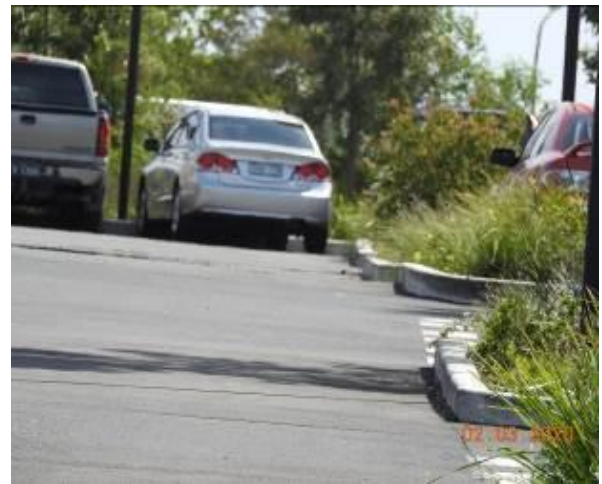
Figure 3099 – General Condition of kerb

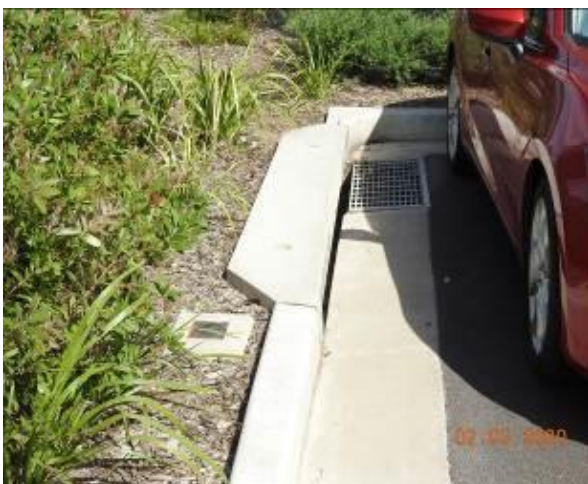
Figure 3100 – General Condition of kerb and gutter
