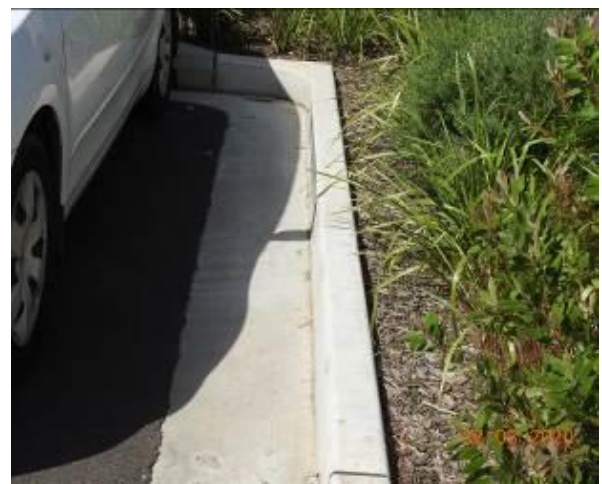
Figure 3101 – General Condition of kerb and gutter

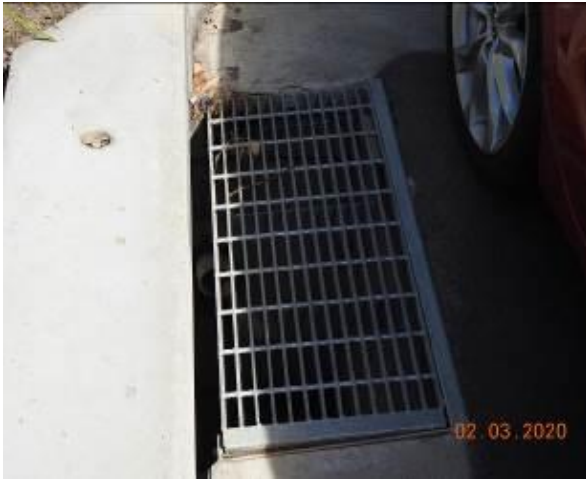
Figure 3102 – General Condition of stormwater inlet pit

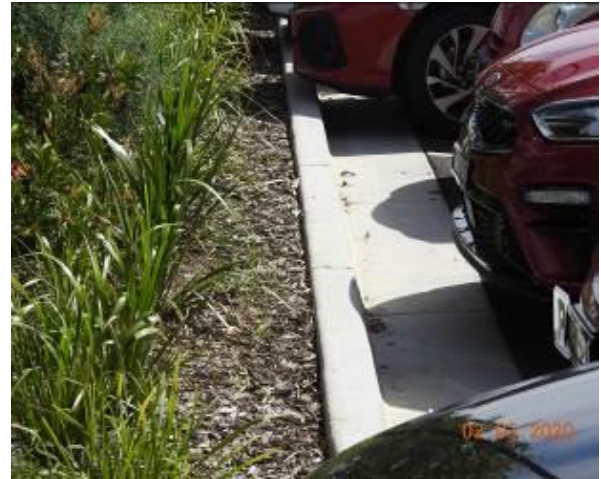
Figure 3103 – General Condition of kerb and gutter

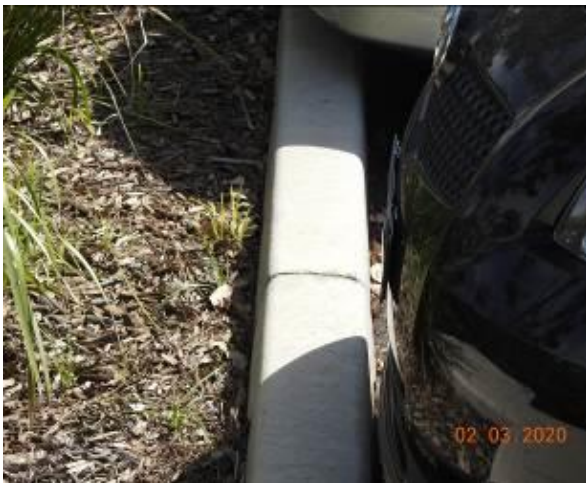
Figure 3104 – Crack propagation through kerb

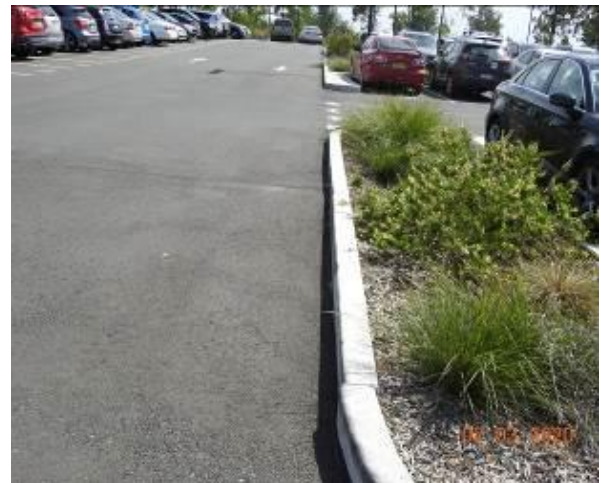
Figure 3105 – General Condition of kerb

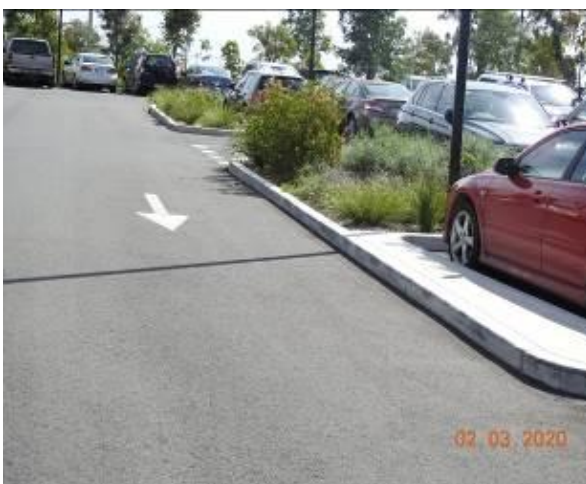
Figure 3106 – General Condition of kerb

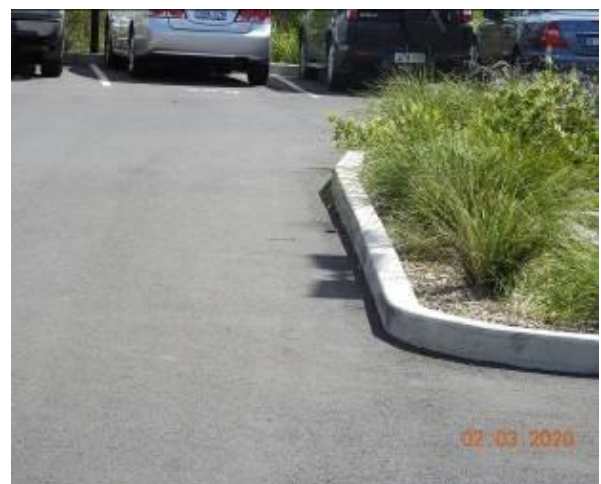
Figure 3107 – General Condition of kerb

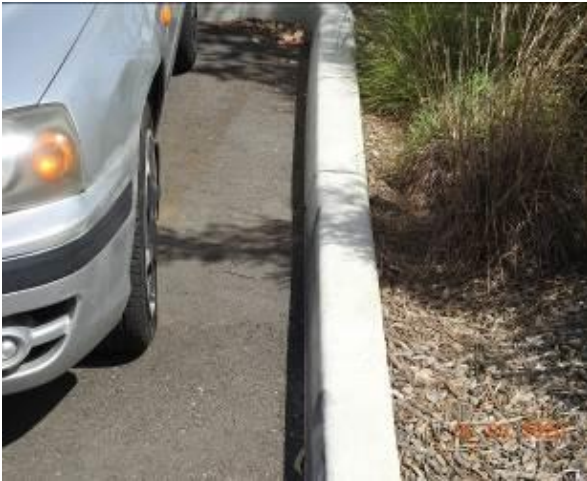
Figure 3108 – General Condition of kerb

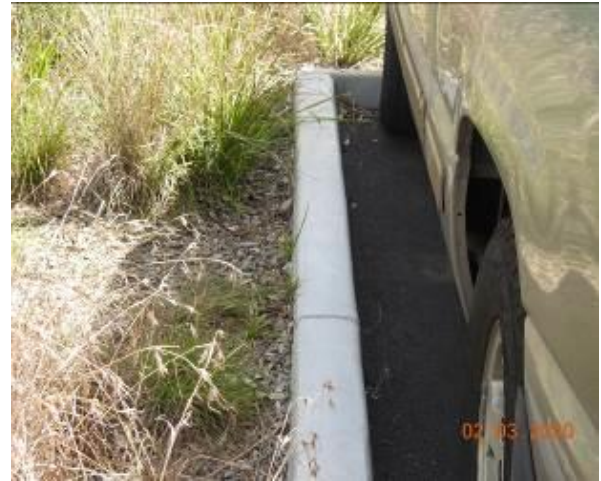
Figure 3109 – General Condition of kerb

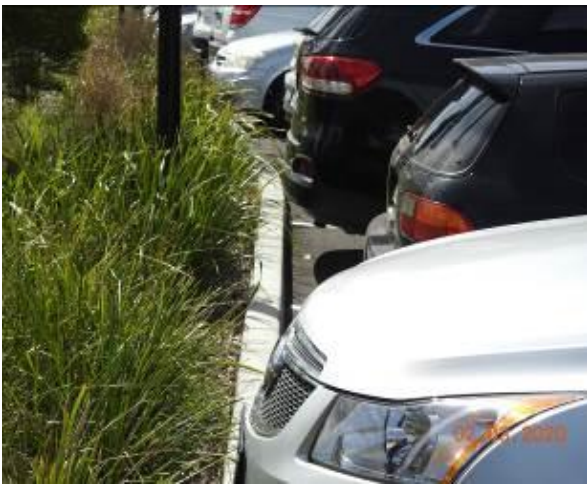
Figure 3110 – General Condition of kerb

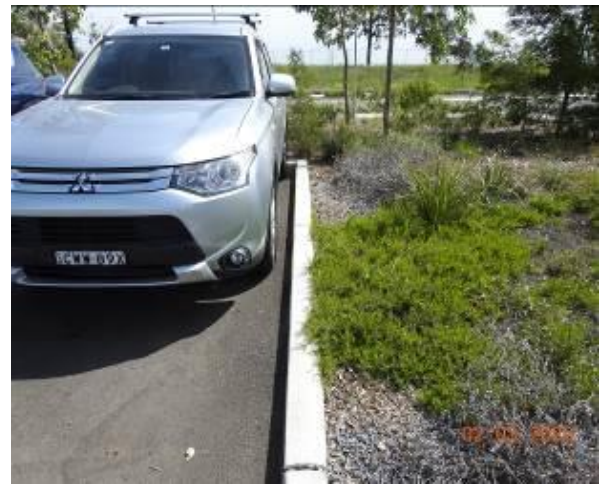
Figure 3111 – General Condition of kerb

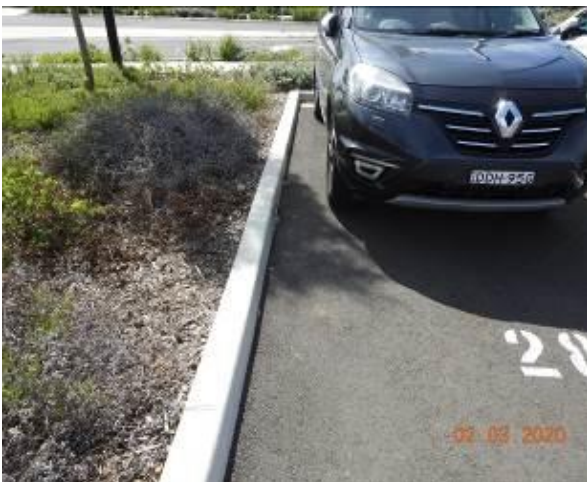
Figure 3112 – General Condition of kerb

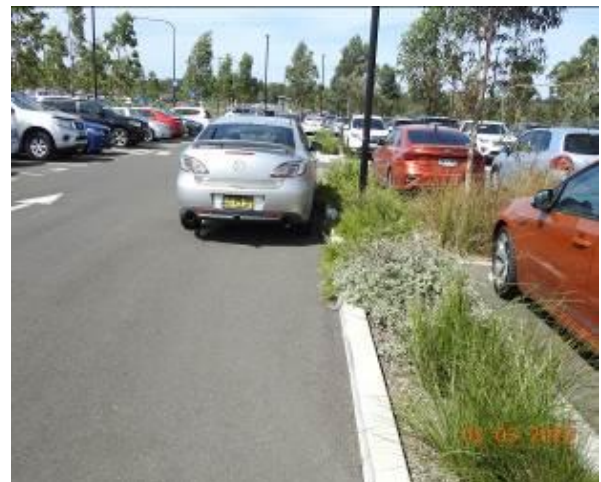
Figure 3113 – General Condition of kerb

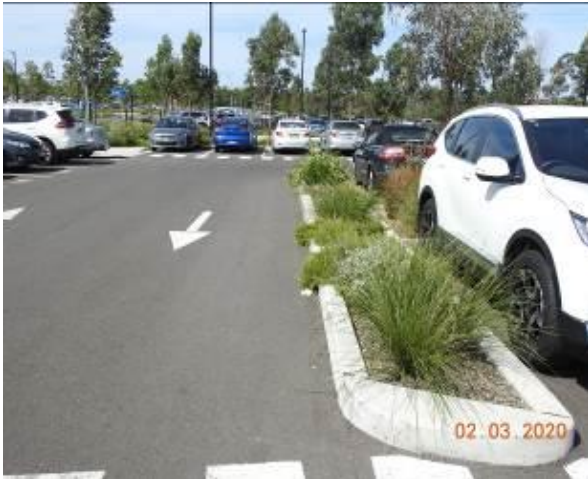
Figure 3114 – General Condition of kerb

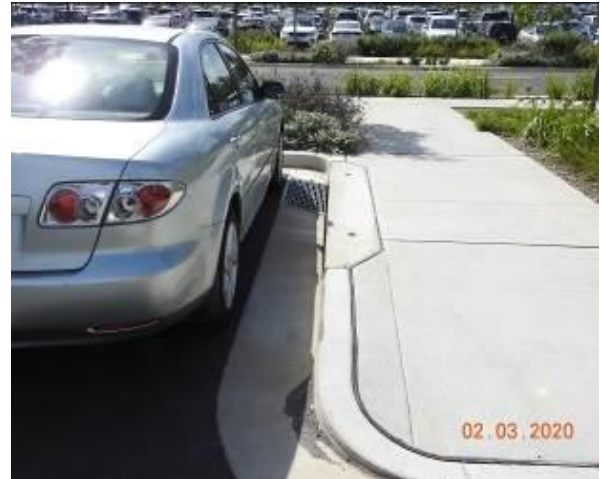
Figure 3115 – General Condition of kerb and gutter

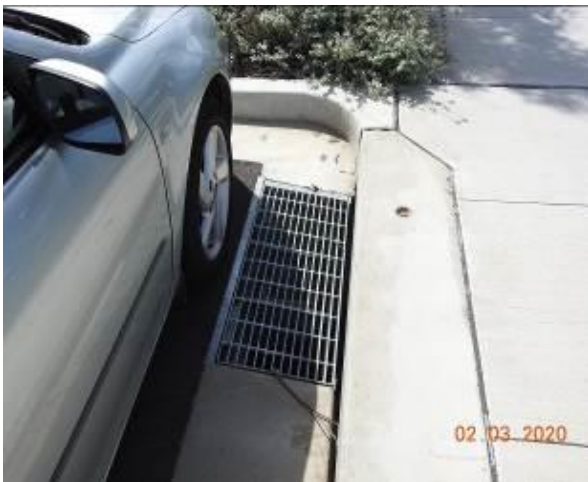
Figure 3116 – General Condition of stormwater inlet pit

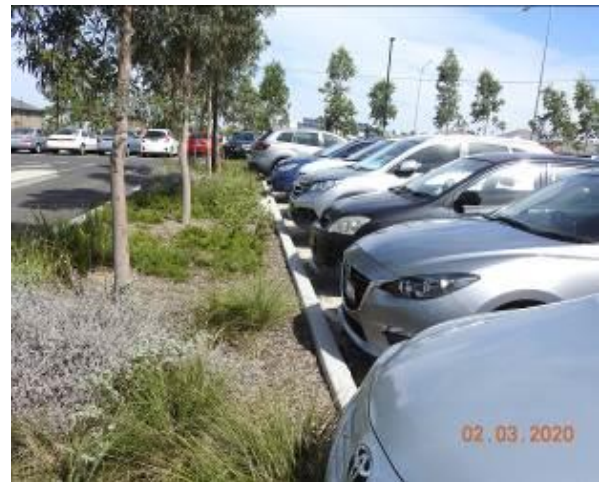
Figure 3117 – General Condition of kerb

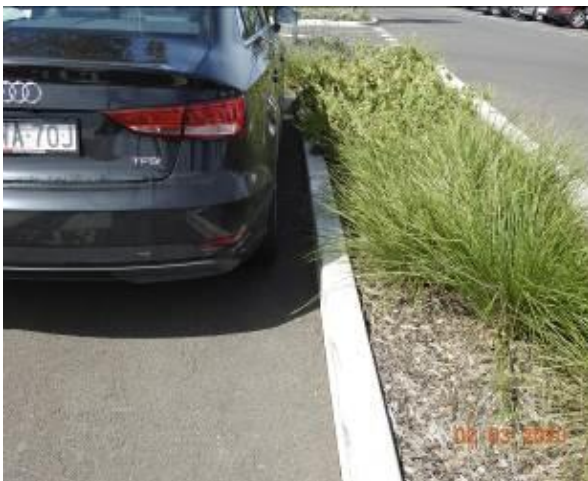
Figure 3118 – General Condition of kerb

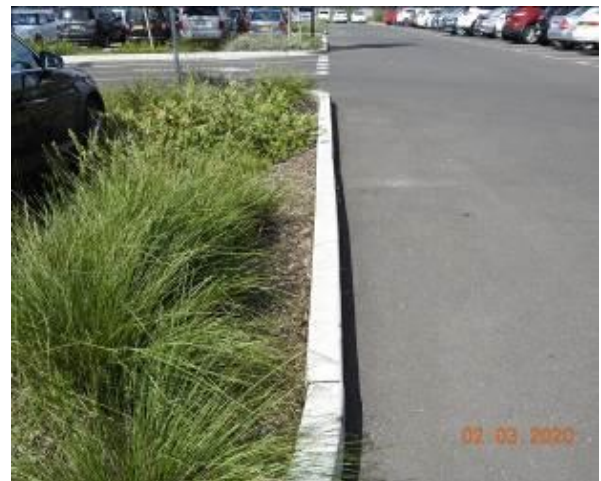
Figure 3119 – General Condition of kerb

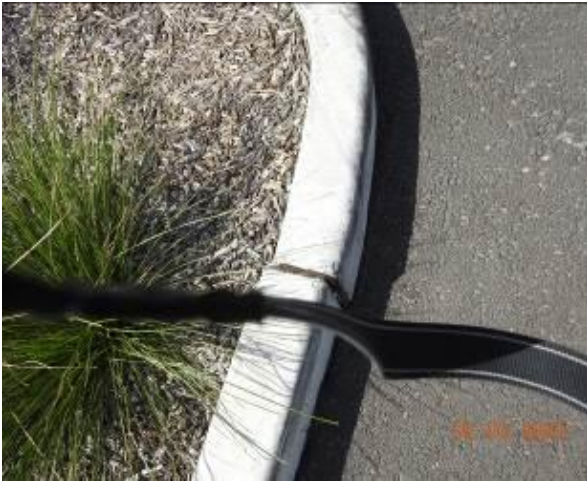
Figure 3120 – Displacement through kerb

The road pavement of the car park was in a reasonable condition with evidence of cracking, material loss and patchwork. The kerb and gutter in the car park were also inspected, they were in a reasonable condition with evidence of displacement through the kerb.

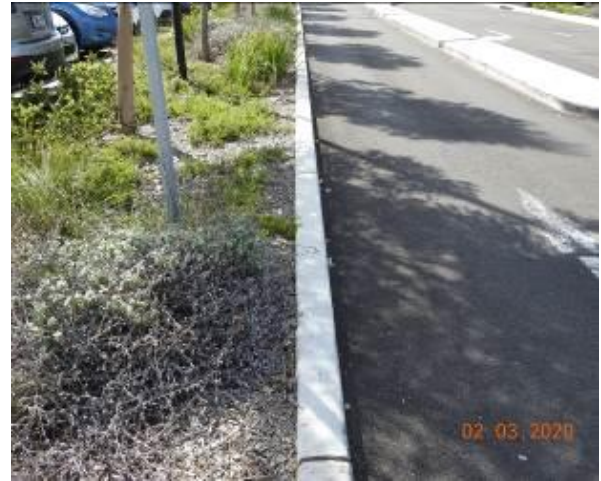
Figure 3121 – General Condition of kerb

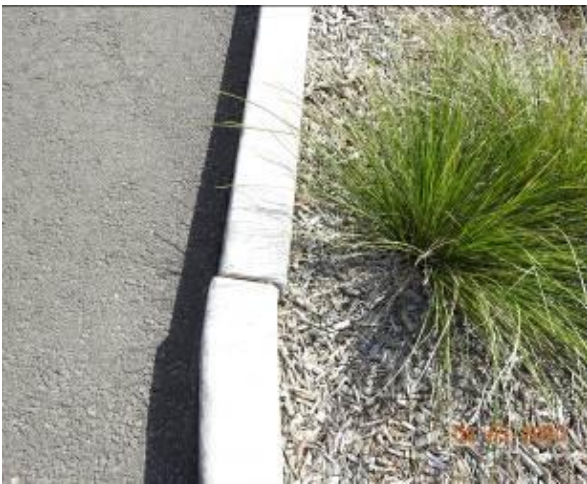
Figure 3122 – Displacement through kerb

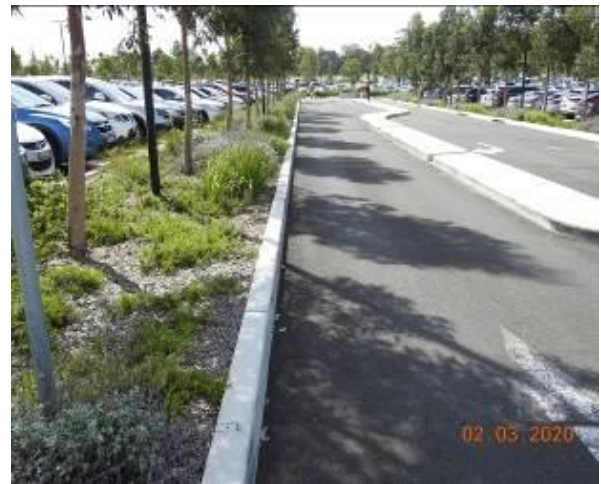
Figure 3123 – General Condition of kerb

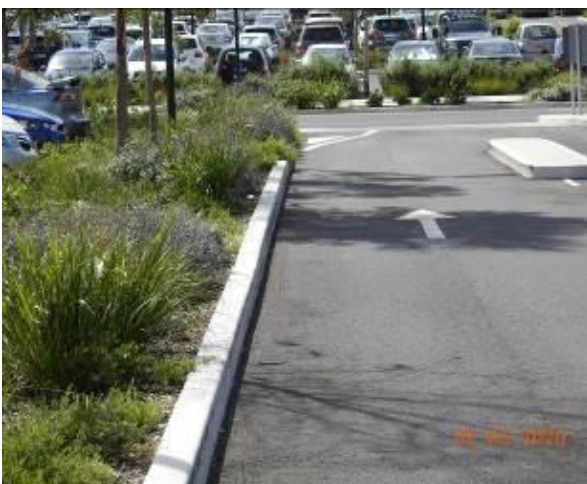
Figure 3124 – General Condition of kerb

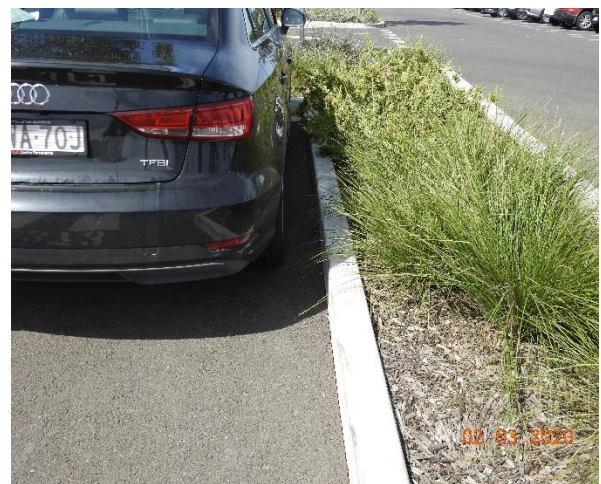
Figure 3125 – General Condition of kerb
