# DILAPIDATION REPORT

## Council Assets/Public Infrastructure

**WATERLOO STATION  
COPE STREET**

**24 January 2023**

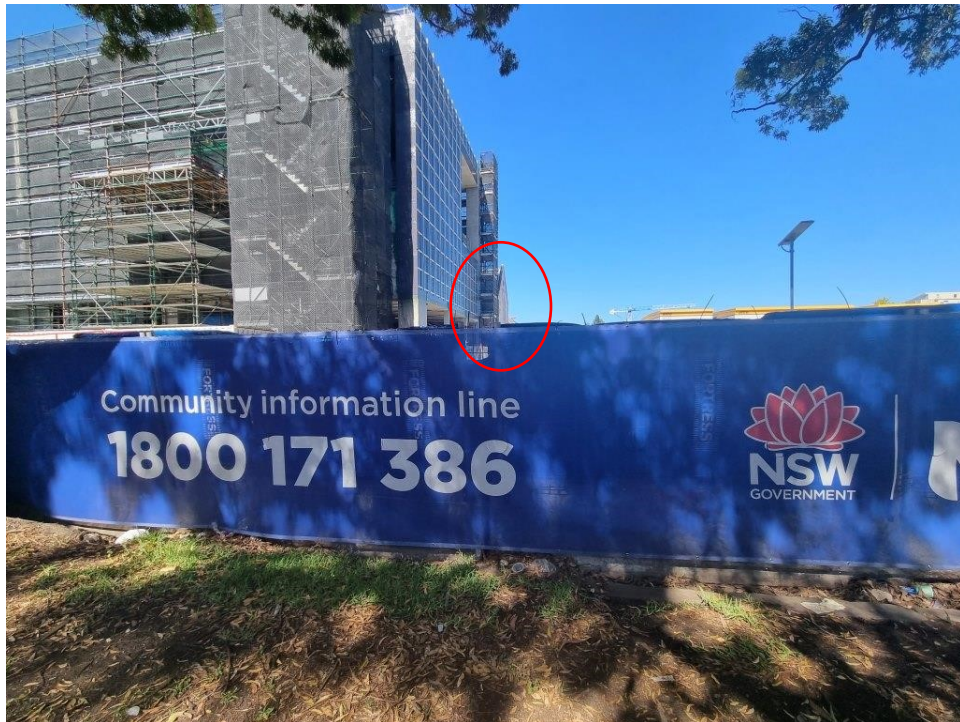
**PHOTO 1**

(Photo showing start point of dilapidation inspection in line of the Waterloo Congregation Church, circled in red, on Cope Street)

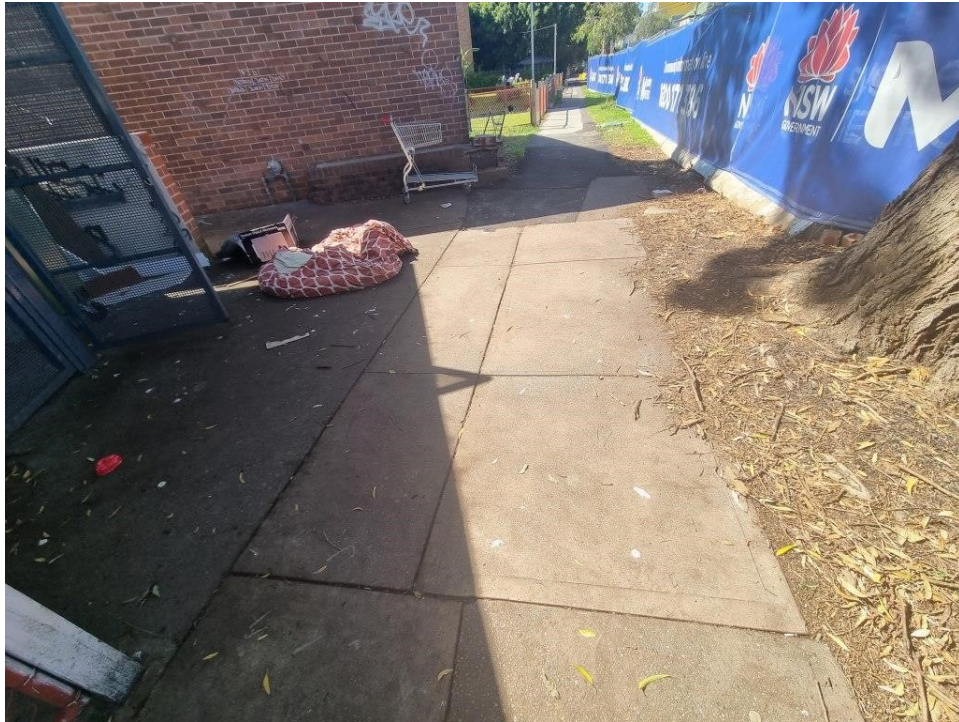
**PHOTO 7**

(Overview of footpath adjacent 213-215 Cope Street)

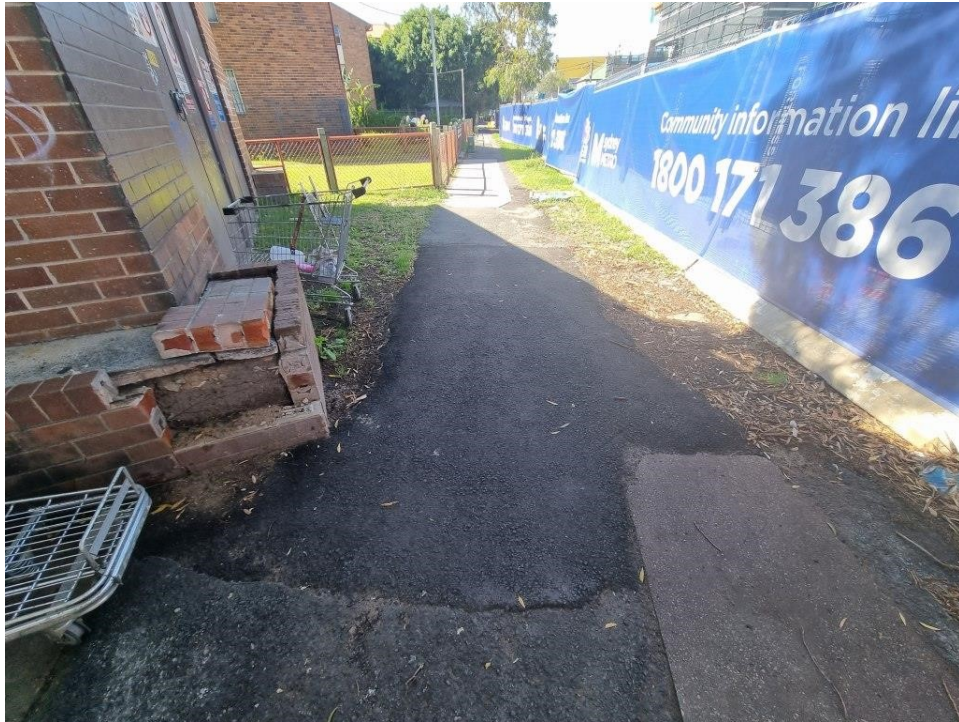
**PHOTO 9**

(Overview of uneven footpath adjacent 215 Cope Street)

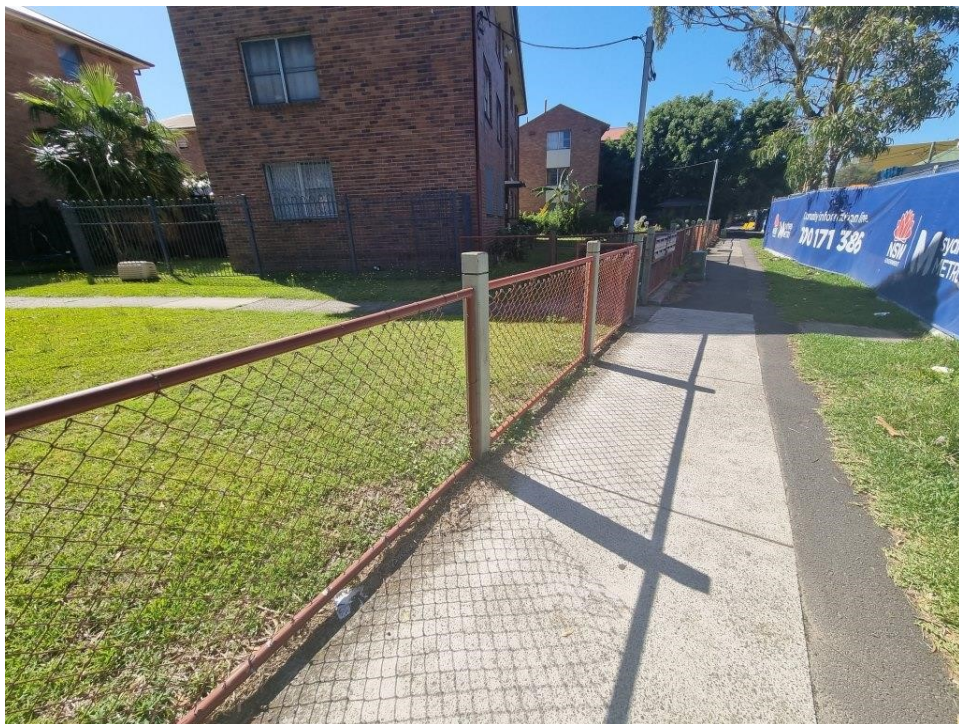
**PHOTO 16**

(Photo showing mesh boundary fence with timber posts of 215 Cope Street and adjacent footpath)

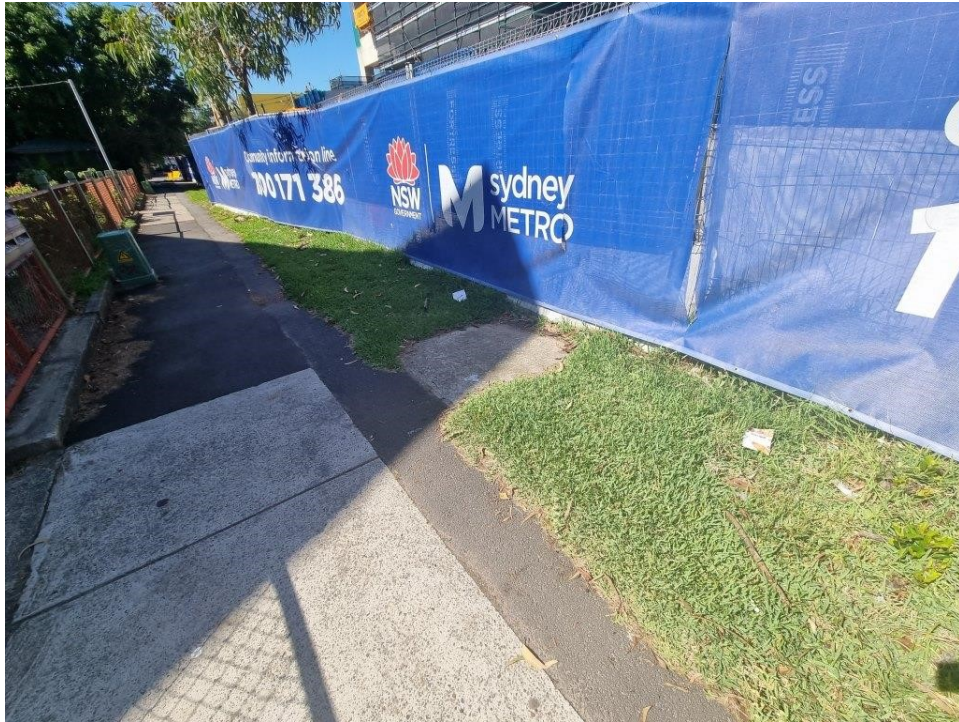
**PHOTO 17**

(Photo showing footpath adjacent to 215 Cope Street)

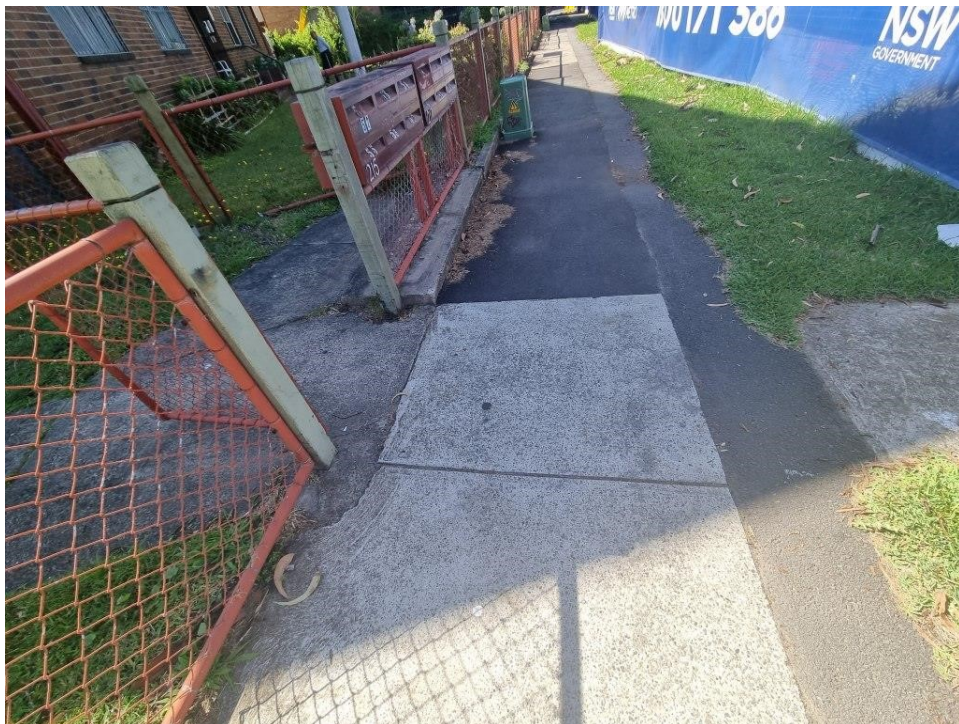
**PHOTO 18**

(Photo showing footpath adjacent to 215 Cope Street)

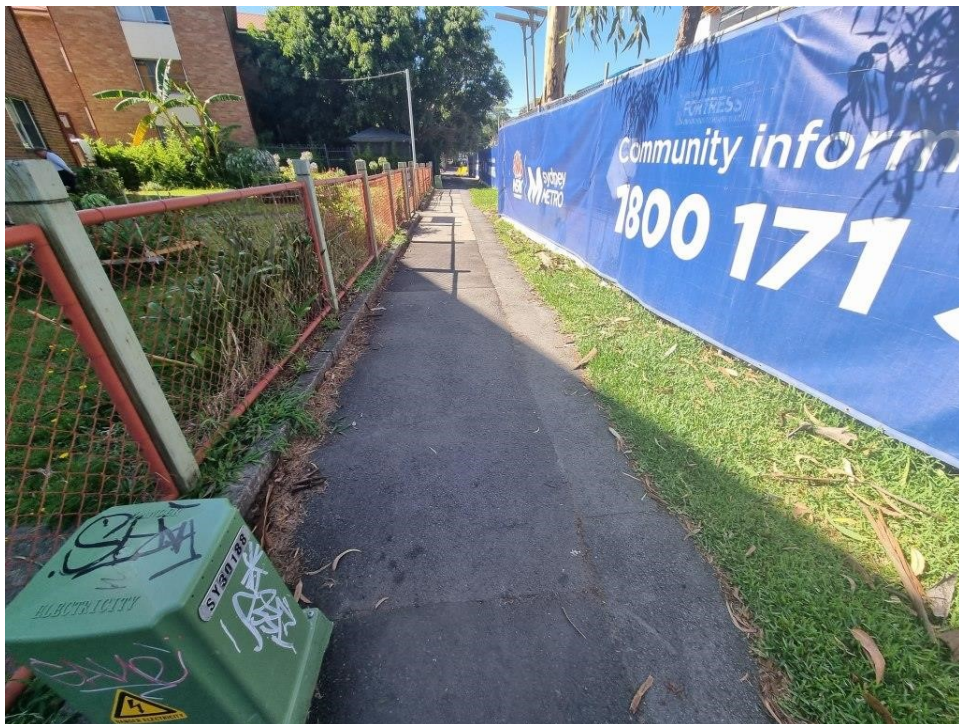
**PHOTO 22**

(Photo showing footpath adjacent to 217 Cope Street mailboxes)

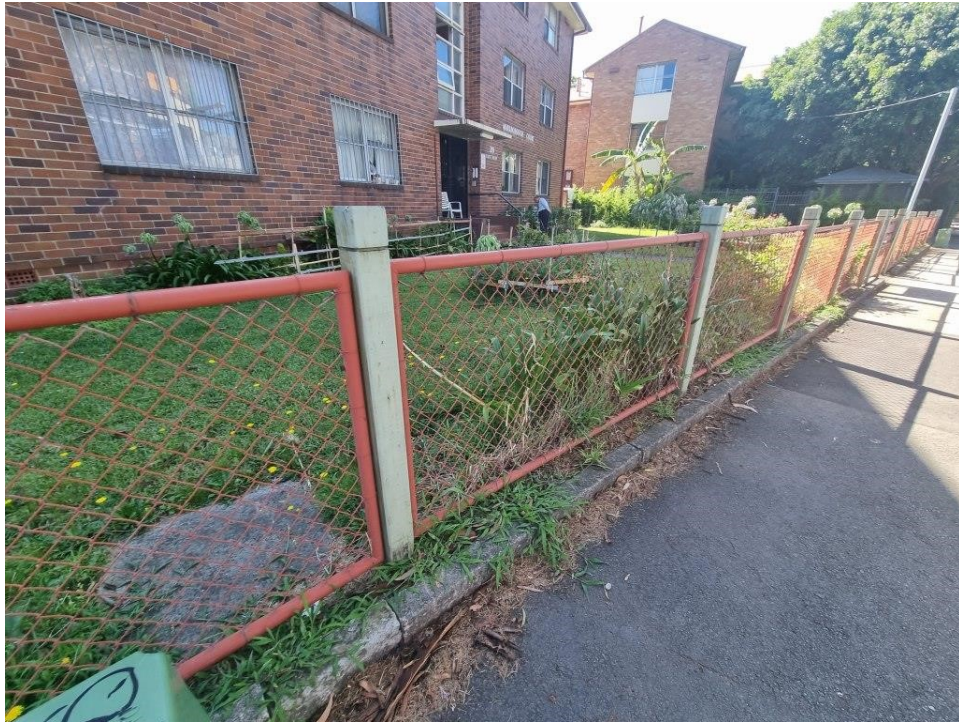
**PHOTO 23**

(Photo showing boundary fence adjacent to 215 Cope Street)

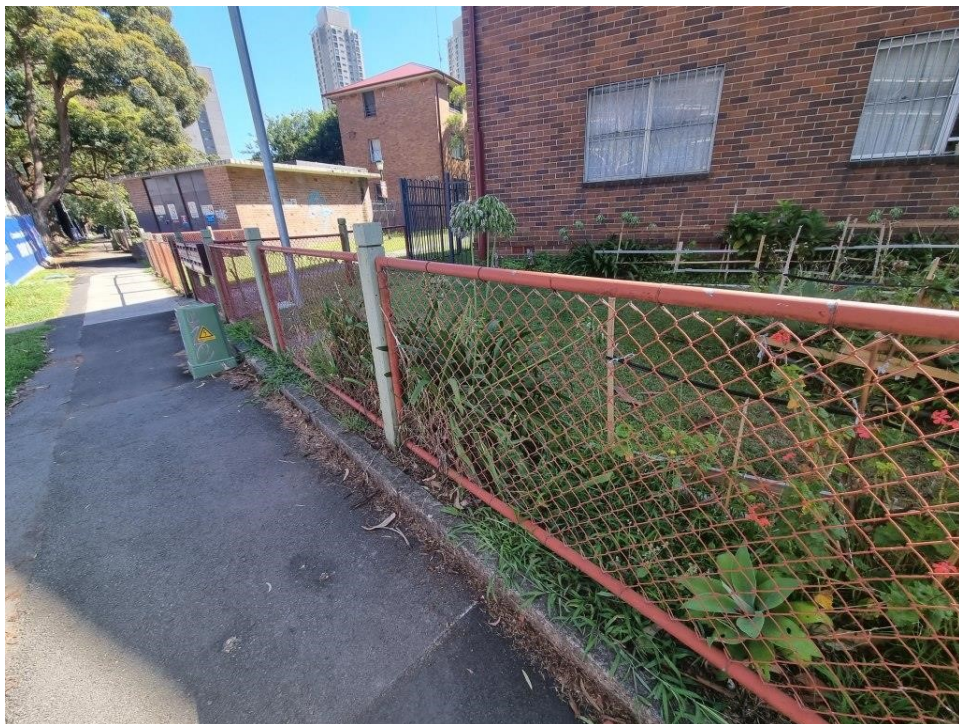
**PHOTO 24**

(Photo showing footpath adjacent to 215 Cope Street and boundary fence)

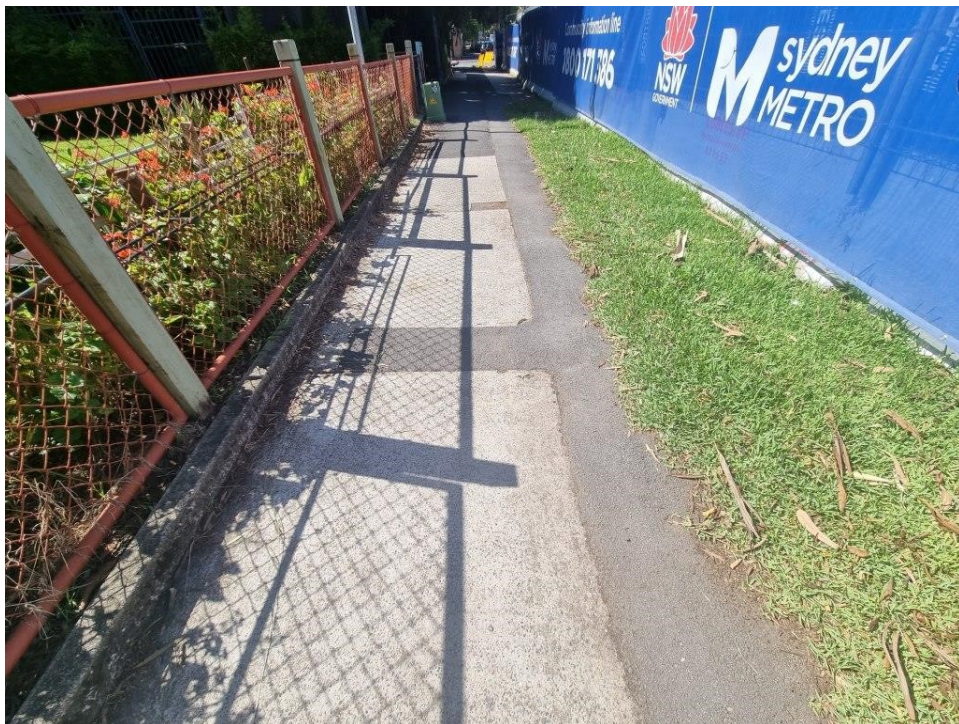
**PHOTO 28**

(Photo showing footpath adjacent 219 Cope Street and boundary fence)

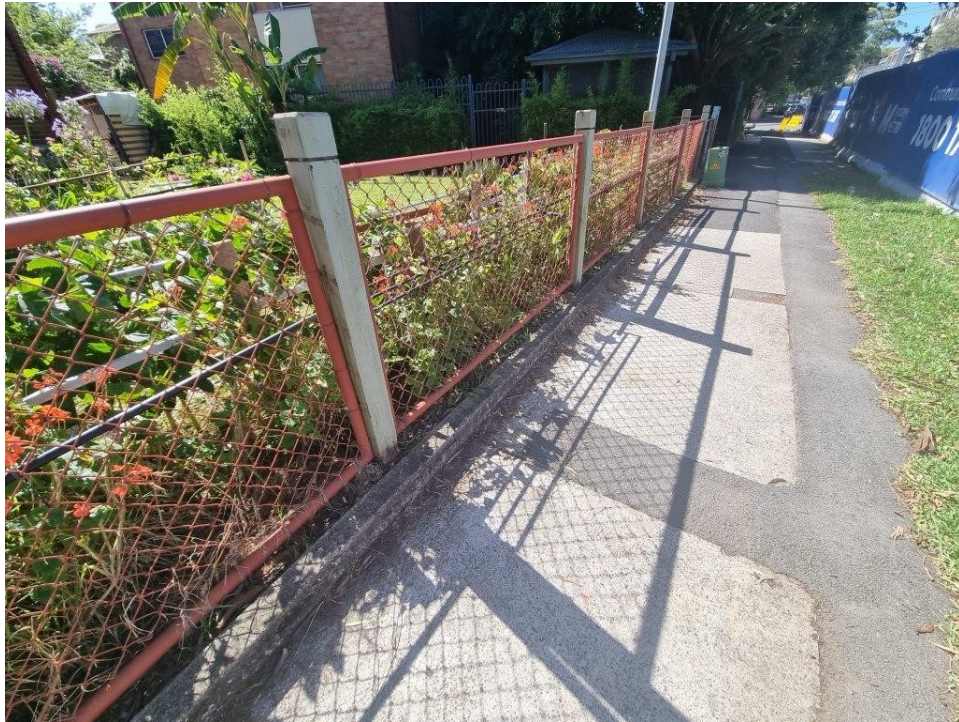
**PHOTO 29**

(Photo showing footpath adjacent 219 Cope Street and boundary fence)

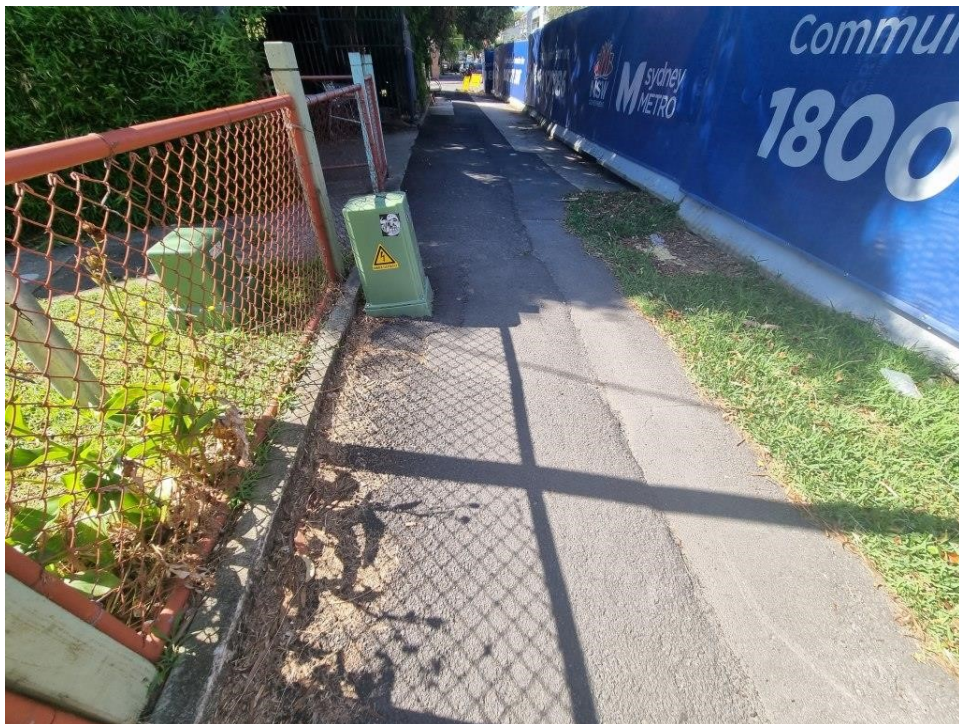
**PHOTO 30**

(Photo showing footpath adjacent 219 Cope Street and boundary fence)

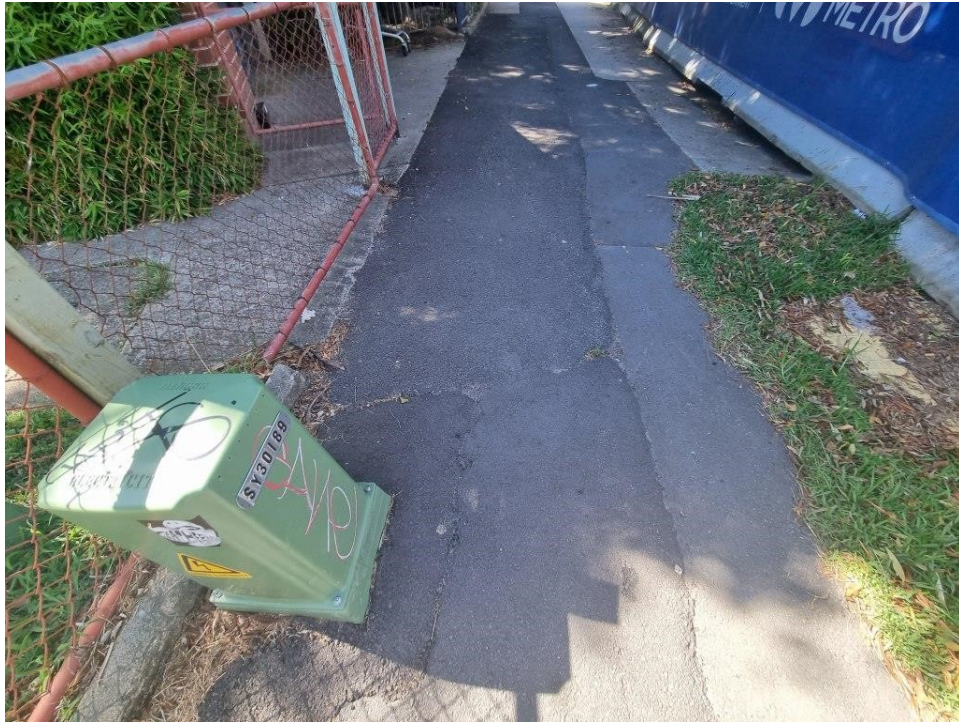
**PHOTO 31**

(Photo showing footpath adjacent 219 Cope Street, boundary fence and electricity box)

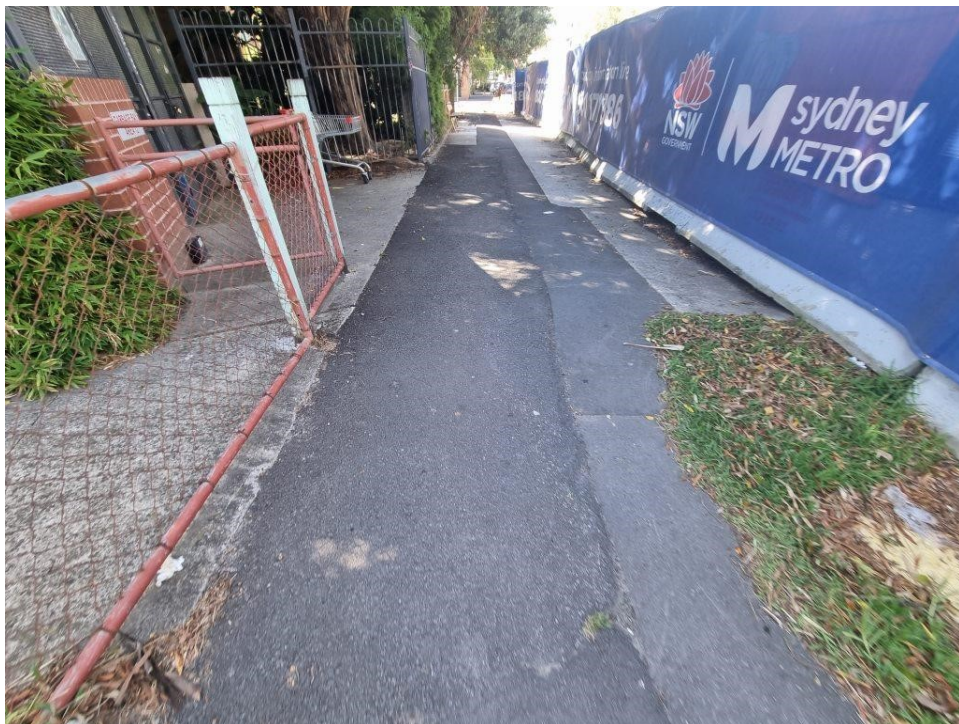
**PHOTO 32**

(Photo showing footpath adjacent 219 Cope Street and boundary fence)

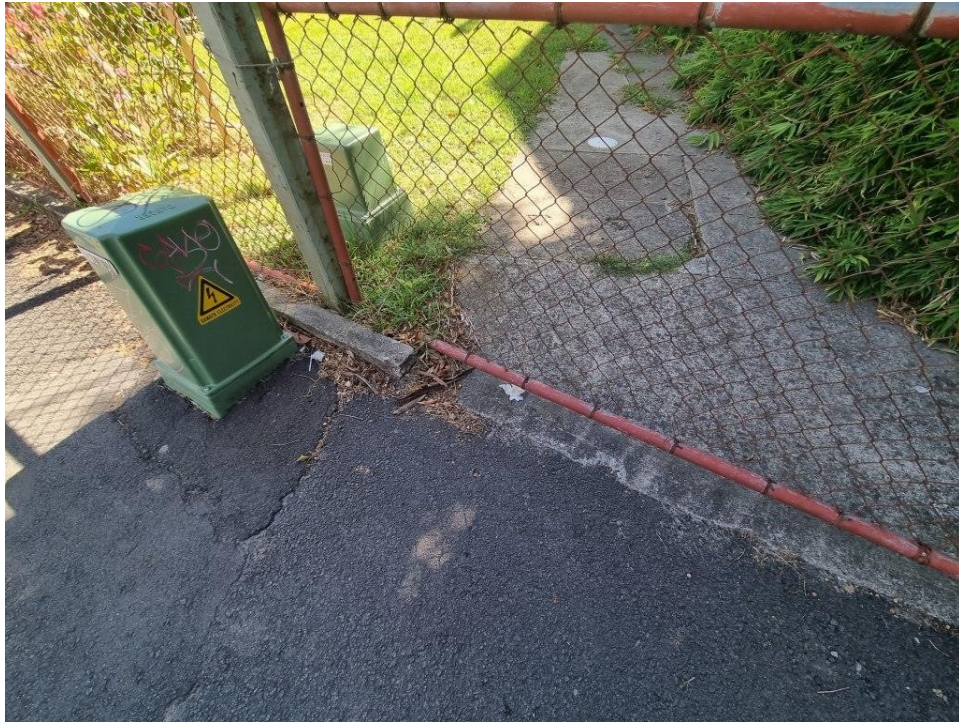
**PHOTO 33**

(Photo showing footpath adjacent 219 Cope Street, boundary fence and electricity box)

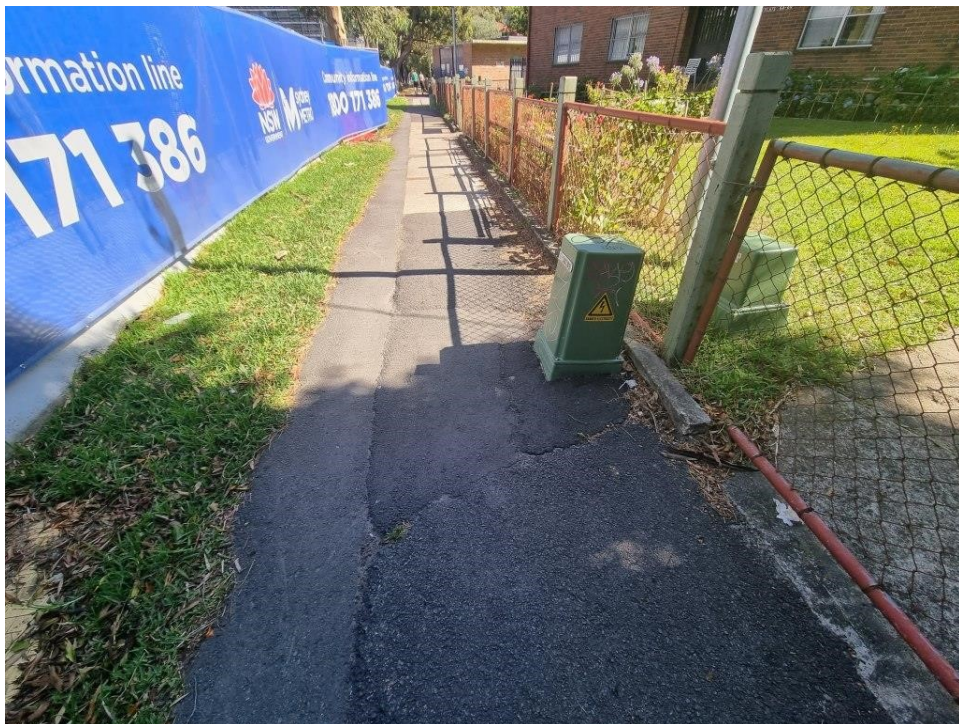
**PHOTO 34**

(Photo showing footpath adjacent 219 Cope Street, boundary fence and electricity box)

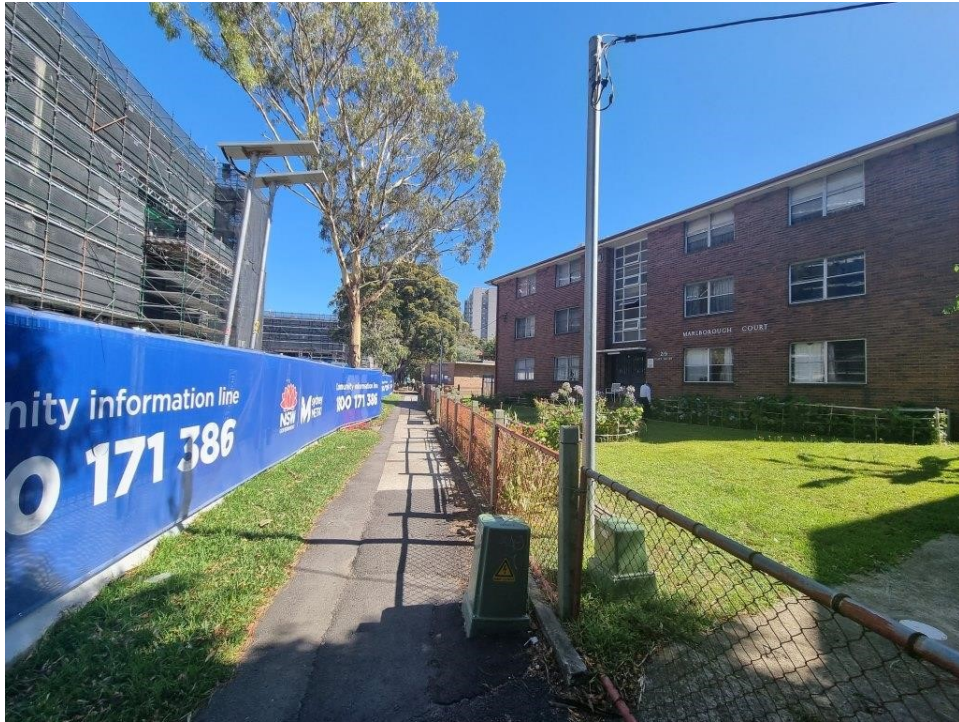
**PHOTO 35**

(Overview of Cope Street facing North from 219 Cope Street)

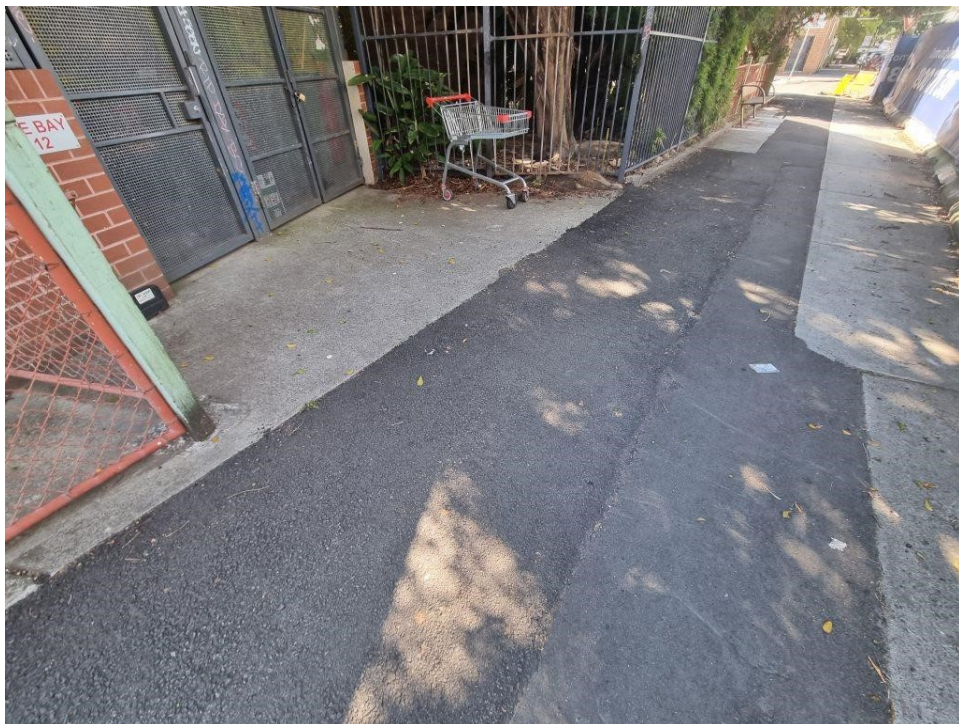
**PHOTO 36**

(Overview of footpath adjacent garage bay of 219 Cope Street)

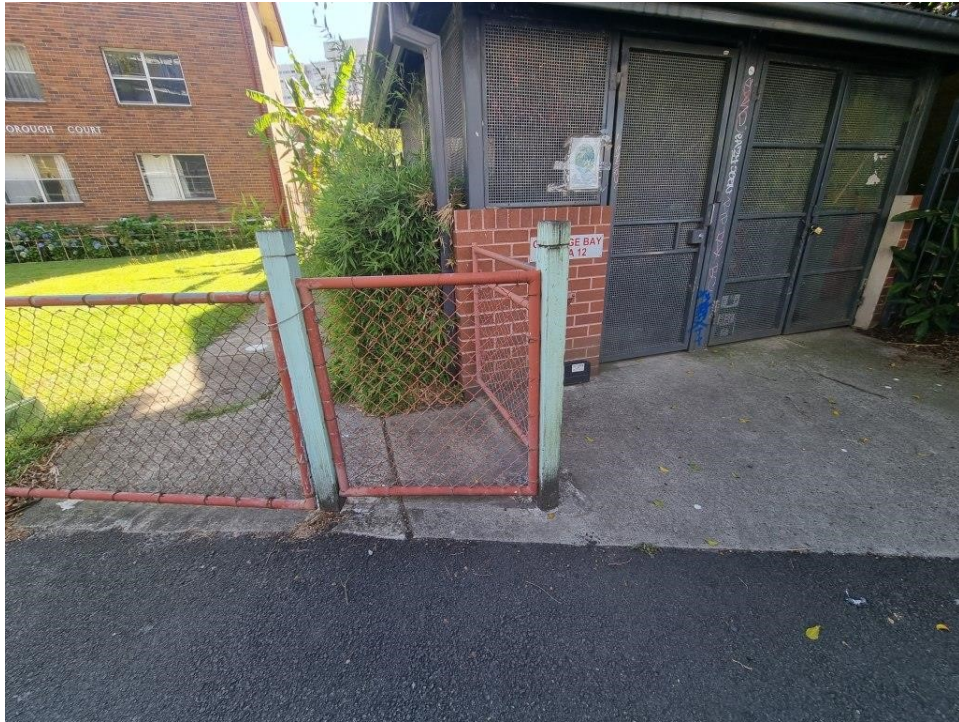
**PHOTO 37**

(Overview of footpath adjacent garage bay of 219 Cope Street and boundary fence)

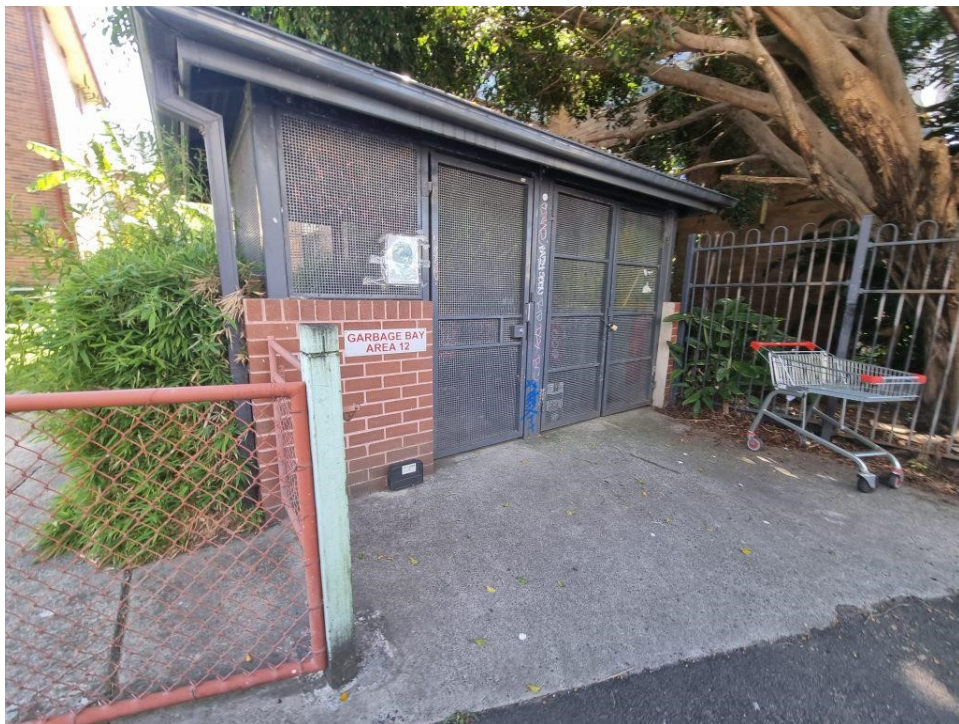
**PHOTO 38**

(Overview of footpath adjacent garage bay of 219 Cope Street and boundary fence)

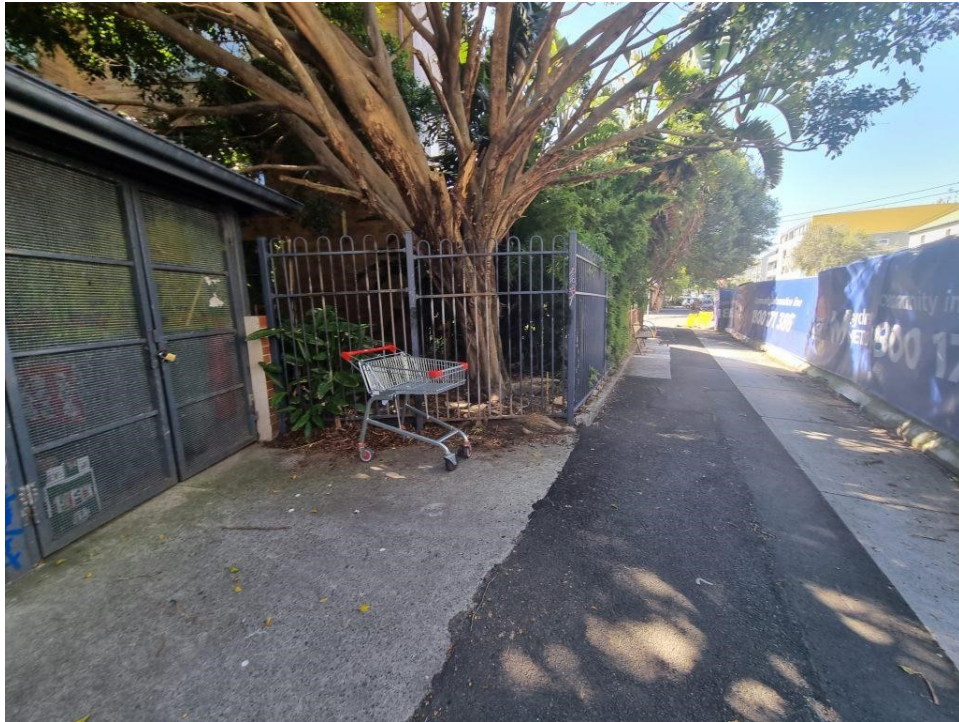
**PHOTO 39**

(Overview of footpath adjacent garage bay of 219 Cope Street and boundary fence)

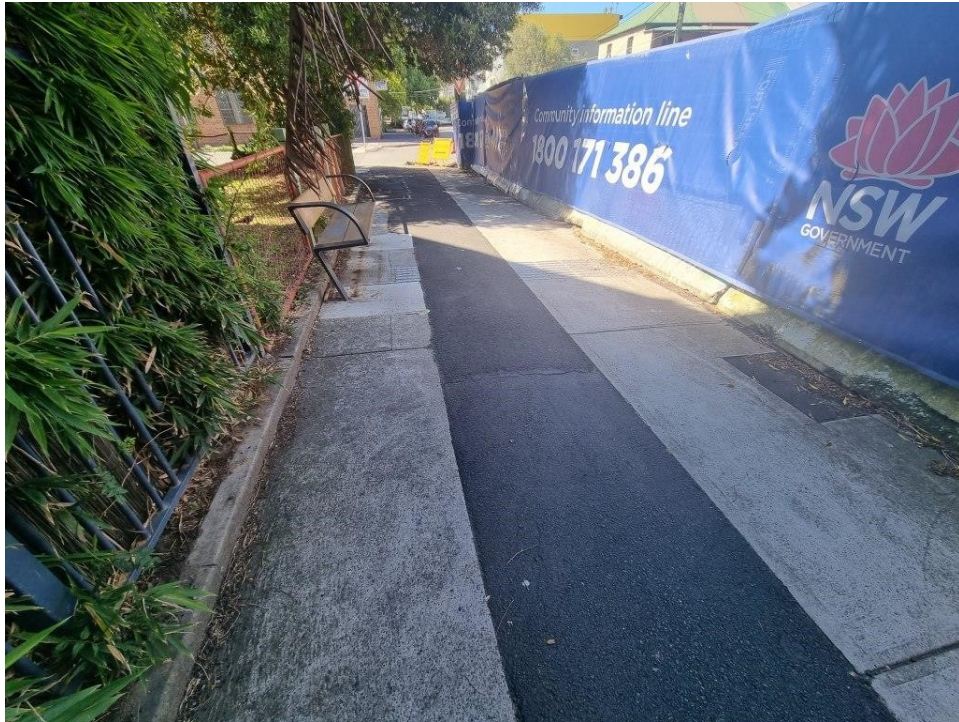
**PHOTO 45**

(Overview of footpath, bench adjacent to 113 Wellington Street along Cope Street)

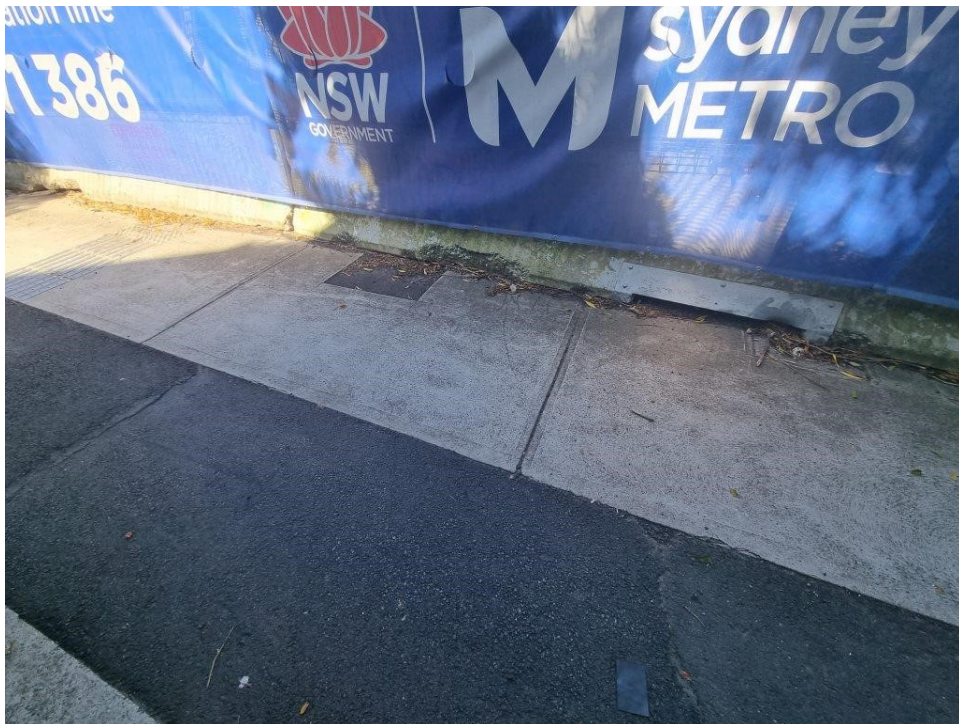
**PHOTO 46**

(Overview of footpath adjacent to 113 Wellington Street along Cope Street)

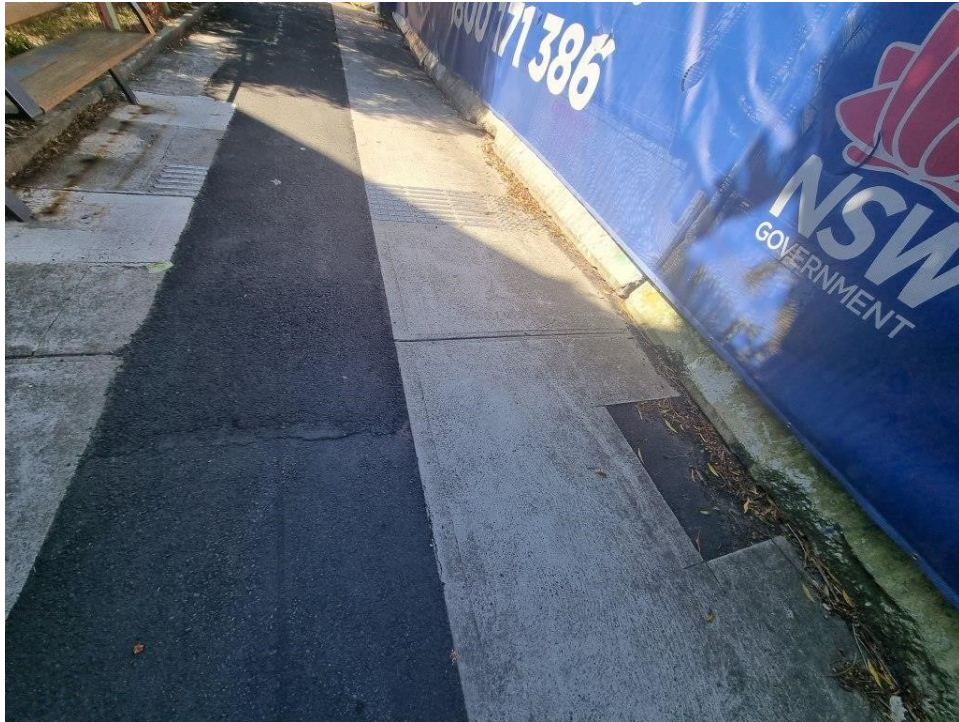
**PHOTO 47**

(Overview of footpath adjacent to 113 Wellington Street along Cope Street)

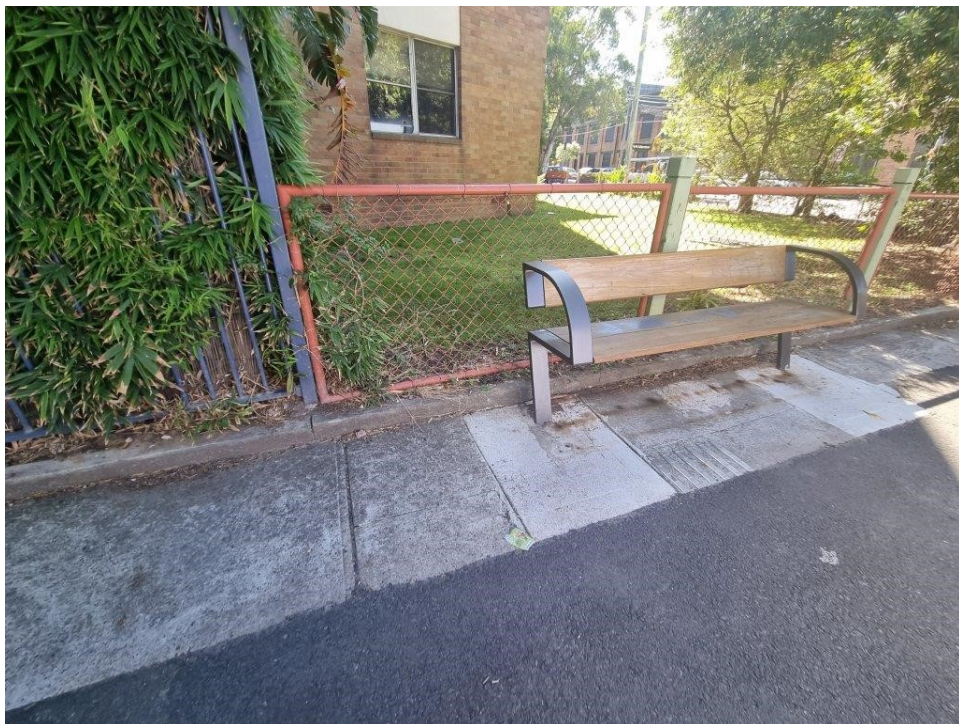
**PHOTO 48**

(Overview of footpath, bench adjacent to 113 Wellington Street along Cope Street)

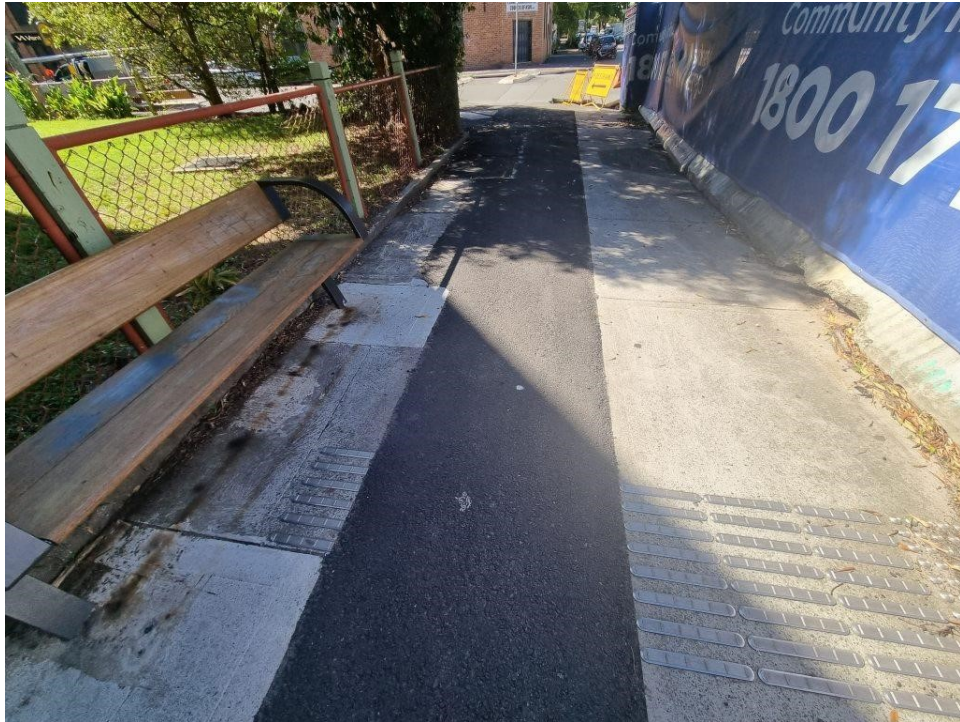
**PHOTO 49**

(Overview of footpath, bench adjacent to 113 Wellington Street along Cope Street)

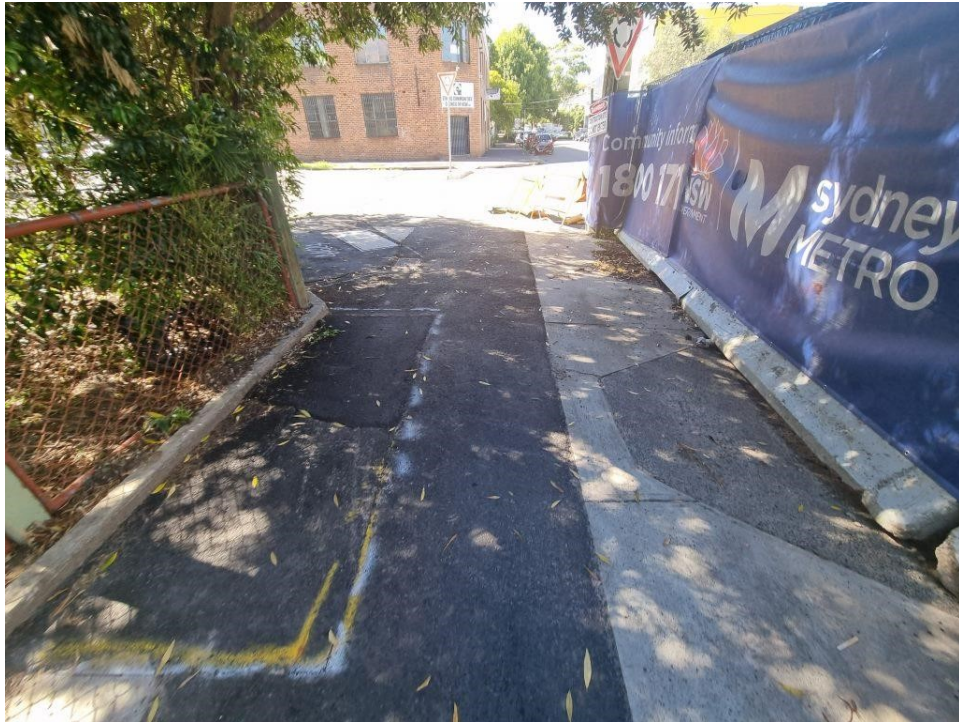
**PHOTO 51**

(Overview of footpath adjacent to 113 Wellington Street along Cope Street)

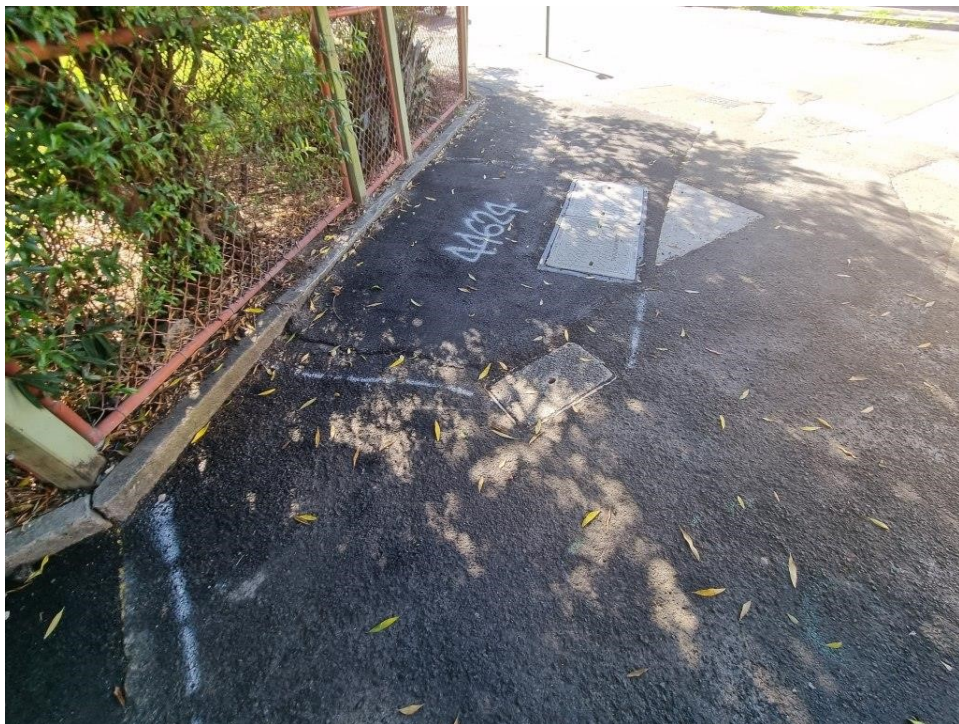
**PHOTO 52**

(Overview of footpath adjacent to 113 Wellington Street in corner of Cope Street and Wellington Street)

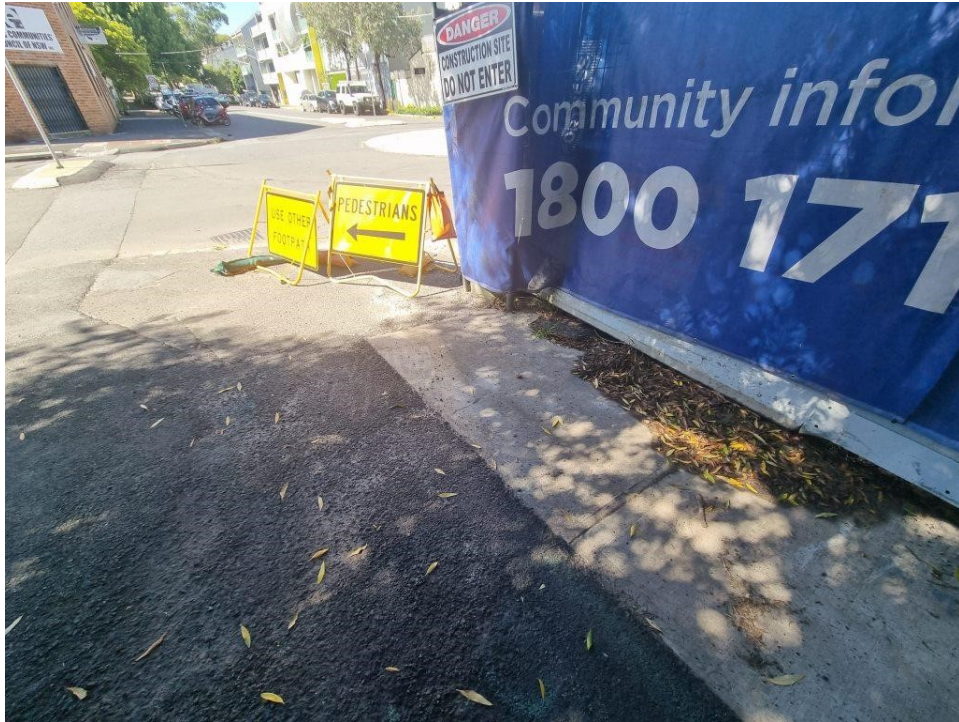
**PHOTO 53**

(Overview of footpath adjacent to 113 Wellington Street in corner of Cope Street and Wellington Street)

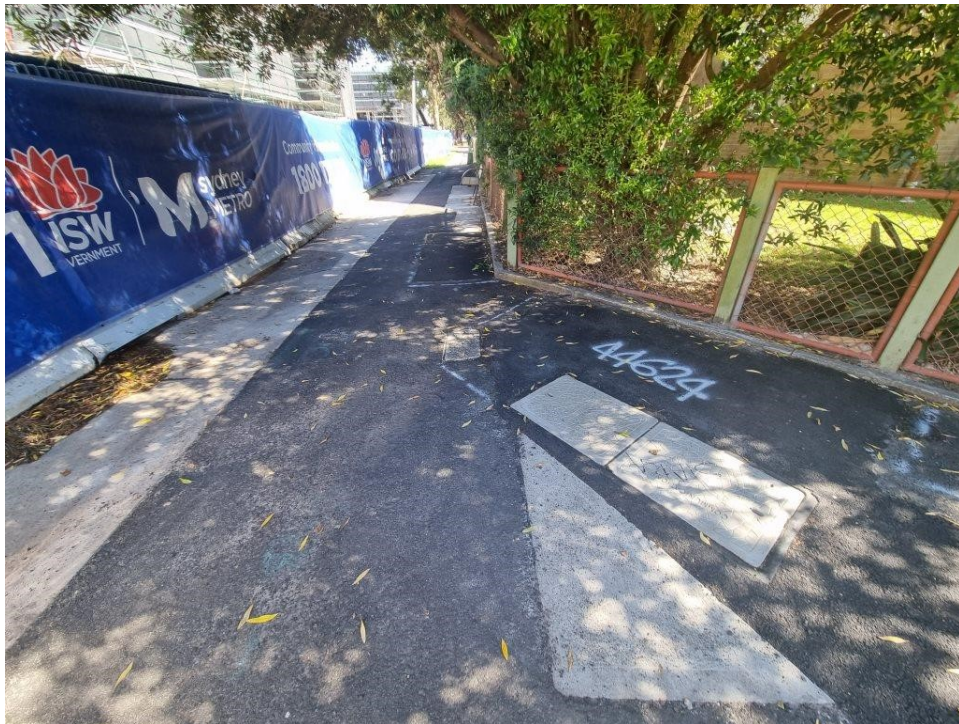
**PHOTO 54**

(Overview of footpath adjacent to 113 Wellington Street in corner of Cope Street and Wellington Street)

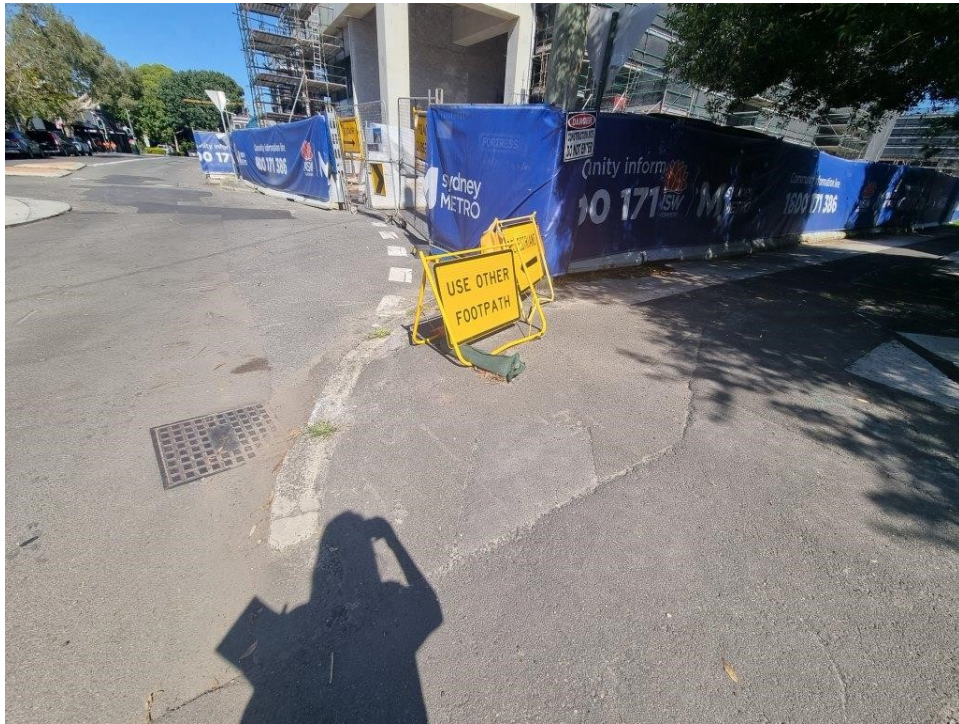
**PHOTO 58**

(Photo showing roundabout intersection of Cope Street and Wellington Road)

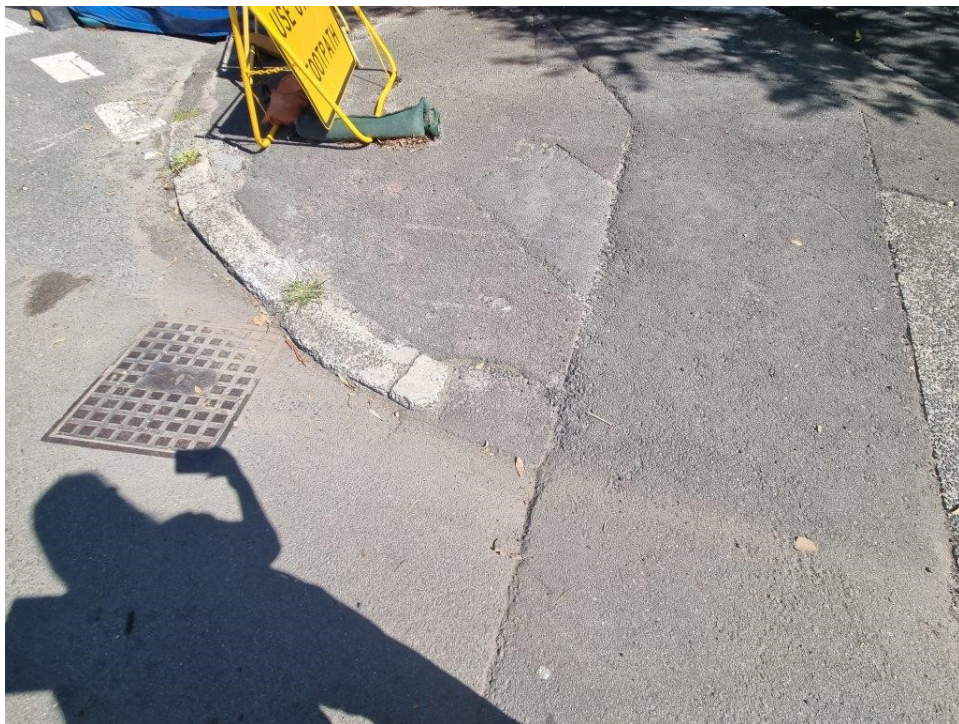
**PHOTO 59**

(Photo showing blocked off road and footpath along Wellington Street and Cope Street)
