# DILAPIDATION REPORT

## Council Assets/Public Infrastructure

**WATERLOO STATION  
COPE STREET**

**24 January 2023**

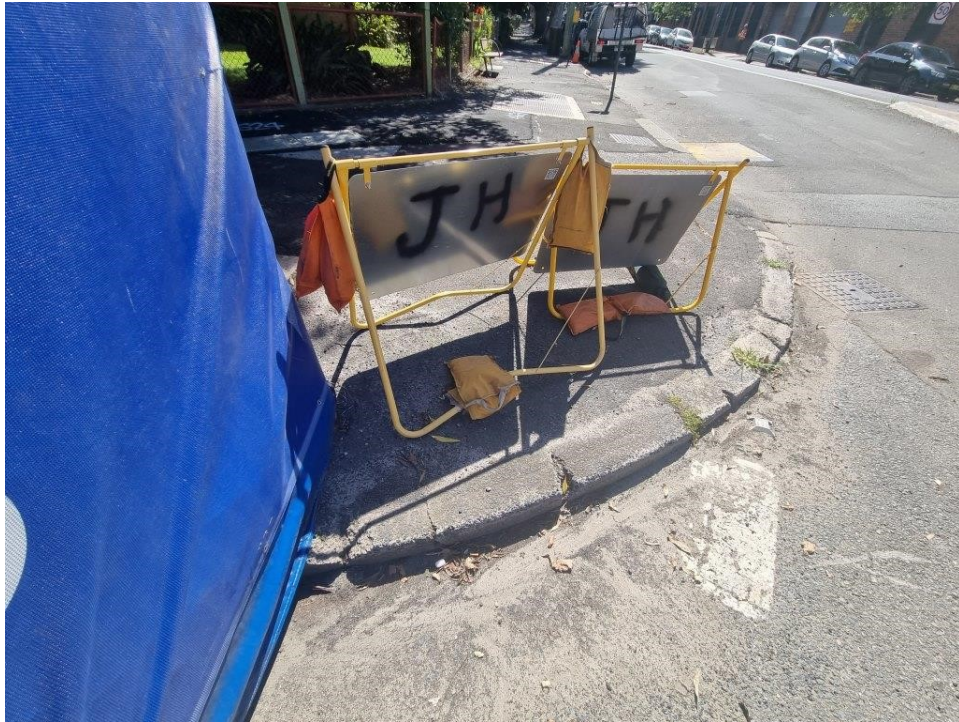
**PHOTO 60**

(Photo showing footpath and kerb in the corner of Cope ad Street and Wellington Street)

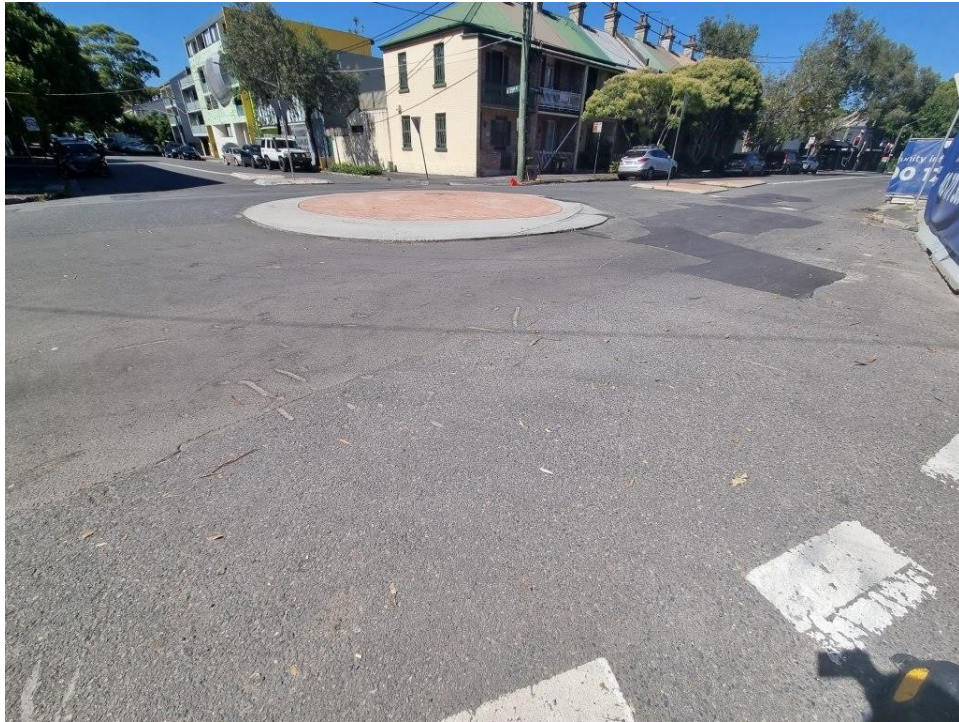
**PHOTO 62**

(Photo showing roundabout intersection of Cope street and Wellington Road)

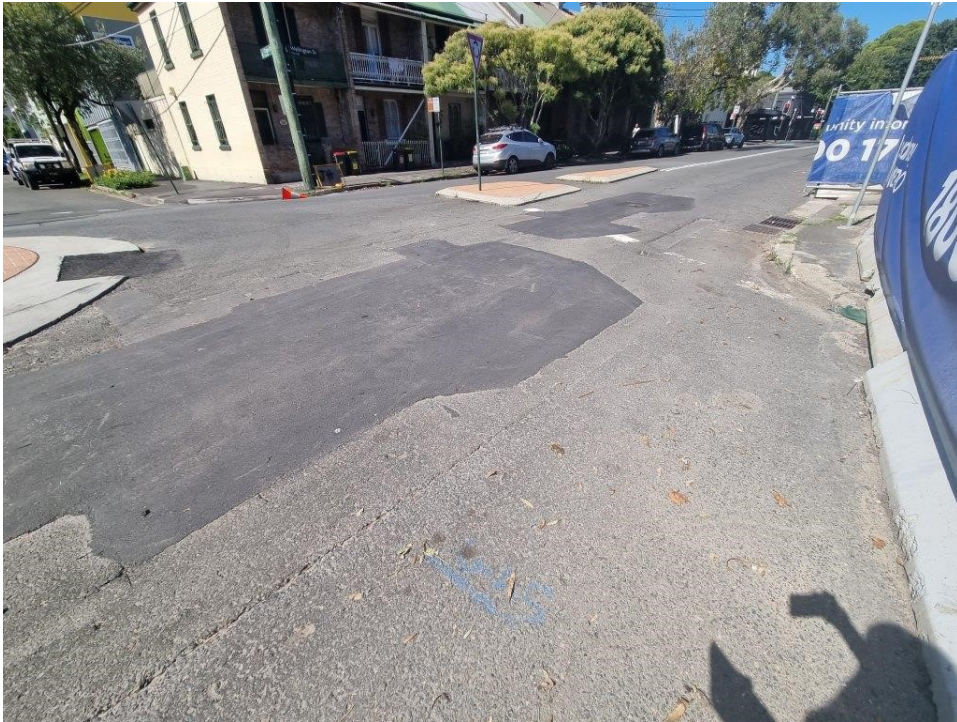
**PHOTO 64**

(Photo showing road along Wellington Street. Footpath has been blocked off)

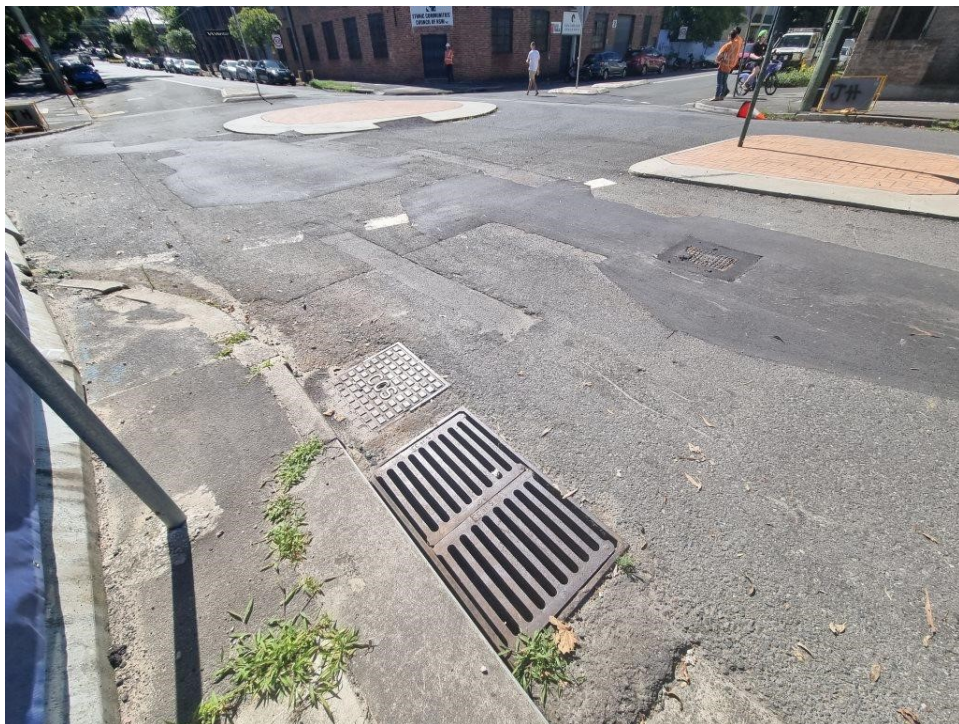
**PHOTO 69**

(Photo showing road along Wellington Street. Footpath has been blocked off)

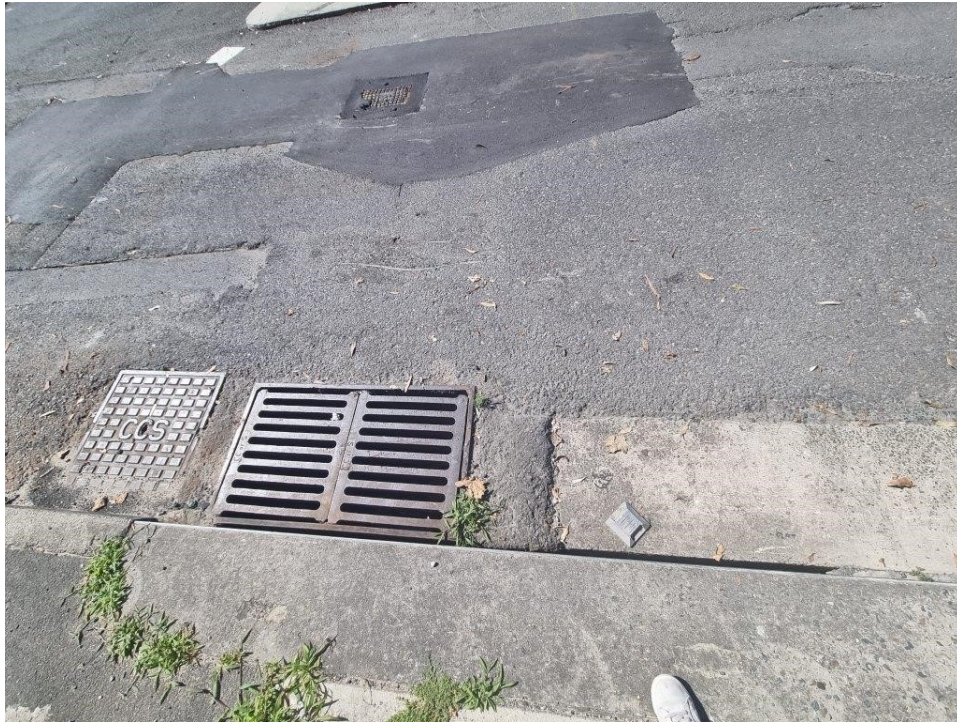
**PHOTO 70**

(Photo showing roundabout intersection of Cope Street and Wellington Street, stormwater inlet pit and cable pit)

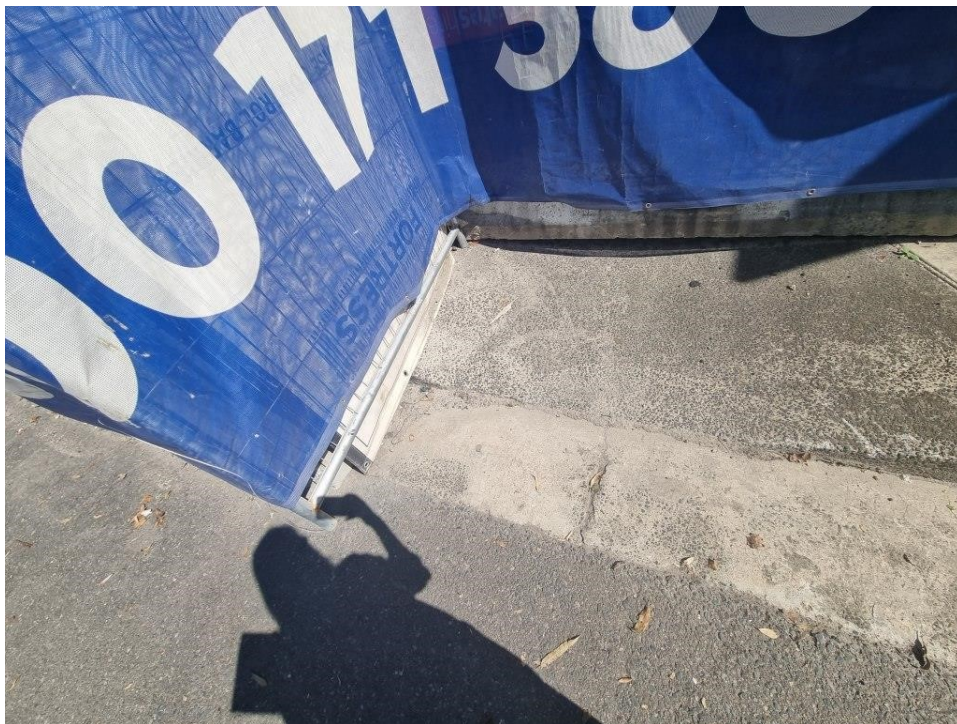
**PHOTO 71**

(Photo showing stormwater inlet pit and cable pit adjacent roundabout intersection of Cope Street and Wellington Street)

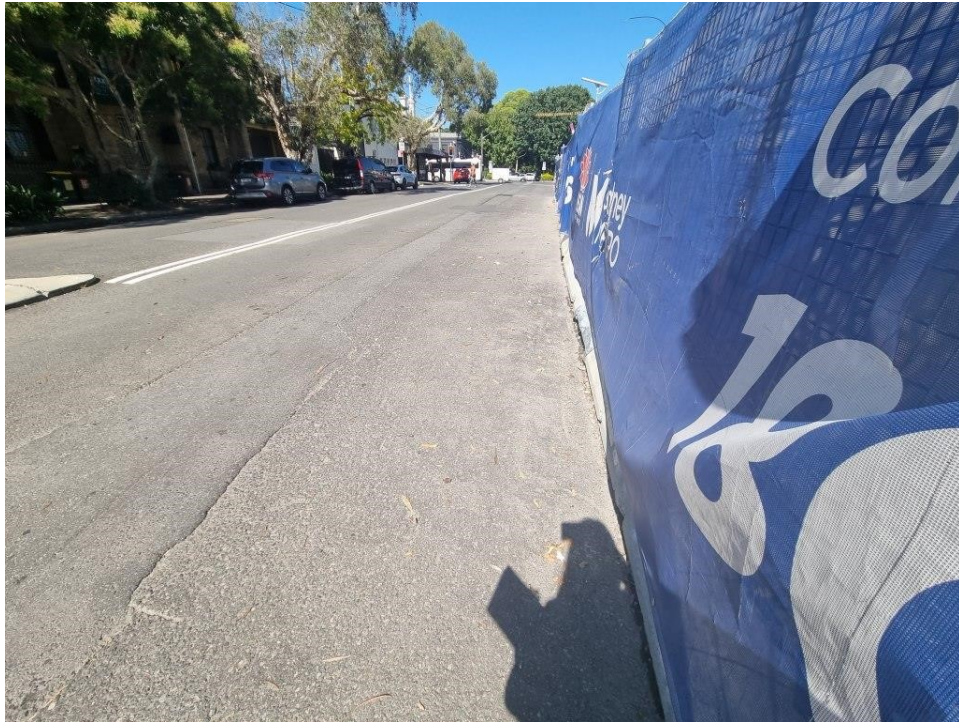
**PHOTO 72**

(Photo showing footpath along Wellington Street. Footpath has been blocked off)

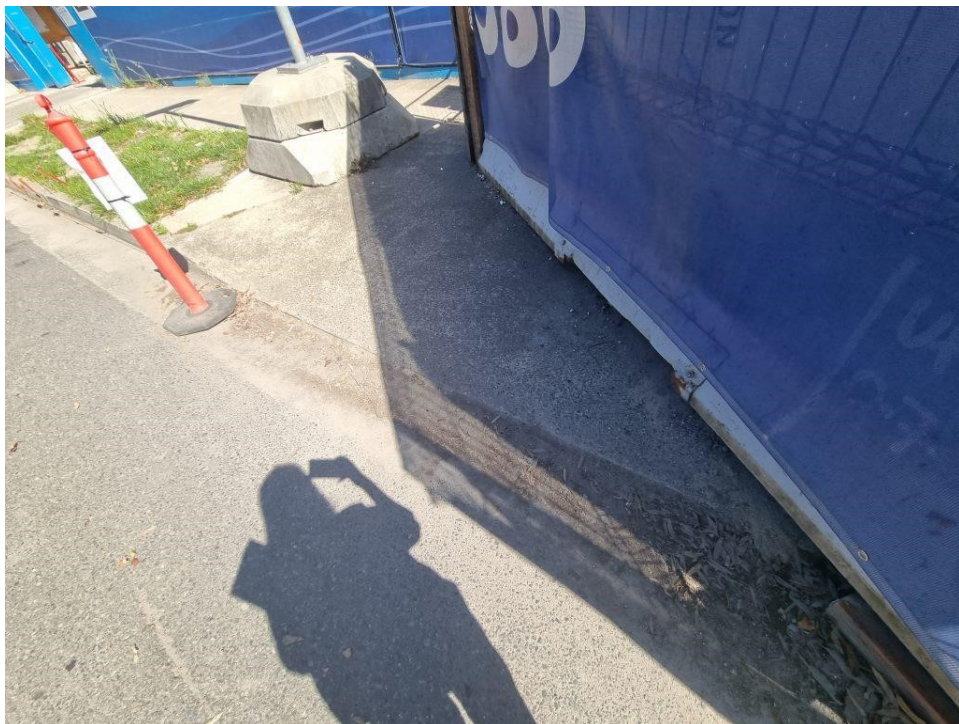
**PHOTO 73**

(Photo showing road along Wellington Street. Footpath has been blocked off)

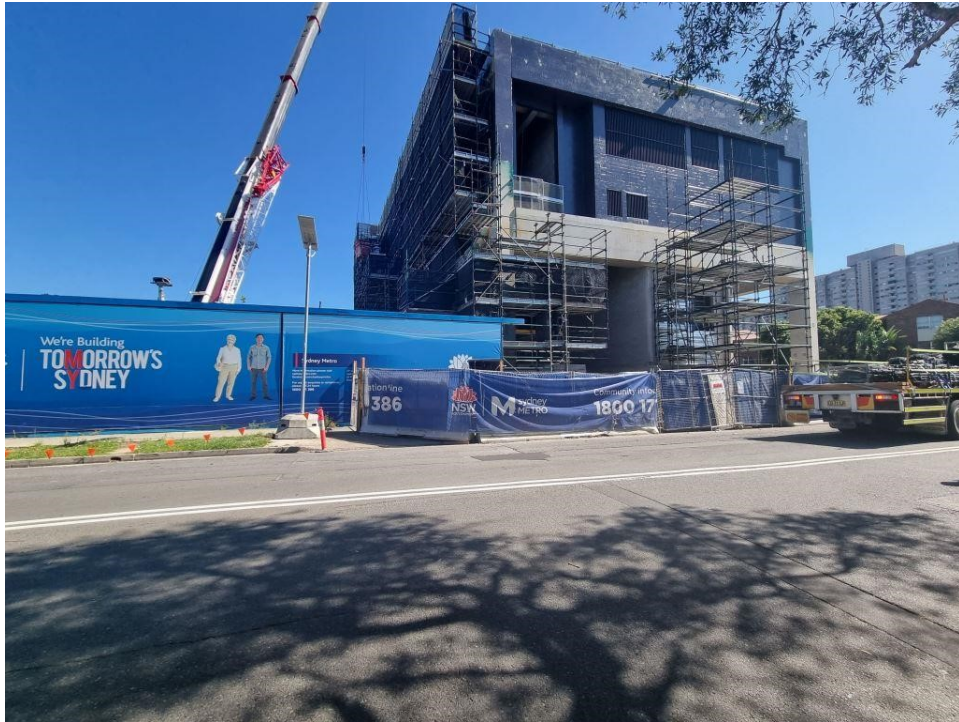
**PHOTO 74**

Wellington Street, between Cope Street and Botany Road, was generally in good condition, except for the driveway, footpath, kerb and road pavement adjacent to the driveway which were severely cracked. There was a depression in the driveway which had been filled. The driveway is the truck entrance to the active construction site for the Waterloo Station project.

(Photo showing driveway and footpath on Wellington Street)

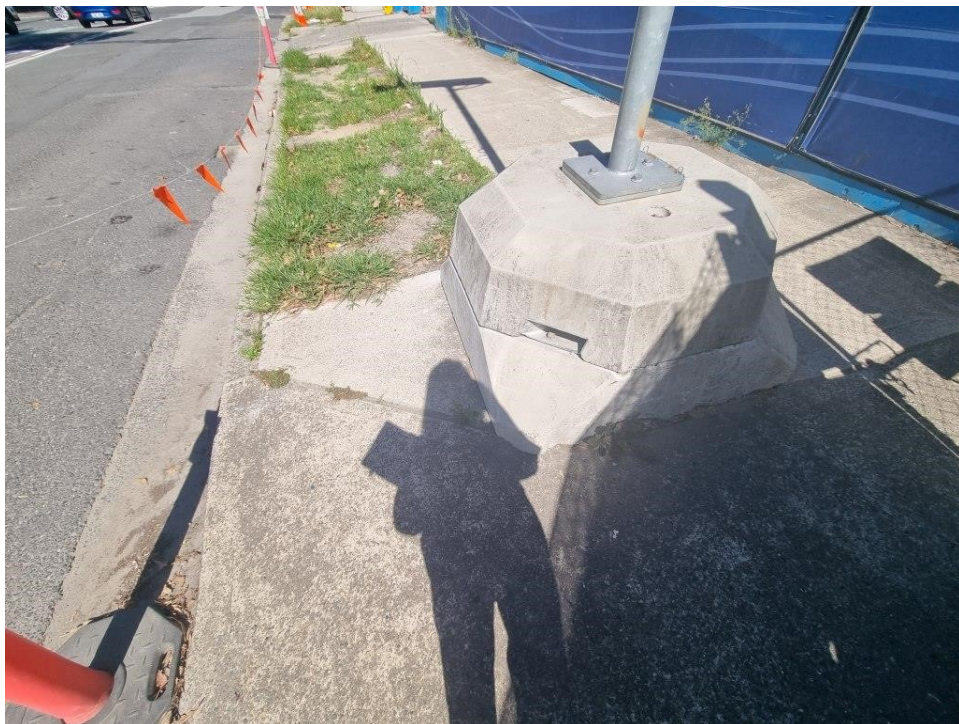
**PHOTO 75**

(Photo showing road along Wellington Street. Footpath has been blocked off)

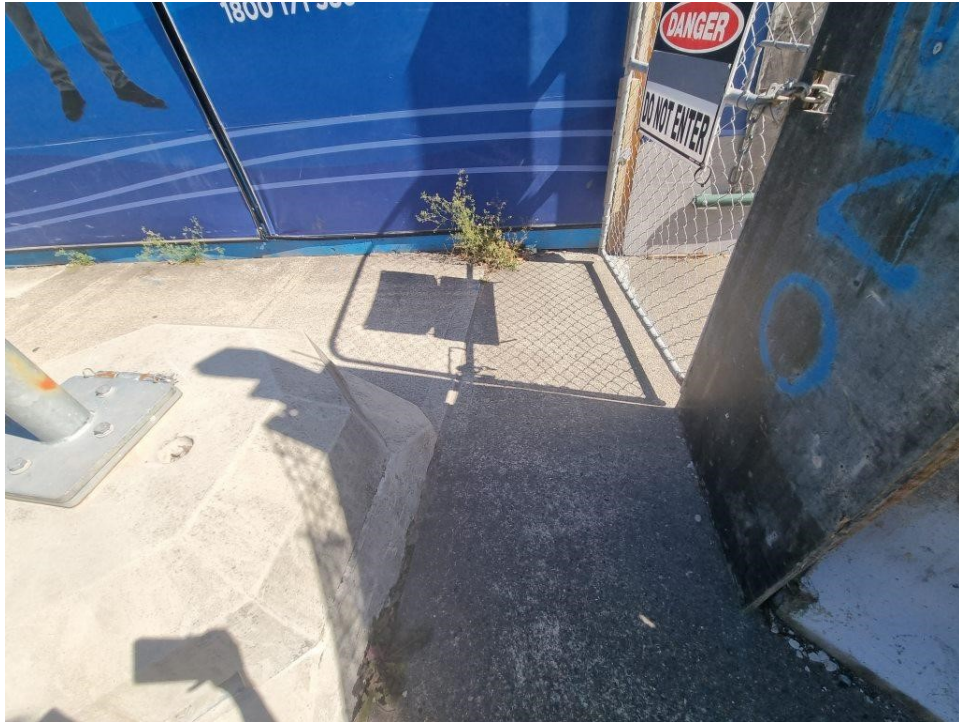
**PHOTO 76**

(Overview of footpath on Wellington Street)

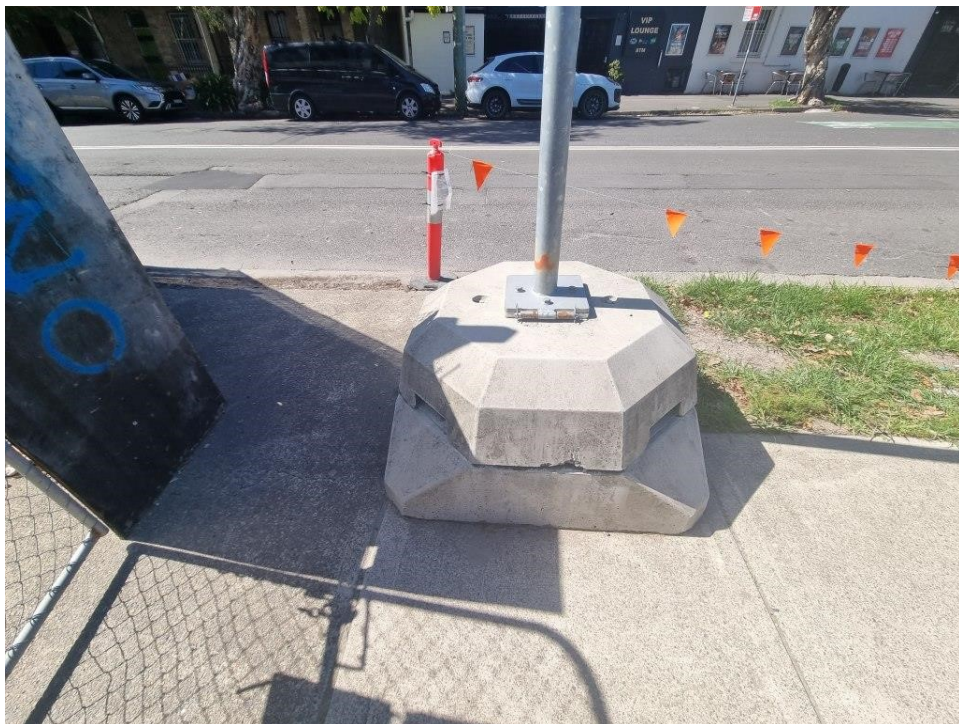
**PHOTO 77**  
(Overview of footpath on Wellington Street)

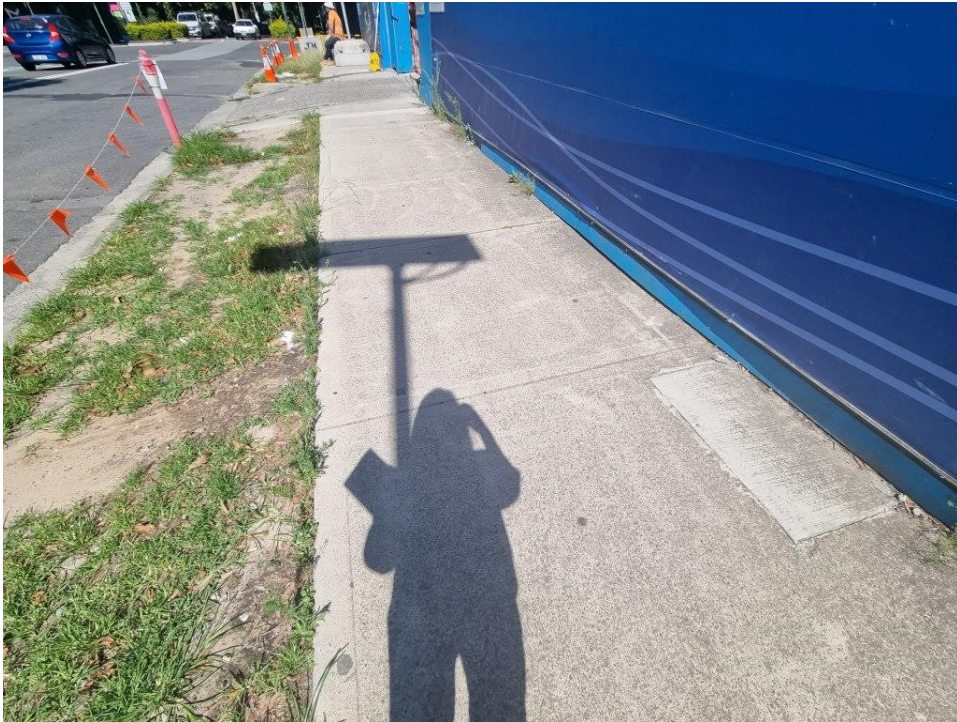
**PHOTO 78**  
(Overview of footpath on Wellington Street)

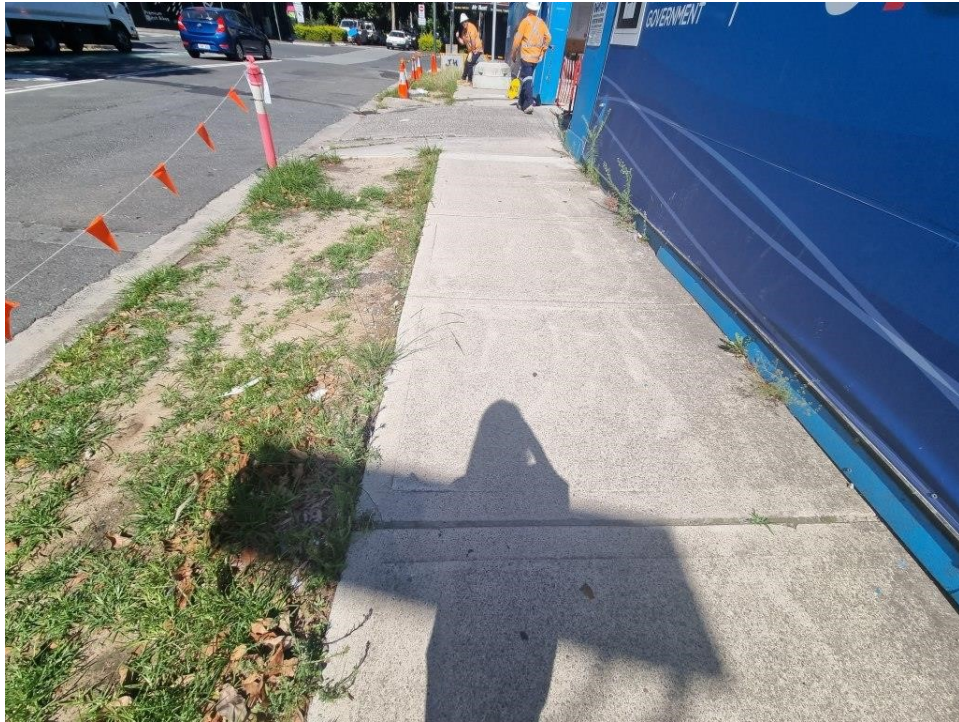
**PHOTO 80**  
(Overview of footpath and road on Wellington Street)

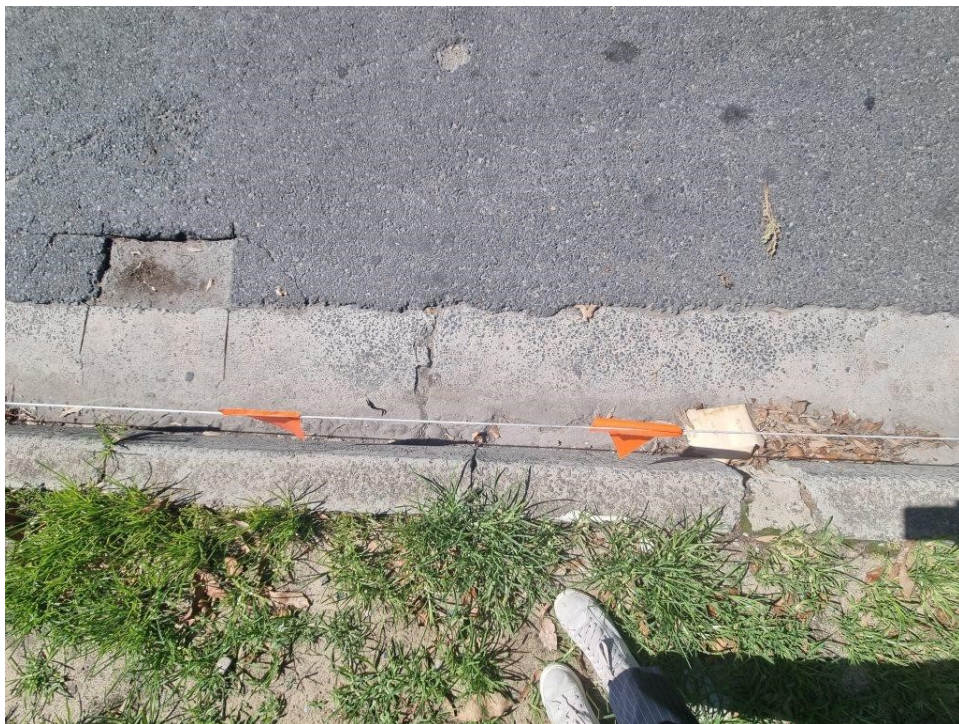
**PHOTO 81**

(Overview of footpath and road on Wellington Street facing West)

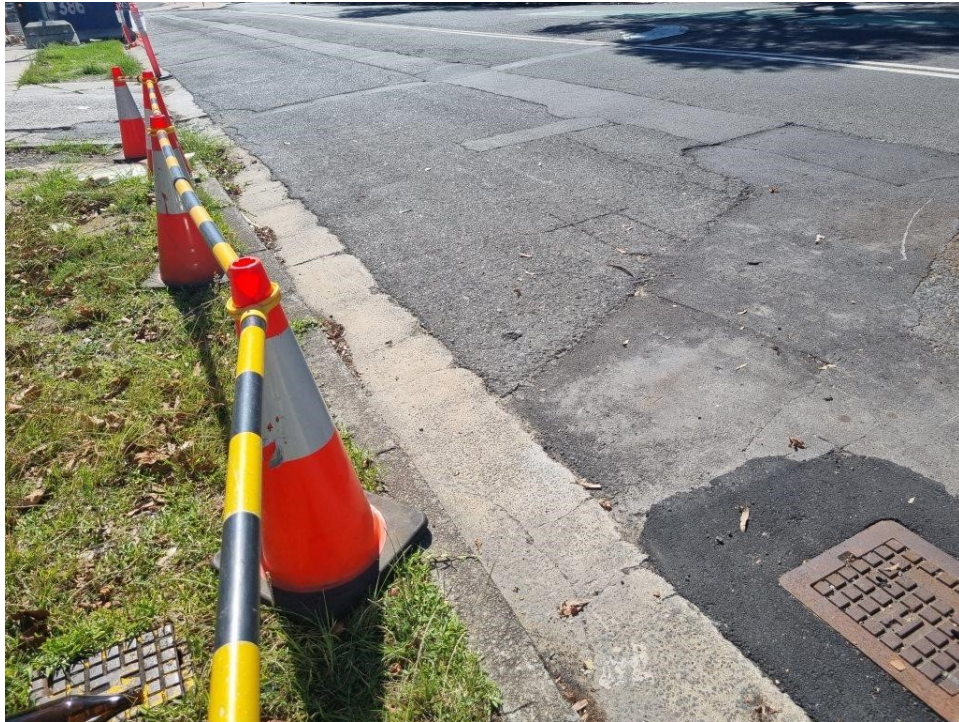
**PHOTO 94**

(Overview of footpath Wellington Street near corner of Wellington Street and Botany Road)

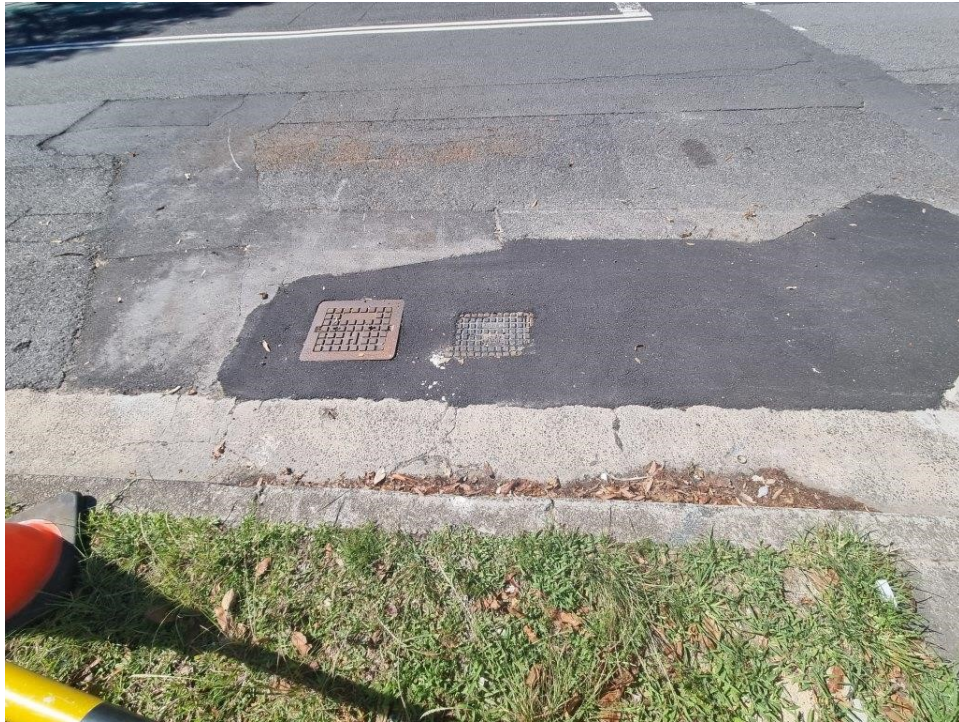
**PHOTO 96**

(Overview of road and footpath on Wellington Street between Cope Street and Botany Road, facing east)

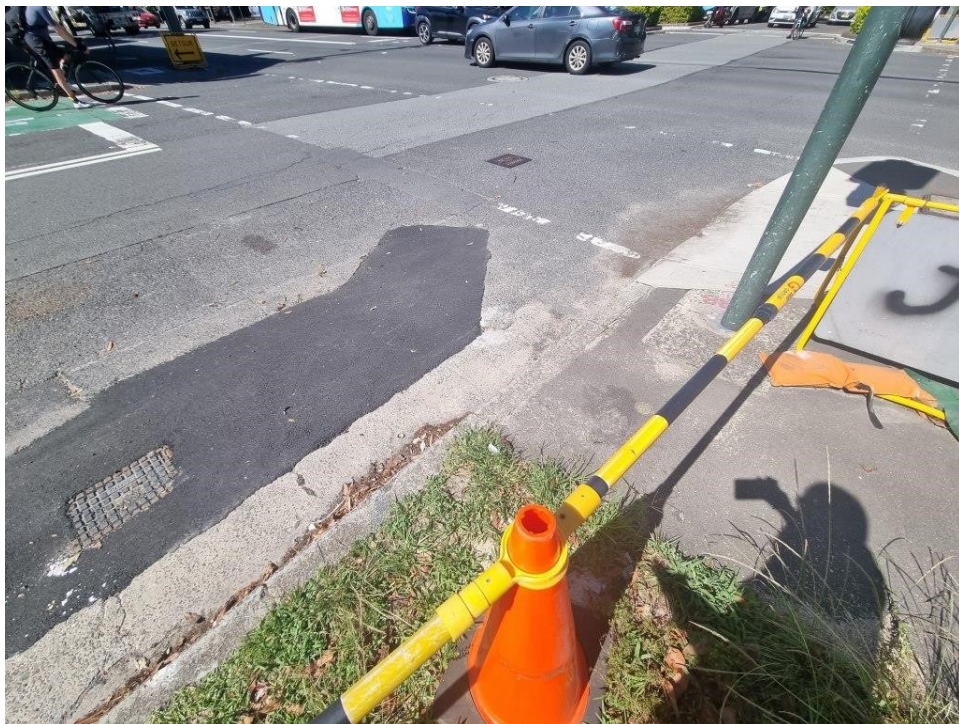
**PHOTO 97**

(Overview of cable pits on Wellington Street between Cope Street and Botany Road)

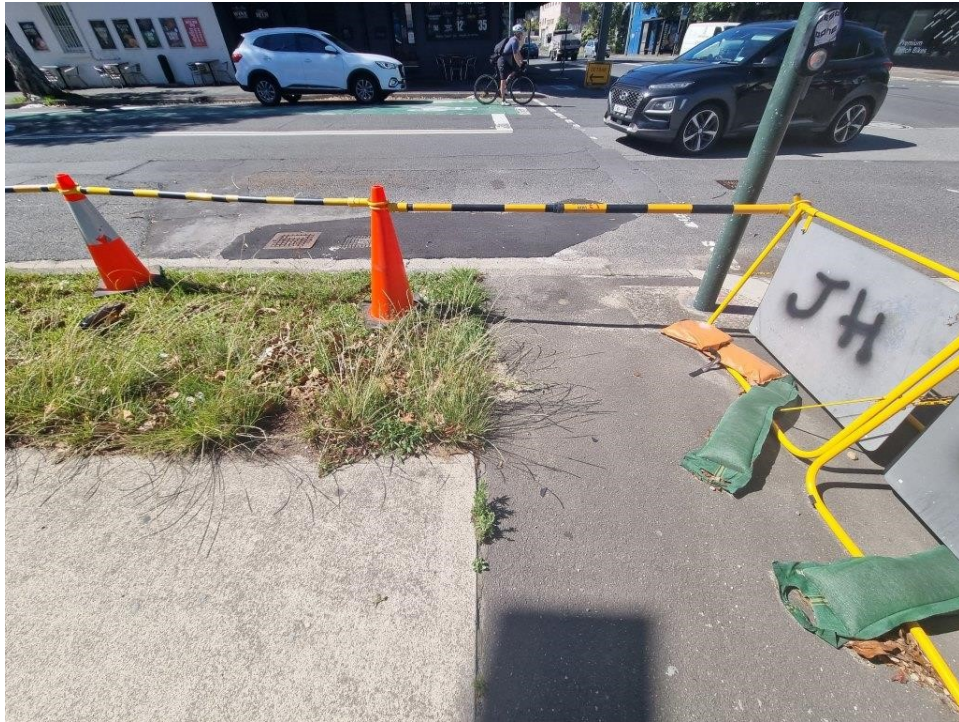
**PHOTO 98**

(Overview of road at the intersection between Wellington Street and Botany Road, facing West)

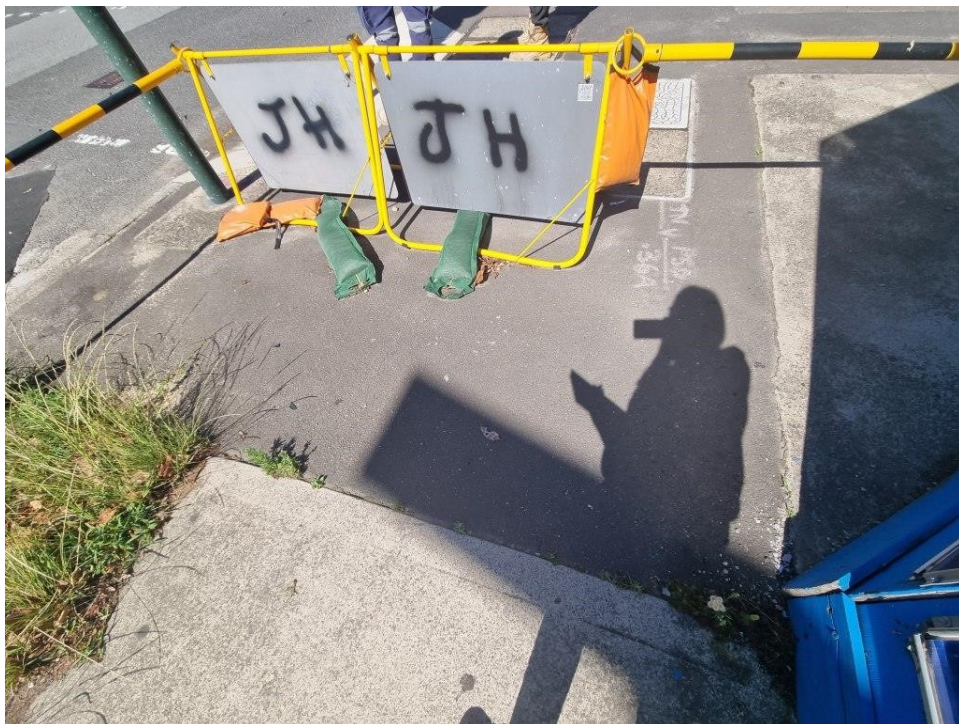
**PHOTO 99**

(Overview of road and footpath at the intersection between Wellington Street and Botany Road, facing South)

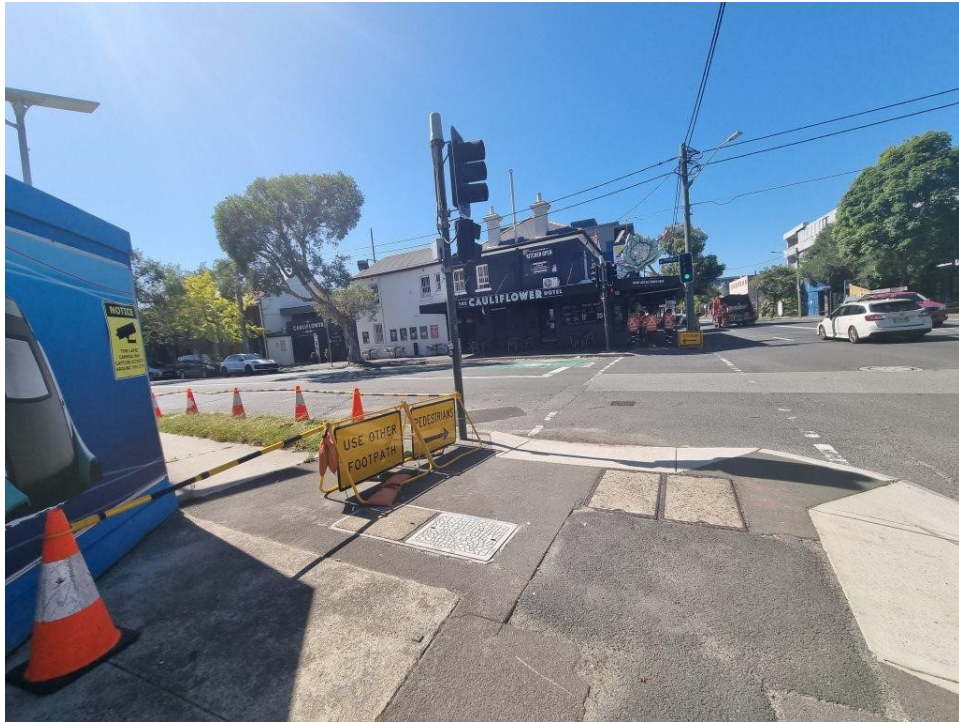
**PHOTO 100**

(Overview of footpath at the intersection between Wellington Street and Botany Road, facing West)

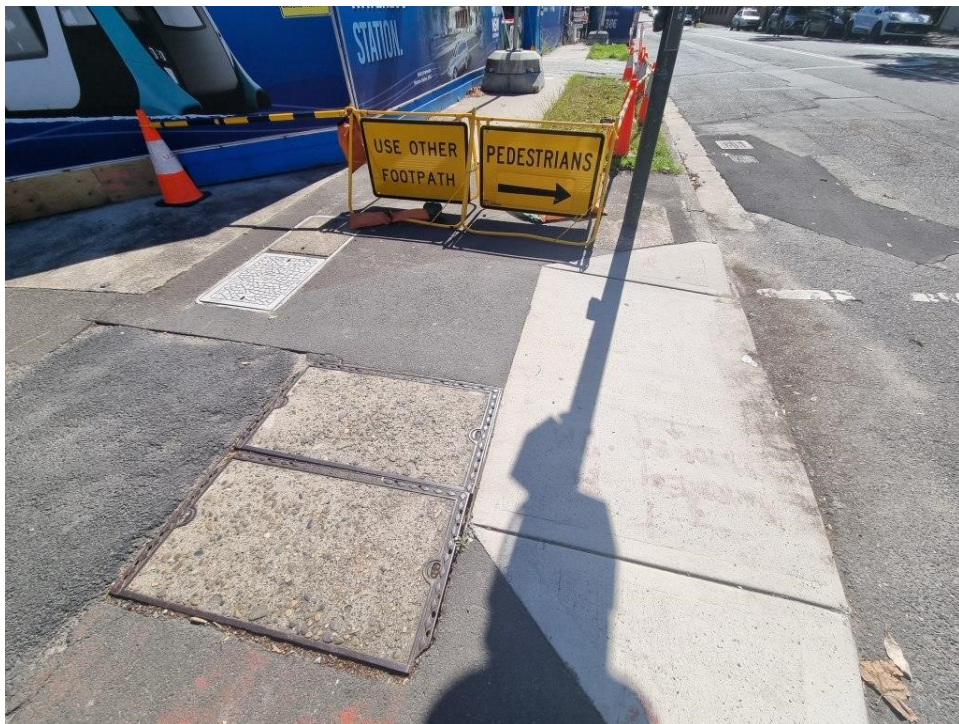
**PHOTO 101**

(Overview of road and footpath at the intersection between Wellington Street and Botany Road, facing South)

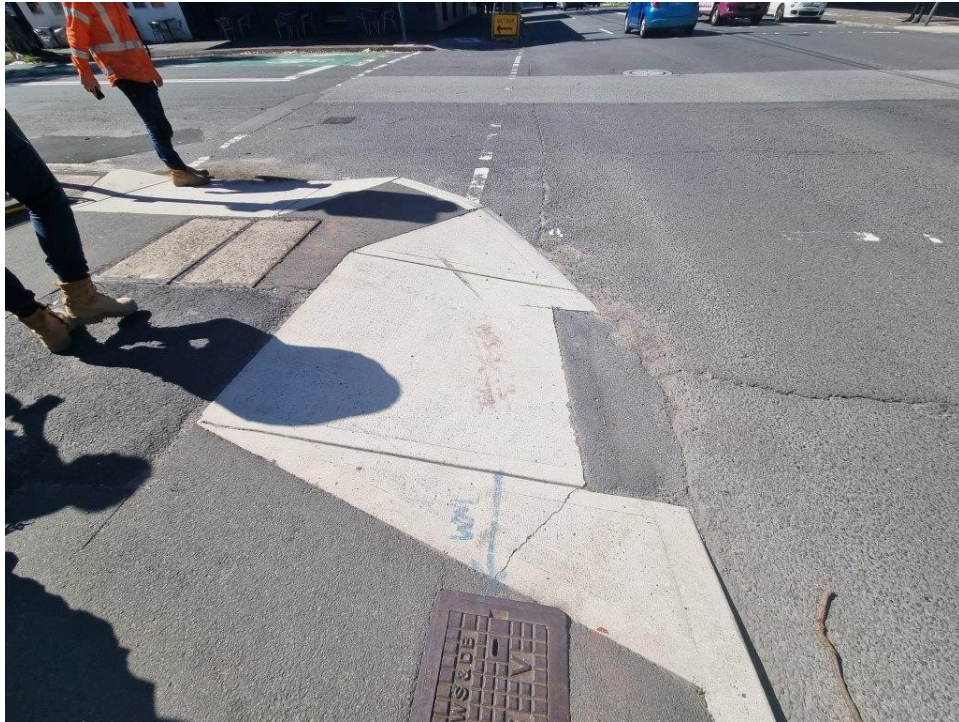
**PHOTO 102**

(Overview of footpath at the intersection between Wellington Street and Botany Road, facing East)

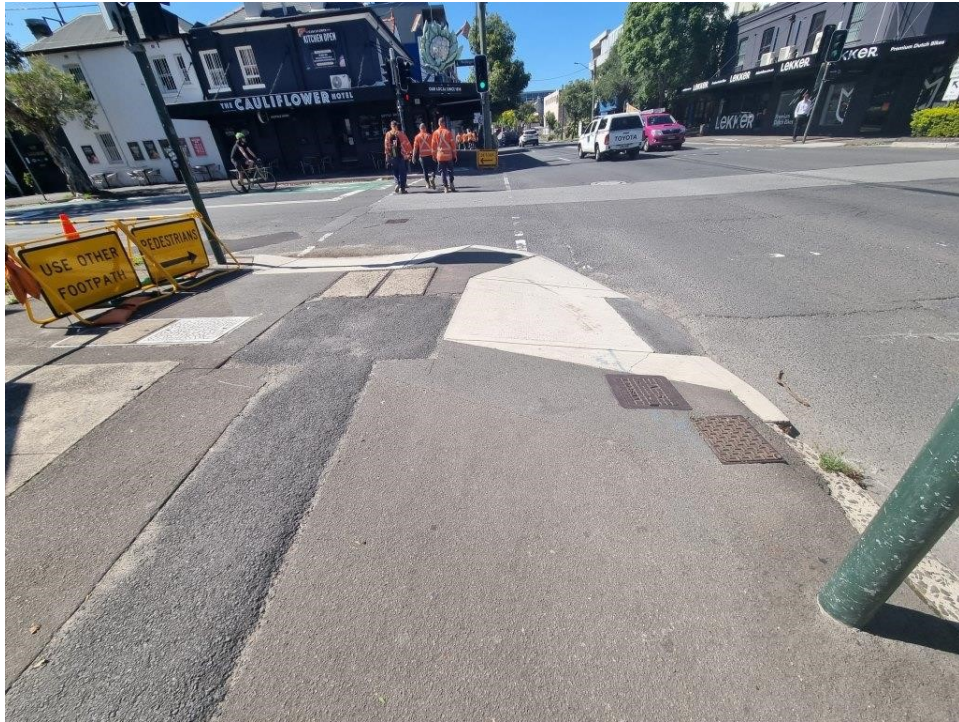
**PHOTO 104**

(Overview of footpath at the intersection between Wellington Street and Botany Road, facing East)

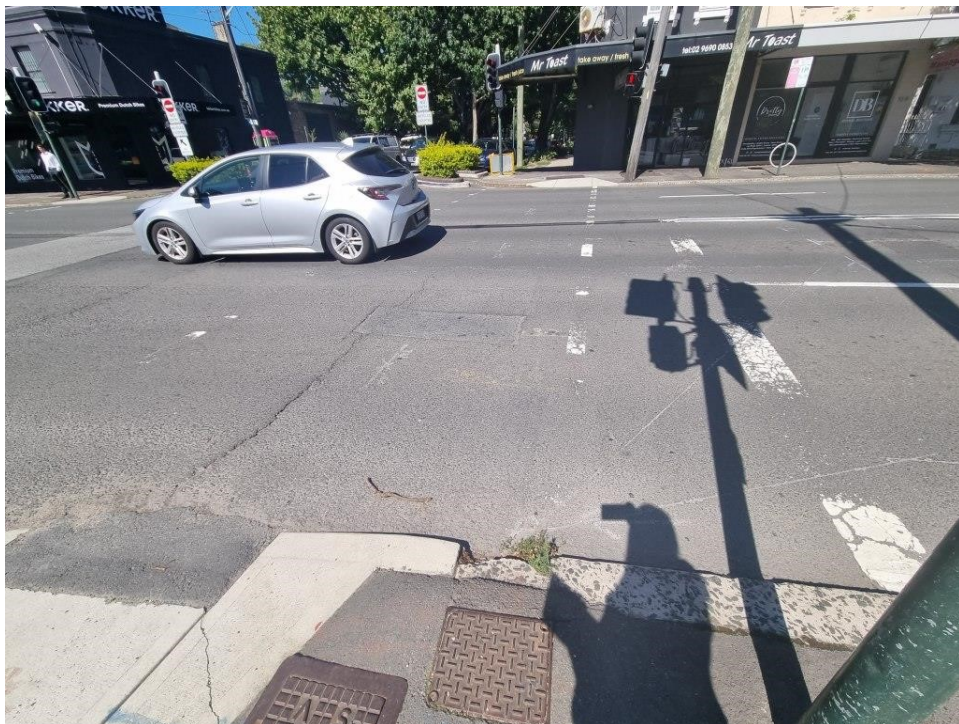
**PHOTO 105**

(Overview of road and footpath at the intersection between Wellington Street and Botany Road, facing South)

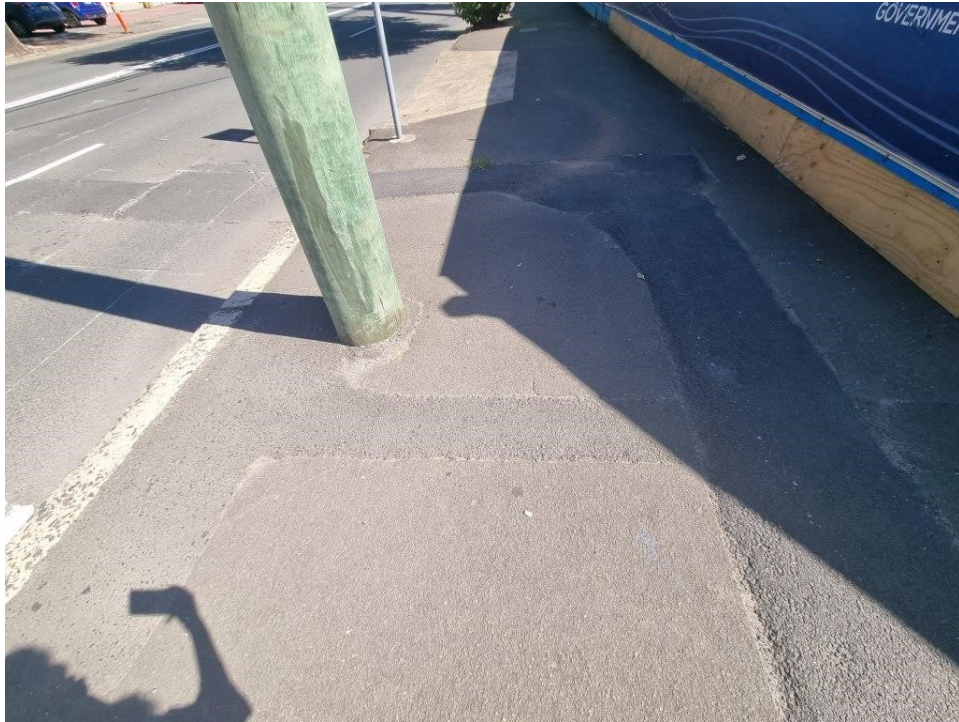
**PHOTO 106**

(Overview of Botany Road at intersection between Botany Road and Wellington Street)

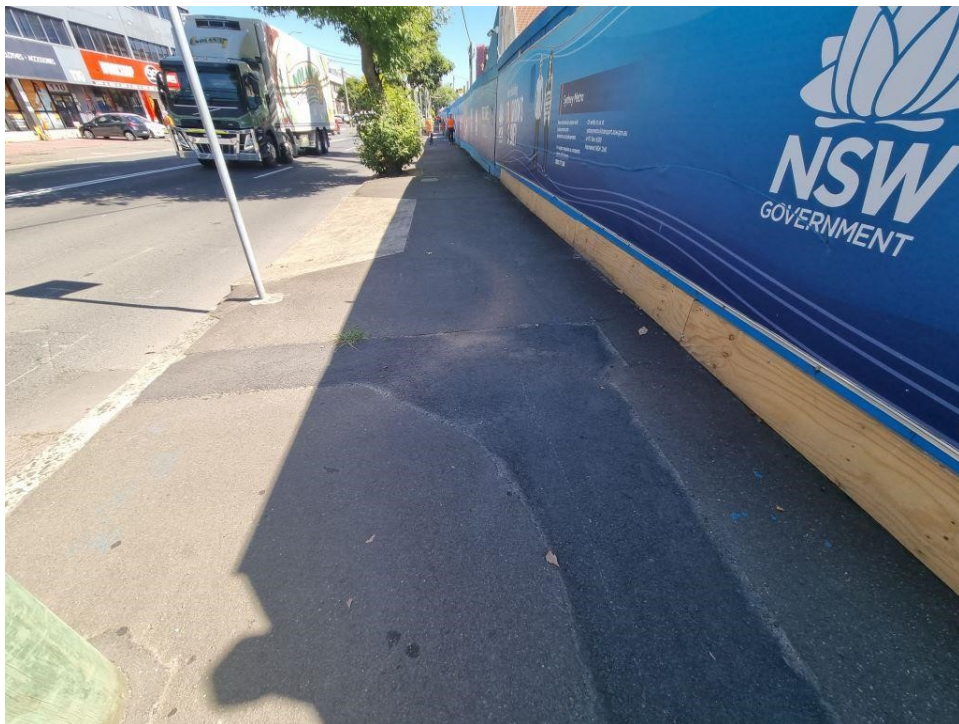
**PHOTO 107**  
(Overview of Eastern footpath on Botany Road)

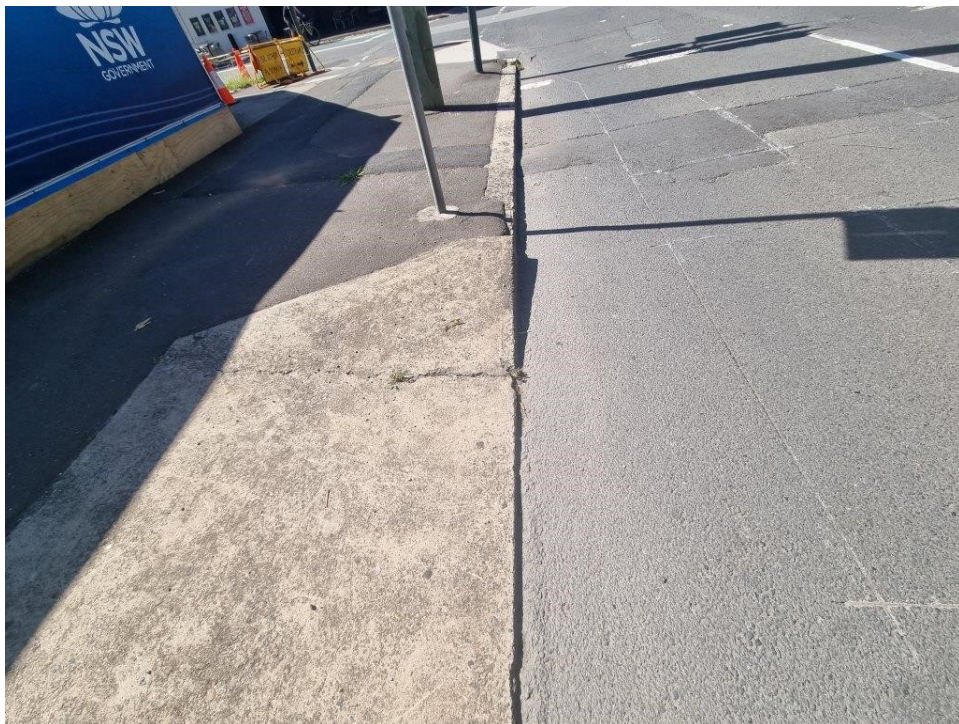
**PHOTO 109**

(Overview of Eastern footpath and road sign on Botany Road)

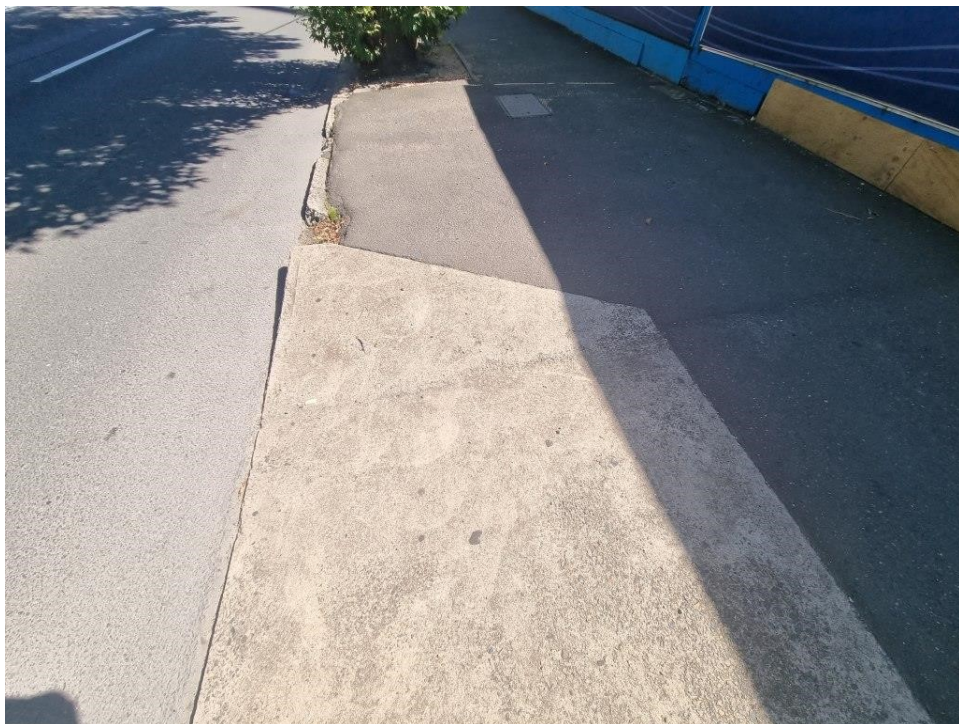
**PHOTO 111**

(Overview of Botany Road near intersection between Botany Road and Wellington Street)

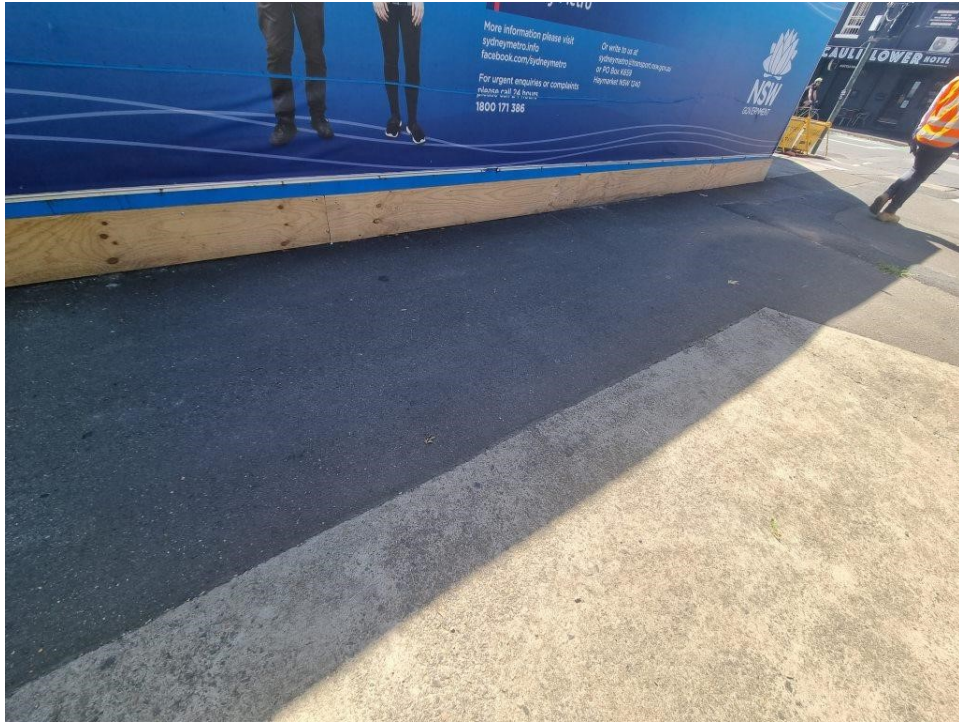
**PHOTO 112**

(Overview of footpath and kerb along Botany Road near intersection between Botany Road and Wellington Street)

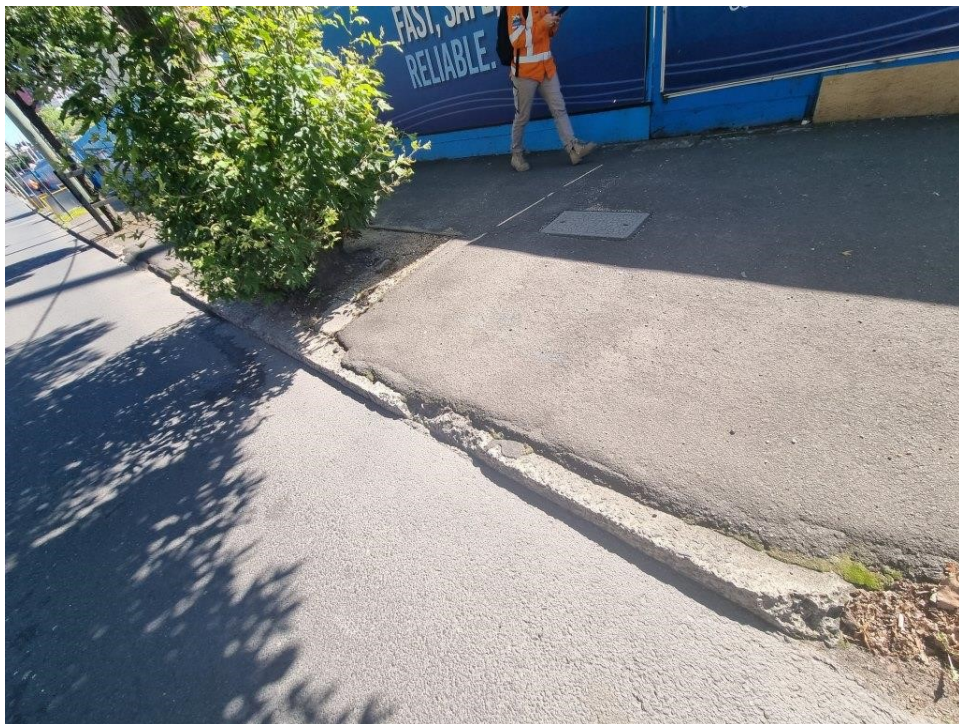
**PHOTO 113**

(Overview of footpath along Botany Road near intersection between Botany Road and Wellington Street)

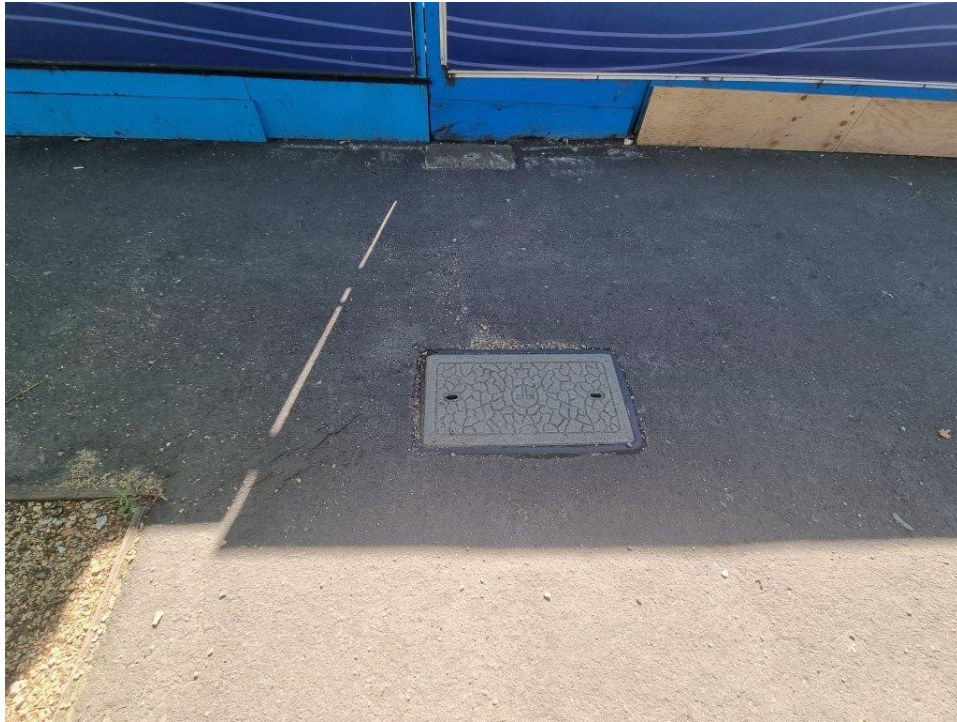
**PHOTO 114**

(Overview of footpath and kerb along Botany Road)
