# DILAPIDATION REPORT

## Council Assets/Public Infrastructure

**WATERLOO STATION  
COPE STREET**

**24 January 2023**

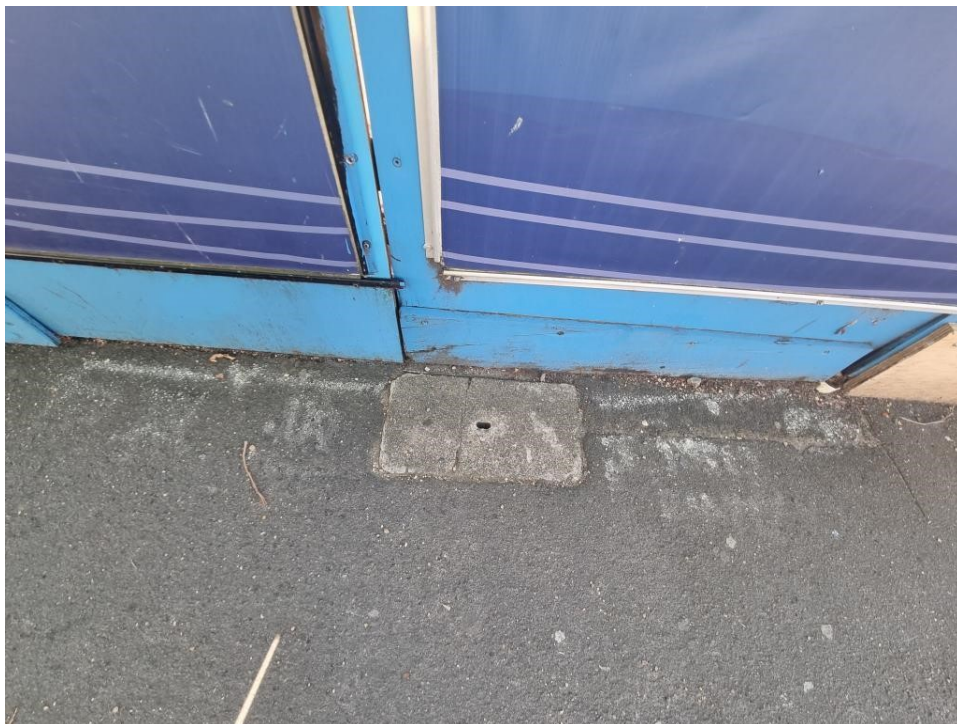
**PHOTO 115**

(Photo showing cable pit on footpath along Botany Road)

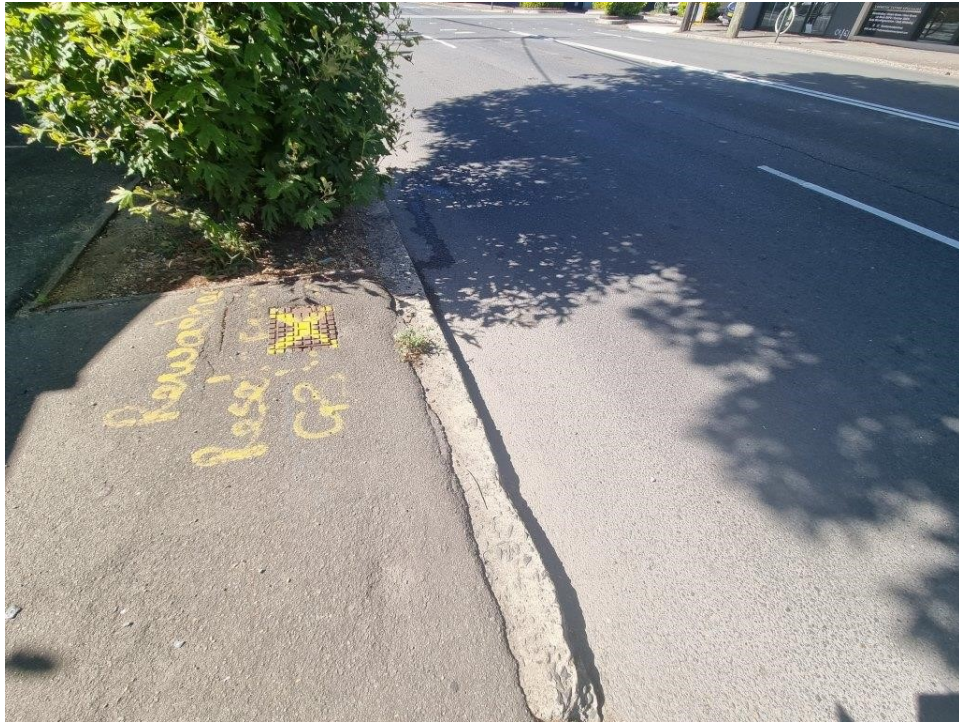
**PHOTO 116**

(Photo showing cable pit on footpath along Botany Road)

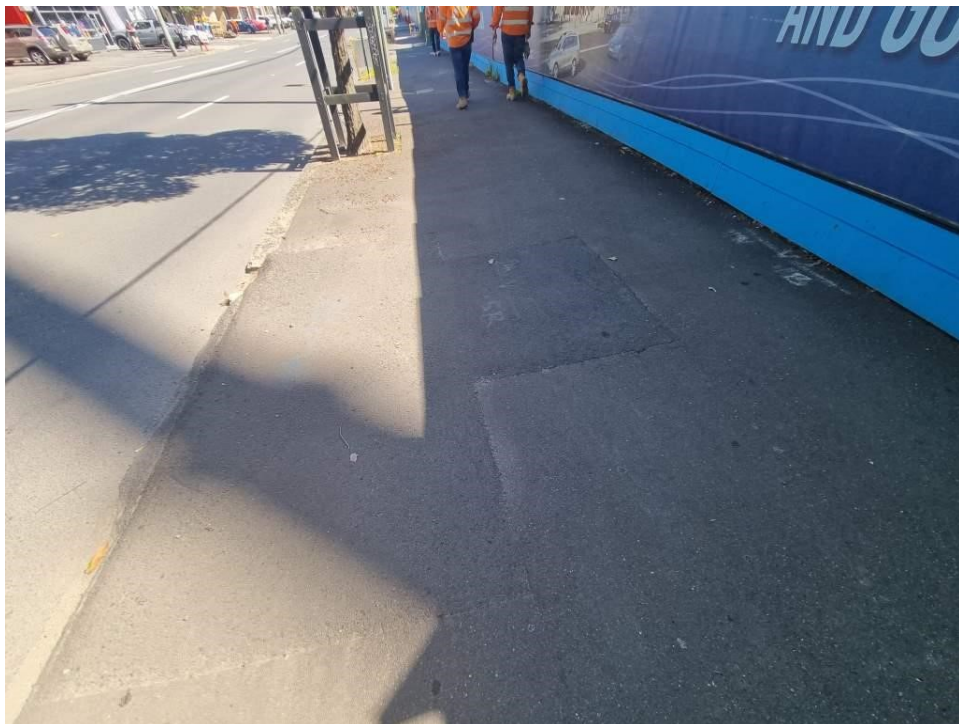
**PHOTO 117**

(Overview of footpath, kerb and hydrant cover along Botany Road)

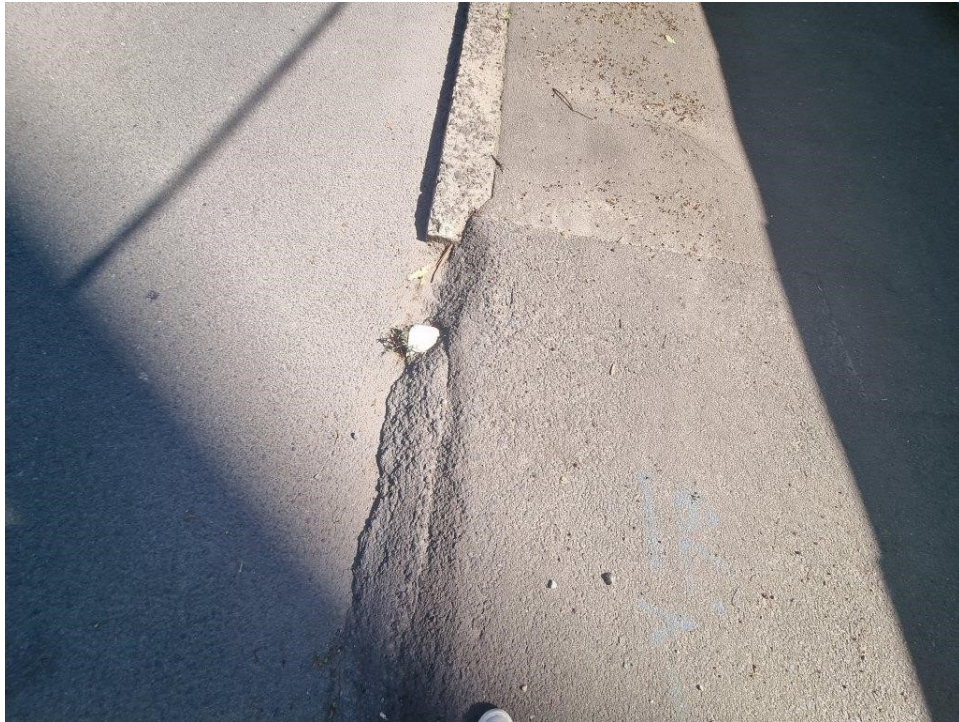
**PHOTO 118**

(Overview of footpath and kerb along Botany Road)

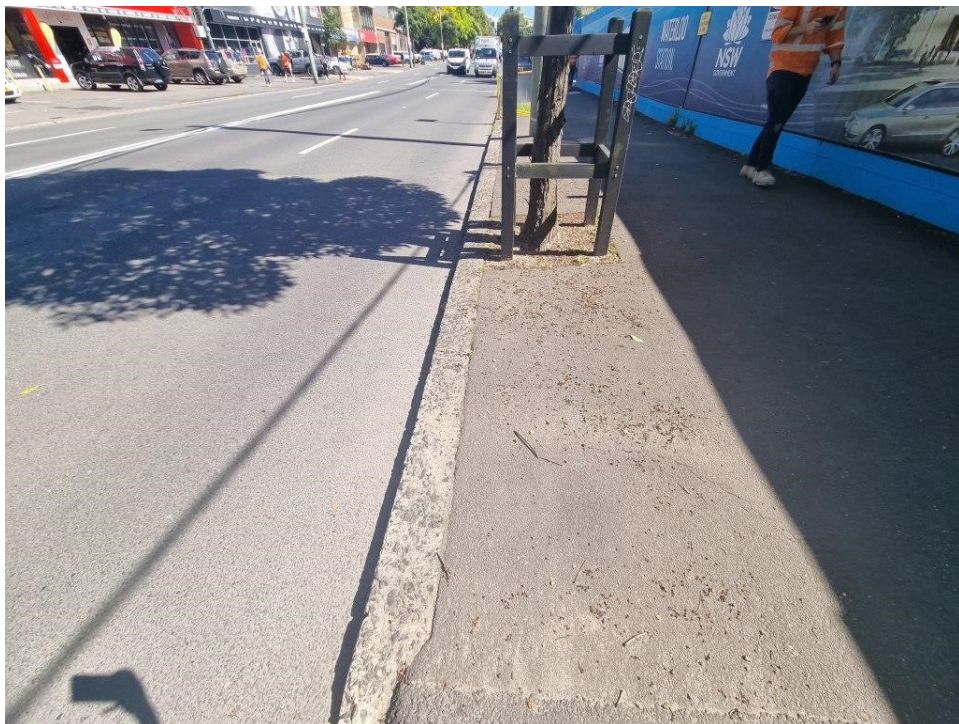
**PHOTO 119**

(Overview of kerb and stormwater pipe on Botany Road)

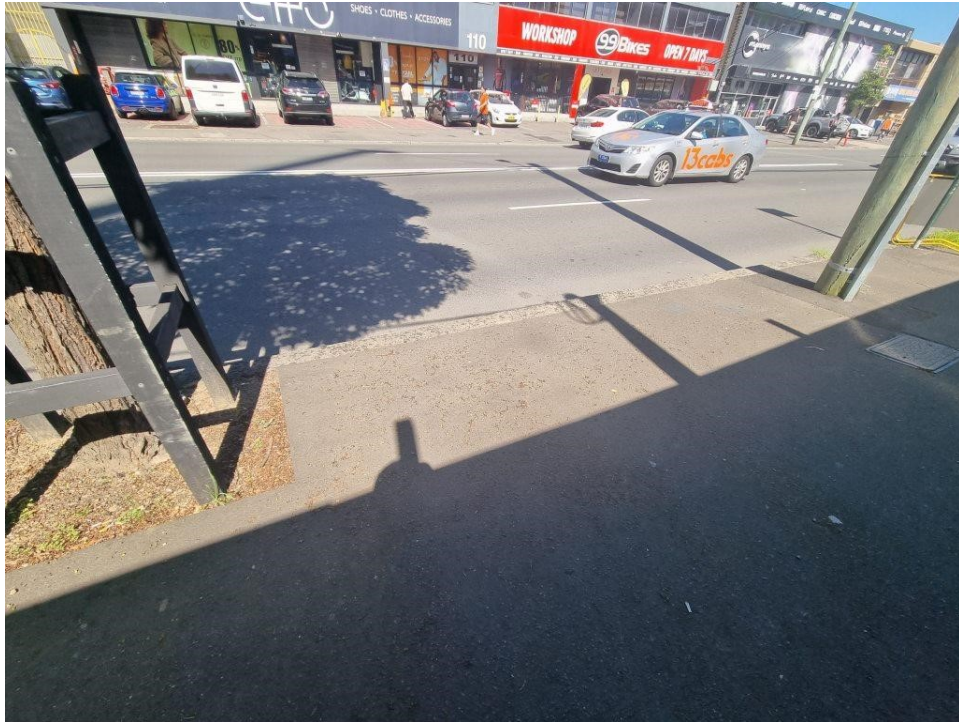
**PHOTO 122**  
(Overview of footpath, kerb and tree along Botany Road)

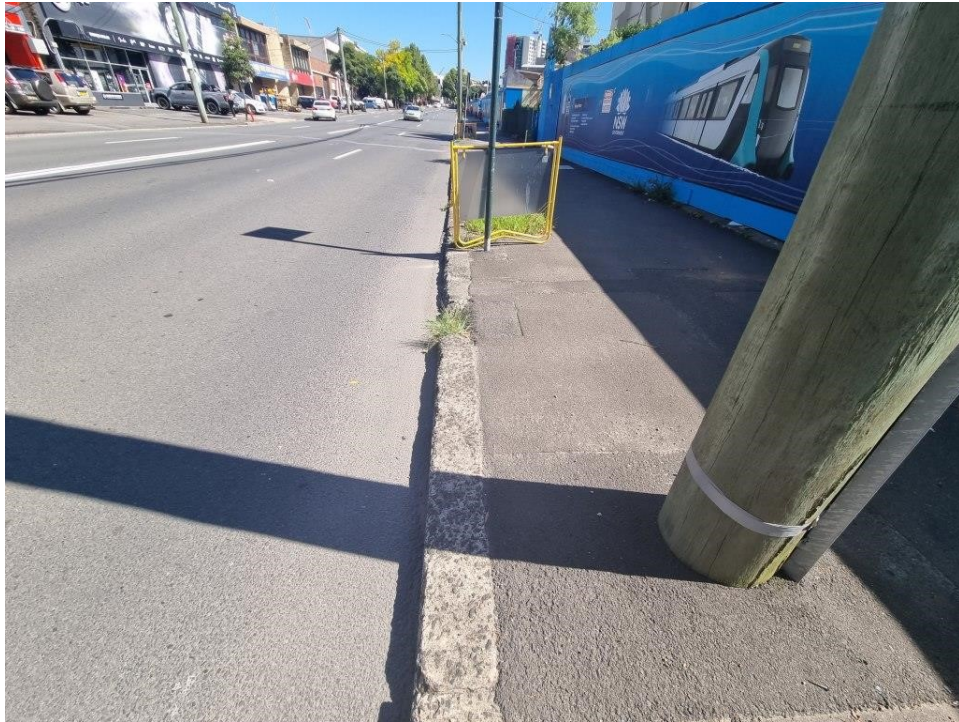
**PHOTO 124**

(Overview of footpath and kerb along Botany Road)

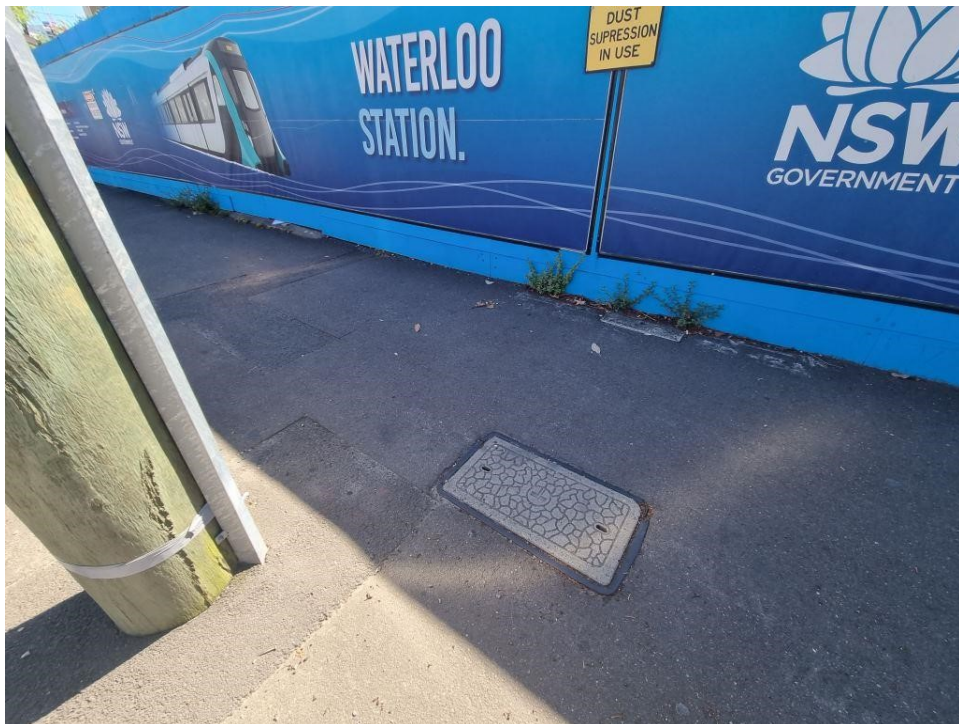
**PHOTO 125**

(Overview of footpath and kerb along Botany Road)

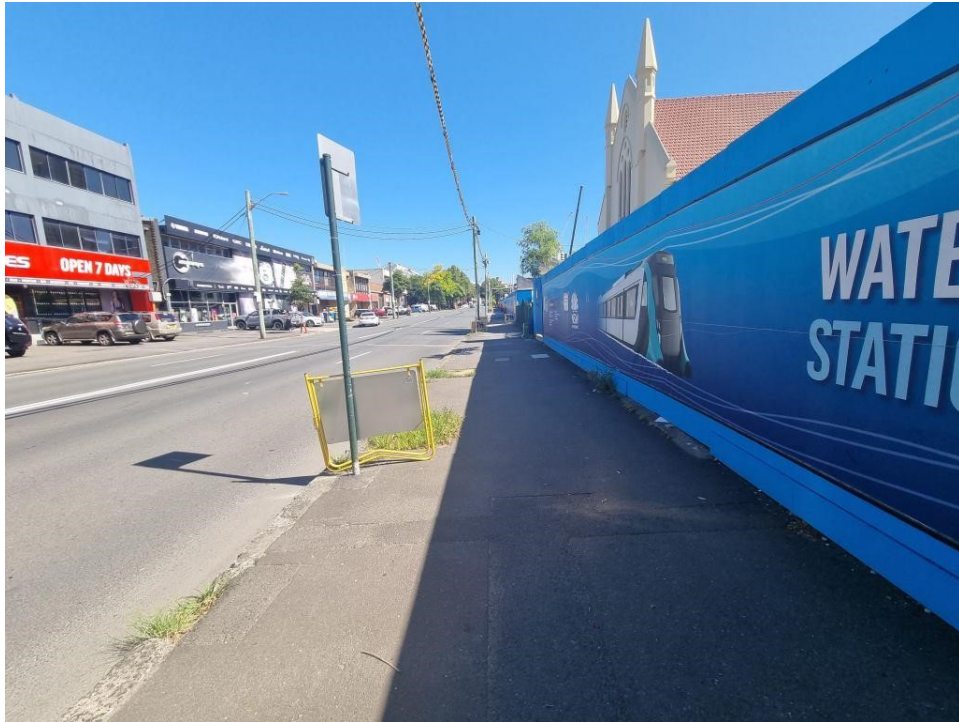
**PHOTO 126**

(Overview of footpath and cable pit along Botany Road)

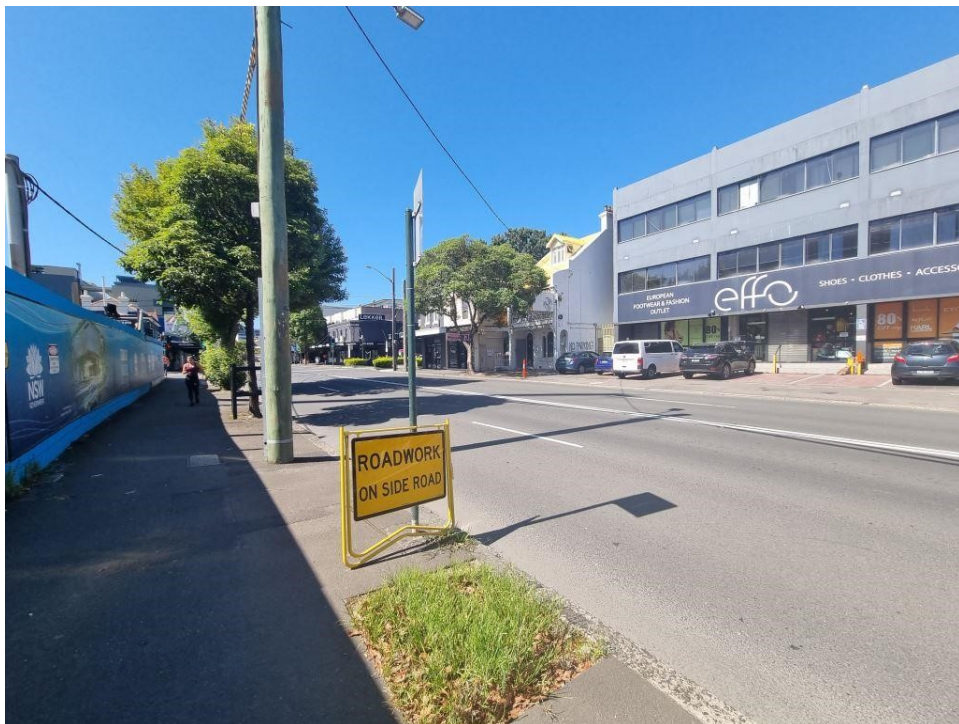
**PHOTO 127**

(Overview of footpath and kerb along Botany Road)

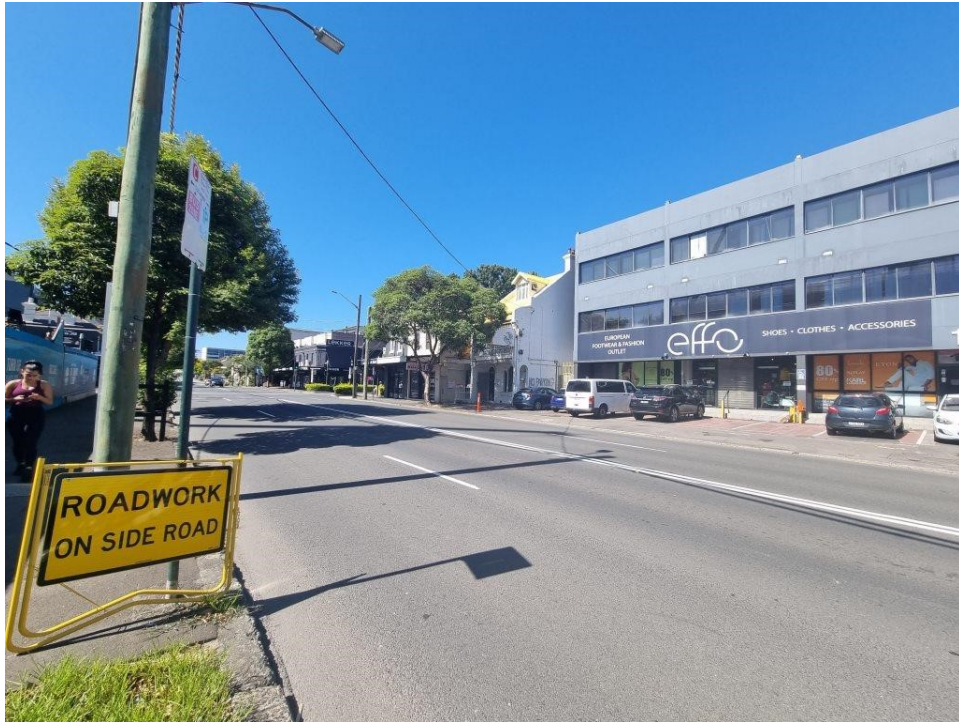
**PHOTO 128**

(Overview of footpath, road and road sign along Botany Road)

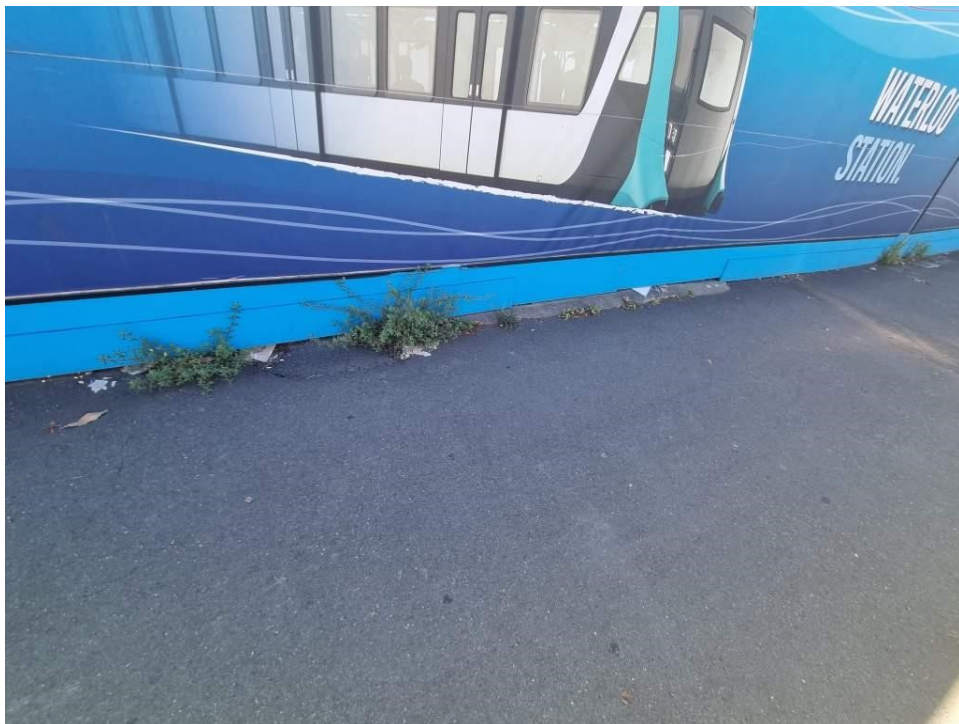
**PHOTO 129**

(Overview of road, signs and street light on Botany Road adjacent 110 Botany Road)

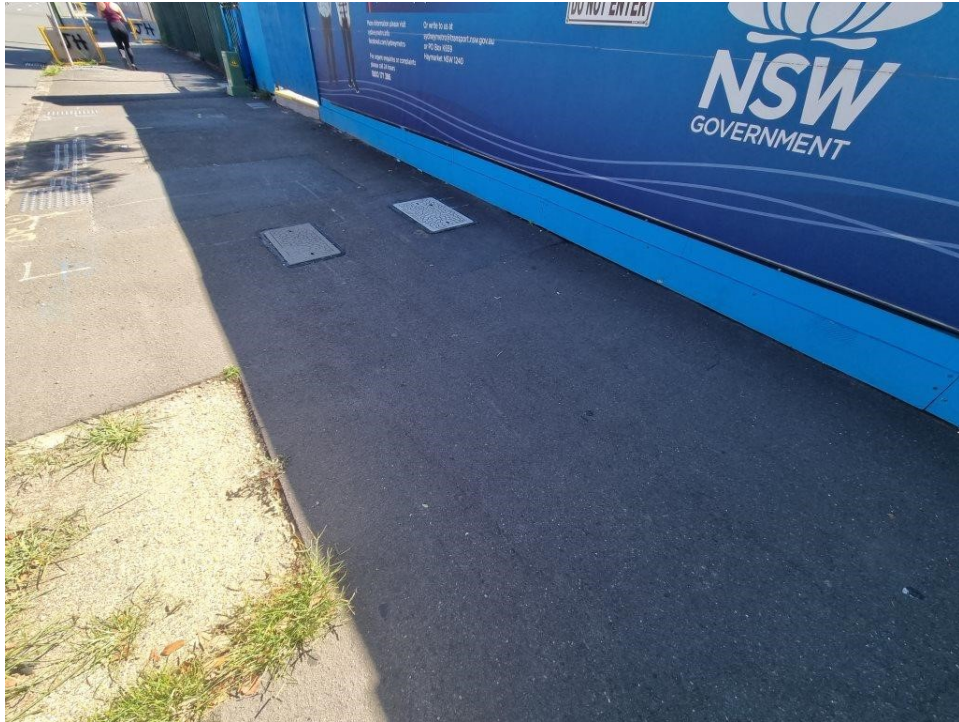
**PHOTO 130**

(Overview of footpath on Botany Road opposite 110 Botany Road)

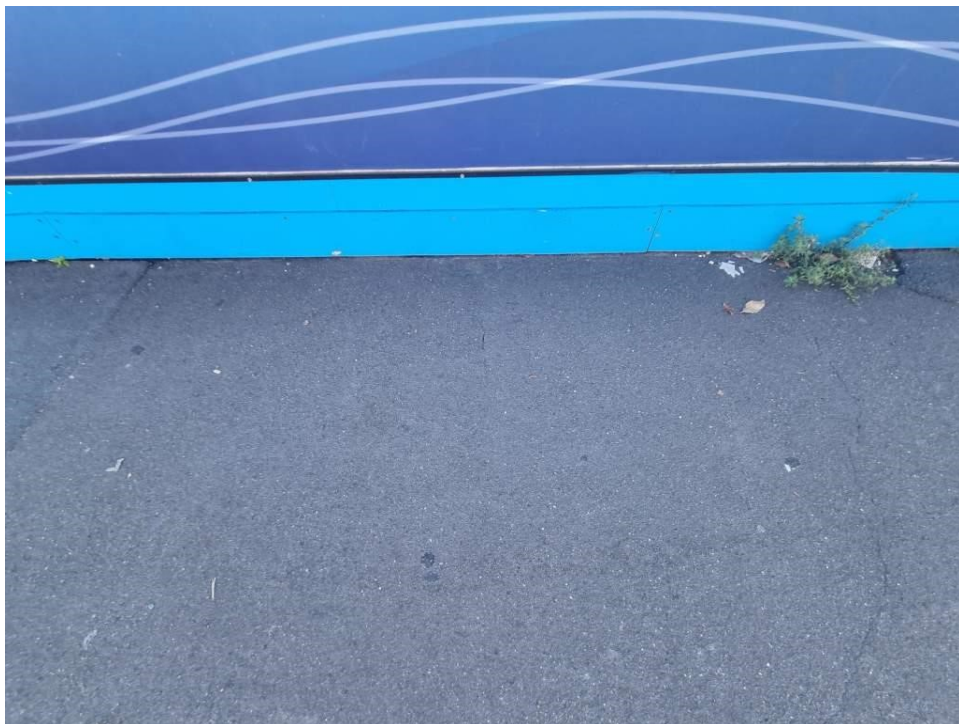
**PHOTO 131**

(Overview of footpath and cable pits on Botany Road opposite 110 Botany Road)

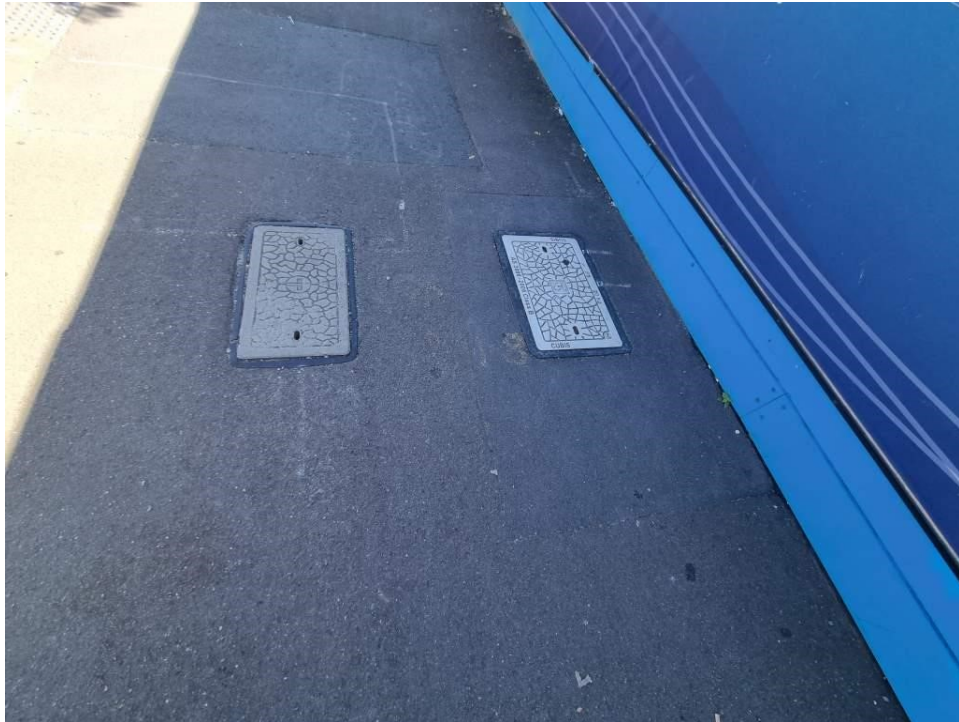
**PHOTO 132**

(Overview of footpath on Botany Road opposite 110 Botany Road)

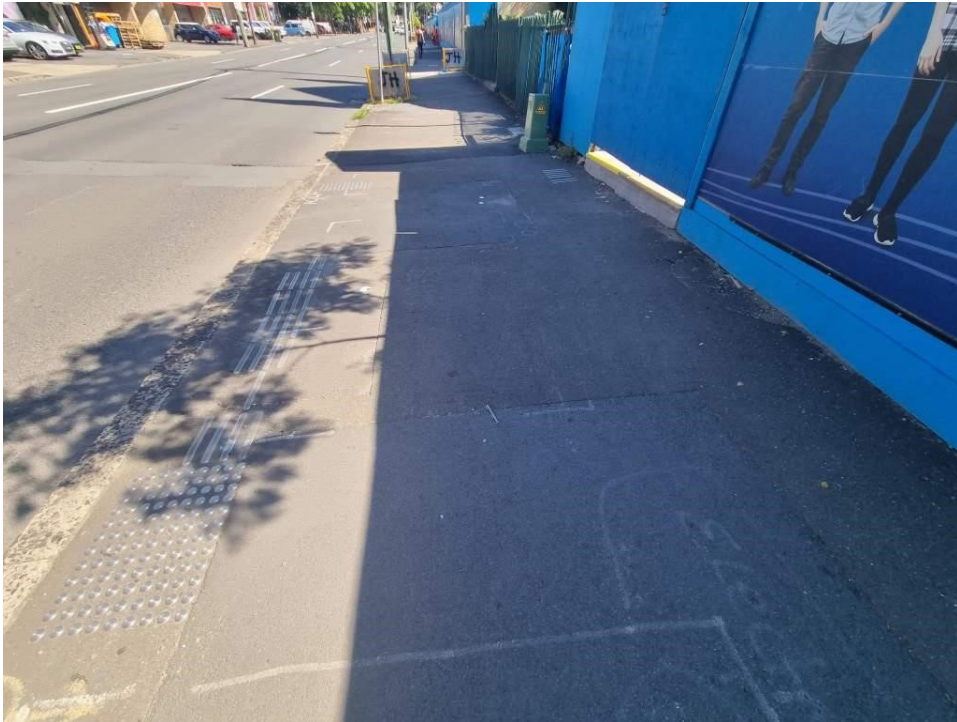
**PHOTO 134**

(Overview of footpath and cable pits on Botany Road opposite 110 Botany Road)

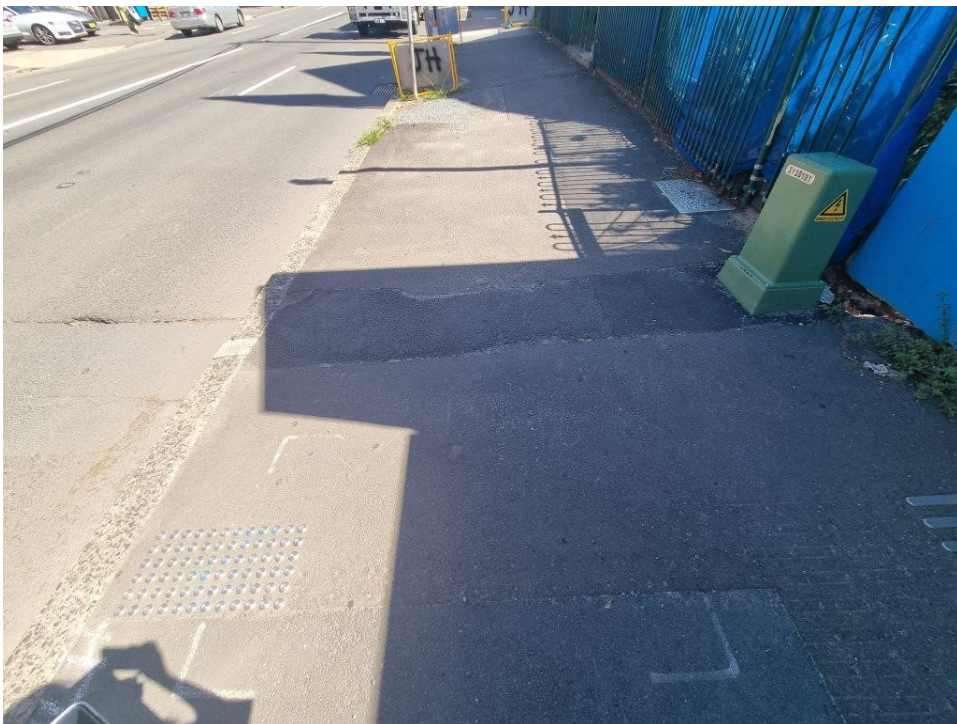
**PHOTO 135**

(Overview of footpath on Botany Road opposite 110 Botany Road)

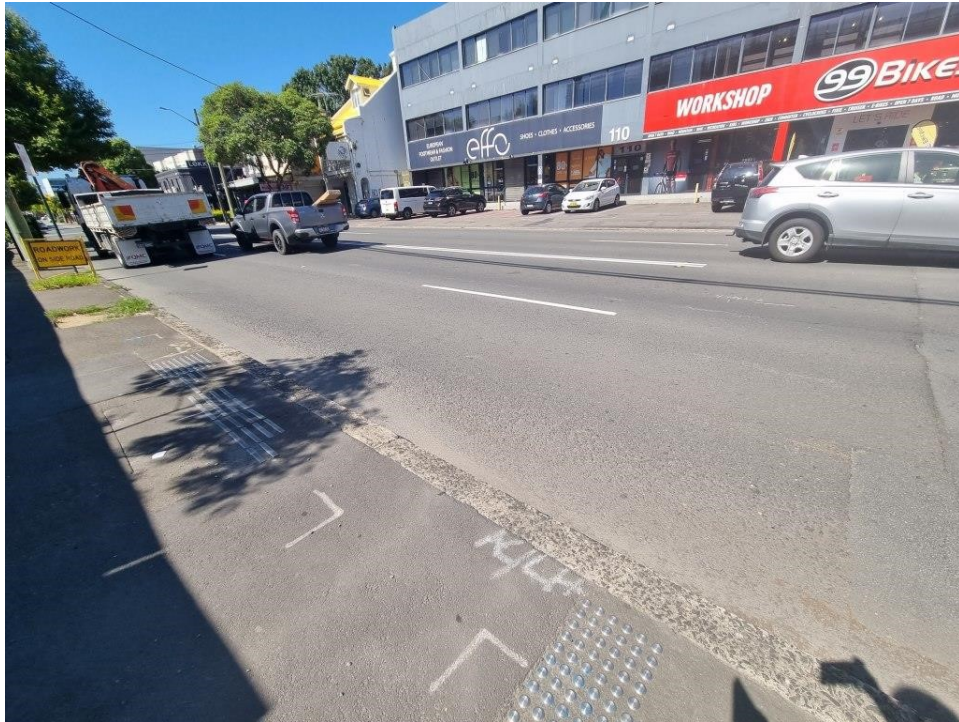
**PHOTO 136**

(Overview of footpath on Botany Road opposite 110 Botany Road)

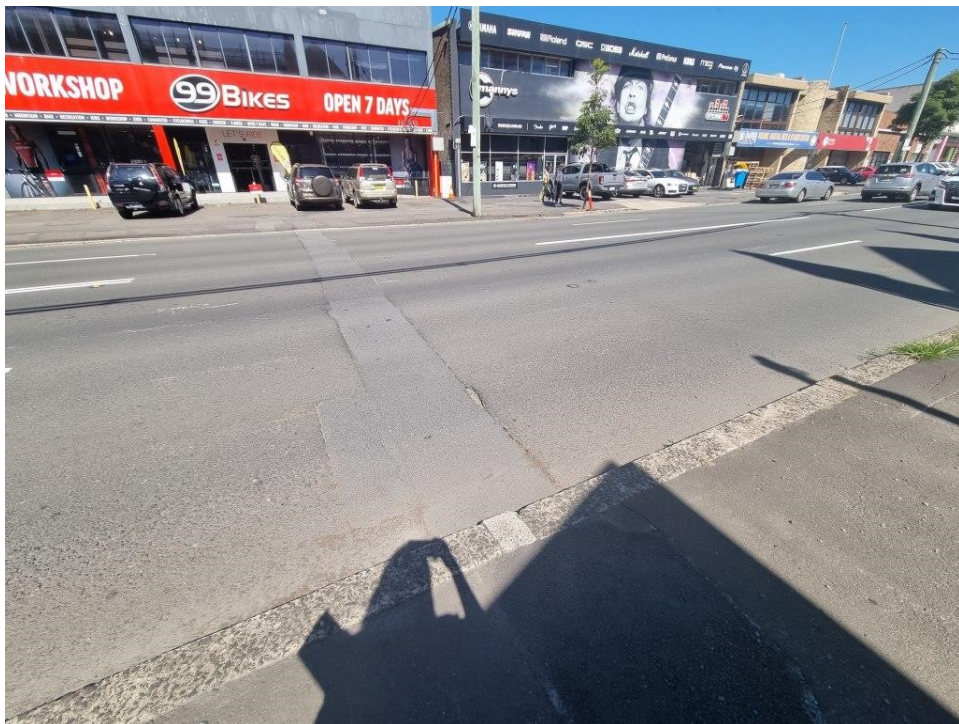
**PHOTO 137**

(Overview of footpath and road on Botany Road opposite 110 Botany Road)

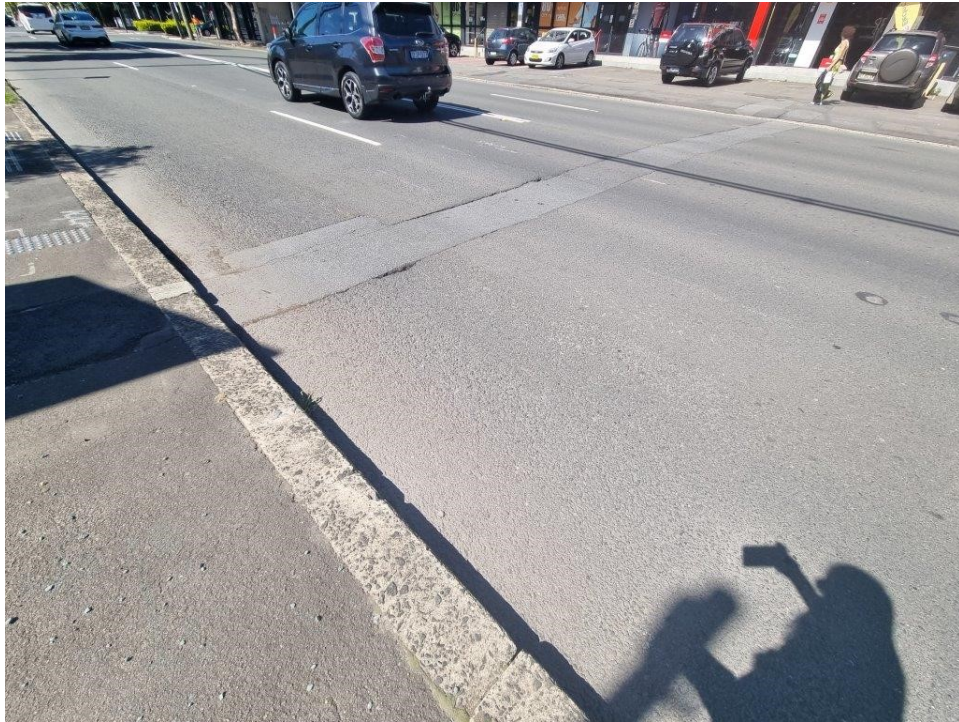
**PHOTO 138**

(Overview of road on Botany Road opposite 110 Botany Road)

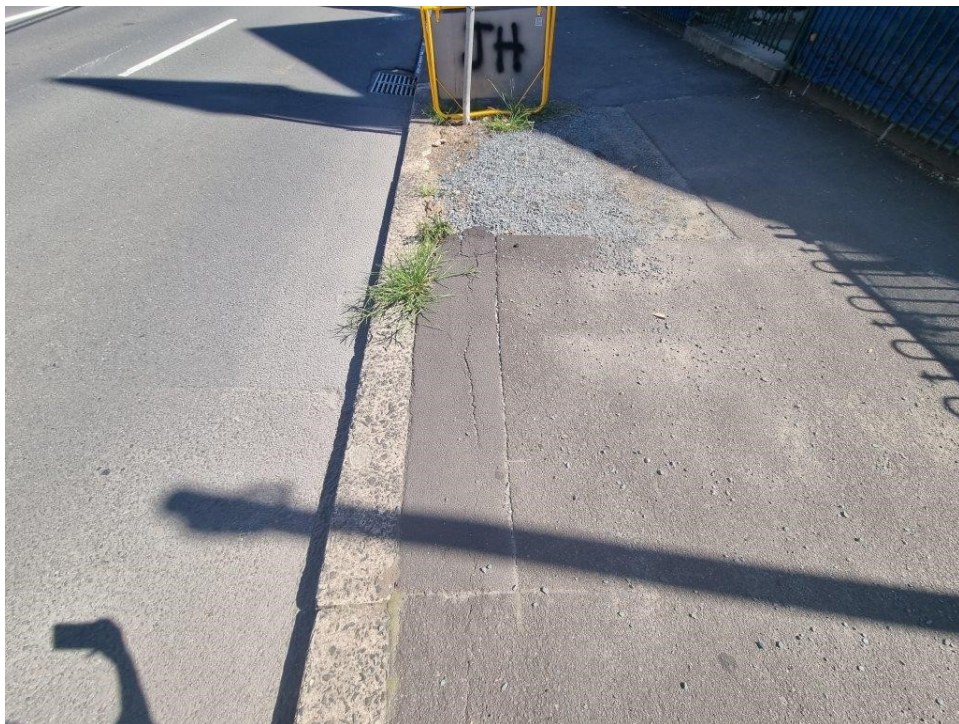
**PHOTO 139**

(Overview of road and kerb on Botany Road opposite 110 Botany Road)

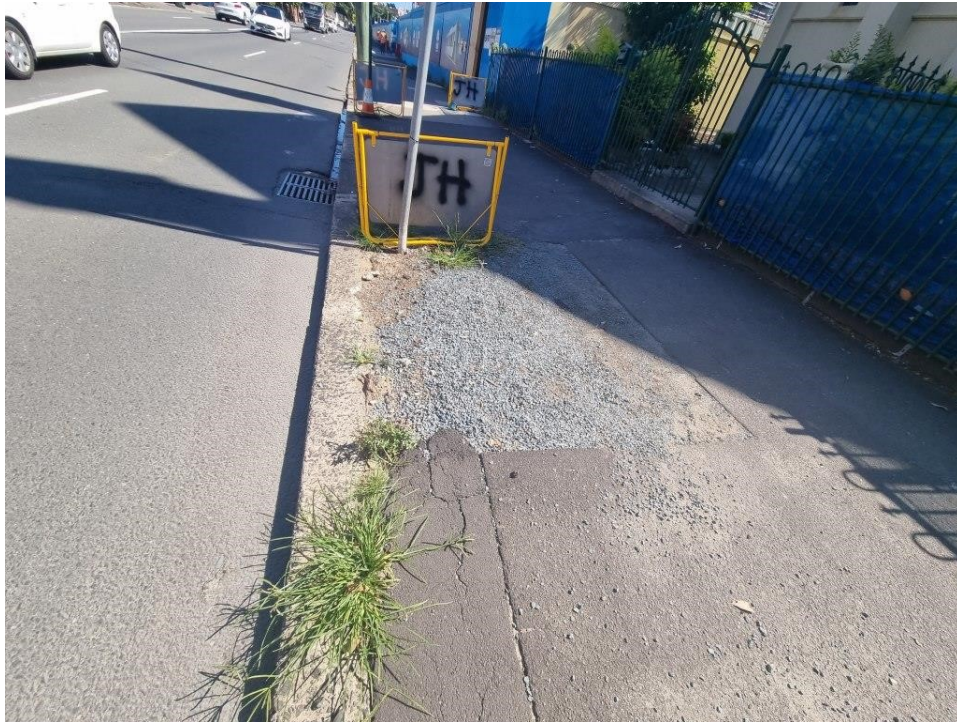
**PHOTO 140**

(Overview of footpath and kerb on Botany Road adjacent Waterloo Congregation Church)

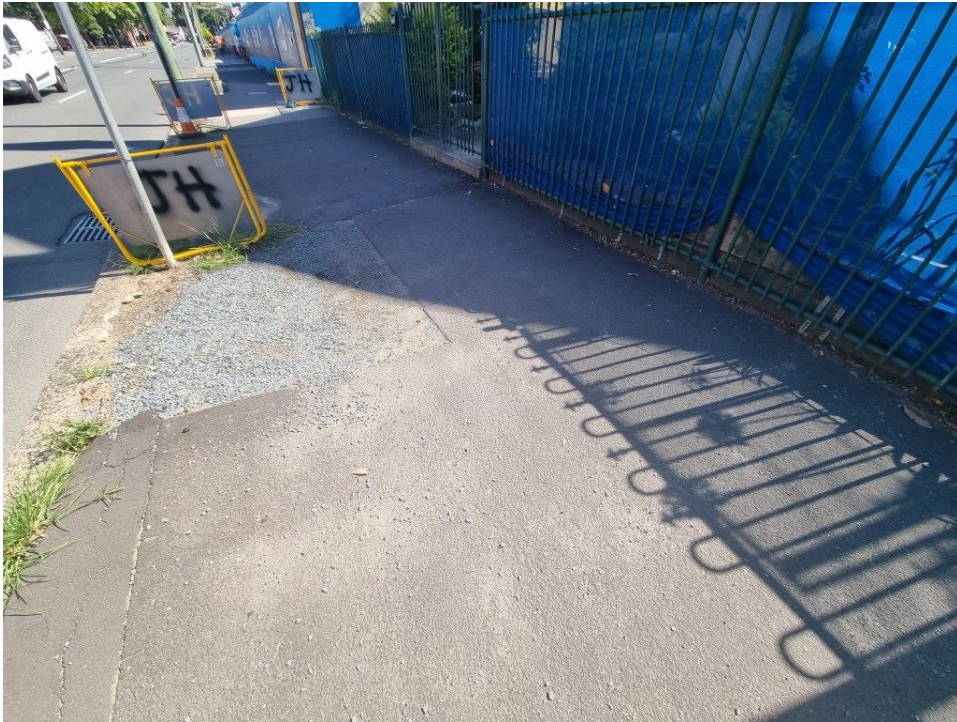
**PHOTO 142**

(Photo showing boundary fence of Waterloo Congregational Church, cable pit and electrical box)

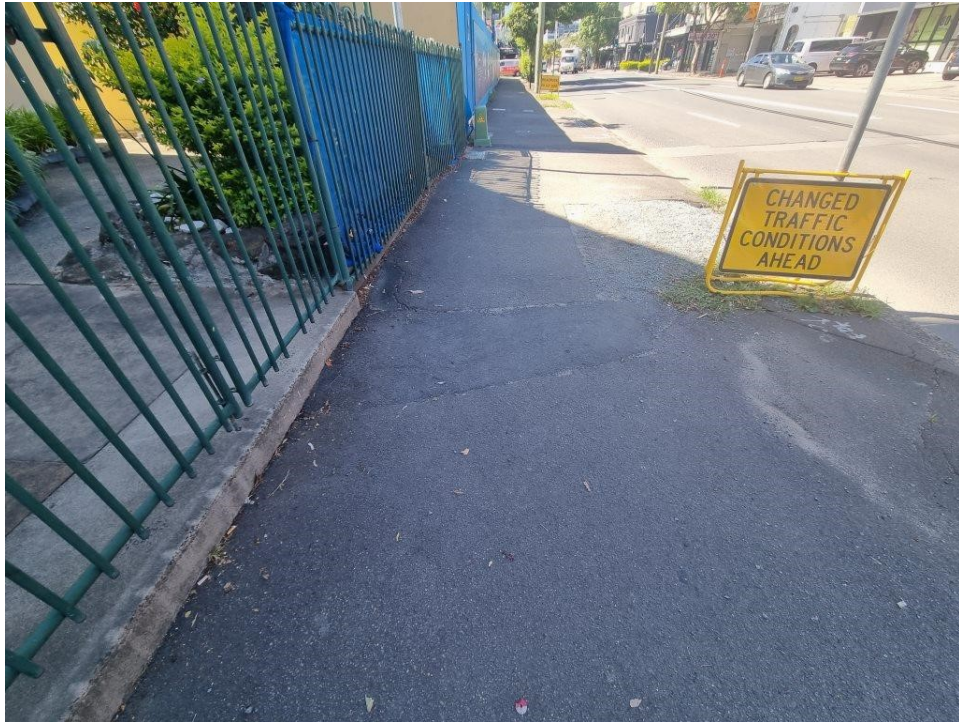
**PHOTO 144**

(Overview of Botany Road footpath, road and sign adjacent to church facing South)

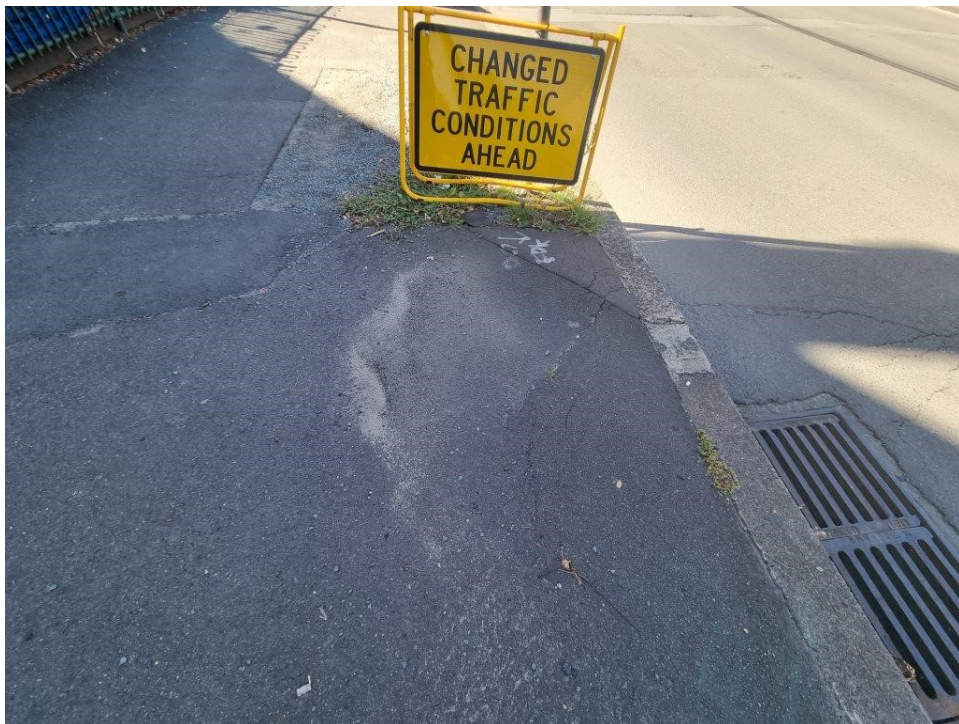
**PHOTO 145**

(Overview of Botany Road footpath and boundary fence adjacent to church facing South)

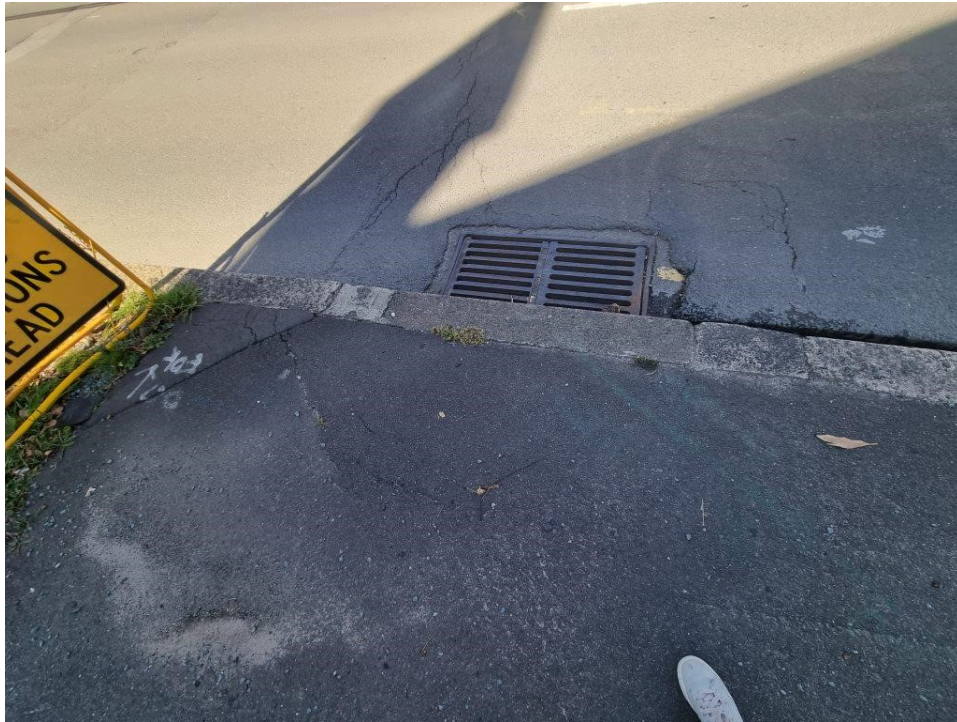
**PHOTO 146**

(Photo showing uneven footpath and stormwater inlet pit adjacent church)

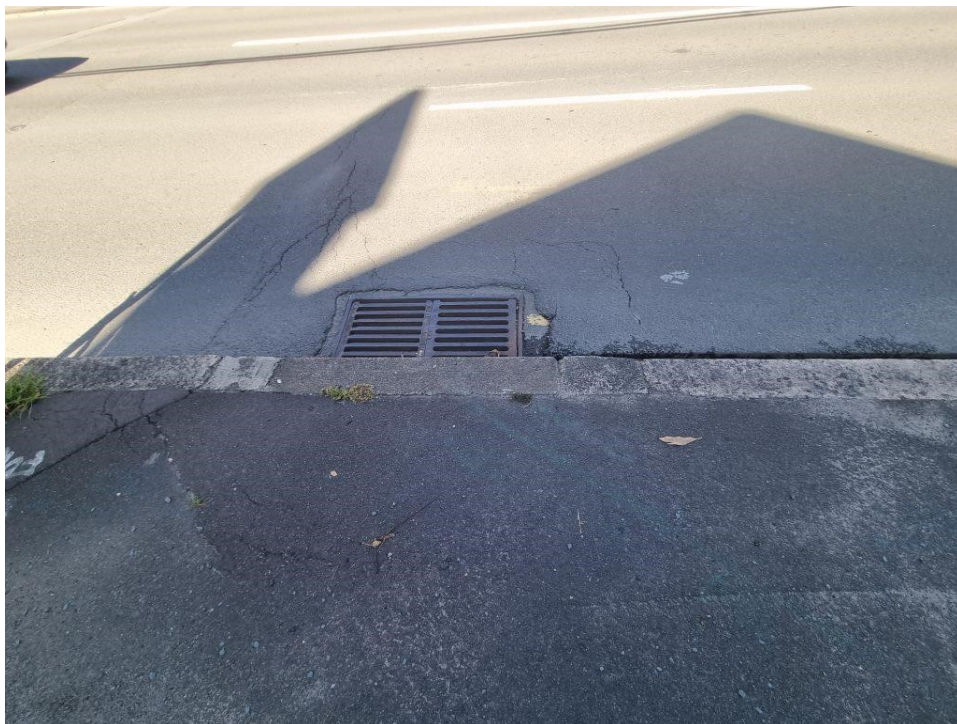
**PHOTO 147**

(Photo showing uneven footpath and stormwater inlet pit adjacent church)

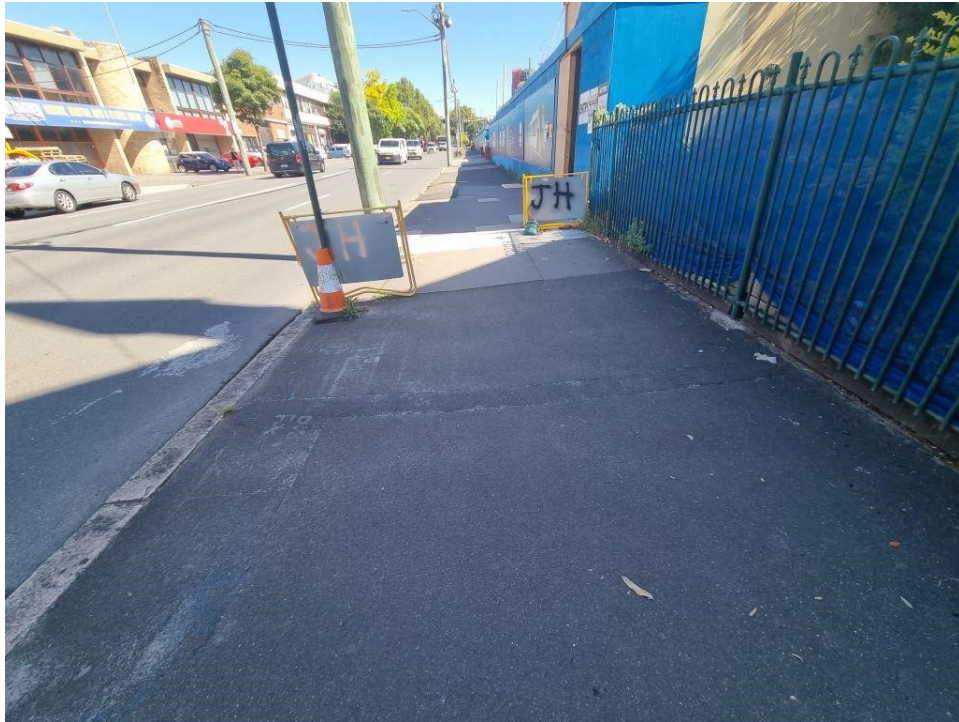
**PHOTO 148**

(Photo showing uneven footpath and stormwater inlet pit adjacent church)

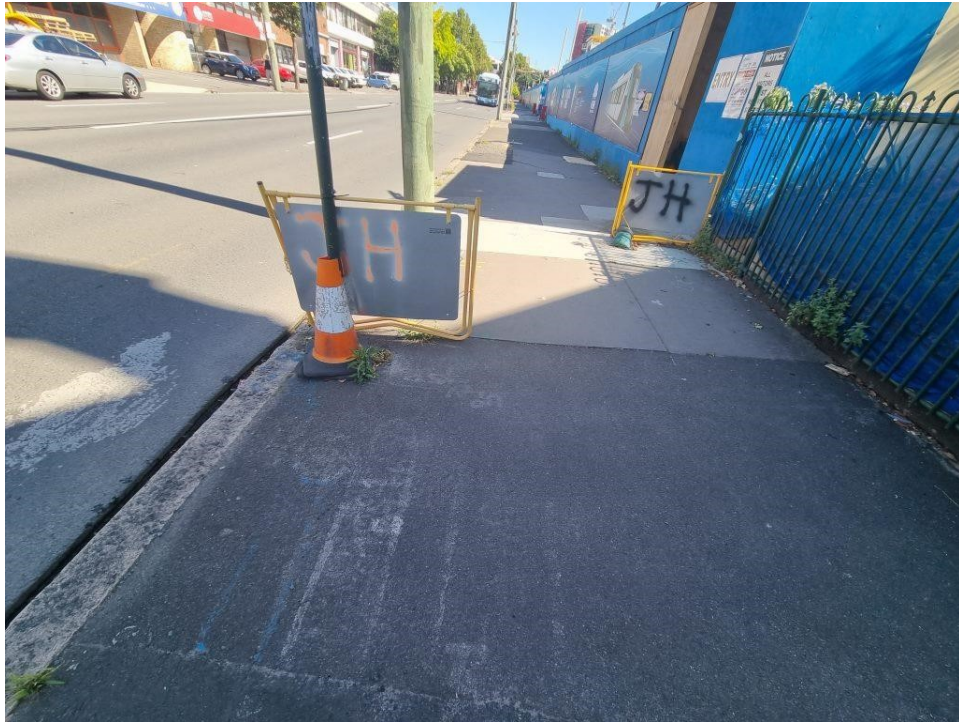
**PHOTO 150**

(Overview of boundary fence of church and footpath on Botany Road)

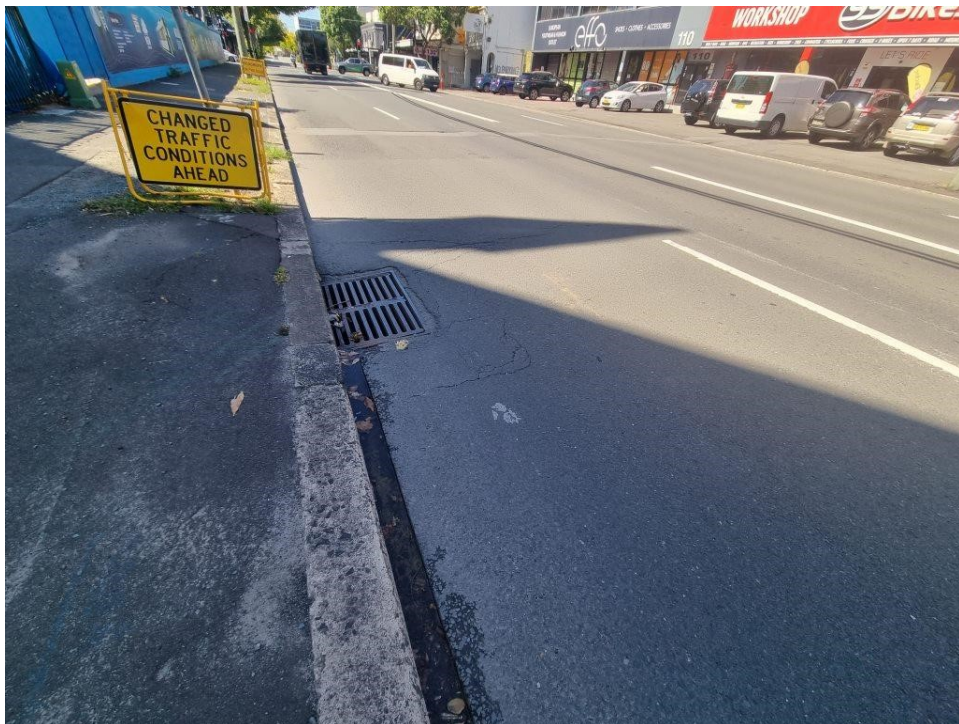
**PHOTO 151**

(Overview of footpath adjacent church facing North)

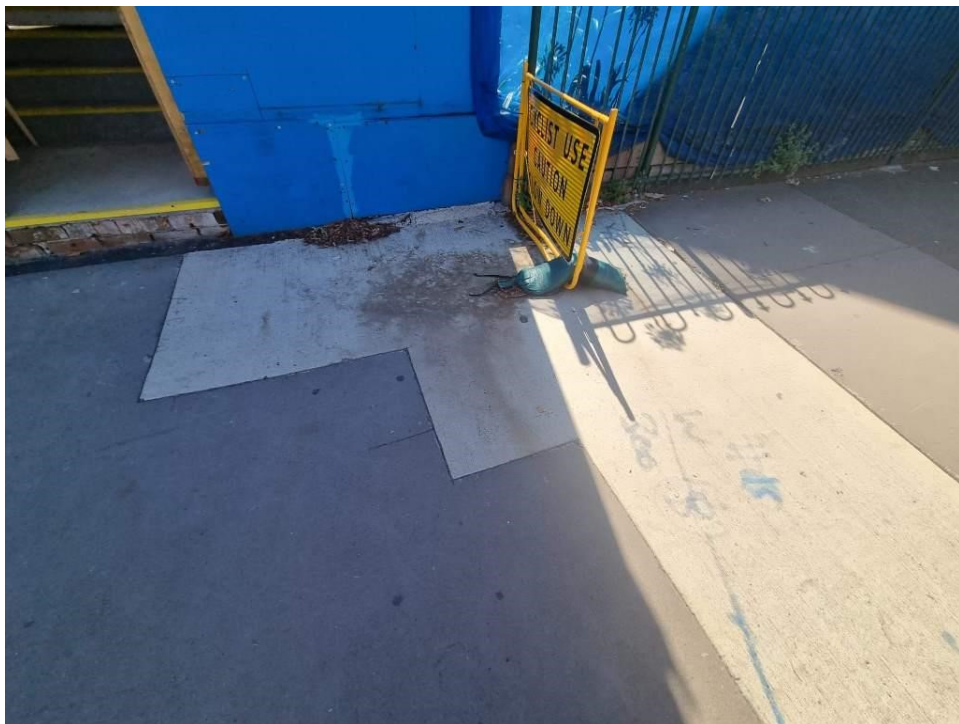
**PHOTO 155**

(Overview of footpath adjacent church facing North)
