# DILAPIDATION REPORT

**WATERLOO CONGREGATIONAL CHURCH  
103 BOTANY ROAD  
WATERLOO NSW 2017**

**WATERLOO STATION  
COPE STREET**

**24 January 2023**

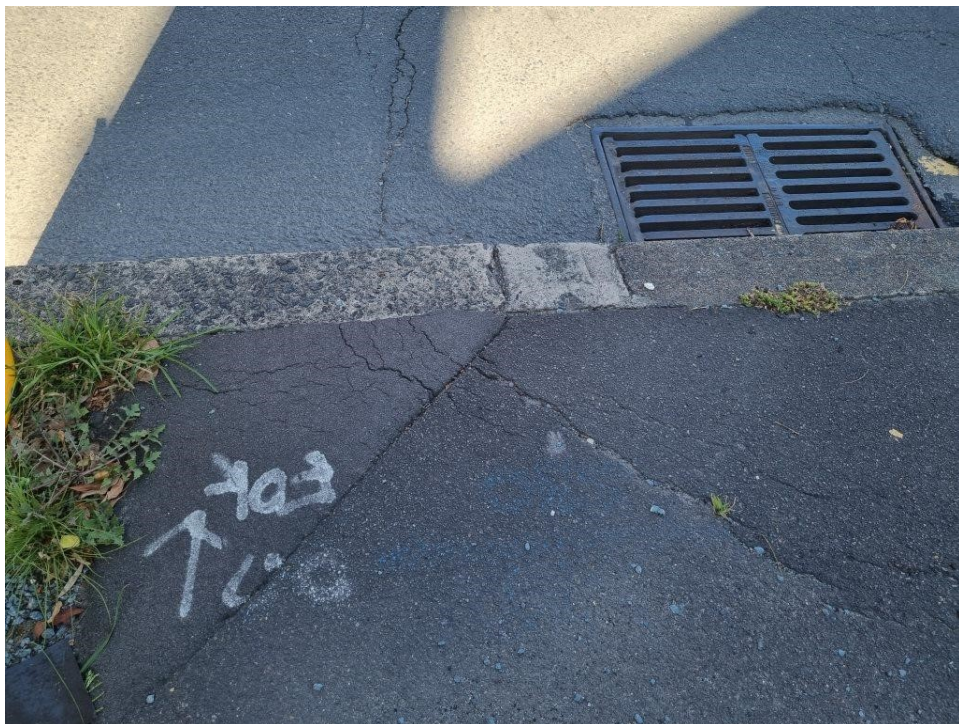
**PHOTO 6**

(Photo showing cracks in the road pavement)

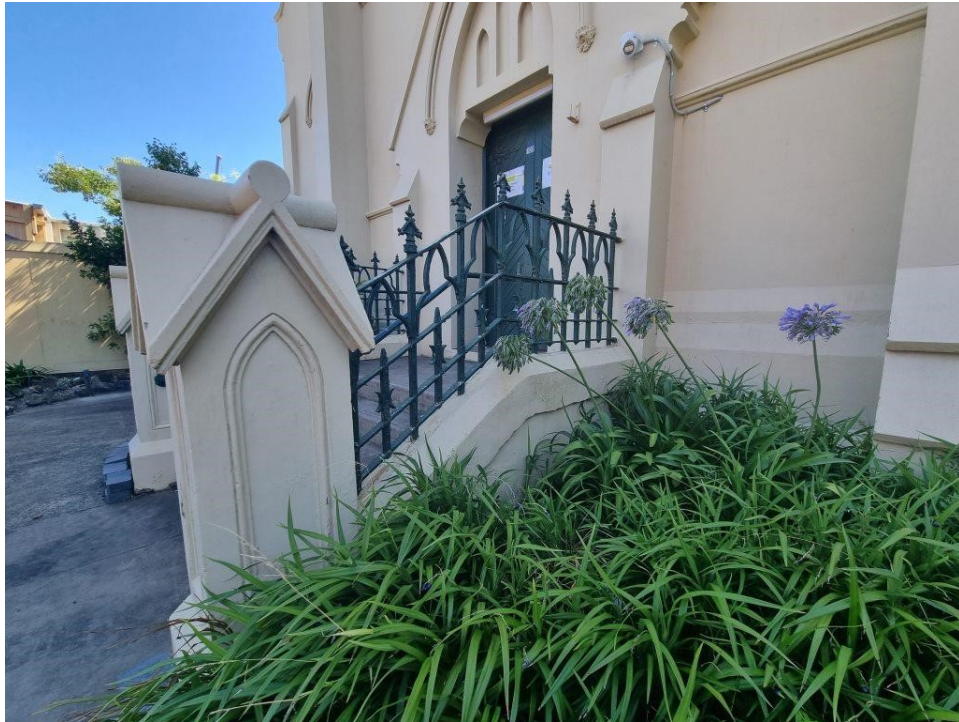
**PHOTO 11**

(Overview of church southern side front porch and foot path)

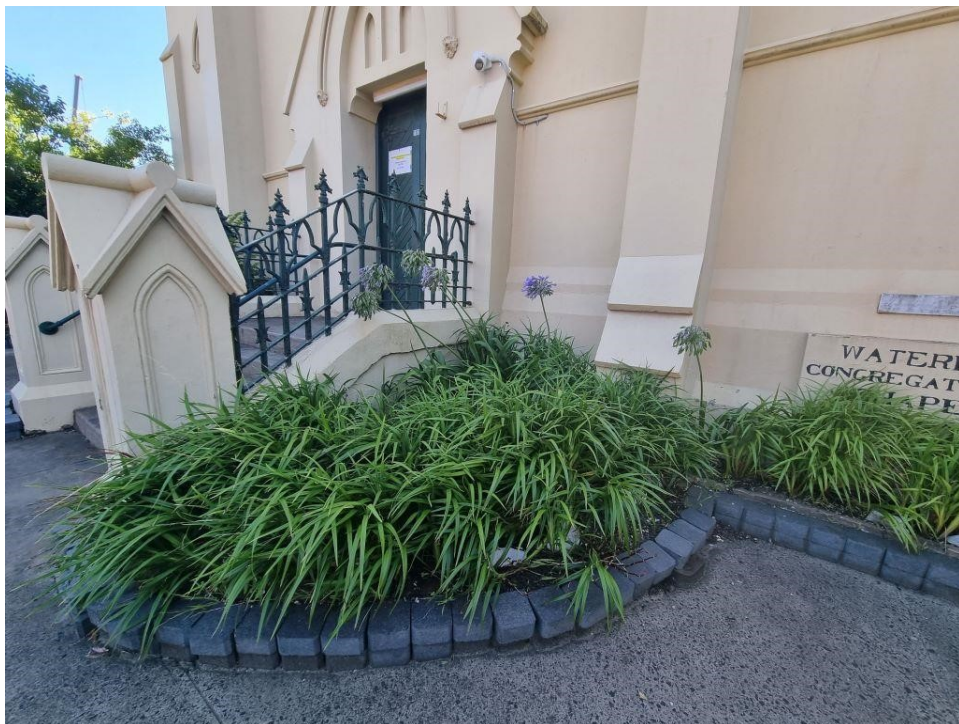
**PHOTO 12**

(Photo showing loose bricks of the front garden bed on the southern side)

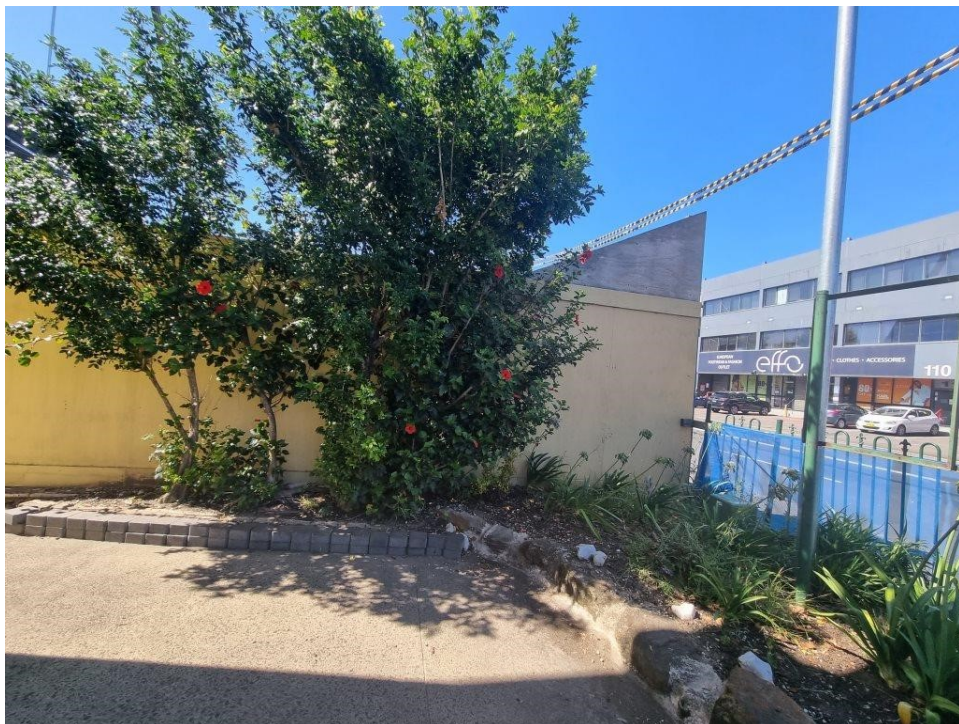
**PHOTO 14**

(Overview of the external brick wall looking at the western side)

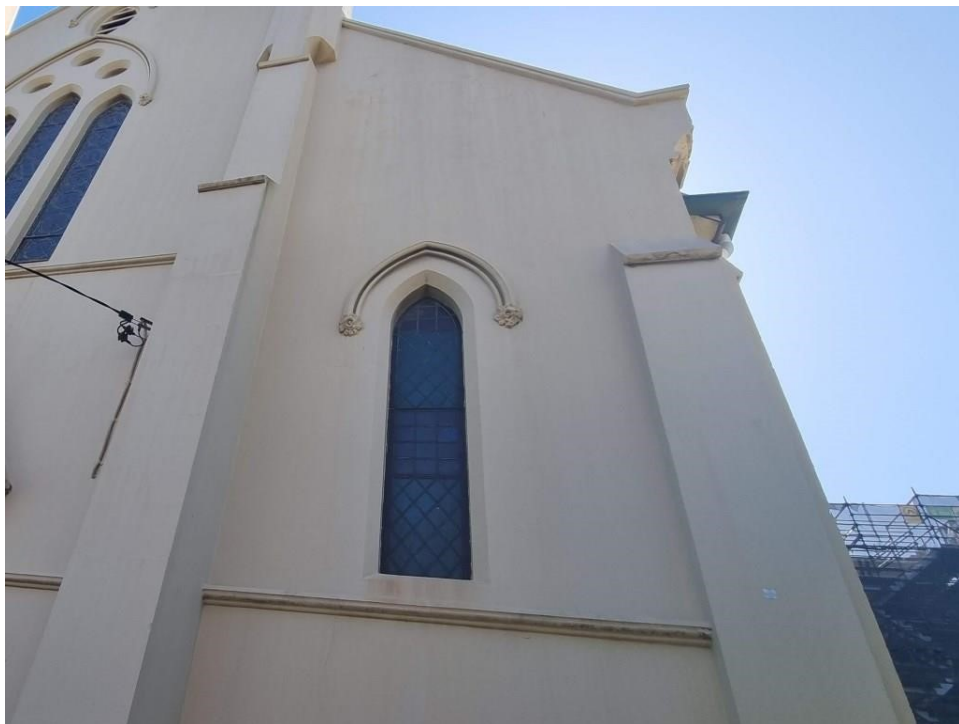
**PHOTO 18**  
(Overview of Church façade)

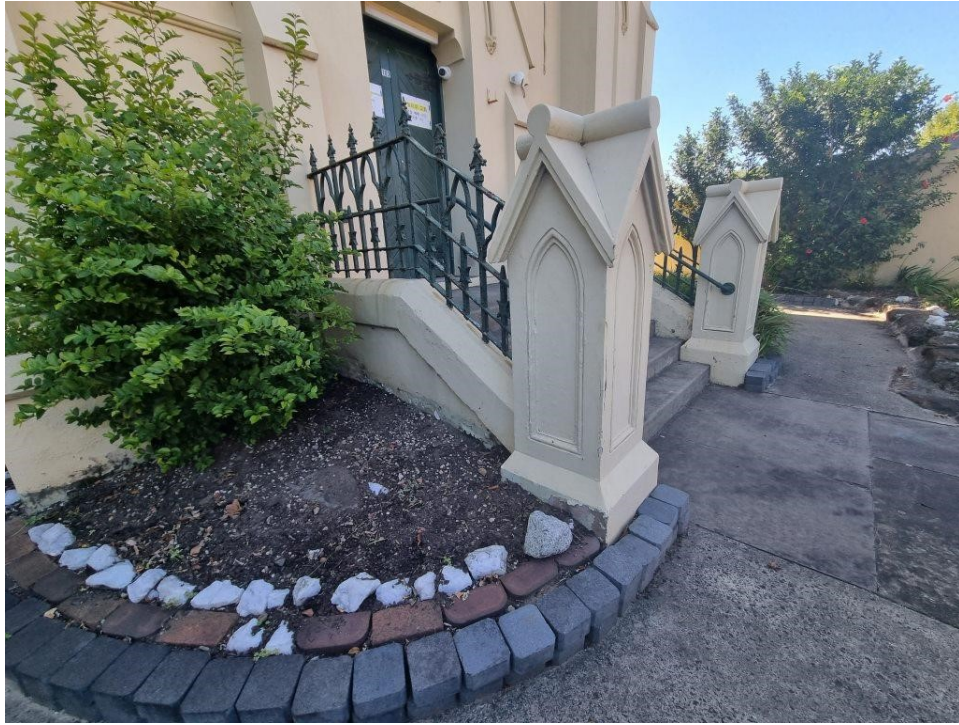
**PHOTO 25**

(Overview of railing and garden bed on northern side of courtyard)

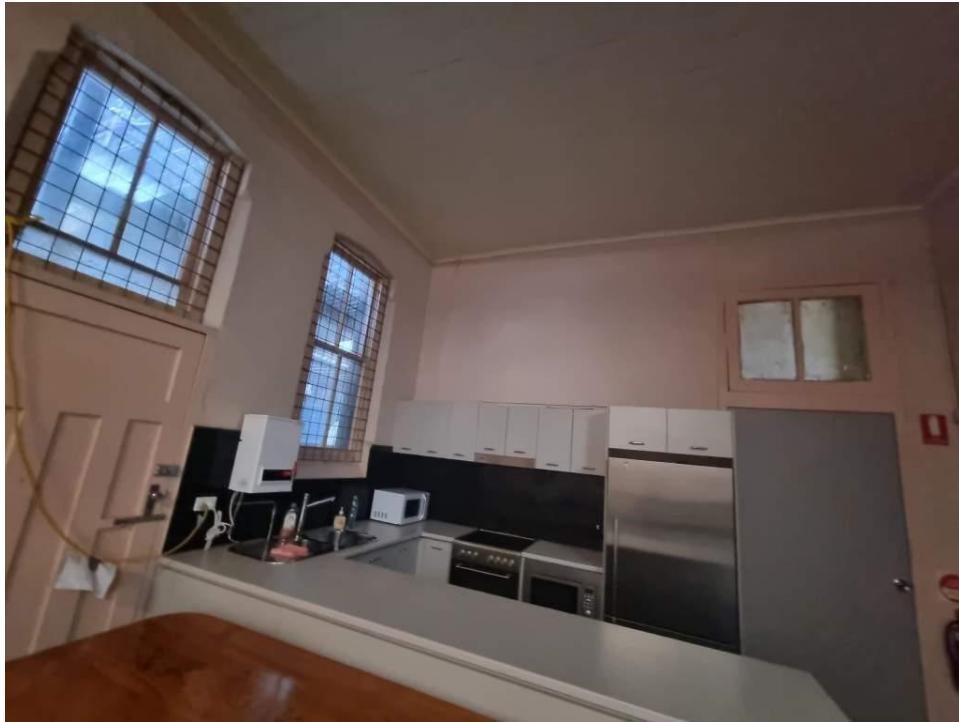
**PHOTO 51**

(Overview of kitchen area back of the church on level 1)

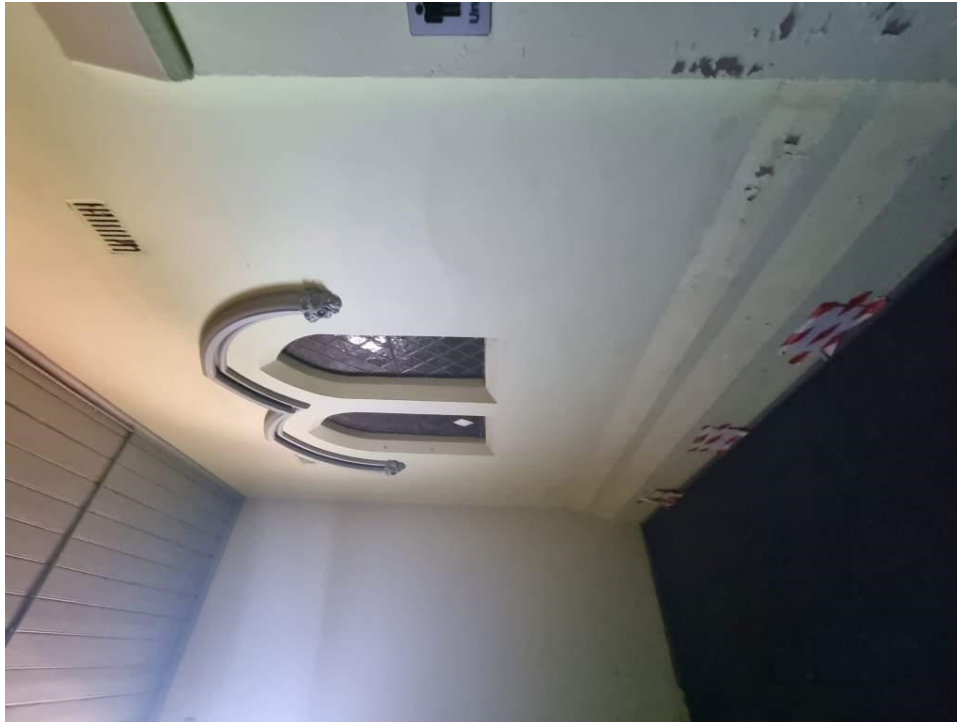
**PHOTO 54**  
(Photo showing paint peeling on wall on level 1)

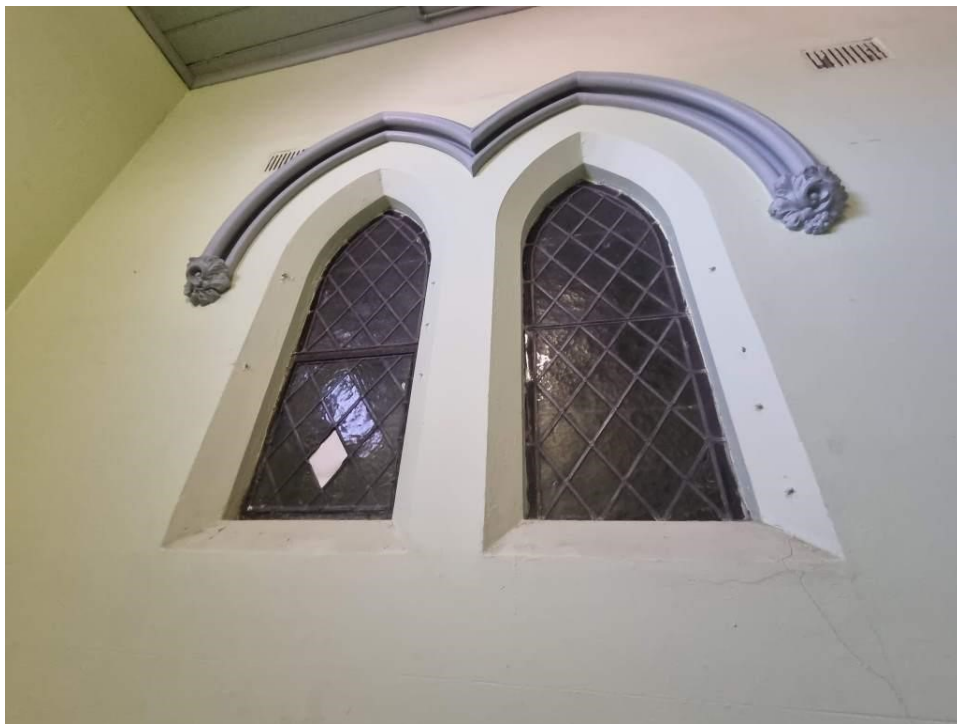
**PHOTO 55**

(Overview of wall and windows adjacent to the stairs)

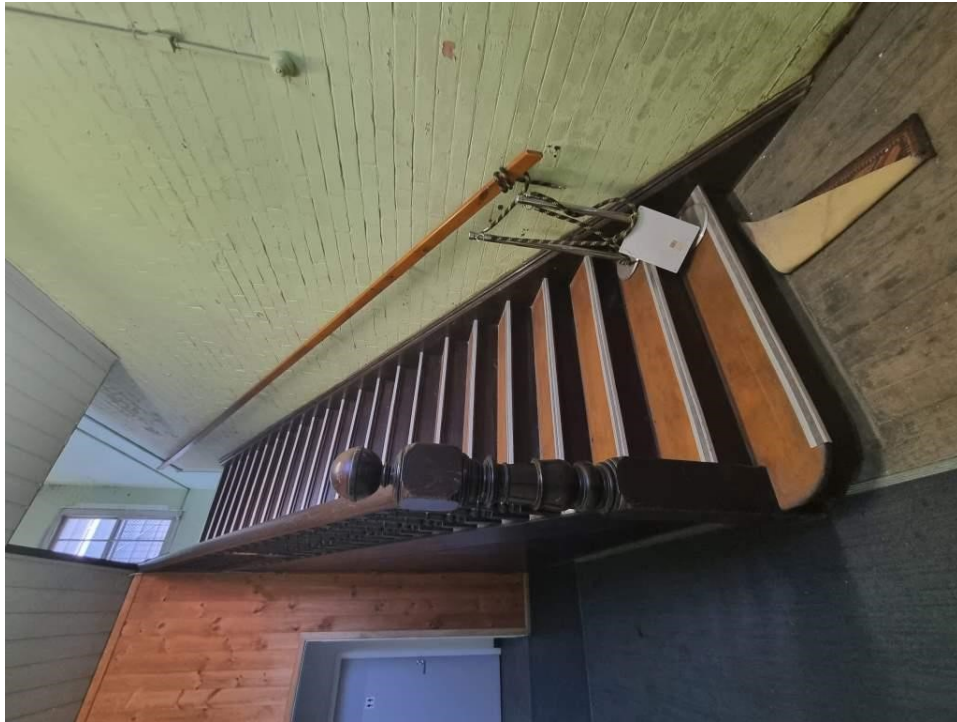
**PHOTO 58**

(Overview of wooden door adjacent to stairs)

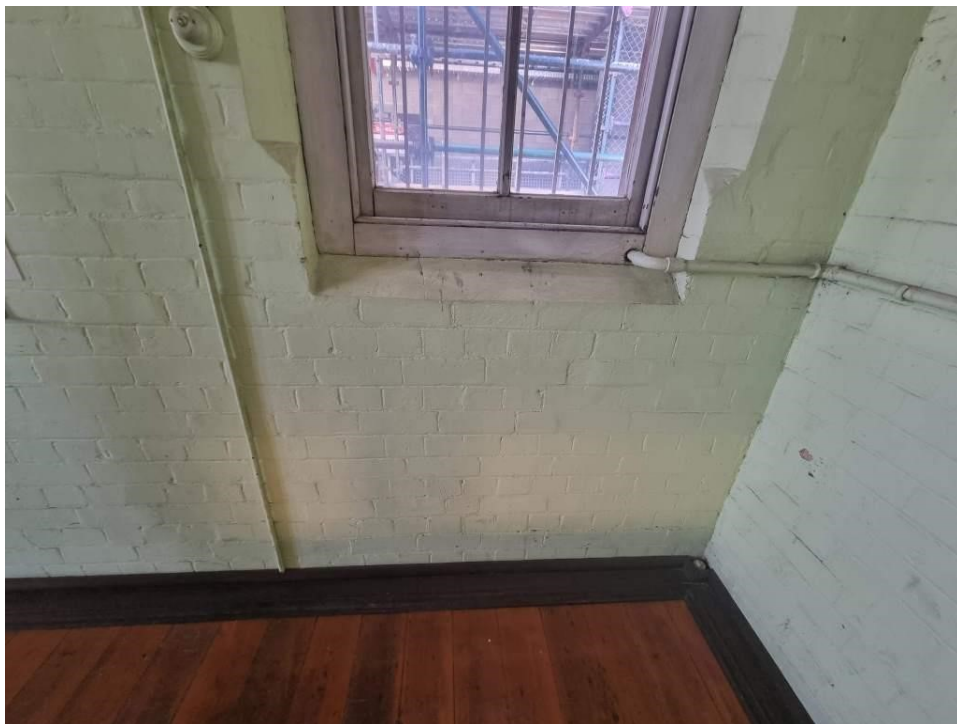
**PHOTO 59**  
(Overview of stairs at the back of the building)

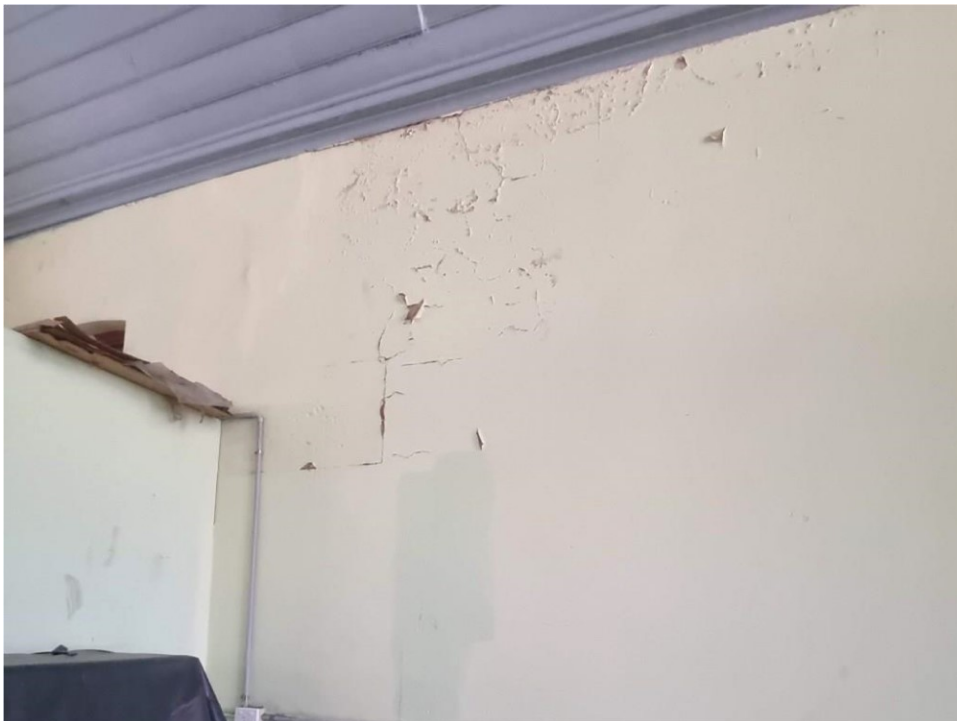
**PHOTO 63**

(Photo of paint peeling on wall on level 2 of the back of the property)

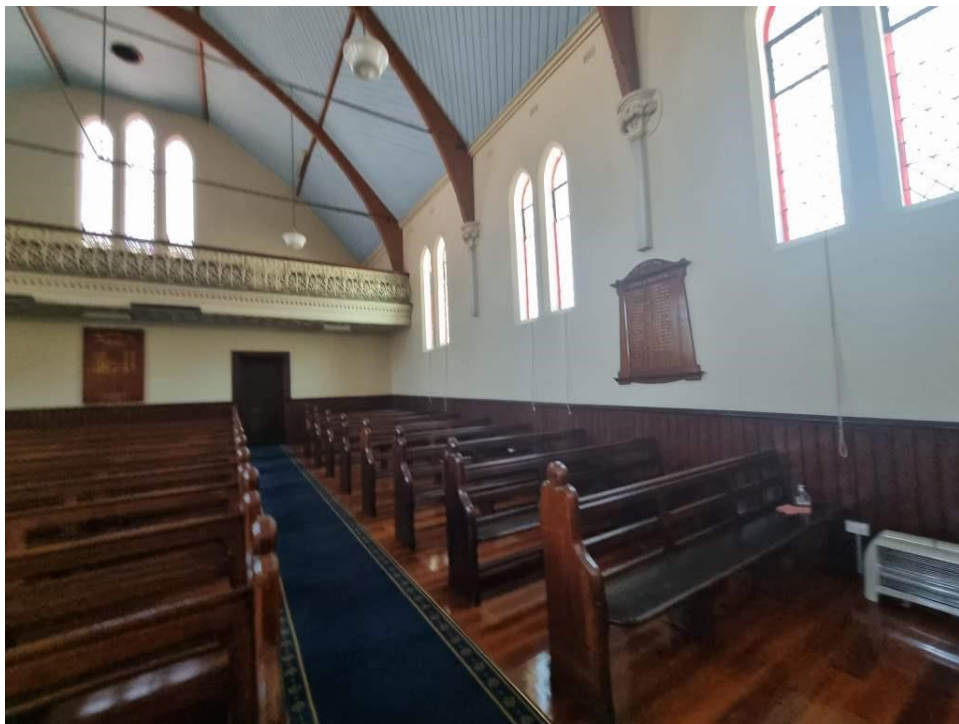
**PHOTO 77**

(Overview of church main room level 1, looking west)

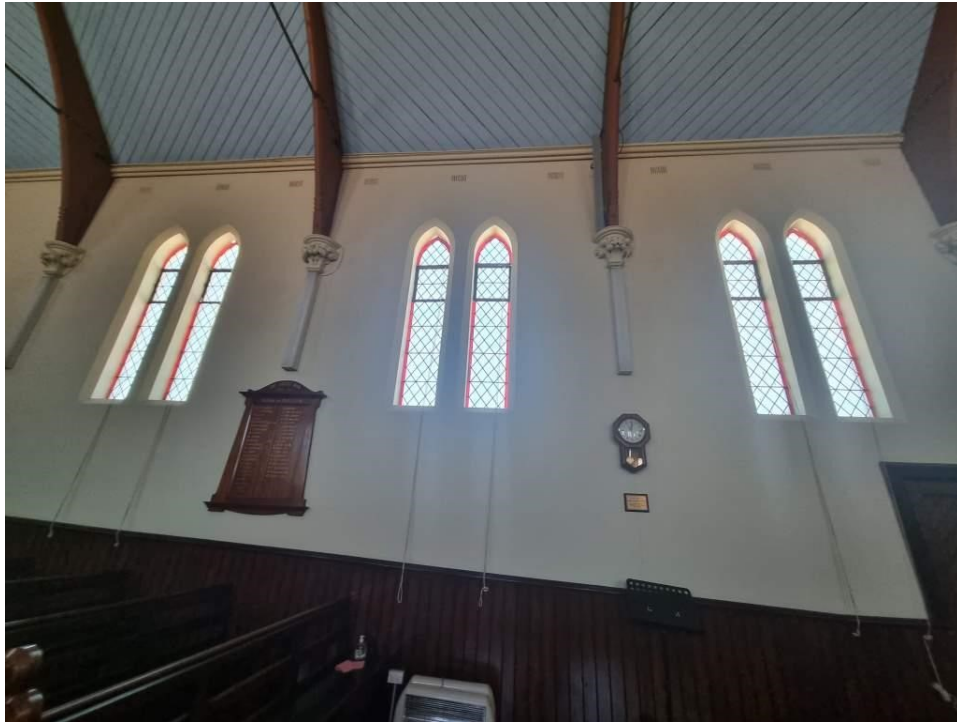
**PHOTO 78**

(Overview of church main room level 1)

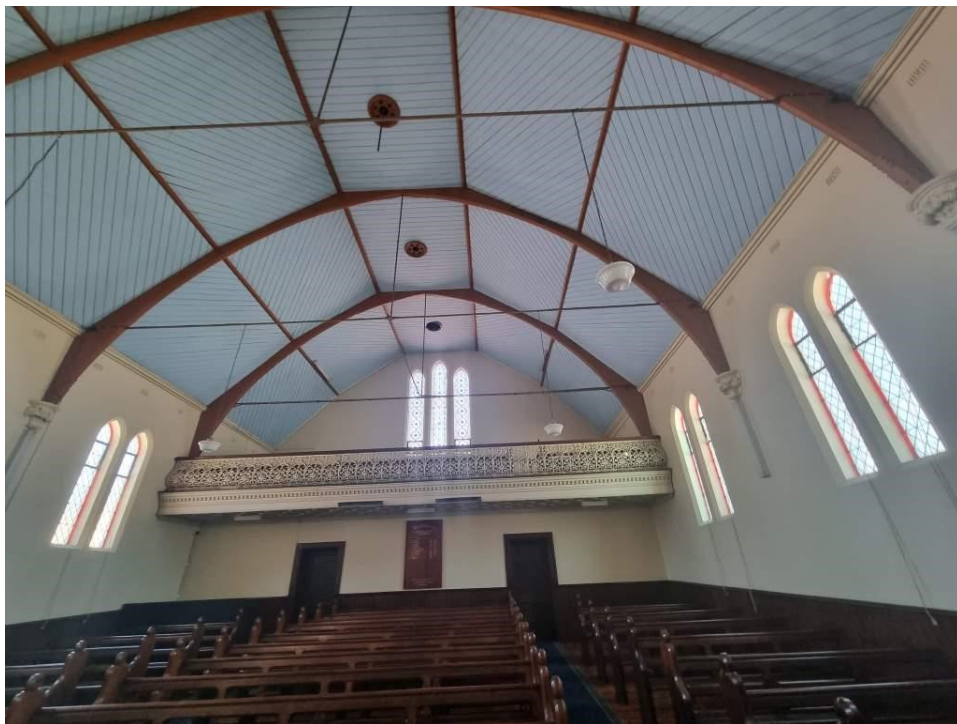
**PHOTO 79**  
(Overview of church main room windows)

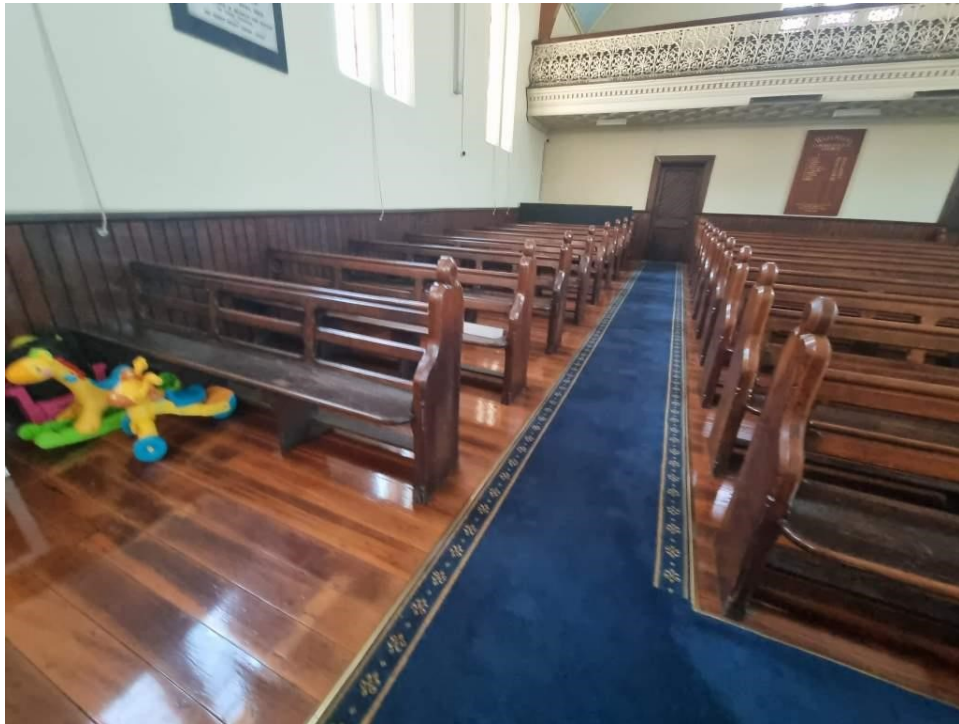
**PHOTO 80**  
(Overview of church main room level 1)

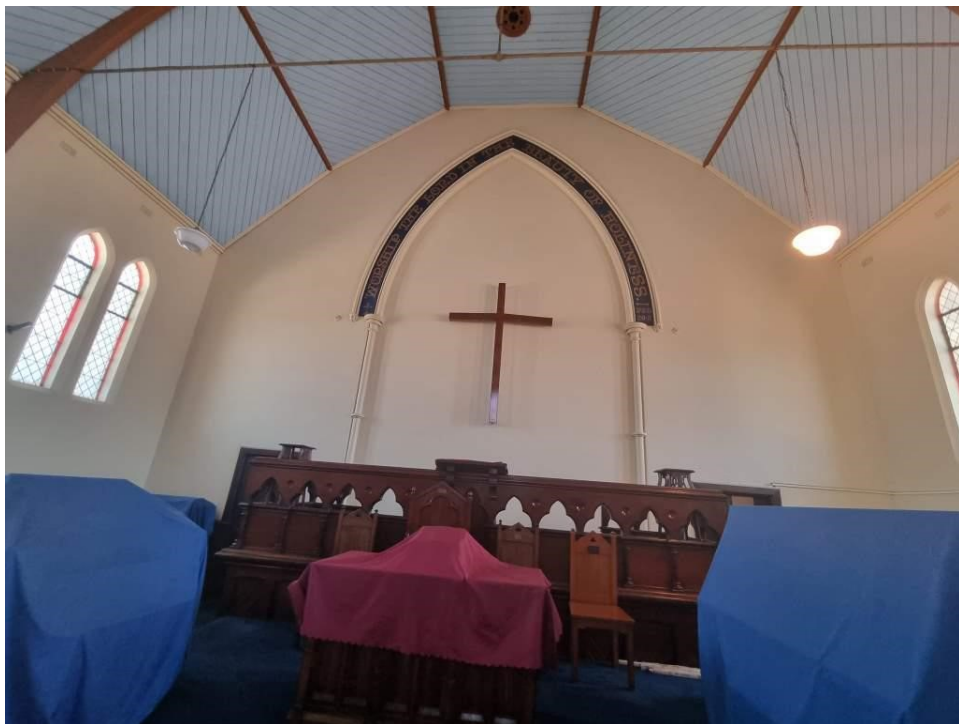
**PHOTO 81**  
(Overview of church main room level 1)

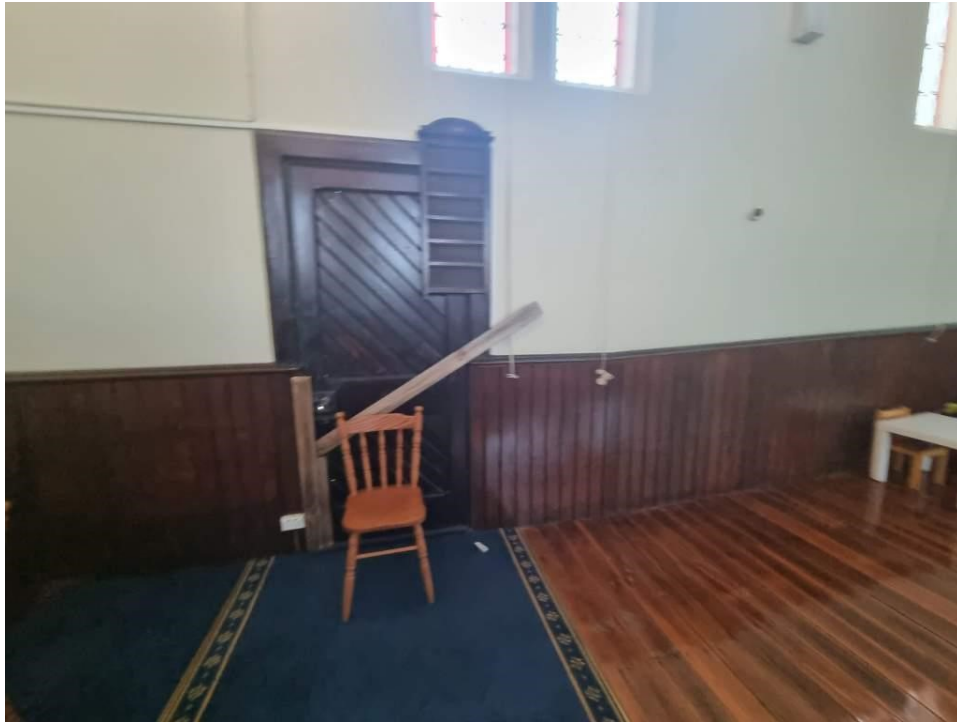
**PHOTO 82**  
(Overview of church main room, looking east)

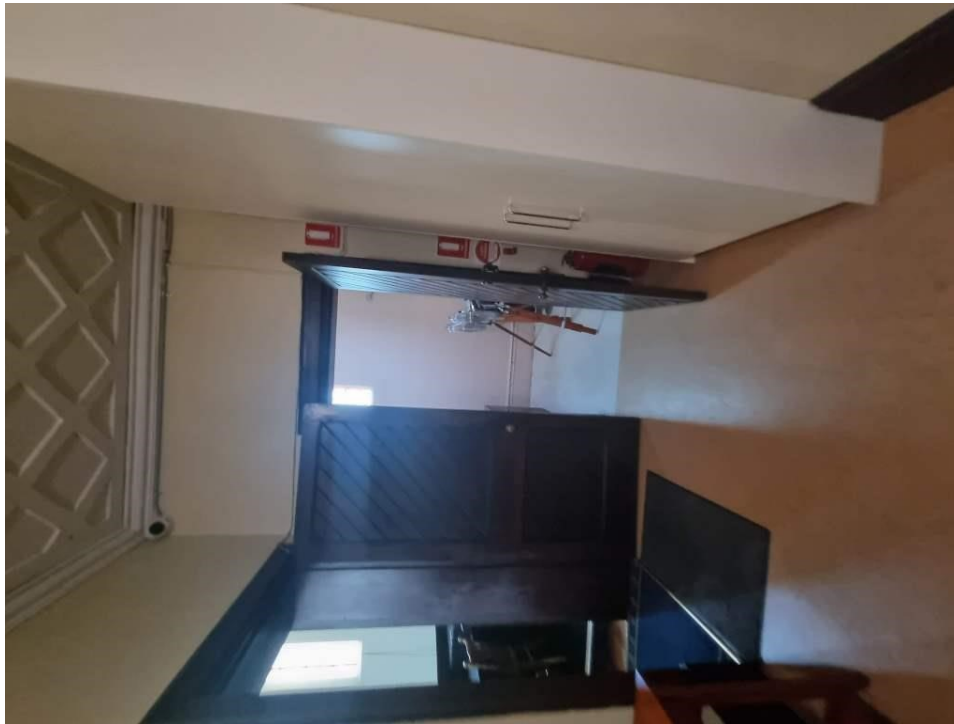
**PHOTO 84**

(Overview of door to front of the property from the main room)

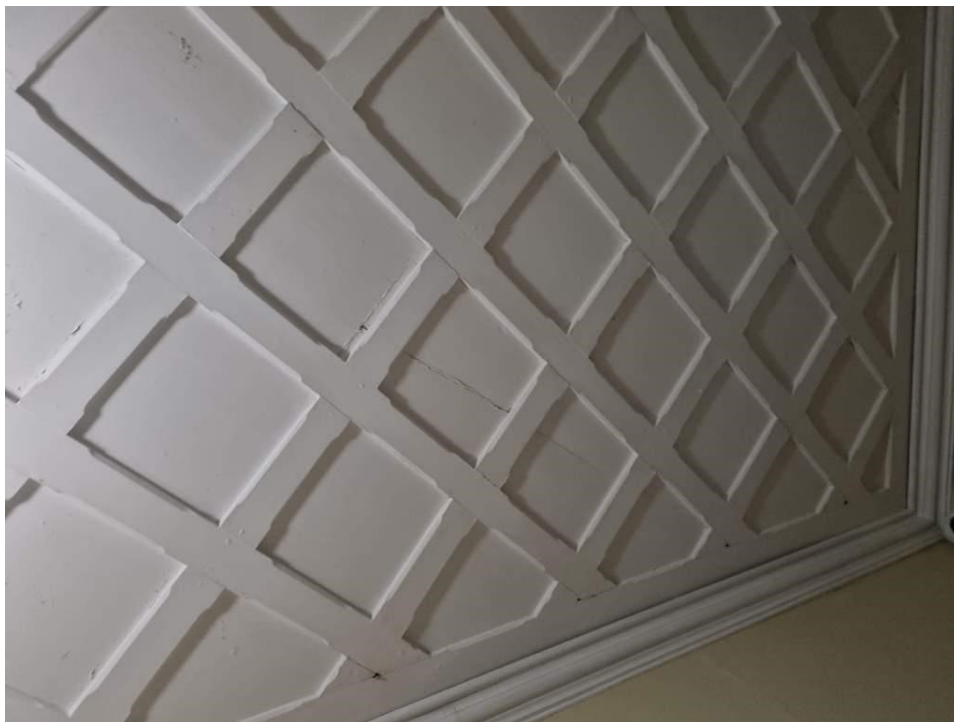
**PHOTO 85**  
(Overview of room adjacent to main area of church)

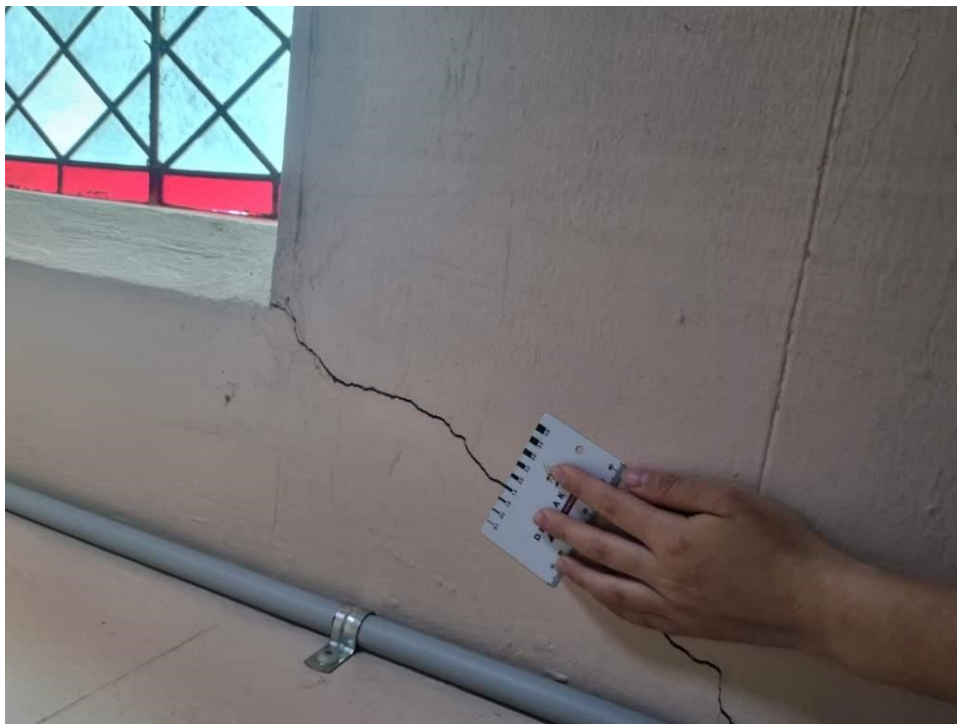
**PHOTO 87**

(Photo showing condition of wall and window on stairs to level 1 in main church room)

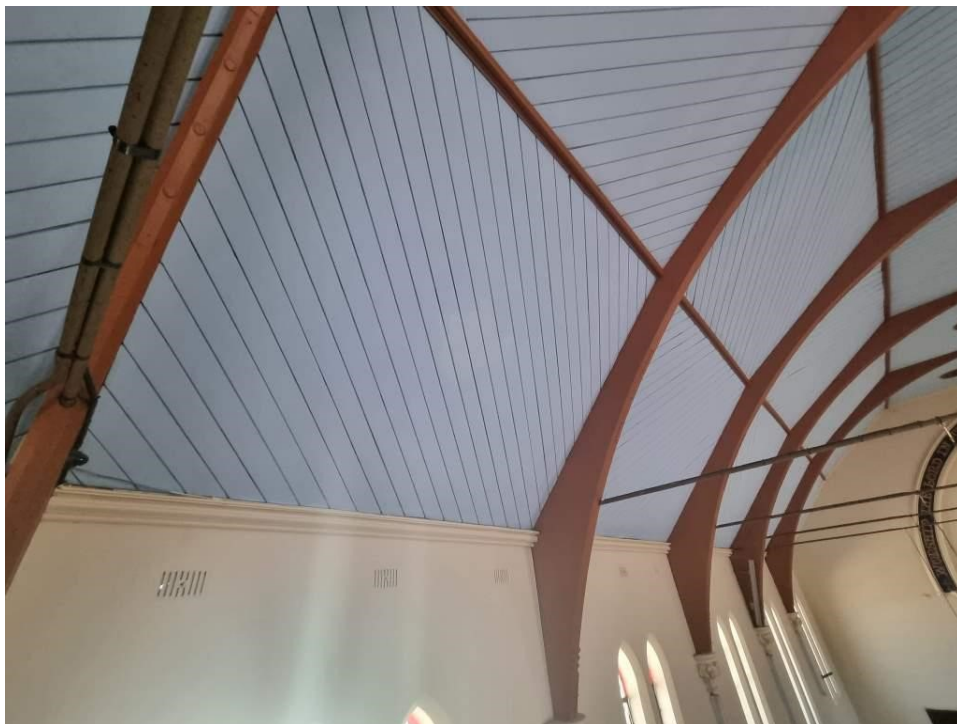
**PHOTO 89**  
(Overview of ceiling in main church room)

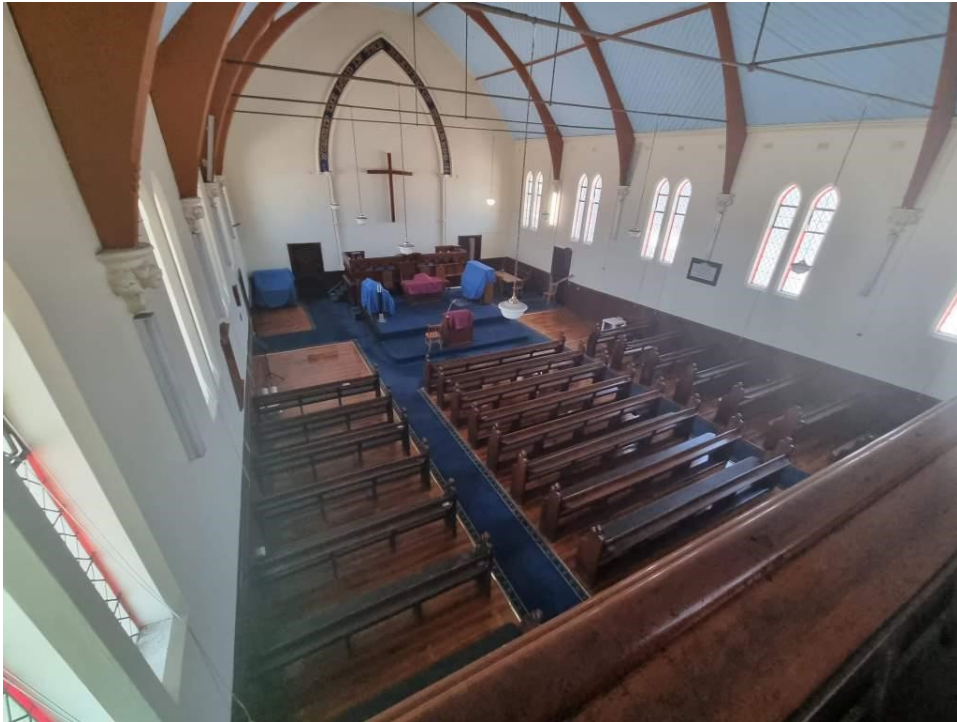
**PHOTO 90**  
(Overview of ceiling in main church room)

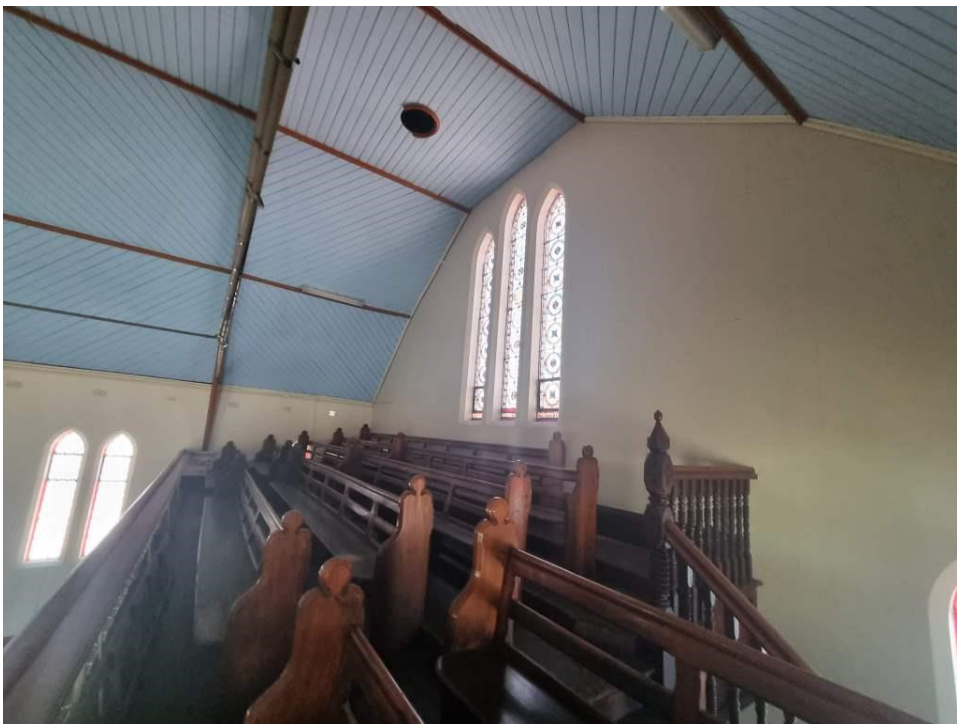
**PHOTO 91**

(Overview of main church room from level 2, looking east)
