DILAPIDATION REPORT

Council Assets/Public Infrastructure

**WATERLOO STATION
COPE STREET**

DEMLAKIAN CONSULTING ENGINEERS

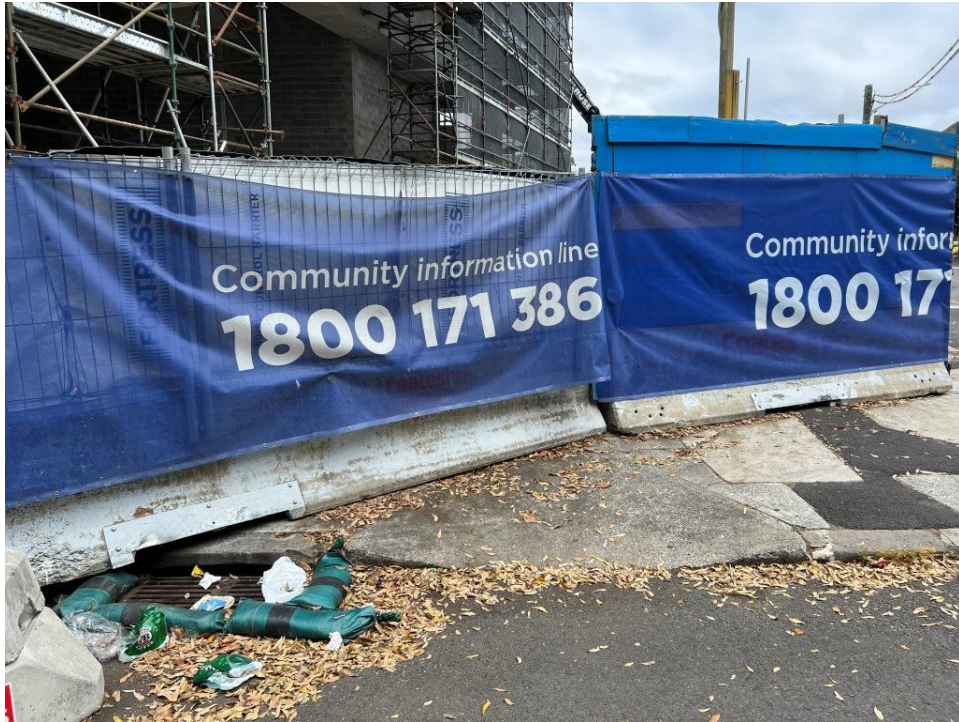
PHOTO 1

(Overview of starting point of dilapidation inspection - Raglan Street)

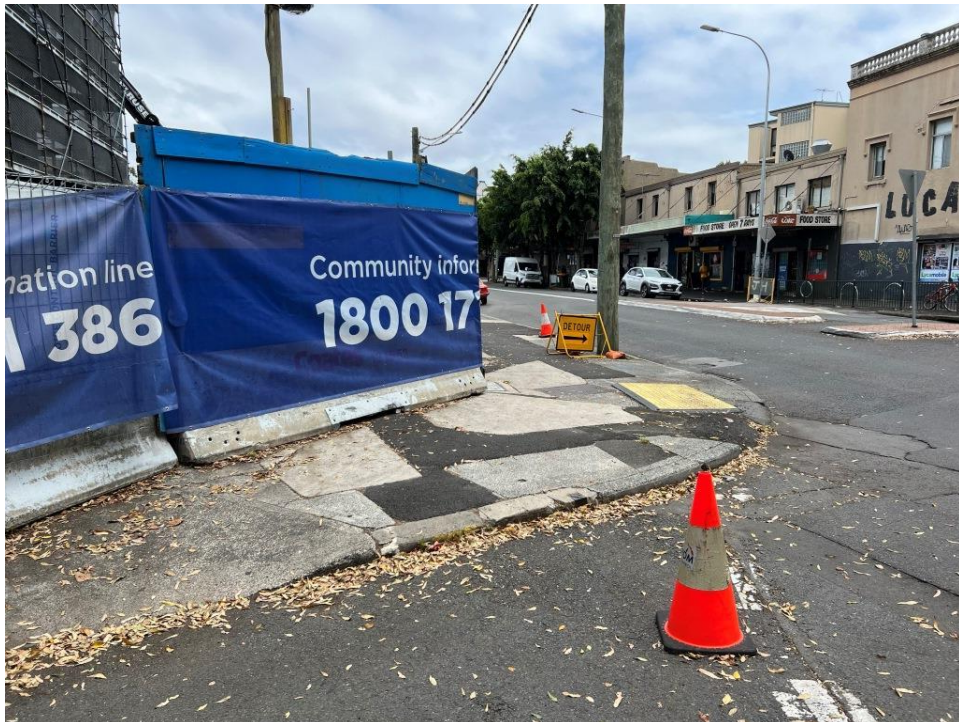
PHOTO 2

(Overview of starting point of dilapidation inspection - Raglan Street)

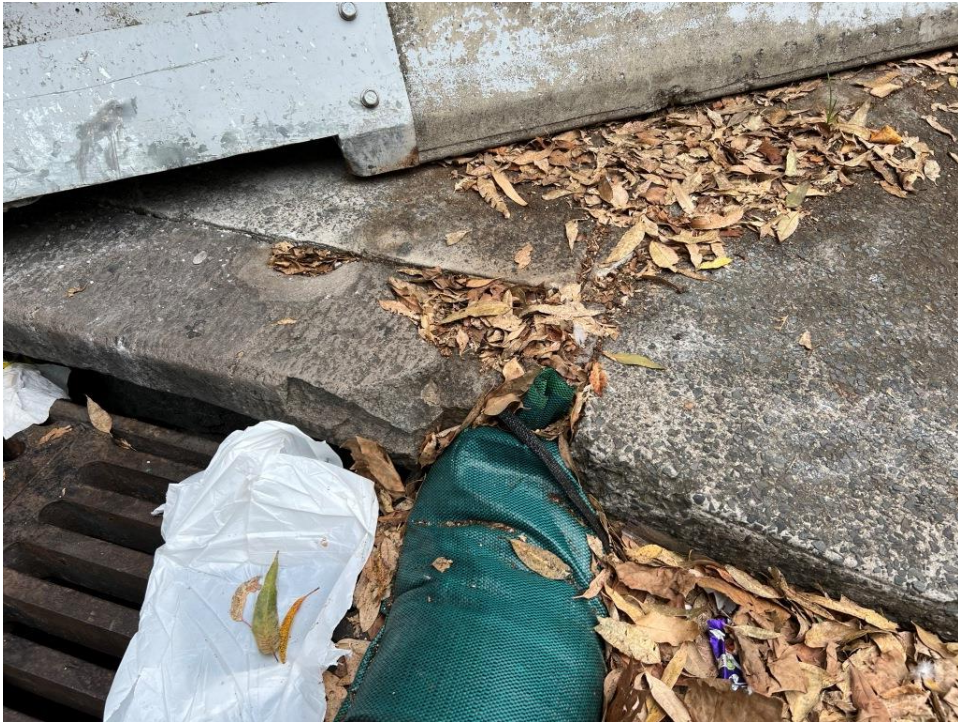
PHOTO 3

(Photo showing cracked and missing concrete in footpath adjacent stormwater pit)

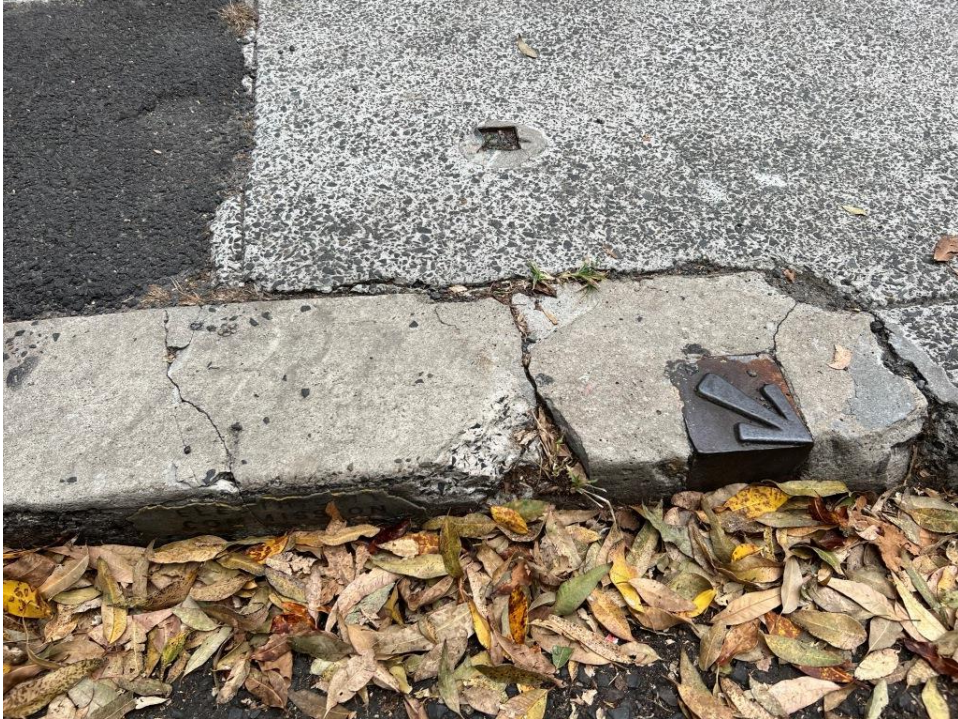
PHOTO 5

(Photo showing cracks and missing concrete in kerb – Raglan Street)

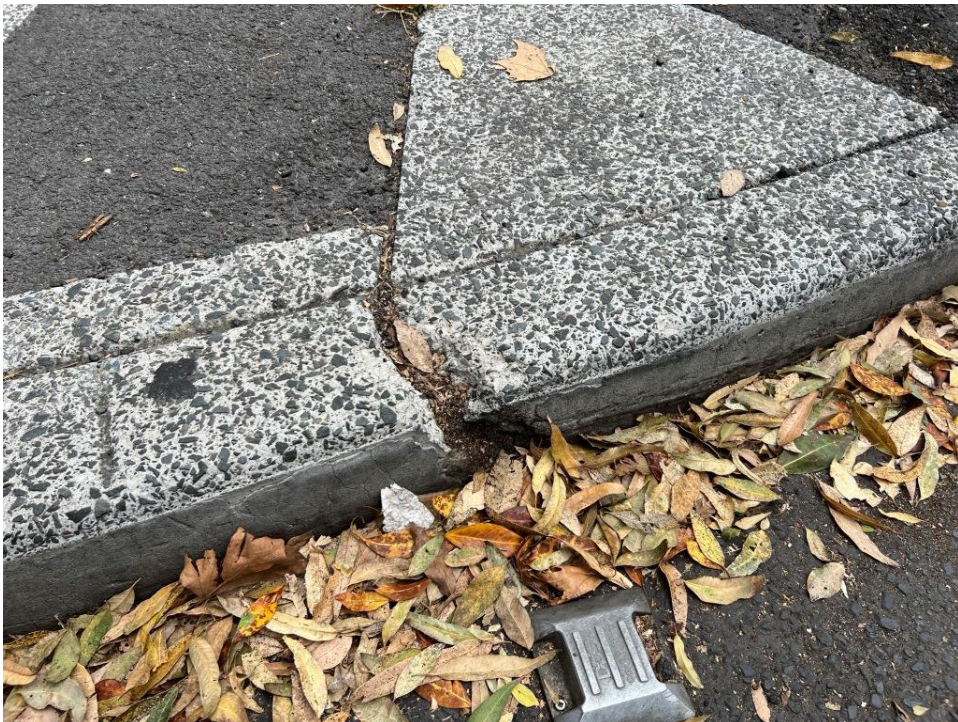
PHOTO 6

(Photo showing cracked and missing concrete in kerb – Raglan Street)

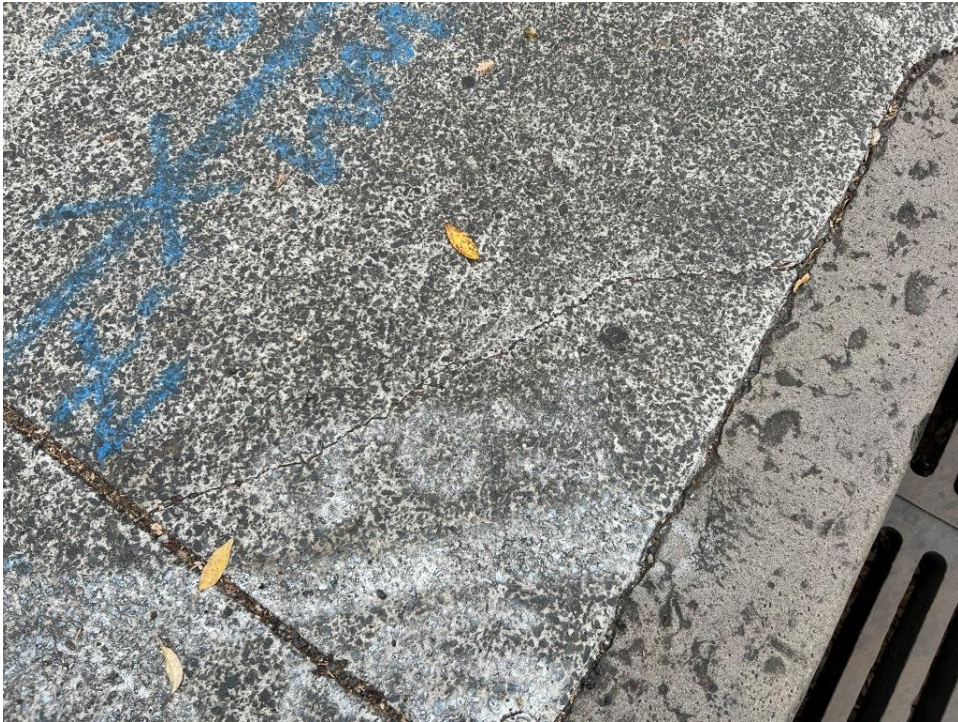
PHOTO 11

(Photo showing crack in footpath and kerb adjacent stormwater pit – Raglan Street)

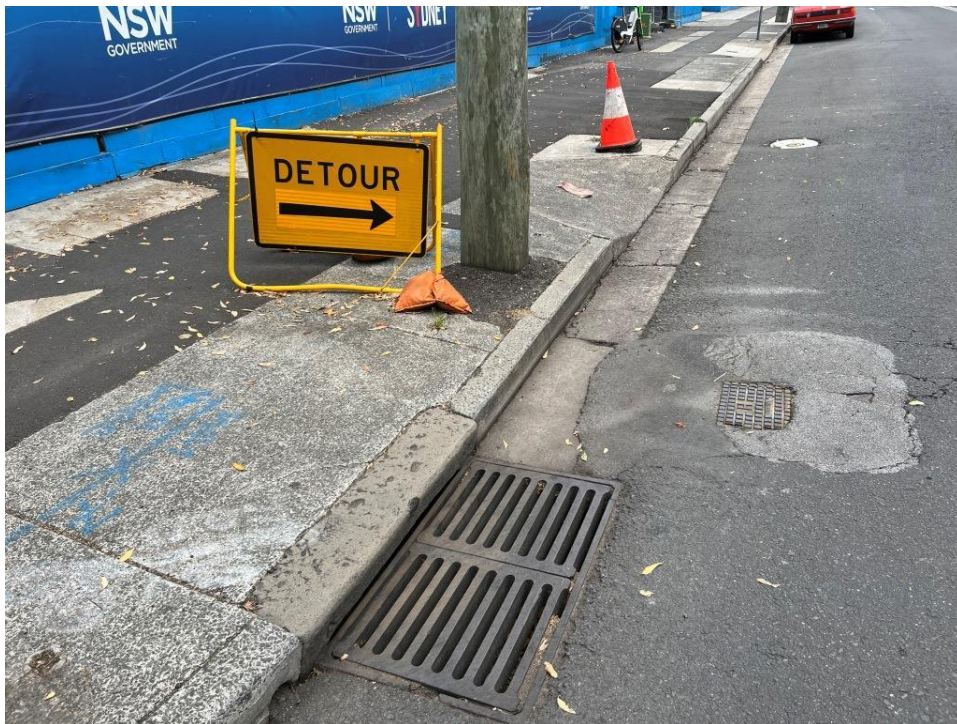
PHOTO 12

(Overview of footpath – Raglan Street)

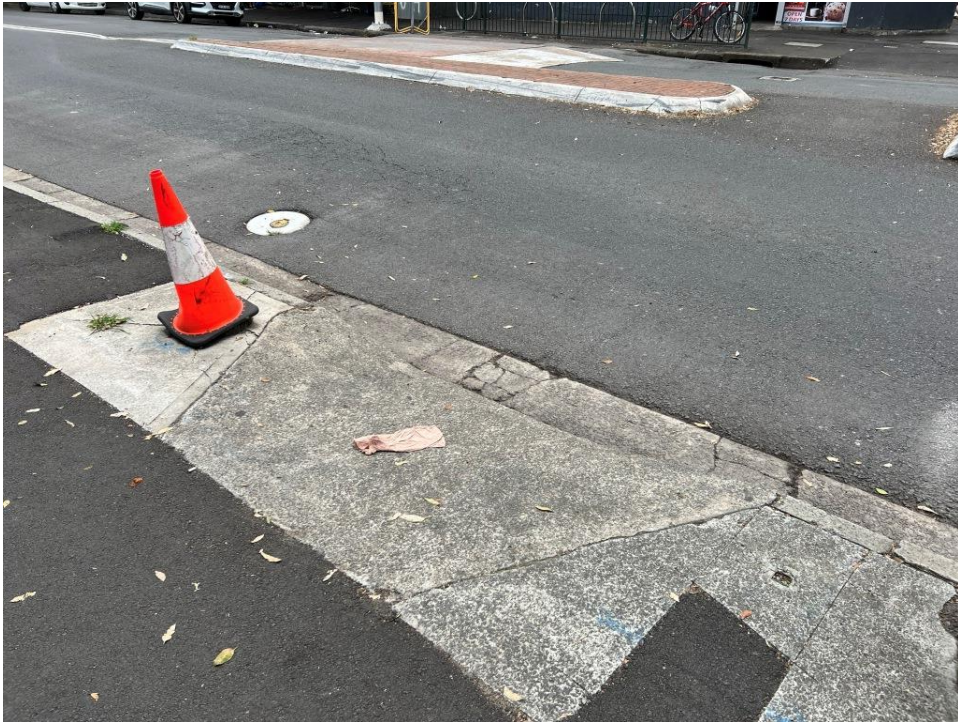
PHOTO 15

(Photo showing cracked footpath and gutter – Raglan Street)

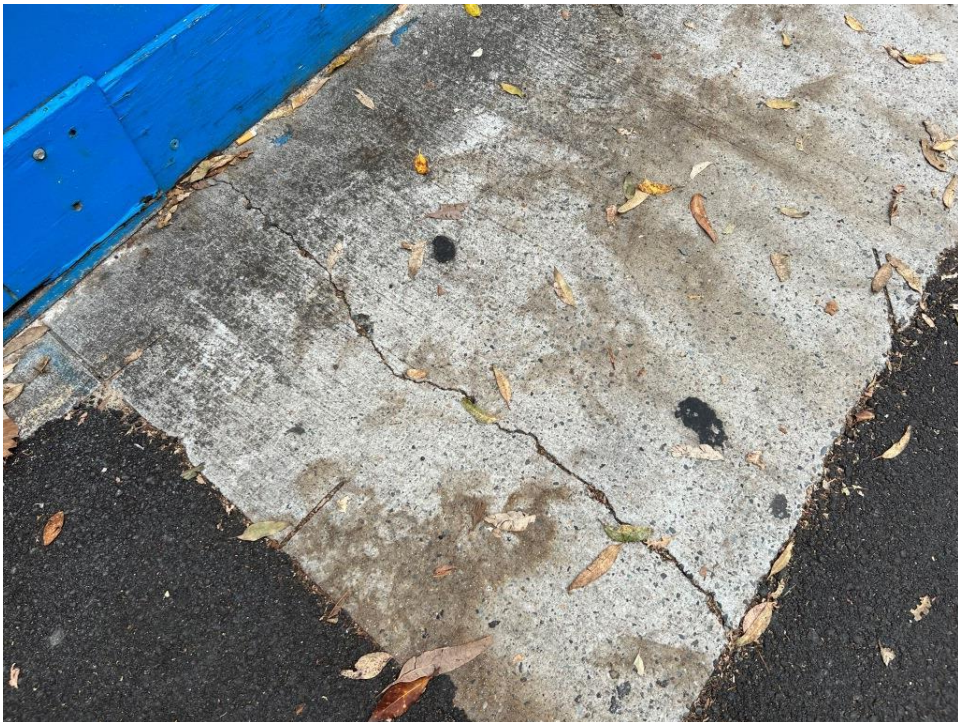
PHOTO 16

(Photo showing crack in footpath – Raglan Street)

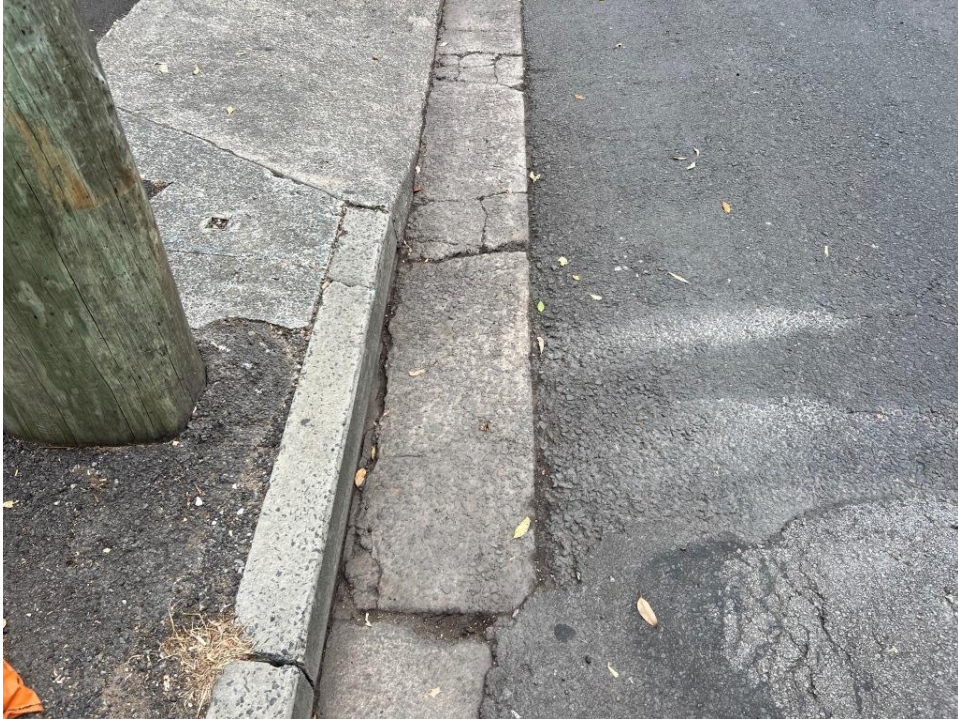
PHOTO 17

(Photo showing cracked kerb and gutter – Raglan Street)

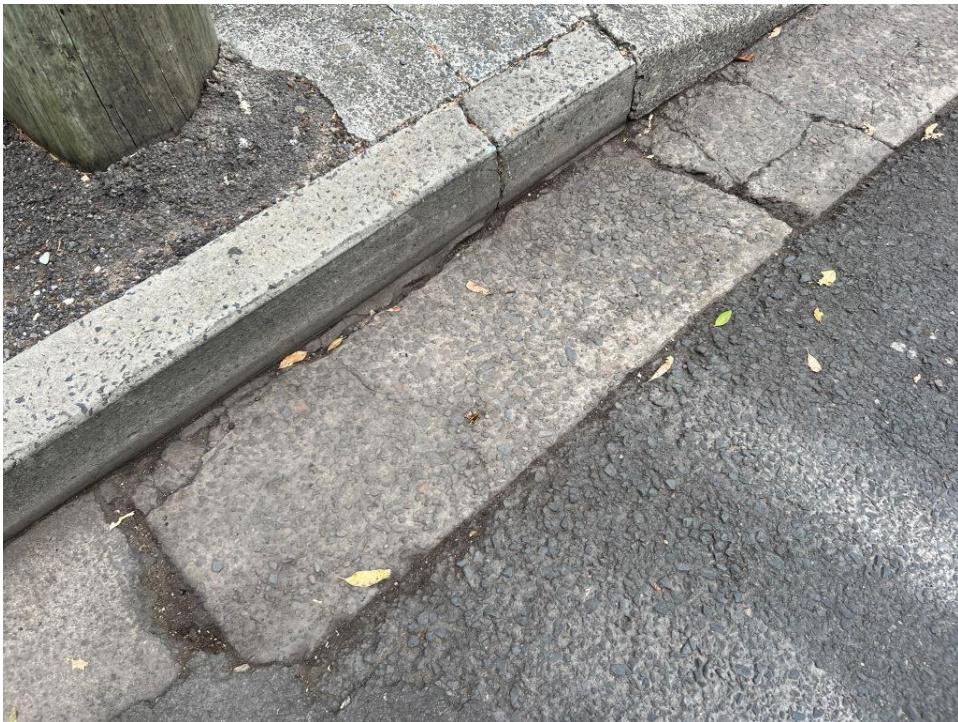
PHOTO 18

(Photo showing cracked kerb and gutter – Raglan Street)

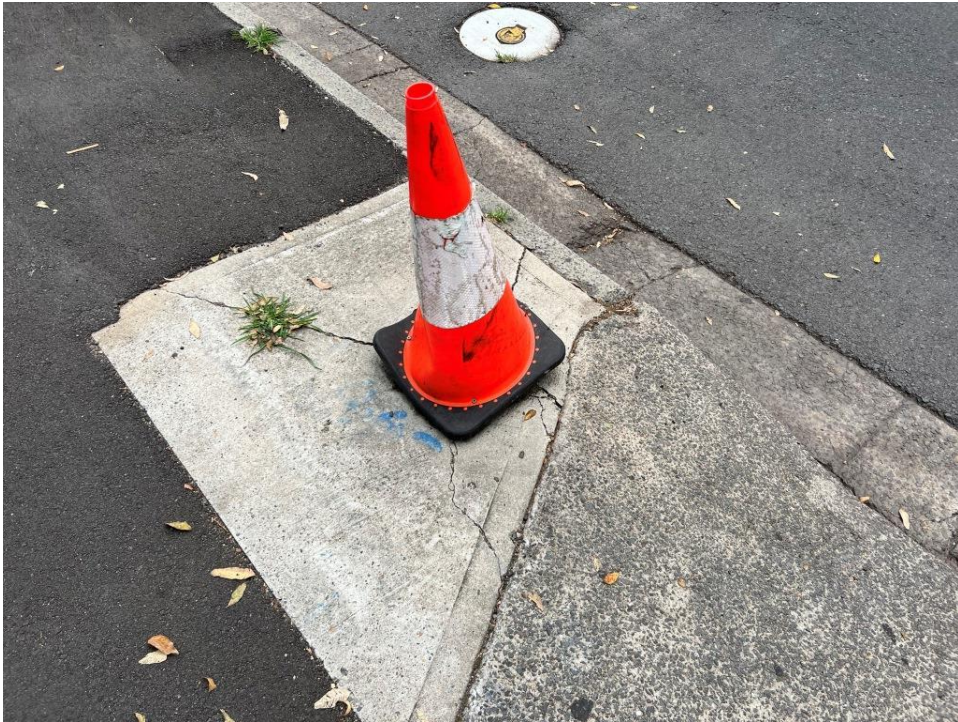
PHOTO 21

(Photo showing cracks in footpath developing from electricity pole's former location – Raglan Street)

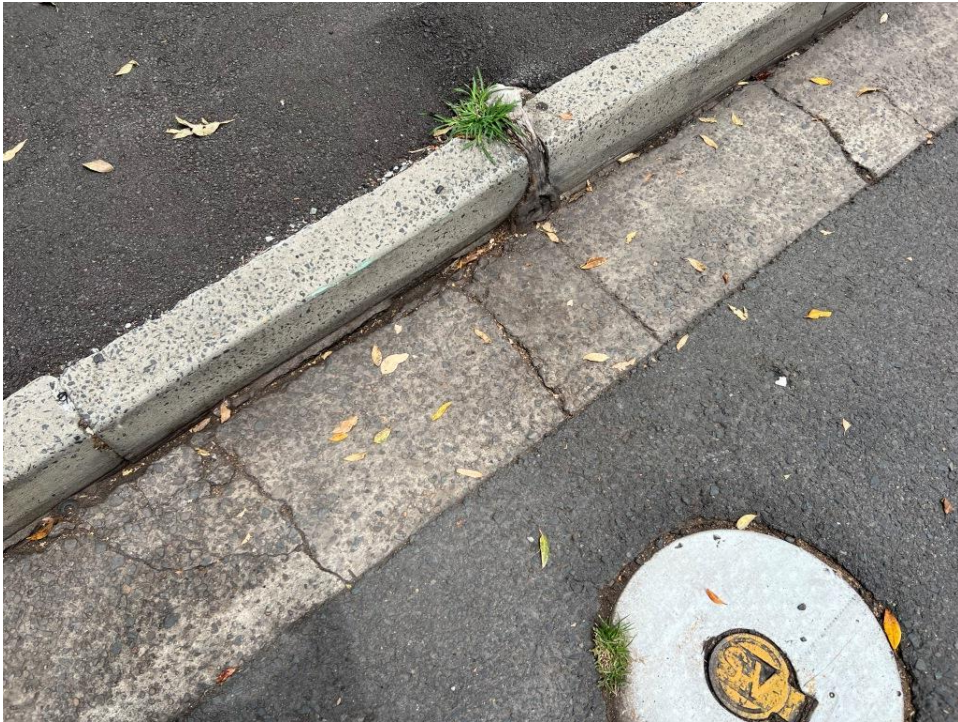
PHOTO 23

(Photo showing cracks in kerb and gutter – Raglan Street)

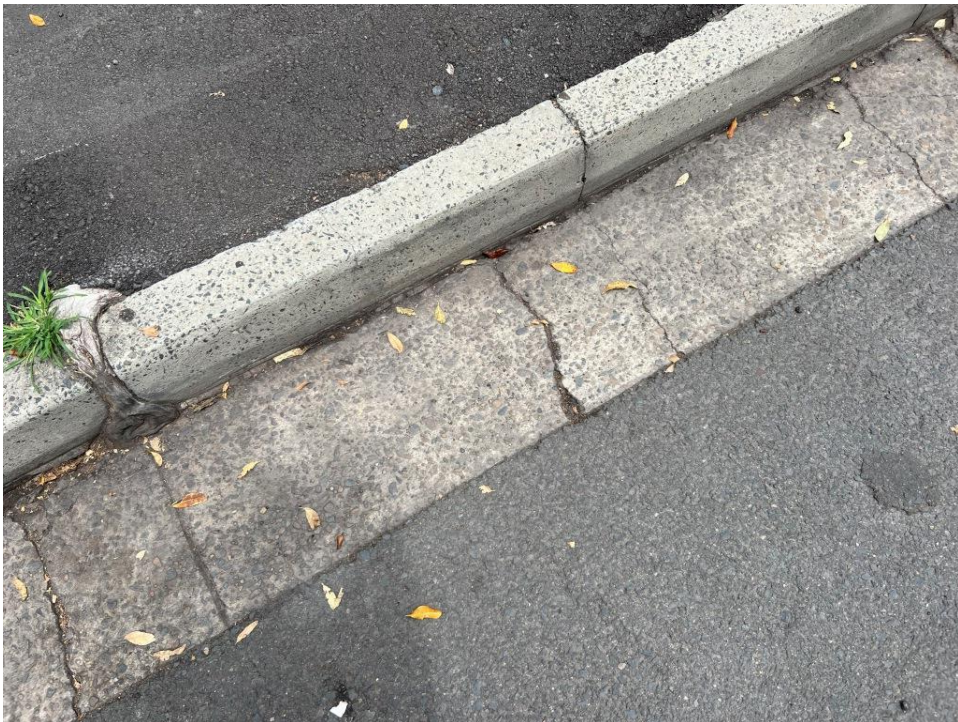
PHOTO 24

(Photo showing cracks in kerb and gutter – Raglan Street)

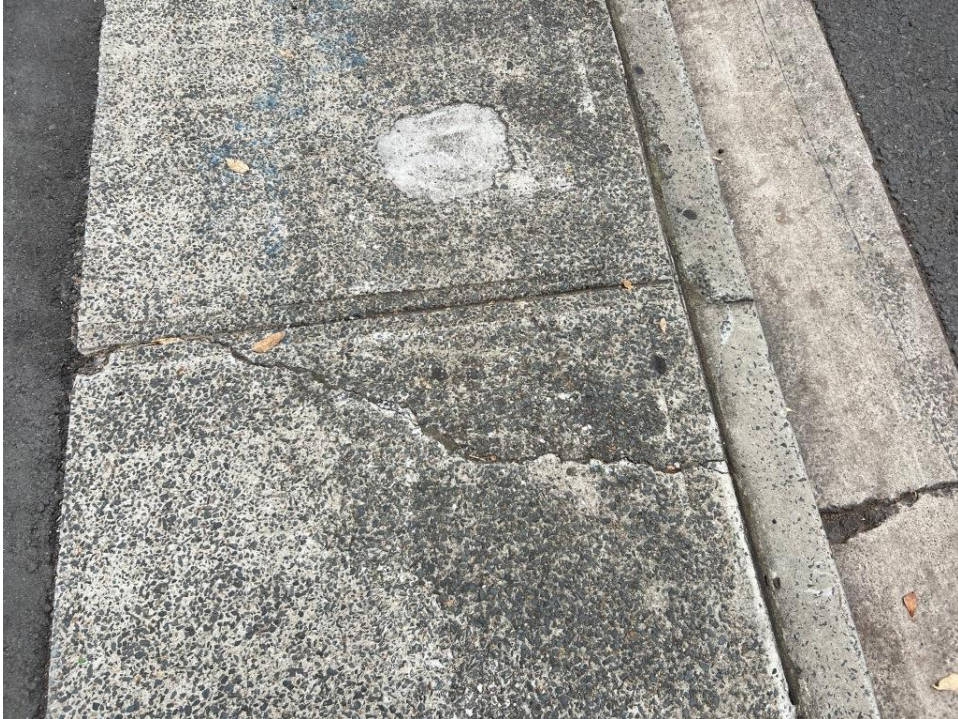
PHOTO 31

(Photo showing crack in footpath and crack/missing concrete in gutter – Raglan Street)

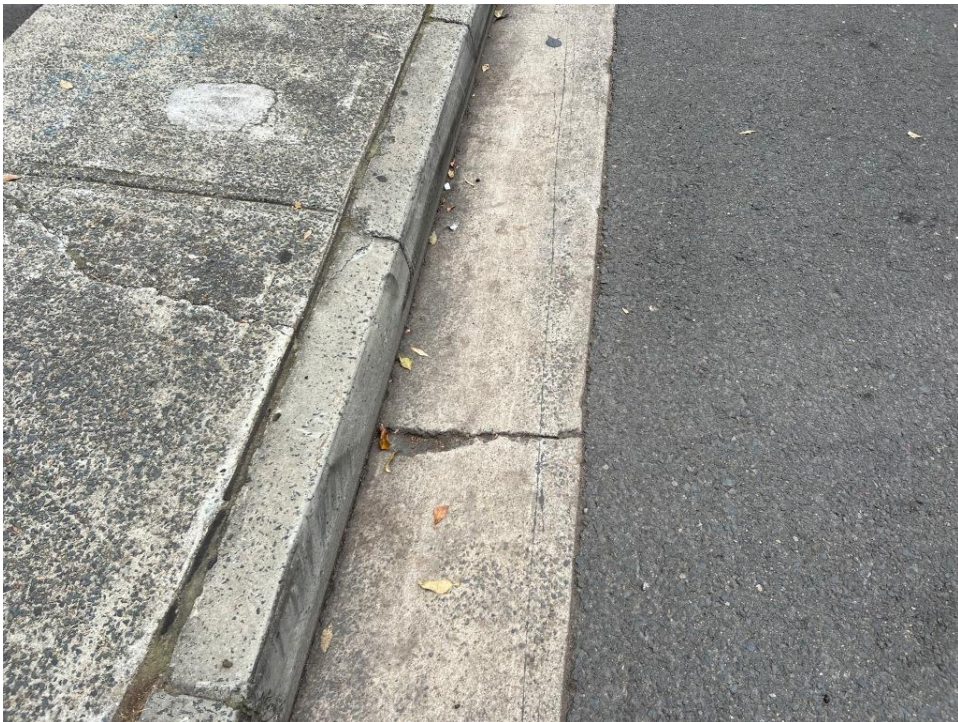
PHOTO 32

(Photo showing crack/missing concrete in gutter – Raglan Street)

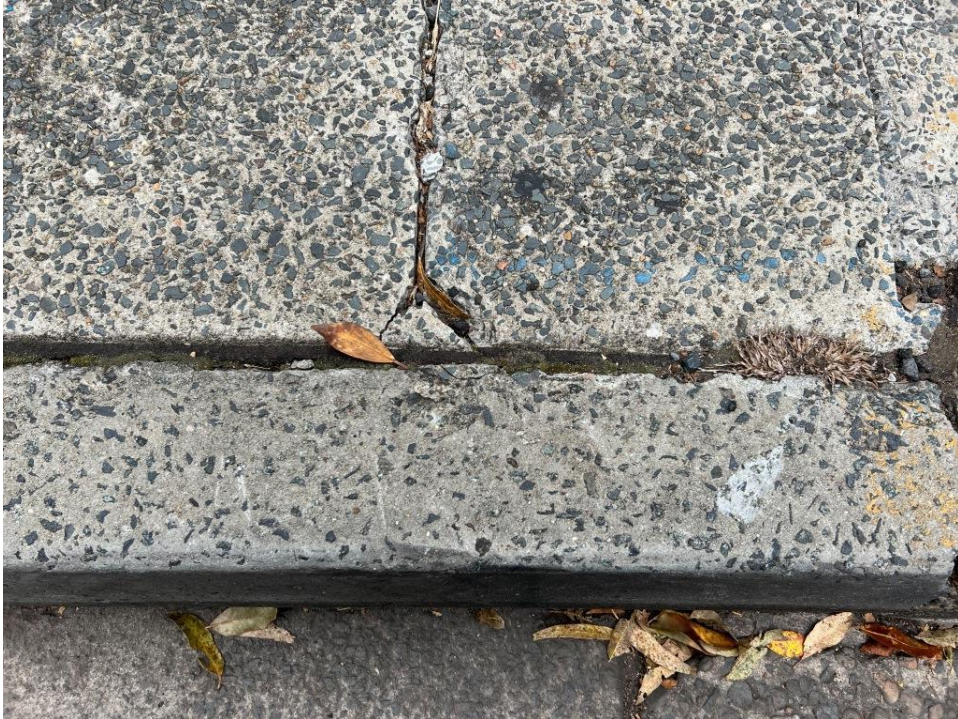
PHOTO 33

(Photo showing crack at end of footpath's saw cut joint – Raglan Street)

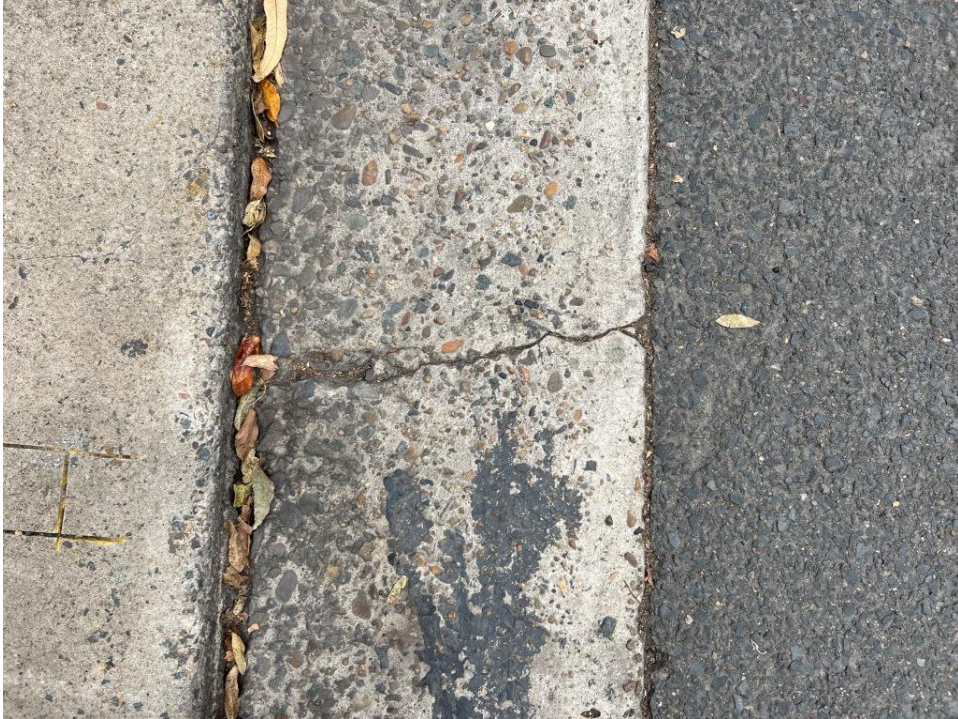
PHOTO 37

(Photo showing crack/missing concrete in gutter – Raglan Street)

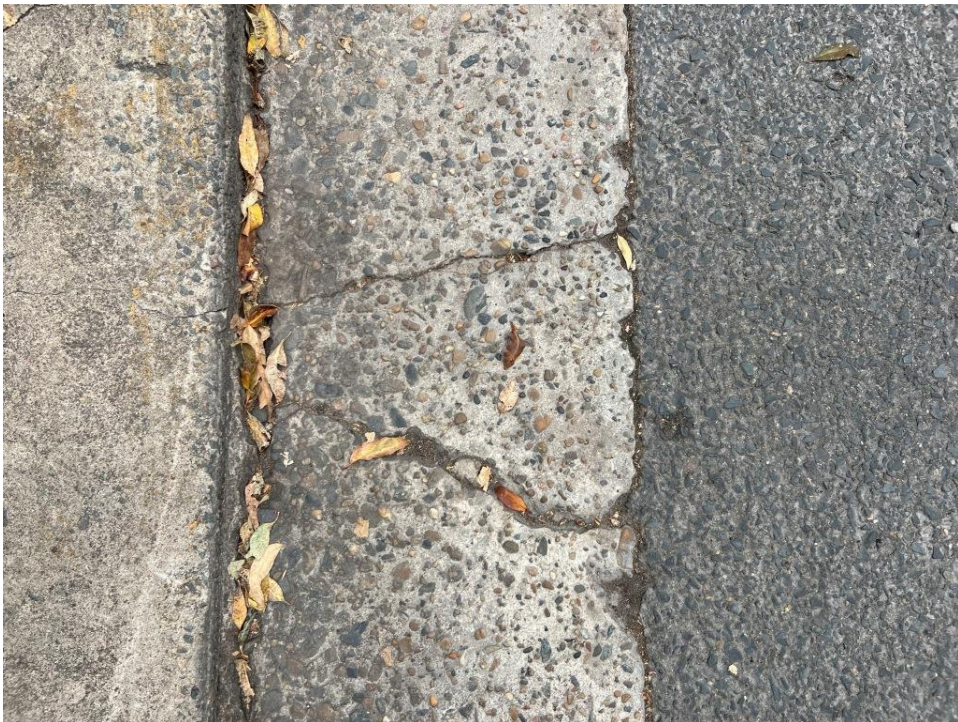
PHOTO 38

(Photo showing cracks/missing concrete in gutter – Raglan Street)

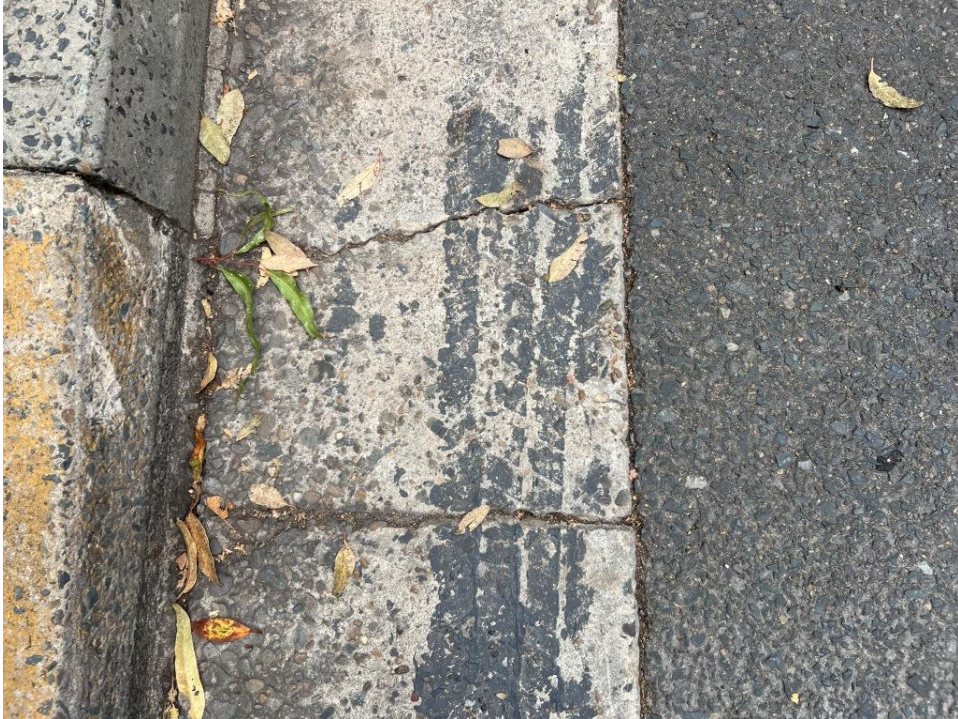
PHOTO 39

(Photo showing cracks/missing concrete in gutter – Raglan Street)

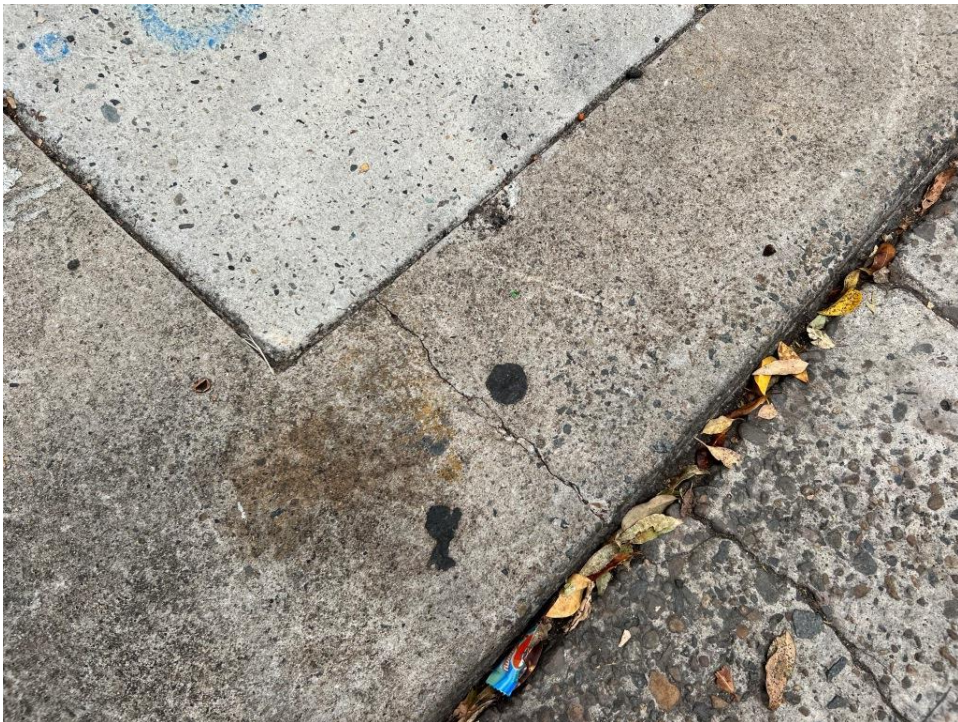
PHOTO 40

(Photo showing cracks in footpath and gutter – Raglan Street)

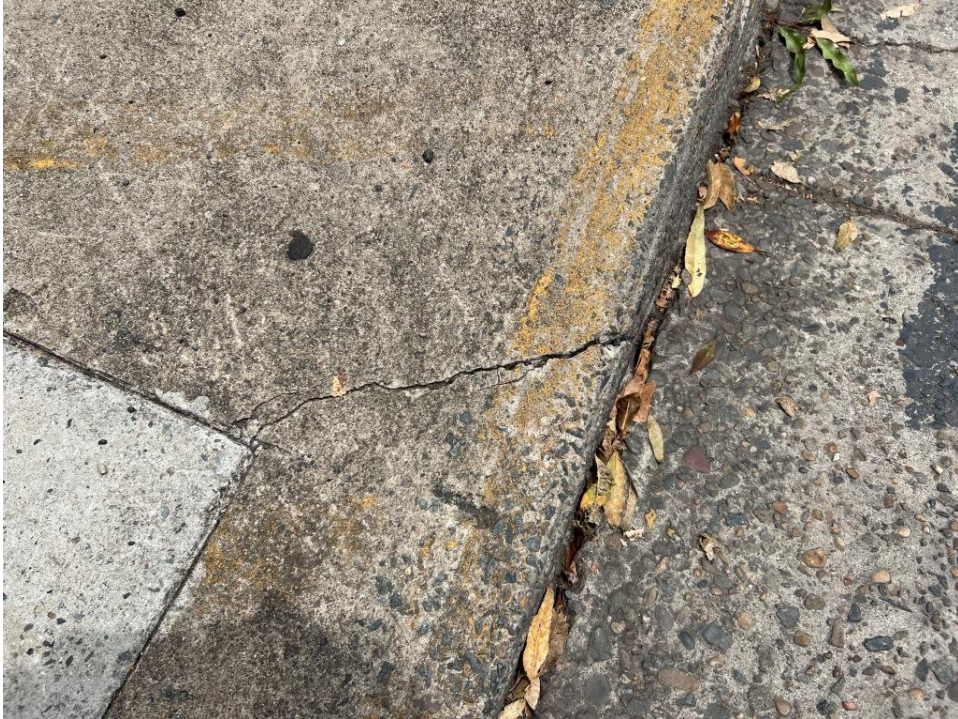
PHOTO 43

(Photo showing crack in footpath/kerb – Raglan Street)

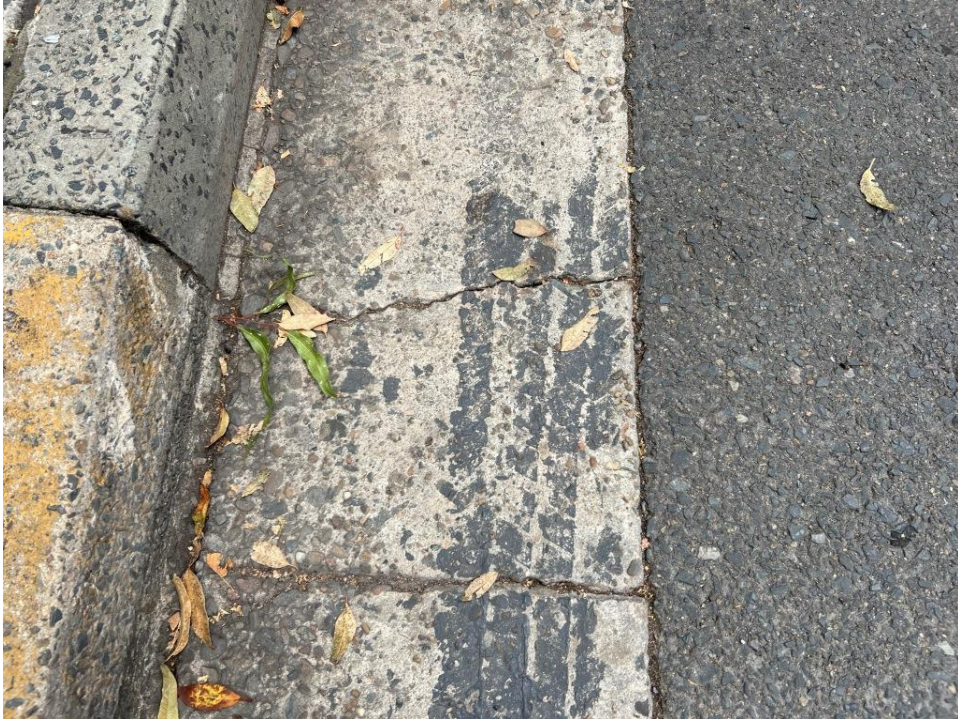
PHOTO 45

(Photo showing cracks in gutter – Raglan Street)

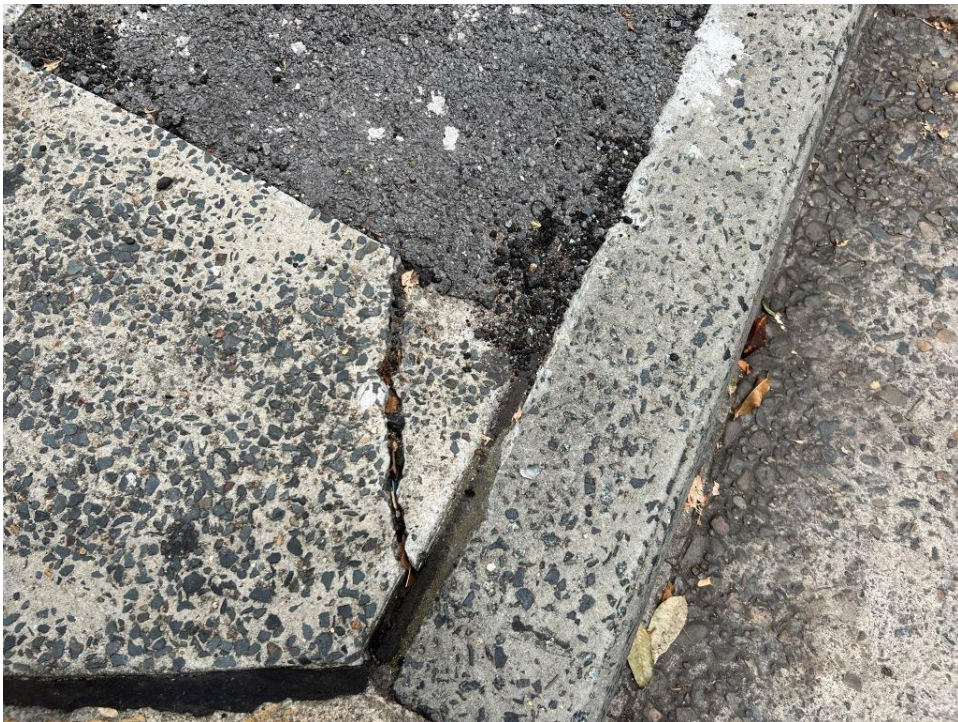
PHOTO 46

(Photo showing crack in footpath – Raglan Street)

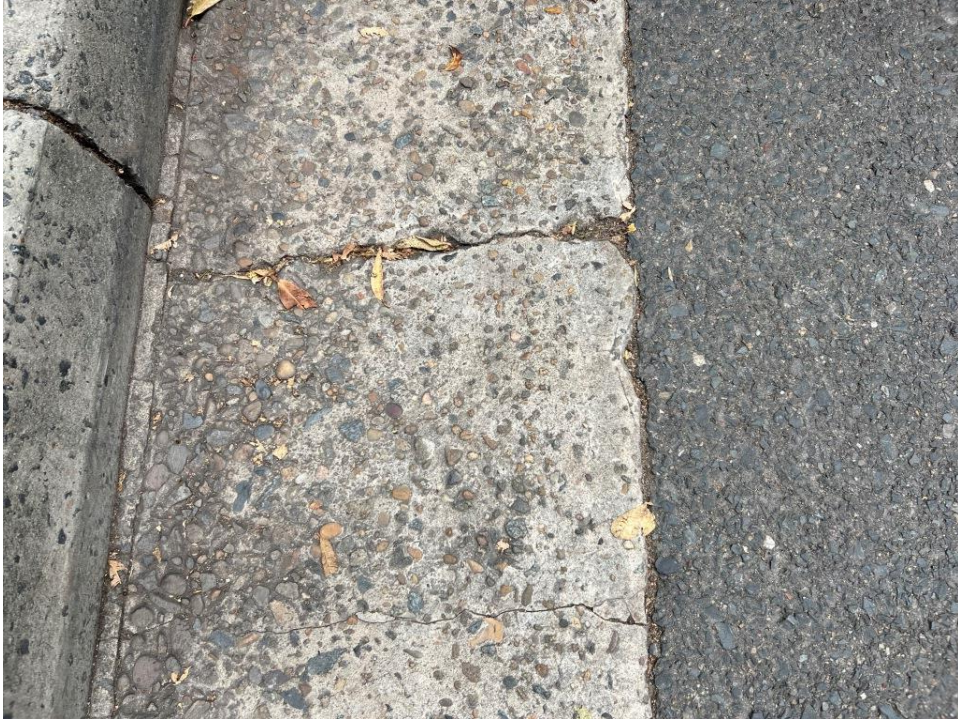
PHOTO 47

(Photo showing cracks in gutter – Raglan Street)

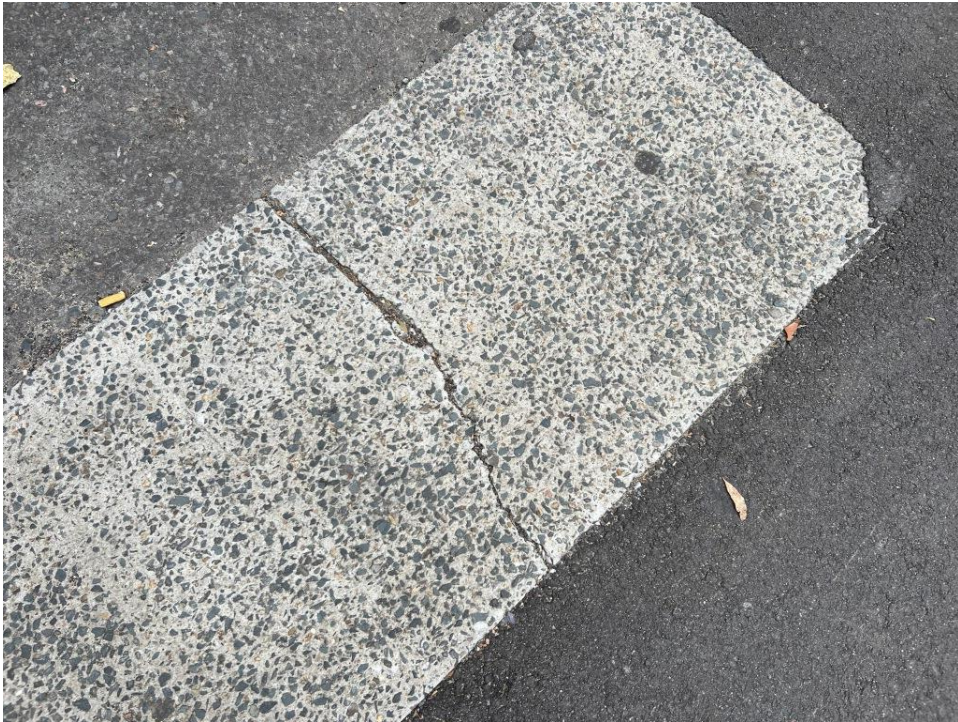
PHOTO 48

(Photo showing crack in footpath – Raglan Street)

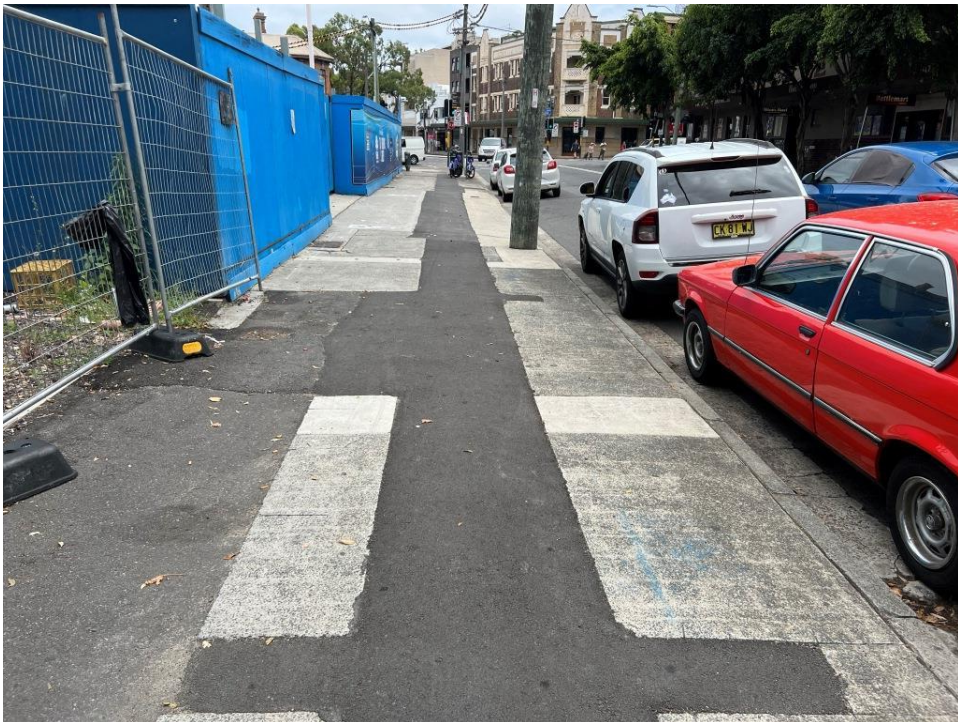
PHOTO 49

(Photo showing crack in footpath – Raglan Street)

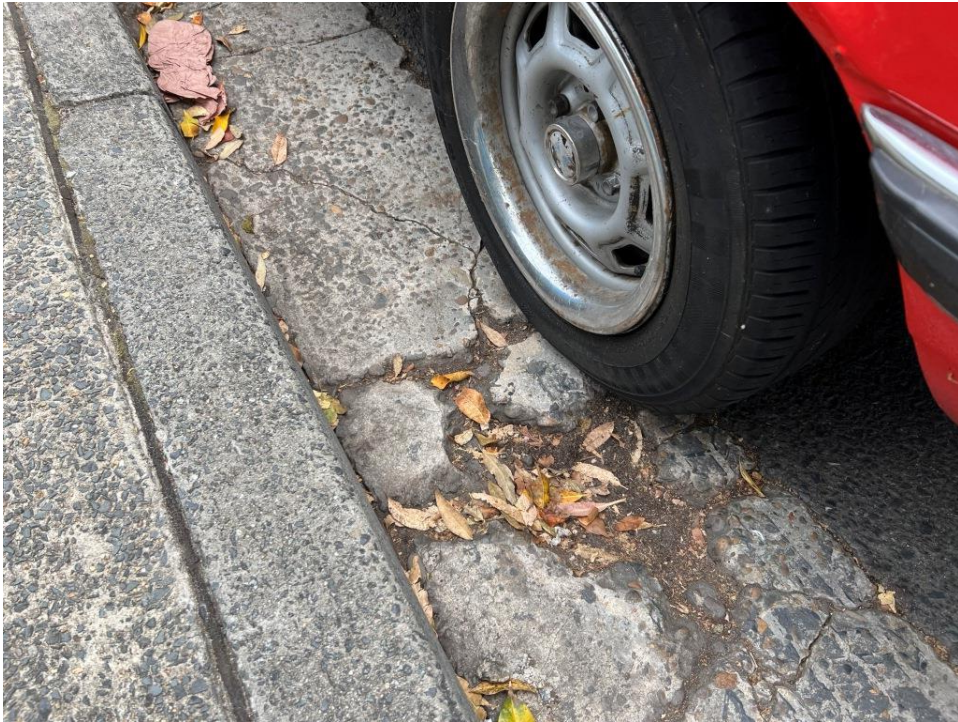
PHOTO 52

(Photo showing cracks in gutter – Raglan Street)

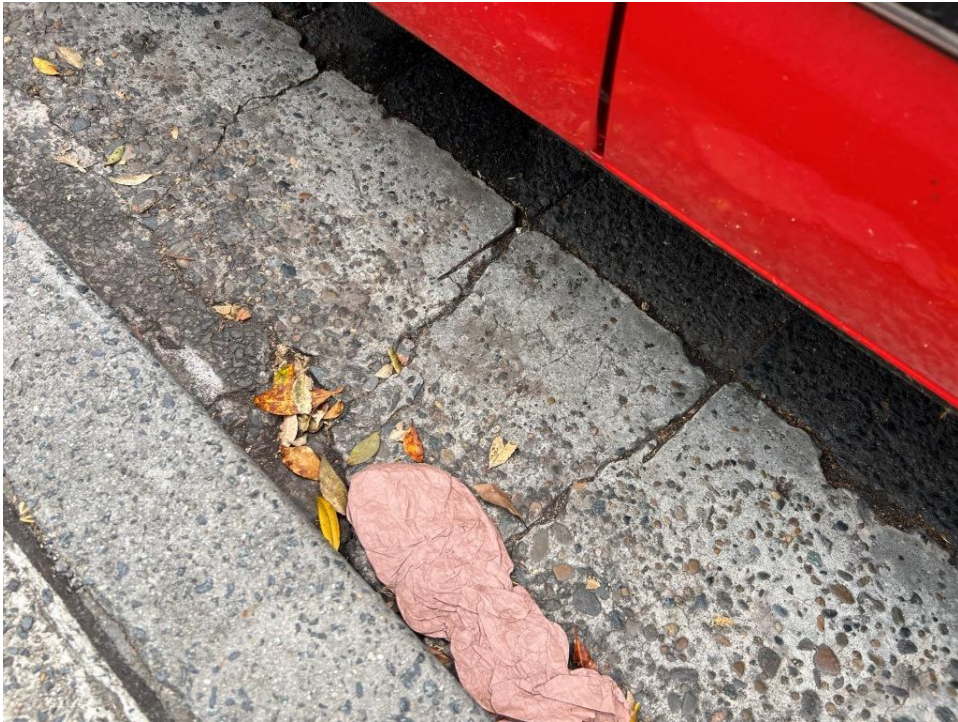
PHOTO 54

(Photo showing cracks in gutter – Raglan Street)

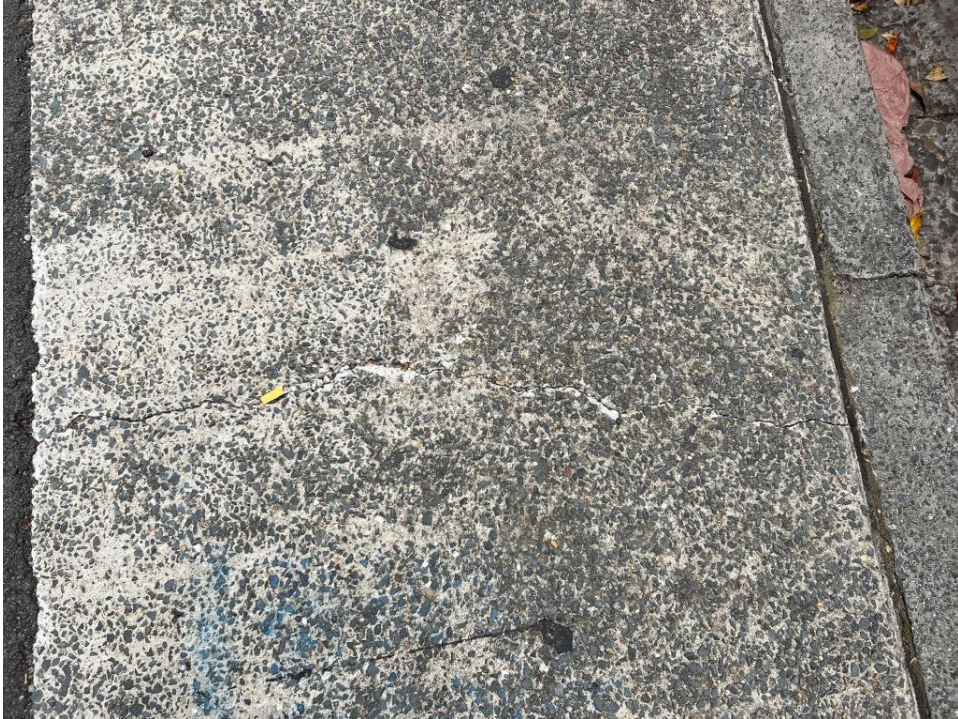
PHOTO 56

(Photo showing cracks in gutter – Raglan Street)

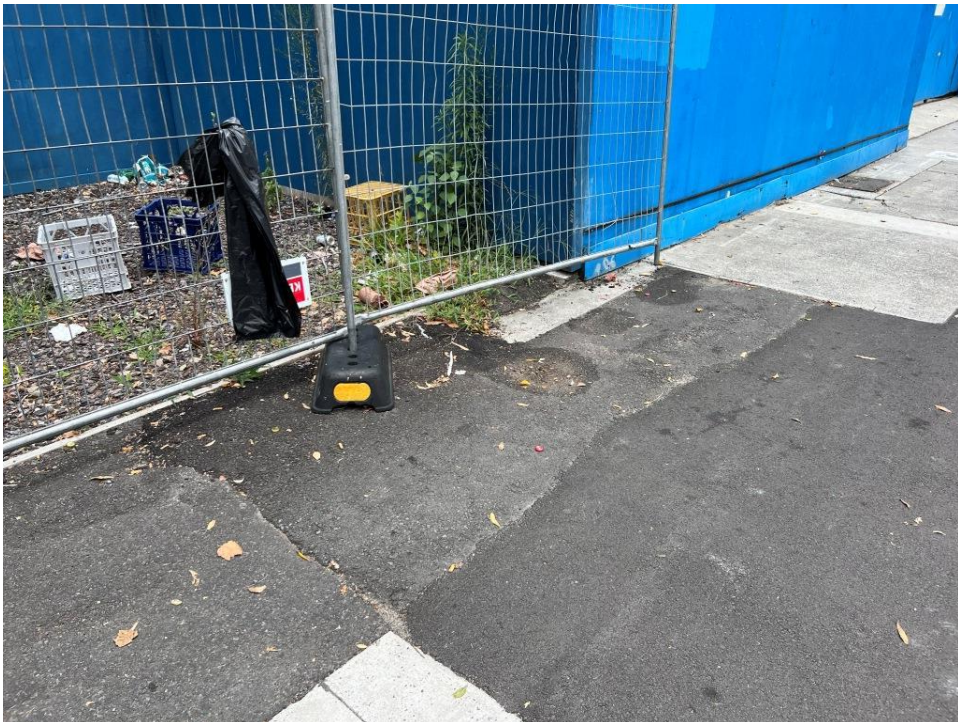
PHOTO 57

(Photo showing crack in footpath – Raglan Street)

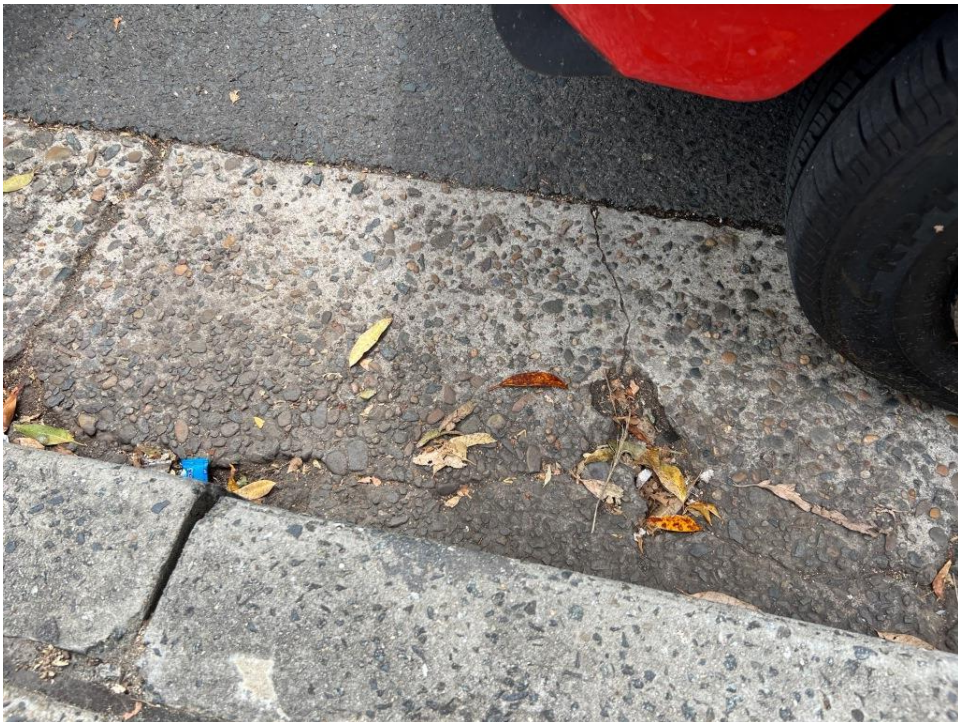
PHOTO 67

(Photo showing cracks in gutter – Raglan Street)
