DILAPIDATION REPORT

Council Assets/Public Infrastructure

**WATERLOO STATION
COPE STREET**

DEMLAKIAN CONSULTING ENGINEERS

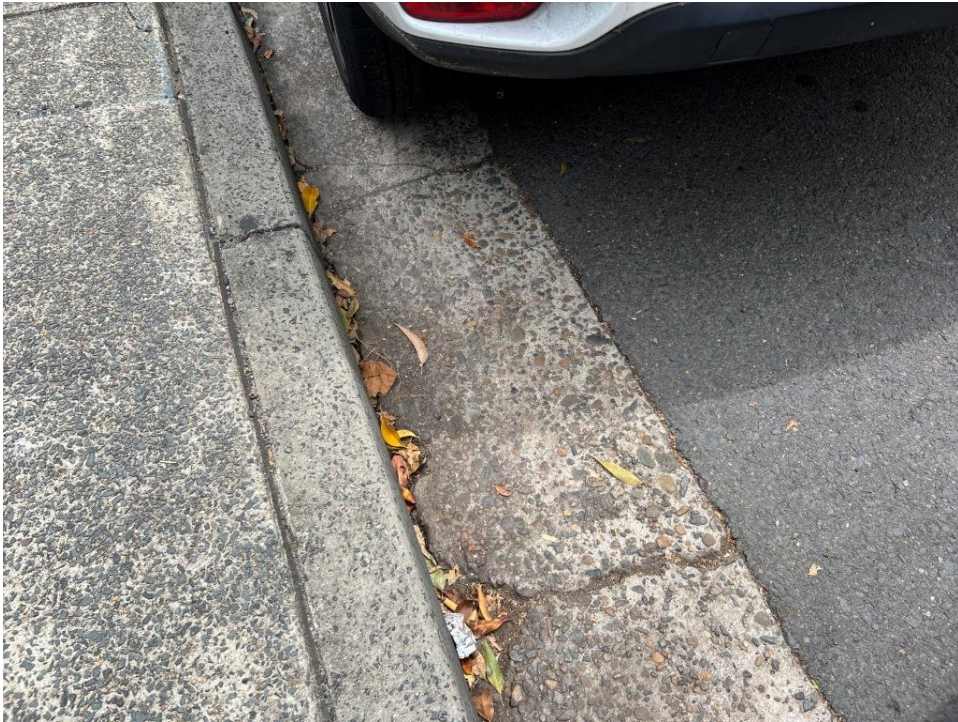
PHOTO 68

(Photo showing cracks in gutter and chipped concrete in kerb – Raglan Street)

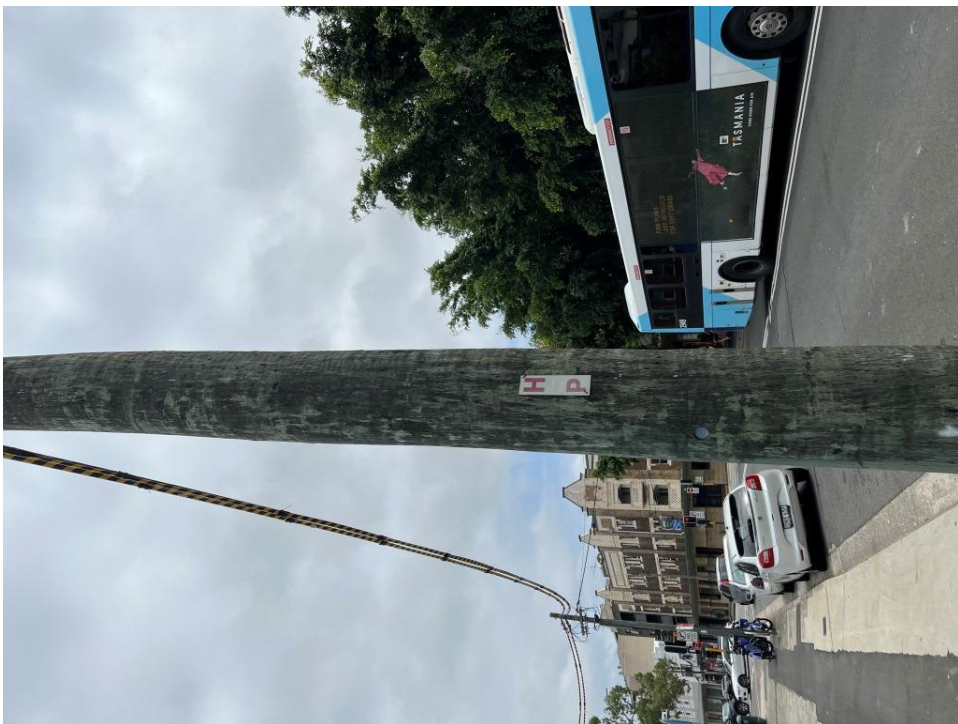
PHOTO 75

(Photo showing condition of electricity pole – Raglan Street)

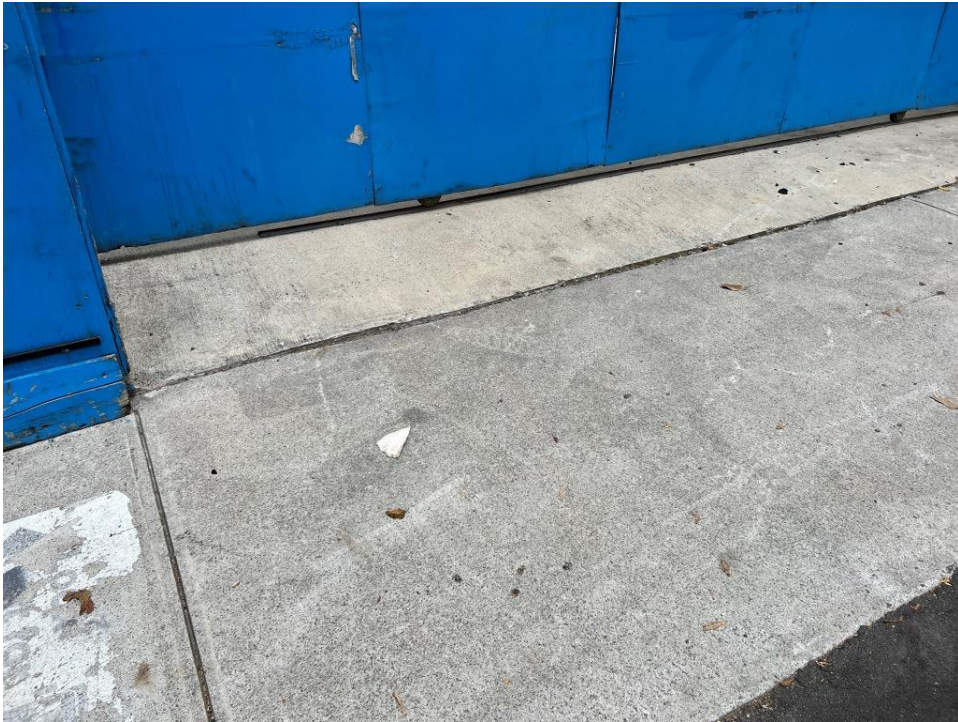
PHOTO 82
(Photo showing footpath's condition adjacent to truck driveway – Raglan Street)

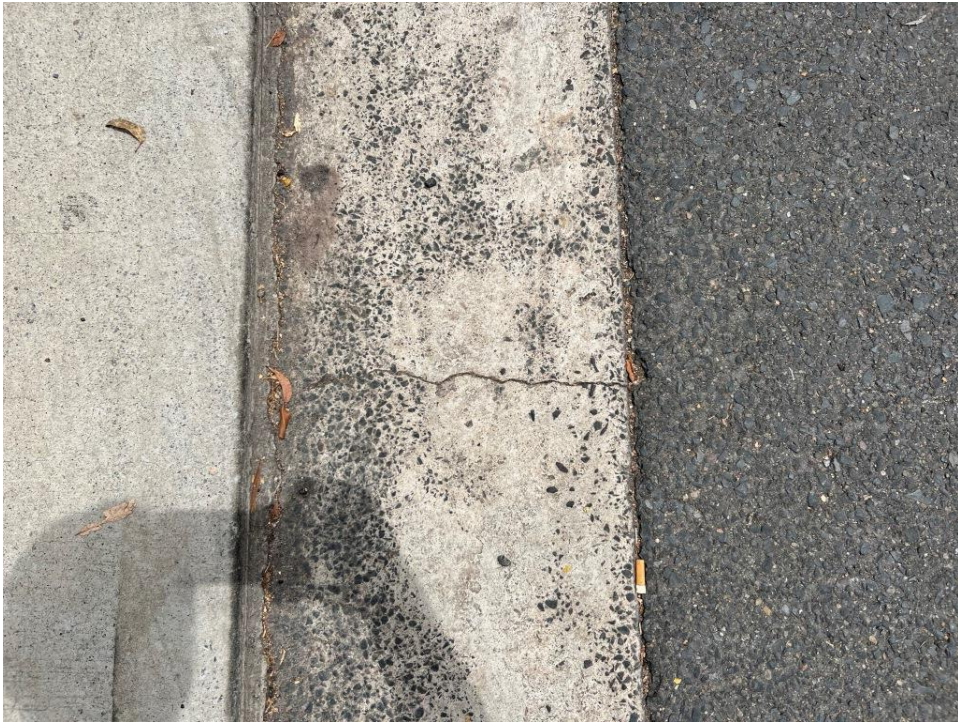
PHOTO 86

(Photo showing crack in gutter in front of truck driveway – Raglan Street)

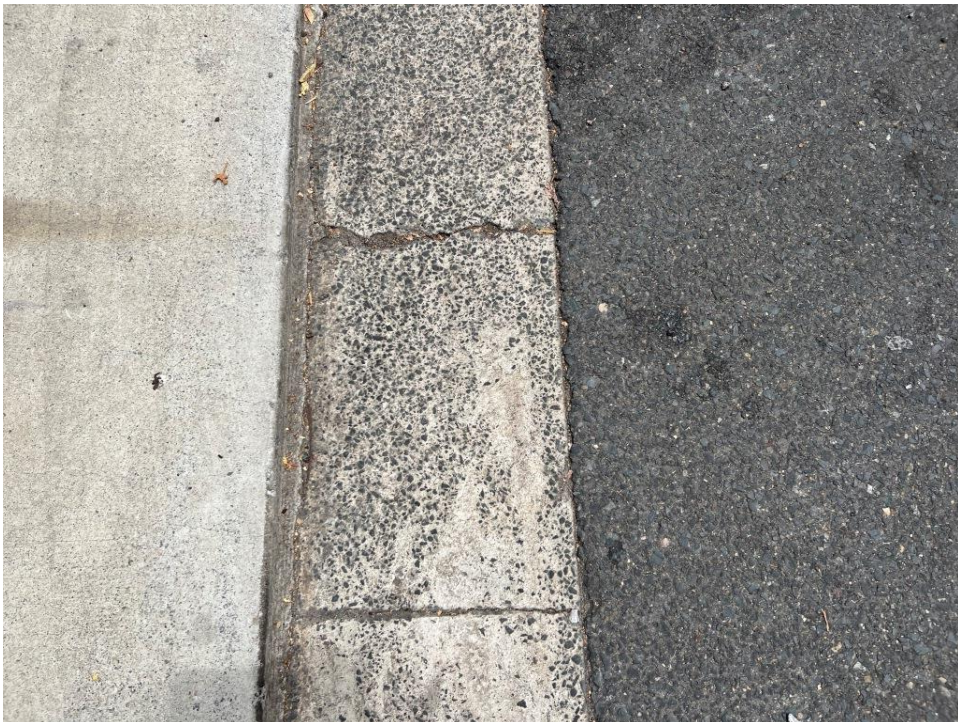
PHOTO 87

(Photo showing crack in gutter in front of truck driveway – Raglan Street)

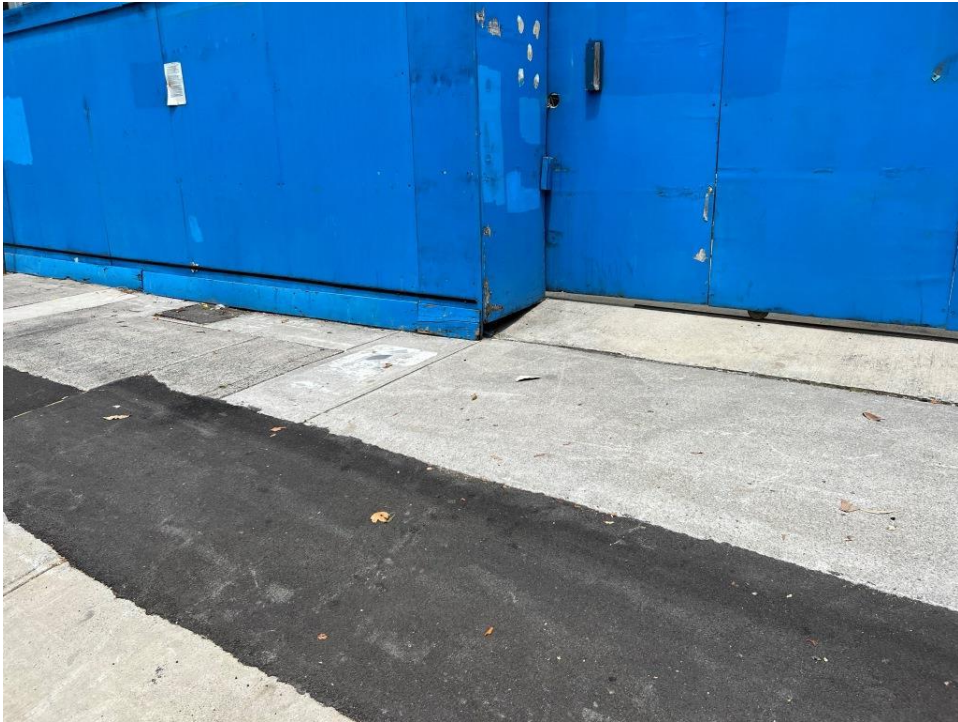
PHOTO 88

(Photo showing cracks in gutter in front of truck driveway – Raglan Street)

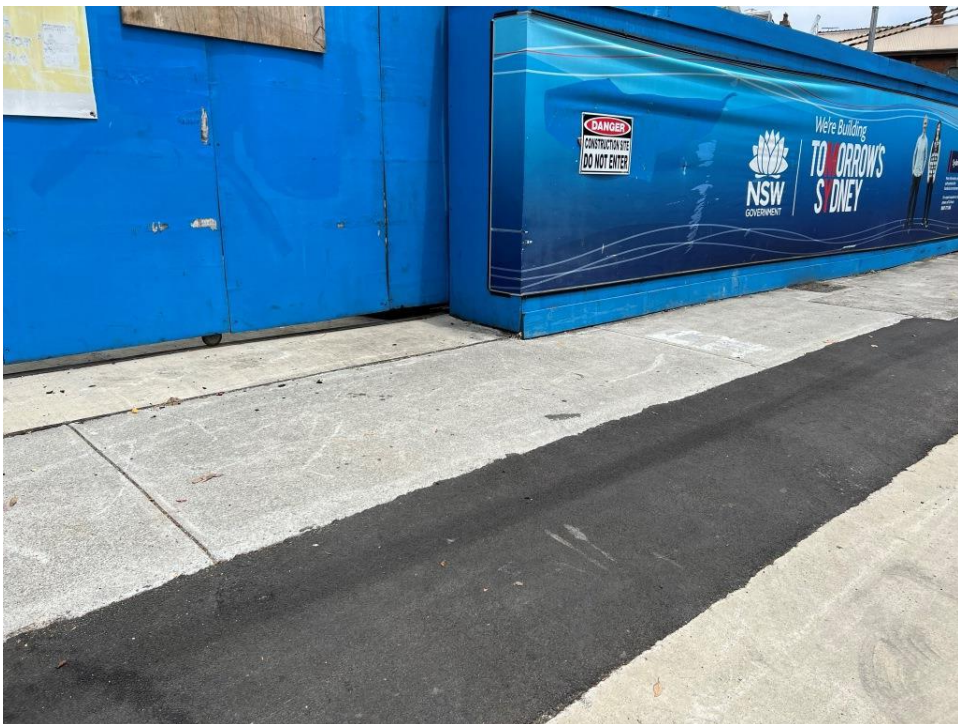
PHOTO 89

(Photo showing footpath's condition adjacent to truck driveway – Raglan Street)

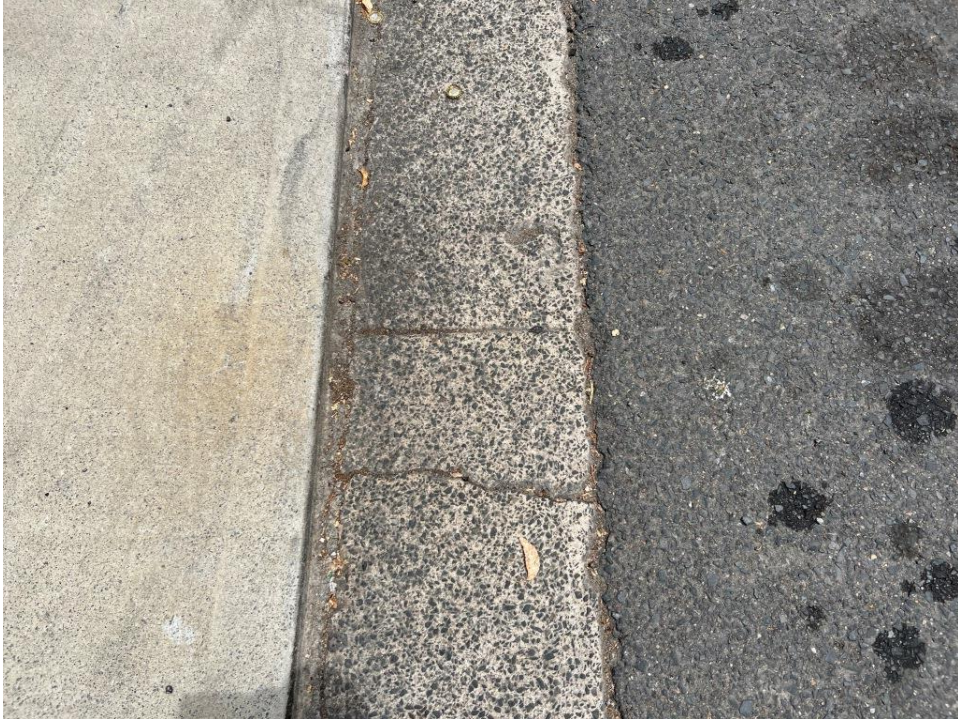
PHOTO 90

(Photo showing footpath's condition adjacent to truck driveway – Raglan Street)

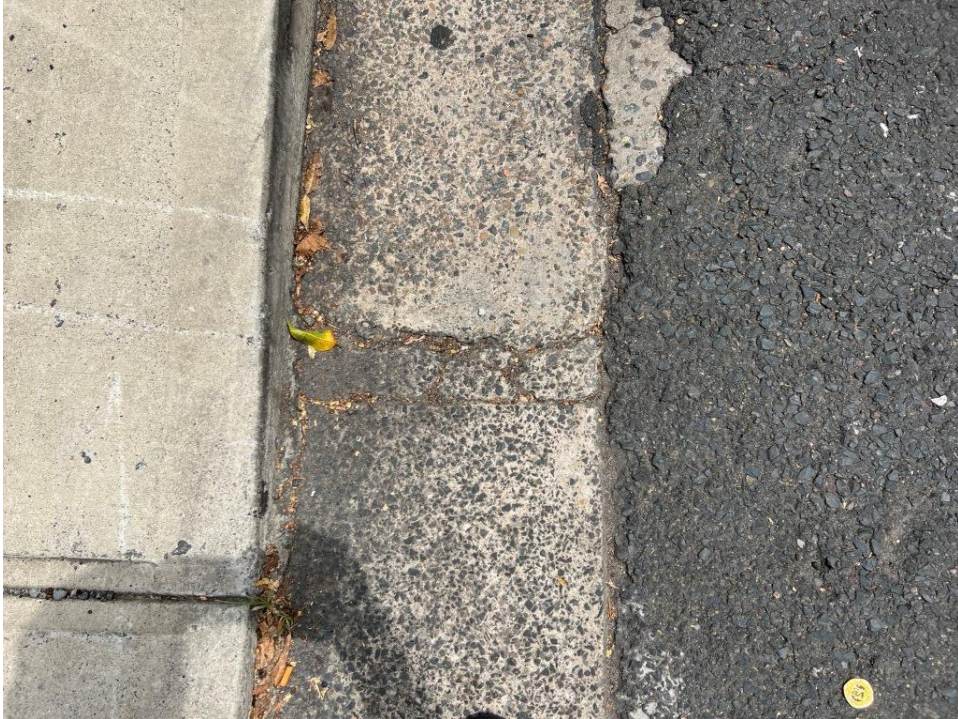
PHOTO 95

(Photo showing cracks in gutter in front of truck driveway – Raglan Street)

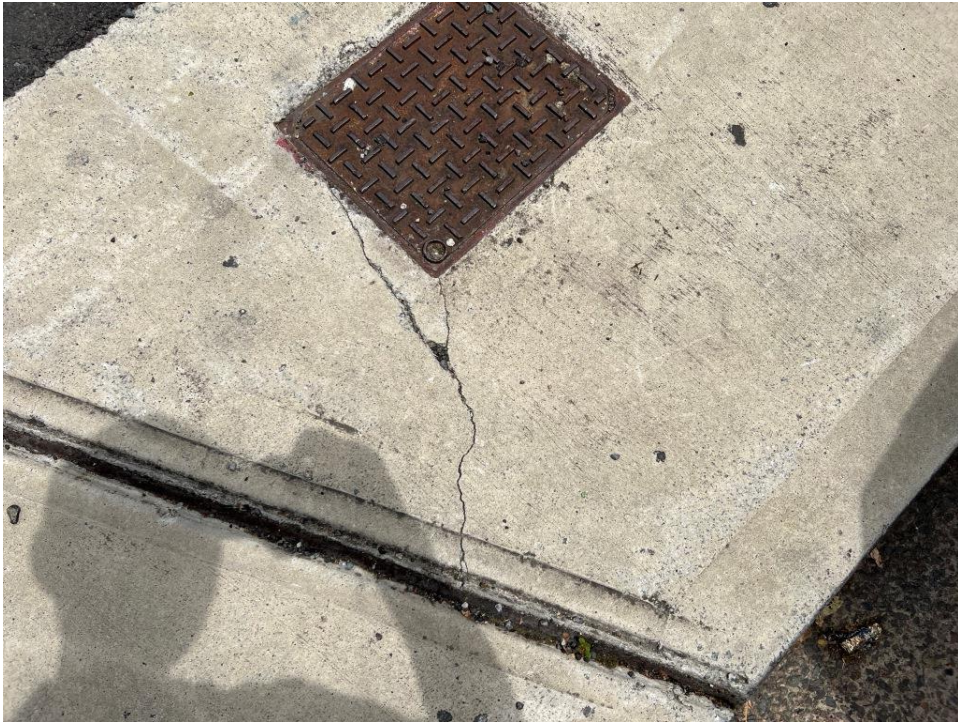
PHOTO 97

(Photo showing cracks in footpath – Raglan Street)

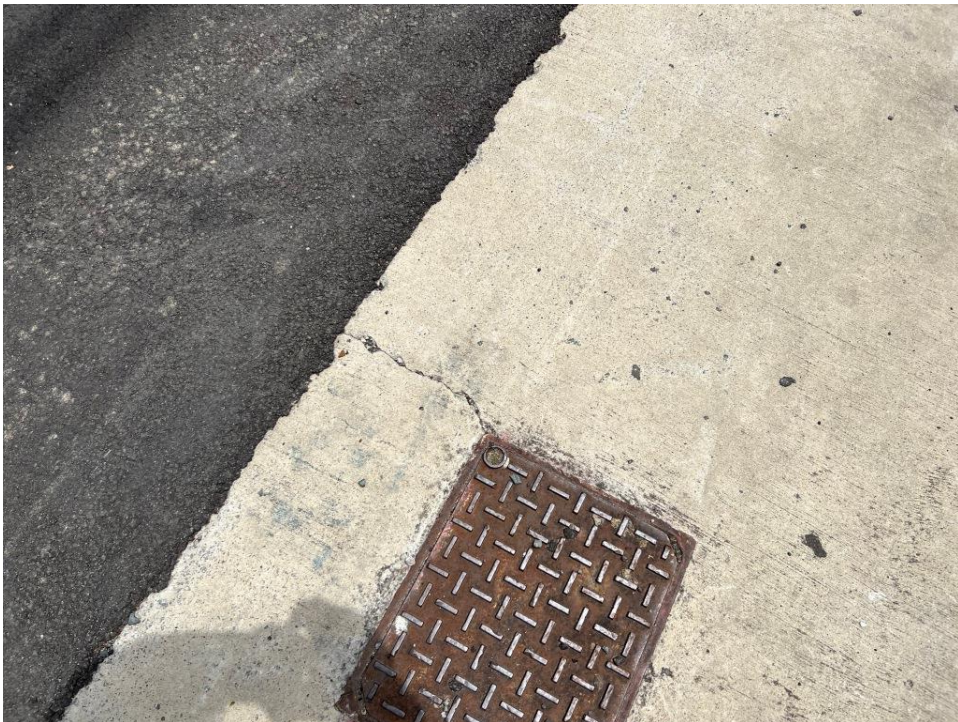
PHOTO 98

(Photo showing crack in footpath – Raglan Street)

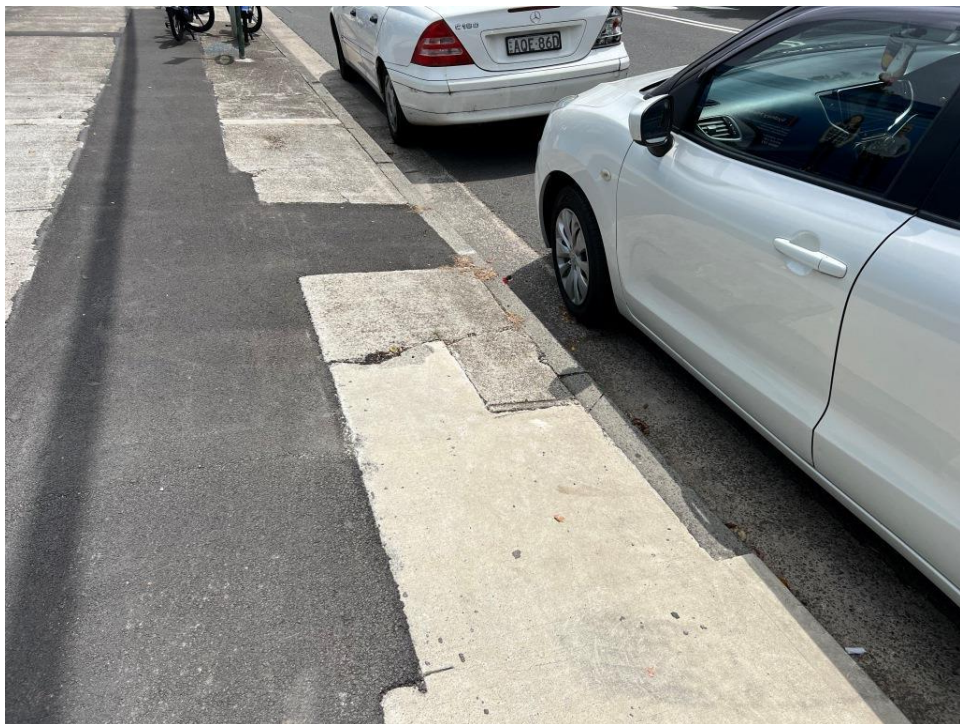
PHOTO 102

(Photo showing condition of footpath – Raglan Street)

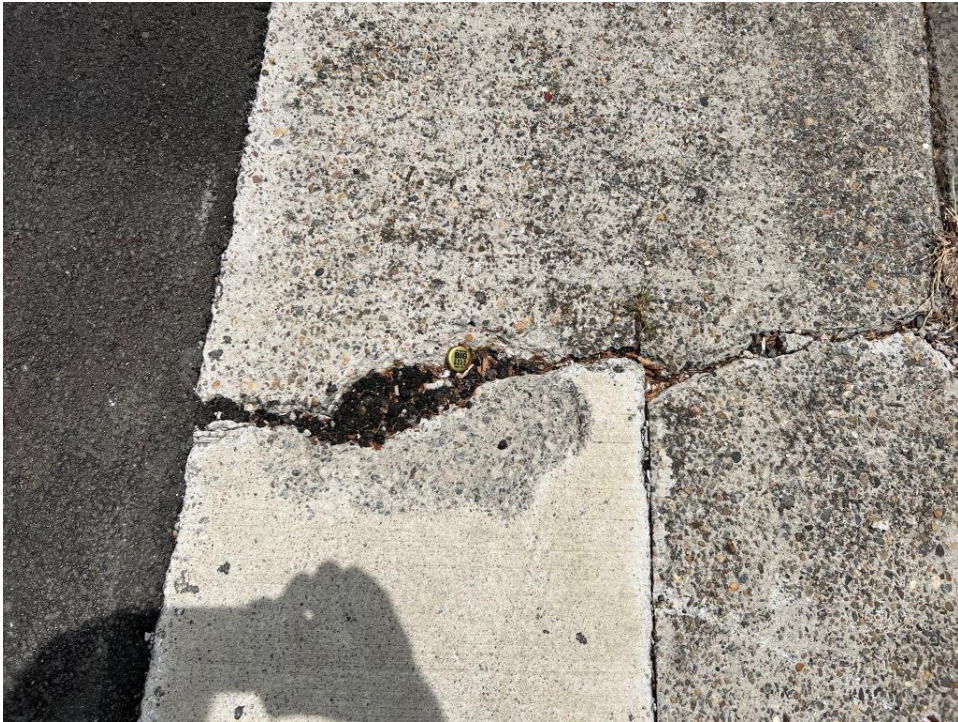
PHOTO 103

(Photo showing crack/missing concrete in footpath – Raglan Street)

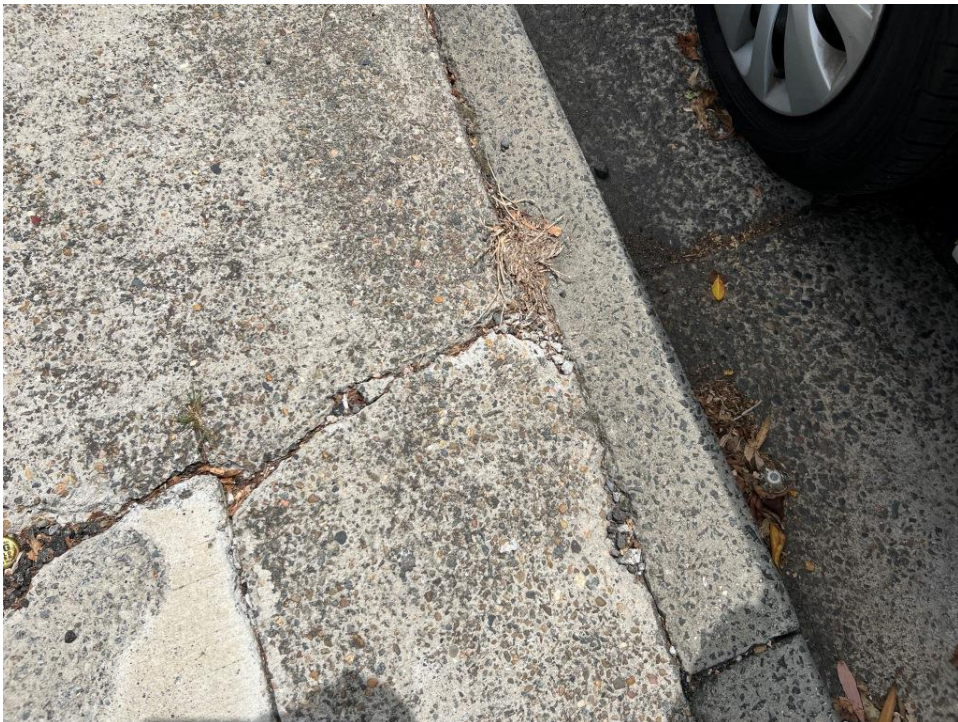
PHOTO 104

(Photo showing crack/missing concrete in footpath – Raglan Street)

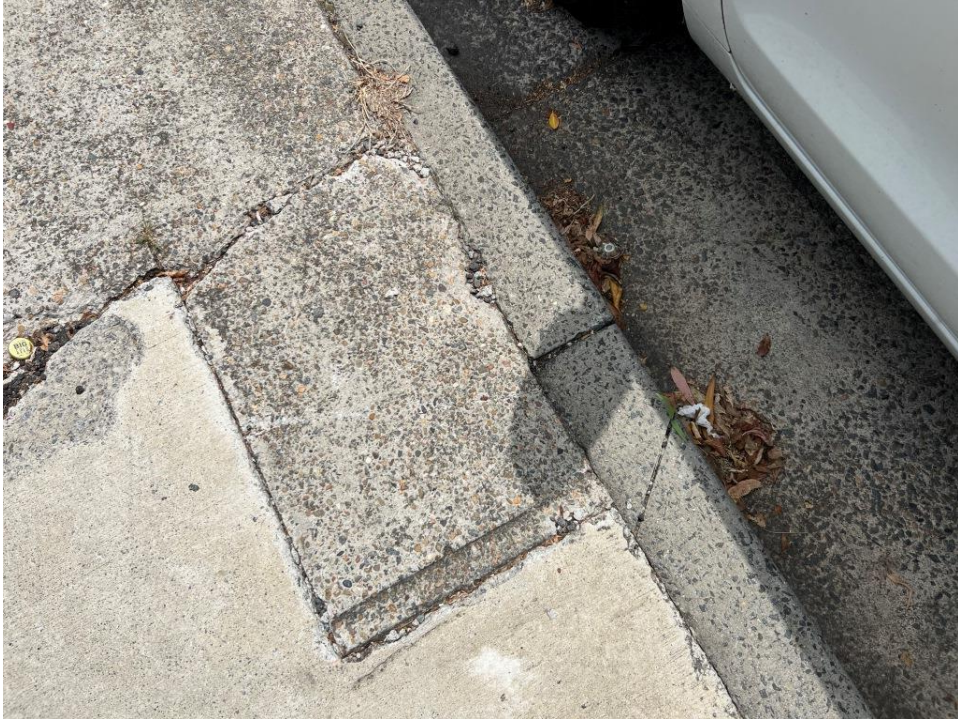
PHOTO 105

(Photo showing crack/missing concrete in footpath – Raglan Street)

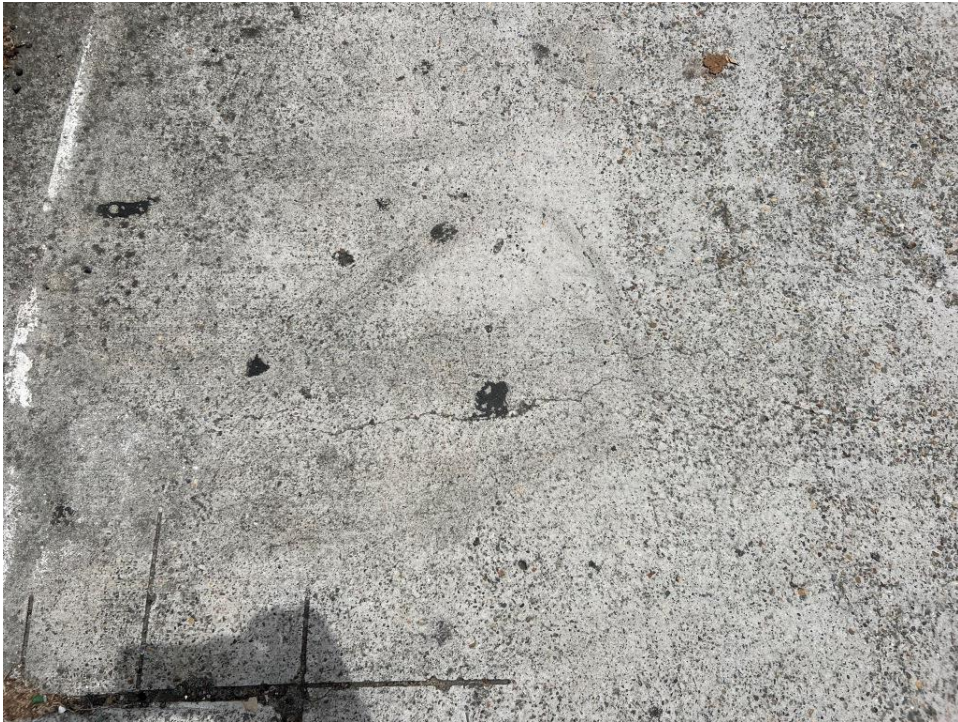
PHOTO 109

(Photo showing crack in footpath – Raglan Street)

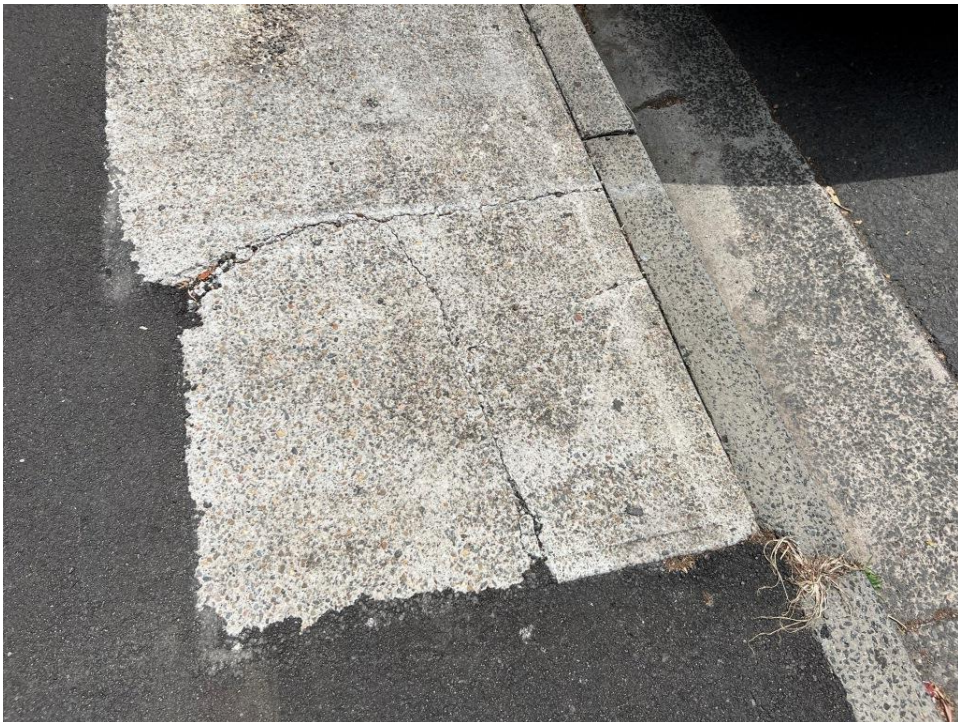
PHOTO 110

(Photo showing cracks in footpath – Raglan Street)

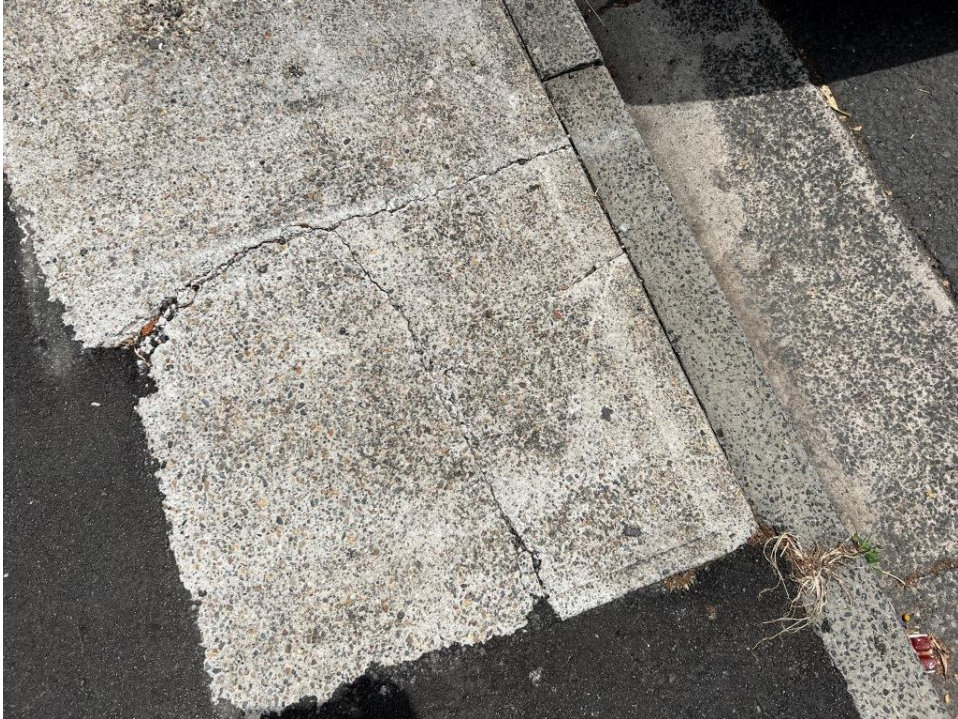
PHOTO 111

(Photo showing cracks in footpath – Raglan Street)

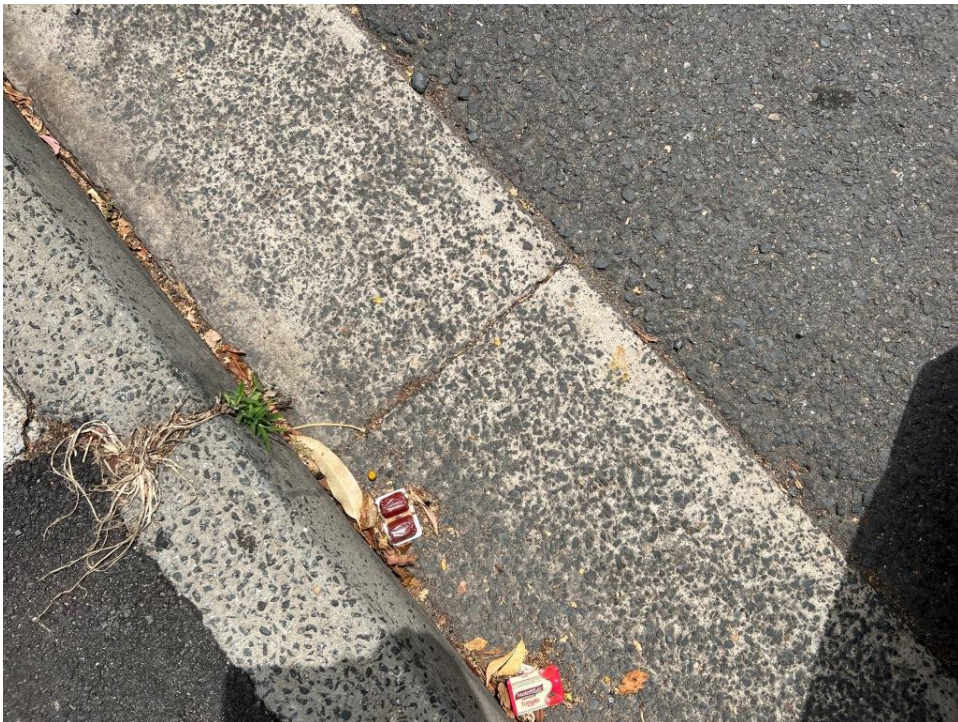
PHOTO 112

(Photo showing crack in gutter – Raglan Street)

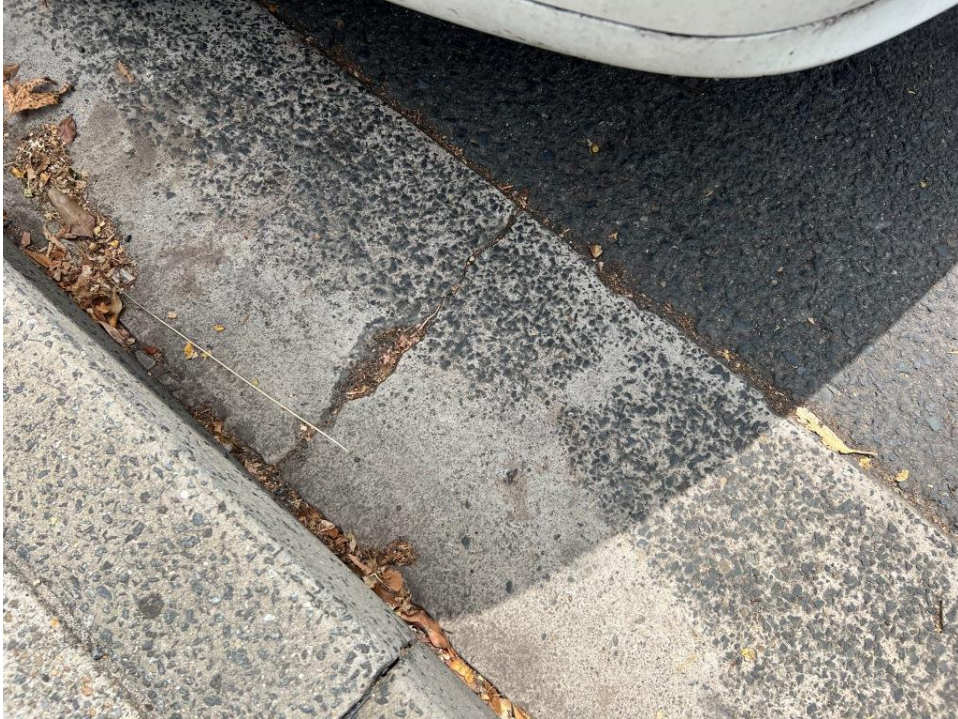
PHOTO 113

(Photo showing crack/missing concrete in gutter – Raglan Street)

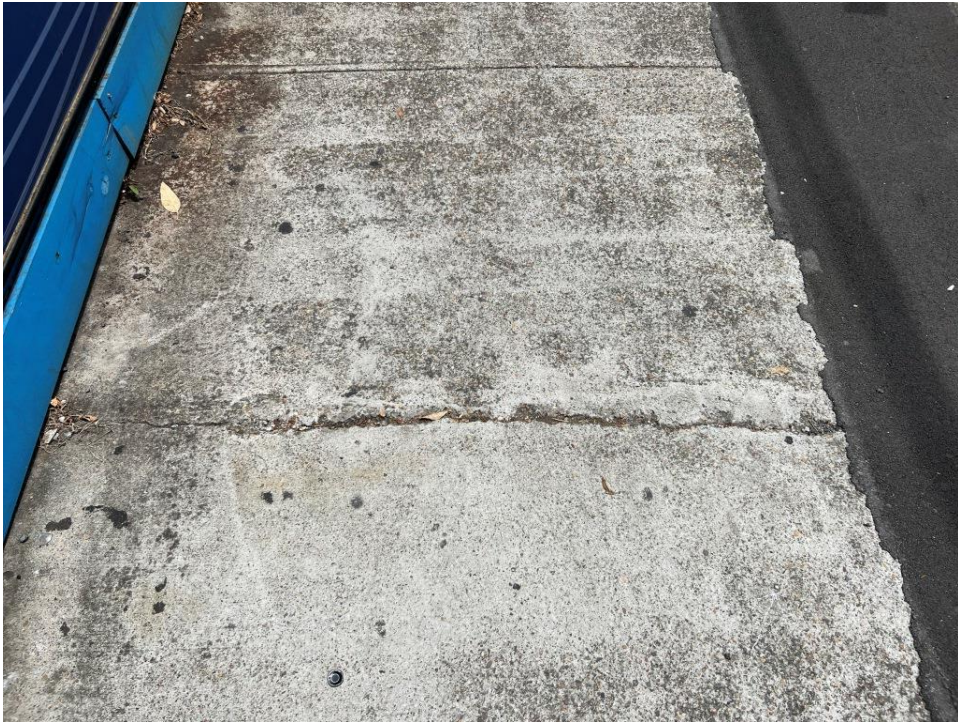
PHOTO 117

(Photo showing crack/missing concrete in footpath – Raglan Street)

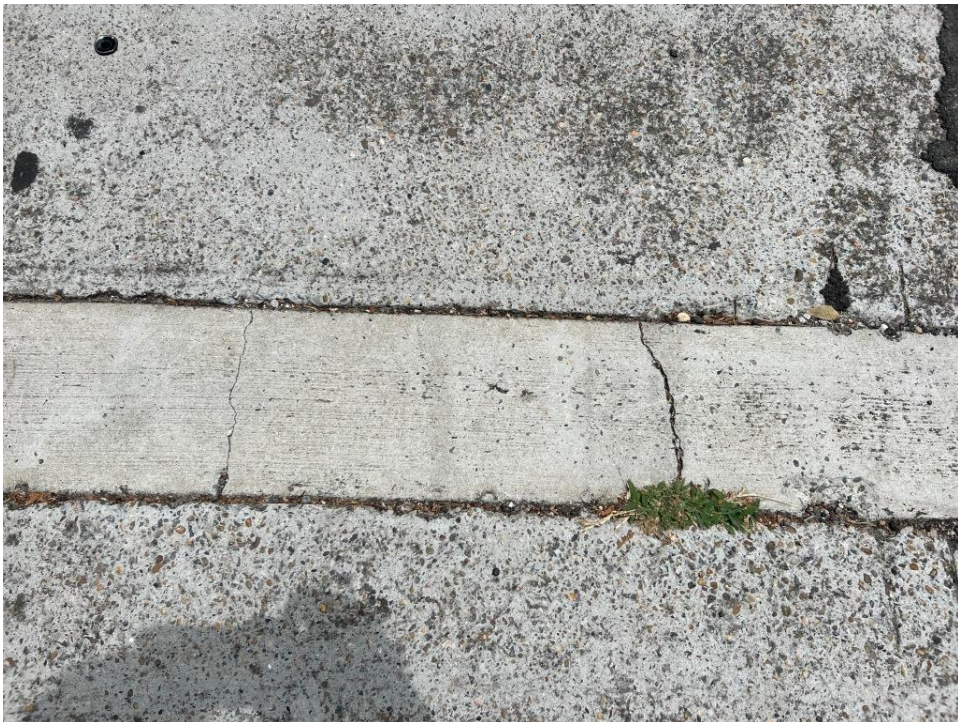
PHOTO 118

(Photo showing cracks in footpath – Raglan Street)

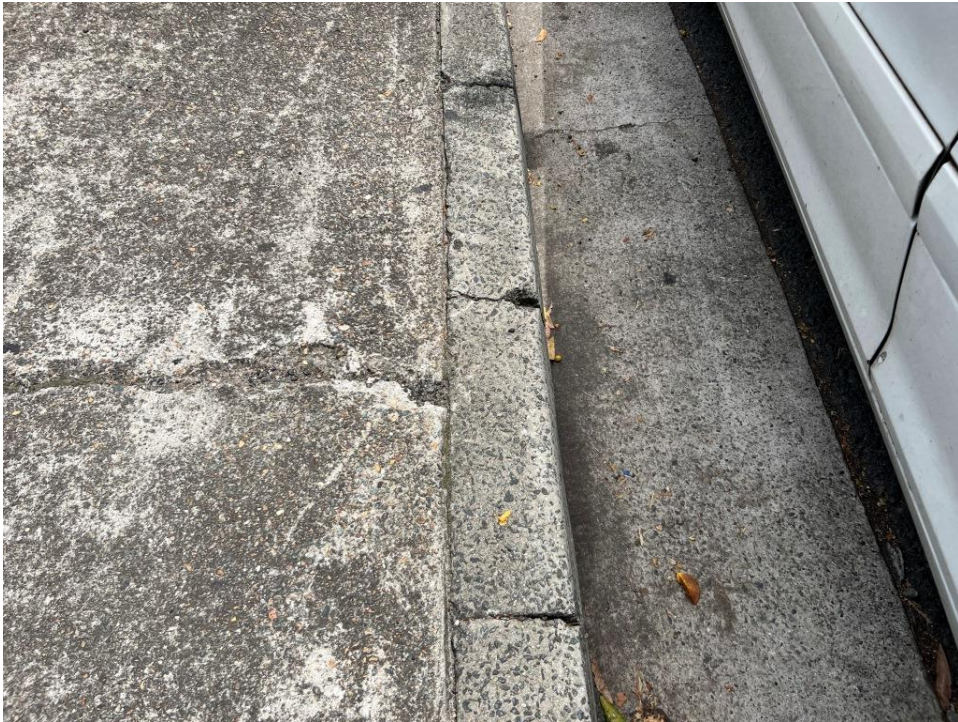
PHOTO 119

(Photo showing crack/missing concrete in footpath and kerb – Raglan Street)

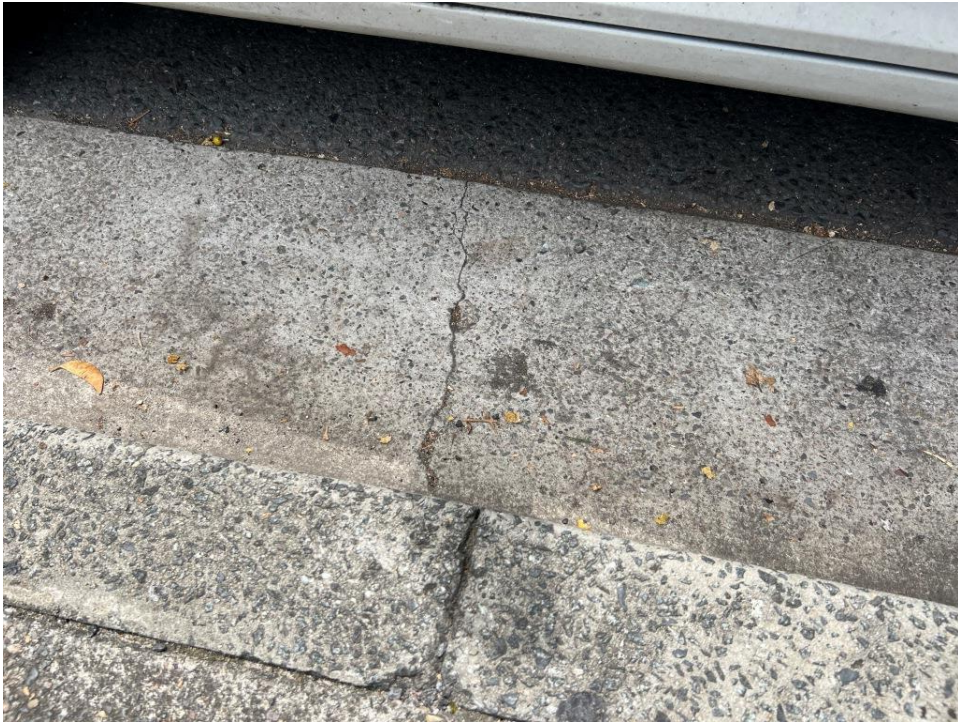
PHOTO 121

(Photo showing crack/missing concrete in kerb and gutter – Raglan Street)

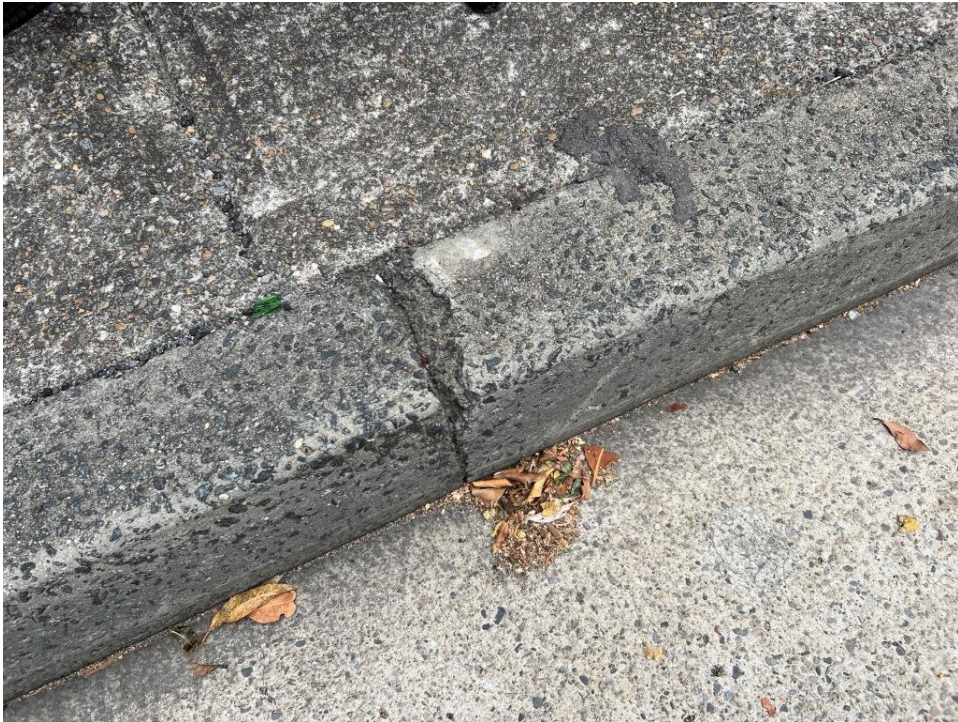
PHOTO 127

(Photo showing crack/missing concrete in kerb – Raglan Street)

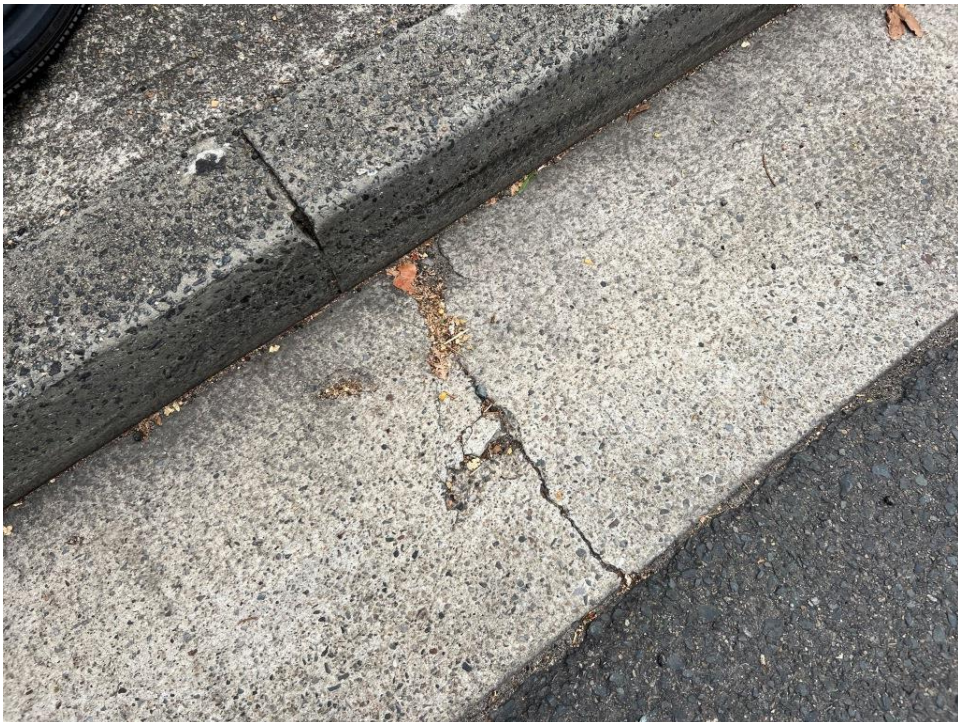
PHOTO 128

(Photo showing crack/missing concrete in kerb and gutter – Raglan Street)

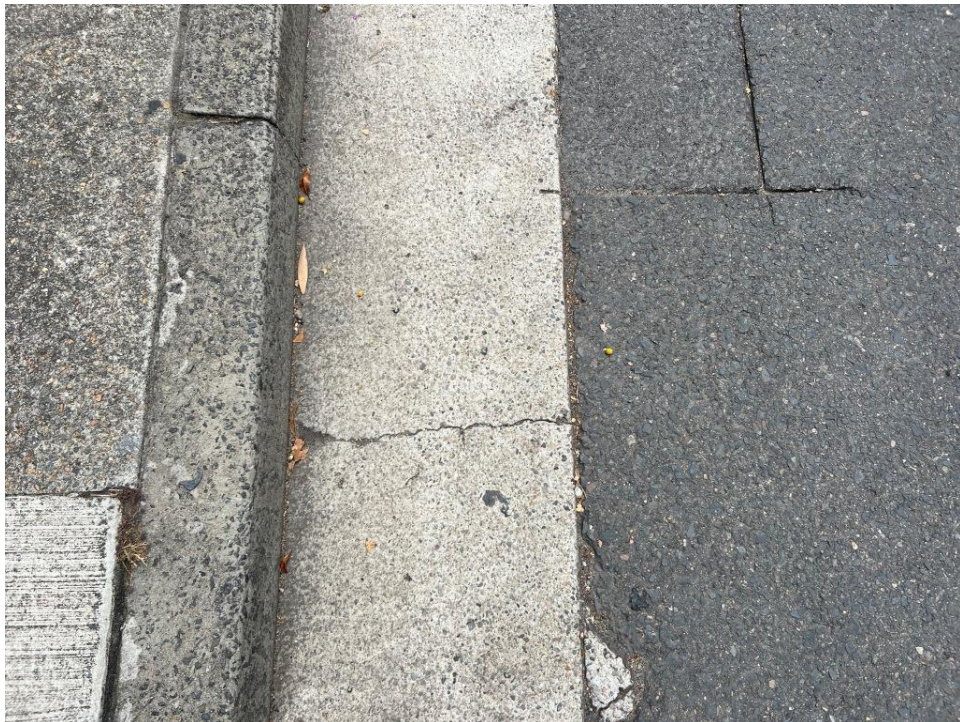
PHOTO 130

(Photo showing crack/missing concrete gutter – Raglan Street)

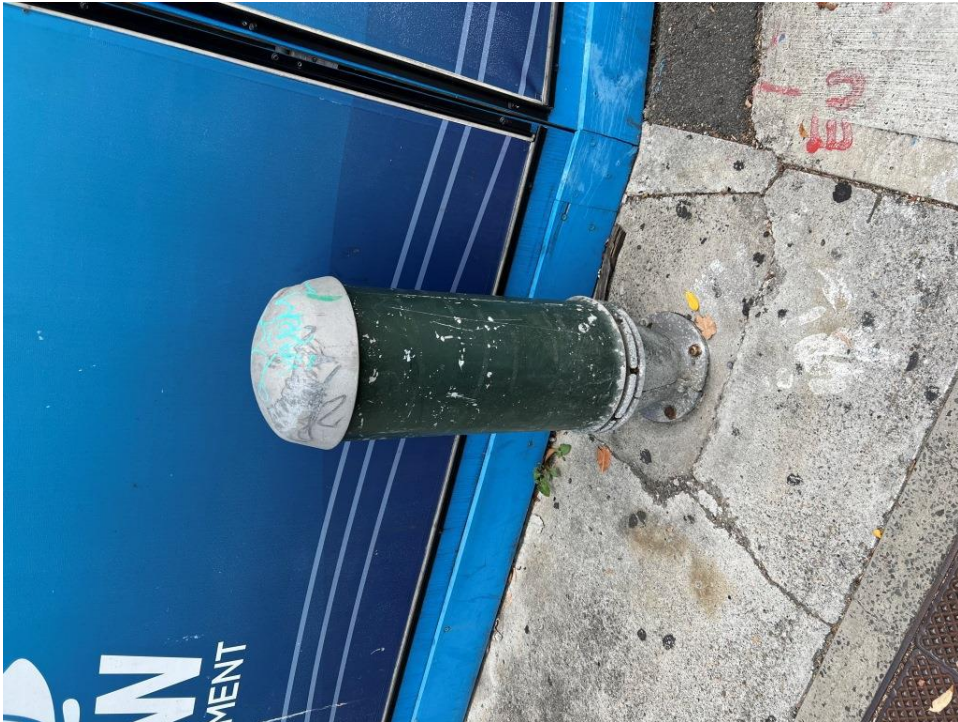
PHOTO 137

(Photo showing cracks in footpath – Raglan Street and Botany Road intersection)

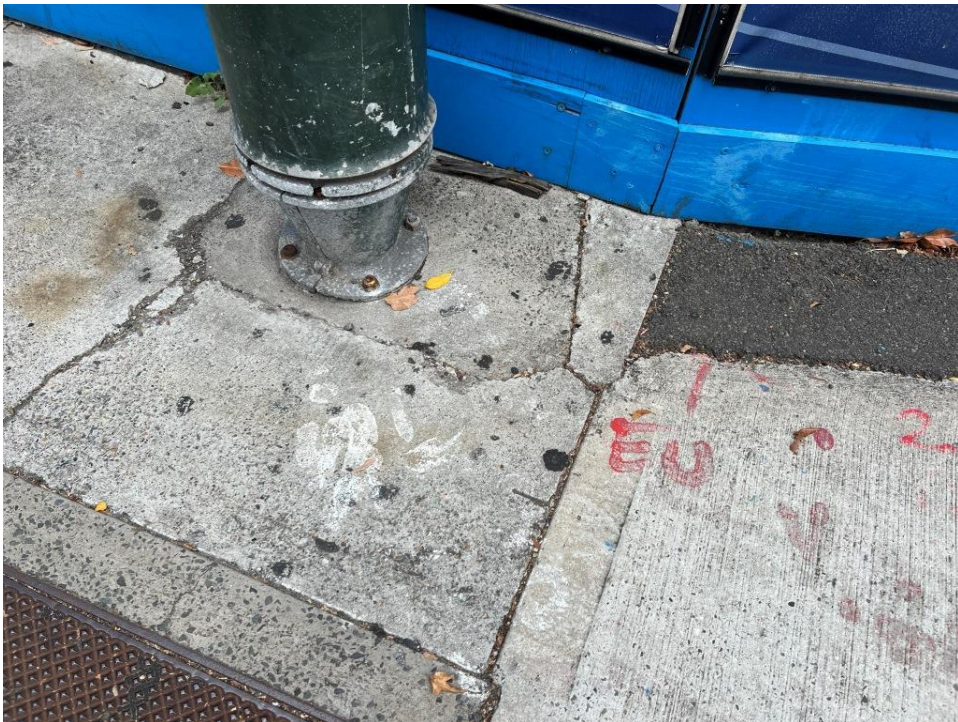
PHOTO 138

(Photo showing cracks in footpath – Raglan Street and Botany Road intersection)

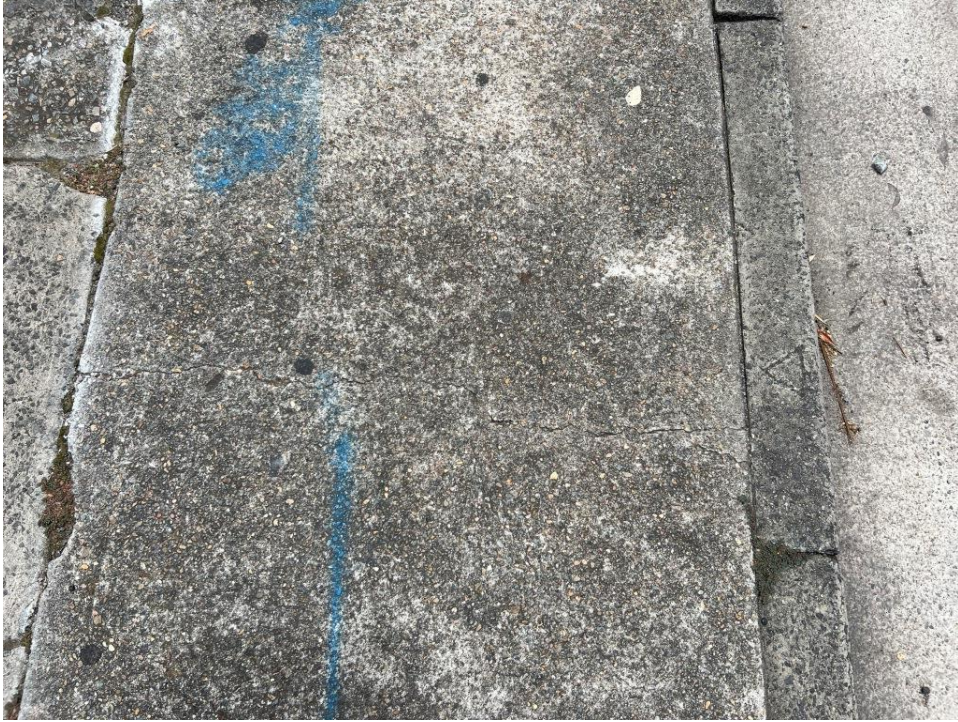
PHOTO 139

(Photo showing crack and missing concrete in footpath – Raglan Street and Botany Road intersection)

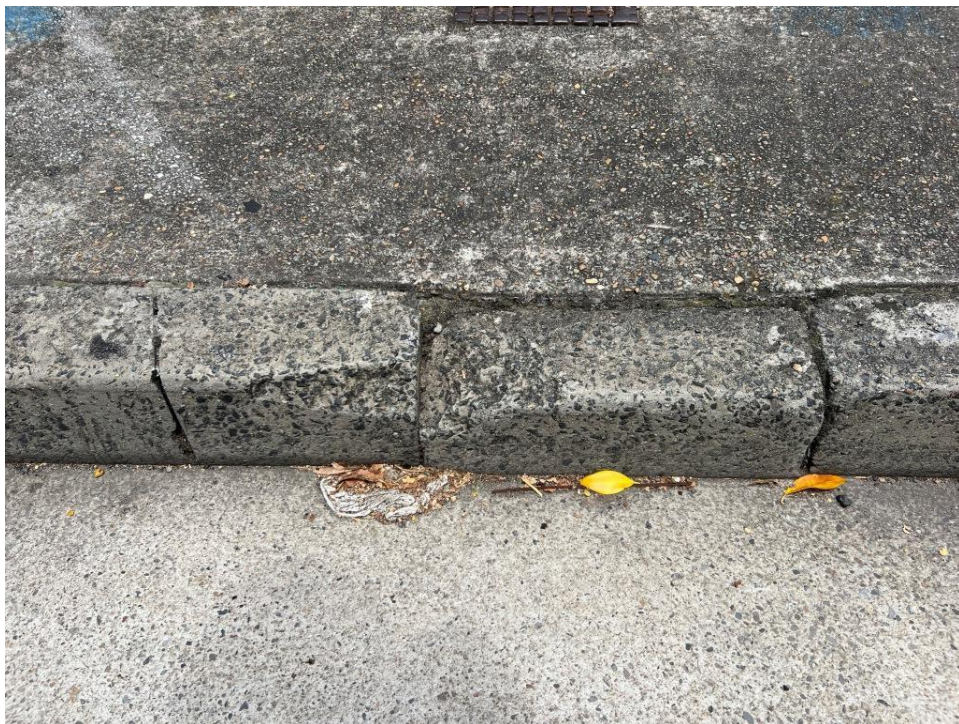
PHOTO 142

(Photo showing cracked and chipped concrete in kerb – Raglan Street and Botany Road intersection)

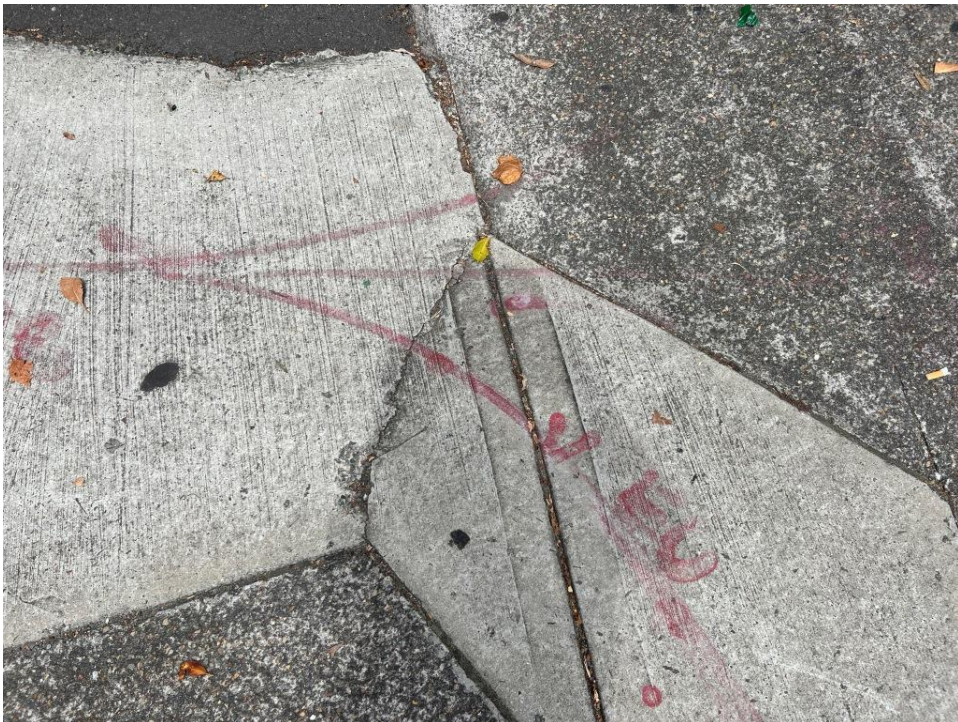
PHOTO 143

(Photo showing crack in gutter – Raglan Street and Botany Road intersection)
