DILAPIDATION REPORT

Council Assets/Public Infrastructure

**WATERLOO STATION
COPE STREET**

DEMLAKIAN CONSULTING ENGINEERS

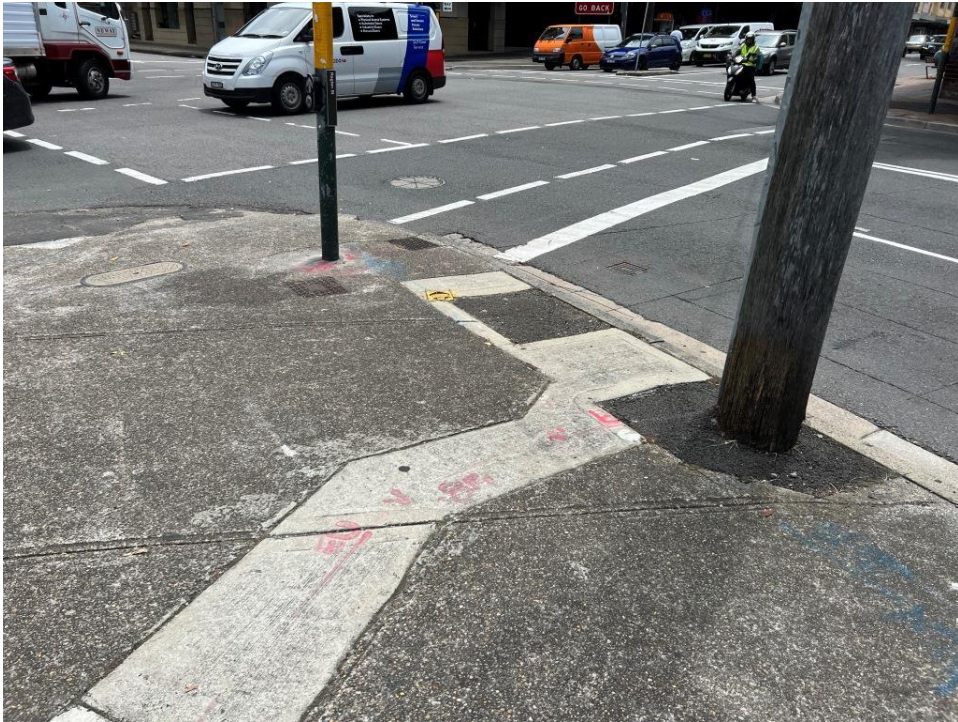
PHOTO 144

(Photo showing crack in footpath – Raglan Street and Botany Road intersection)

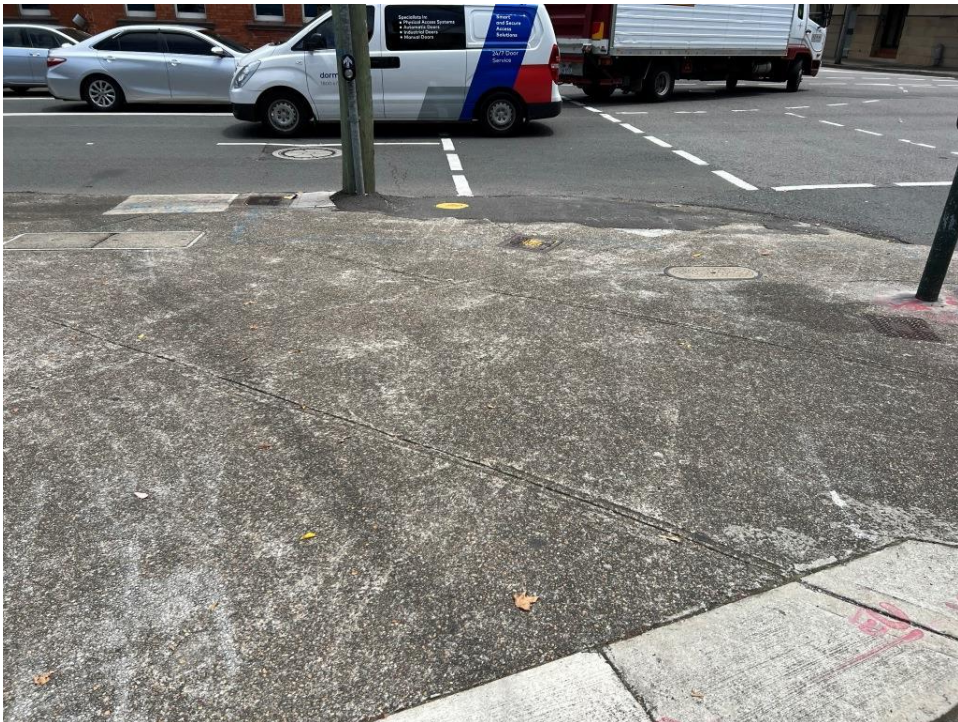
PHOTO 145

(Overview of footpath – Raglan Street and Botany Road intersection)

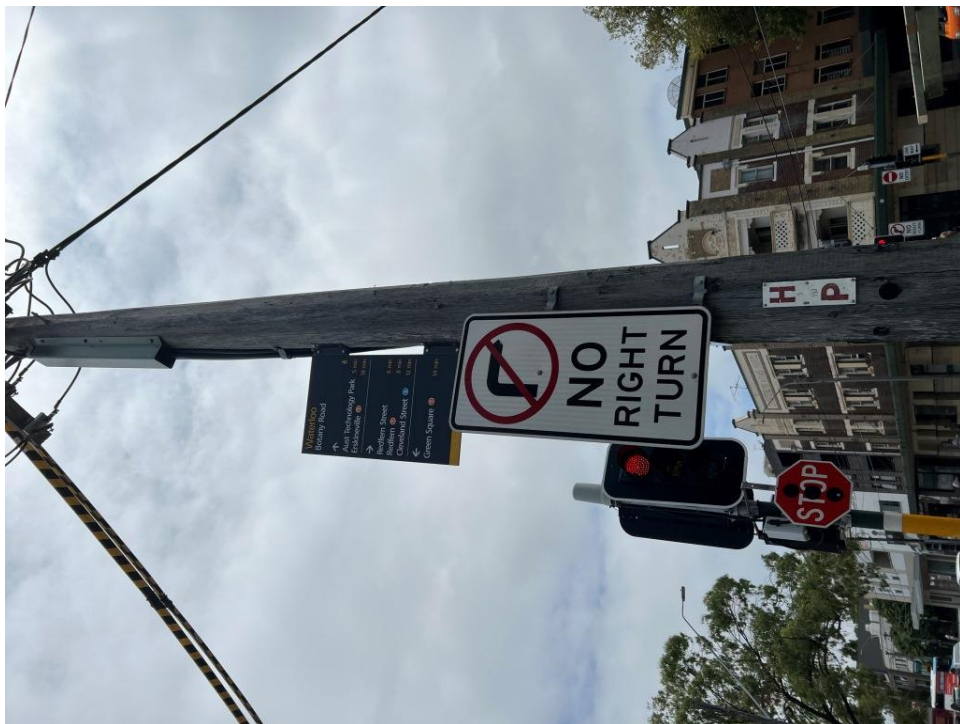
PHOTO 147

(Overview of footpath – Raglan Street and Botany Road intersection)

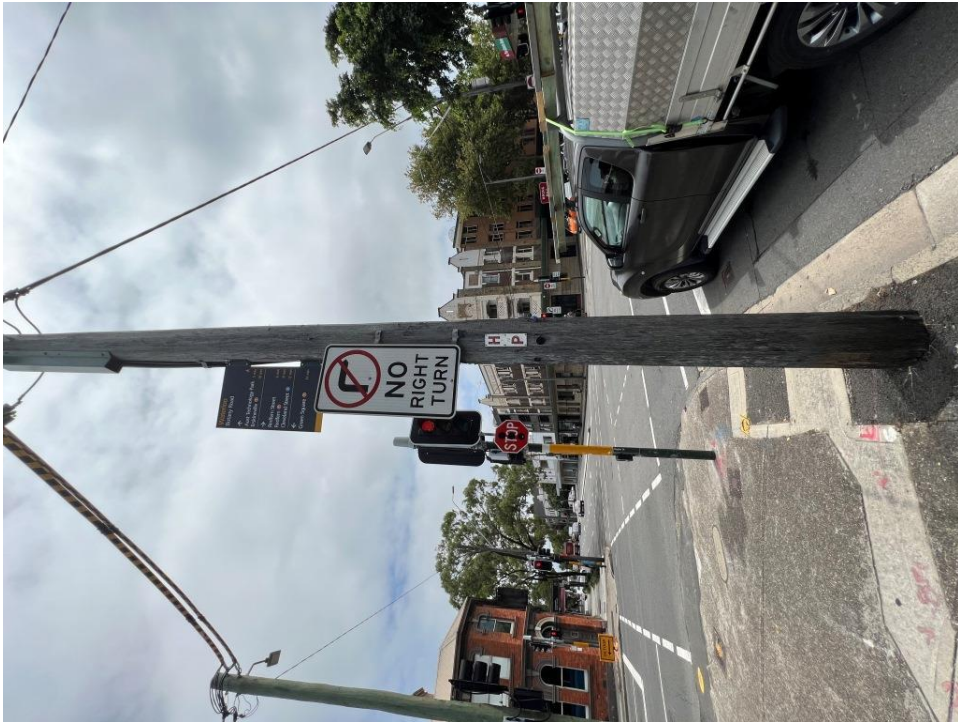
PHOTO 148

(Photo showing condition of electricity pole and street sign – Raglan Street and Botany Road intersection)

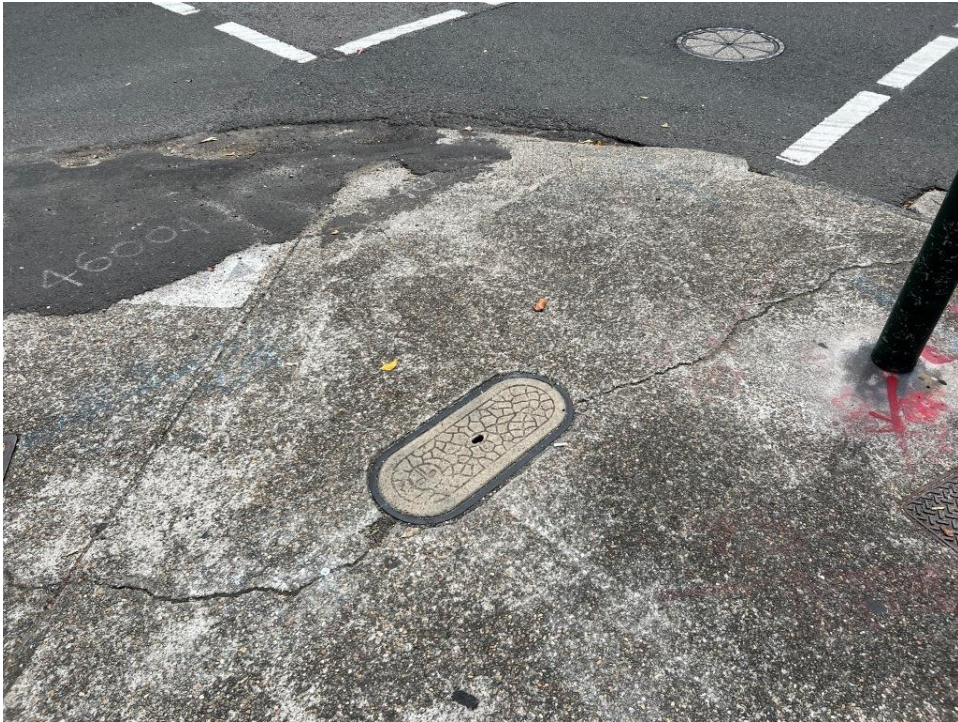
PHOTO 150

(Photo showing condition of traffic light – Raglan Street and Botany Road intersection)

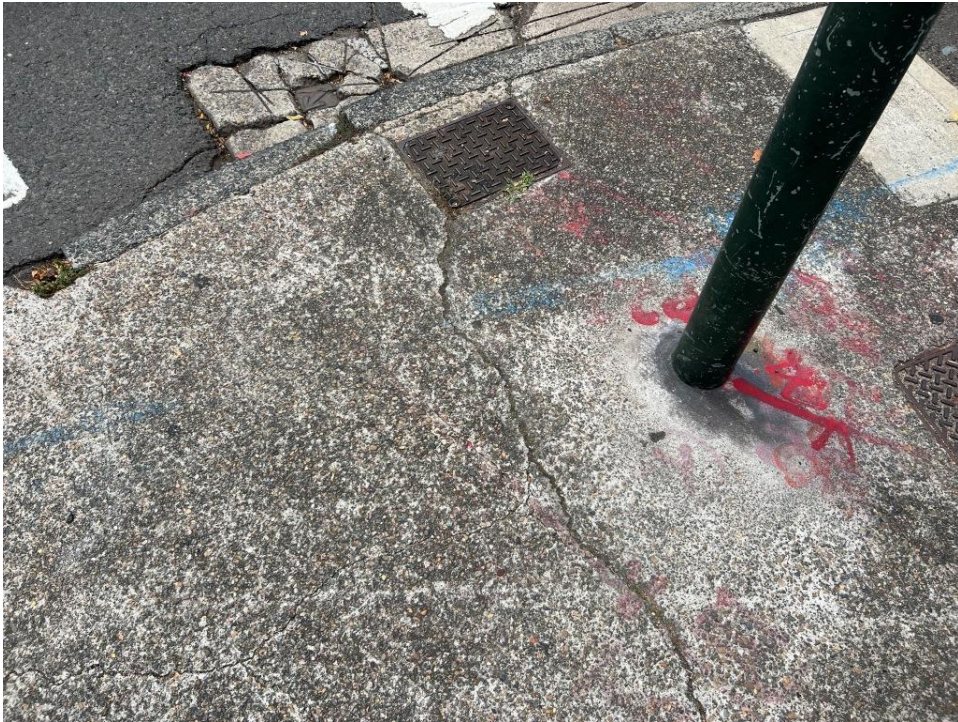
PHOTO 152

(Photo showing cracks in footpath and gutter – Raglan Street and Botany Road intersection)

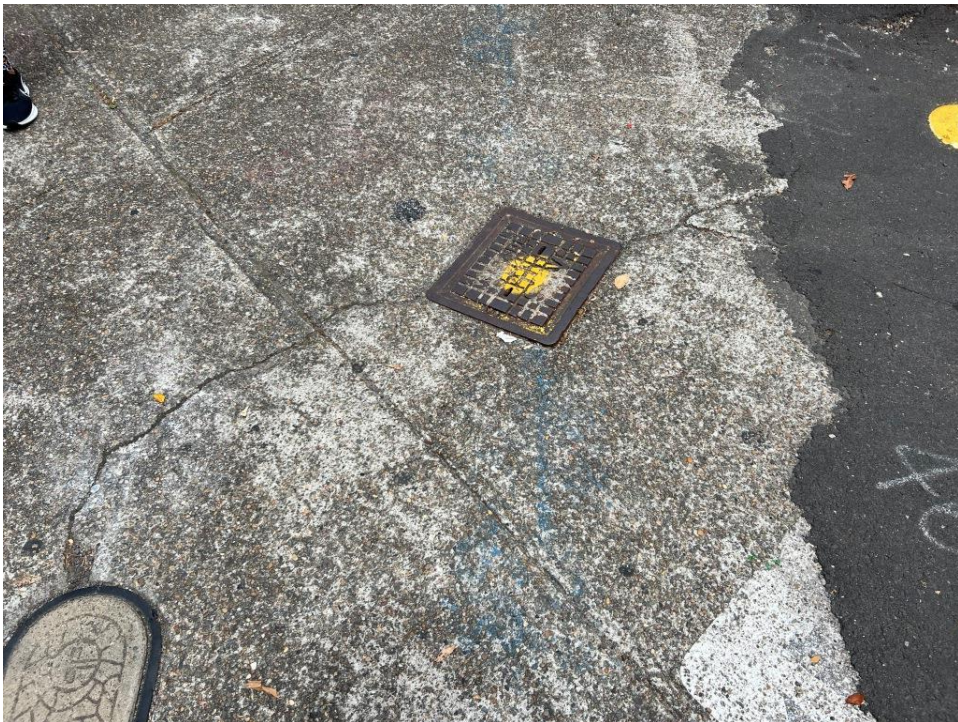
PHOTO 153

(Photo showing cracks in footpath and gutter – Raglan Street and Botany Road intersection)

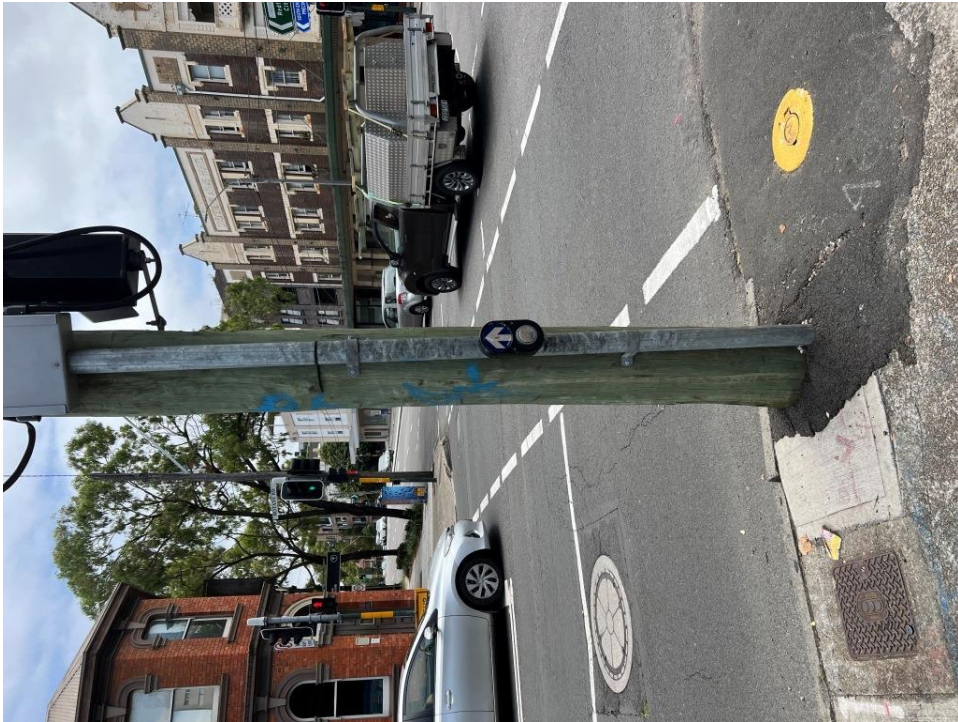
PHOTO 154

(Photo showing cracks in footpath – Raglan Street and Botany Road intersection)

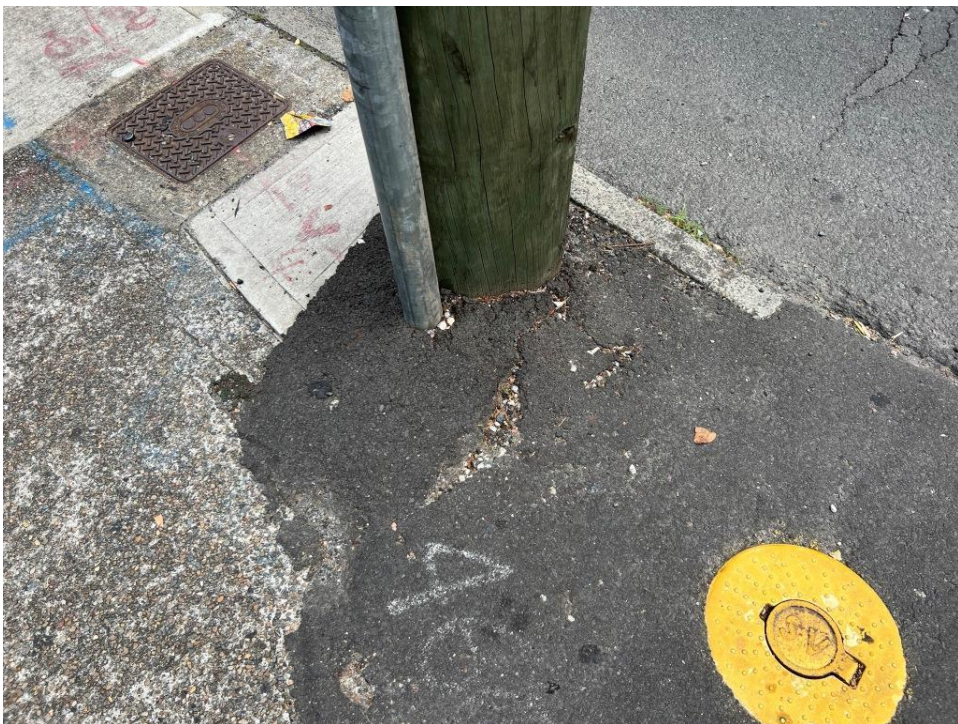
PHOTO 155

(Photo showing condition of electricity pole and traffic light – Raglan Street and Botany Road intersection)

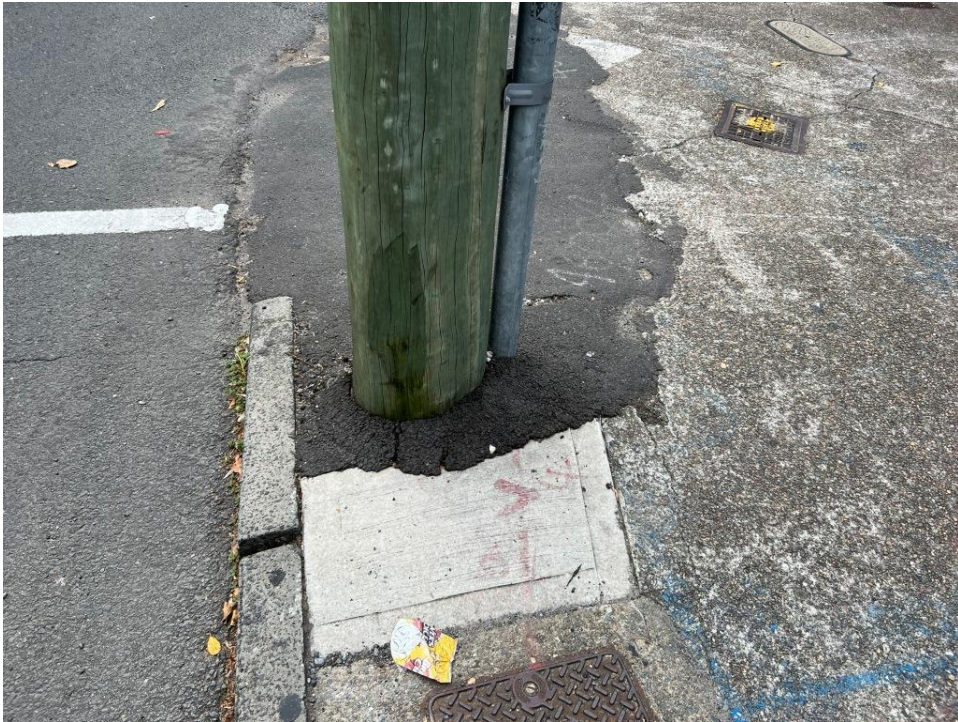
PHOTO 160
(Photo showing cracked asphalt – Botany Road)

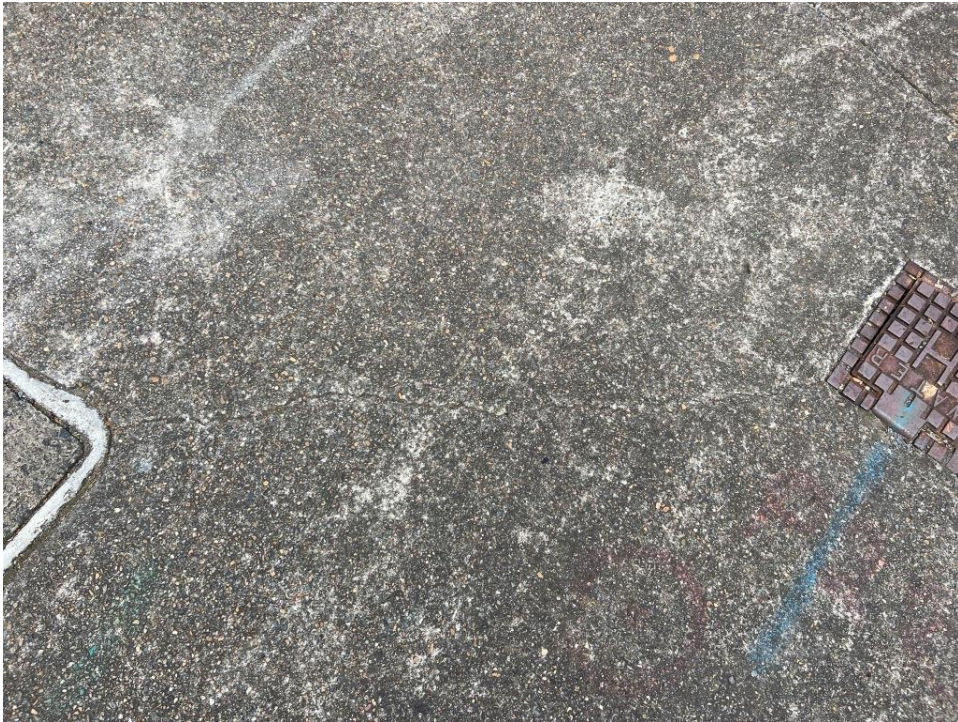
PHOTO 162

(Overview of footpath - Botany Road)

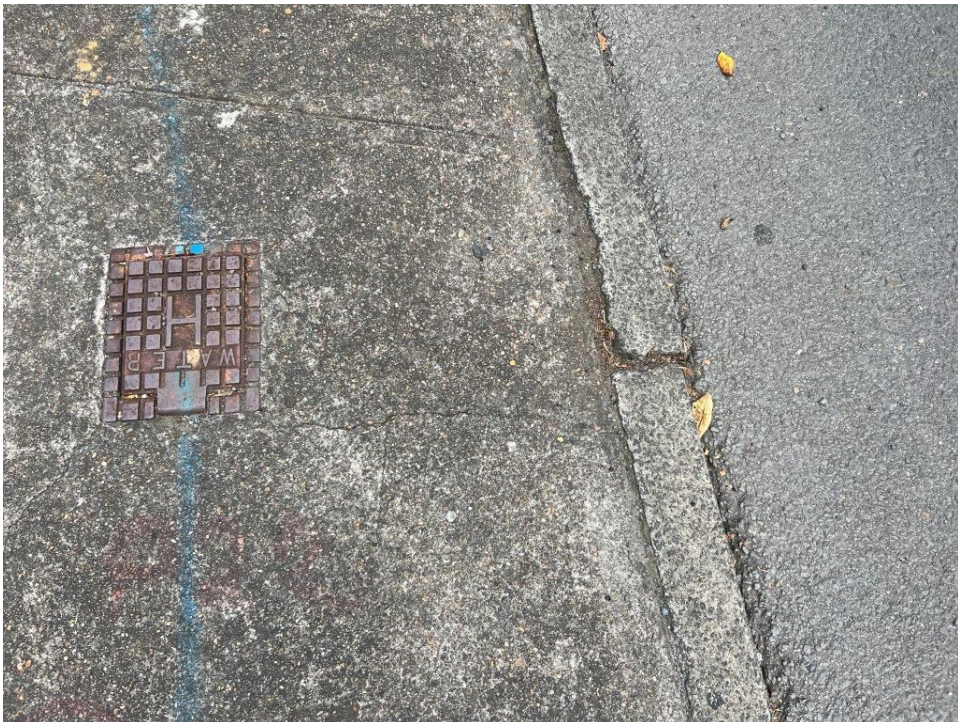
PHOTO 163

(Photo showing crack in footpath – Botany Road)

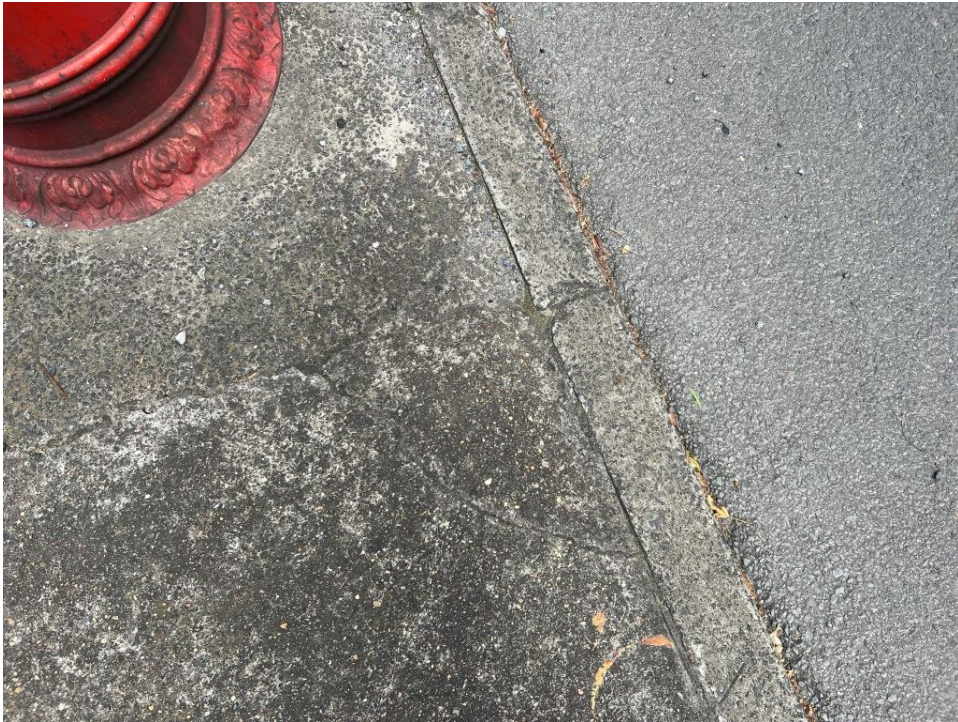
PHOTO 166
(Photo showing condition of mails drop off station – Botany Road)

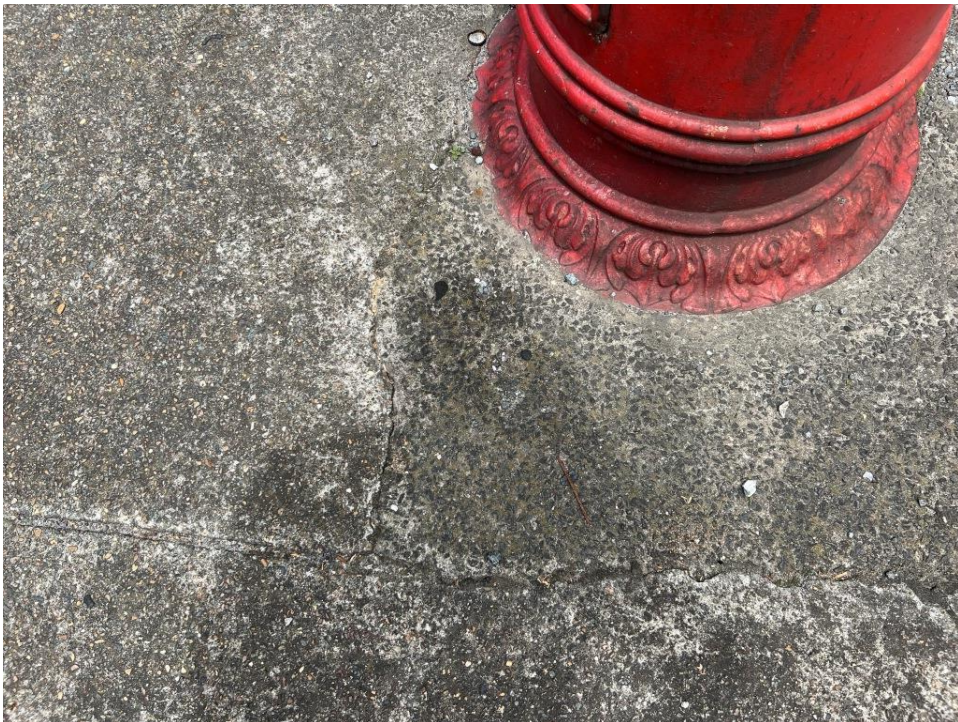
PHOTO 167

(Photo showing crack in footpath – Botany Road)

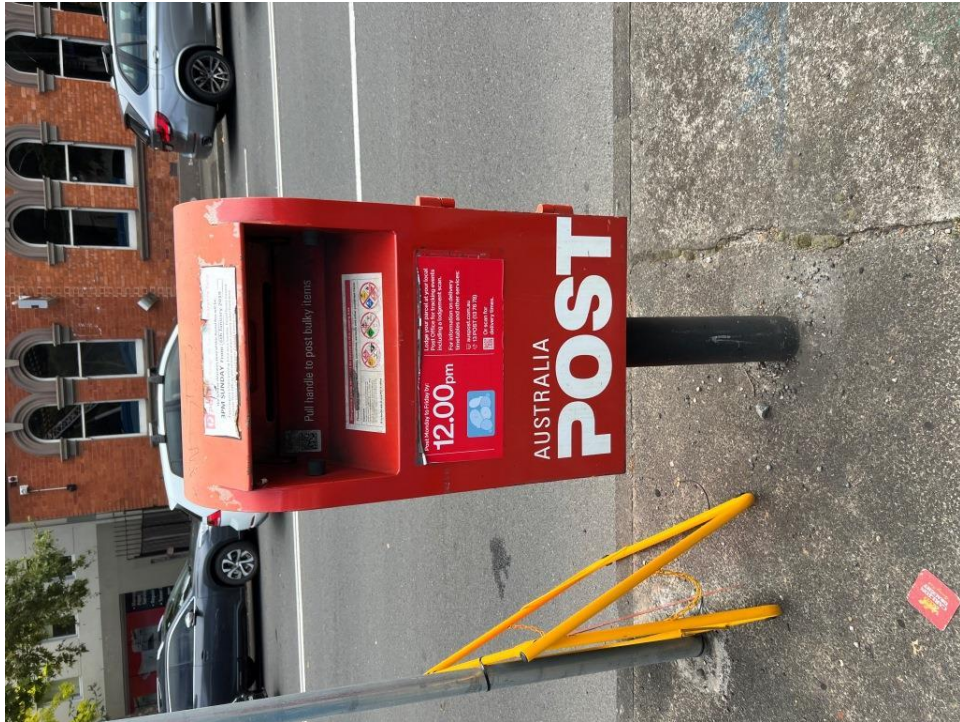
PHOTO 170
(Photo showing condition of mails drop off station – Botany Road)

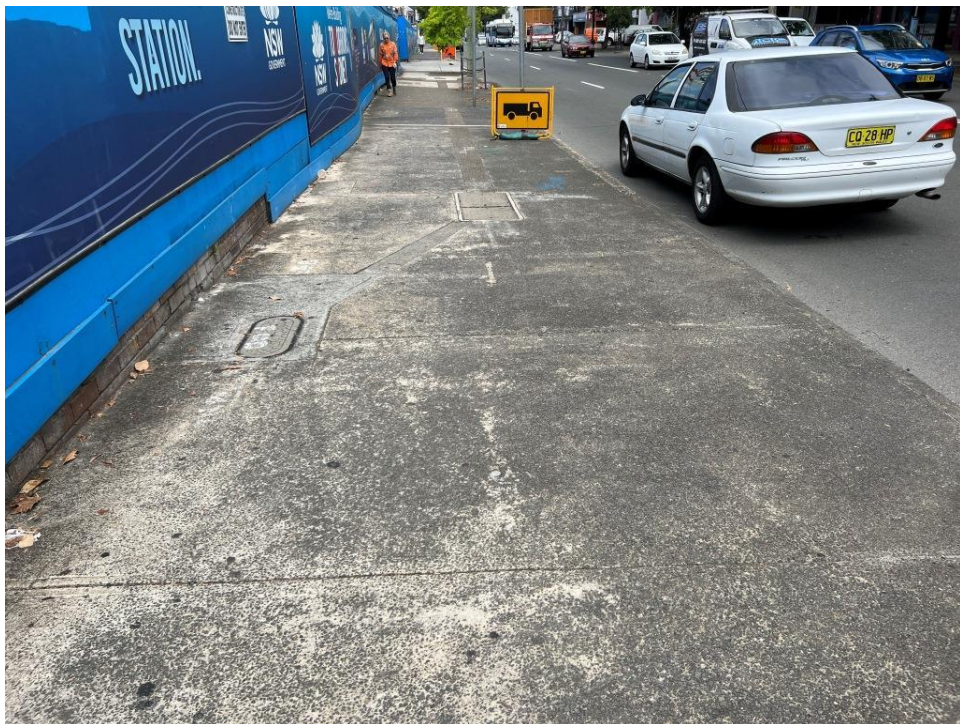
PHOTO 171

(Photo showing condition of mails drop off station – Botany Road)

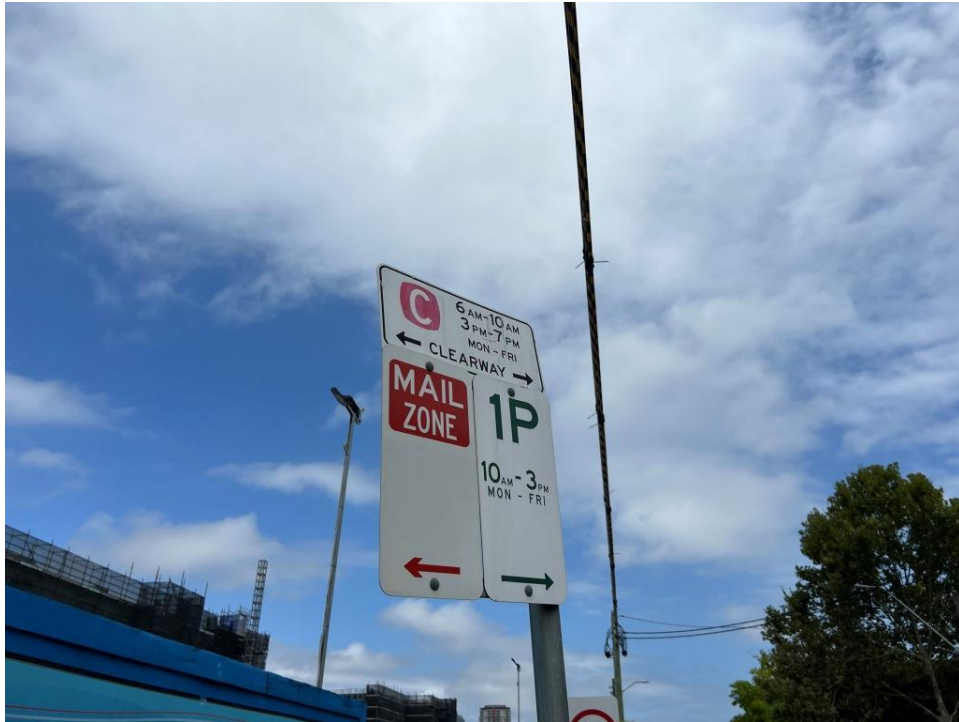
PHOTO 174

(Photo showing condition of parking sign – Botany Road)

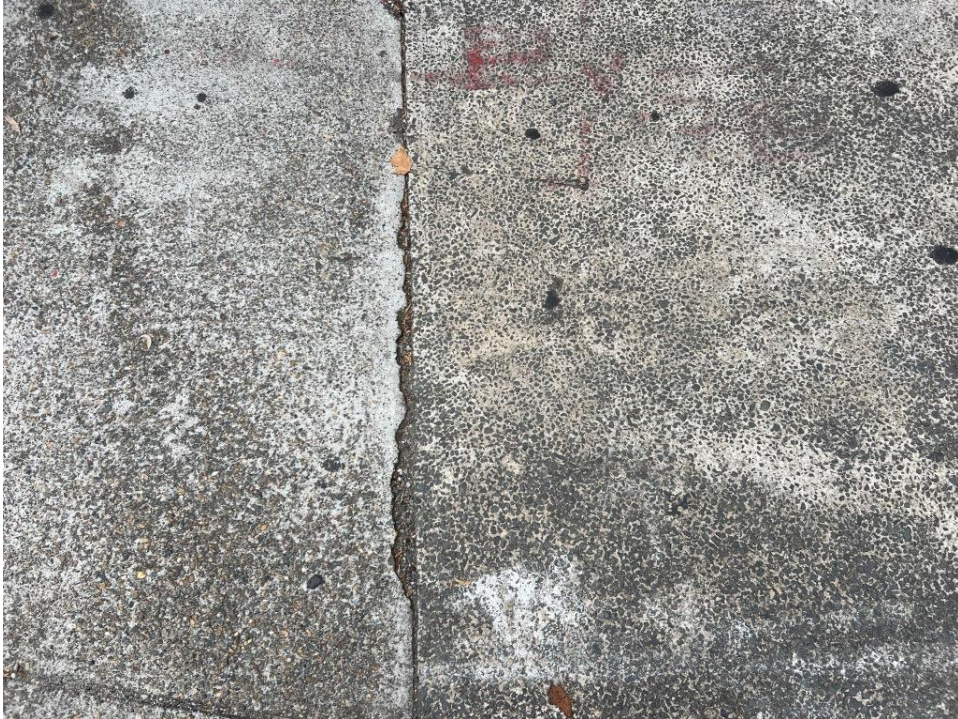
PHOTO 176

(Overview of footpath – Botany Road)

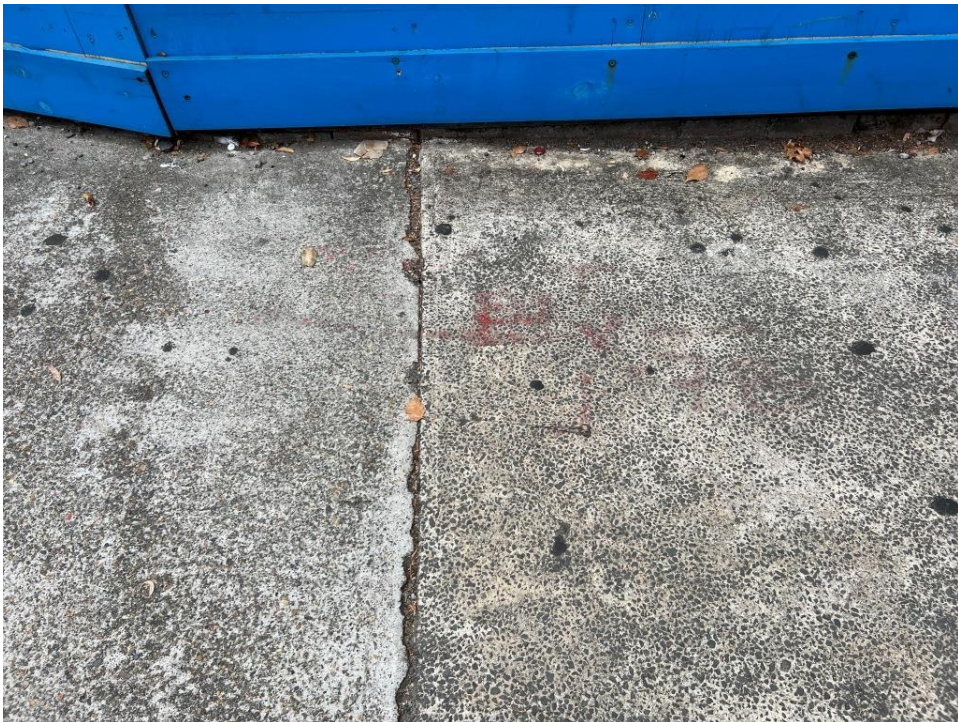
PHOTO 177

(Photo showing chipped concrete along footpath's saw cut joint – Botany Road)

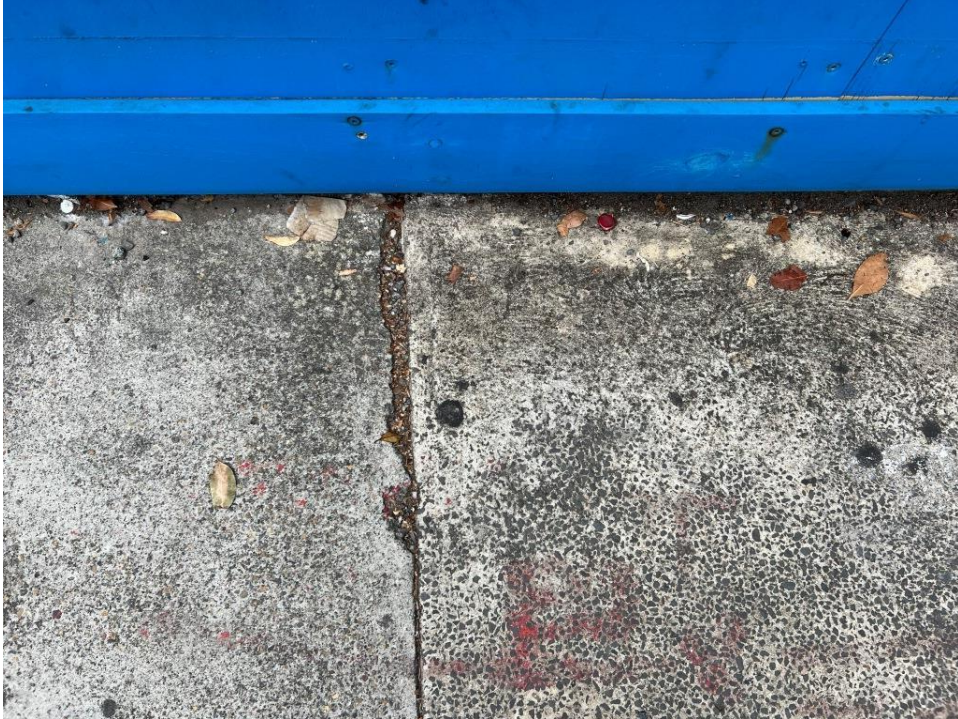
PHOTO 178

(Photo showing chipped concrete along footpath's saw cut joint – Botany Road)

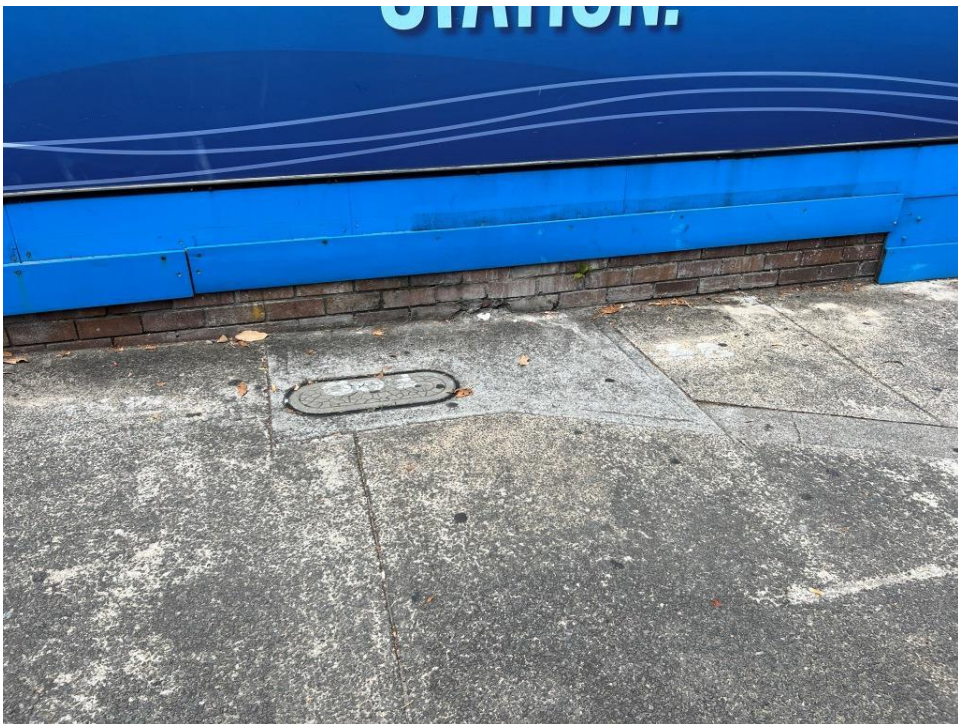
PHOTO 179

(Photo showing chipped concrete along footpath's saw cut joint – Botany Road)

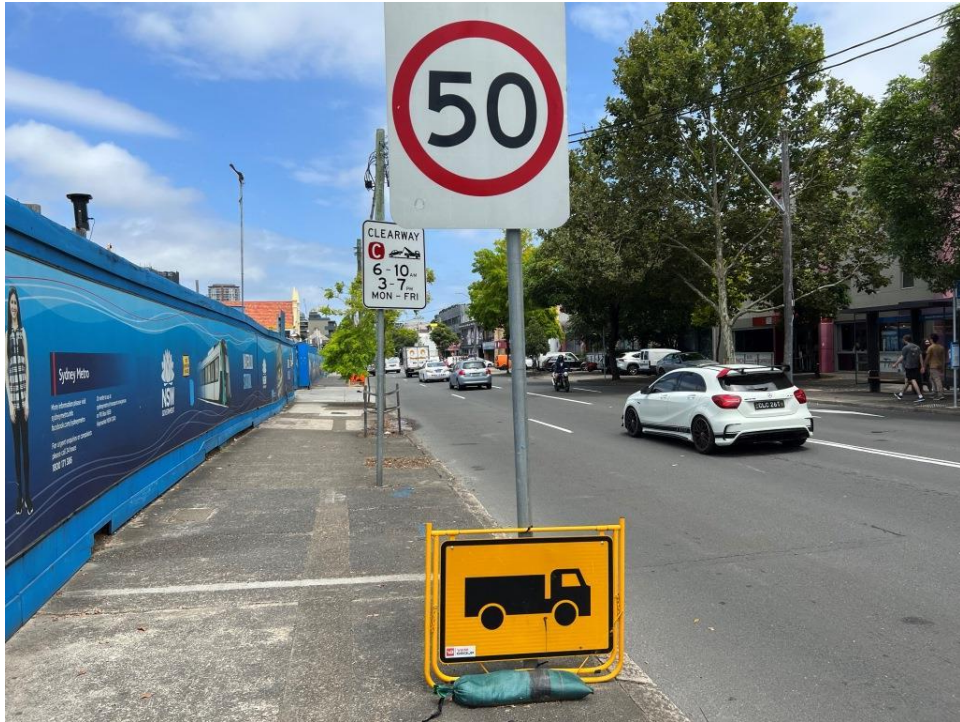
PHOTO 185

(Overview of footpath and roadway – Botany Road)

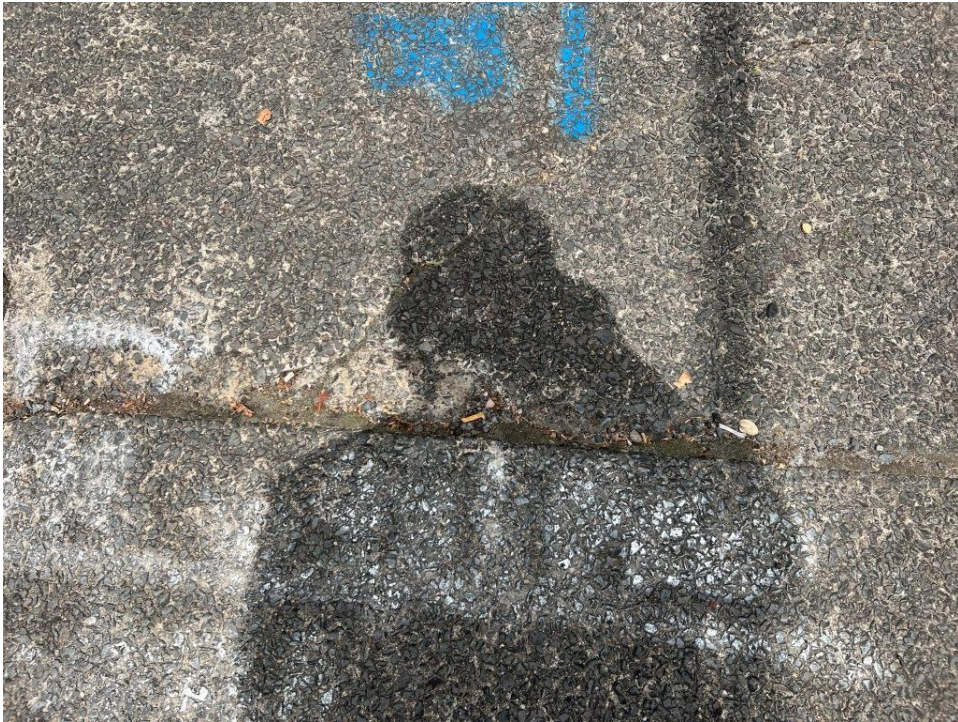
PHOTO 193

(Photo showing chipped concrete along footpath's joint – Botany Road)

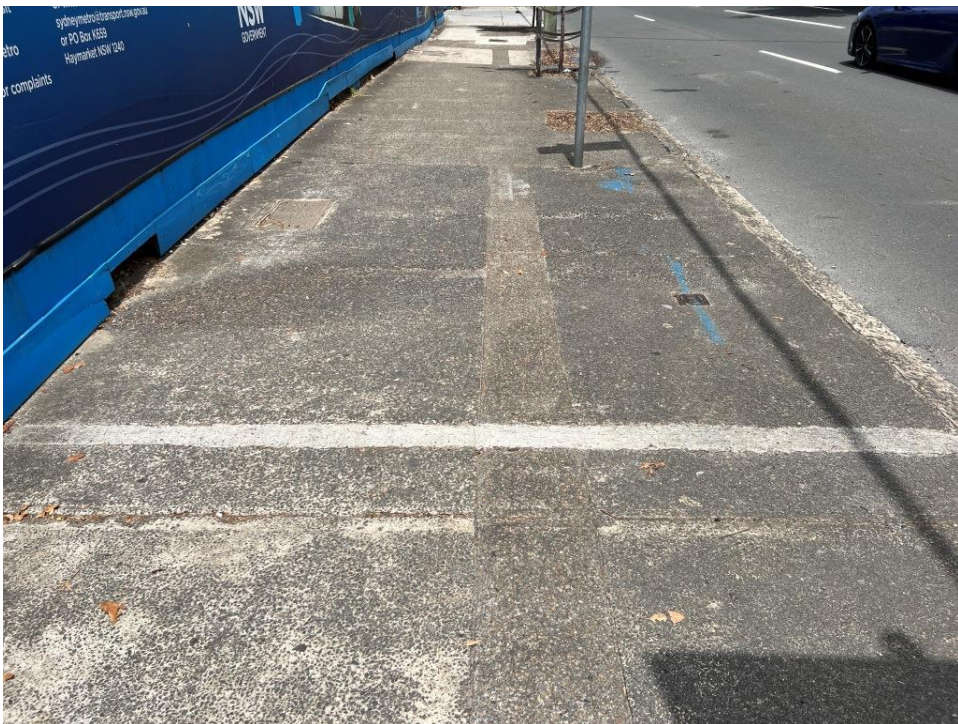
PHOTO 194

(Overview of footpath – Botany Road)

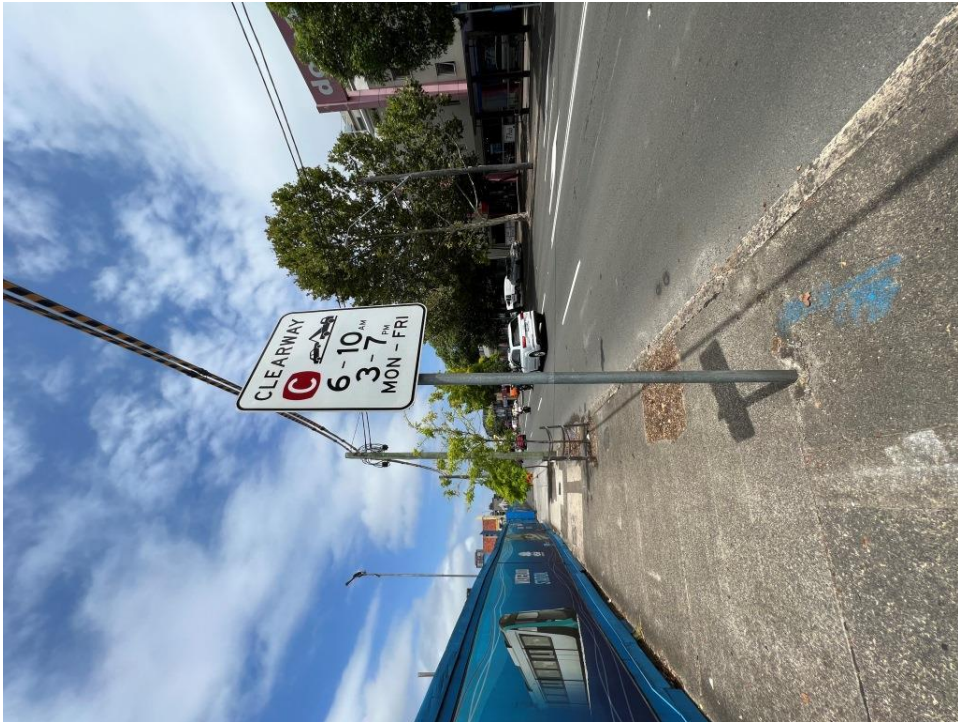
PHOTO 197

(Overview of footpath and road sign – Botany Road)

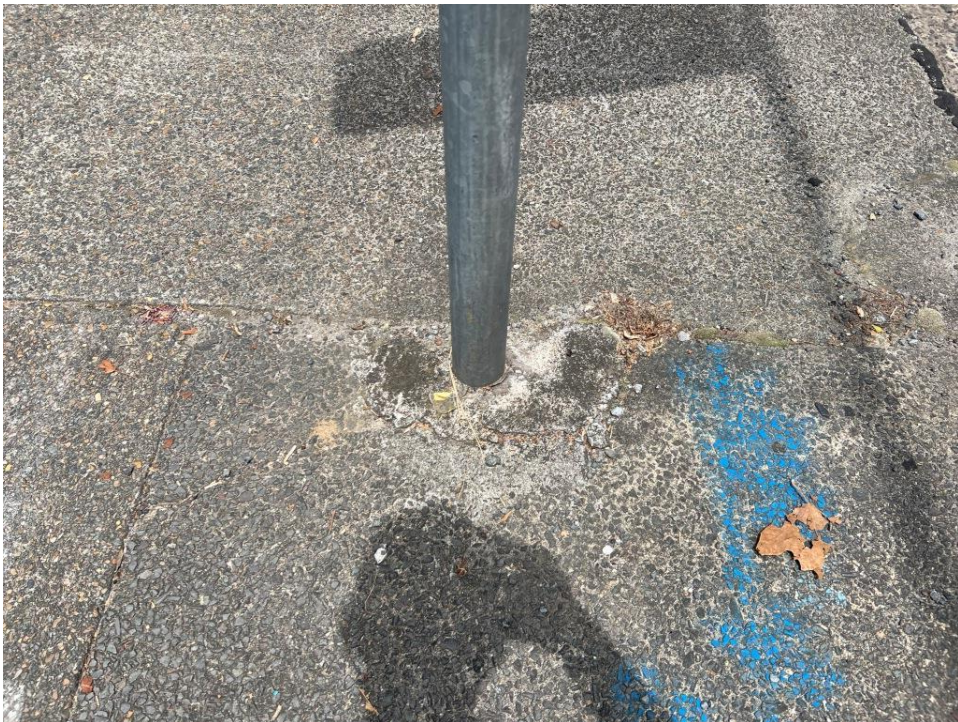
PHOTO 198

(Photo showing cracks in footpath at base of road sign post – Botany Road)

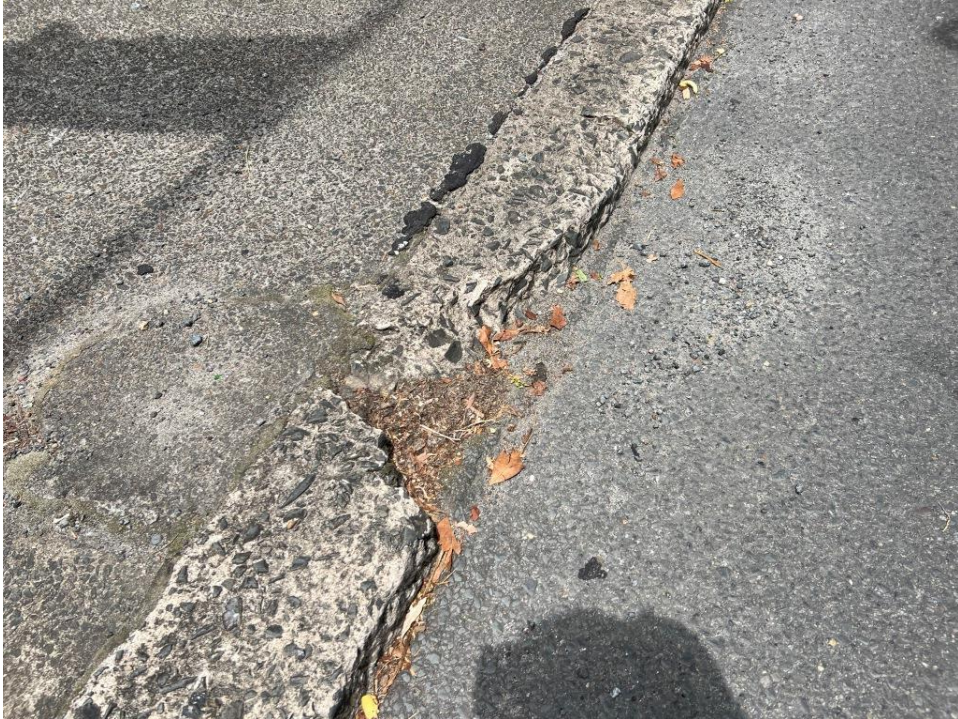
PHOTO 199

(Photo showing missing concrete in kerb – Botany Road)

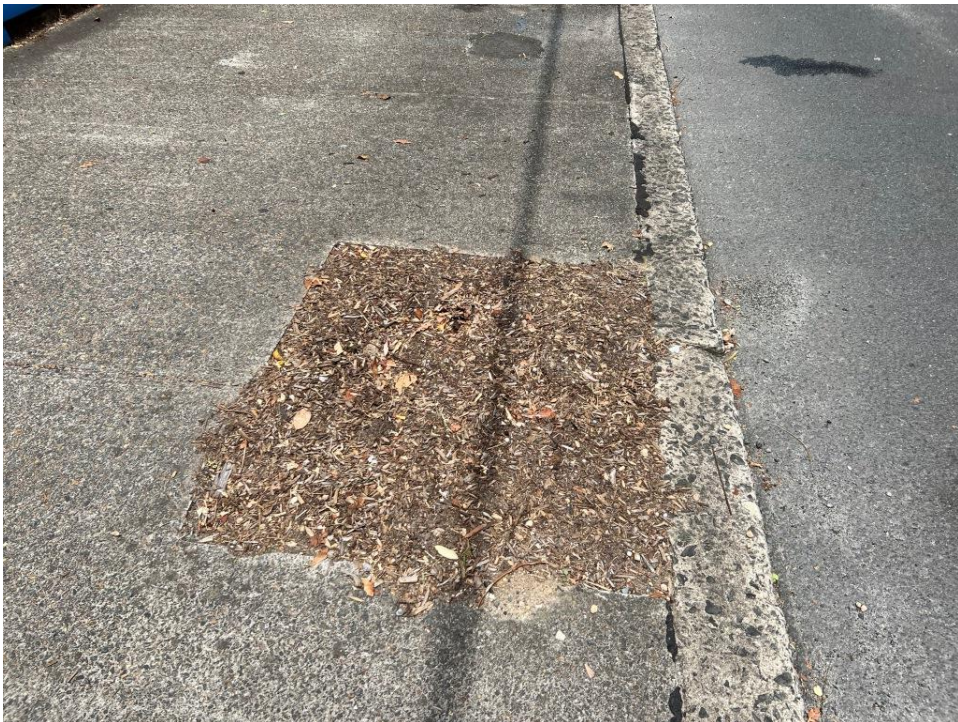
PHOTO 200

(Photo showing condition of footpath at former tree location – Botany Road)

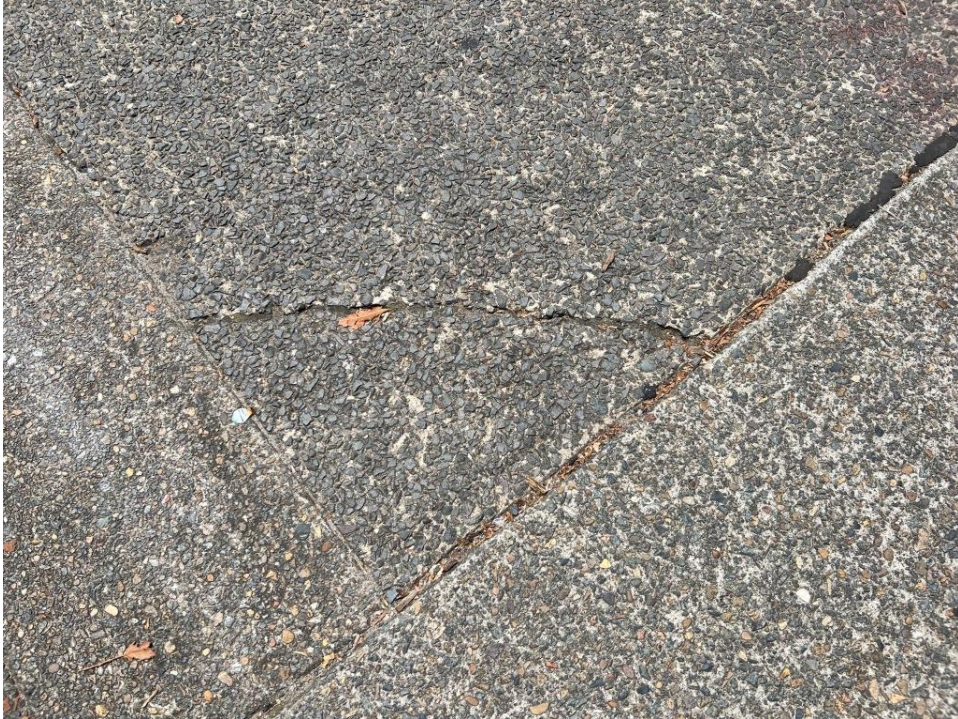
PHOTO 201

(Photo showing crack in footpath – Botany Road)

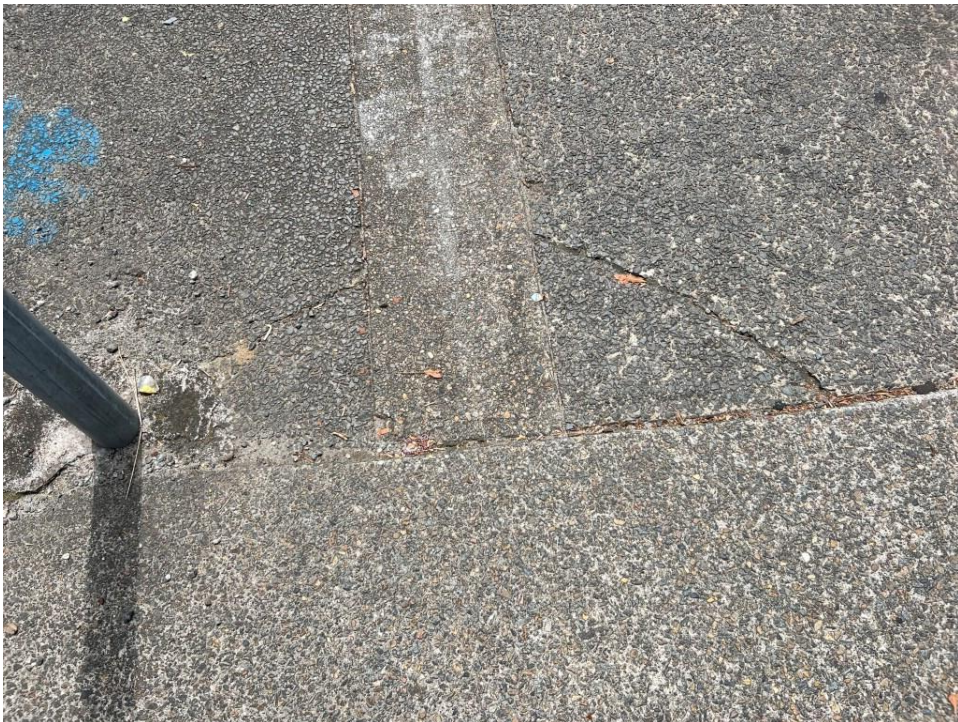
PHOTO 202

(Photo showing crack in footpath – Botany Road)

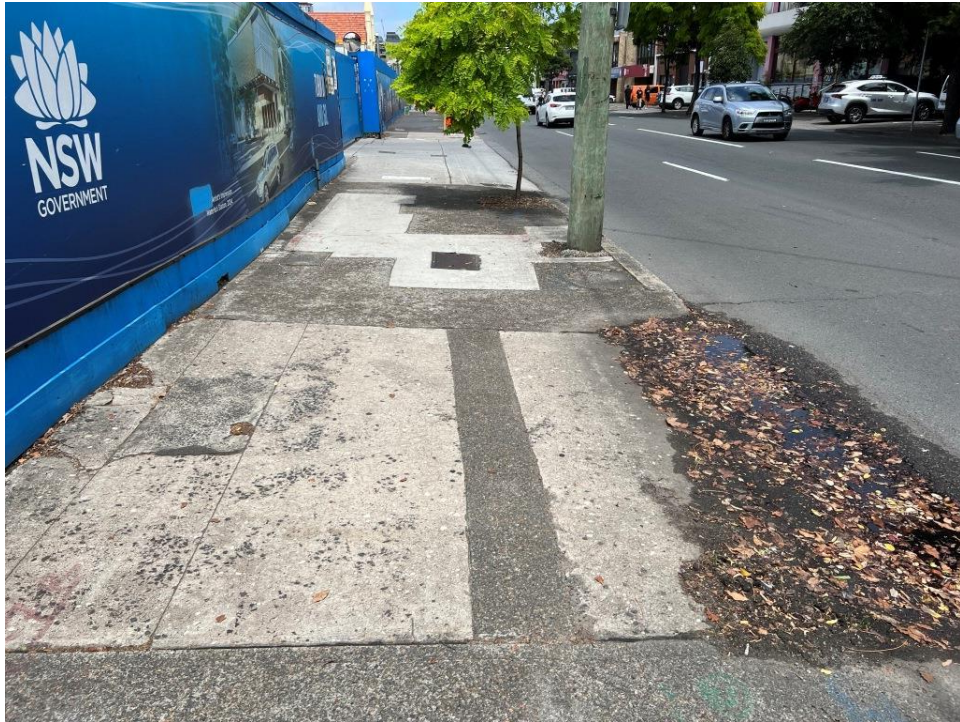
PHOTO 207
(Overview of former driveway – Botany Road)

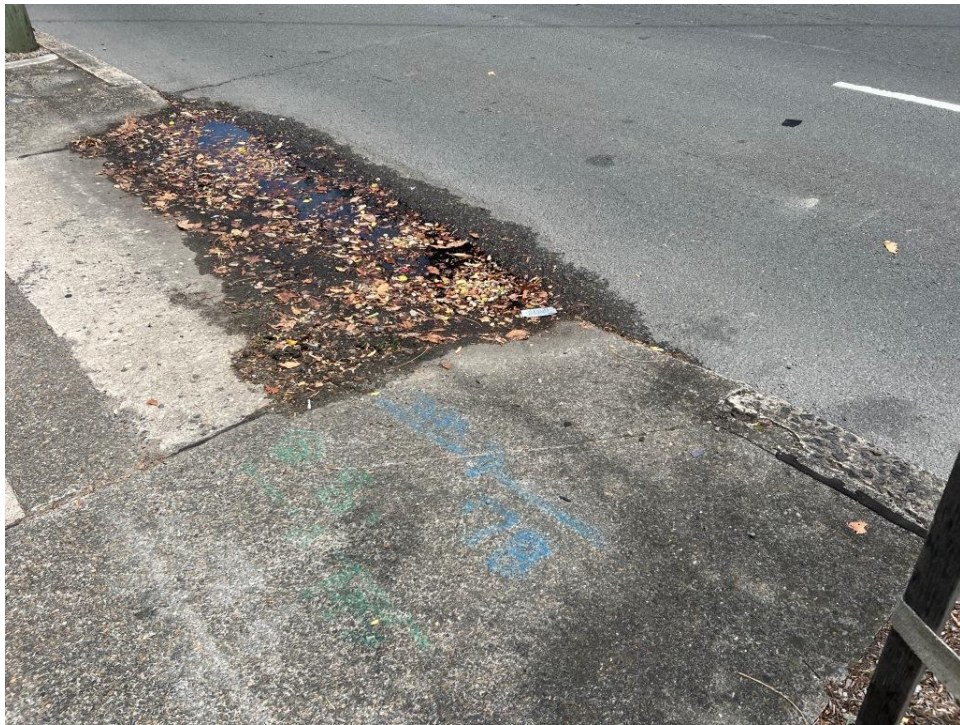
PHOTO 208
(Overview of former driveway – Botany Road)
