DILAPIDATION REPORT

Council Assets/Public Infrastructure

**WATERLOO STATION
COPE STREET**

DEMLAKIAN CONSULTING ENGINEERS

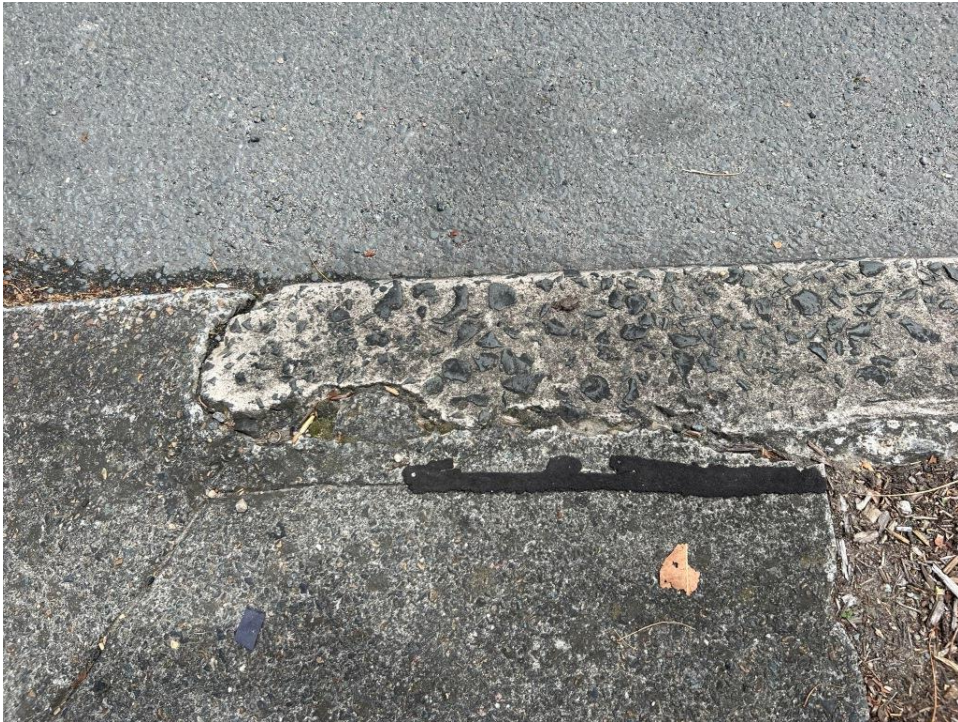
PHOTO 209

(Photo showing crack in kerb adjacent former driveway – Botany Road)

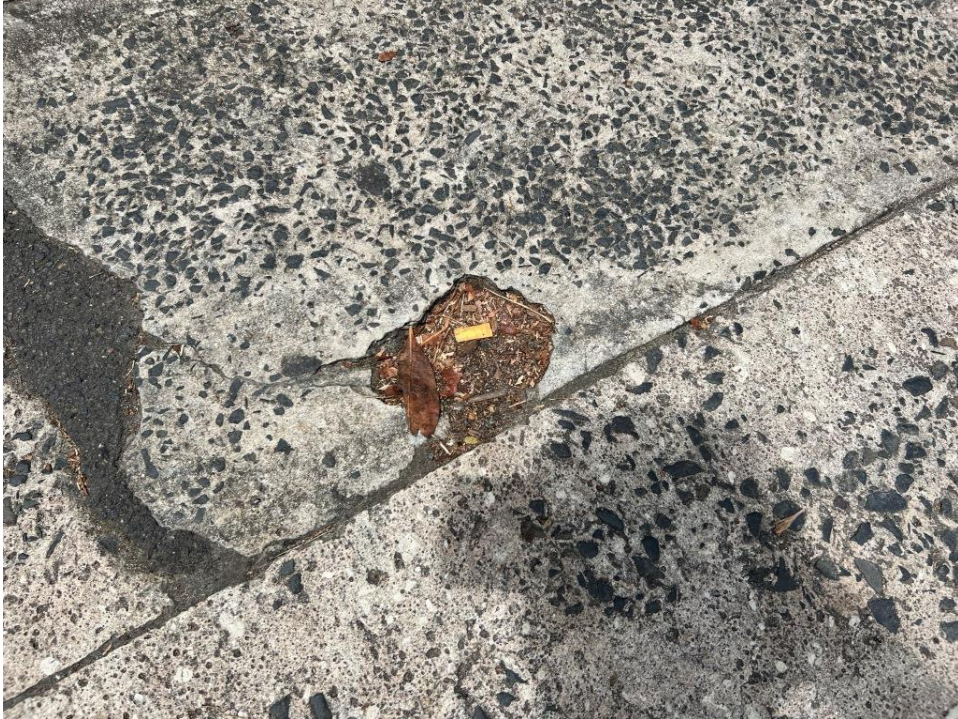
PHOTO 211

(Photo showing crack/missing concrete in former driveway – Botany Road)

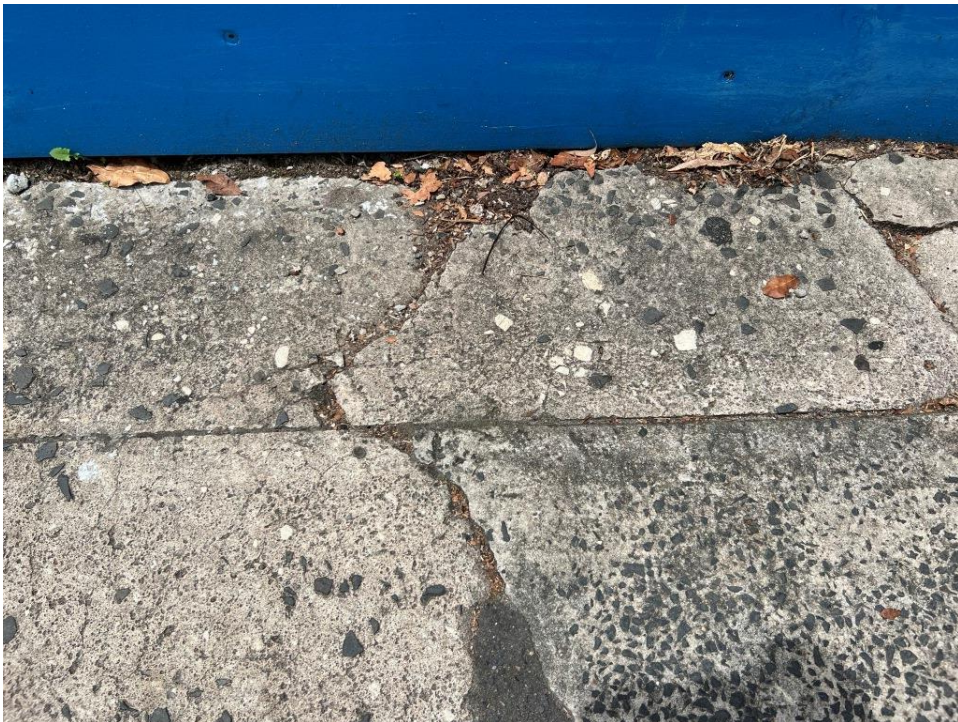
PHOTO 212

(Photo showing crack/missing concrete in former driveway – Botany Road)

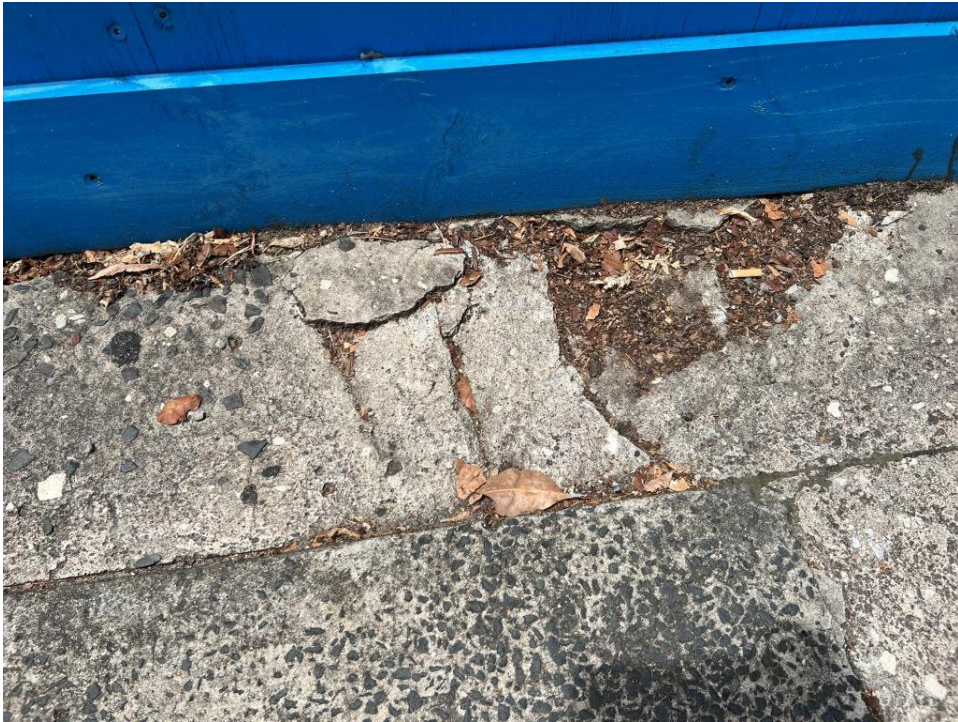
PHOTO 213

(Photo showing crack/missing concrete in former driveway – Botany Road)

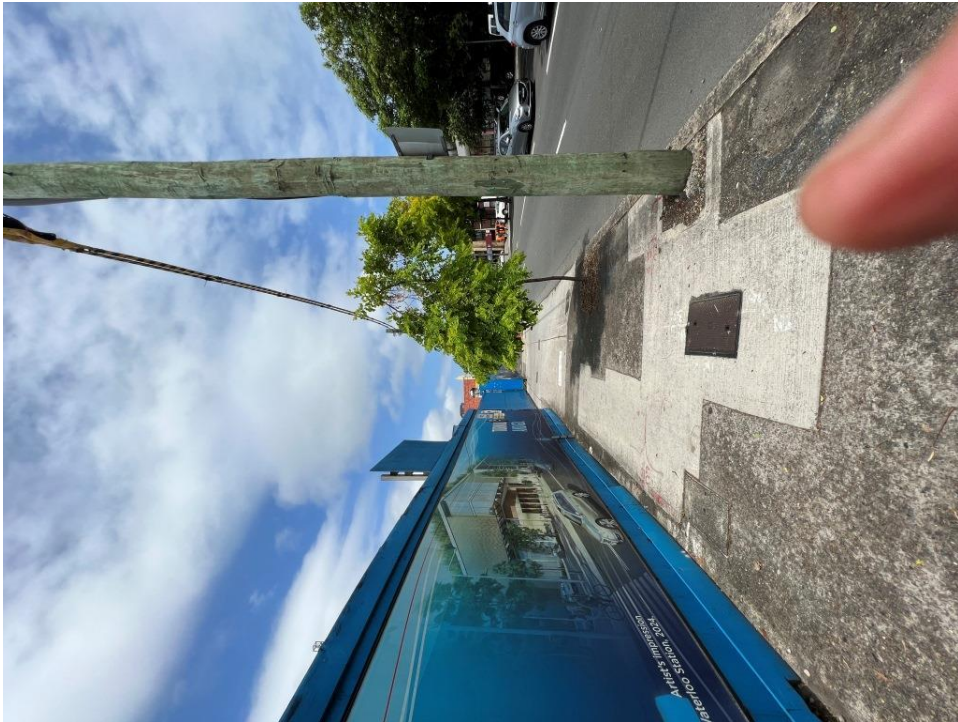
PHOTO 215

(Overview of footpath and electricity pole – Botany Road)

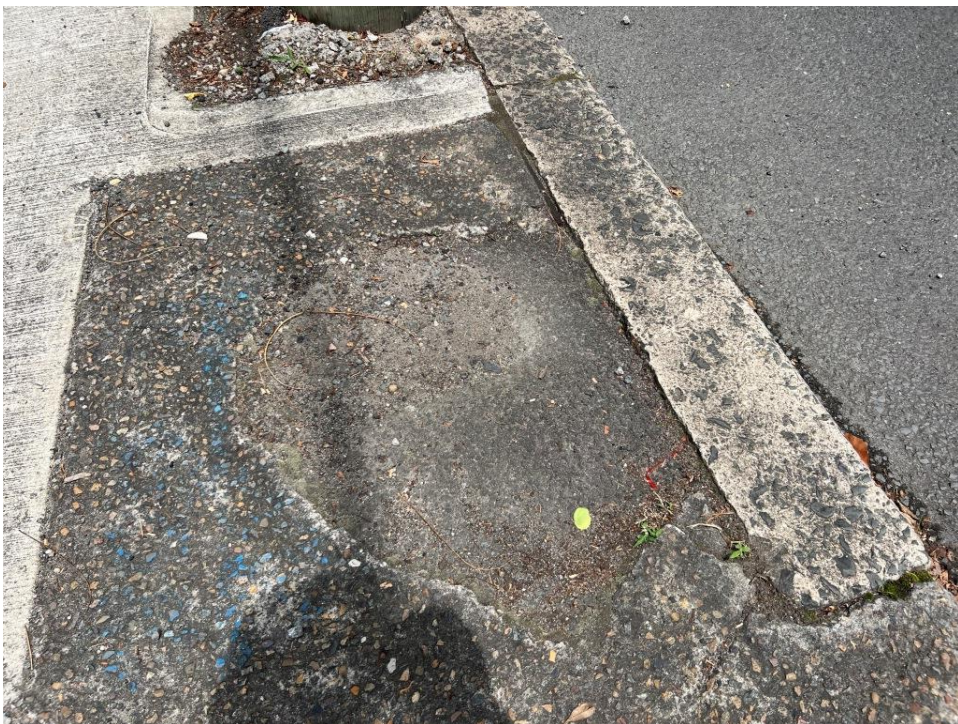
PHOTO 216

(Photo showing uneven footpath – Botany Road)

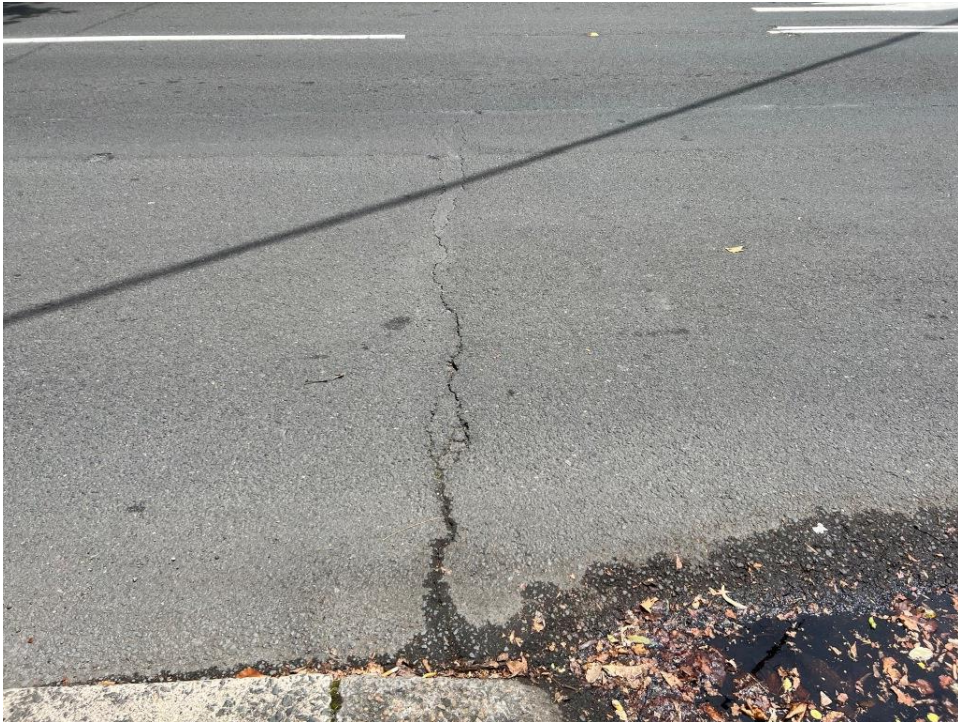
PHOTO 217

(Photo showing cracks in asphalt – Botany Road)

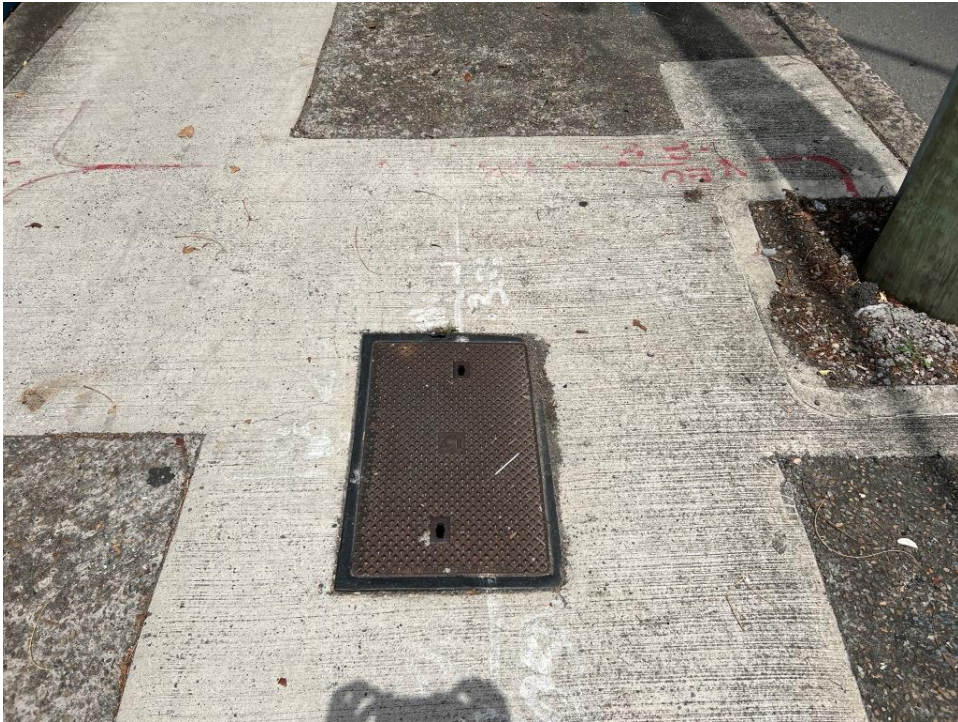
PHOTO 219

(Photo showing condition of footpath adjacent to electricity pole – Botany Road)

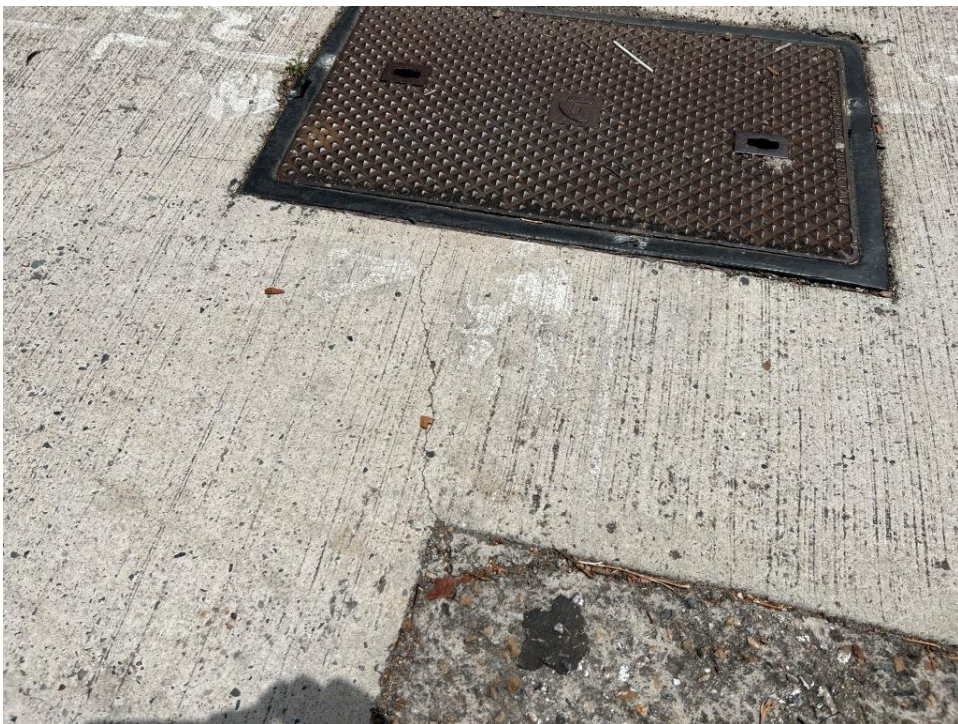
PHOTO 220

(Photo showing crack in footpath – Botany Road)

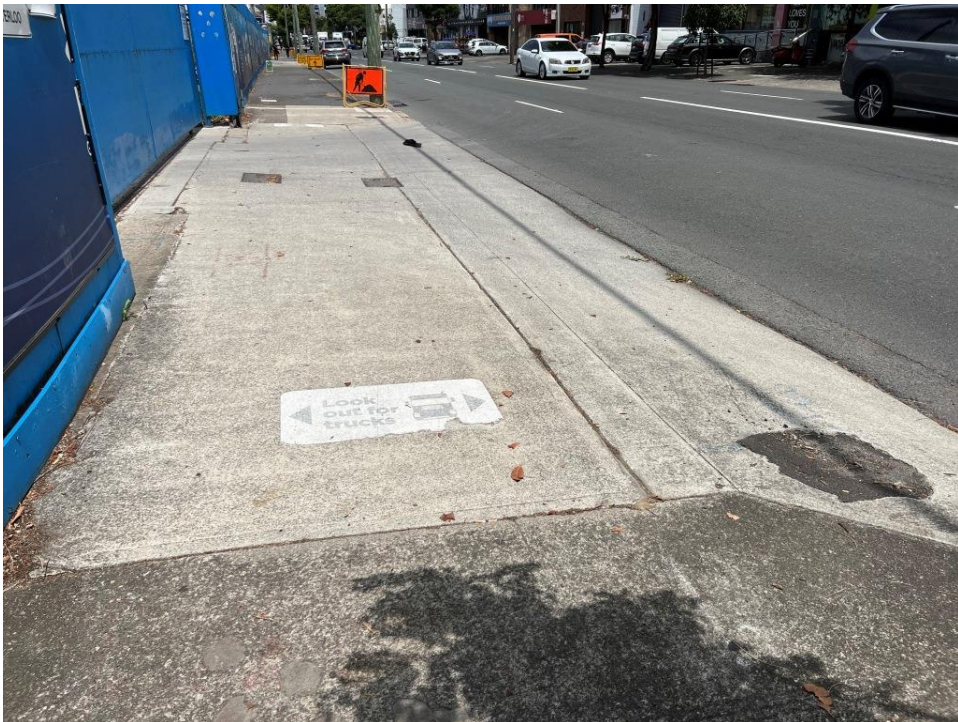
PHOTO 224
(Overview of truck driveway – Botany Road)

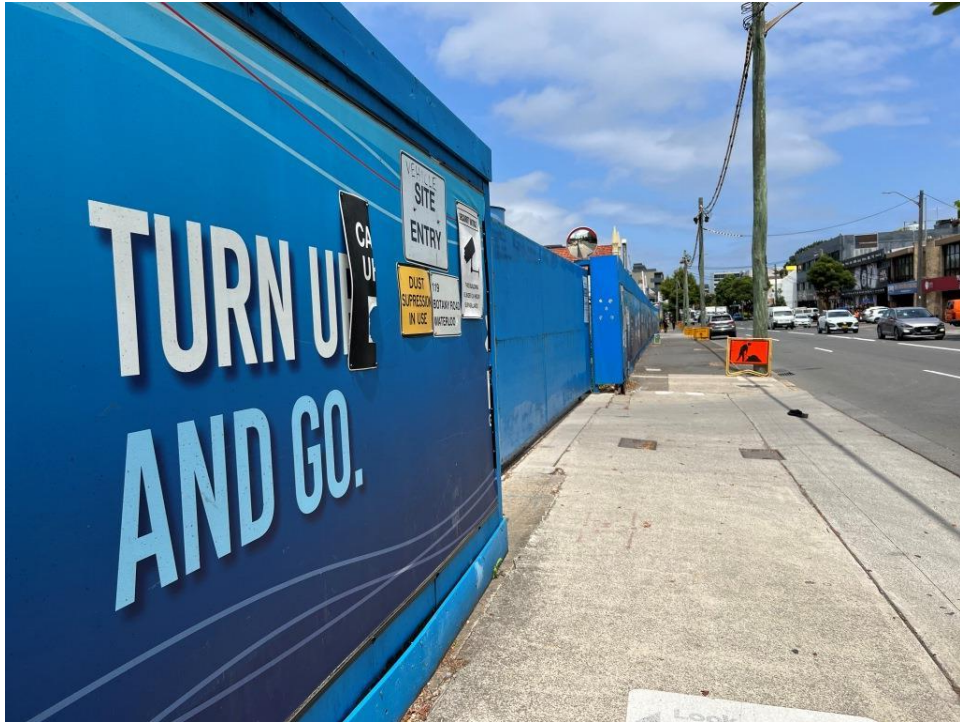
PHOTO 225
(Overview of truck driveway – Botany Road)

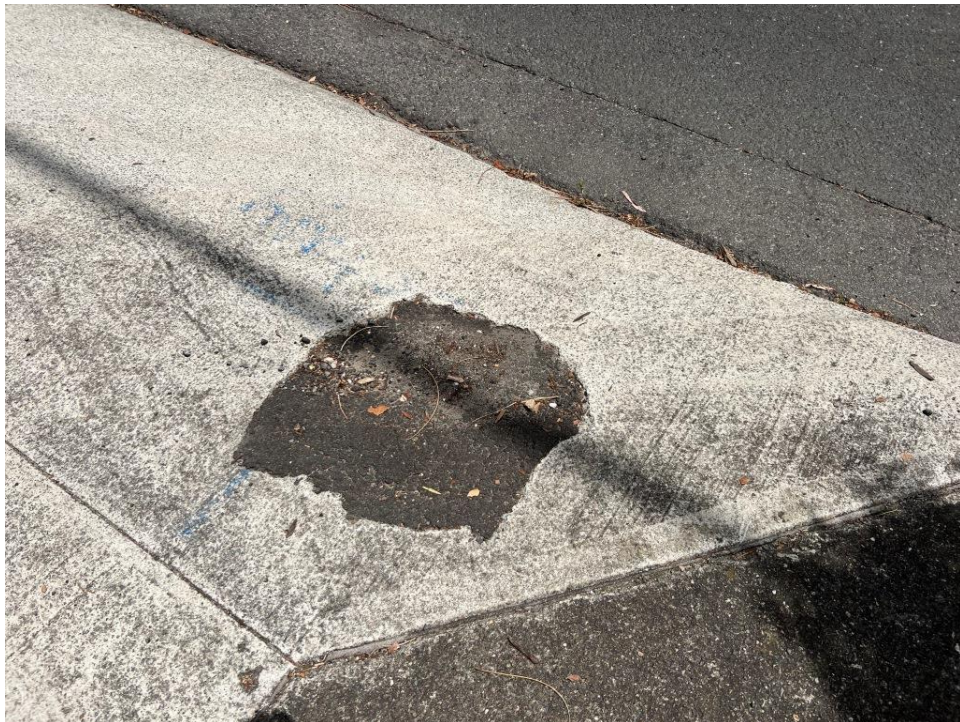
PHOTO 226
(Photo showing uneven surface in truck driveway – Botany Road)

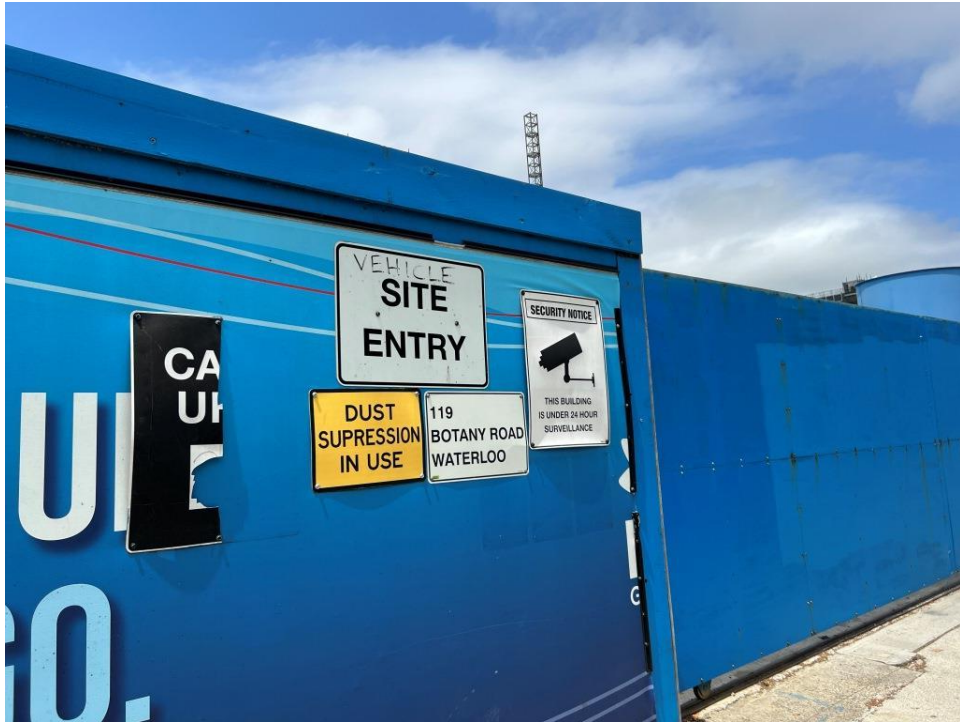
PHOTO 227

(Photo included for location reference only)

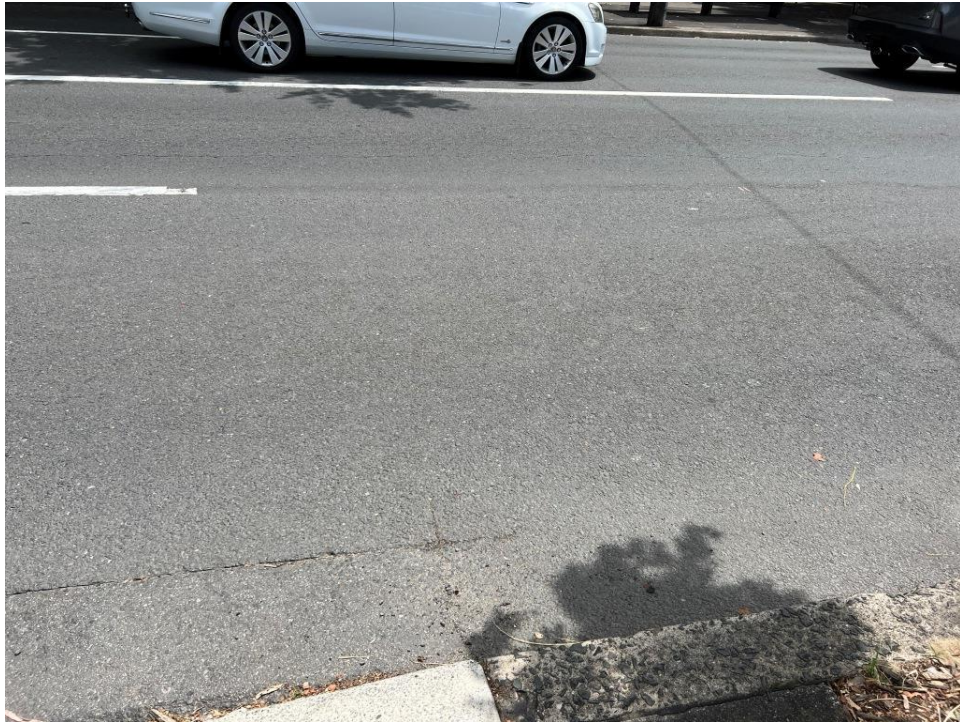
PHOTO 229

(Overview of roadway in front of truck driveway – Botany Road)

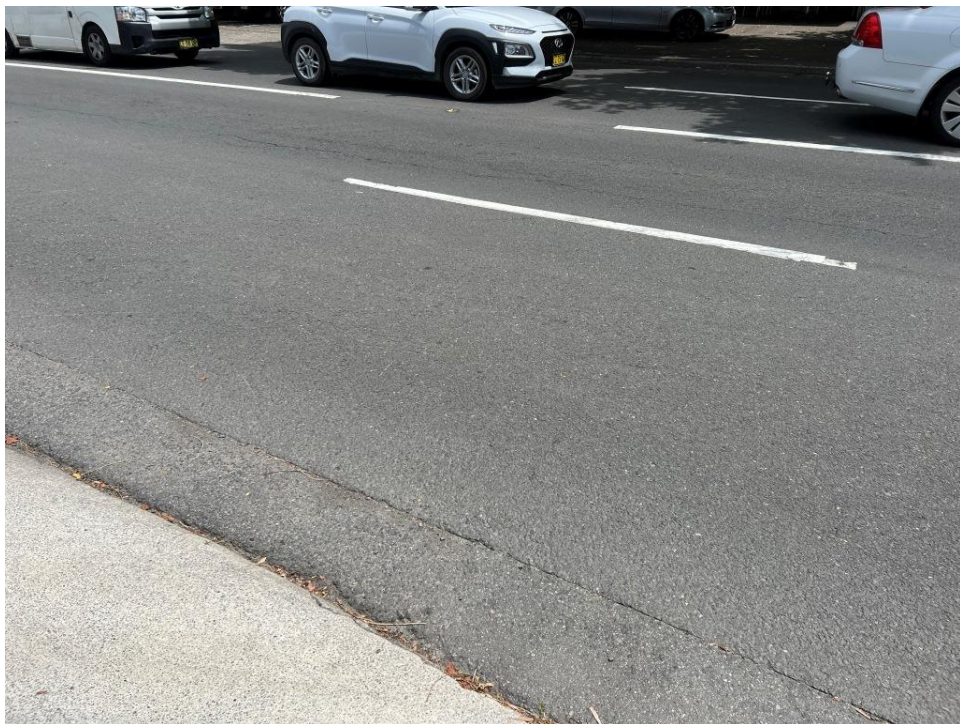
PHOTO 230

(Overview of roadway in front of truck driveway – Botany Road)

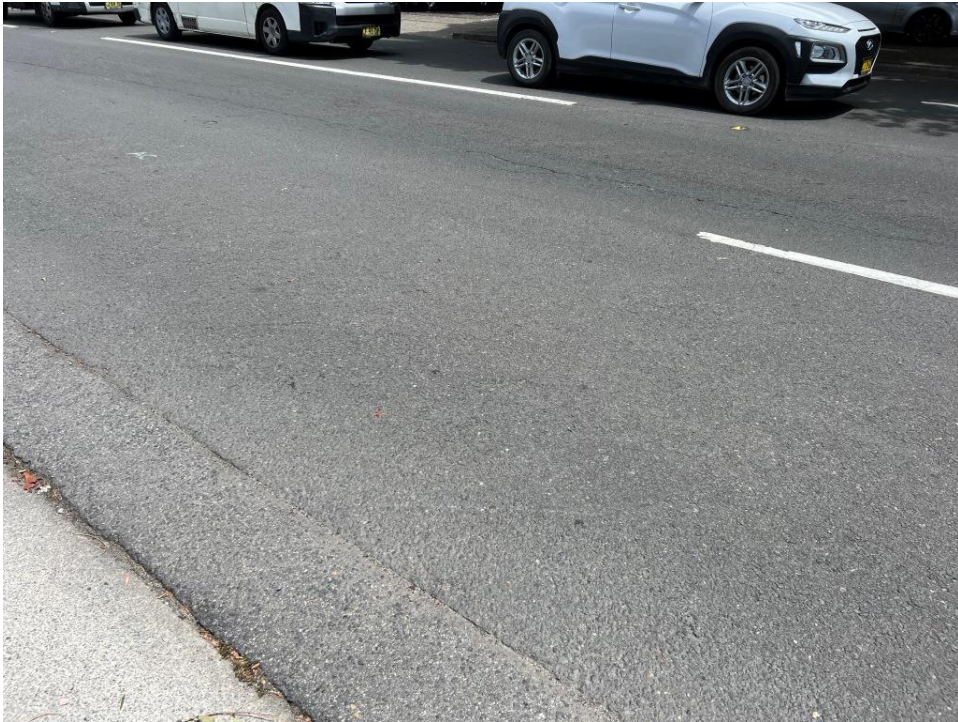
PHOTO 231

(Overview of roadway in front of truck driveway – Botany Road)

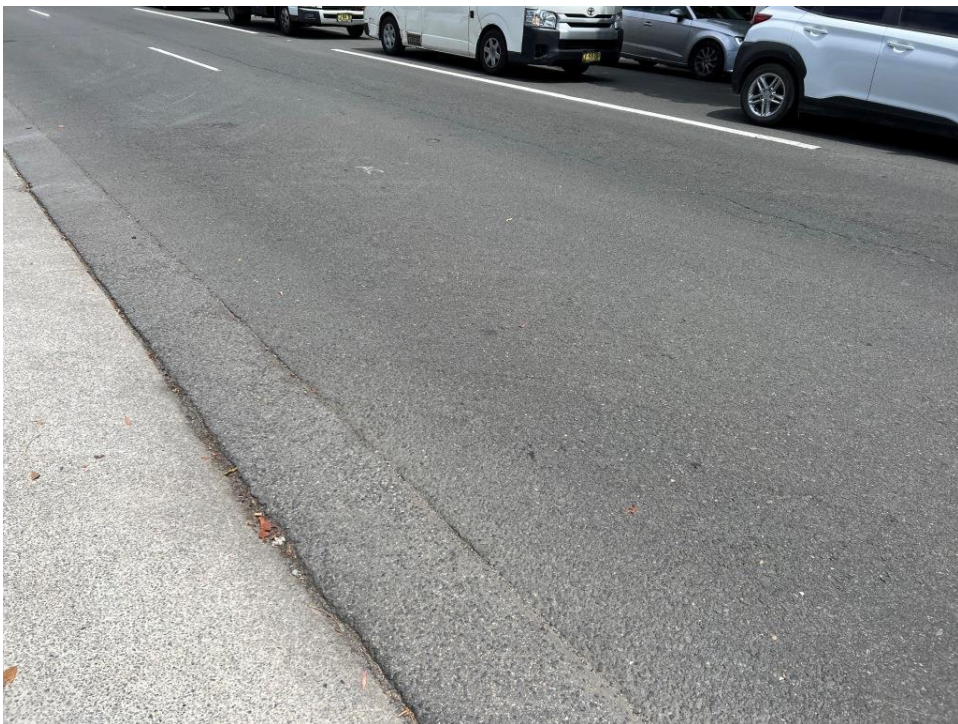
PHOTO 232

(Overview of roadway in front of truck driveway – Botany Road)

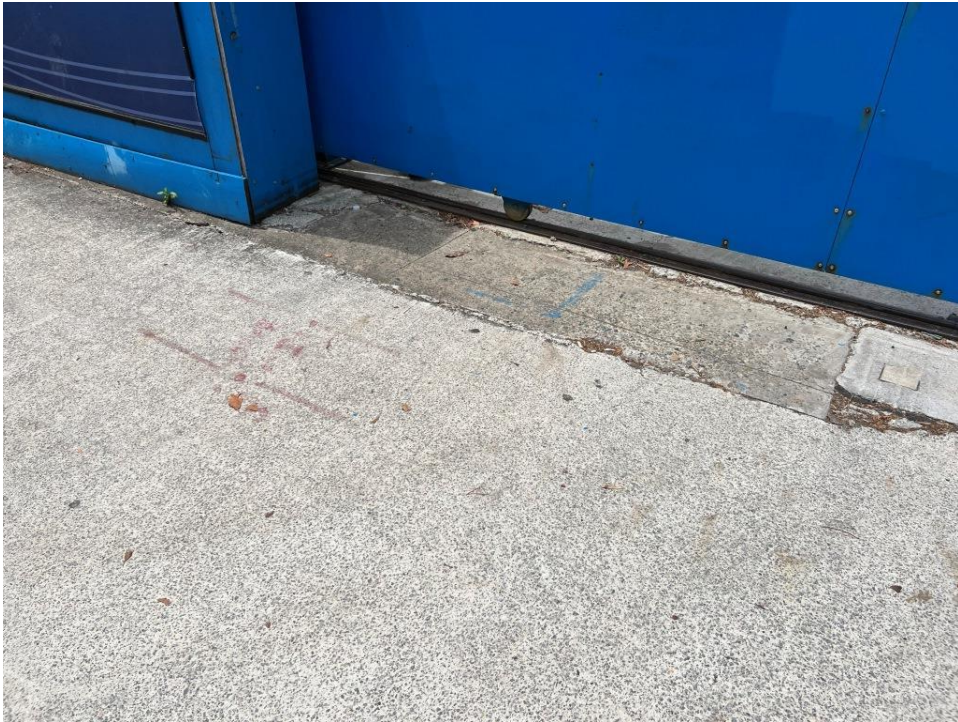
PHOTO 233

(Photo showing condition of truck driveway – Botany Road)

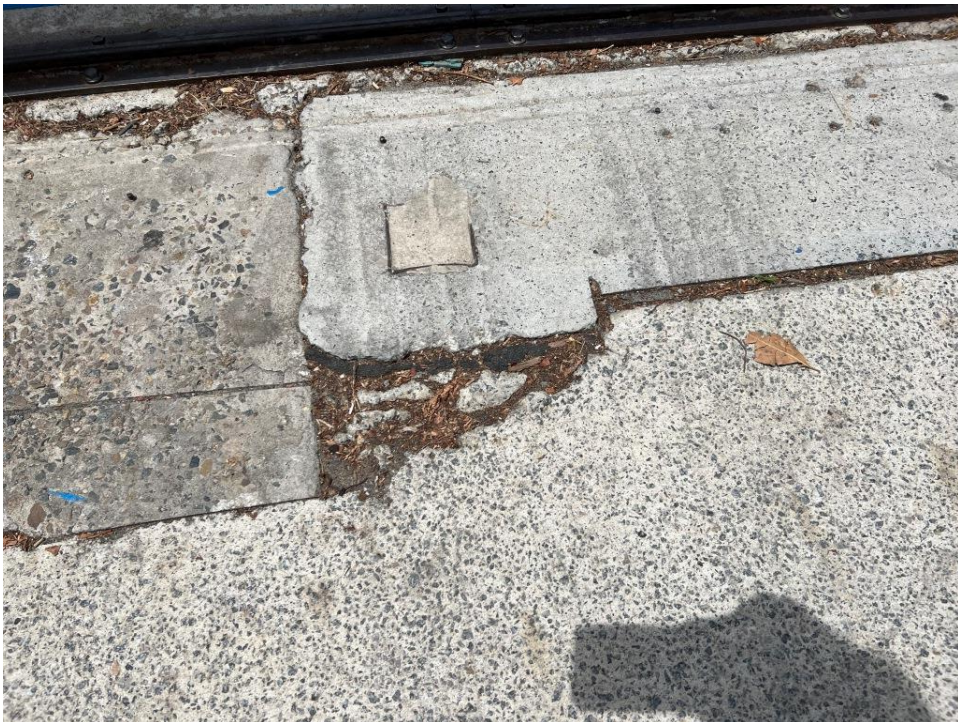
PHOTO 234

(Photo showing cracks and missing concrete in truck driveway – Botany Road)

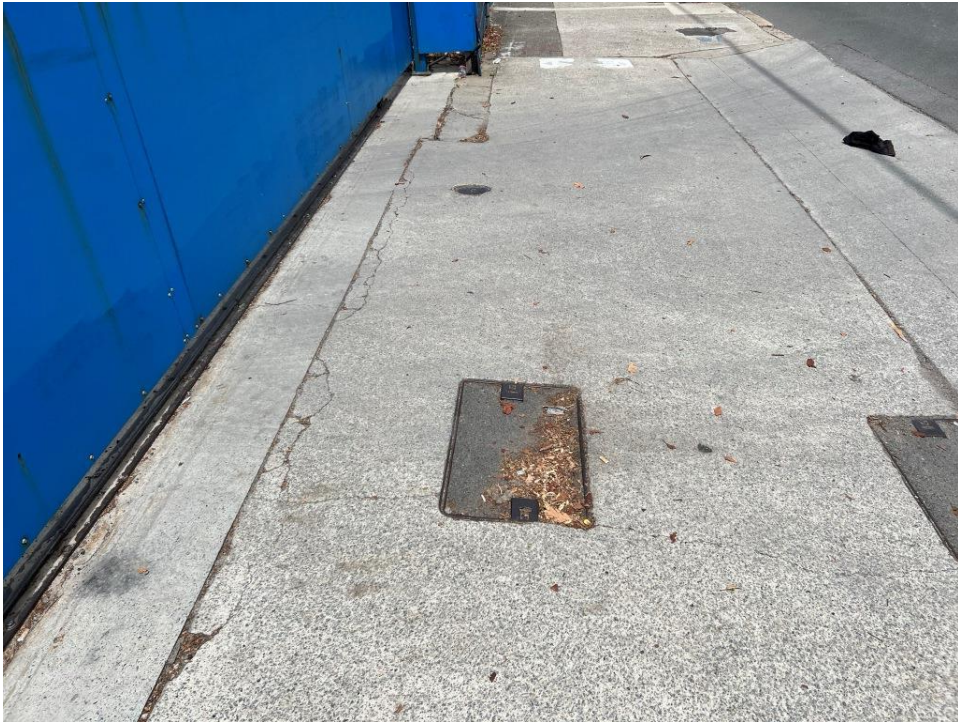
PHOTO 235

(Photo showing cracks in truck driveway – Botany Road)

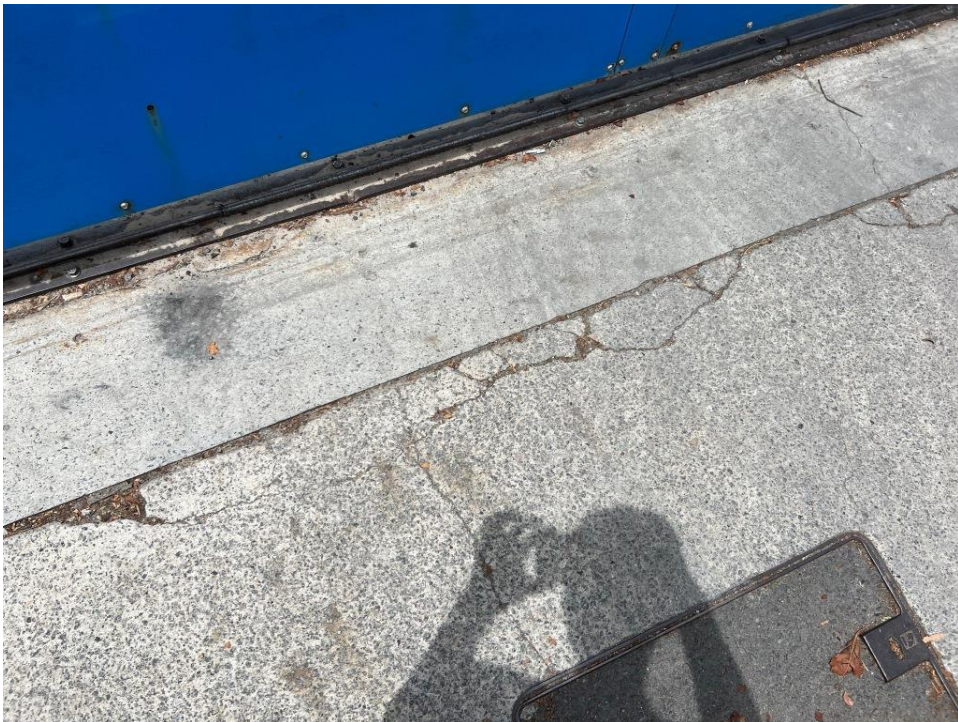
PHOTO 236

(Photo showing cracks in truck driveway – Botany Road)

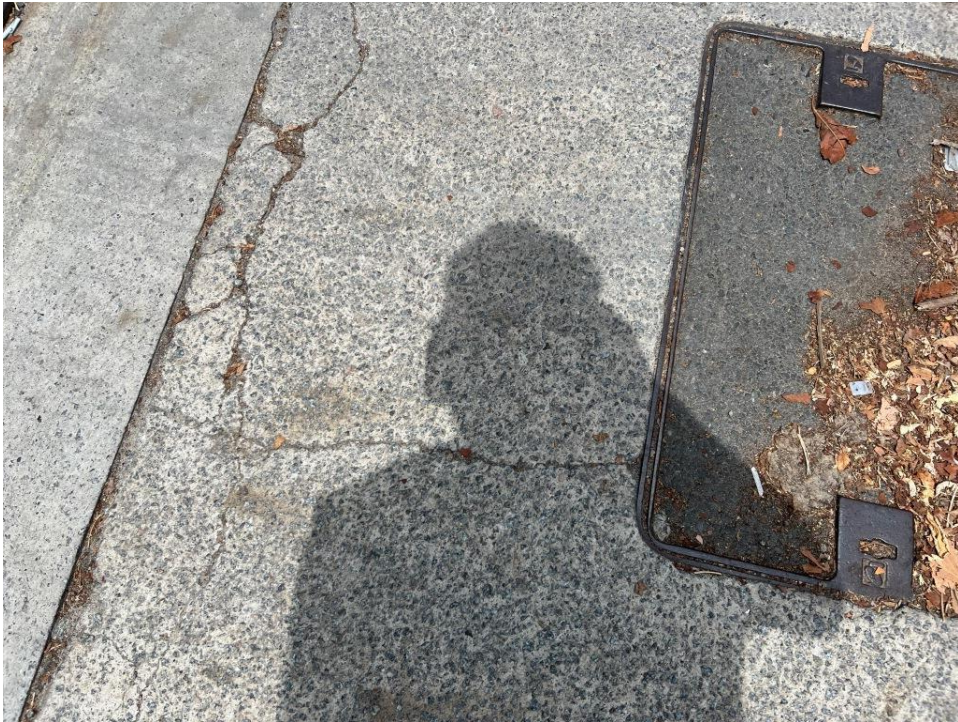
PHOTO 237

(Photo showing cracks in truck driveway – Botany Road)

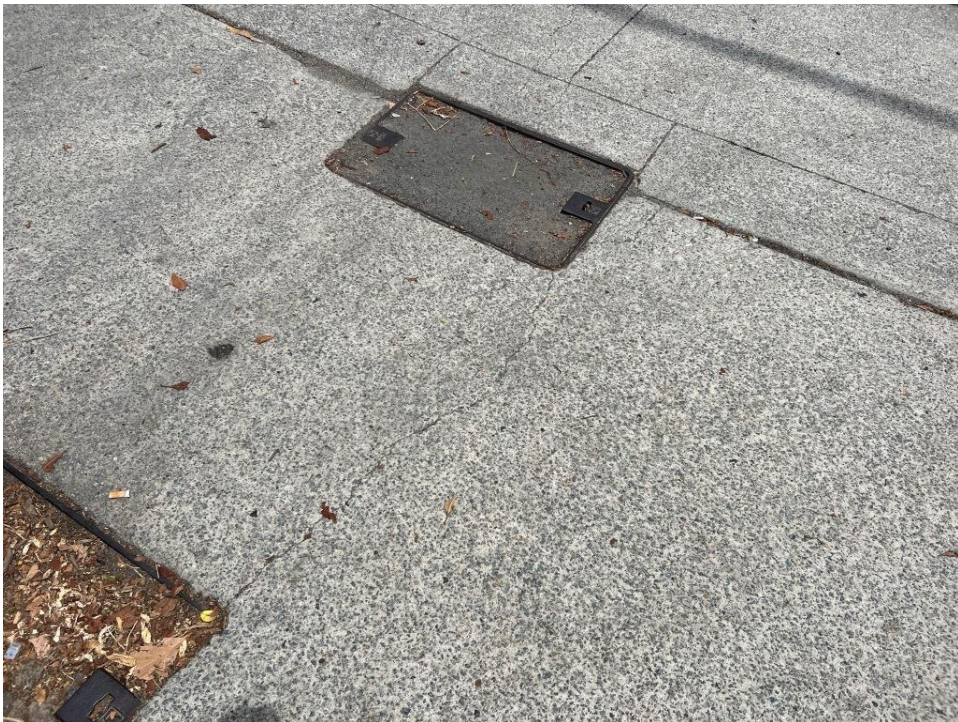
PHOTO 238

(Photo showing crack in truck driveway – Botany Road)

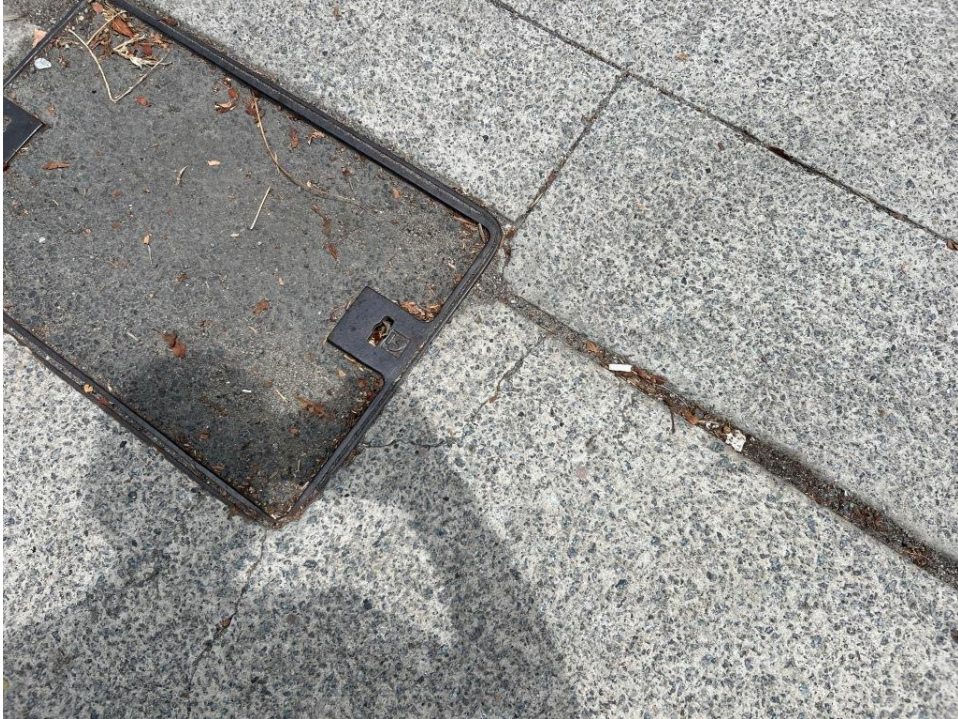
PHOTO 239

(Photo showing cracks in truck driveway – Botany Road)

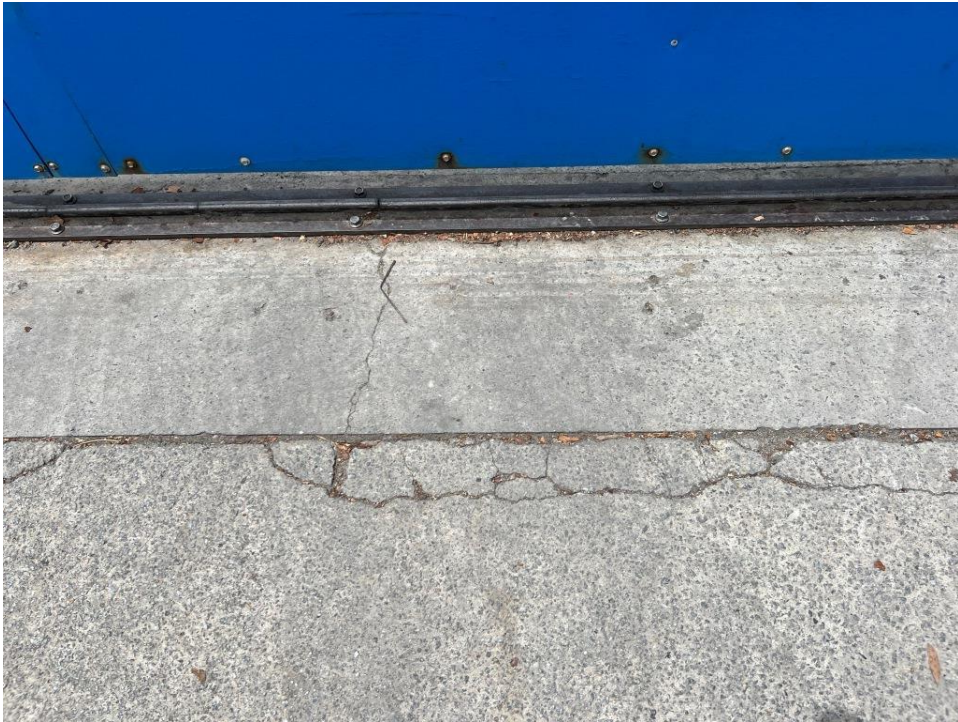
PHOTO 241

(Photo showing cracks in truck driveway – Botany Road)

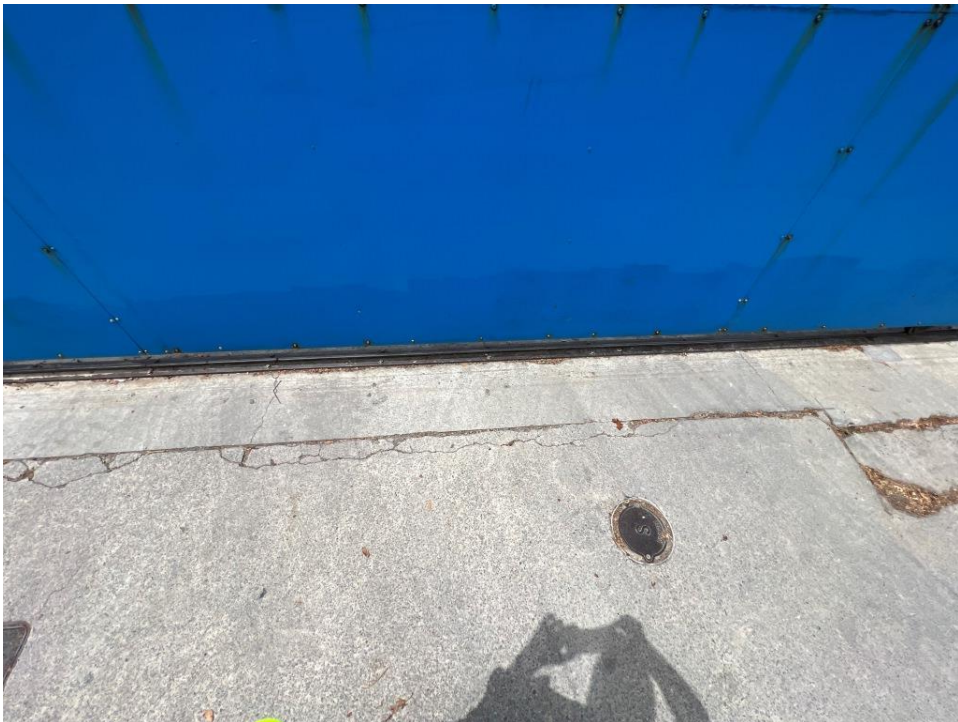
PHOTO 242

(Photo showing cracks in truck driveway – Botany Road)

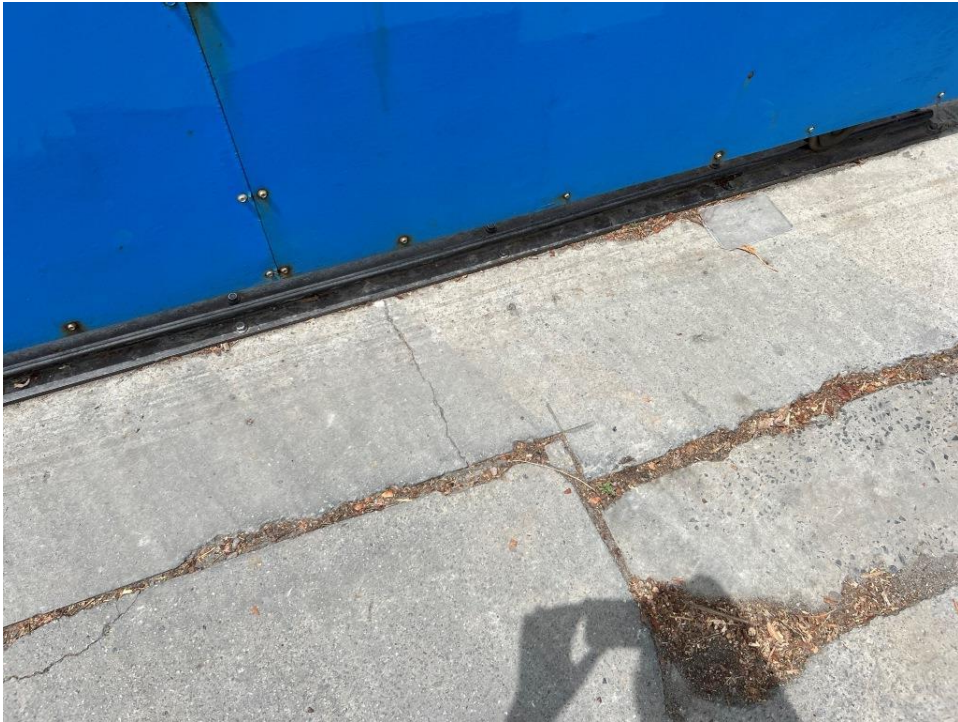
PHOTO 243

(Photo showing cracks and missing concrete in truck driveway – Botany Road)

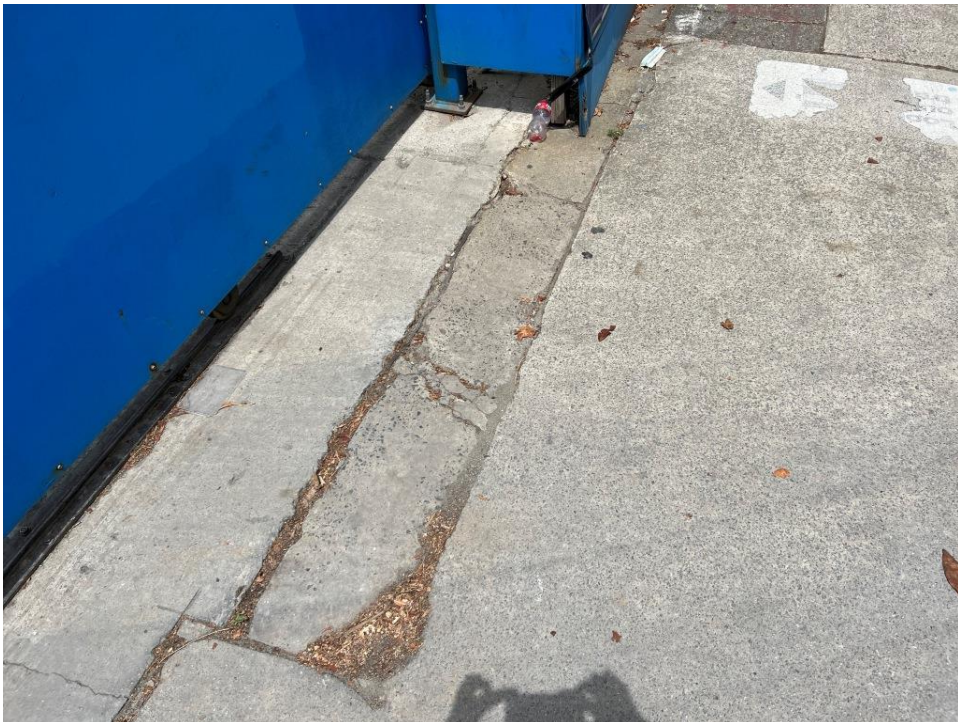
PHOTO 244

(Photo showing cracks and missing concrete in truck driveway – Botany Road)

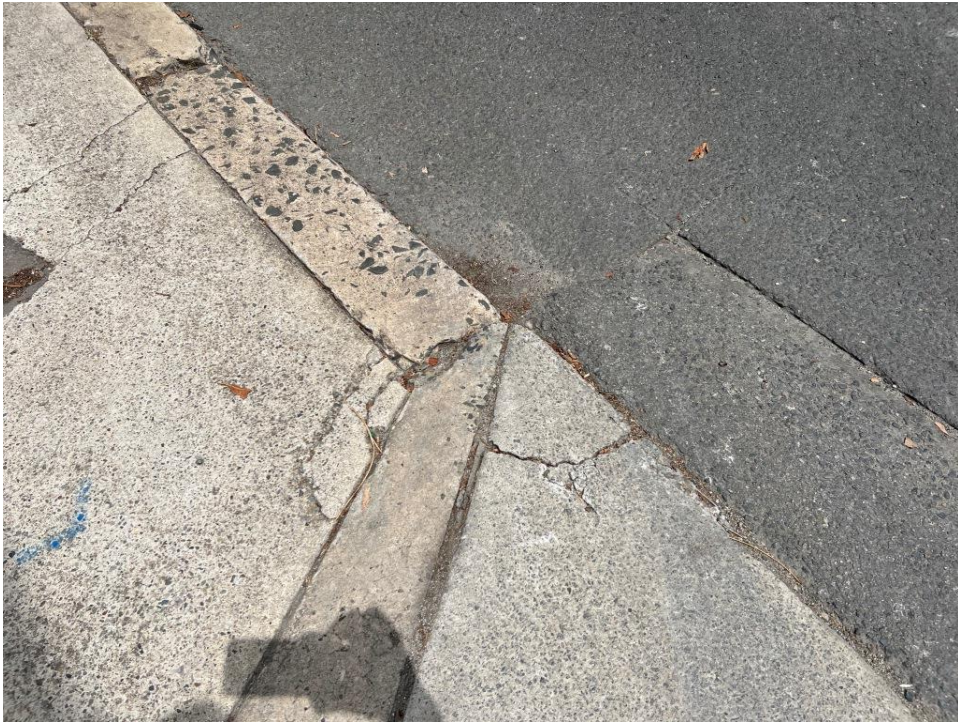
PHOTO 247

(Photo showing cracks adjacent to truck driveway – Botany Road)

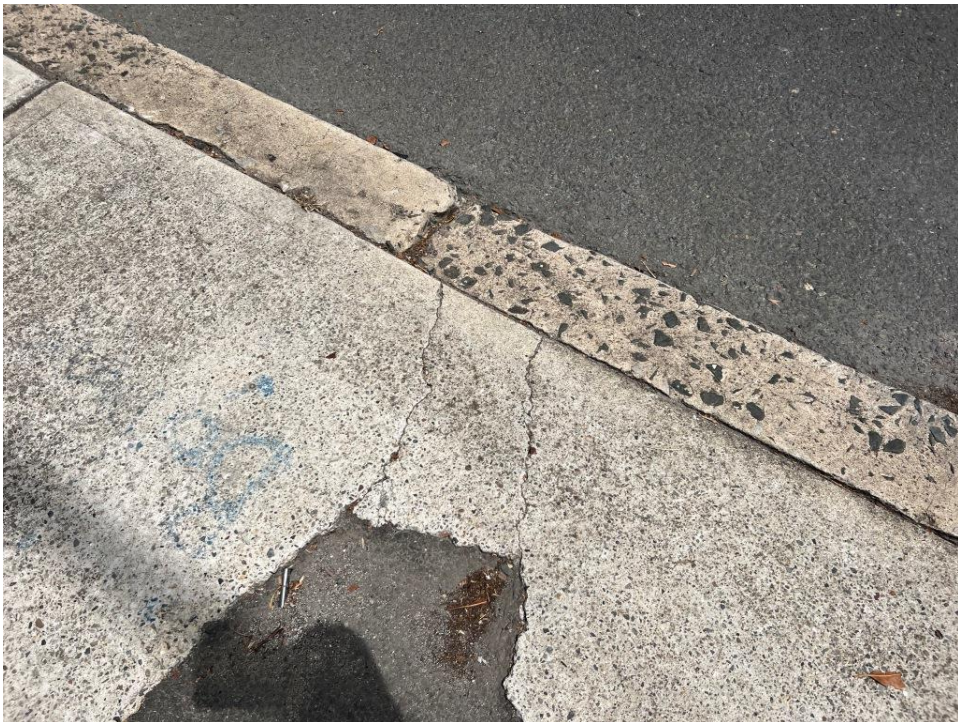
PHOTO 248

(Photo showing cracks adjacent to truck driveway – Botany Road)

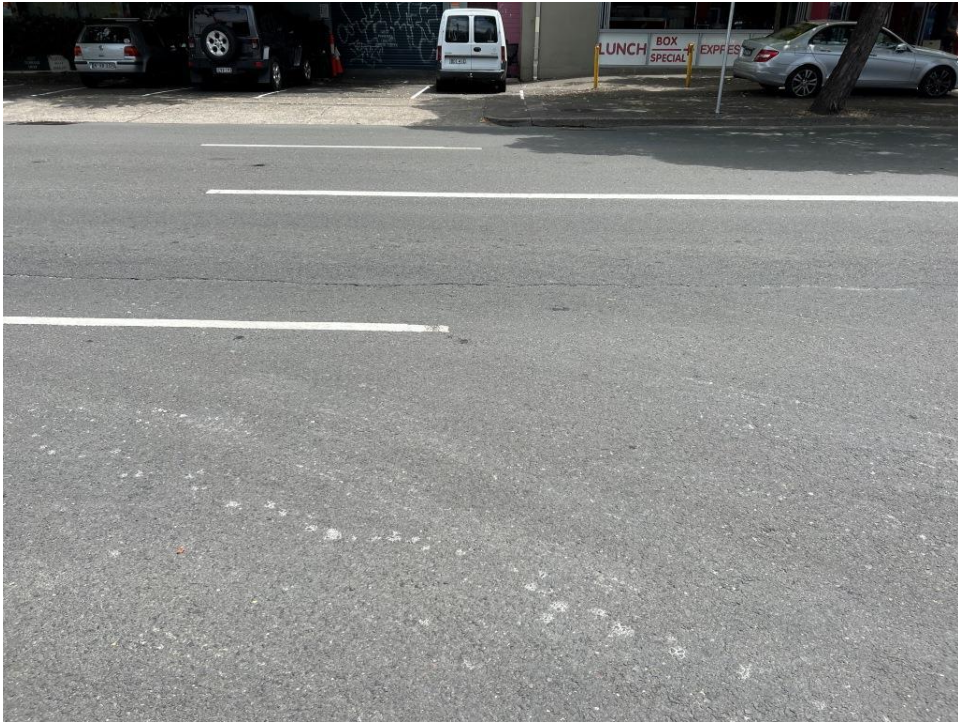
PHOTO 249

(Overview of roadway adjacent to truck driveway – Botany Road)

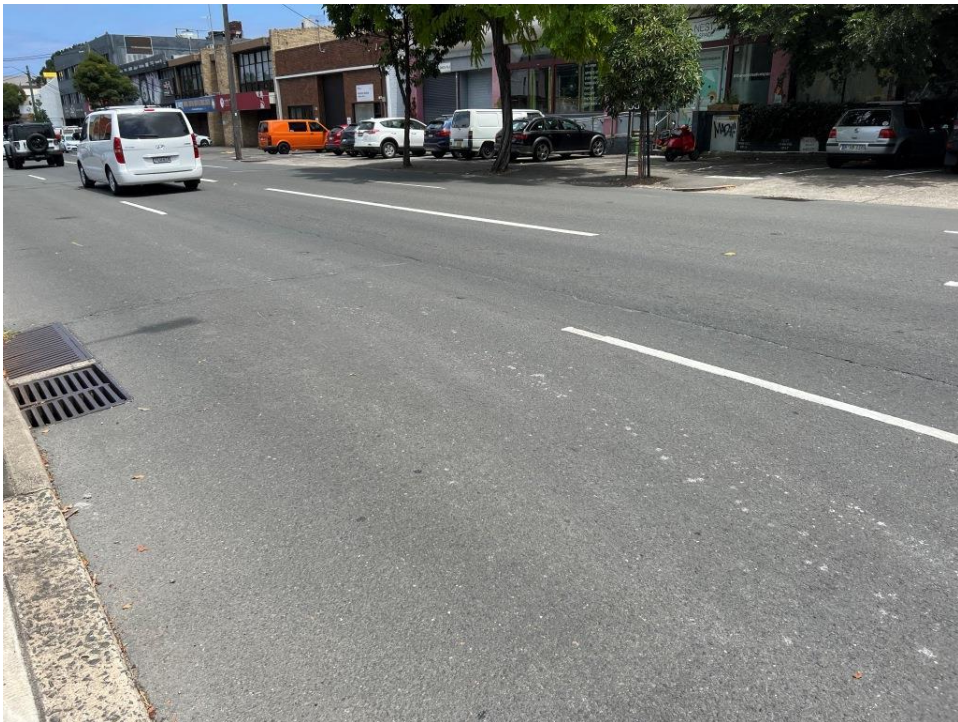
PHOTO 250

(Overview of roadway adjacent to truck driveway – Botany Road)
