DILAPIDATION REPORT

Council Assets/Public Infrastructure

**WATERLOO STATION
COPE STREET**

DEMLAKIAN CONSULTING ENGINEERS

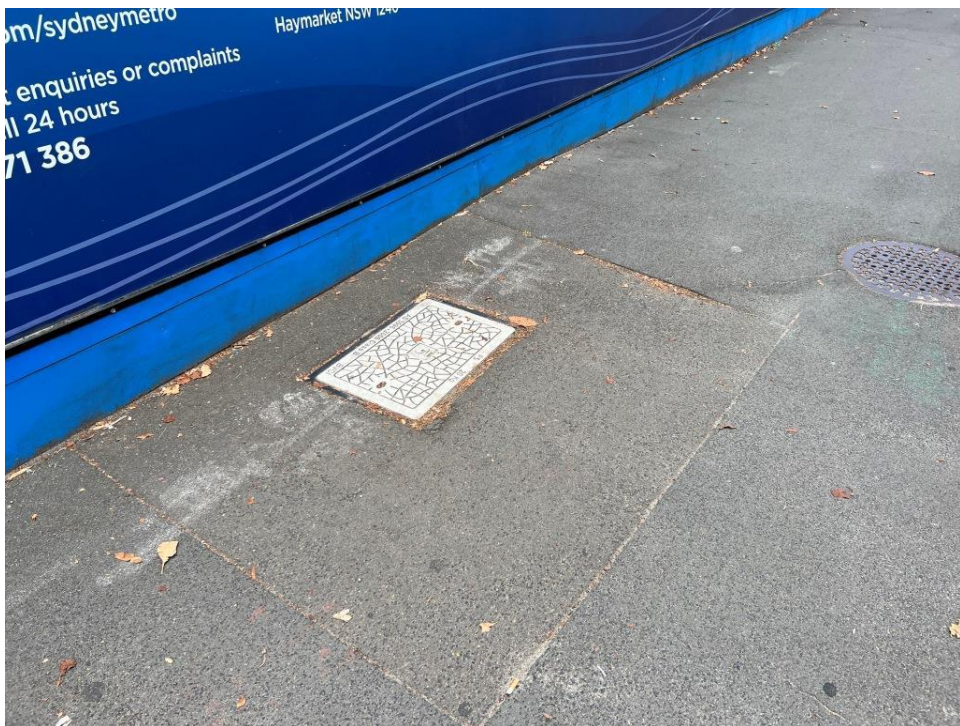
PHOTO 254

(Overview of footpath – Botany Road)

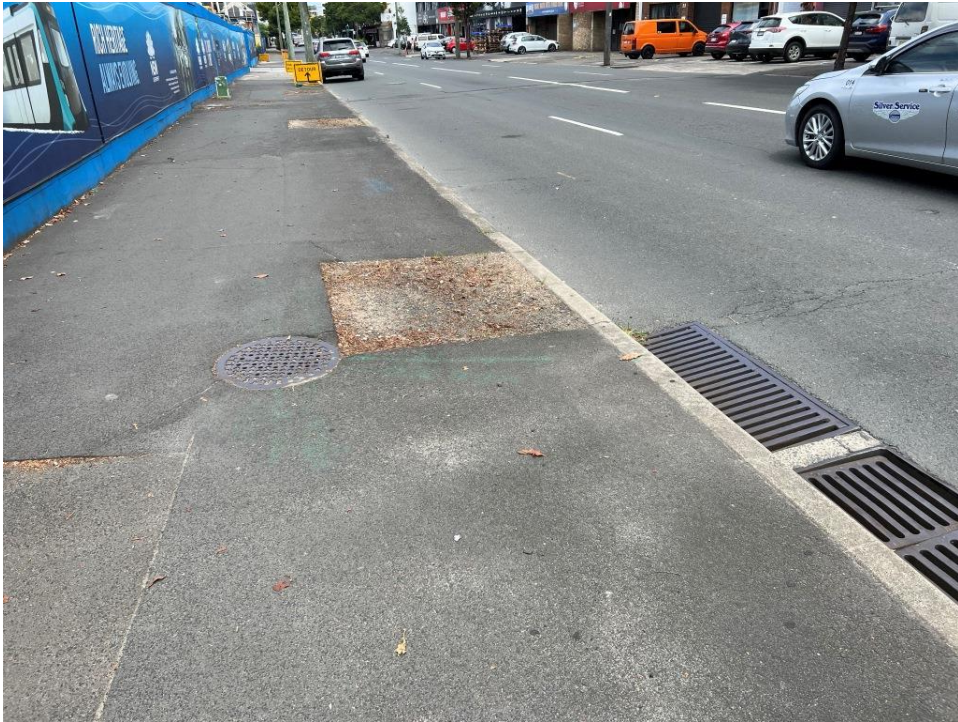
PHOTO 255

(Overview of footpath and roadway – Botany Road)

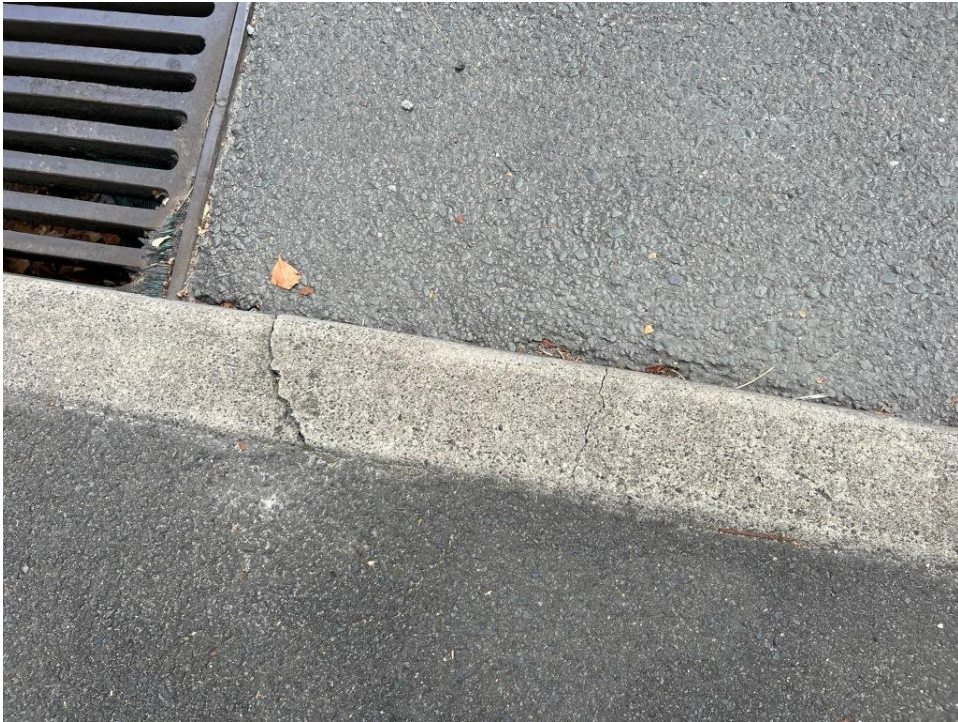
PHOTO 257

(Photo showing crack in kerb – Botany Road)

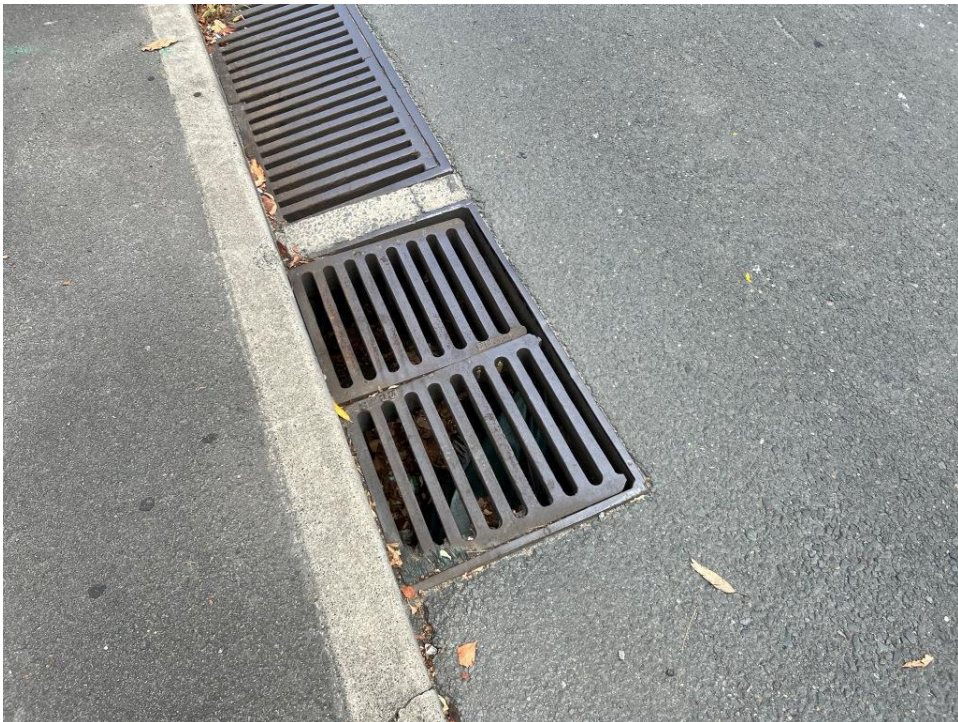
PHOTO 258

(Photo showing conditions of stormwater pits – Botany Road)

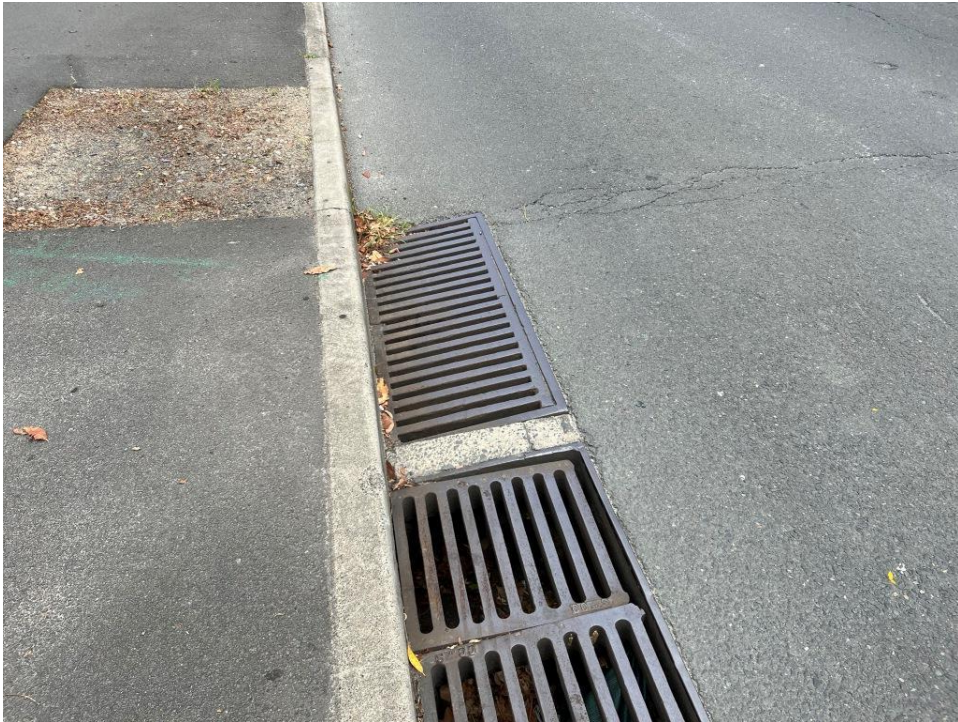
PHOTO 259

(Photo showing conditions of stormwater pits – Botany Road)

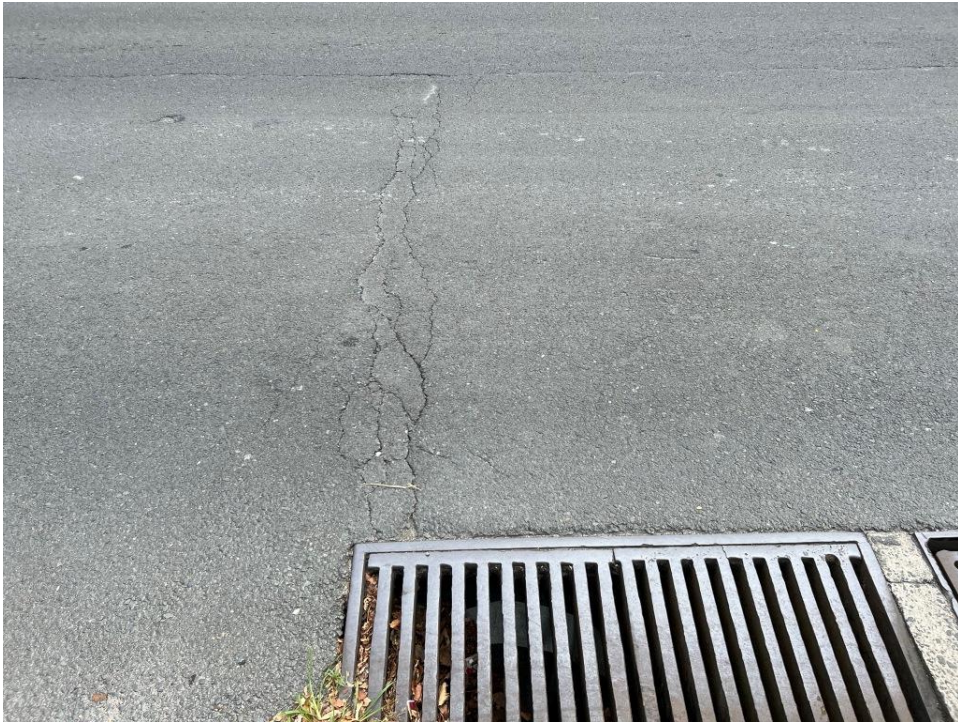
PHOTO 261

(Photo showing cracks in asphalt – Botany Road)

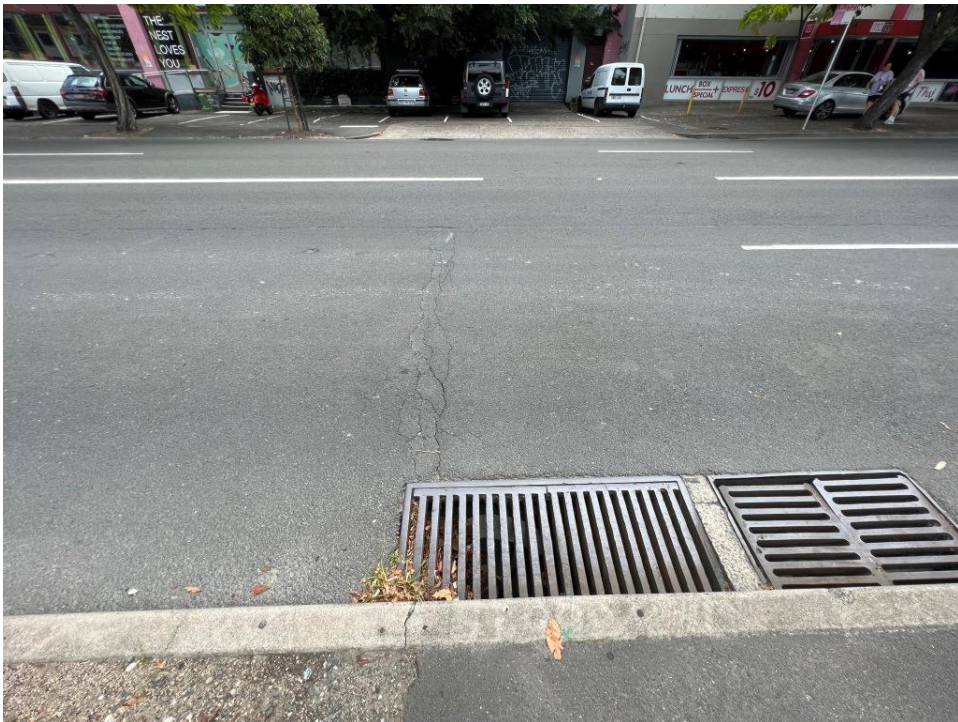
PHOTO 262

(Photo showing cracks in asphalt – Botany Road)

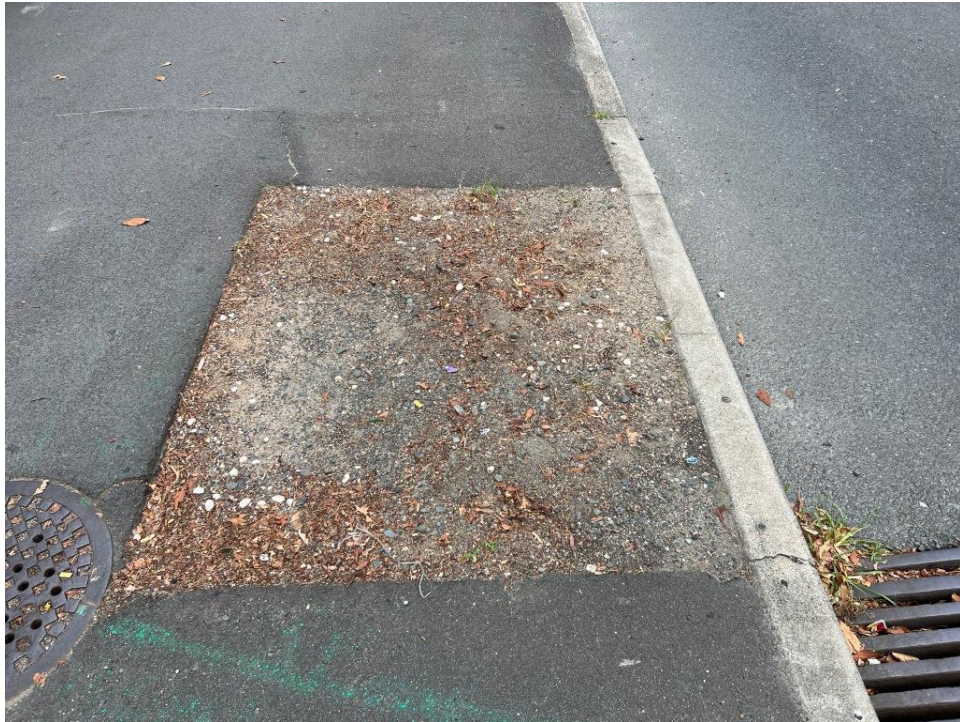
PHOTO 263

(Photo showing condition of tree former location – Botany Road)

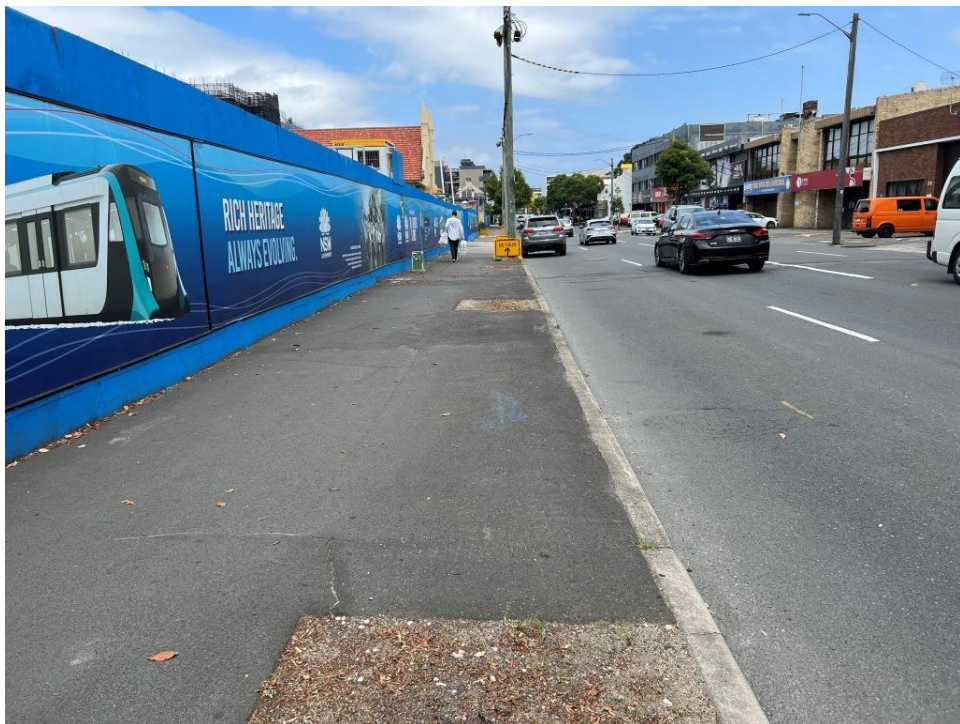
PHOTO 264

(Overview of footpath and roadway – Botany Road)

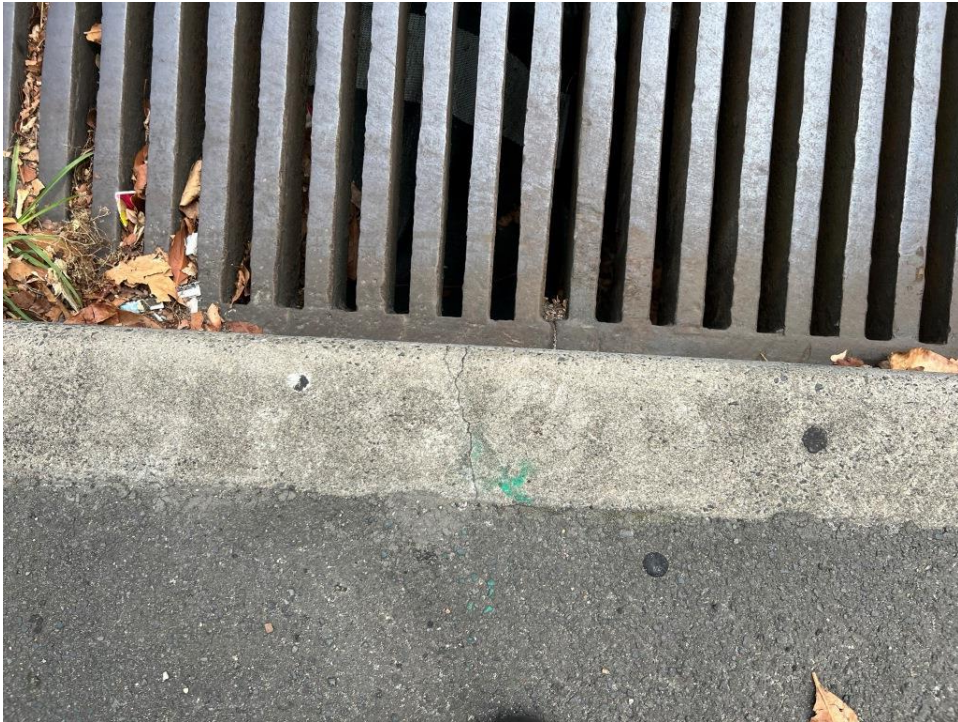
PHOTO 265

(Photo showing crack in kerb – Botany Road)

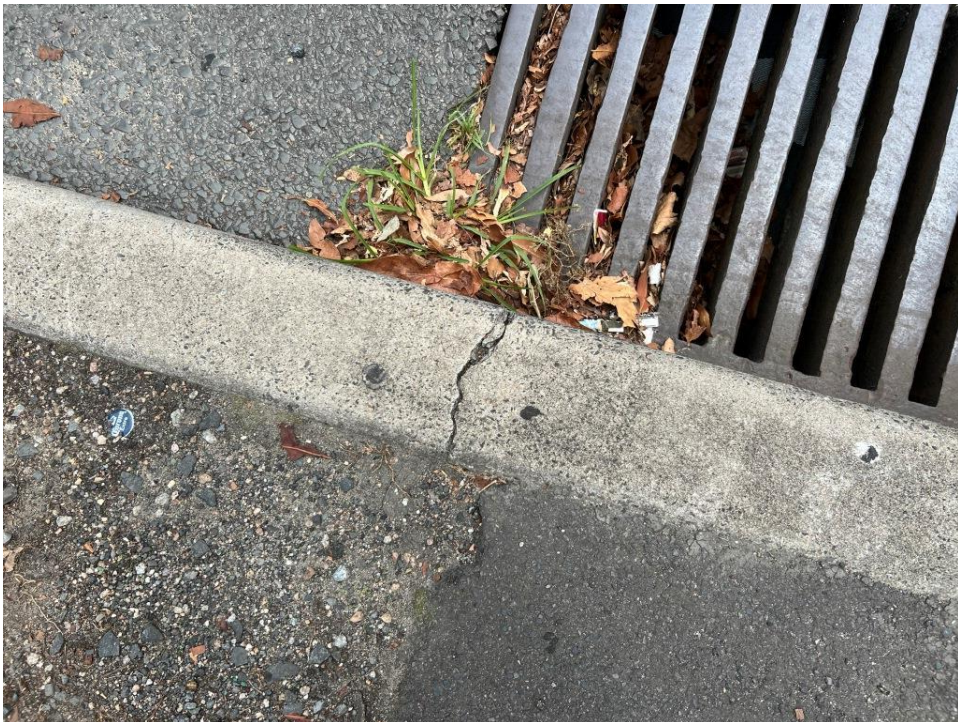
PHOTO 266

(Photo showing crack in kerb – Botany Road)

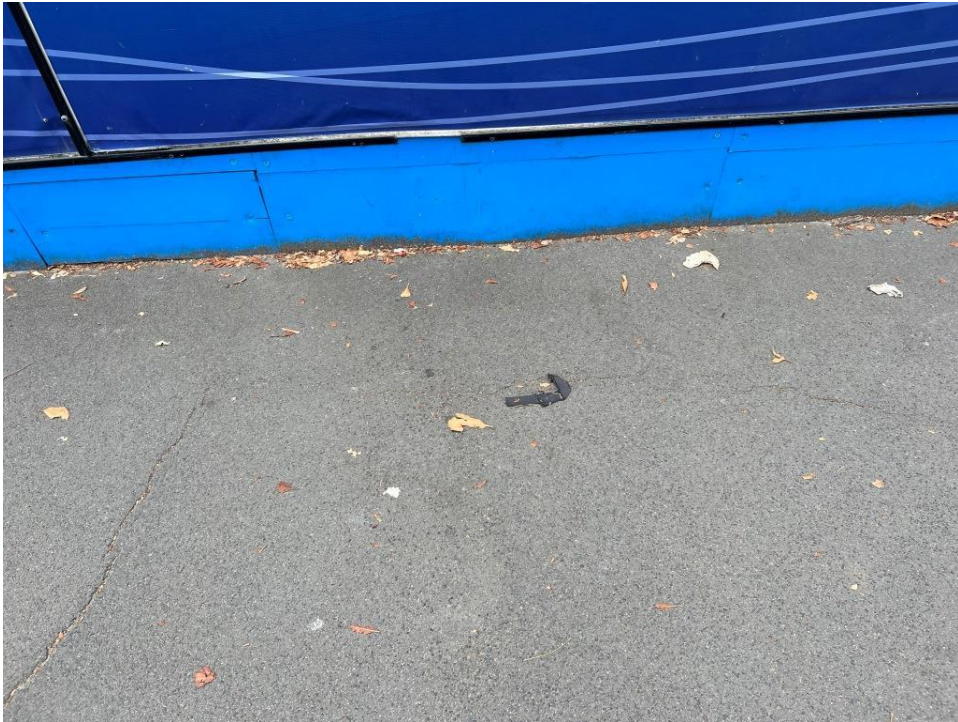
PHOTO 274
(Photo showing crack in footpath – Botany Road)

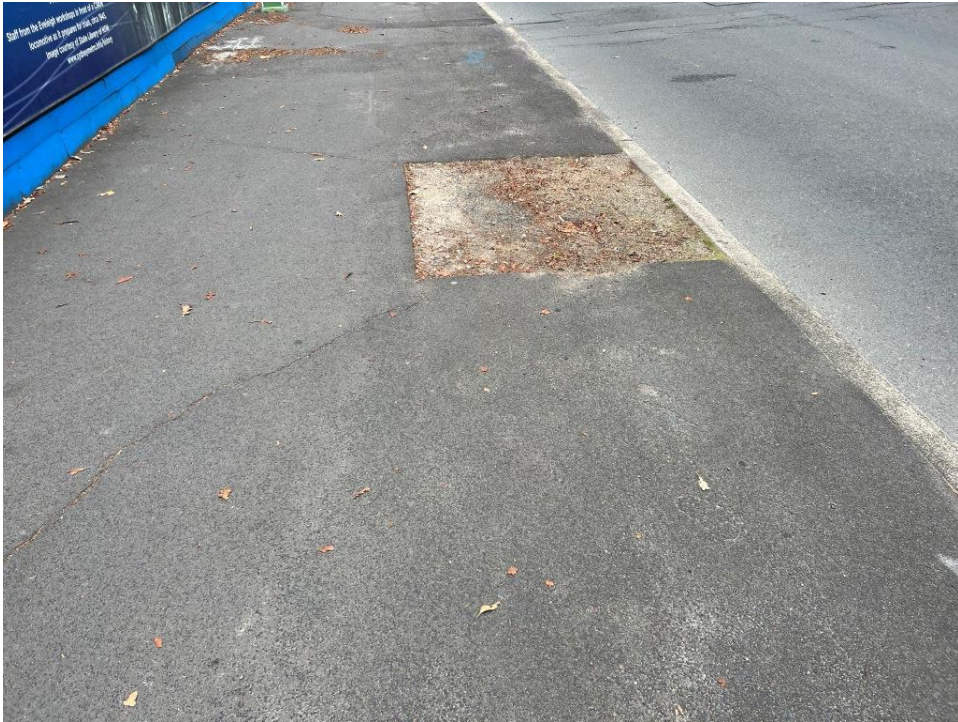
PHOTO 276

(Photo showing crack in footpath – Botany Road)

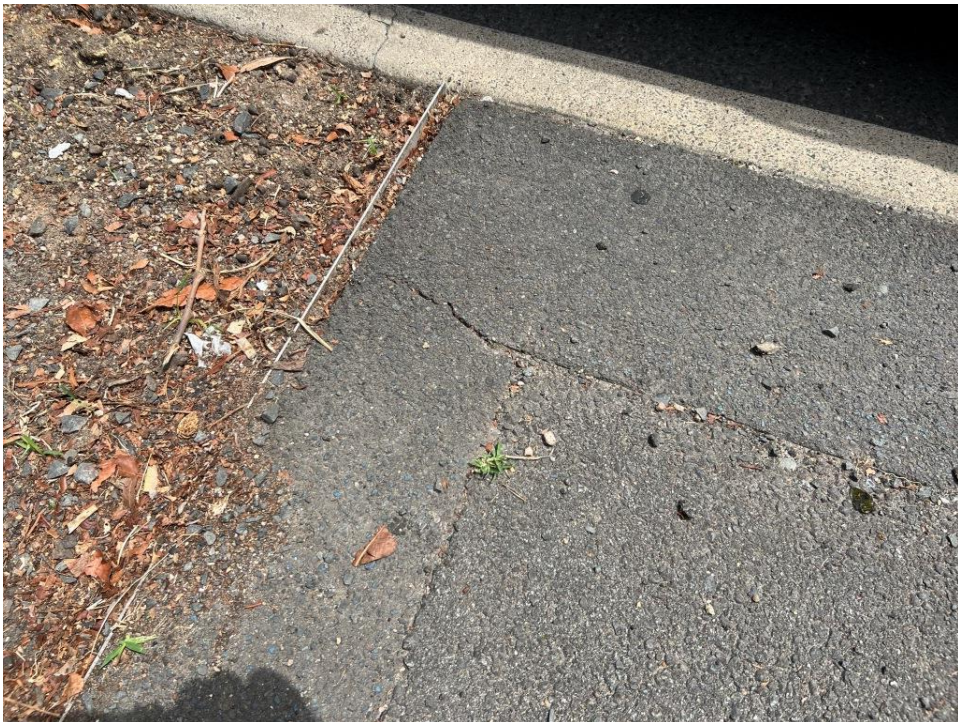
PHOTO 297

(Photo showing uneven surface of footpath – Botany Road)

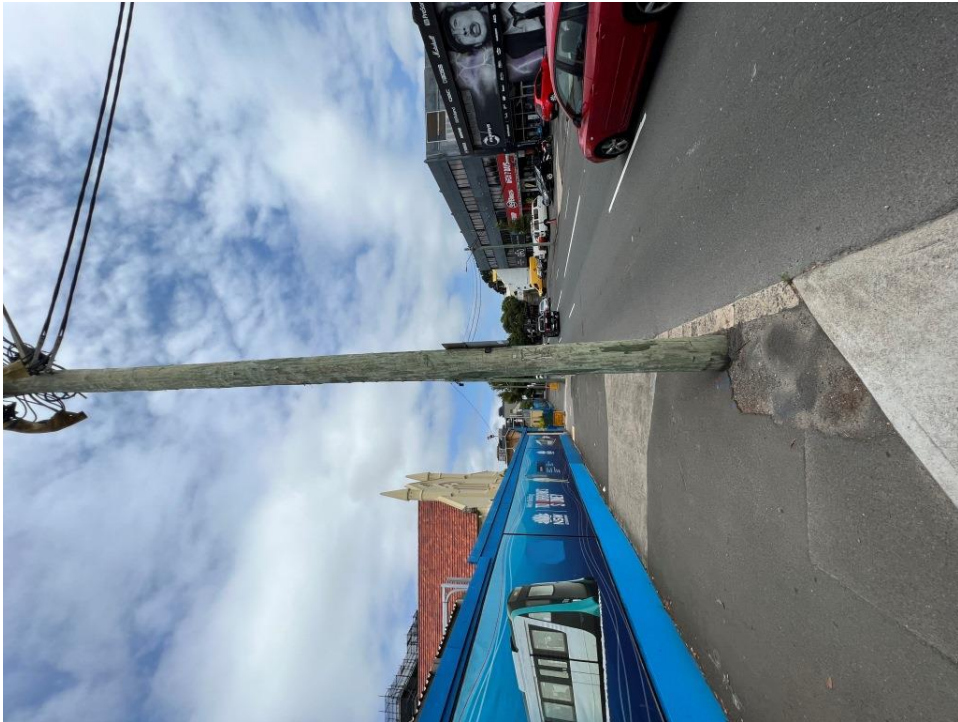
PHOTO 320

(Overview of footpath and truck driveway – Botany Road)

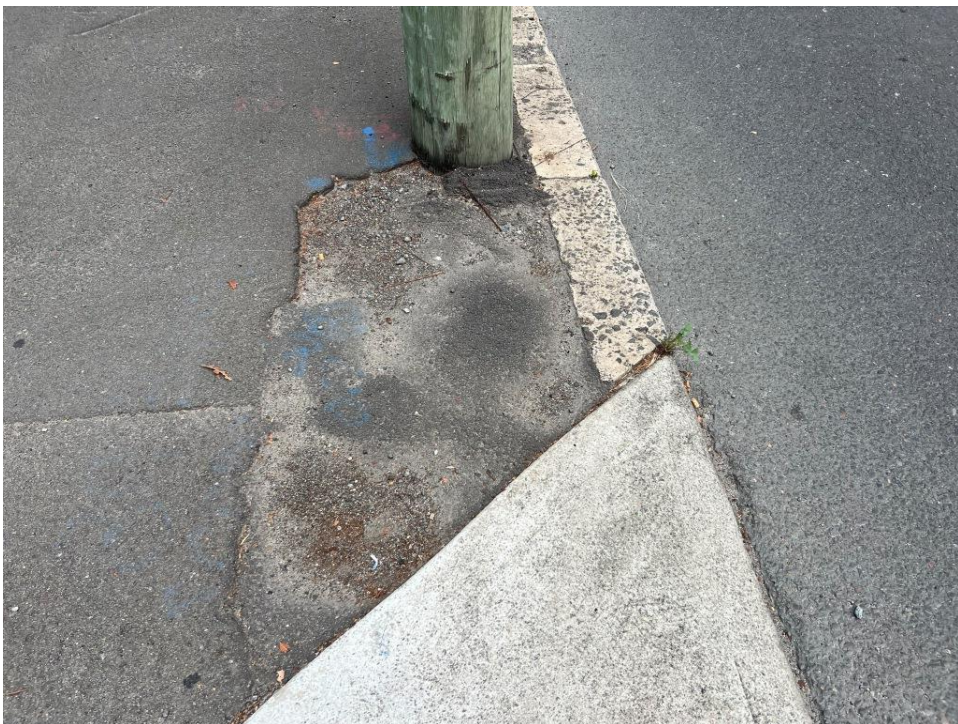
PHOTO 321

(Overview of footpath and electricity pole – Botany Road)

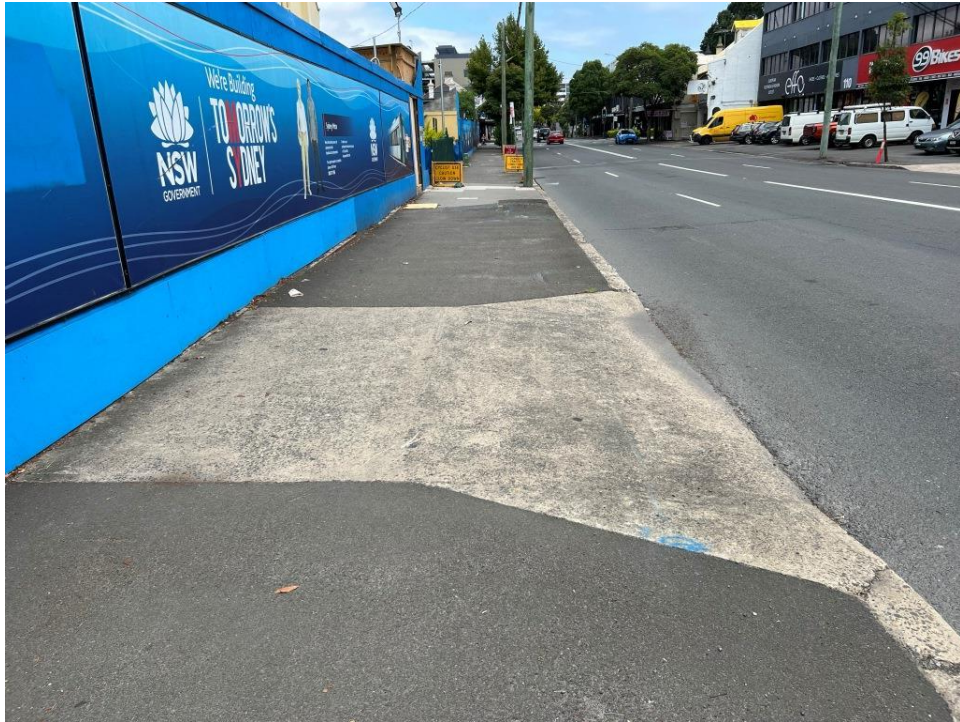
PHOTO 322

(Photo showing uneven footpath surface at base electricity pole – Botany Road)

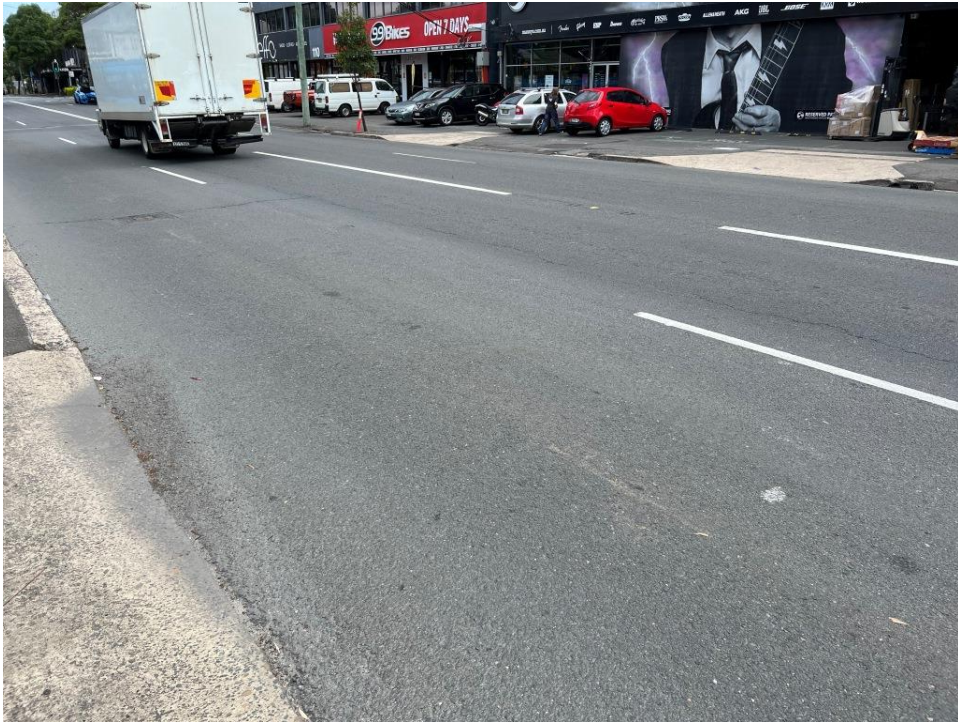
PHOTO 326

(Overview of footpath and former driveway – Botany Road)

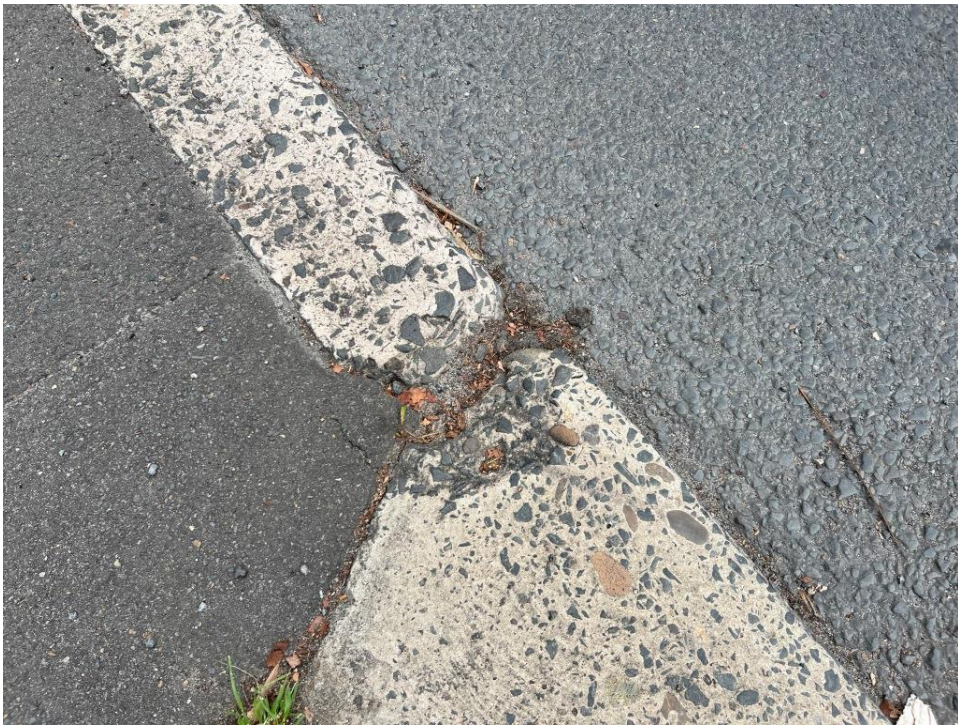
PHOTO 327

(Overview of roadway in front of former driveway – Botany Road)

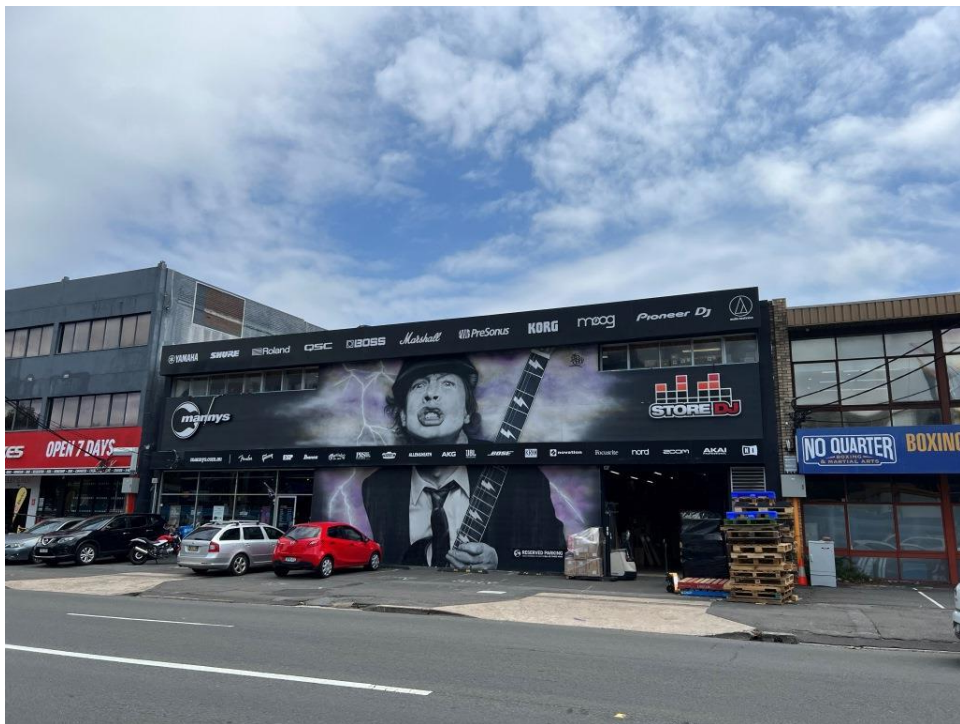
PHOTO 329
(Overview of footpath – Botany Road)

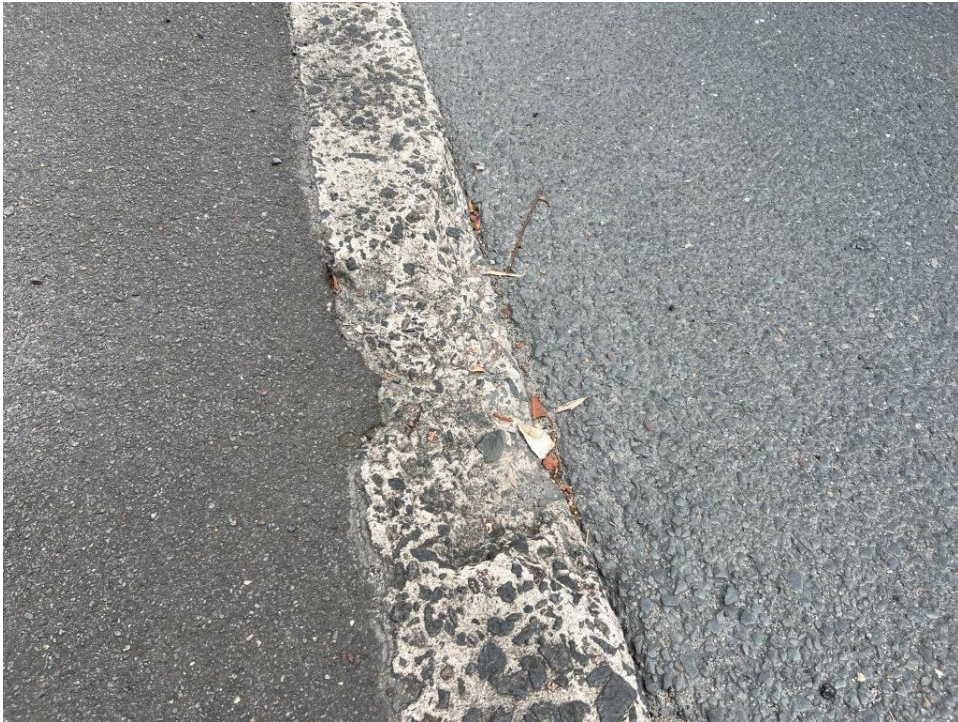
PHOTO 332
(Overview of roadway – Botany Road)

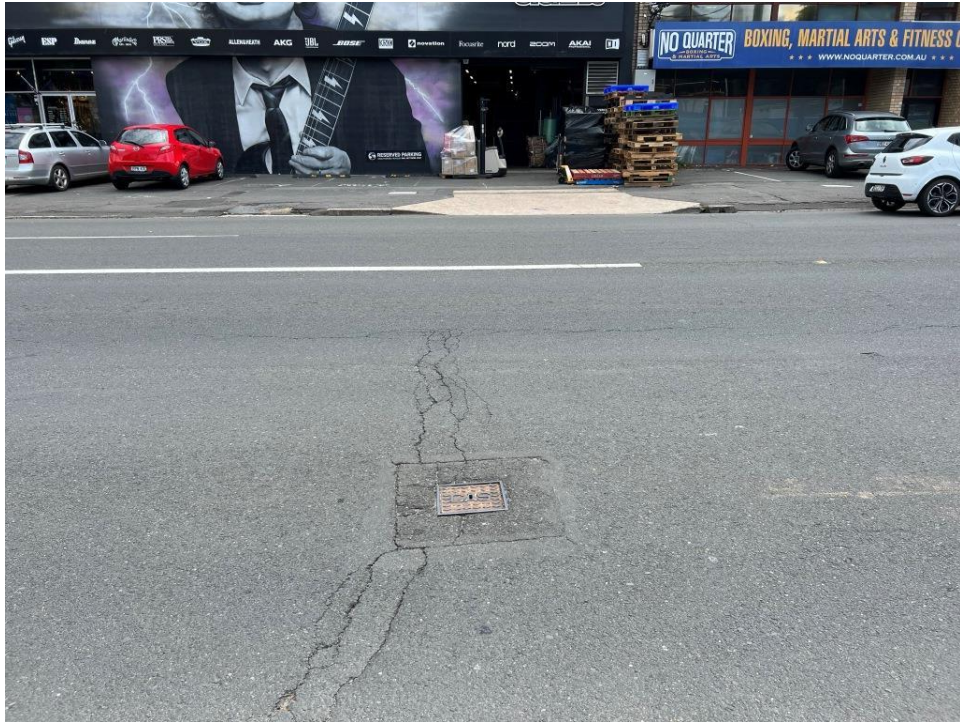
PHOTO 334

(Photo showing cracks in asphalt – Botany Road)

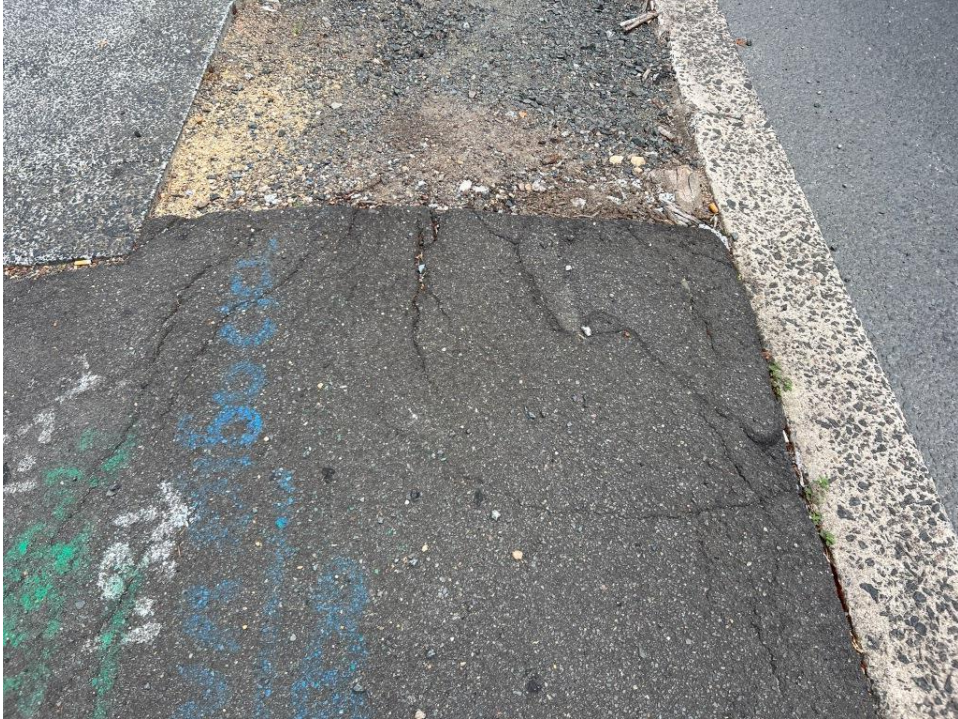
PHOTO 336

(Overview of uneven footpath surface – Botany Road)

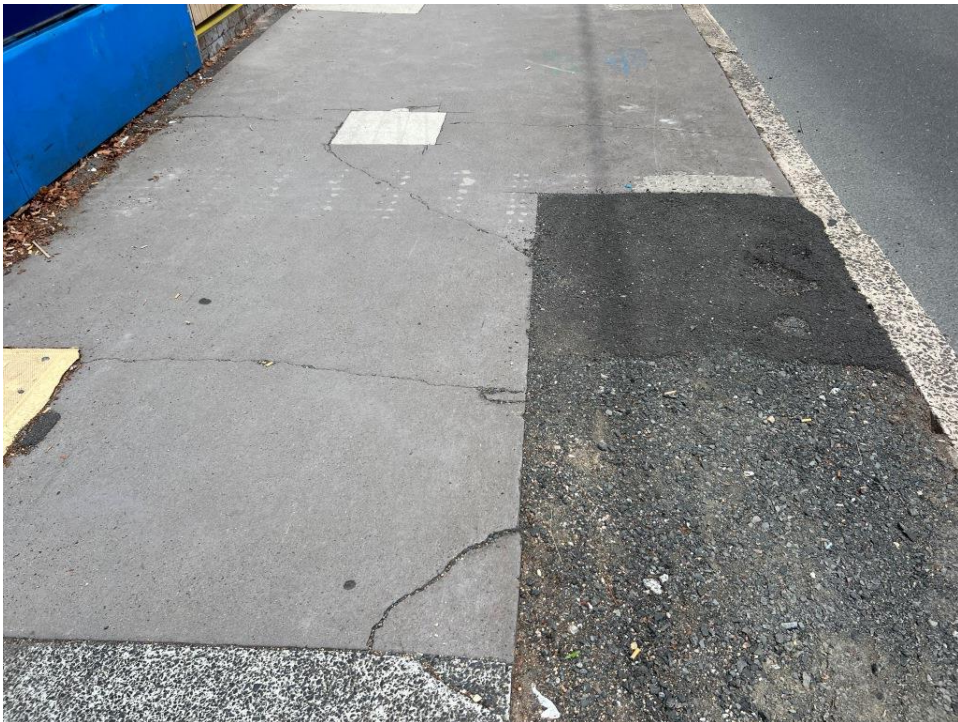
PHOTO 337

(Photo showing cracks in footpath – Botany Road)

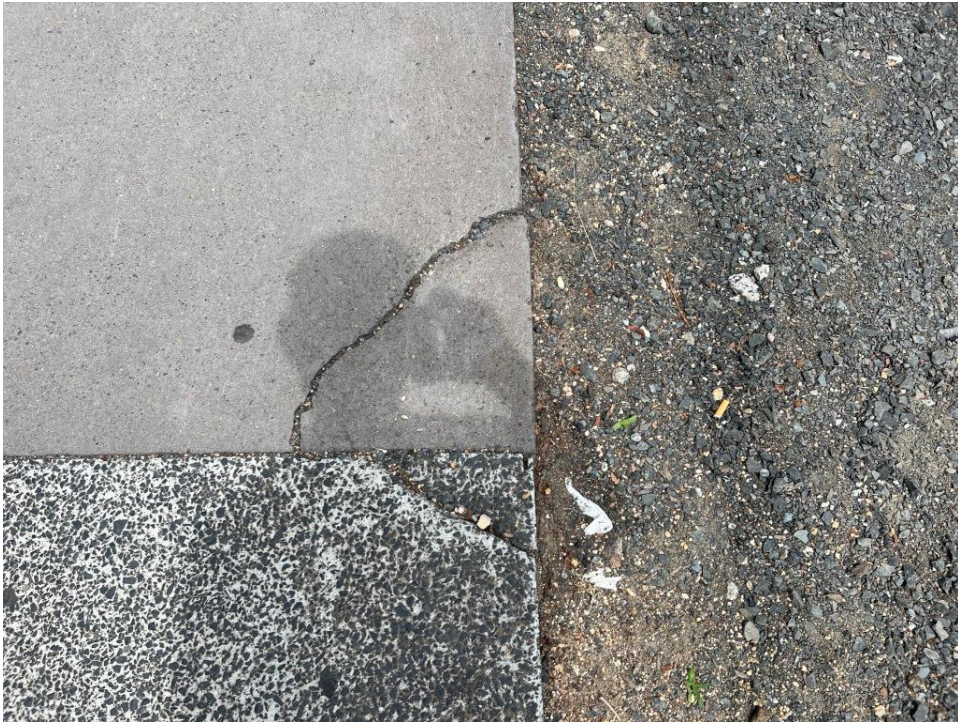
PHOTO 338

(Photo showing cracks in footpath – Botany Road)

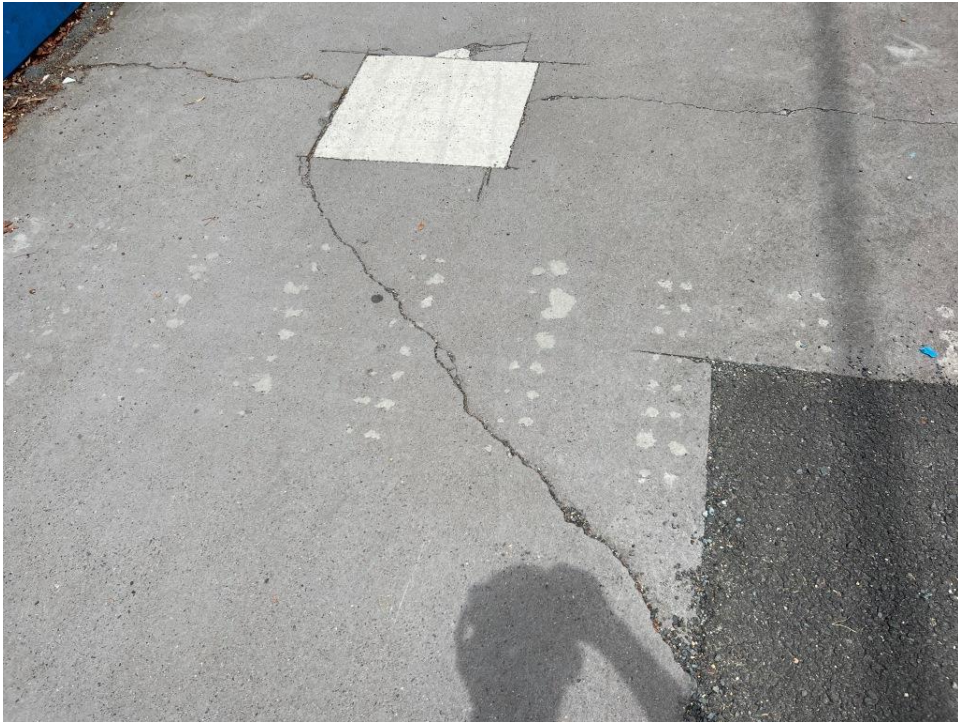
PHOTO 340

(Photo showing cracks in footpath – Botany Road)

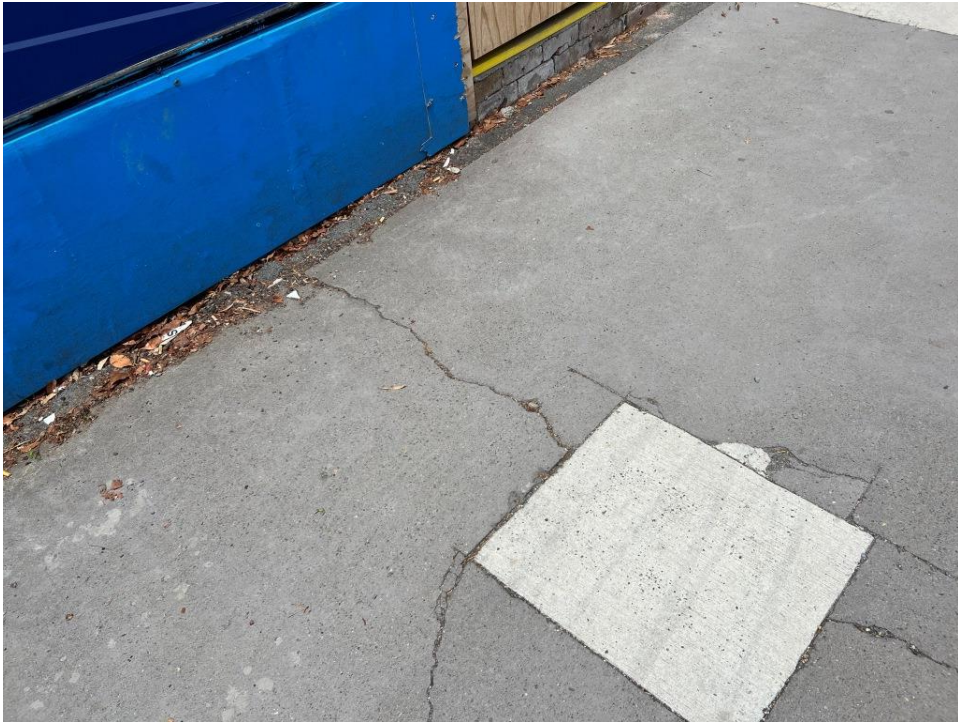
PHOTO 342

(Photo showing cracks in footpath – Botany Road)

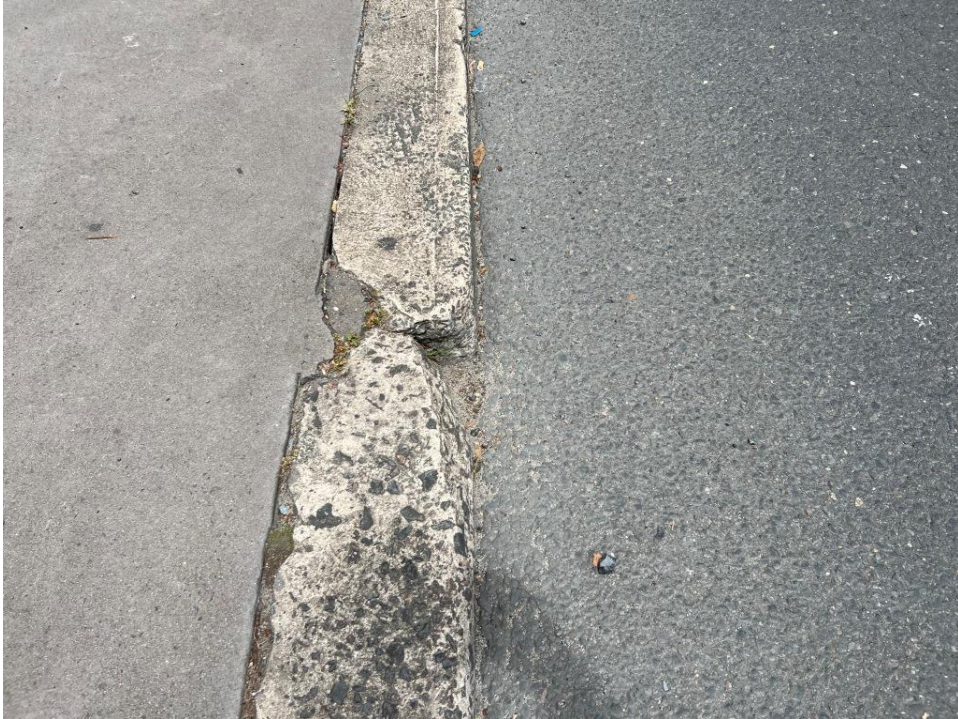
PHOTO 344

(Photo showing chipped/missing concrete in kerb – Botany Road)

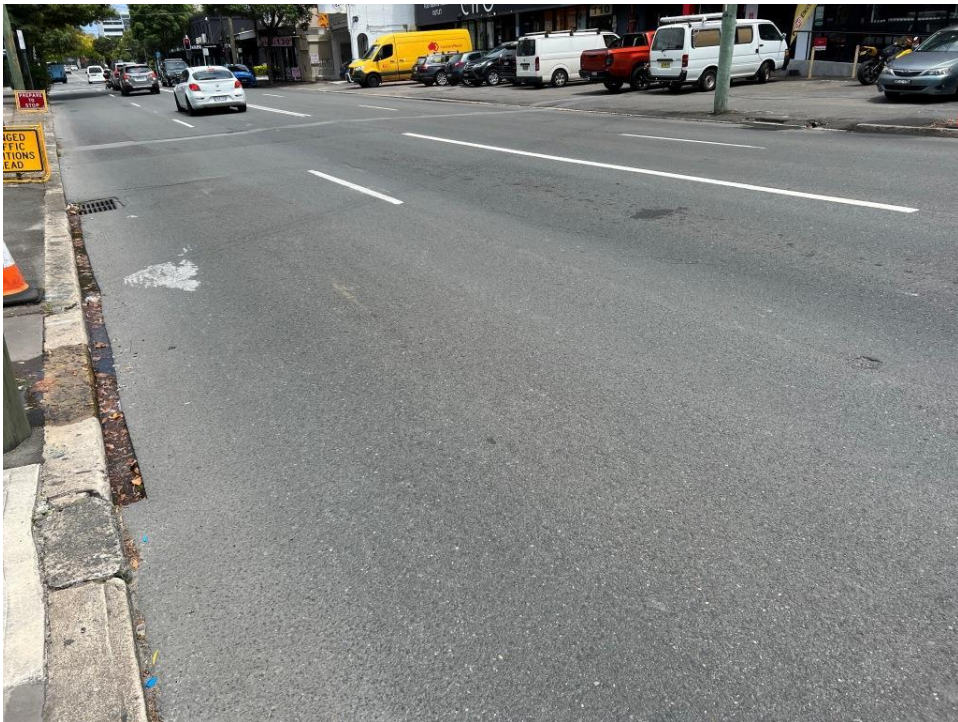
PHOTO 345

(Photo showing chipped/missing concrete in kerb – Botany Road)
