# REMEDIATION ACTION PLAN

Aspect Industrial Estate, Mamre Road, Kemps Creek, NSW  
2178 – Rev 3 Final

Prepared for Mirvac Projects Pty Ltd

15 OCTOBER 2020

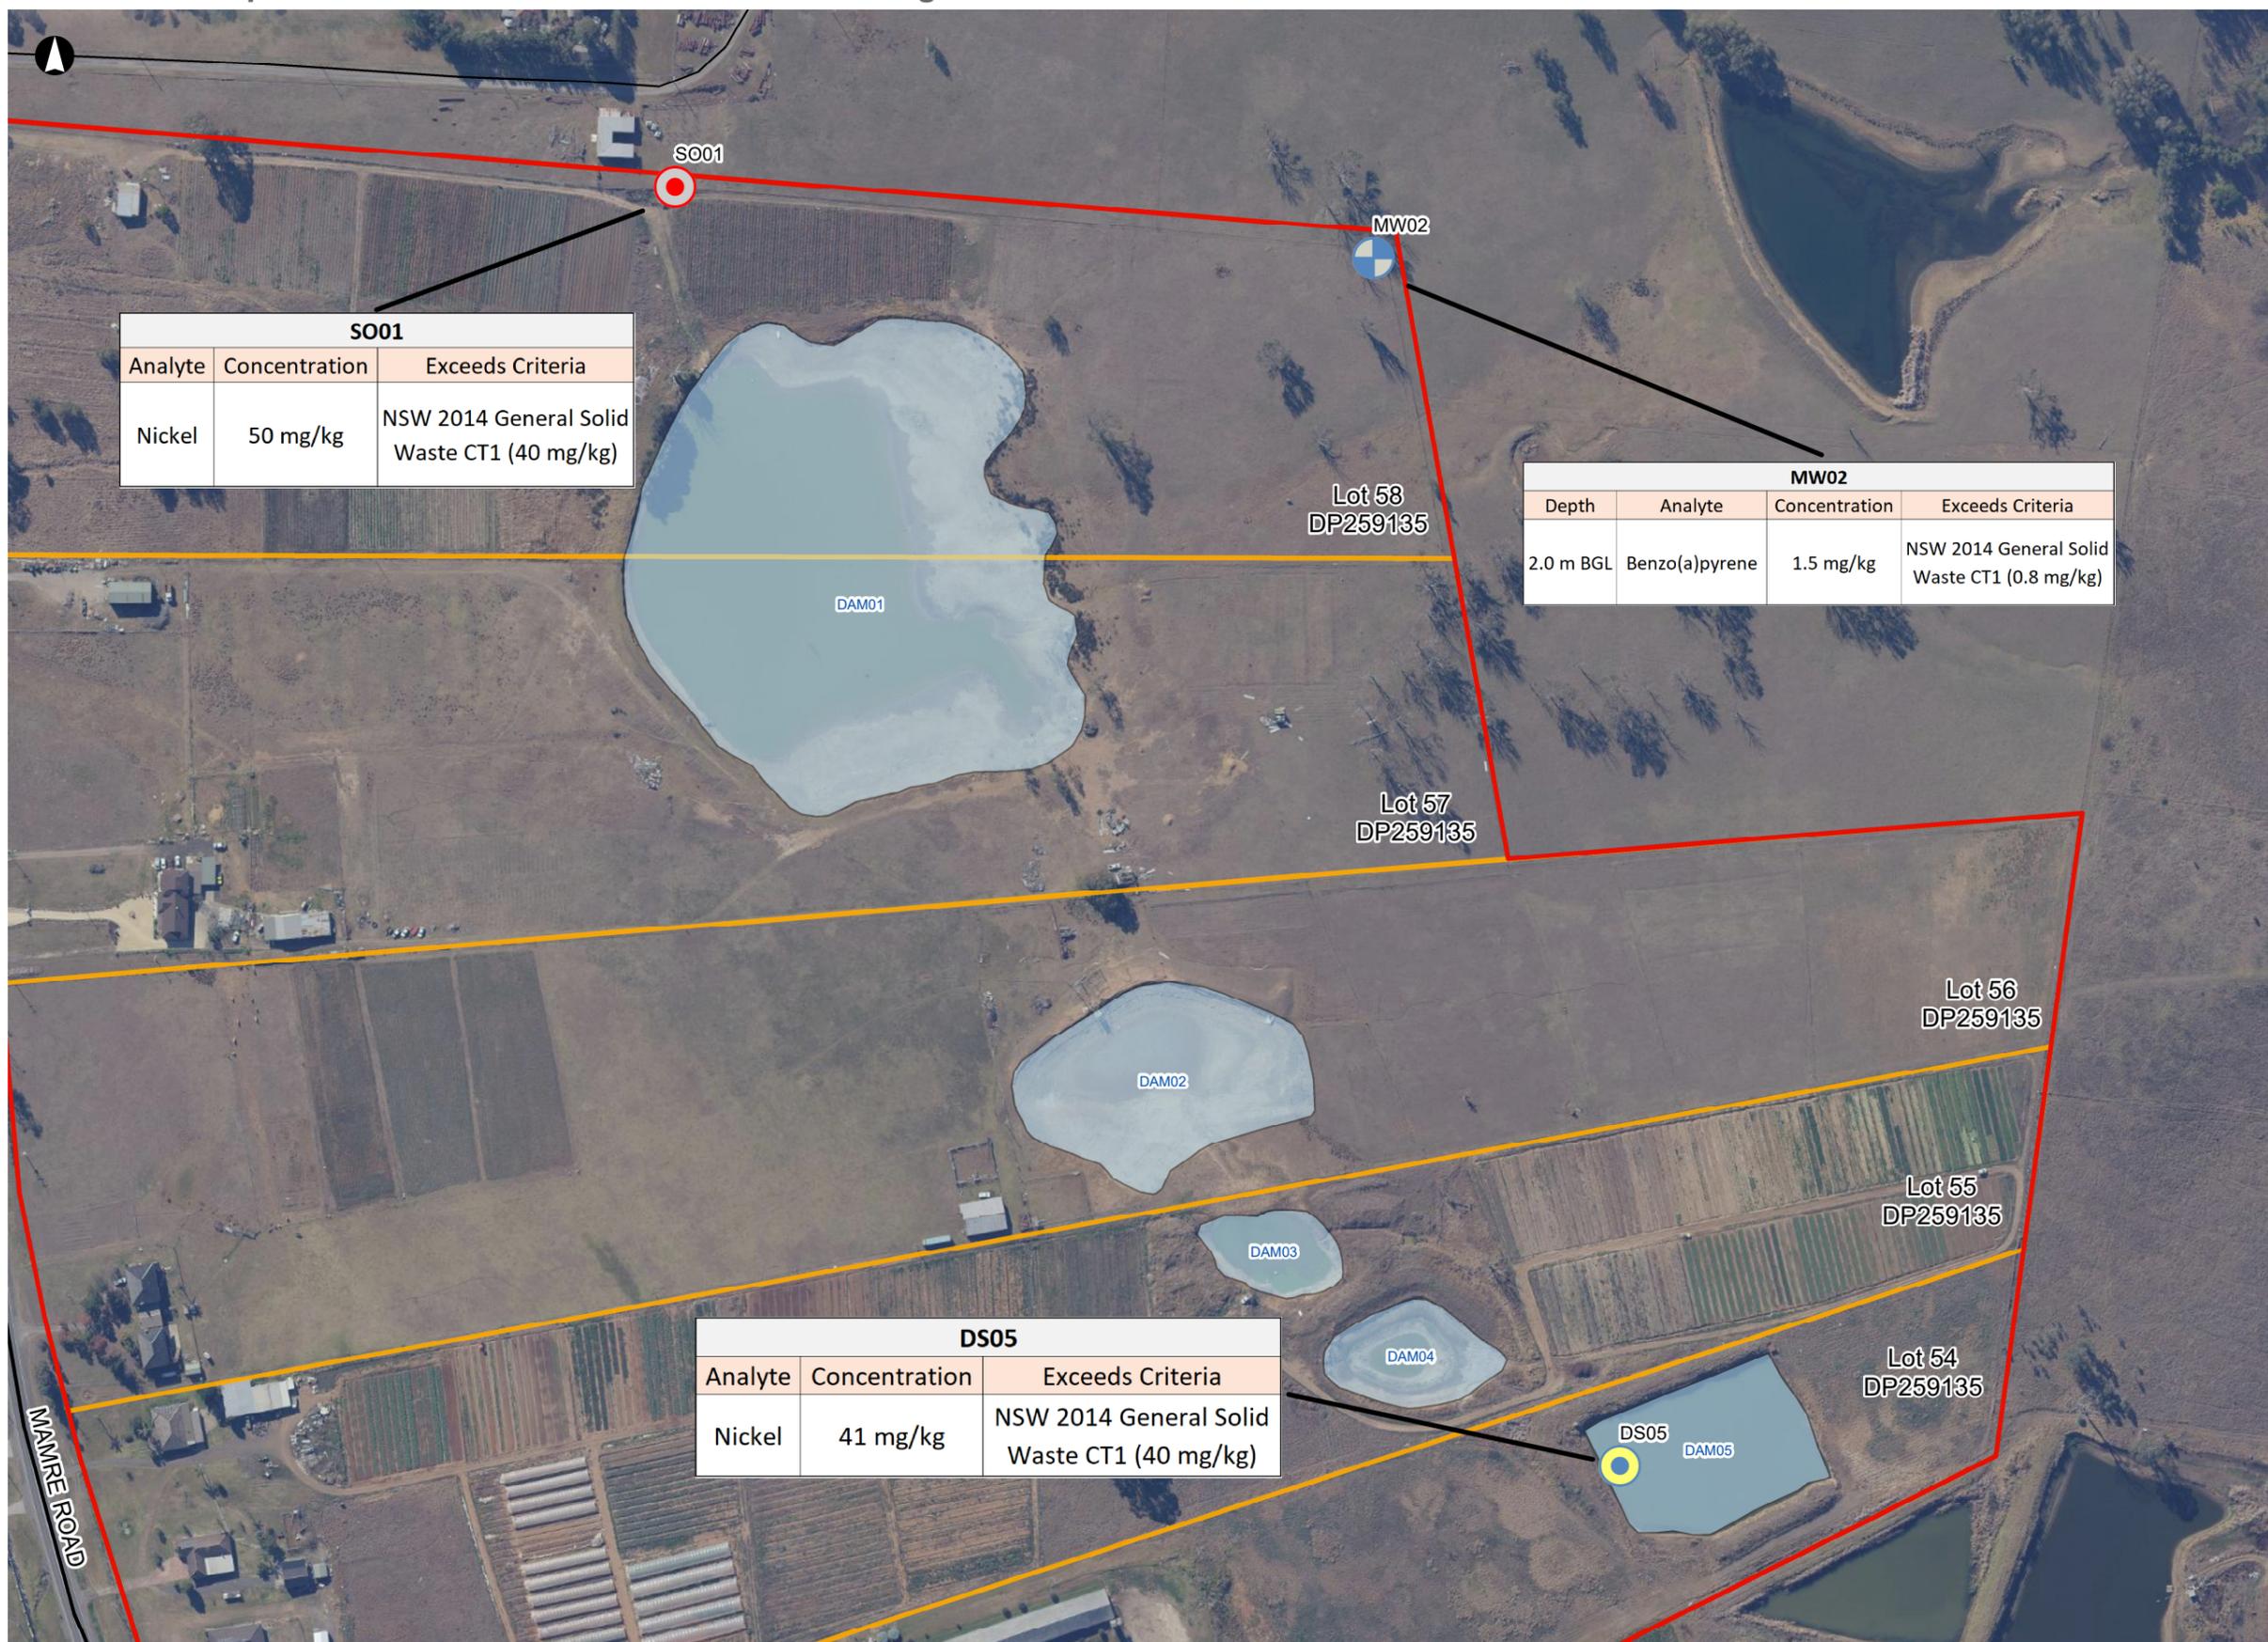
Figure 7, Appendix C - DSI Waste Classification Exceedances

SO01		
Analyte	Concentration	Exceeds Criteria
Nickel	50 mg/kg	NSW 2014 General Solid Waste CT1 (40 mg/kg)

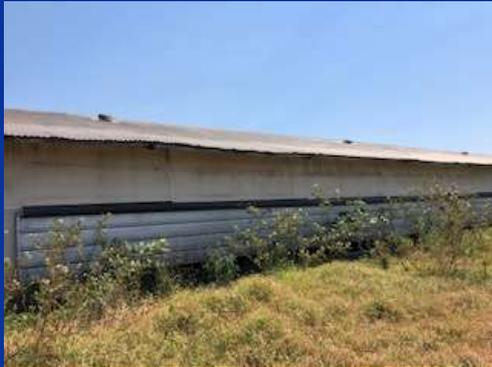
Photo No.  
1

**Asbestos**

Lot 54  
Chicken Sheds – Upper Wall Section

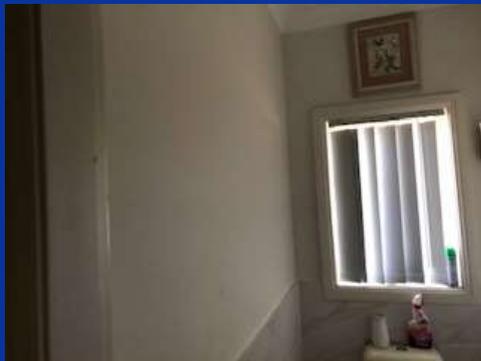
Photo No.  
3

**Asbestos**

Lot 55  
House 1/844- Bathroom Walls

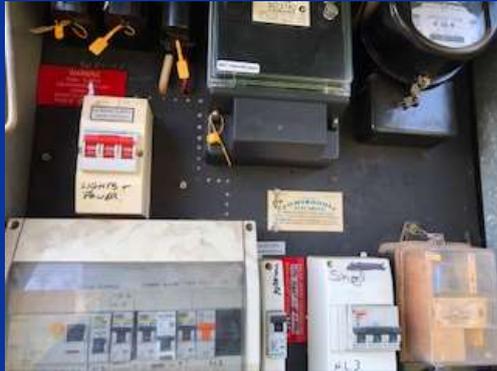
**Photo No.  
5**

**Asbestos**

House 1/844 - Electrical Backing Board - electrical backing board

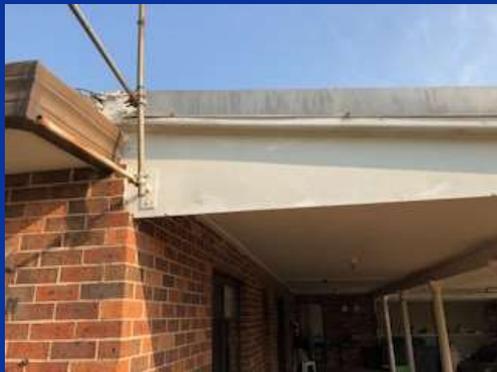
**Photo No.  
6**

**Asbestos**

House 1/844 – Rear Veranda - Fascia

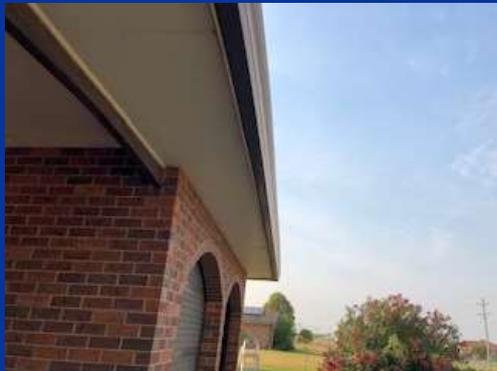
**Photo No.  
7**

**Asbestos**

House 1/844 – Eaves – Eave Lining

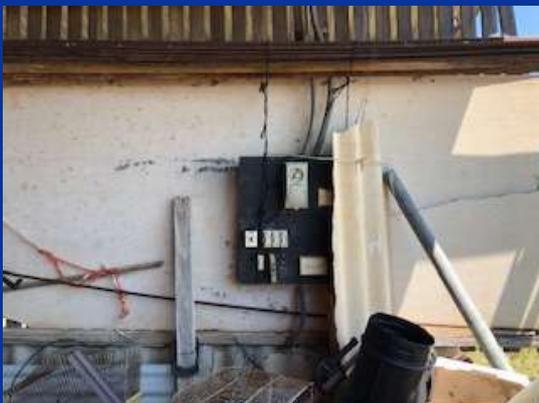
**Photo No.  
8**

**Asbestos**

Rear Shed – Upper Wall Sheetting

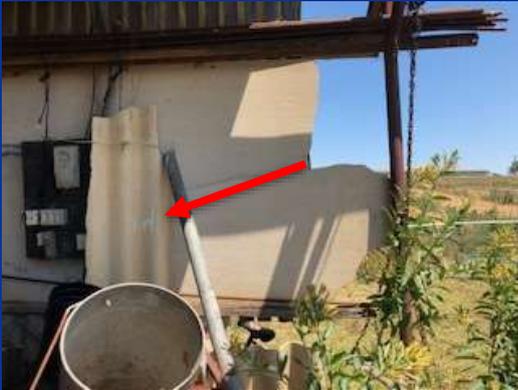
Photo No.  
9

**Asbestos**

Rear Shed – Lower Section – Corrugated Sheetting

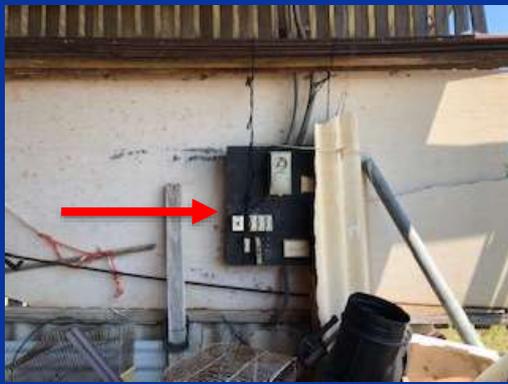
Photo No.  
10

**Asbestos**

Rear Shed – Electrical Backing Board

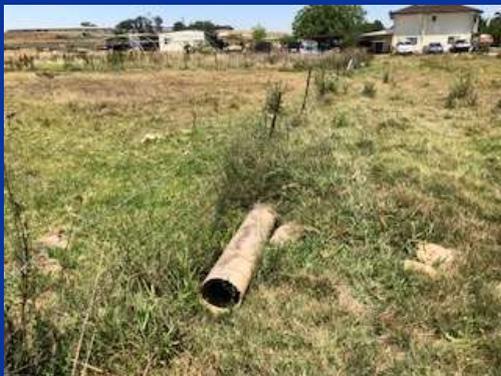
Photo No.  
11

**Asbestos**

Drainage Pipe

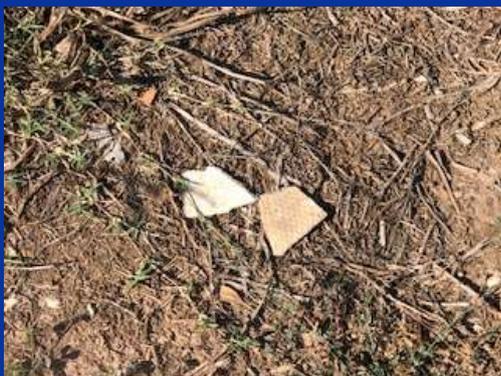
Photo No.  
12

**Asbestos**

Driveway to property – Fragments

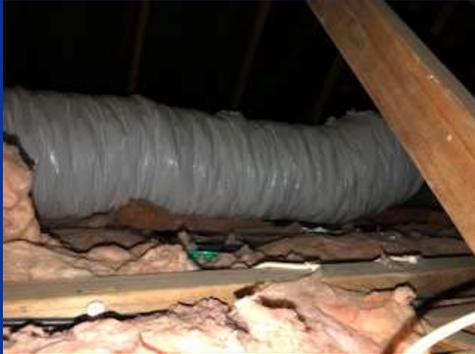
Photo No.  
13

**Synthetic Mineral Fibres**

House 1/844 – Ceiling Void – Fibrous Insulation

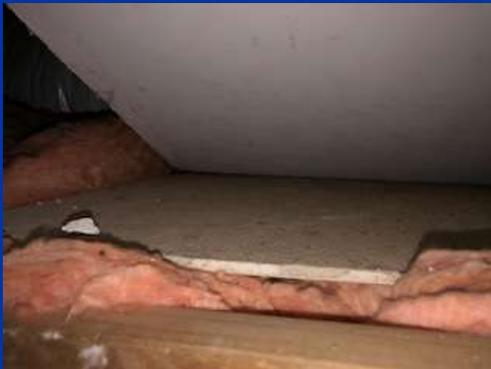
Photo No.  
14

**Synthetic Mineral Fibres**

House 2/844 – Ceiling Void – Fibrous insulation

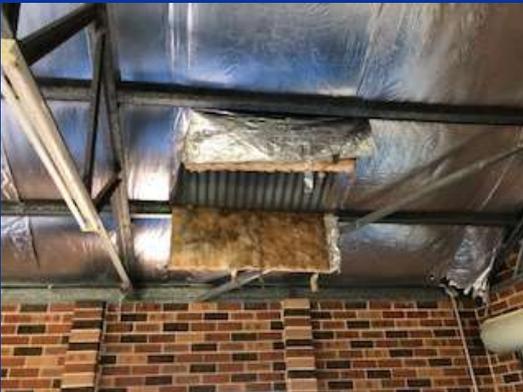
Photo No.  
15

**Synthetic Mineral Fibres**

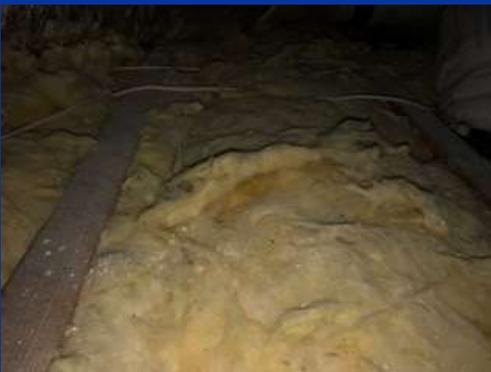
Photo No.  
16

Car Shed behind 2/844 – Fibrous Insulation

**Synthetic Mineral Fibres**

Lot 57
