DILAPIDATION REPORT

74 EDINBURGH ROAD, MARRICKVILLE NSW 2204

Docui	ment Information
Job Number	221079
Document Number	1
Report Title	Dilapidation Report
Site Address	74 Edinburgh Road, Marrickville NSW 2204
Lot	202 in DP1133999

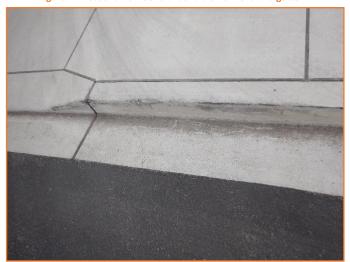
Figure 2: Reasonable - General condition of kerb and gutter. Minor spalling observed.

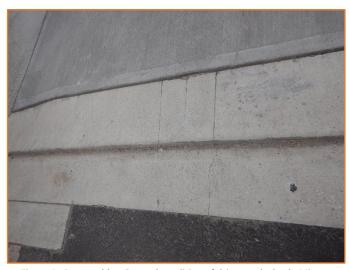
Figure 4: Reasonable - General condition of driveway layback. Minor cracking observed.

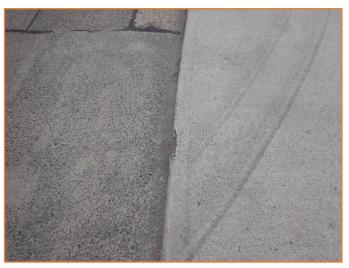
Figure 7: Reasonable - General condition of driveway layback. Minor spalling observed.

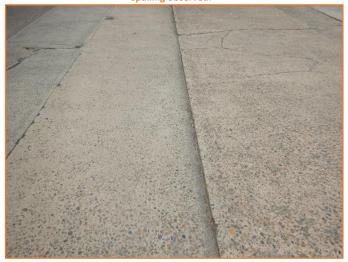
Figure 8: Reasonable - General condition of driveway layback.

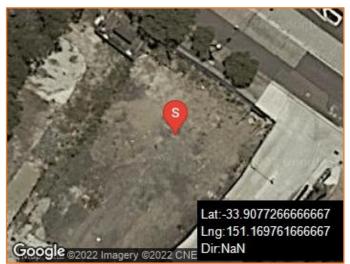
Figure 9: Reasonable - General condition of driveway splay. Minor cracking and spalling observed.

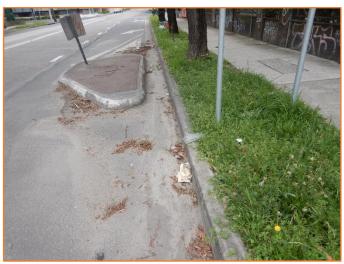
Figure 10: Reasonable - General condition of kerb and gutter.

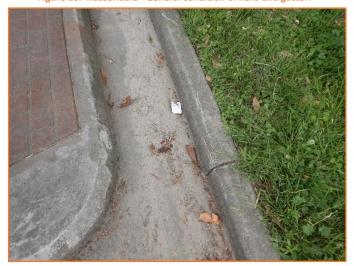
Figure 11: Reasonable - General condition of kerb and gutter. Minor cracking observed

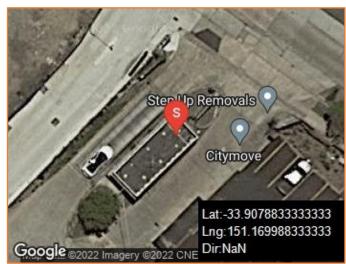
Figure 14: Reasonable - General condition of kerb and gutter.

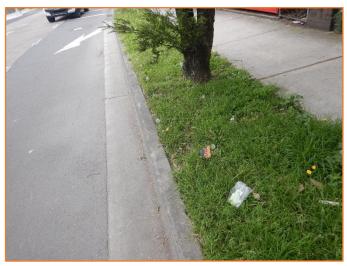
Figure 16: Reasonable - General condition of kerb and gutter.

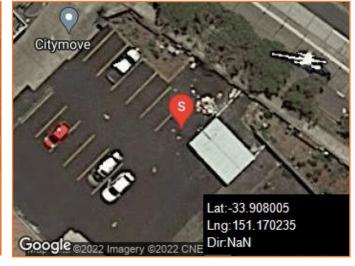
Figure 18: Reasonable - General condition of kerb inlet pit.

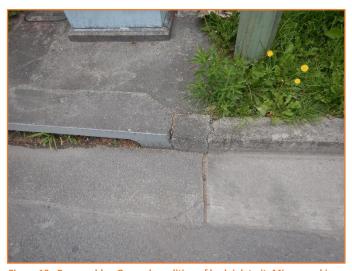
Figure 19: Reasonable - General condition of kerb inlet pit. Minor cracking observed.

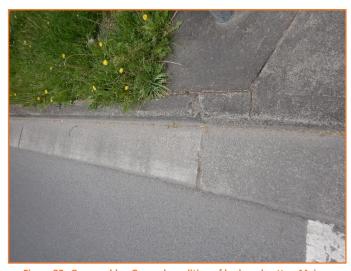
Figure 22: Reasonable - General condition of kerb and gutter. Major spalling observed.

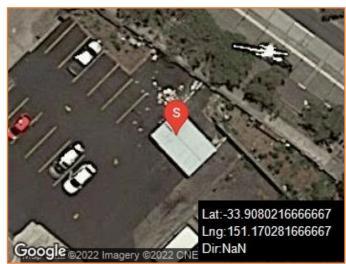
Figure 23: Reasonable - General condition of kerb and gutter.

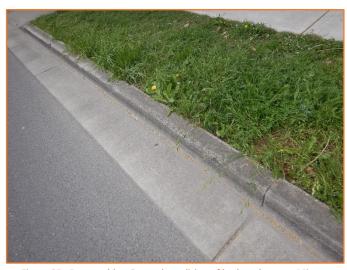
Figure 25: Reasonable - General condition of kerb and gutter. Minor spalling observed.

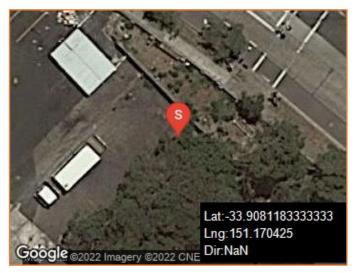
Figure 26: Reasonable - General condition of kerb and gutter. Minor spalling observed.

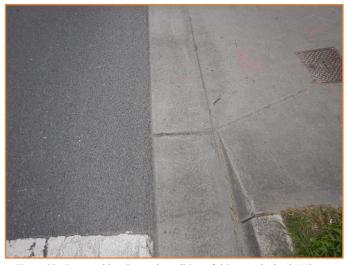
Figure 28: Reasonable - General condition of driveway layback. Minor cracking observed.

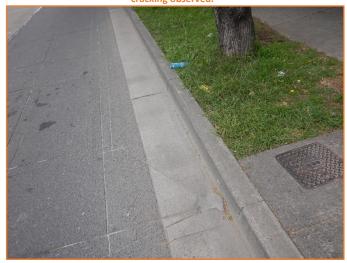
Figure 30: Reasonable - General condition of kerb and gutter. Minor cracking observed.

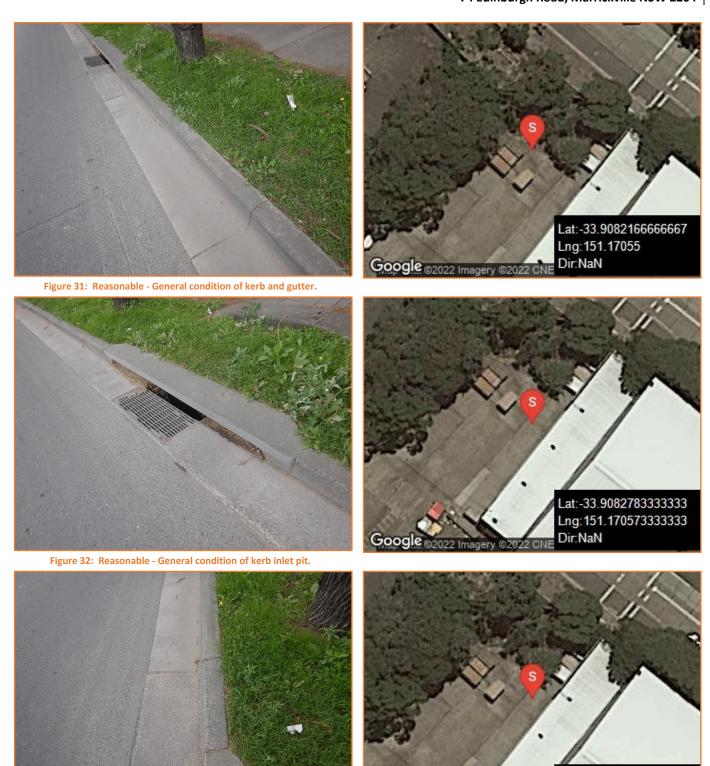
Figure 33: Reasonable - General condition of kerb and gutter. Minor cracking observed.

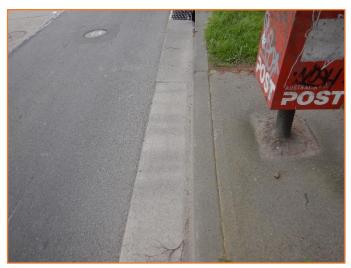
Figure 37: Reasonable - General condition of kerb and gutter.

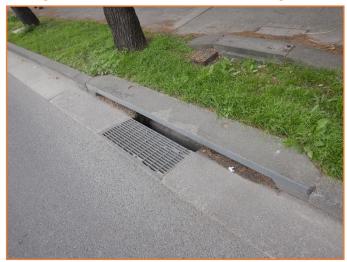
Figure 38: Reasonable - General condition of kerb inlet pit.

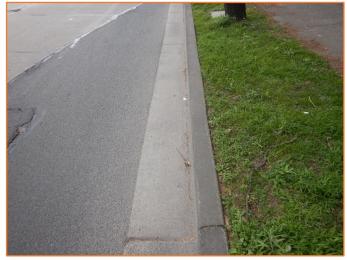
Figure 39: Reasonable - General condition of kerb and gutter.

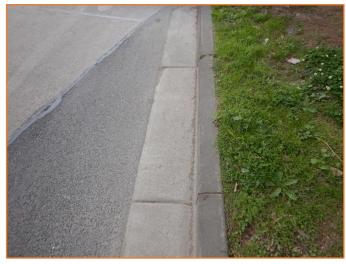
Figure 40: Reasonable - General condition of kerb and gutter. Minor cracking observed.

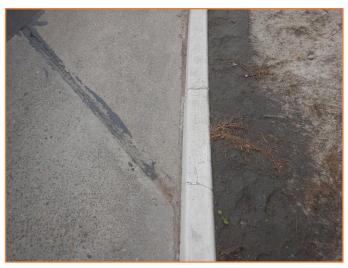
Figure 43: Reasonable - General condition of kerb and gutter. Minor hairline cracking observed.

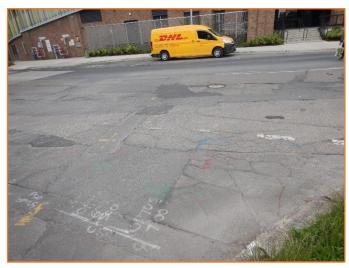
Figure 46: Poor - General condition of flexible pavement. Extensive cracking observed. Previous repairs observed.

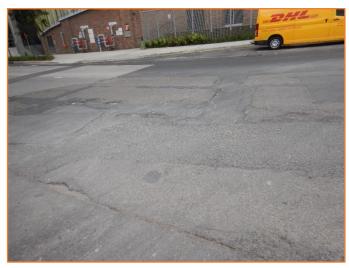
Figure 49: Poor - General condition of flexible pavement. Extensive cracking observed. Previous repairs observed.

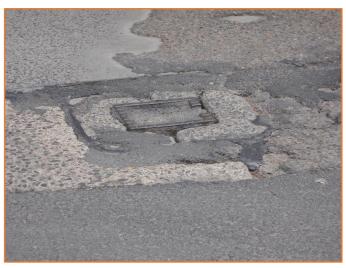
Figure 52: Reasonable - General condition of service pit. Minor cracking observed.

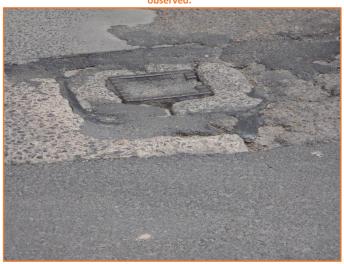
Figure 53: Reasonable - General condition of service pit. Minor cracking

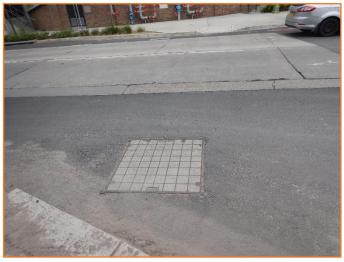
Figure 55: Reasonable - General condition of service pit.

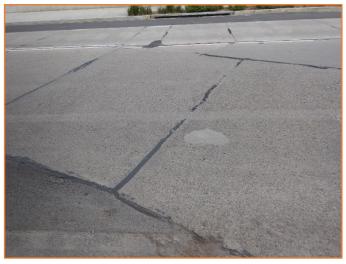
Figure 61: Reasonable - General condition of rigid pavement. Minor cracking observed.

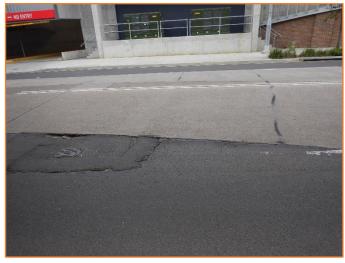
Figure 64: Reasonable - General condition of rigid pavement.

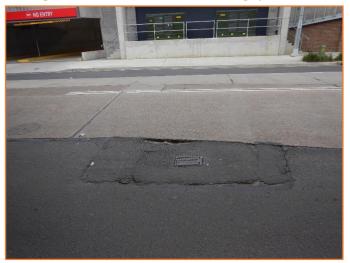
Figure 65: Reasonable - General condition of flexible and rigid pavement.

Minor cracking observed.

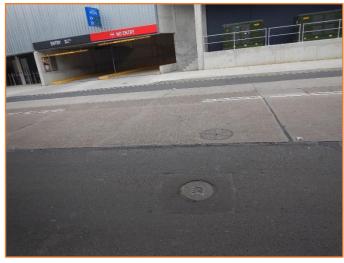
Figure 67: Reasonable - General condition of rigid pavement.

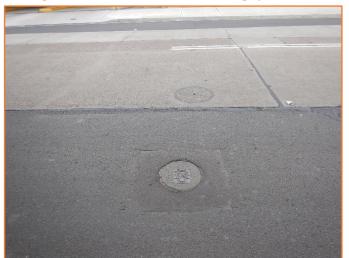
Figure 68: Reasonable - General condition of service pit.

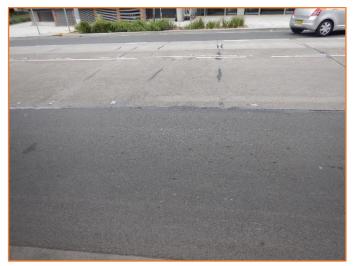
Figure 73: Reasonable - General condition of flexible and rigid pavement.

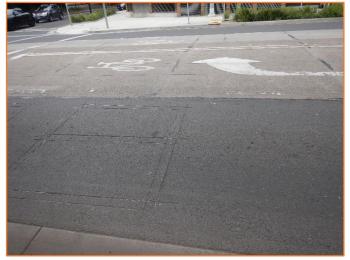
Figure 75: Reasonable - General condition of flexible and rigid pavement.

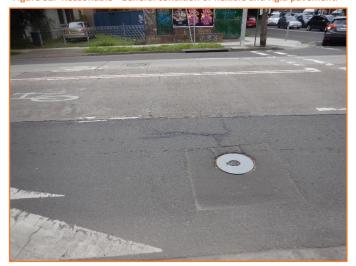
Figure 83: Reasonable - General condition of flexible and rigid pavement. Minor cracking observed.

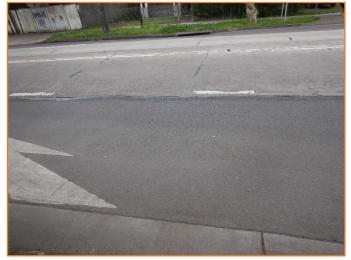
Figure 87: Reasonable - General condition of flexible and rigid pavement.

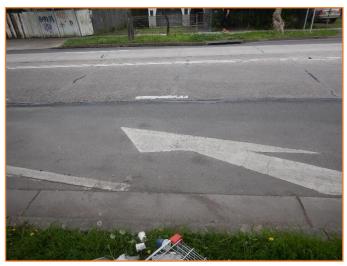
Figure 88: Reasonable - General condition of flexible and rigid pavement.

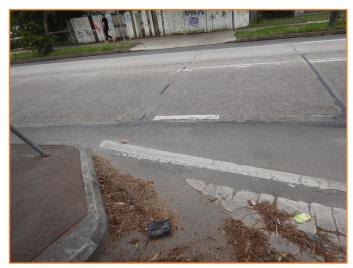
Figure 91: Reasonable - General condition of flexible and rigid pavement.

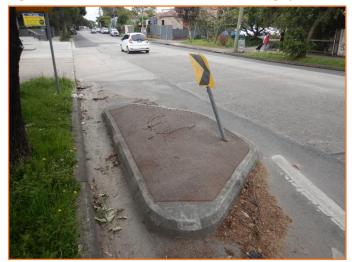
Figure 92: Reasonable - General condition of traffic island and signage. Minor rotation observed.

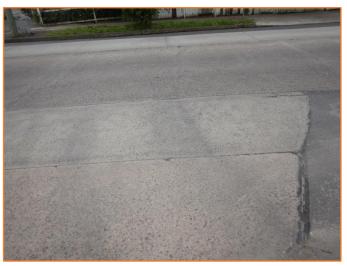
Figure 97: Reasonable - General condition of rigid pavement. Minor cracking observed.

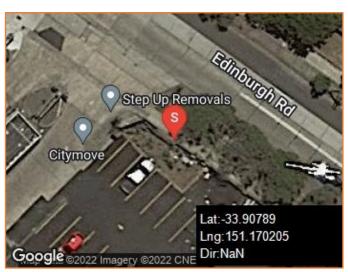
Figure 98: Reasonable - General condition of rigid pavement. Minor cracking observed.

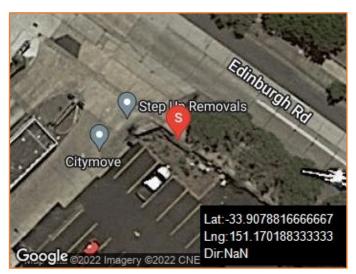
Figure 99: Reasonable - General condition of rigid pavement. Extensive cracking observed.

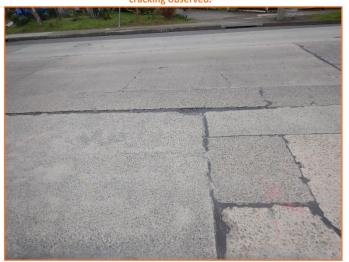
Figure 101: Reasonable - General condition of rigid pavement. Extensive cracking observed.

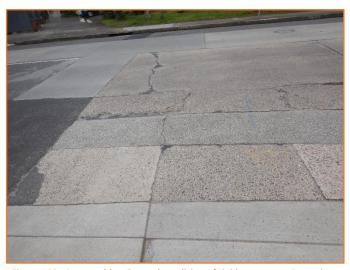
Figure 103: Reasonable - General condition of rigid pavement. Extensive cracking observed.

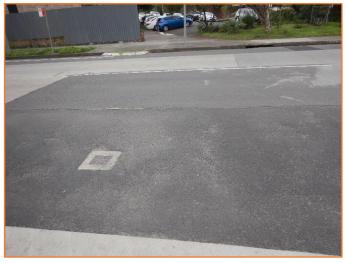
Figure 106: Reasonable - General condition of flexible pavement.

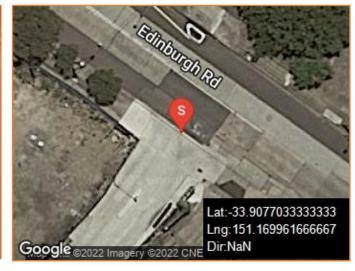
Figure 108: Reasonable - General condition of flexible and rigid pavement.

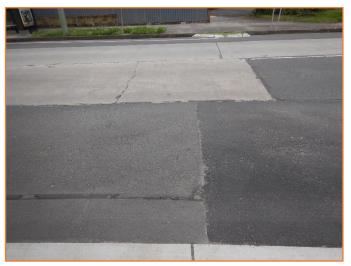
Figure 109: Reasonable - General condition of flexible and rigid pavement. Minor cracking observed.

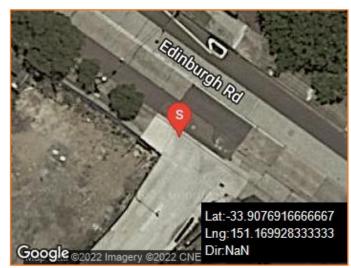
Figure 110: Reasonable - General condition of flexible and rigid pavement. Minor cracking observed.

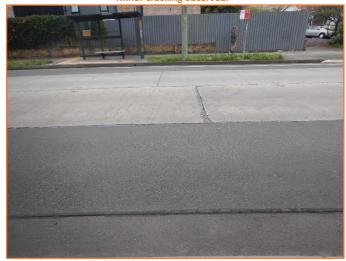
Figure 111: Reasonable - General condition of flexible and rigid pavement.

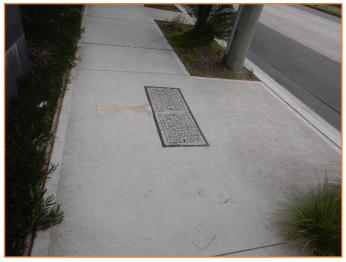
Figure 112: Reasonable - General condition of footpath and service pit.

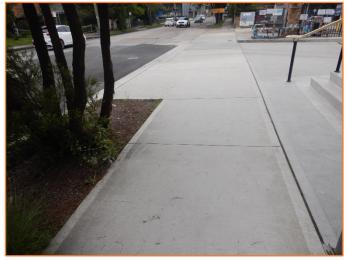
Figure 114: Reasonable - General condition of footpath.

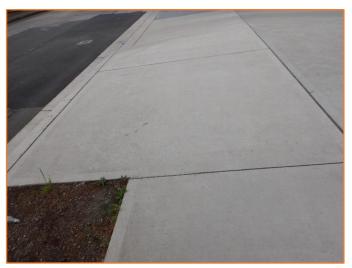
Figure 115: Reasonable - General condition of footpath.

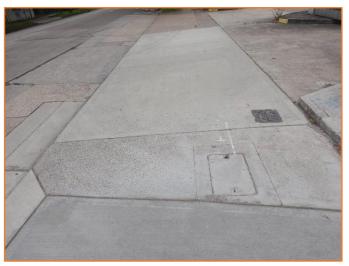
Figure 118: Reasonable - General condition of driveway crossover.

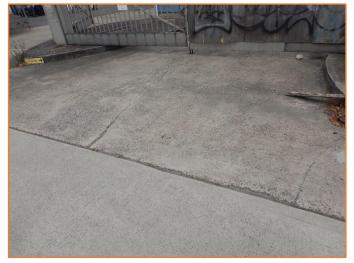
Figure 119: Reasonable - General condition of driveway crossover. Minor cracking observed.

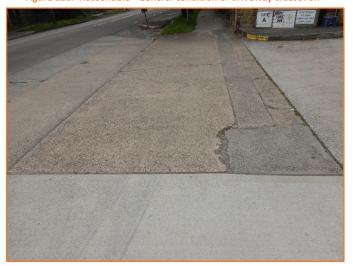
Figure 122: Reasonable - General condition of driveway crossover. Major cracking observed.

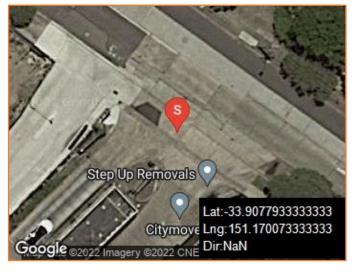
Figure 124: Reasonable - General condition of footpath. Major cracking observed.

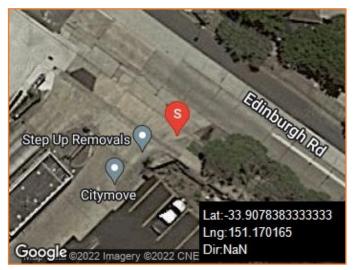
Figure 126: Reasonable - General condition of signage.

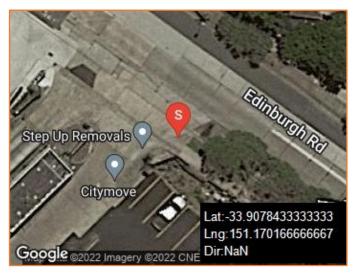
Figure 127: Reasonable - General condition of service pit.

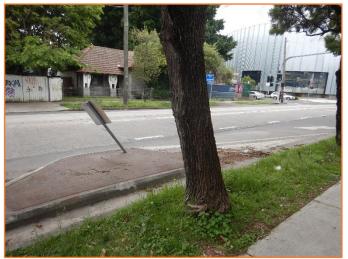
Figure 128: Reasonable - General condition of street planting.

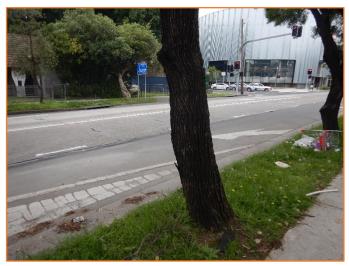
Figure 130: Reasonable - General condition of street planting.

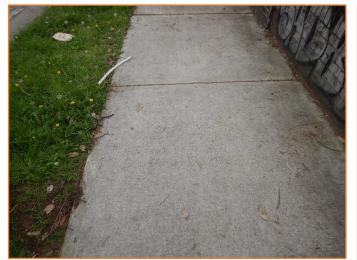
Figure 131: Reasonable - General condition of footpath.

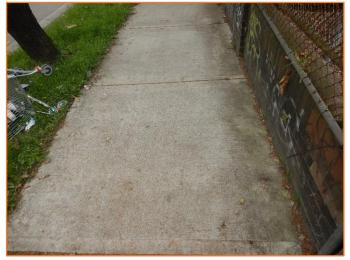
Figure 132: Reasonable - General condition of footpath.

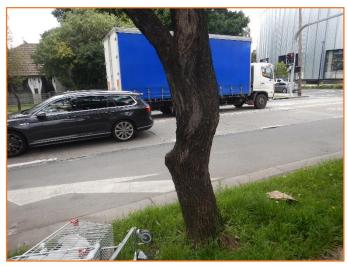
Figure 133: Reasonable - General condition of street planting.

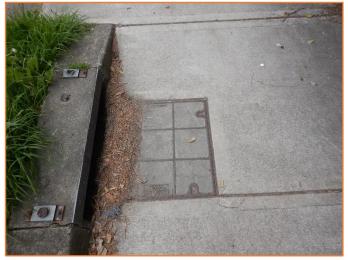
Figure 141: Reasonable - General condition of service pit.

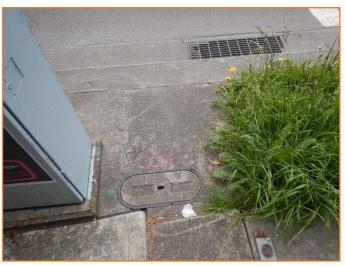
Figure 142: Reasonable - General condition of service pit.

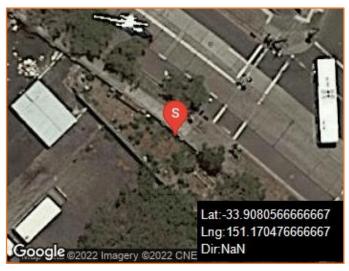
Figure 143: Reasonable - General condition of footpath.

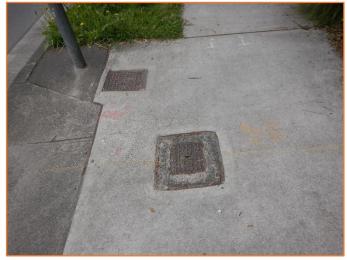
Figure 144: Reasonable - General condition of service pit.

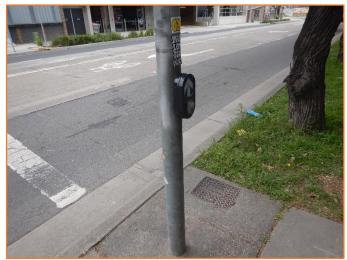
Figure 154: Reasonable - General condition of service pit.

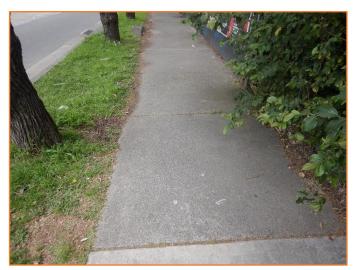
Figure 157: Reasonable - General condition of footpath.

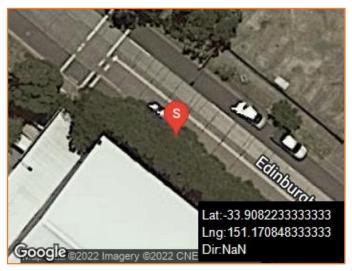
Figure 159: Reasonable - General condition of street planting.

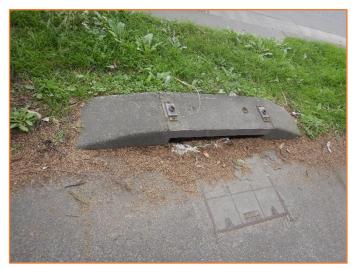
Figure 160: Reasonable - General condition of inlet pit and service pit.

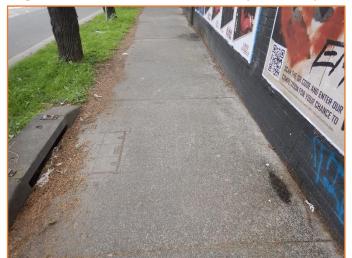
Figure 161: Reasonable - General condition of footpath.

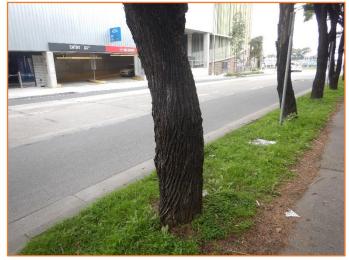
Figure 162: Reasonable - General condition of street planting.

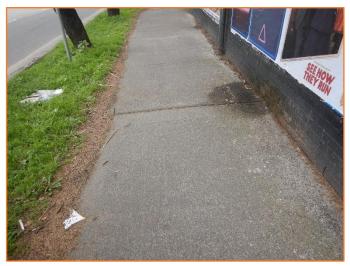
Figure 163: Reasonable - General condition of footpath.

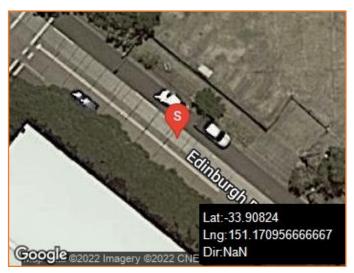
Figure 164: Reasonable - General condition of street planting and signage.

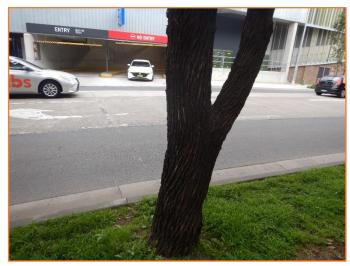
Figure 166: Reasonable - General condition of street planting.

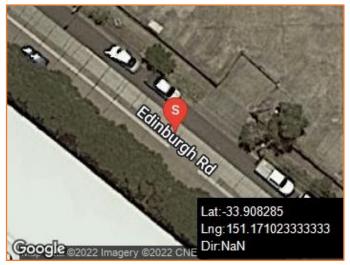
Figure 167: Reasonable - General condition of footpath.

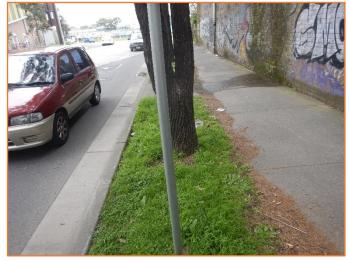
Figure 168: Reasonable - General condition of signage.

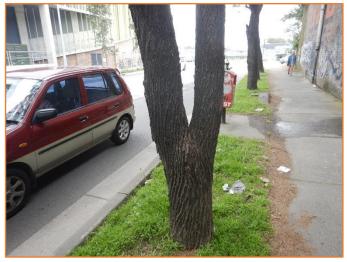
Figure 169: Reasonable - General condition of street planting.

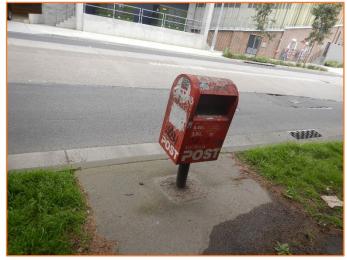
Figure 171: Reasonable - General condition of Australian Post box.

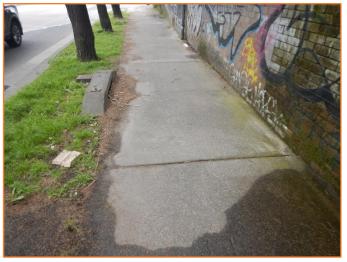
Figure 172: Reasonable - General condition of footpath.

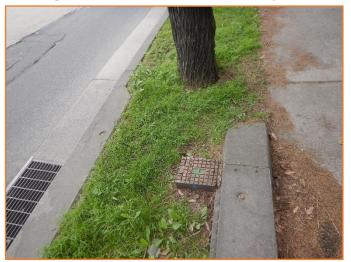
Figure 173: Reasonable - General condition of service pit.

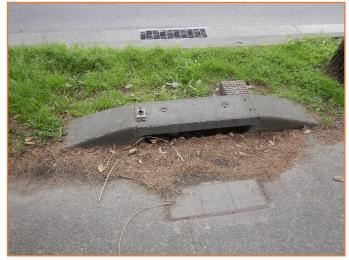
Figure 174: Reasonable - General condition of inlet pit and service pit.

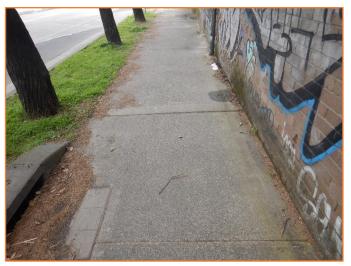
Figure 175: Reasonable - General condition of footpath.

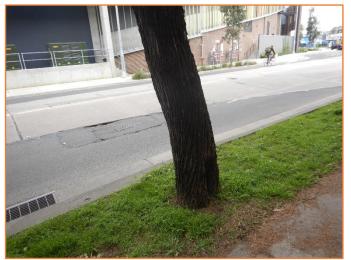
Figure 176: Reasonable - General condition of street planting.

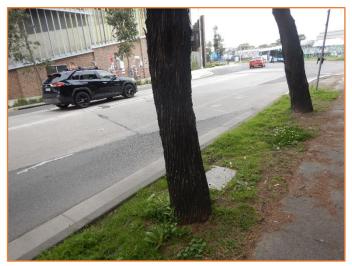
Figure 178: Reasonable - General condition of street planting.

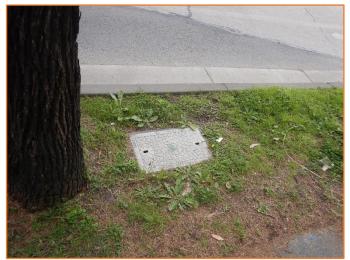
Figure 179: Reasonable - General condition of service pit.

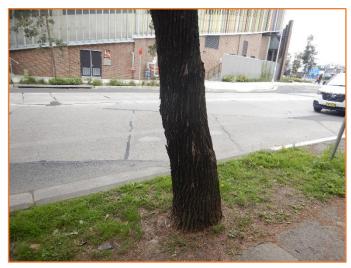
Figure 181: Reasonable - General condition of street planting.

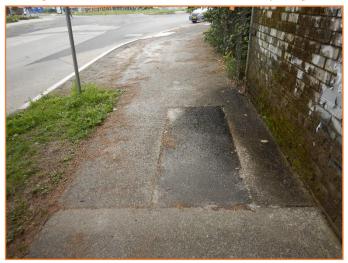
Figure 182: Reasonable - General condition of footpath. Previous repairs observed.

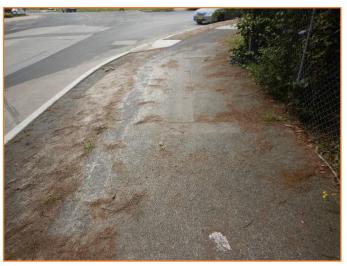
Figure 184: Reasonable - General condition of footpath.

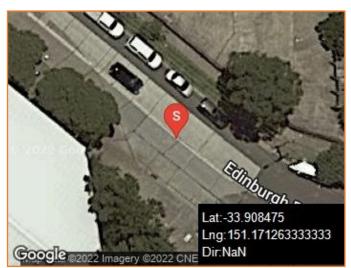
Figure 185: Reasonable - General condition of footpath.

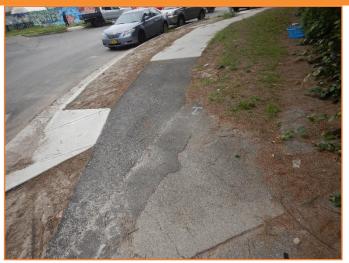
Figure 186: Reasonable - General condition of footpath. Minor cracking observed. Previous repairs observed.

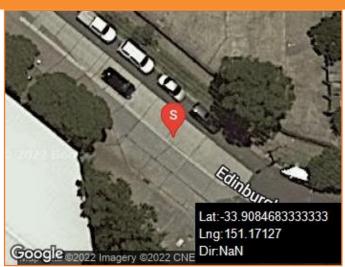
Figure 187: Reasonable - General condition of footpath. Minor cracking observed.

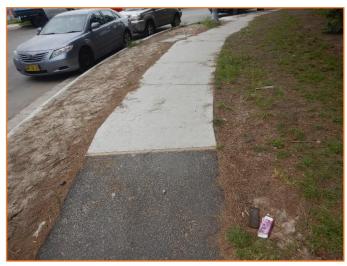
Figure 189: Reasonable - General condition of footpath.

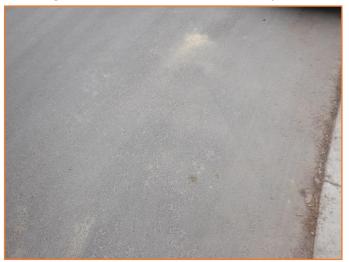
Figure 190: Reasonable - General condition of flexible pavement. Minor physical damage observed.

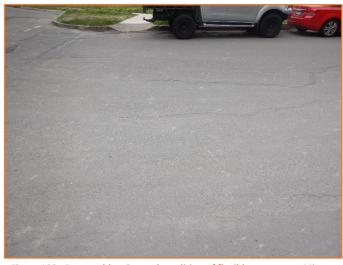
Figure 192: Reasonable - General condition of flexible pavement. Minor cracking observed.

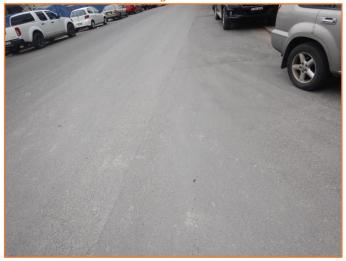
Figure 193: Reasonable - General condition of flexible pavement. Minor cracking observed.

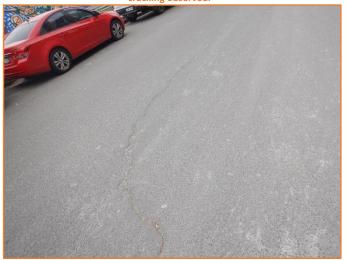
Figure 194: Reasonable - General condition of flexible pavement. Minor cracking observed.

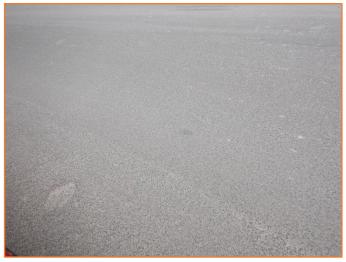
Figure 195: Reasonable - General condition of flexible pavement.

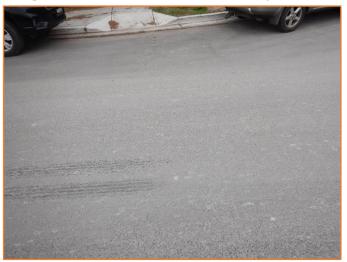
Figure 196: Reasonable - General condition of flexible pavement. Minor cracking observed.

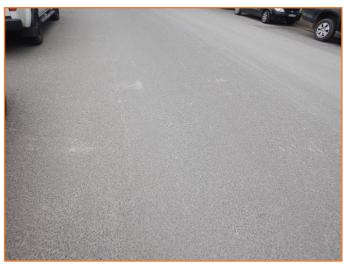
Figure 198: Reasonable - General condition of flexible pavement.

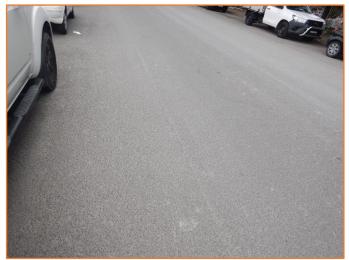
Figure 199: Reasonable - General condition of flexible pavement.

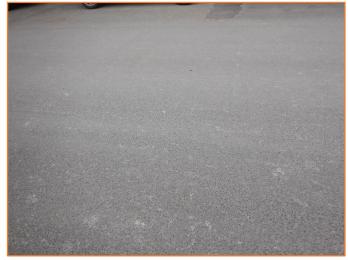
Figure 200: Reasonable - General condition of flexible pavement.

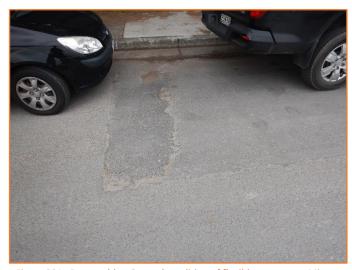
Figure 201: Reasonable - General condition of flexible pavement. Minor cracking observed. Previous repairs observed.

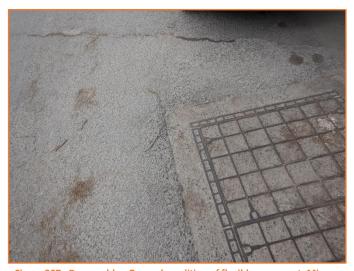
Figure 207: Reasonable - General condition of flexible pavement. Minor cracking observed.

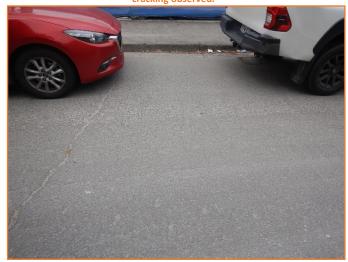
Figure 209: Reasonable - General condition of flexible pavement.

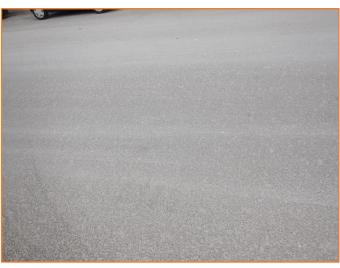
Figure 210: Reasonable - General condition of flexible pavement.

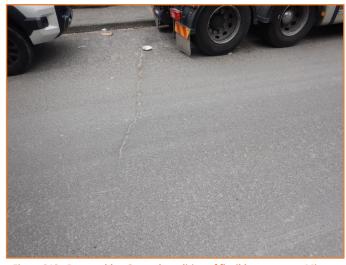
Figure 213: Reasonable - General condition of flexible pavement. Minor cracking observed.

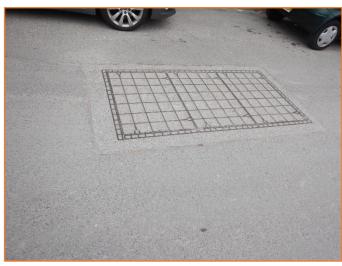
Figure 216: Reasonable - General condition of service pit.

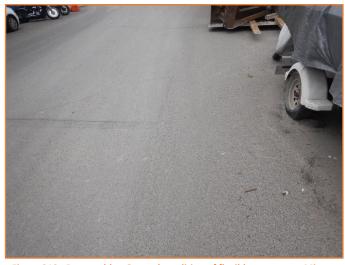
Figure 219: Reasonable - General condition of flexible pavement. Minor cracking observed.

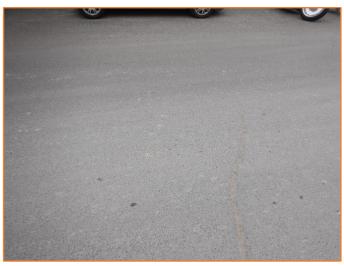
Figure 222: Reasonable - General condition of flexible pavement. Minor cracking observed.

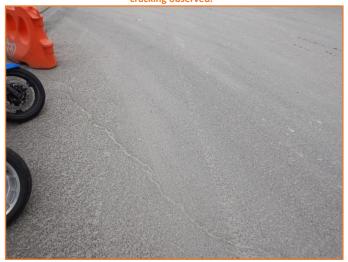
Figure 224: Reasonable - General condition of flexible pavement. Minor cracking observed.

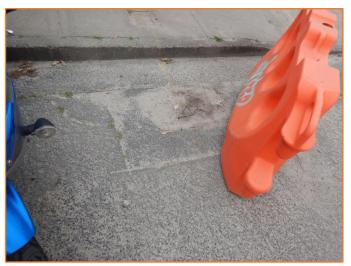
Figure 225: Reasonable - General condition of flexible pavement. Minor cracking observed. Previous repairs observed.

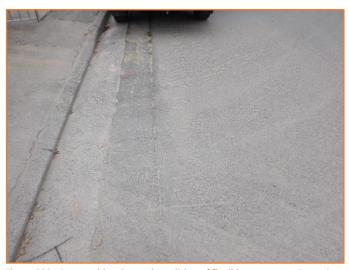
Figure 228: Reasonable - General condition of flexible pavement. Extensive cracking observed. Previous repairs observed.

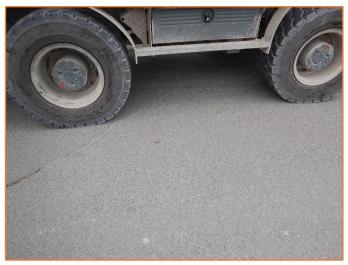
Figure 231: Reasonable - General condition of flexible pavement. Minor cracking observed.

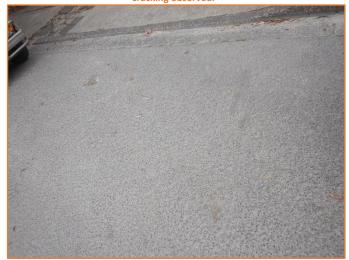
Figure 233: Reasonable - General condition of flexible pavement.

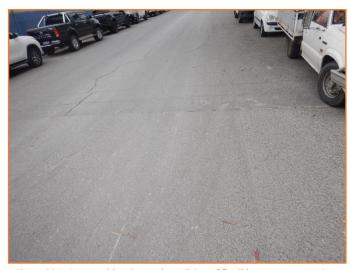
Figure 234: Reasonable - General condition of flexible pavement. Major cracking observed.

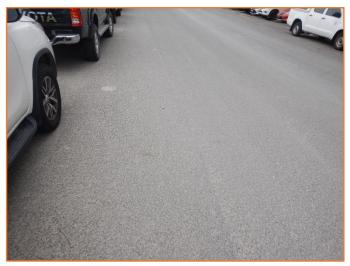
Figure 237: Reasonable - General condition of flexible pavement.

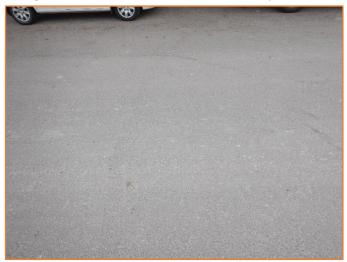
Figure 238: Reasonable - General condition of flexible pavement. Minor cracking observed.

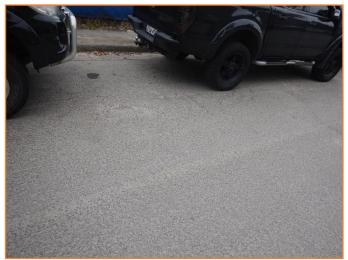
Figure 241: Reasonable - General condition of flexible pavement.

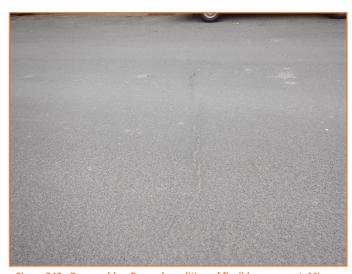
Figure 243: Reasonable - General condition of flexible pavement. Minor cracking observed.

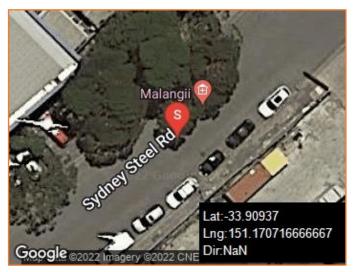
Figure 244: Reasonable - General condition of flexible pavement.

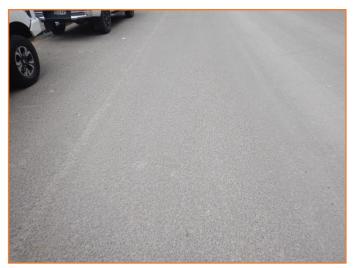
Figure 246: Reasonable - General condition of flexible pavement.

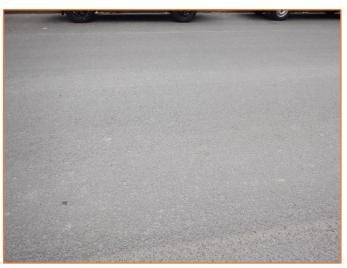
Figure 249: Reasonable - General condition of flexible pavement.

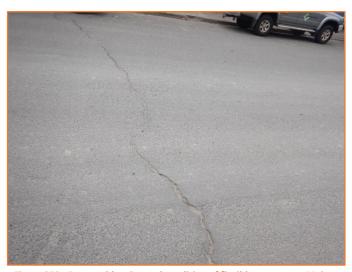
Figure 252: Reasonable - General condition of flexible pavement. Major cracking observed.

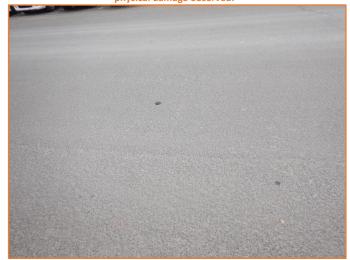
Figure 254: Reasonable - General condition of flexible pavement.

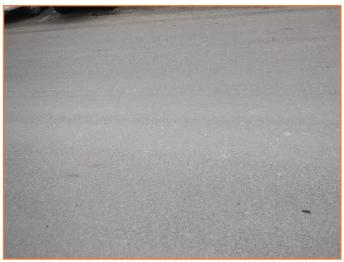
Figure 255: Reasonable - General condition of flexible pavement.

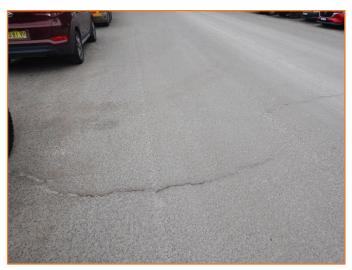
Figure 258: Reasonable - General condition of flexible pavement. Major cracking observed.

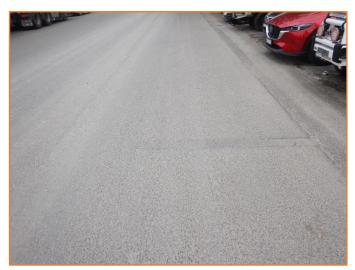
Figure 261: Reasonable - General condition of flexible pavement. Previous repairs observed.

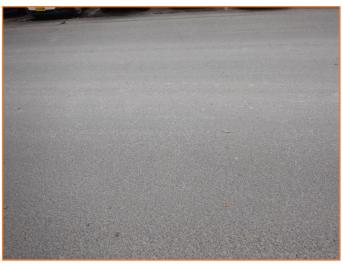
Figure 264: Reasonable - General condition of flexible pavement.

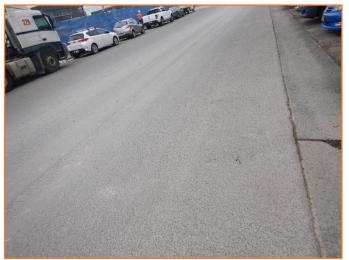
Figure 265: Reasonable - General condition of flexible pavement.

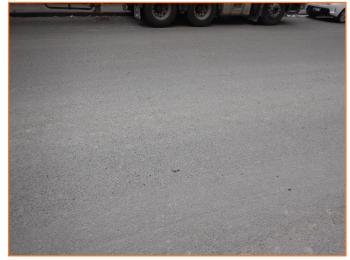
Figure 266: Reasonable - General condition of flexible pavement.

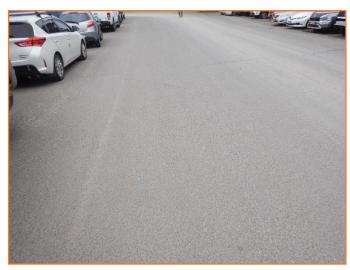
Figure 267: Reasonable - General condition of flexible pavement.

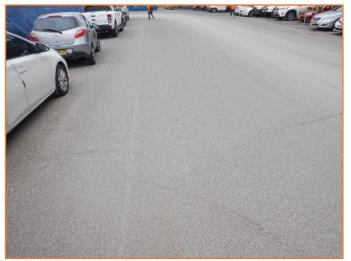
Figure 268: Reasonable - General condition of flexible pavement. Minor cracking observed.

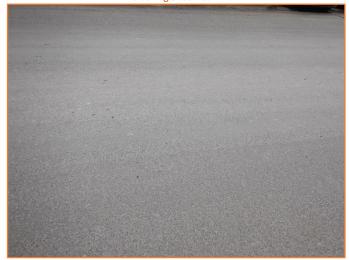
Figure 269: Reasonable - General condition of flexible pavement.

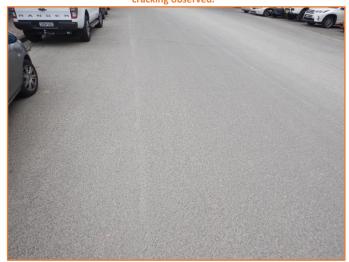
Figure 271: Reasonable - General condition of flexible pavement.

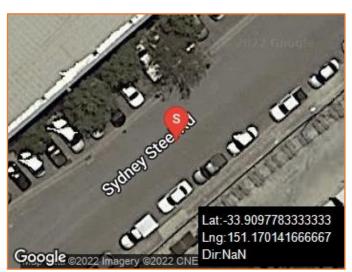
Figure 272: Reasonable - General condition of flexible pavement.

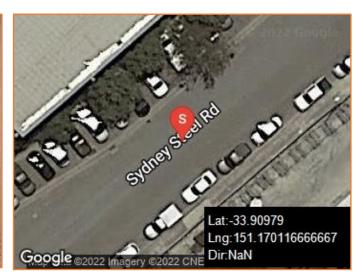
Figure 273: Reasonable - General condition of flexible pavement. Major cracking observed.

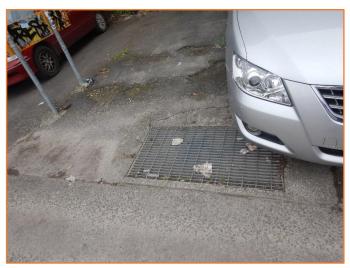
Figure 276: Reasonable - General condition of service pit. Minor cracking observed.

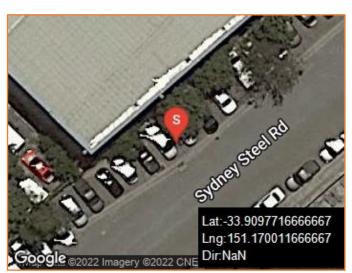
Figure 278: Reasonable - General condition of flexible pavement.

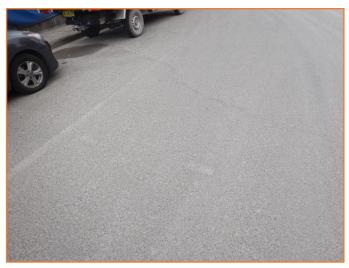
Figure 279: Reasonable - General condition of flexible pavement. Minor cracking observed.

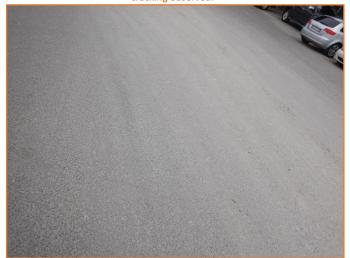
Figure 280: Reasonable - General condition of flexible pavement.

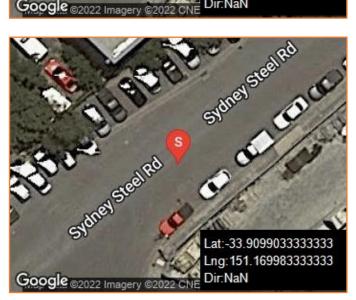
Figure 282: Reasonable - General condition of flexible pavement.

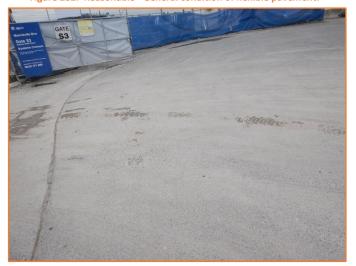
Figure 283: Reasonable - General condition of flexible pavement.

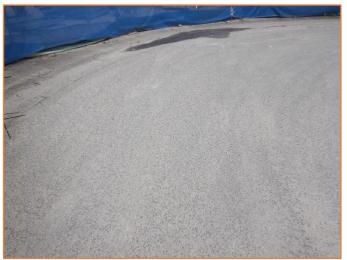
Figure 286: Reasonable - General condition of flexible pavement.

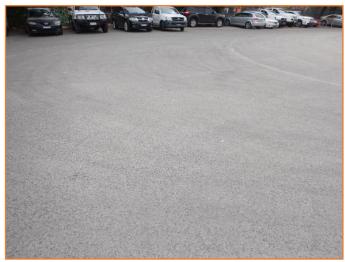
Figure 288: Reasonable - General condition of flexible pavement.

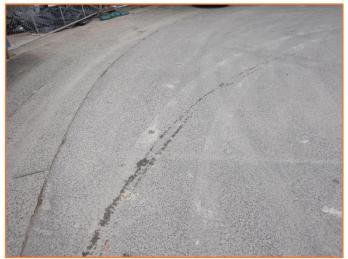
Figure 289: Reasonable - General condition of flexible pavement.

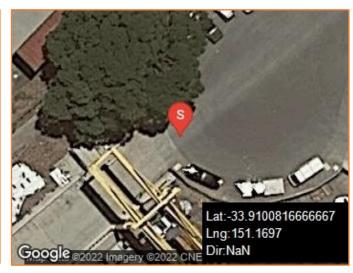
Figure 292: Reasonable - General condition of flexible pavement.

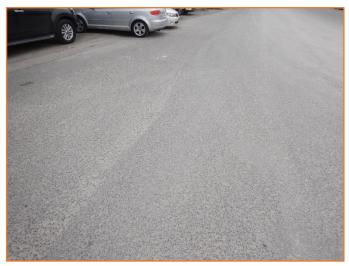
Figure 294: Reasonable - General condition of flexible pavement.

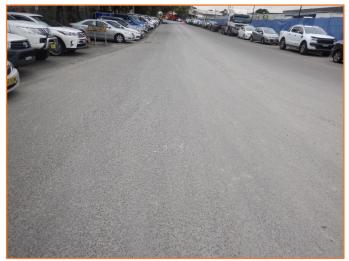
Figure 295: Reasonable - General condition of flexible pavement.

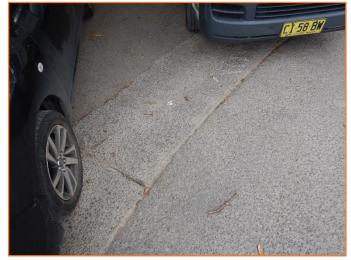
Figure 296: Reasonable - General condition of kerb and gutter.

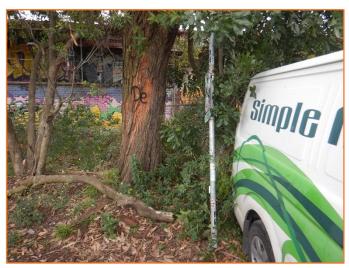
Figure 297: Reasonable - General condition of signage. Minor rotation

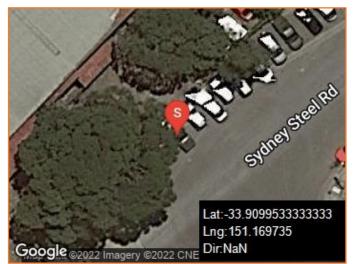
Figure 298: Reasonable - General condition of kerb and gutter.

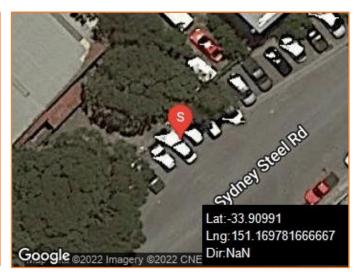
Figure 299: Reasonable - General condition of kerb and gutter.

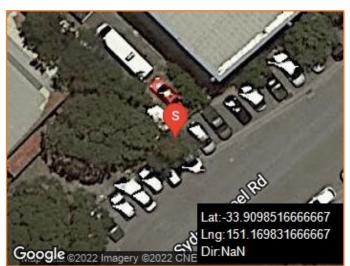
Figure 302: Reasonable - General condition of kerb and gutter.

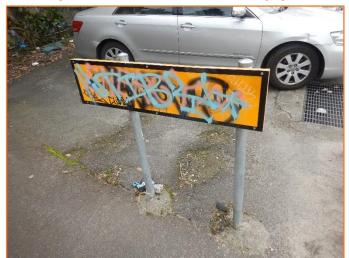
Figure 304: Reasonable - General condition of signage.

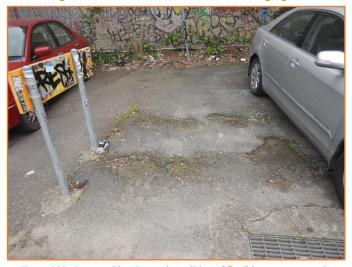
Figure 305: Reasonable - General condition of flexible pavement and signage. Moderate potholes and cracking observed.

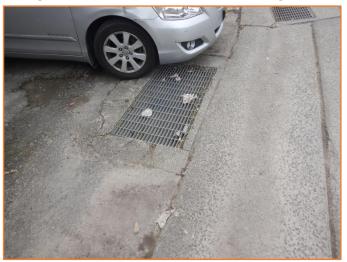
Figure 307: Reasonable - General condition of kerb and gutter. Minor cracking observed.

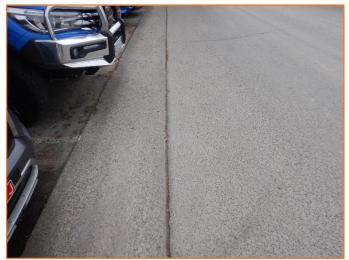
Figure 310: Reasonable - General condition of kerb and gutter.

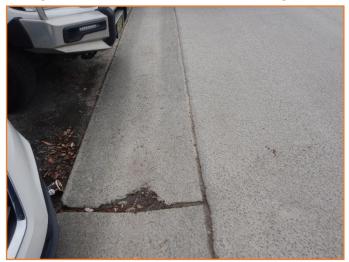
Figure 316: Reasonable - General condition of kerb and gutter. Minor spalling observed.

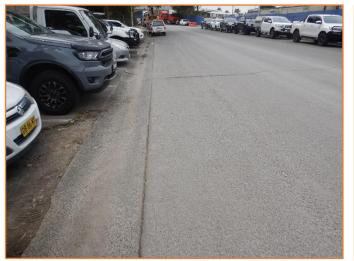
Figure 323: Reasonable - General condition of kerb and gutter. Minor cracking observed.

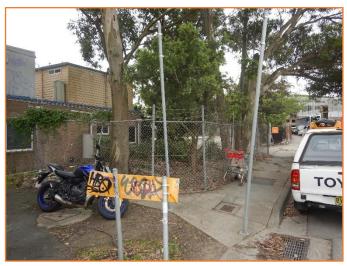
Figure 333: Reasonable - General condition of signage. Minor rotation observed.

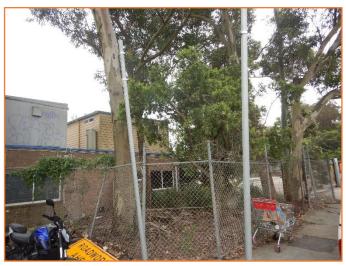
Figure 336: Reasonable - General condition of signage. Minor rotation observed.

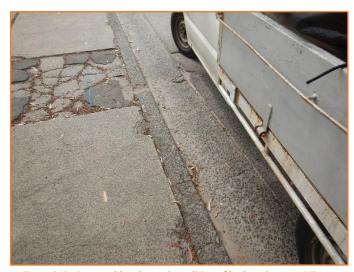
Figure 342: Reasonable - General condition of kerb and gutter. Minor cracking observed.

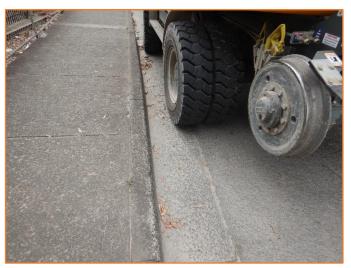
Figure 345: Reasonable - General condition of kerb and gutter.

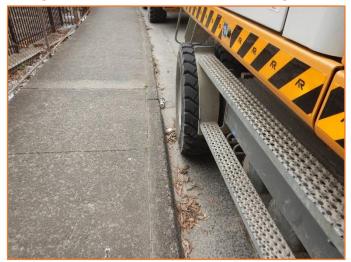
Figure 346: Reasonable - General condition of kerb and gutter.

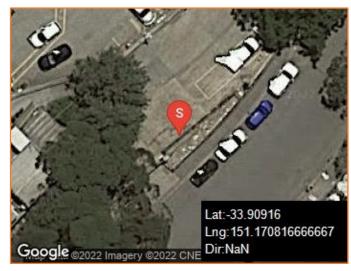
Figure 349: Reasonable - General condition of kerb and gutter.

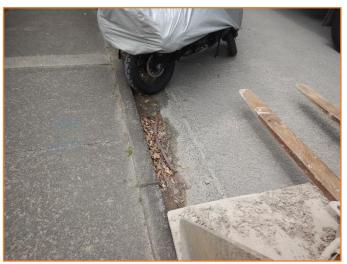
Figure 351: Reasonable - General condition of kerb and gutter.

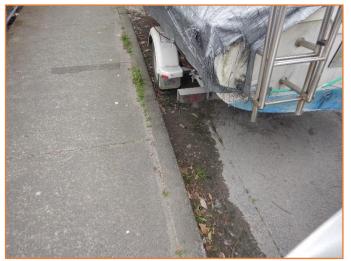
Figure 352: Reasonable - General condition of kerb and gutter.

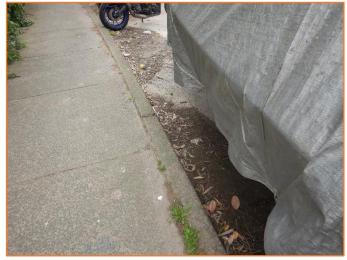
Figure 353: Reasonable - General condition of kerb and gutter.

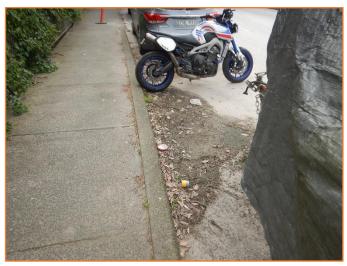
Figure 354: Reasonable - General condition of kerb and gutter.

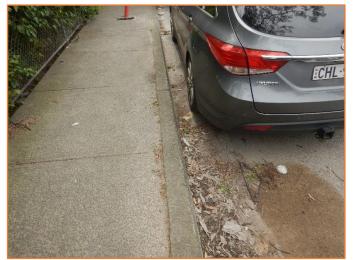
Figure 355: Reasonable - General condition of kerb and gutter.

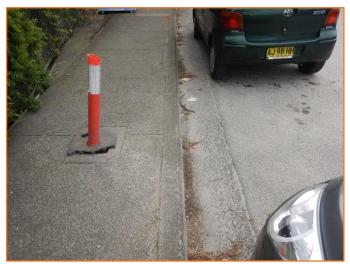
Figure 357: Reasonable - General condition of kerb and gutter.

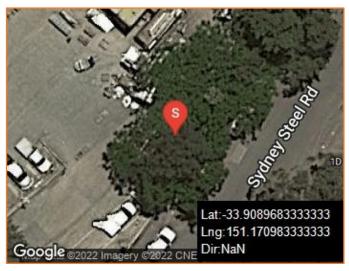
Figure 358: Reasonable - General condition of kerb and gutter.

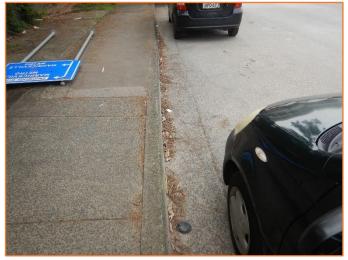
Figure 359: Reasonable - General condition of kerb and gutter.

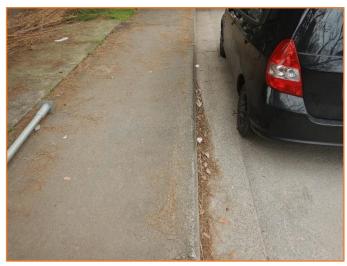
Figure 360: Reasonable - General condition of kerb and gutter.

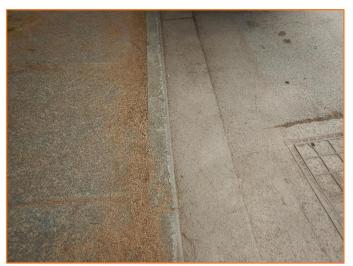
Figure 363: Reasonable - General condition of kerb and gutter.

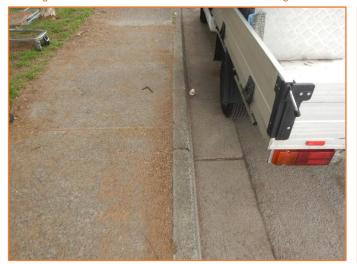
Figure 364: Reasonable - General condition of kerb and gutter.

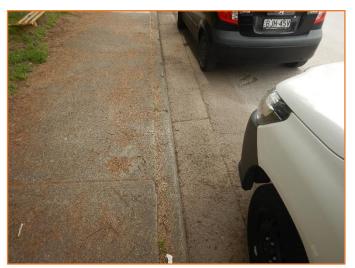
Figure 366: Reasonable - General condition of kerb and gutter.

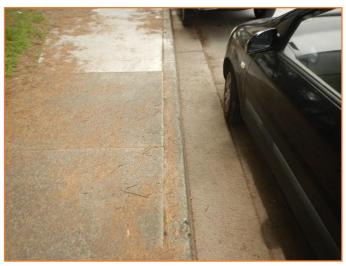
Figure 369: Reasonable - General condition of kerb and gutter.

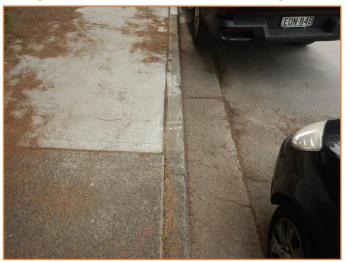
Figure 370: Reasonable - General condition of kerb and gutter. Minor cracking observed.

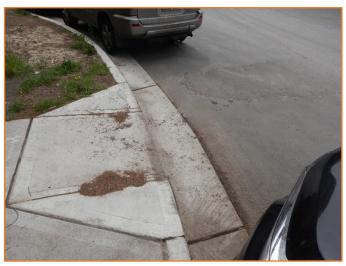
Figure 372: Reasonable - General condition of kerb and gutter.

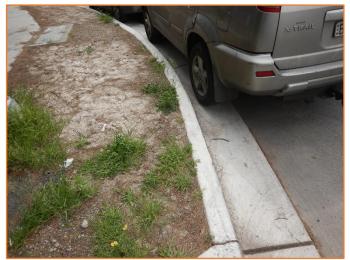
Figure 373: Reasonable - General condition of kerb and gutter.

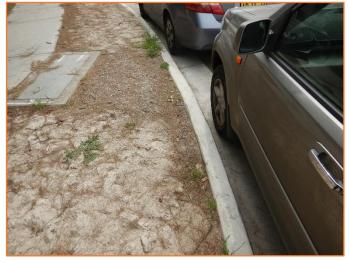
Figure 374: Reasonable - General condition of kerb and gutter.

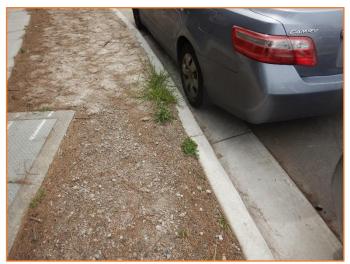
Figure 375: Reasonable - General condition of kerb and gutter.

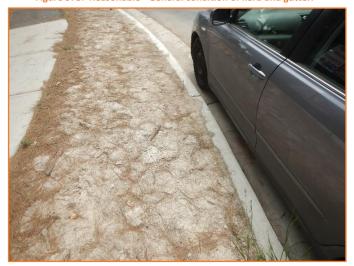
Figure 376: Reasonable - General condition of kerb and gutter.

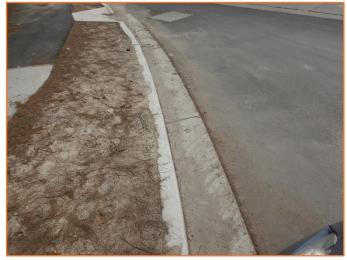
Figure 377: Reasonable - General condition of kerb and gutter.

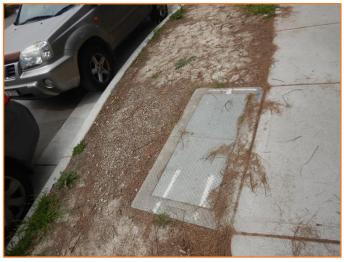
Figure 378: Reasonable - General condition of service pit.

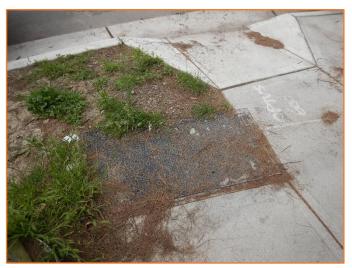
Figure 381: Reasonable - General condition of service pit.

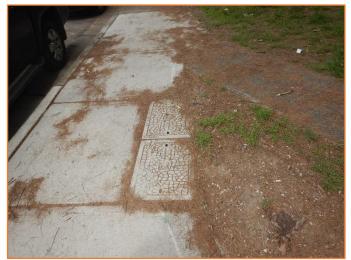
Figure 382: Reasonable - General condition of service pit.

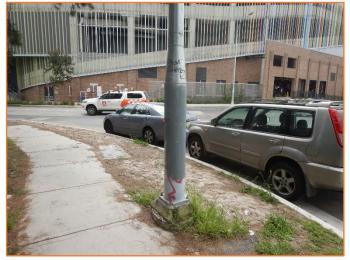
Figure 383: Reasonable - General condition of monopole assembly.

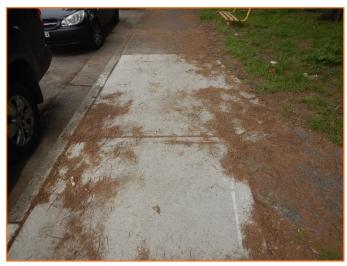
Figure 387: Reasonable - General condition of footpath.

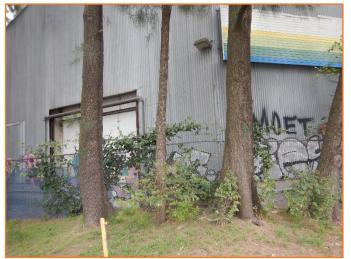
Figure 388: Reasonable - General condition of street planting.

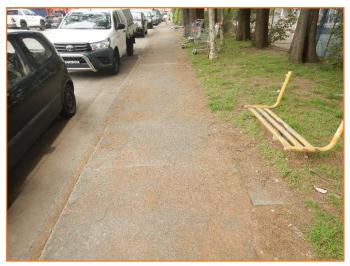
Figure 389: Reasonable - General condition of street planting.

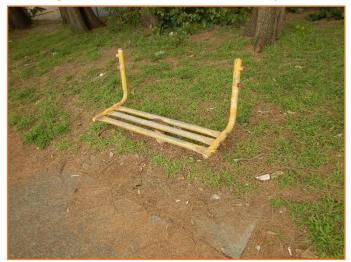
Figure 390: Reasonable - General condition of footpath.

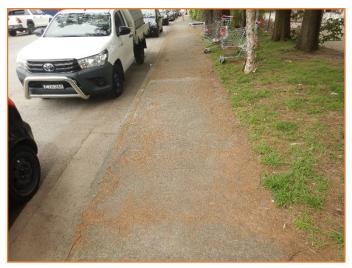
Figure 392: Reasonable - General condition of street planting.

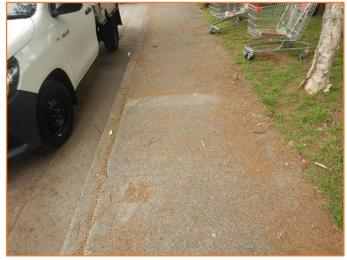
Figure 394: Reasonable - General condition of street planting.
