DILAPIDATION REPORT

74 EDINBURGH ROAD, MARRICKVILLE NSW 2204

Docui	ment Information
Job Number	221079
Document Number	1
Report Title	Dilapidation Report
Site Address	74 Edinburgh Road, Marrickville NSW 2204
Lot	202 in DP1133999

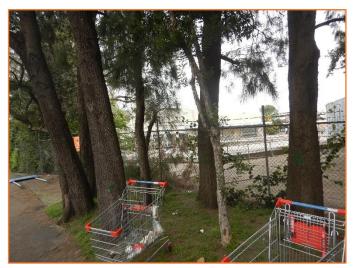
Figure 395: Reasonable - General condition of footpath. Minor cracking observed.

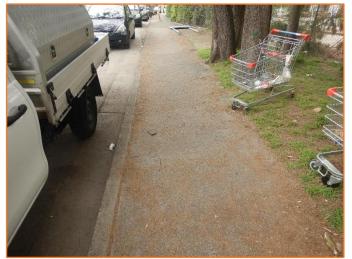
Figure 396: Reasonable - General condition of street planting.

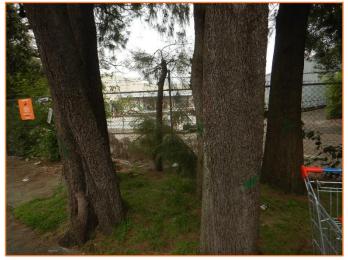
Figure 397: Reasonable - General condition of footpath.

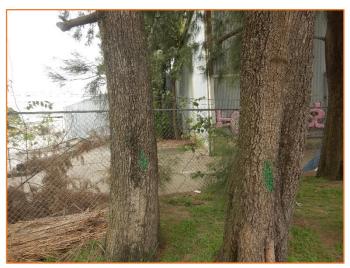
Figure 398: Reasonable - General condition of street planting.

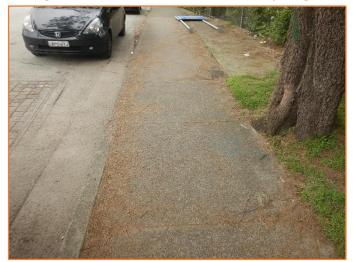
Figure 399: Reasonable - General condition of street planting.

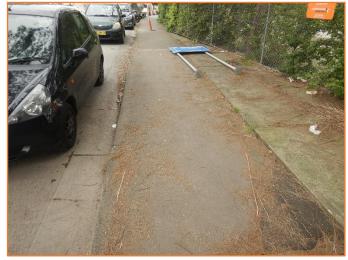
Figure 400: Reasonable - General condition of footpath.

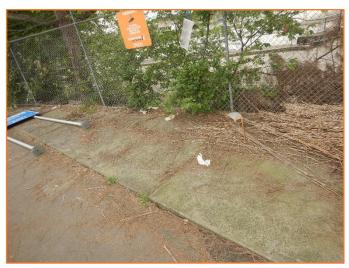
Figure 401: Reasonable - General condition of footpath.

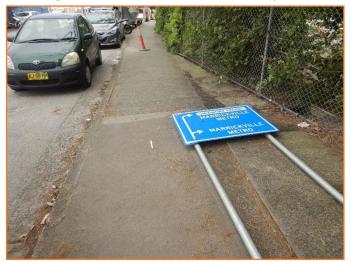
Figure 402: Reasonable - General condition of footpath.

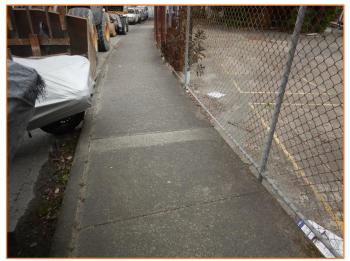
Figure 408: Reasonable - General condition of footpath.

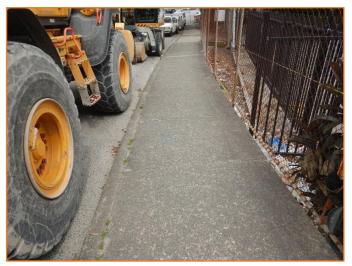
Figure 410: Reasonable - General condition of footpath. Minor cracking observed.

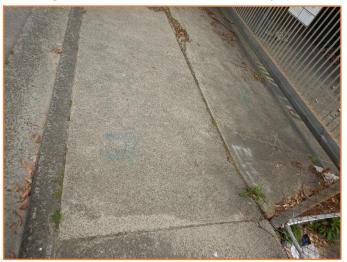
Figure 414: Reasonable - General condition of footpath.

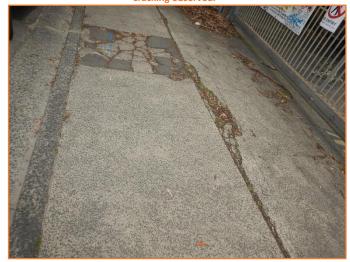
Figure 415: Reasonable - General condition of driveway crossover. Minor cracking observed.

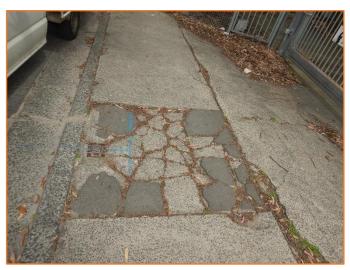
Figure 416: Reasonable - General condition of driveway crossover. Extensive cracking observed.

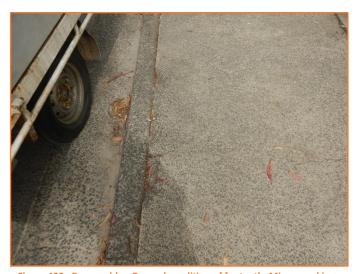
Figure 419: Reasonable - General condition of driveway crossover. Minor cracking observed.

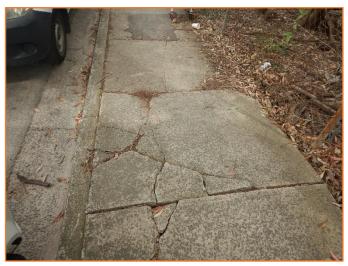
Figure 422: Poor - General condition of footpath. Extensive cracking observed.

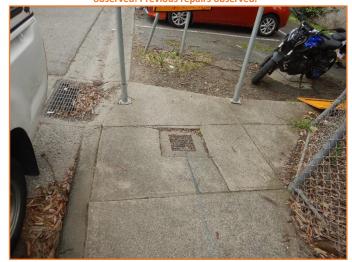
Figure 424: Reasonable - General condition of footpath. Major cracking observed. Previous repairs observed.

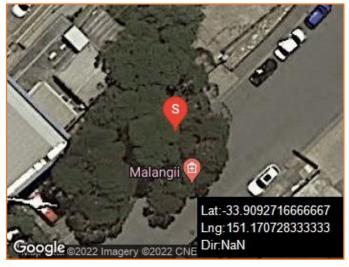
Figure 425: Reasonable - General condition of footpath. Minor cracking observed.

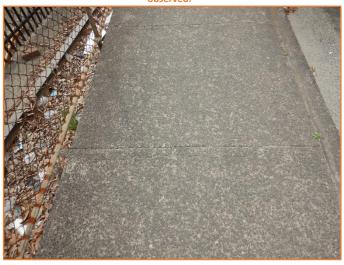
Figure 427: Reasonable - General condition of footpath. Minor cracking observed.

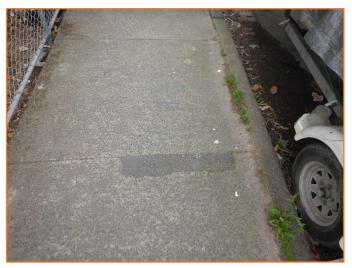
Figure 428: Reasonable - General condition of footpath.

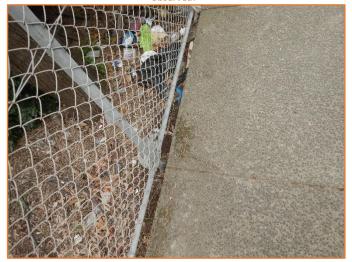
Figure 429: Reasonable - General condition of footpath. Previous repairs observed.

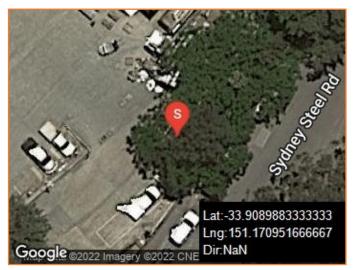
Figure 431: Reasonable - General condition of footpath. Previous repairs observed.

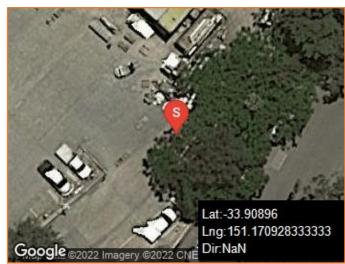
Figure 432: Reasonable - General condition of footpath. Previous repairs observed.

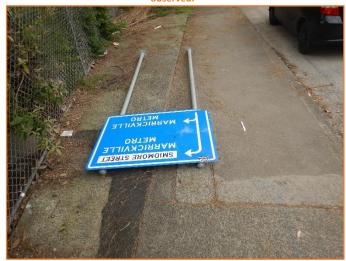
Figure 433: Reasonable - General condition of footpath. Major physical damage observed. Previous repairs observed.

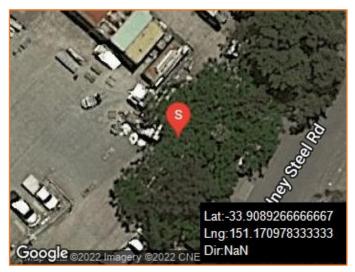
Figure 434: Reasonable - General condition of footpath. Previous repairs observed.

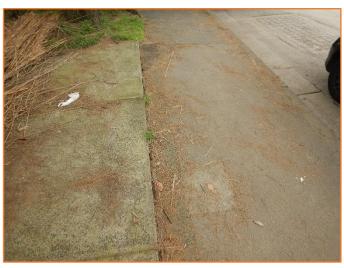
Figure 435: Reasonable - General condition of footpath. Minor cracking observed.

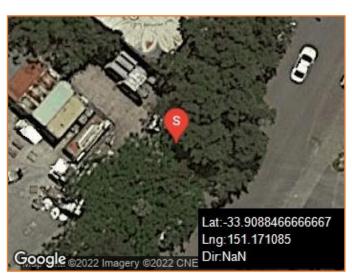
Figure 436: Reasonable - General condition of footpath.

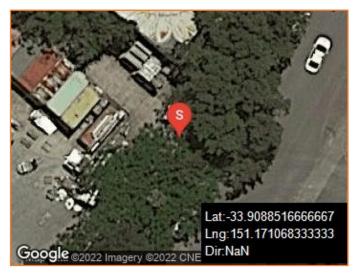
Figure 437: Reasonable - General condition of footpath.

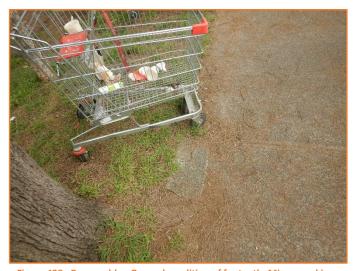
Figure 438: Reasonable - General condition of footpath. Minor cracking observed.

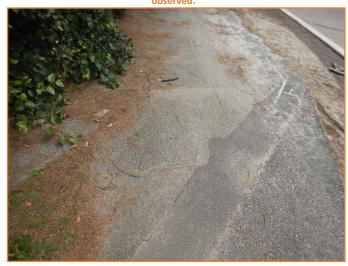
Figure 440: Reasonable - General condition of footpath. Minor cracking observed. Previous repairs observed.

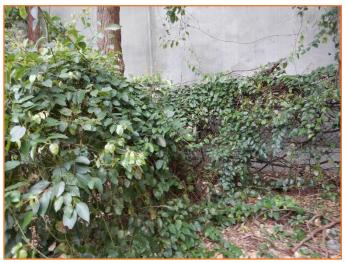
Figure 525: Poor - General condition of fence. Major physical damage observed.

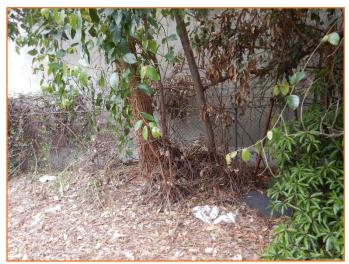
Figure 529: Reasonable - General condition of fence.

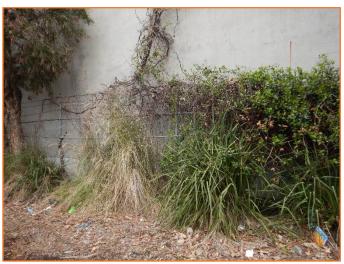
Figure 531: Reasonable - General condition of fence.
