## DILAPIDATION REPORT

MUSEUM DISCOVERY CENTRE

MONDAY, 9 AUGUST 2021

Document Information	
Job Number	210722
Document Number	3
Report Title	Dilapidation Report
Site Address	172 Showground Road and 2 Green Road Castle Hill, NSW, 2154
Lot	1 in DP1066281 & 102 in DP1130271

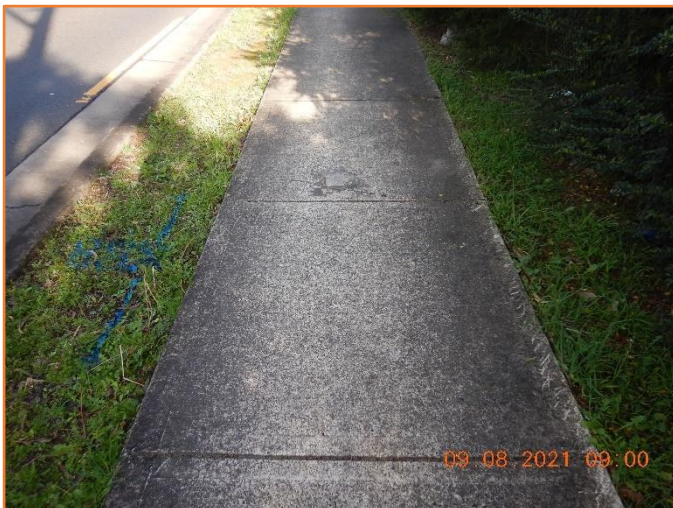
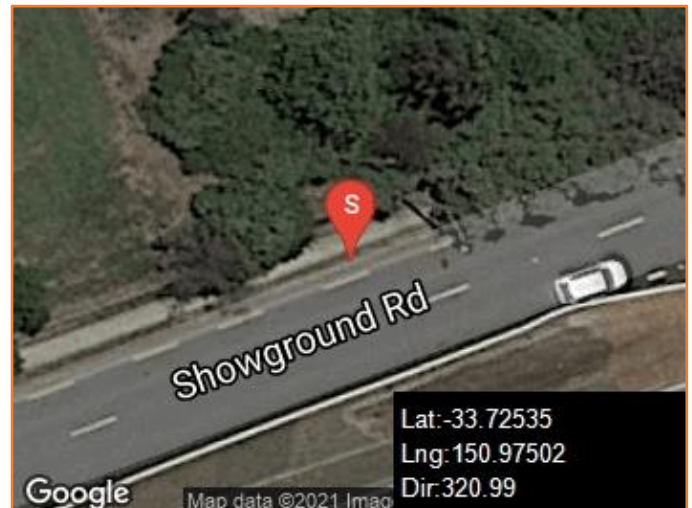
Figure 2: Good - General condition of footpath.

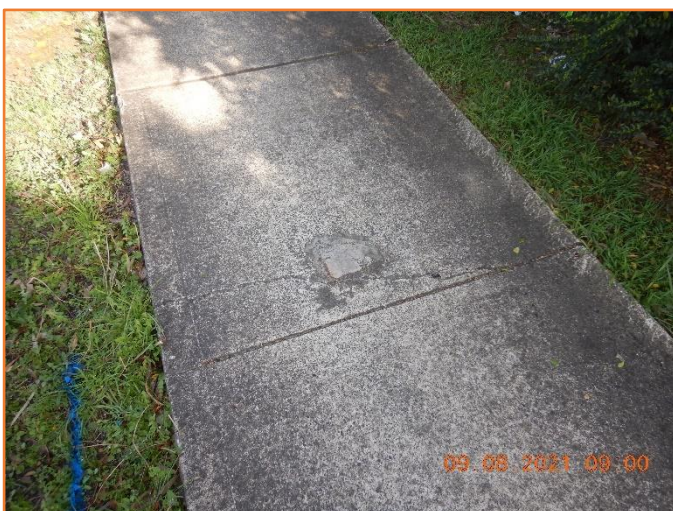
Figure 3: Reasonable - General condition of footpath. Moderate cracking and physical damage observed.

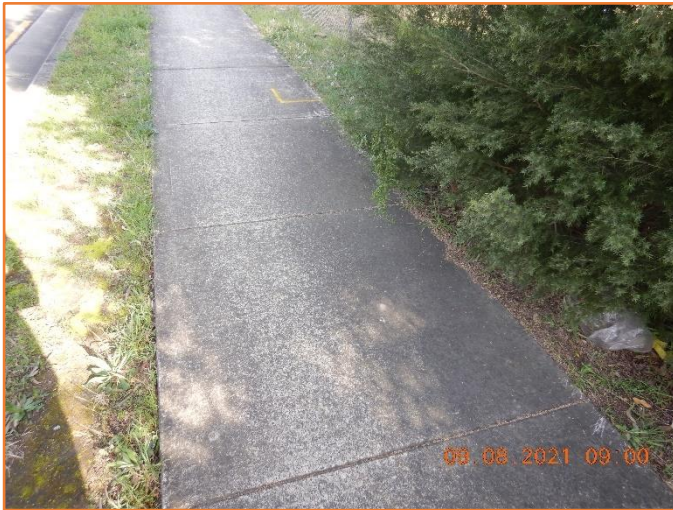
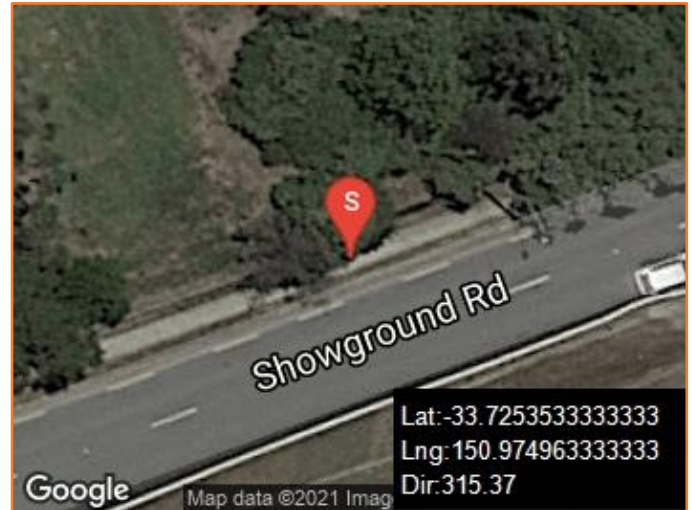
Figure 4: Good - General condition of footpath.

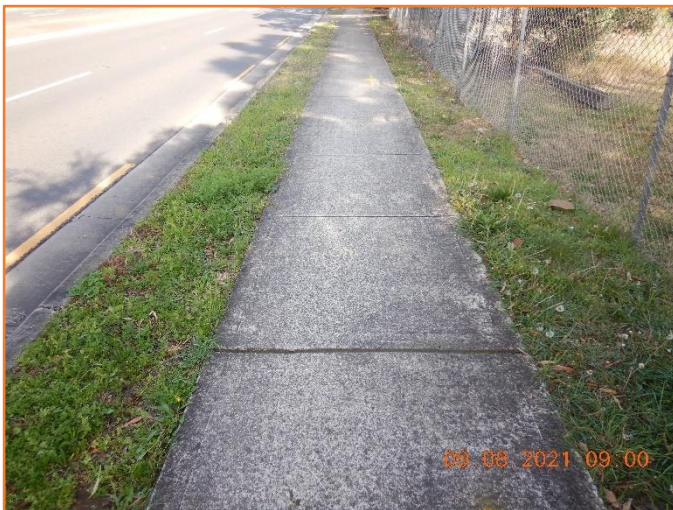
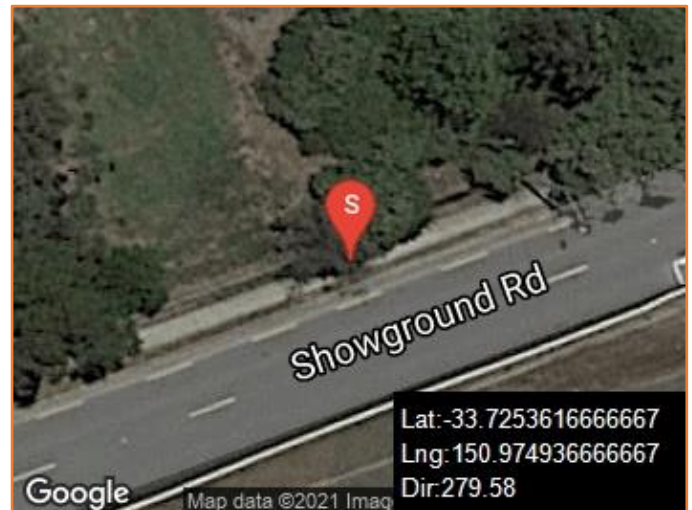
Figure 5: Good - General condition of footpath.

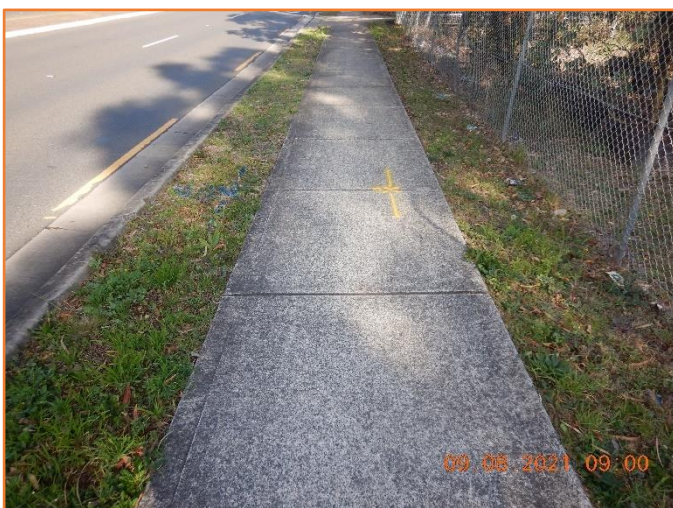
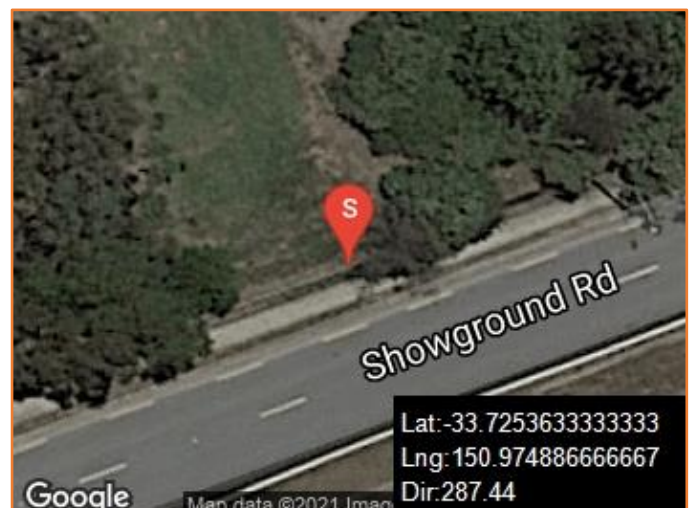
Figure 6: Good - General condition of footpath.

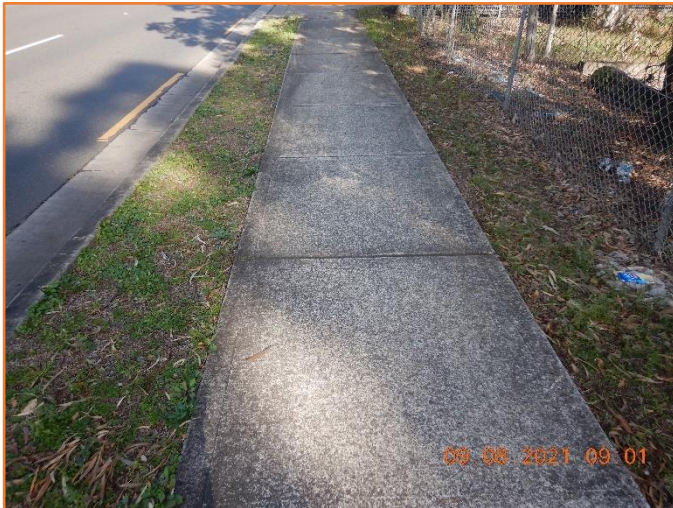
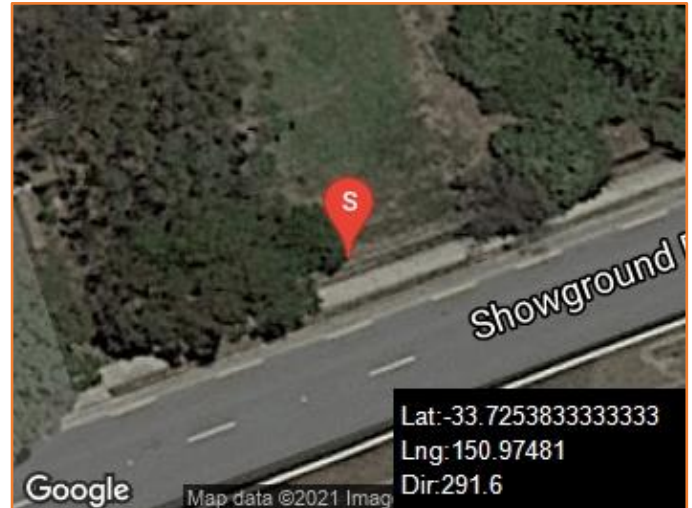
Figure 7: Good - General condition of footpath.

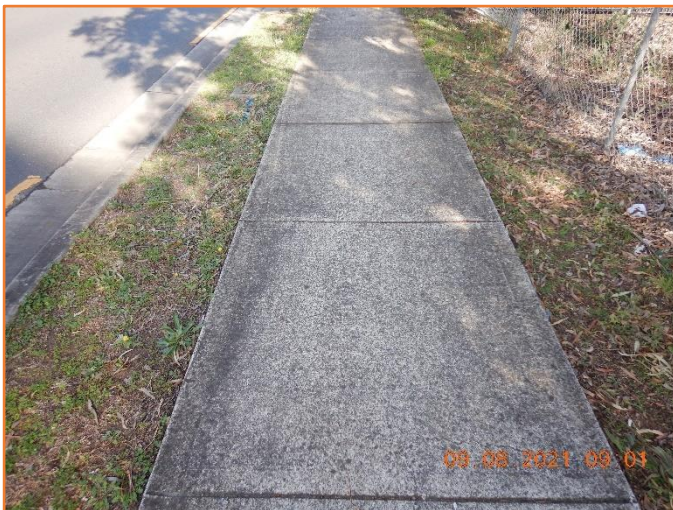
Figure 8: Good - General condition of footpath.

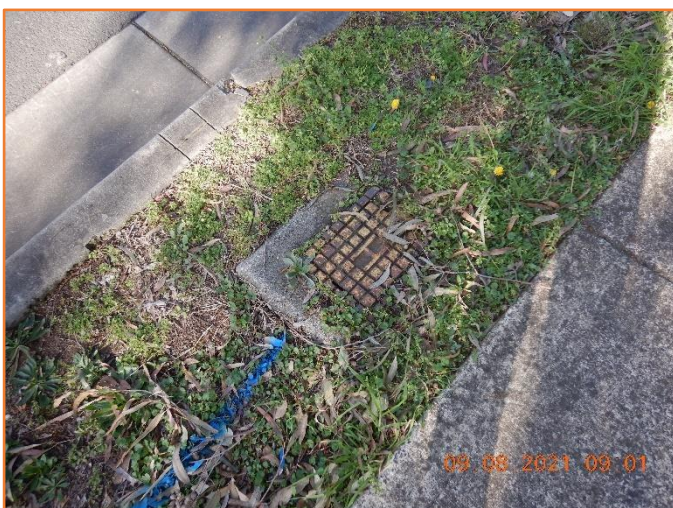
Figure 9: Reasonable - General condition of service pit.

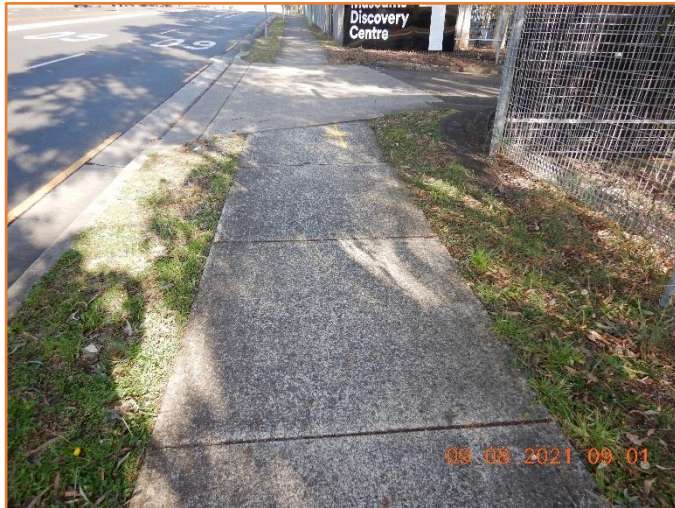
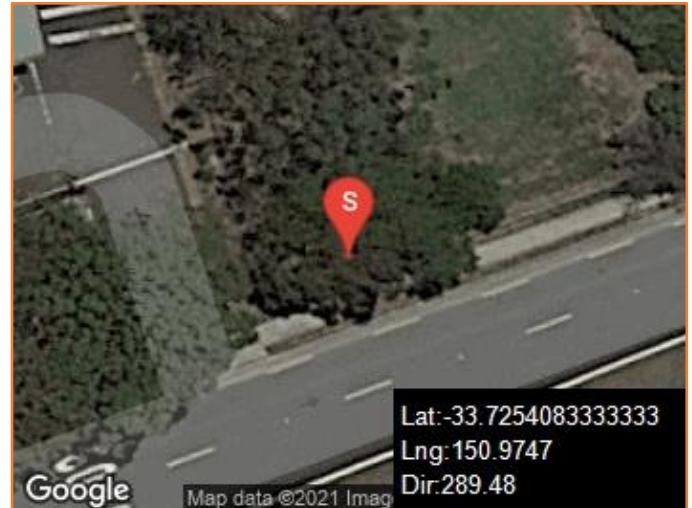
Figure 10: Good - General condition of footpath.

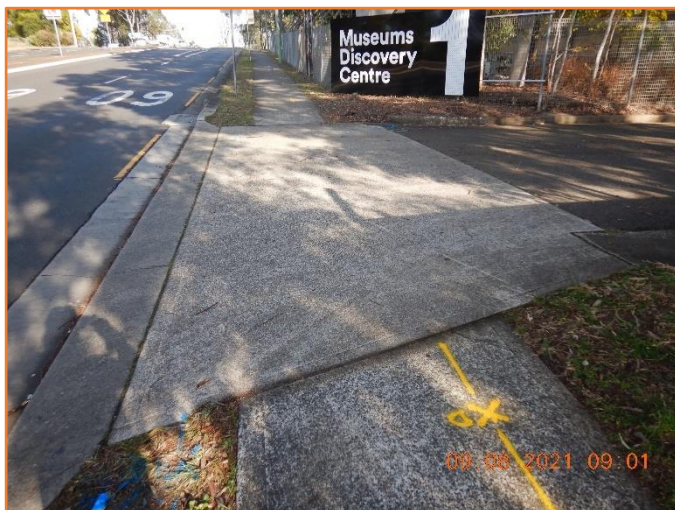
Figure 11: Reasonable - General condition of driveway crossover.

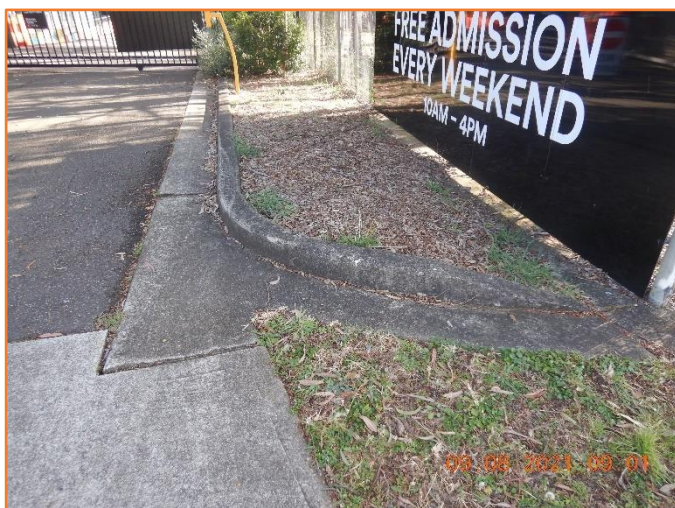
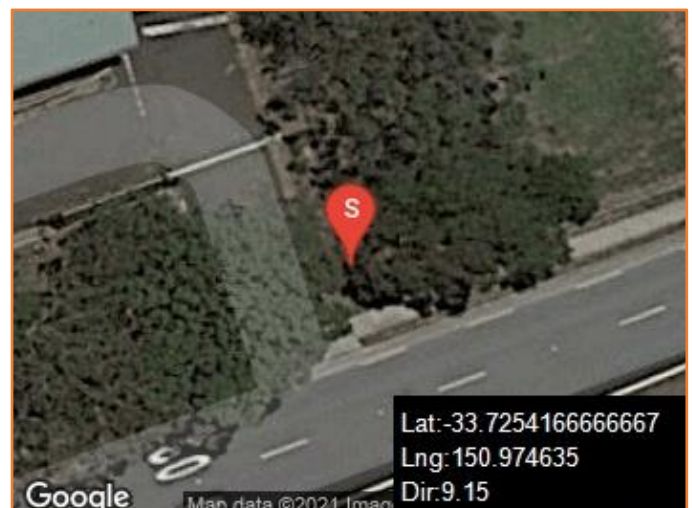
Figure 12: Reasonable - General condition of kerb and gutter.

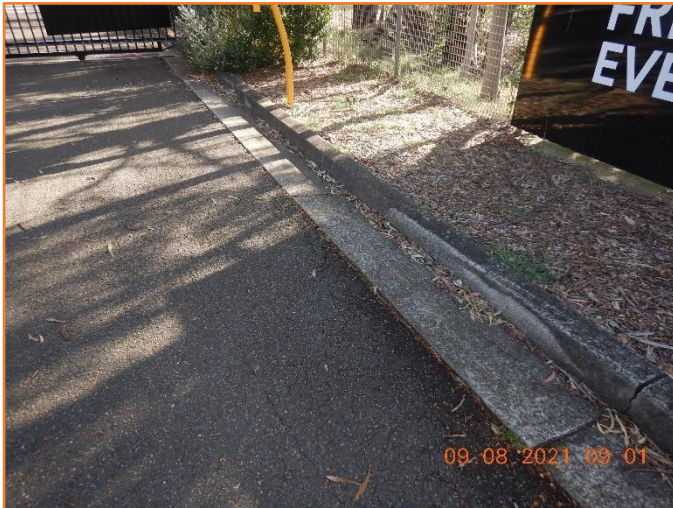
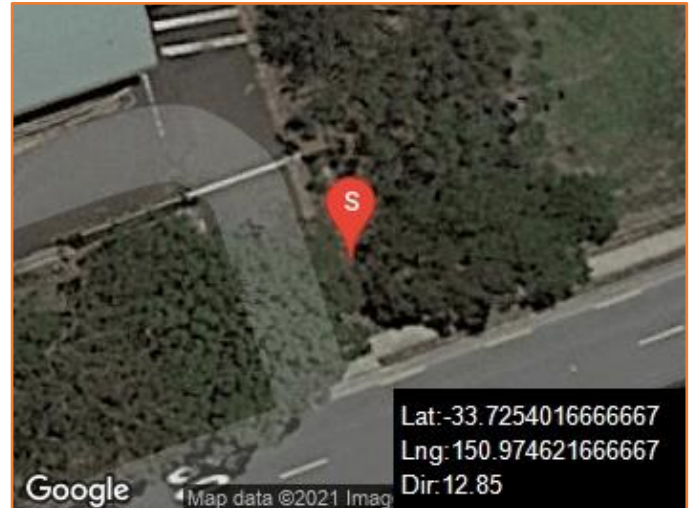
Figure 13: Reasonable - General condition of kerb and gutter.

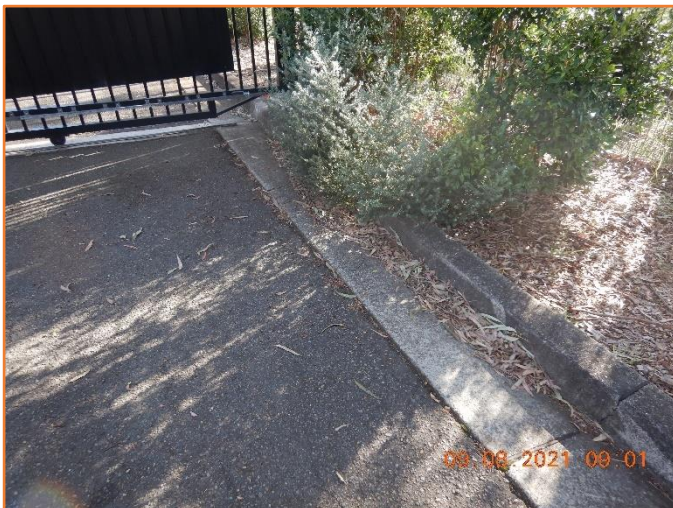
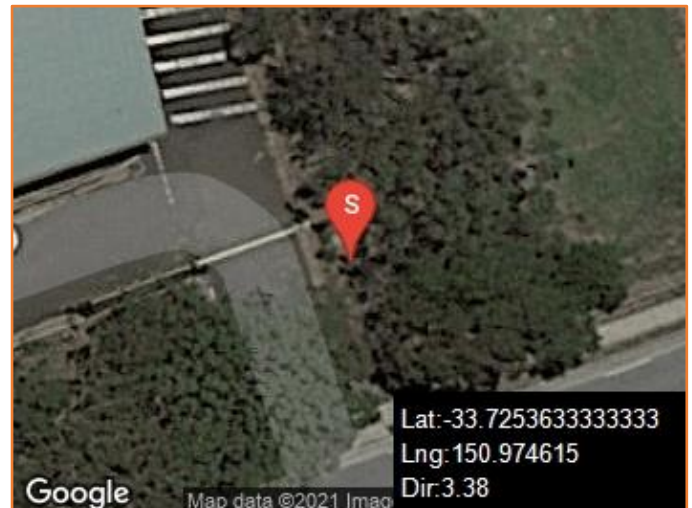
Figure 14: Reasonable - General condition of kerb and gutter.

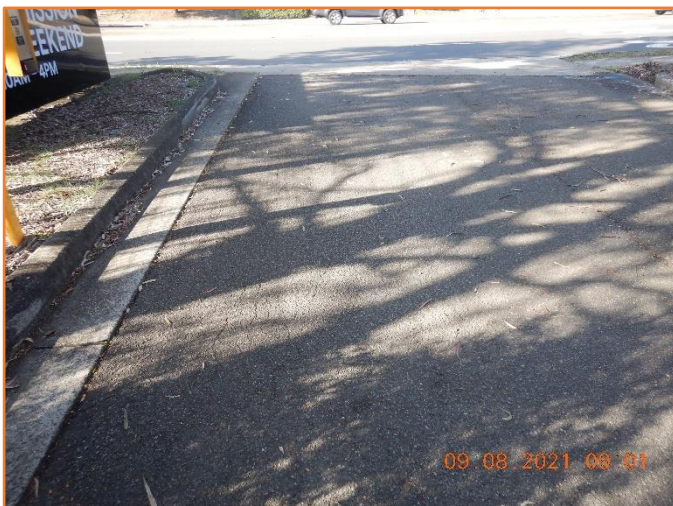
Figure 15: Reasonable - General condition of flexible pavement. Moderate cracking observed.

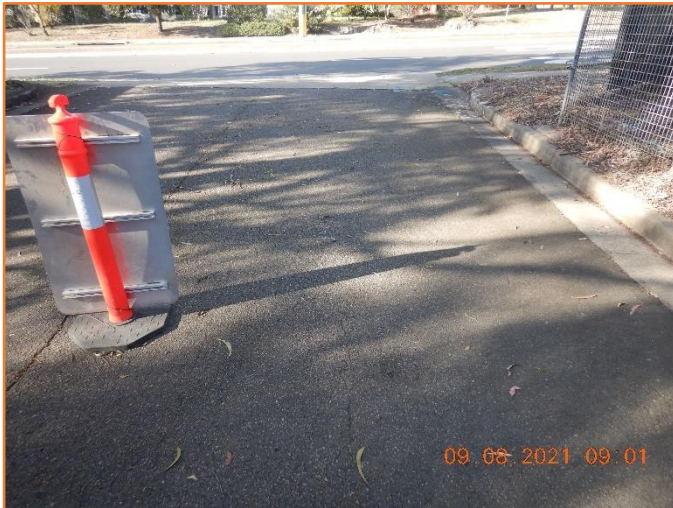
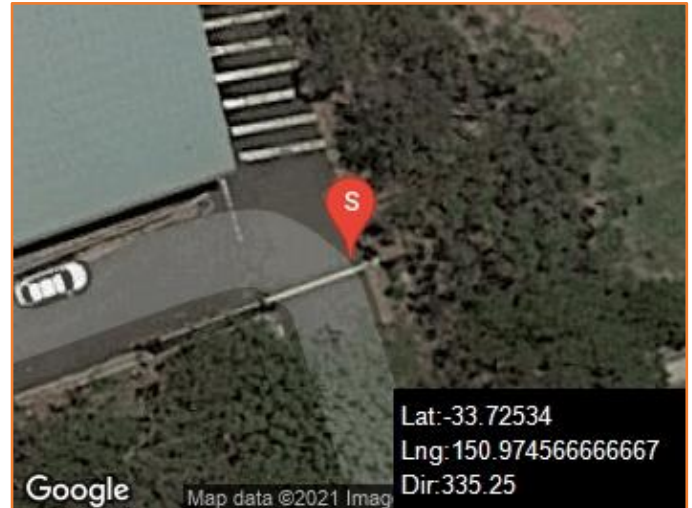
Figure 16: Reasonable - General condition of flexible pavement. Moderate cracking observed.

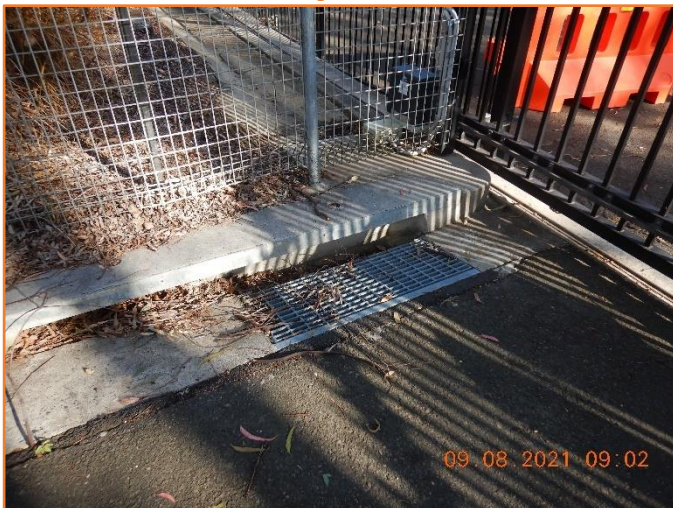
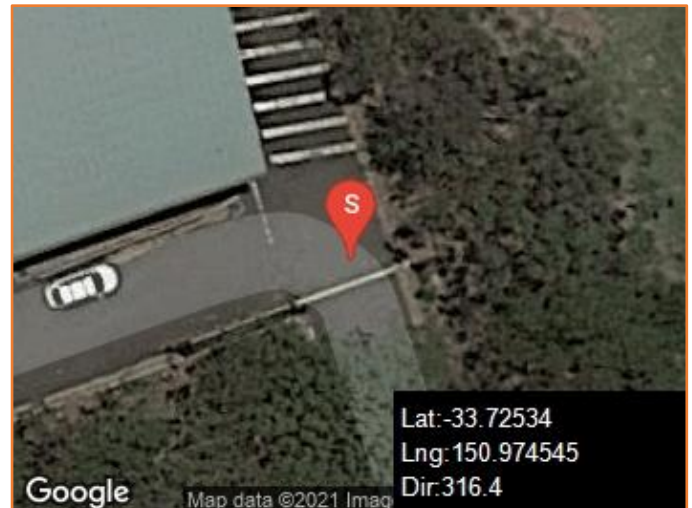
Figure 17: Good - General condition of kerb inlet pit.

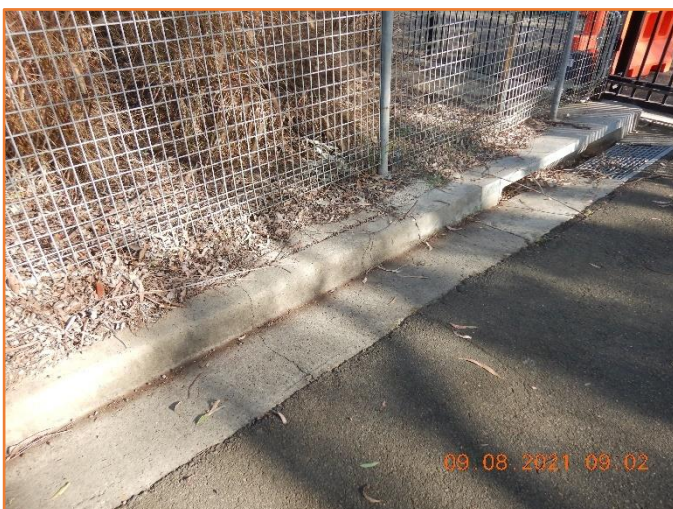
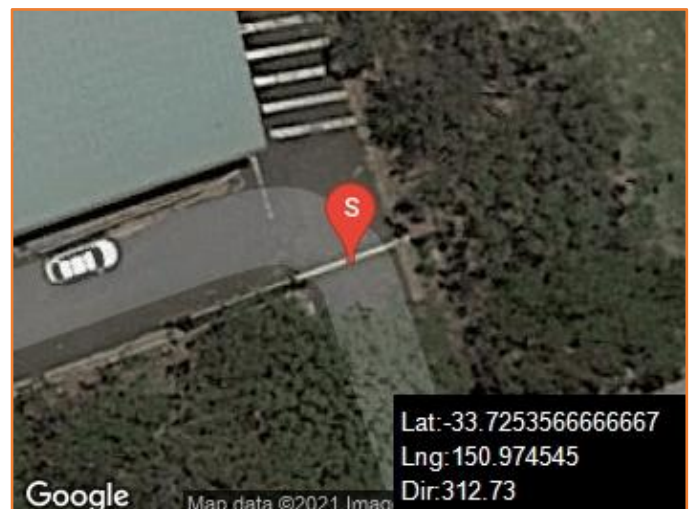
Figure 18: Reasonable - General condition of kerb and gutter. Minor hairline cracking observed.

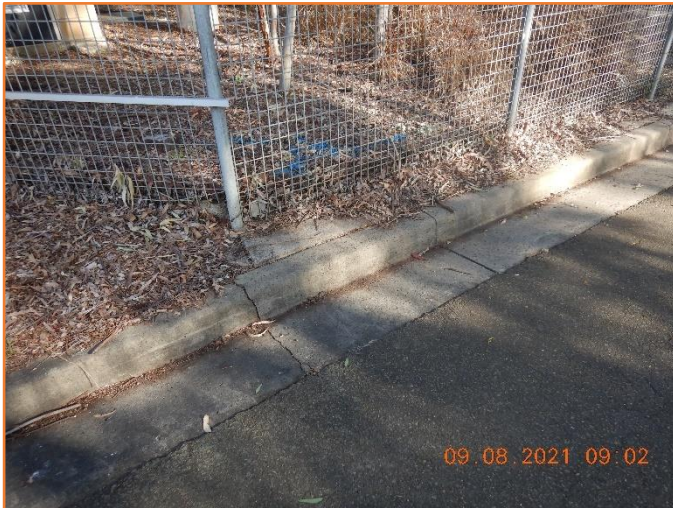
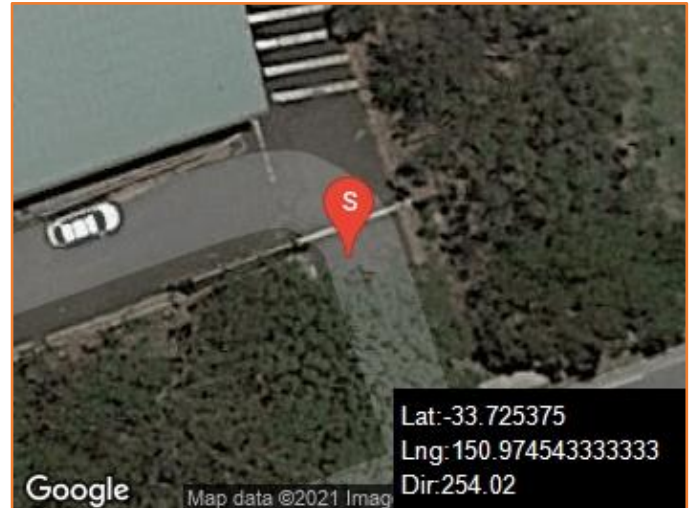
Figure 19: Reasonable - General condition of kerb and gutter. Moderate cracking observed.

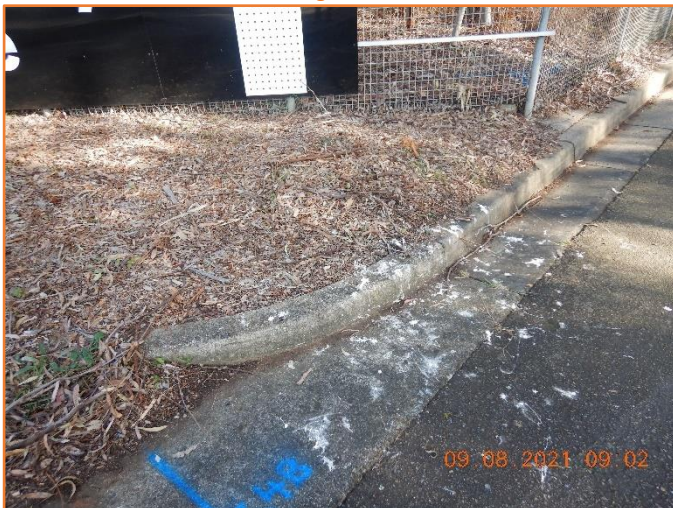
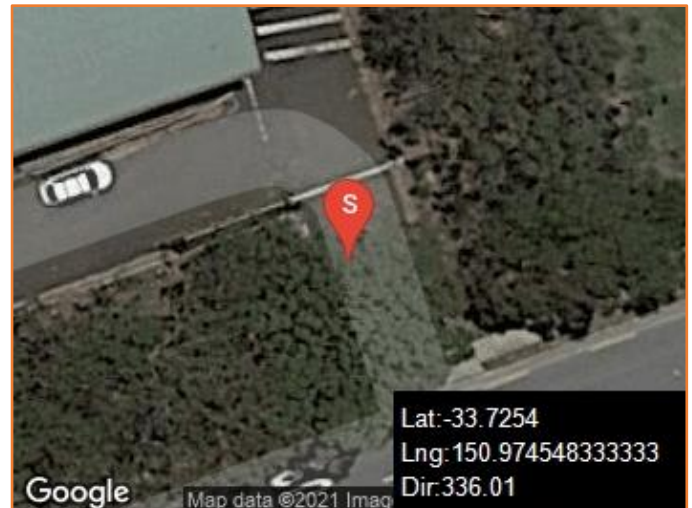
Figure 20: Reasonable - General condition of kerb and gutter.

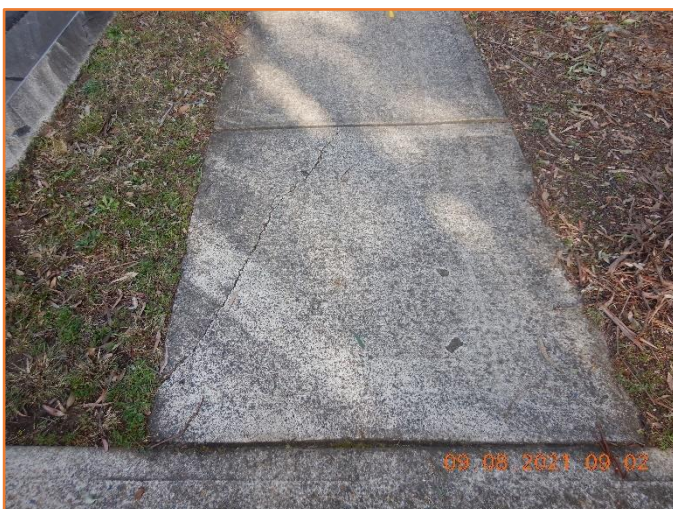
Figure 21: Defective - General condition of footpath. Major cracking and vertical displacement observed.

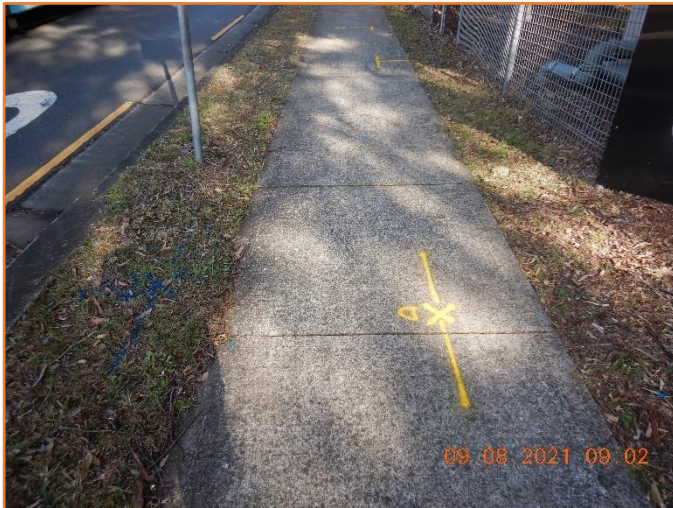
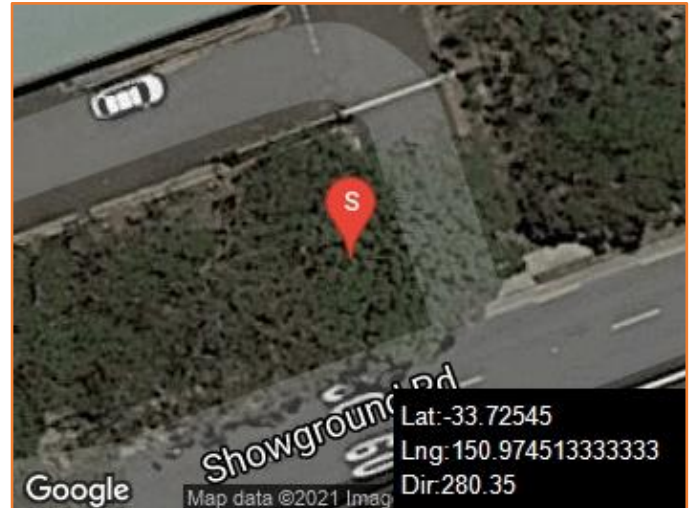
Figure 22: Good - General condition of footpath.

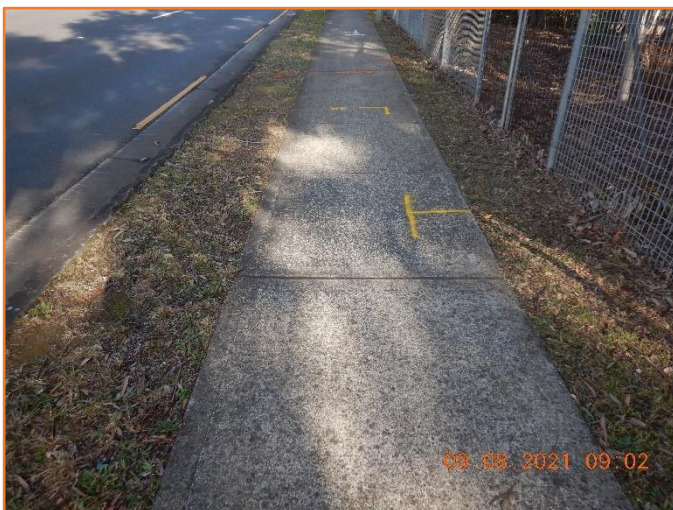
Figure 23: Good - General condition of footpath.

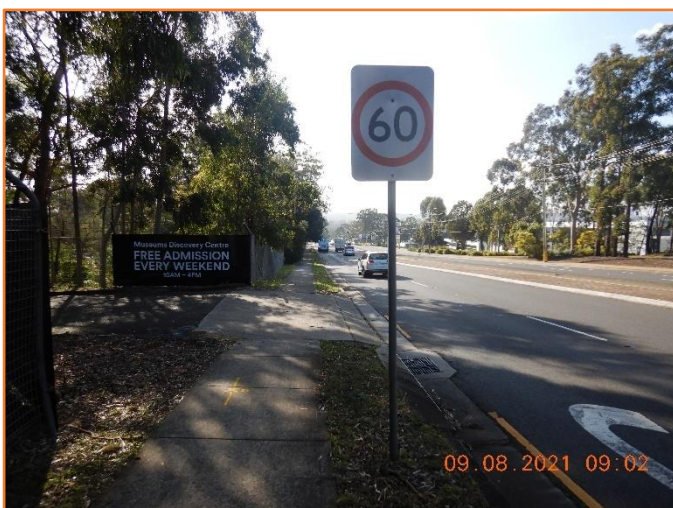
Figure 24: Good - General condition of traffic signage.

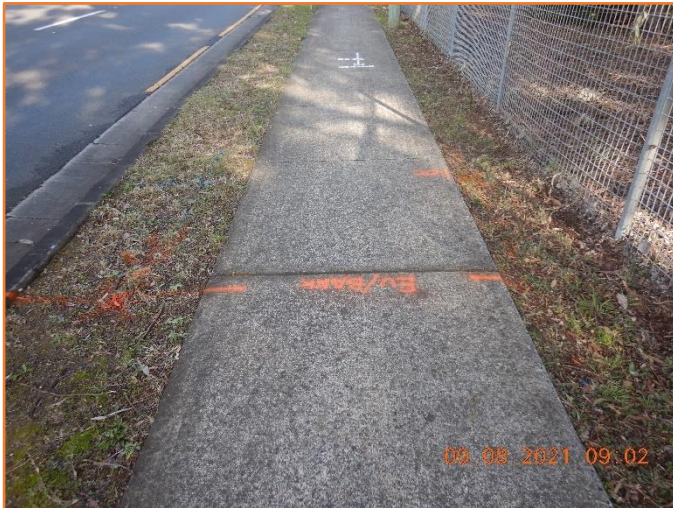
Figure 25: Good - General condition of footpath.

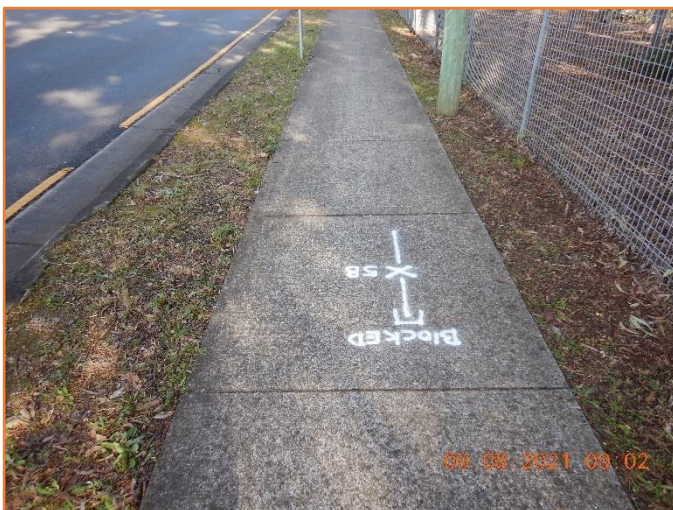
Figure 26: Good - General condition of footpath.

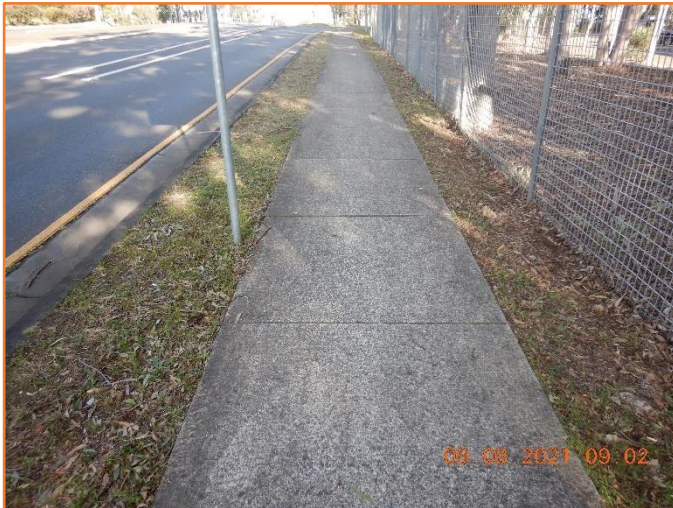
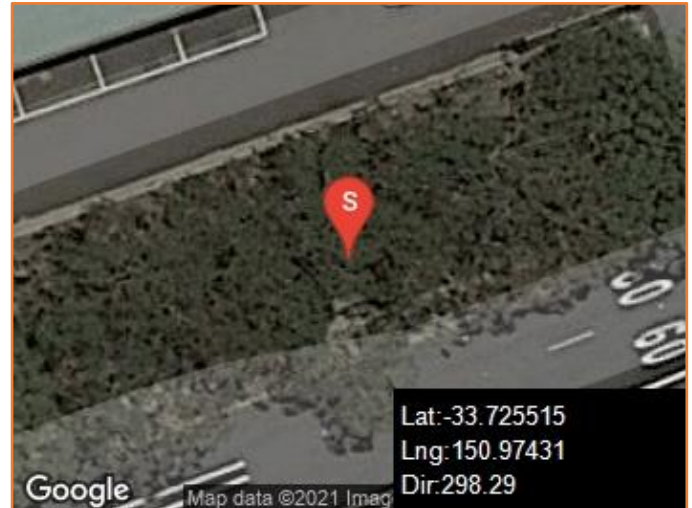
Figure 28: Good - General condition of footpath.

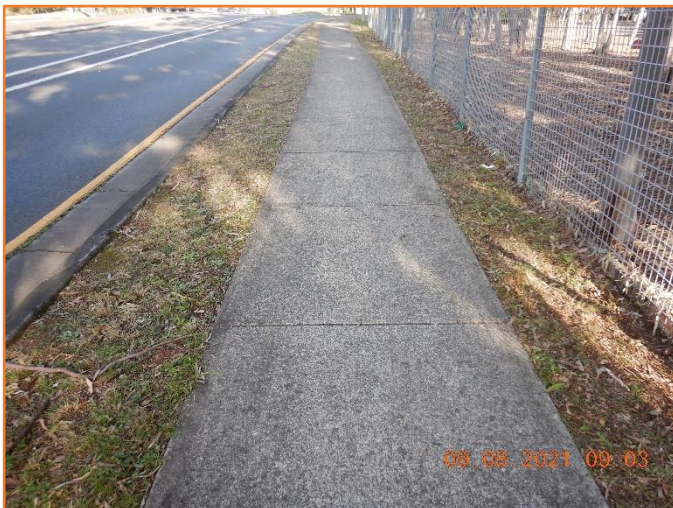
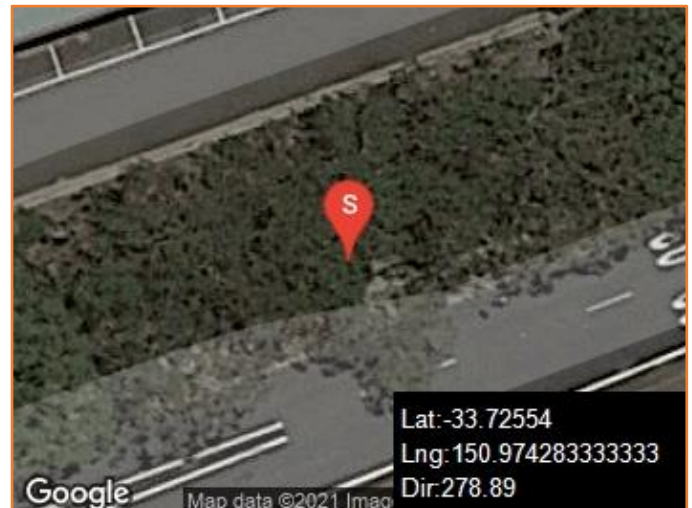
Figure 29: Good - General condition of footpath.

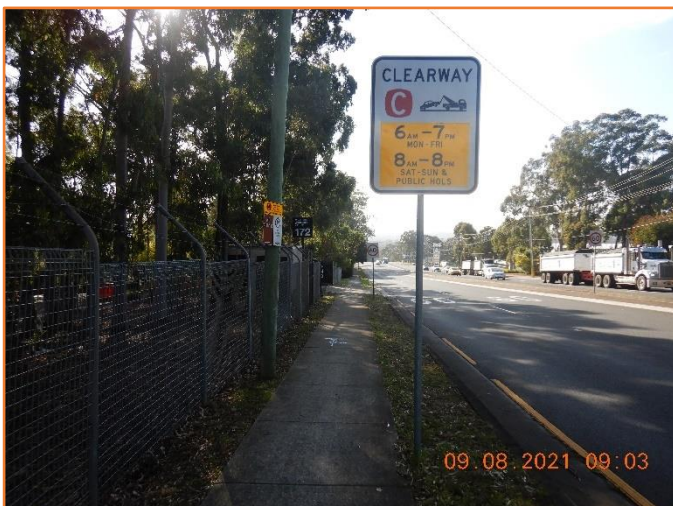
Figure 30: Good - General condition of traffic signage.

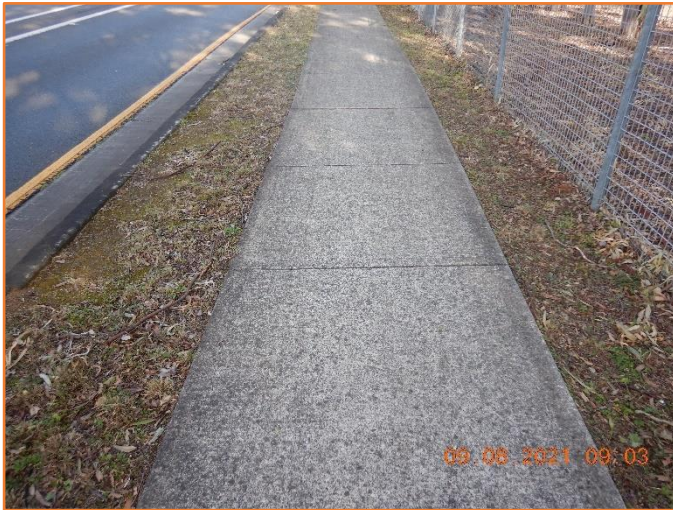
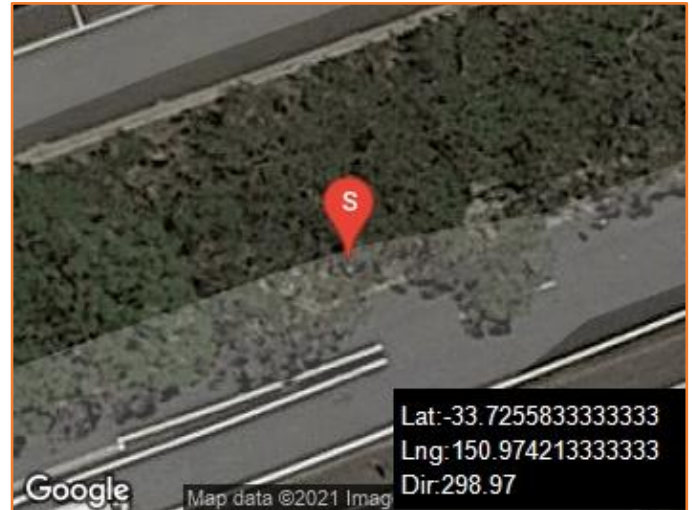
Figure 31: Good - General condition of footpath.

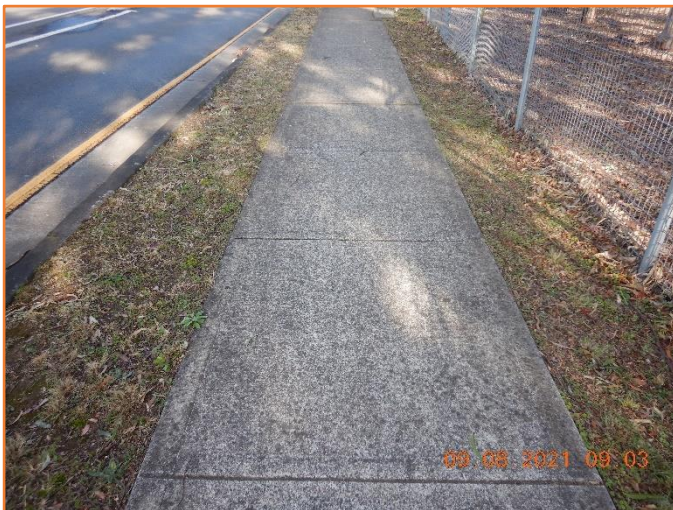
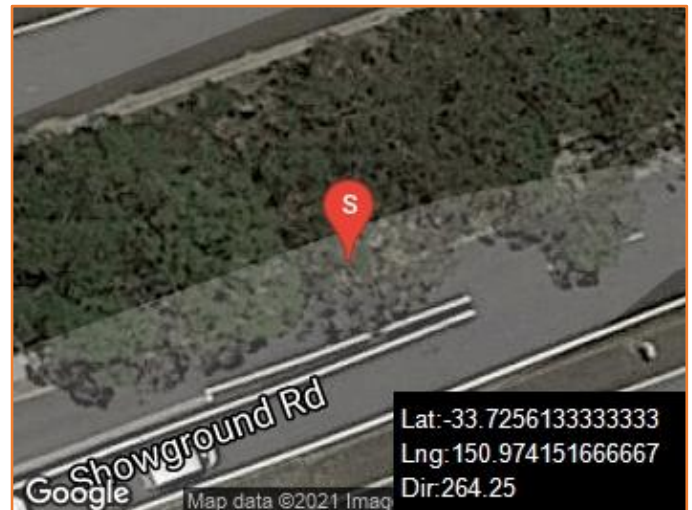
Figure 32: Good - General condition of footpath.

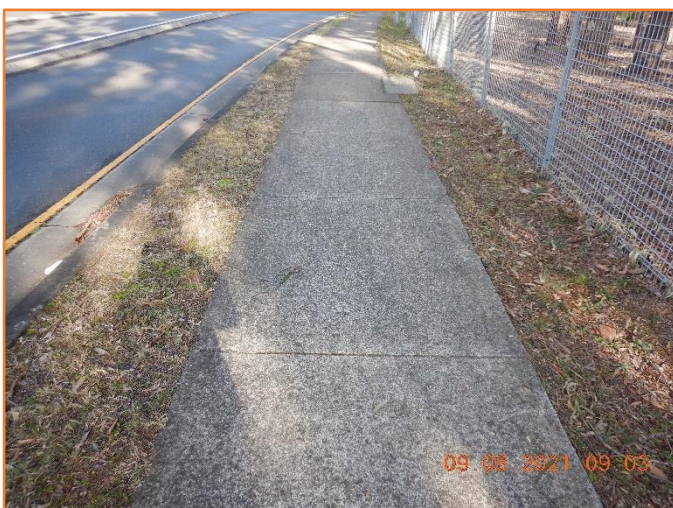
Figure 33: Good - General condition of footpath.

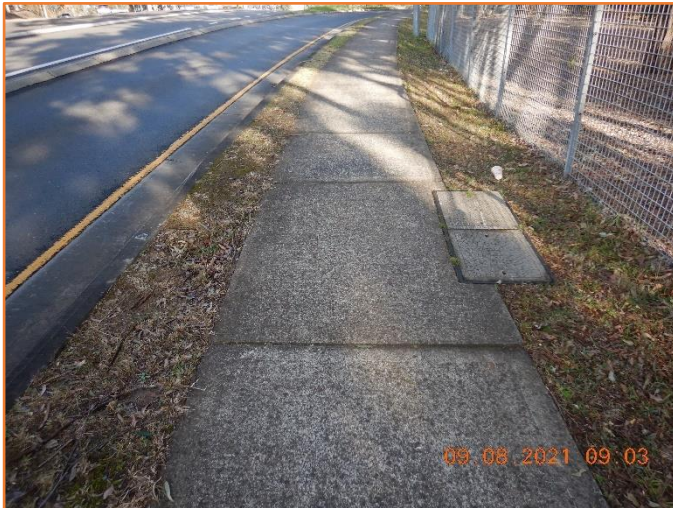
Figure 34: Good - General condition of footpath.

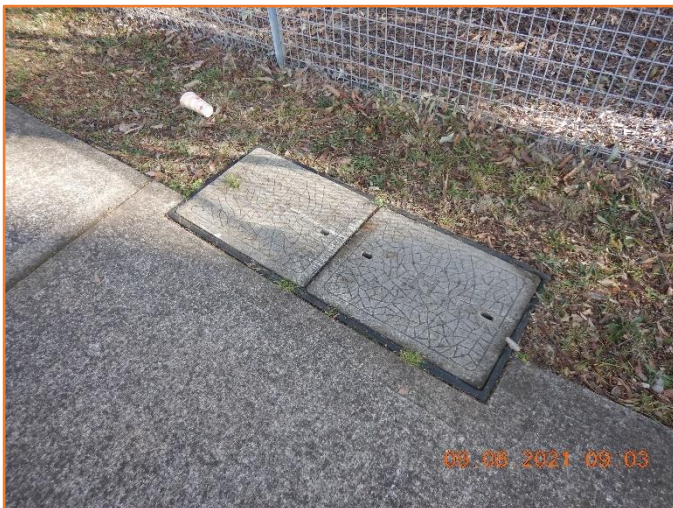
Figure 35: Good - General condition of service pits.

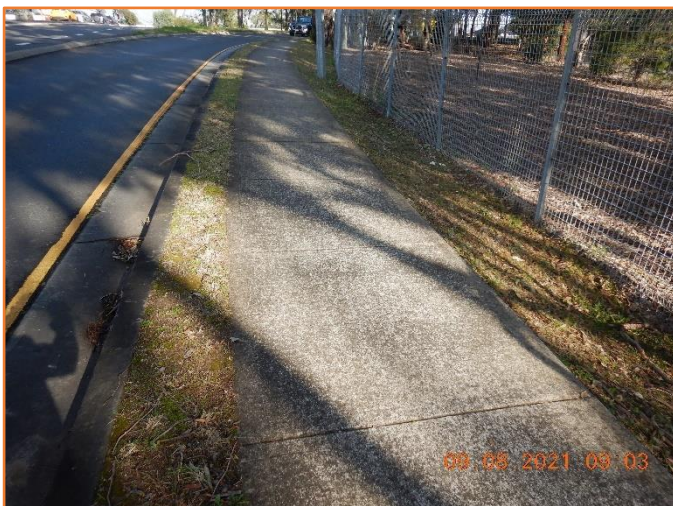
Figure 36: Good - General condition of footpath.

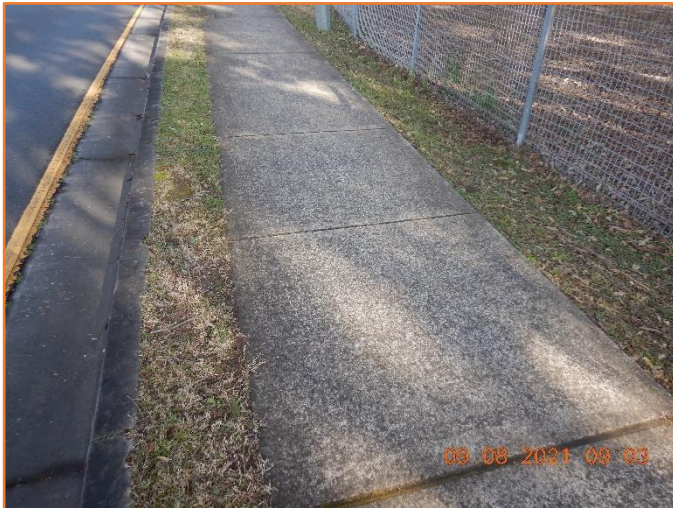
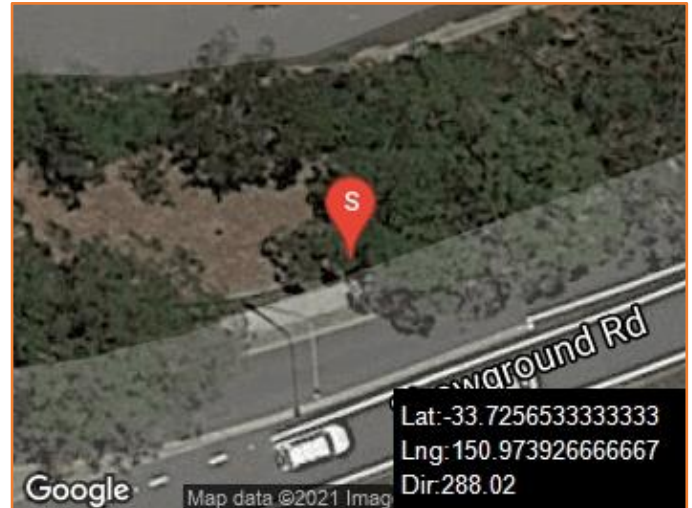
Figure 37: Good - General condition of footpath.

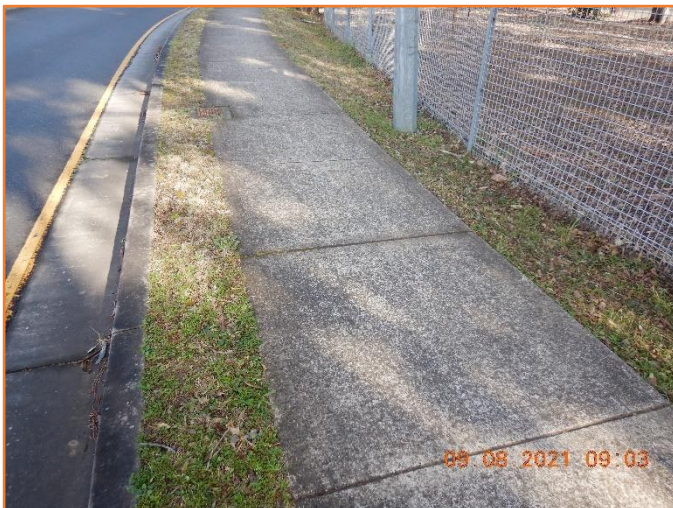
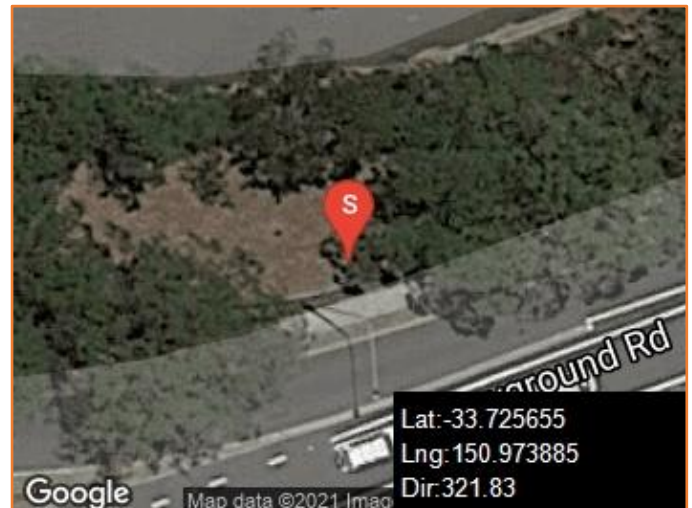
Figure 38: Good - General condition of footpath.

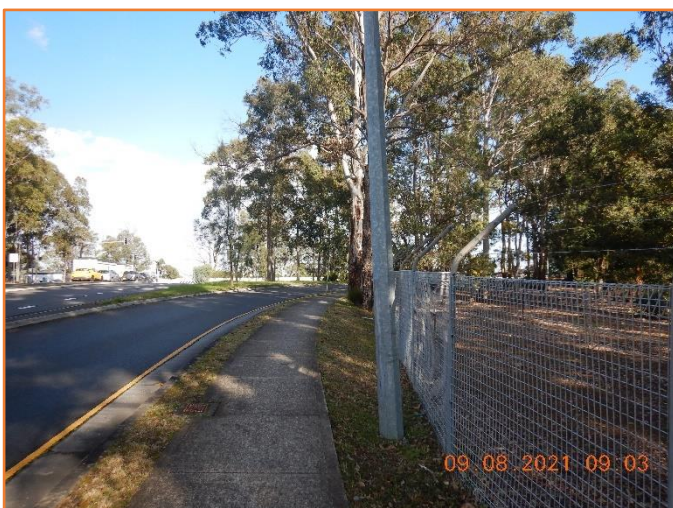
Figure 39: Poor - General condition of monopole assembly. Moderate rotation observed.

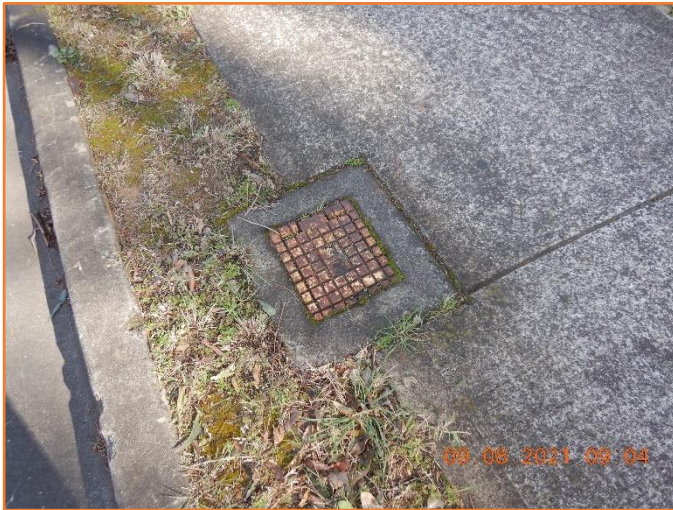
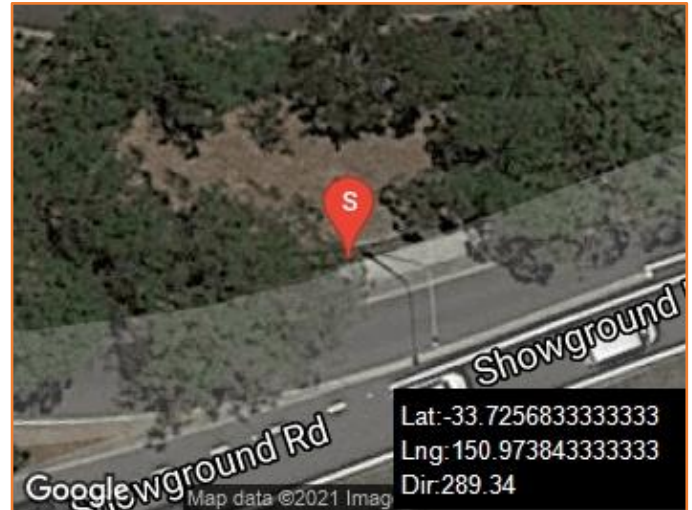
Figure 40: Reasonable - General condition of service pit.

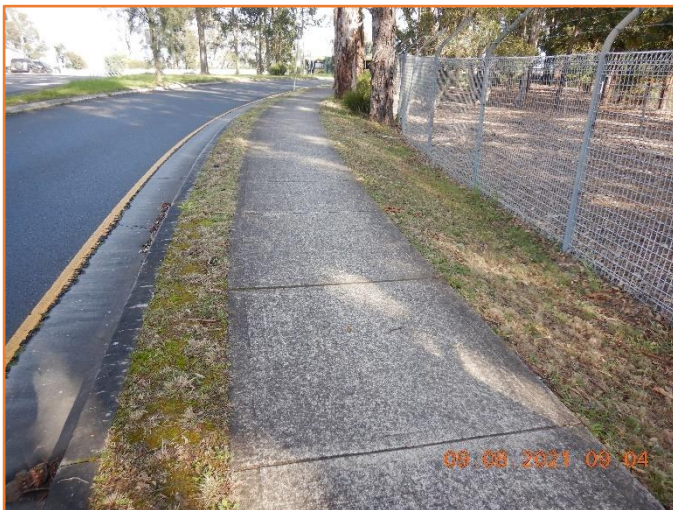
Figure 41: Good - General condition of footpath.

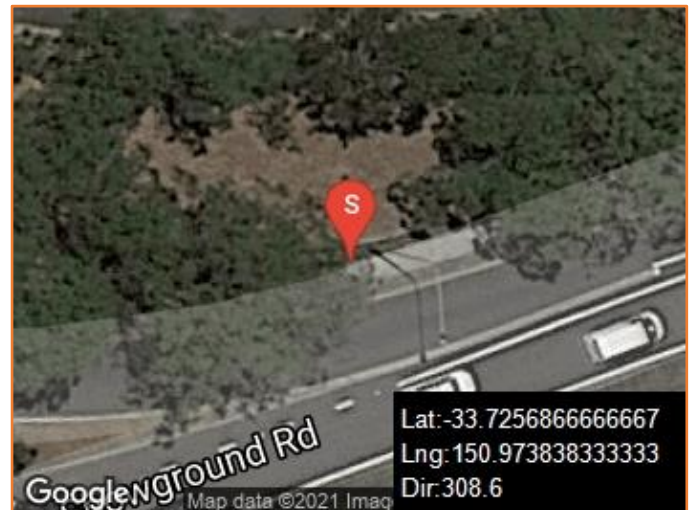
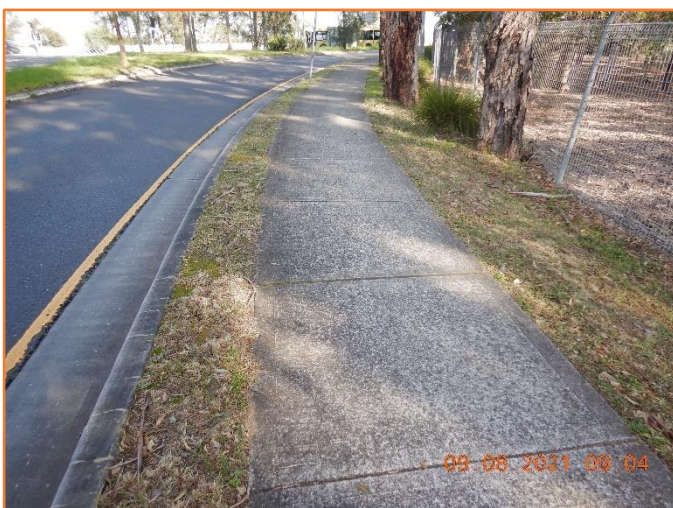
Figure 42: Good - General condition of footpath.

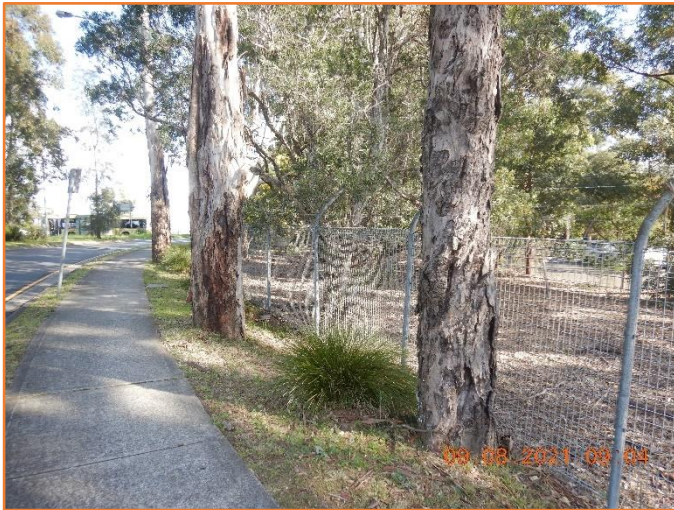
Figure 43: Good - General condition of street planting.
