## DILAPIDATION REPORT

MUSEUM DISCOVERY CENTRE

MONDAY, 9 AUGUST 2021

Document Information	
Job Number	210722
Document Number	3
Report Title	Dilapidation Report
Site Address	172 Showground Road and 2 Green Road Castle Hill, NSW, 2154
Lot	1 in DP1066281 & 102 in DP1130271

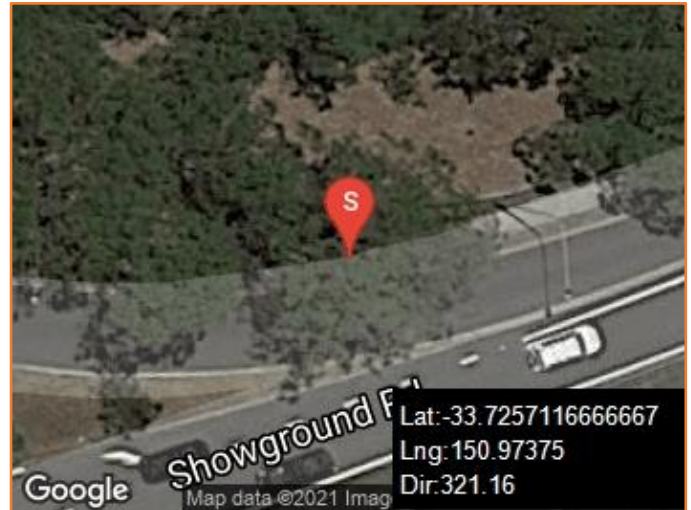
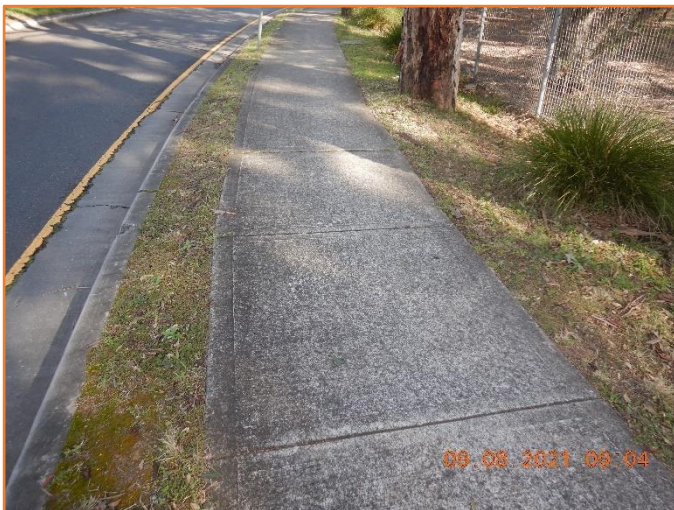
Figure 44: Good - General condition of footpath.

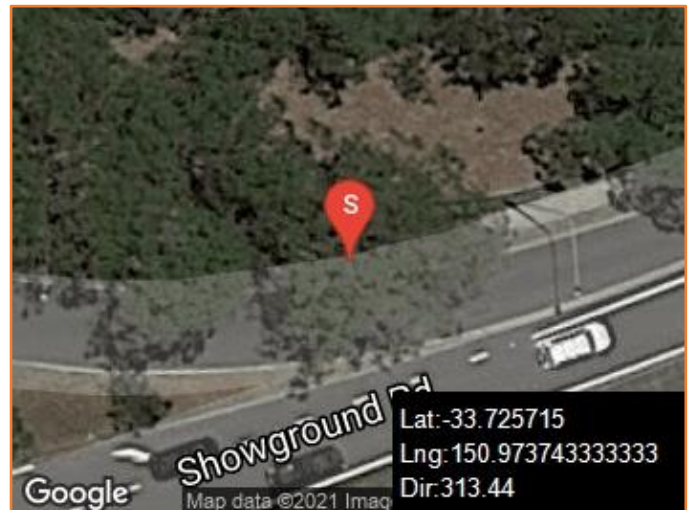
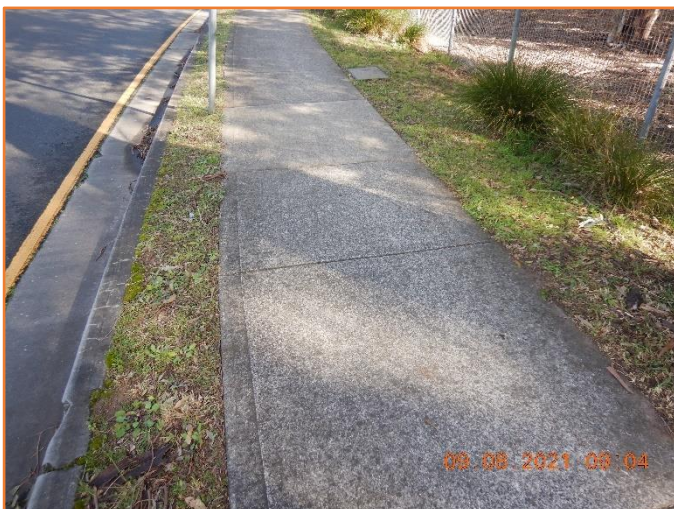
Figure 45: Good - General condition of footpath.

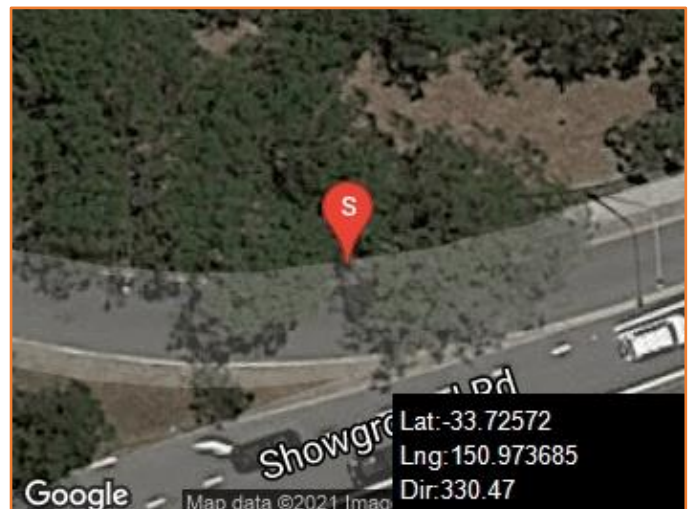
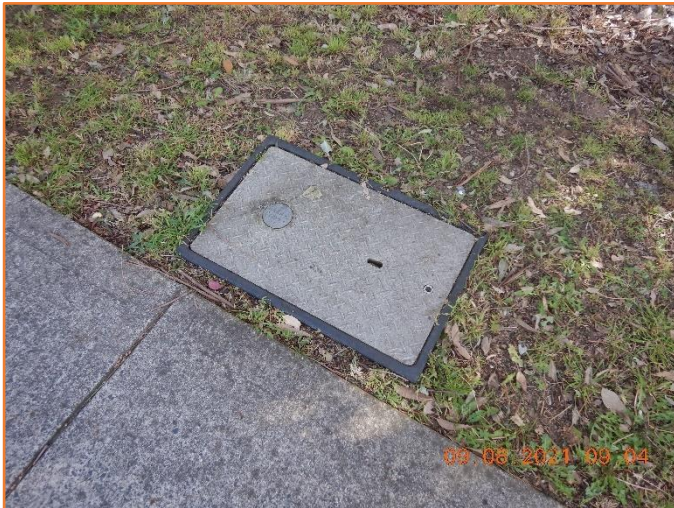
Figure 46: Good - General condition of service pit.

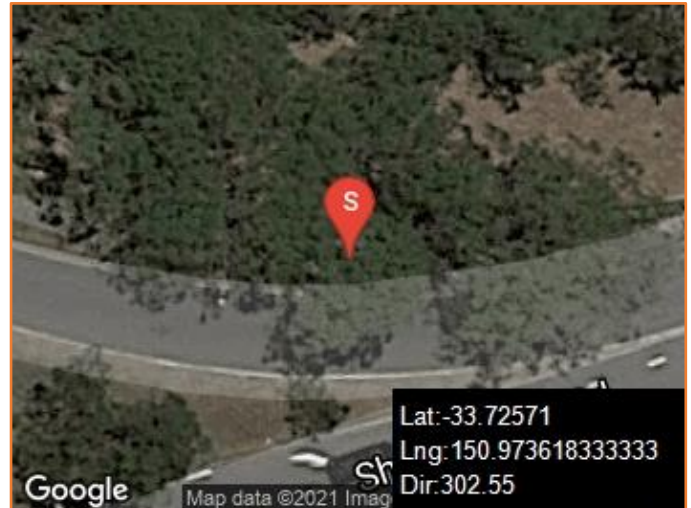
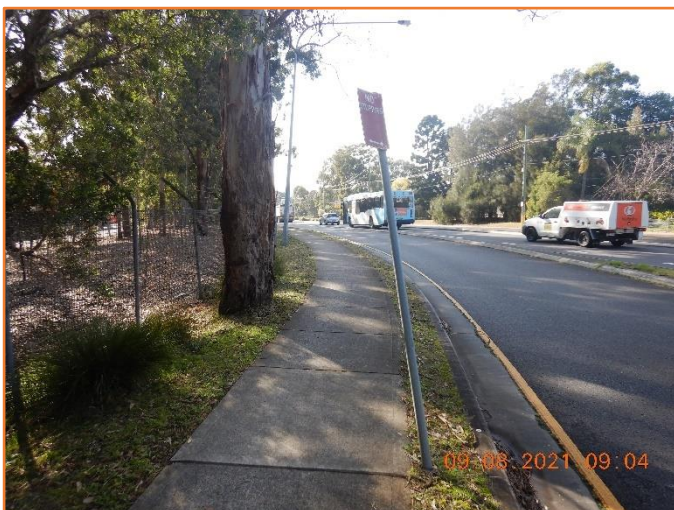
Figure 47: Defective - General condition of traffic signage. Major rotation observed.

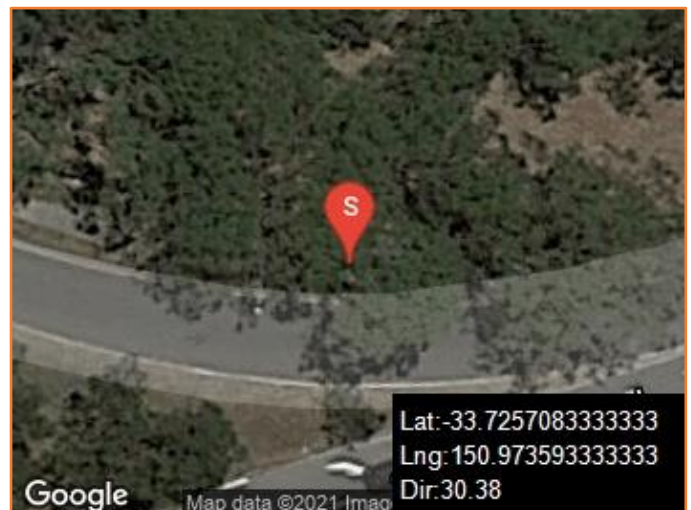
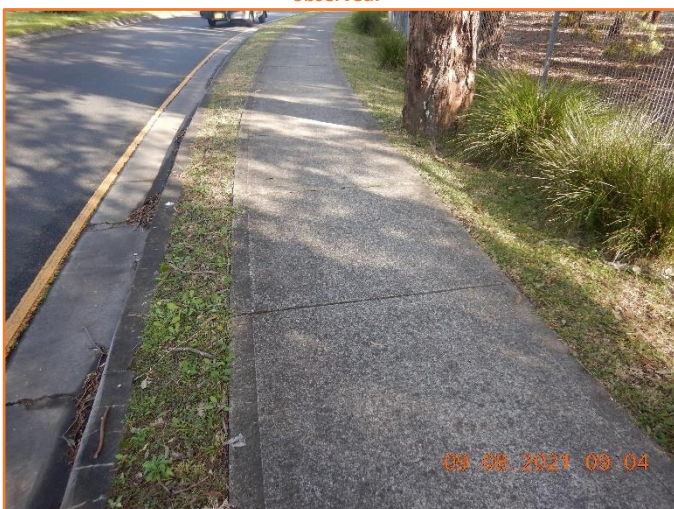
Figure 48: Good - General condition of footpath.

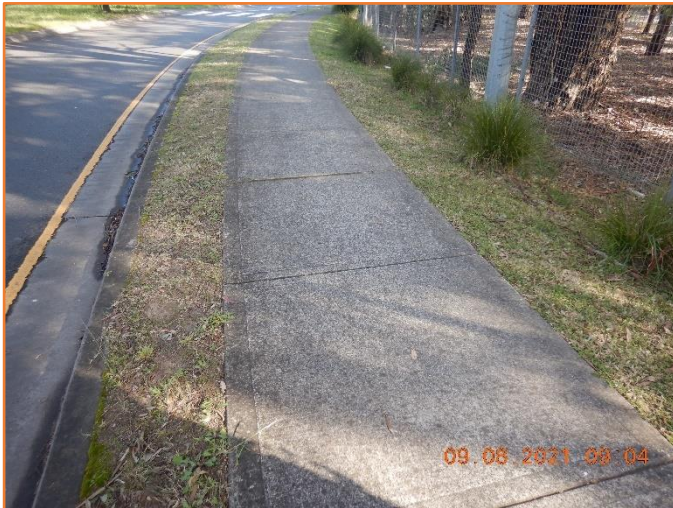
Figure 49: Good - General condition of footpath.

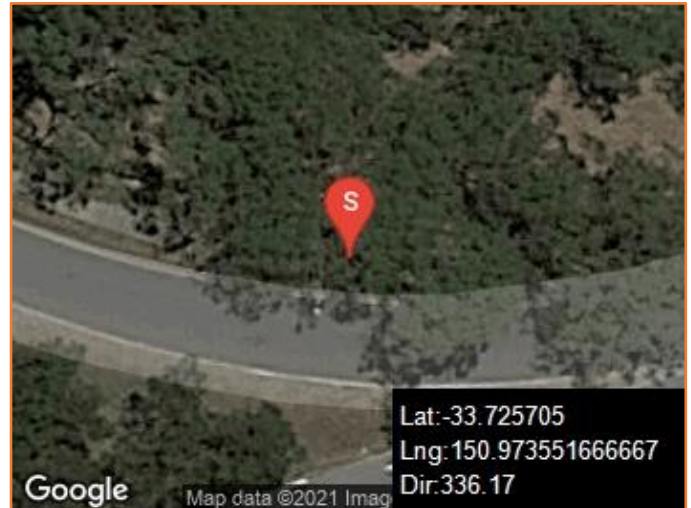
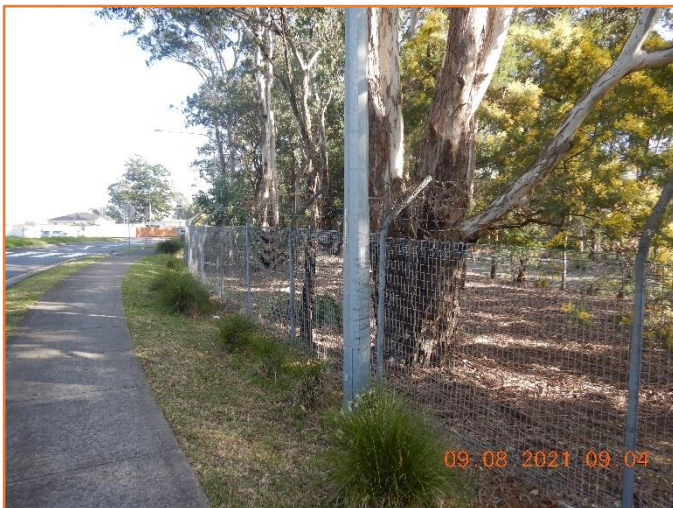
Figure 50: Good - General condition of monopole assembly.

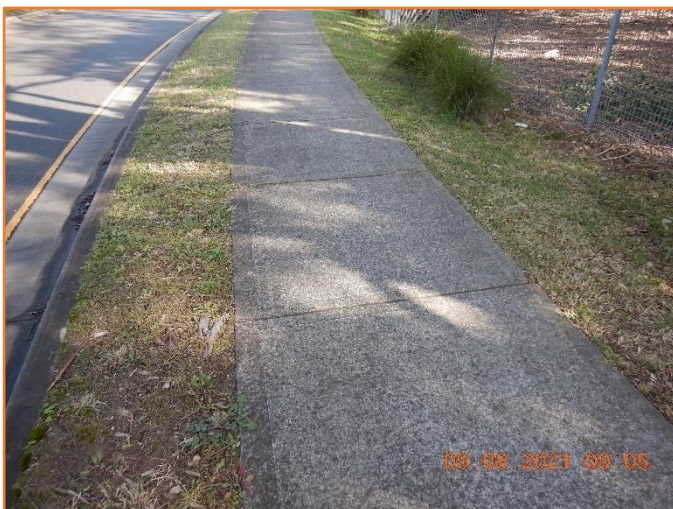
Figure 51: Good - General condition of footpath.

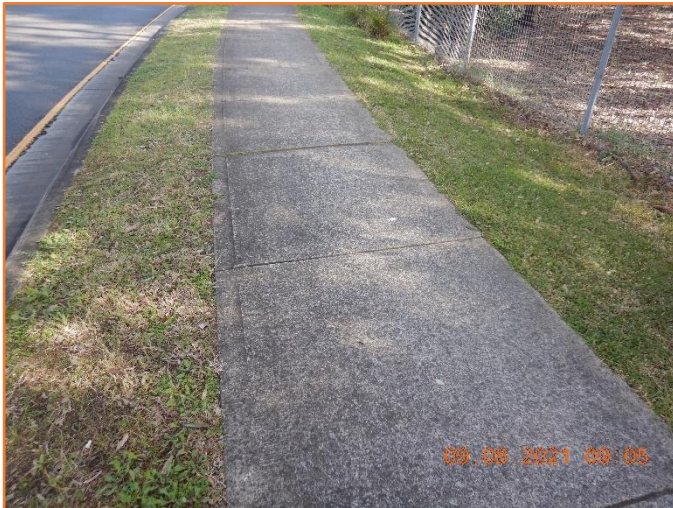
Figure 52: Good - General condition of footpath.

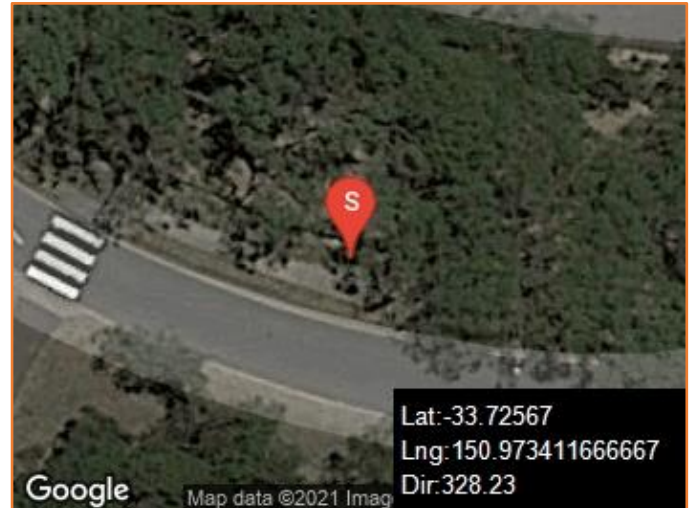
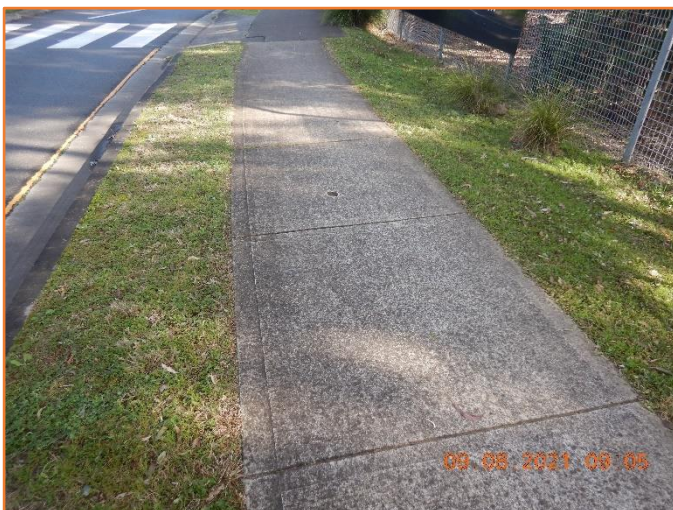
Figure 53: Good - General condition of footpath.

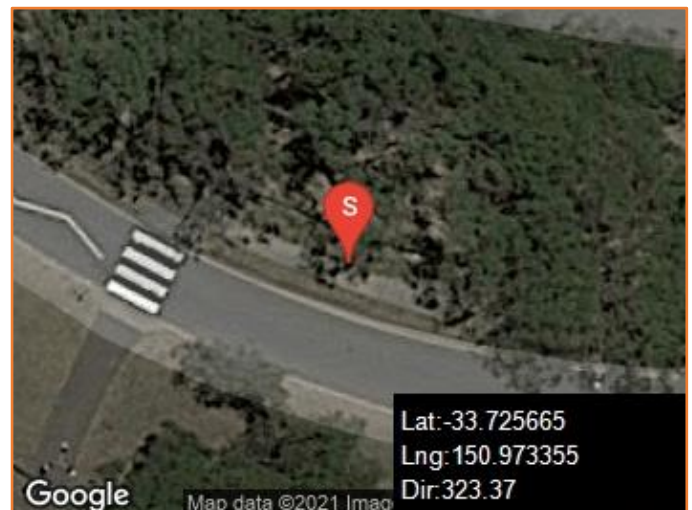
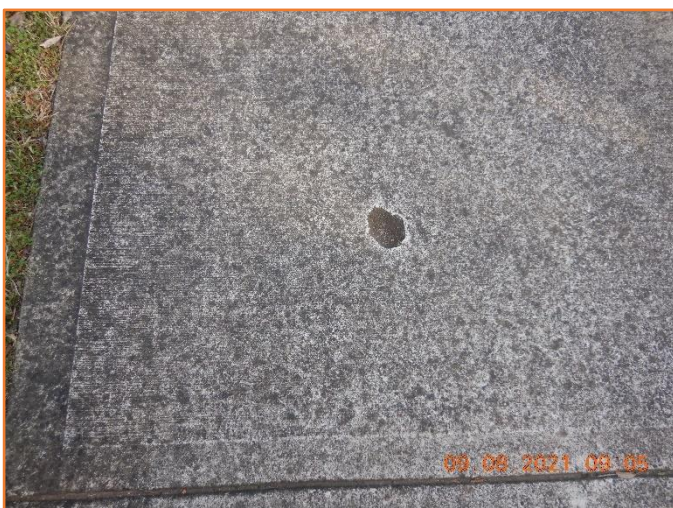
Figure 54: Reasonable - General condition of footpath. Minor physical damage observed.

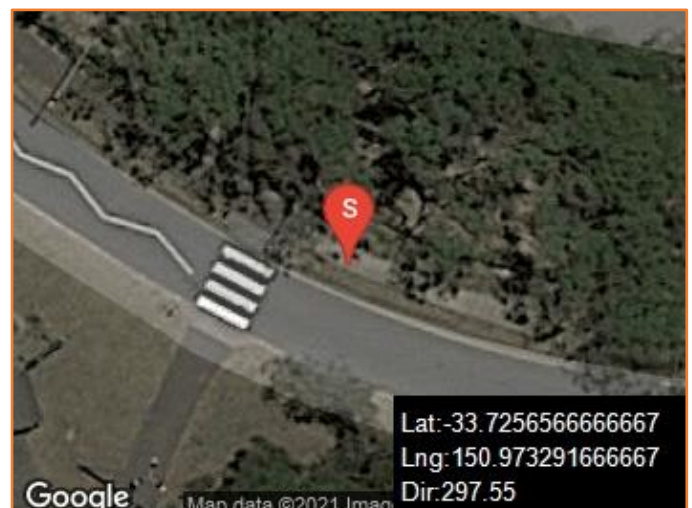
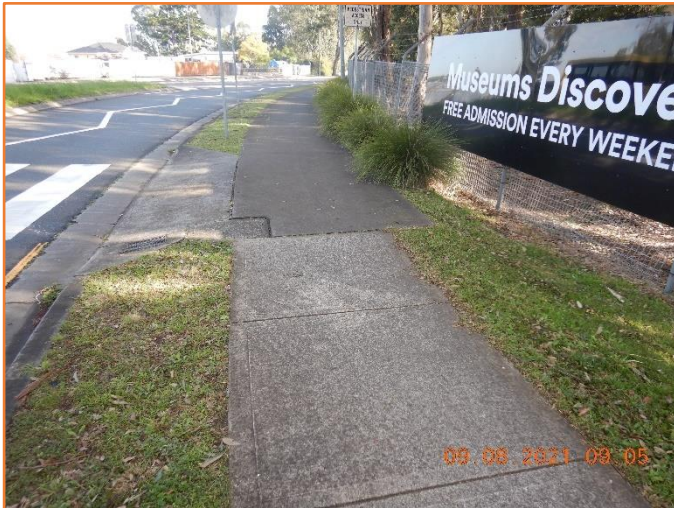
Figure 55: Good - General condition of footpath.

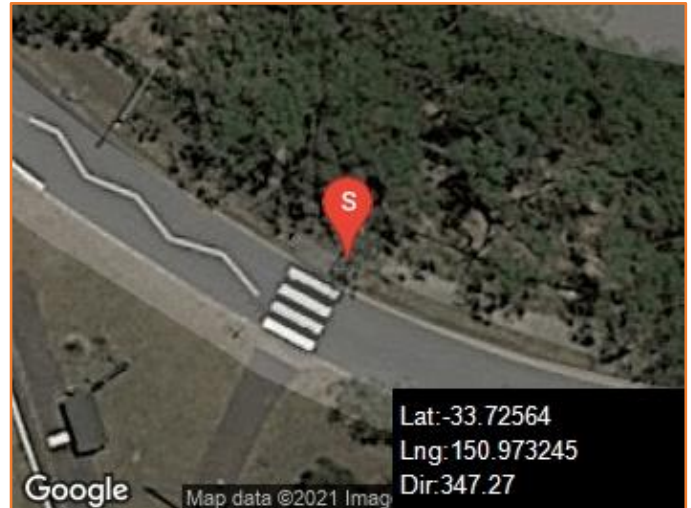
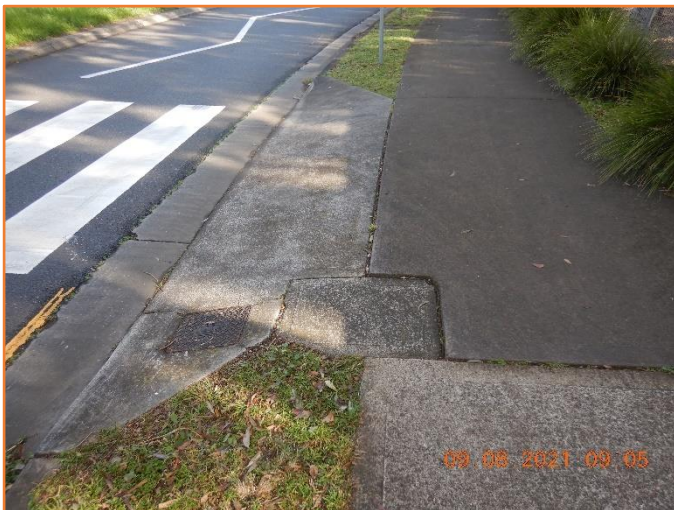
Figure 56: Reasonable - General condition of driveway crossover and service pit. Moderate cracking observed.

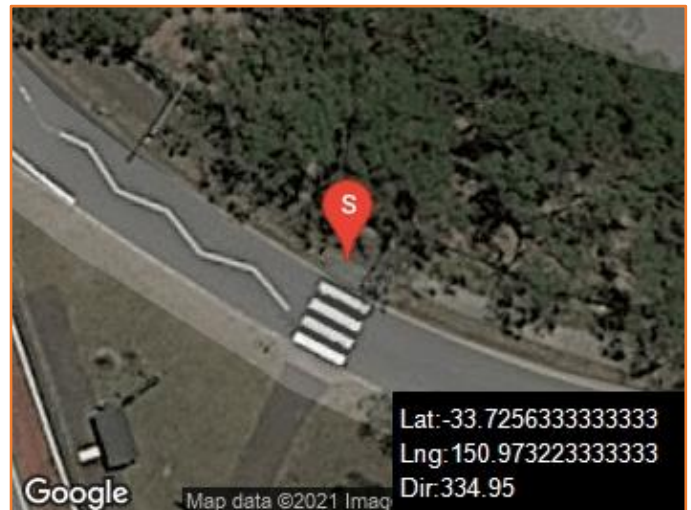
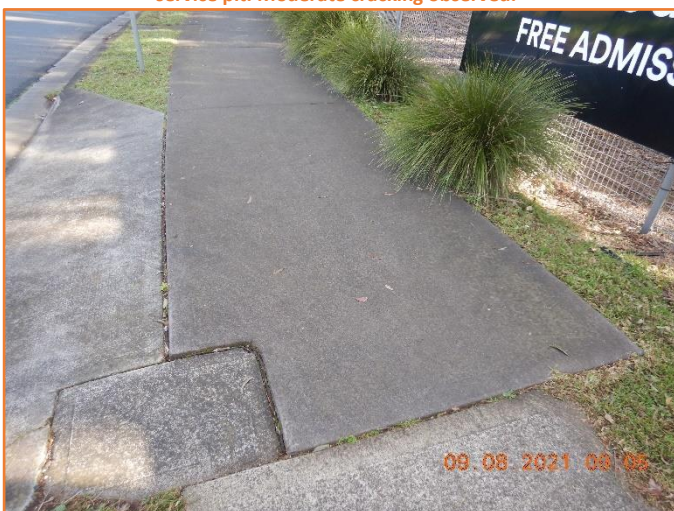
Figure 57: Good - General condition of footpath.

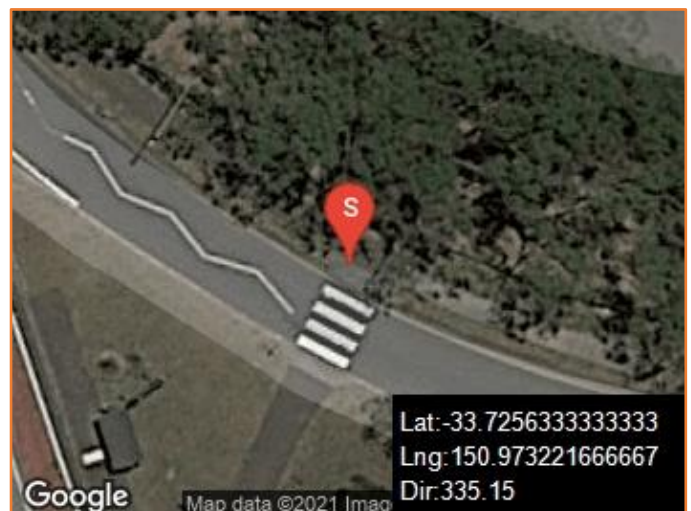
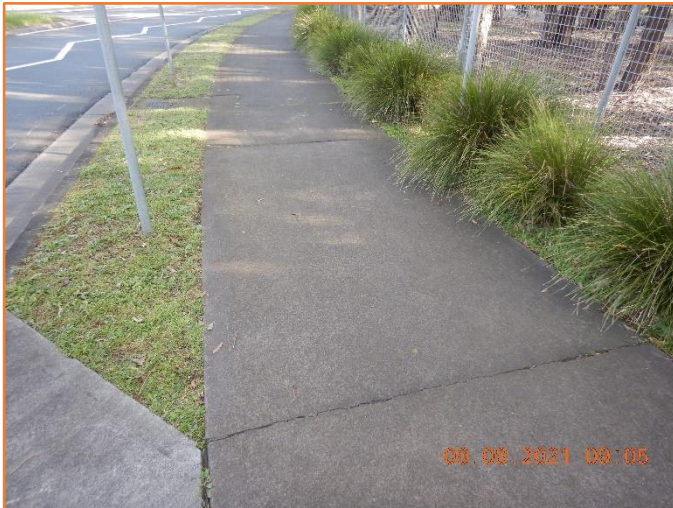
Figure 58: Reasonable - General condition of footpath. Moderate cracking observed.

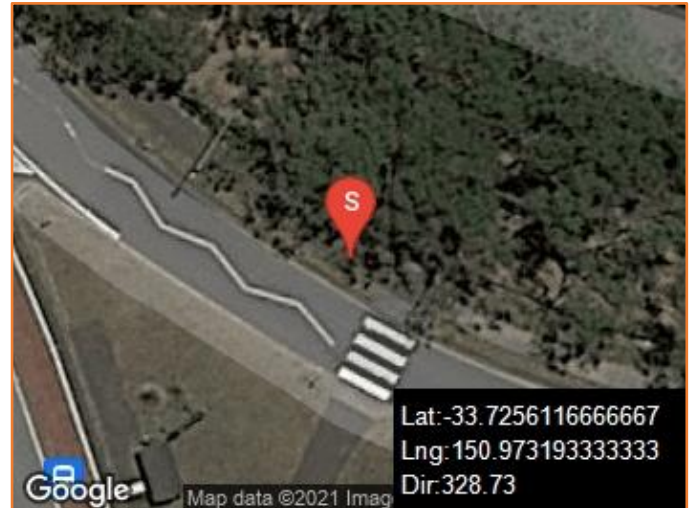
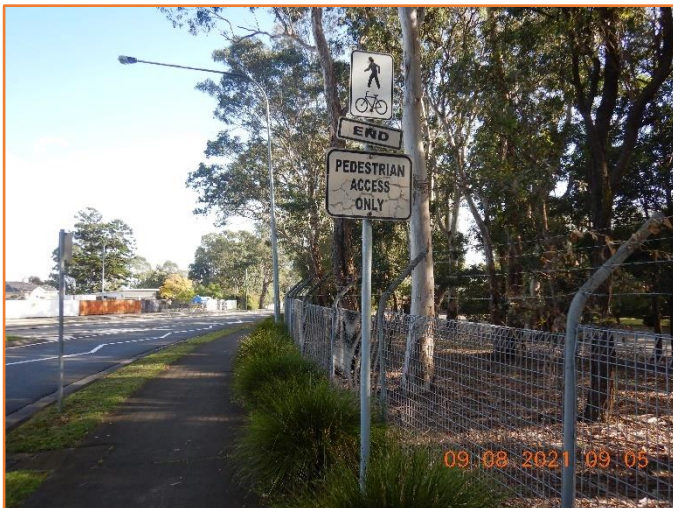
Figure 59: Reasonable - General condition of traffic signage.

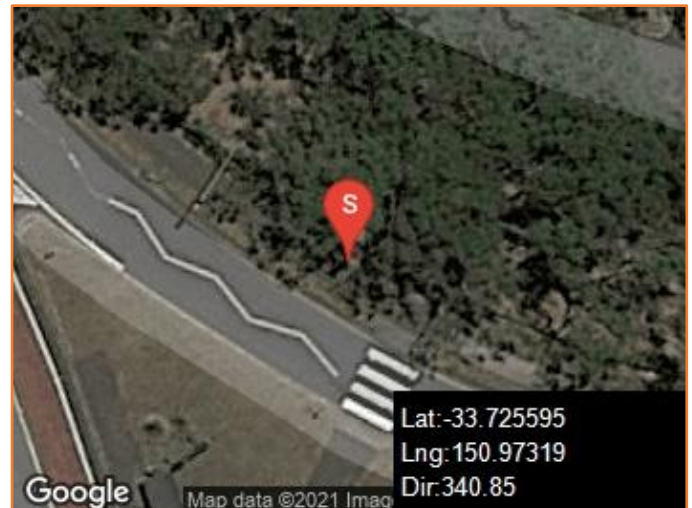
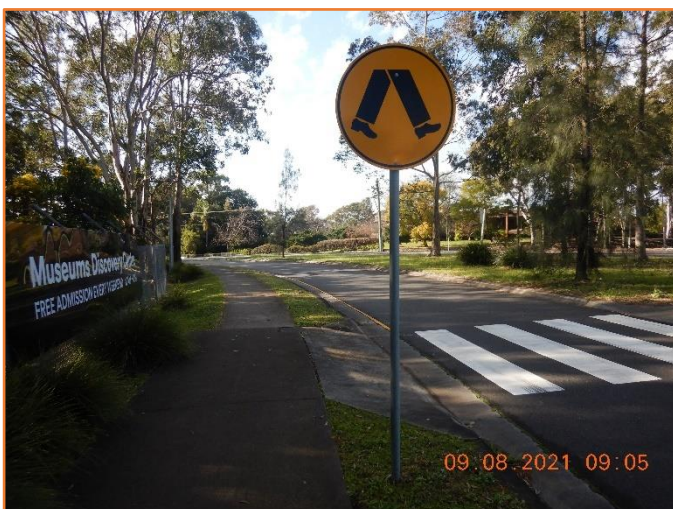
Figure 60: Good - General condition of traffic signage.

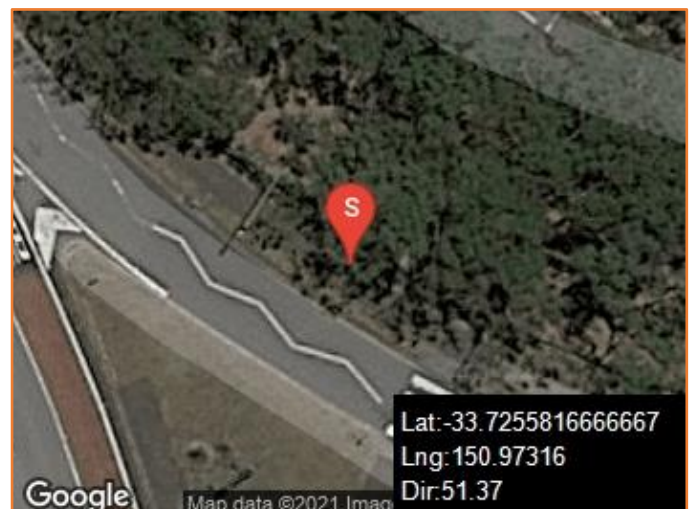
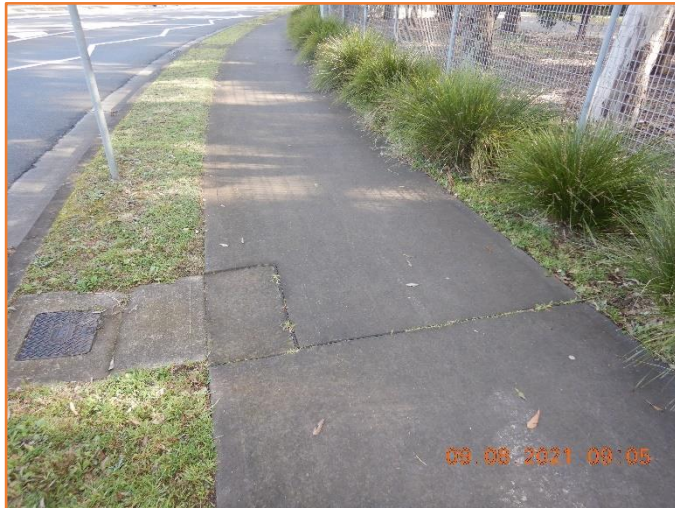
Figure 61: Reasonable - General condition of footpath.

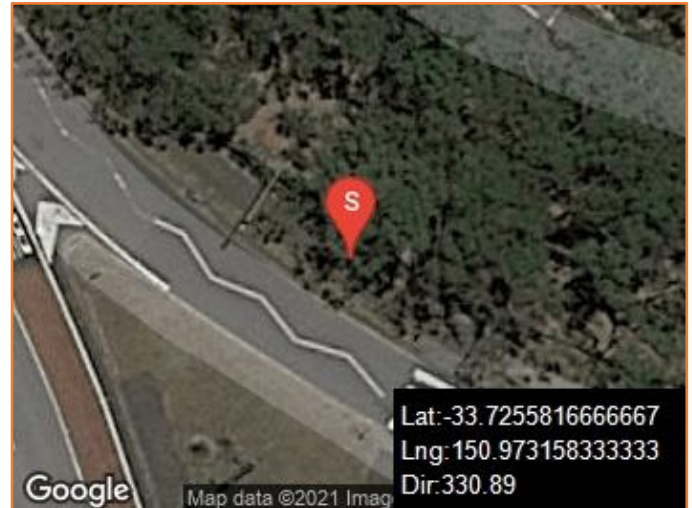
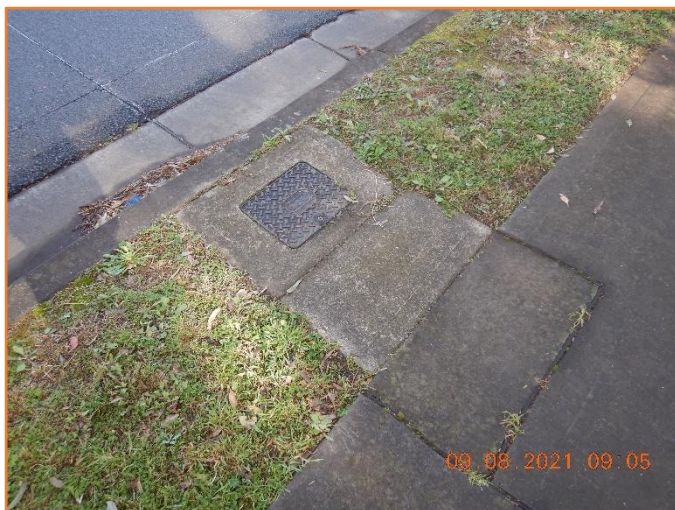
Figure 62: Reasonable - General condition of service pit.

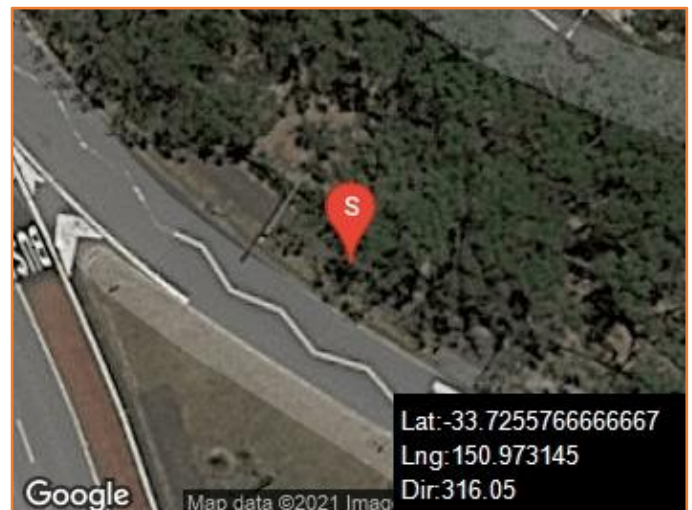
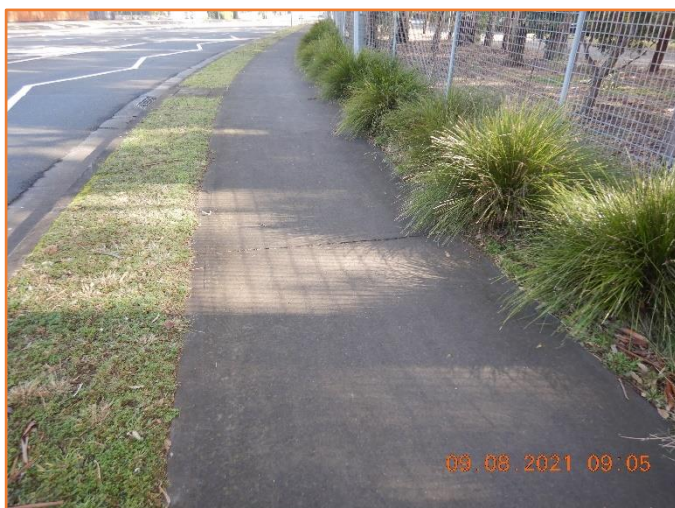
Figure 63: Good - General condition of footpath.

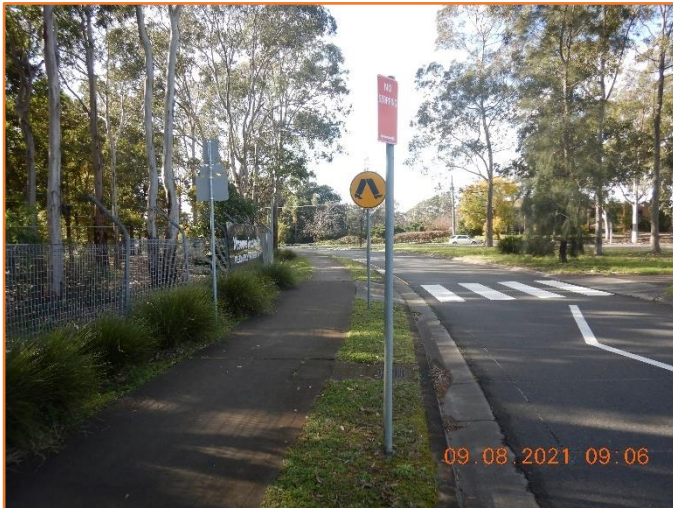
Figure 64: Good - General condition of traffic signage.

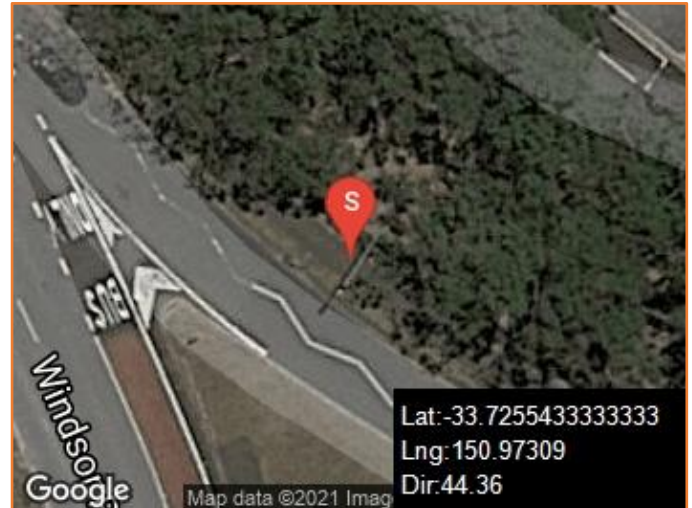
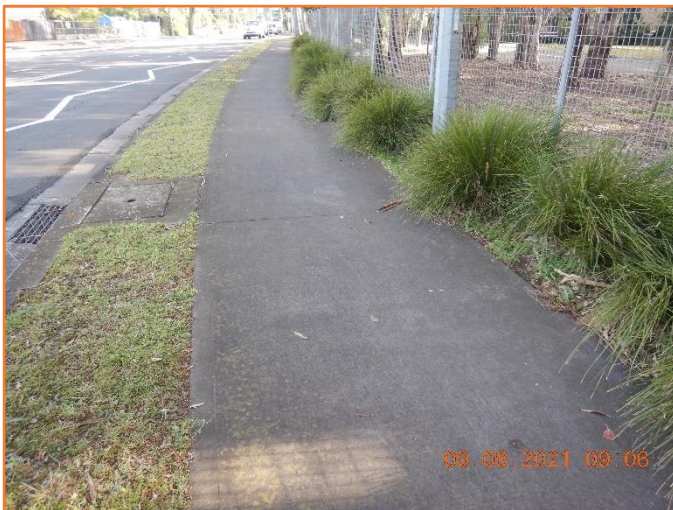
Figure 65: Good - General condition of footpath.

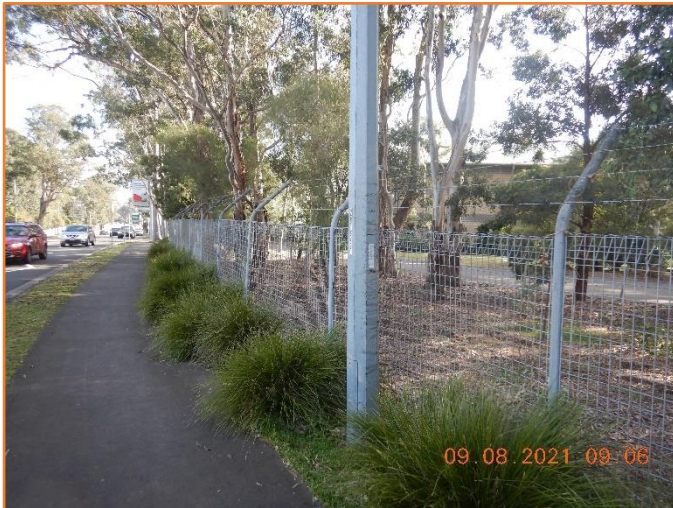
Figure 67: Good - General condition of monopole assembly.

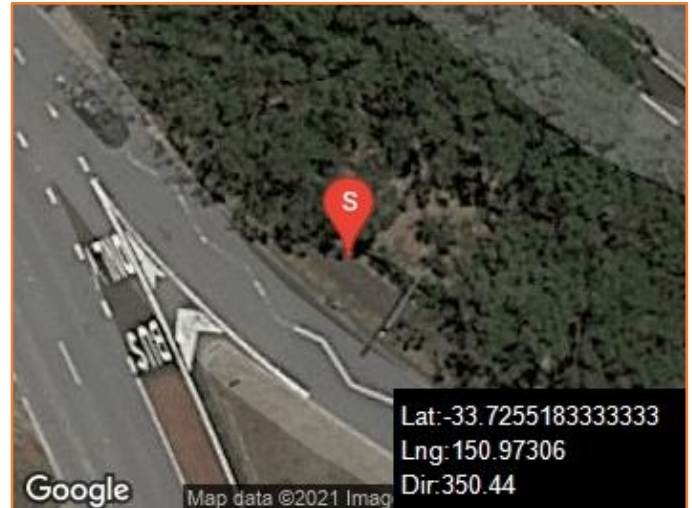
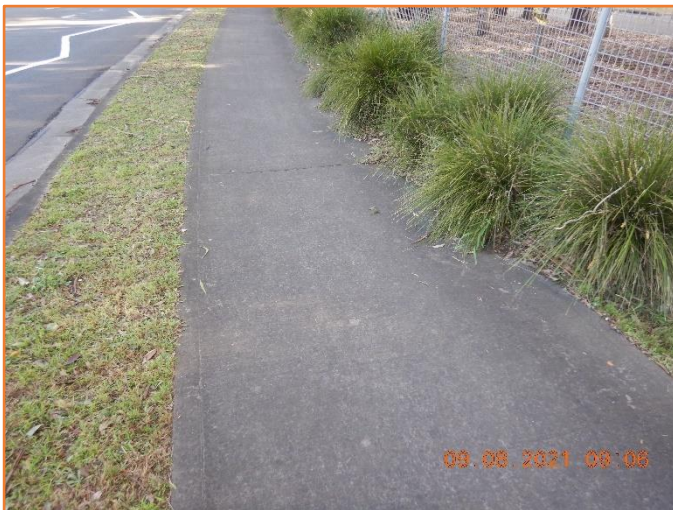
Figure 68: Good - General condition of footpath.

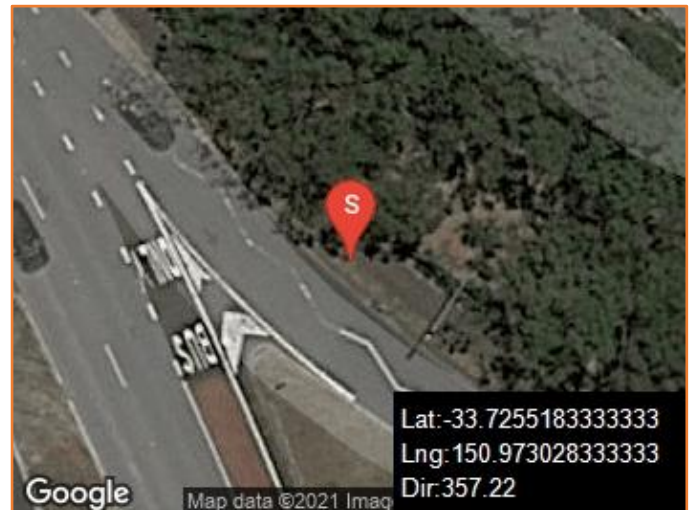
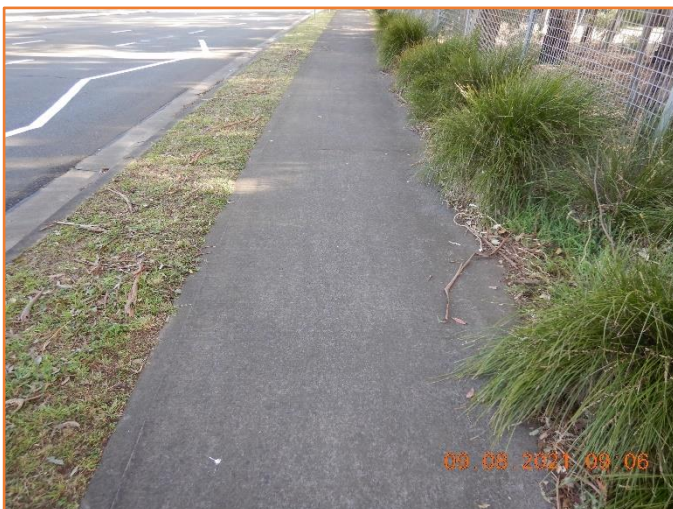
Figure 69: Good - General condition of footpath.

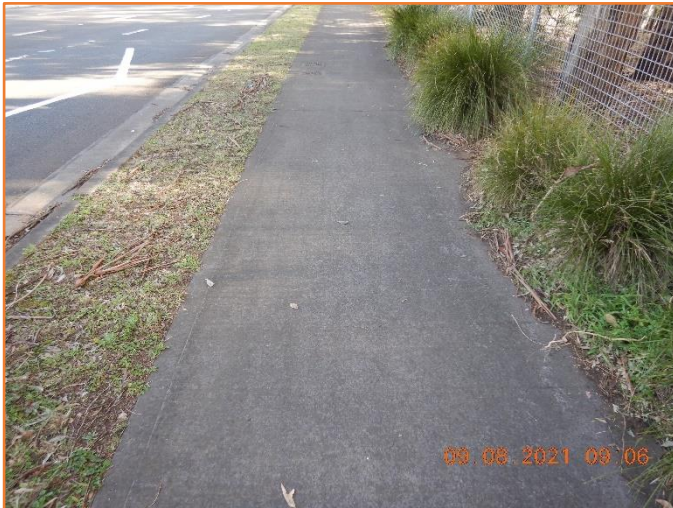
Figure 70: Good - General condition of footpath.

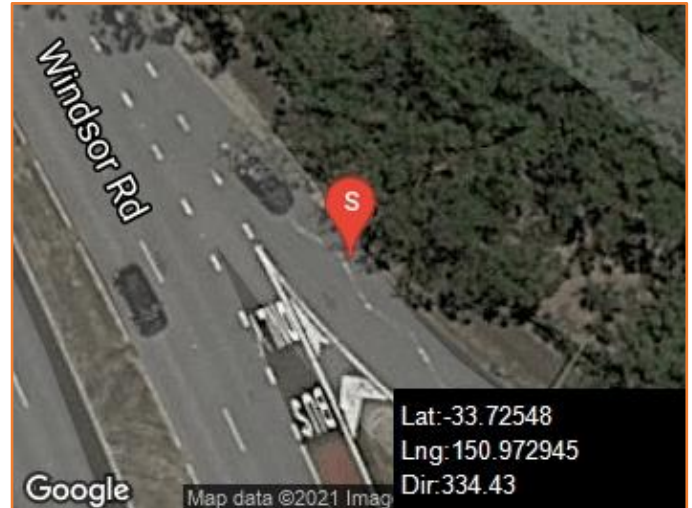
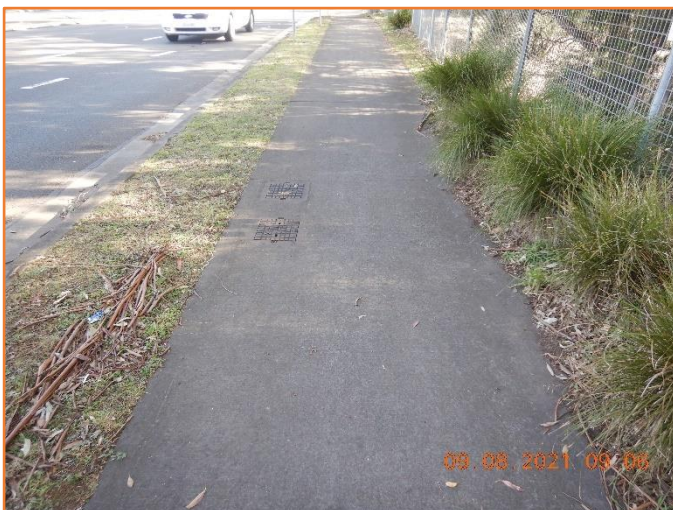
Figure 71: Good - General condition of footpath.

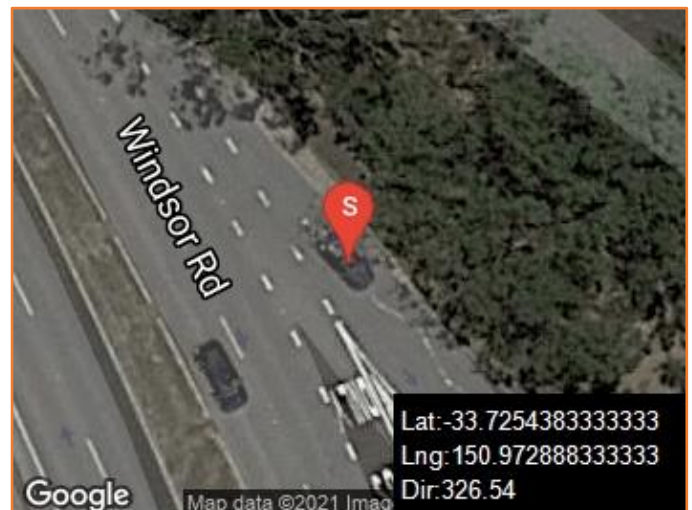
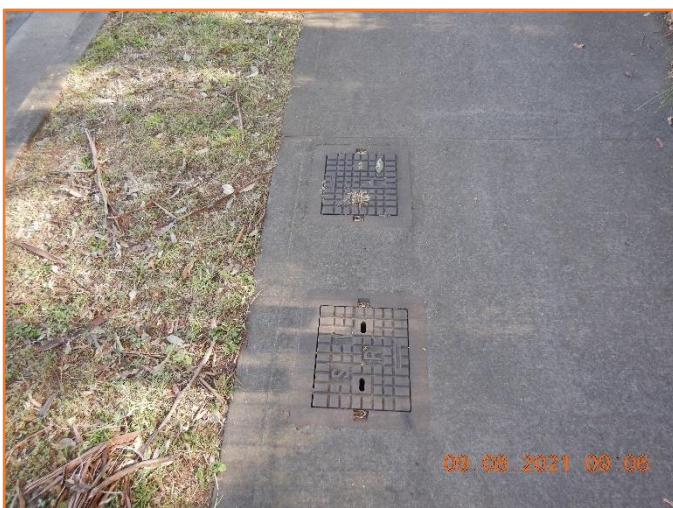
Figure 72: Good - General condition of service pits.

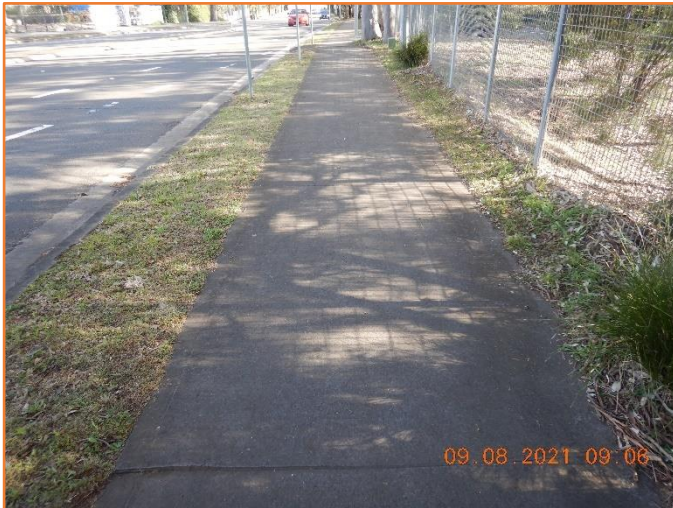
Figure 73: Good - General condition of footpath.

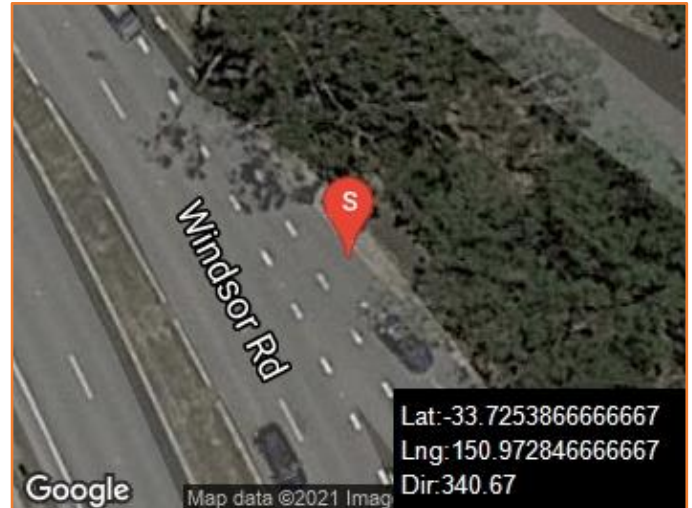
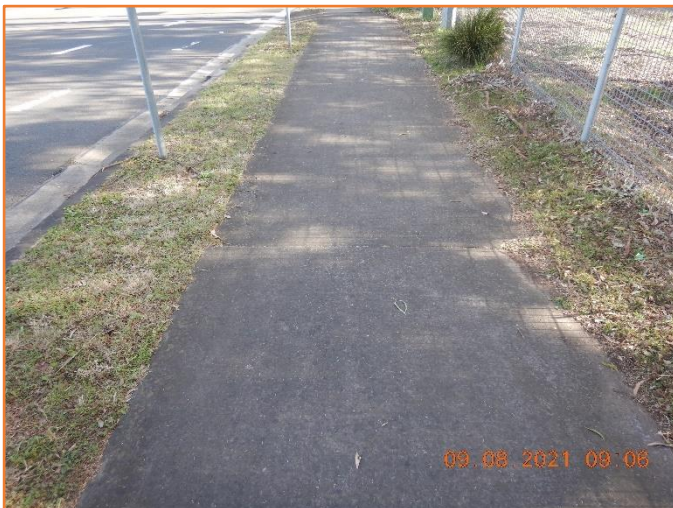
Figure 74: Good - General condition of footpath.

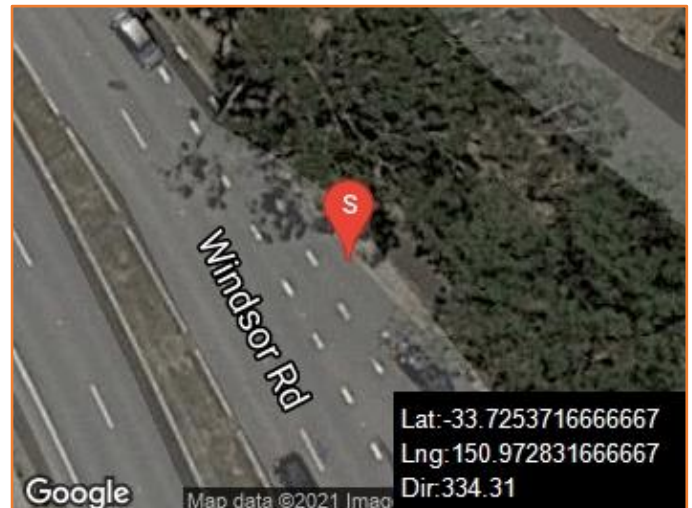
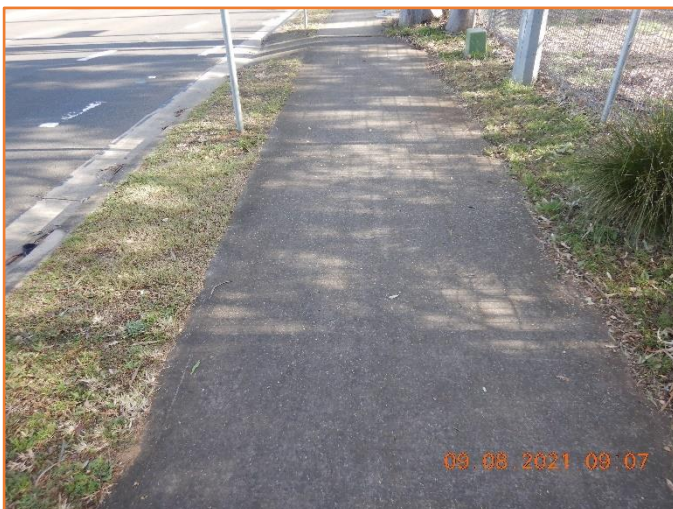
Figure 75: Good - General condition of footpath.

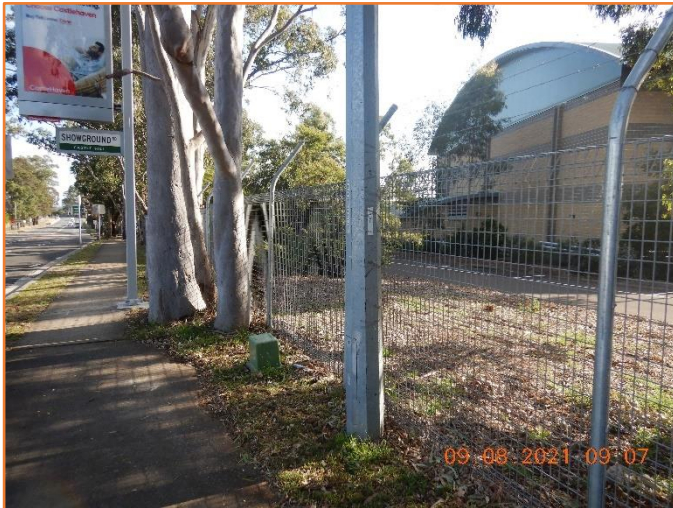
Figure 76: Good - General condition of monopole assembly.

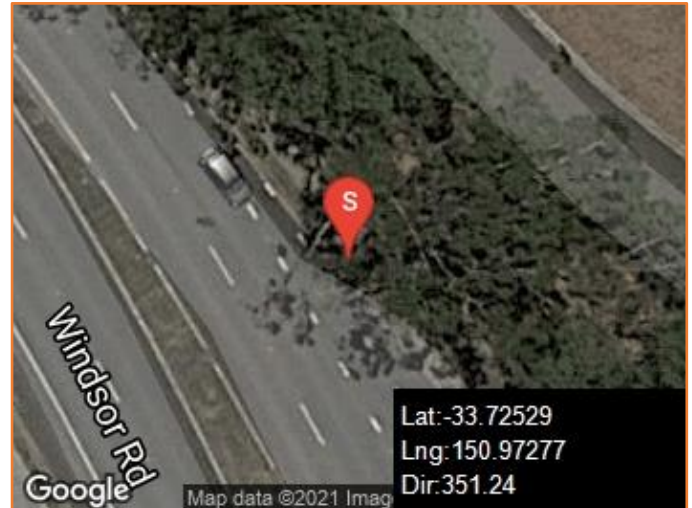
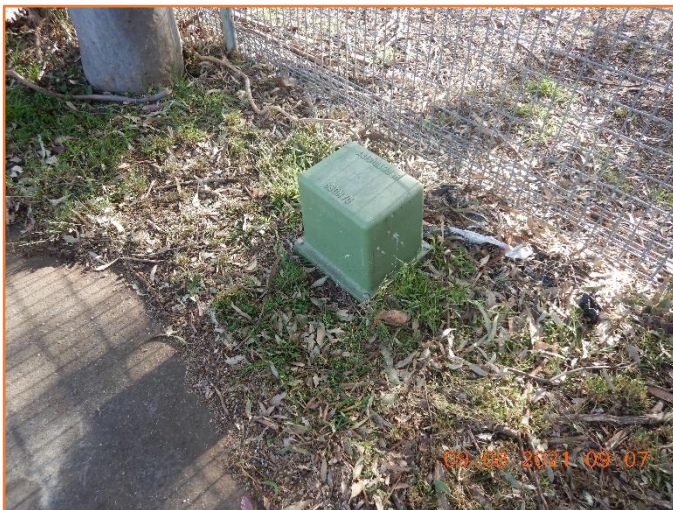
Figure 77: Good - General condition of substation.

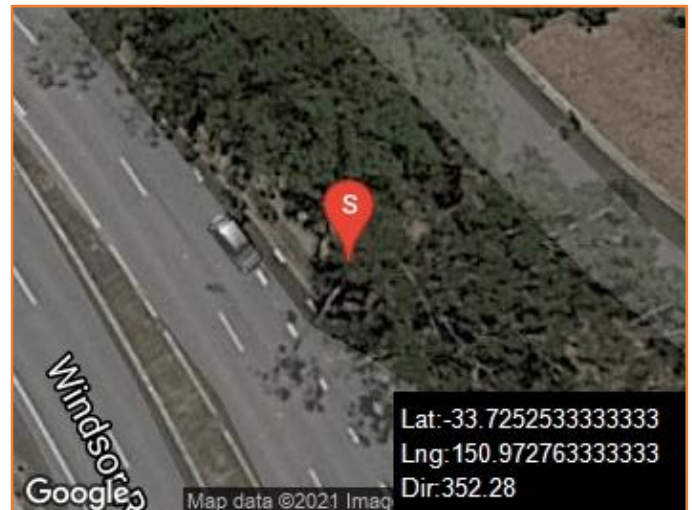
Figure 78: Good - General condition of street planting.

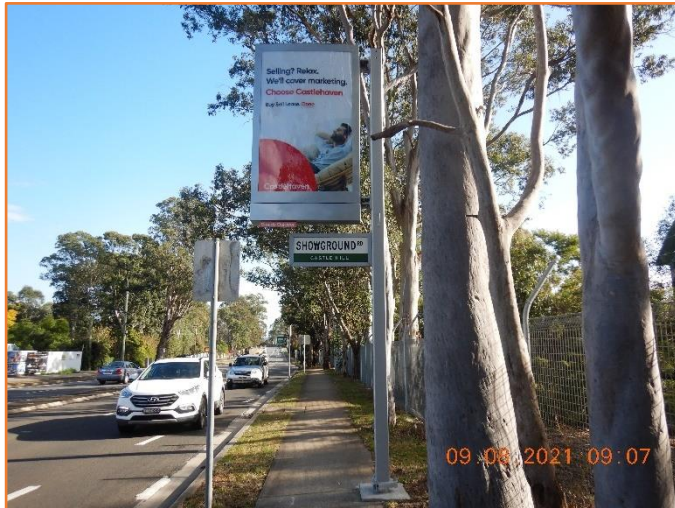
Figure 79: Good - General condition of signage.

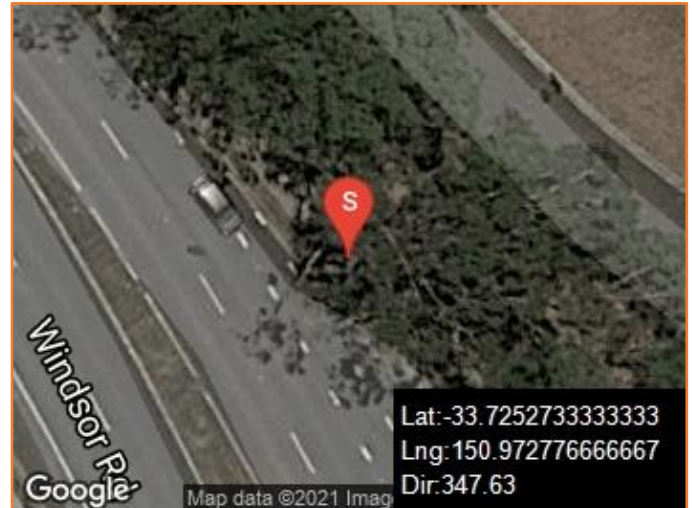
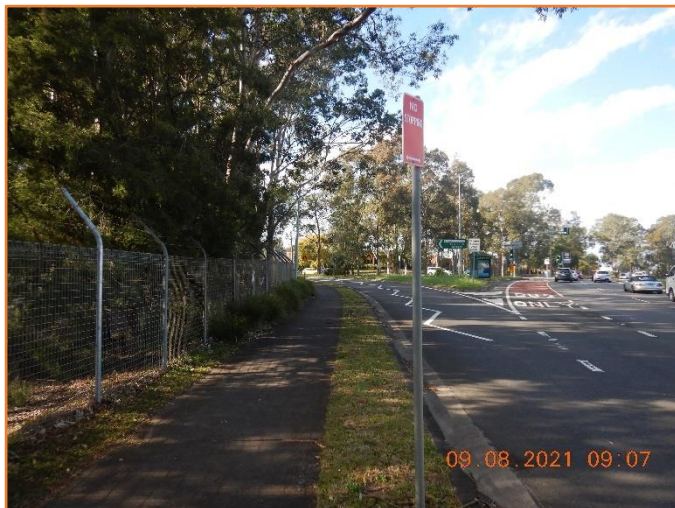
Figure 80: traffic signage.

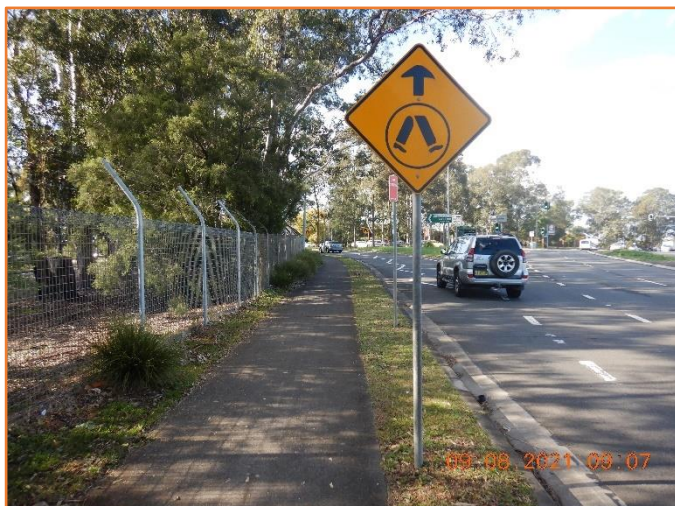
Figure 81: Good - General condition of traffic signage.

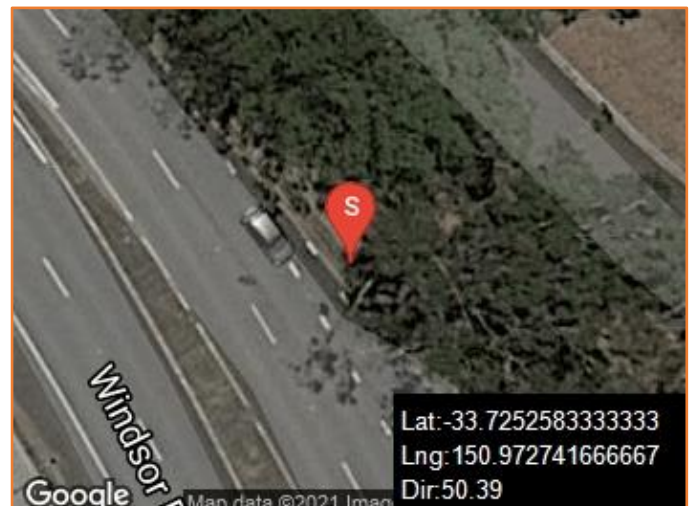
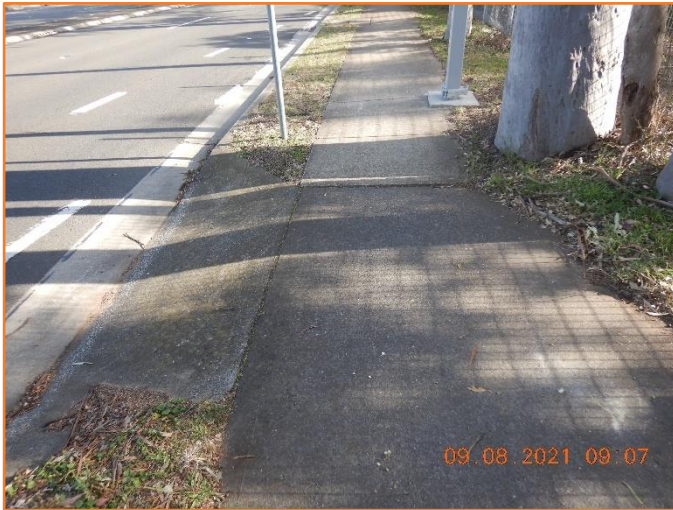
Figure 82: Reasonable - General condition of driveway crossover and footpath.
