## DILAPIDATION REPORT

MUSEUM DISCOVERY CENTRE

MONDAY, 9 AUGUST 2021

Document Information	
Job Number	210722
Document Number	3
Report Title	Dilapidation Report
Site Address	172 Showground Road and 2 Green Road Castle Hill, NSW, 2154
Lot	1 in DP1066281 & 102 in DP1130271

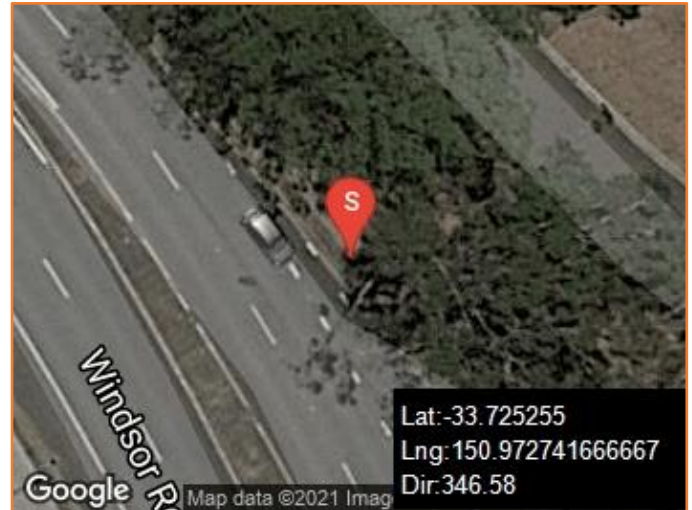
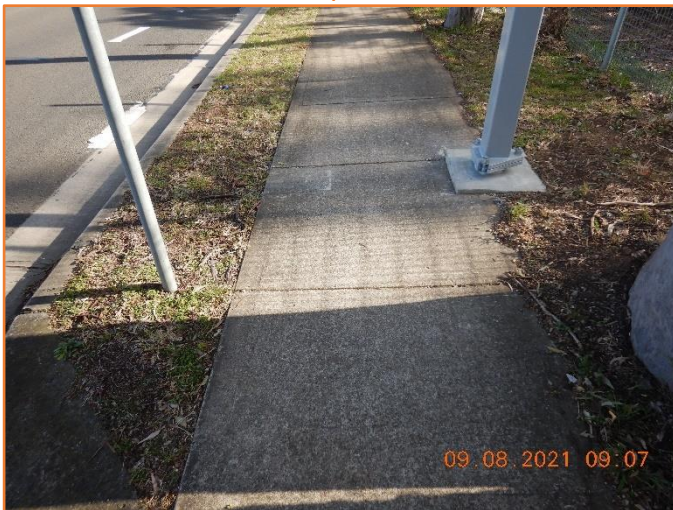
Figure 83: Good - General condition of footpath.

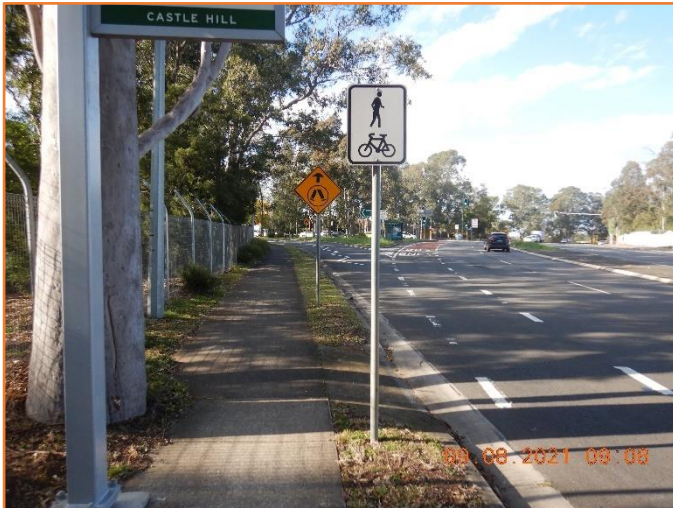
Figure 85: Good - General condition of traffic signage.

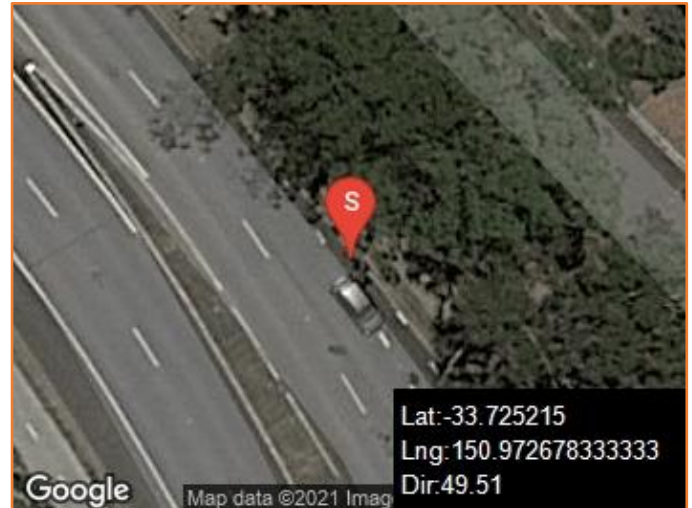
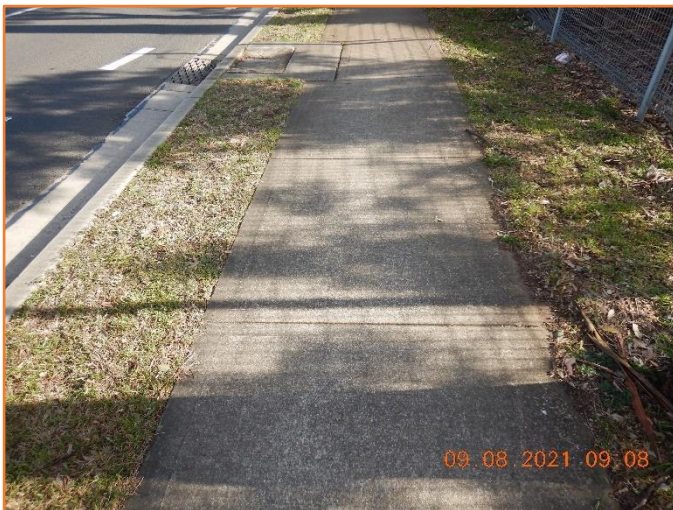
Figure 86: Good - General condition of footpath.

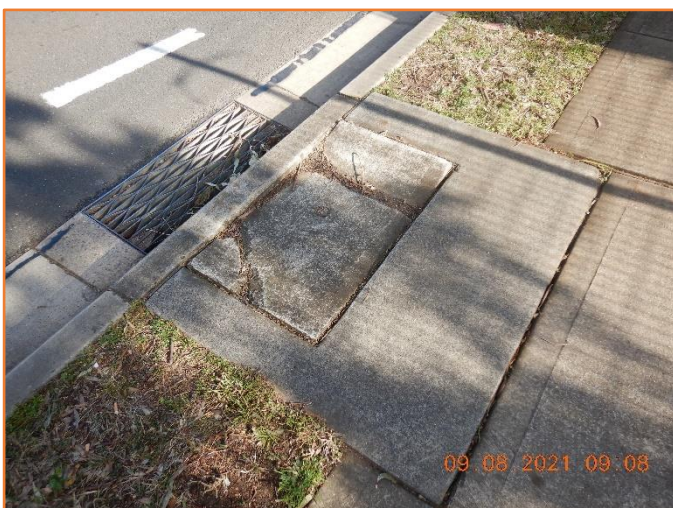
Figure 87: Defective - General condition of kerb inlet pit. Extensive cracking observed.

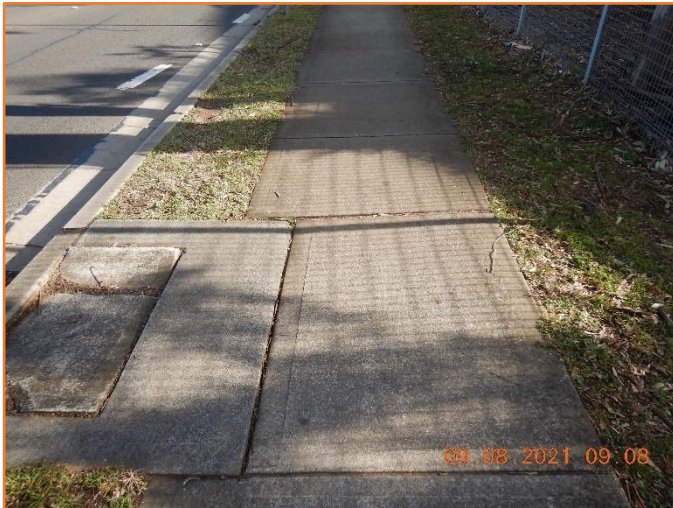
Figure 88: Good - General condition of footpath.

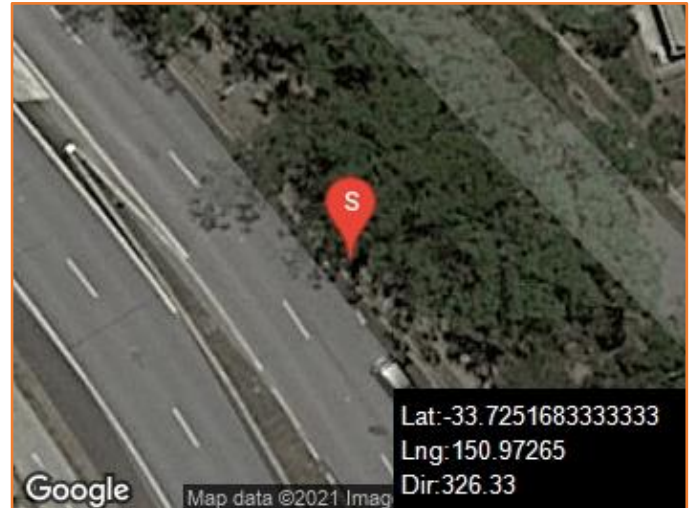
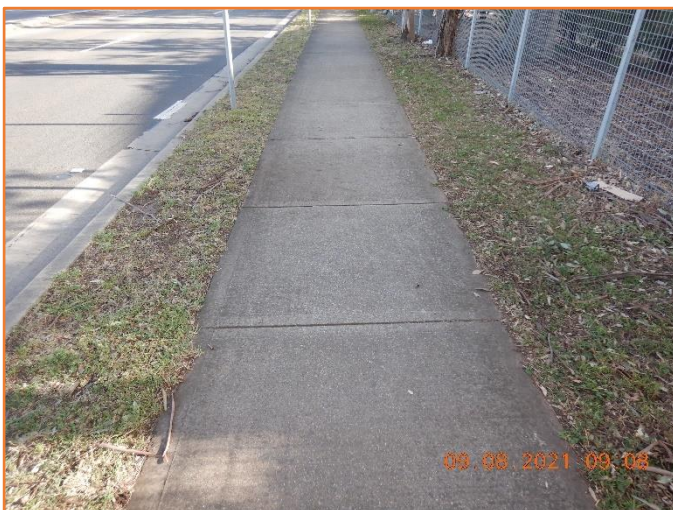
Figure 89: Good - General condition of footpath.

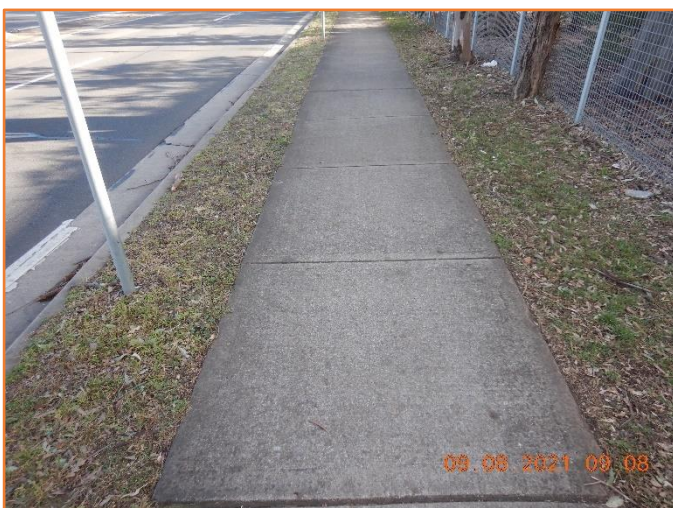
Figure 90: Good - General condition of footpath.

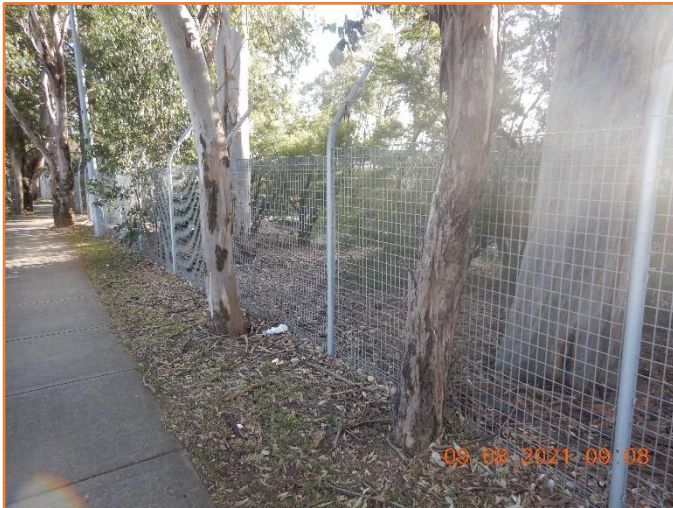
Figure 91: Good - General condition of street planting.

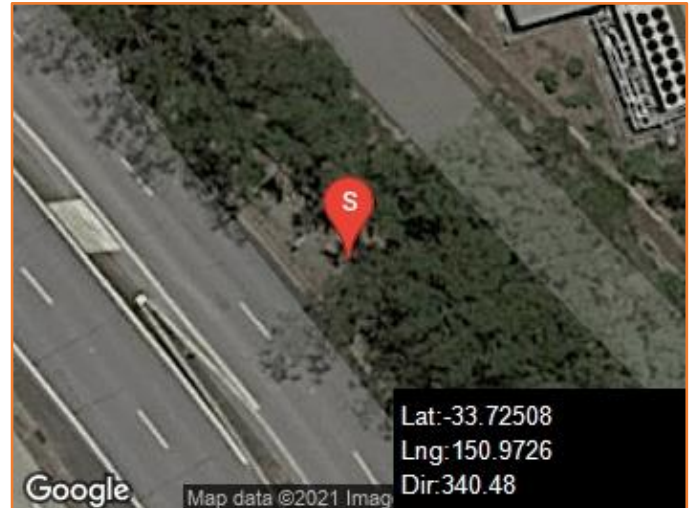
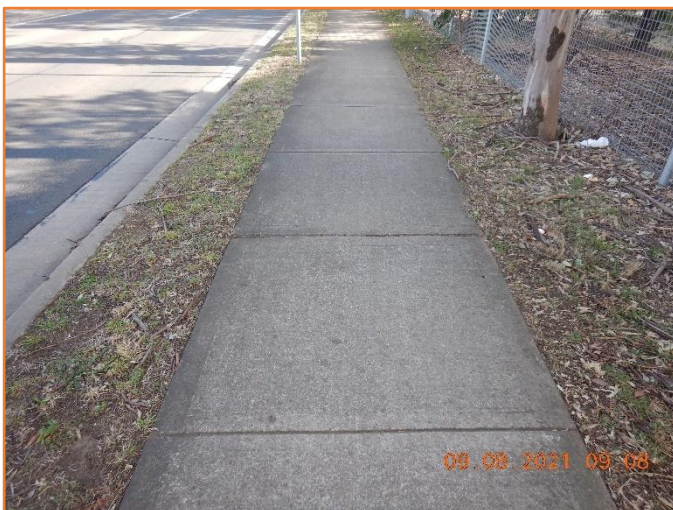
Figure 92: Good - General condition of footpath.

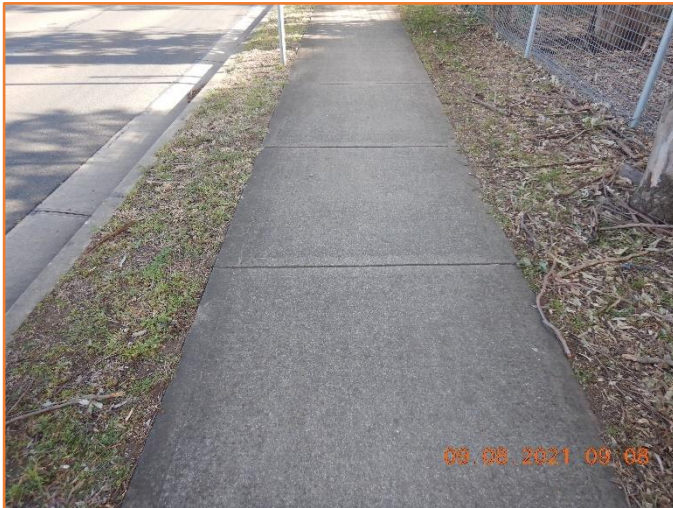
Figure 94: Good - General condition of footpath.

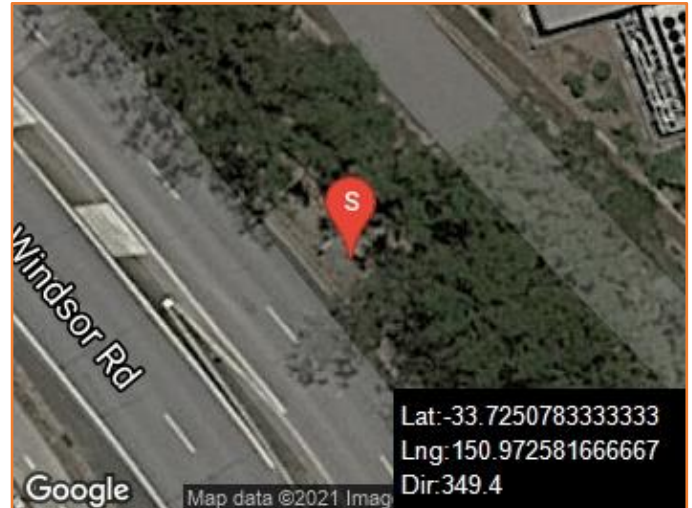
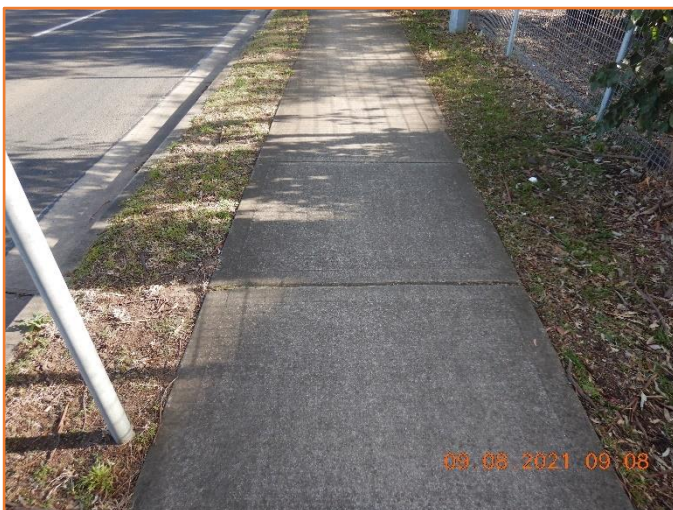
Figure 95: Good - General condition of footpath.

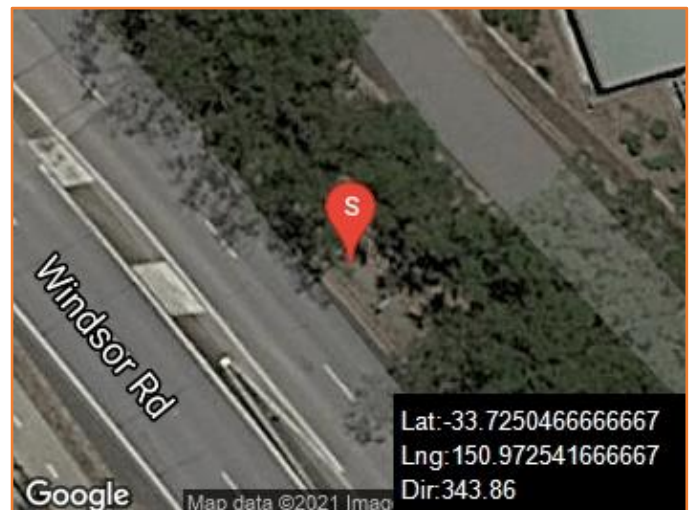
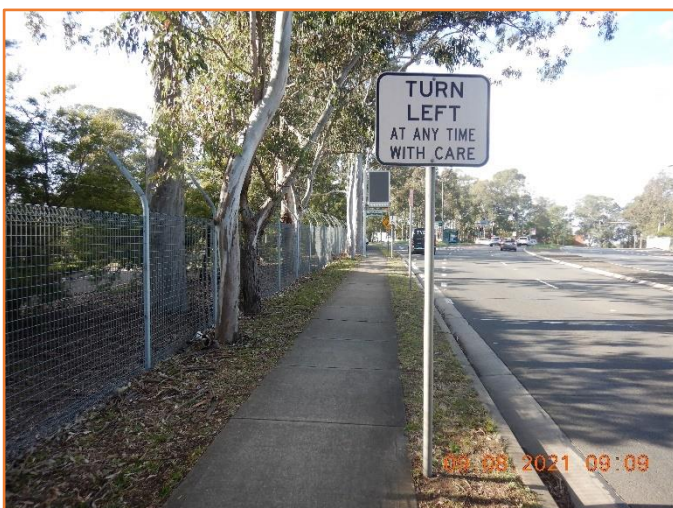
Figure 96: Good - General condition of traffic signage.

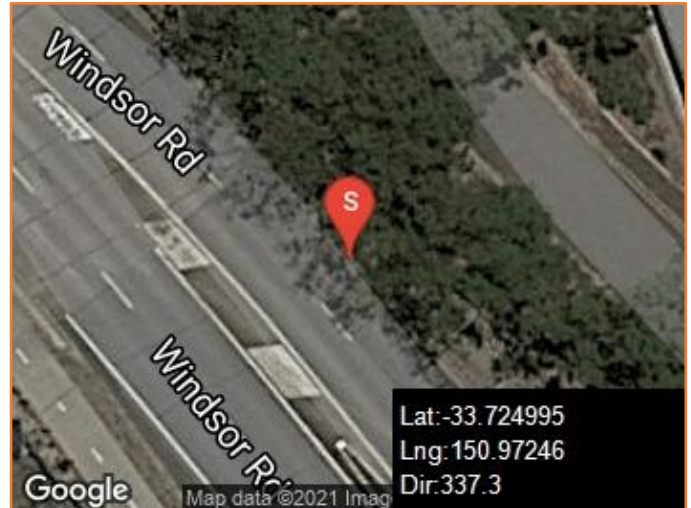
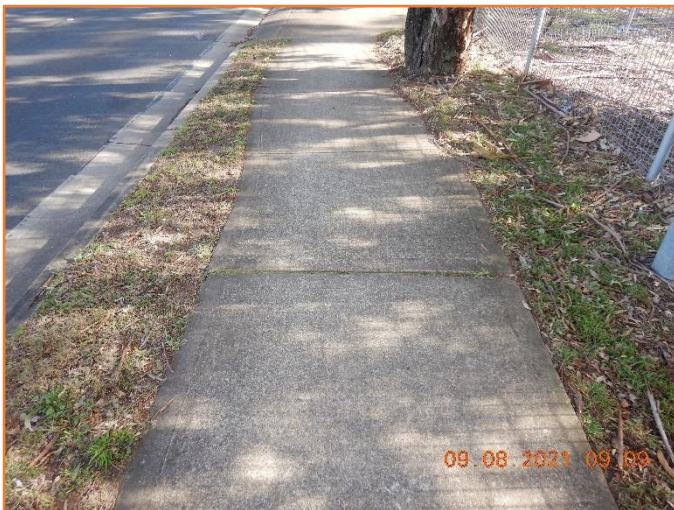
Figure 98: Reasonable - General condition of footpath. Minor differential settlement observed.

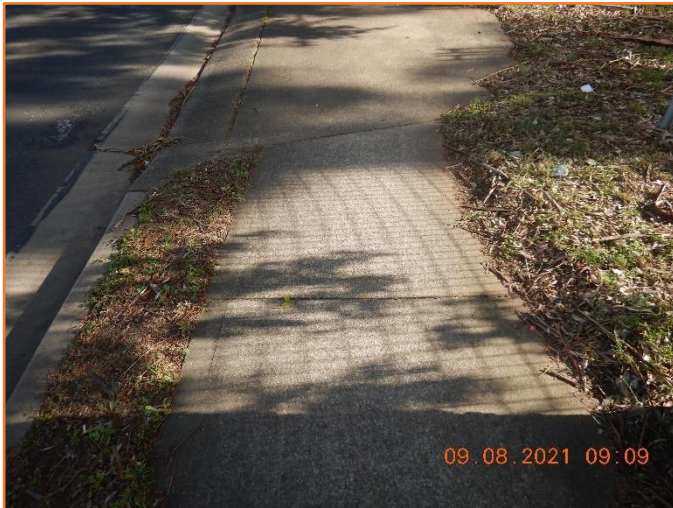
Figure 100: Good - General condition of footpath.

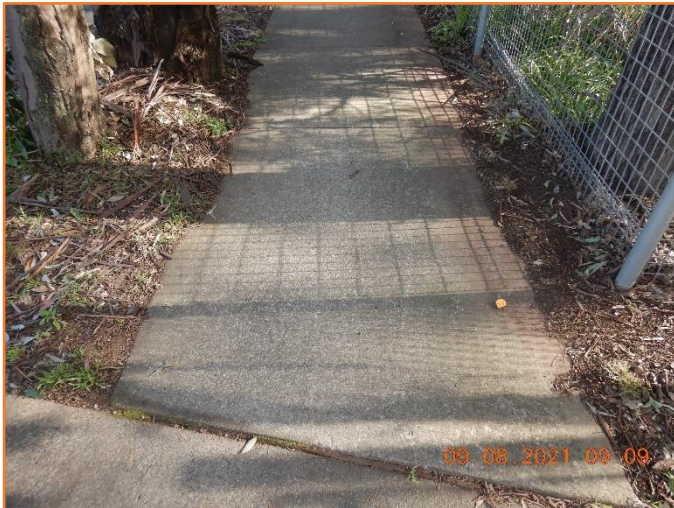
Figure 103: Good - General condition of footpath.

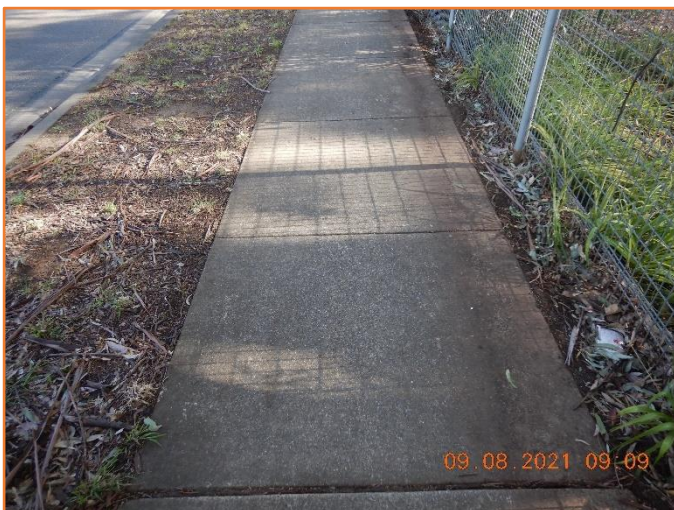
Figure 104: Good - General condition of footpath.

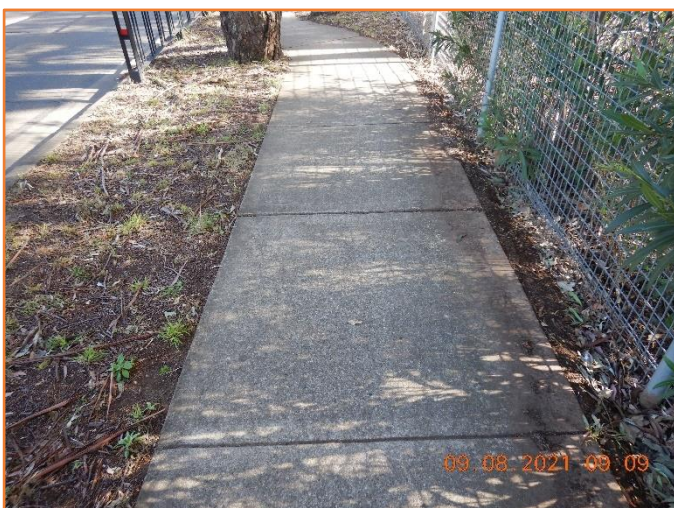
Figure 105: Good - General condition of footpath.

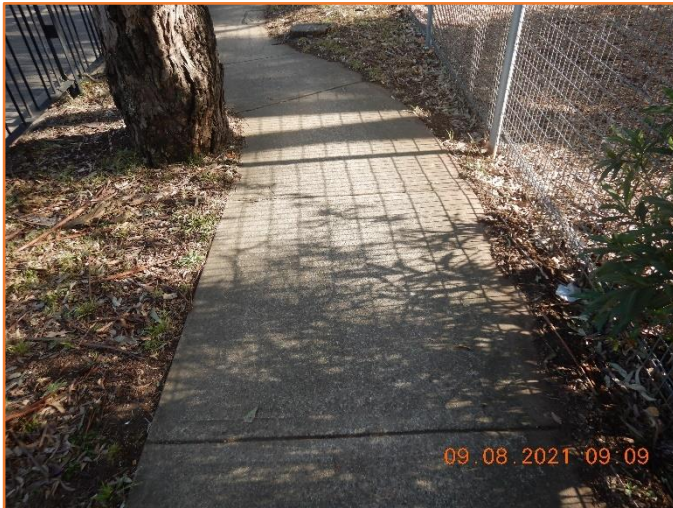
Figure 106: Good - General condition of footpath.

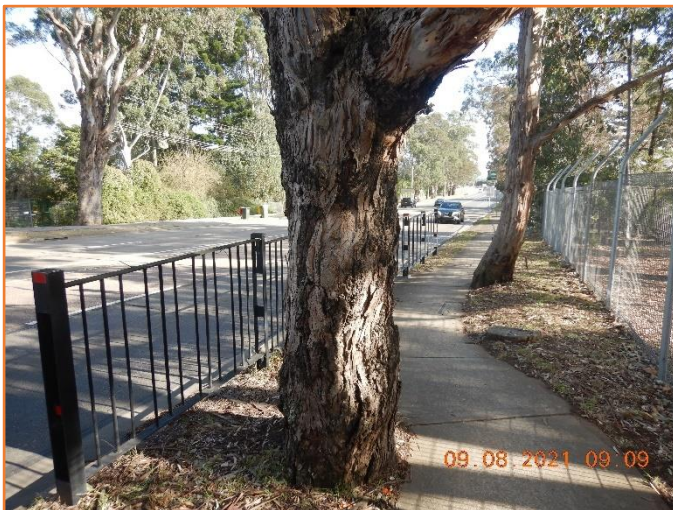
Figure 107: Good - General condition of street planting.

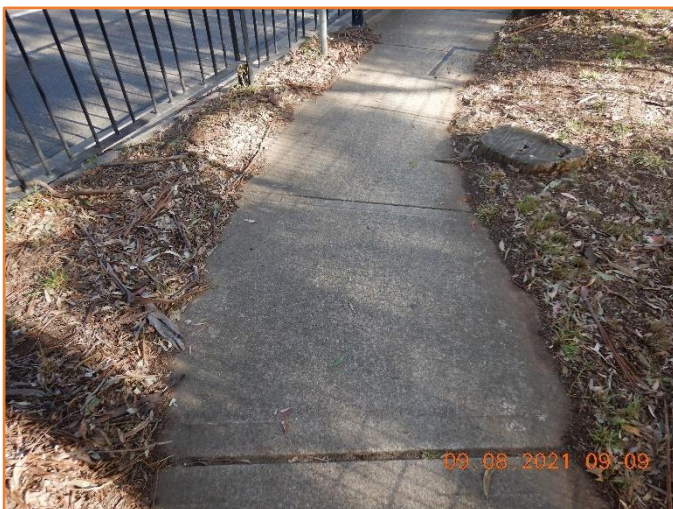
Figure 108: Good - General condition of footpath.

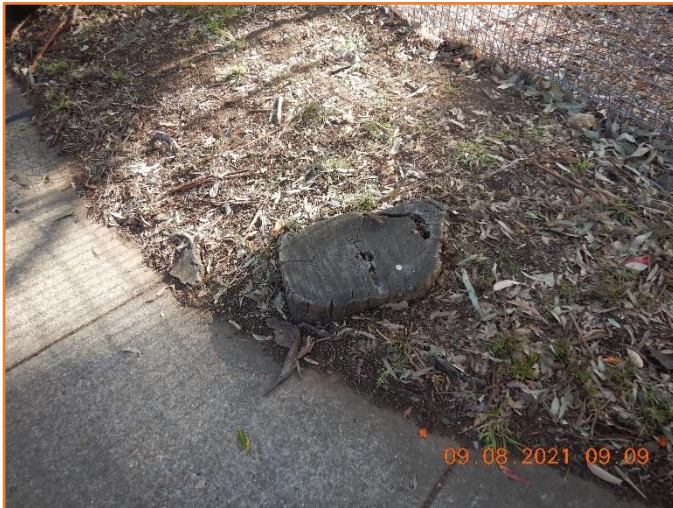
Figure 109: Cut tree observed.

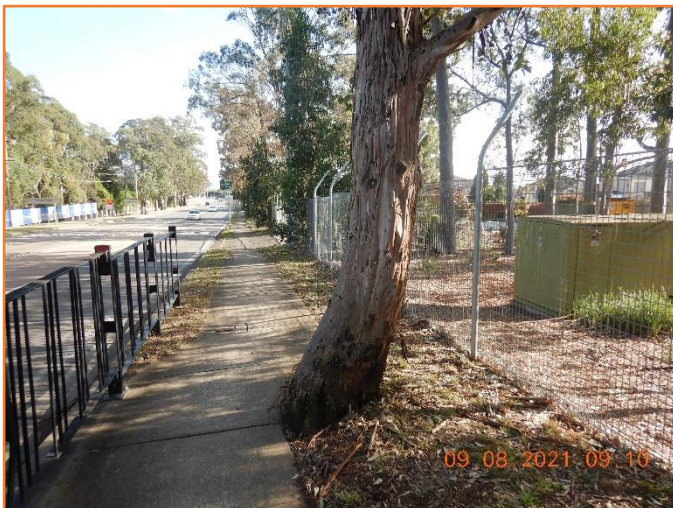
Figure 110: Good - General condition of street planting.

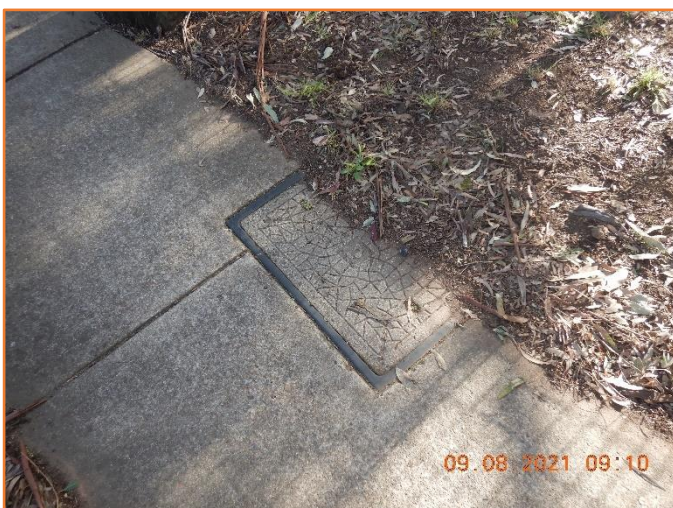
Figure 111: Reasonable - General condition of service pit.

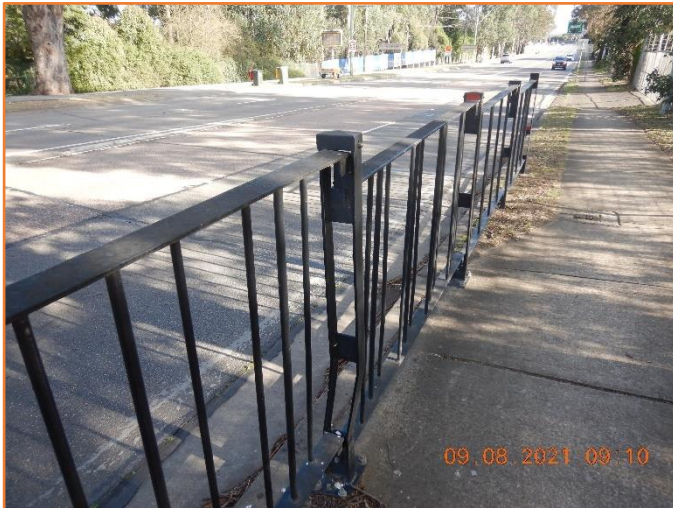
Figure 112: Reasonable - General condition of crash barrier. Moderate physical damage observed.

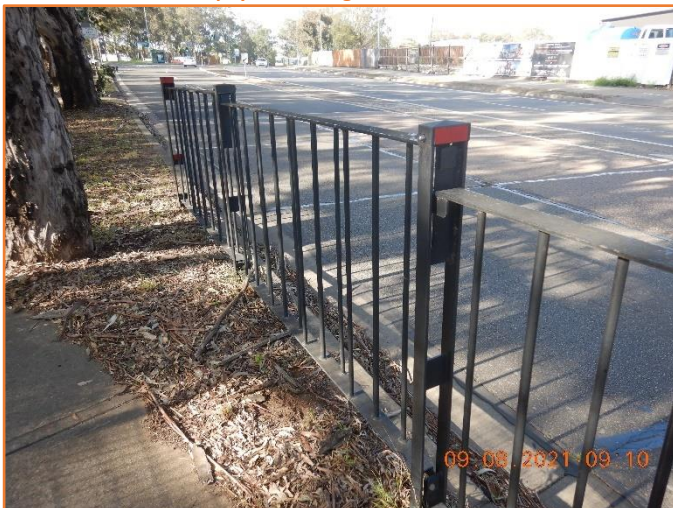
Figure 113: Reasonable - General condition of crash barrier.

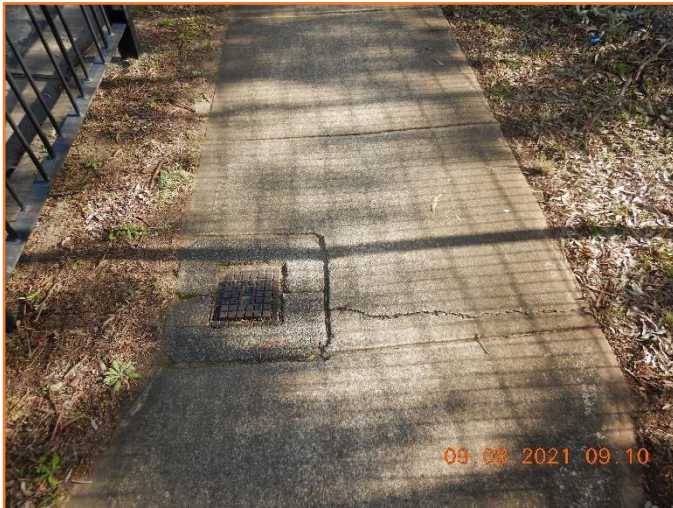
**Figure 115: Defective - General condition of footpath and service pit.**  
**Major cracking observed.**

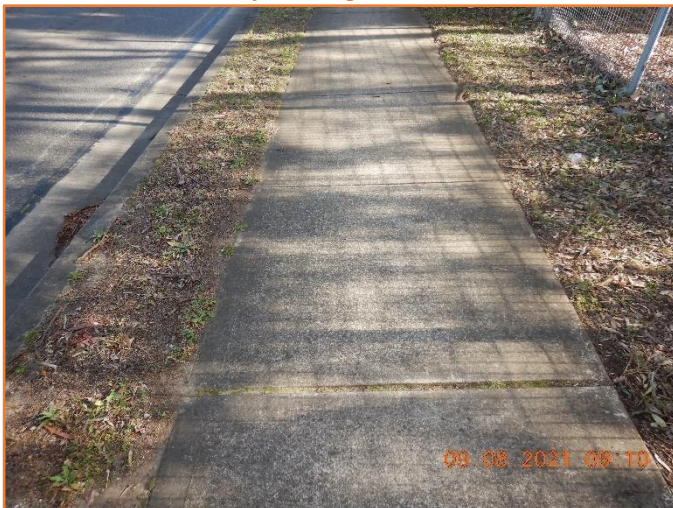
**Figure 116: Good - General condition of footpath.**

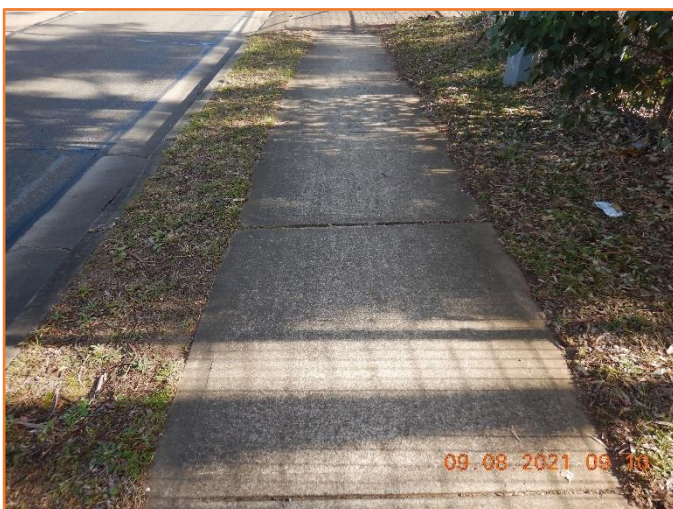
**Figure 117: Good - General condition of footpath.**

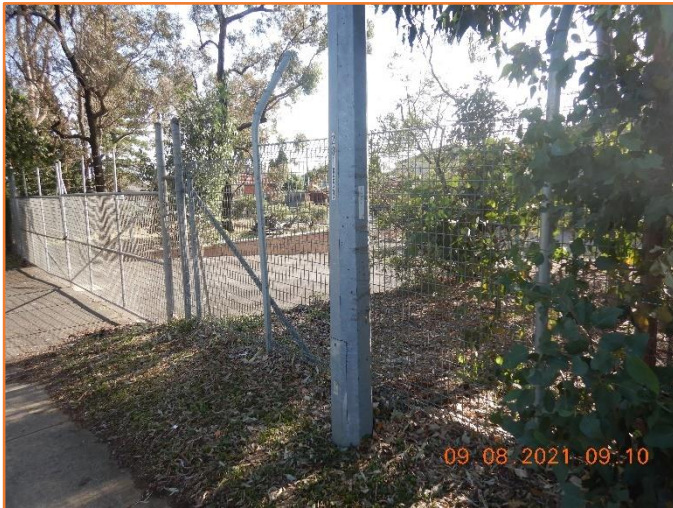
Figure 118: Good - General condition of monopole assembly.

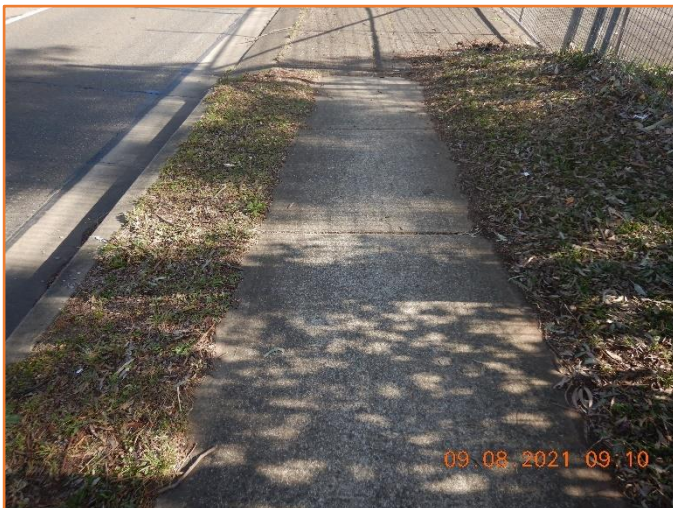
Figure 119: Good - General condition of footpath.

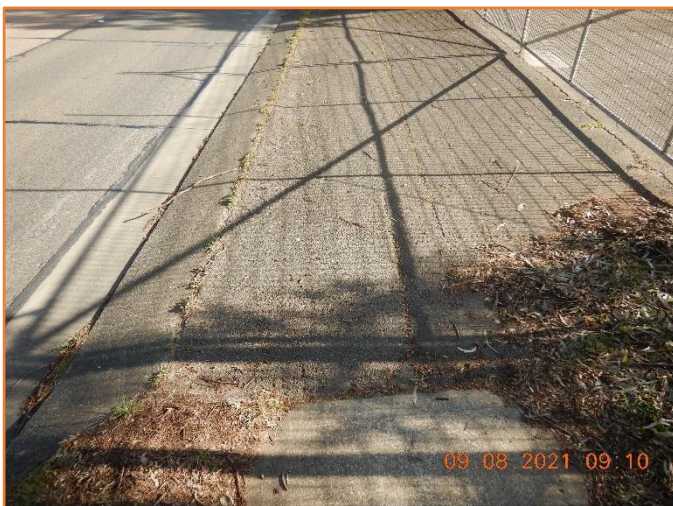
Figure 120: Reasonable - General condition of driveway crossover.  
 Moderate cracking observed.

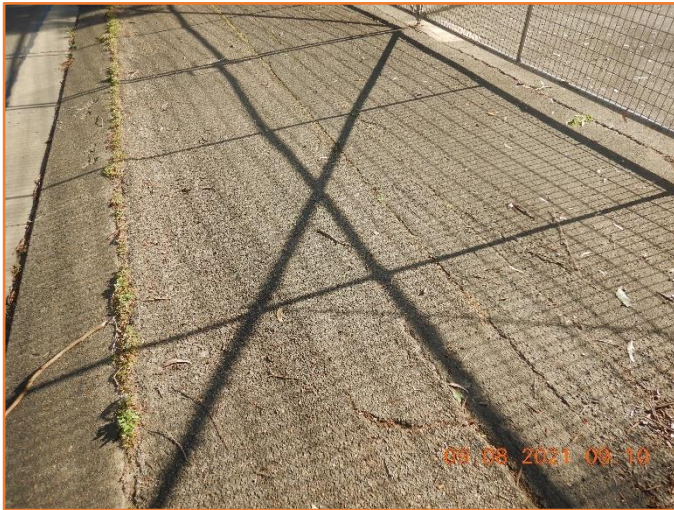
Figure 121: Reasonable - General condition of driveway crossover.  
 Moderate cracking observed.

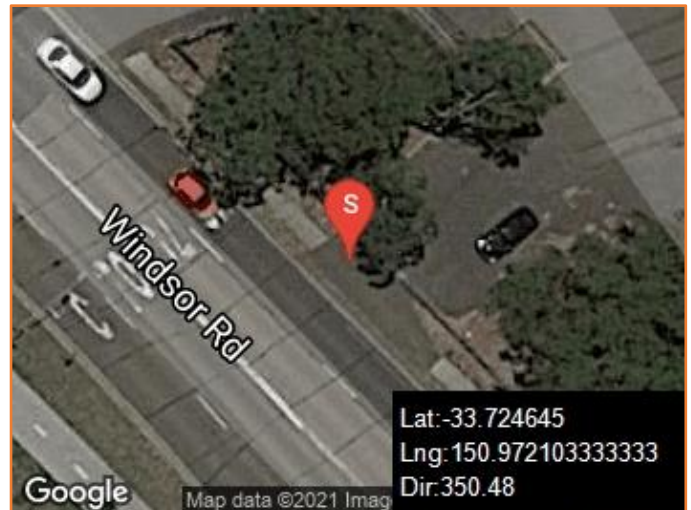
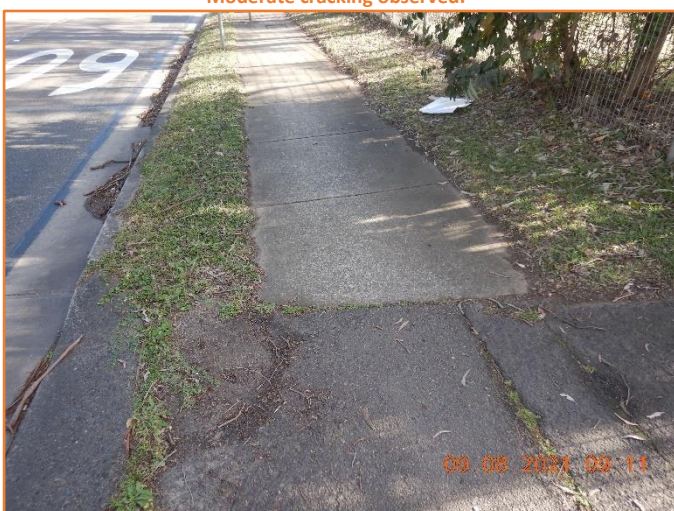
Figure 122: Reasonable - General condition of driveway crossover.  
 Moderate cracking observed.

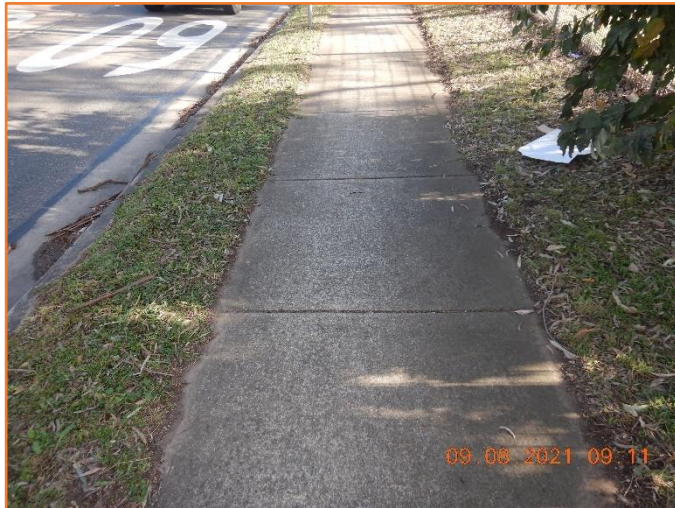
Figure 123: Reasonable - General condition of driveway crossover.  
 Moderate cracking observed.

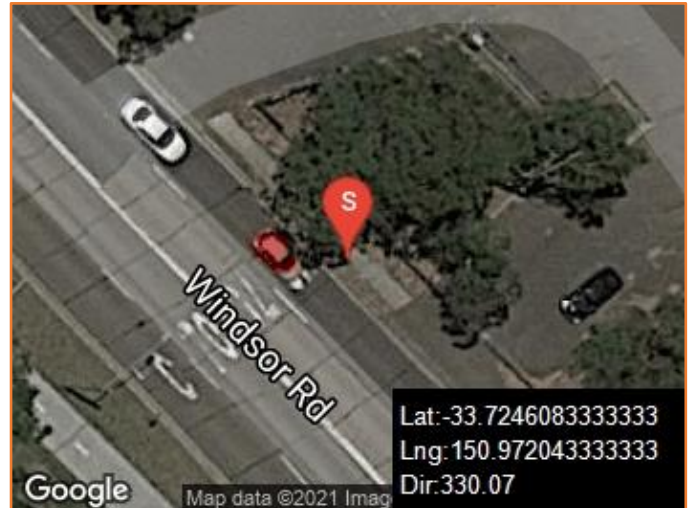
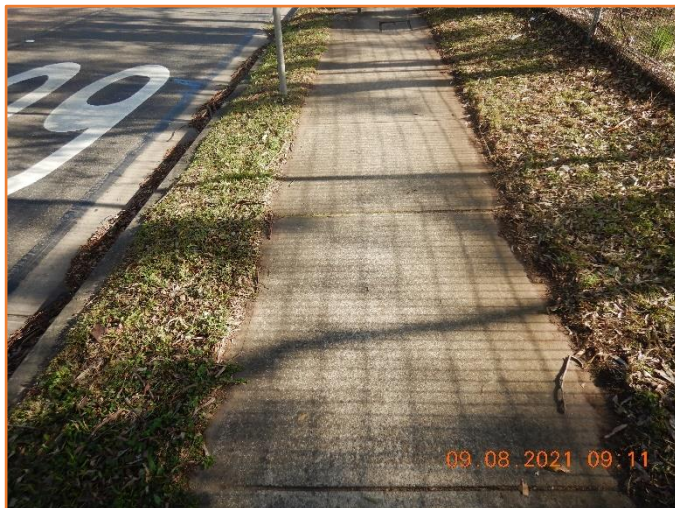
Figure 124: Good - General condition of footpath.

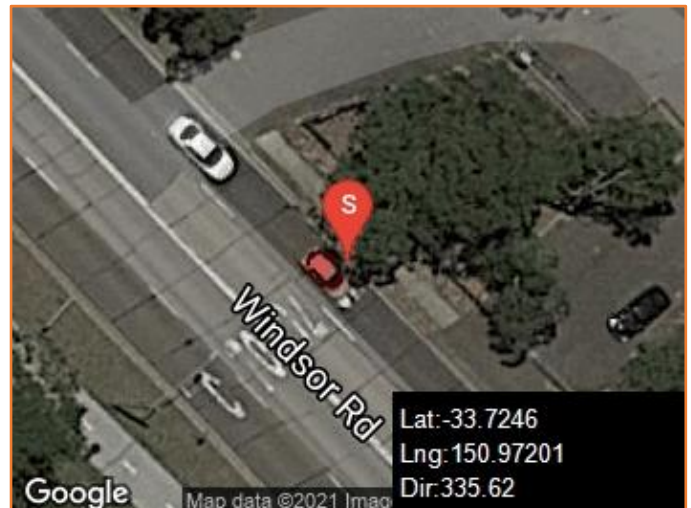
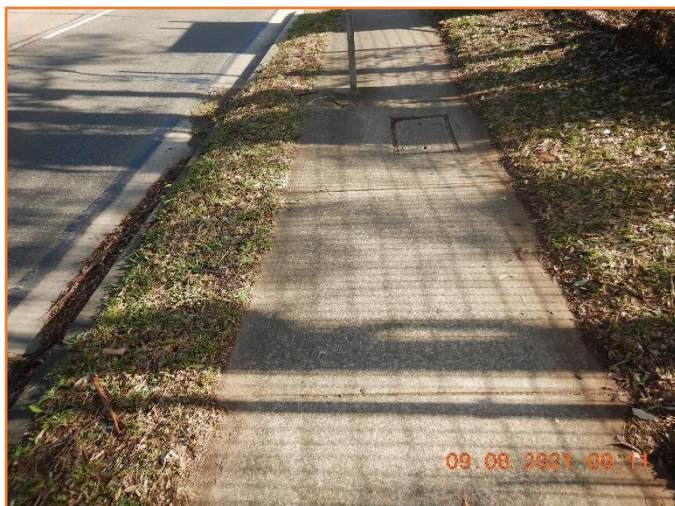
Figure 125: Reasonable - General condition of footpath.

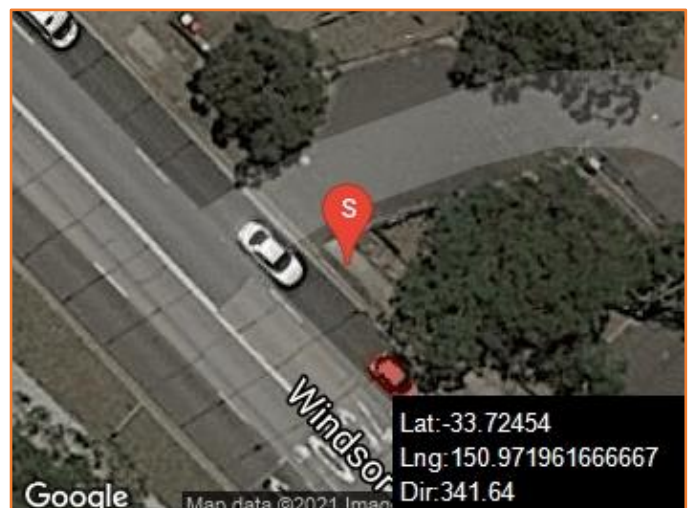
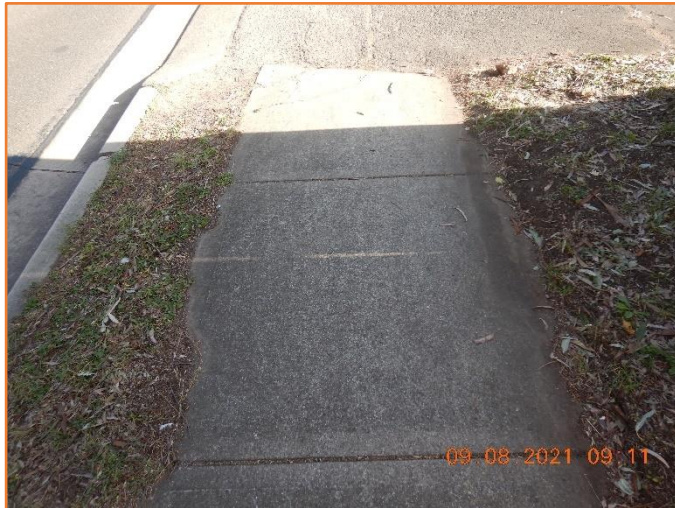
Figure 129: Good - General condition of footpath.

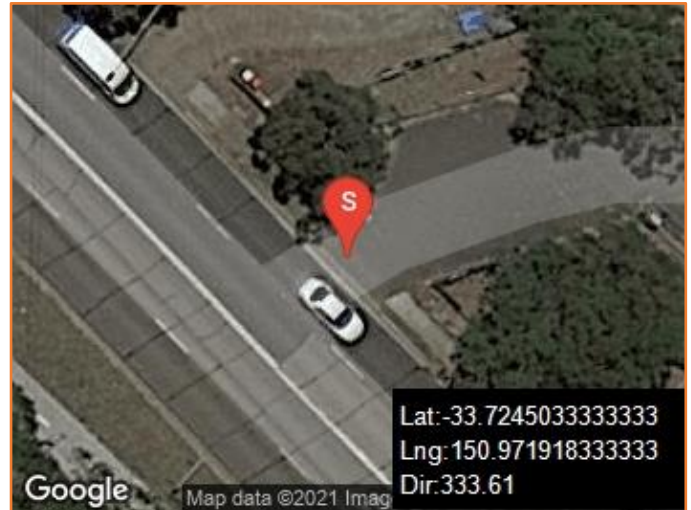
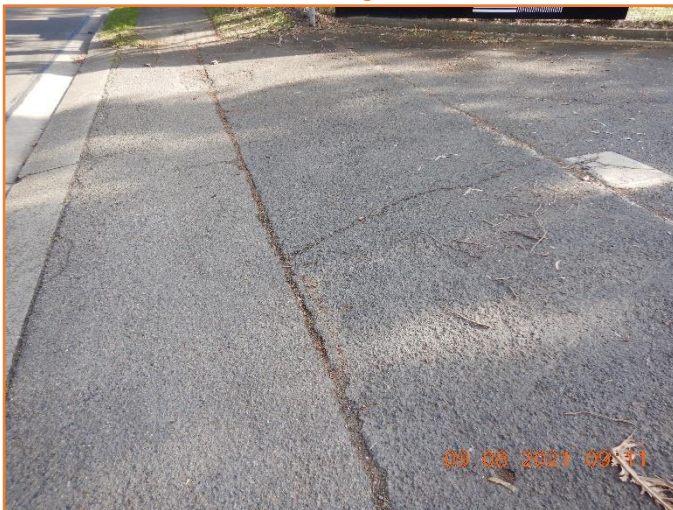
Figure 133: Reasonable - General condition of driveway crossover.  
 Moderate cracking observed.

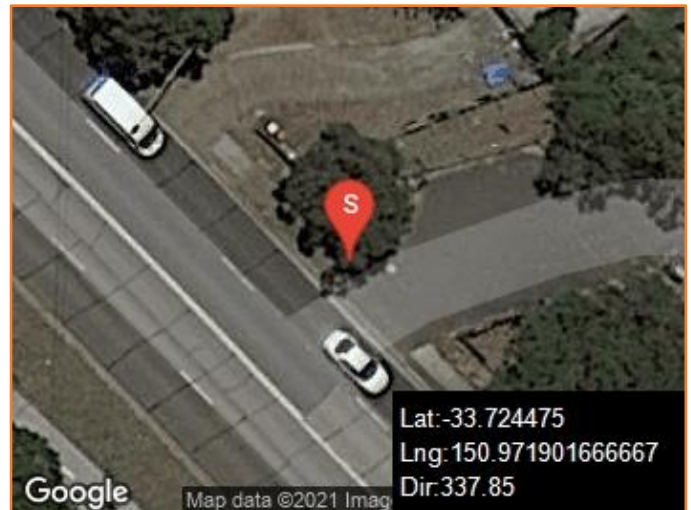
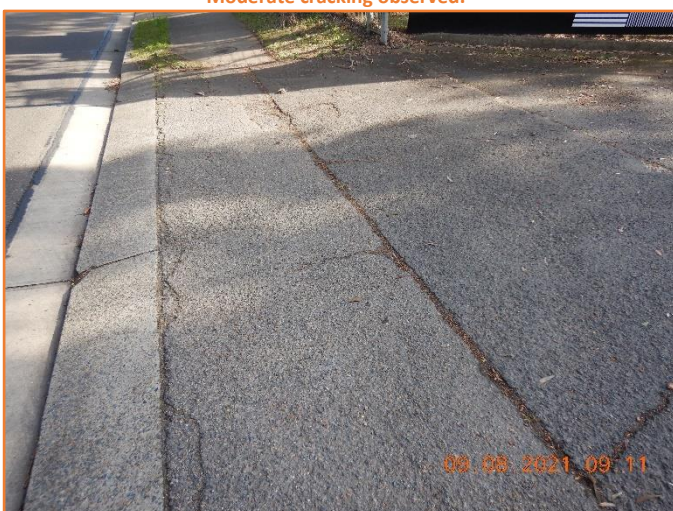
Figure 134: Reasonable - General condition of driveway crossover.  
 Moderate cracking observed.

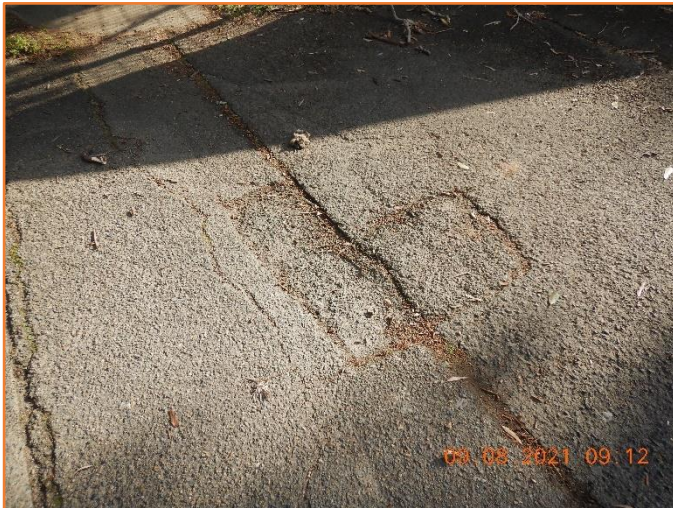
Figure 135: Reasonable - General condition of driveway crossover.  
 Moderate cracking observed.

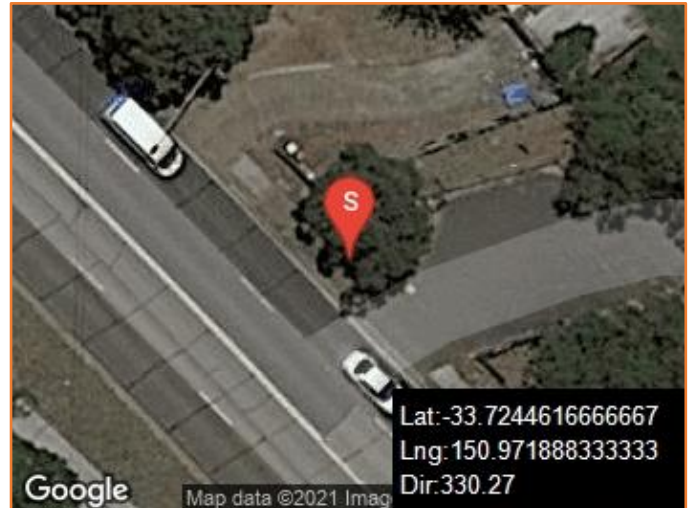
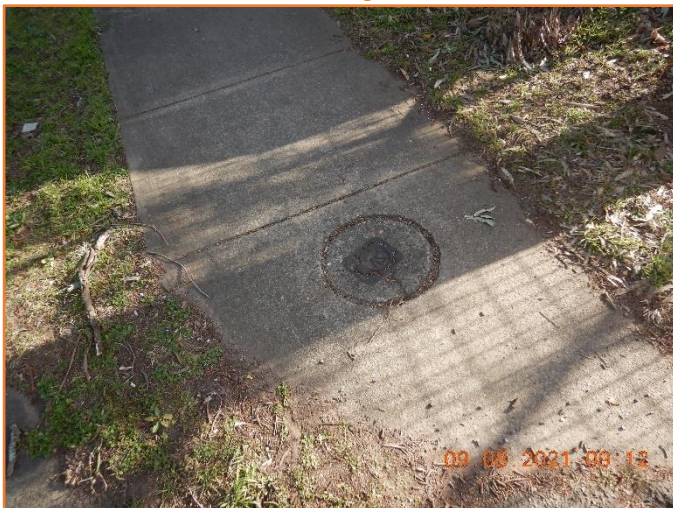
Figure 136: Reasonable - General condition of driveway crossover.  
 Moderate cracking observed.

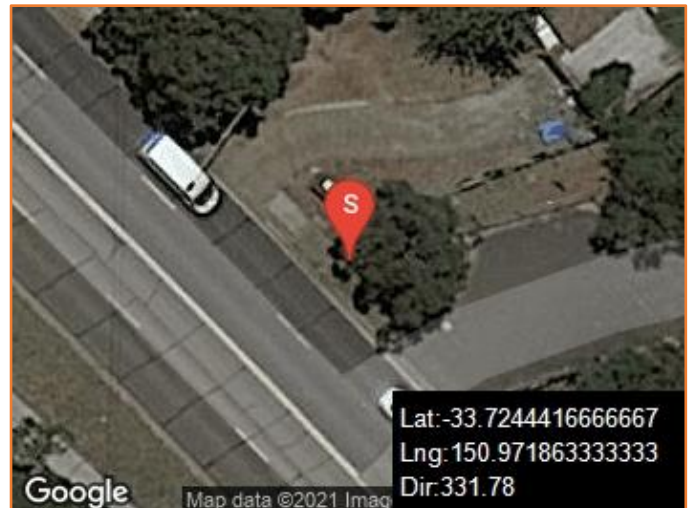
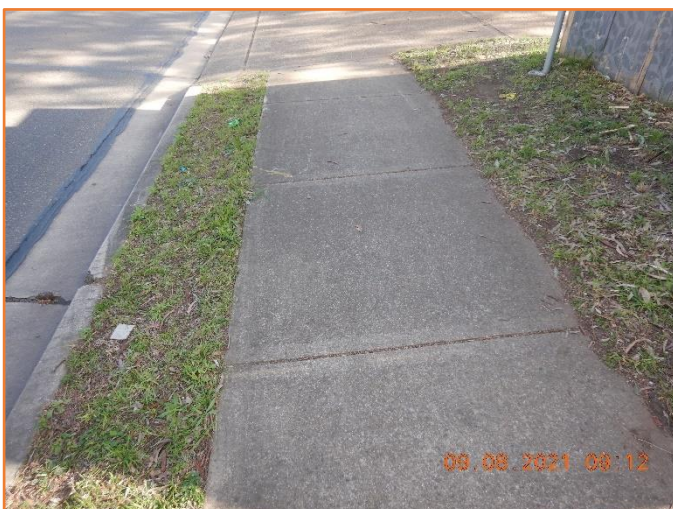
Figure 137: Reasonable - General condition of footpath and service pit.

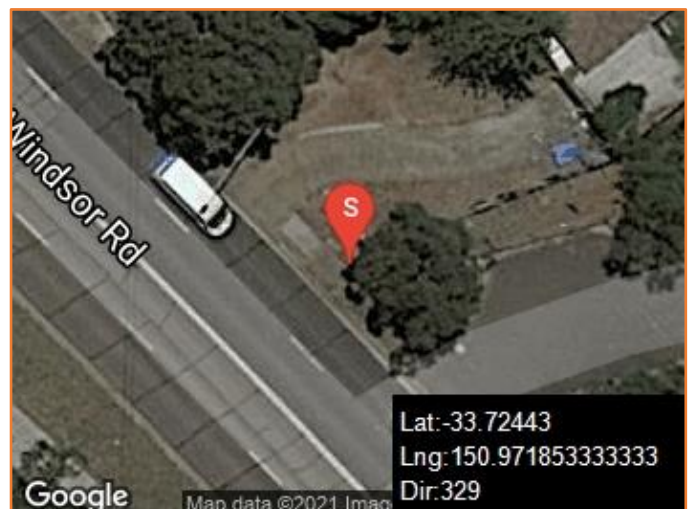
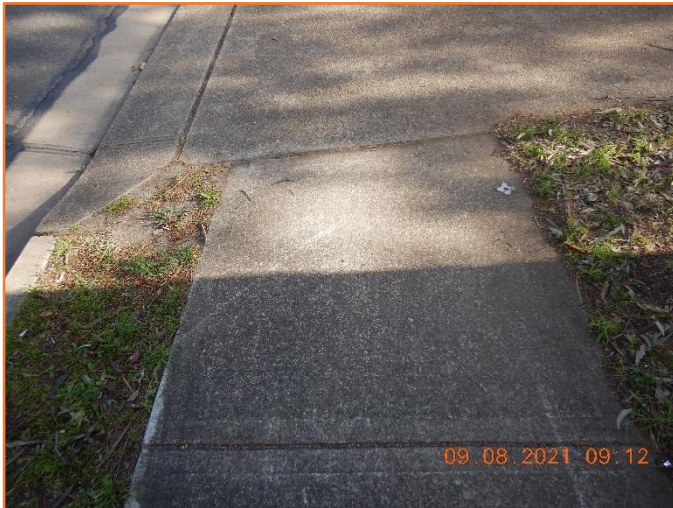
Figure 138: Good - General condition of footpath.

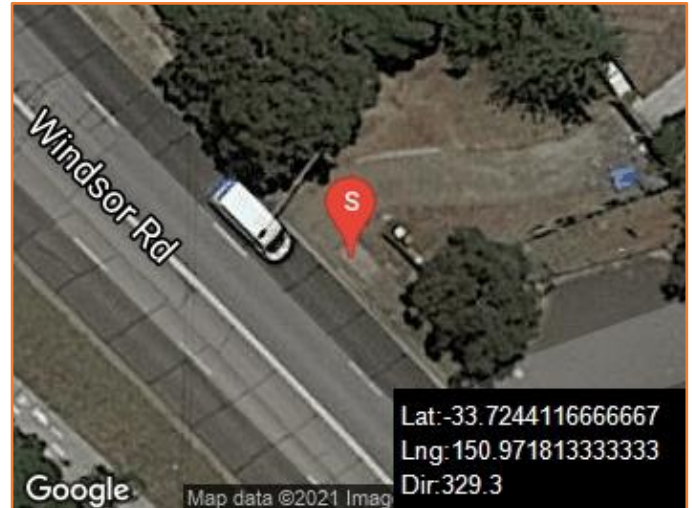
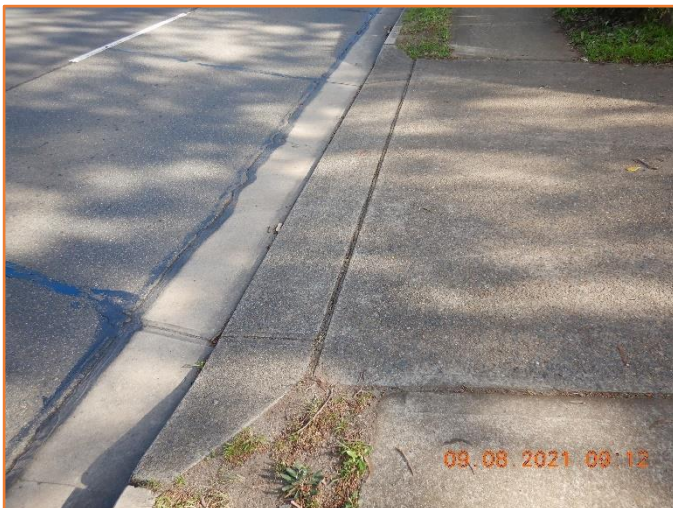
Figure 139: Good - General condition of footpath.

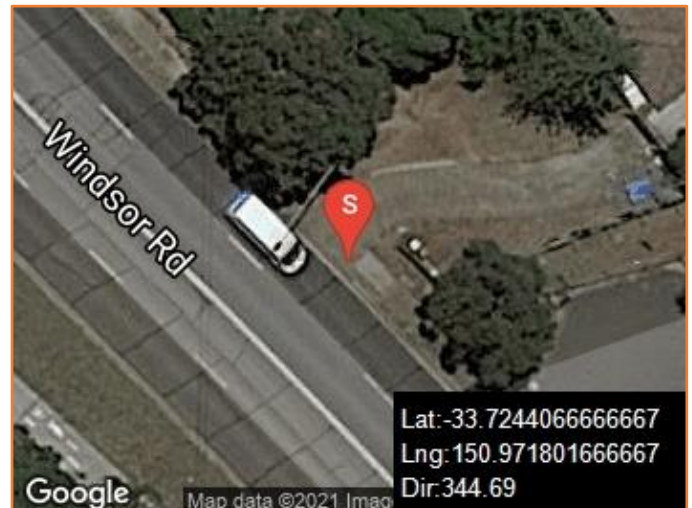
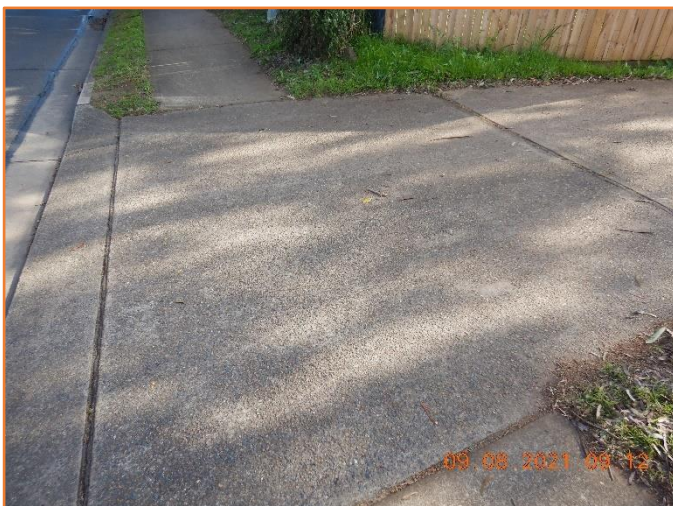
Figure 140: Reasonable - General condition of driveway crossover.

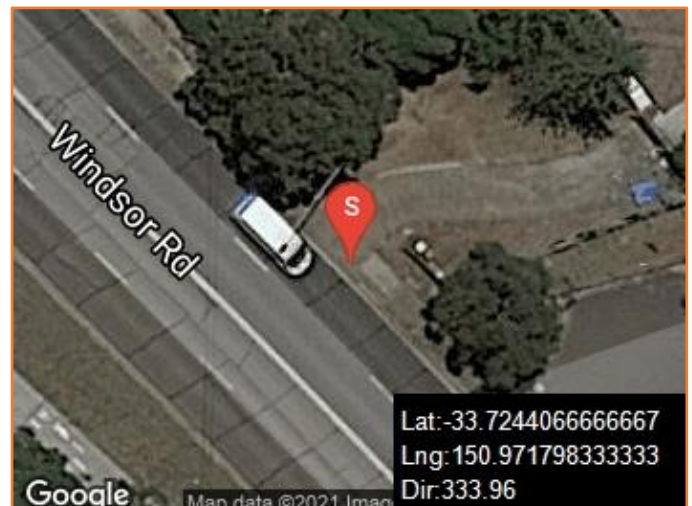
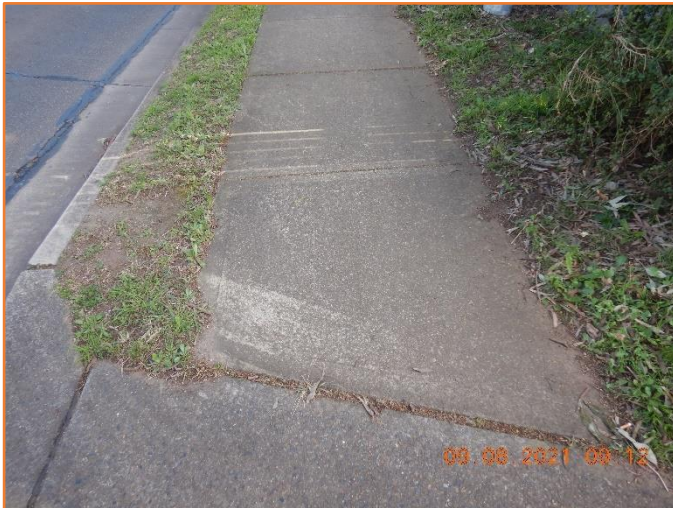
Figure 141: Reasonable - General condition of driveway crossover.
