## DILAPIDATION REPORT

MUSEUM DISCOVERY CENTRE

MONDAY, 9 AUGUST 2021

Document Information	
Job Number	210722
Document Number	3
Report Title	Dilapidation Report
Site Address	172 Showground Road and 2 Green Road Castle Hill, NSW, 2154
Lot	1 in DP1066281 & 102 in DP1130271

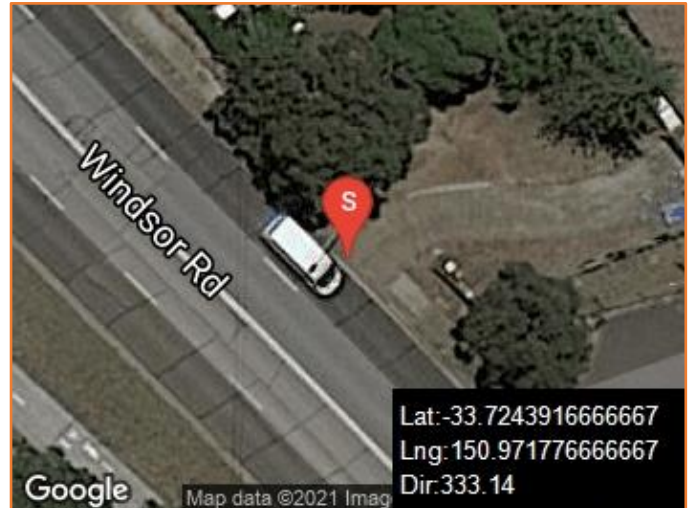
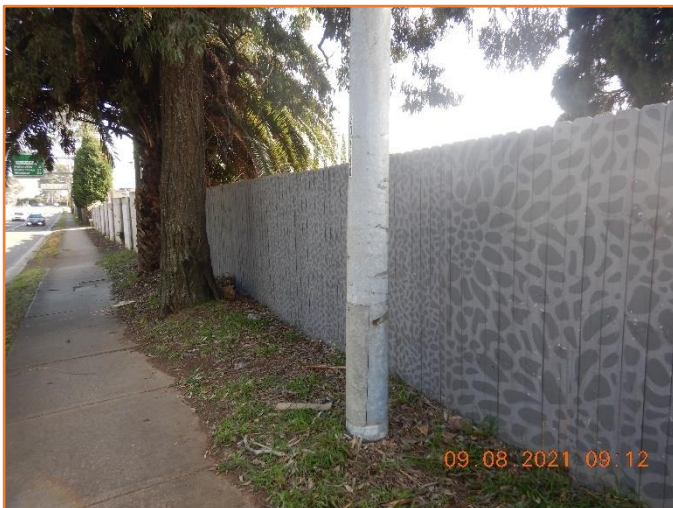
Figure 142: Good - General condition of footpath.

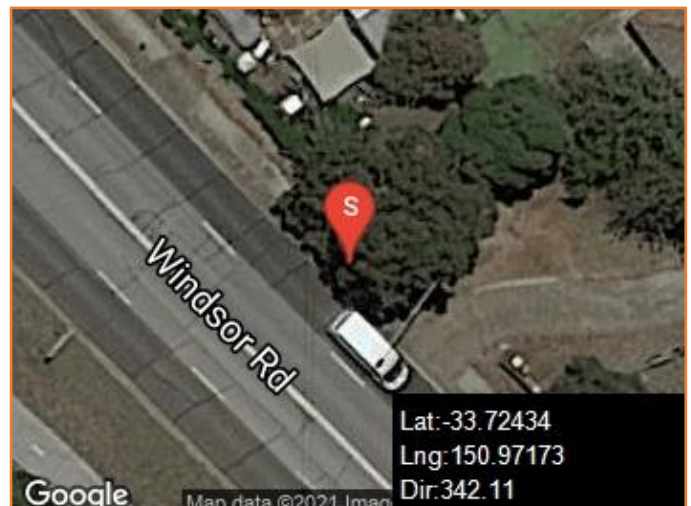
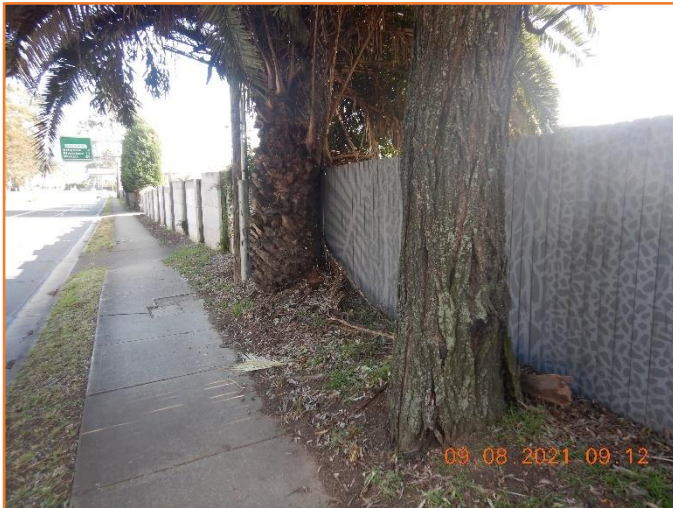
Figure 144: Good - General condition of footpath.

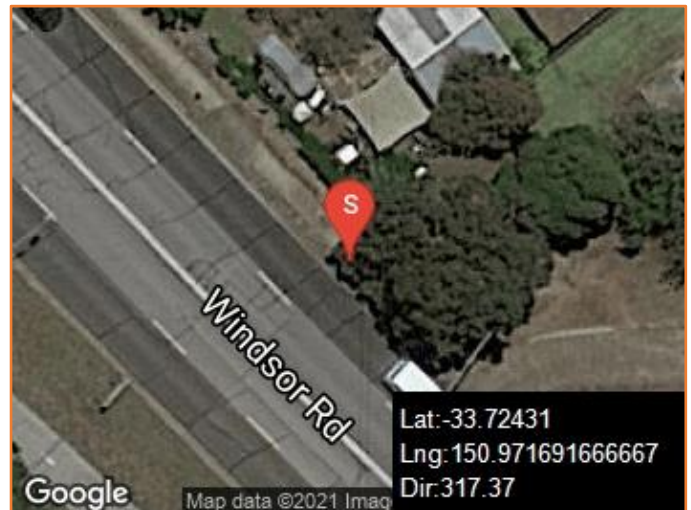
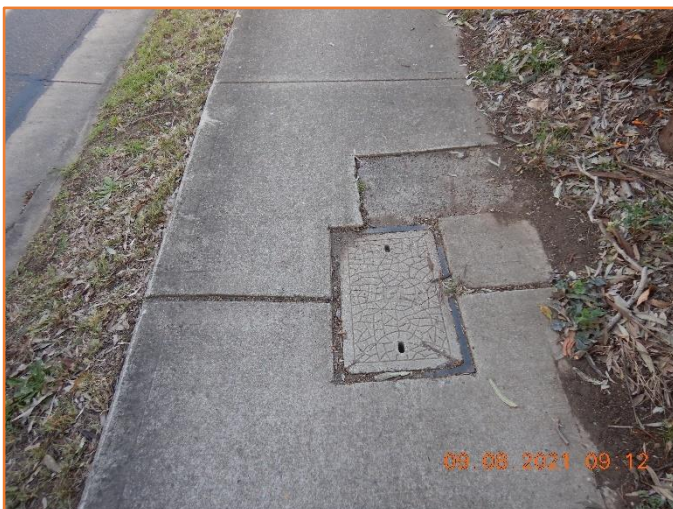
Figure 146: Good - General condition of footpath.

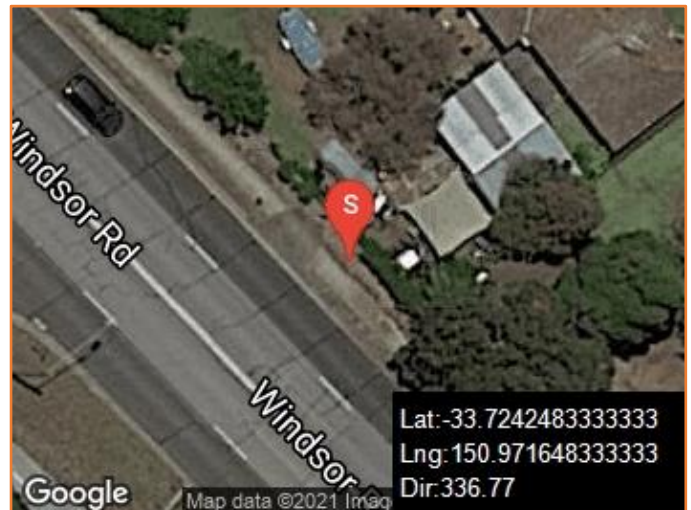
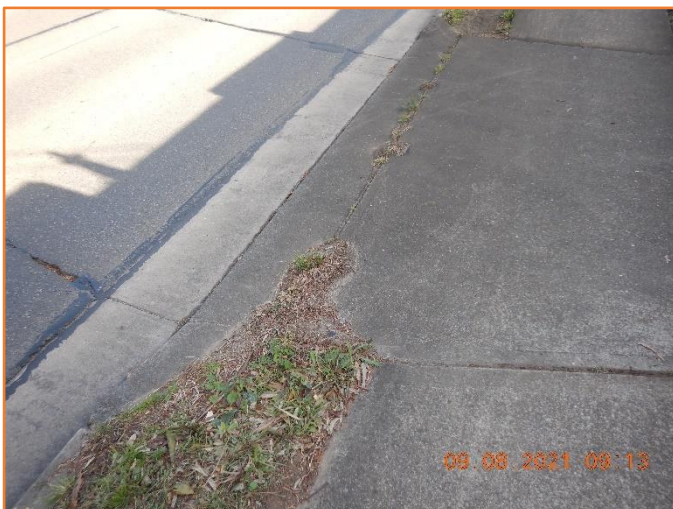
Figure 149: Good - General condition of footpath.

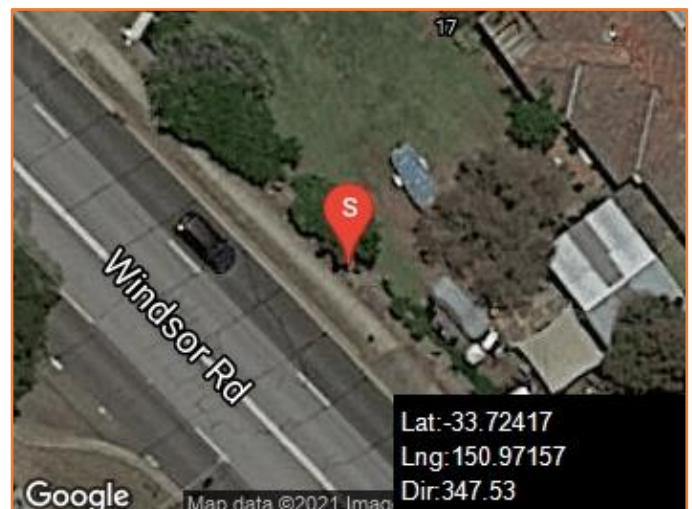
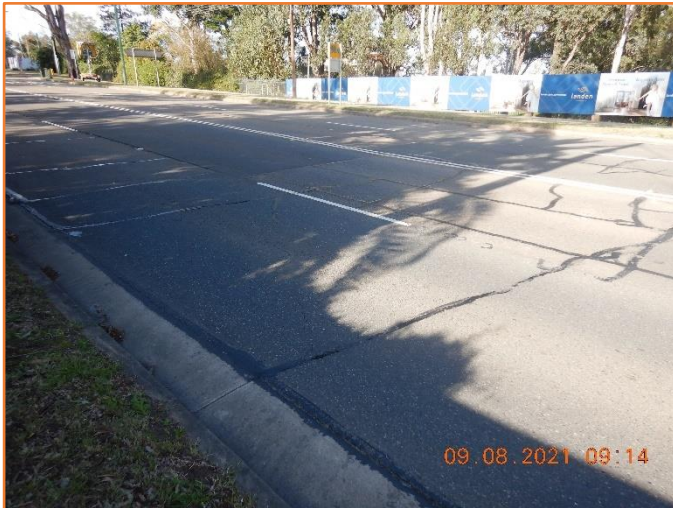
Figure 153: Reasonable - General condition of flexible pavement. Moderate previous repair observed.

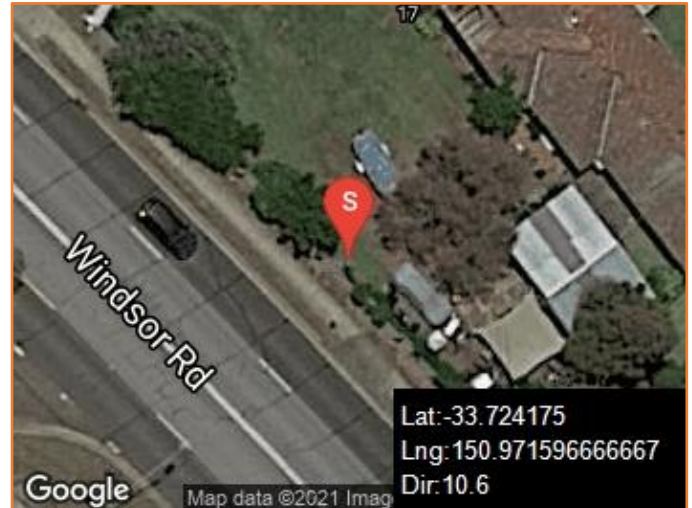
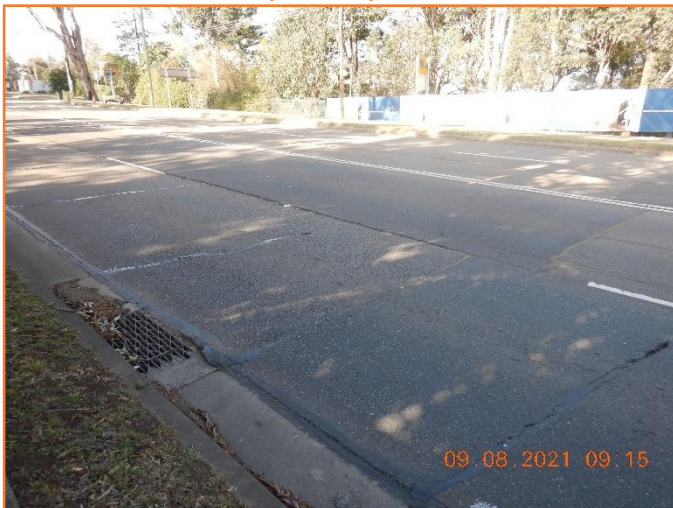
**Figure 154: Reasonable - General condition of flexible pavement.**  
**Moderate previous repair observed.**

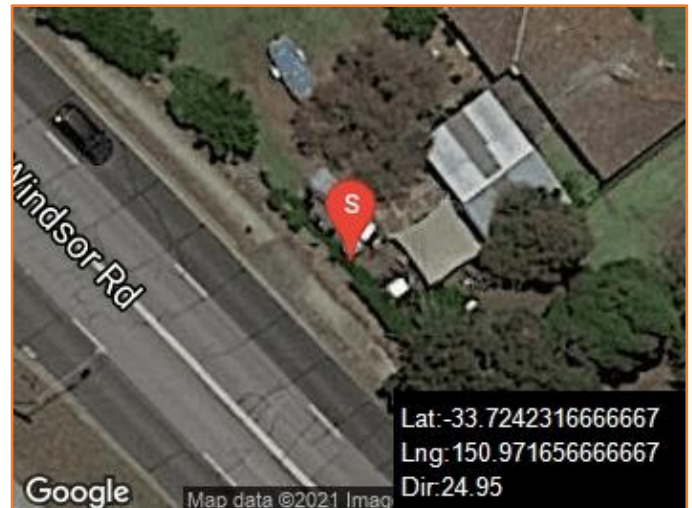
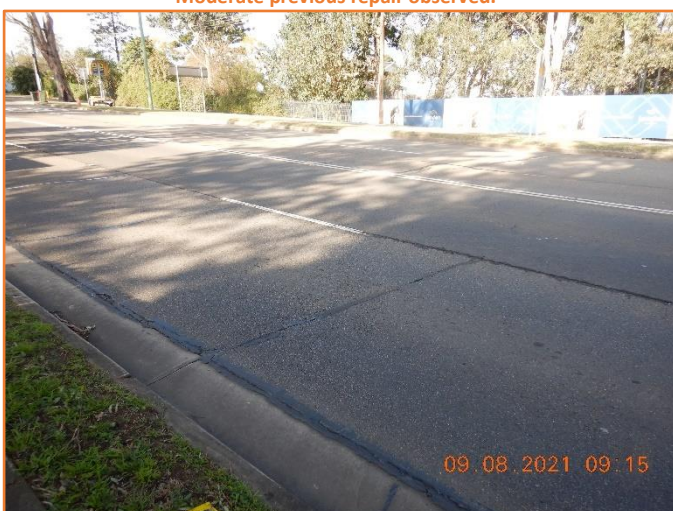
**Figure 155: Reasonable - General condition of flexible pavement.**  
**Moderate previous repair observed.**

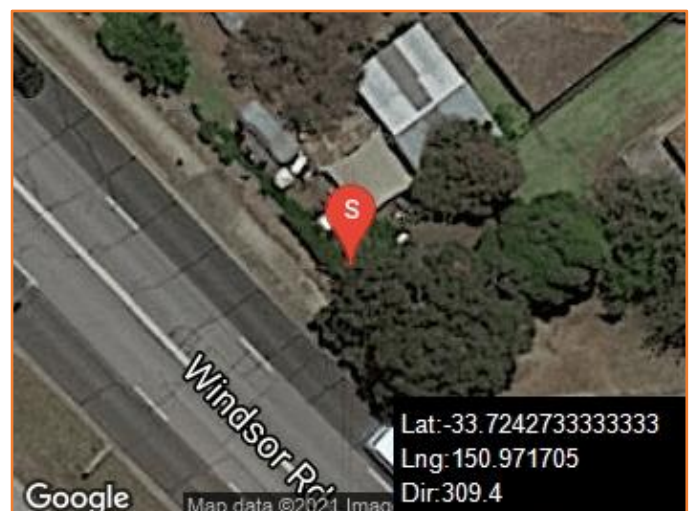
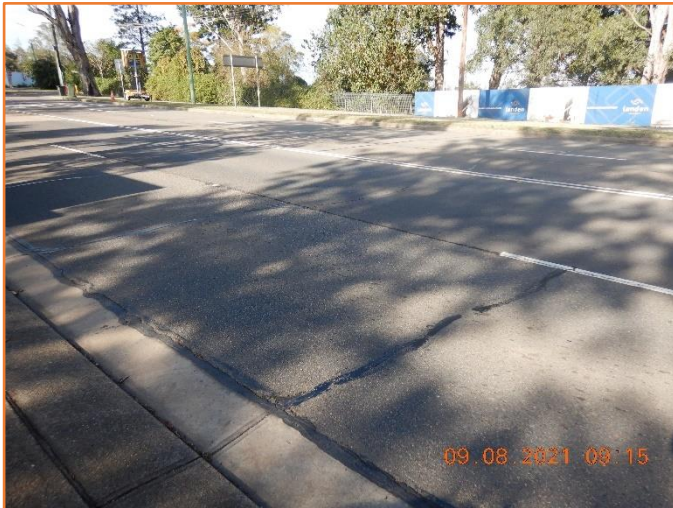
**Figure 156: Reasonable - General condition of flexible pavement.**  
**Moderate previous repair observed.**

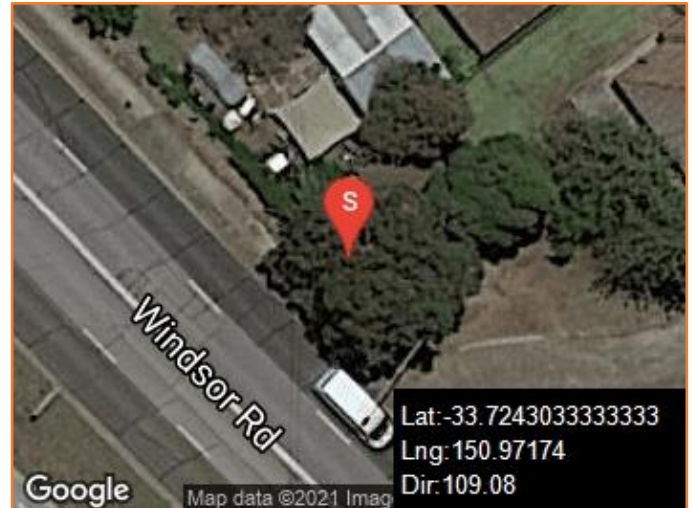
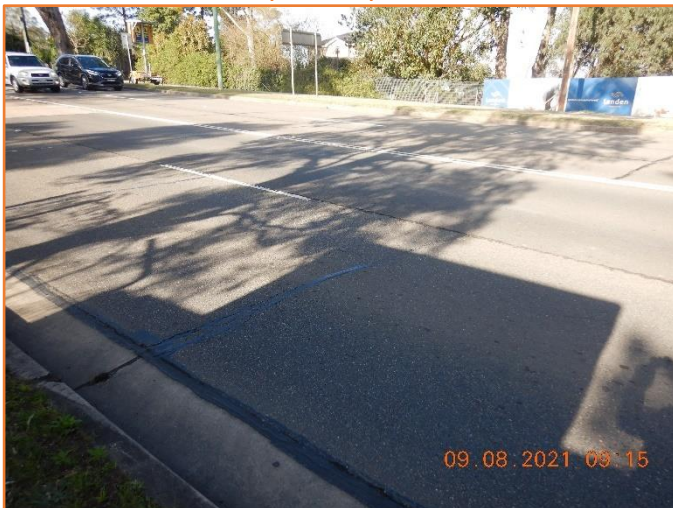
Figure 157: Reasonable - General condition of flexible pavement. Moderate previous repair observed.

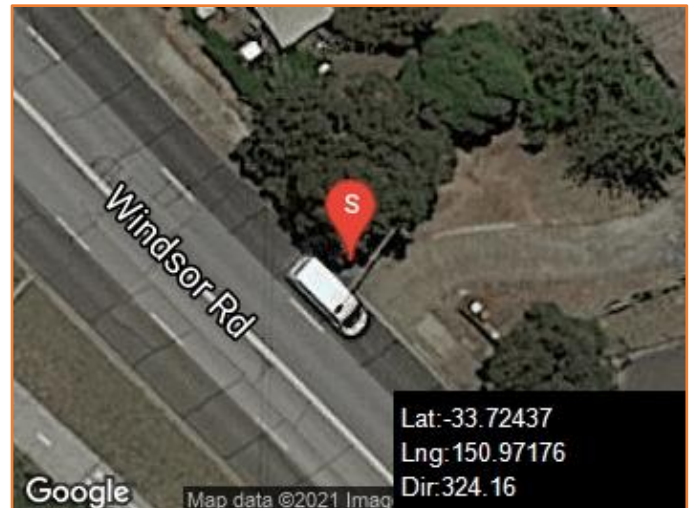
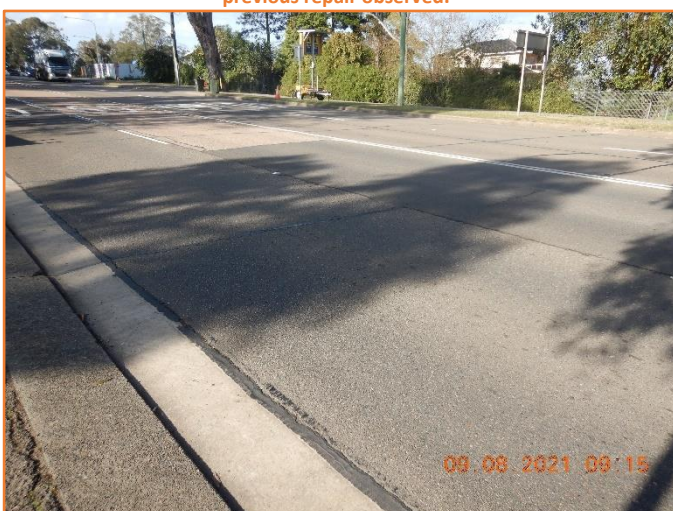
Figure 158: Reasonable - General condition of flexible pavement. Minor previous repair observed.

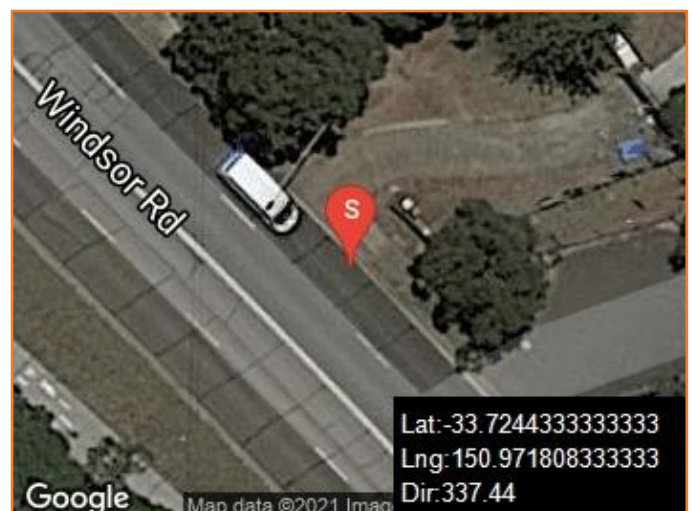
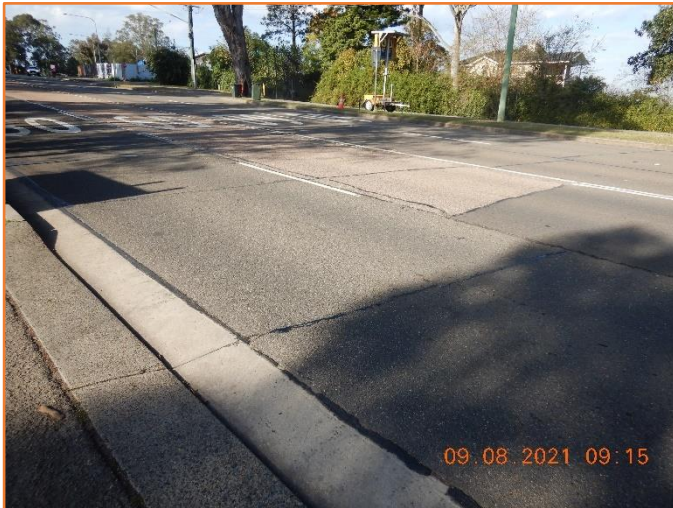
Figure 159: Reasonable - General condition of flexible pavement. Minor previous repair observed.

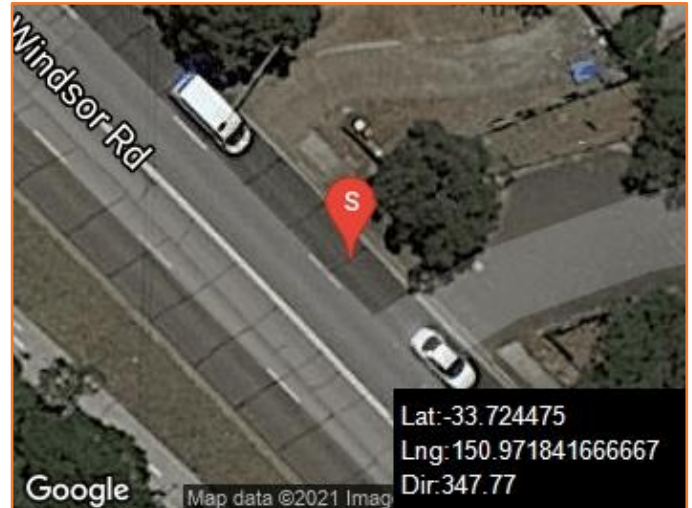
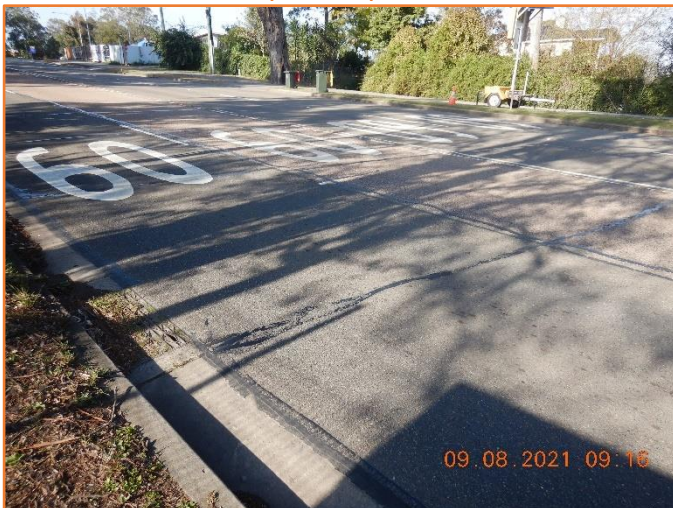
**Figure 160: Reasonable - General condition of flexible pavement.  
 Moderate previous repair observed.**

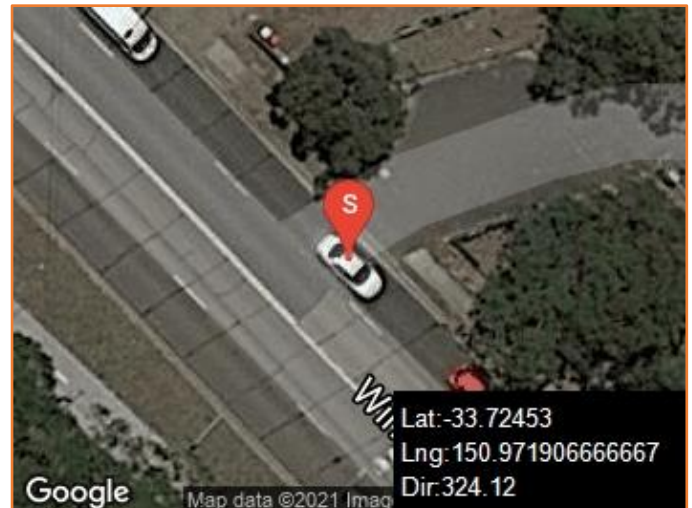
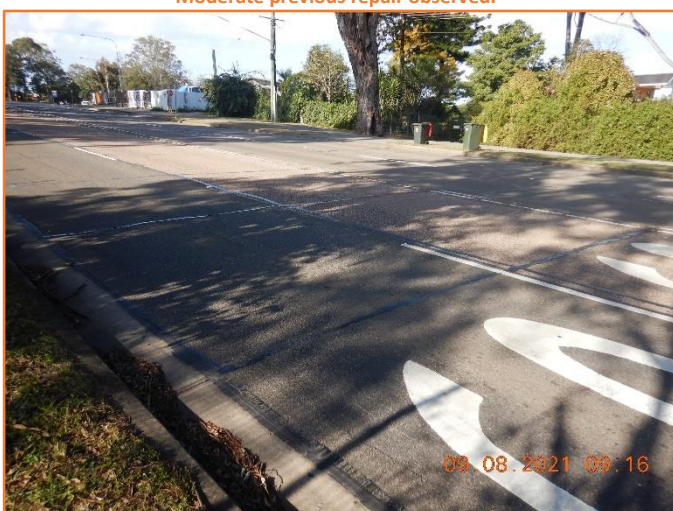
**Figure 162: Reasonable - General condition of flexible pavement.  
 Moderate previous repair observed.**

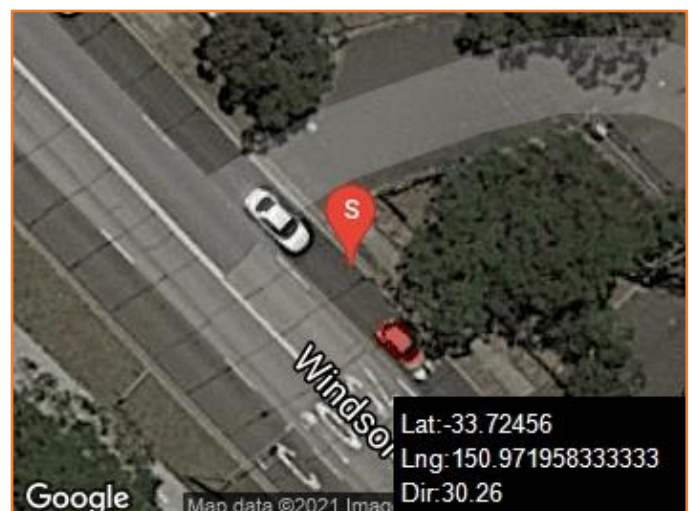
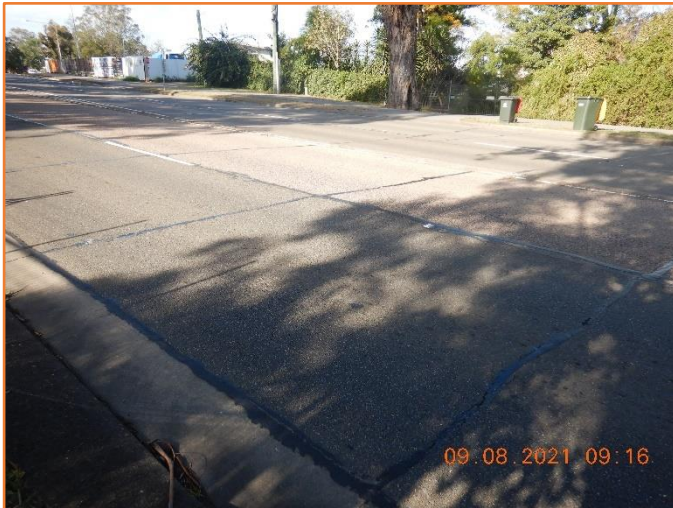
**Figure 163: Reasonable - General condition of flexible pavement.**  
**Moderate previous repair observed.**

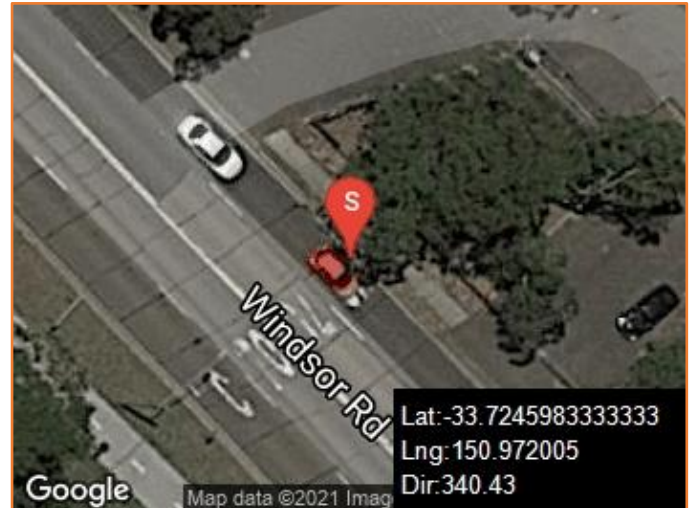
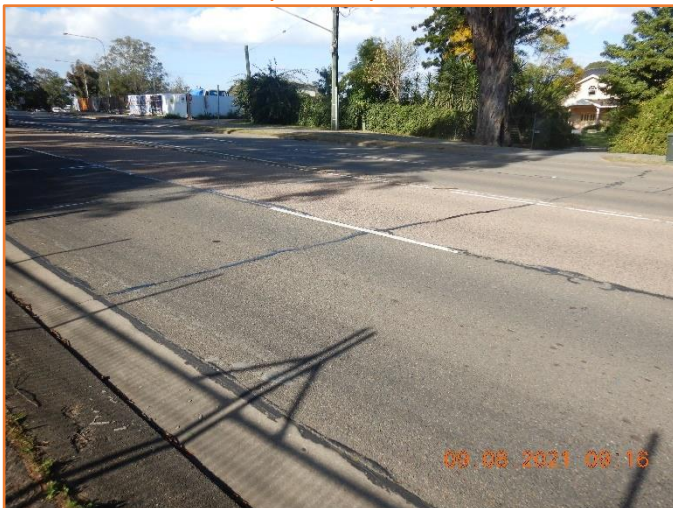
**Figure 164: Reasonable - General condition of flexible pavement.**  
**Moderate previous repair observed.**

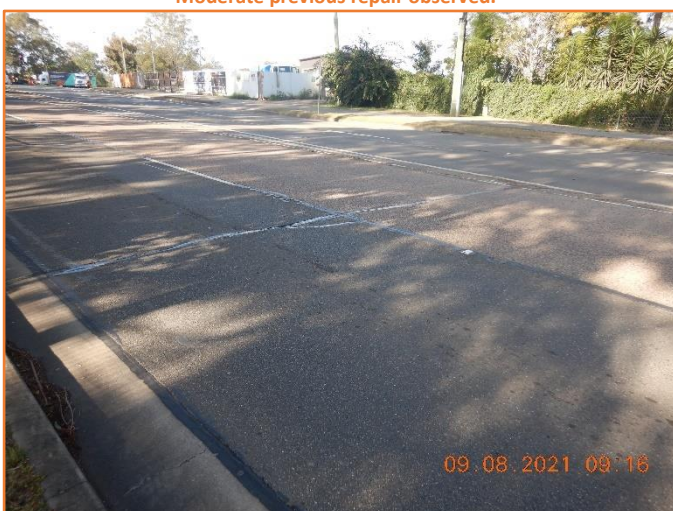
**Figure 165: Reasonable - General condition of flexible pavement.**  
**Moderate previous repair observed.**

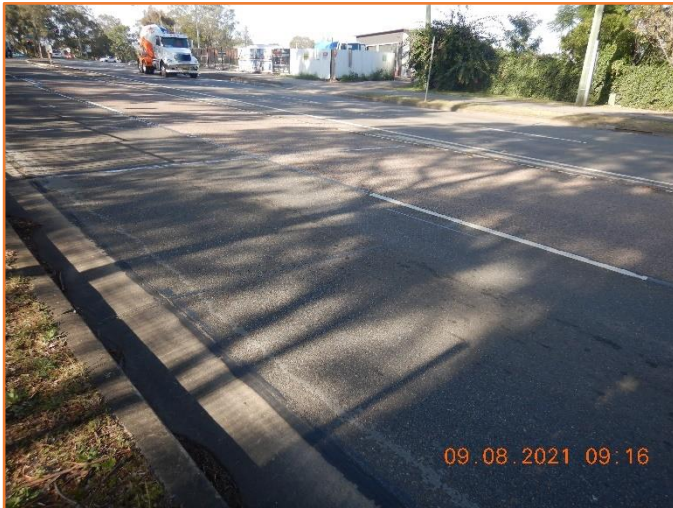
**Figure 166: Reasonable - General condition of flexible pavement.  
 Moderate previous repair observed.**

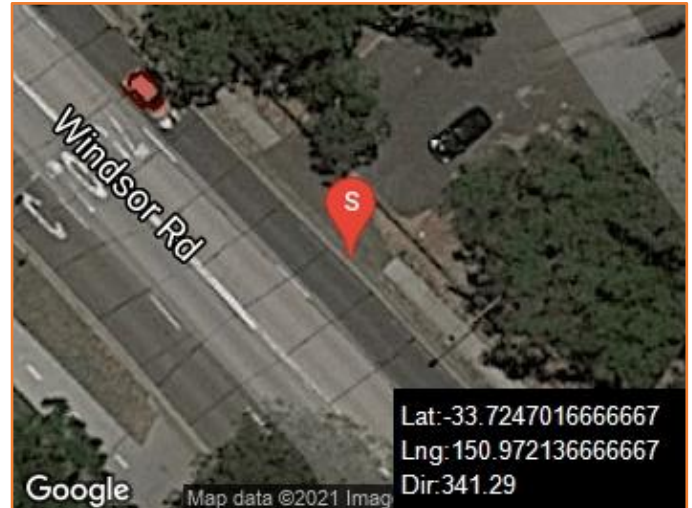
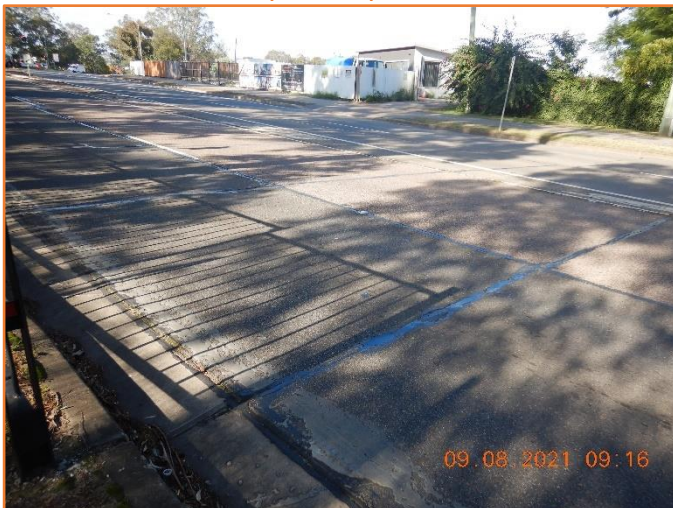
**Figure 167: Reasonable - General condition of flexible pavement.  
 Moderate previous repair observed.**

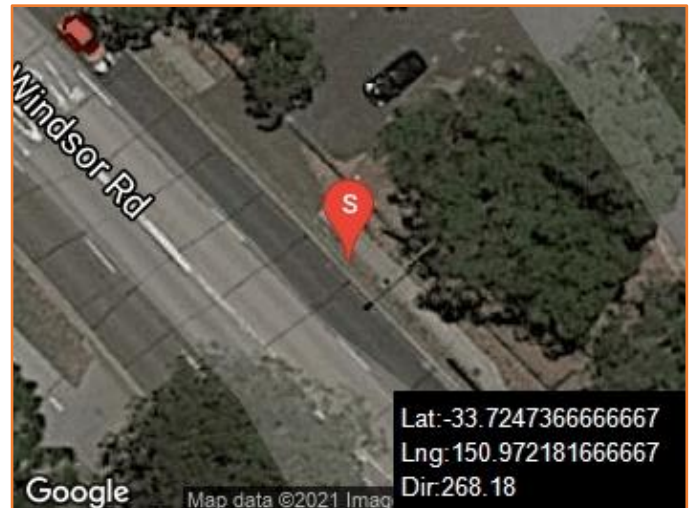
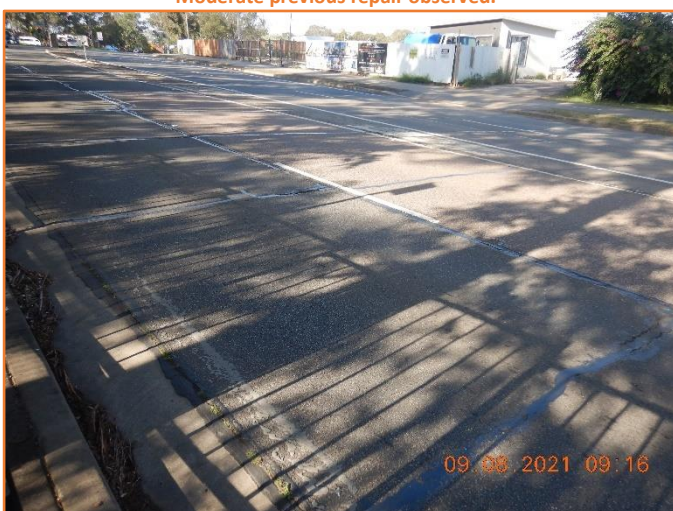
**Figure 168: Reasonable - General condition of flexible pavement.  
 Moderate previous repair observed.**

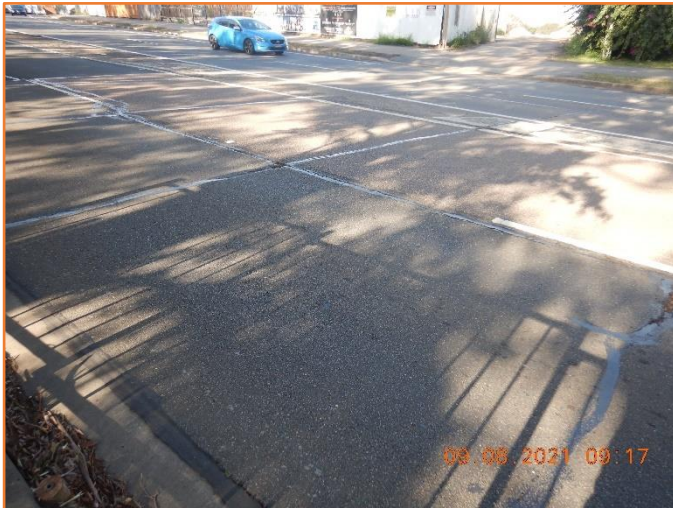
**Figure 169: Reasonable - General condition of flexible pavement.**  
**Moderate previous repair observed.**

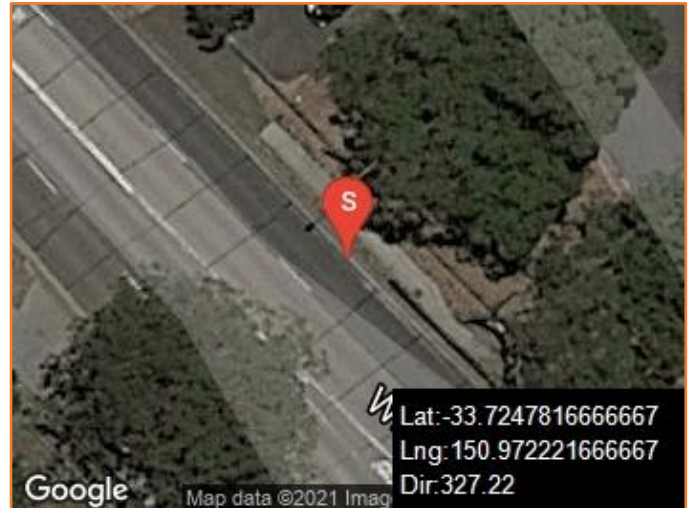
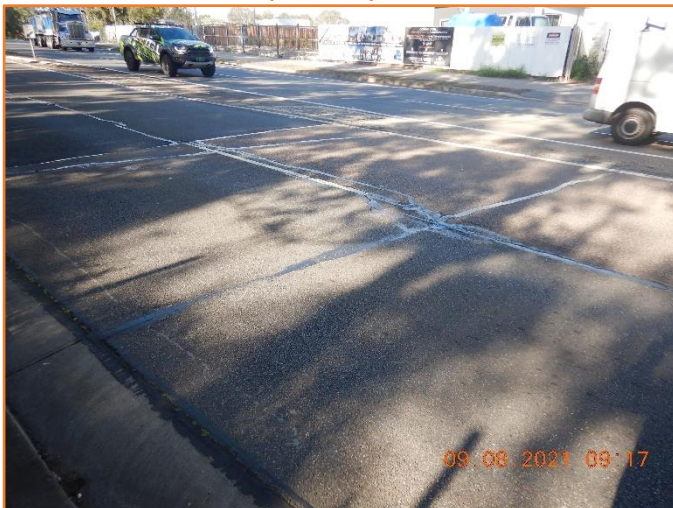
**Figure 170: Reasonable - General condition of flexible pavement.**  
**Moderate previous repair observed.**

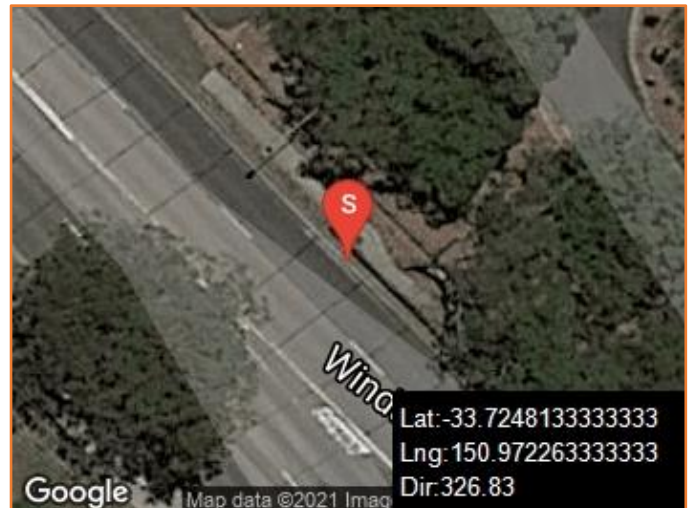
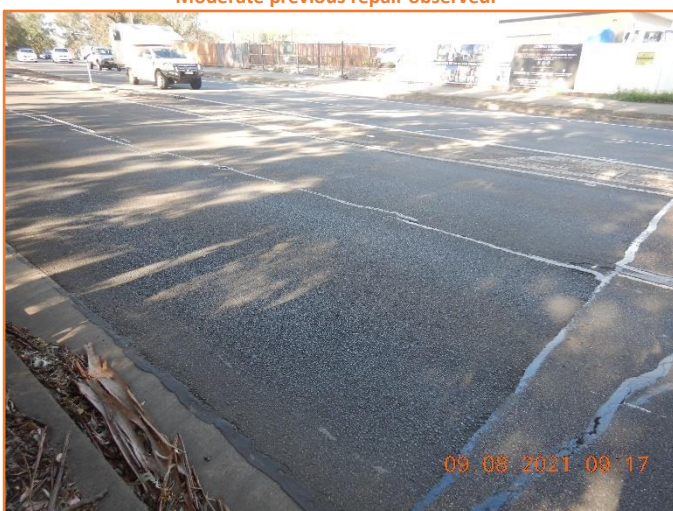
**Figure 171: Reasonable - General condition of flexible pavement.**  
**Moderate previous repair observed.**

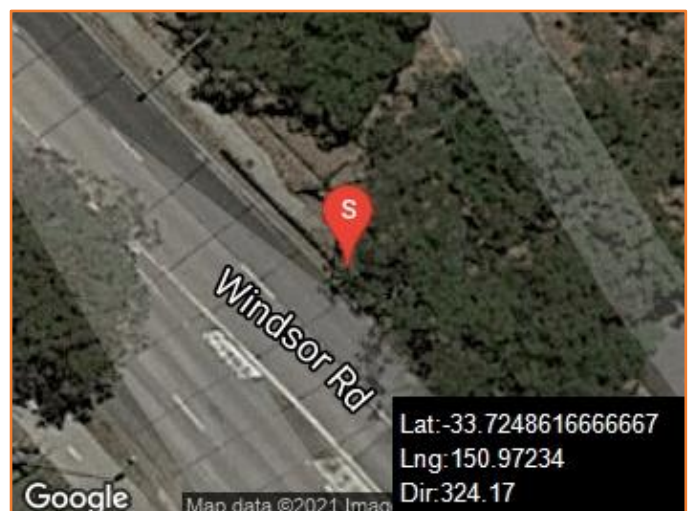
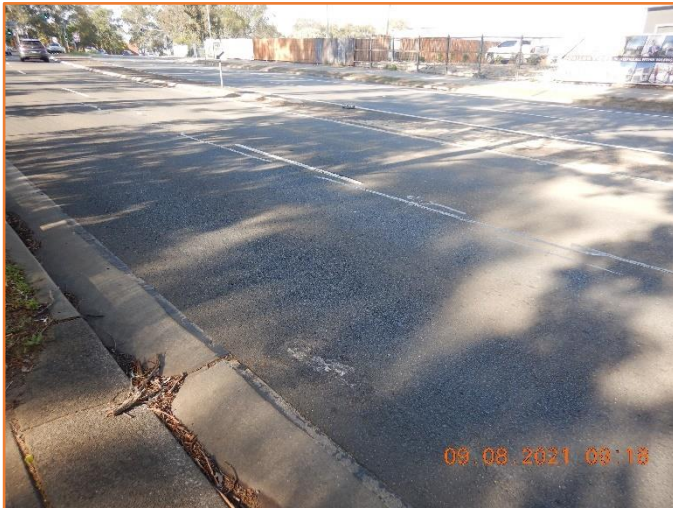
Figure 172: Reasonable - General condition of flexible pavement. Minor previous repair observed.

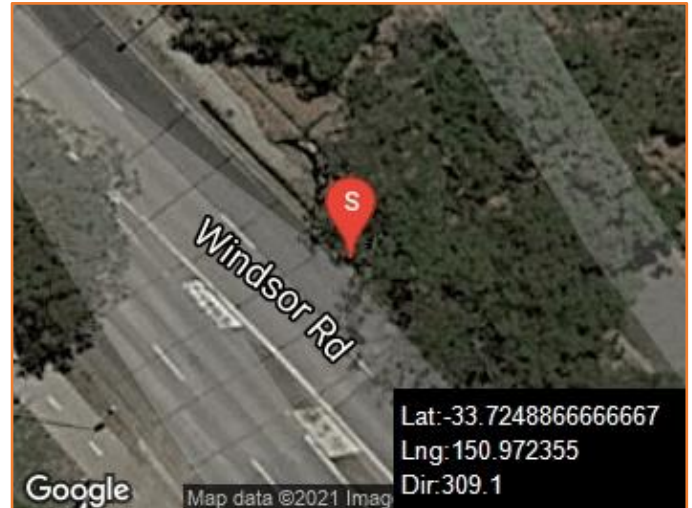
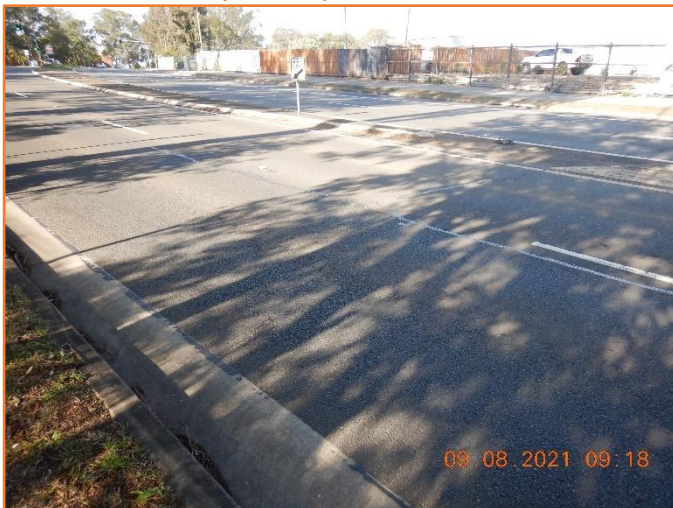
Figure 173: Reasonable - General condition of flexible pavement. Minor previous repair observed.

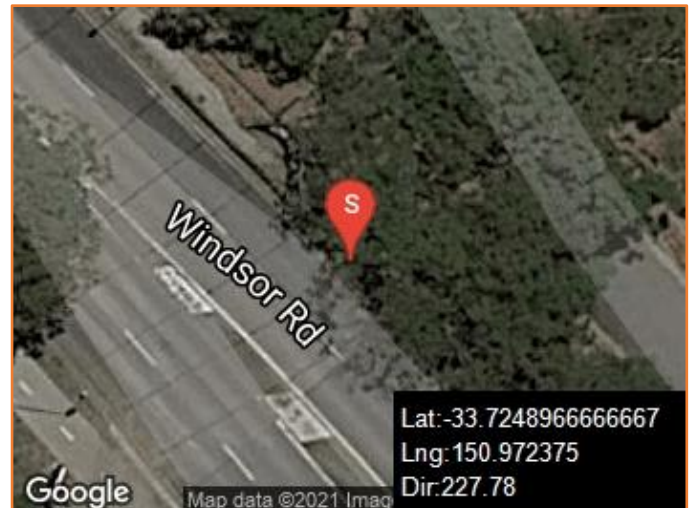
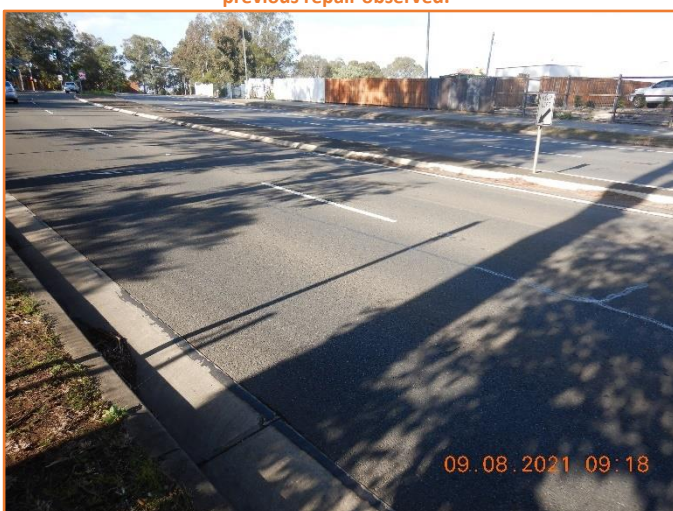
Figure 174: Reasonable - General condition of flexible pavement. Minor previous repair observed.

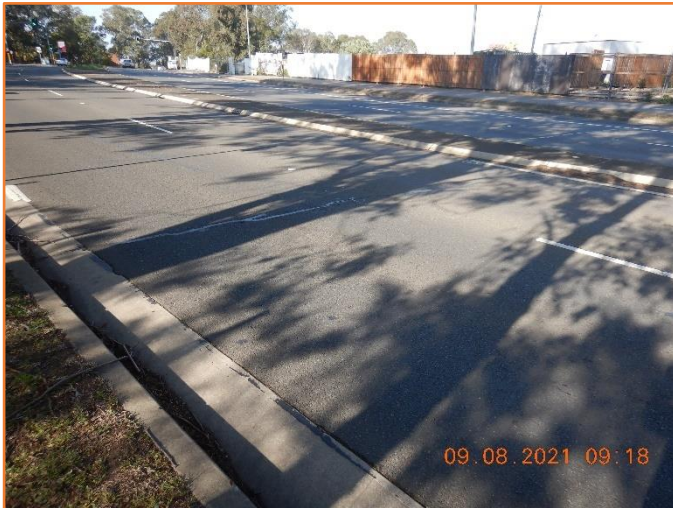
Figure 175: Reasonable - General condition of flexible pavement. Minor previous repair observed.

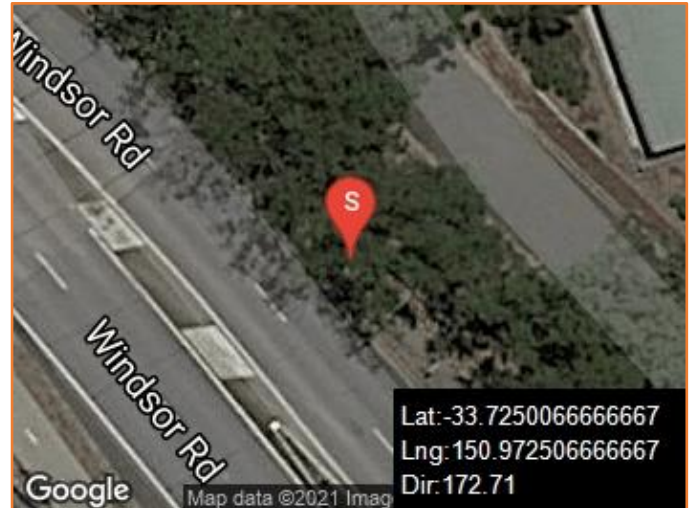
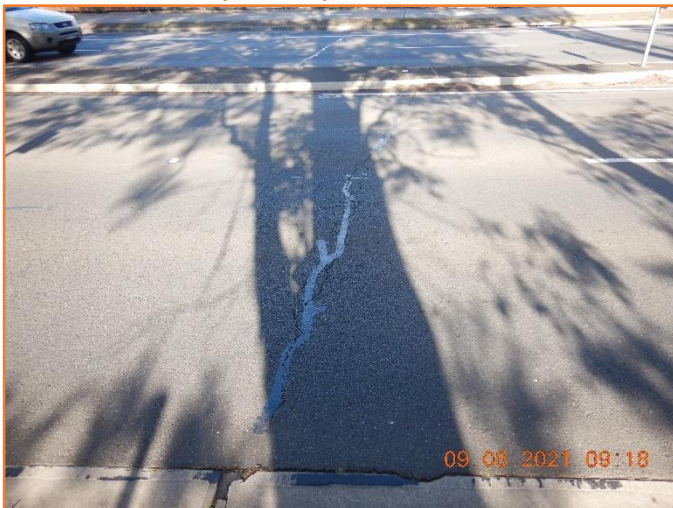
Figure 176: Reasonable - General condition of flexible pavement. Moderate cracking observed.

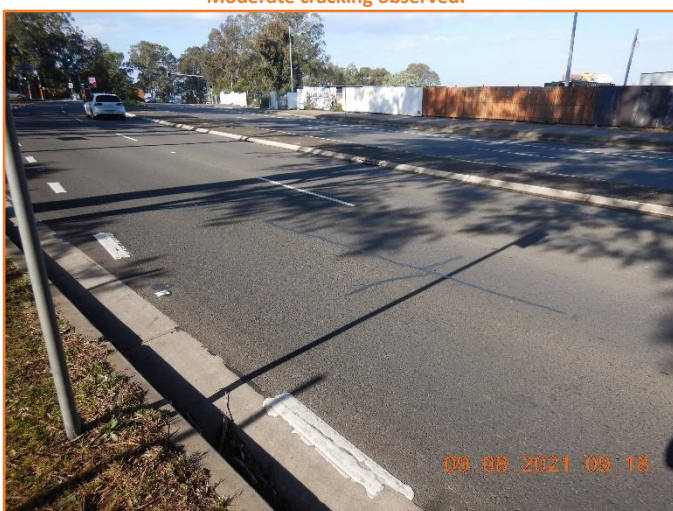
Figure 177: Reasonable - General condition of flexible pavement. Minor previous repair observed.

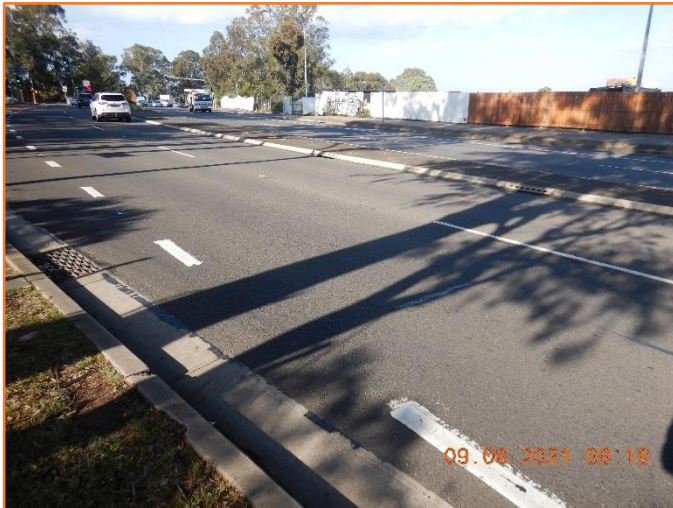
Figure 178: Good - General condition of flexible pavement.

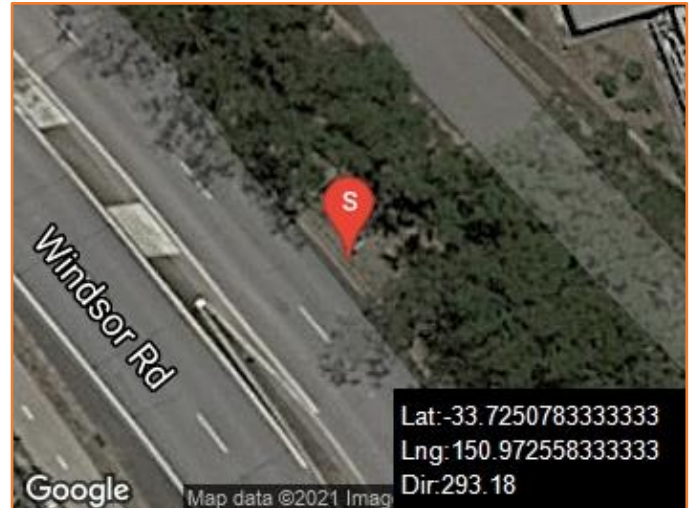
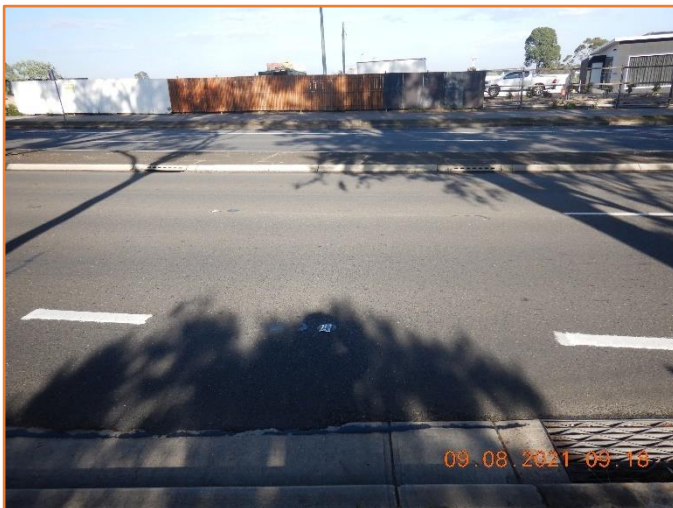
Figure 179: Good - General condition of flexible pavement.

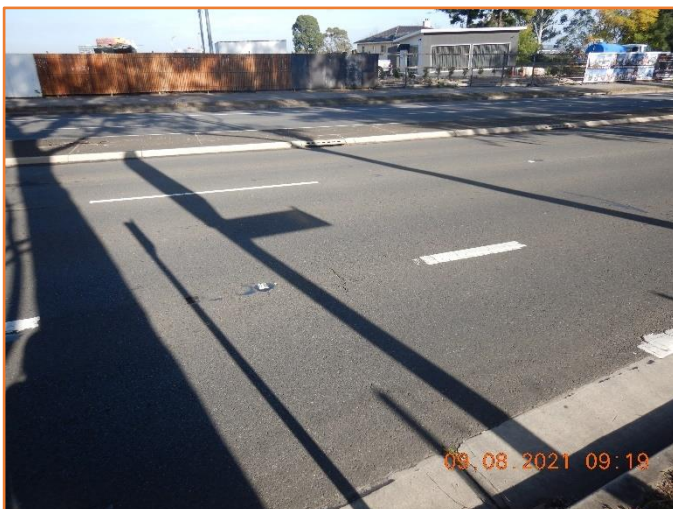
Figure 180: Reasonable - General condition of flexible pavement. Minor cracking observed.

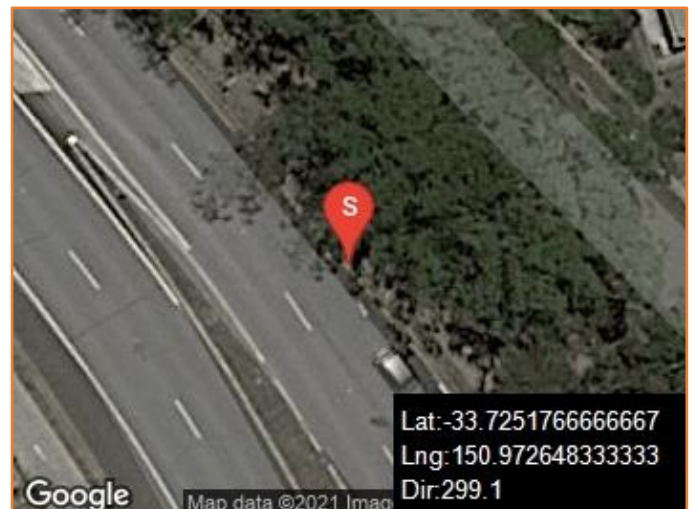
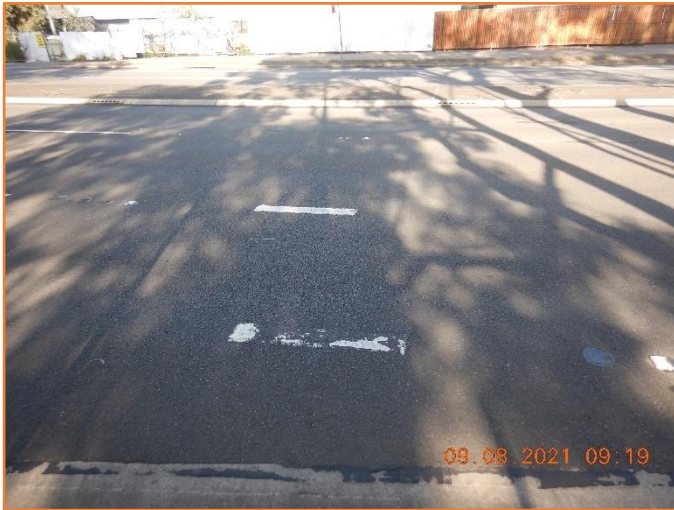
Figure 181: Good - General condition of flexible pavement.

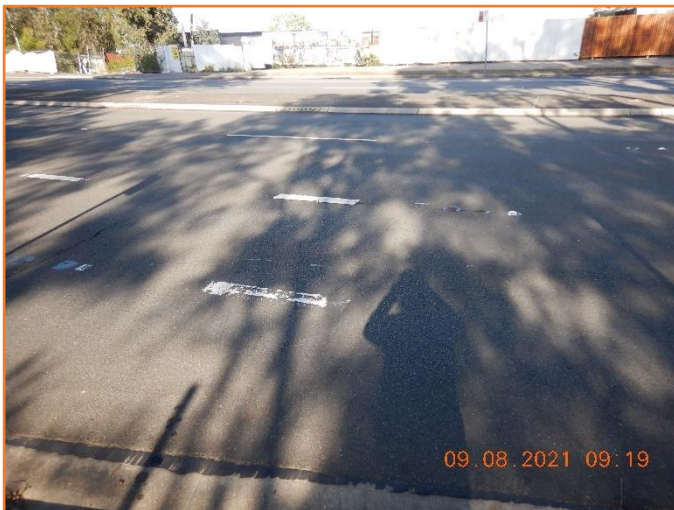
Figure 182: Good - General condition of flexible pavement.

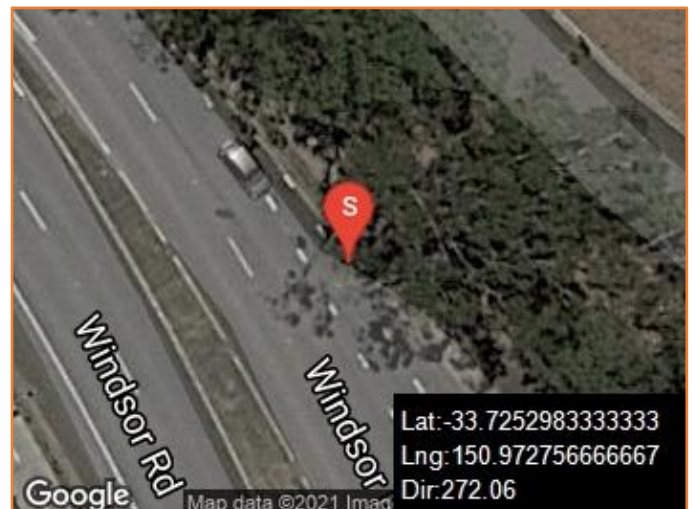
Figure 183: Reasonable - General condition of flexible pavement.  
 Moderate cracking observed.

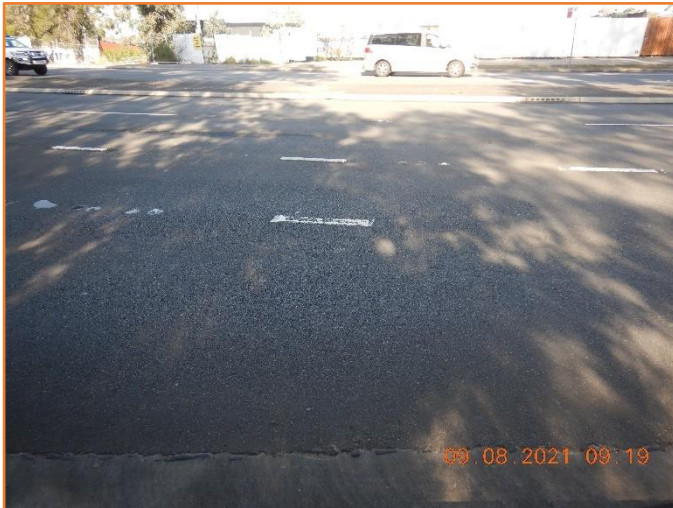
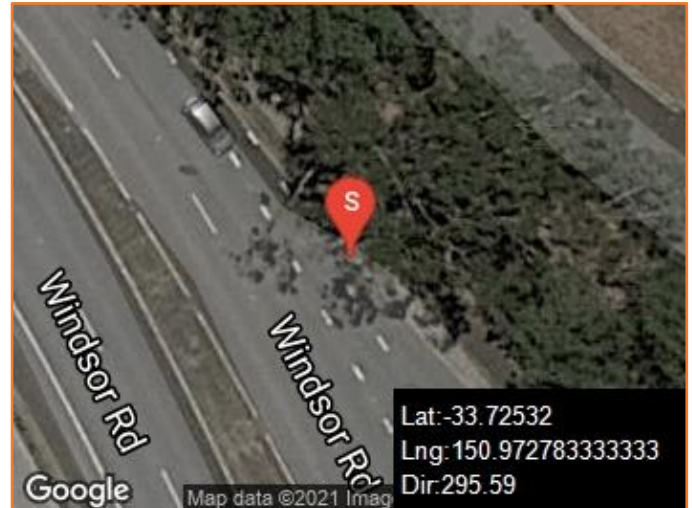
Figure 184: Good - General condition of flexible pavement.

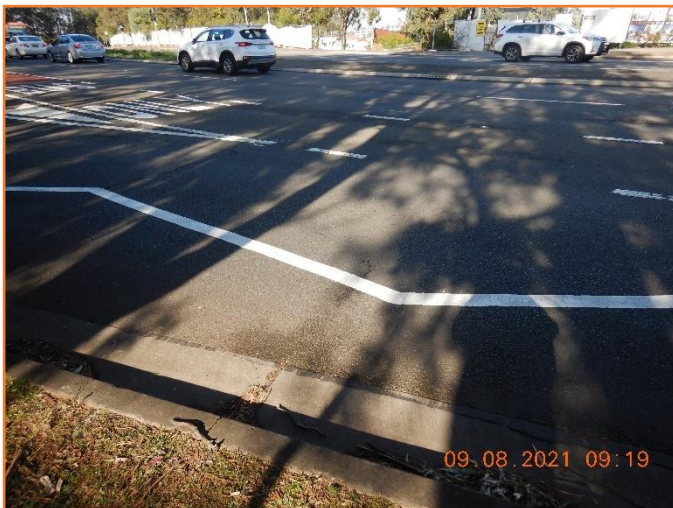
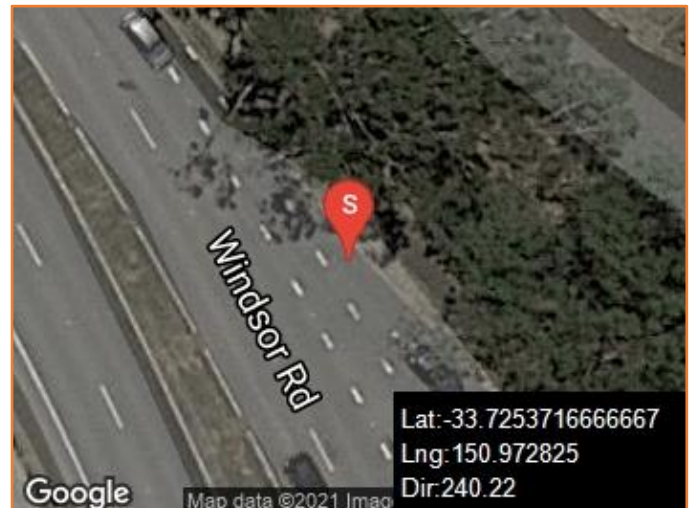
Figure 185: Good - General condition of flexible pavement.
