## DILAPIDATION REPORT

MUSEUM DISCOVERY CENTRE

MONDAY, 9 AUGUST 2021

Document Information	
Job Number	210722
Document Number	3
Report Title	Dilapidation Report
Site Address	172 Showground Road and 2 Green Road Castle Hill, NSW, 2154
Lot	1 in DP1066281 & 102 in DP1130271

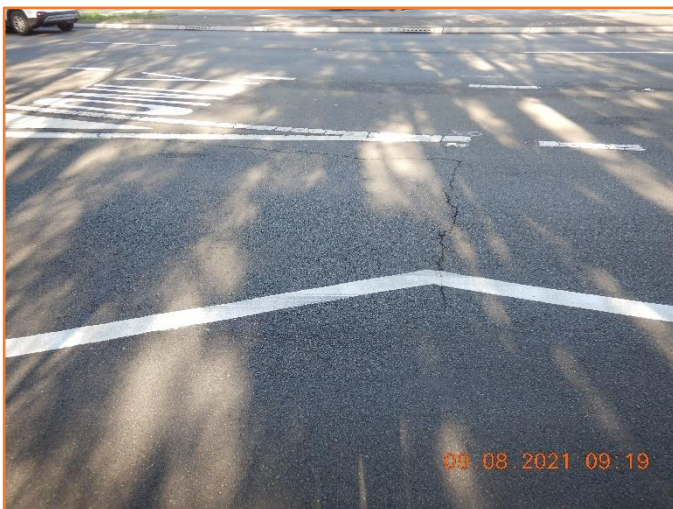
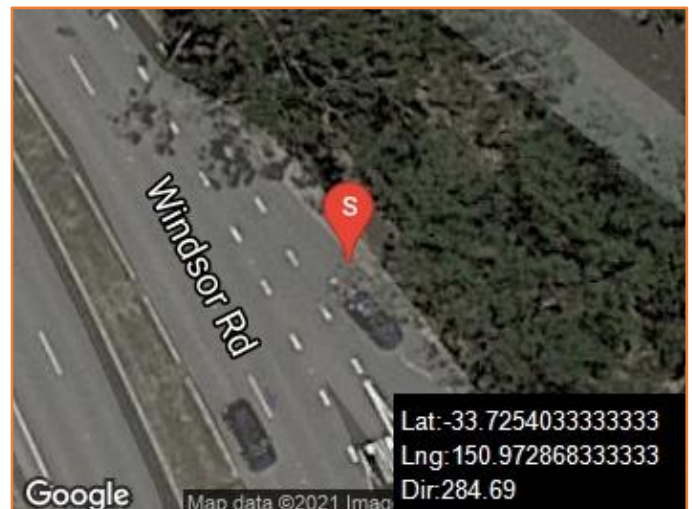
Figure 186: Poor - General condition of flexible pavement. Moderate cracking observed.

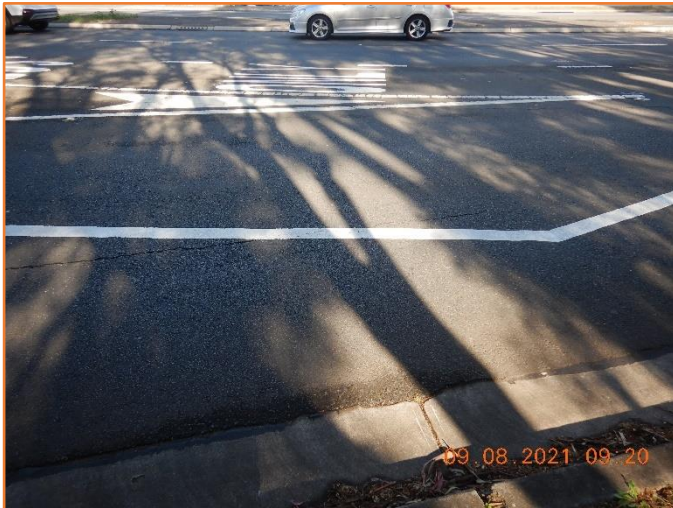
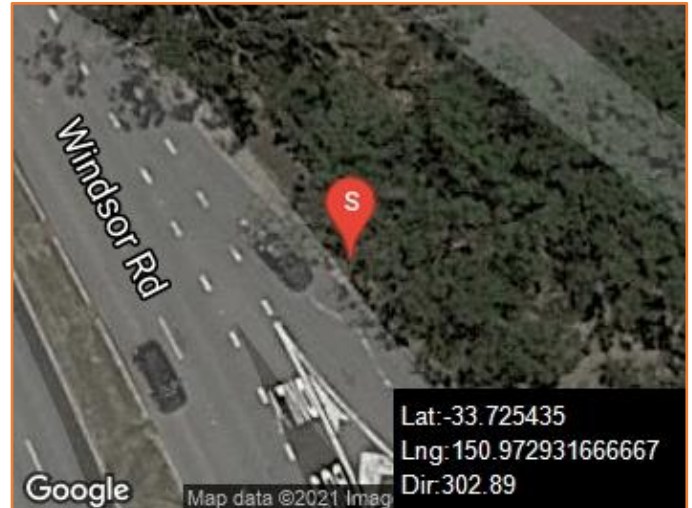
Figure 187: Poor - General condition of flexible pavement. Moderate cracking observed.

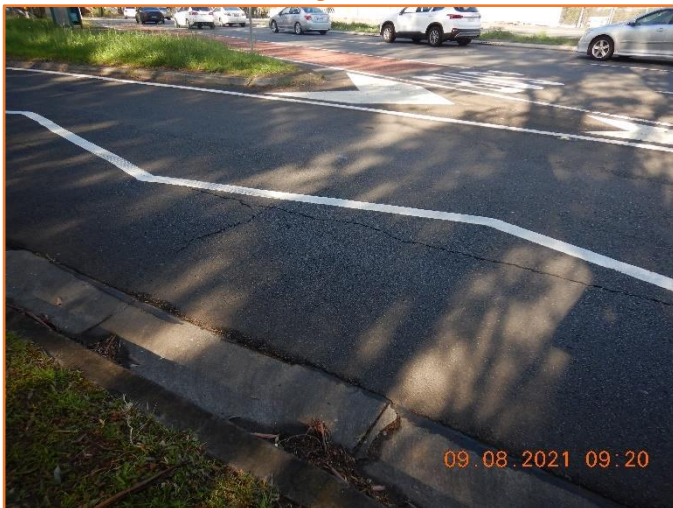
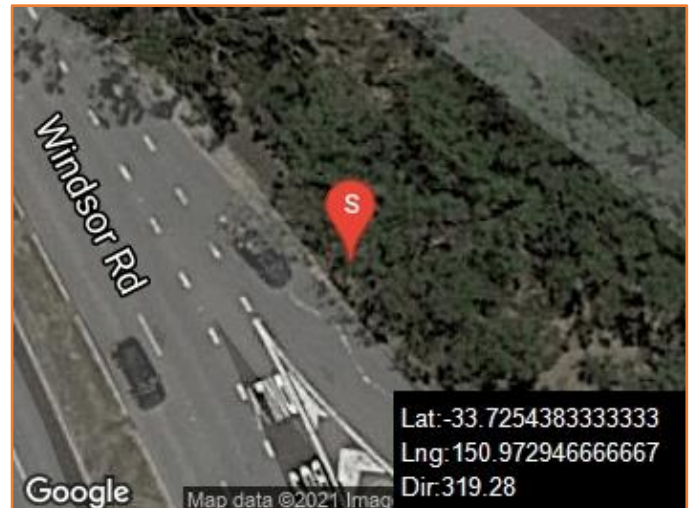
Figure 188: Poor - General condition of flexible pavement. Moderate cracking observed.

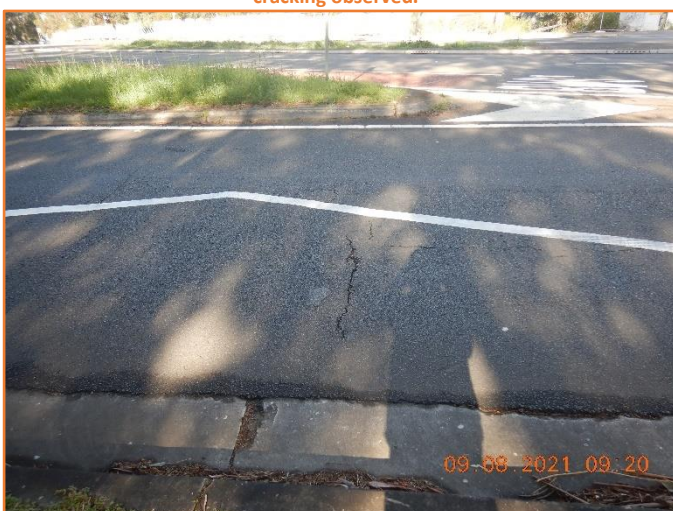
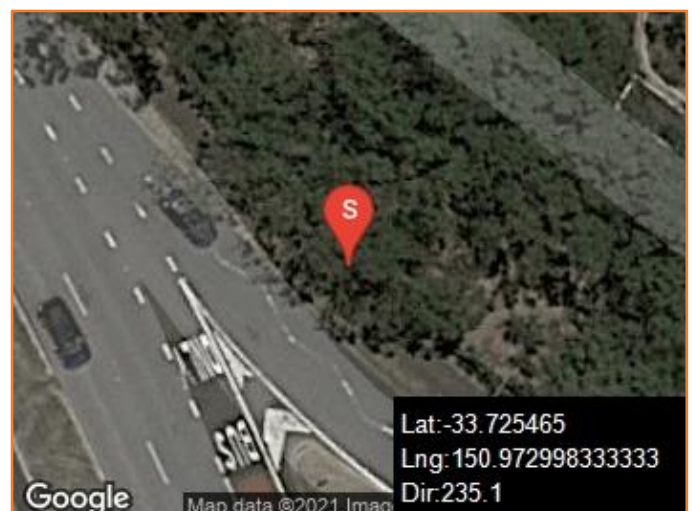
Figure 189: Reasonable - General condition of flexible pavement. Minor cracking observed.

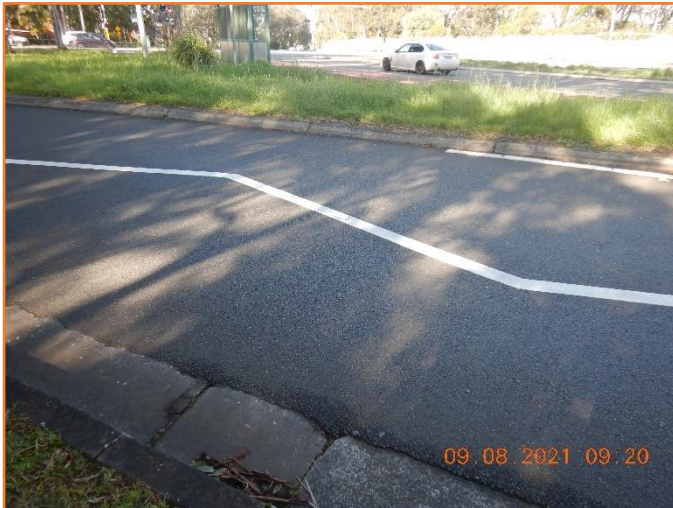
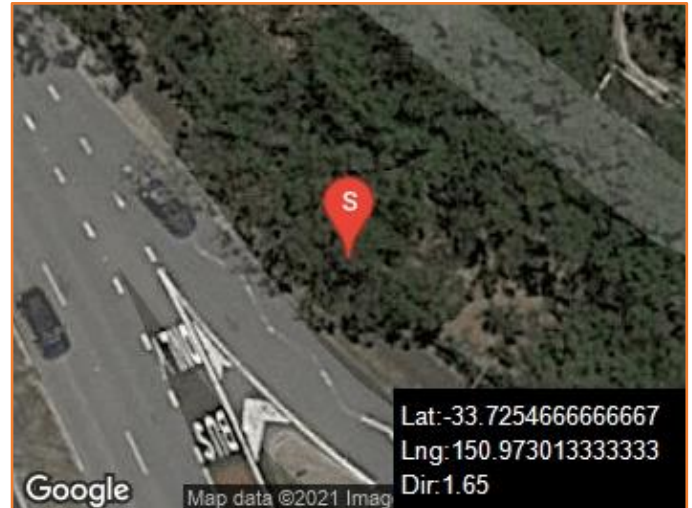
Figure 190: Good - General condition of flexible pavement.

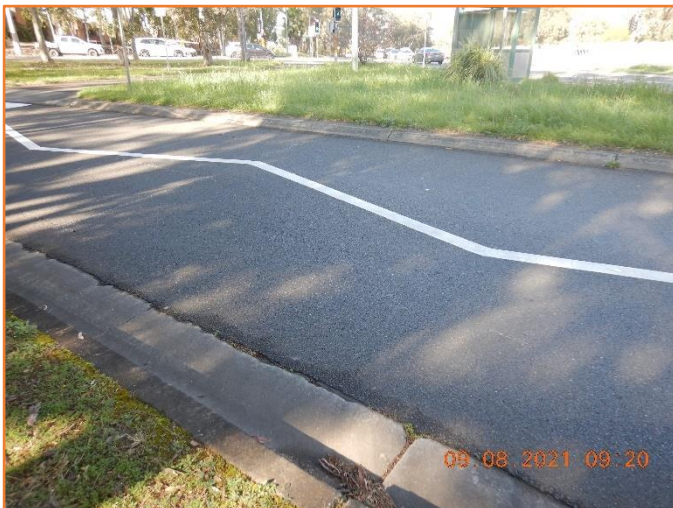
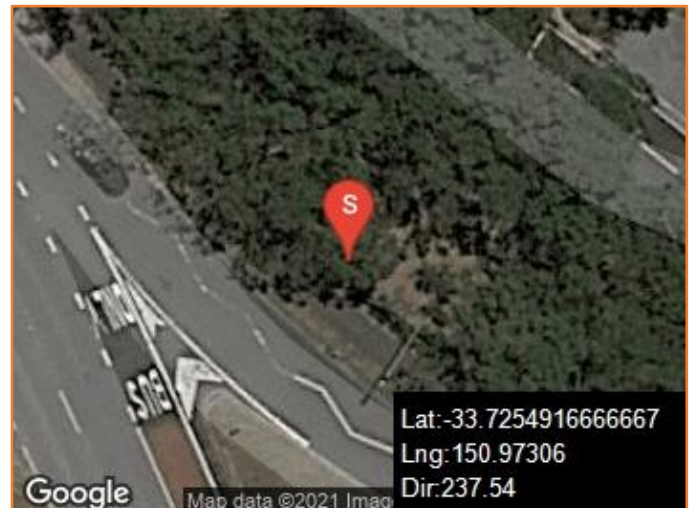
Figure 191: Good - General condition of flexible pavement.

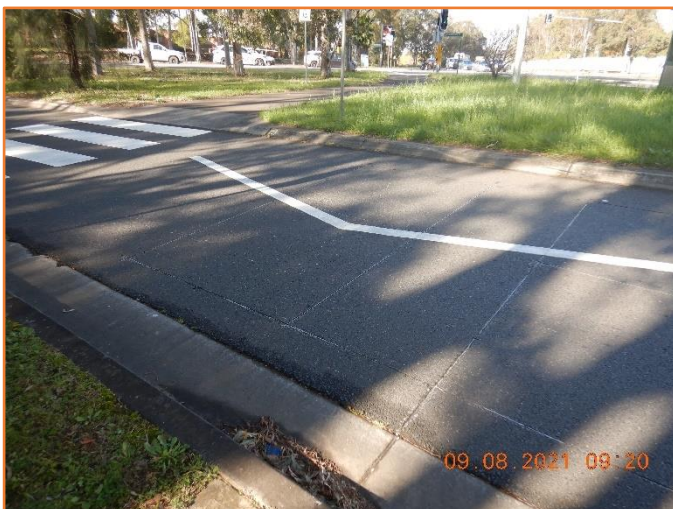
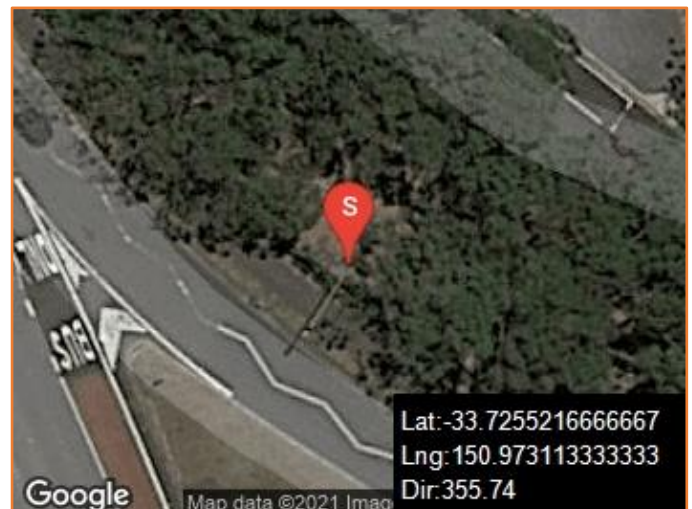
Figure 192: Good - General condition of flexible pavement.

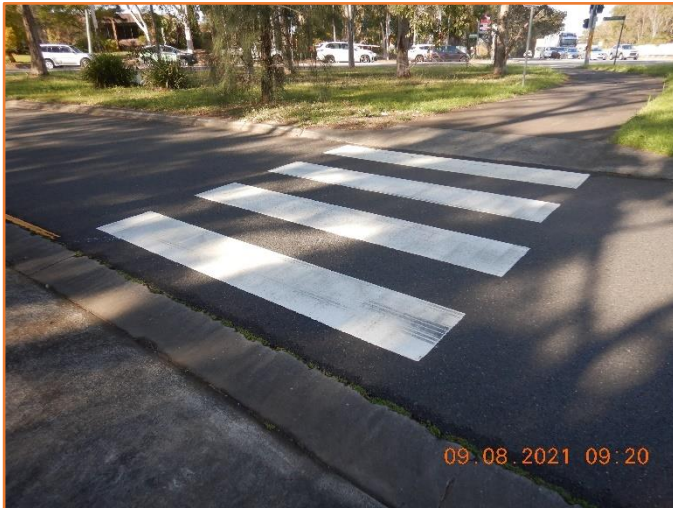
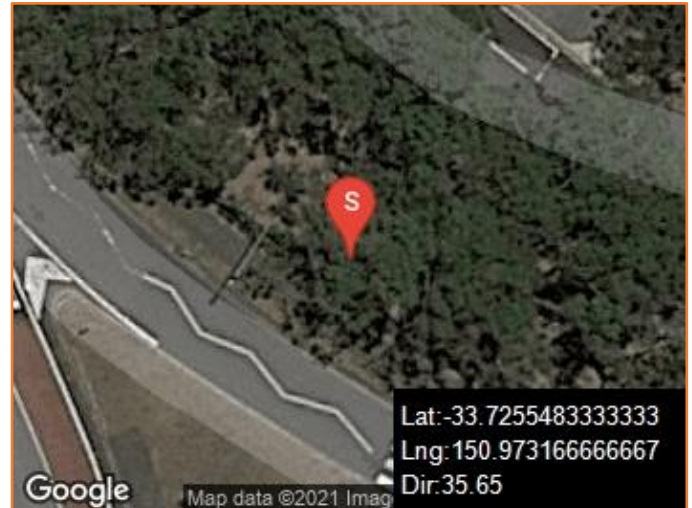
Figure 193: Good - General condition of flexible pavement.

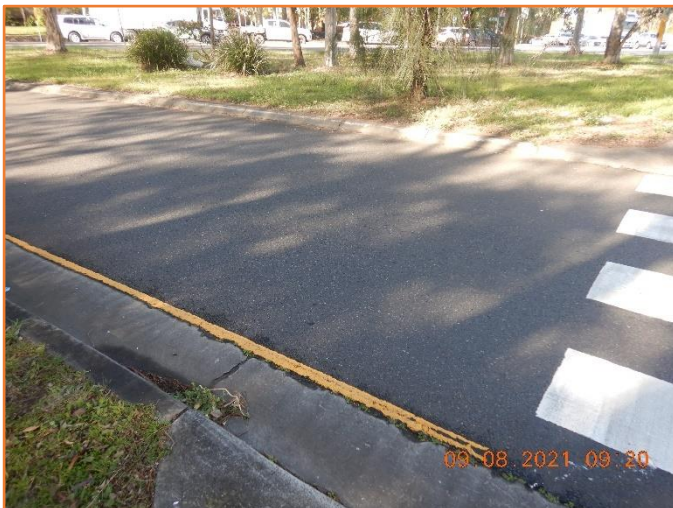
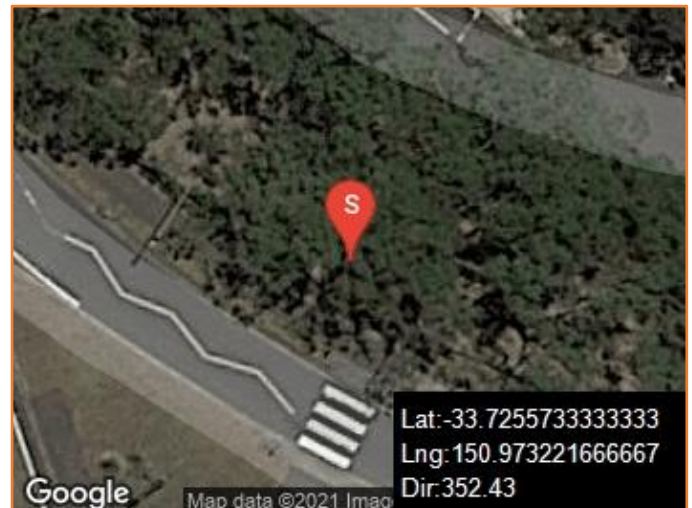
Figure 194: Good - General condition of flexible pavement.

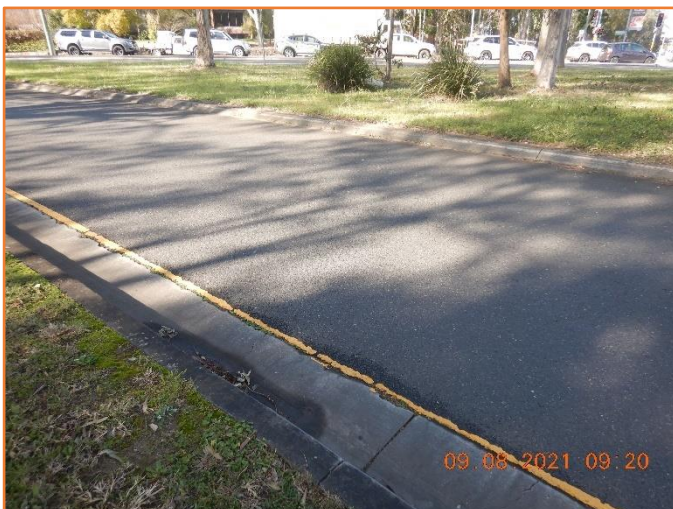
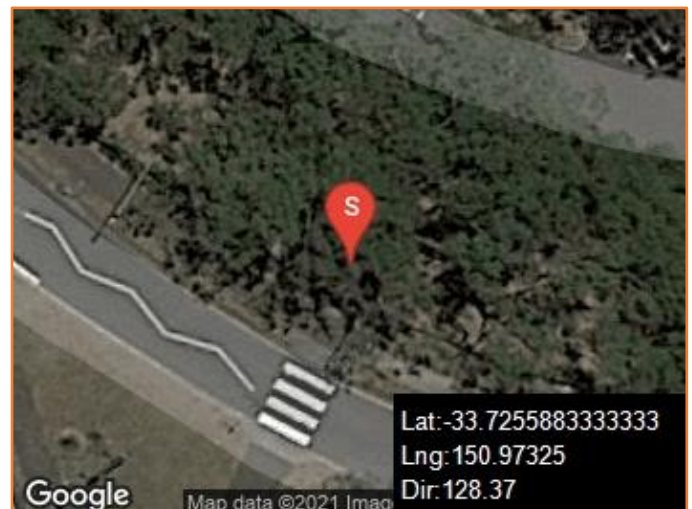
Figure 195: Good - General condition of flexible pavement.

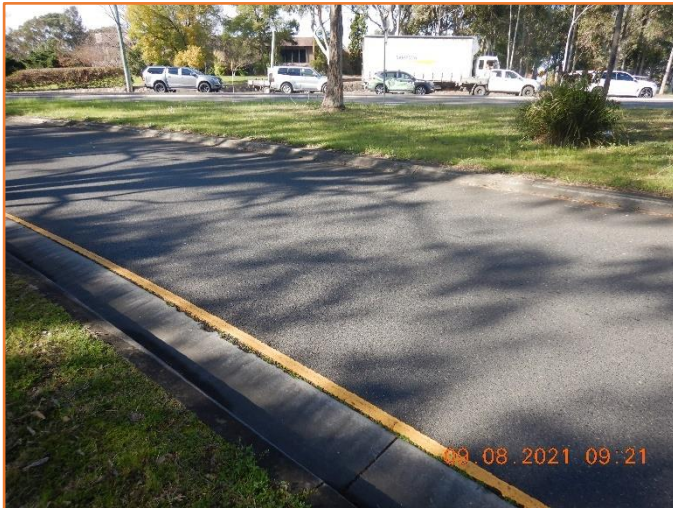
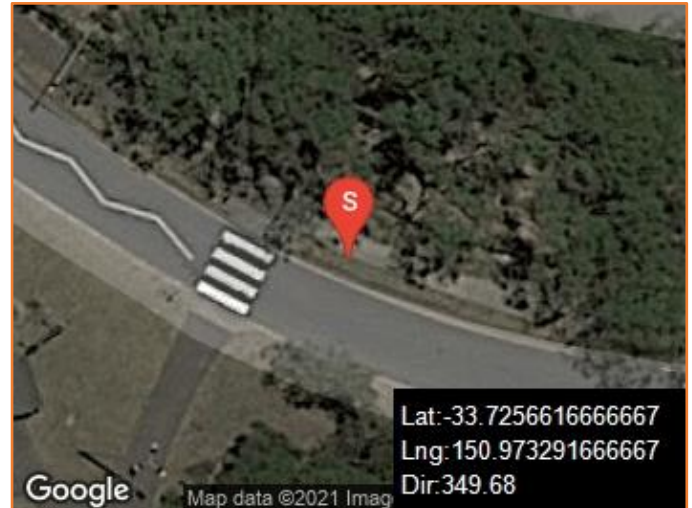
Figure 196: Good - General condition of flexible pavement.

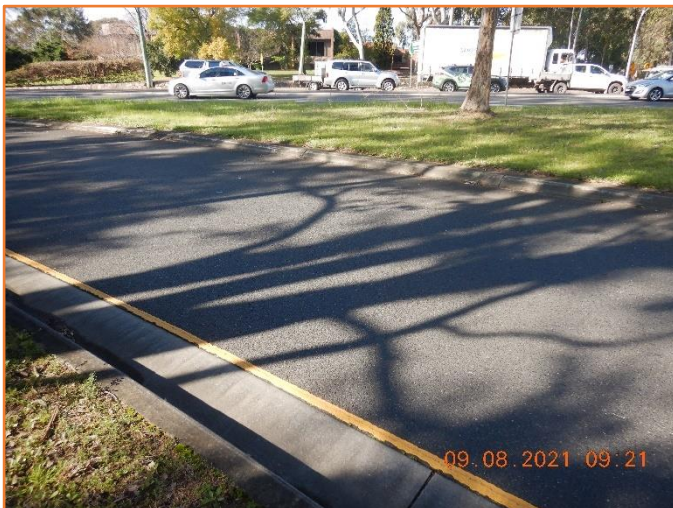
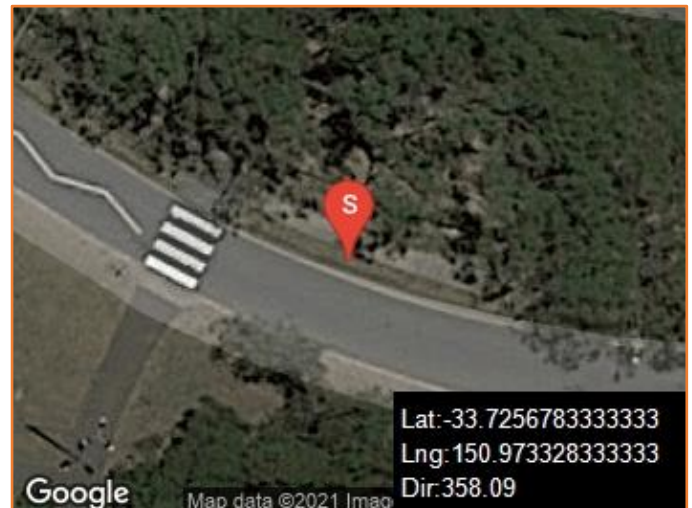
Figure 197: Good - General condition of flexible pavement.

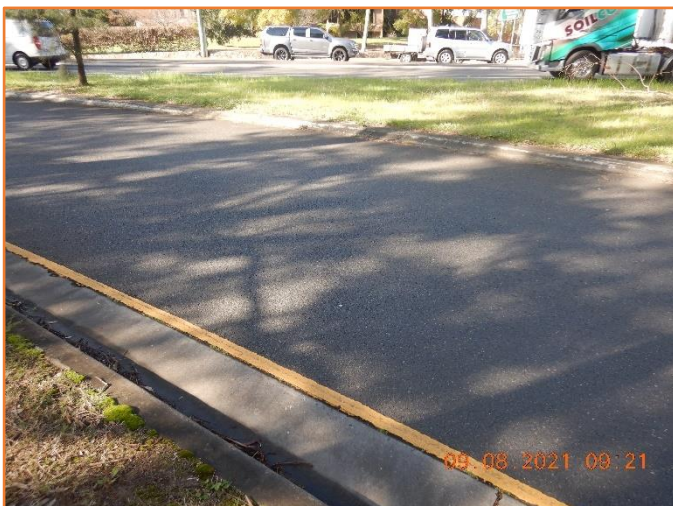
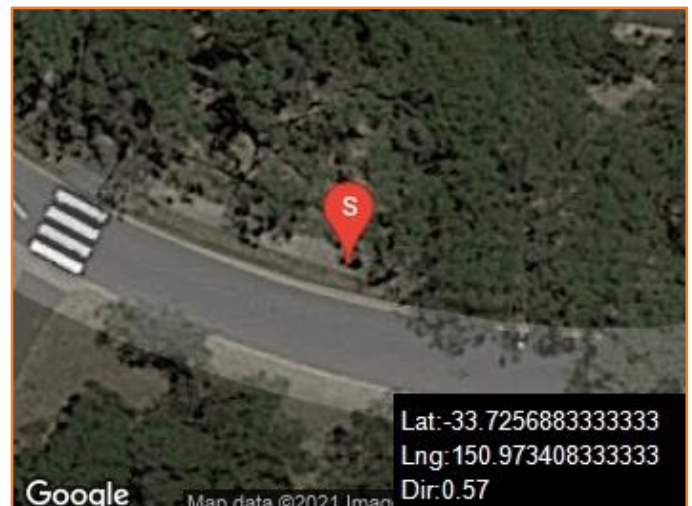
Figure 198: Good - General condition of flexible pavement.

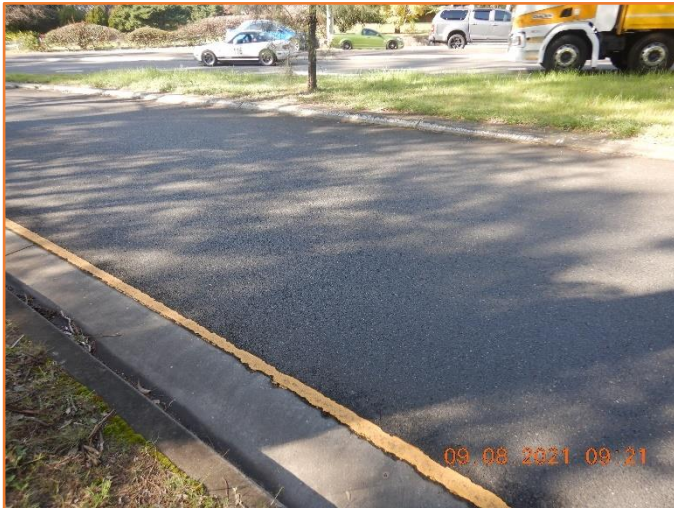
Figure 199: Good - General condition of flexible pavement.

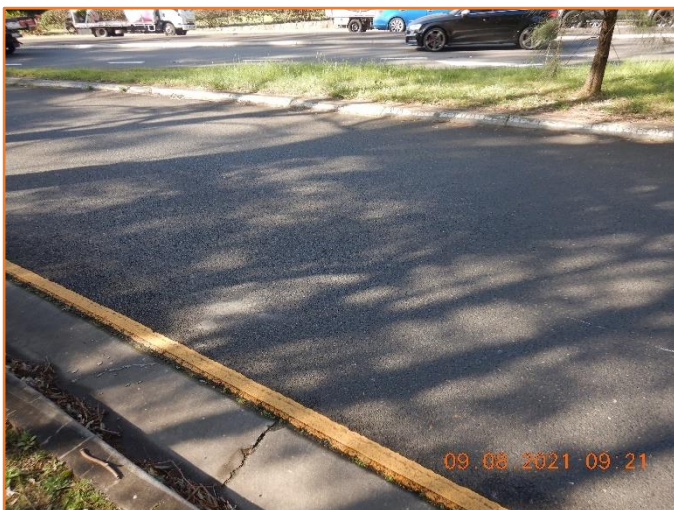
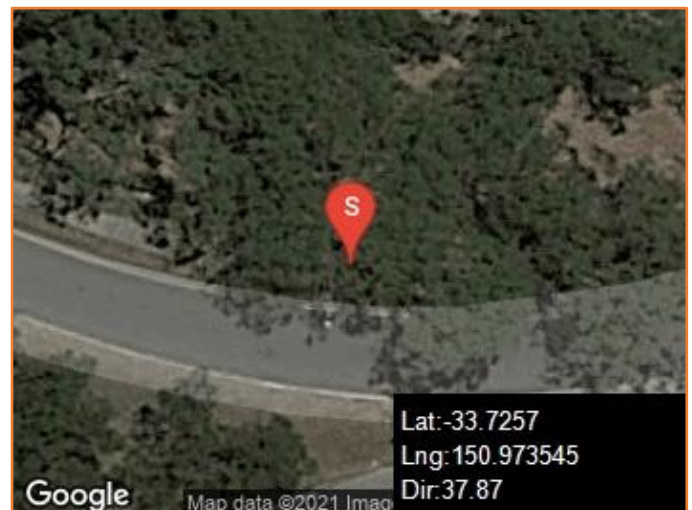
Figure 200: Good - General condition of flexible pavement.

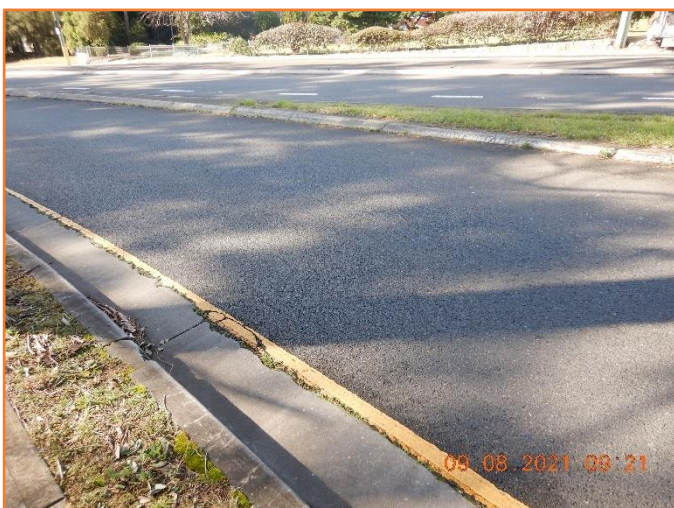
Figure 201: Good - General condition of flexible pavement.

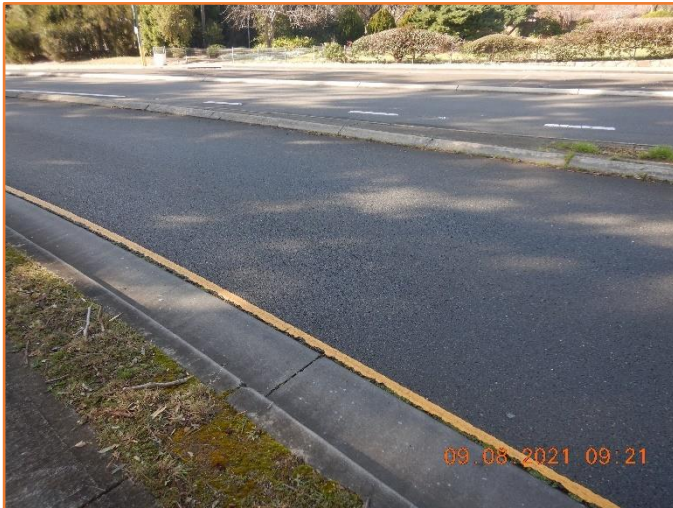
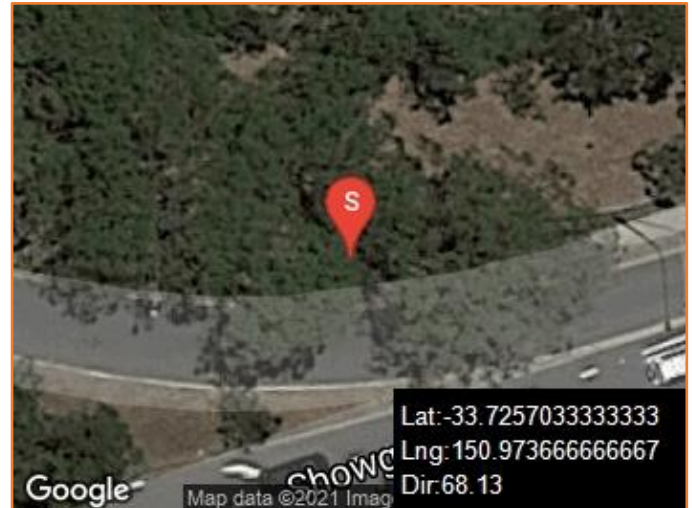
Figure 202: Good - General condition of flexible pavement.

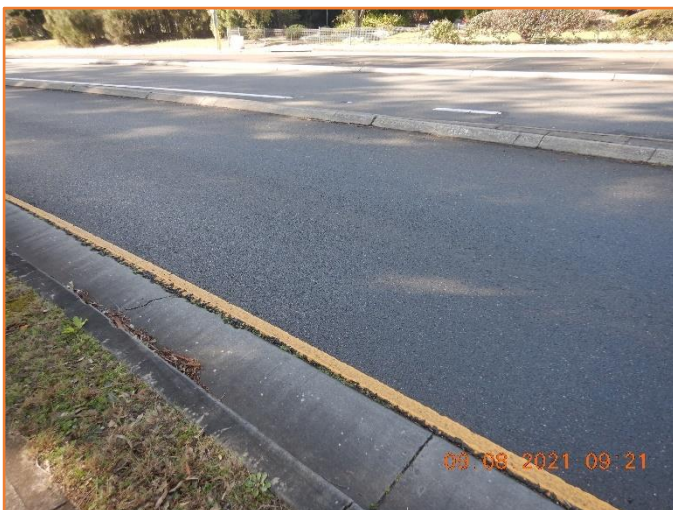
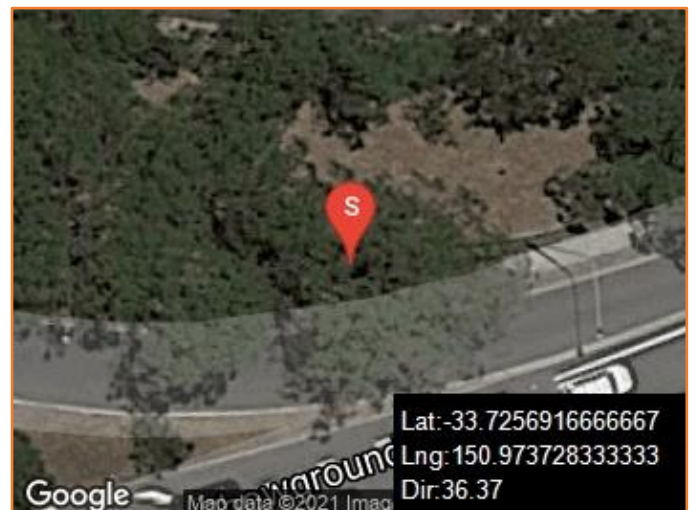
Figure 203: Good - General condition of flexible pavement.

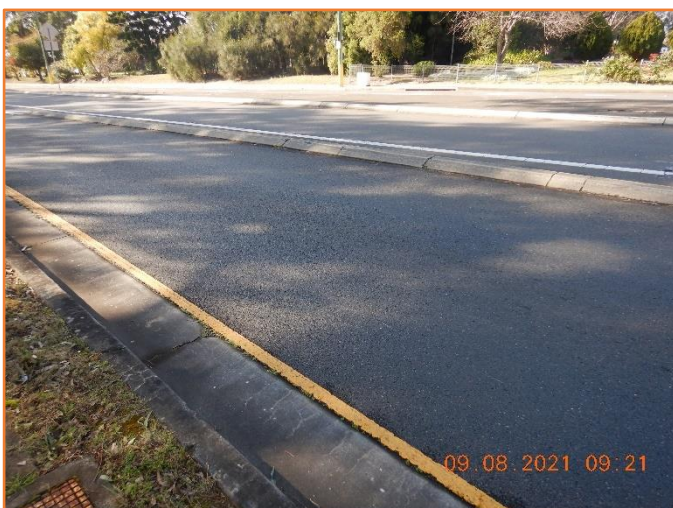
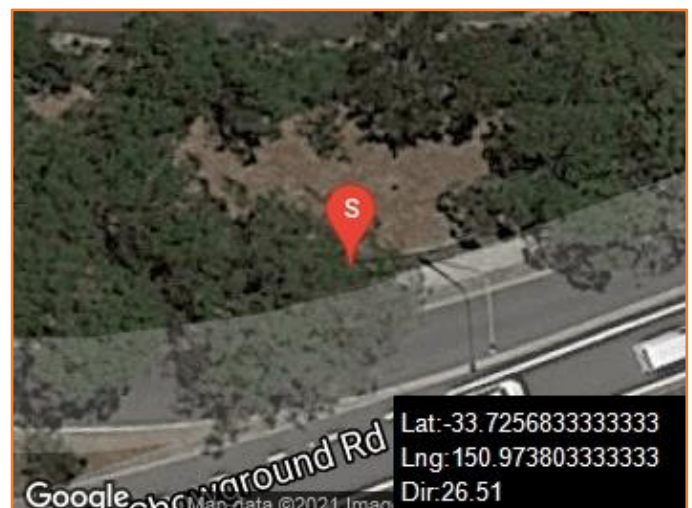
Figure 204: Good - General condition of flexible pavement.

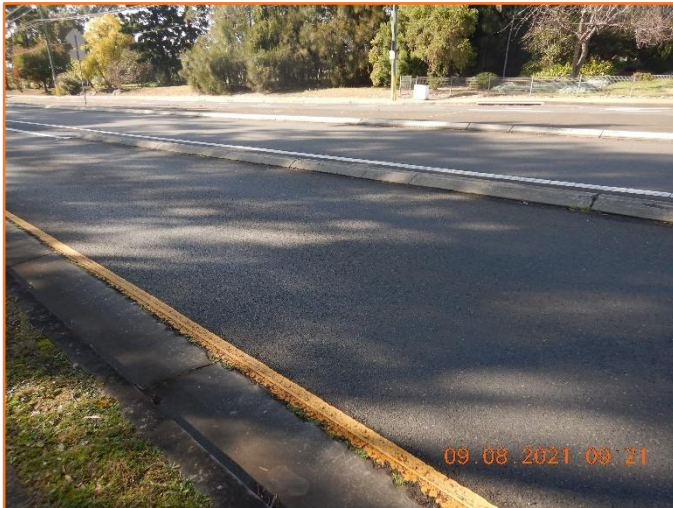
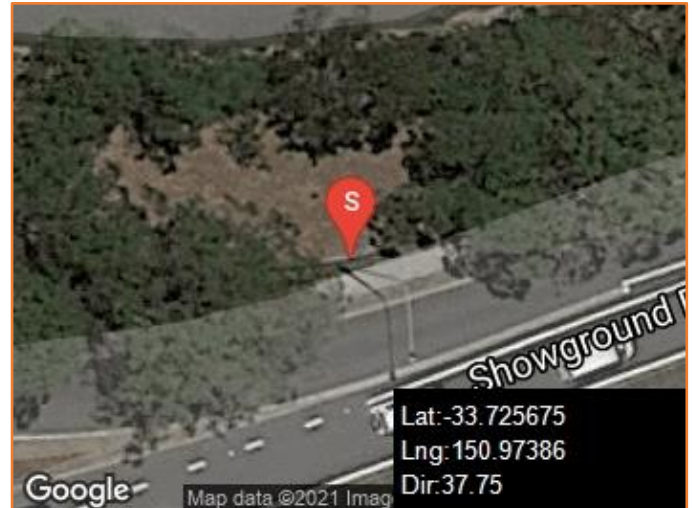
Figure 205: Good - General condition of flexible pavement.

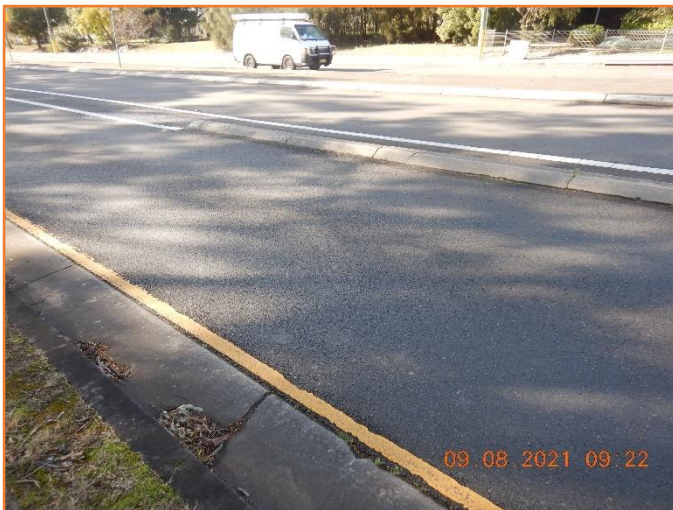
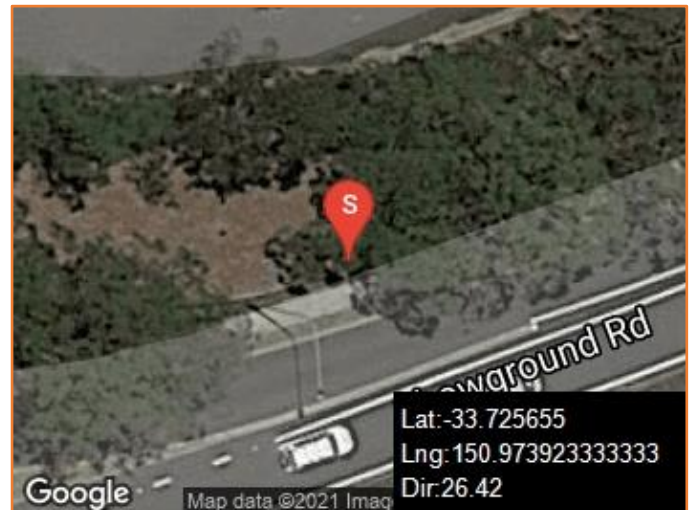
Figure 206: Good - General condition of flexible pavement.

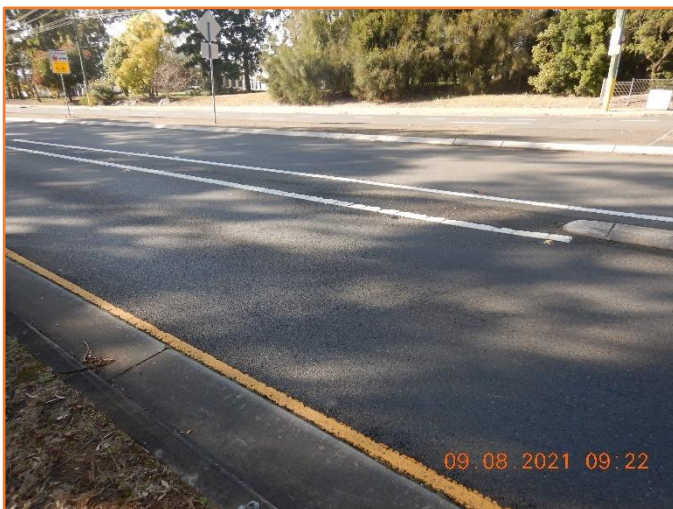
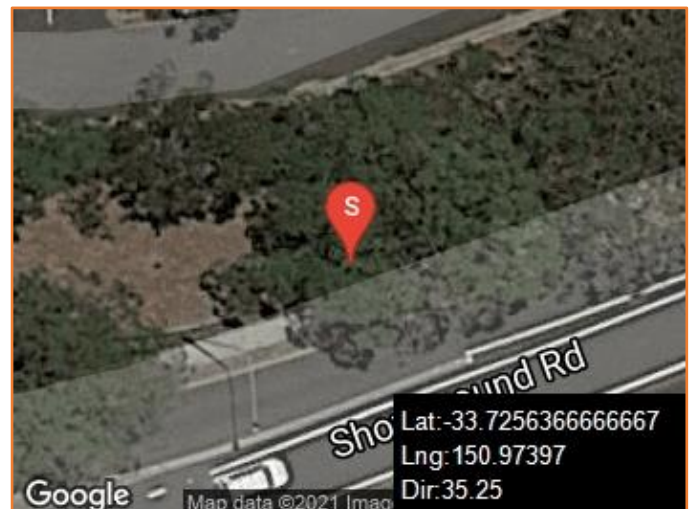
Figure 207: Good - General condition of flexible pavement.

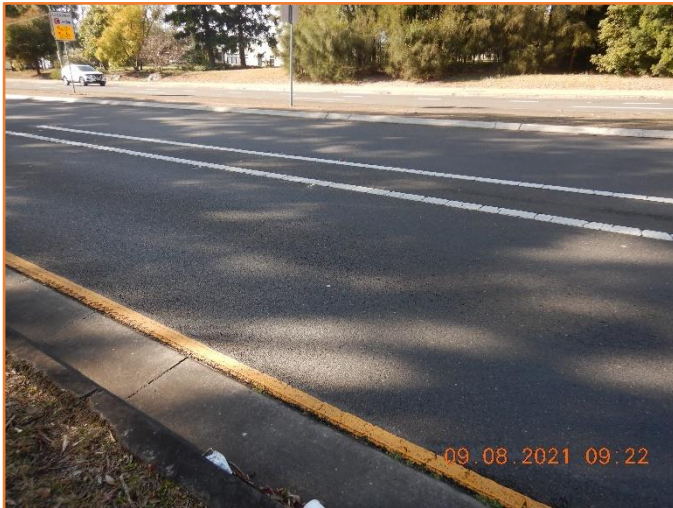
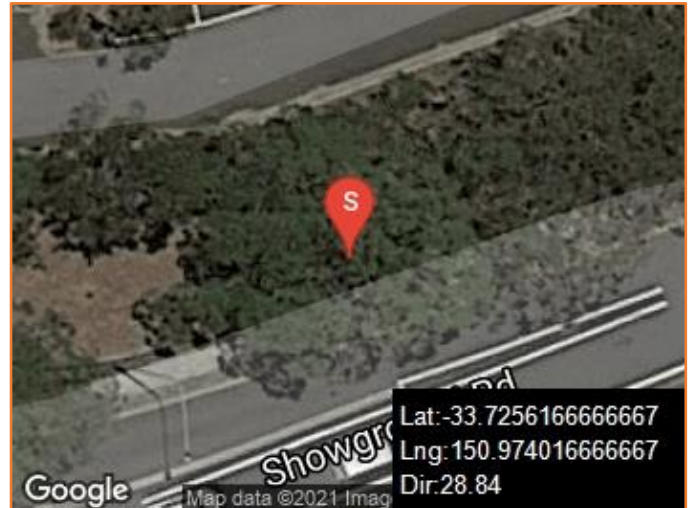
Figure 208: Good - General condition of flexible pavement.

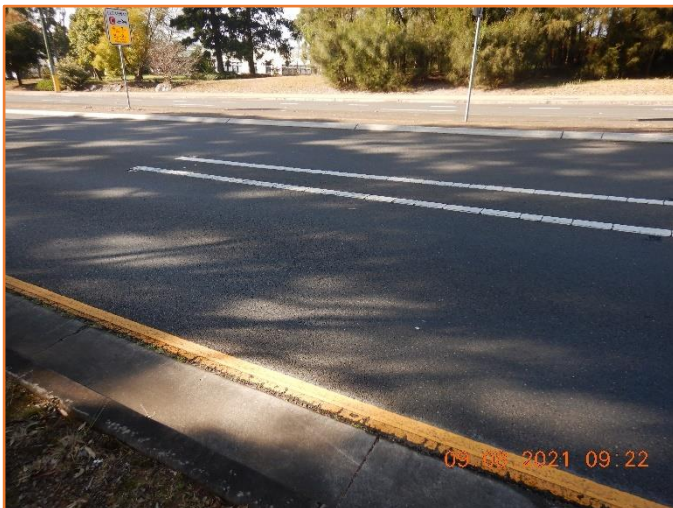
Figure 209: Good - General condition of flexible pavement.

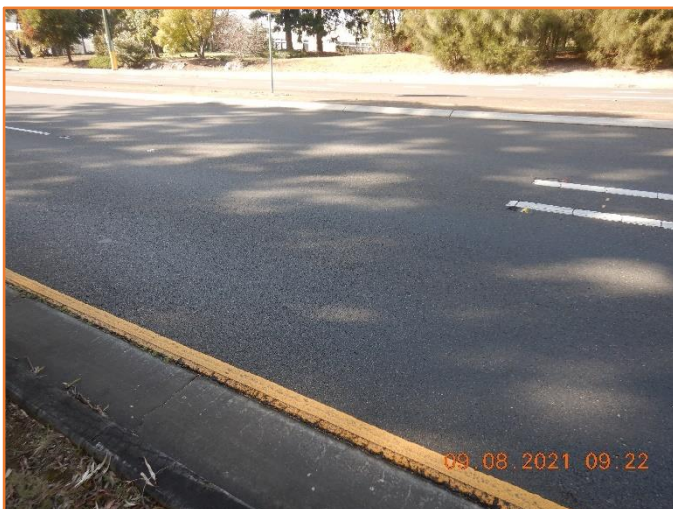
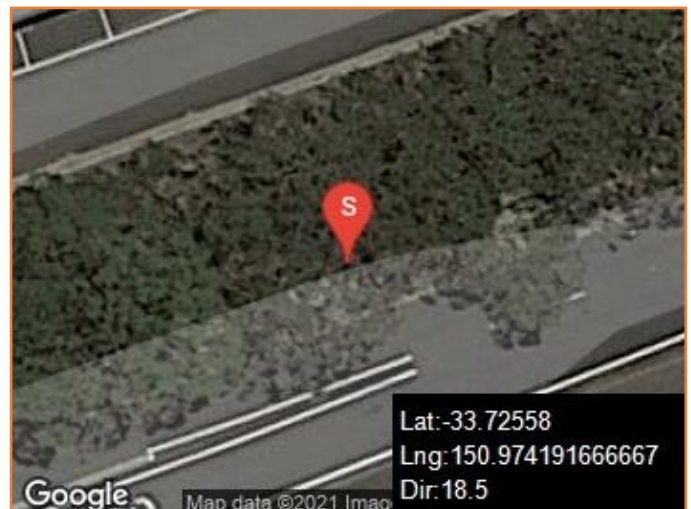
Figure 210: Good - General condition of flexible pavement.

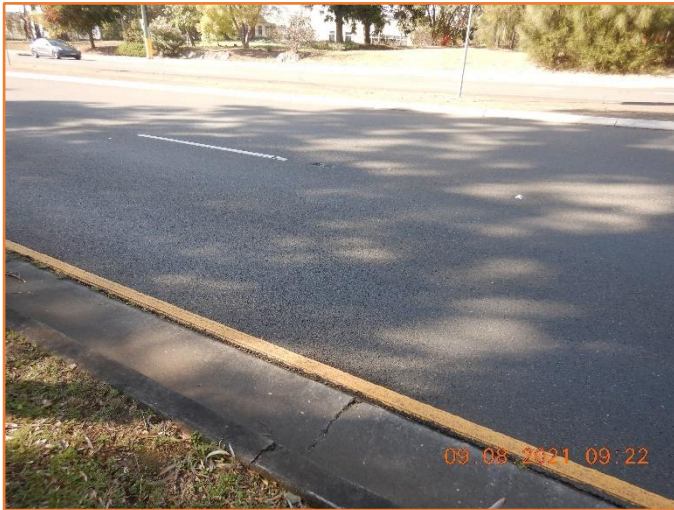
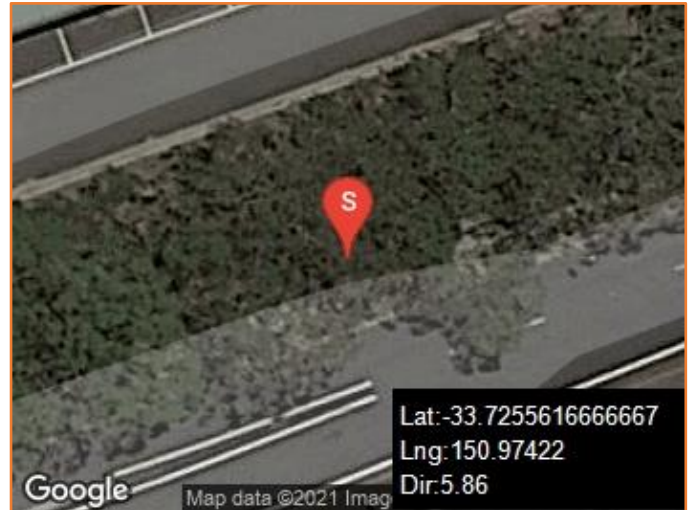
Figure 211: Good - General condition of flexible pavement.

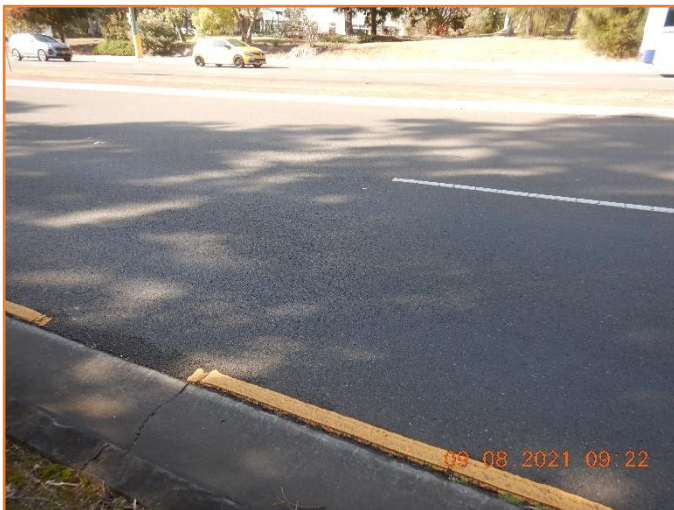
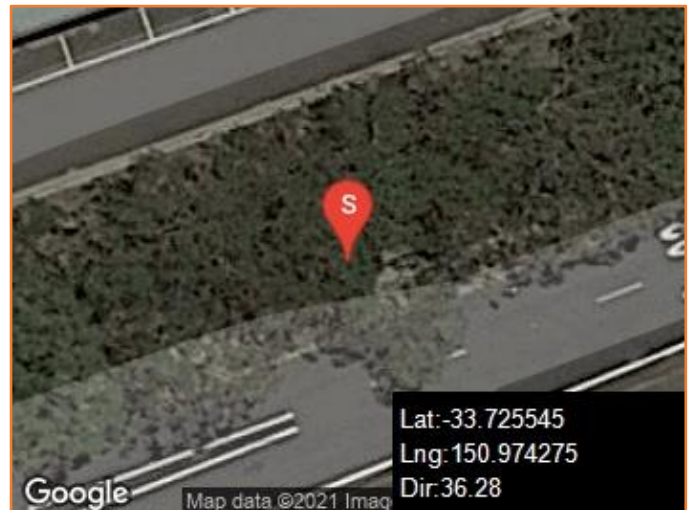
Figure 212: Good - General condition of flexible pavement.

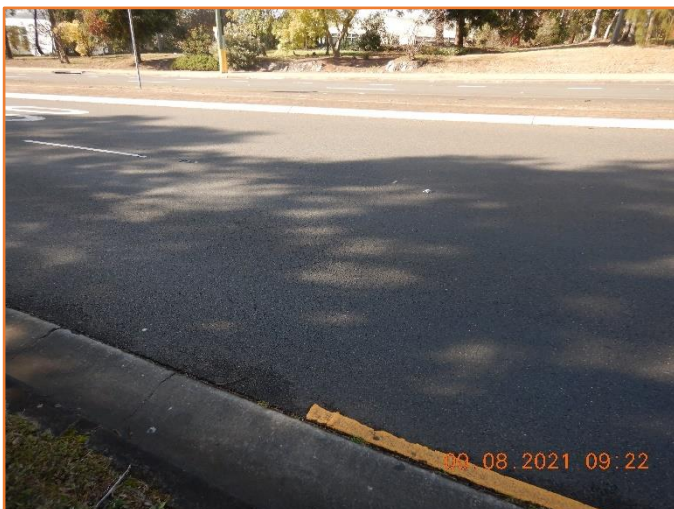
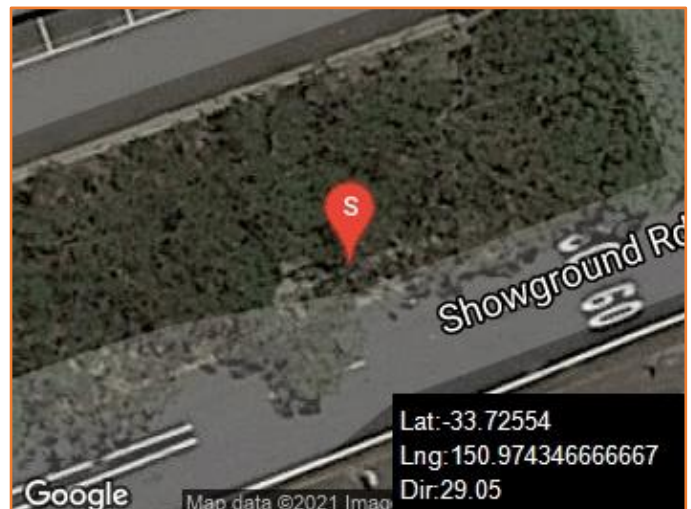
Figure 213: Good - General condition of flexible pavement.

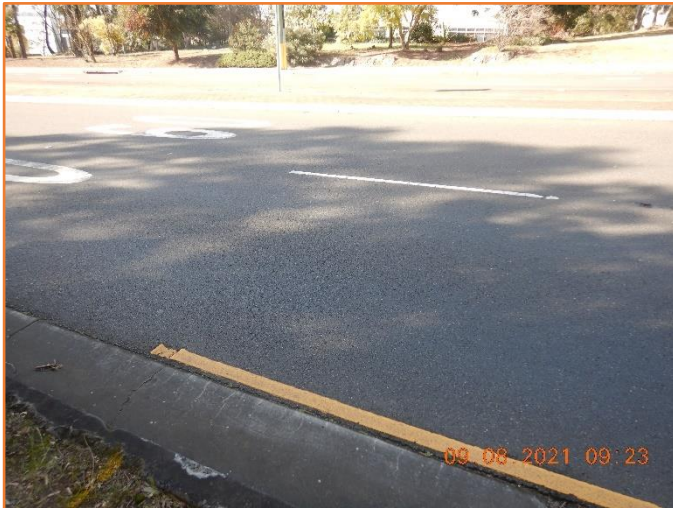
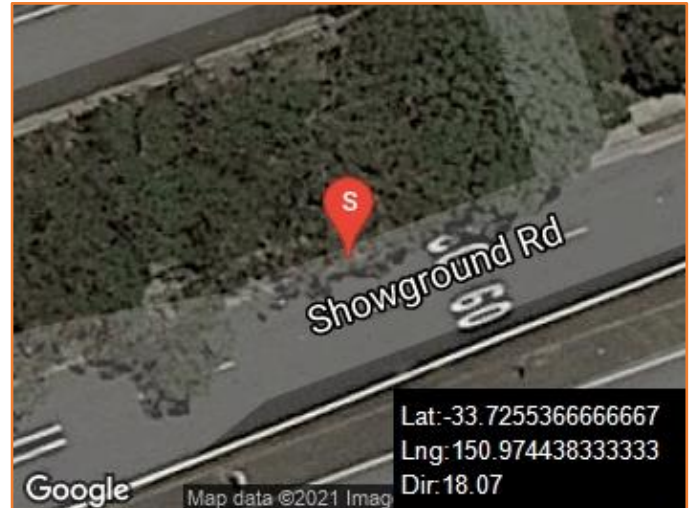
Figure 214: Good - General condition of flexible pavement.

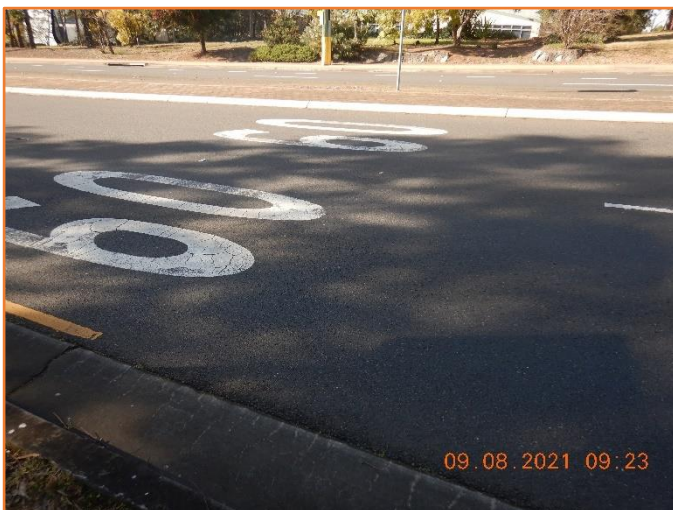
Figure 215: Good - General condition of flexible pavement.

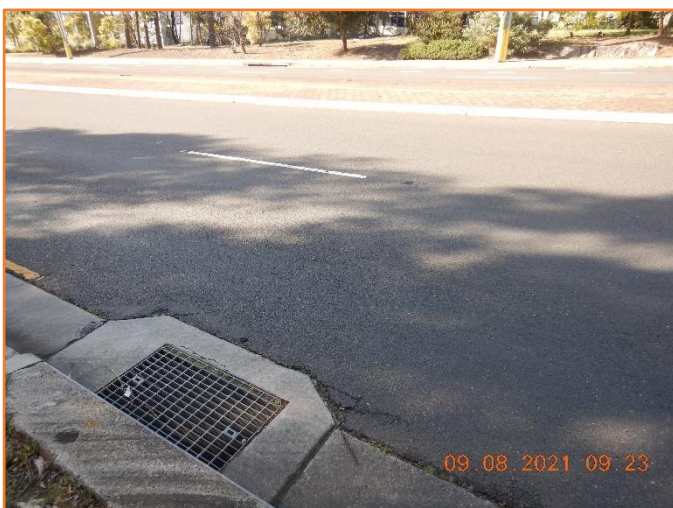
Figure 216: Good - General condition of flexible pavement.

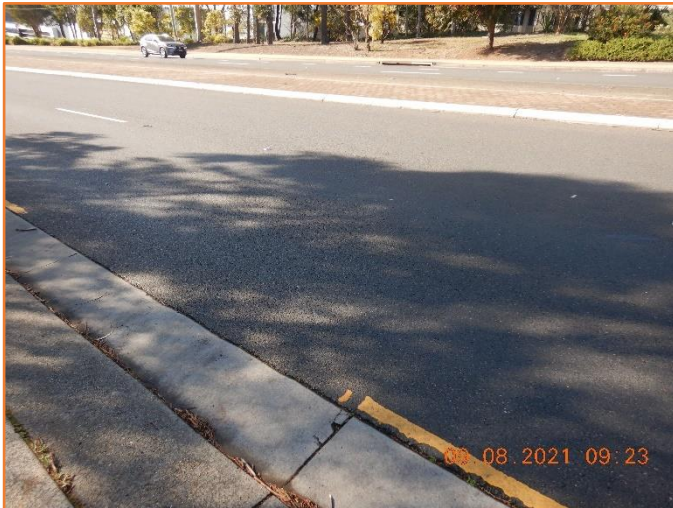
Figure 217: Good - General condition of flexible pavement.

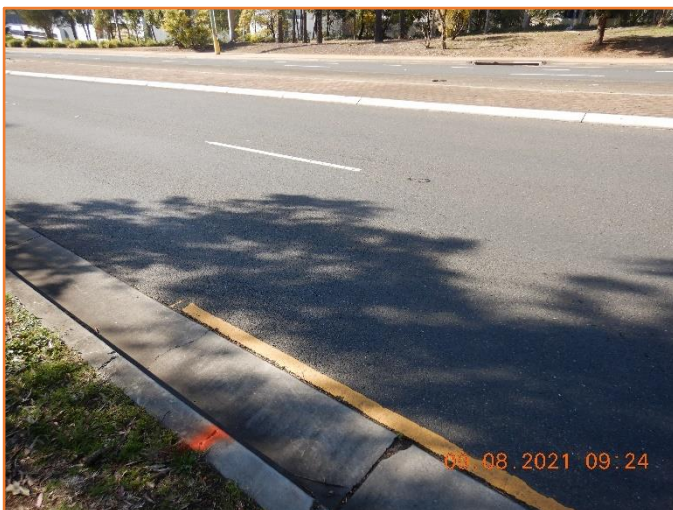
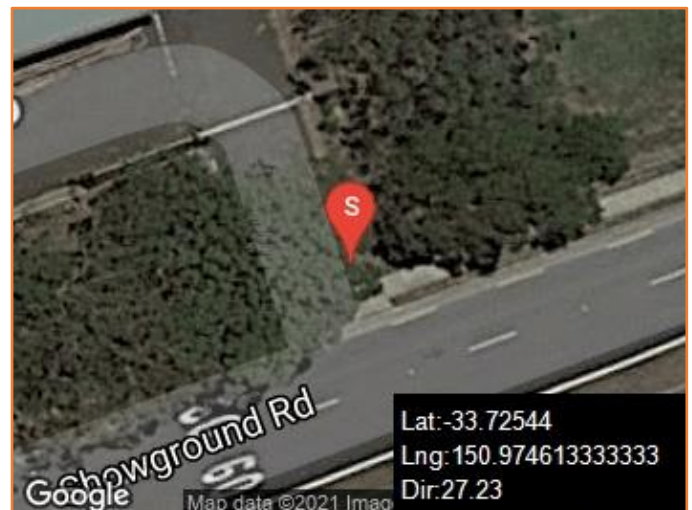
Figure 218: Good - General condition of flexible pavement.

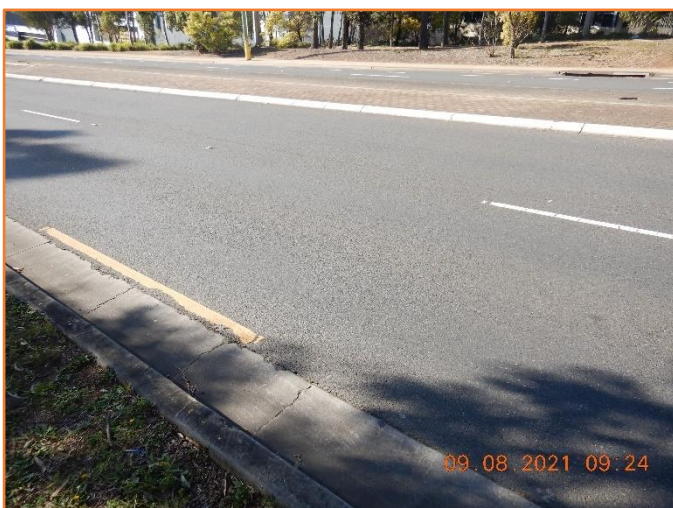
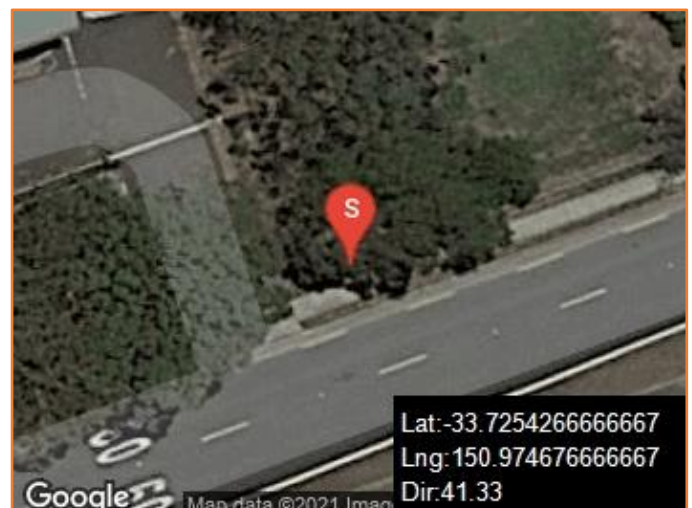
Figure 219: Good - General condition of flexible pavement.

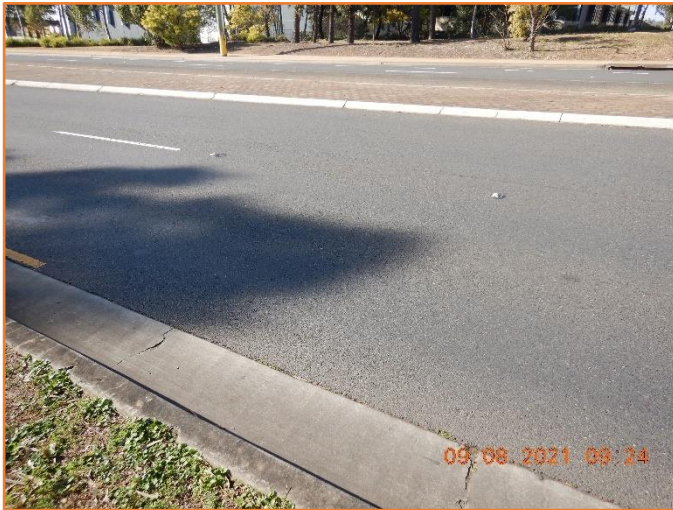
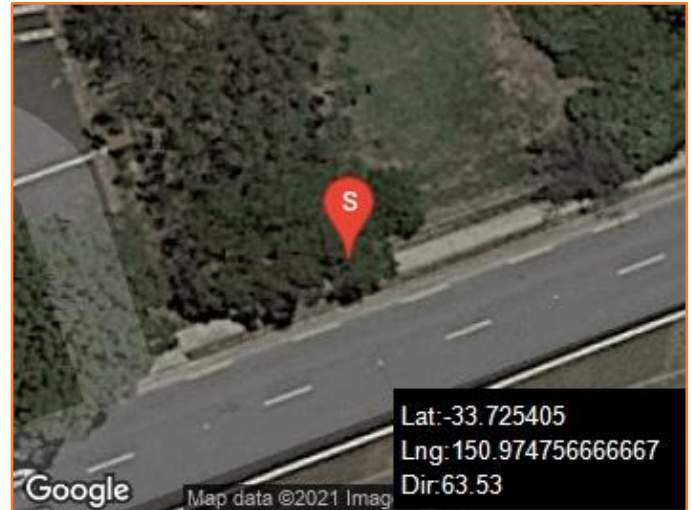
Figure 220: Good - General condition of flexible pavement.

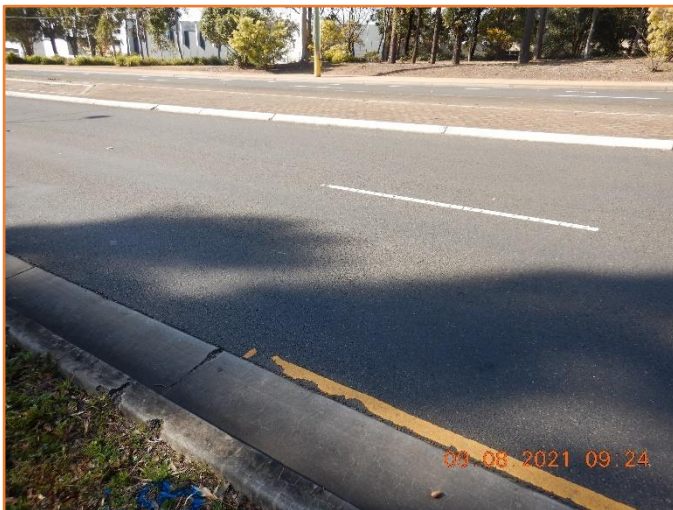
Figure 221: Good - General condition of flexible pavement.
