## DILAPIDATION REPORT

MUSEUM DISCOVERY CENTRE

MONDAY, 9 AUGUST 2021

Document Information	
Job Number	210722
Document Number	3
Report Title	Dilapidation Report
Site Address	172 Showground Road and 2 Green Road Castle Hill, NSW, 2154
Lot	1 in DP1066281 & 102 in DP1130271

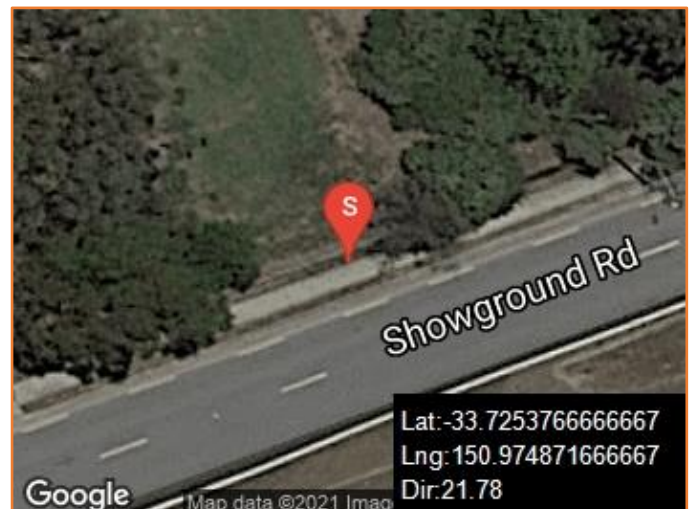
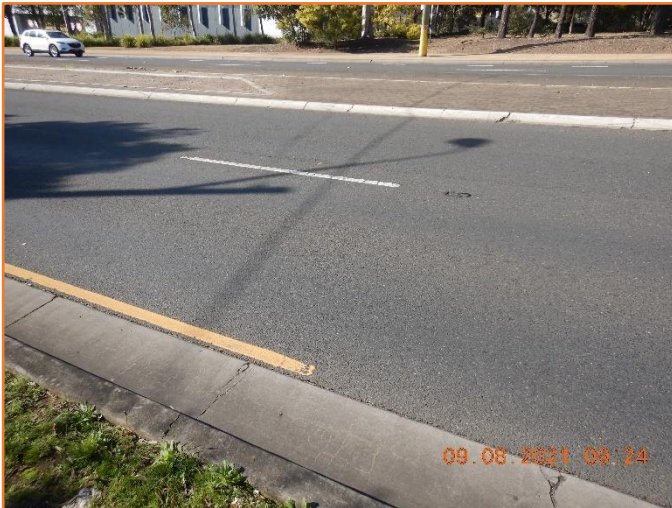
Figure 222: Good - General condition of flexible pavement.

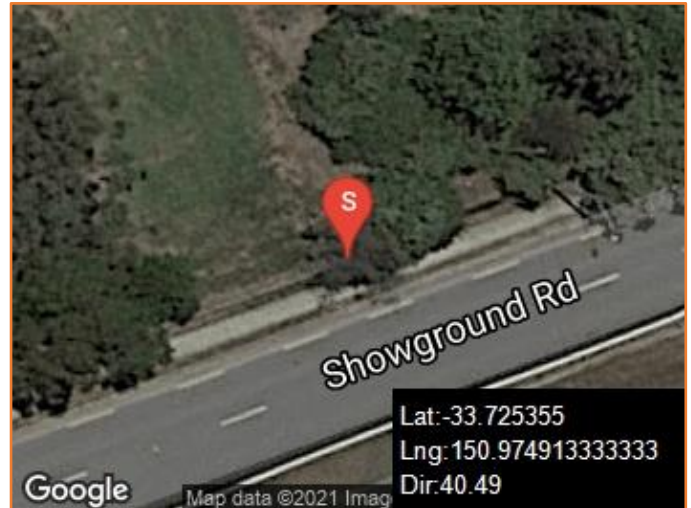
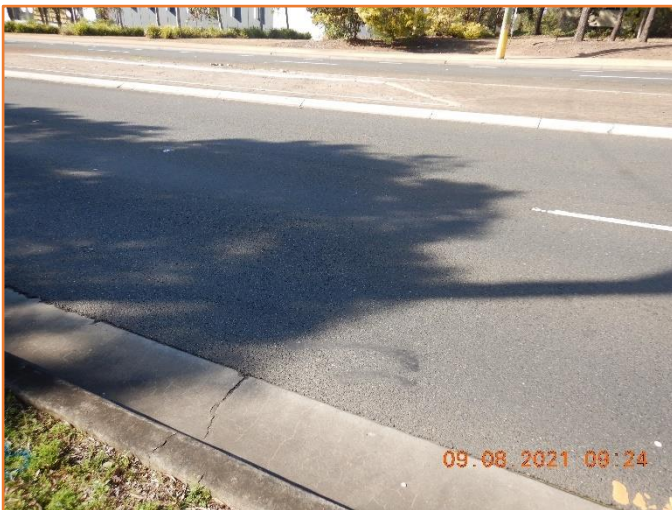
Figure 223: Good - General condition of flexible pavement.

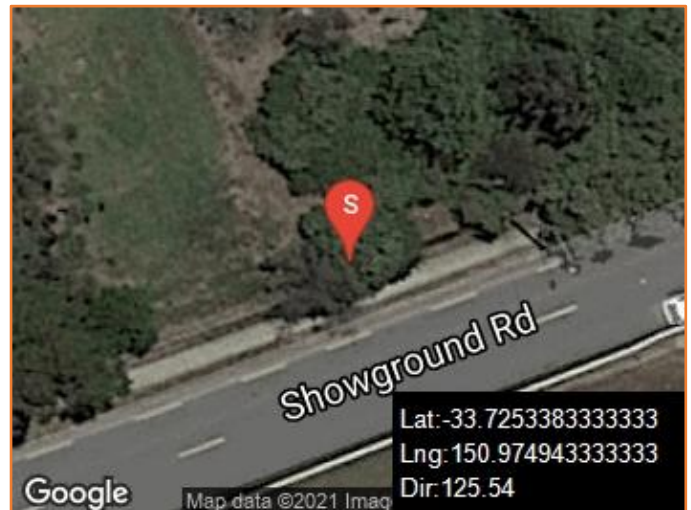
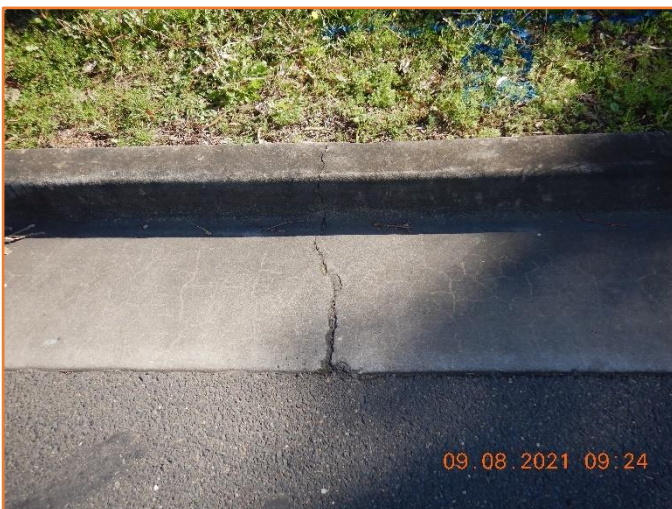
Figure 224: Good - General condition of flexible pavement.

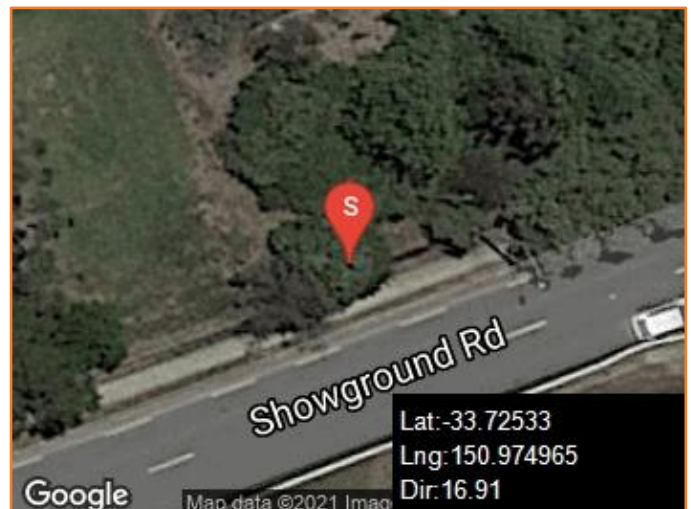
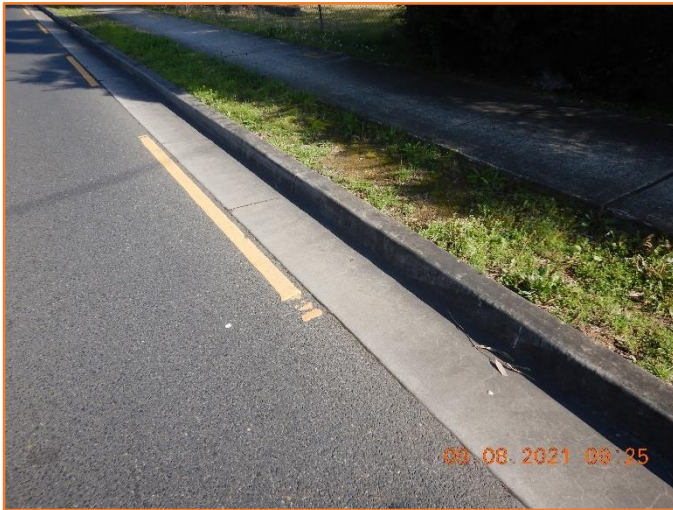
Figure 225: Reasonable - General condition of kerb and gutter. Minor hairline cracking observed.

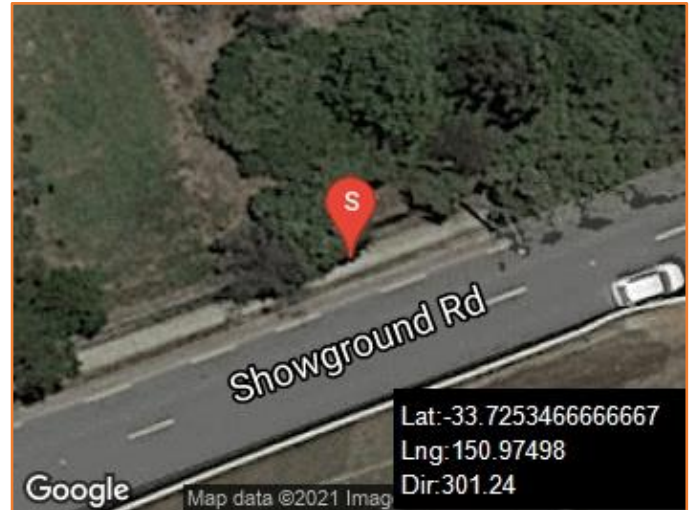
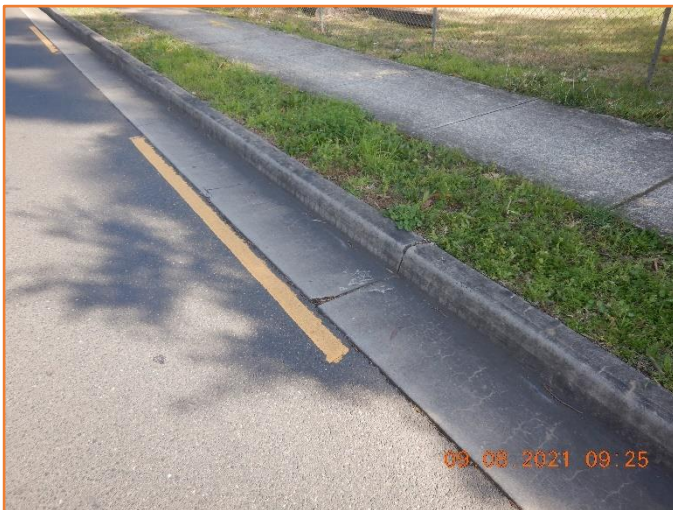
Figure 226: Reasonable - General condition of kerb and gutter.

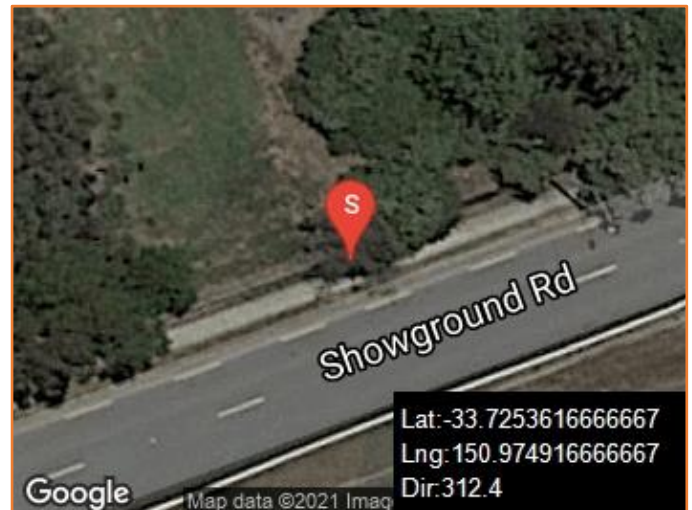
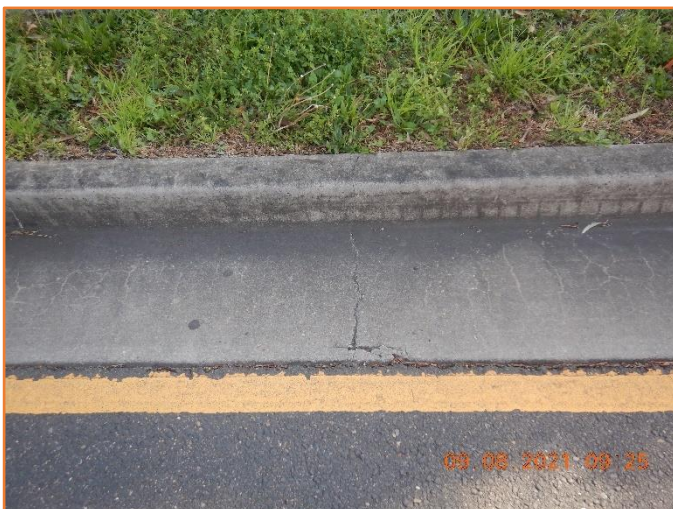
Figure 227: Reasonable - General condition of kerb and gutter.

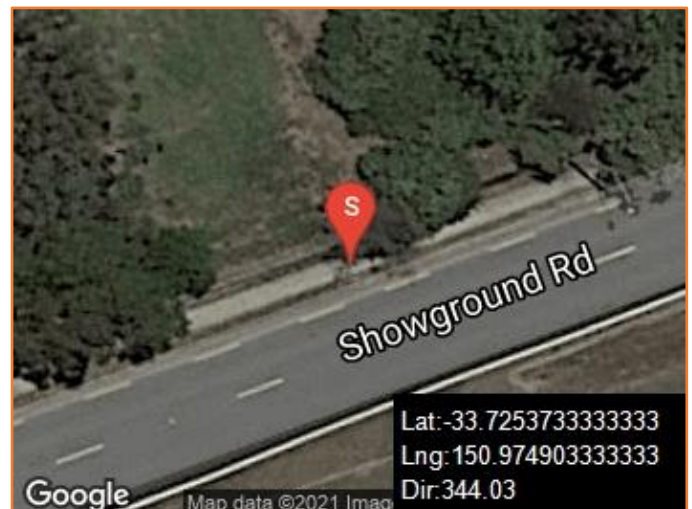
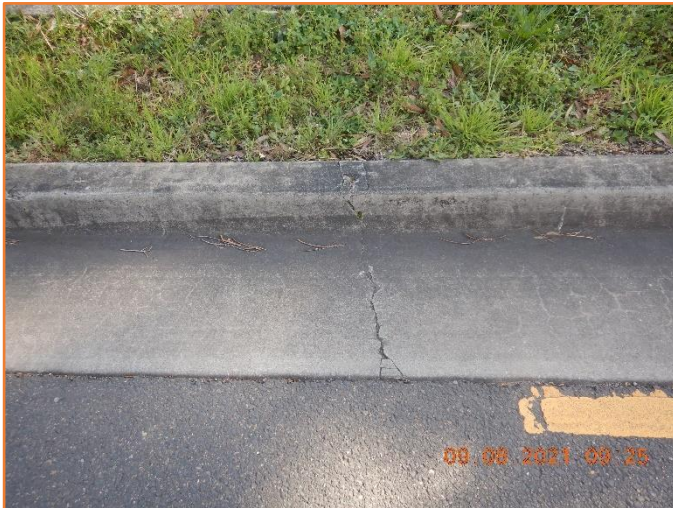
Figure 228: Reasonable - General condition of kerb and gutter. Minor hairline cracking observed.

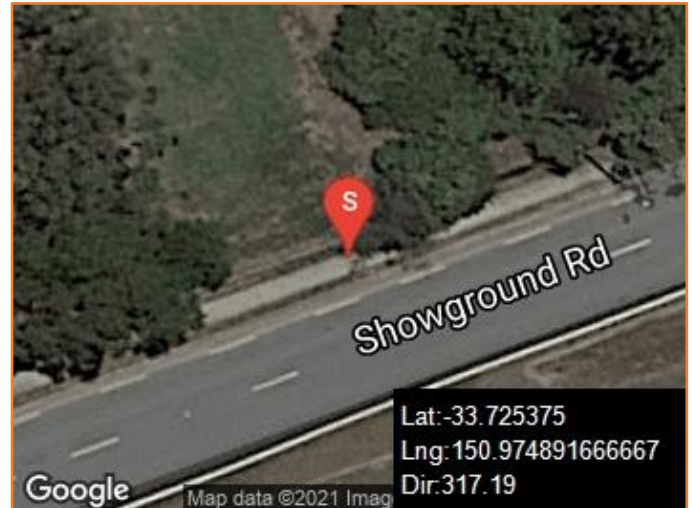
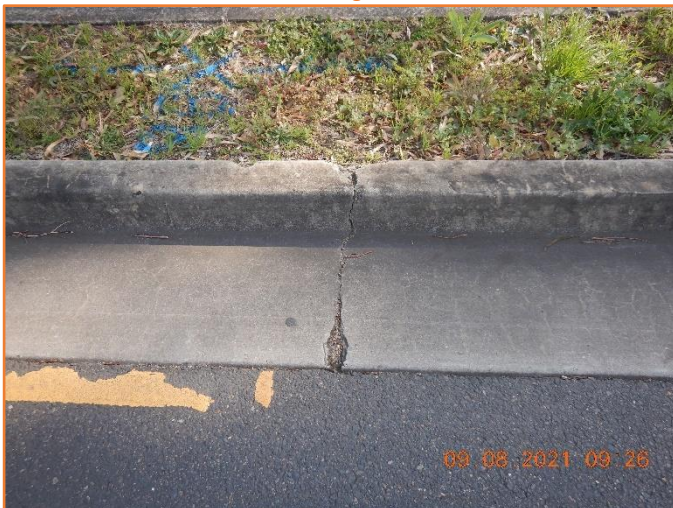
Figure 229: Reasonable - General condition of kerb and gutter. Minor hairline cracking observed.

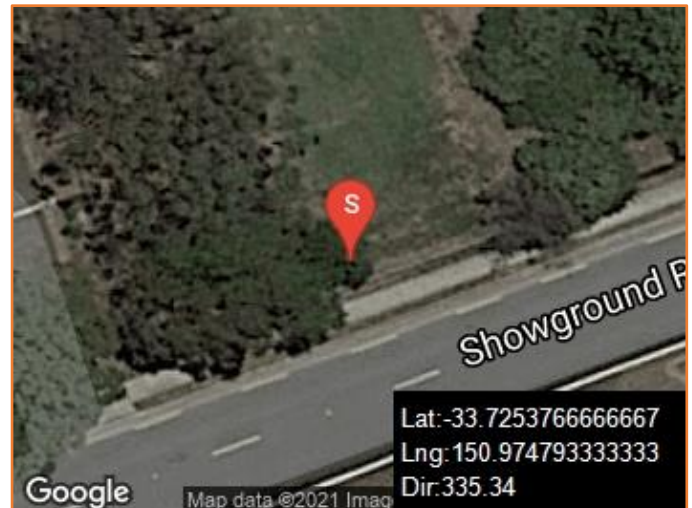
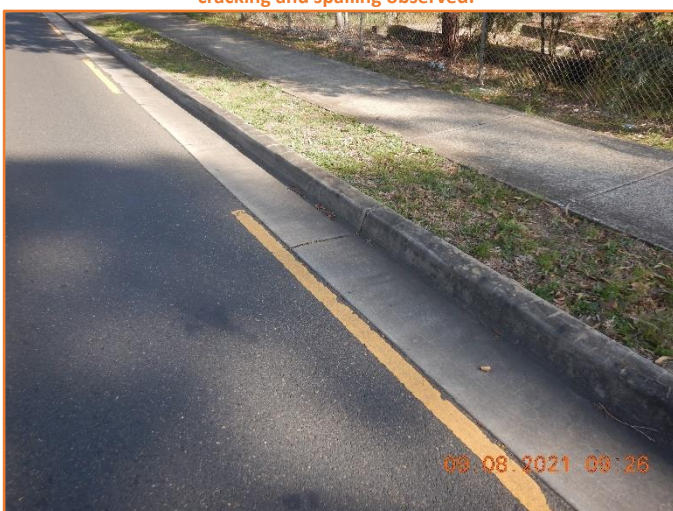
Figure 230: Reasonable - General condition of kerb and gutter. Moderate cracking and spalling observed.

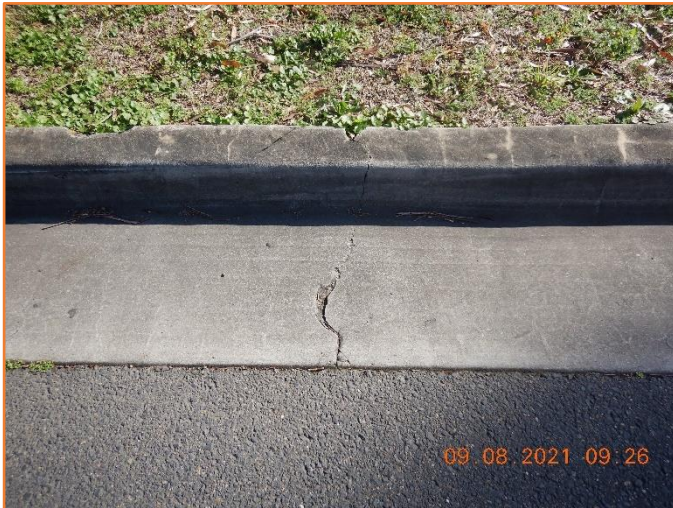
Figure 231: Reasonable - General condition of kerb and gutter.

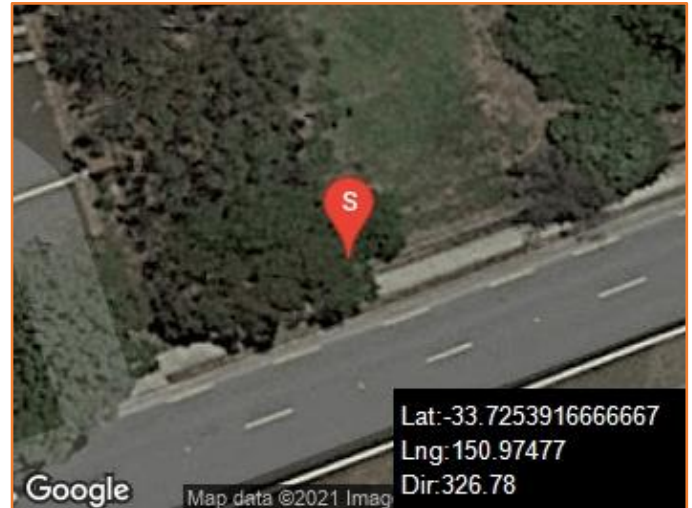
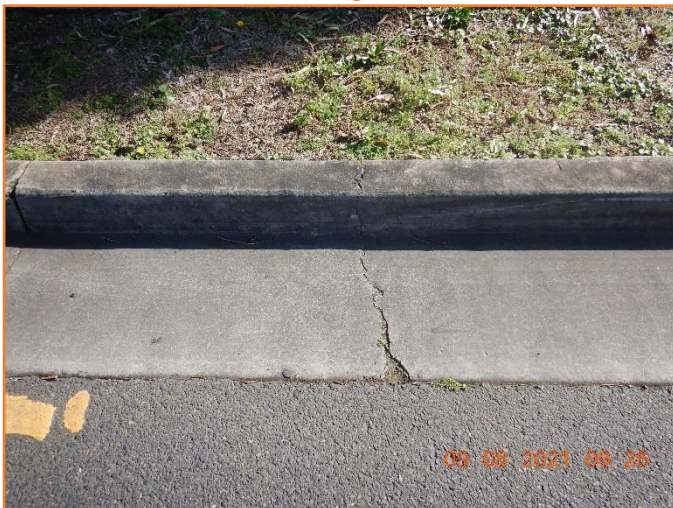
Figure 232: Reasonable - General condition of kerb and gutter. Minor hairline cracking observed.

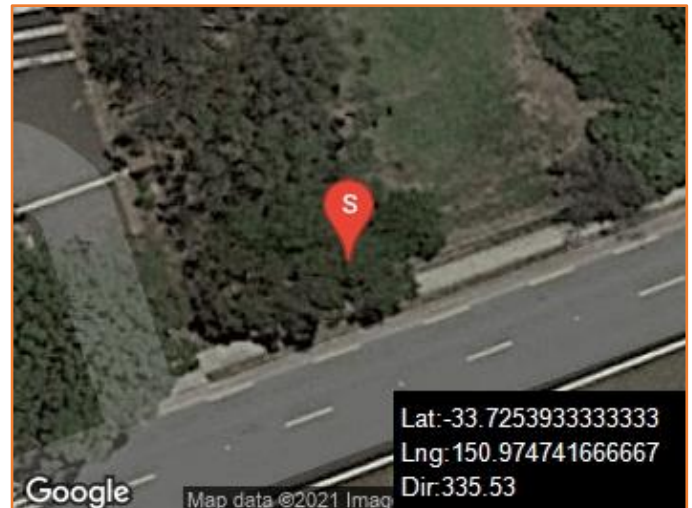
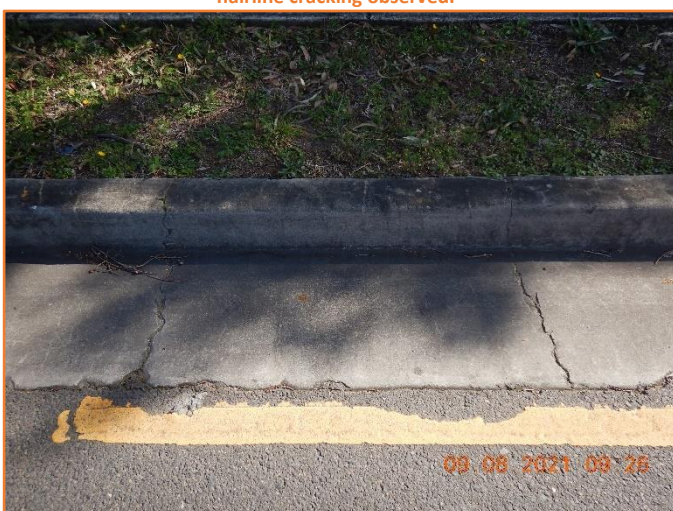
Figure 233: Reasonable - General condition of kerb and gutter. Minor hairline cracking observed.

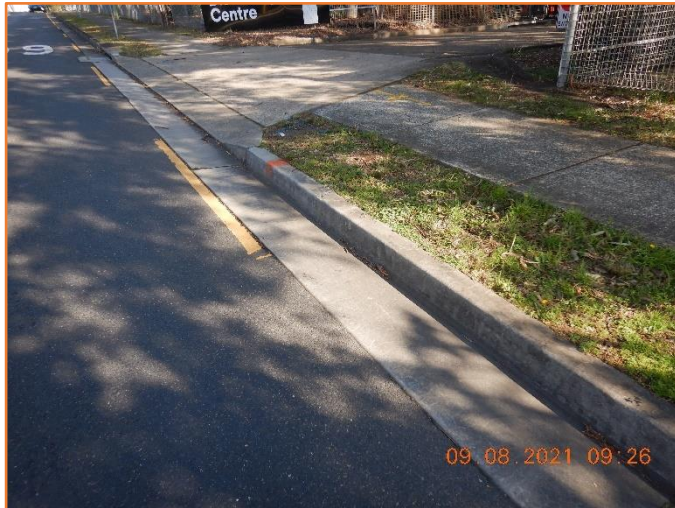
Figure 234: Reasonable - General condition of kerb and gutter. Minor hairline cracking observed.

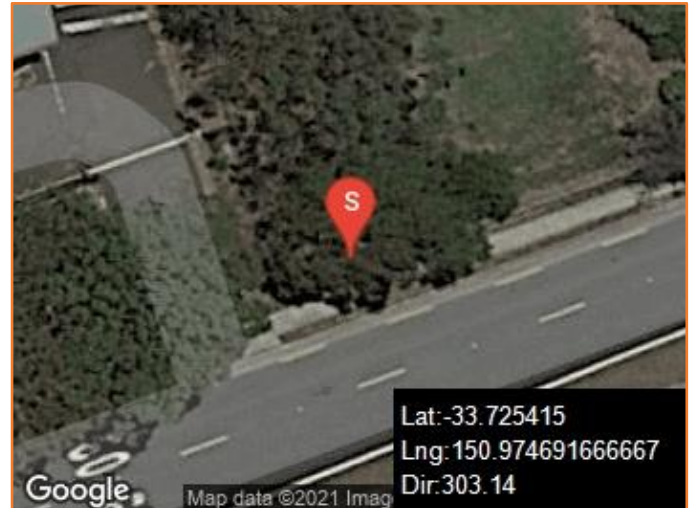
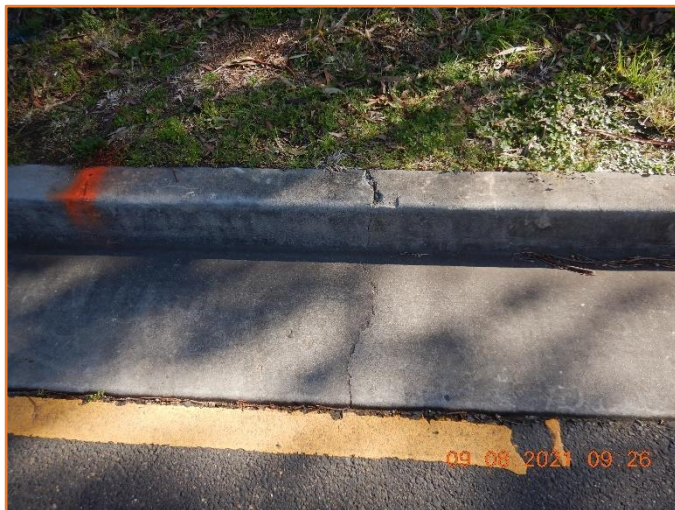
Figure 235: Reasonable - General condition of kerb and gutter.

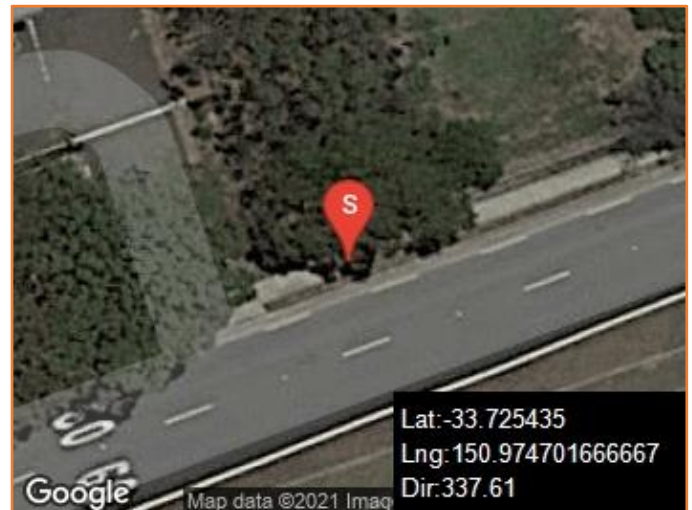
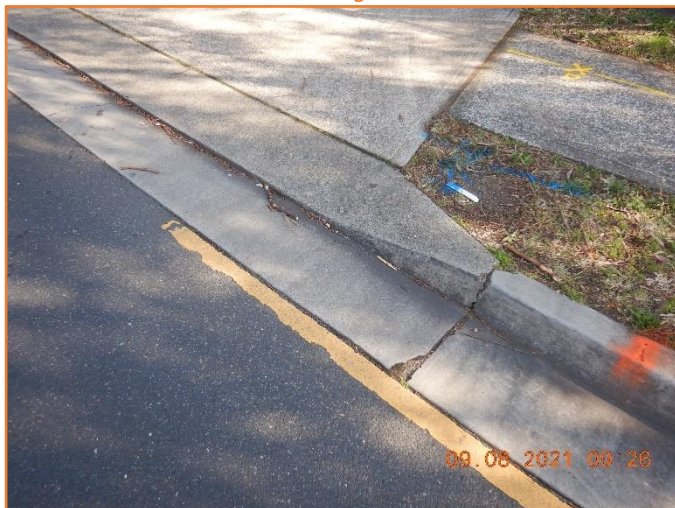
Figure 236: Reasonable - General condition of kerb and gutter. Minor hairline cracking observed.

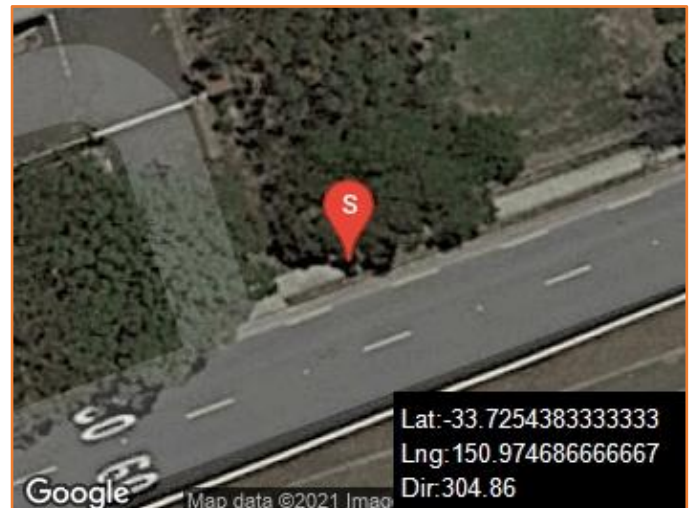
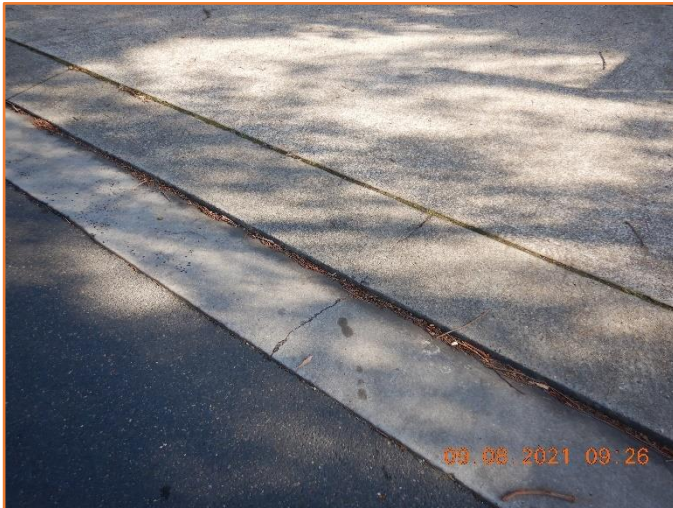
Figure 237: Reasonable - General condition of kerb and gutter and driveway splay. Moderate cracking observed.

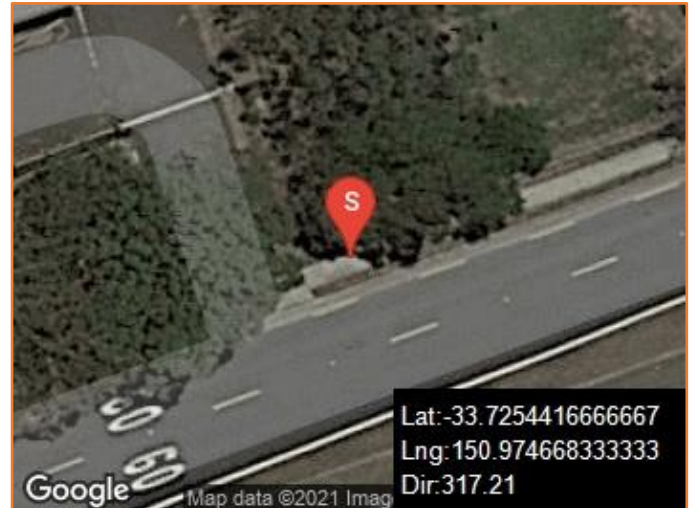
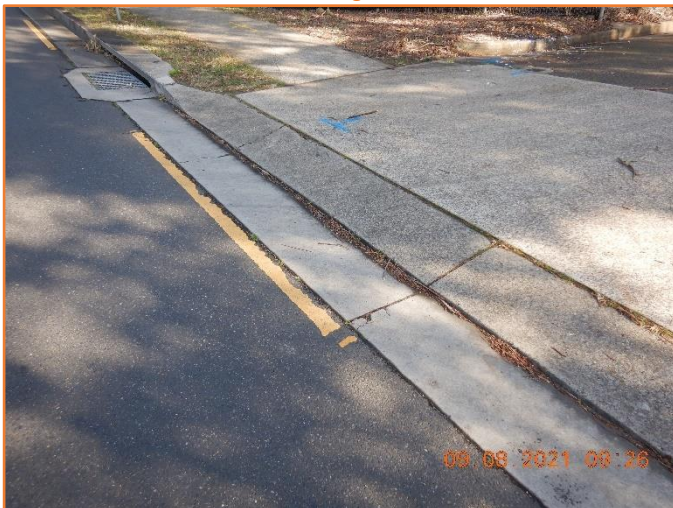
Figure 238: Reasonable - General condition of driveway crossover. Minor hairline cracking observed.

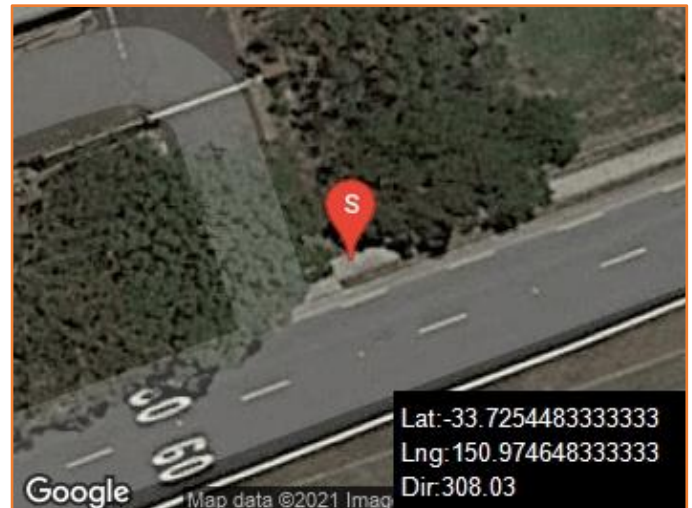
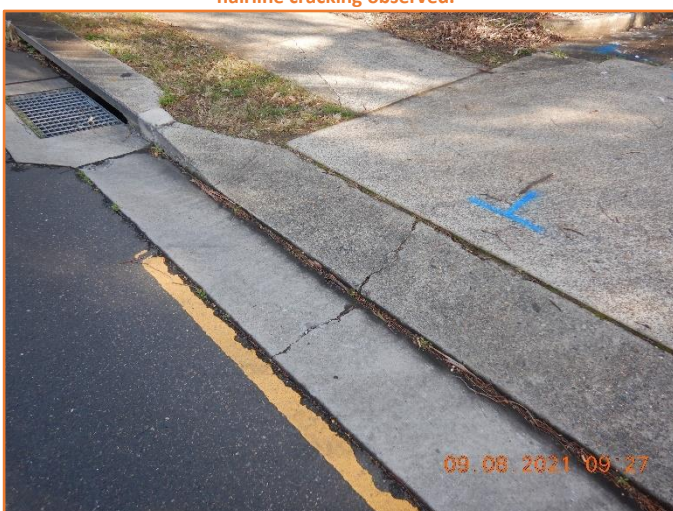
Figure 239: Reasonable - General condition of driveway crossover. Minor hairline cracking observed.

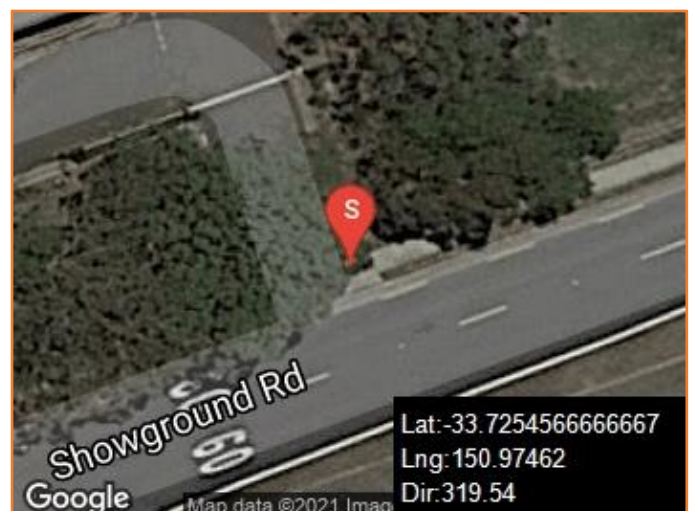
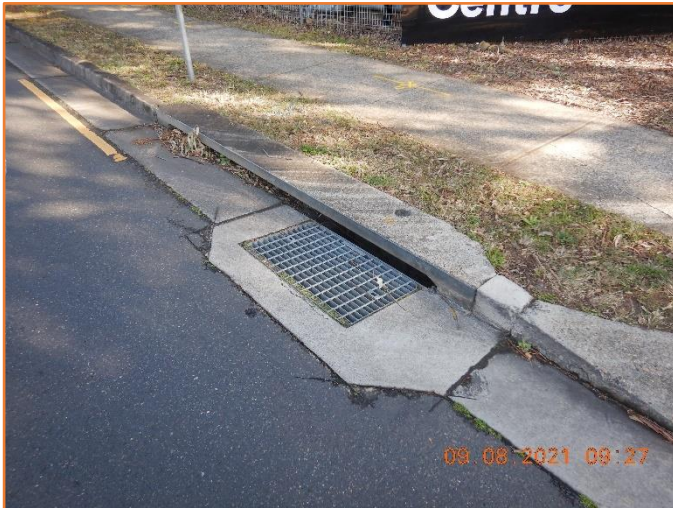
Figure 240: Reasonable - General condition of driveway crossover. Moderate cracking observed.

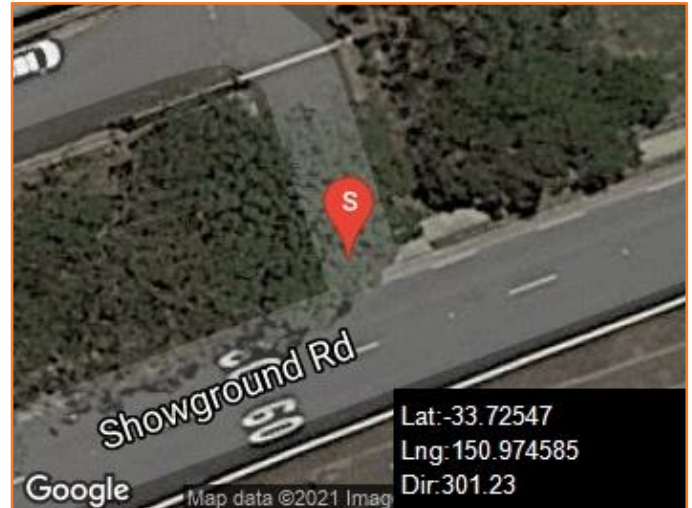
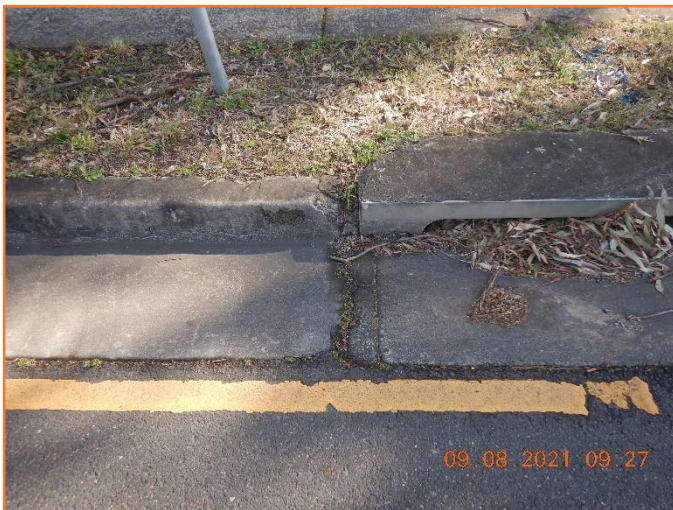
Figure 242: Poor - General condition of kerb and gutter. Moderate loss of material observed.

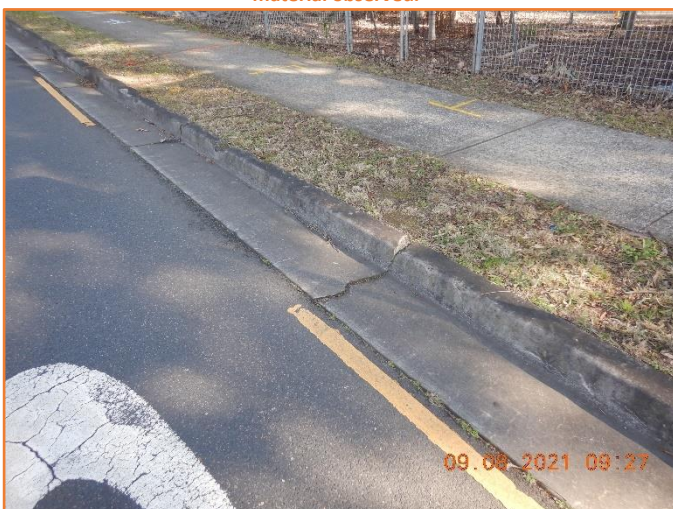
Figure 243: Poor - General condition of kerb and gutter. Moderate cracking and spalling observed.

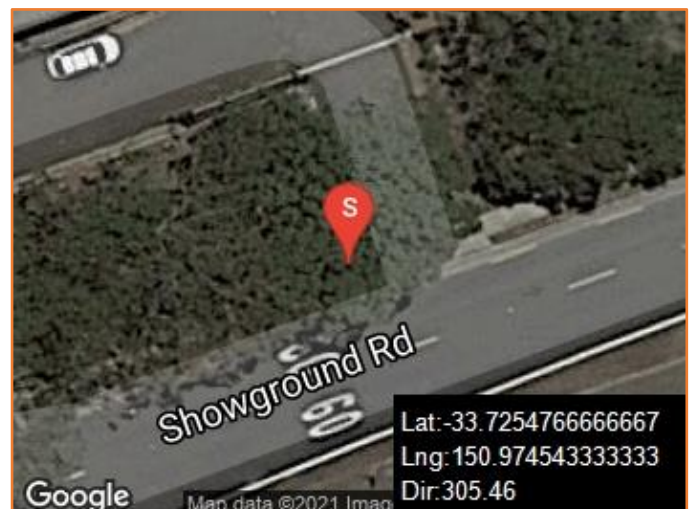
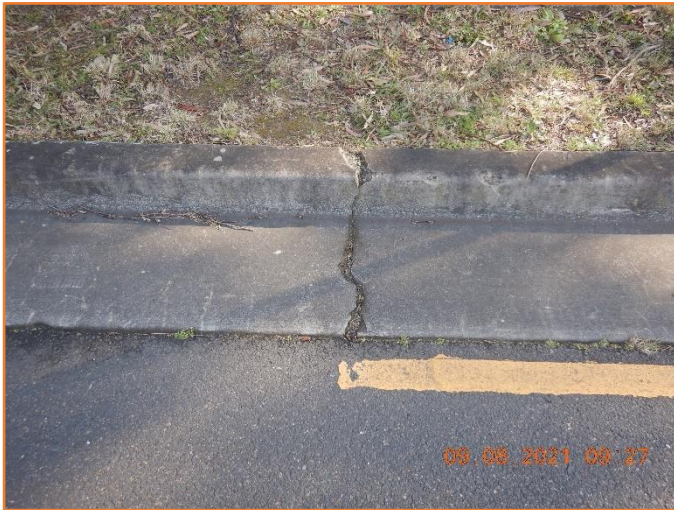
Figure 244: Poor - General condition of kerb and gutter. Moderate cracking and spalling observed.

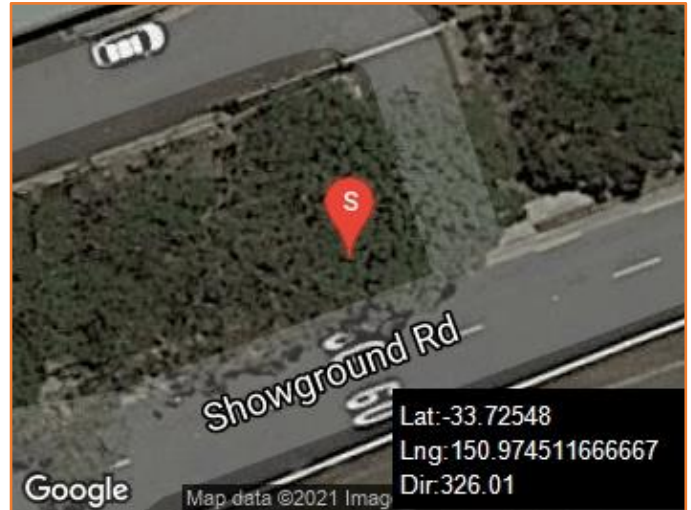
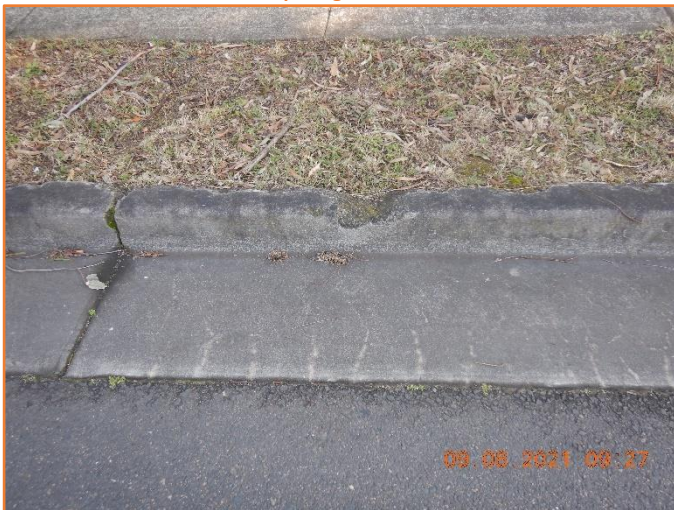
Figure 245: Poor - General condition of kerb and gutter. Moderate cracking and spalling observed.

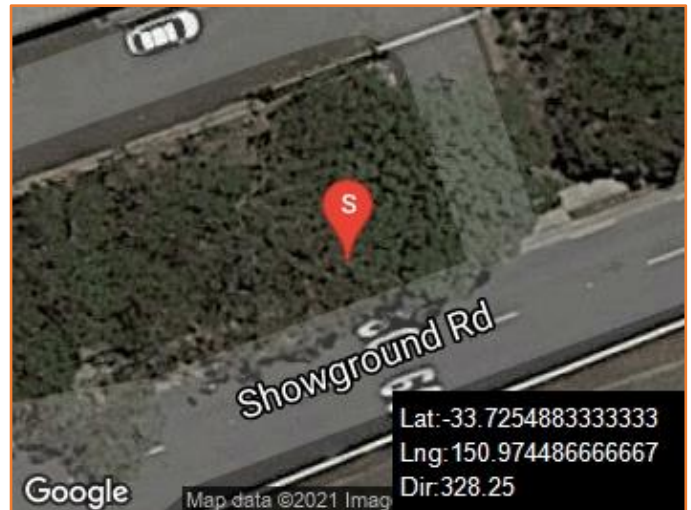
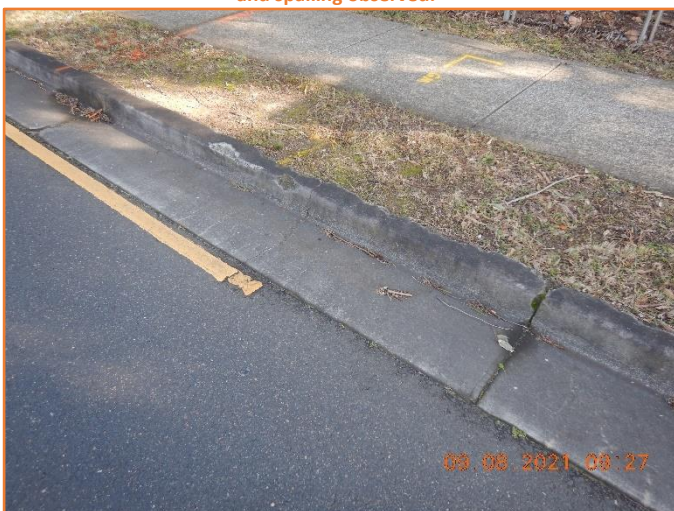
Figure 246: Poor - General condition of kerb and gutter. Moderate cracking and spalling observed.

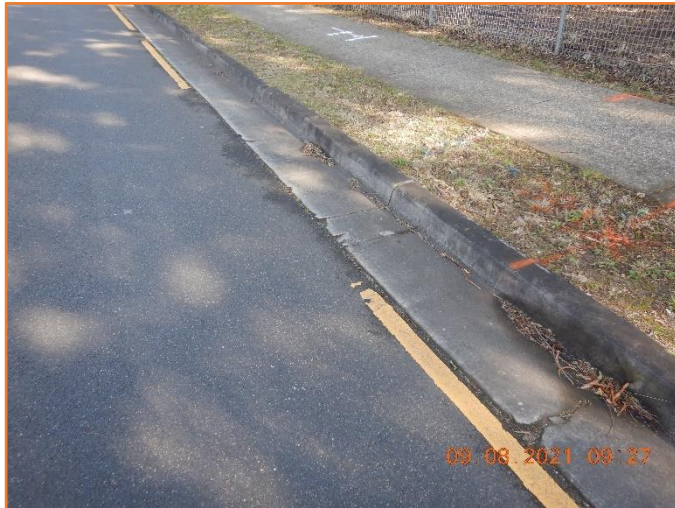
Figure 247: Reasonable - General condition of kerb and gutter.

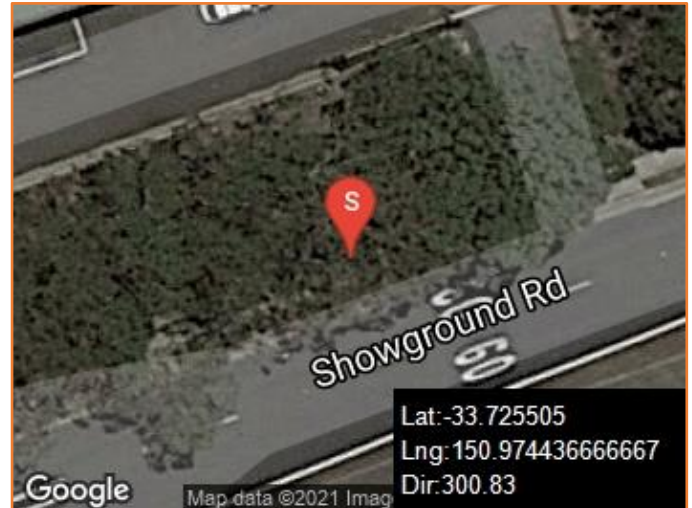
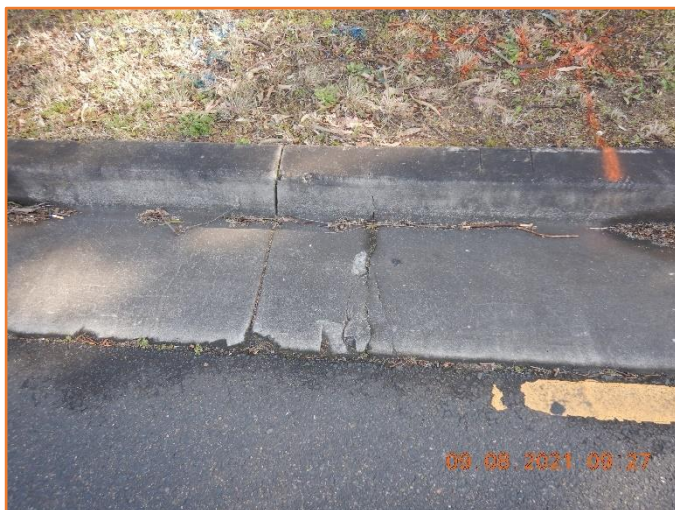
Figure 248: Reasonable - General condition of kerb and gutter. Minor hairline cracking observed.

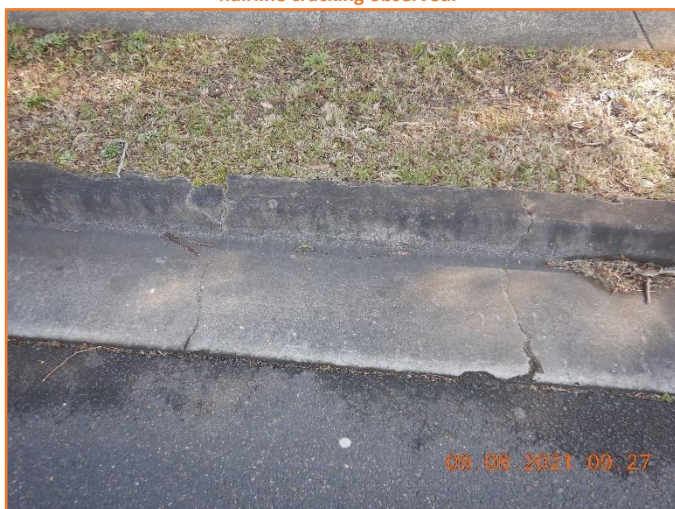
Figure 249: Poor - General condition of kerb and gutter. Moderate cracking and spalling observed.

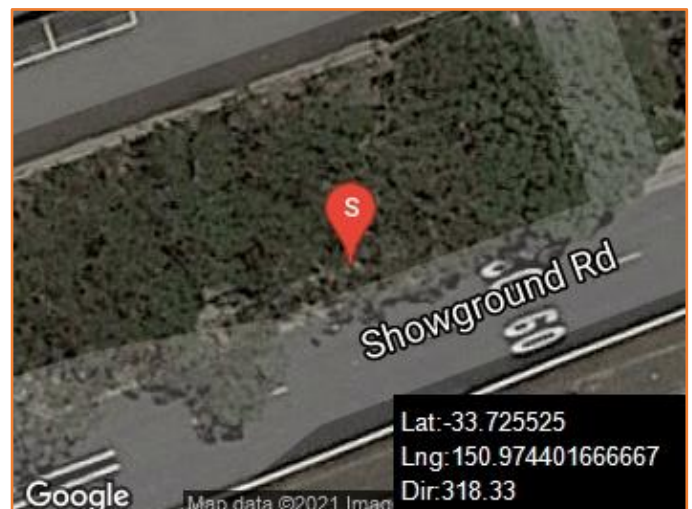
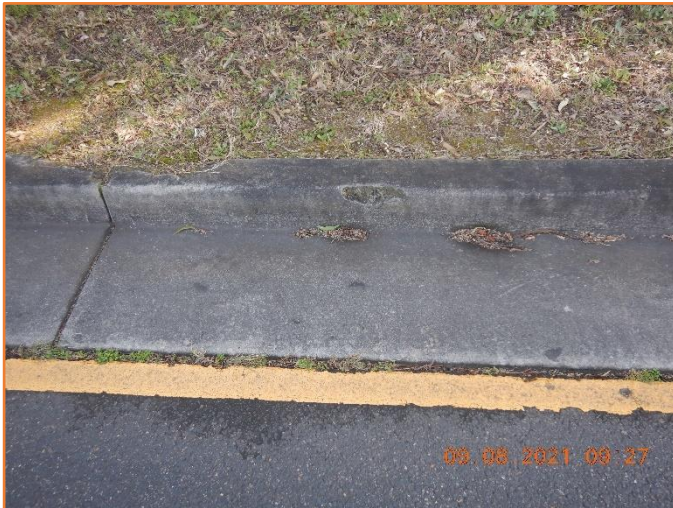
Figure 250: Reasonable - General condition of kerb and gutter. Minor spalling observed.

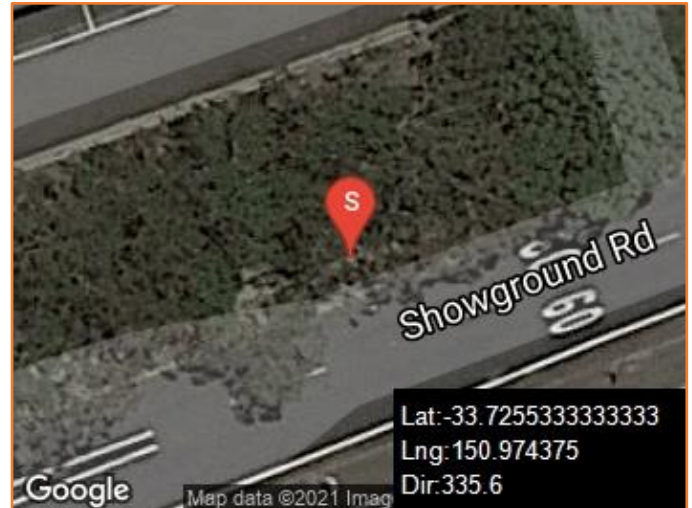
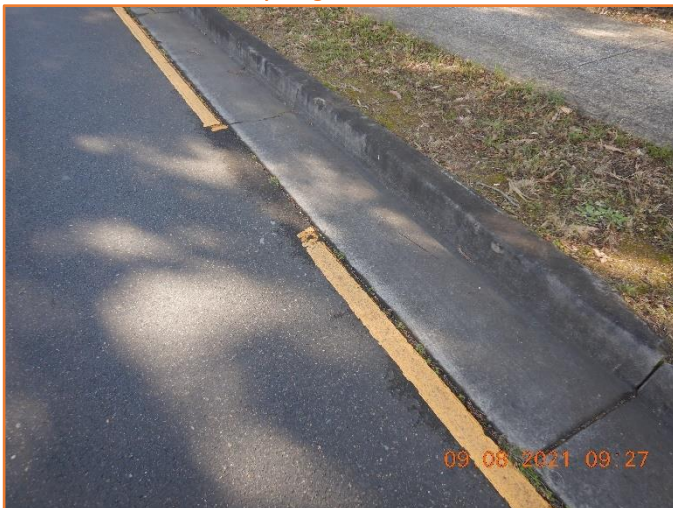
Figure 251: Reasonable - General condition of kerb and gutter. Minor spalling observed.

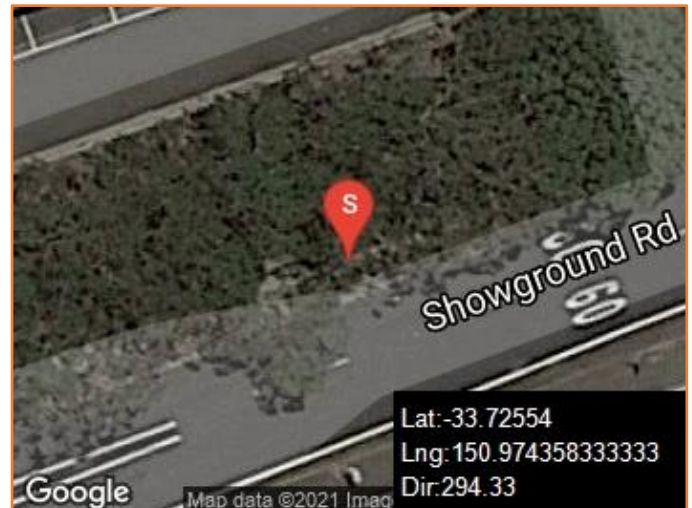
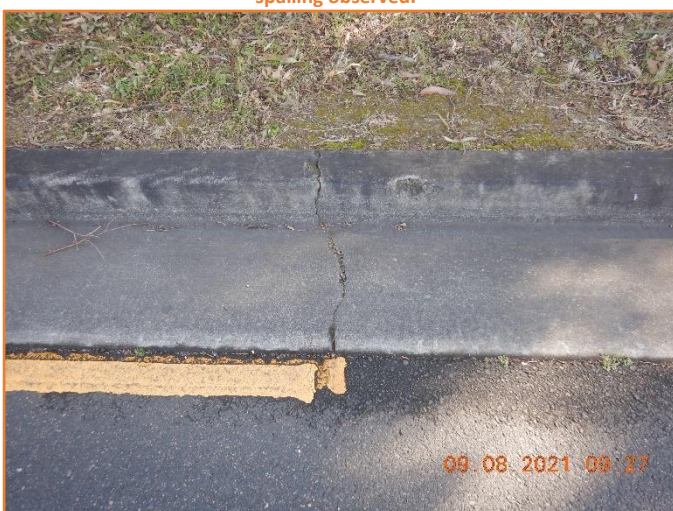
Figure 252: Reasonable - General condition of kerb and gutter. Moderate hairline cracking and spalling observed.

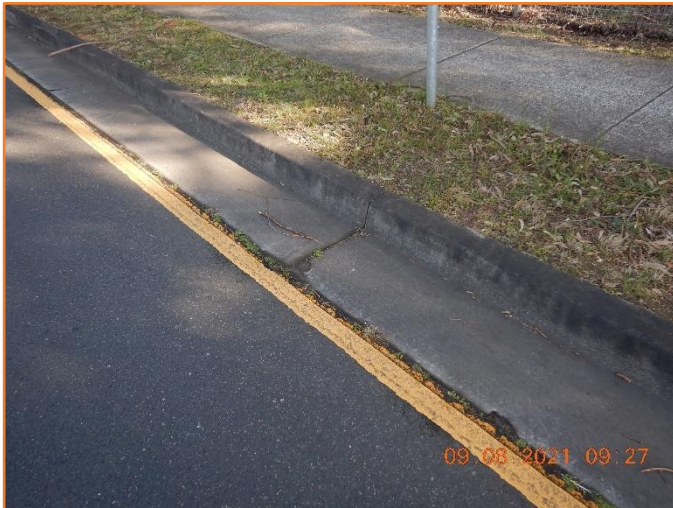
Figure 253: Reasonable - General condition of kerb and gutter.

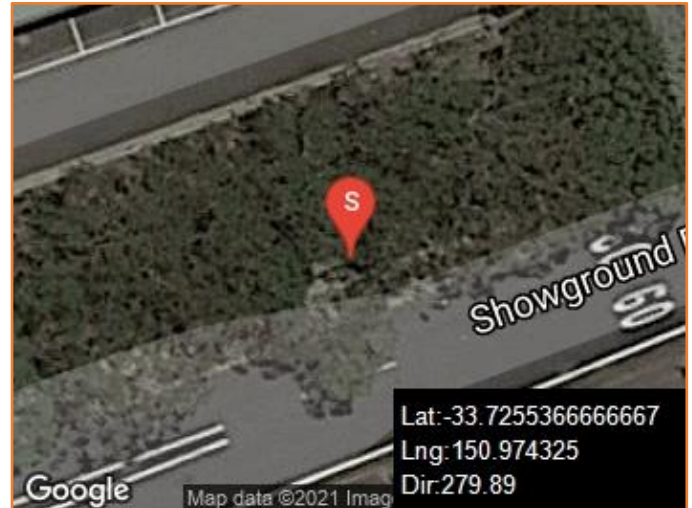
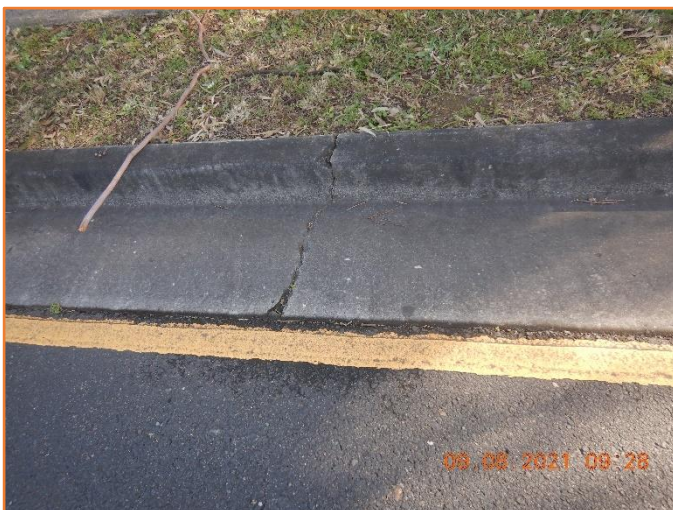
Figure 254: Reasonable - General condition of kerb and gutter. Moderate cracking observed.

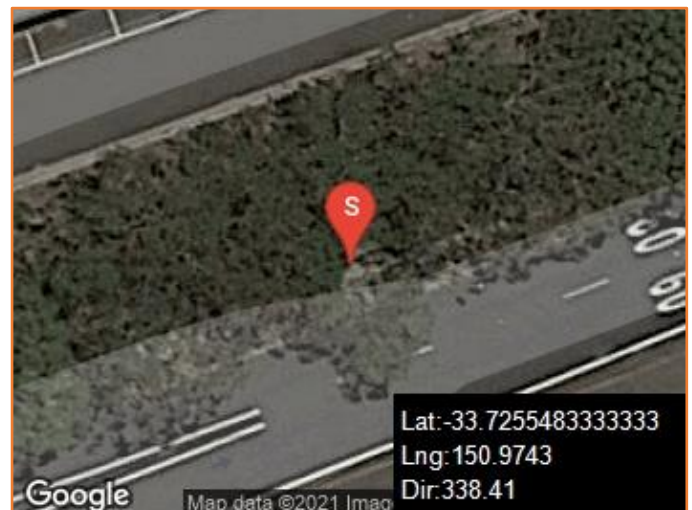
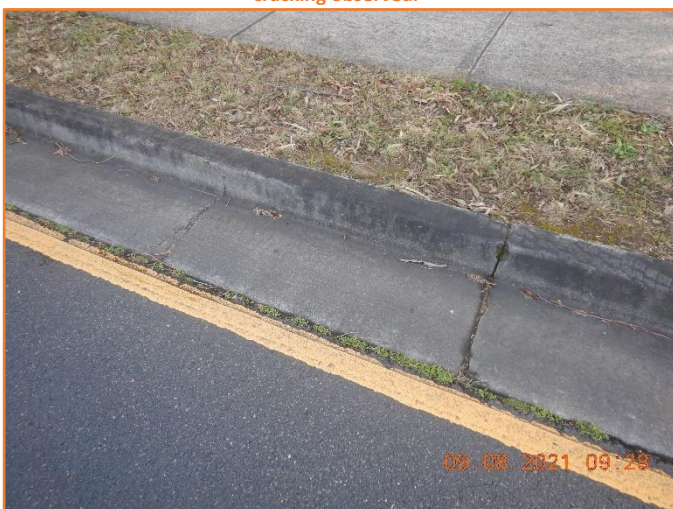
Figure 255: Reasonable - General condition of kerb and gutter. Minor hairline cracking observed.

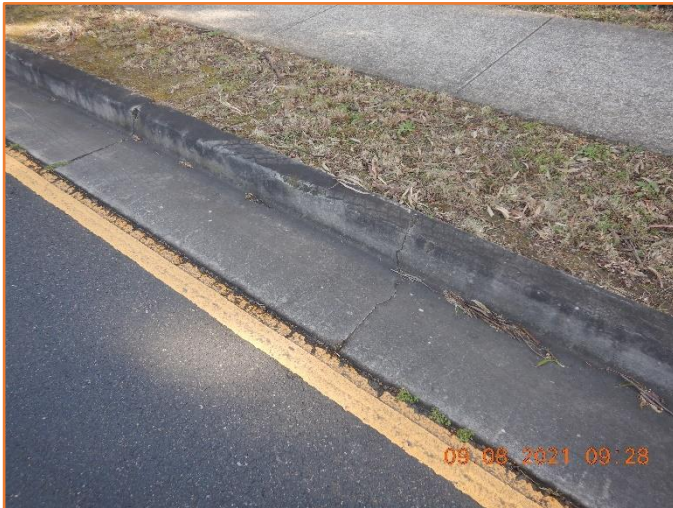
Figure 256: Reasonable - General condition of kerb and gutter. Minor hairline cracking observed.

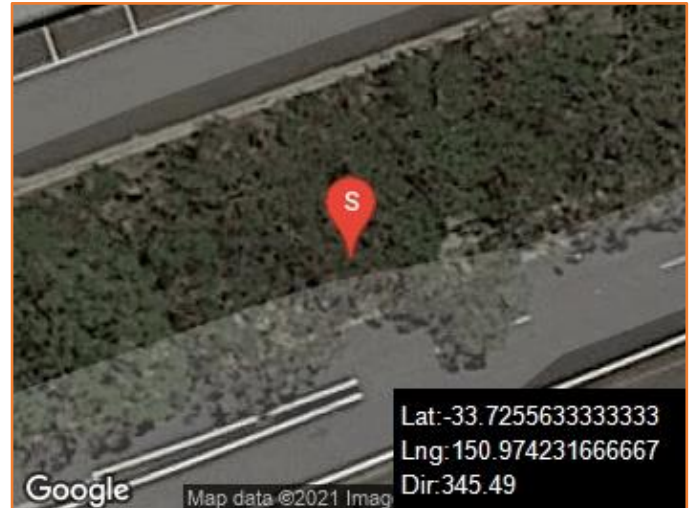
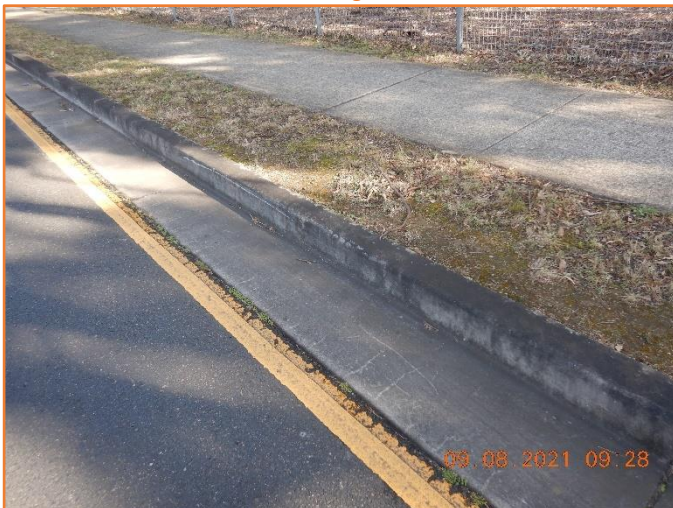
Figure 257: Reasonable - General condition of kerb and gutter. Minor hairline cracking observed.
