## DILAPIDATION REPORT

MUSEUM DISCOVERY CENTRE

MONDAY, 9 AUGUST 2021

Document Information	
Job Number	210722
Document Number	3
Report Title	Dilapidation Report
Site Address	172 Showground Road and 2 Green Road Castle Hill, NSW, 2154
Lot	1 in DP1066281 & 102 in DP1130271

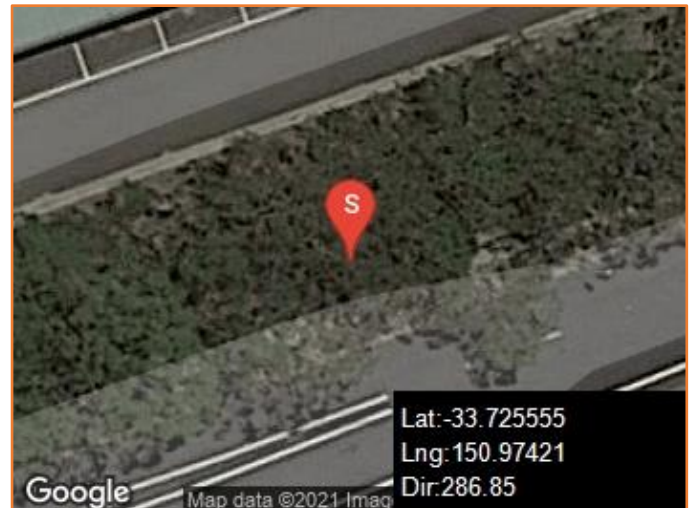
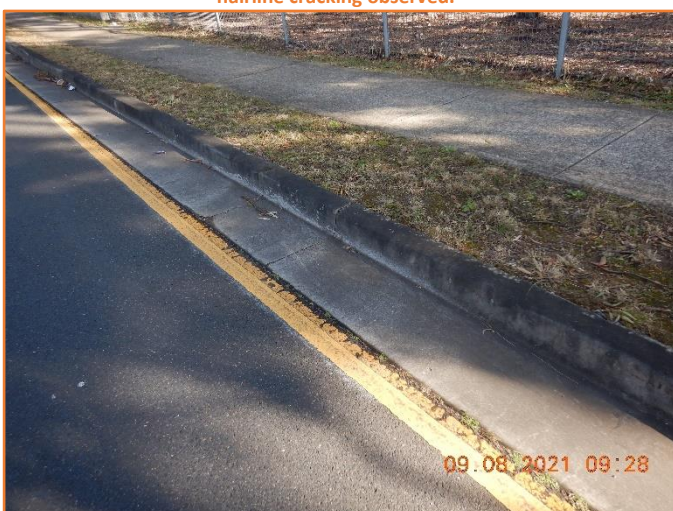
Figure 258: Reasonable - General condition of kerb and gutter.

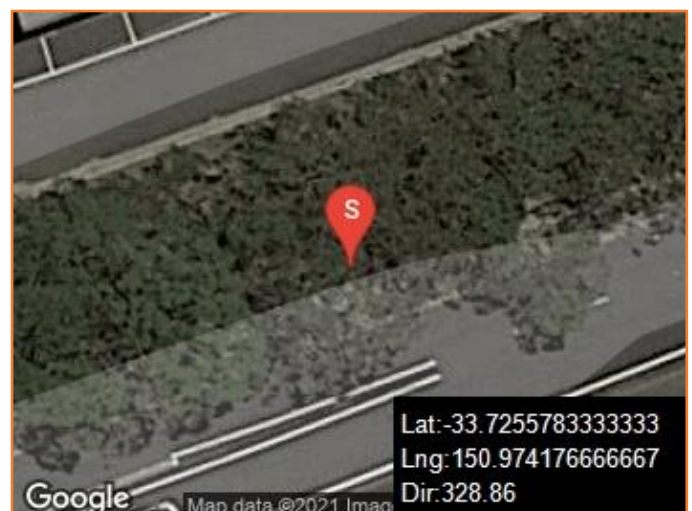
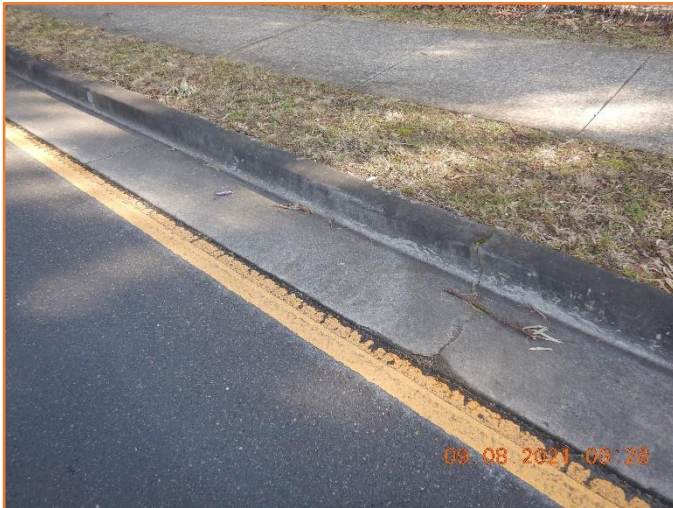
Figure 259: Reasonable - General condition of kerb and gutter. Moderate hairline cracking observed.

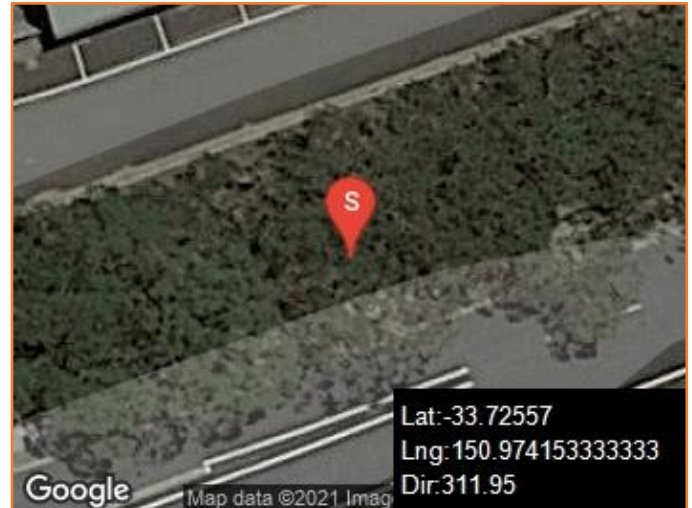
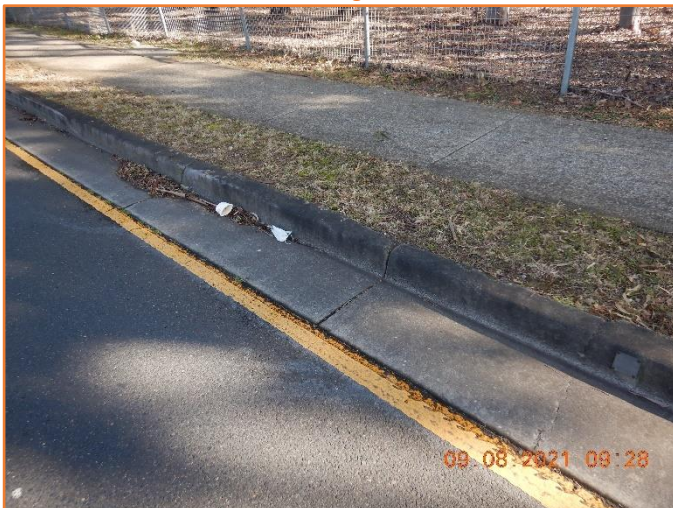
Figure 260: Reasonable - General condition of kerb and gutter. Minor hairline cracking observed.

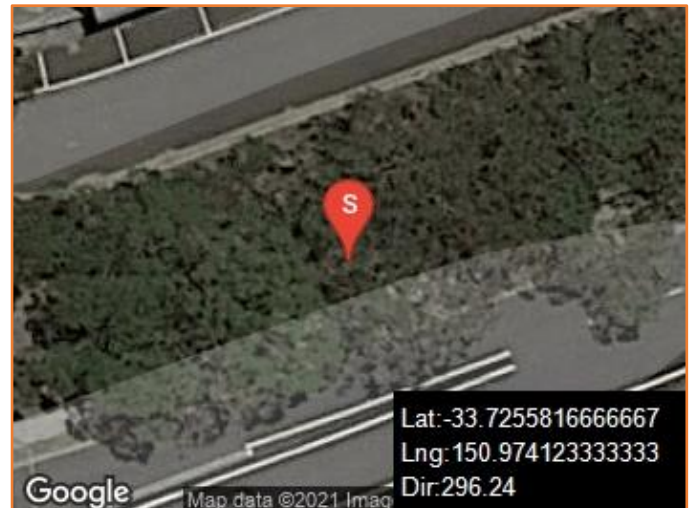
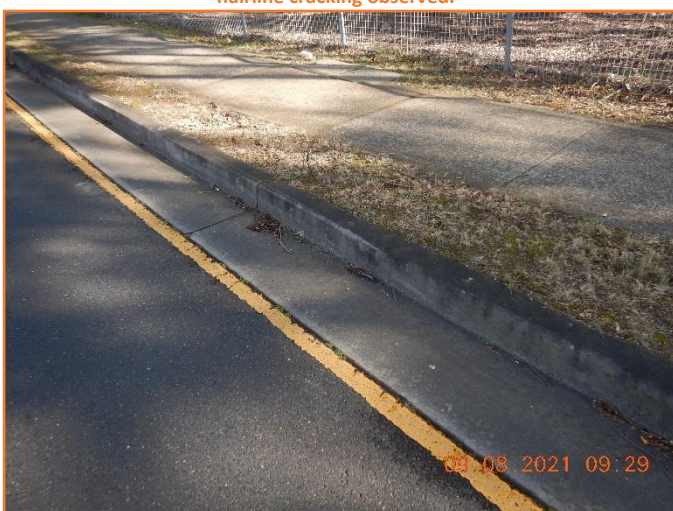
Figure 261: Reasonable - General condition of kerb and gutter.

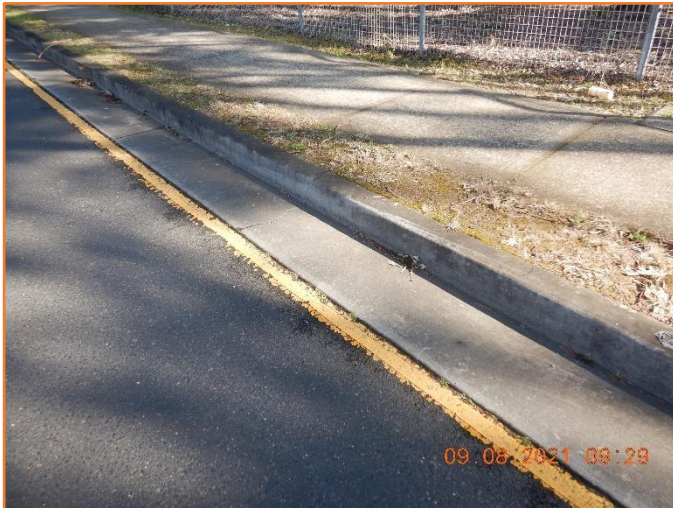
Figure 262: Reasonable - General condition of kerb and gutter.

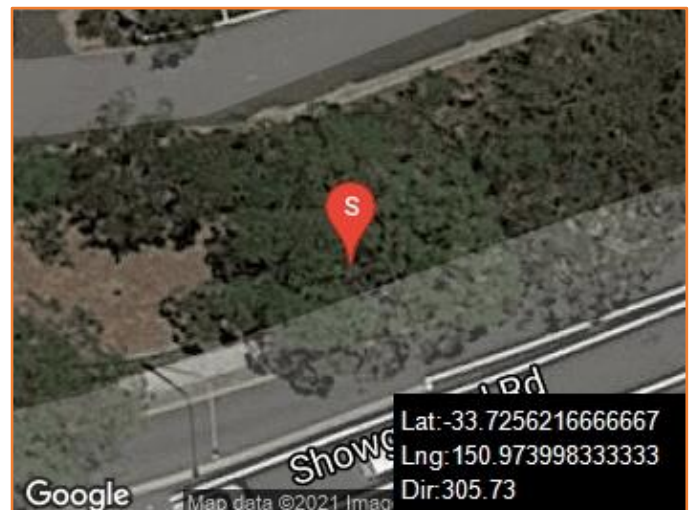
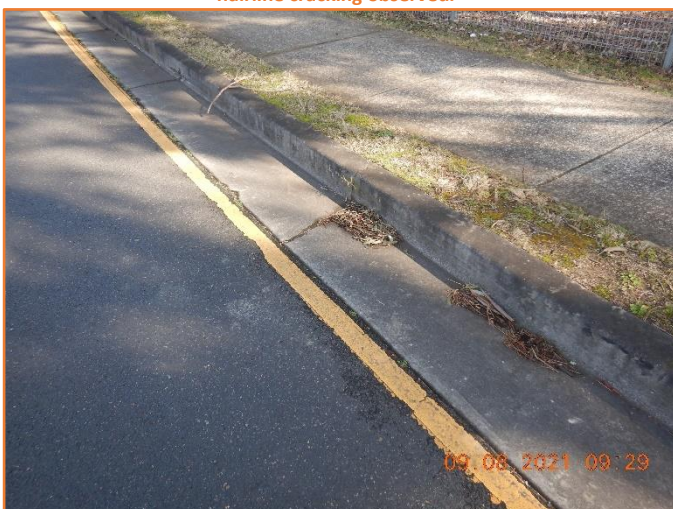
Figure 263: Reasonable - General condition of kerb and gutter. Moderate hairline cracking observed.

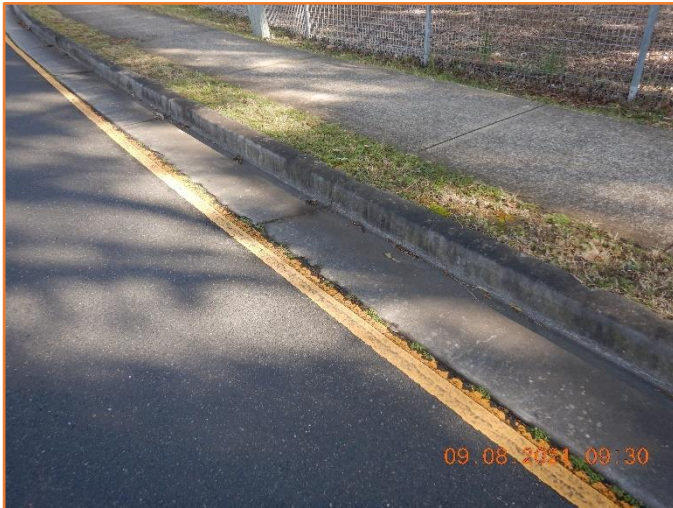
Figure 264: Reasonable - General condition of kerb and gutter. Minor hairline cracking observed.

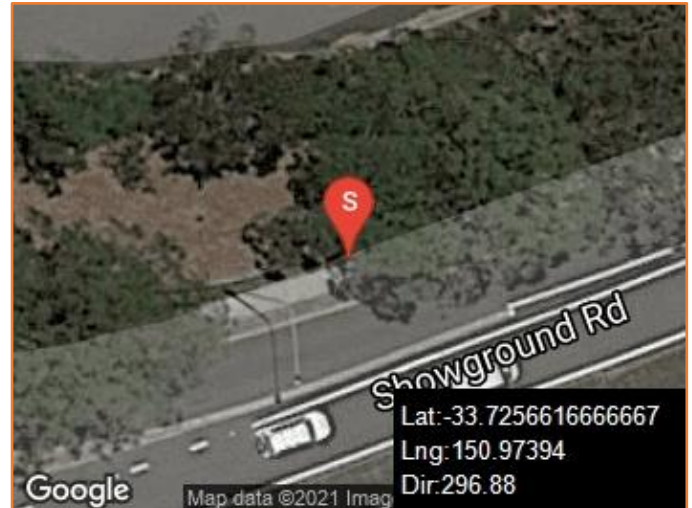
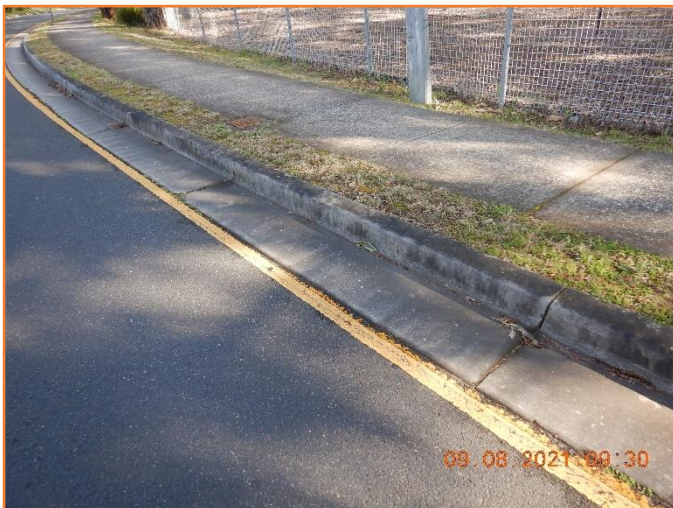
Figure 265: Reasonable - General condition of kerb and gutter.

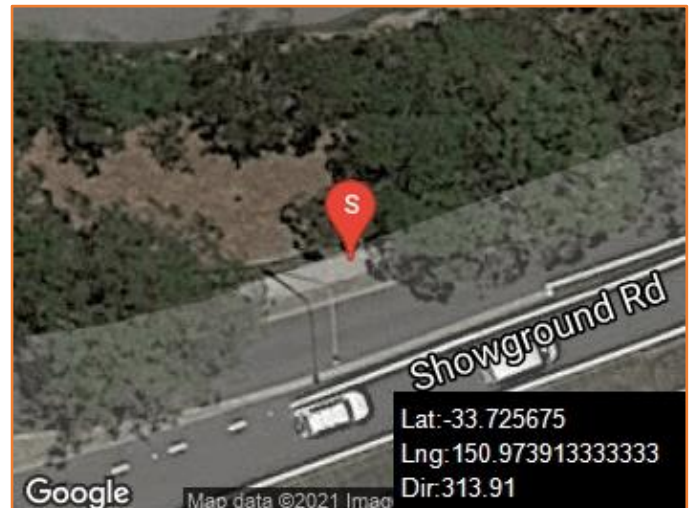
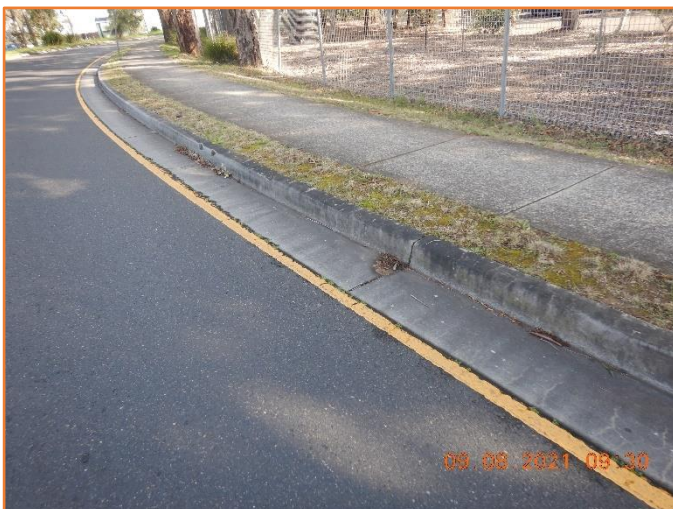
Figure 266: Reasonable - General condition of kerb and gutter.

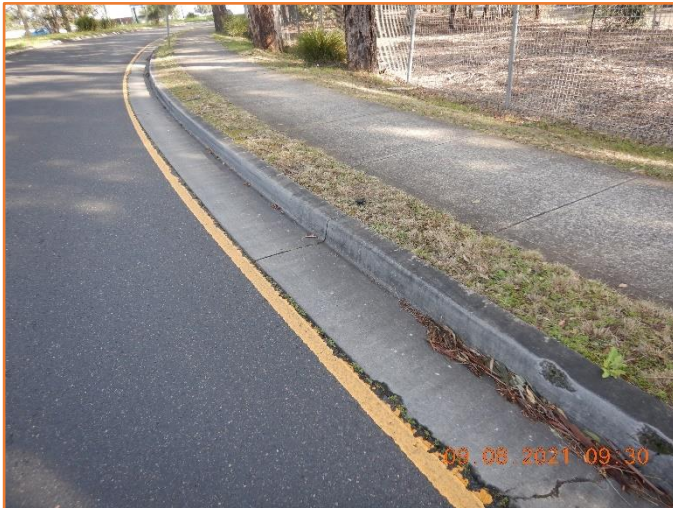
Figure 267: Reasonable - General condition of kerb and gutter.

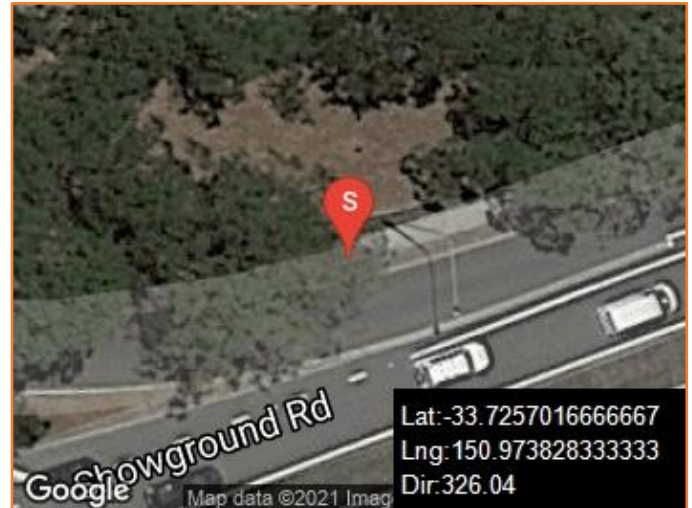
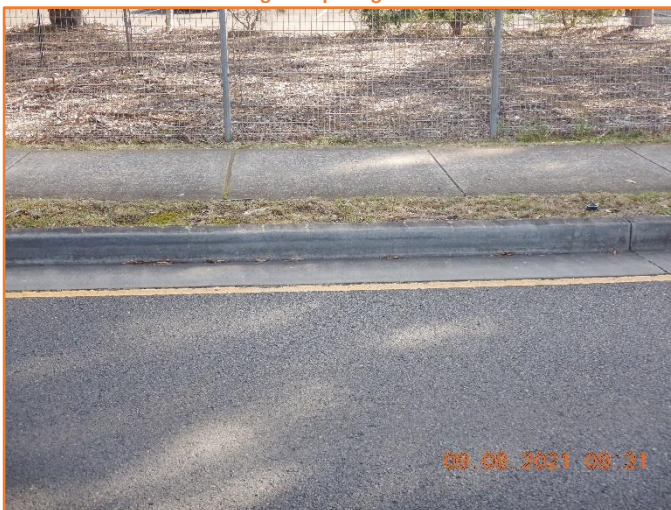
Figure 268: Reasonable - General condition of kerb and gutter. Moderate cracking and spalling observed.

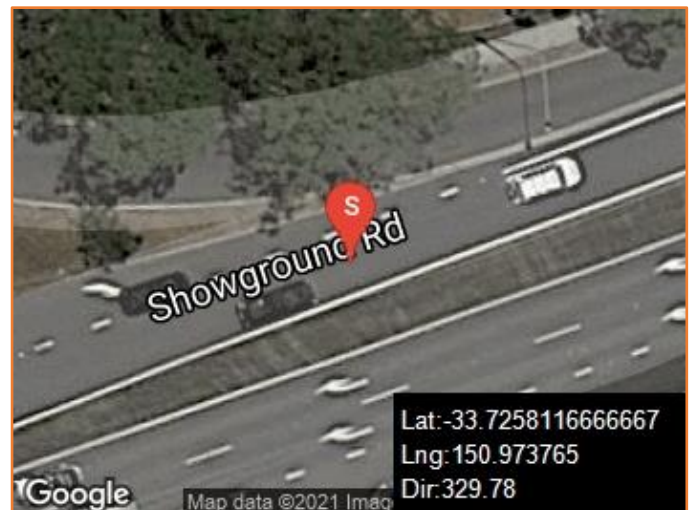
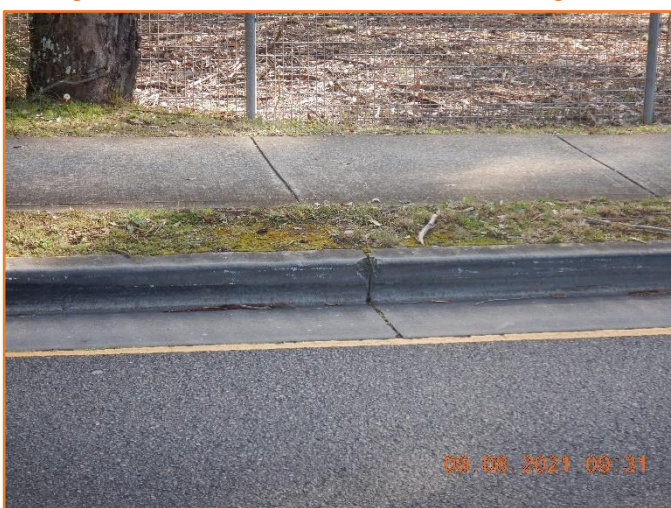
Figure 269: Reasonable - General condition of kerb and gutter.

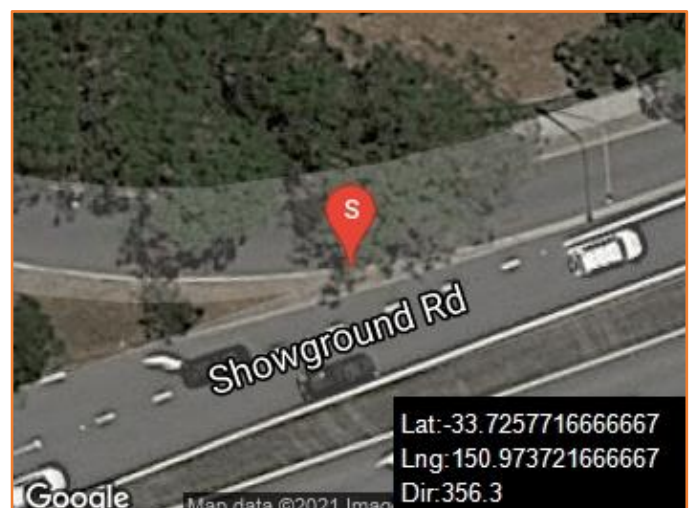
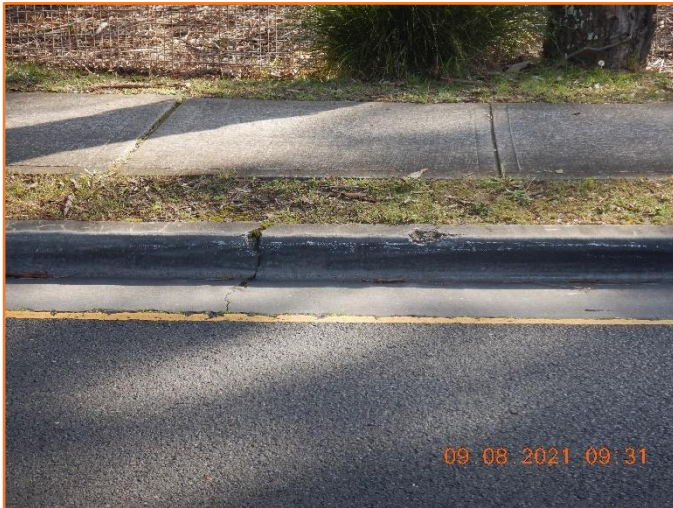
Figure 270: Reasonable - General condition of kerb and gutter. Moderate spalling observed.

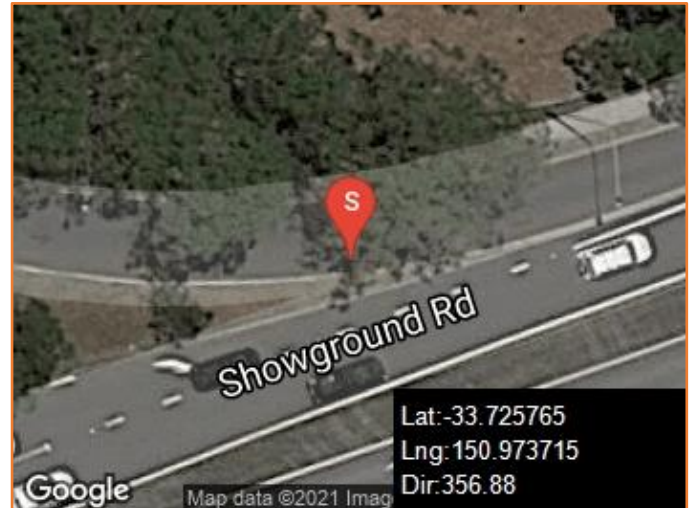
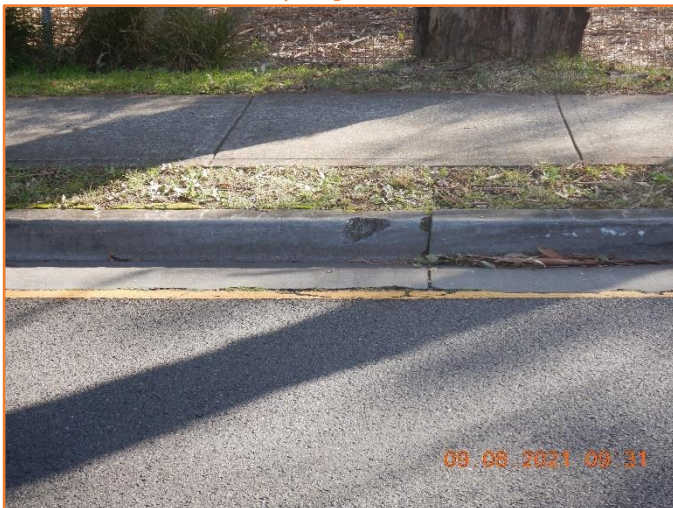
Figure 271: Poor - General condition of kerb and gutter. Moderate cracking and spalling observed.

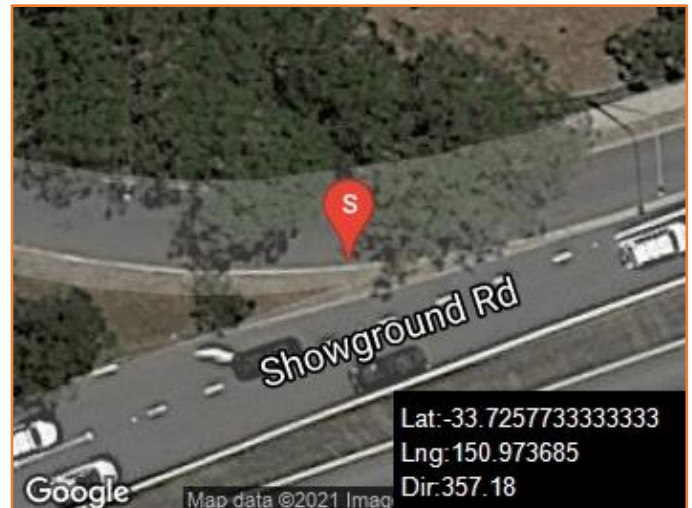
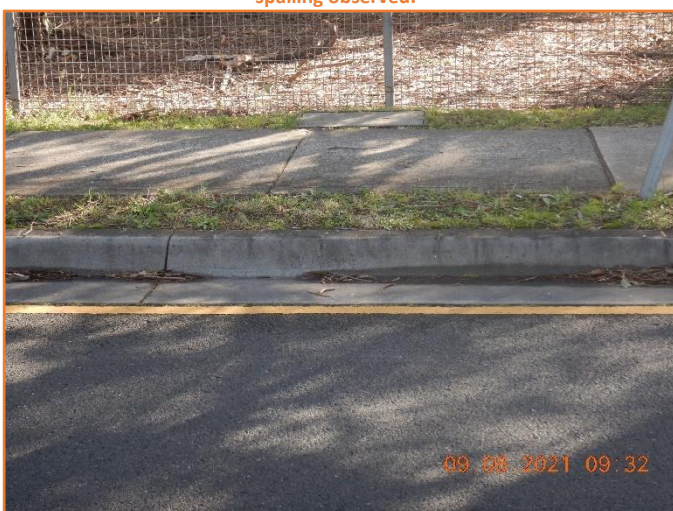
Figure 272: Reasonable - General condition of kerb and gutter. Moderate spalling observed.

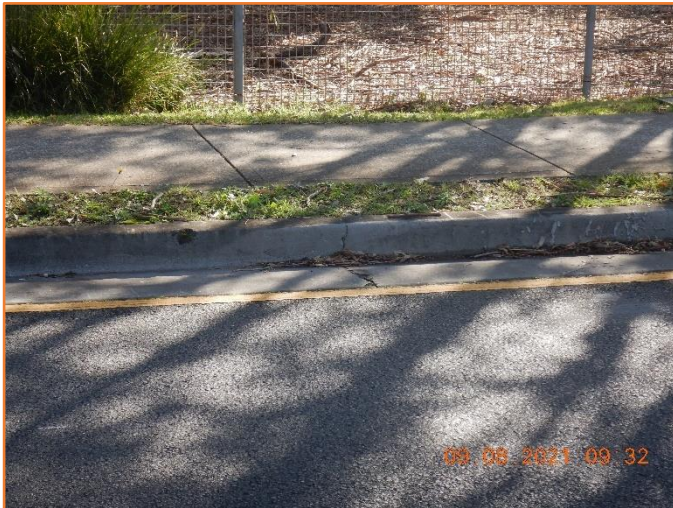
Figure 273: Reasonable - General condition of kerb and gutter.

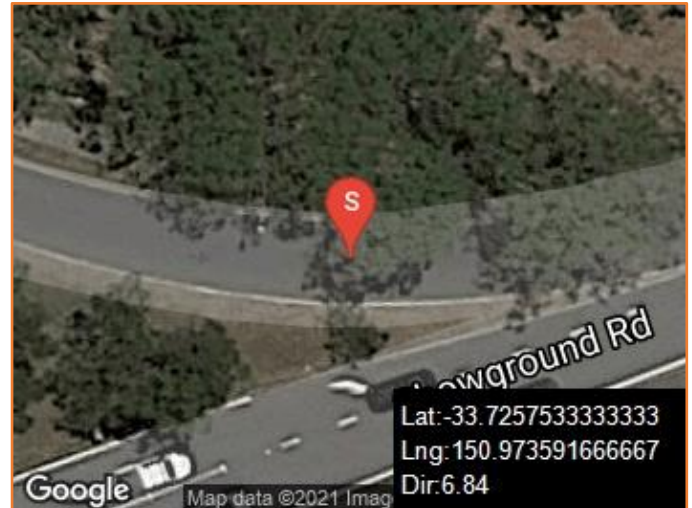
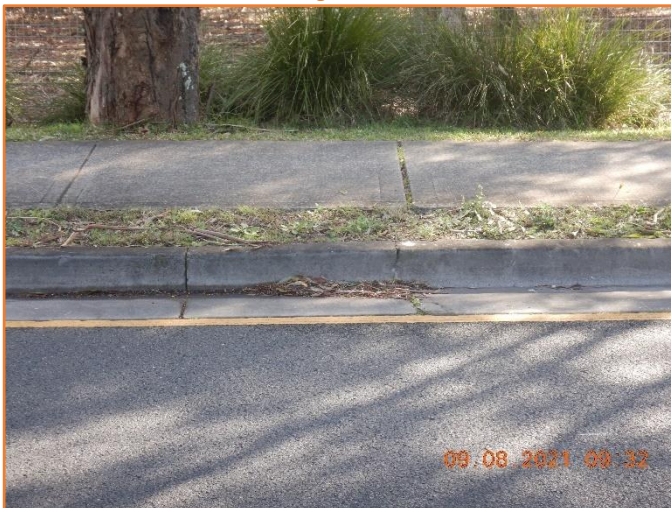
Figure 274: Reasonable - General condition of kerb and gutter. Moderate cracking observed.

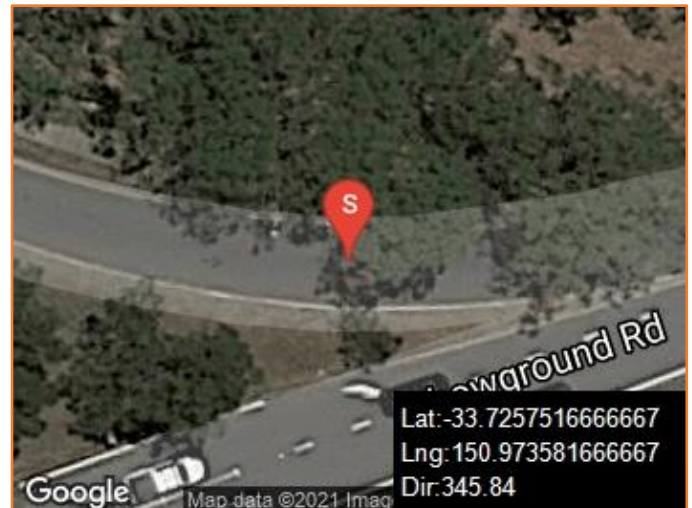
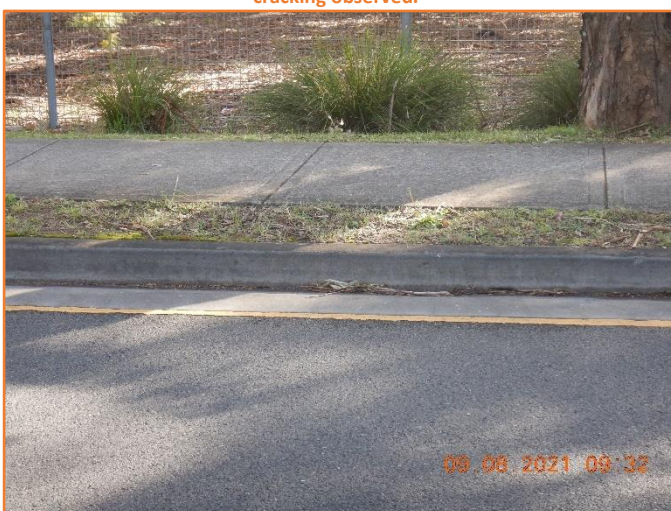
Figure 275: Reasonable - General condition of kerb and gutter. Moderate cracking observed.

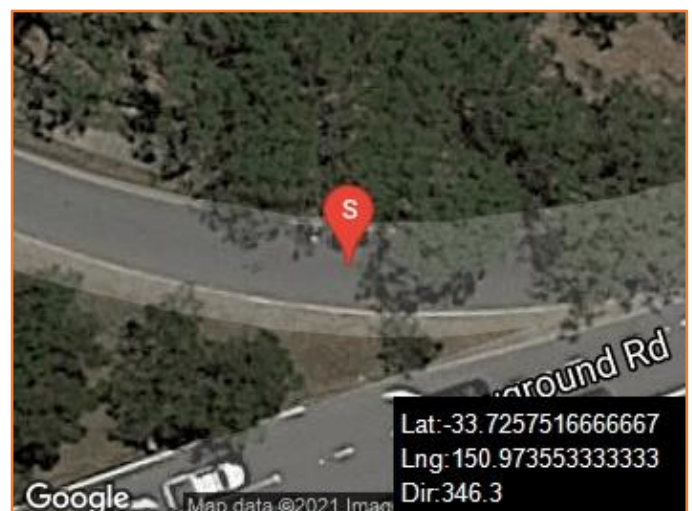
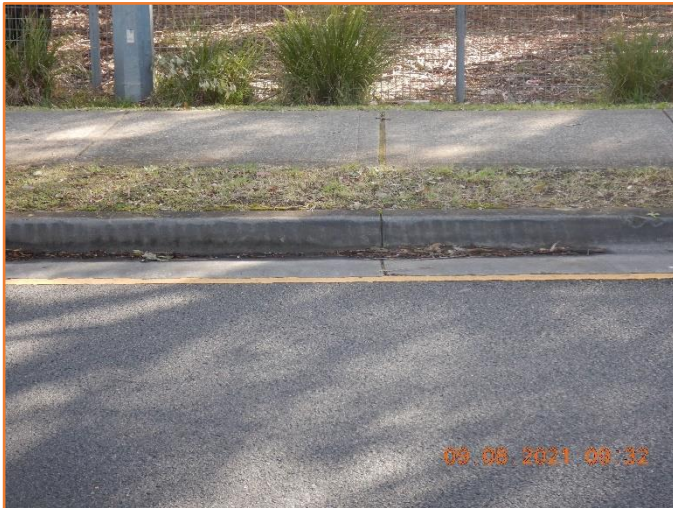
Figure 276: Reasonable - General condition of kerb and gutter.

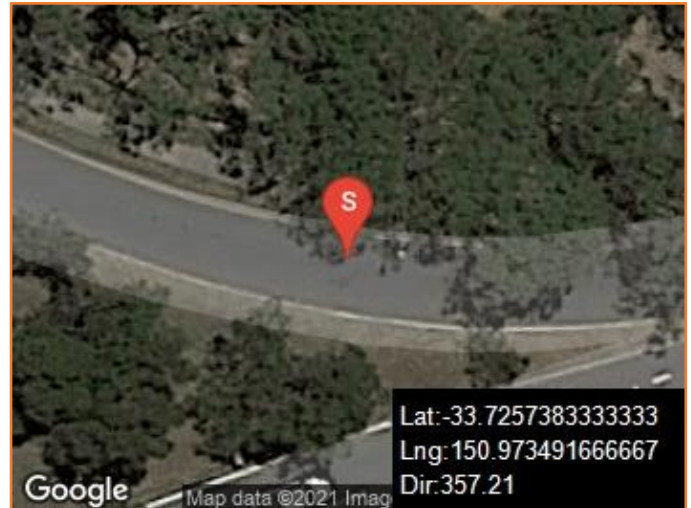
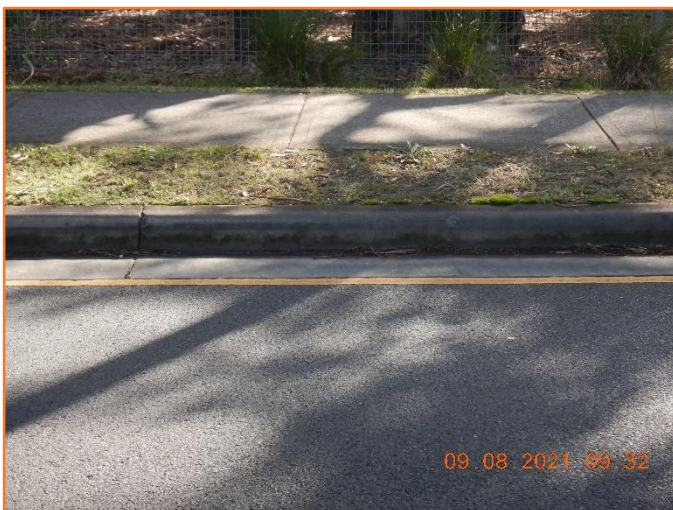
Figure 277: Reasonable - General condition of kerb and gutter.

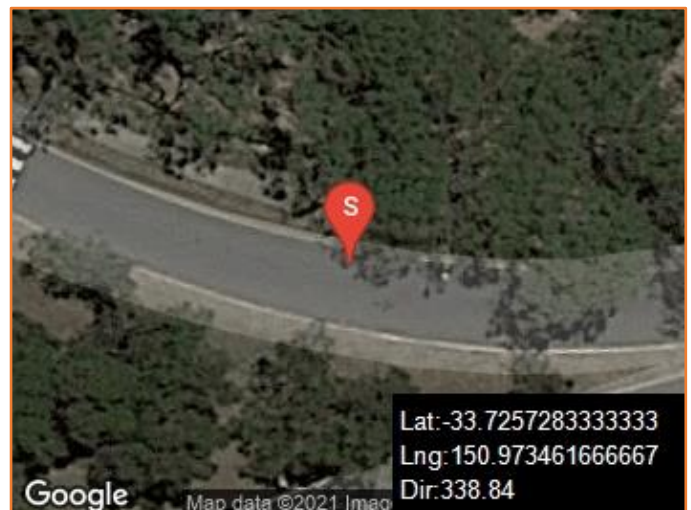
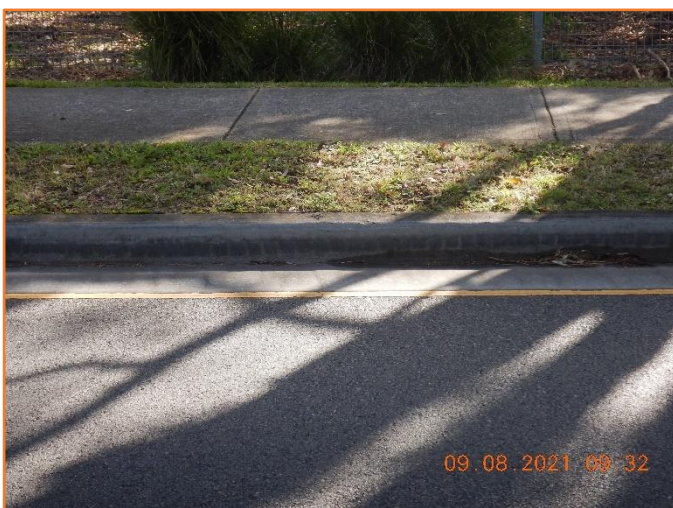
Figure 278: Reasonable - General condition of kerb and gutter.

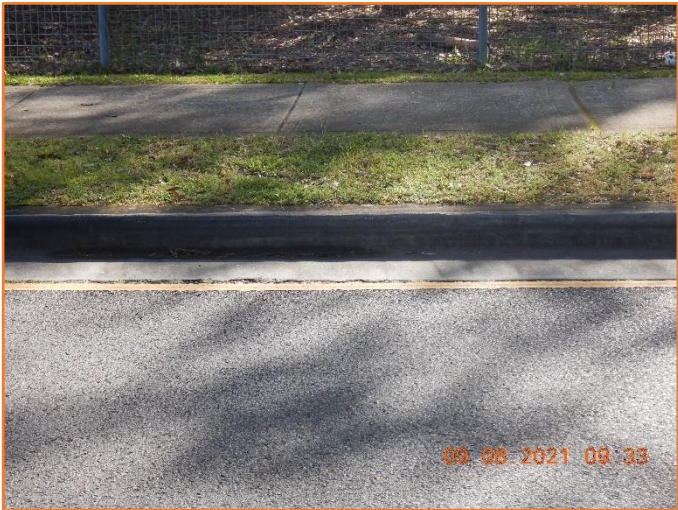
Figure 279: Reasonable - General condition of kerb and gutter.

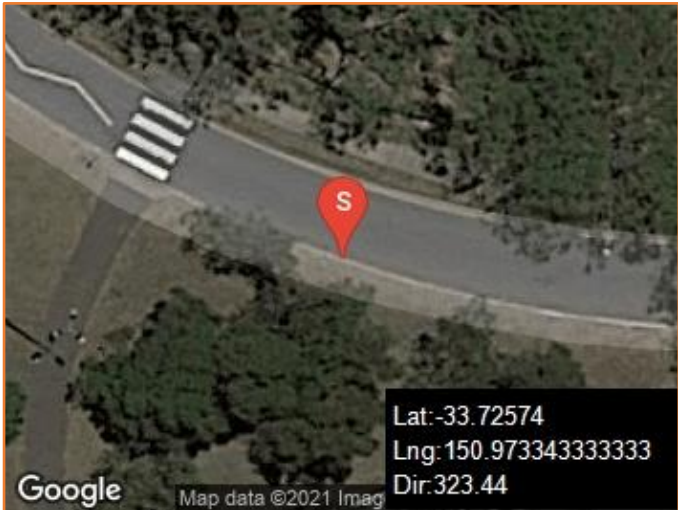
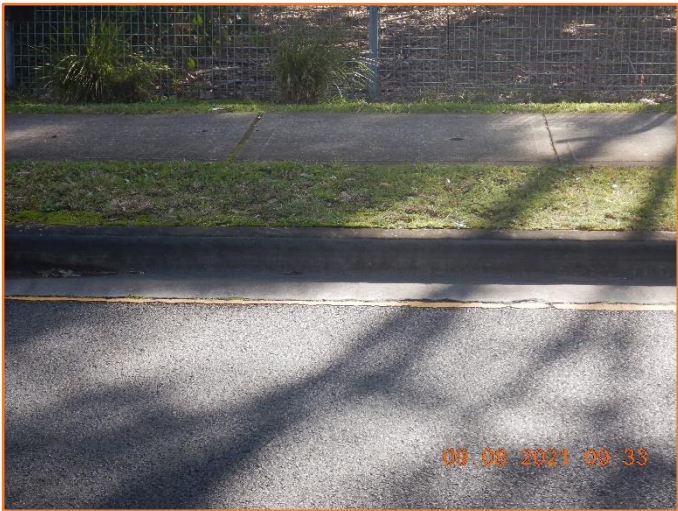
Figure 280: Reasonable - General condition of kerb and gutter.

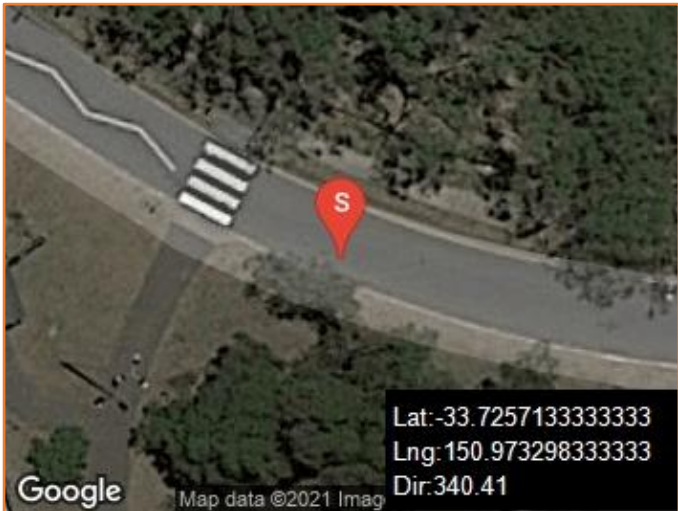
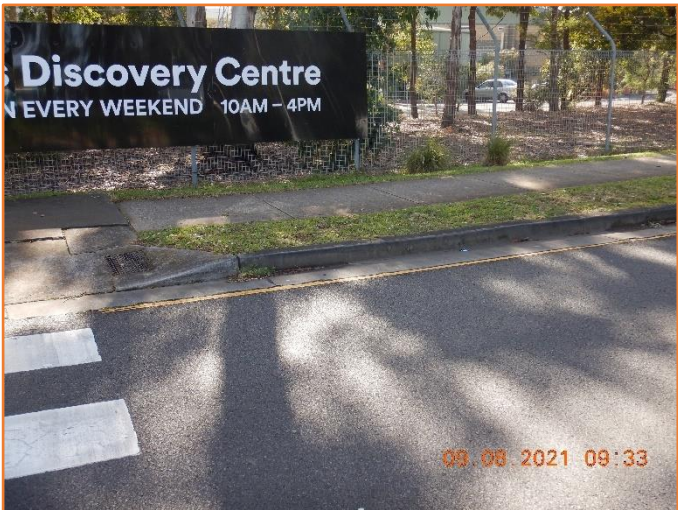
Figure 281: Reasonable - General condition of kerb and gutter.

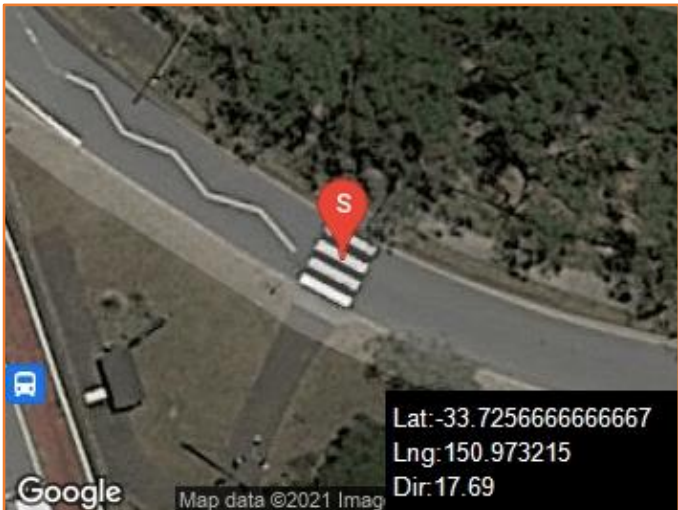
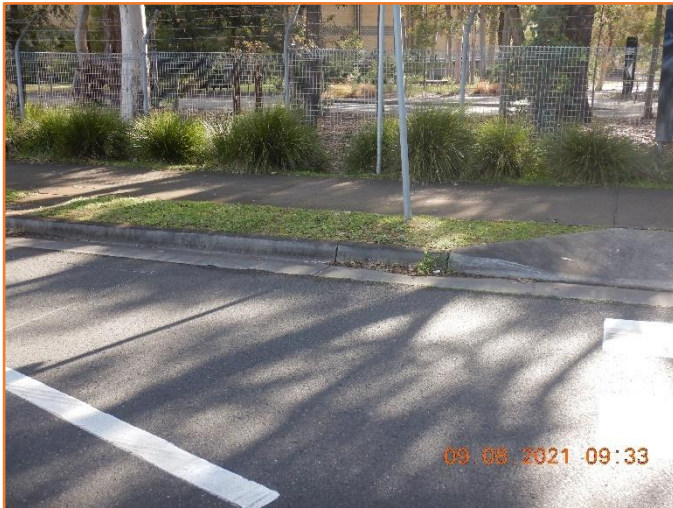
Figure 283: Reasonable - General condition of kerb and gutter and footpath splay.

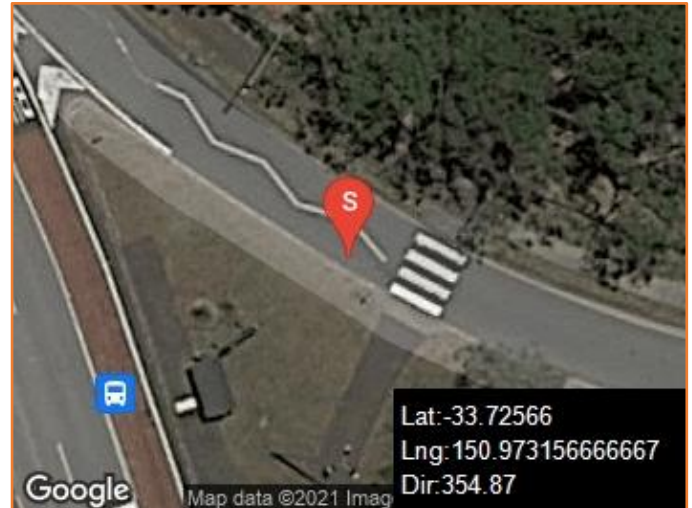
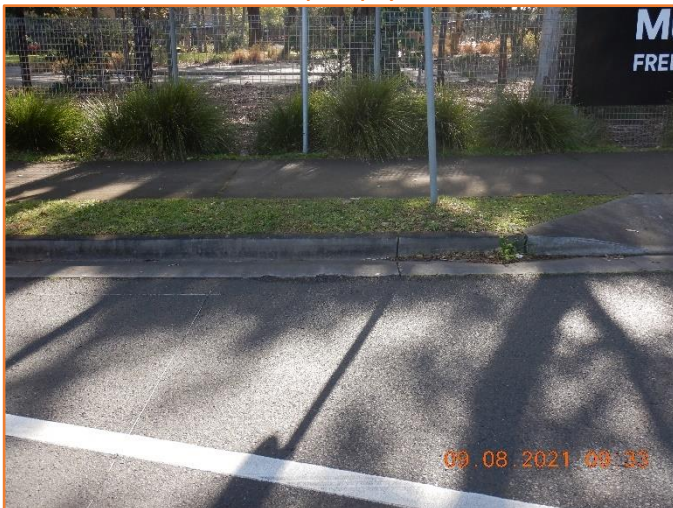
Figure 284: Reasonable - General condition of kerb and gutter and footpath splay.

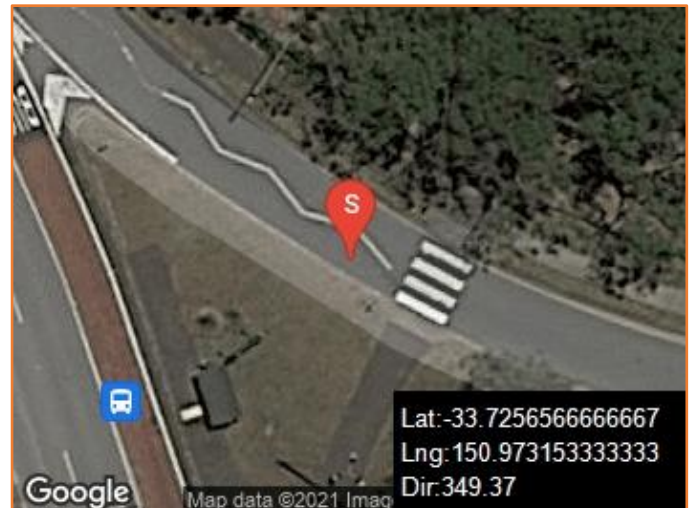
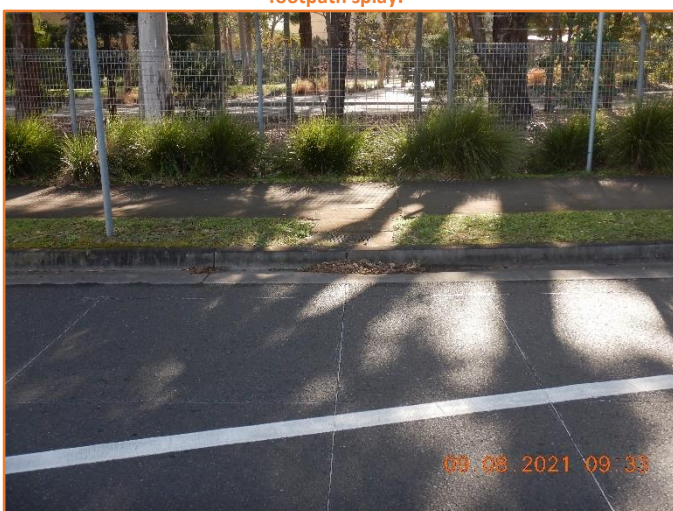
Figure 285: Reasonable - General condition of kerb and gutter.

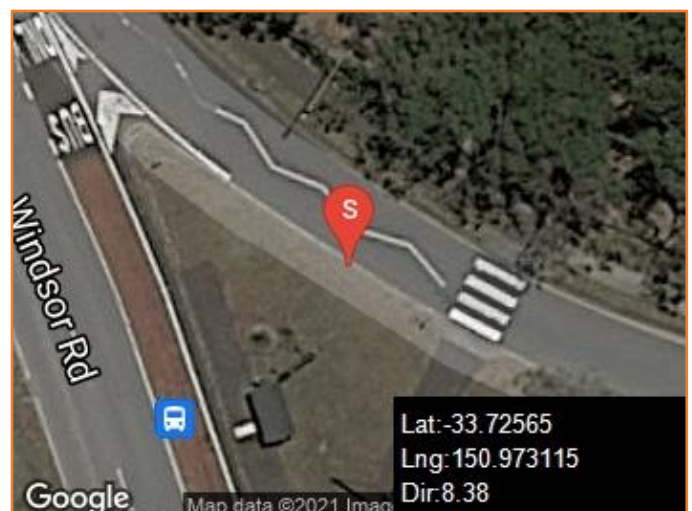
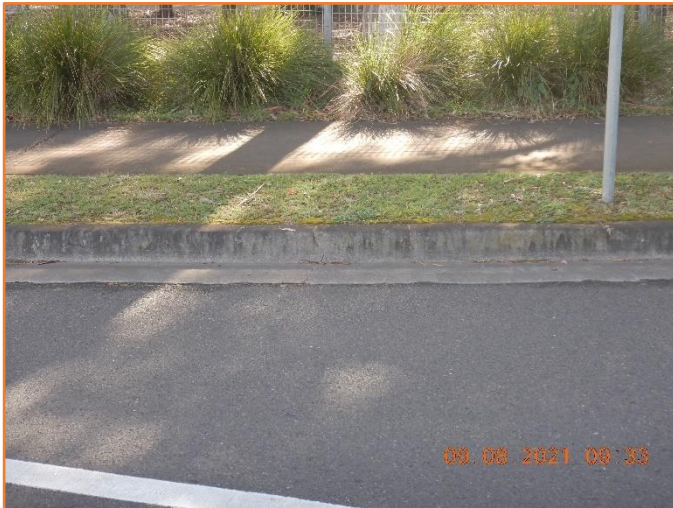
Figure 286: Reasonable - General condition of kerb and gutter. Minor hairline cracking observed.

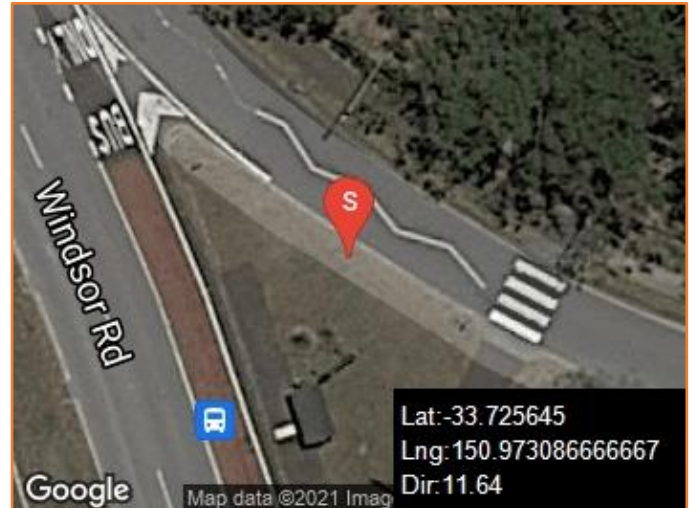
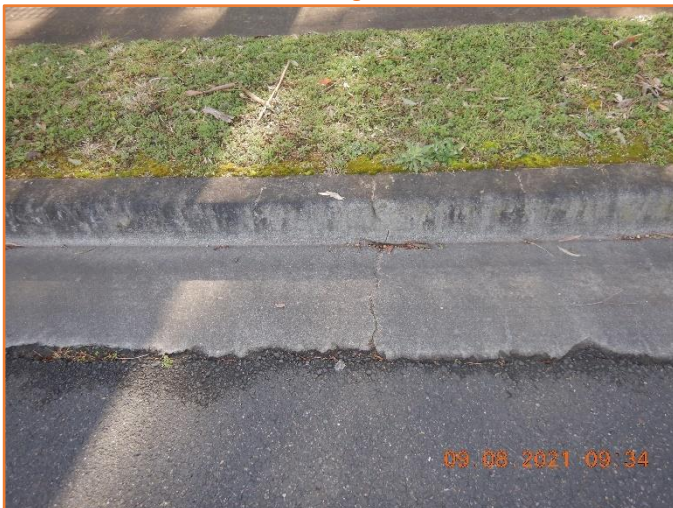
Figure 287: Reasonable - General condition of kerb and gutter. Minor hairline cracking observed.

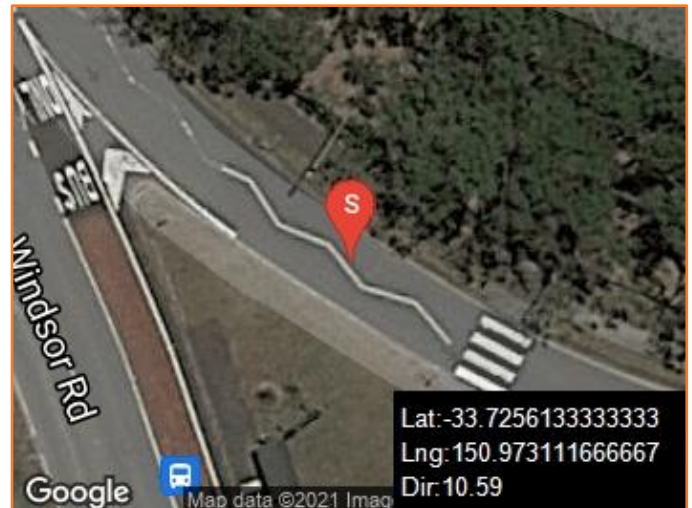
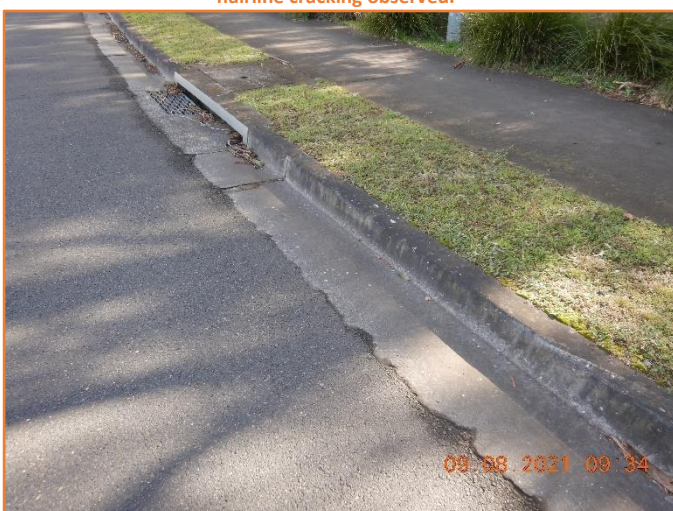
Figure 288: Reasonable - General condition of kerb and gutter.

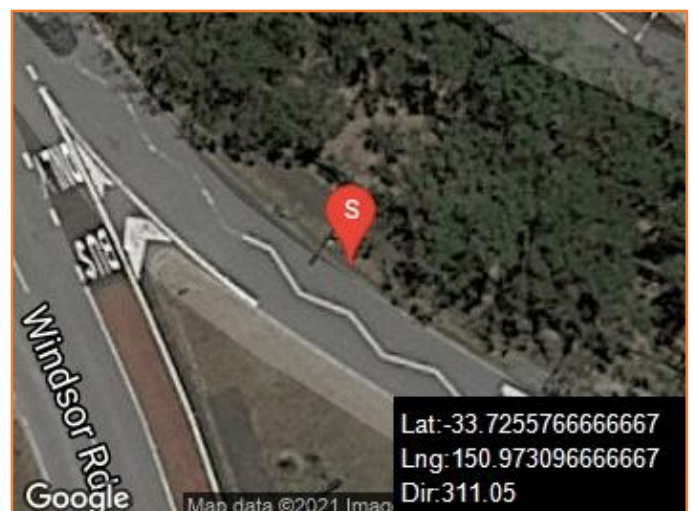
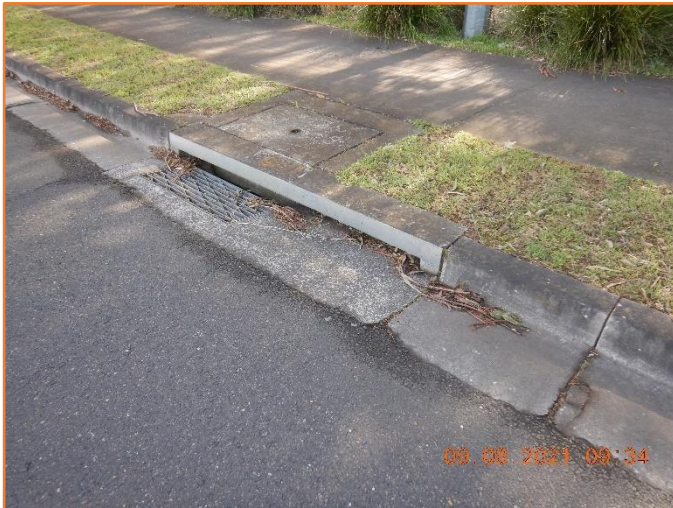
Figure 289: Reasonable - General condition of kerb inlet pit.

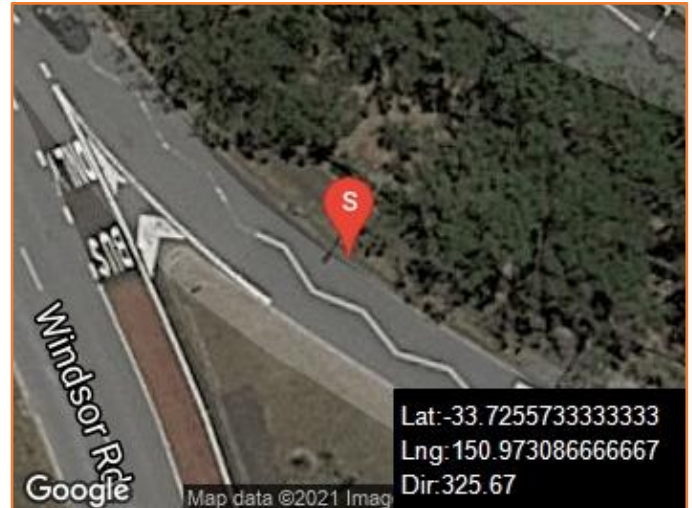
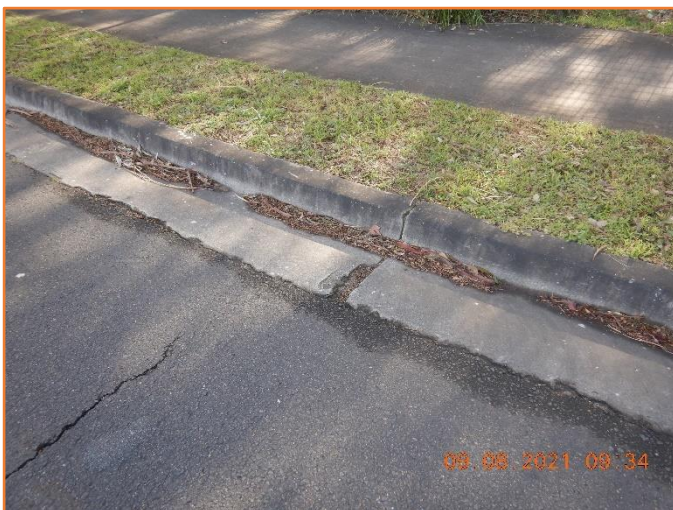
Figure 290: Reasonable - General condition of kerb and gutter. Moderate cracking and loss of material observed.

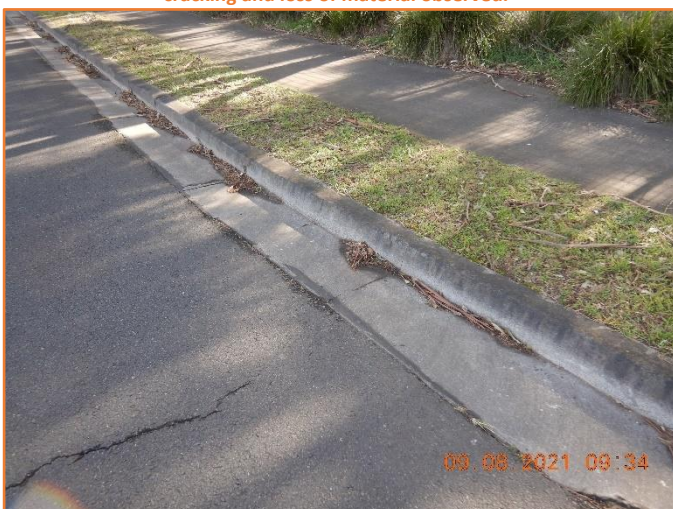
Figure 291: Reasonable - General condition of kerb and gutter.

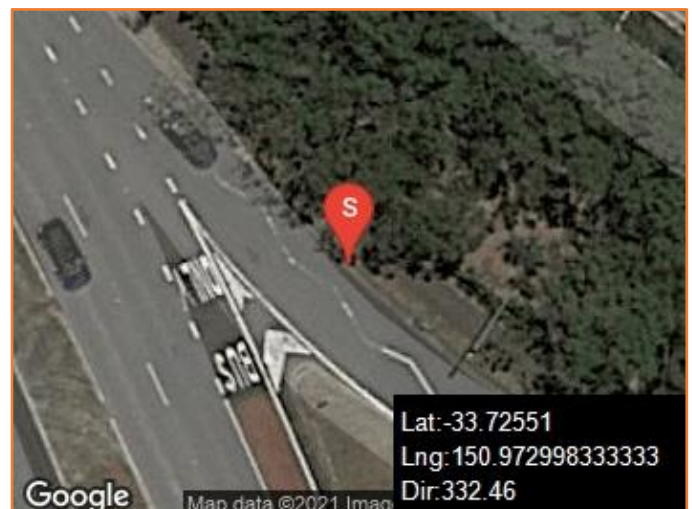
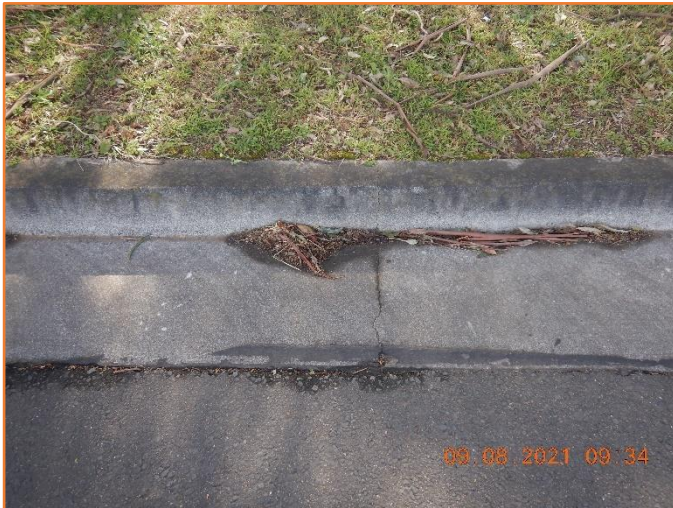
Figure 292: Reasonable - General condition of kerb and gutter. Minor hairline cracking observed.

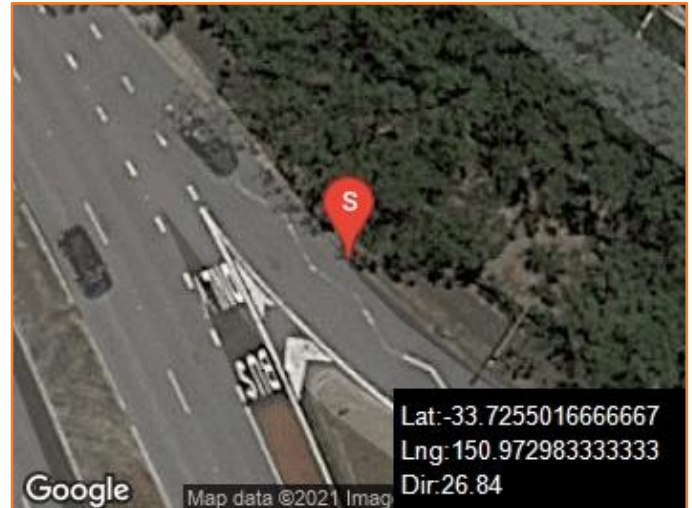
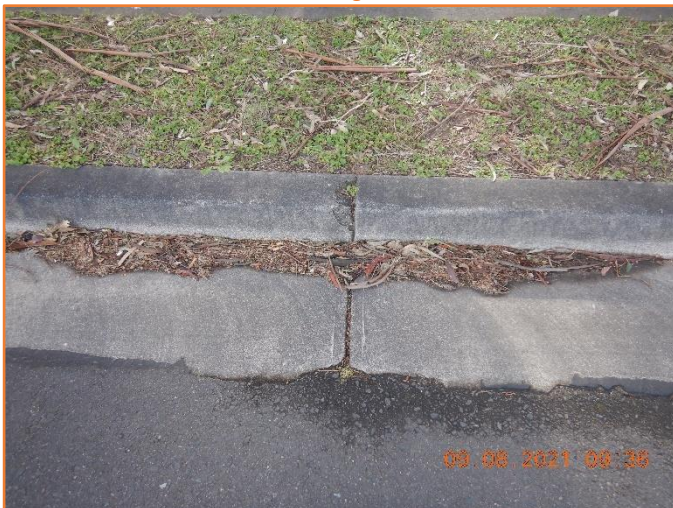
Figure 293: Reasonable - General condition of kerb and gutter. Minor loss of material observed.
