## DILAPIDATION REPORT

MUSEUM DISCOVERY CENTRE

MONDAY, 9 AUGUST 2021

Document Information	
Job Number	210722
Document Number	3
Report Title	Dilapidation Report
Site Address	172 Showground Road and 2 Green Road Castle Hill, NSW, 2154
Lot	1 in DP1066281 & 102 in DP1130271

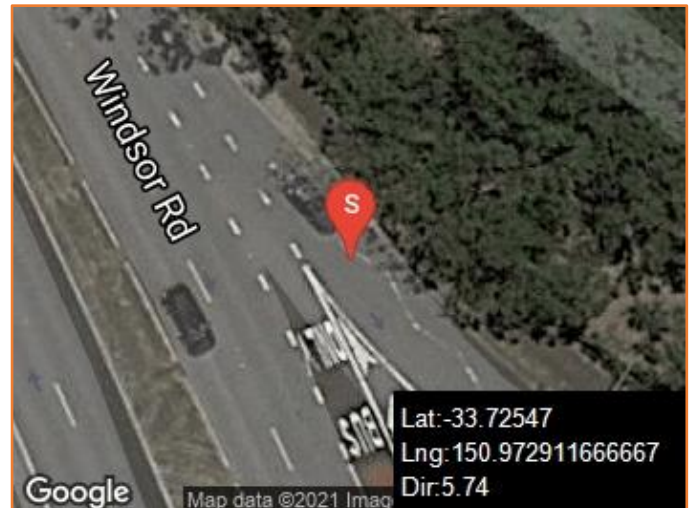
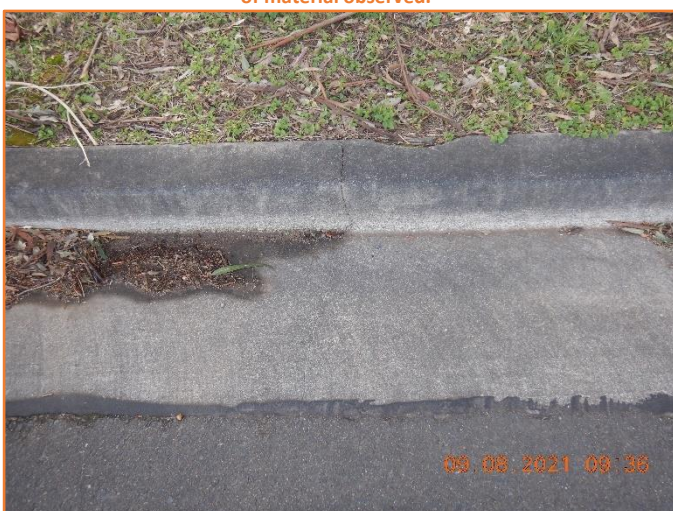
Figure 294: Reasonable - General condition of kerb and gutter. Minor hairline cracking observed.

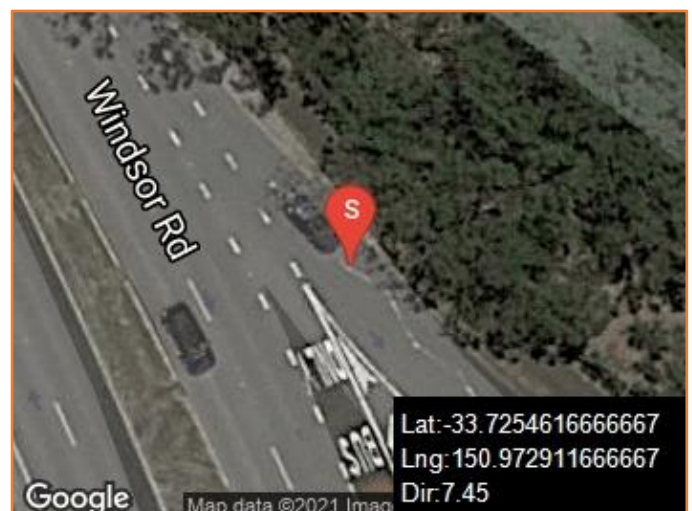
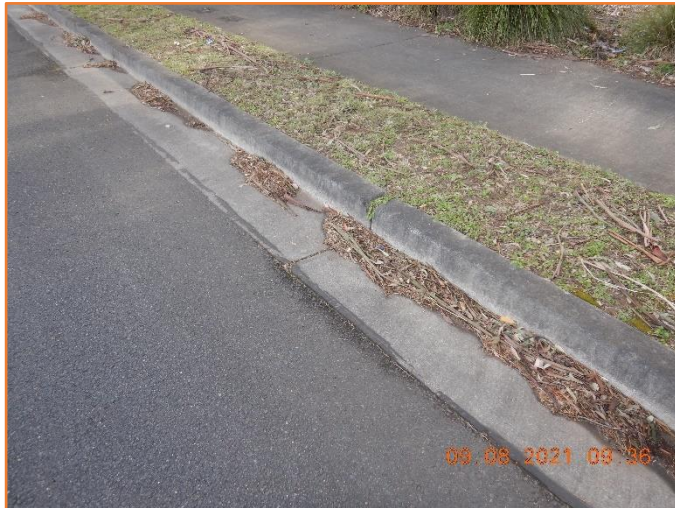
Figure 295: Reasonable - General condition of kerb and gutter.

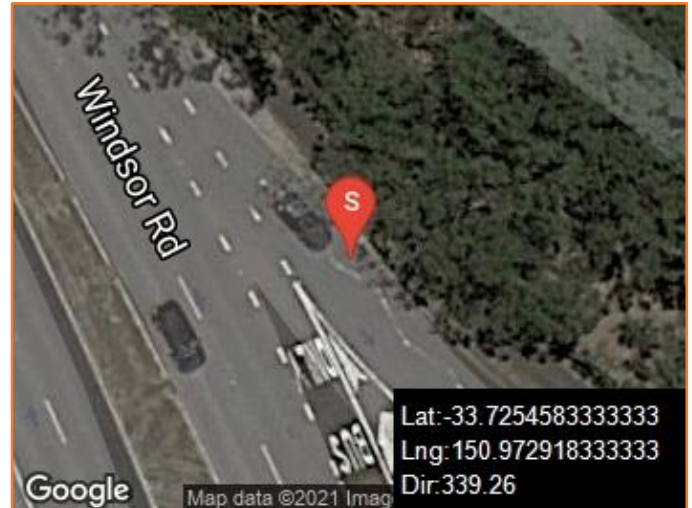
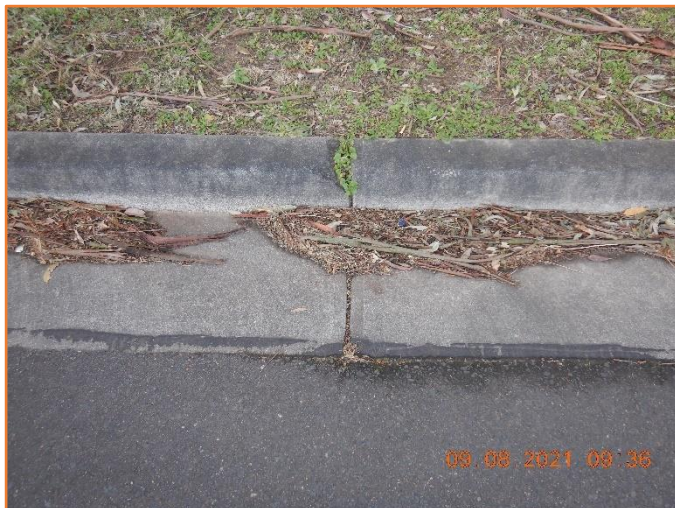
Figure 296: Reasonable - General condition of kerb and gutter. Minor loss of material observed.

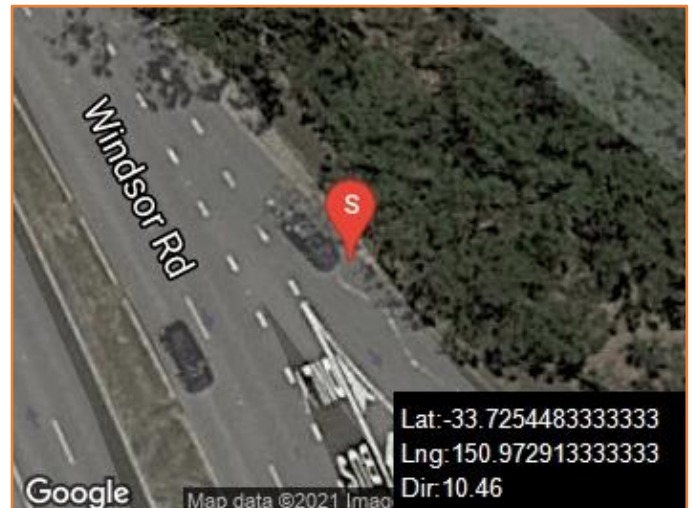
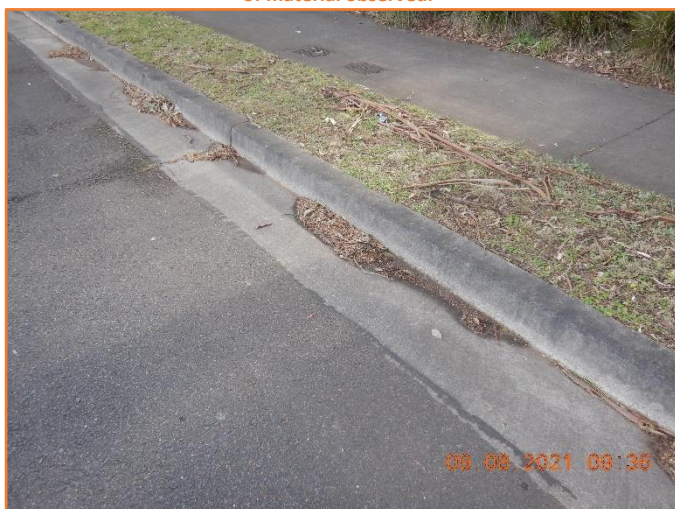
Figure 297: Reasonable - General condition of kerb and gutter.

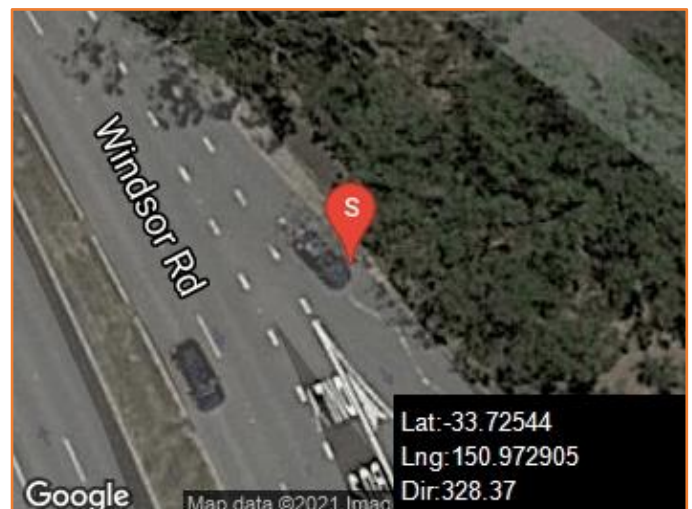
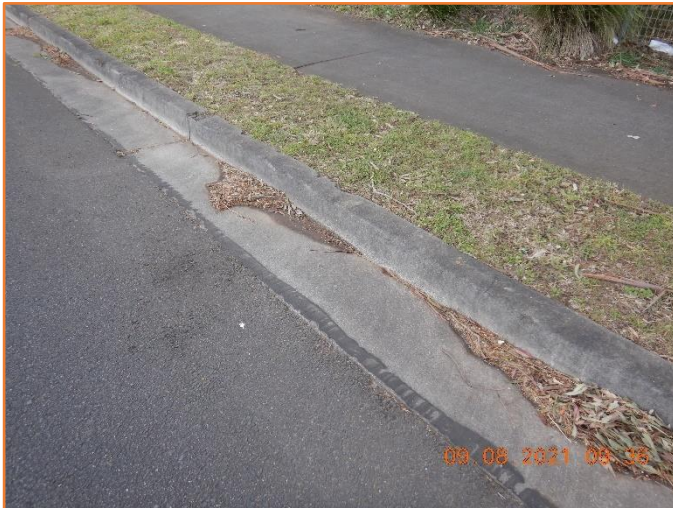
Figure 298: Reasonable - General condition of kerb and gutter.

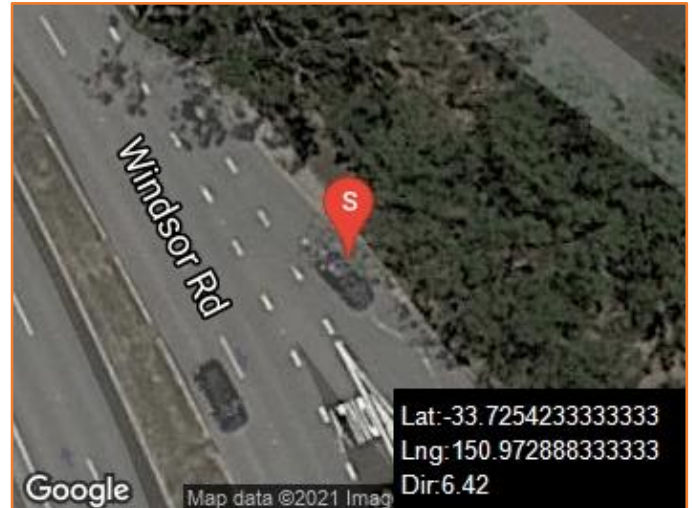
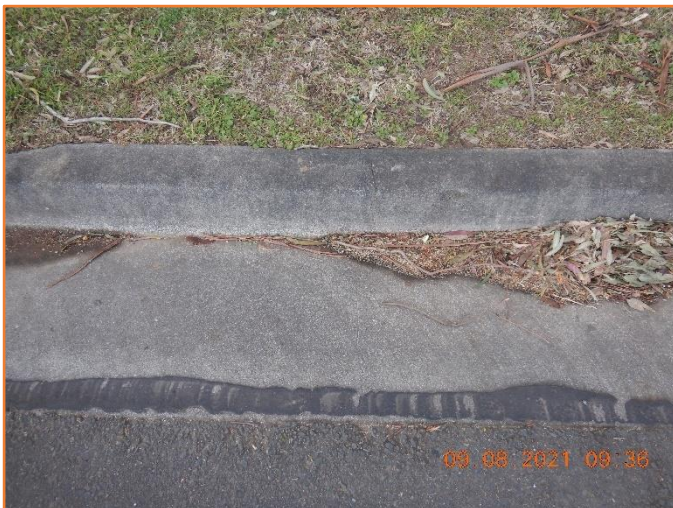
Figure 299: Reasonable - General condition of kerb and gutter. Minor hairline cracking observed.

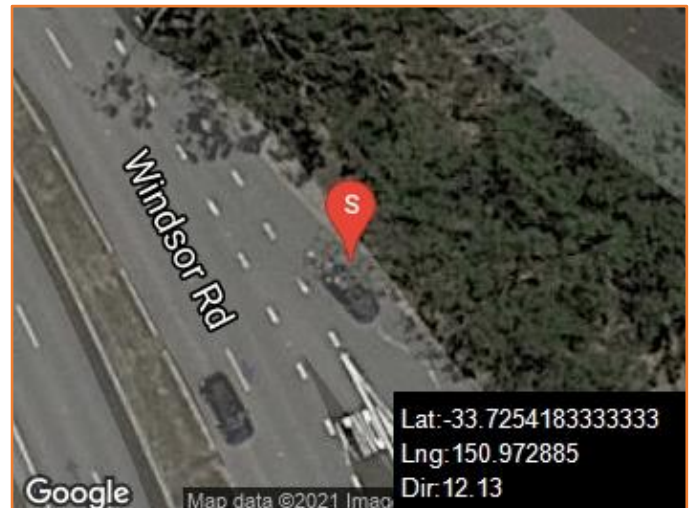
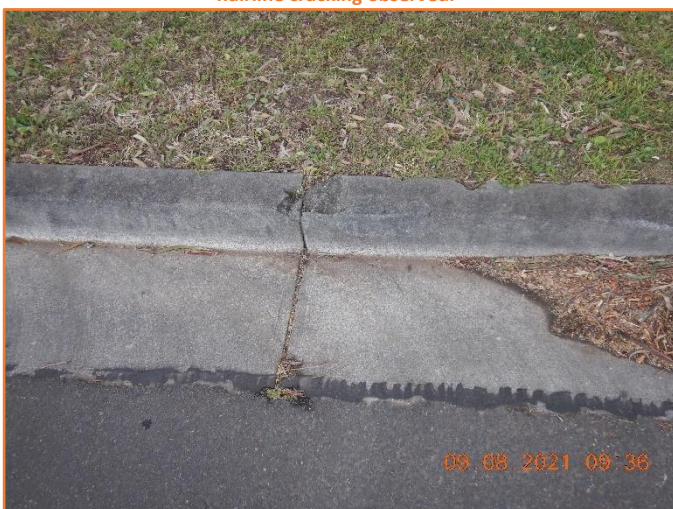
Figure 300: Reasonable - General condition of kerb and gutter. Moderate spalling observed.

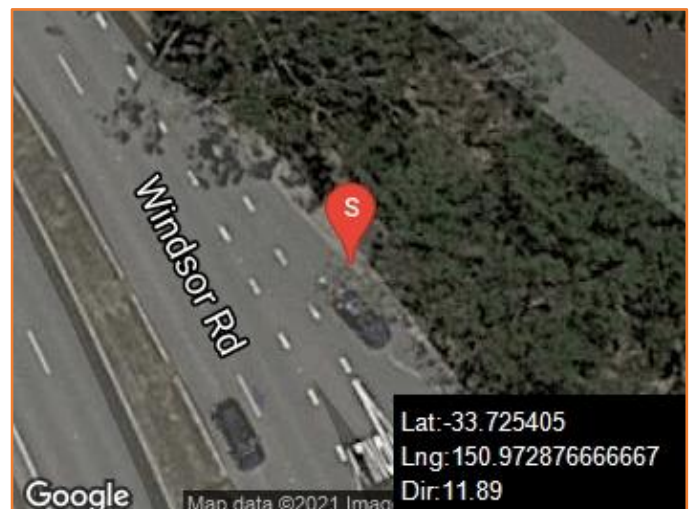
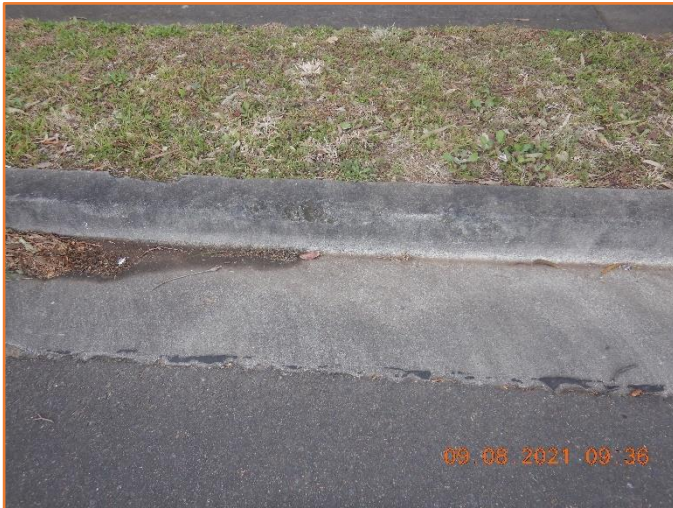
Figure 301: Reasonable - General condition of kerb and gutter. Minor spalling observed.

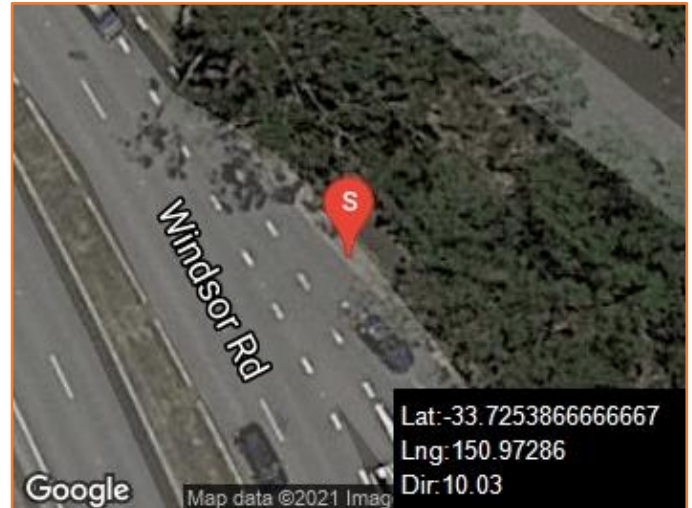
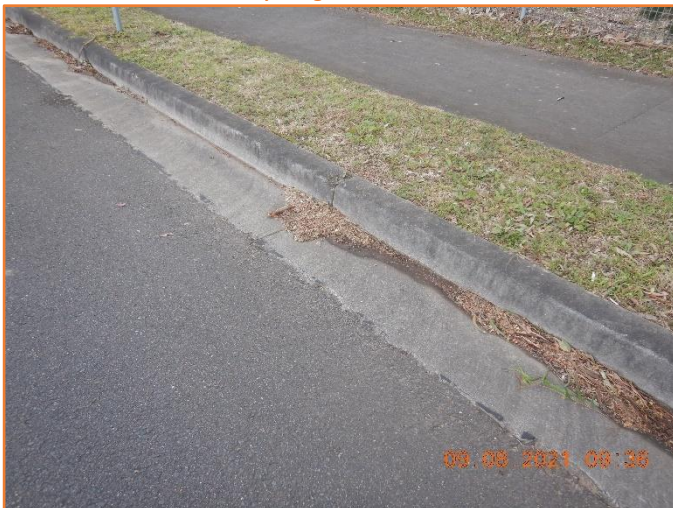
Figure 302: Reasonable - General condition of kerb and gutter.

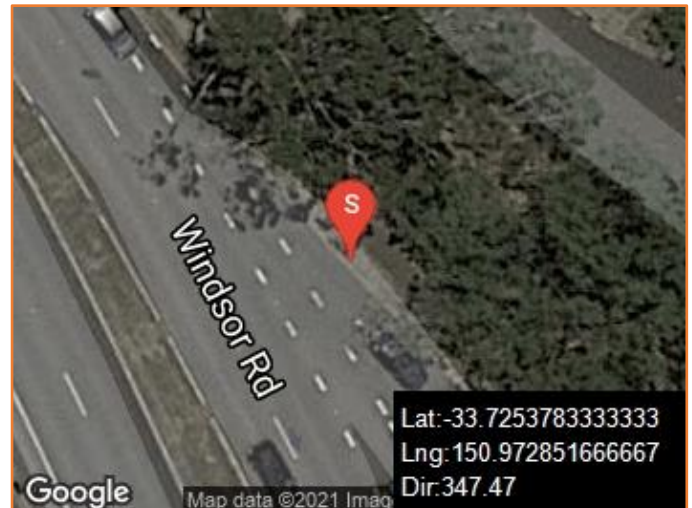
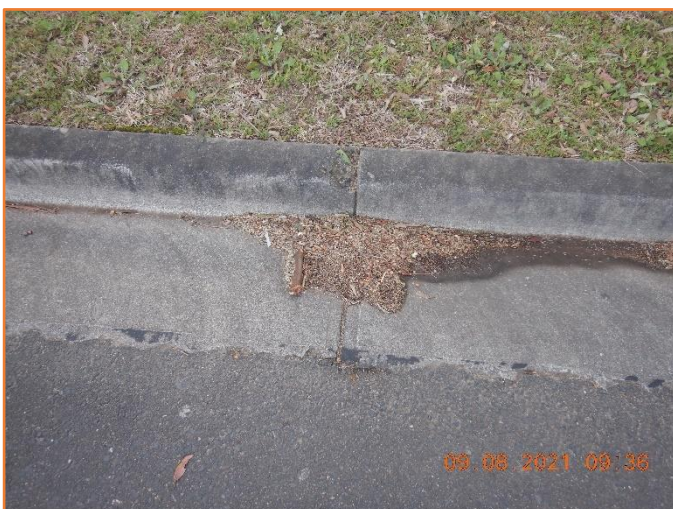
Figure 303: Reasonable - General condition of kerb and gutter. Minor spalling observed.

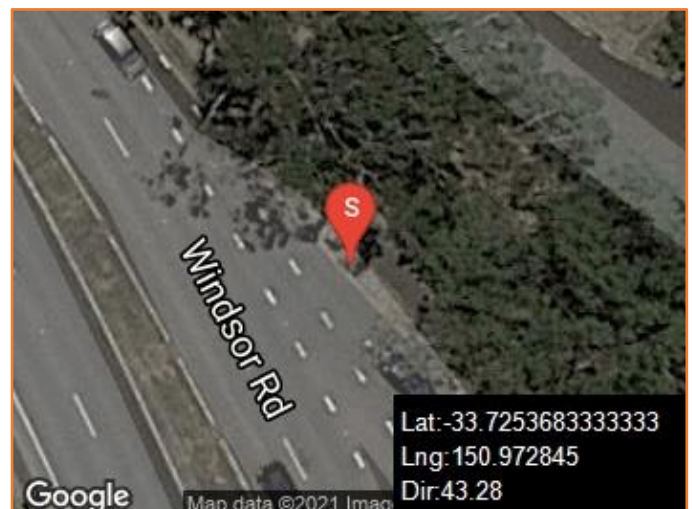
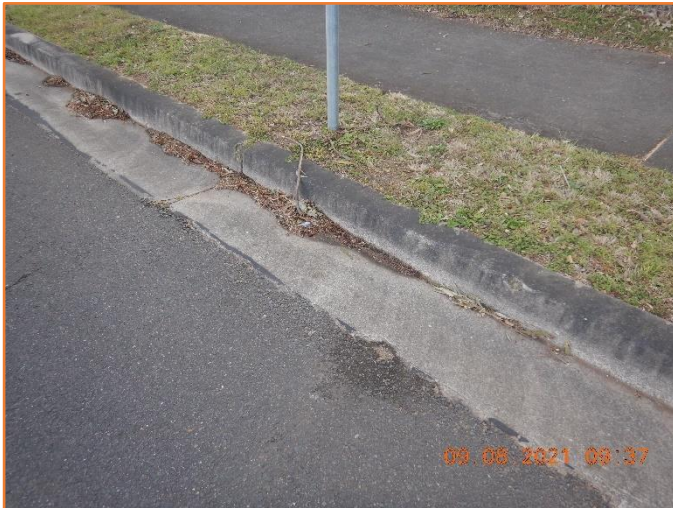
Figure 304: Reasonable - General condition of kerb and gutter.

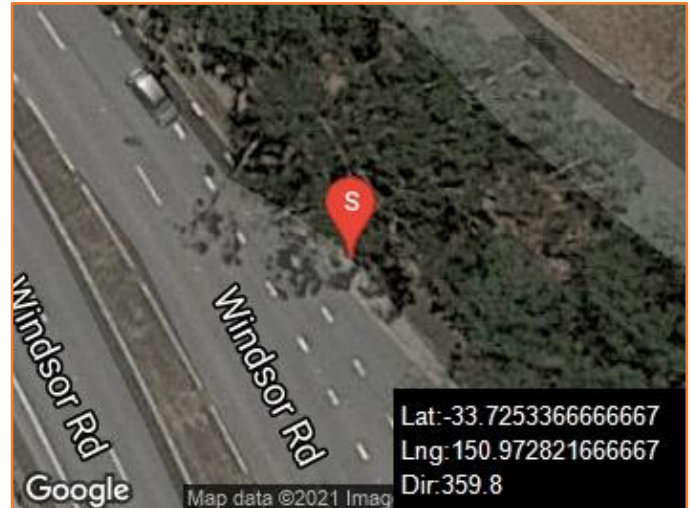
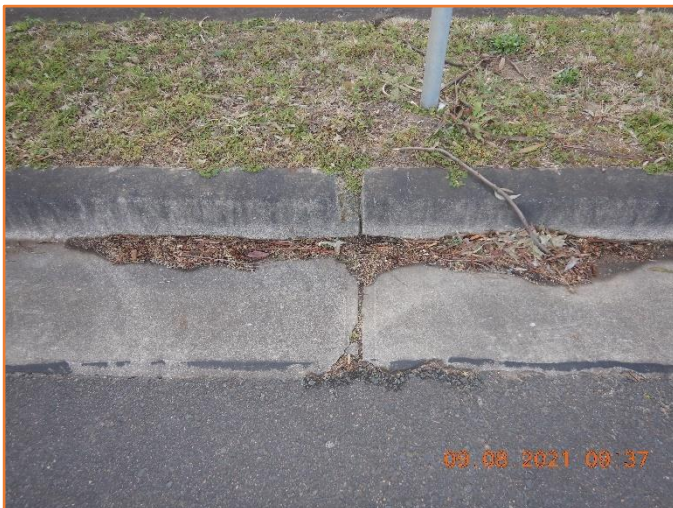
Figure 305: Reasonable - General condition of kerb and gutter. Minor spalling observed.

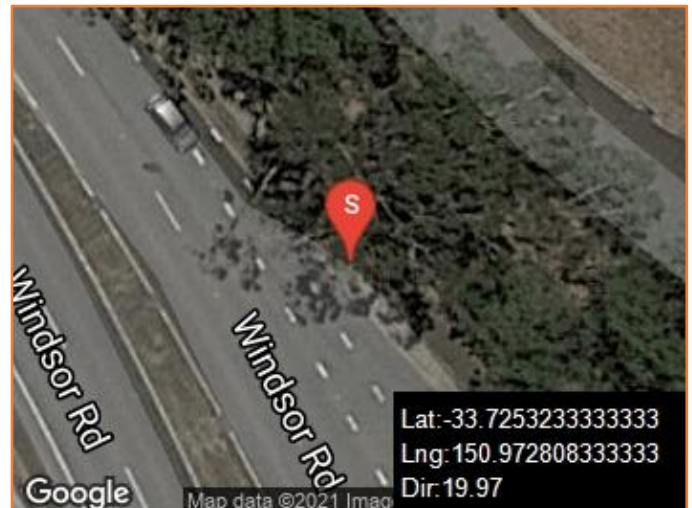
Figure 306: Reasonable - General condition of kerb and gutter.

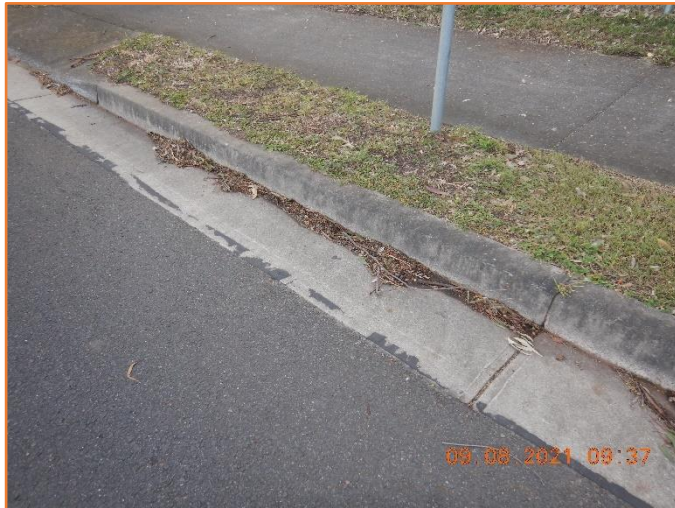
Figure 307: Reasonable - General condition of kerb and gutter.

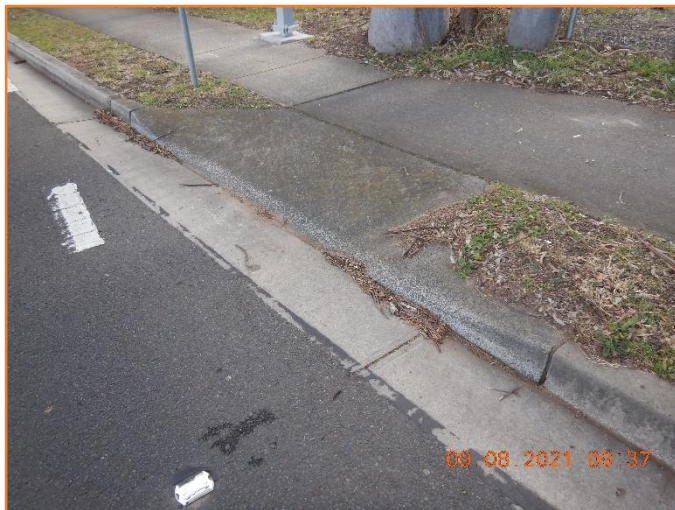
Figure 308: Reasonable - General condition of kerb and gutter and footpath crossover.

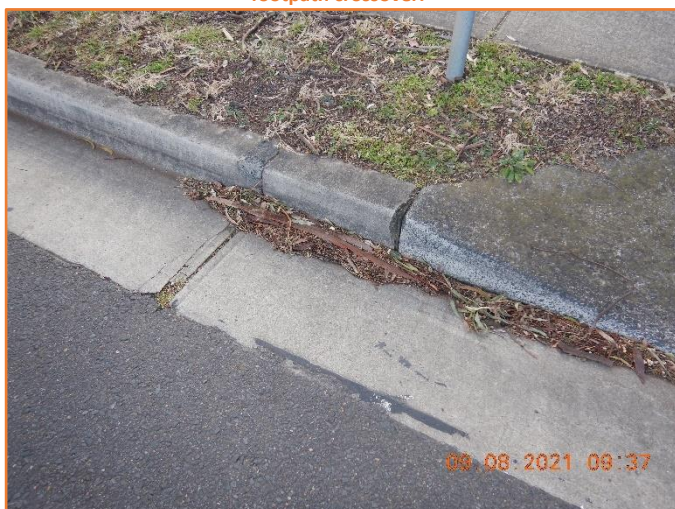
Figure 309: Reasonable - General condition of footpath splay. Moderate cracking observed.

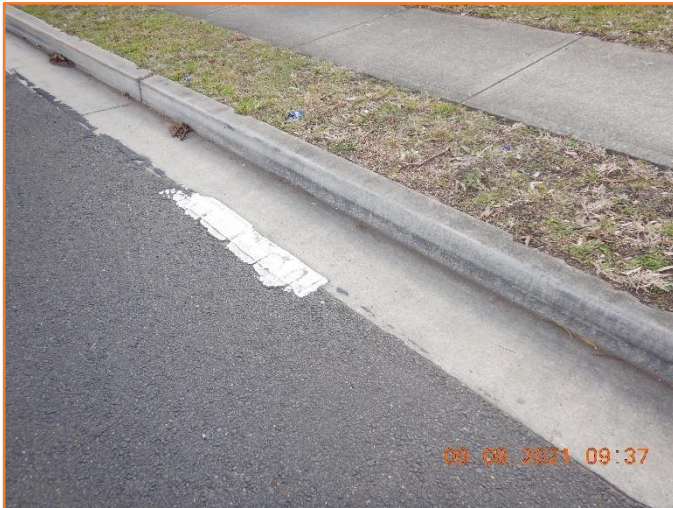
Figure 310: Reasonable - General condition of kerb and gutter.

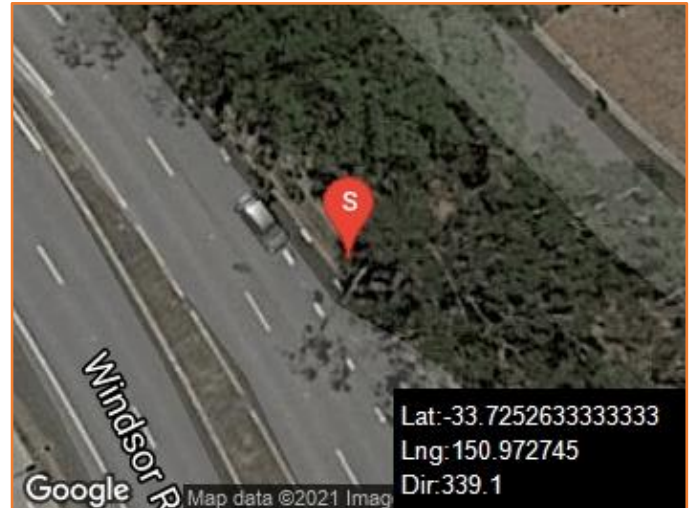
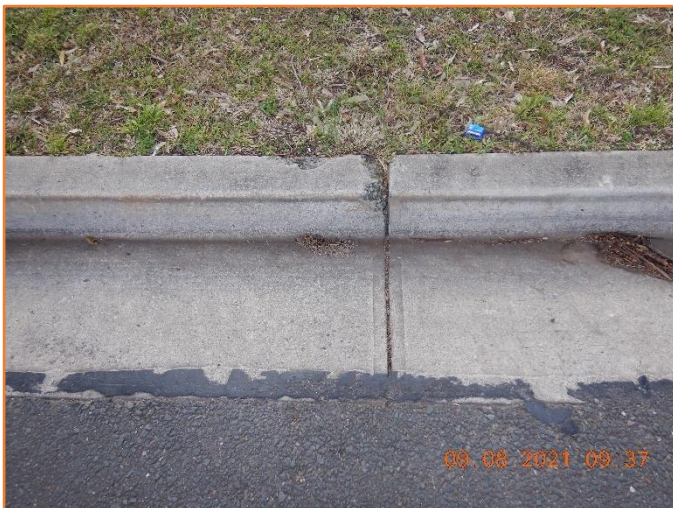
Figure 311: Reasonable - General condition of kerb and gutter. Minor spalling observed.

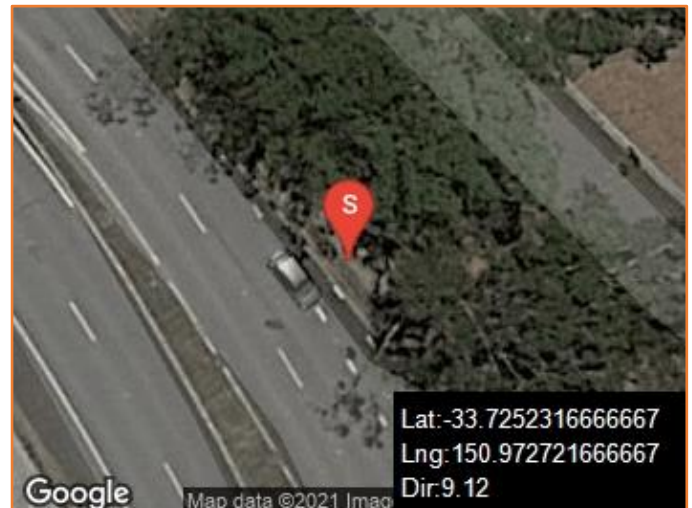
Figure 312: Reasonable - General condition of kerb and gutter. Minor spalling observed.

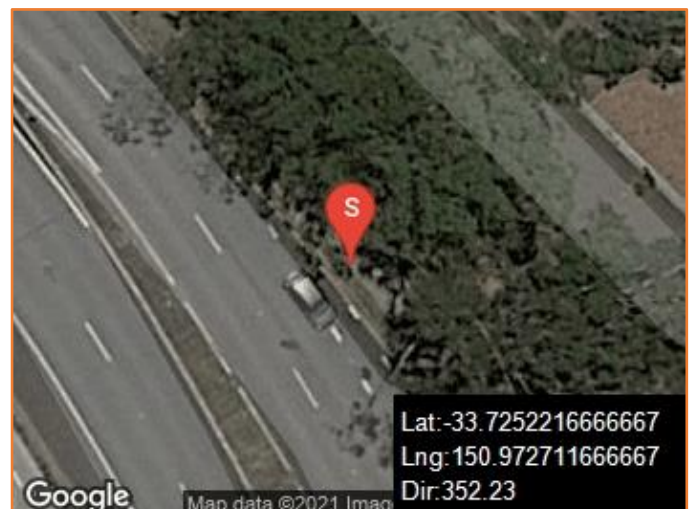
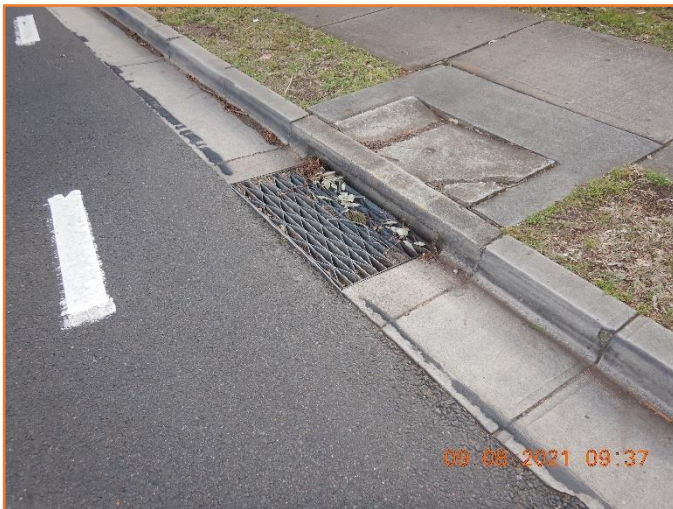
Figure 313: Defective - General condition of kerb inlet pit. Extensive cracking observed.

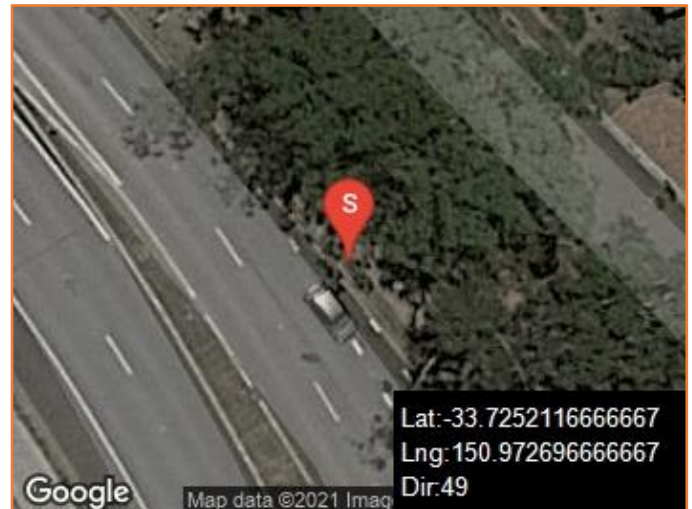
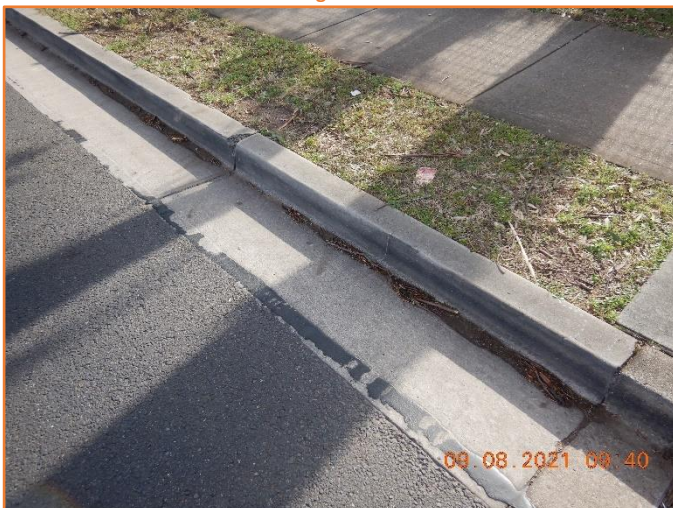
Figure 314: Reasonable - General condition of kerb and gutter. Moderate spalling observed.

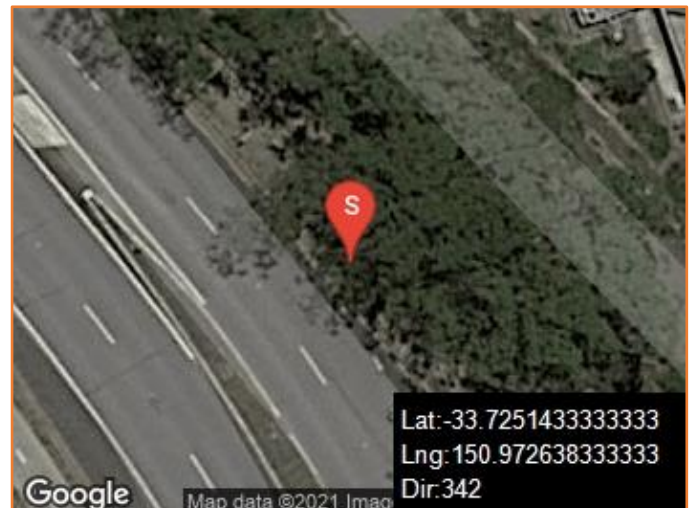
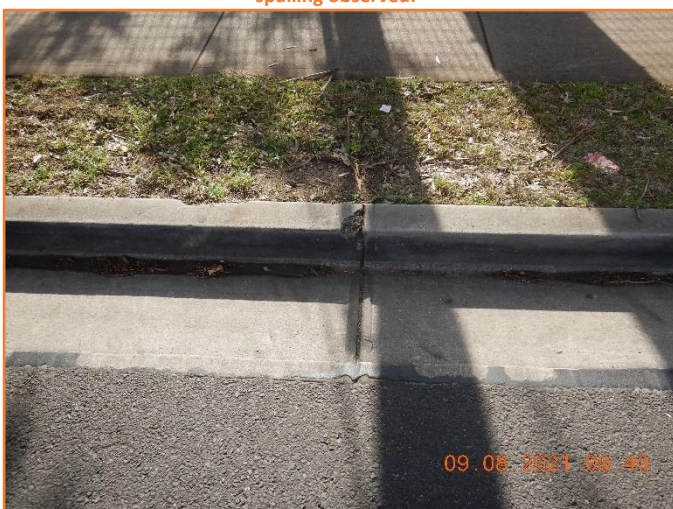
Figure 315: Reasonable - General condition of kerb and gutter. Moderate spalling observed.

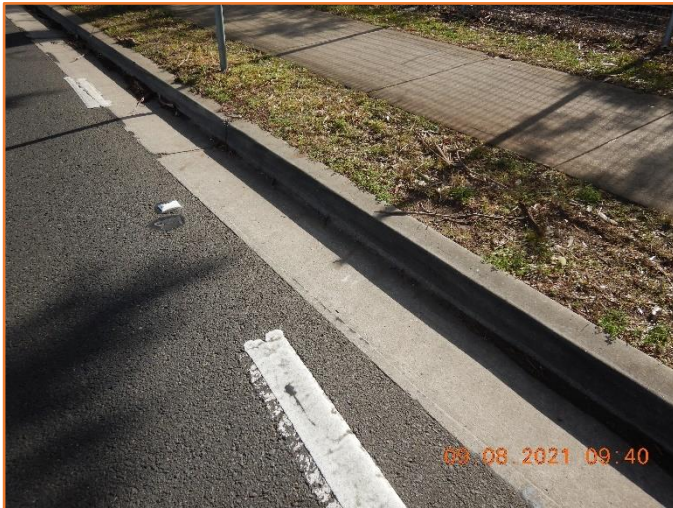
Figure 316: Reasonable - General condition of kerb and gutter.

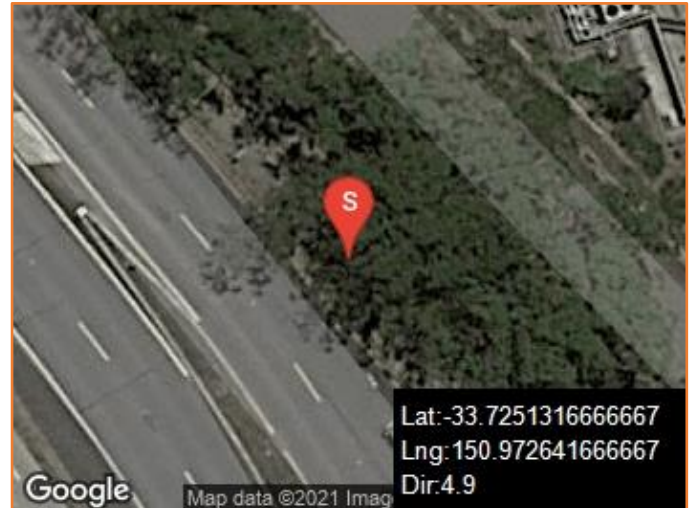
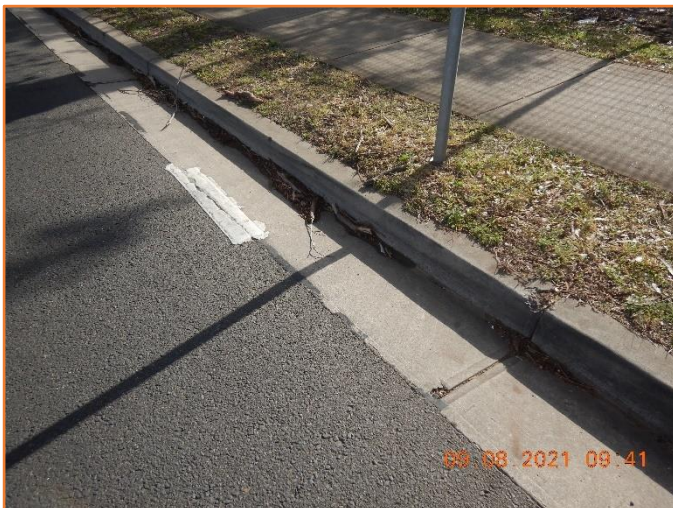
Figure 317: Reasonable - General condition of kerb and gutter. Moderate spalling observed.

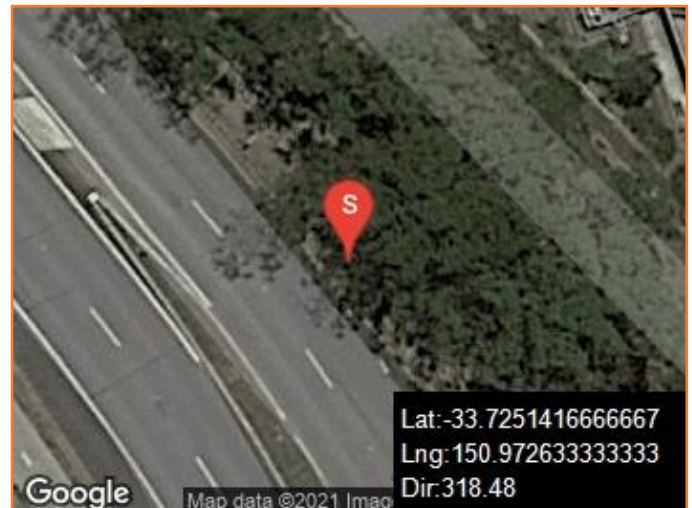
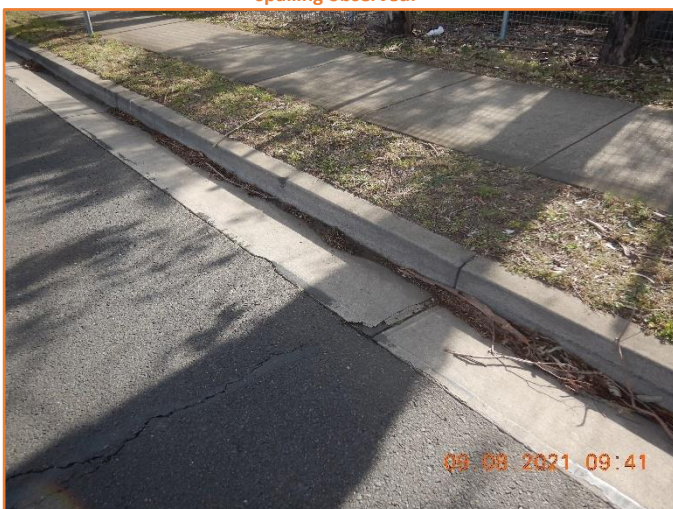
Figure 318: Reasonable - General condition of kerb and gutter.

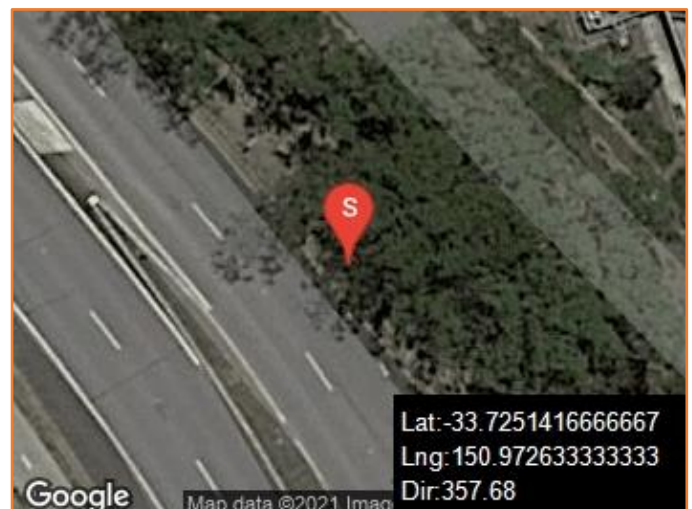
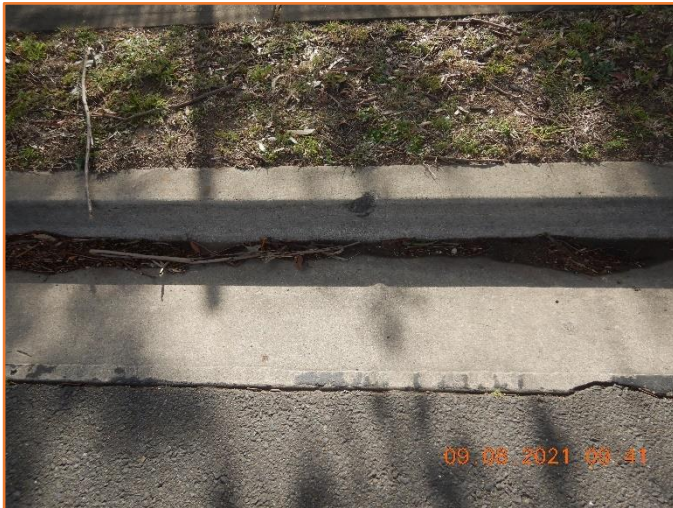
Figure 319: Reasonable - General condition of kerb and gutter. Minor spalling observed.

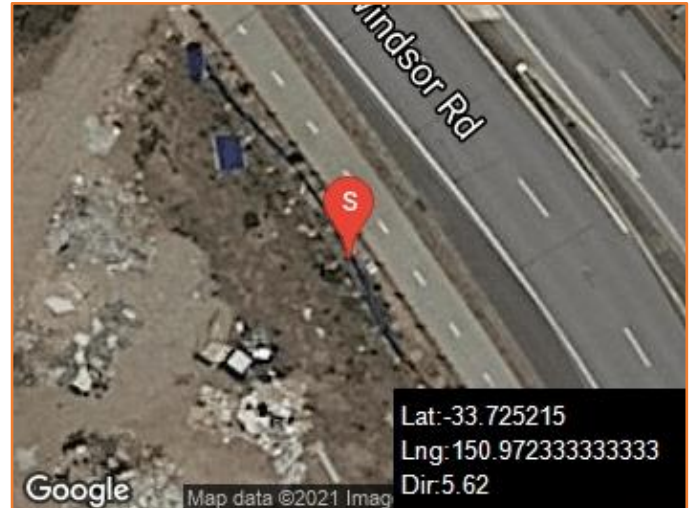
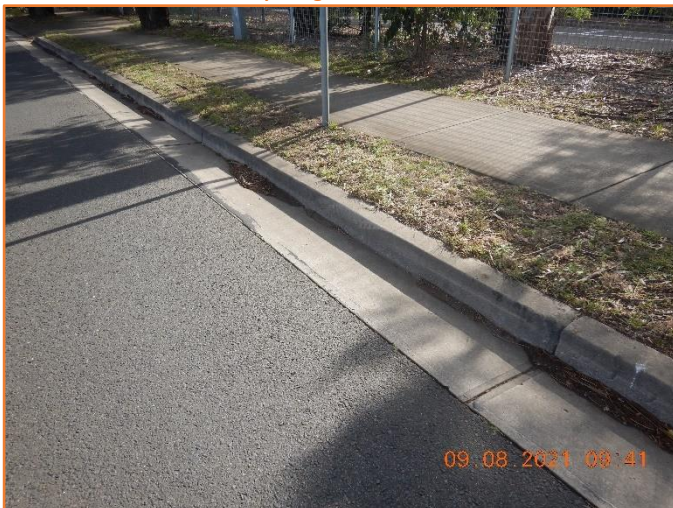
Figure 320: Reasonable - General condition of kerb and gutter.

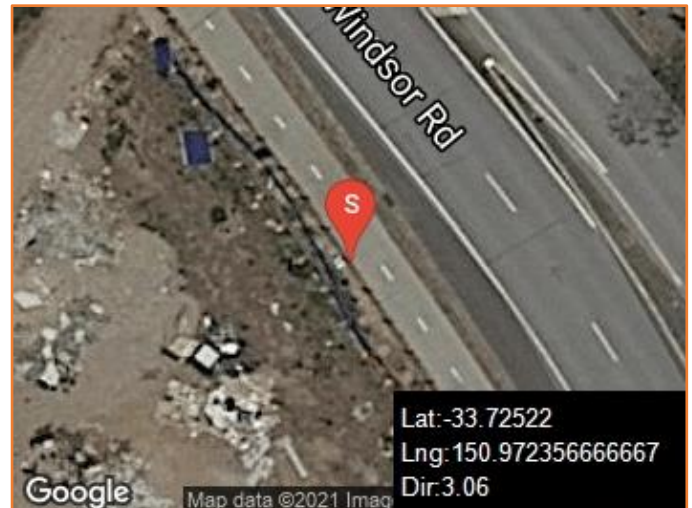
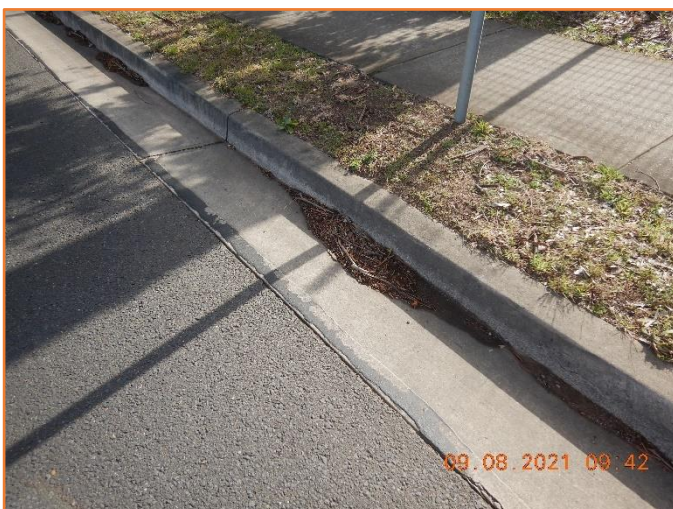
Figure 321: Reasonable - General condition of kerb and gutter.

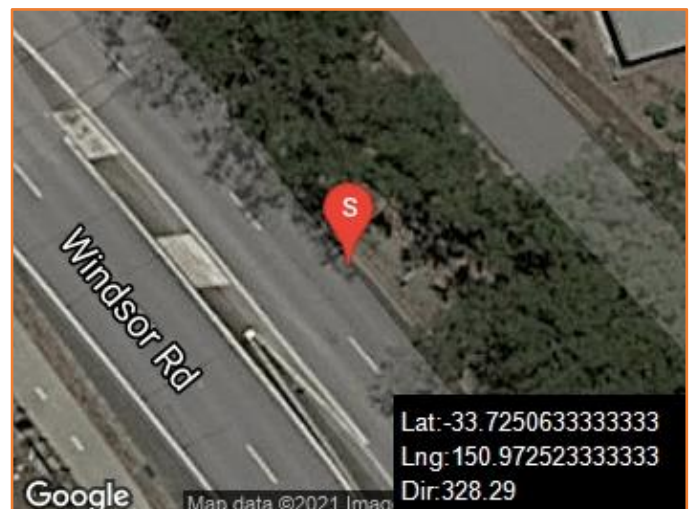
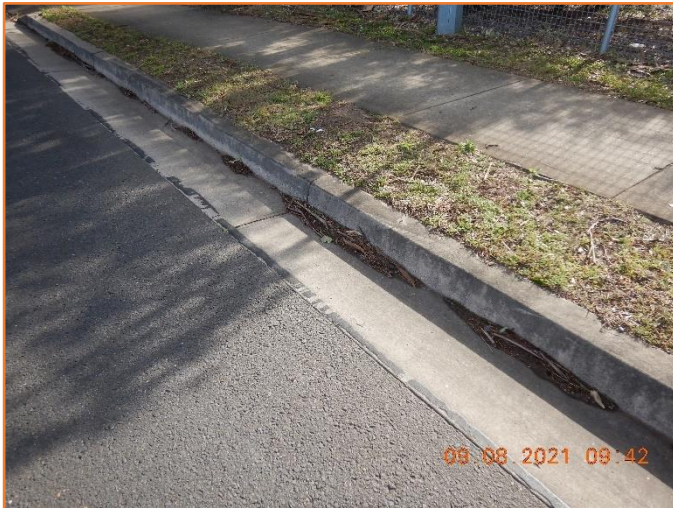
Figure 322: Reasonable - General condition of kerb and gutter.

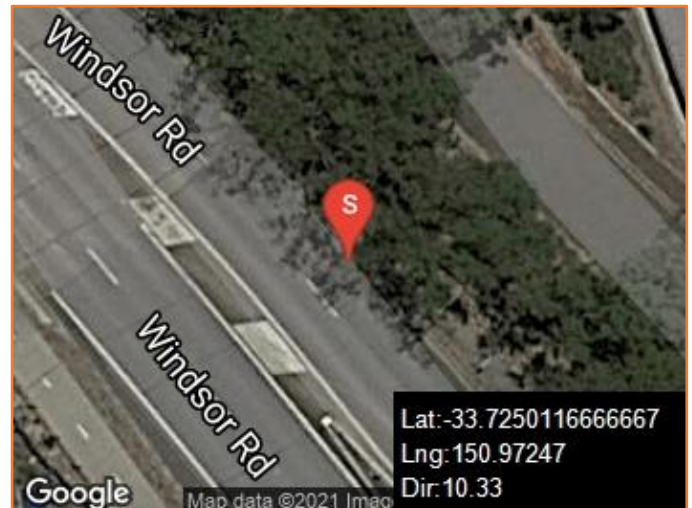
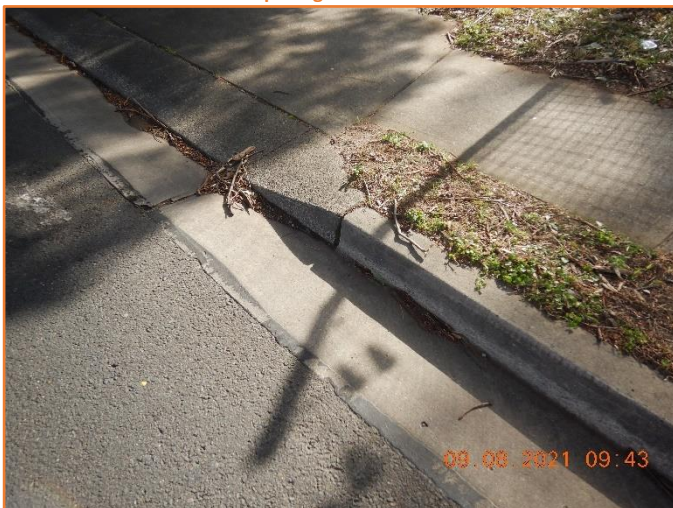
Figure 323: Reasonable - General condition of kerb and gutter. Minor spalling observed.

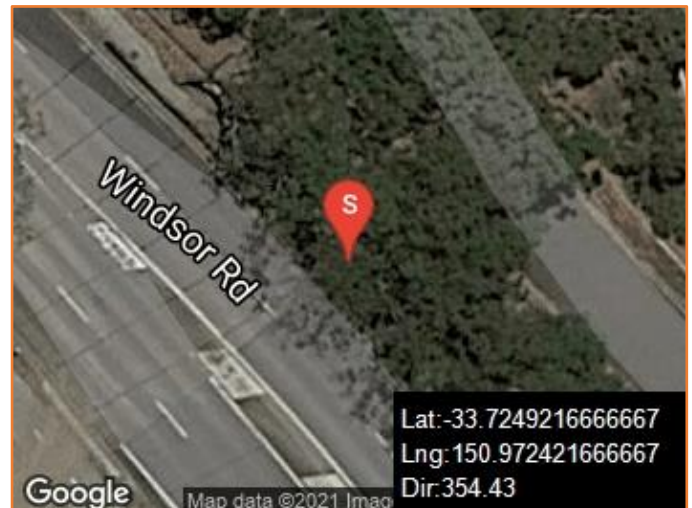
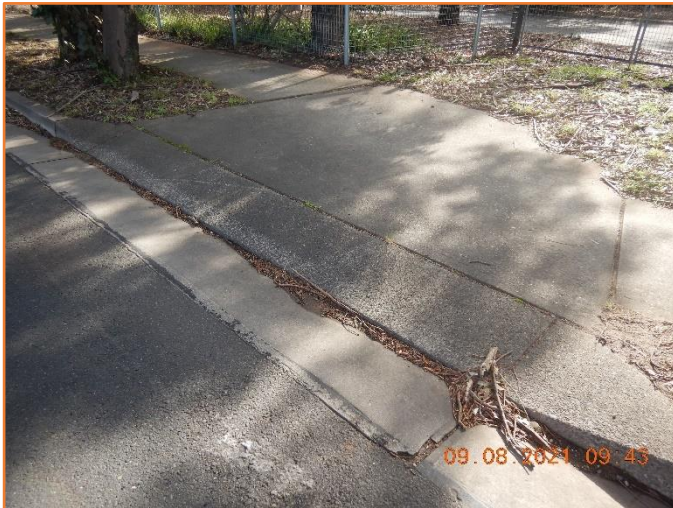
Figure 324: Reasonable - General condition of kerb and gutter and driveway splay.

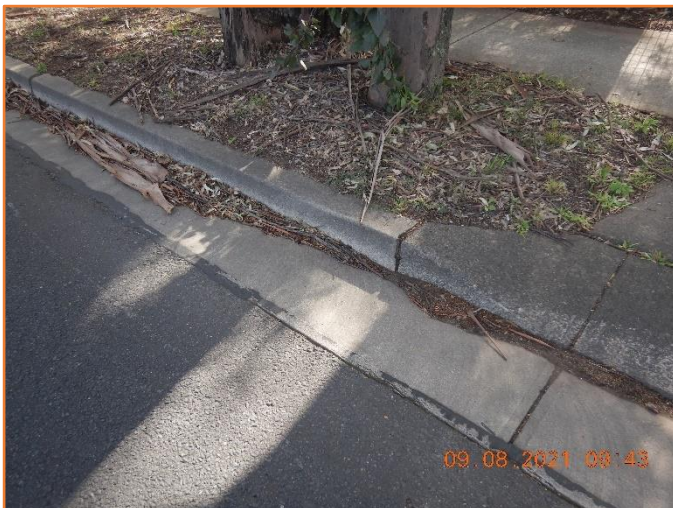
Figure 325: Reasonable - General condition of driveway crossover.

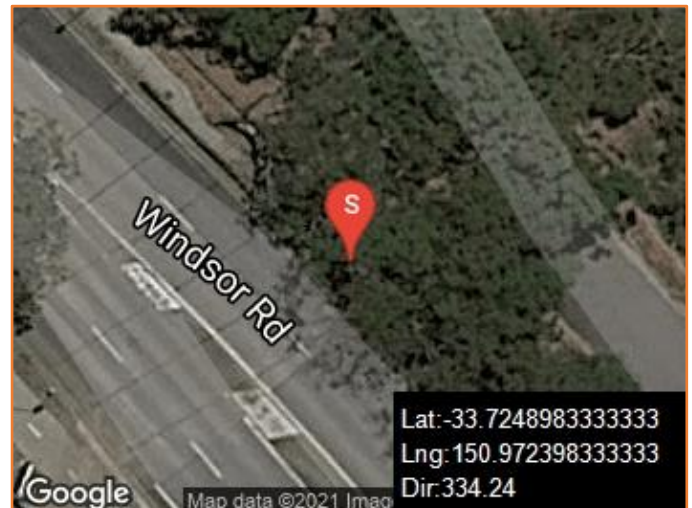
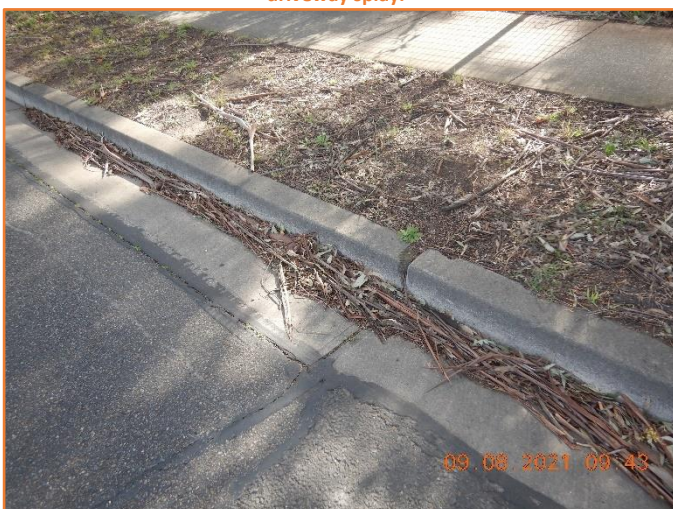
Figure 326: Reasonable - General condition of kerb and gutter and driveway splay.

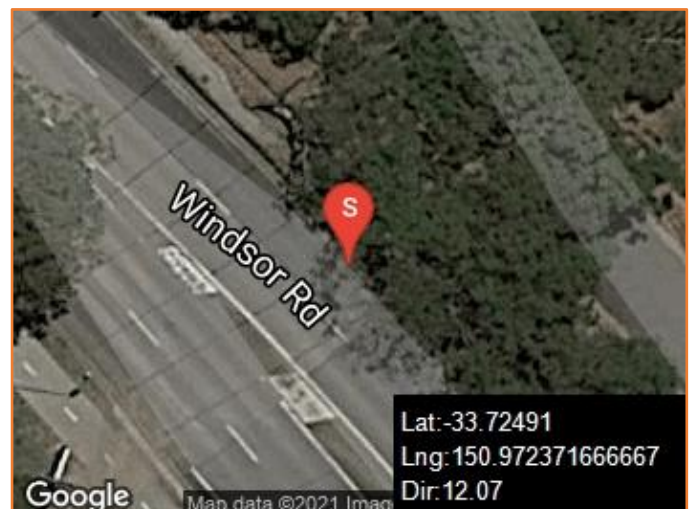
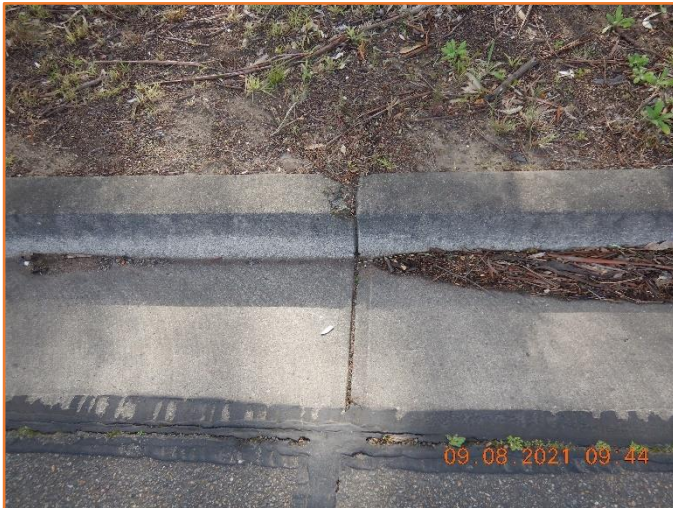
Figure 327: Reasonable - General condition of kerb and gutter.

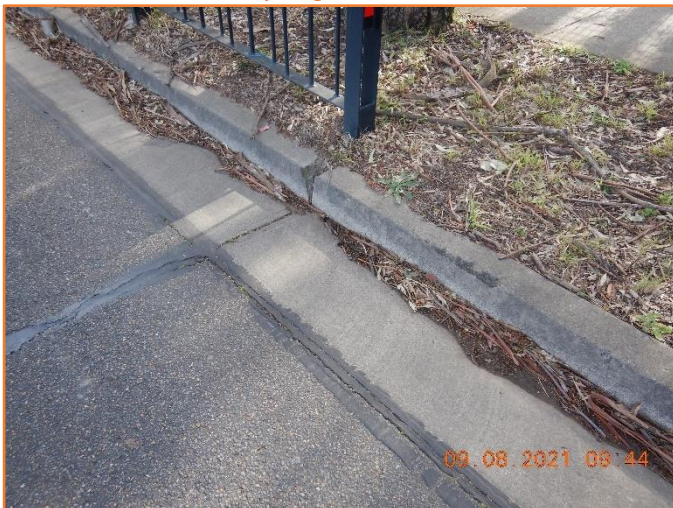
Figure 328: Reasonable - General condition of kerb and gutter. Minor spalling observed.

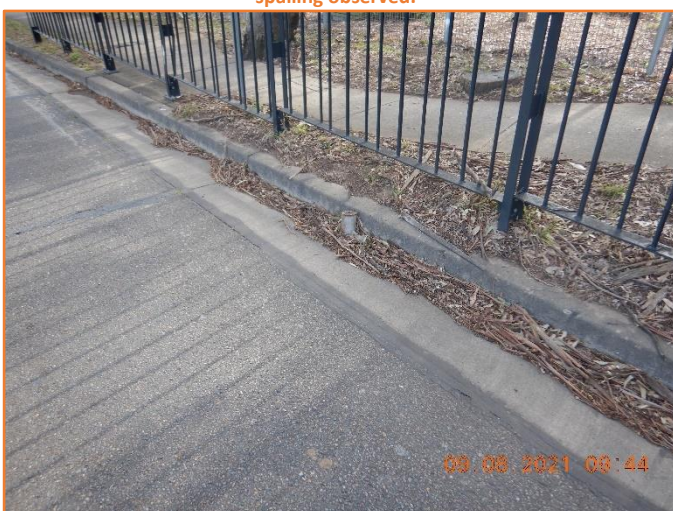
Figure 329: Reasonable - General condition of kerb and gutter. Moderate spalling observed.
