## DILAPIDATION REPORT

MUSEUM DISCOVERY CENTRE

MONDAY, 9 AUGUST 2021

Document Information	
Job Number	210722
Document Number	3
Report Title	Dilapidation Report
Site Address	172 Showground Road and 2 Green Road Castle Hill, NSW, 2154
Lot	1 in DP1066281 & 102 in DP1130271

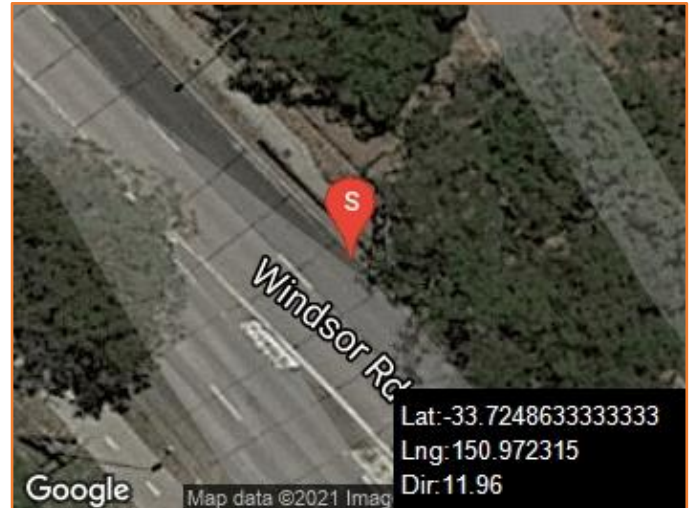
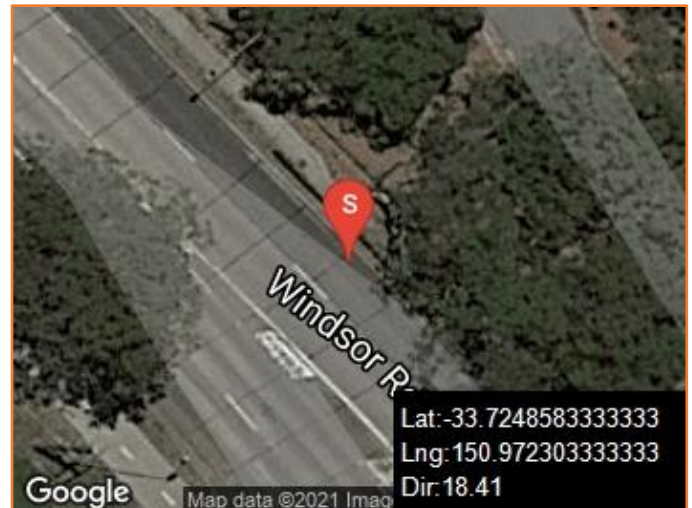
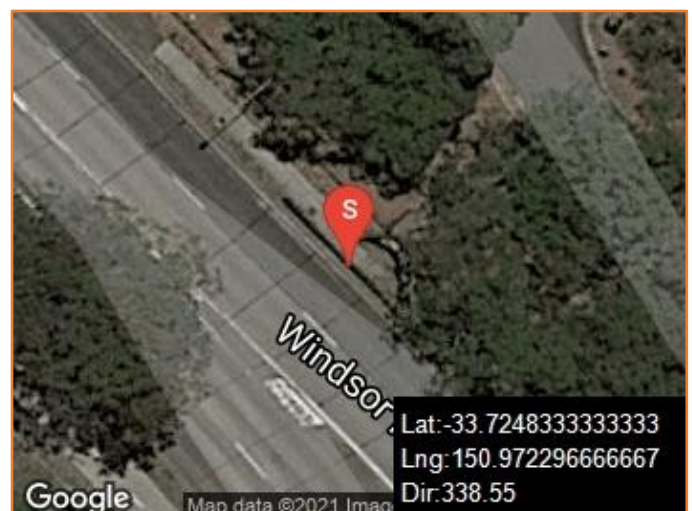
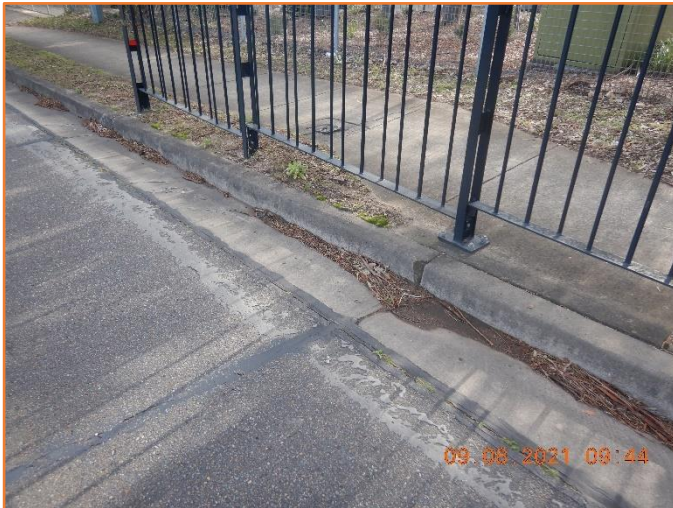
Figure 330: Reasonable - General condition of kerb and gutter.

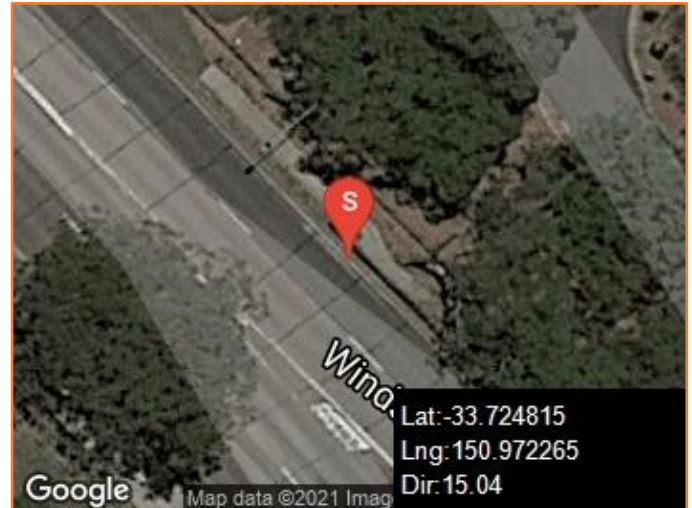
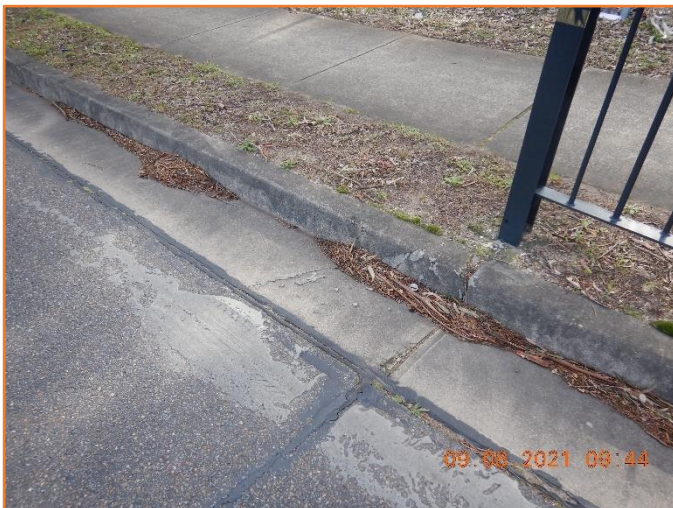
Figure 331: Reasonable - General condition of kerb and gutter.

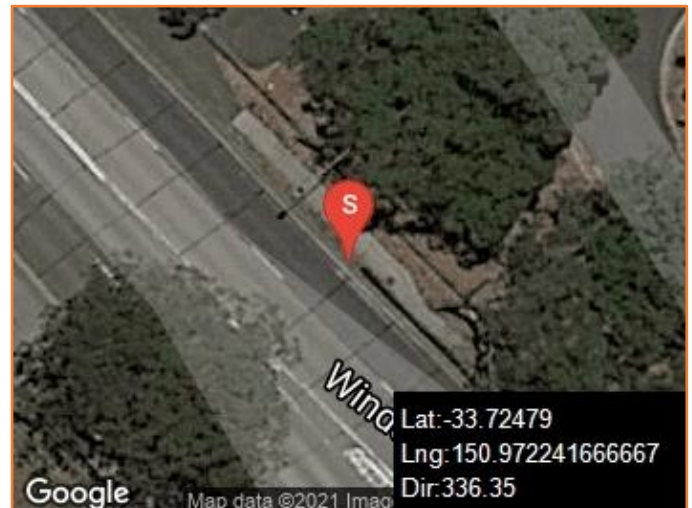
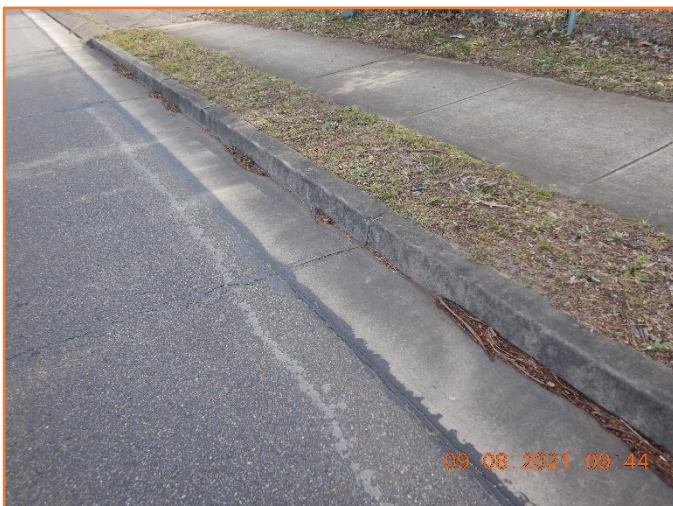
Figure 332: Reasonable - General condition of kerb and gutter.

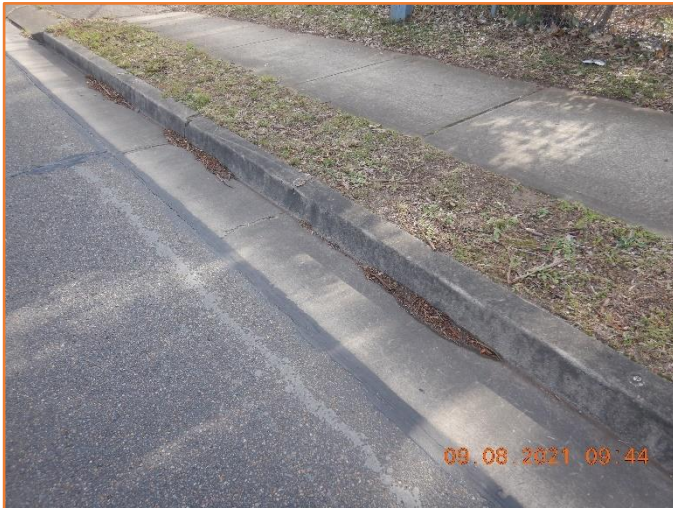
Figure 333: Reasonable - General condition of kerb and gutter.

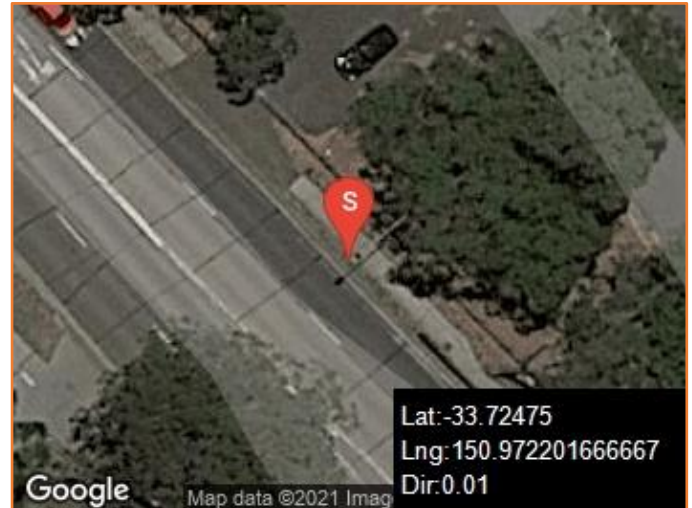
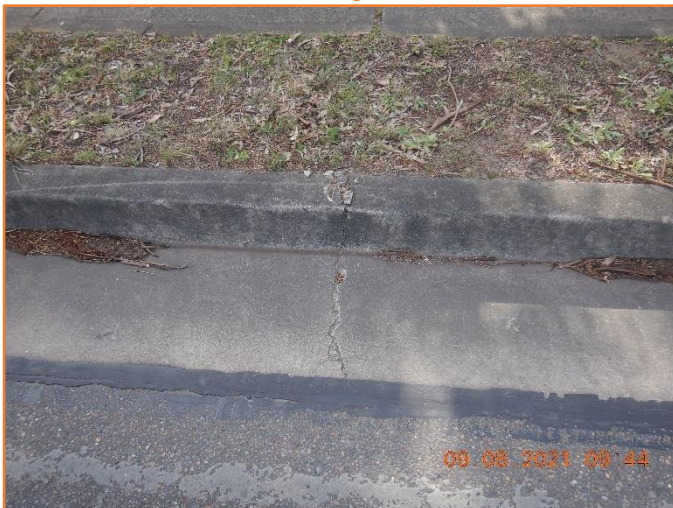
Figure 334: Reasonable - General condition of kerb and gutter. Moderate hairline cracking observed.

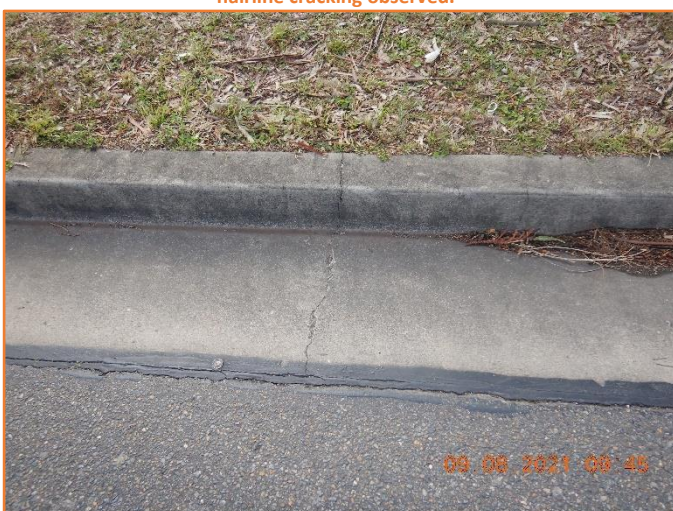
Figure 335: Reasonable - General condition of kerb and gutter. Moderate hairline cracking observed.

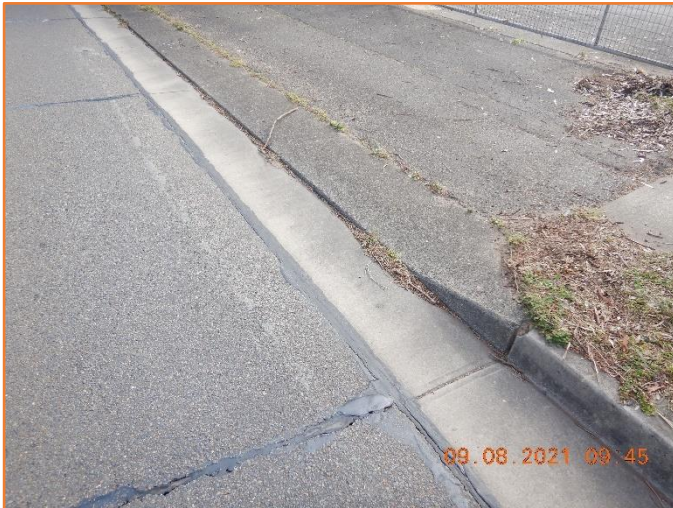
Figure 336: Reasonable - General condition of kerb and gutter. Minor hairline cracking observed.

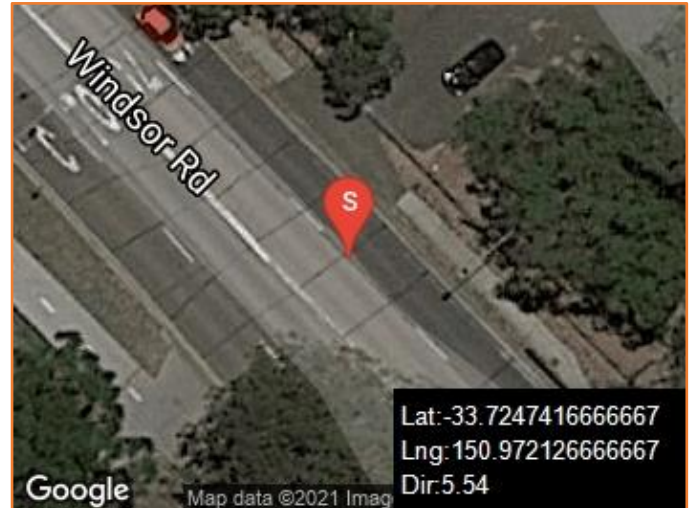
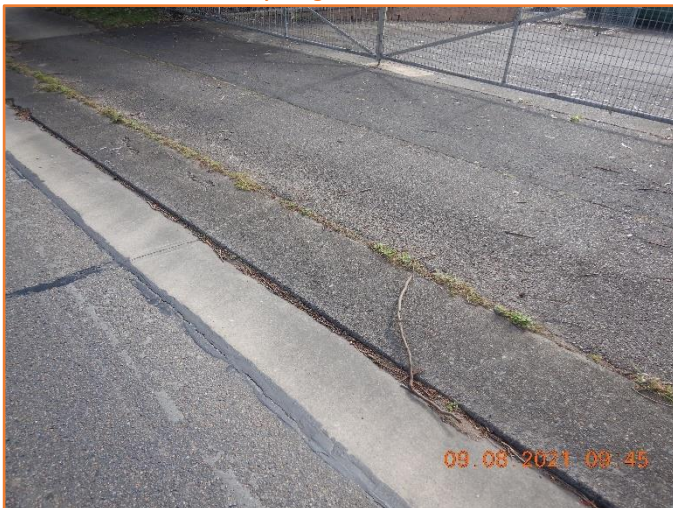
Figure 337: Reasonable - General condition of driveway splay. Minor spalling observed.

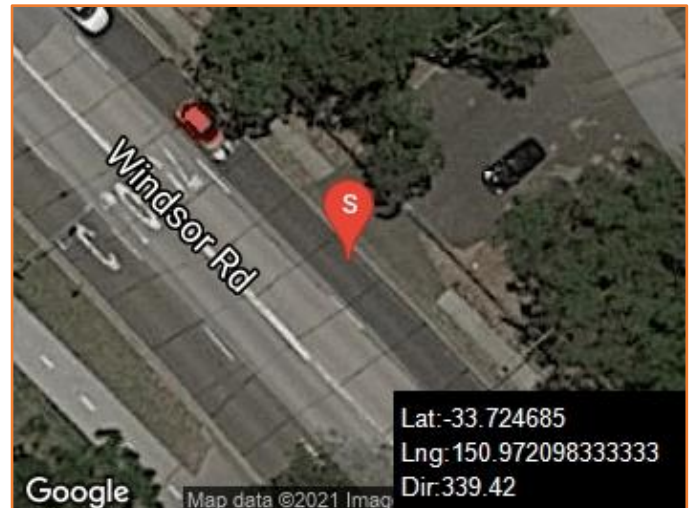
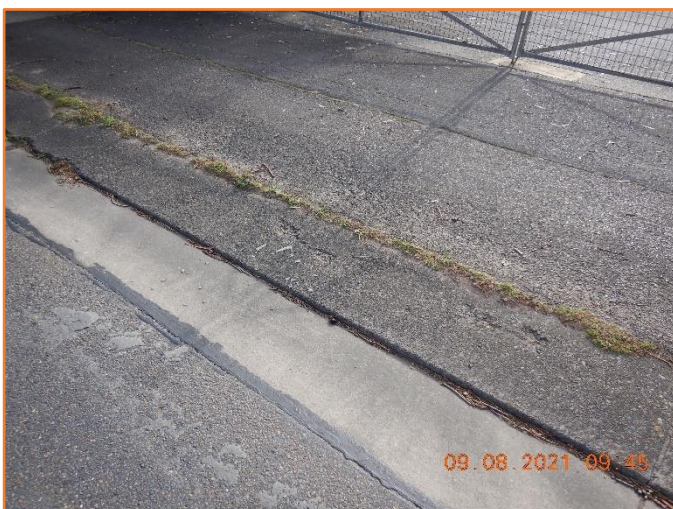
Figure 338: Reasonable - General condition of driveway crossover.

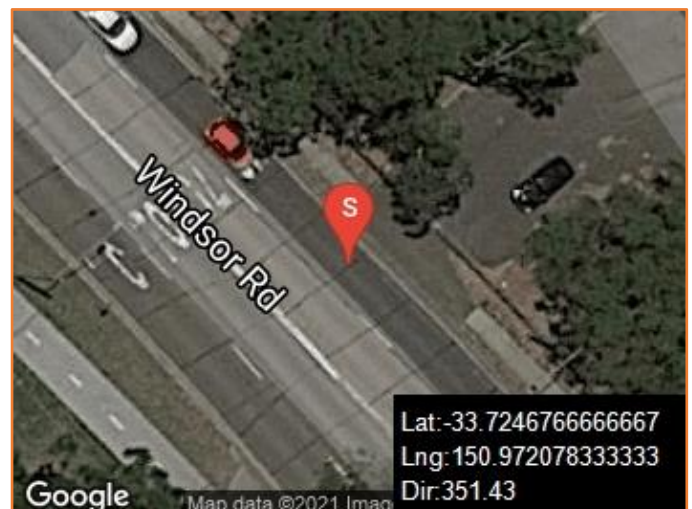
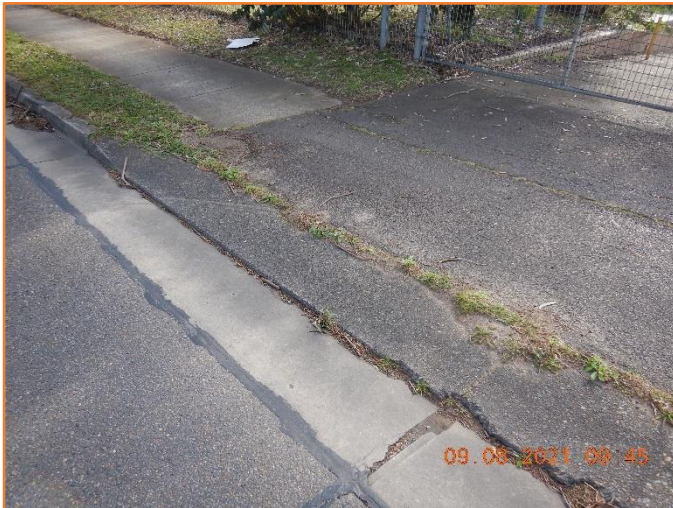
Figure 339: Reasonable - General condition of driveway crossover. Moderate cracking observed.

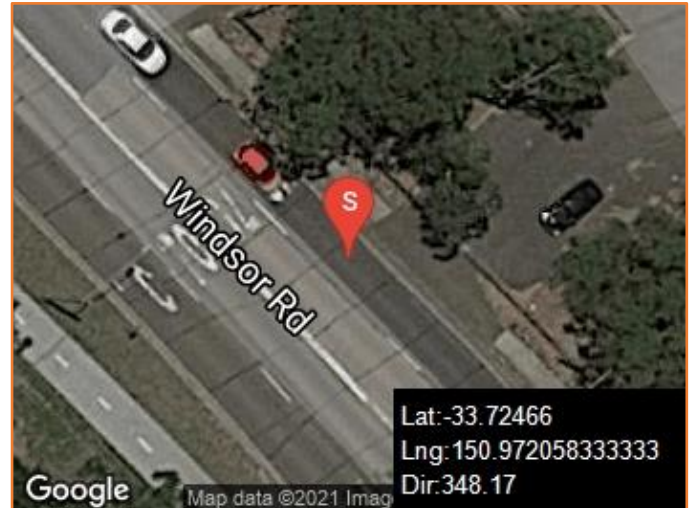
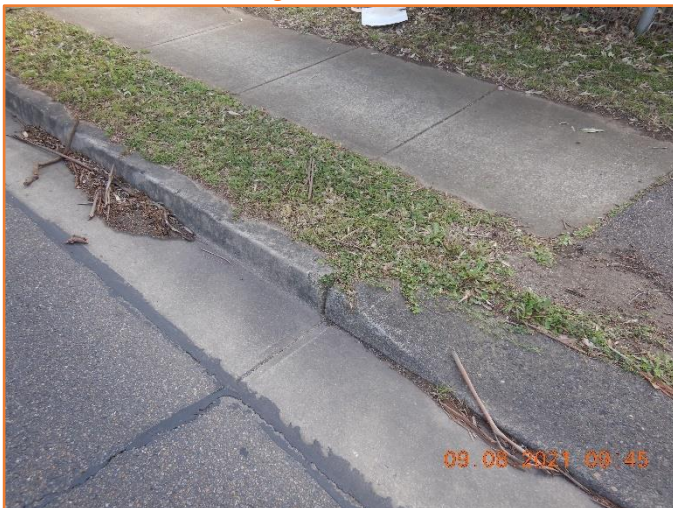
Figure 340: Reasonable - General condition of driveway crossover.  
 Moderate cracking and loss of material observed.

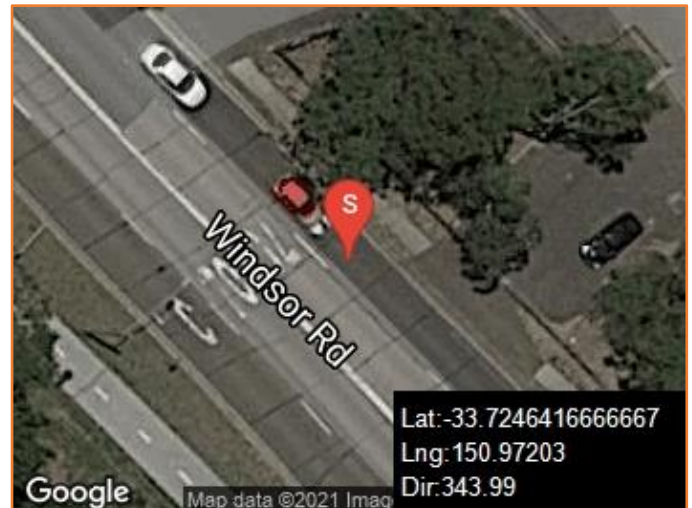
Figure 341: Reasonable - General condition of driveway splay.

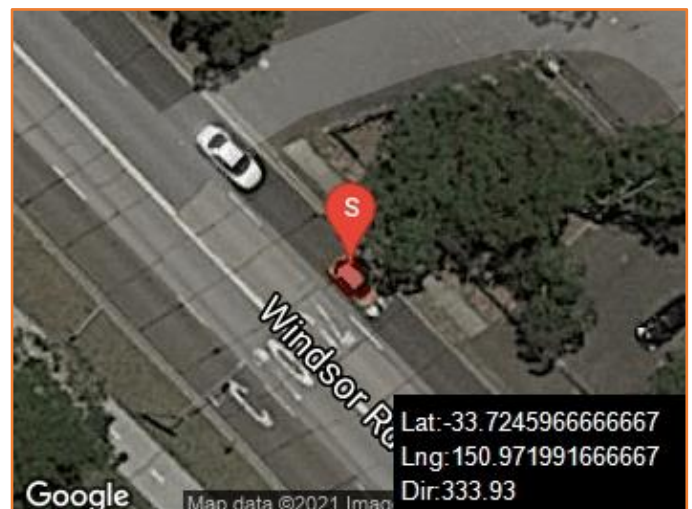
Figure 342: Reasonable - General condition of kerb and gutter.

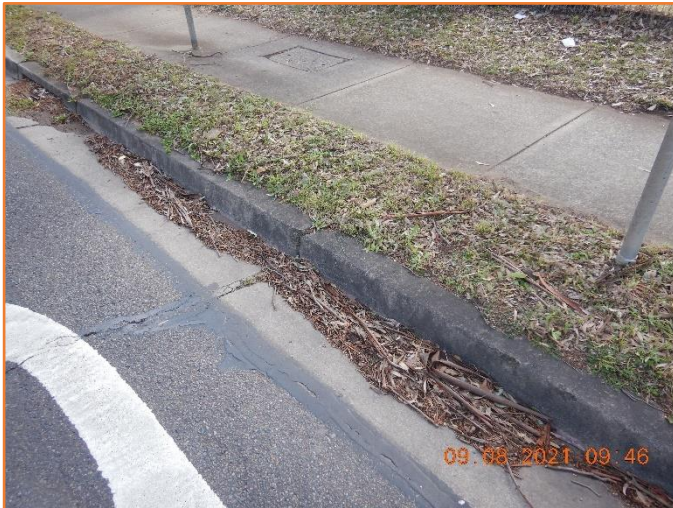
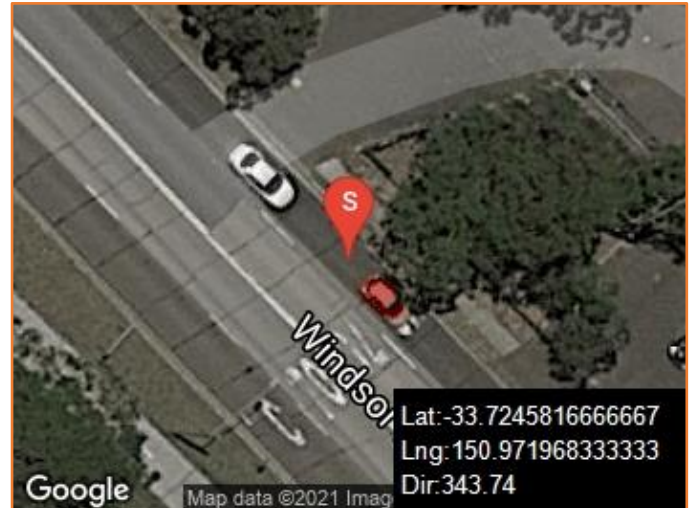
Figure 343: Reasonable - General condition of kerb and gutter.

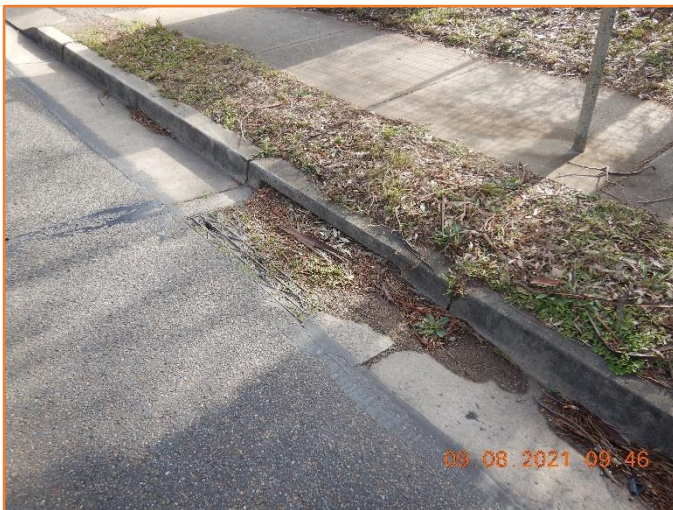
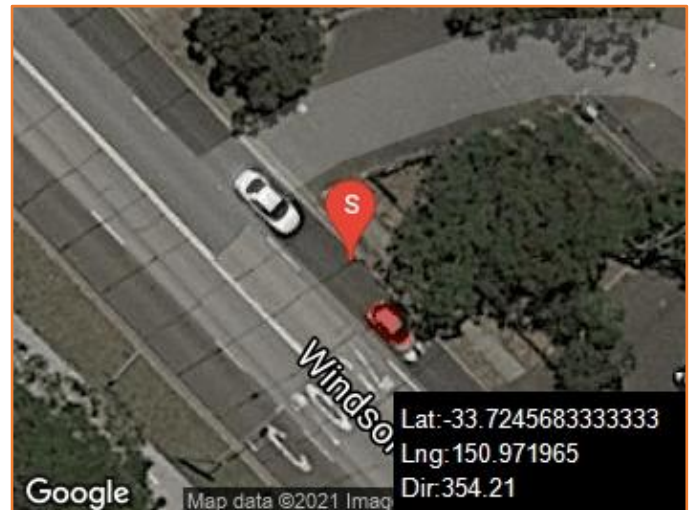
Figure 344: Poor - General condition of kerb inlet pit. Extensive debris build-up observed.

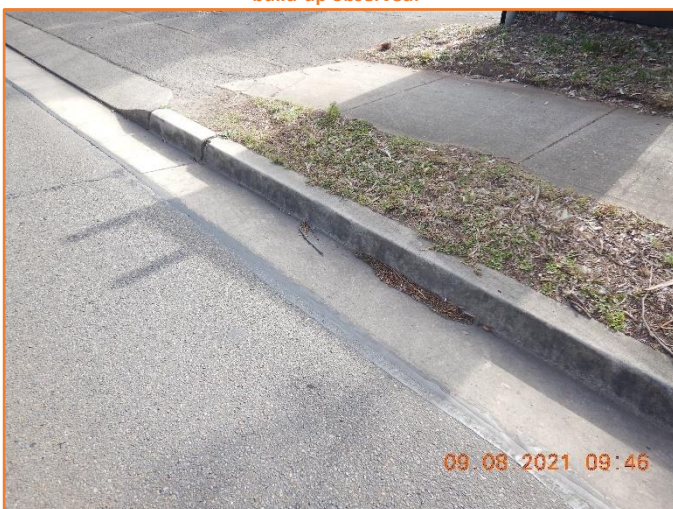
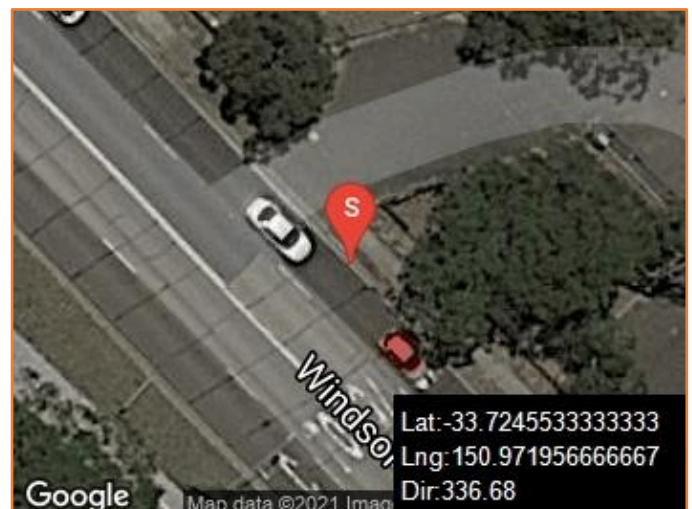
Figure 345: Reasonable - General condition of kerb and gutter.

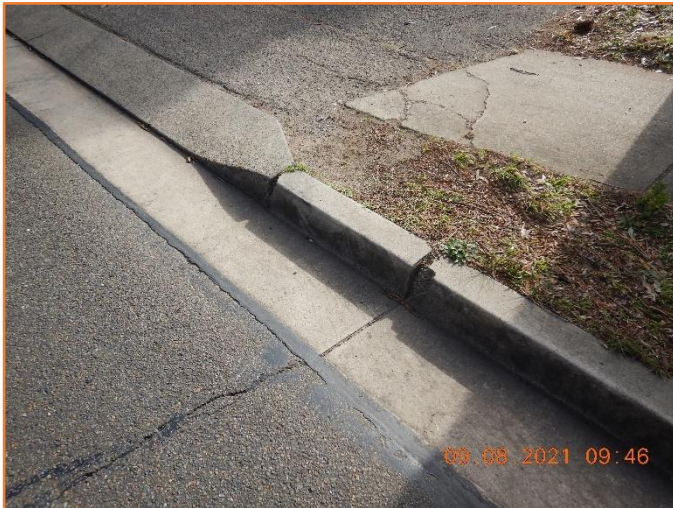
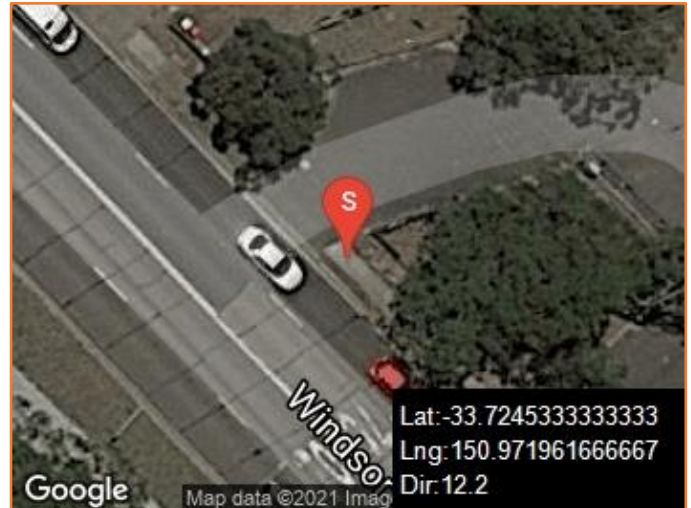
Figure 346: Reasonable - General condition of kerb and gutter and driveway splay. Moderate spalling observed.

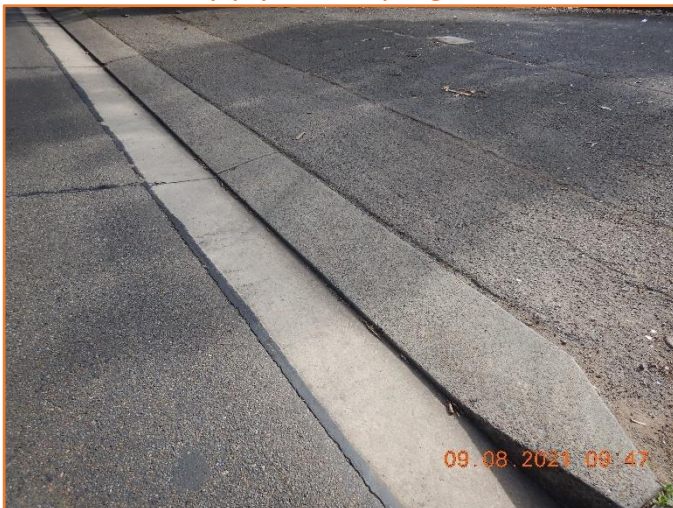
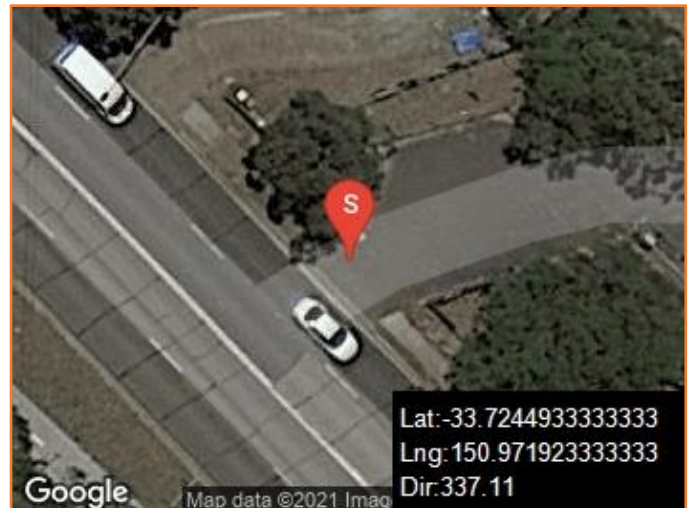
Figure 347: Reasonable - General condition of driveway crossover.

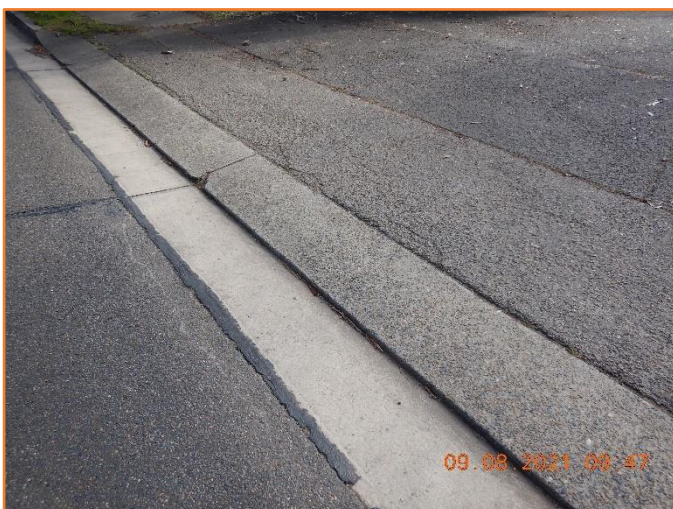
Figure 348: Reasonable - General condition of driveway crossover. Minor cracking observed.

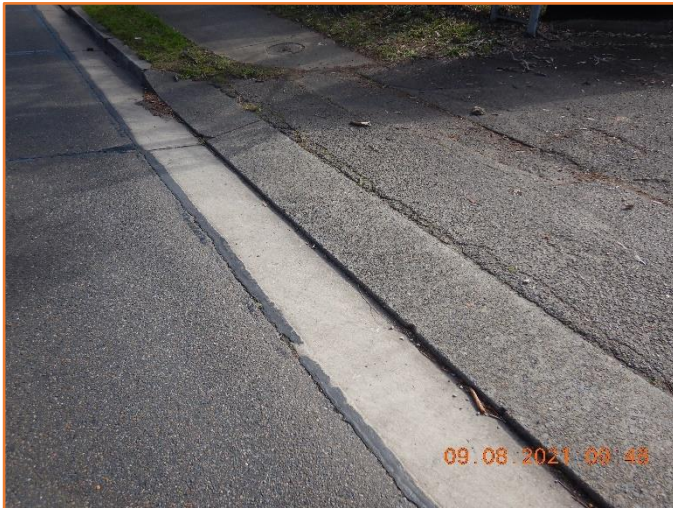
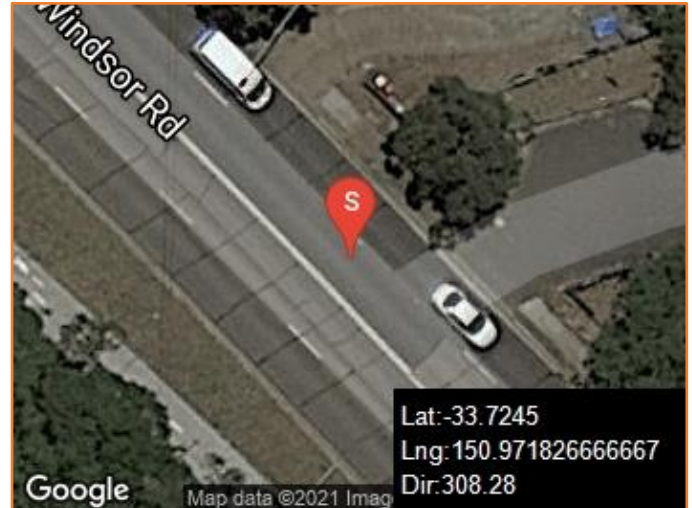
Figure 349: Reasonable - General condition of driveway crossover.  
 Moderate cracking observed.

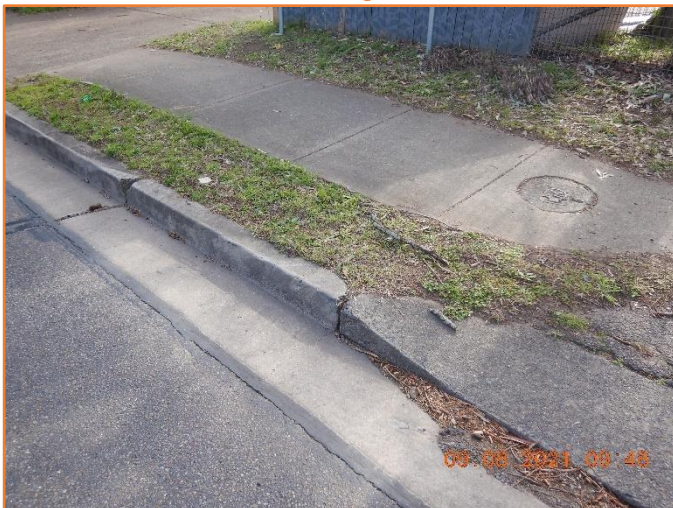
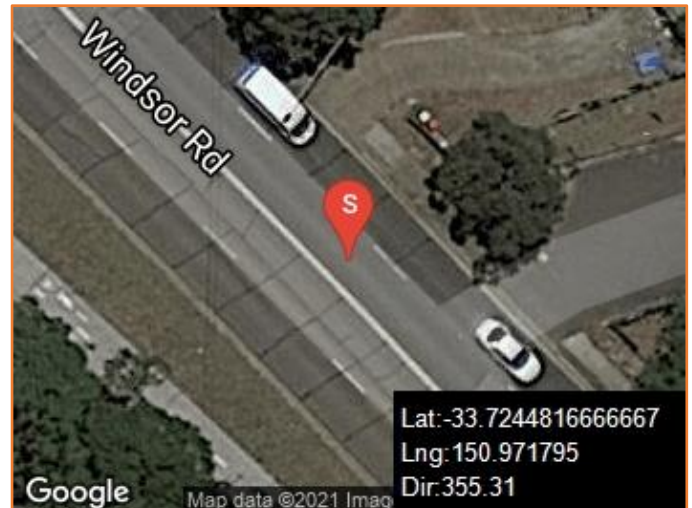
Figure 350: Reasonable - General condition of driveway splay.

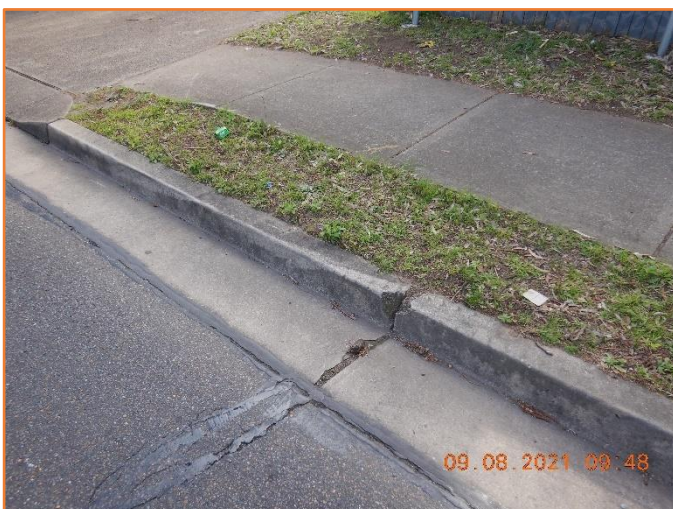
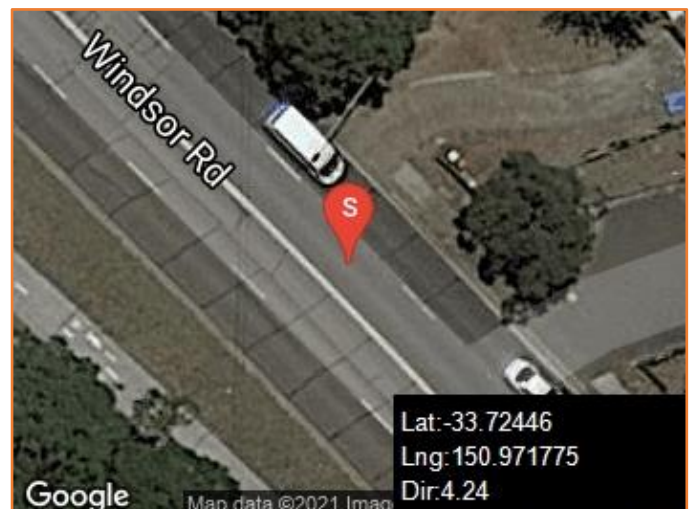
Figure 351: Poor - General condition of kerb and gutter. Major spalling observed.

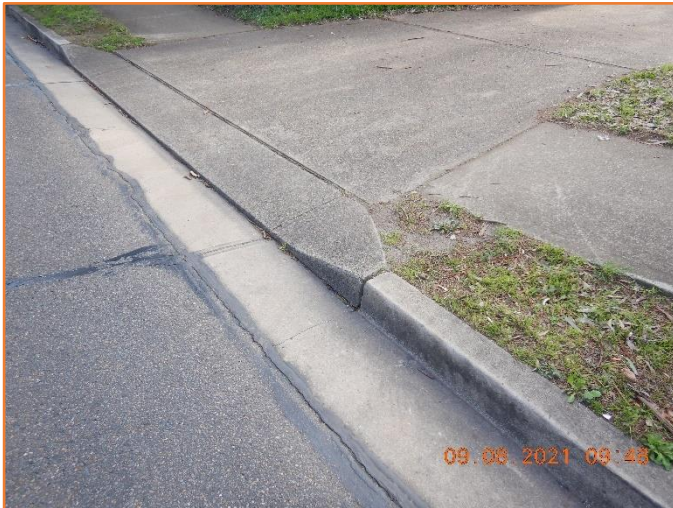
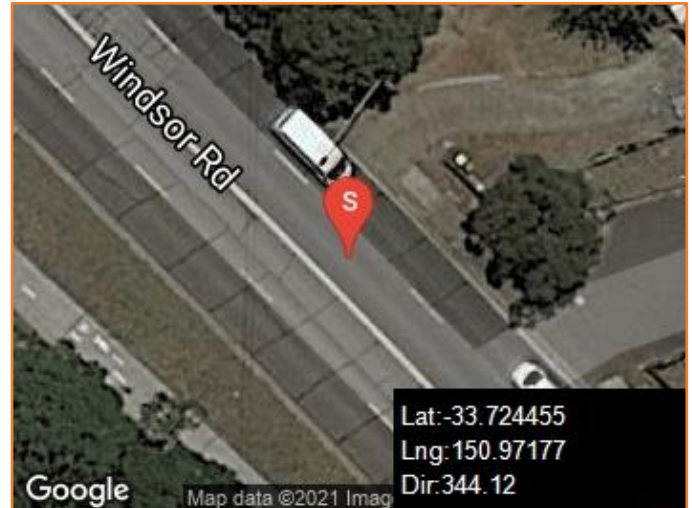
Figure 352: Reasonable - General condition of kerb and gutter and driveway splay. Minor hairline cracking observed.

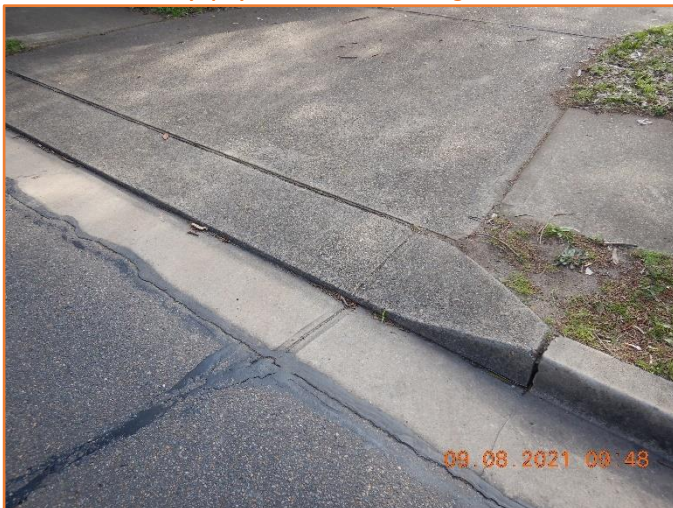
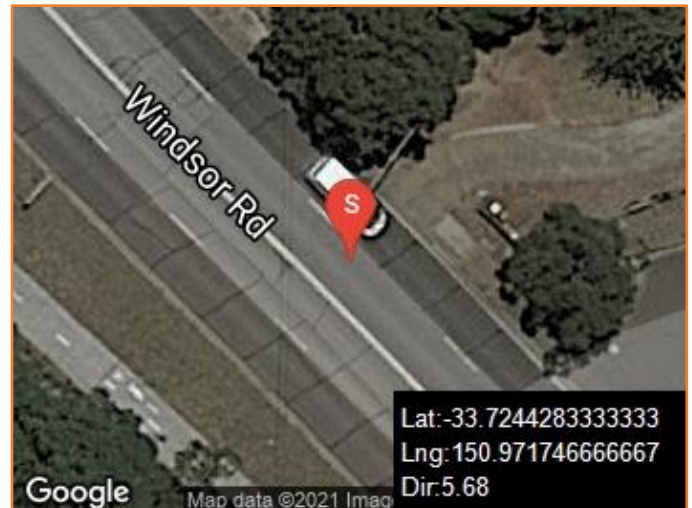
Figure 353: Reasonable - General condition of driveway crossover.

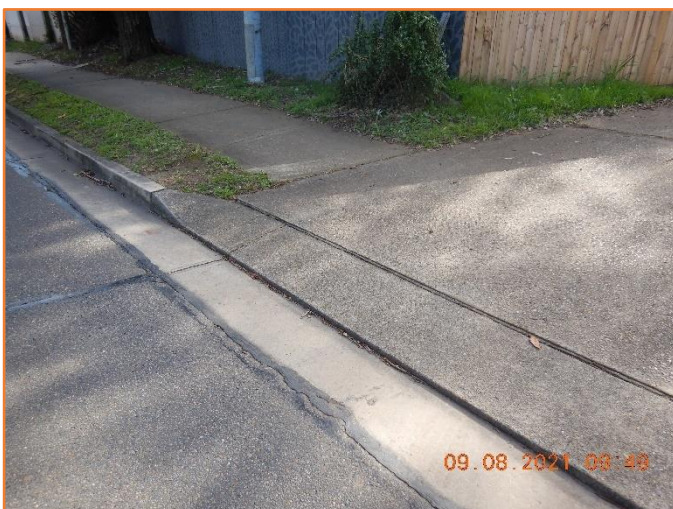
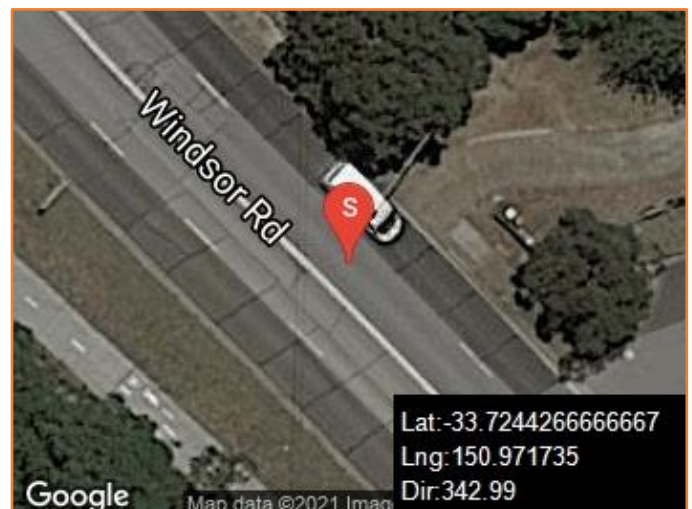
Figure 354: Reasonable - General condition of driveway crossover.

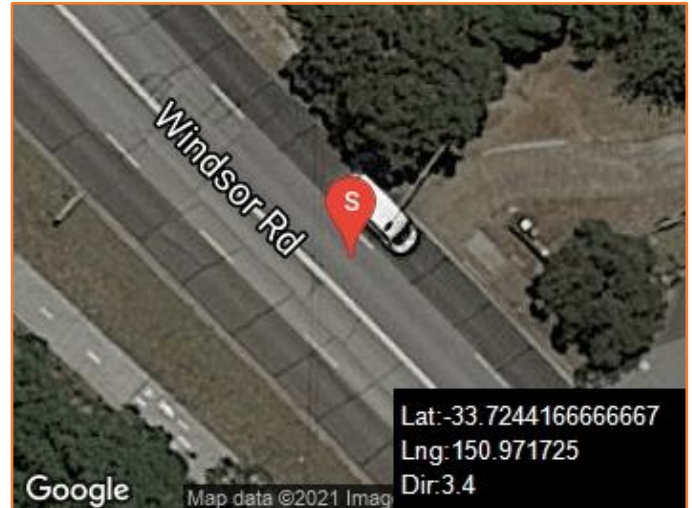
Figure 355: Reasonable - General condition of kerb and gutter.

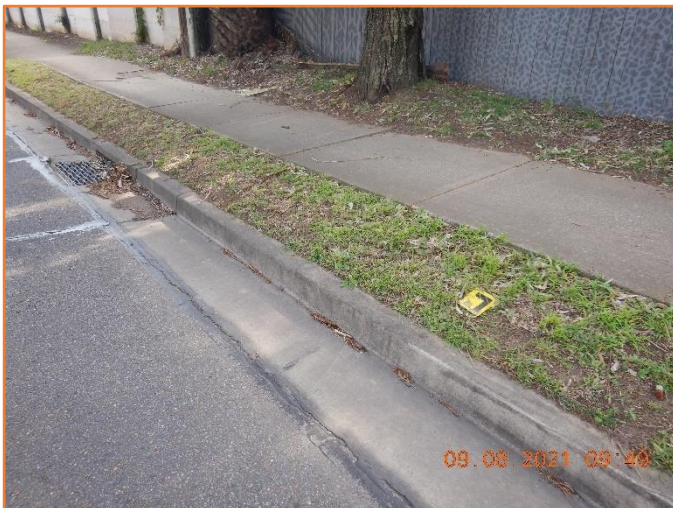
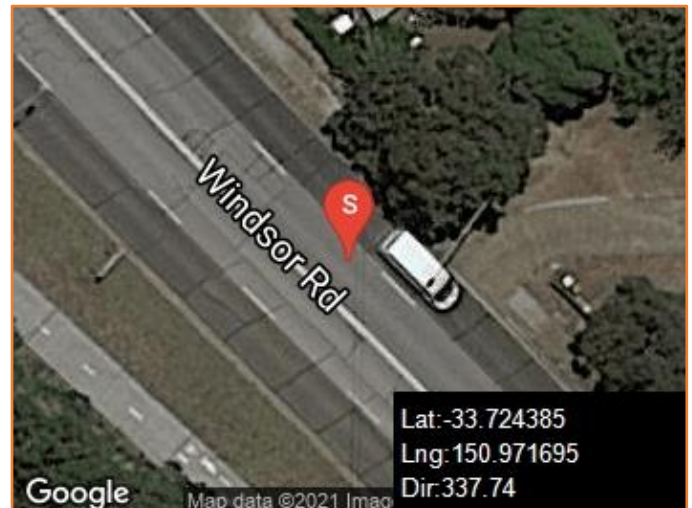
Figure 356: Reasonable - General condition of kerb and gutter.

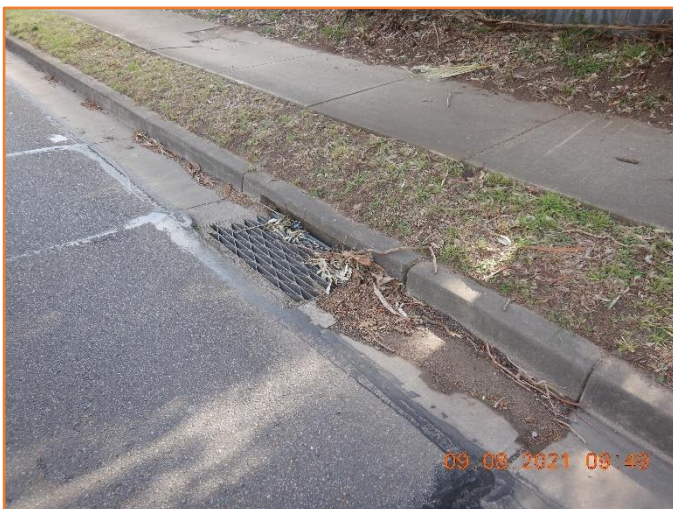
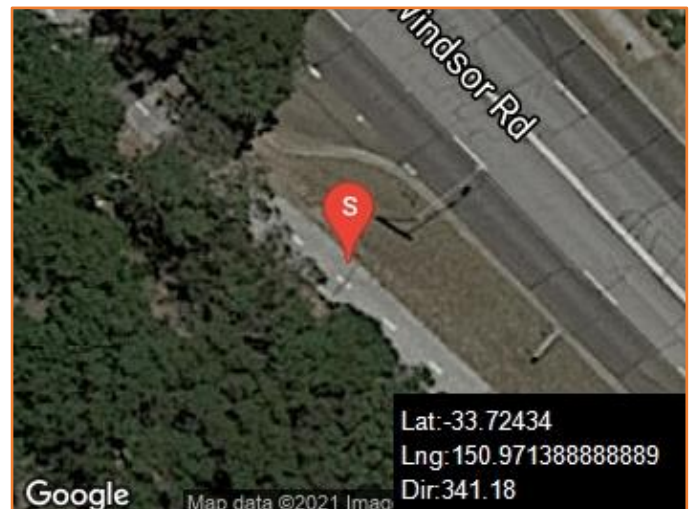
Figure 357: Poor - General condition of kerb inlet pit. Extensive debris build-up observed.

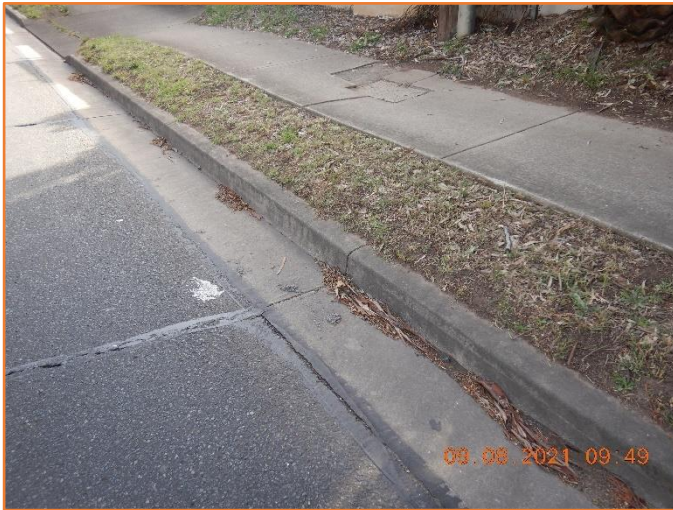
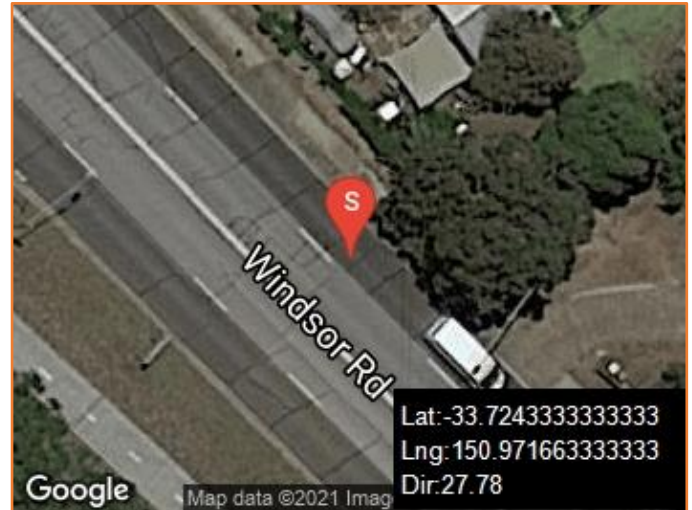
Figure 358: Reasonable - General condition of kerb and gutter.
