Arboriculture Impact Assessment Report

**Site Assessment Conducted and Report Prepared by:
The Tree MD Pty. Ltd. Geoffrey Ashton AQF 5 in Arboriculture**

**Hastings Secondary College Port Macquarie Campus
Owen St Port Macquarie NSW**

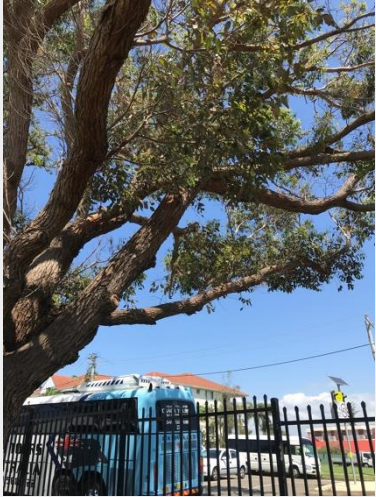
<p>Hard surfaces will need to be above great to avoid damage to read systems</p>

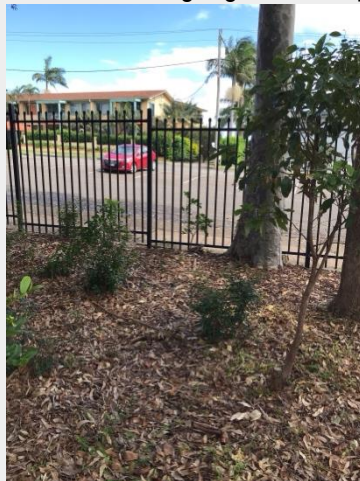
31

Entrance and signage in close proximity to

tree further investigation above grade
construction redesign with porous pavement

Preliminary non-invasive excavation (root mapping) by an AQF level 5 arborist will provide additional information to determine acceptable elevations and the potential size of the path between Trees 30 and 34 the signage is a potential encroachment on the subject trees as well as the hard surface within Tree 4's Tree Protection Zone. The use of porous pavement above the existing root systems allows for water and gaseous exchange and a viable retention option for the subject trees. The stormwater trench between Trees 30 and 34 will also require adjustment to minimise impacts. It is noted this would need to be installed in a tree sensitive manner without compaction root systems. The root mapping can also determine potential impacts or allow for a non-destructive installation of services within any formulated Tree Protection Zones. The below grade cut along of the access ramp under Tree 42 will need preliminary investigation to provide evidence this is achievable without adverse impacts on the tree.

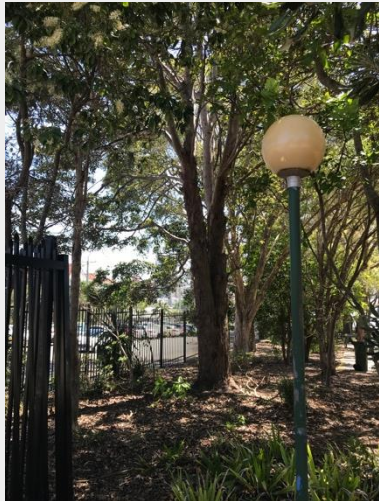
Proposed entrance is within 1 m of tree
redesign about grade for the non-invasive
investigation required

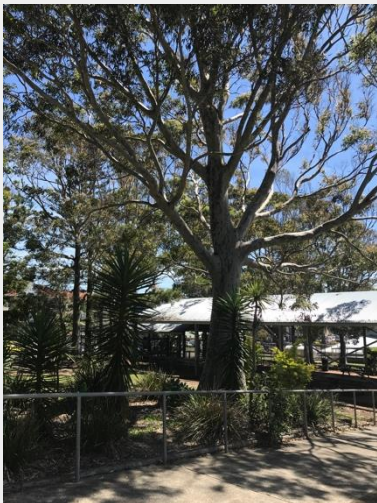
42

Crown lifting of northern and eastern
branches 400mm Final cut

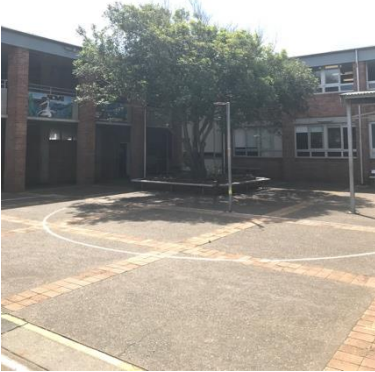
53

A lopped since first assessment

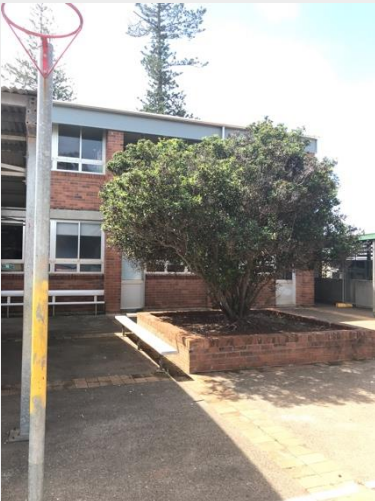
54

Lopped since first assessment

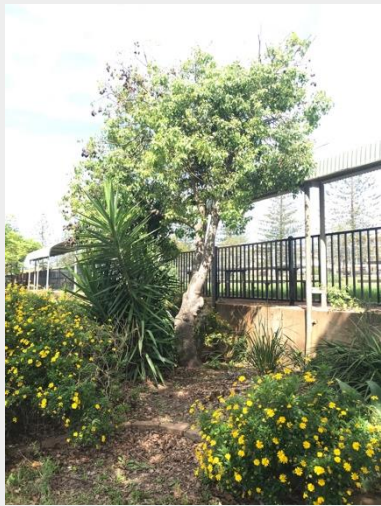
Services are a major encroachment
