Report on  
Hazardous Building Materials (HBM) Survey

Hastings Secondary College - Port Macquarie Campus  
16 Owen Street, Port Macquarie

Prepared for  
School Infrastructure NSW  
on behalf of Department of Education

Project 89754.01  
April 2021

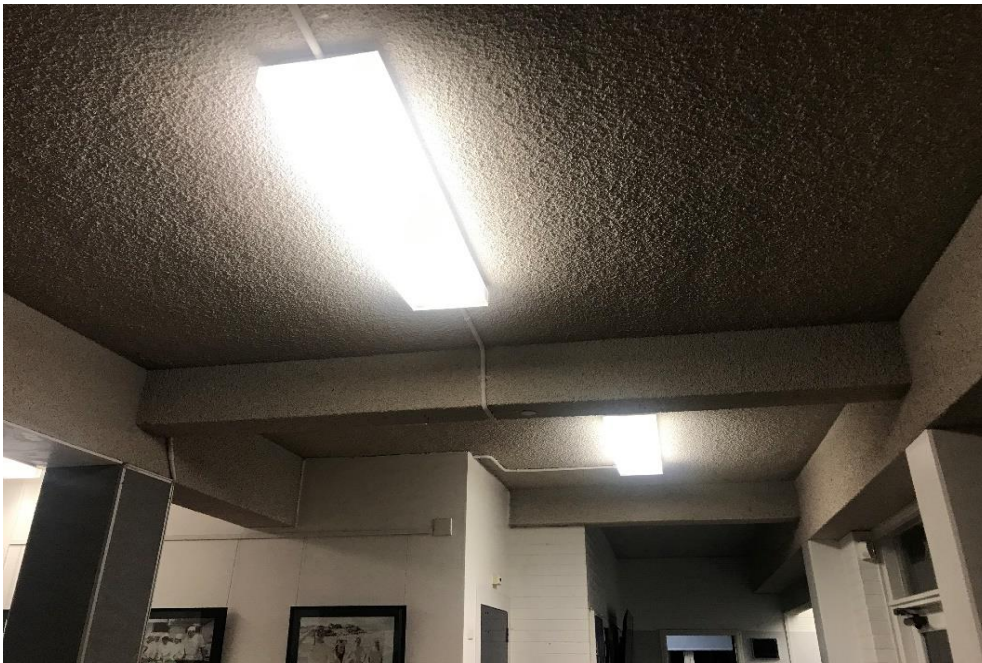
Photograph 6: B00A, AR0022, ceiling, eastern end of room, vermiculite, no asbestos detected by analysis, SMF detected.

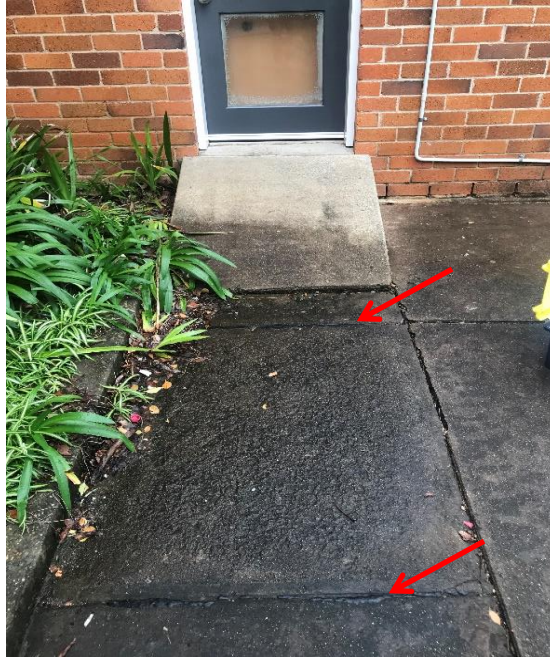
Photograph 15: B00A, exterior, paving outside AR0036, expansion gap, bitumastic, asbestos detected by analysis.

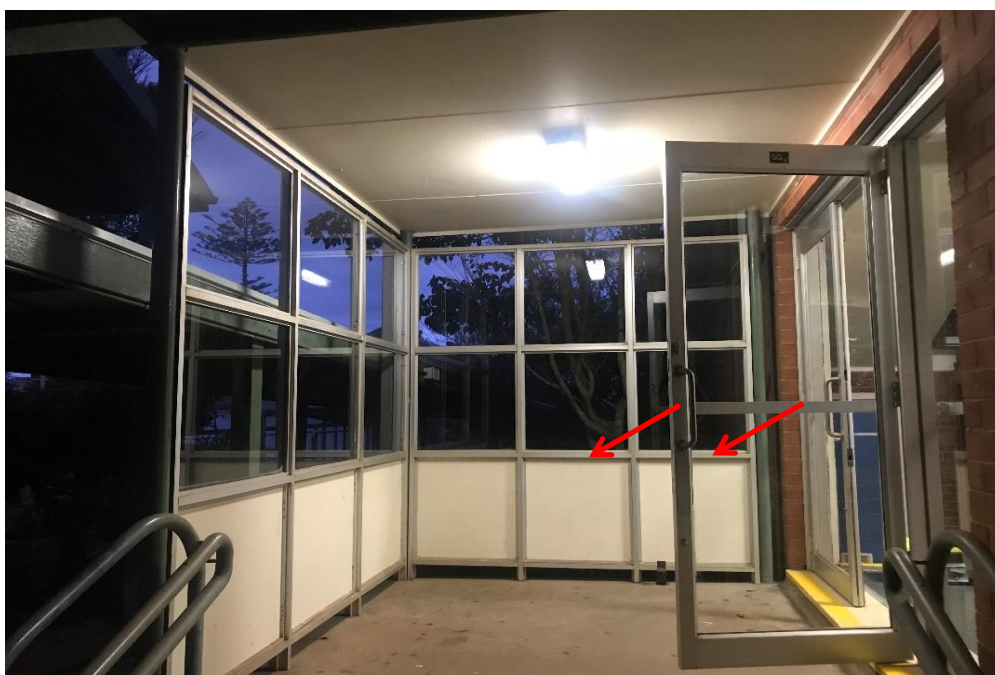
Photograph 10: B00B, BR0019, portion of infill panels (type 3), fibre cement, asbestos detected by analysis.

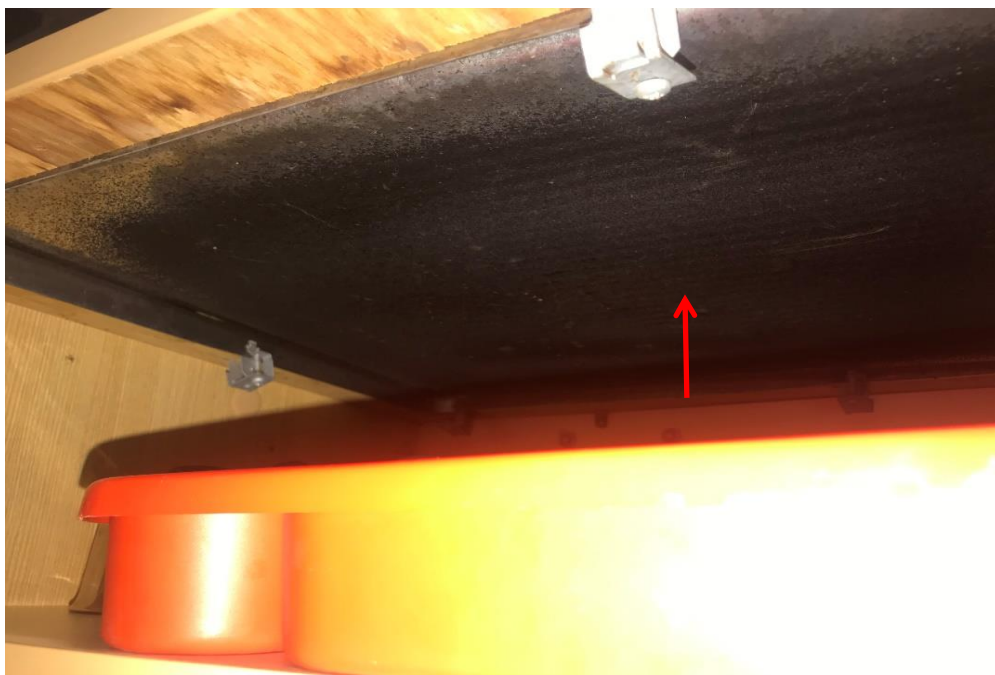
Photograph 12: B00B, BR1002, underside of sink, bituminous lining, asbestos detected by analysis.

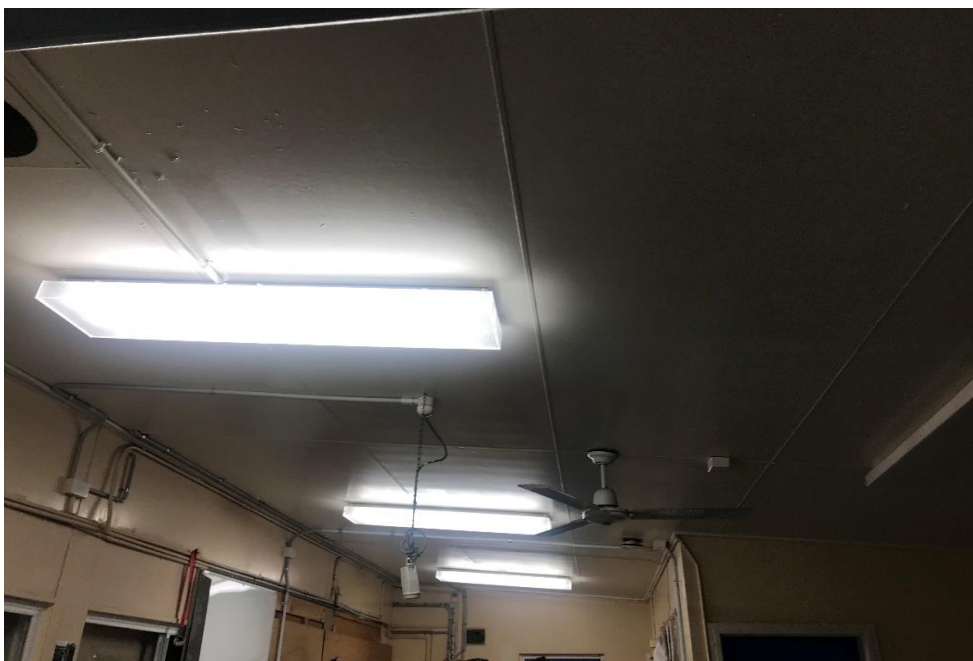
Photograph 4: B00C, CR0001, ceiling, fibre cement sheeting, asbestos detected by analysis.

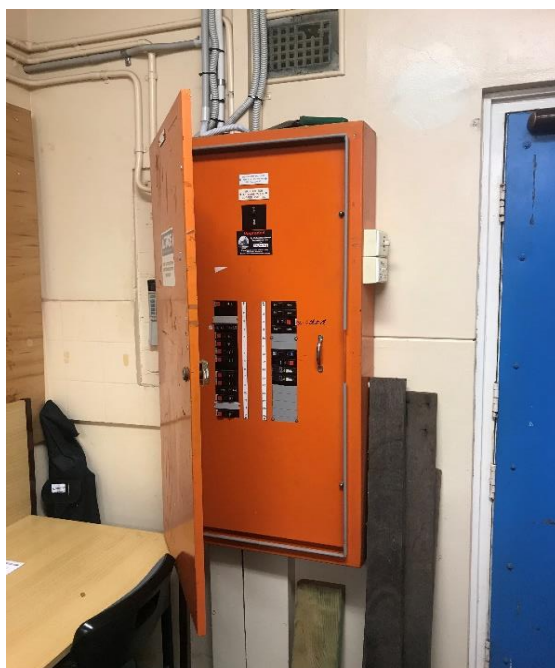
Photograph 5: B00C, CR0001, electrical cabinet, resinous board, asbestos (assumed).

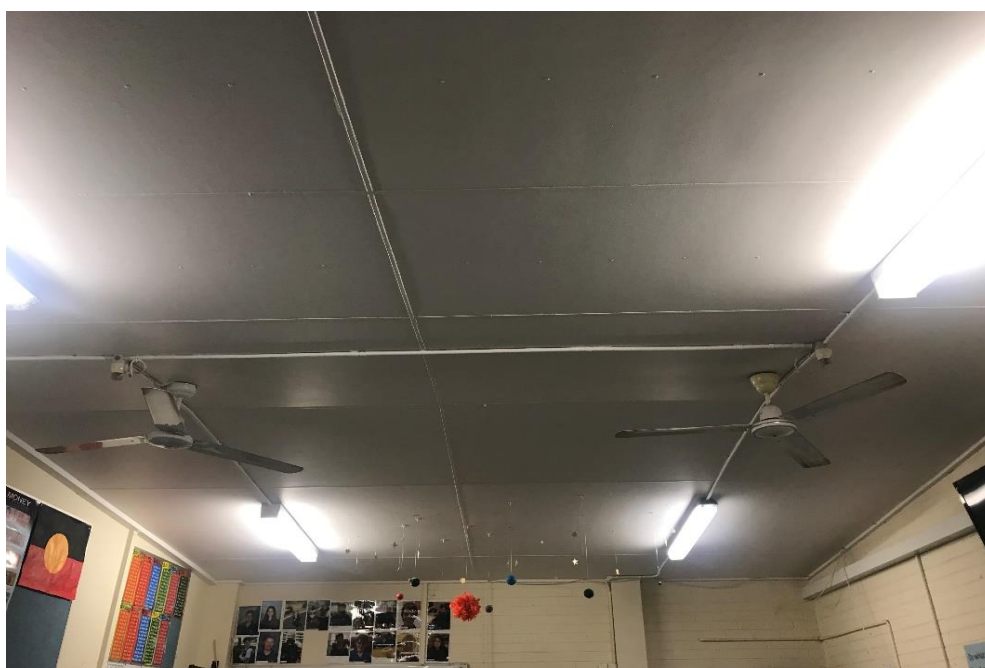
Photograph 6: B00C, CR0016, ceiling, fibre cement sheeting, asbestos detected by analysis.

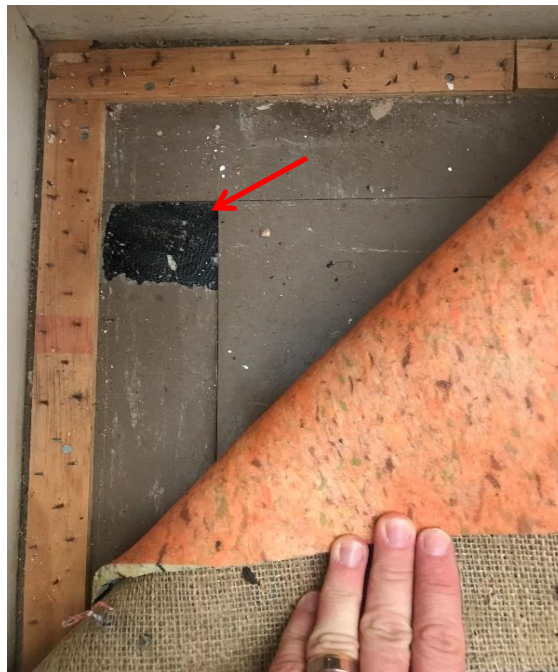
Photograph 12: Typical bituminous adhesive below vinyl tiles with white streaks, asbestos detected by analysis.

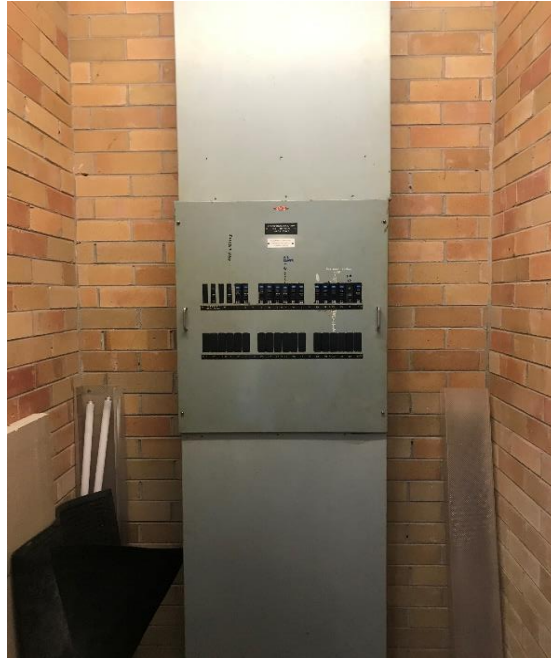
Photograph 19: B00L, LR1027 (adjacent west LR1028), enclosed within electrical cabinet, resinous backing board(s) and/or other components, asbestos (assumed).

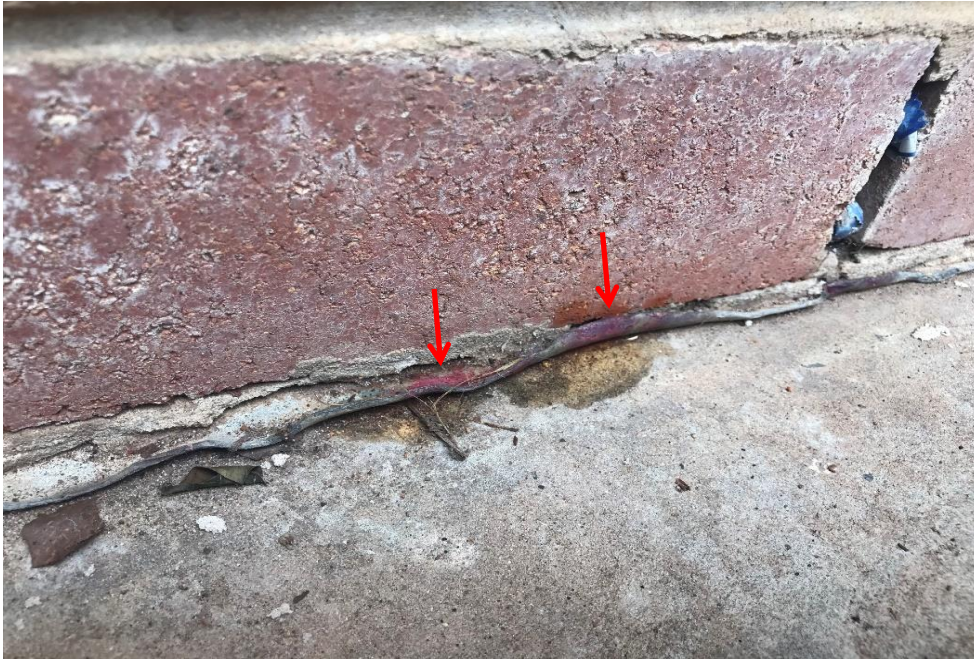
Photograph 23: B00L, exterior, western façade, northern end, typical flashing, positive for lead.

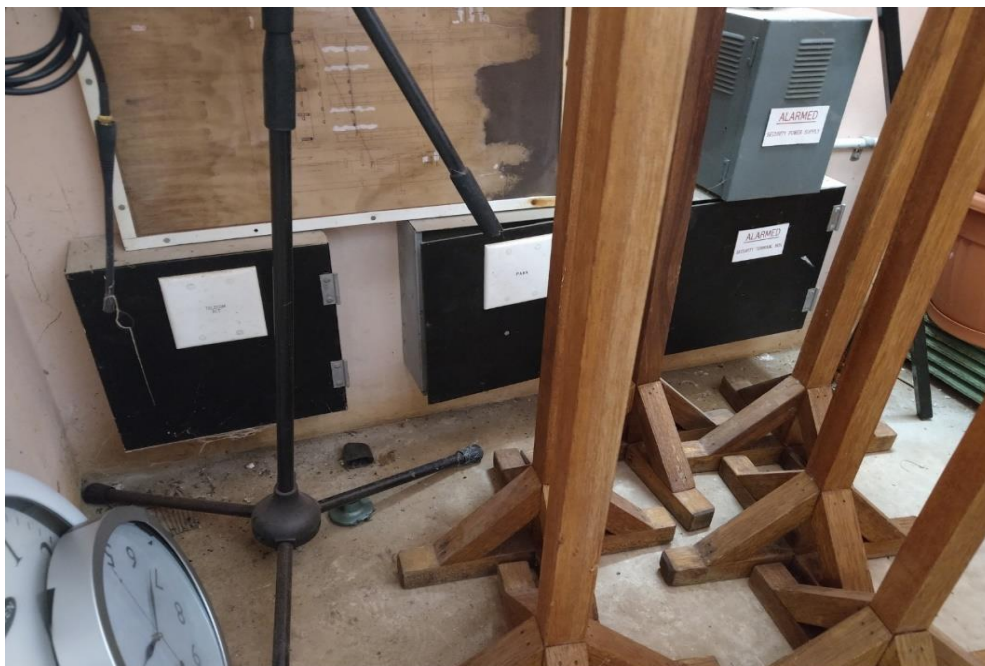
Photograph 6: BMPC, R0014, electrical cupboard, electrical backing board(s), asbestos (assumed).

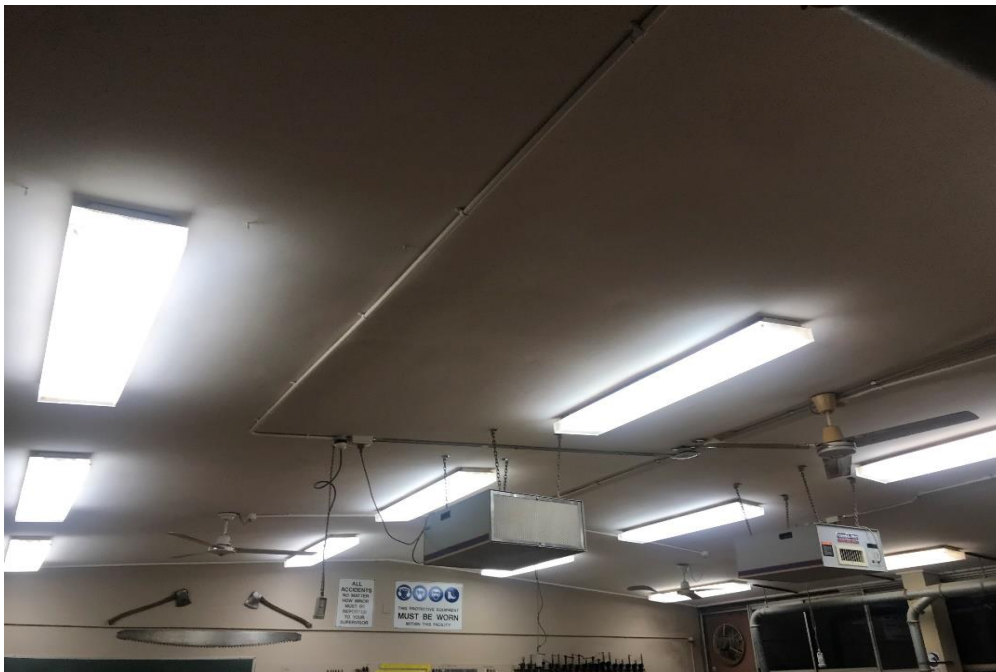
Photograph 4: BTAS, rooms and areas in general, fluorescent light fittings in general, capacitors, insulating oil, PCB (assumed).
