**2 MANDALA PARADE, CASTLE HILL
(DORAN DRIVE PRECINCT)
PRE-DILAPIDATION REPORT
Of Sydney Metro and Hills Shire Council Assets
DEICORP PROJECTS SHOWGROUND
PTY LTD.**

Job No. 200124.3
07/07/2021

ACE Structural Services Pty Ltd

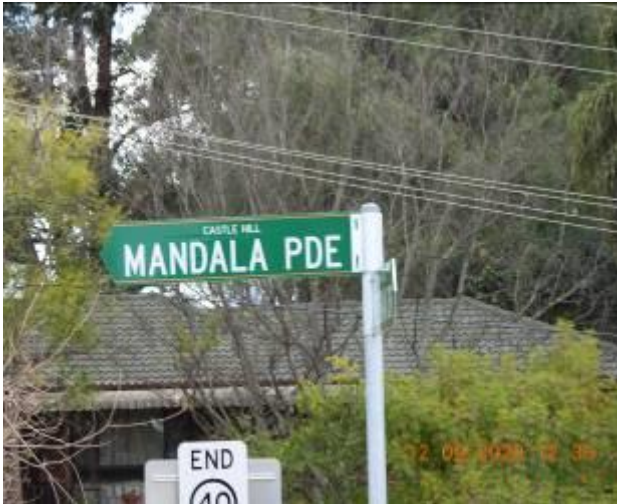
Figure 1 – The following images display the condition of Mandala Parade Council Assets

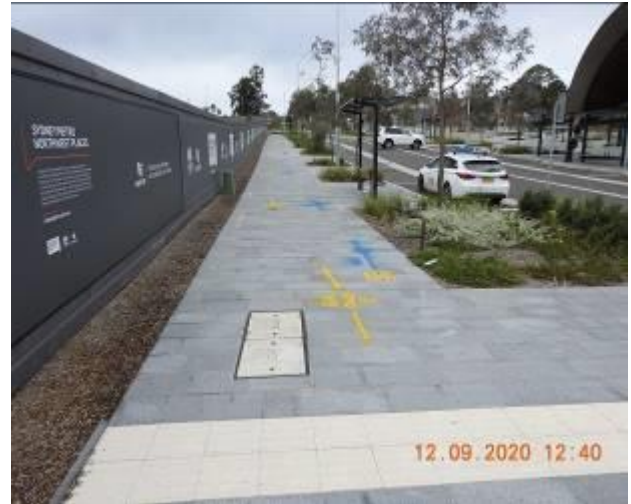
Figure 2 – General condition of footpath pavement heading East

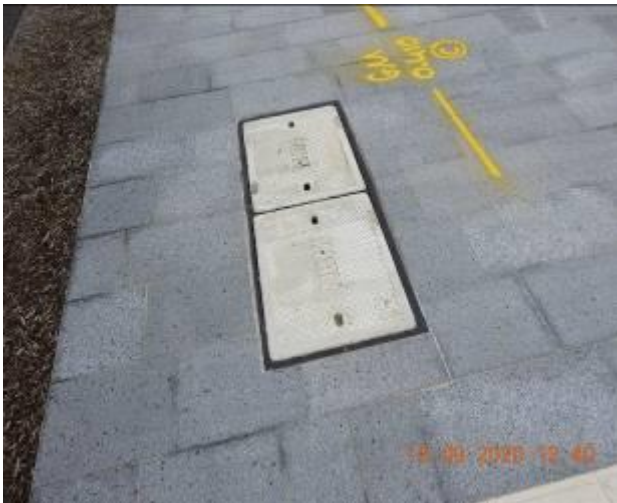
Figure 3 – General condition of service pit

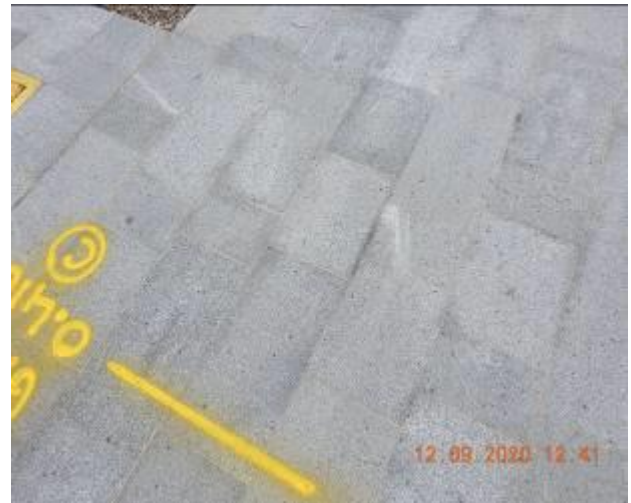
Figure 4 – Crack propagation and efflorescence through footpath pavement

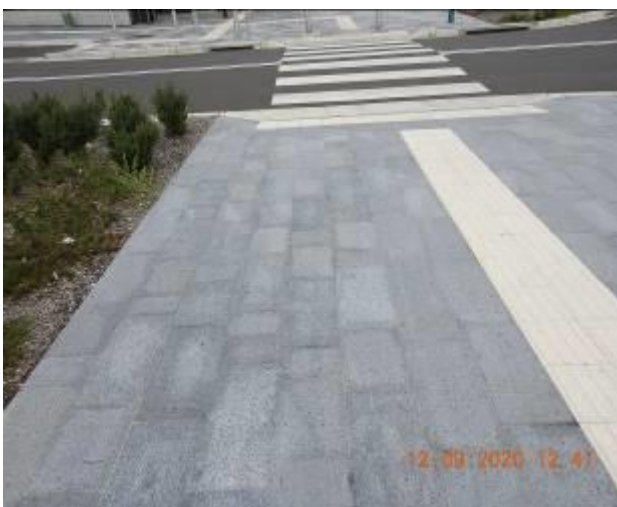
Figure 5 – General condition of footpath pavement

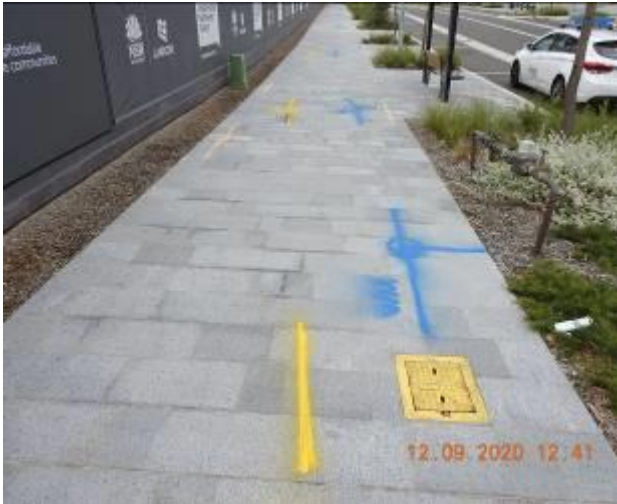
Figure 7 – General condition of service pit

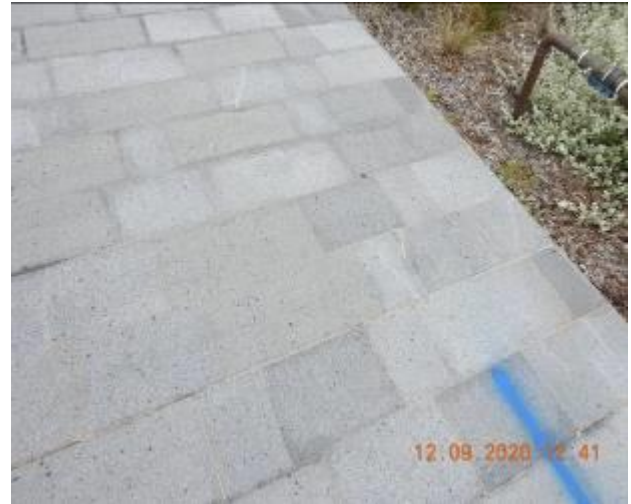
Figure 8 – Hairline cracking and efflorescence through footpath pavement

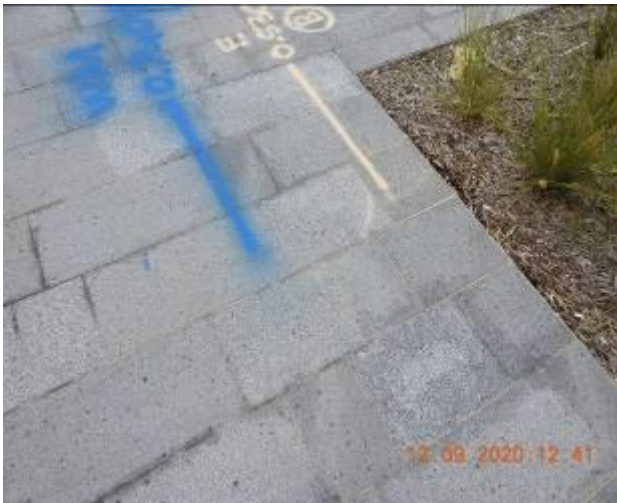
Figure 9 – Hairline cracking and efflorescence through footpath pavement

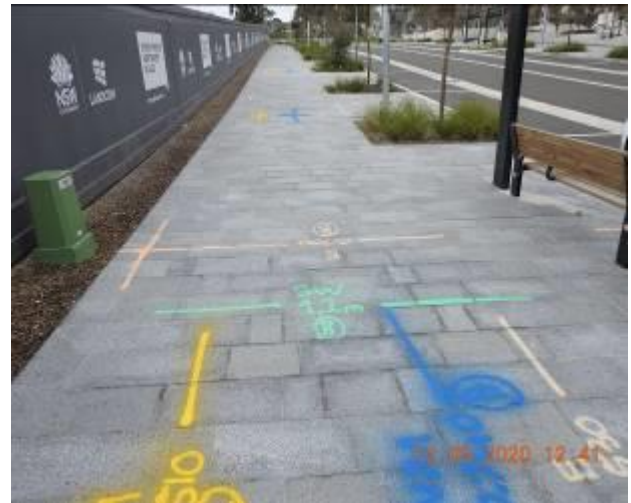
Figure 10 – General condition of footpath pavement

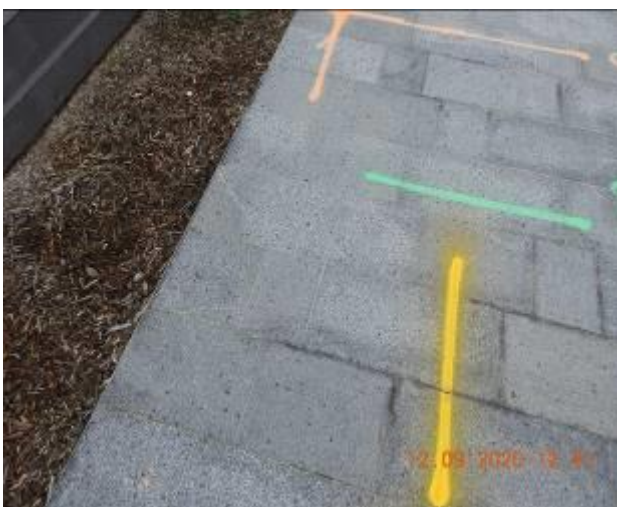
Figure 11 – Hairline cracking and efflorescence through footpath pavement

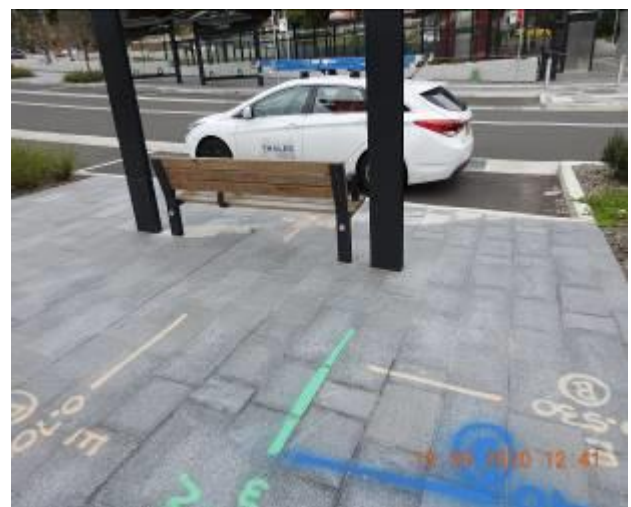
Figure 12 – General condition of footpath pavement

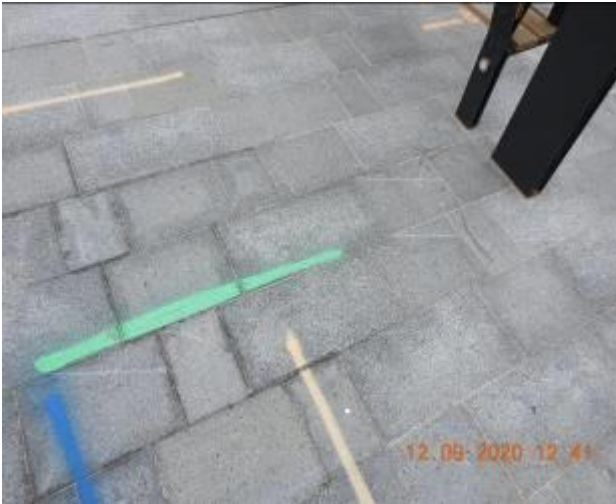
Figure 13 – Hairline cracking and efflorescence through footpath pavement

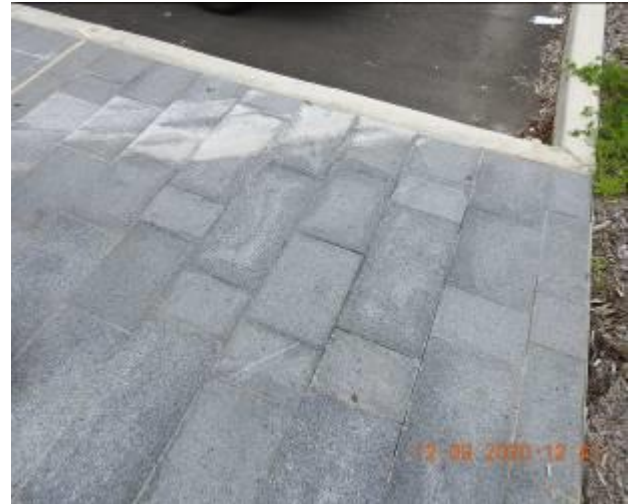
Figure 14 – Hairline cracking and efflorescence through footpath pavement

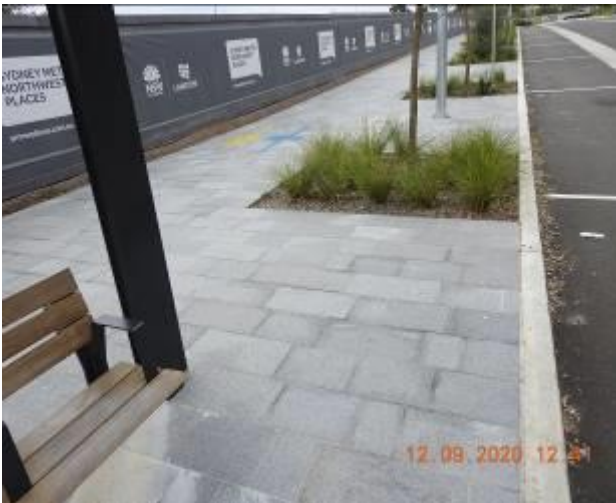
Figure 15 – General condition of footpath pavement

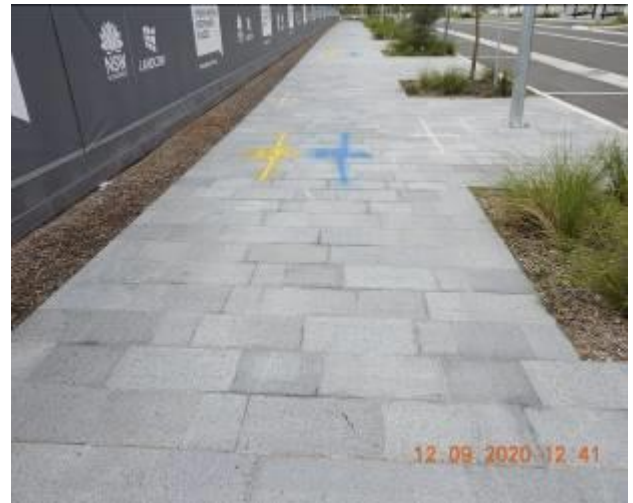
Figure 16 – General condition of footpath pavement

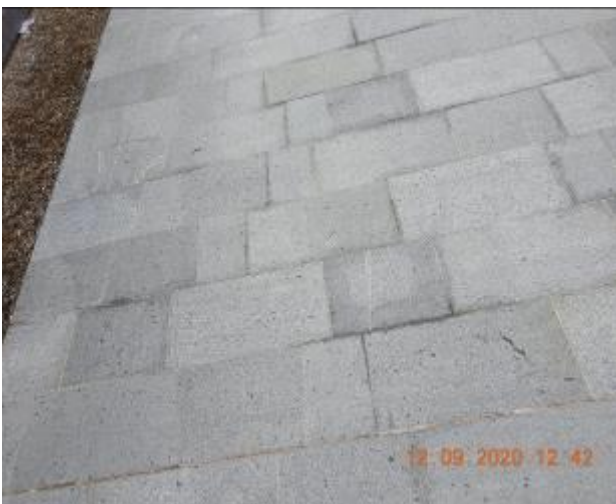
Figure 17 – Efflorescence through footpath pavement

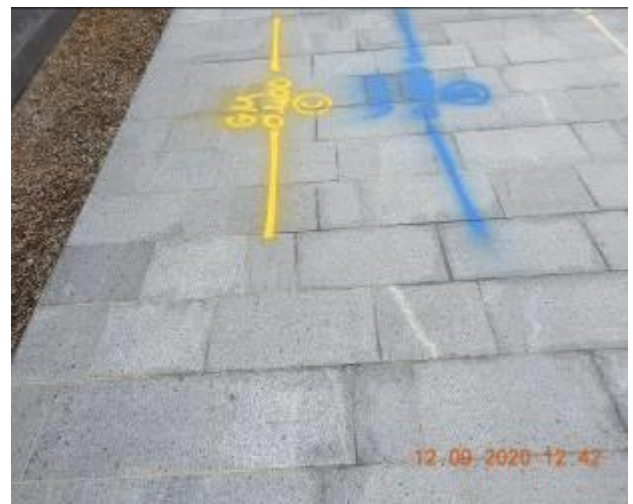
Figure 18 – Hairline cracking and efflorescence through footpath pavement

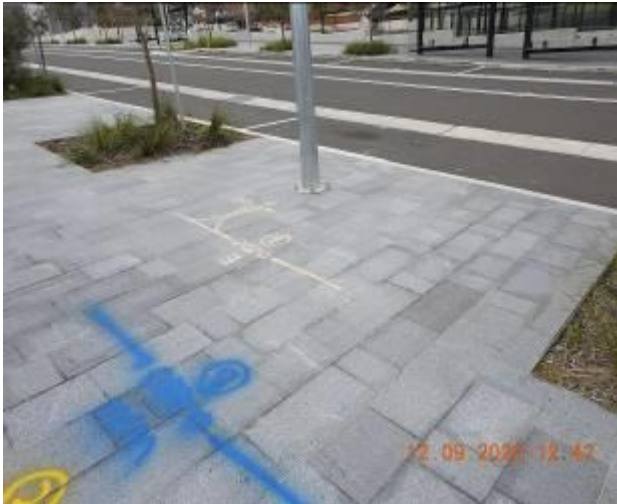
Figure 19 – Hairline cracking and efflorescence through footpath pavement

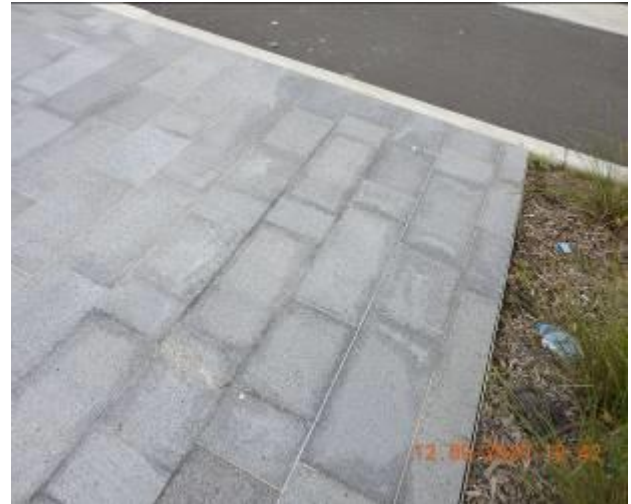
Figure 20 – Hairline cracking and efflorescence through footpath pavement

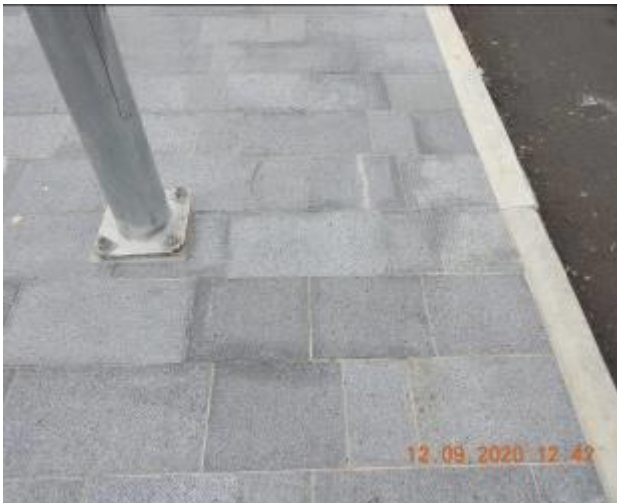
Figure 21 – Hairline cracking and efflorescence through footpath pavement

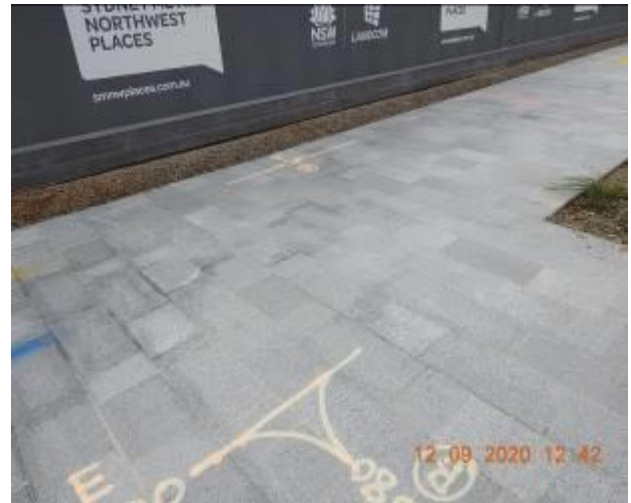
Figure 22 – General condition of footpath pavement

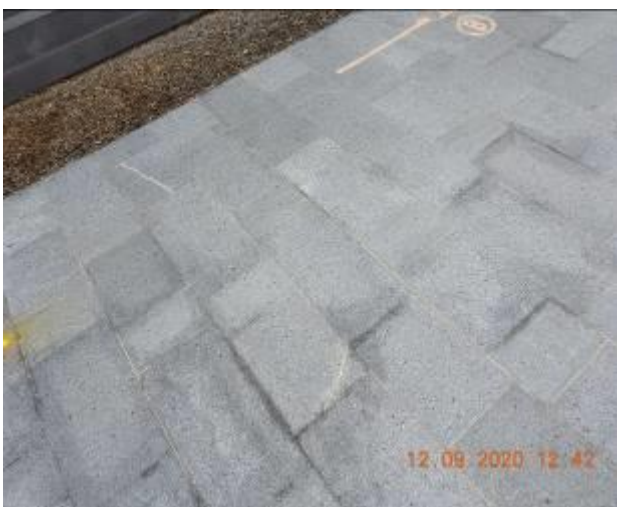
Figure 23 – Hairline cracking and efflorescence through footpath pavement

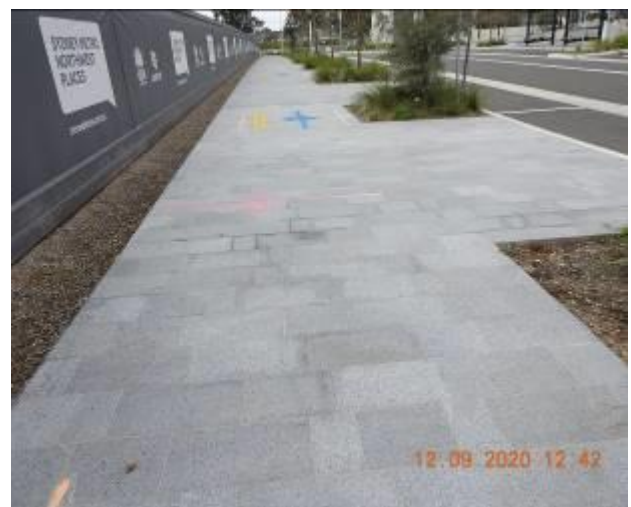
Figure 24 – General condition of footpath pavement

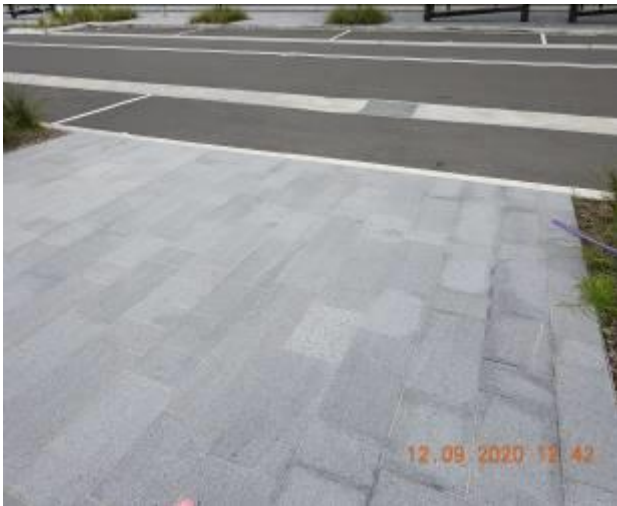
Figure 25 – General condition of footpath pavement

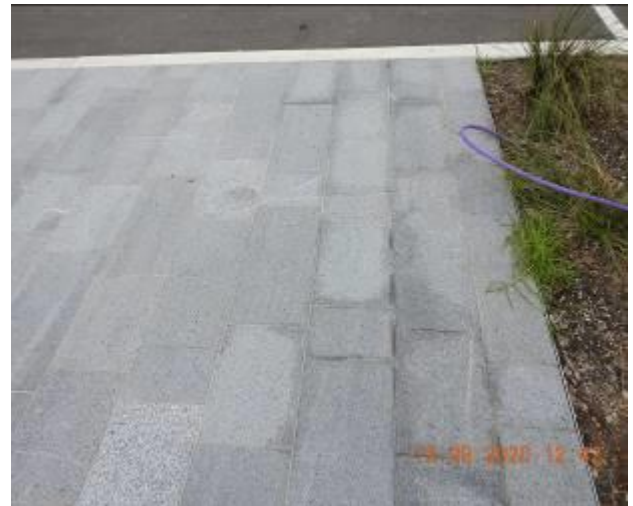
Figure 26 – Hairline cracking and efflorescence through footpath pavement

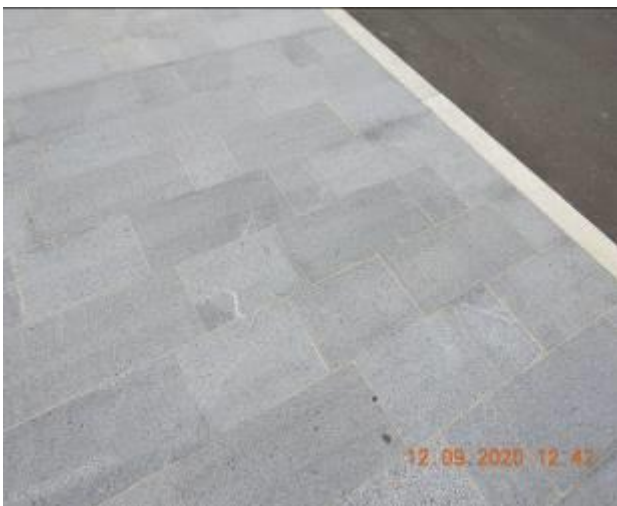
Figure 27 – Hairline cracking and efflorescence through footpath pavement

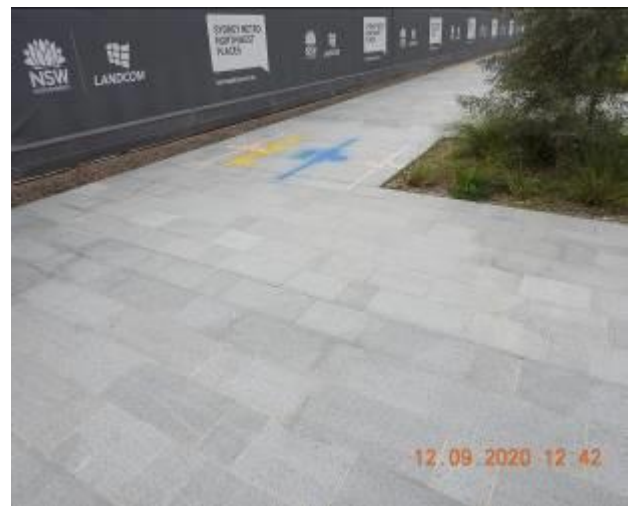
Figure 28 – General condition of footpath pavement

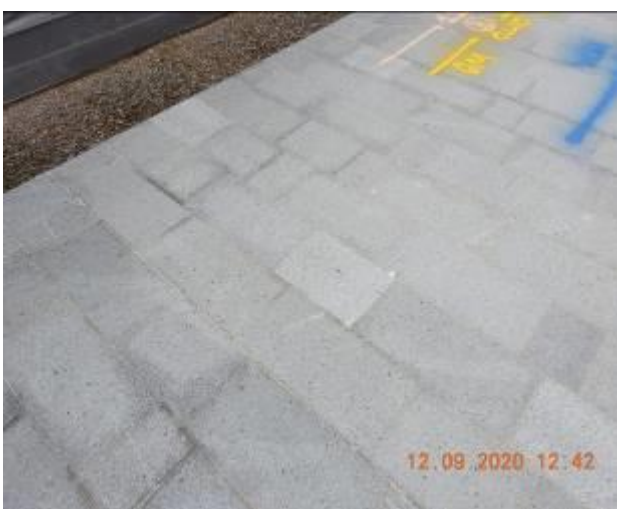
Figure 29 – Hairline cracking and efflorescence through footpath pavement

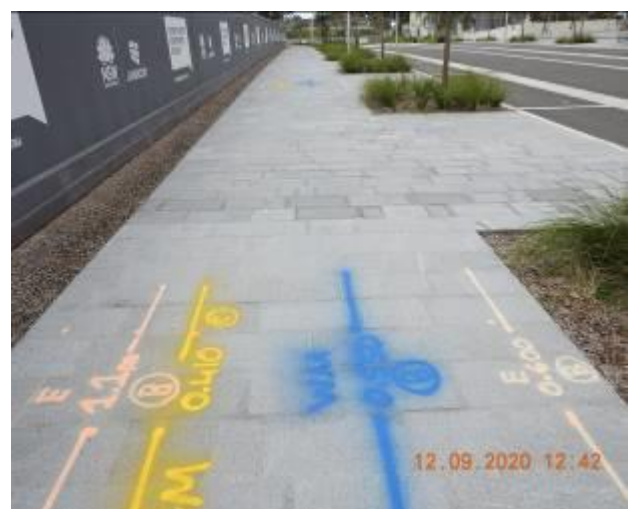
Figure 30 – General condition of footpath pavement

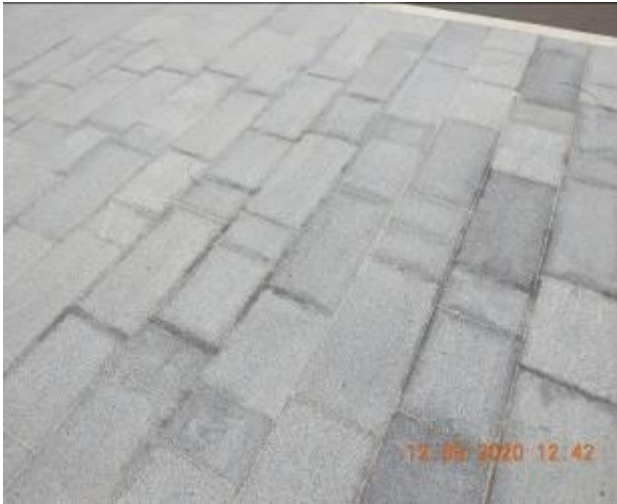
Figure 31 – Hairline cracking and efflorescence through footpath pavement

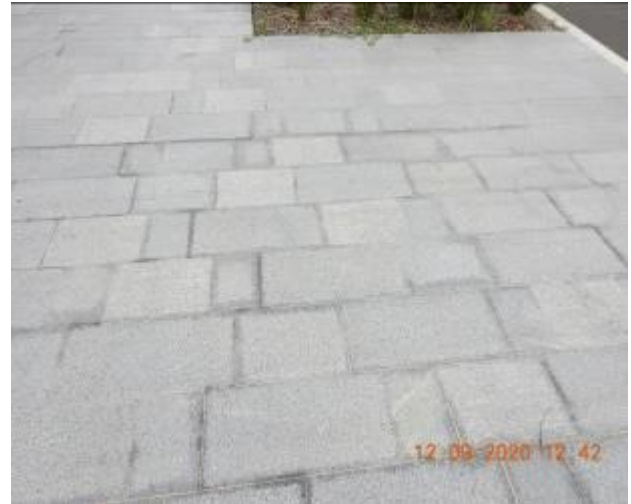
Figure 32 – Hairline cracking and efflorescence through footpath pavement

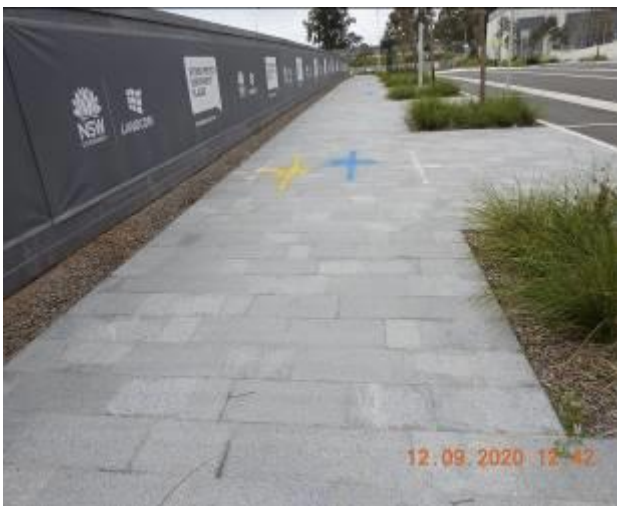
Figure 33 – General condition of footpath pavement

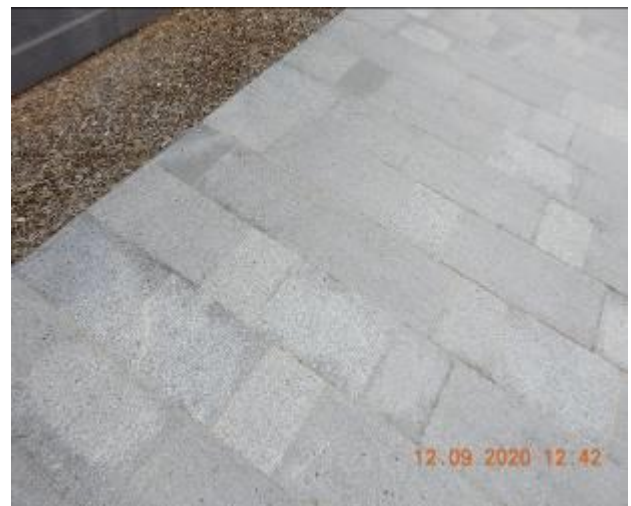
Figure 34 – Hairline cracking and efflorescence through footpath pavement

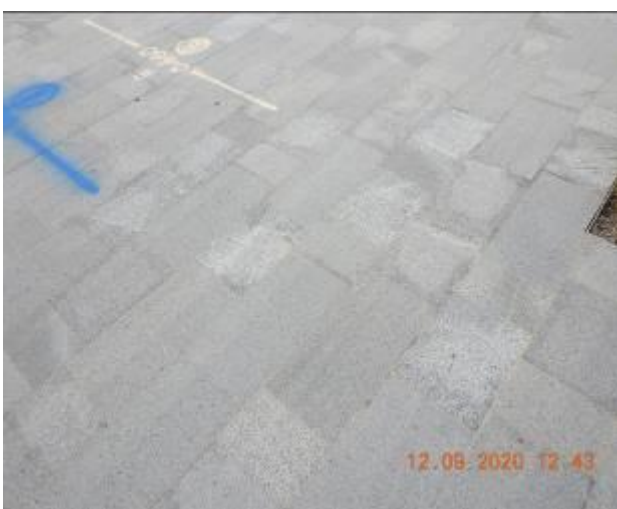
Figure 35 – Hairline cracking and efflorescence through footpath pavement

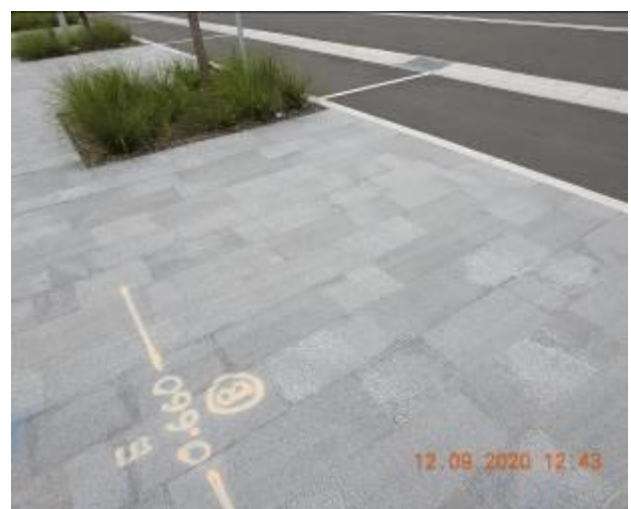
Figure 36 – Hairline cracking and efflorescence through footpath pavement

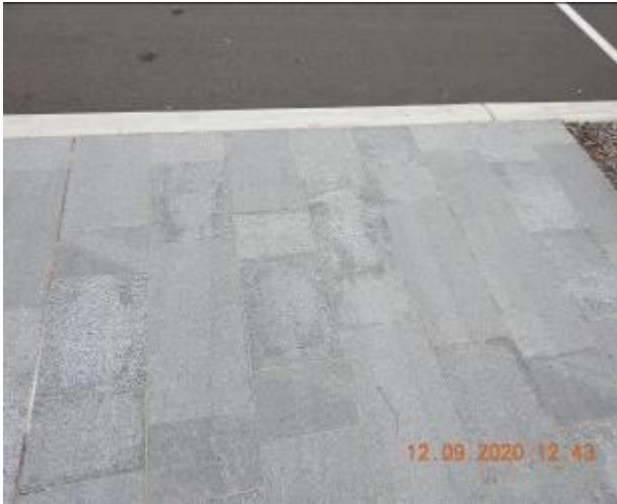
Figure 37 – Hairline cracking and efflorescence through footpath pavement

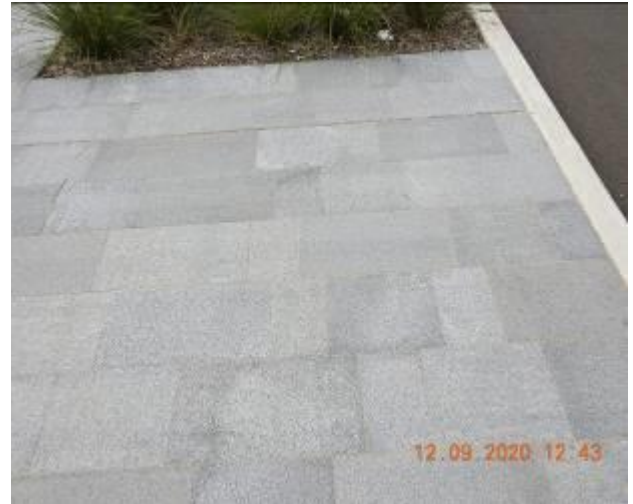
Figure 38 – Hairline cracking and efflorescence through footpath pavement

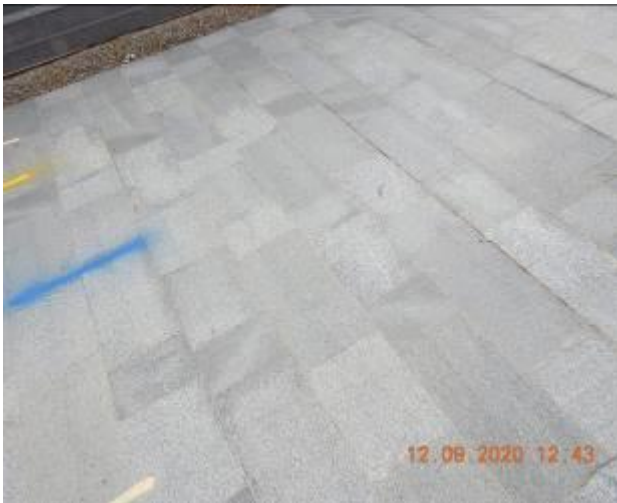
Figure 39 – Hairline cracking and efflorescence through footpath pavement

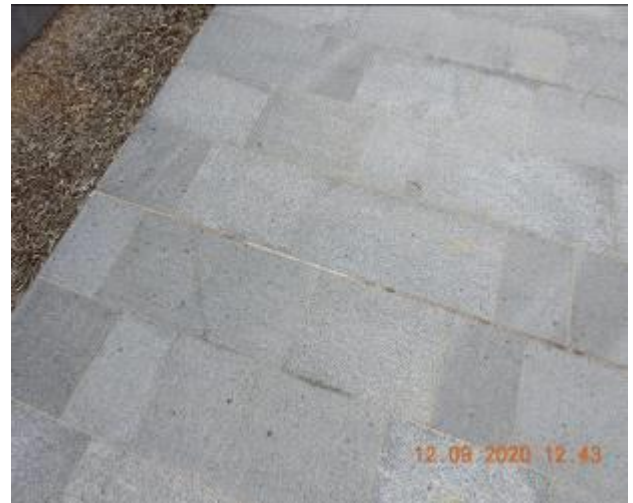
Figure 40 – Hairline cracking and efflorescence through footpath pavement

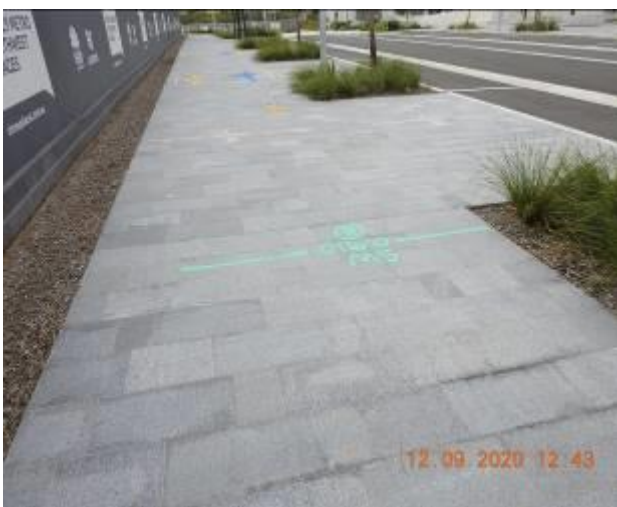
Figure 41 – General condition of footpath pavement

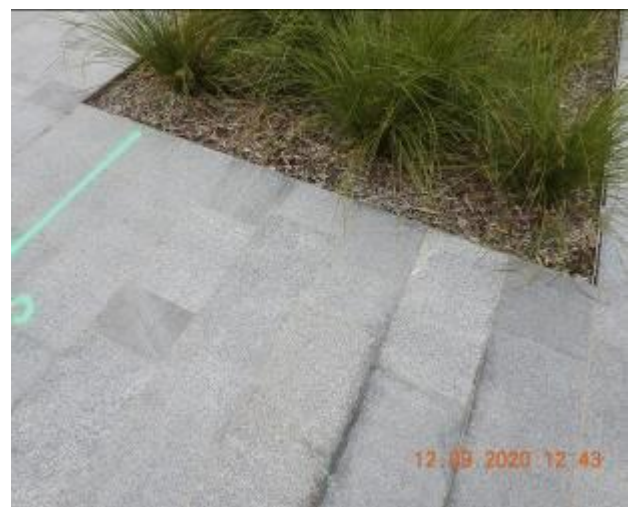
Figure 42 – Hairline cracking and efflorescence through footpath pavement

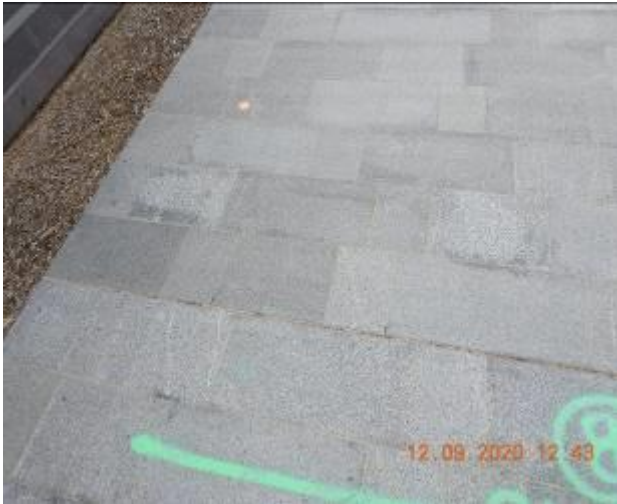
Figure 43 – Hairline cracking and efflorescence through footpath pavement

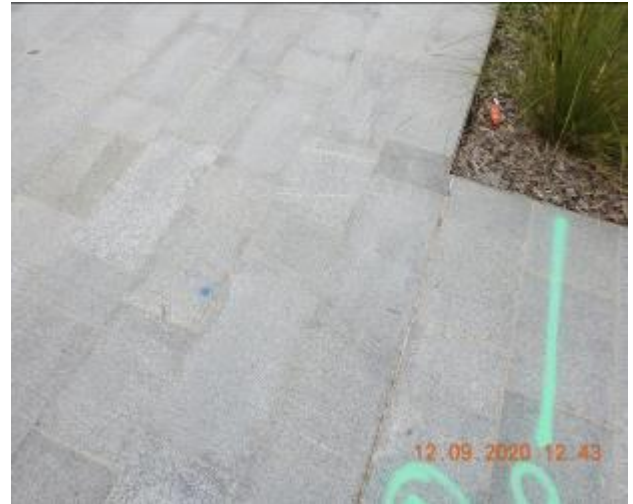
Figure 44 – Hairline cracking and efflorescence through footpath pavement

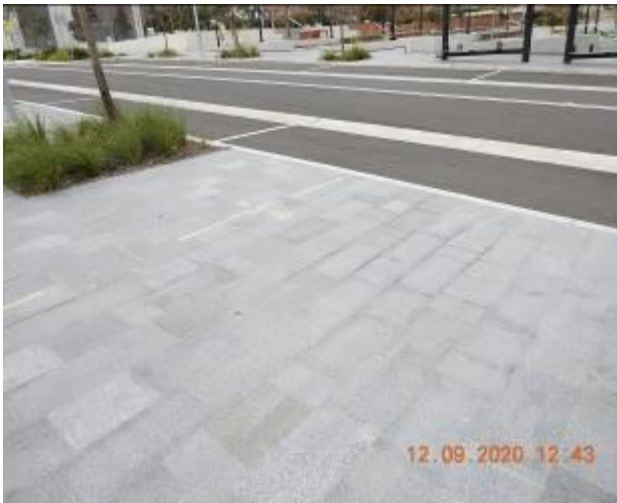
Figure 45 – Hairline cracking and efflorescence through footpath pavement

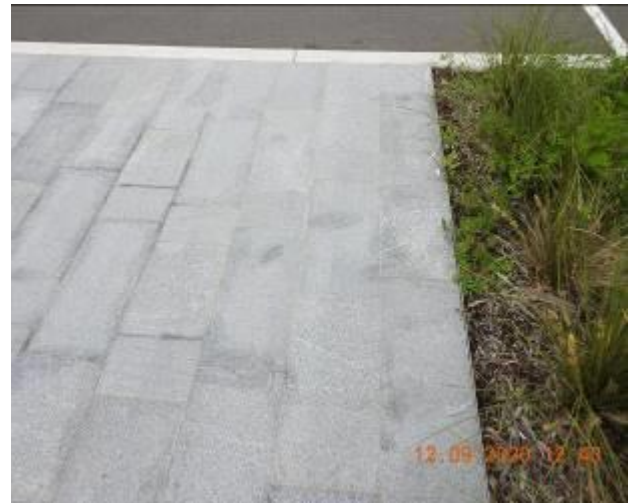
Figure 46 – Hairline cracking and efflorescence through footpath pavement

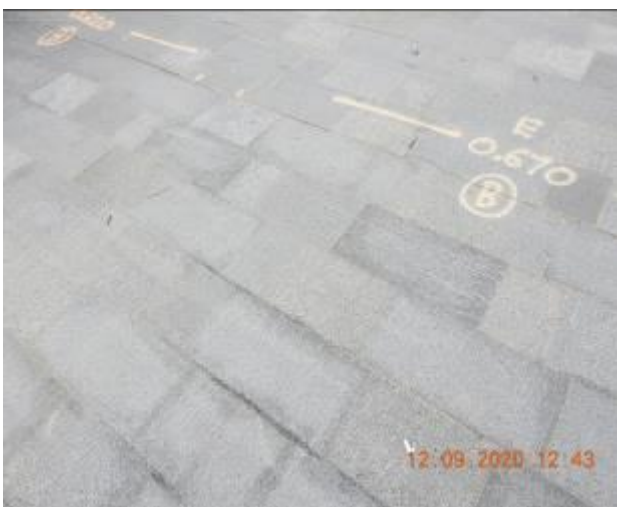
Figure 47 – Hairline cracking and efflorescence through footpath pavement

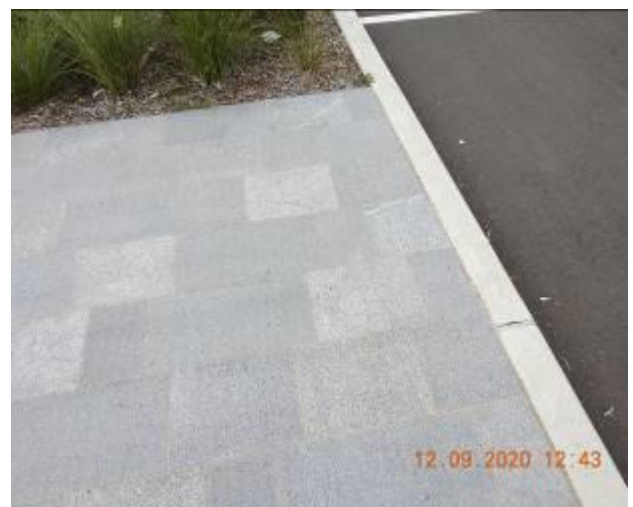
Figure 48 – Hairline cracking and efflorescence through footpath pavement

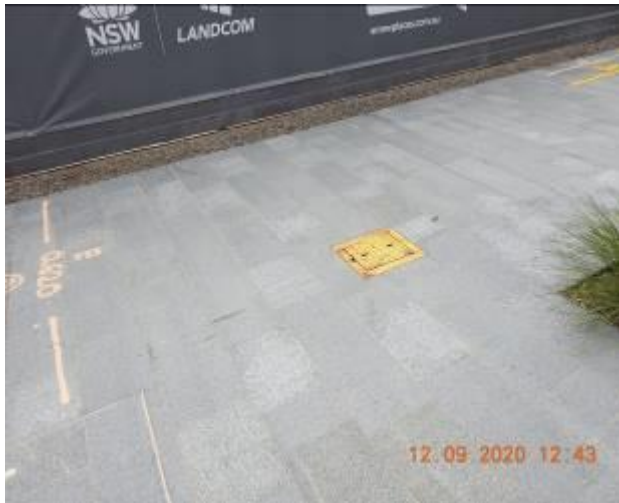
Figure 49 – General condition of service pit

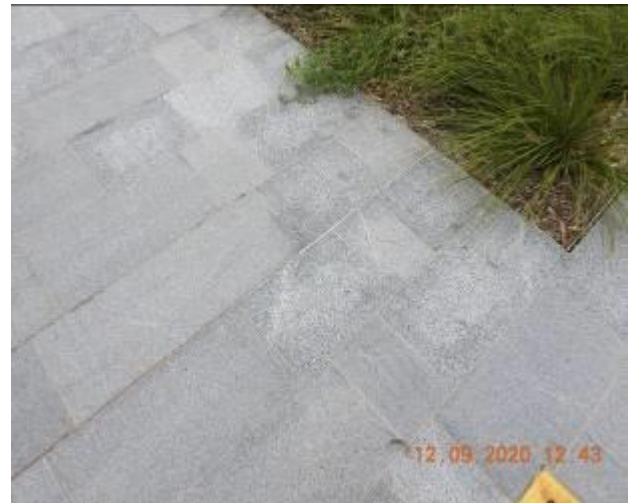
Figure 50 – Hairline cracking and efflorescence through footpath pavement

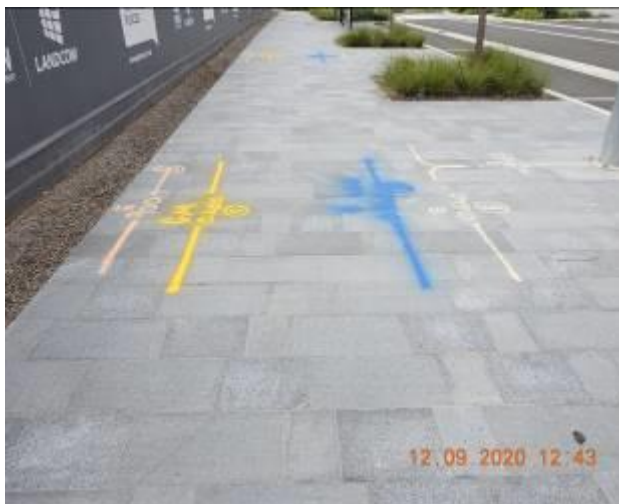
Figure 51 – General condition of footpath pavement

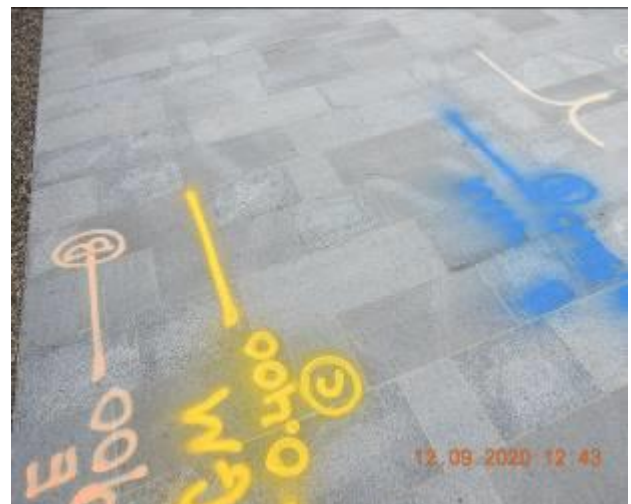
Figure 52 – Hairline cracking and efflorescence through footpath pavement

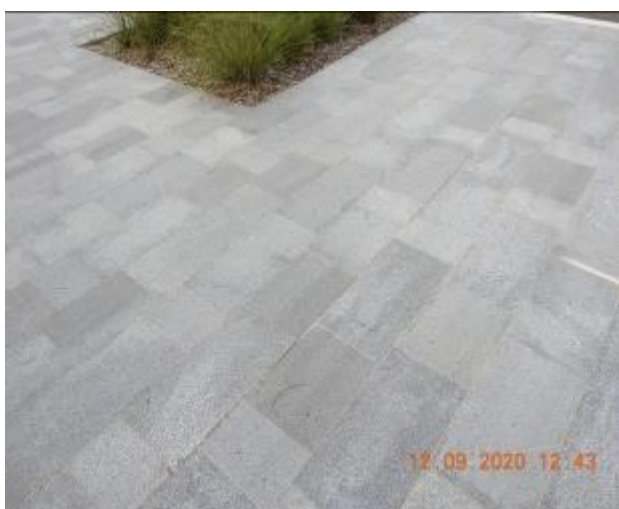
Figure 53 – Hairline cracking and efflorescence through footpath pavement

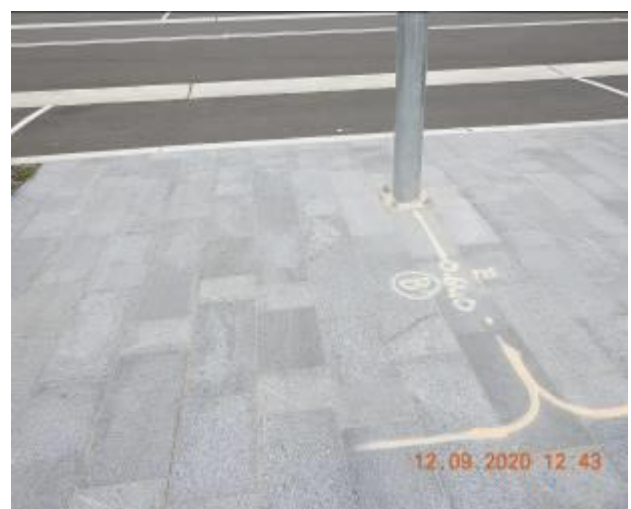
Figure 54 – Hairline cracking and efflorescence through footpath pavement

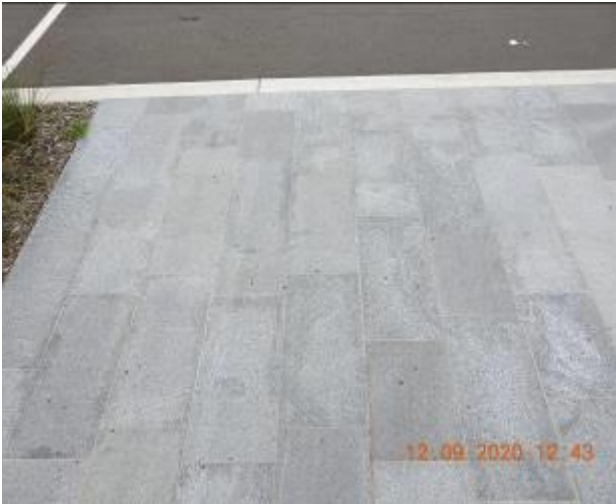
Figure 55 – Hairline cracking and efflorescence through footpath pavement

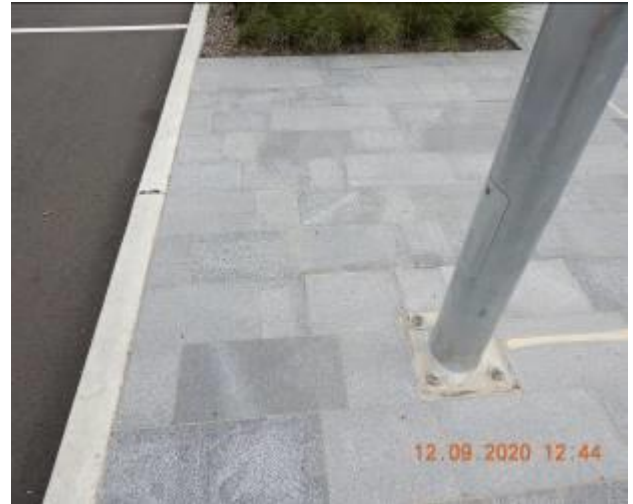
Figure 56 – Hairline cracking and efflorescence through footpath pavement

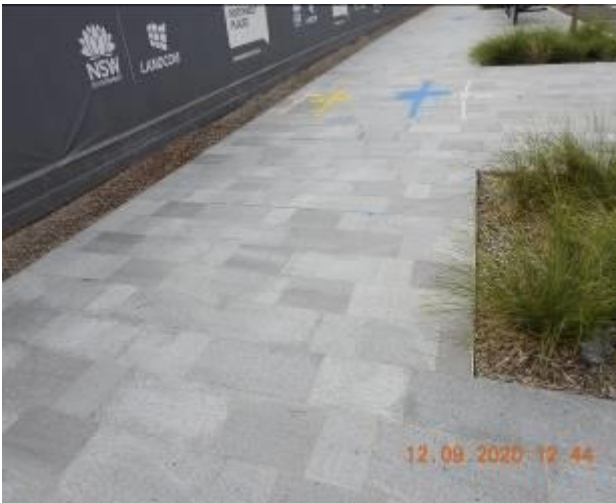
Figure 57 – General condition of footpath pavement

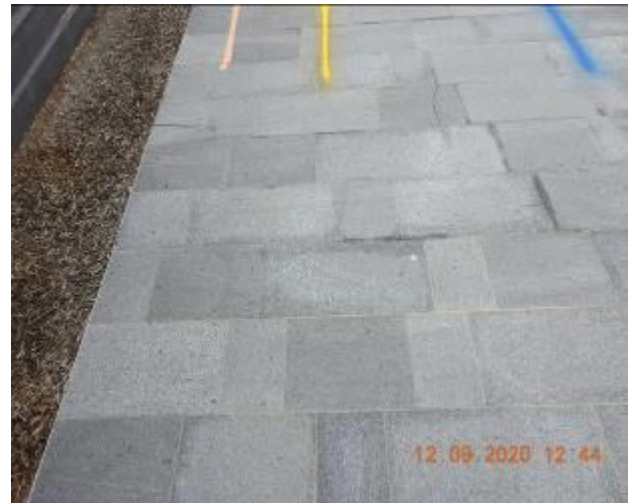
Figure 58 – Hairline cracking and efflorescence through footpath pavement

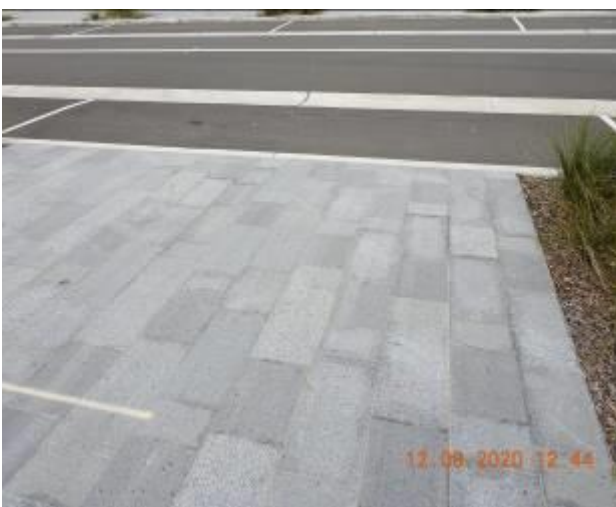
Figure 59 – Hairline cracking and efflorescence through footpath pavement

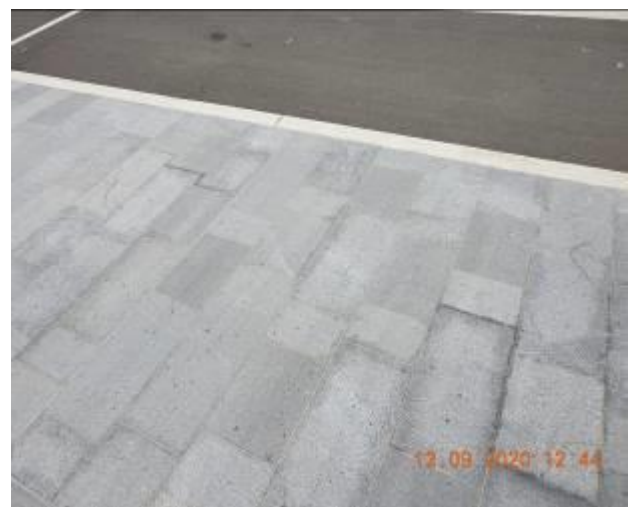
Figure 60 – Hairline cracking and efflorescence through footpath pavement

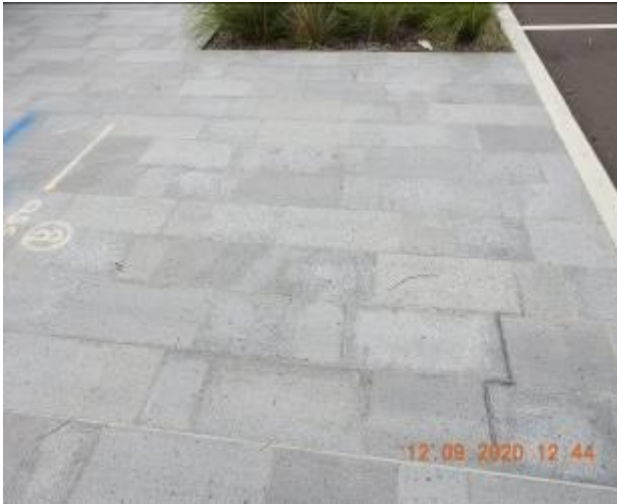
Figure 61 – Hairline cracking and efflorescence through footpath pavement

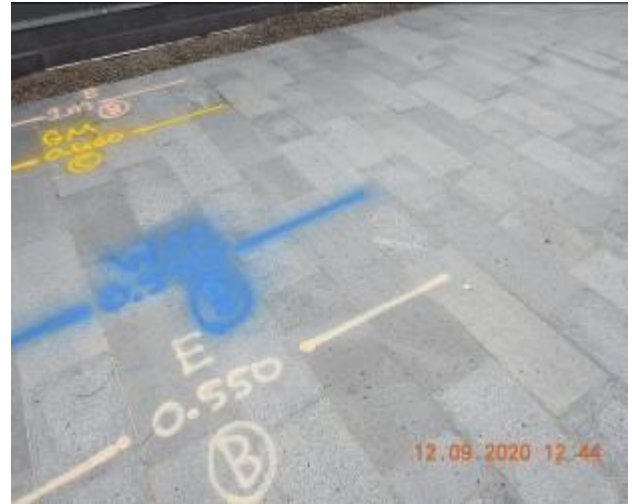
Figure 62 – Hairline cracking and efflorescence through footpath pavement

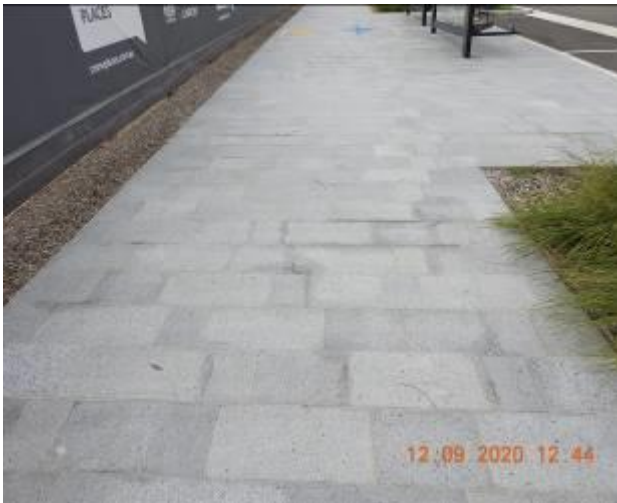
Figure 63 – General condition of footpath pavement

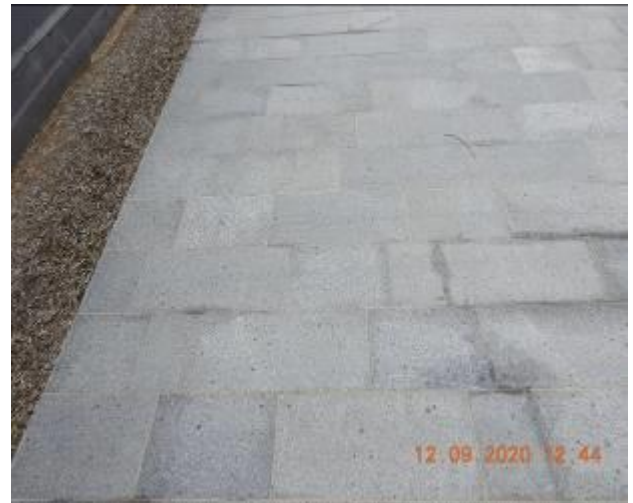
Figure 64 – Hairline cracking and efflorescence through footpath pavement

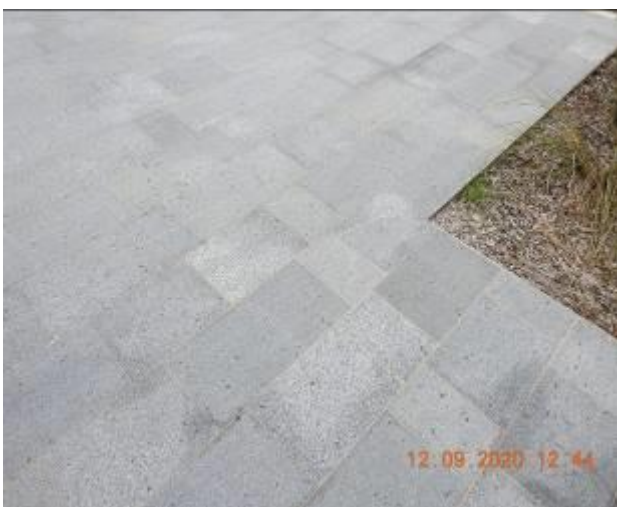
Figure 65 – Hairline cracking and efflorescence through footpath pavement

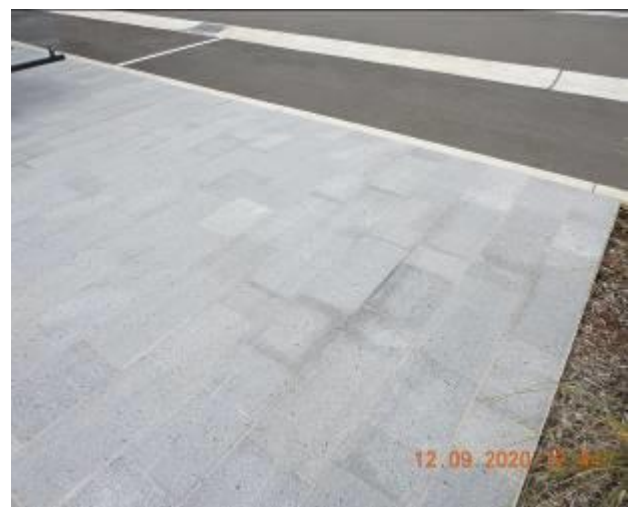
Figure 66 – Hairline cracking and efflorescence through footpath pavement

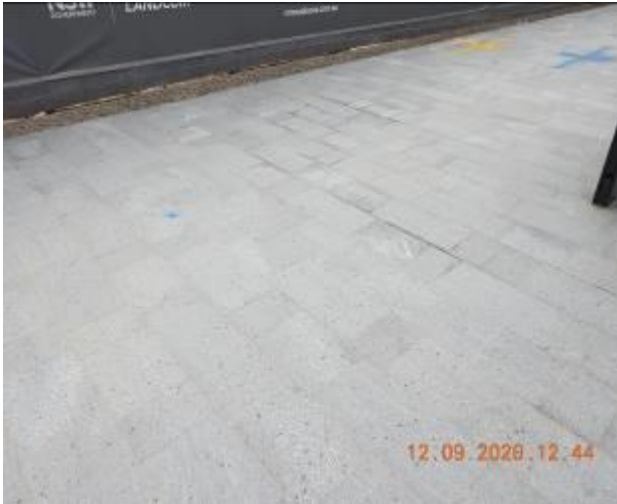
Figure 67 – Hairline cracking and efflorescence through footpath pavement

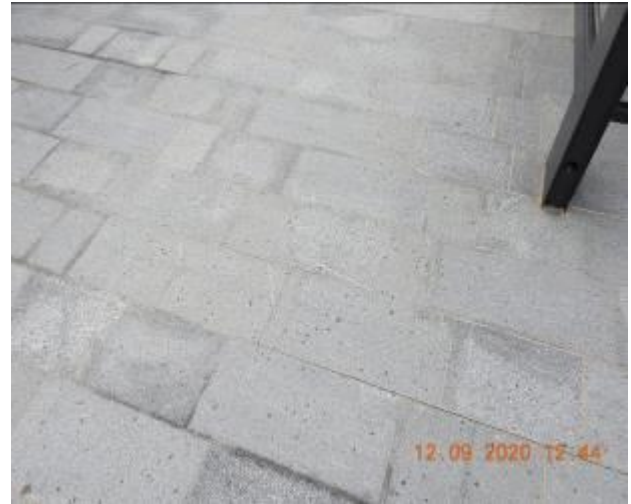
Figure 68 – Hairline cracking and efflorescence through footpath pavement

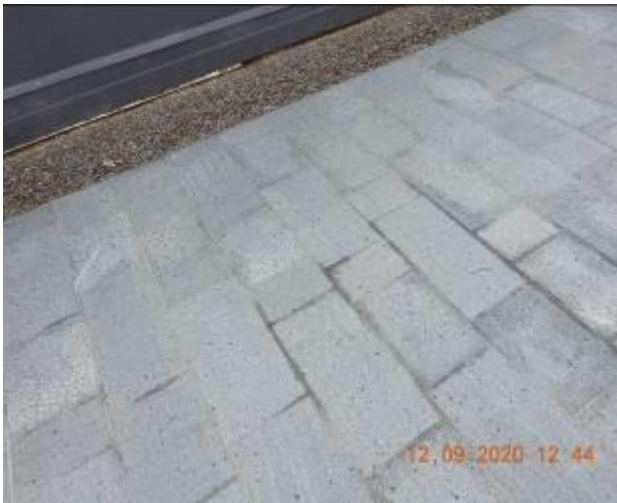
Figure 69 – Hairline cracking and efflorescence through footpath pavement

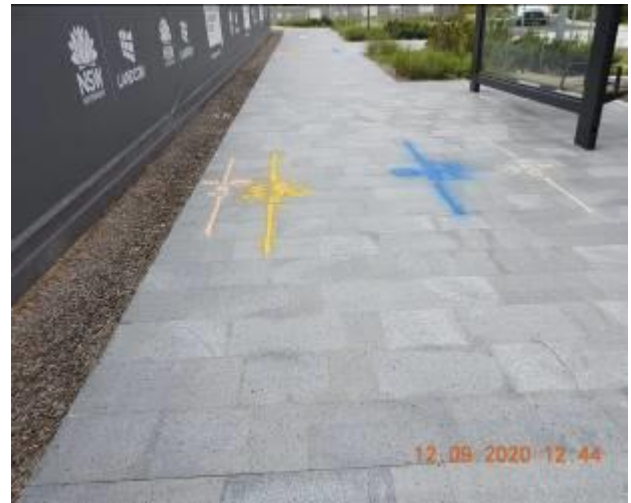
Figure 70 – Hairline cracking and efflorescence through footpath pavement
