**2 MANDALA PARADE, CASTLE HILL
(DORAN DRIVE PRECINCT)
PRE-DILAPIDATION REPORT
Of Sydney Metro and Hills Shire Council Assets
DEICORP PROJECTS SHOWGROUND
PTY LTD.**

Job No. 200124.3
07/07/2021

ACE Structural Services Pty Ltd

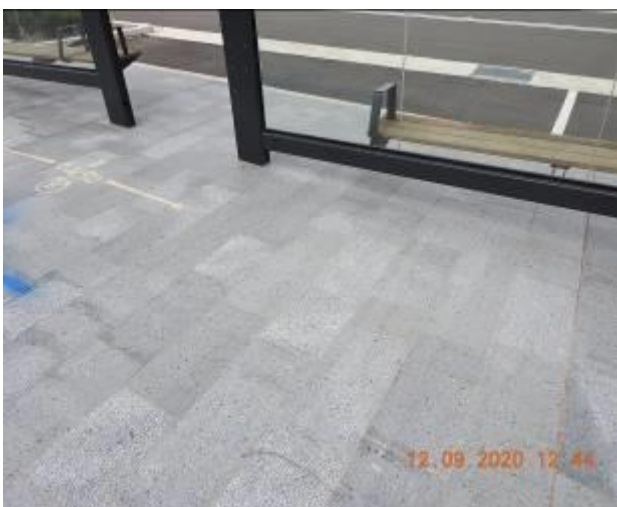
Figure 71 – Hairline cracking and efflorescence through footpath pavement

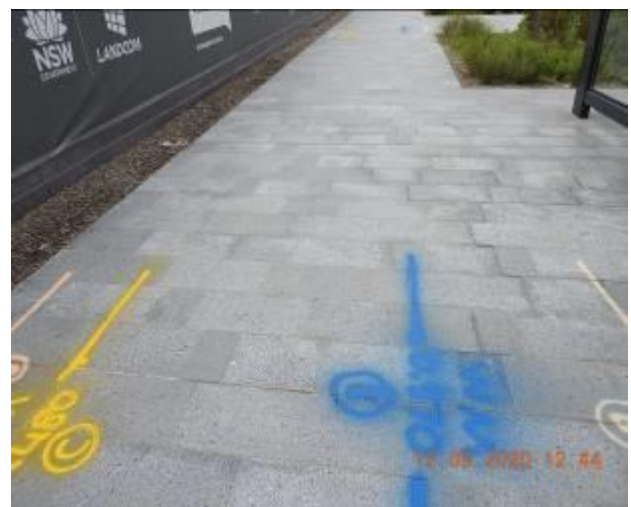
Figure 72 – General condition of footpath pavement

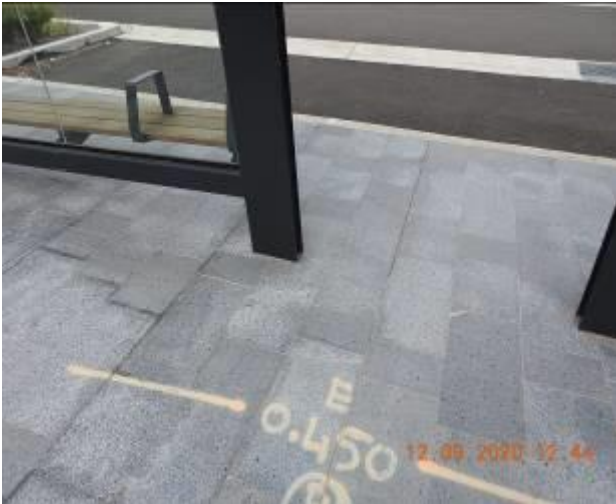
Figure 73 – Hairline cracking and efflorescence through footpath pavement

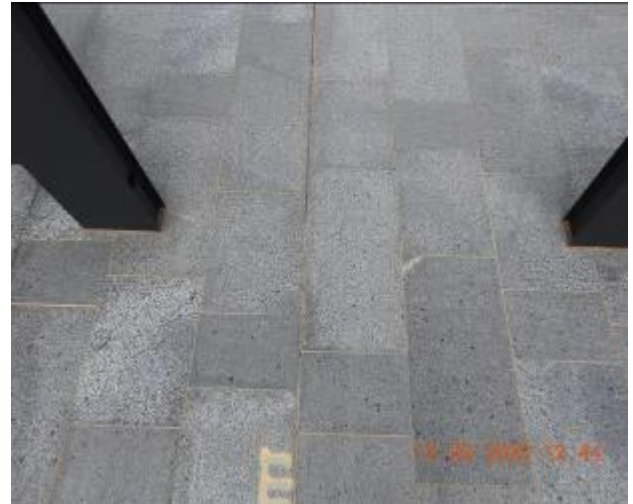
Figure 74 – Hairline cracking and efflorescence through footpath pavement

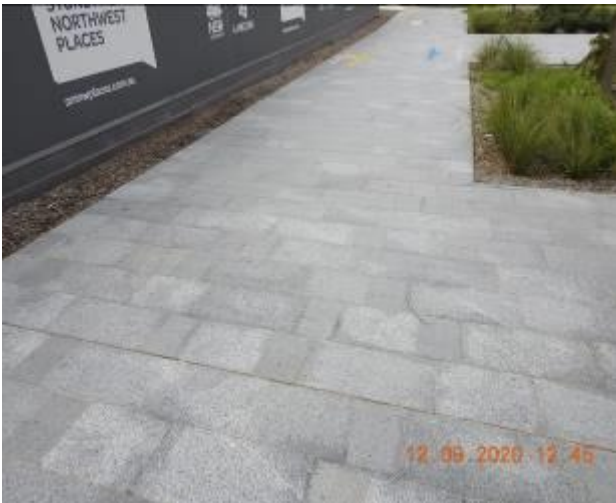
Figure 75 – General condition of footpath pavement

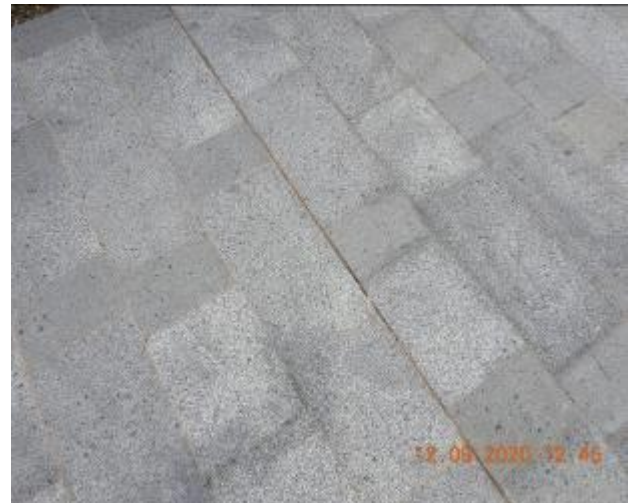
Figure 76 – Hairline cracking and efflorescence through footpath pavement

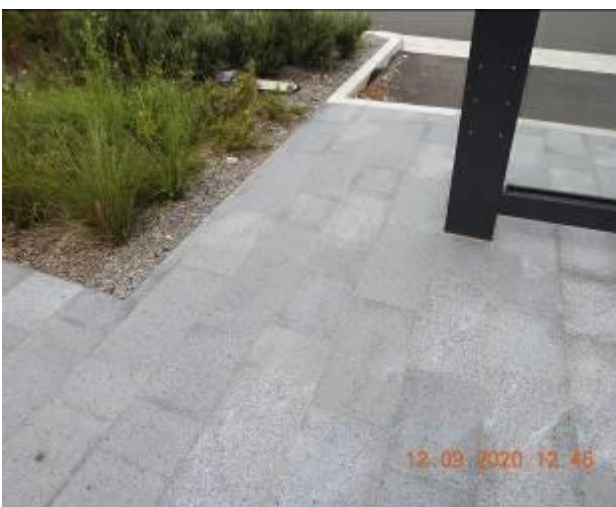
Figure 77 – Hairline cracking and efflorescence through footpath pavement

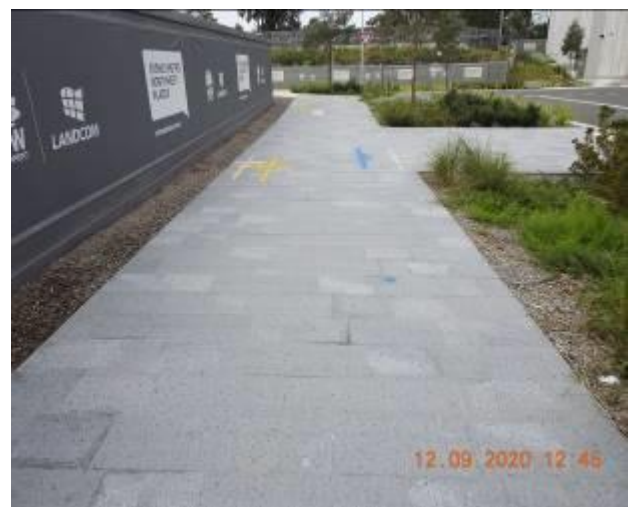
Figure 78 – General condition of footpath pavement

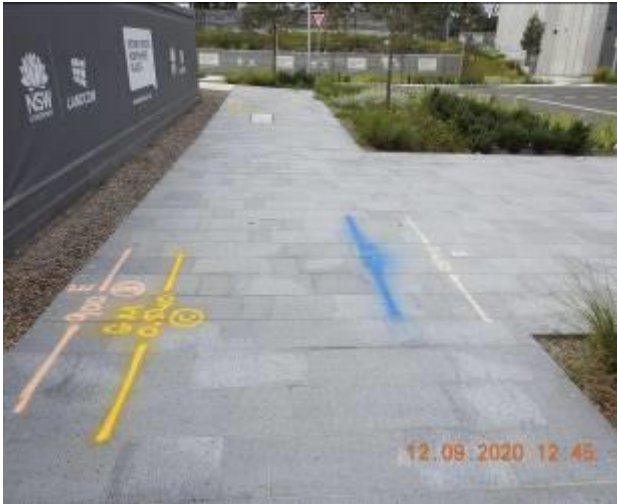
Figure 79 – General condition of footpath pavement

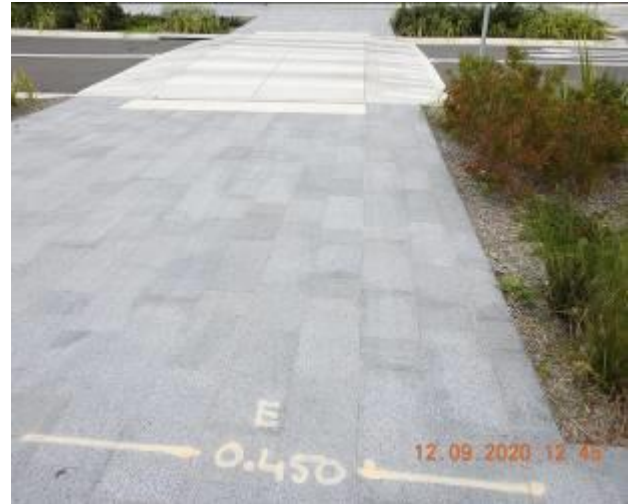
Figure 80 – Hairline cracking and efflorescence through footpath pavement

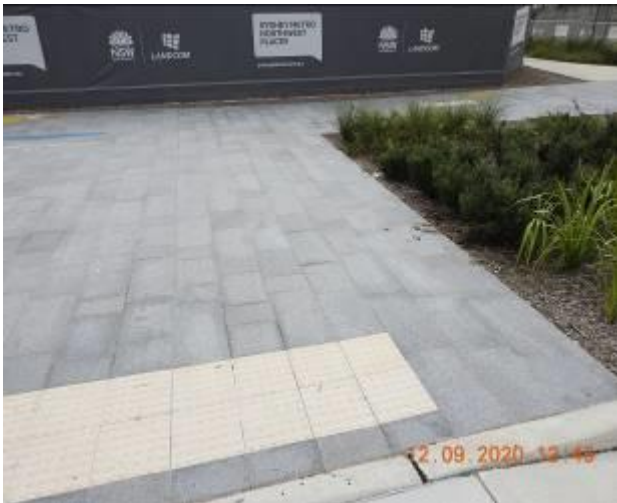
Figure 81 – Hairline cracking and efflorescence through footpath pavement

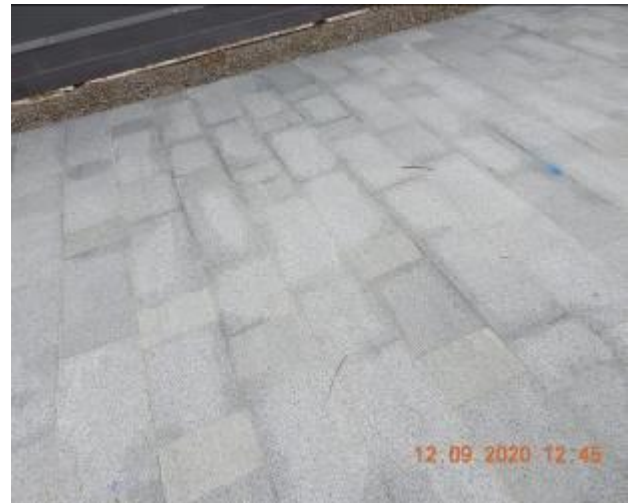
Figure 82 – Hairline cracking and efflorescence through footpath pavement

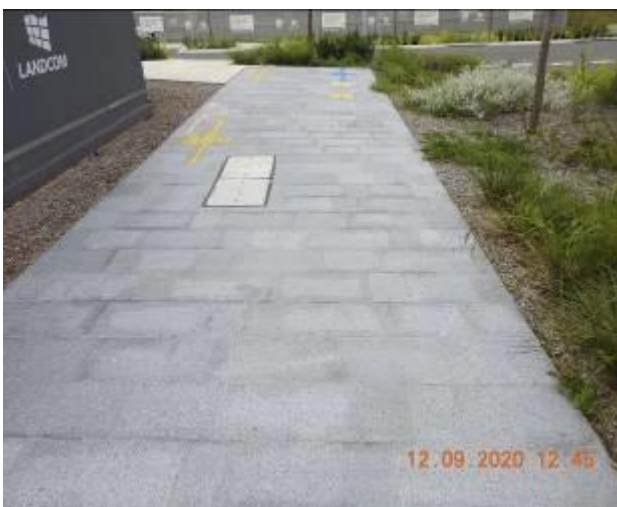
Figure 83 – General condition of footpath pavement

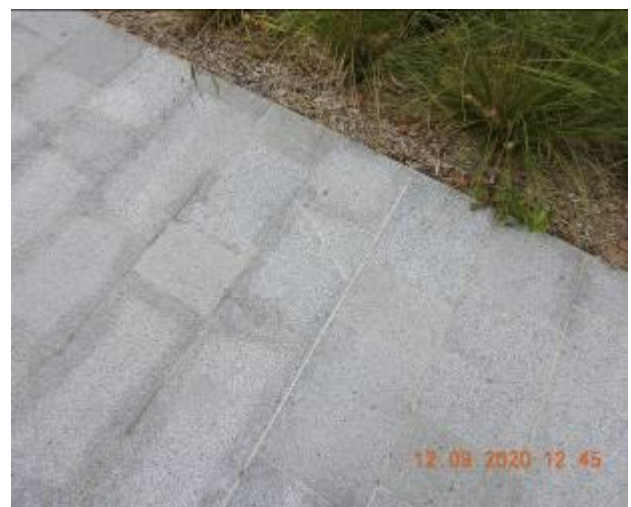
Figure 84 – Hairline cracking and efflorescence through footpath pavement

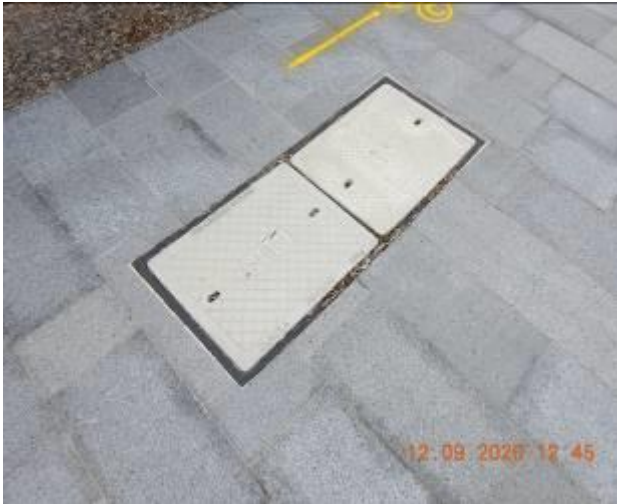
Figure 85 – General condition of service pit

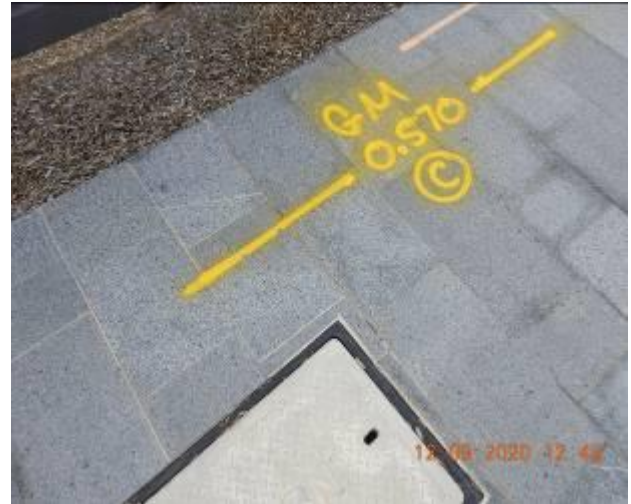
Figure 86 – Hairline cracking and efflorescence through footpath pavement

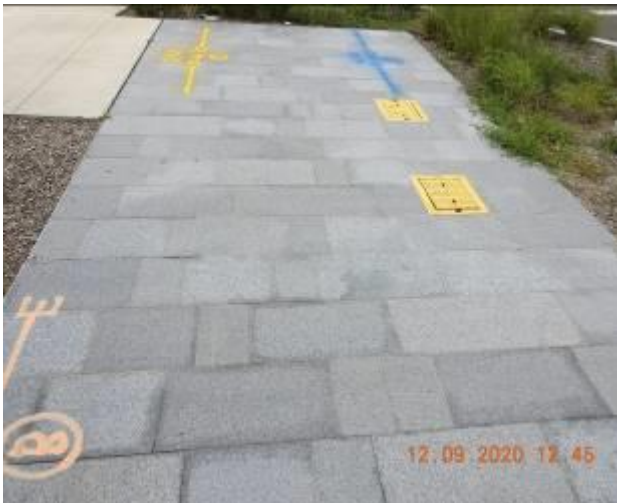
Figure 87 – Hairline cracking and efflorescence through footpath pavement and general condition of service pit

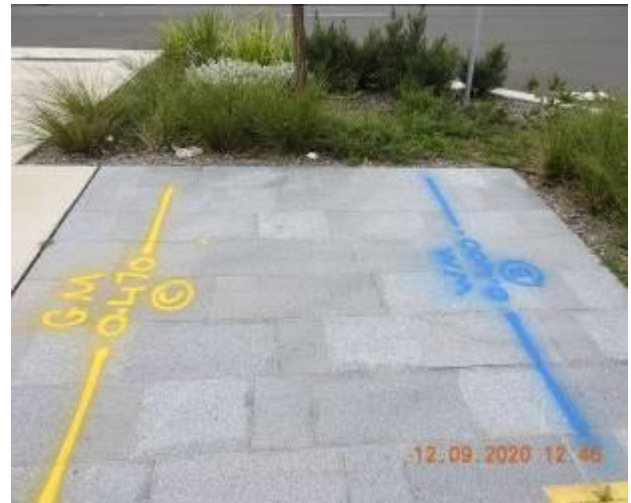
Figure 88 – Hairline cracking and efflorescence through footpath pavement

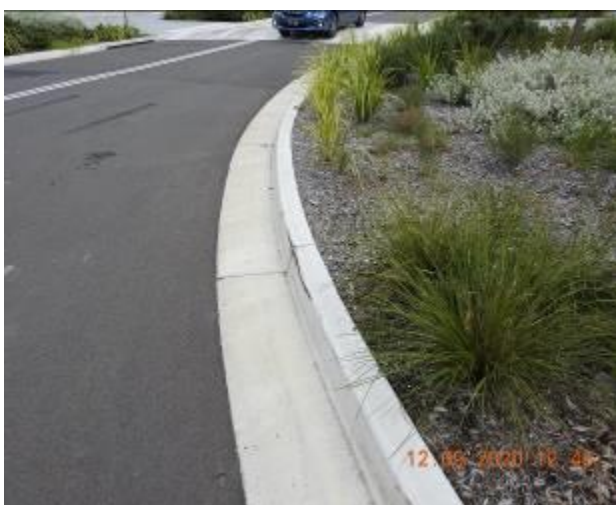
Figure 89 – General condition of kerb and gutter heading West

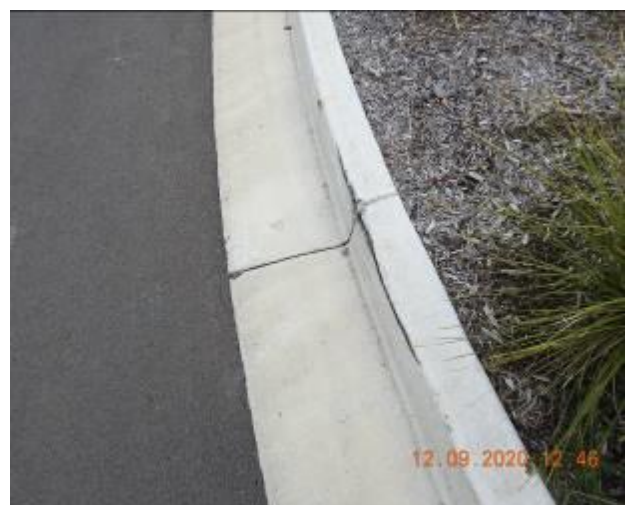
Figure 90 – Loss of material through kerb and gutter

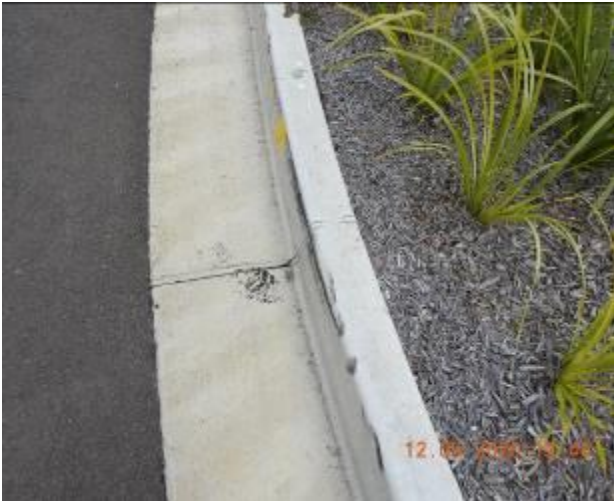
Figure 91 – Crack propagation and loss of material through gutter

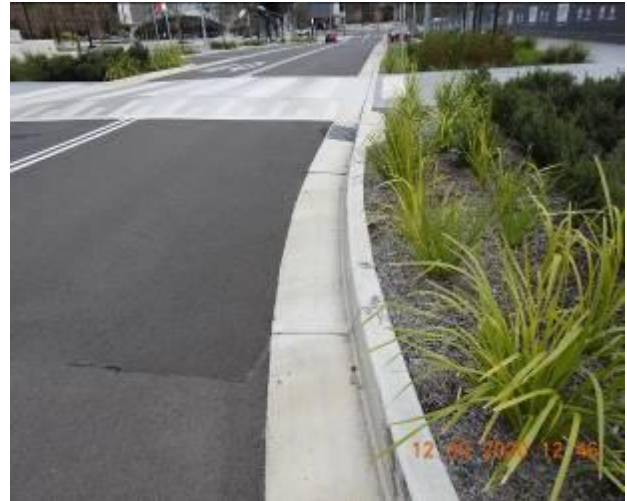
Figure 92 – General condition of kerb and gutter

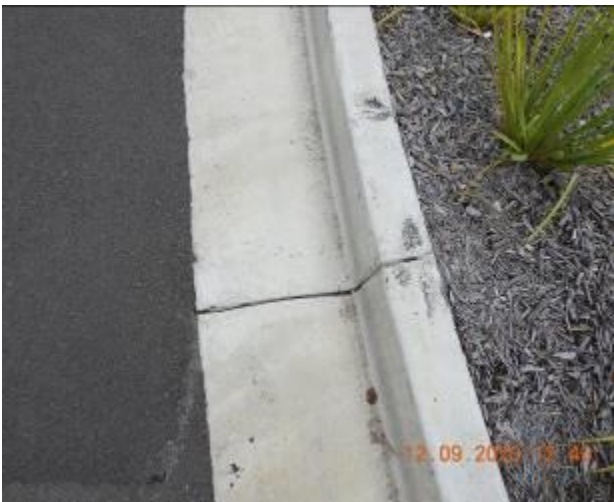
Figure 93 – Crack propagation through kerb

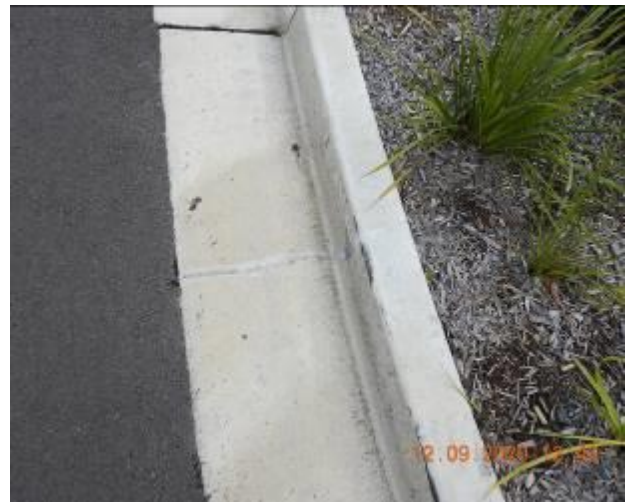
Figure 94 – Evidence of patchwork through kerb and gutter

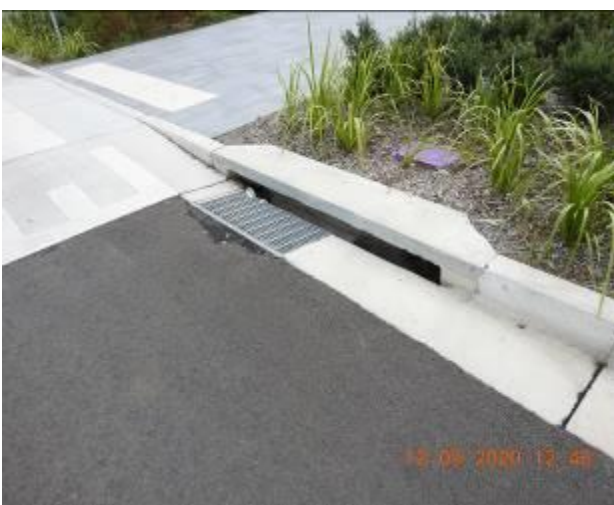
Figure 95 – General condition of kerb inlet pit

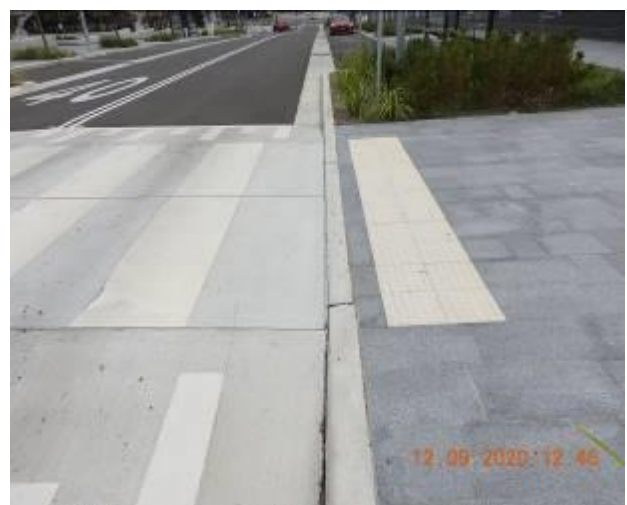
Figure 96 – General condition of layback

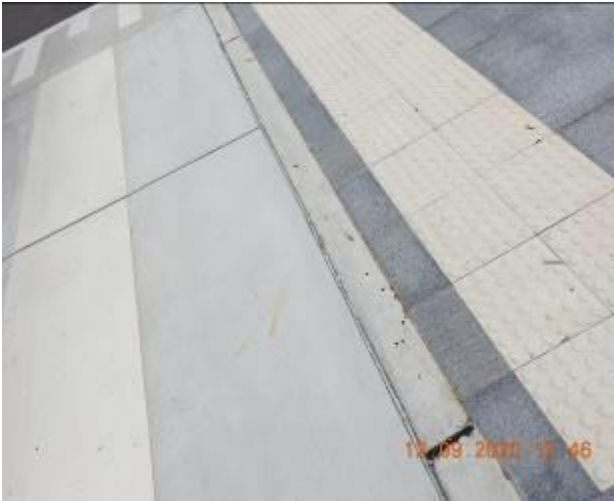
Figure 97 – Crack propagation through layback

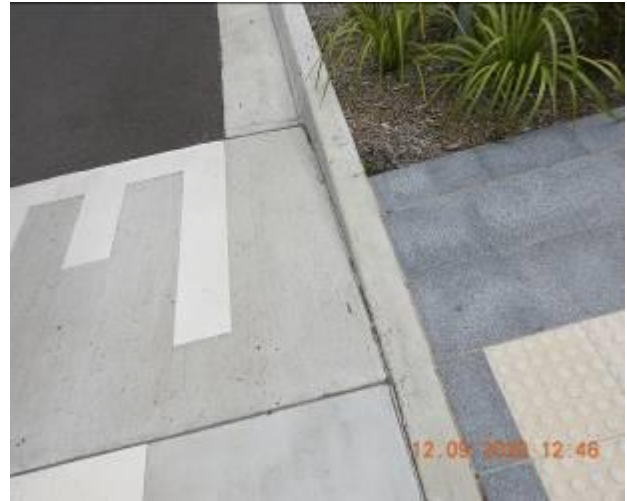
Figure 98 – Crack propagation through layback

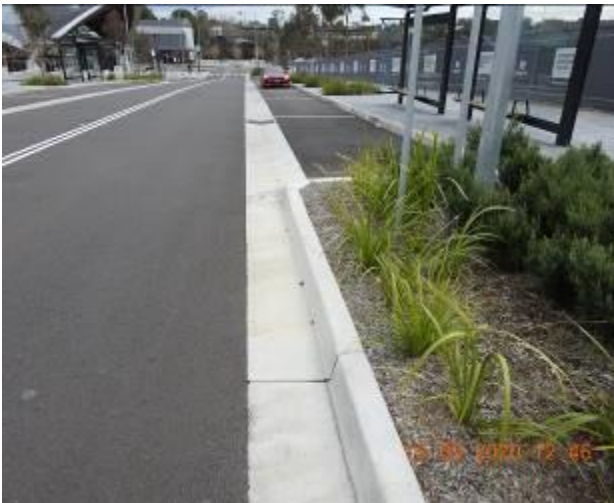
Figure 99 – General condition of kerb and gutter

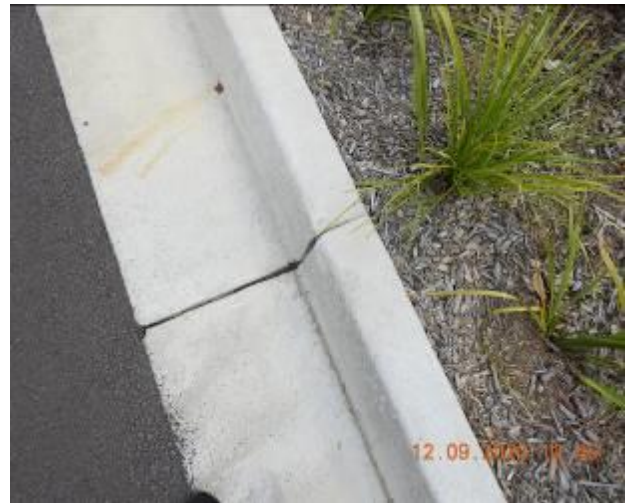
Figure 100 – Crack propagation and loss of material through kerb and gutter

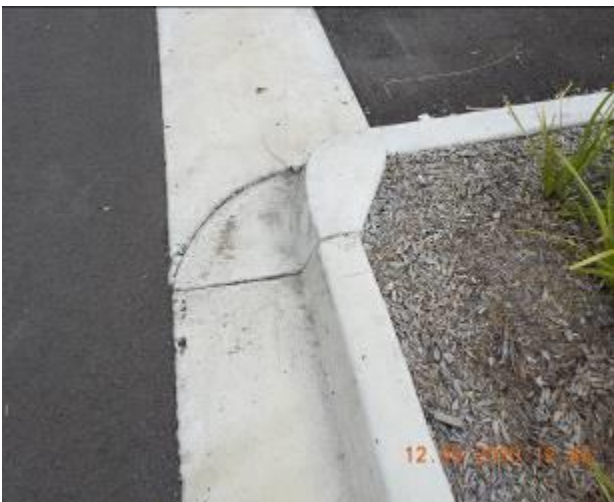
Figure 101 – Crack propagation and loss of material through kerb and gutter

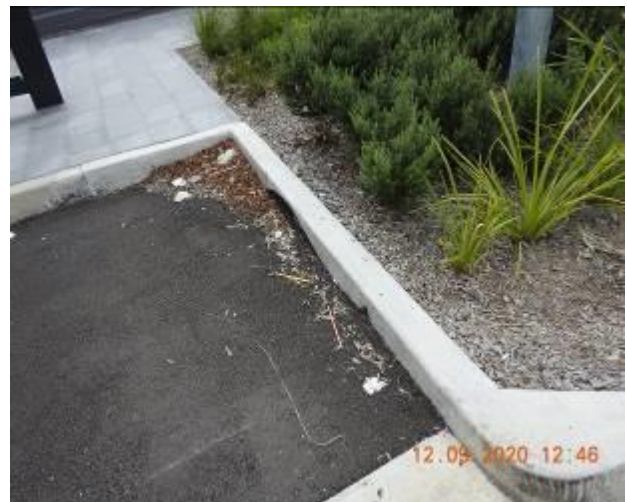
Figure 102 – General condition of kerb

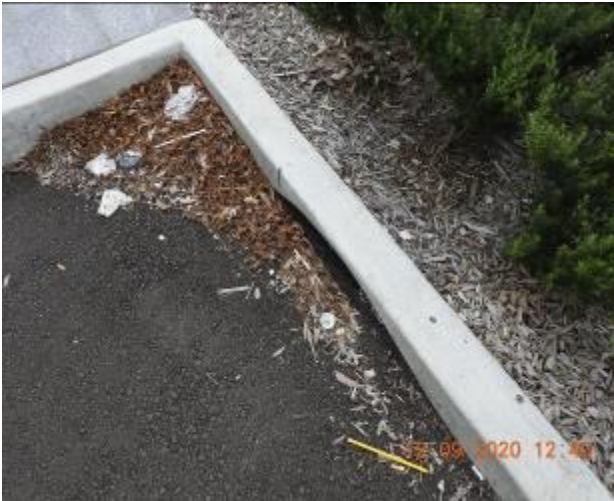
Figure 103 – Crack propagation through kerb

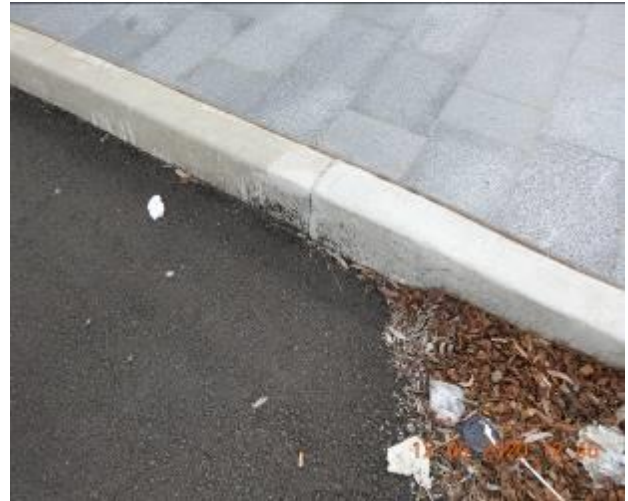
Figure 104 – Evidence of patchwork through kerb

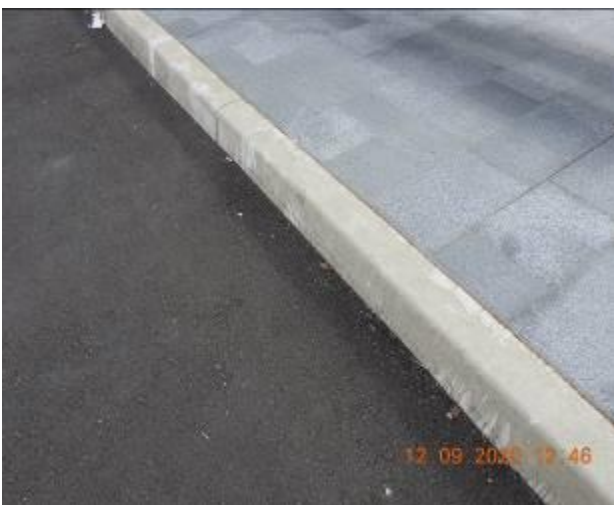
Figure 105 – General condition of kerb

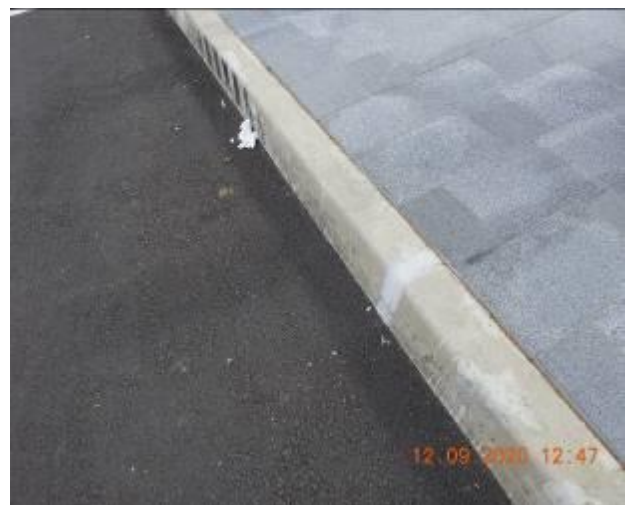
Figure 106 – Evidence of patchwork and crack propagation through kerb

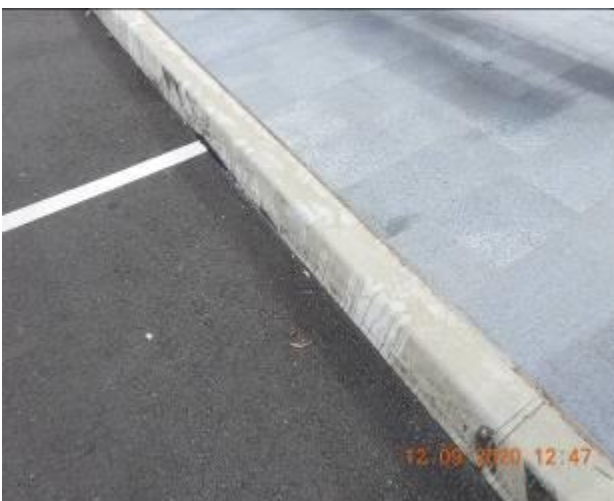
Figure 107 – General condition of kerb

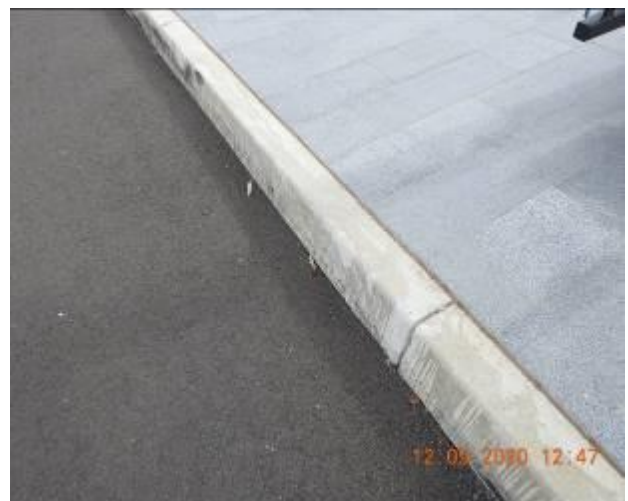
Figure 108 – Crack propagation through kerb

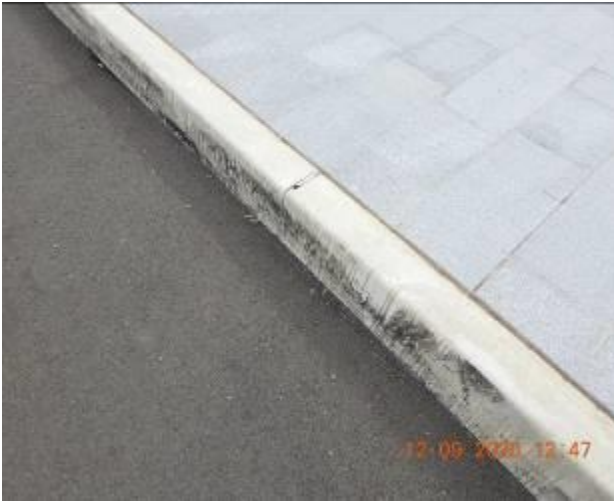
Figure 109 – Loss of material through kerb

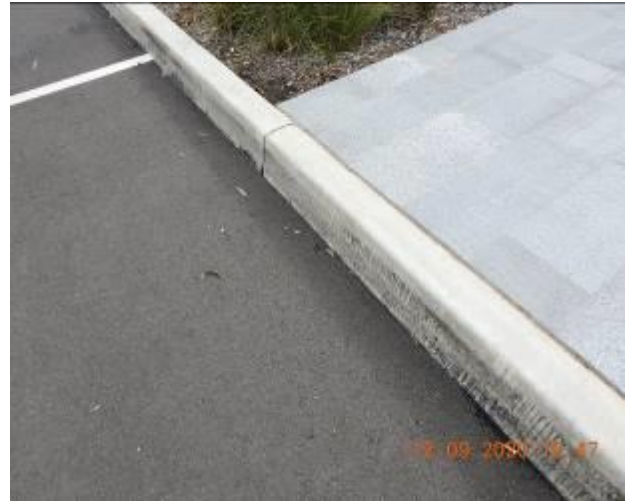
Figure 110 – General condition of kerb

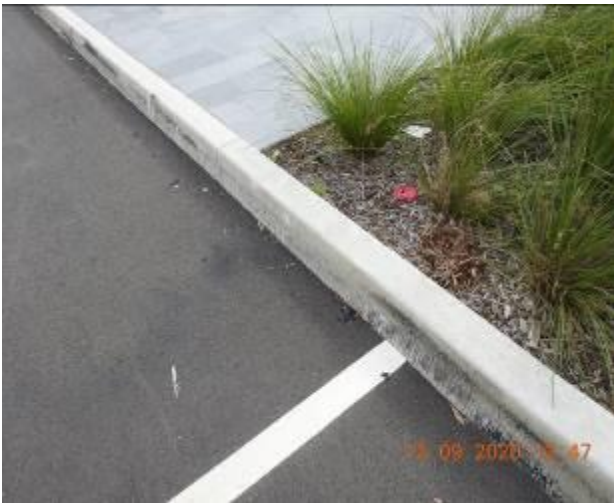
Figure 111 – General condition of kerb

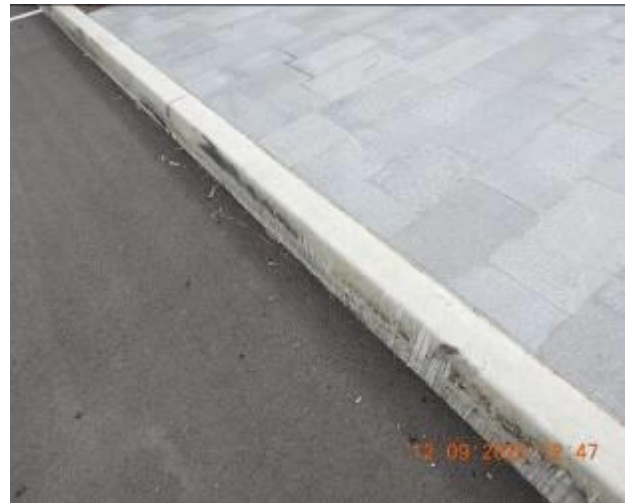
Figure 112 – General condition of kerb

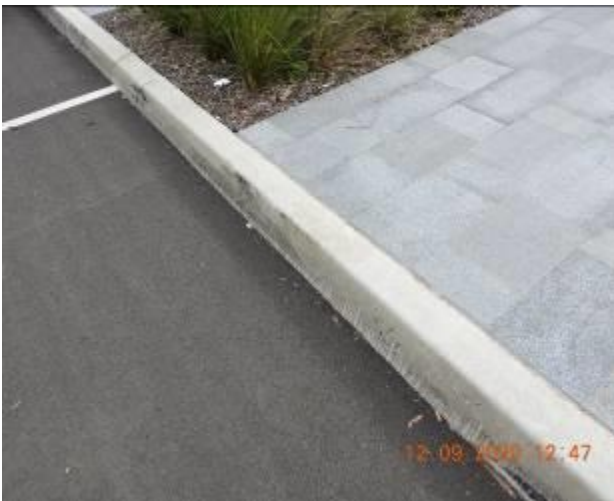
Figure 113 – General condition of kerb

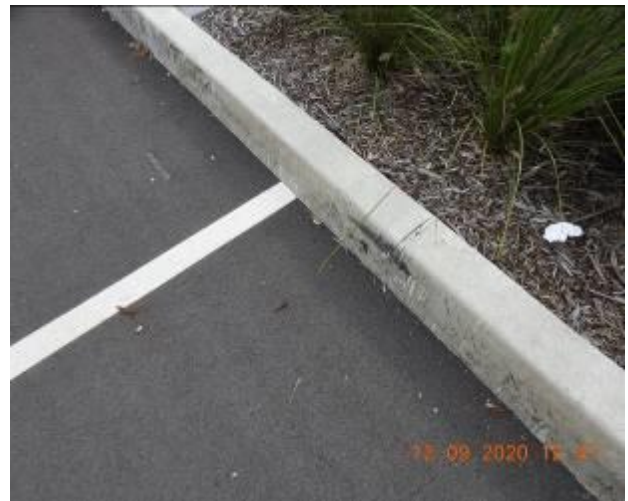
Figure 114 – Crack propagation through kerb

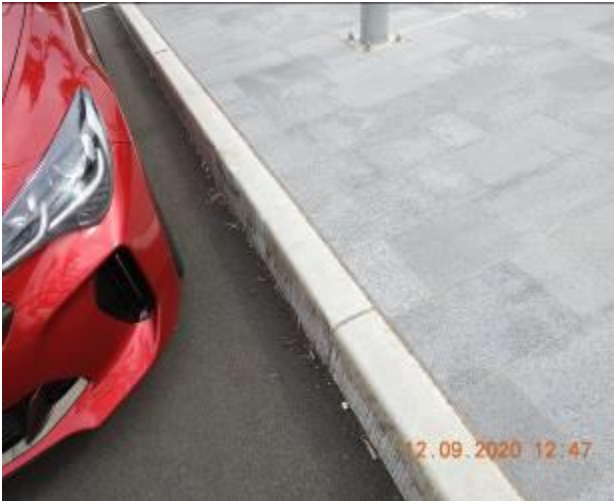
Figure 115 – General condition of kerb

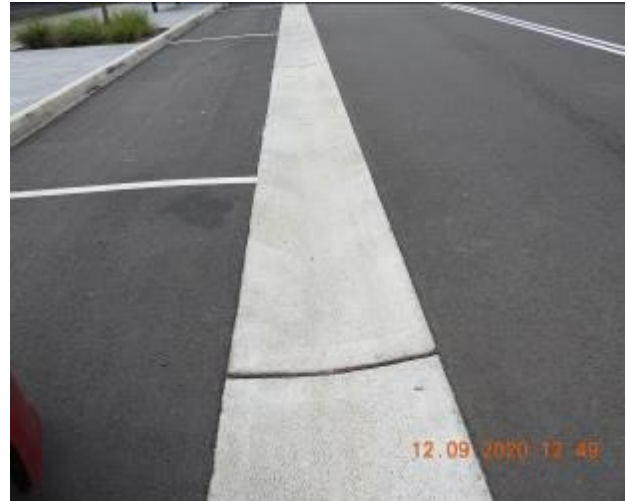
Figure 116 – General condition of gutter heading East

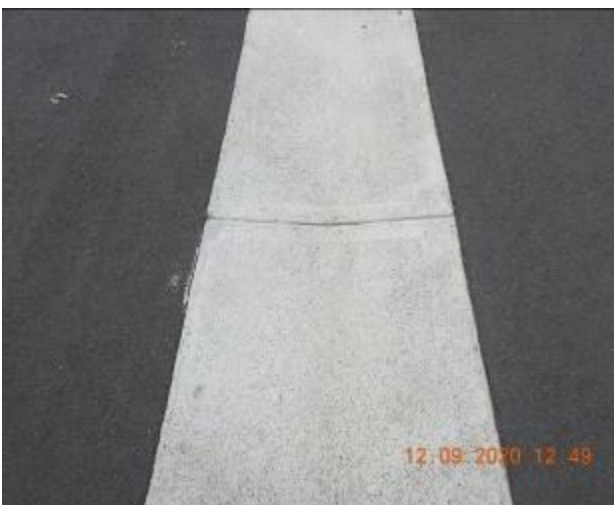
Figure 117 – General condition of gutter

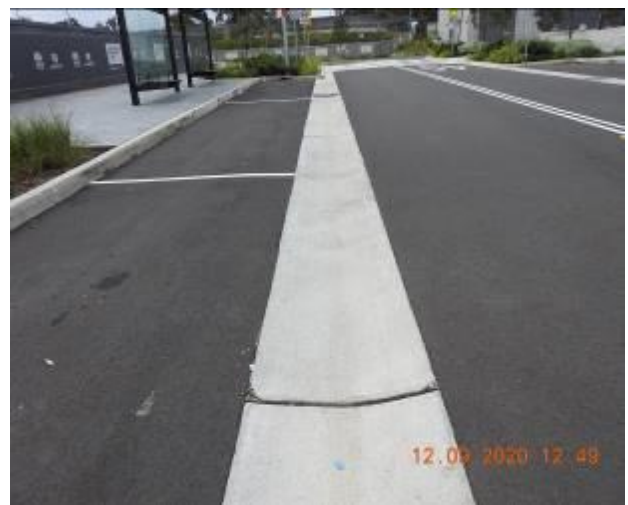
Figure 118 – General condition of gutter

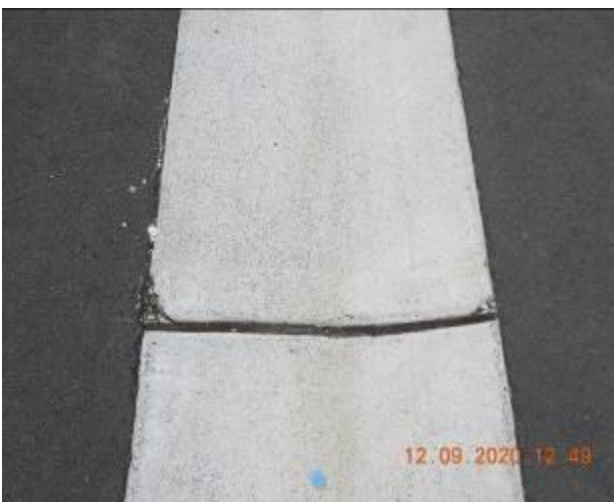
Figure 119 – Crack propagation and loss of material through gutter

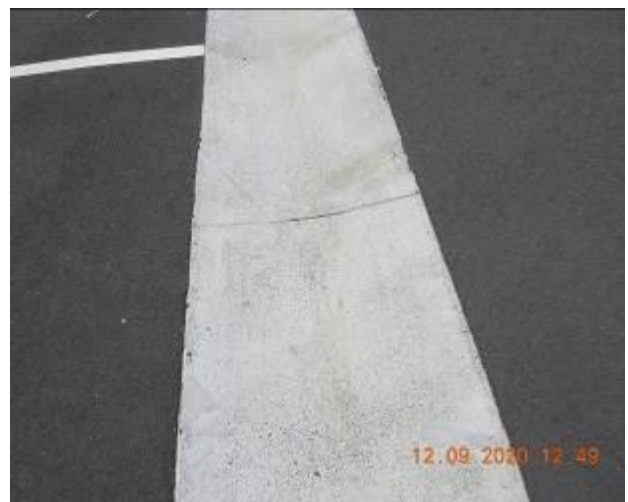
Figure 120 – Crack propagation through gutter

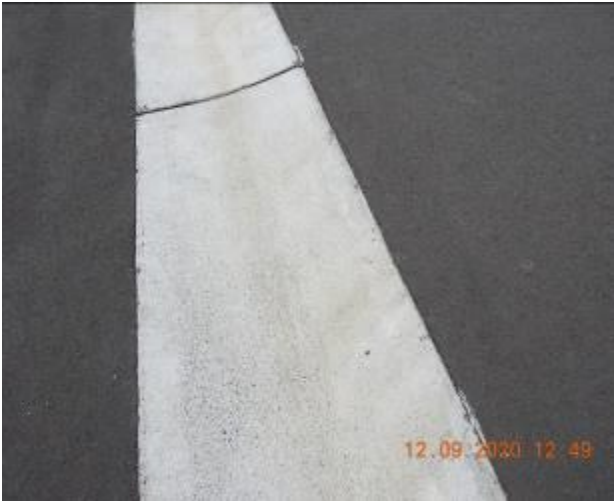
Figure 121 – Crack propagation through gutter

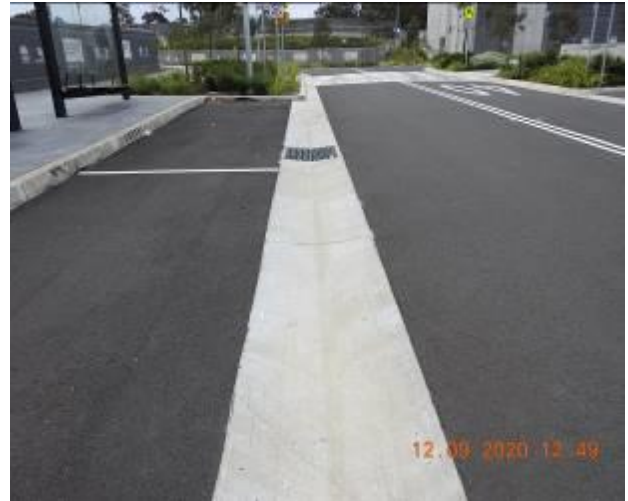
Figure 122 – General condition of gutter

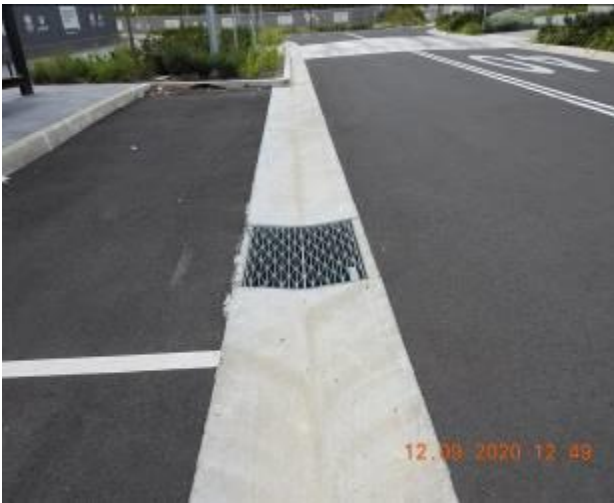
Figure 123 – General condition of gutter

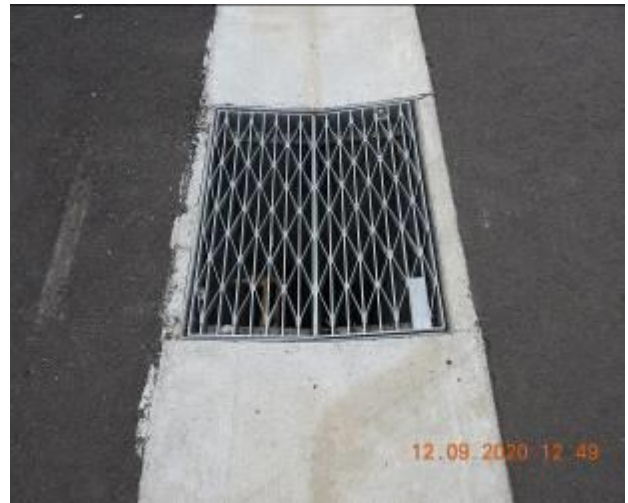
Figure 124 – General condition of stormwater inlet pit and Crack propagation through gutter

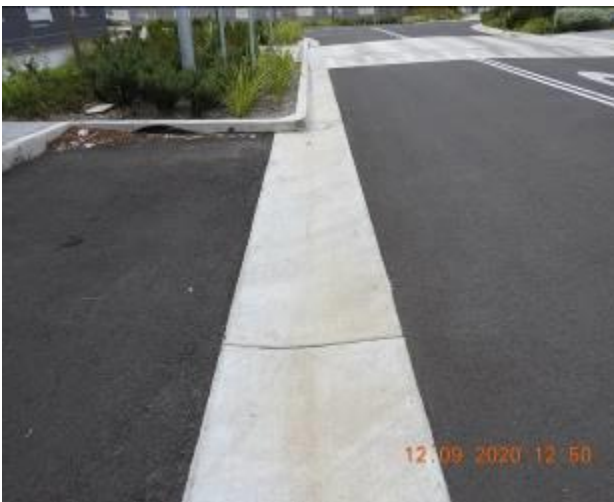
Figure 125 – General condition of gutter

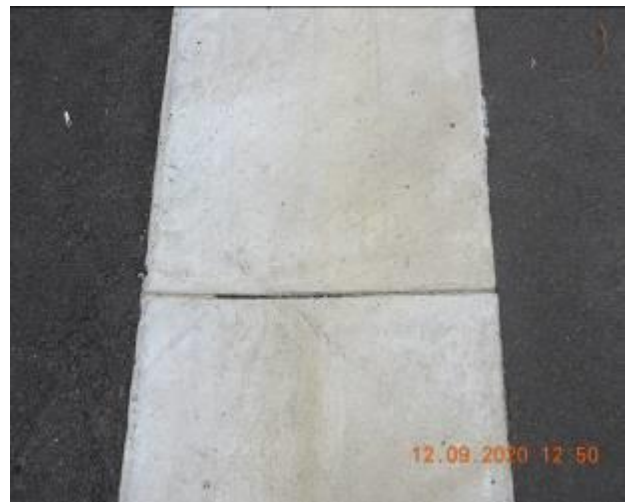
Figure 126 – Crack propagation and loss of material through gutter

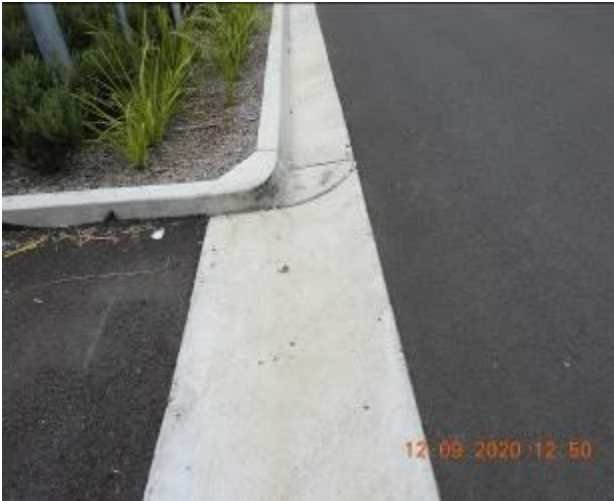
Figure 127 – General condition of gutter

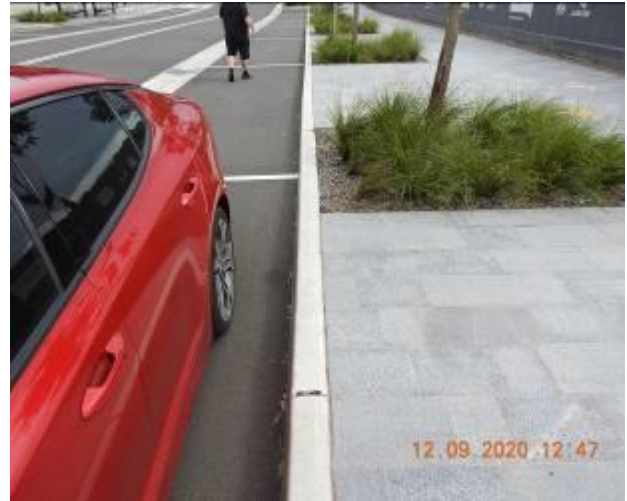
Figure 128 – General condition of kerb

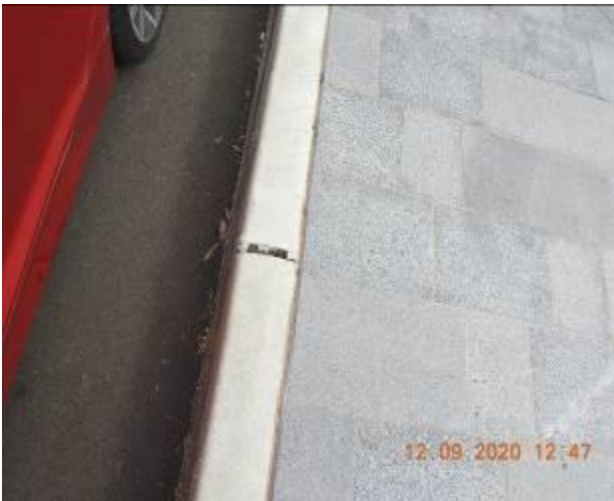
Figure 129 – Crack propagation and loss of material through kerb

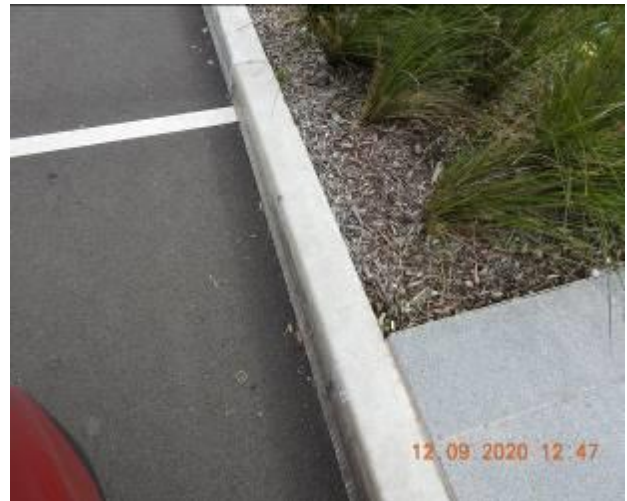
Figure 130 – Evidence of patchwork through kerb

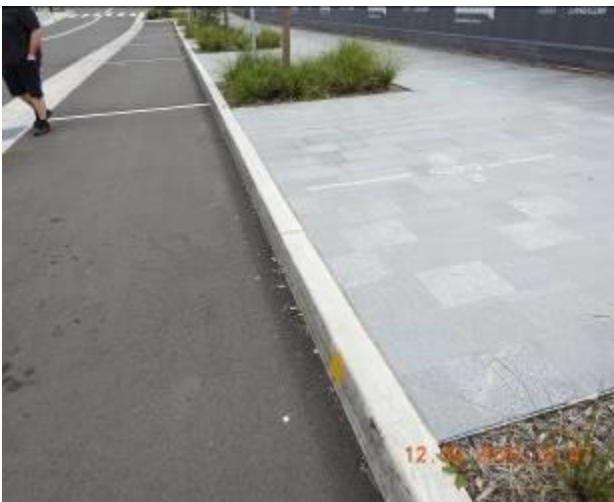
Figure 131 – General condition of kerb

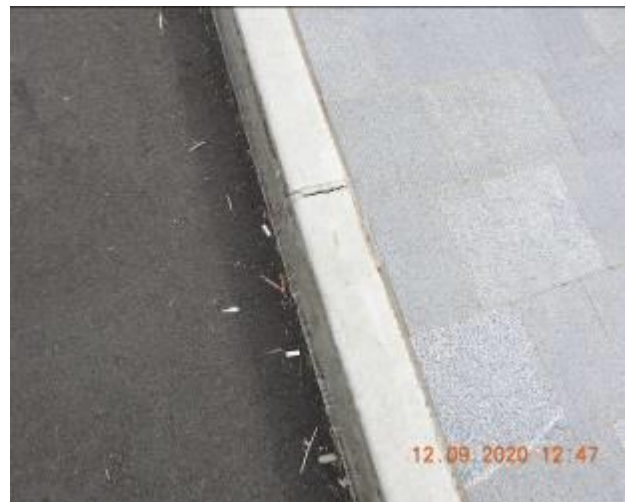
Figure 132 – Crack propagation through kerb

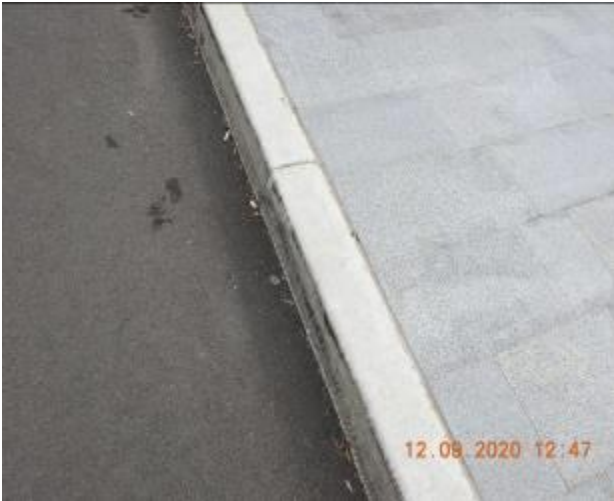
Figure 133 – General condition of kerb

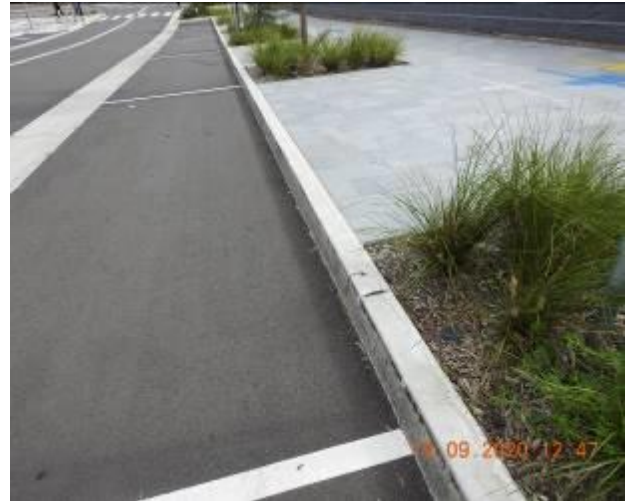
Figure 134 – General condition of kerb

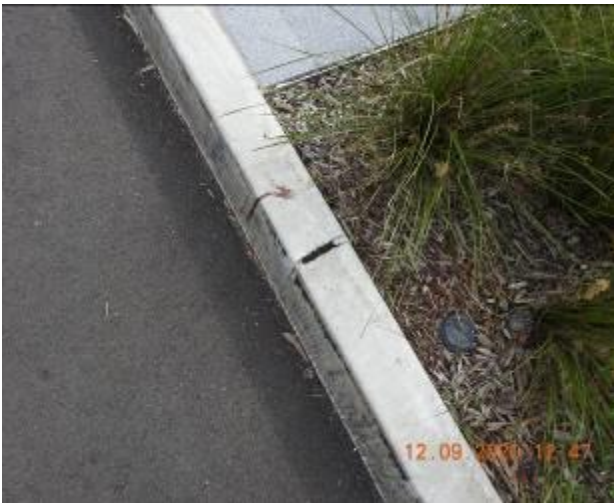
Figure 135 – Crack propagation through kerb

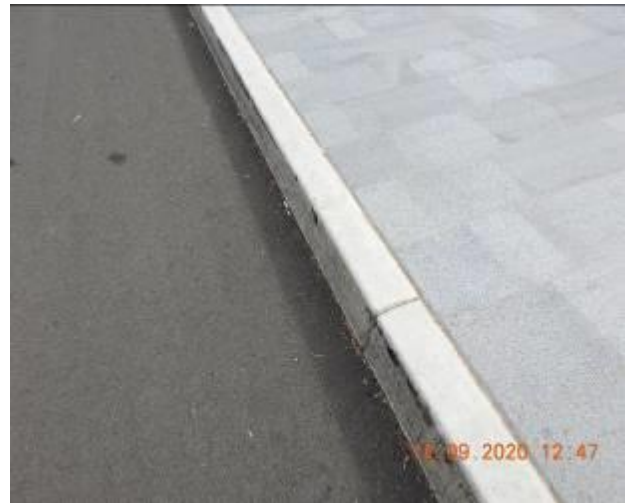
Figure 136 – Crack propagation through kerb

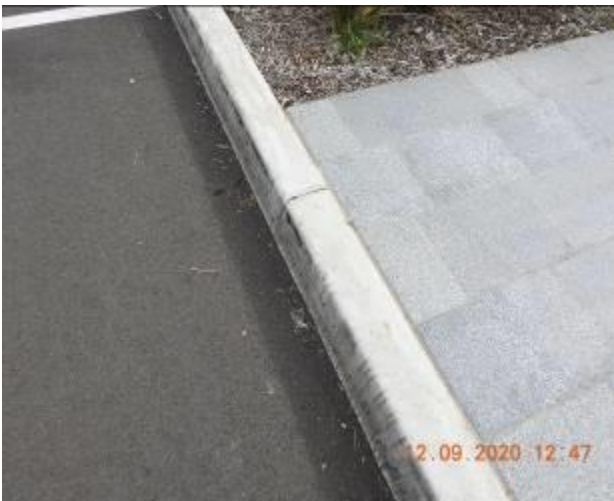
Figure 137 – General condition of kerb

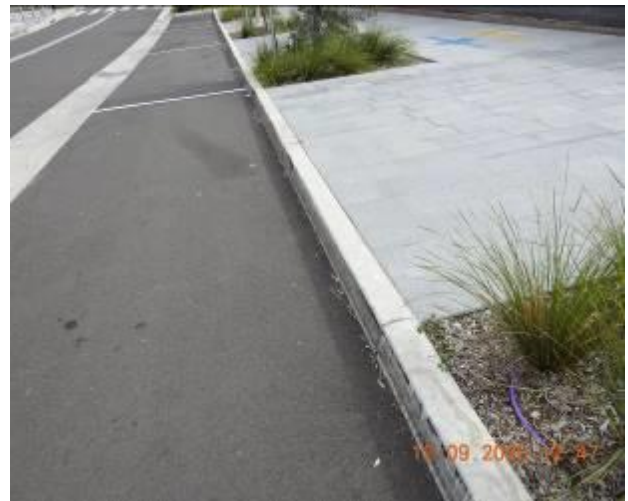
Figure 138 – General condition of kerb

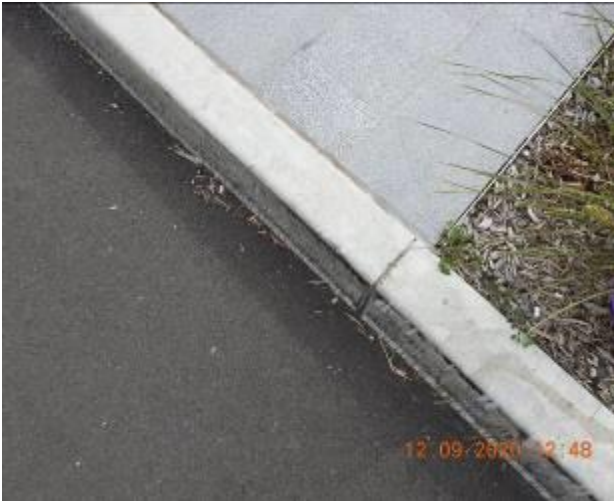
Figure 139 – Crack propagation through kerb

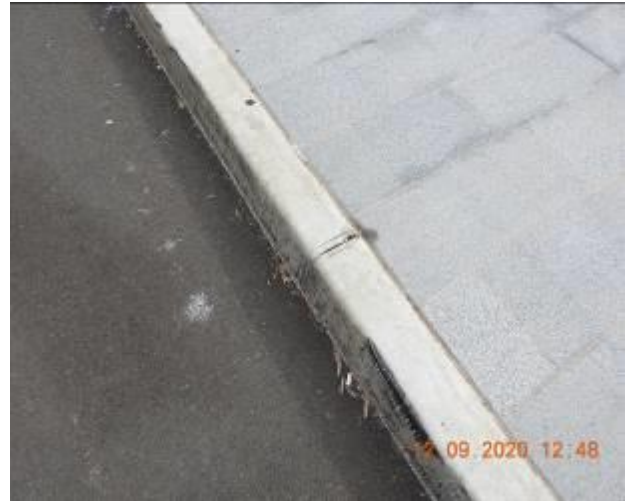
Figure 140 – Crack propagation and loss of material through kerb

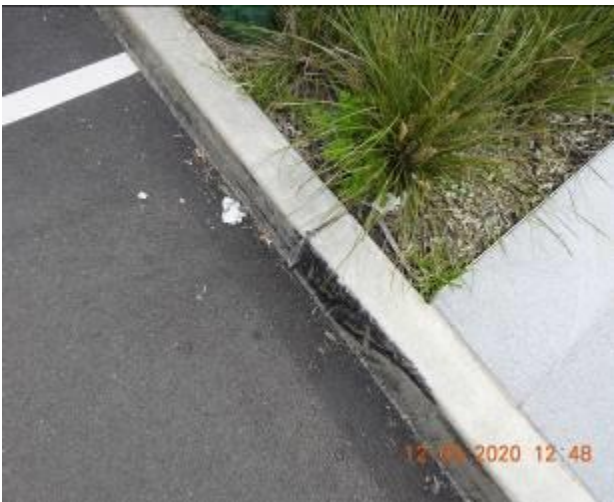
Figure 141 – Crack propagation through kerb
