**2 MANDALA PARADE, CASTLE HILL
(DORAN DRIVE PRECINCT)
PRE-DILAPIDATION REPORT
Of Sydney Metro and Hills Shire Council Assets
DEICORP PROJECTS SHOWGROUND
PTY LTD.**

Job No. 200124.3
07/07/2021

ACE Structural Services Pty Ltd

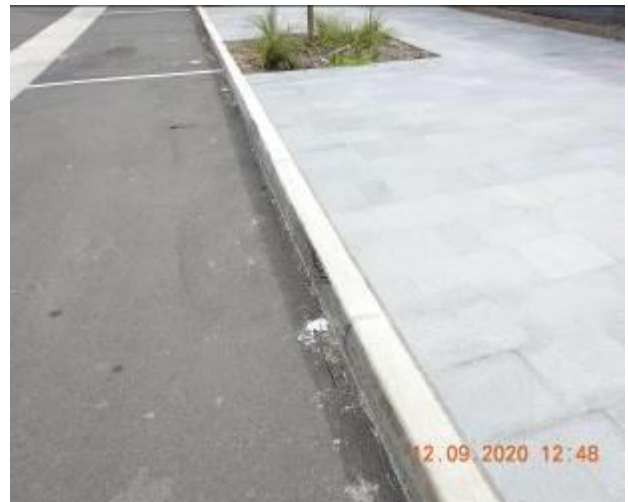
Figure 142 – General condition of kerb

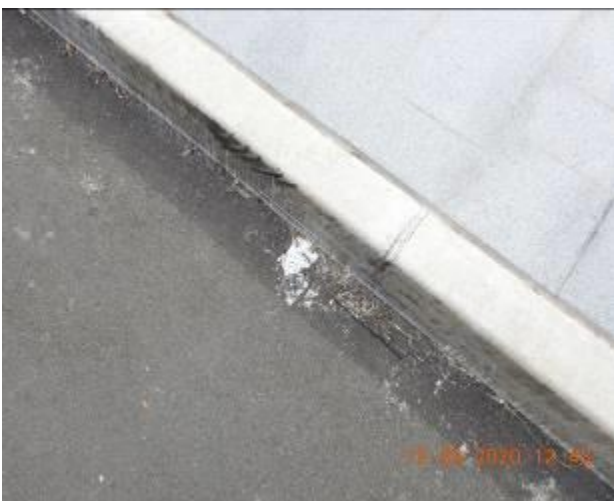
Figure 143 – Crack propagation through kerb

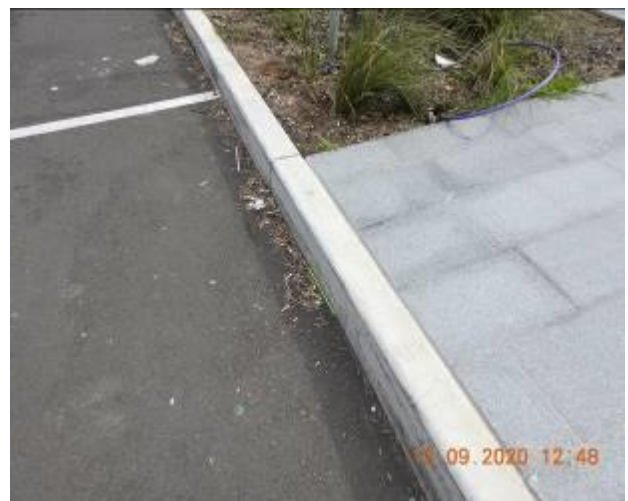
Figure 144 – General condition of kerb

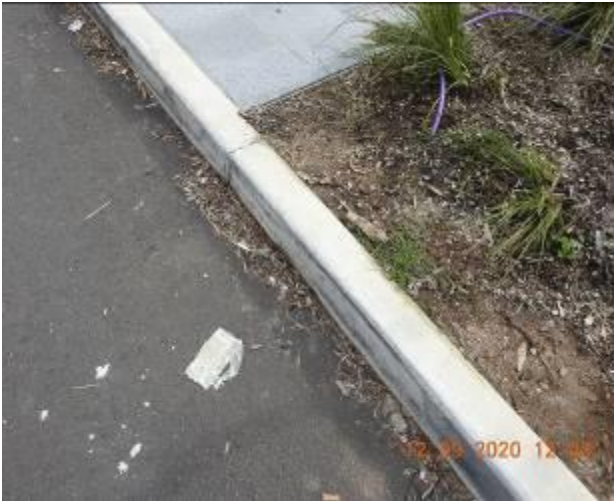
Figure 145 – Crack propagation through kerb

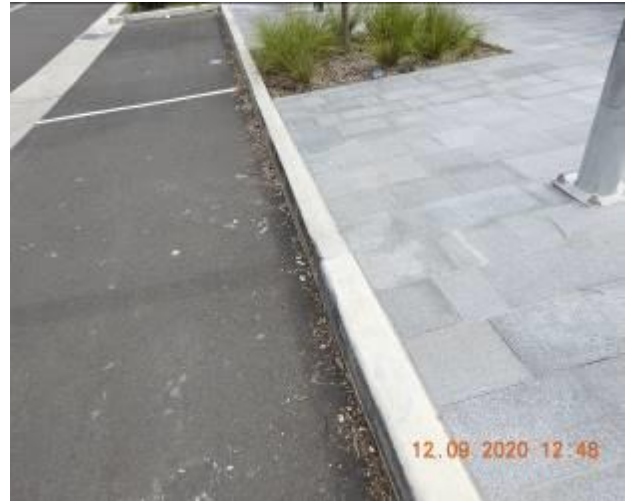
Figure 146 – General condition of kerb

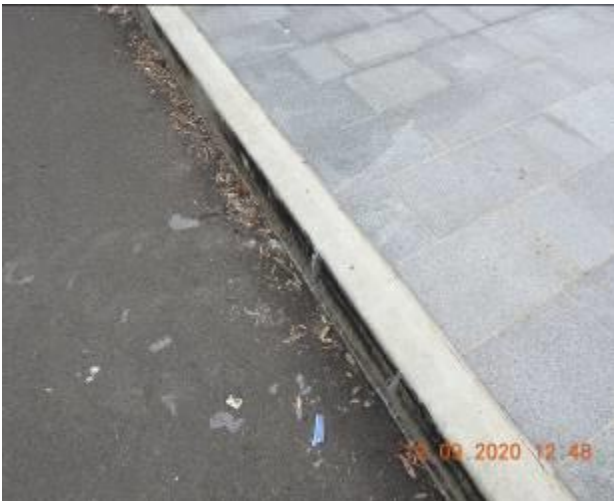
Figure 147 – General condition of kerb

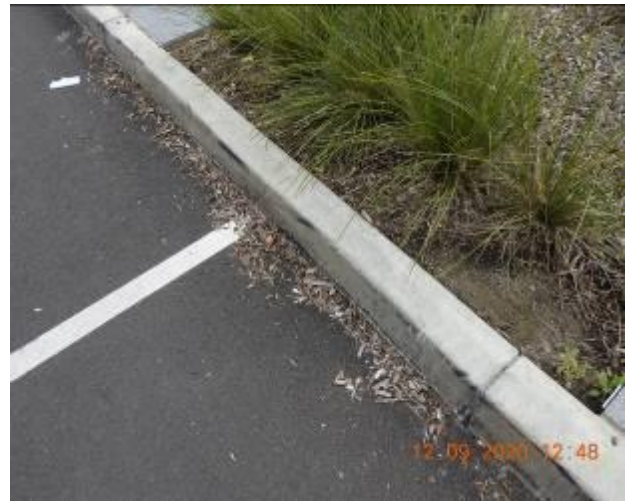
Figure 148 – Crack propagation through kerb

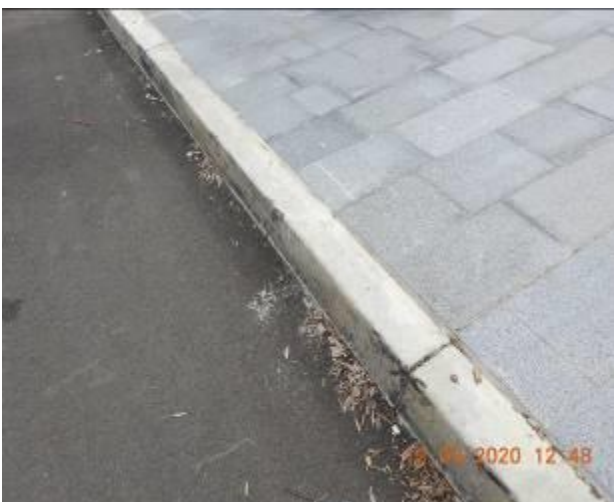
Figure 149 – Crack propagation through kerb

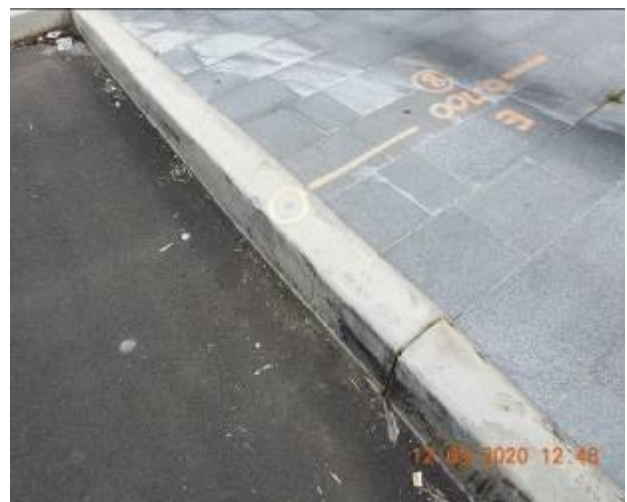
Figure 150 – Crack propagation and loss of material through kerb

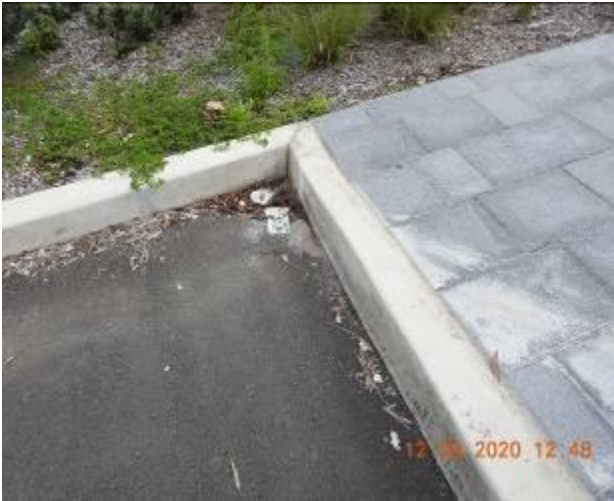
Figure 151 – General condition of kerb

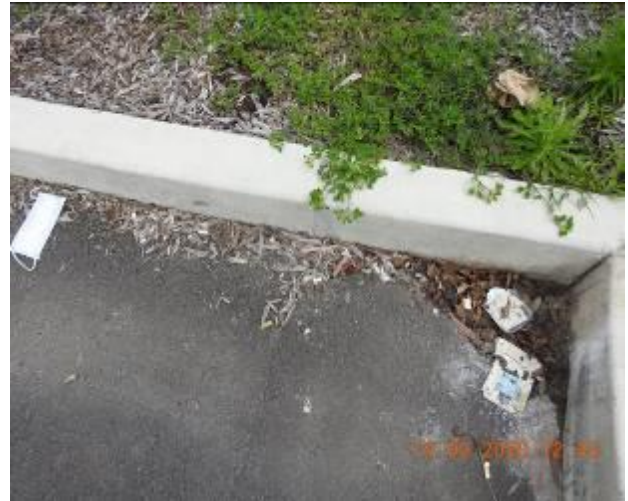
Figure 152 – Evidence of patchwork through kerb

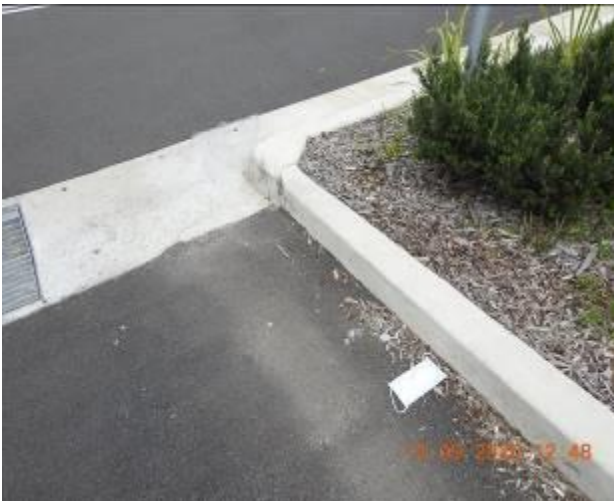
Figure 153 – General condition of kerb

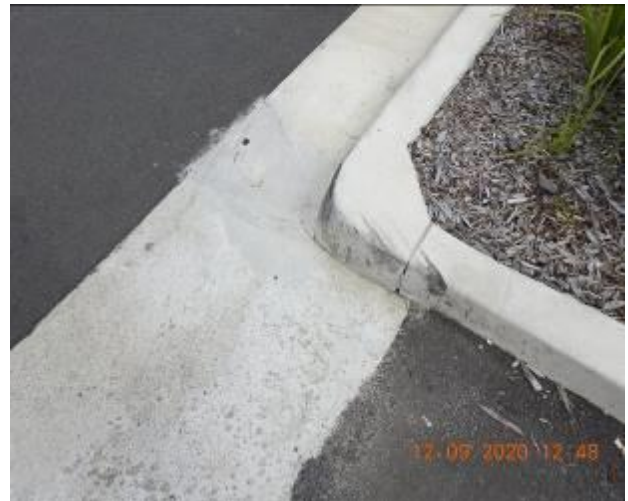
Figure 154 – Evidence of patchwork and crack propagation through gutter

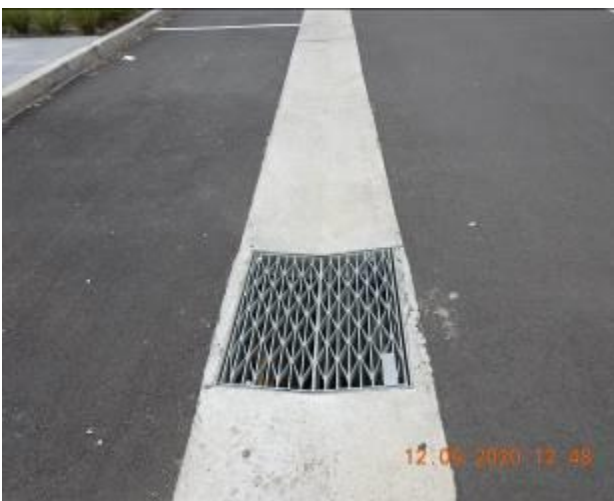
Figure 155 – General condition of gutter heading East

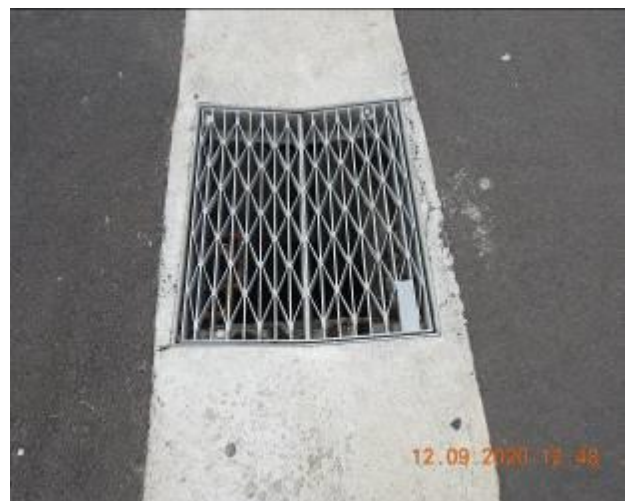
Figure 156 – General condition of stormwater inlet pit and crack propagation through gutter

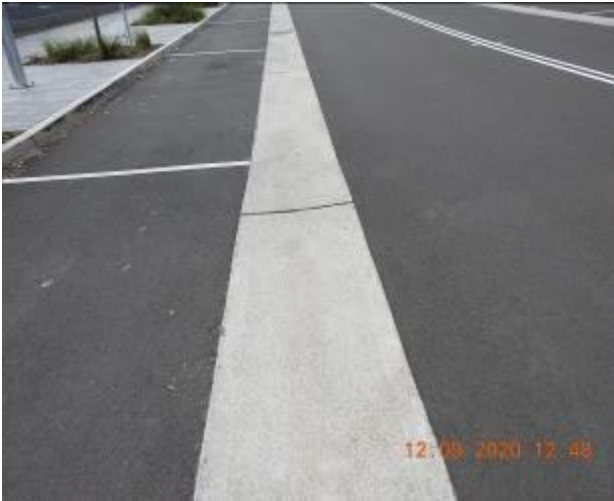
Figure 157 – General condition of gutter

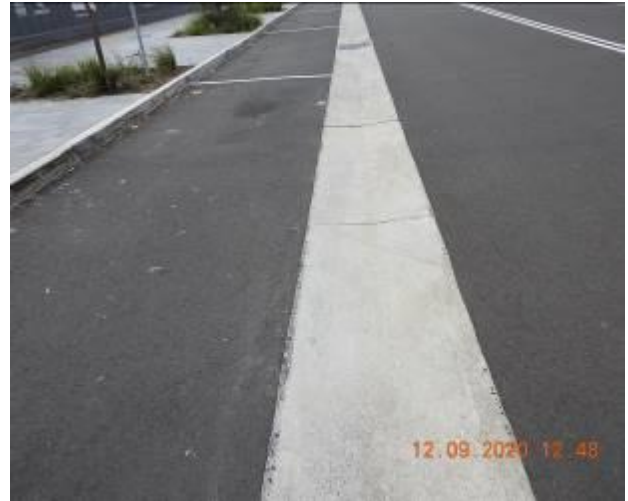
Figure 158 – General condition of gutter

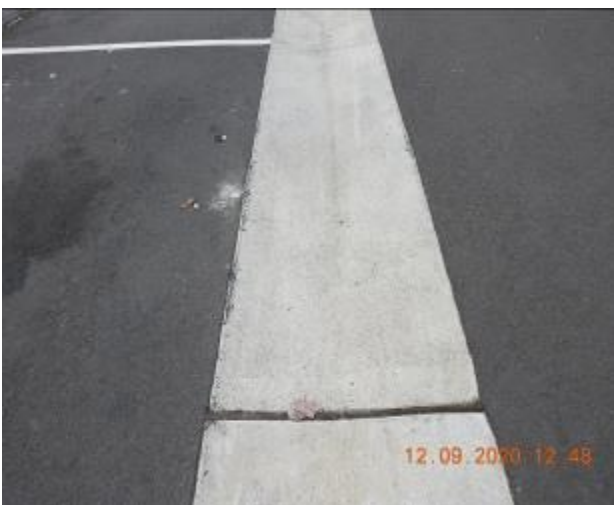
Figure 159 – General condition of gutter

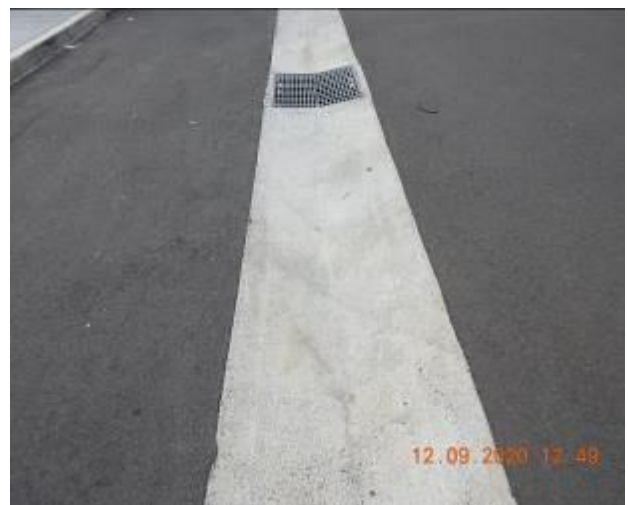
Figure 160 – General condition of gutter

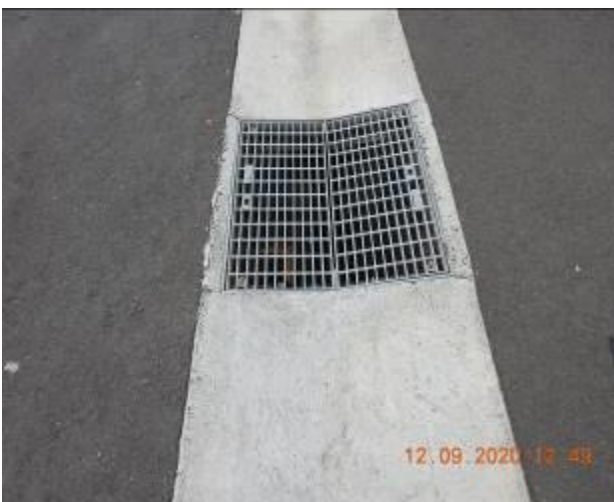
Figure 161 – General condition of stormwater inlet pit and crack propagation through gutter

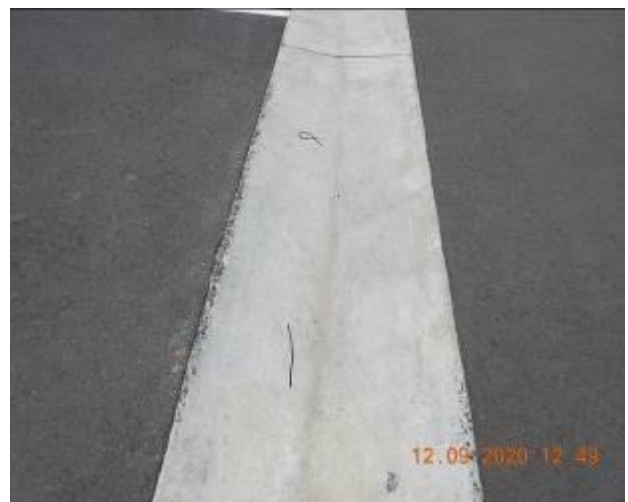
Figure 162 – Loss of material through gutter

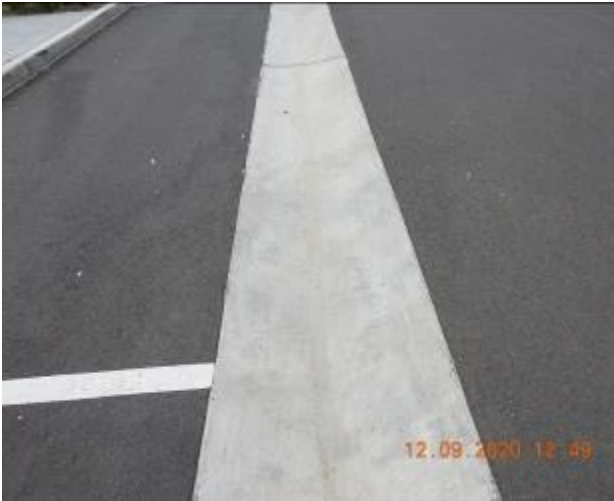
Figure 163 – General condition of gutter

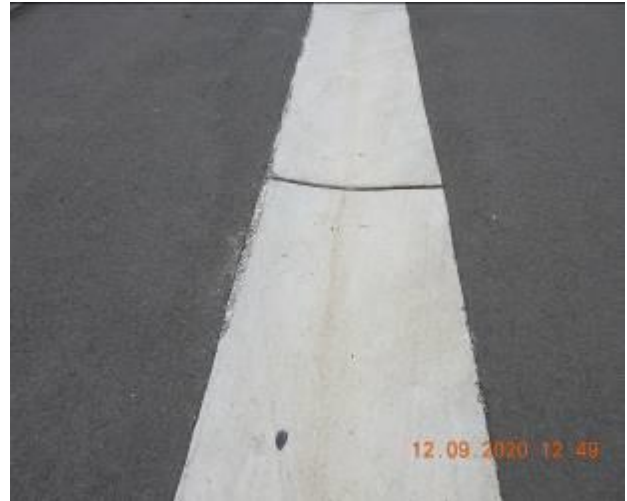
Figure 164 – Crack propagation and loss of material through gutter

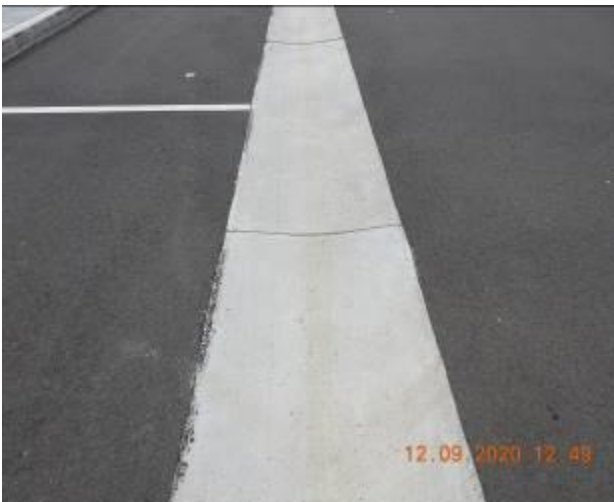
Figure 165 – Crack propagation and loss of material through gutter

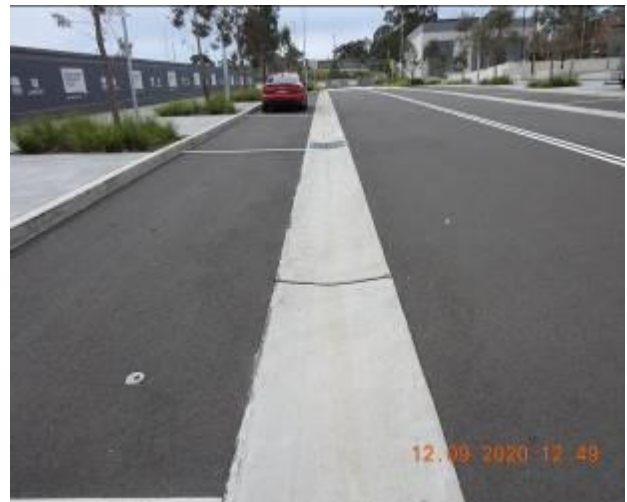
Figure 166 – General condition of gutter

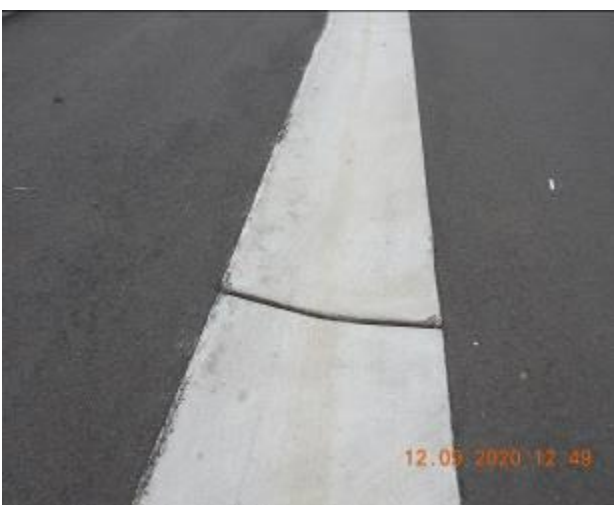
Figure 167 – Crack propagation and loss of material through gutter

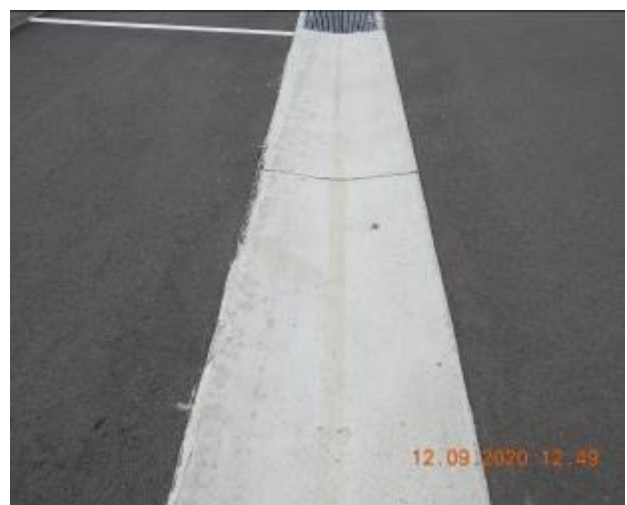
Figure 168 – Crack propagation and loss of material through gutter

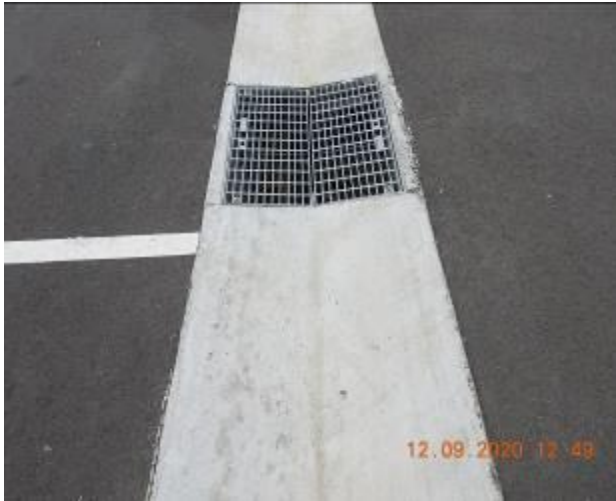
Figure 169 – Crack propagation and loss of material through gutter / General condition of stormwater inlet pit

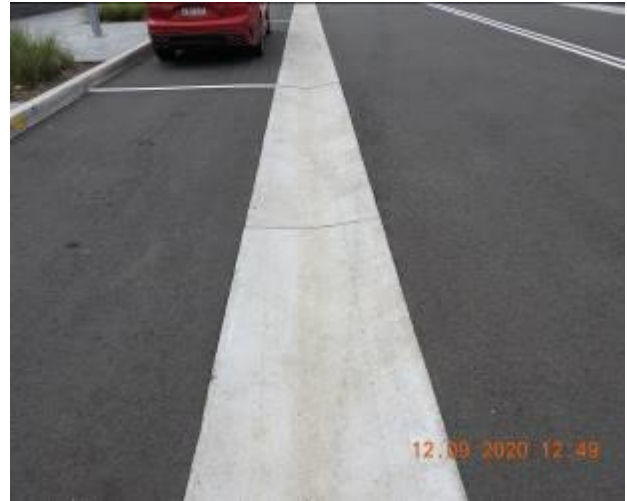
Figure 170 – General condition of gutter

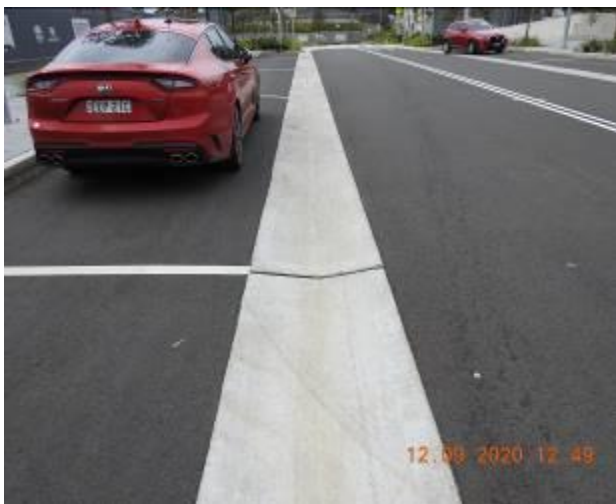
Figure 171 – General condition of gutter

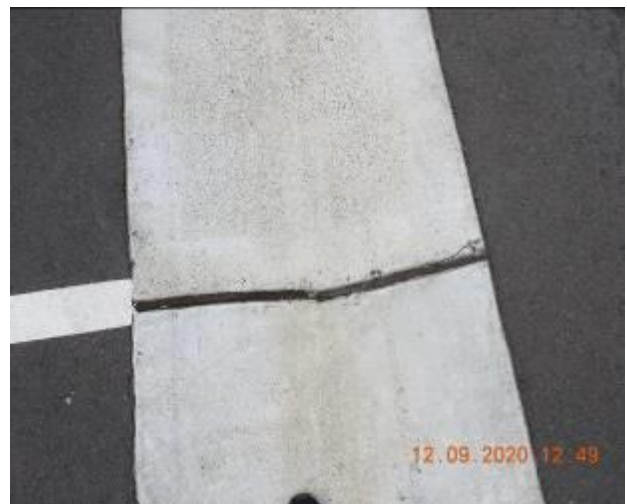
Figure 172 – Crack propagation through gutter

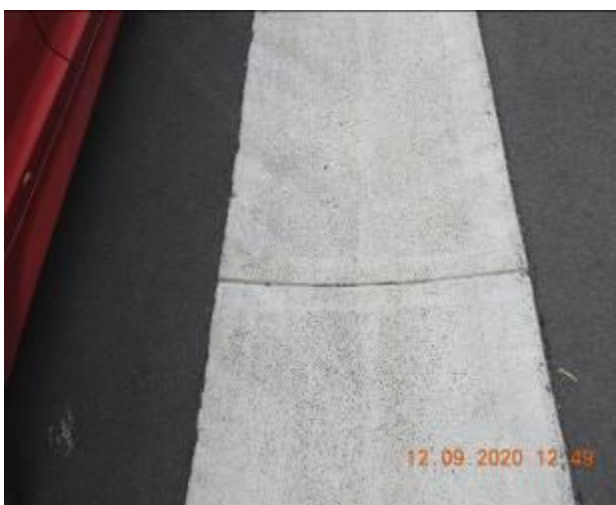
Figure 173 – Evidence of patchwork through gutter

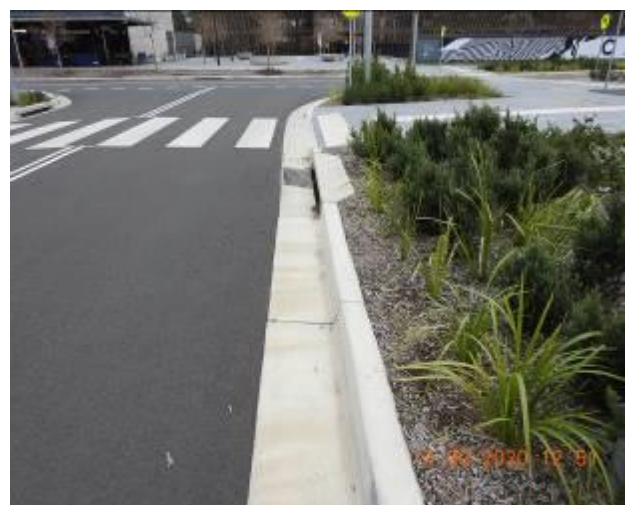
Figure 174 – General condition of kerb and gutter heading West

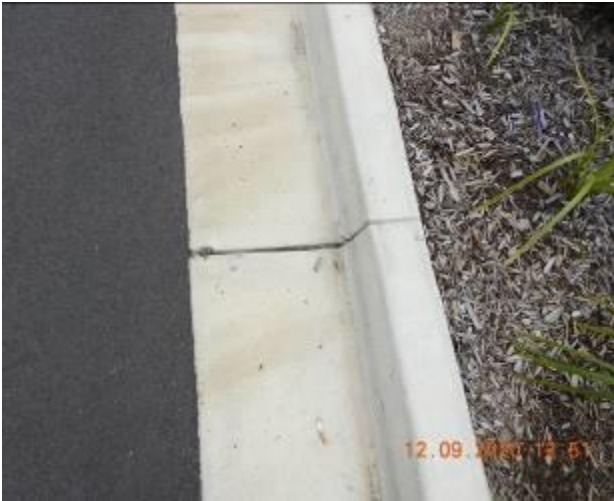
Figure 175 – Loss of material through gutter

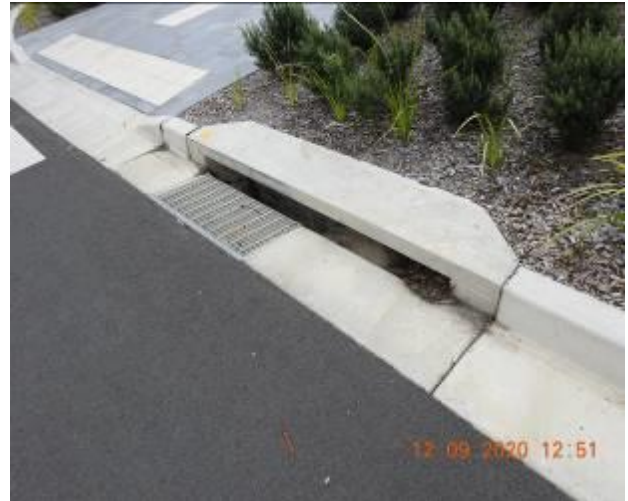
Figure 176 – General condition of kerb inlet pit and stormwater inlet pit

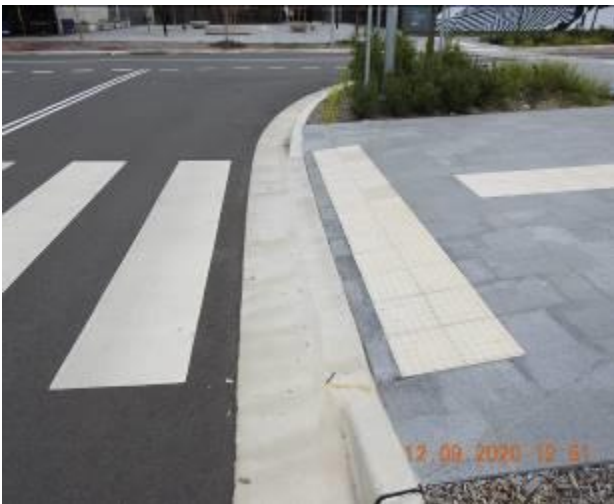
Figure 177 – General condition of layback and gutter

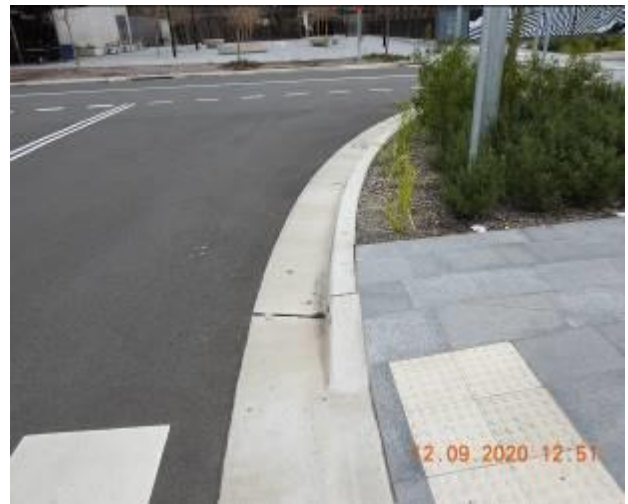
Figure 178 – General condition of kerb and gutter

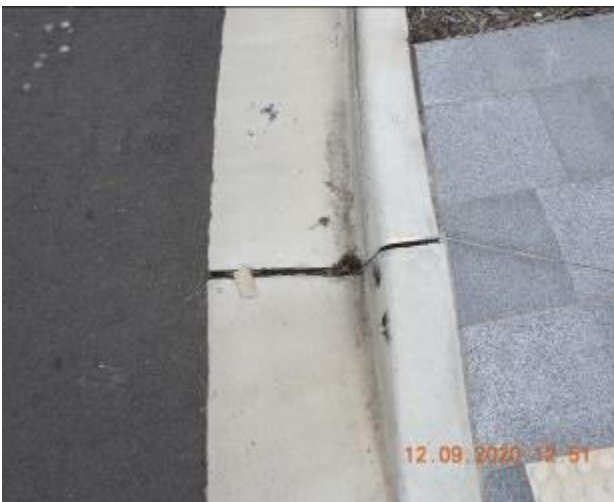
Figure 179 – Loss of material through kerb

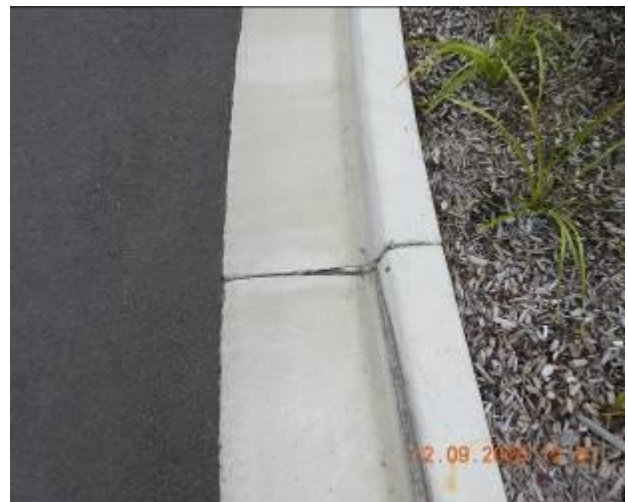
Figure 180 – Crack propagation and loss of material through kerb and gutter

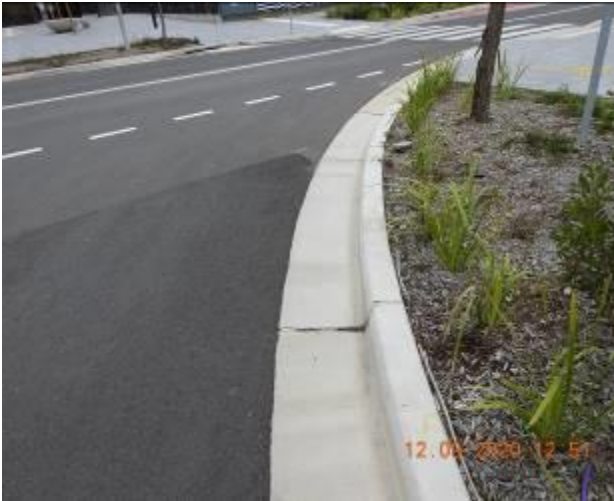
Figure 181 – General condition of kerb and gutter

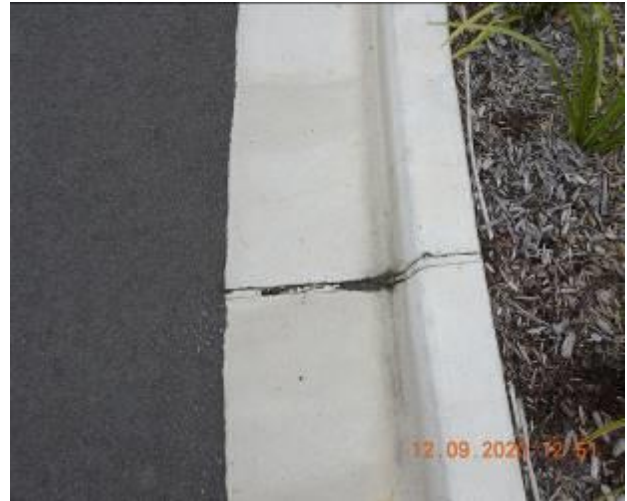
Figure 182 – Crack propagation and loss of material through kerb and gutter

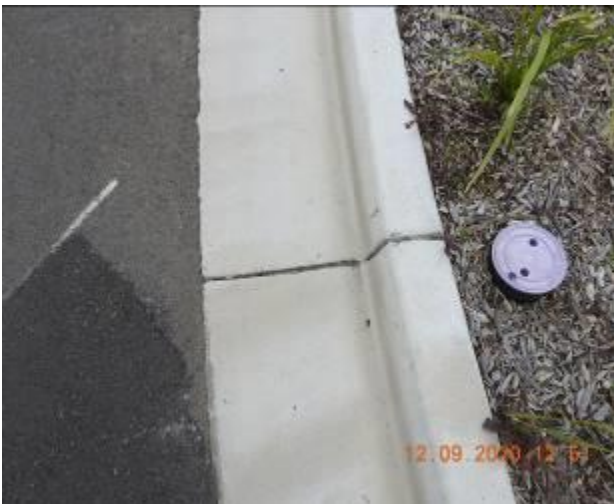
Figure 183 – Crack propagation through kerb

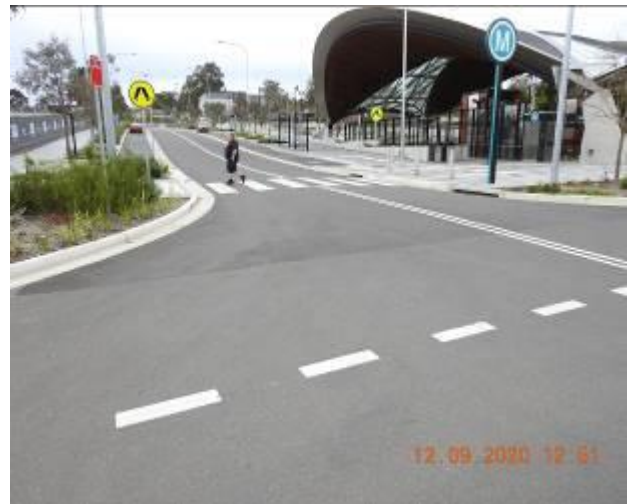
Figure 184 – General condition of road surface heading East

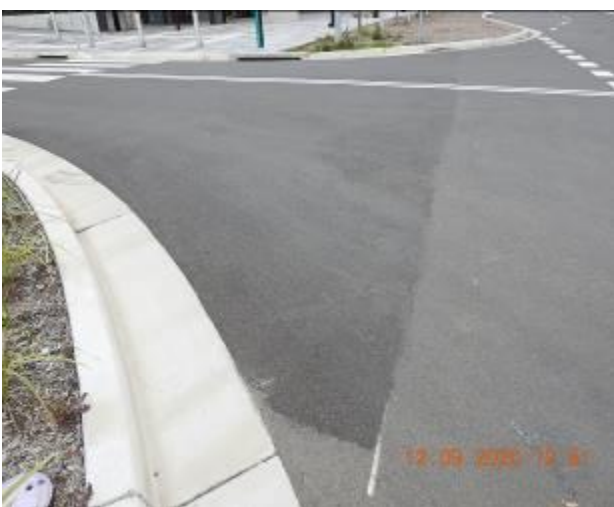
Figure 185 – Loss of material through road surface

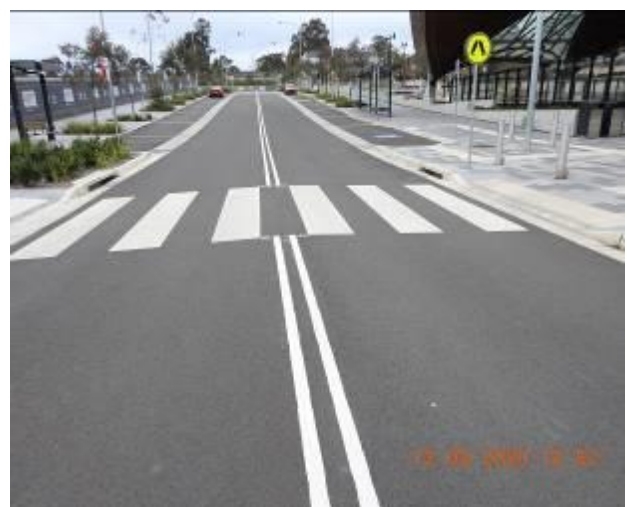
Figure 186 – General condition of road surface

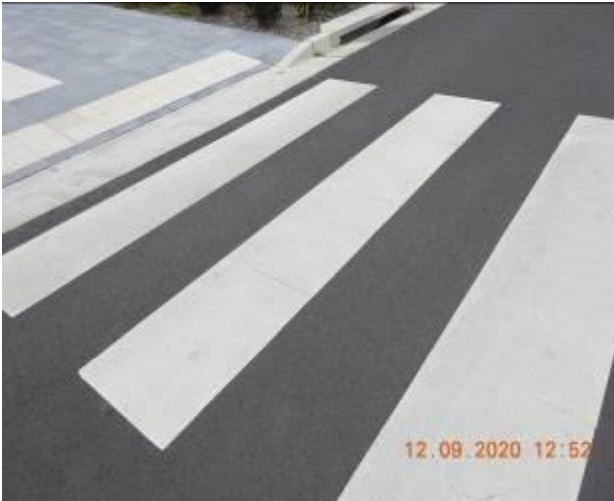
Figure 187 – Crack propagation through road surface

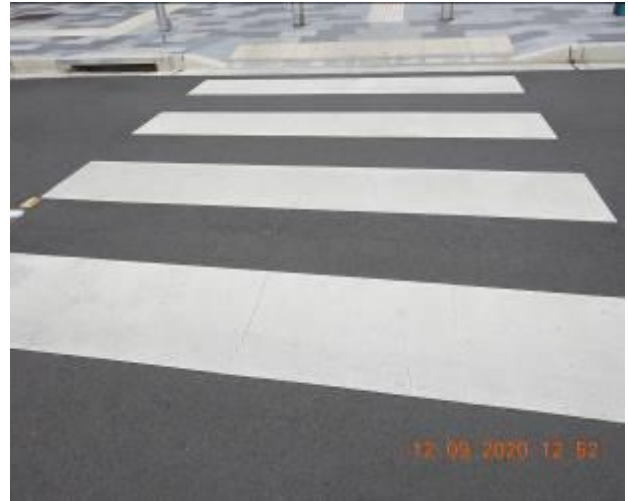
Figure 188 – Crack propagation through road surface

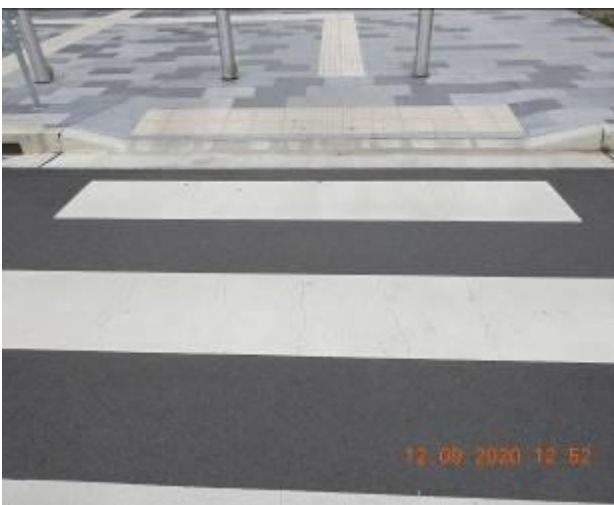
Figure 189 – Crack propagation through road surface

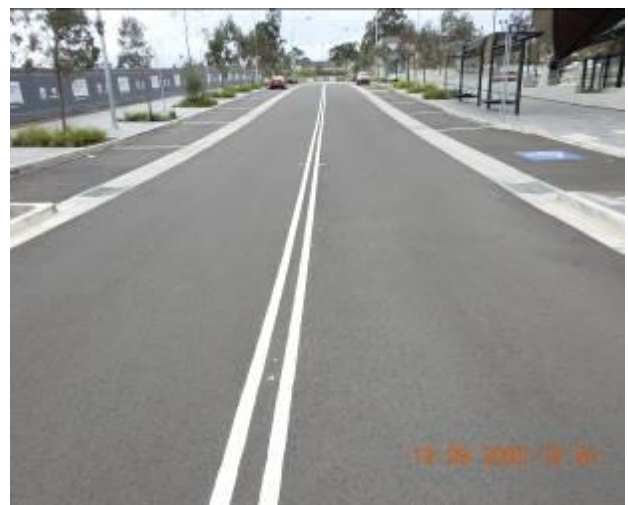
Figure 190 – General condition of road surface

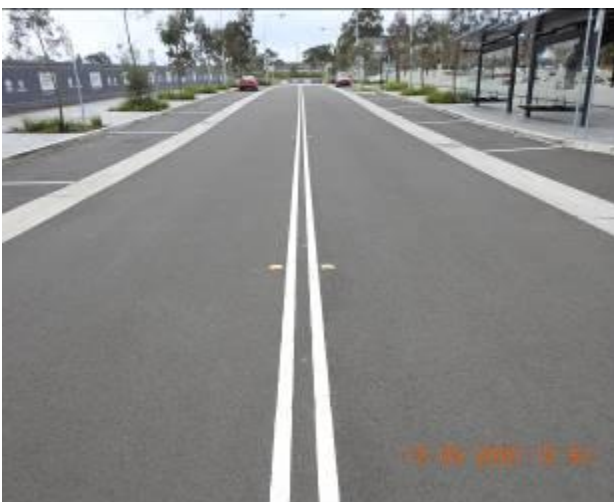
Figure 191 – General condition of road surface

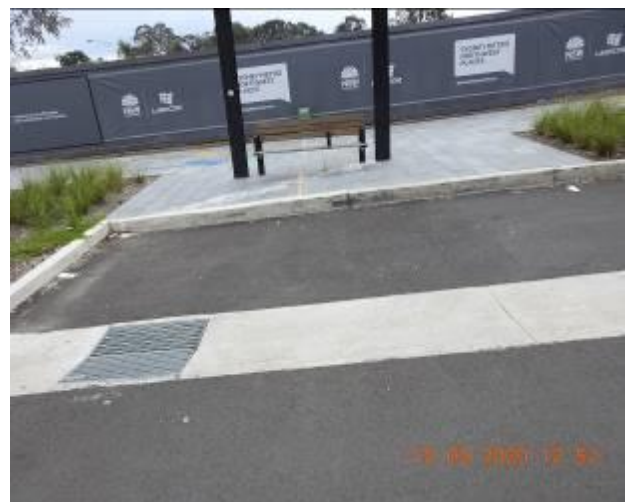
Figure 192 – General condition of road surface

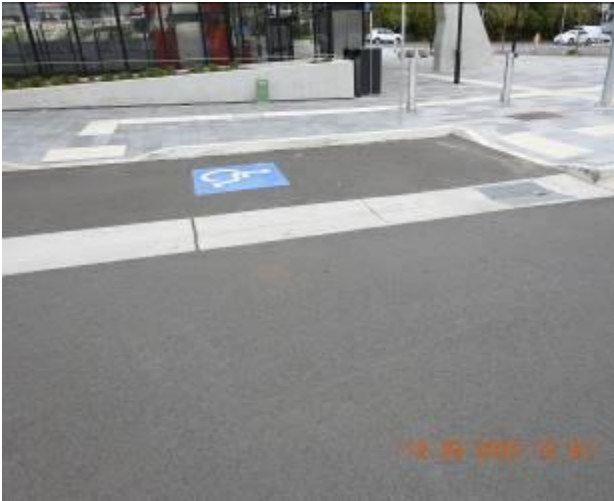
Figure 193 – General condition of road surface

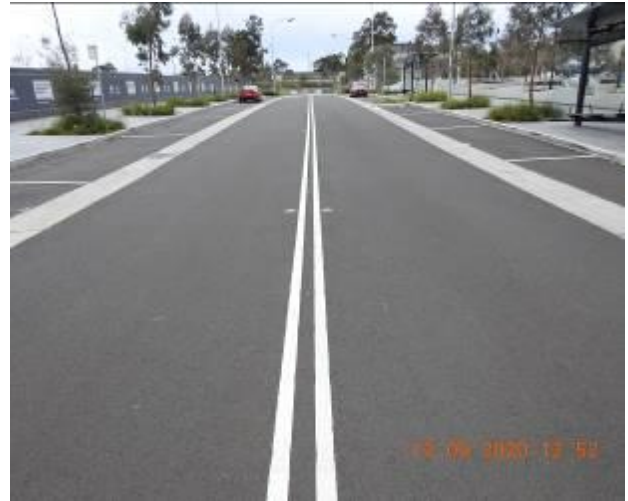
Figure 194 – General condition of road surface

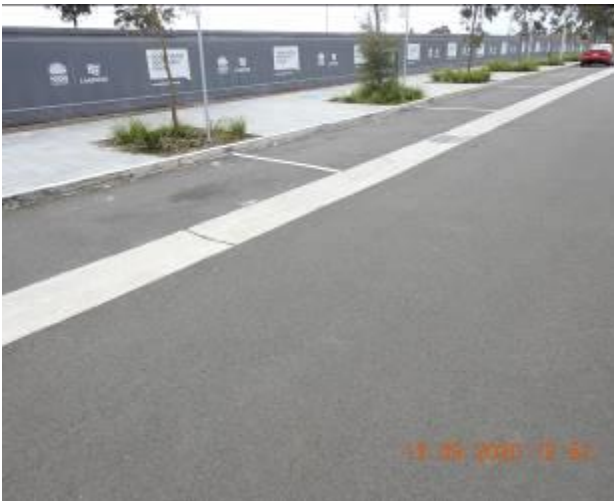
Figure 195 – General condition of road surface

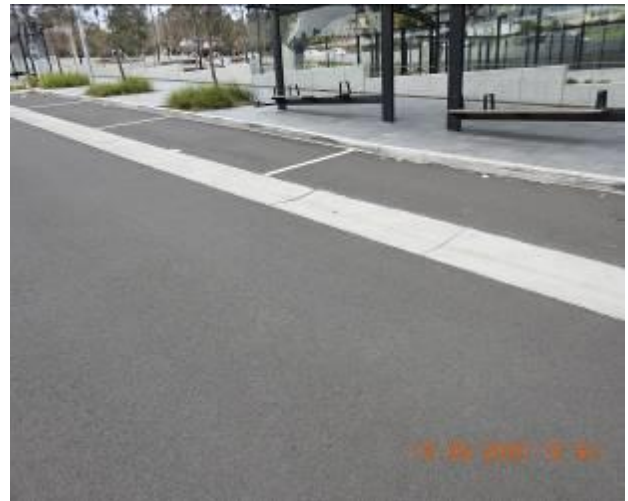
Figure 196 – General condition of road surface

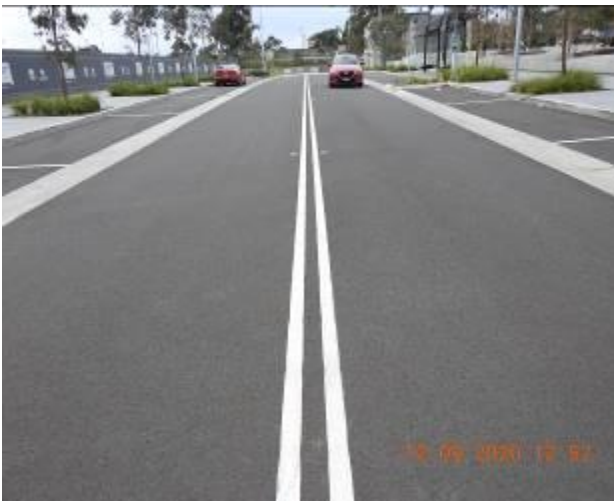
Figure 197 – General condition of road surface

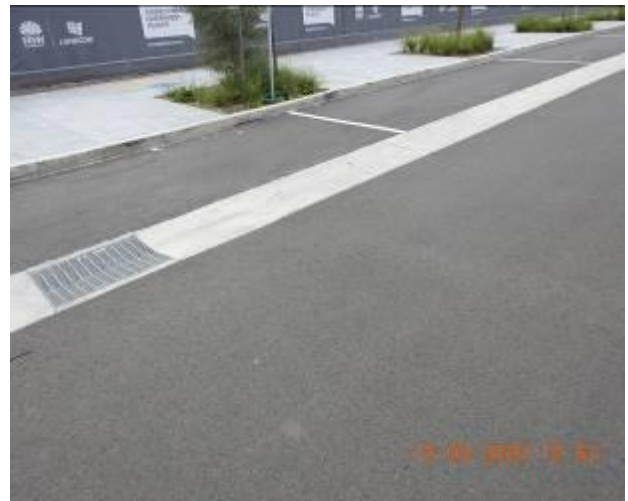
Figure 198 – General condition of road surface

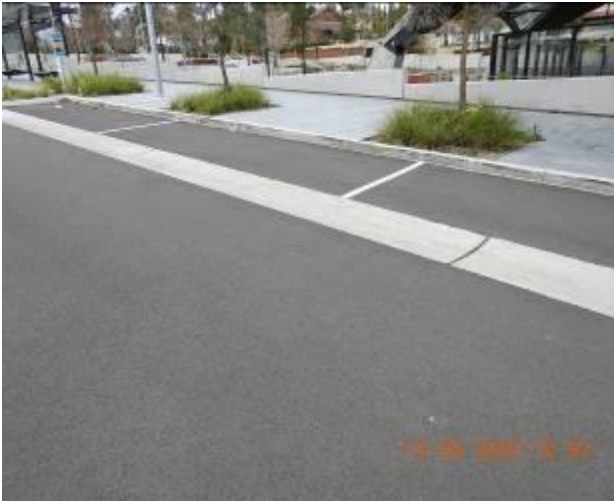
Figure 199 – General condition of road surface

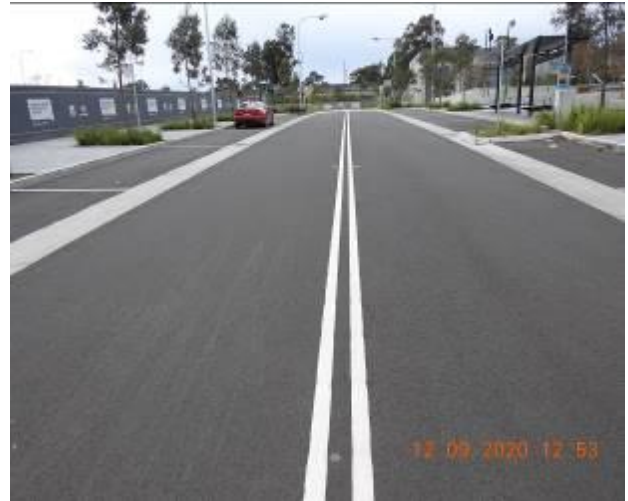
Figure 200 – General condition of road surface

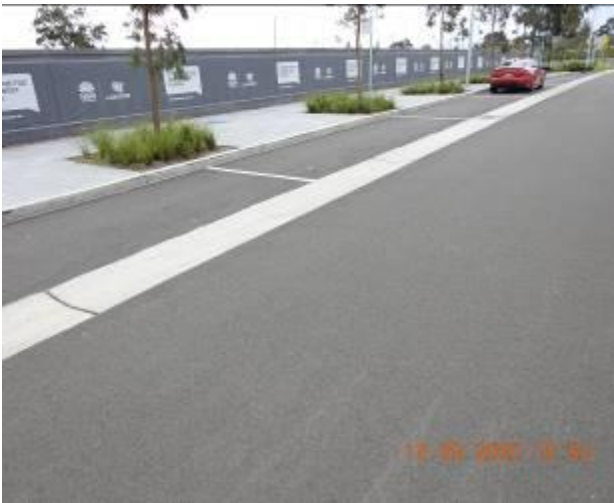
Figure 201 – General condition of road surface

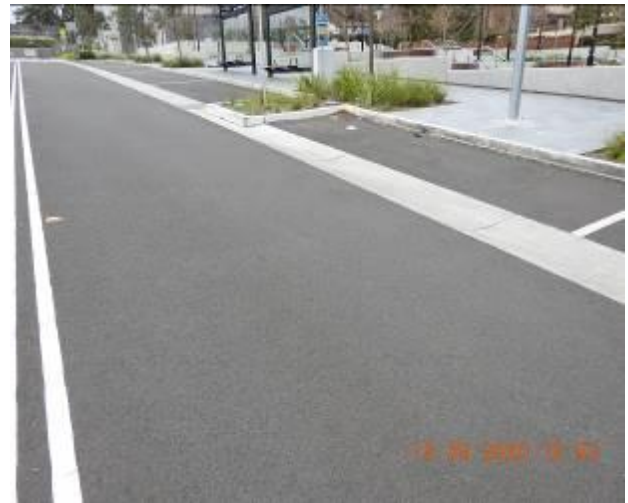
Figure 202 – General condition of road surface

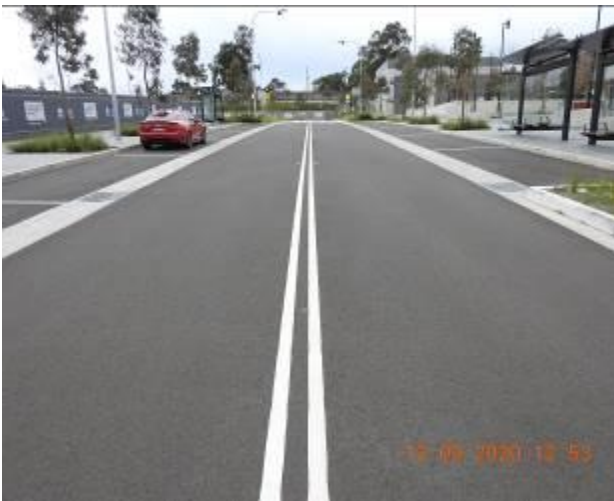
Figure 203 – General condition of road surface

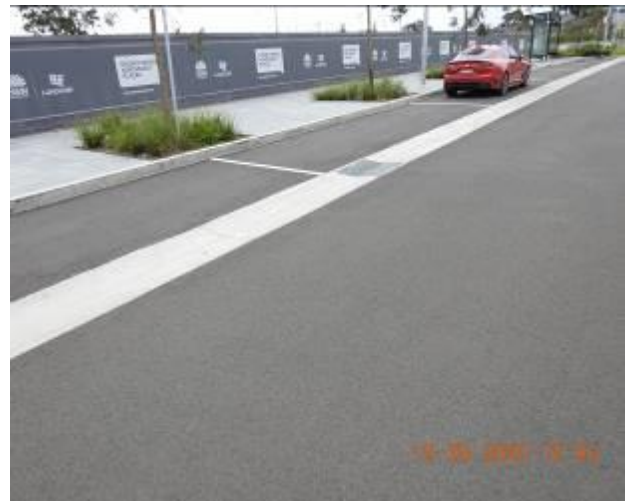
Figure 204 – General condition of road surface

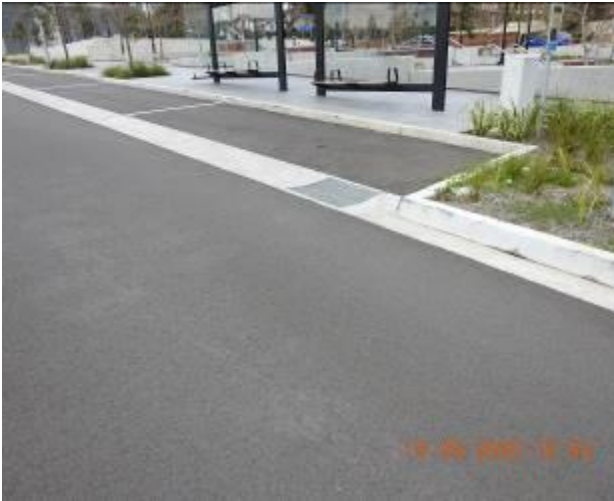
Figure 205 – General condition of road surface

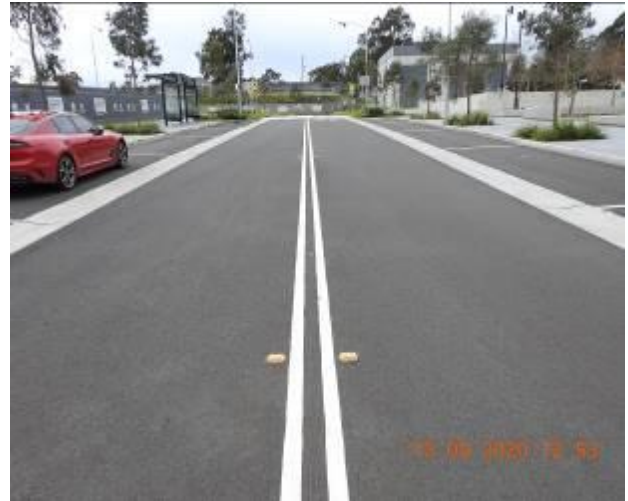
Figure 206 – General condition of road surface

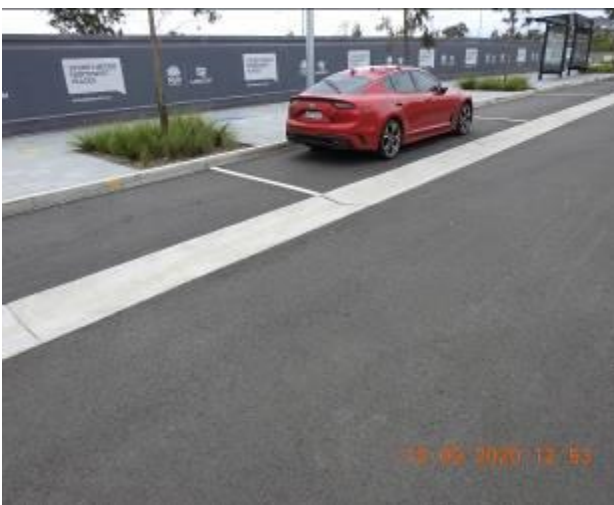
Figure 207 – General condition of road surface

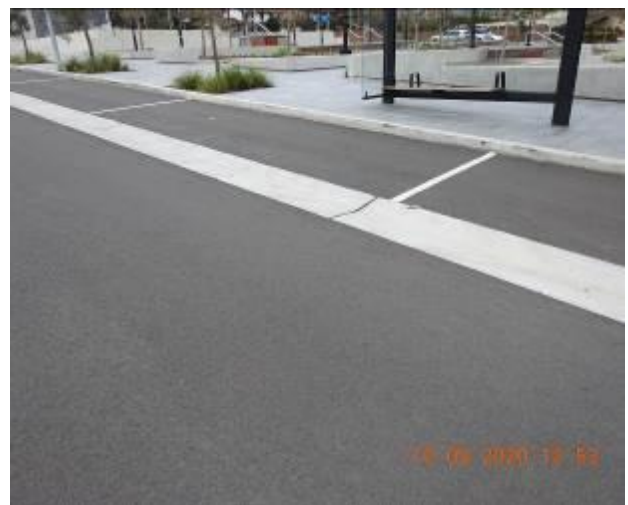
Figure 208 – General condition of road surface

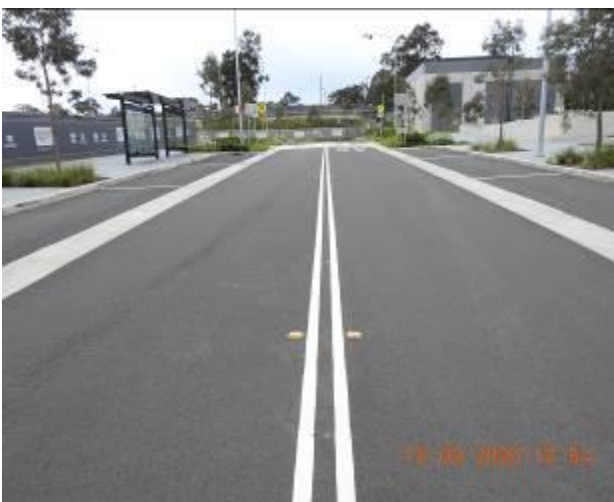
Figure 209 – General condition of road surface

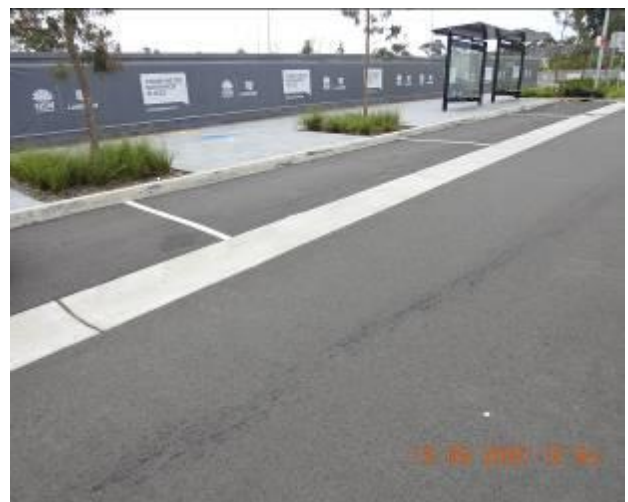
Figure 210 – General condition of road surface

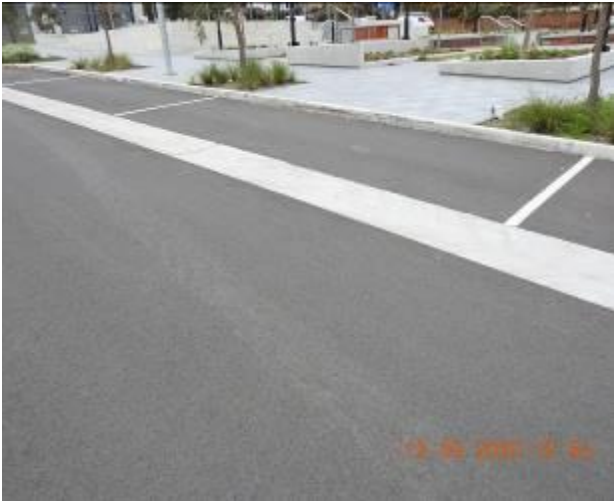
Figure 211 – General condition of road surface

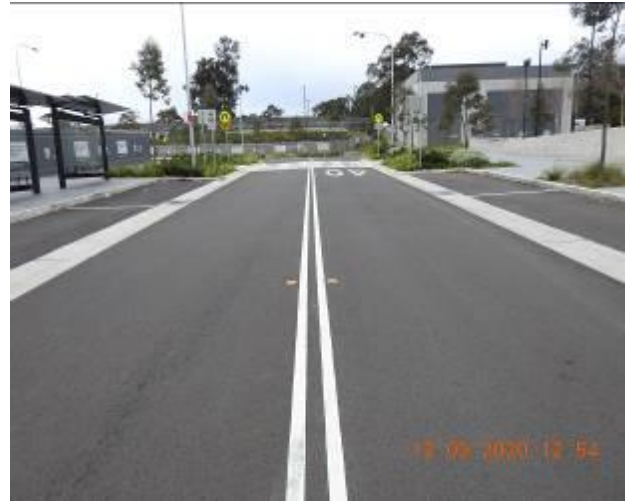
Figure 212 – General condition of road surface
