**2 MANDALA PARADE, CASTLE HILL
(DORAN DRIVE PRECINCT)
PRE-DILAPIDATION REPORT
Of Sydney Metro and Hills Shire Council Assets
DEICORP PROJECTS SHOWGROUND
PTY LTD.**

Job No. 200124.3
07/07/2021

ACE Structural Services Pty Ltd

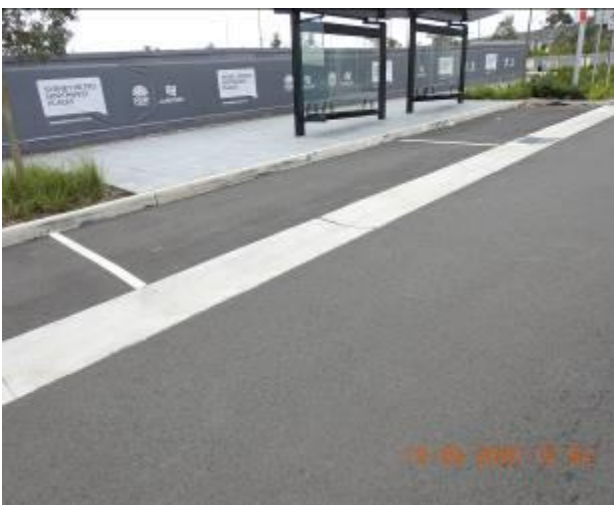
Figure 213 – General condition of road surface

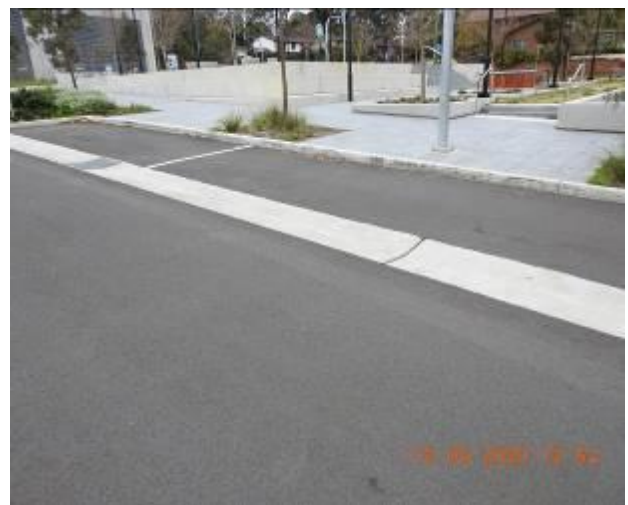
Figure 214 – General condition of road surface

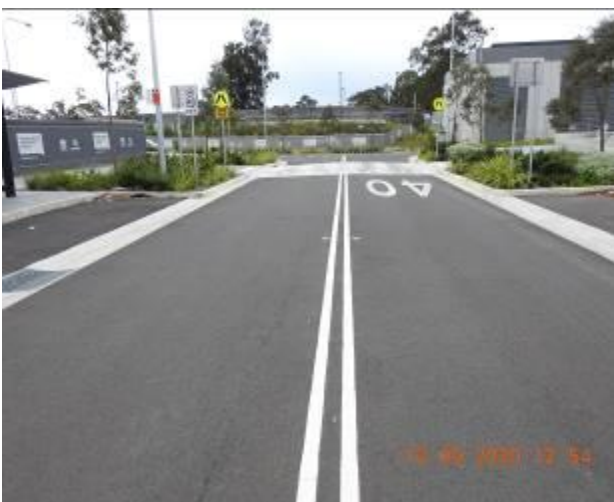
Figure 215 – General condition of road surface

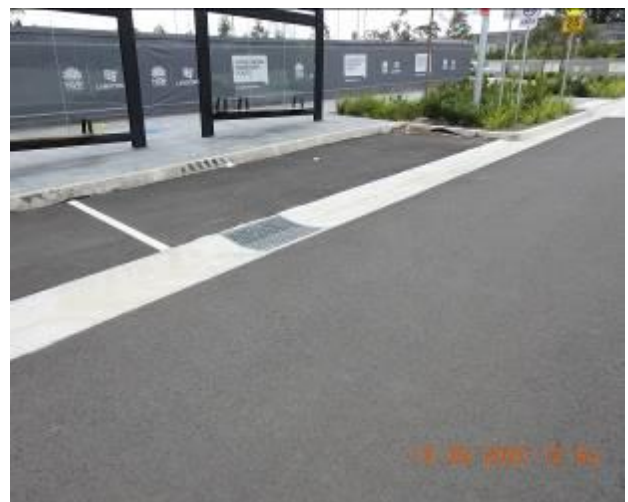
Figure 216 – General condition of road surface

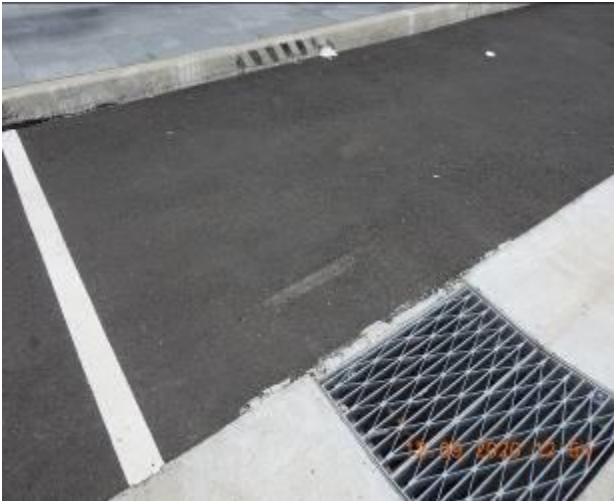
Figure 217 – Loss of material through road surface

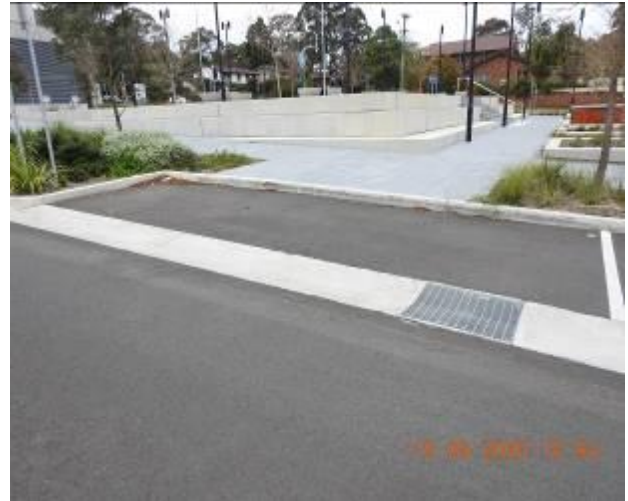
Figure 218 – General condition of road surface

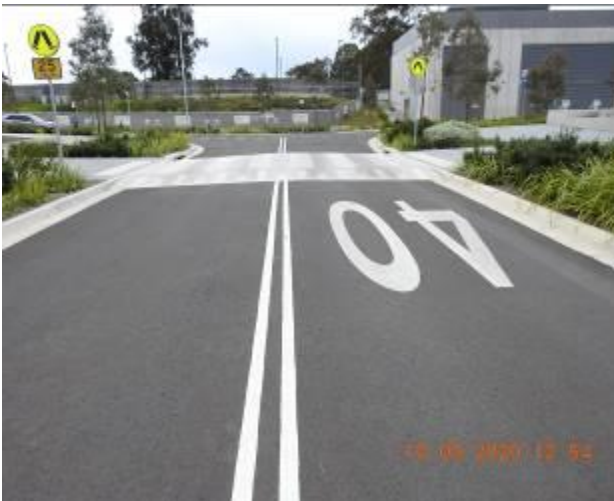
Figure 219 – General condition of road surface

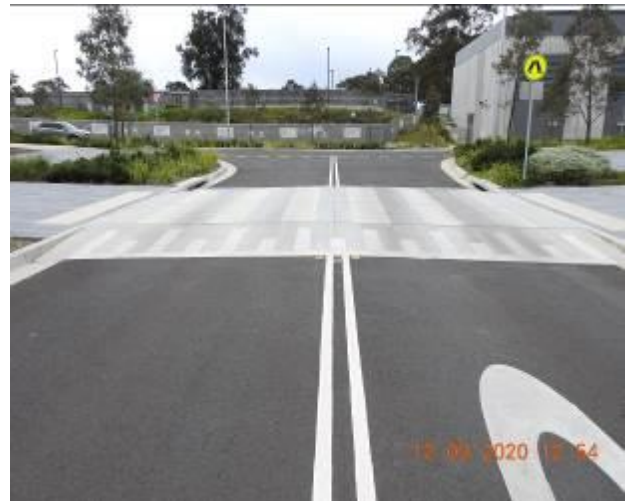
Figure 220 – General condition of road surface

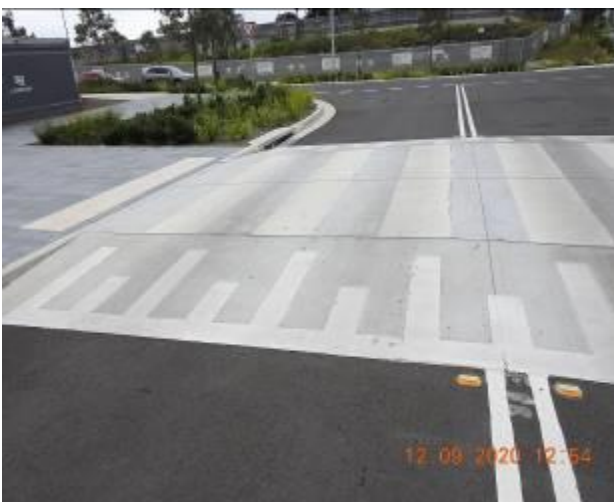
Figure 221 – General condition of road surface

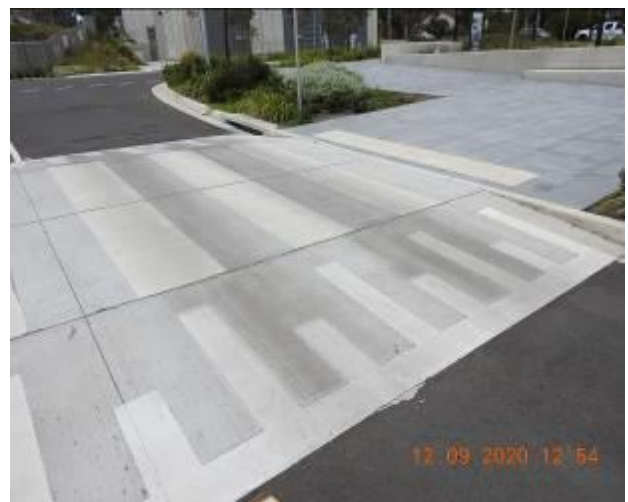
Figure 222 – General condition of road surface

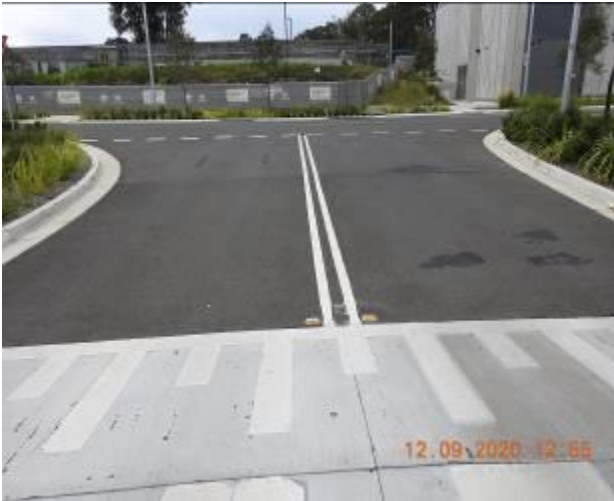
Figure 223 – General condition of road surface

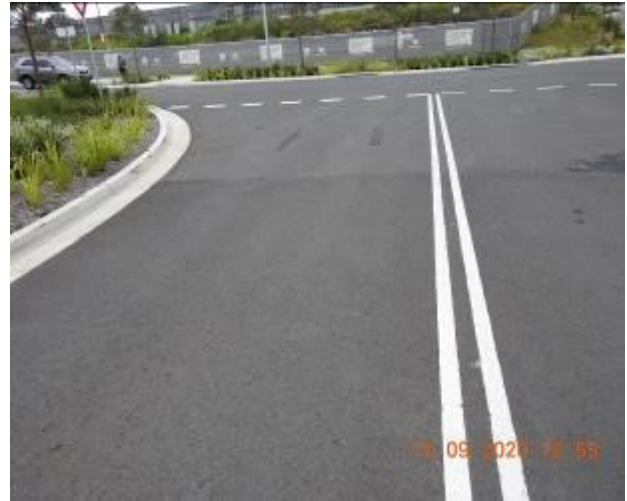
Figure 224 – General condition of road surface

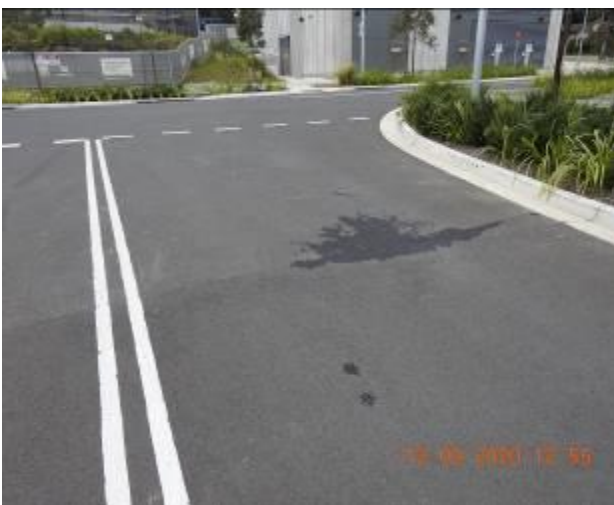
Figure 225 – General condition of road surface

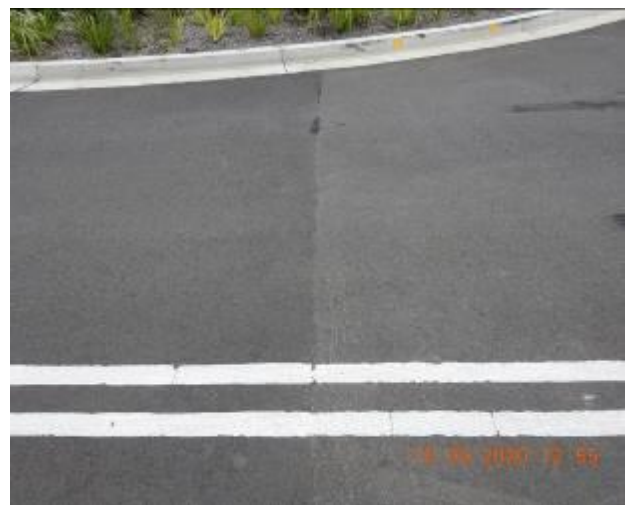
Figure 226 – Loss of material through road surface

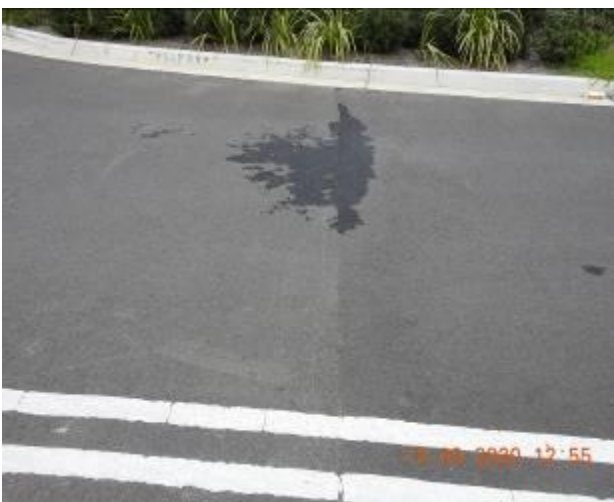
Figure 227 – Loss of material through road surface lines

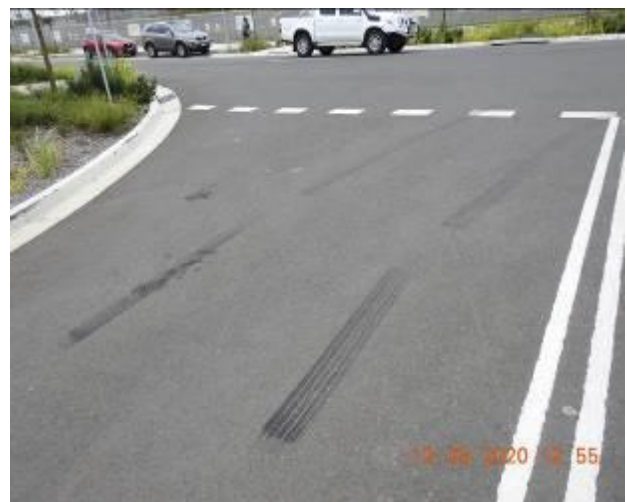
Figure 228 – General condition of road surface lines

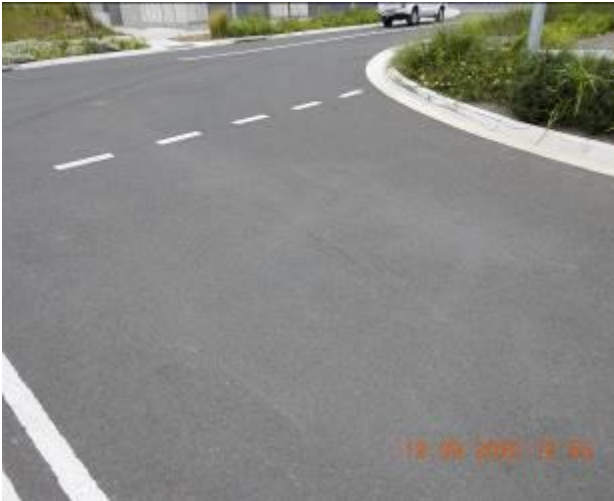
Figure 229 – General condition of road surface

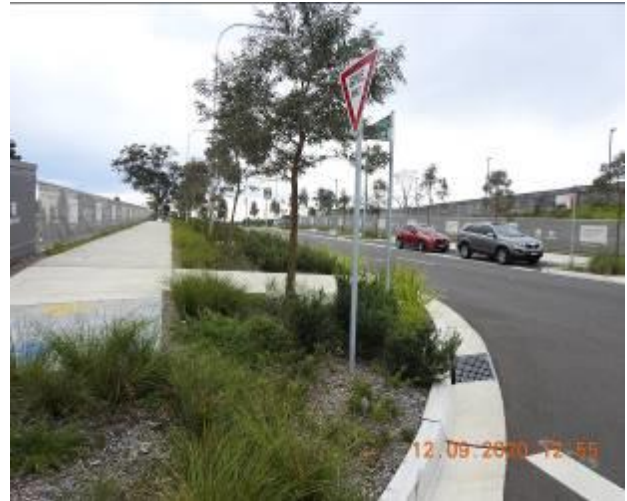
Figure 230 – General condition of street sign heading West

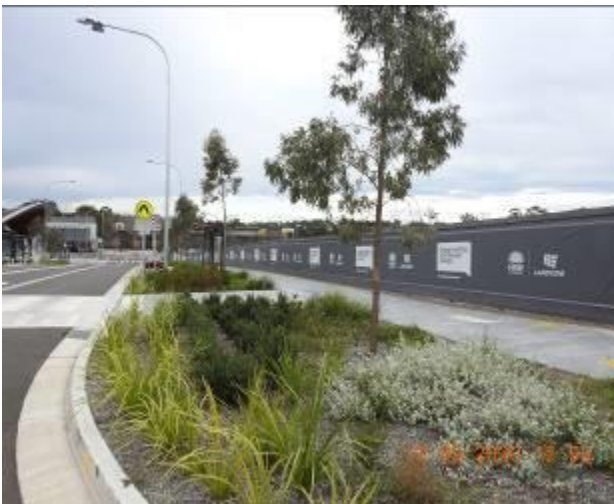
Figure 231 – General condition of plantation

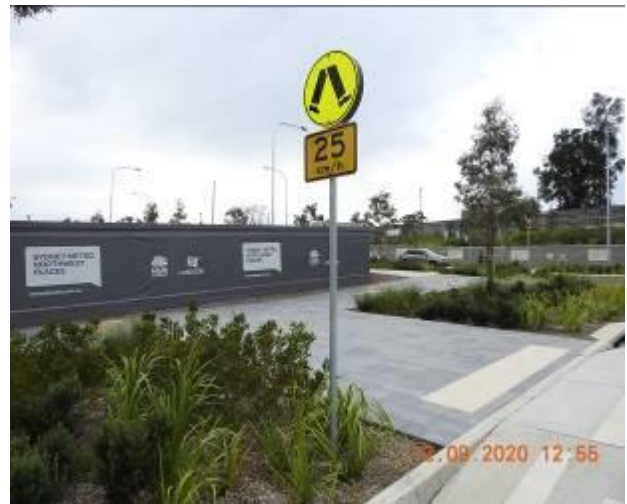
Figure 232 – General condition of street sign

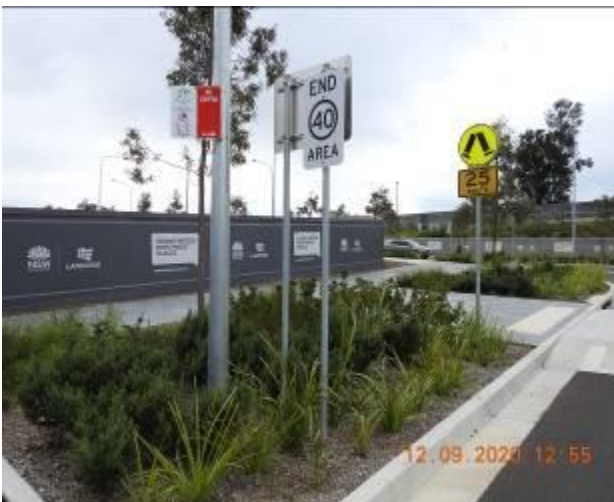
Figure 233 – General condition of street sign

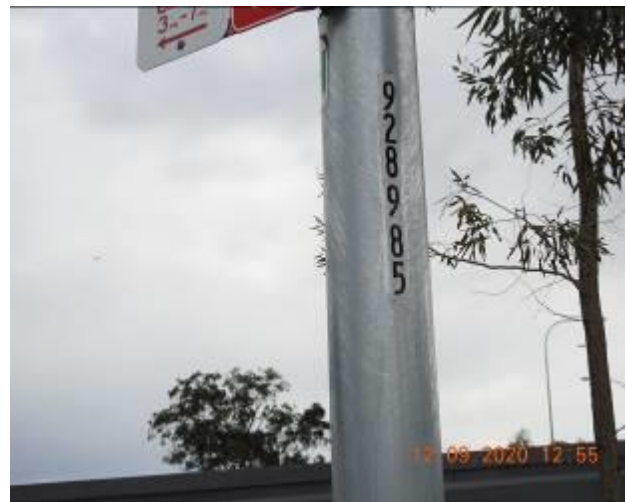
Figure 234 – General condition of lamp post identification No. 928985

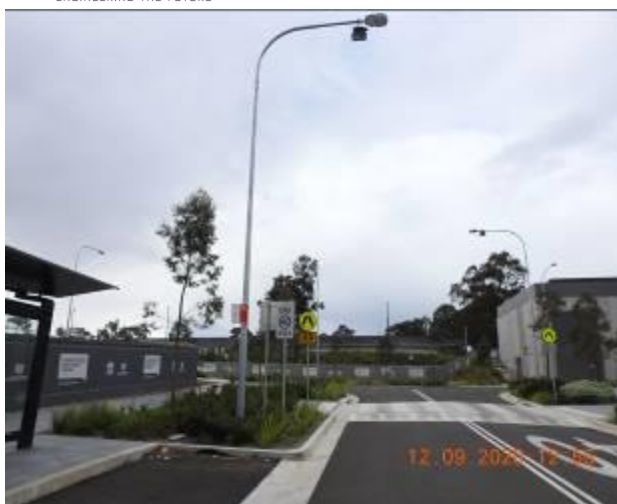
Figure 235 – General condition of lamp post identification No. 928985

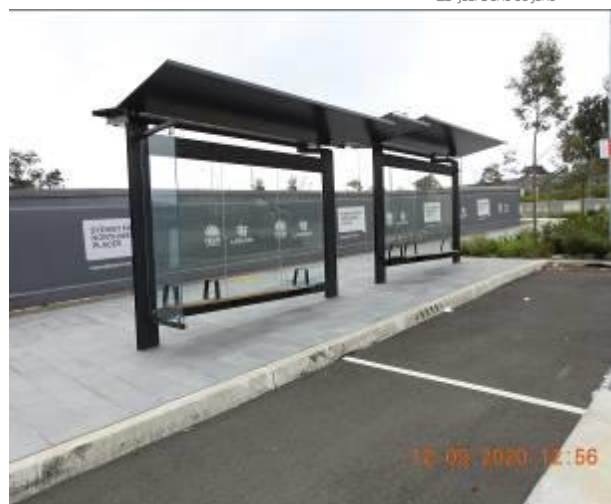
Figure 236 – General condition of bus shelter

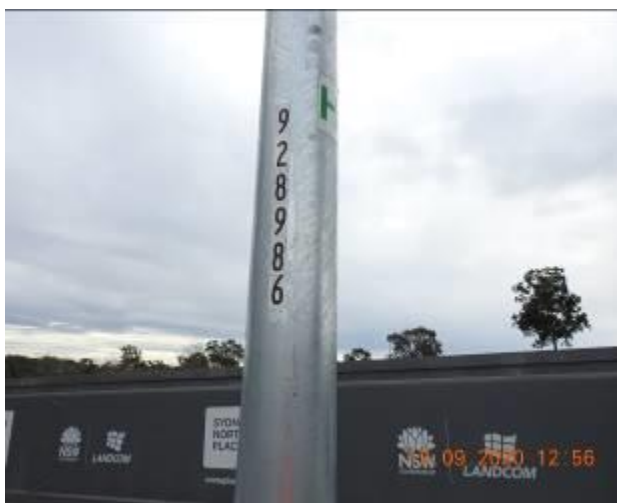
Figure 237 – General condition of lamp post identification No. 928986

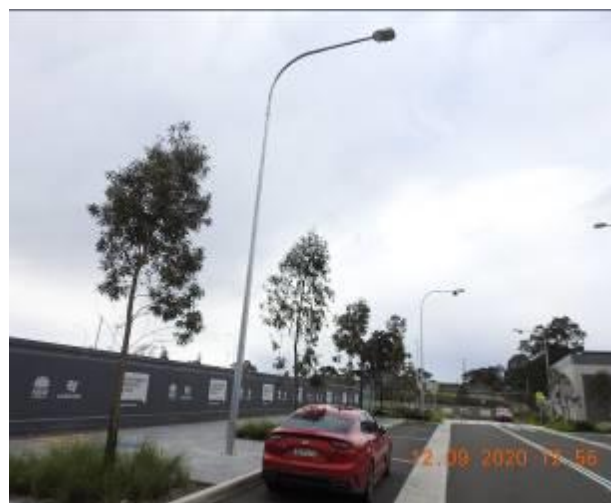
Figure 238 – General condition of lamp post identification No. 928986

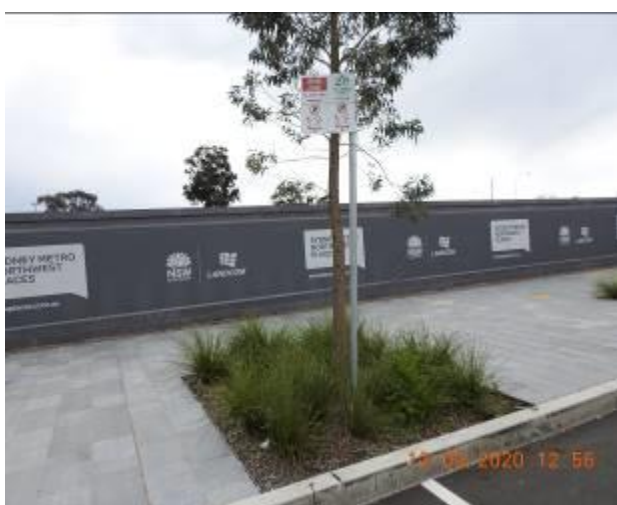
Figure 239 – General condition of street sign

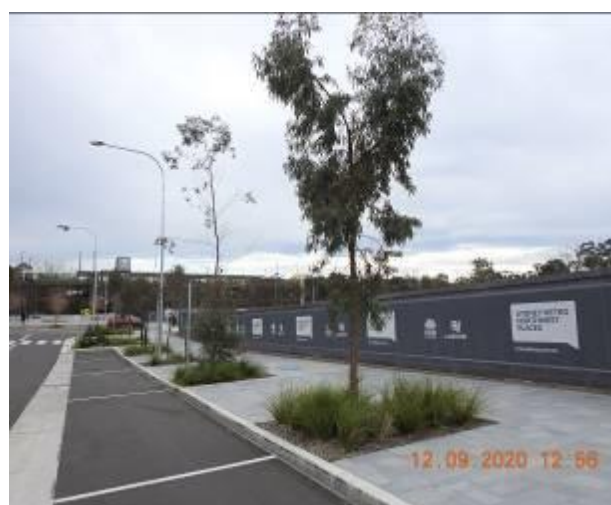
Figure 240 – General condition of plantation

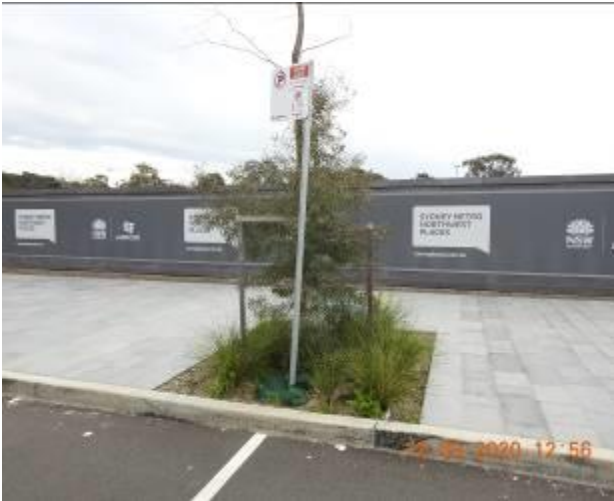
Figure 241 – General condition of street sign

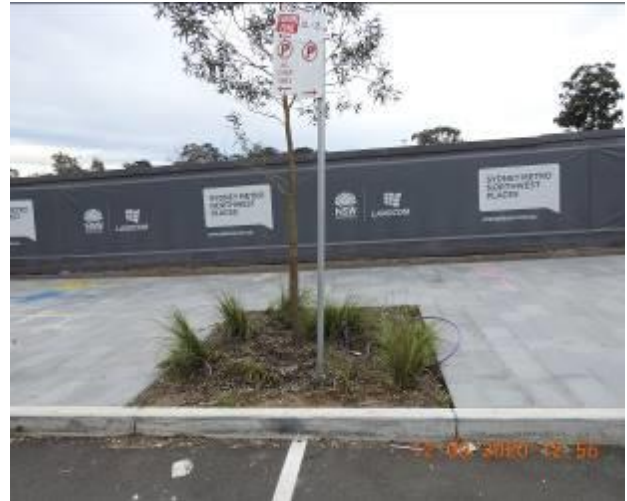
Figure 242 – General condition of street sign

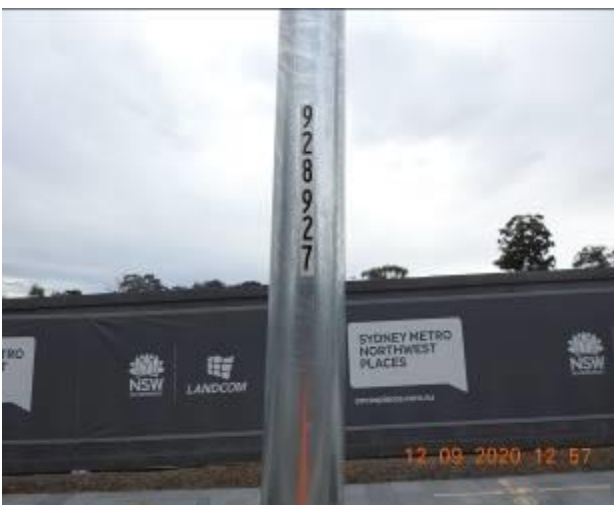
Figure 243 – General condition of lamp post identification No. 928987

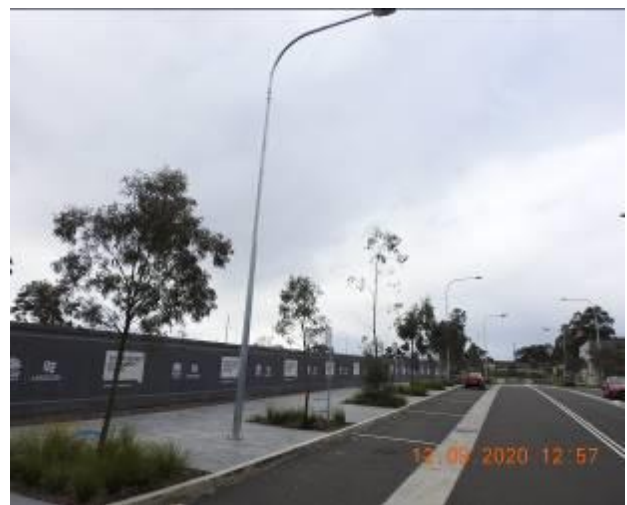
Figure 244 – General condition of lamp post identification No. 928987

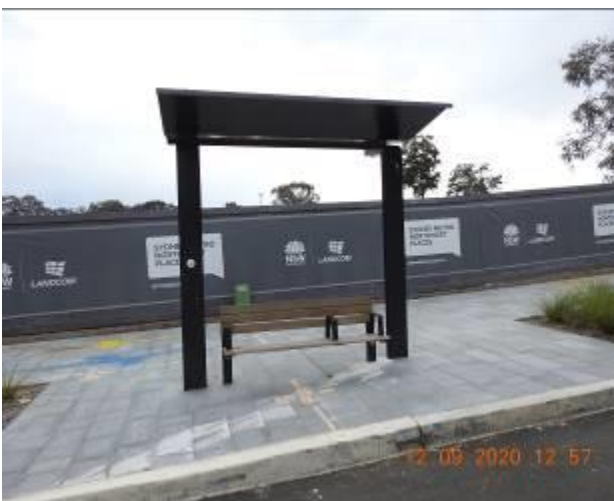
Figure 245 – General condition of bus shelter

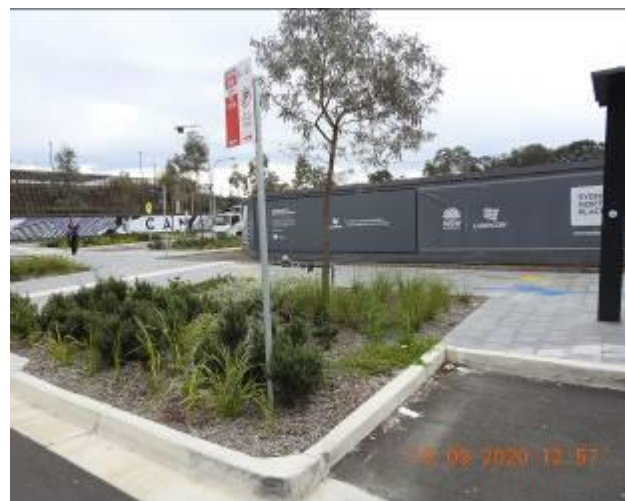
Figure 246 – General condition of street sign

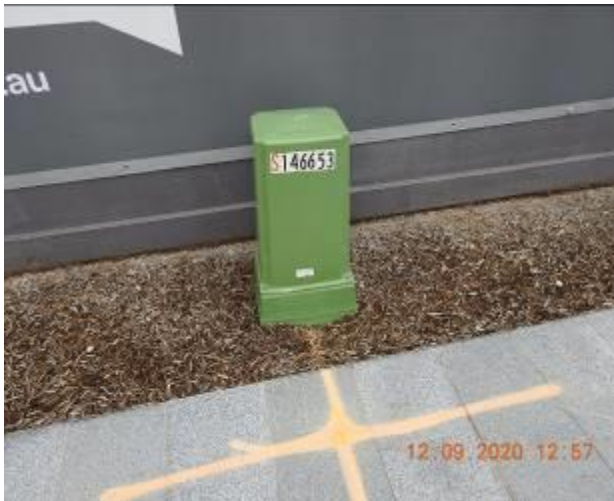
Figure 247 – General condition of electricity box identification No. S146653

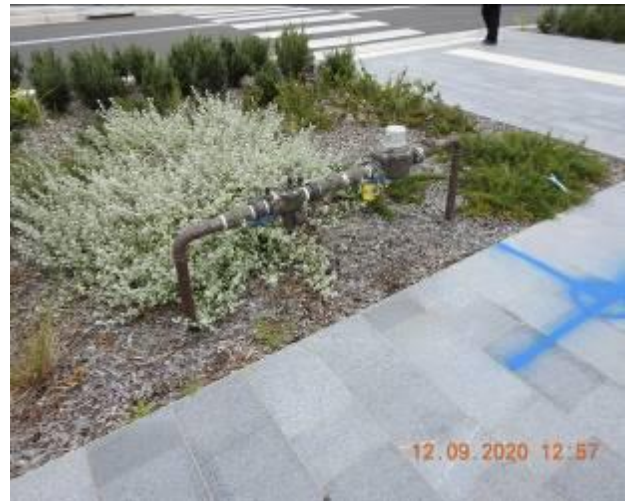
Figure 248 – General condition of hydraulic pump

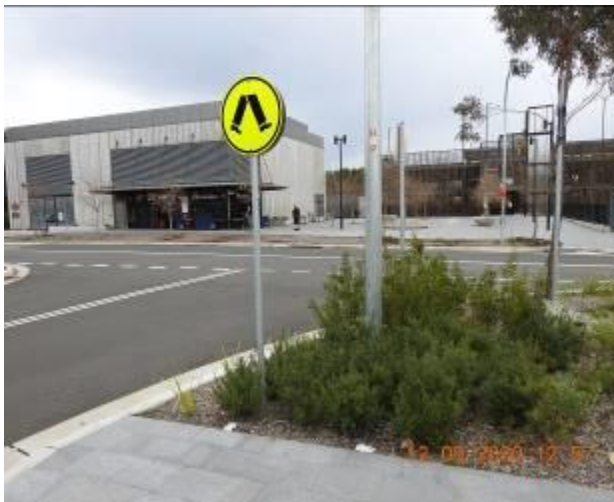
Figure 249 – General condition of street sign

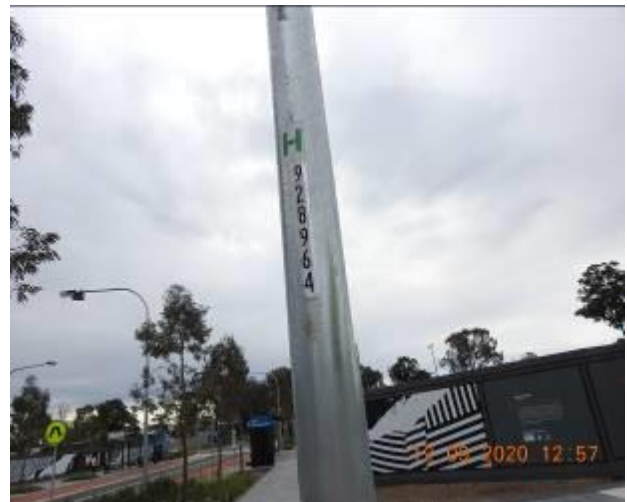
Figure 250 – General condition of lamp post identification No. 928964

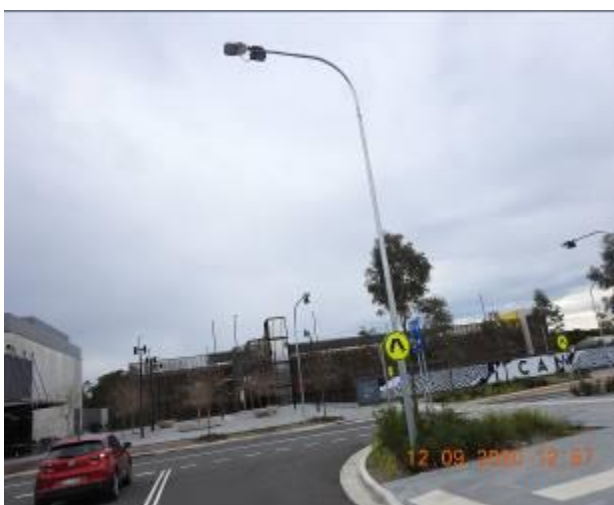
Figure 251 – General condition of lamp post identification No. 928964

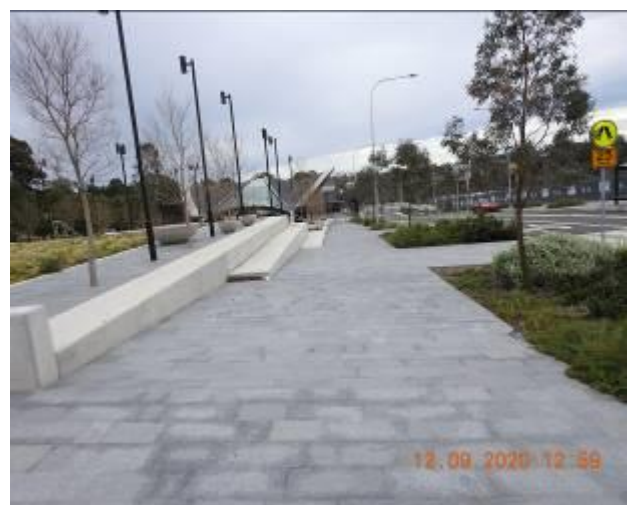
Figure 252 – General condition of footpath pavement heading West

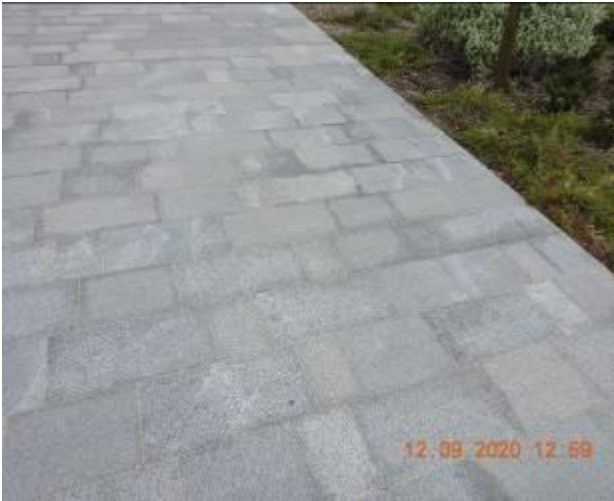
Figure 253 – Hairline cracking and efflorescence through footpath pavement

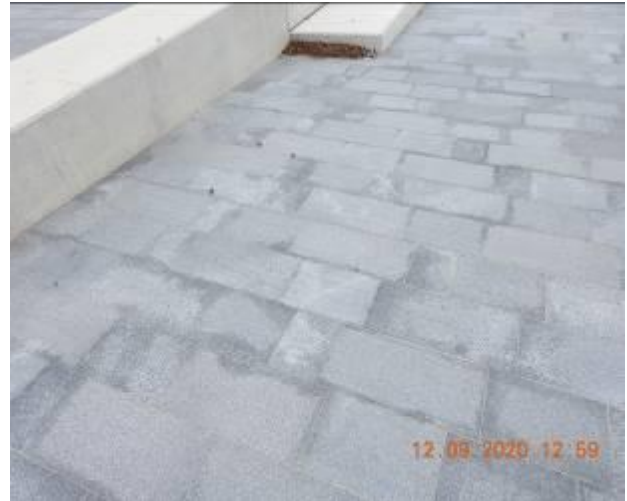
Figure 254 – Hairline cracking and efflorescence through footpath pavement

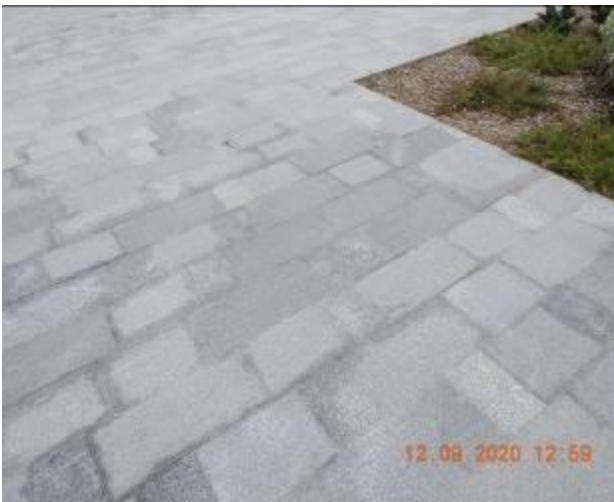
Figure 255 – Hairline cracking and efflorescence through footpath pavement

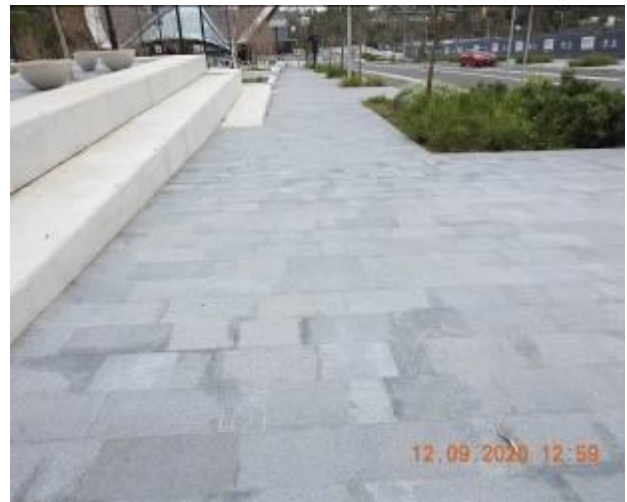
Figure 256 – General condition of footpath pavement

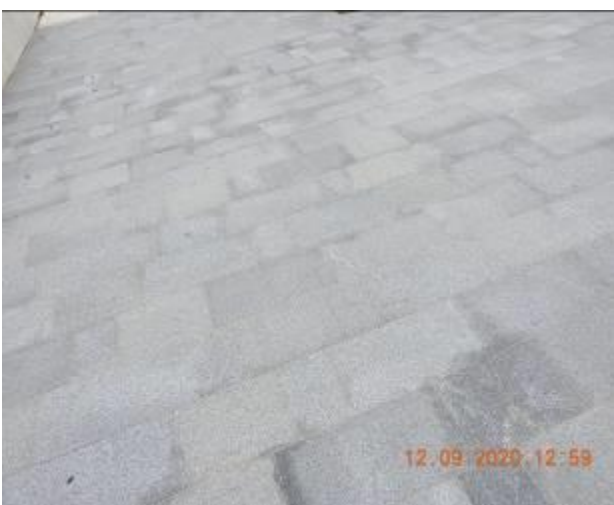
Figure 257 – Hairline cracking and efflorescence through footpath pavement

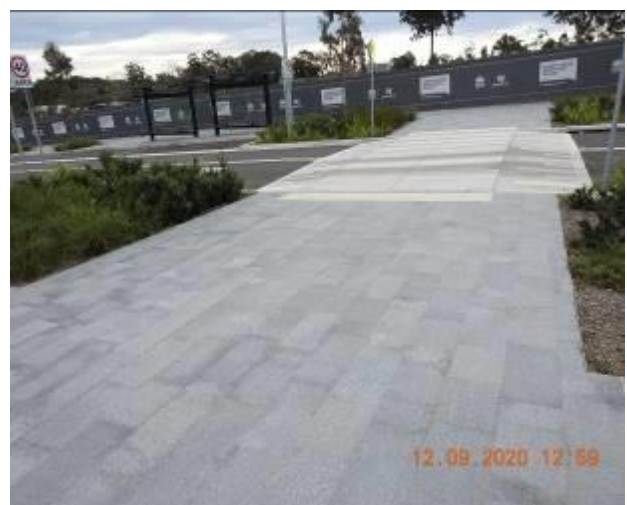
Figure 258 – General condition of footpath pavement

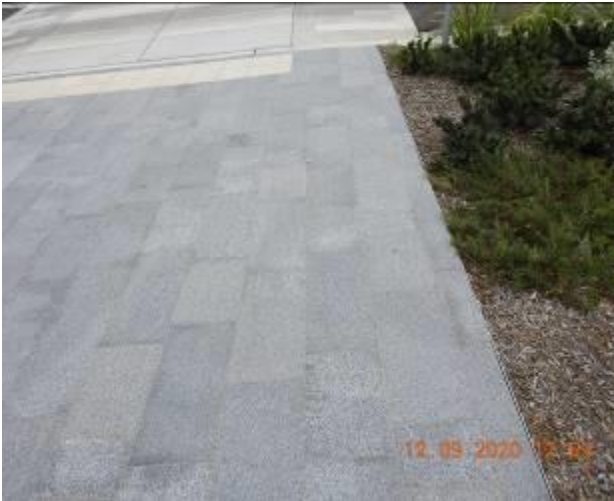
Figure 259 – Hairline cracking and efflorescence through footpath pavement

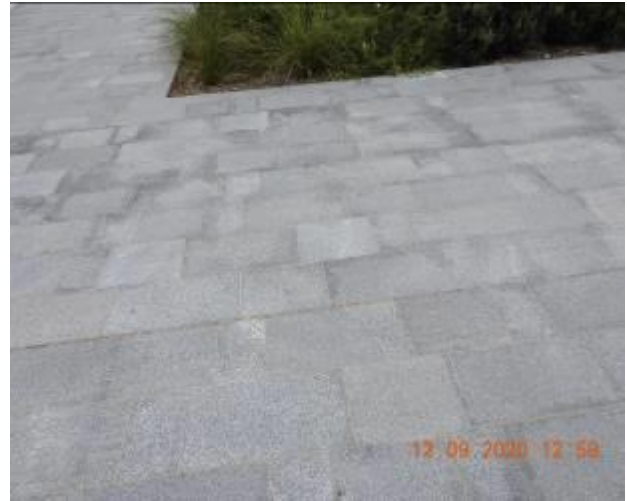
Figure 260 – Hairline cracking and efflorescence through footpath pavement

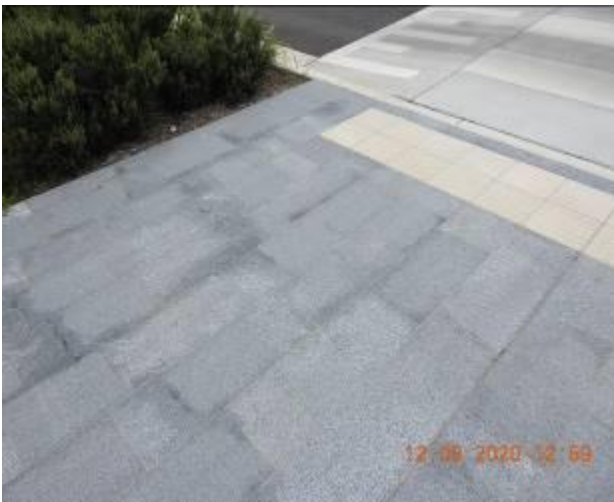
Figure 261 – Hairline cracking and efflorescence through footpath pavement

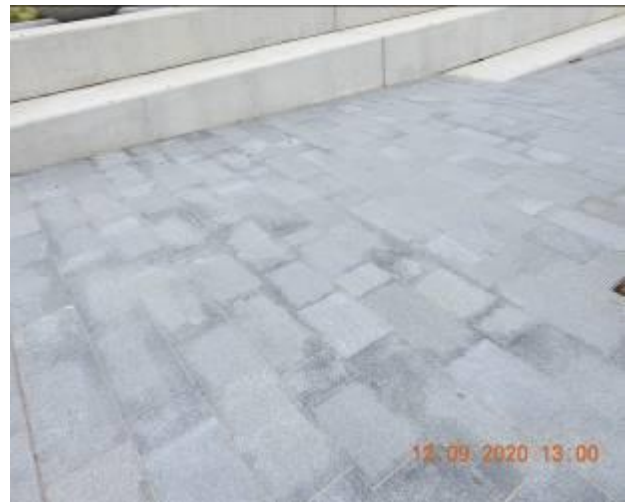
Figure 262 – Hairline cracking and efflorescence through footpath pavement

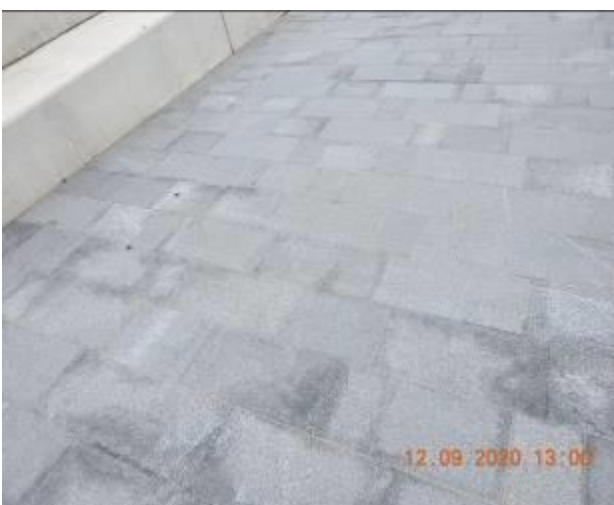
Figure 263 – Hairline cracking and efflorescence through footpath pavement

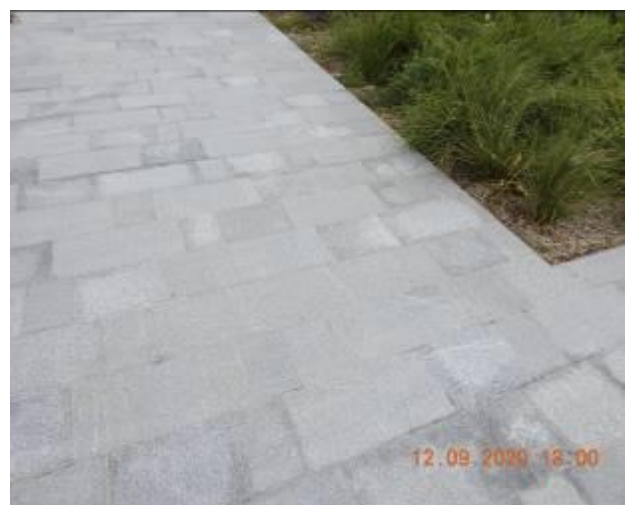
Figure 264 – Hairline cracking and efflorescence through footpath pavement

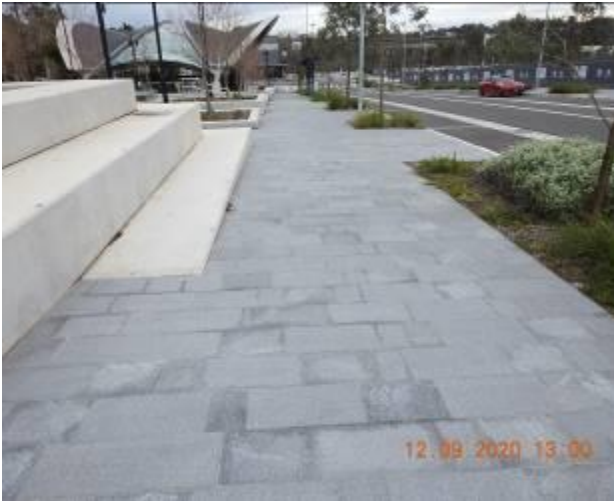
Figure 265 – General condition of footpath pavement

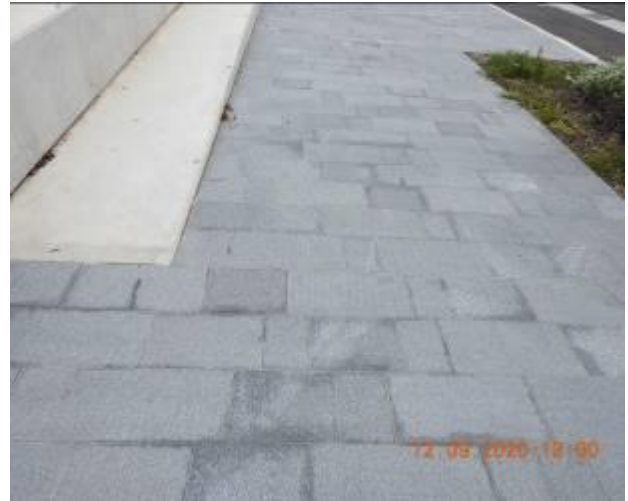
Figure 266 – Hairline cracking and efflorescence through footpath pavement

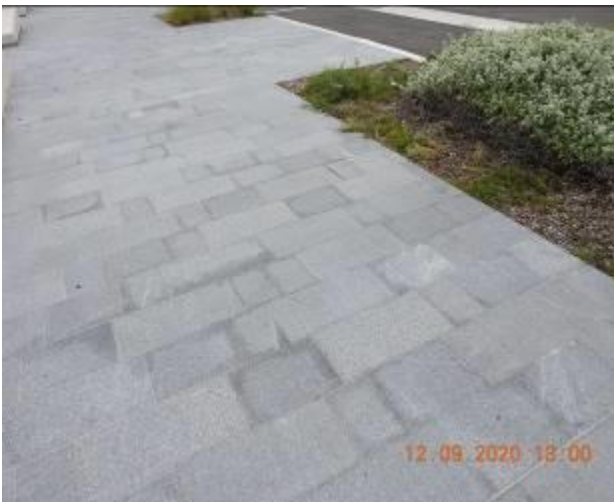
Figure 267 – Hairline cracking and efflorescence through footpath pavement

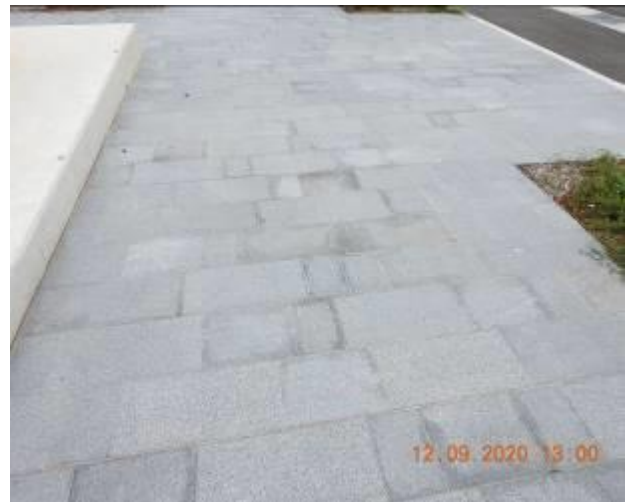
Figure 268 – Hairline cracking and efflorescence through footpath pavement

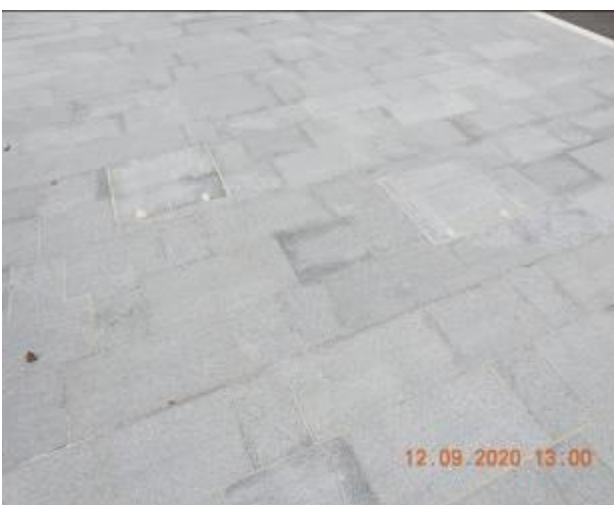
Figure 269 – Hairline cracking and efflorescence through footpath pavement

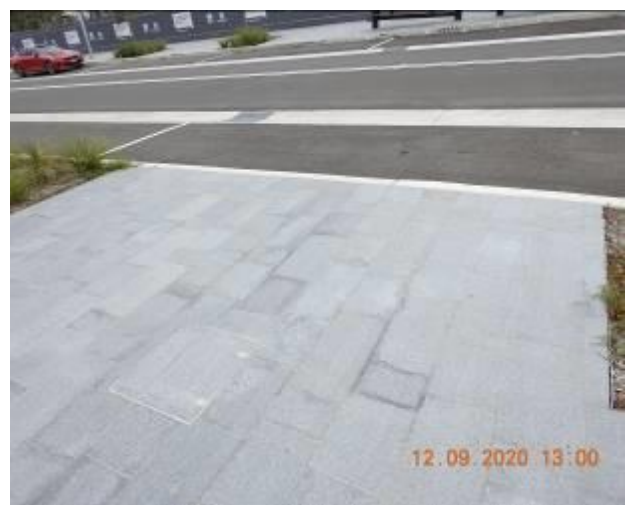
Figure 270 – Hairline cracking and efflorescence through footpath pavement

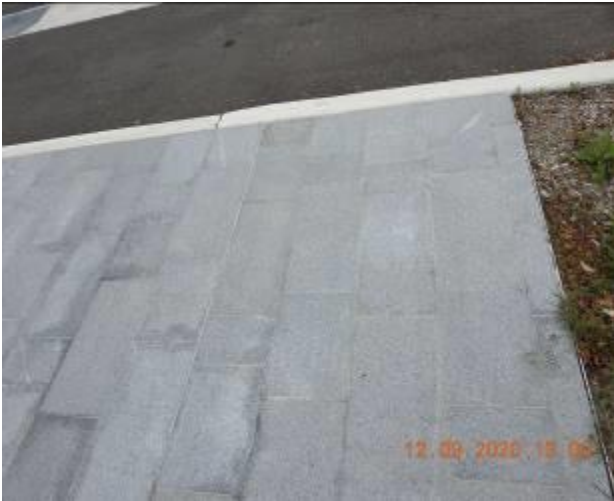
Figure 271 – Hairline cracking and efflorescence through footpath pavement

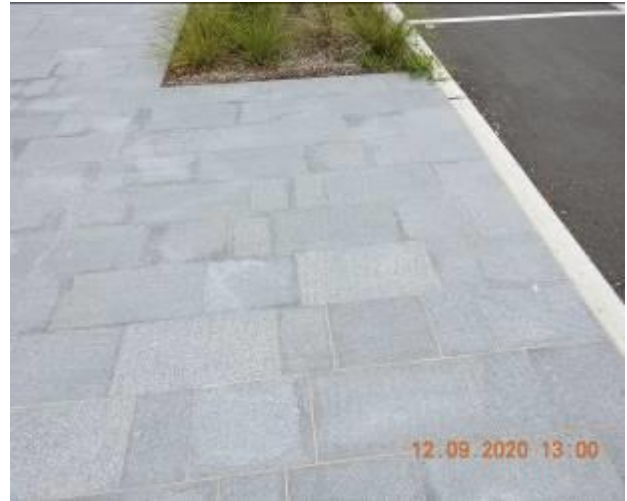
Figure 272 – Hairline cracking and efflorescence through footpath pavement

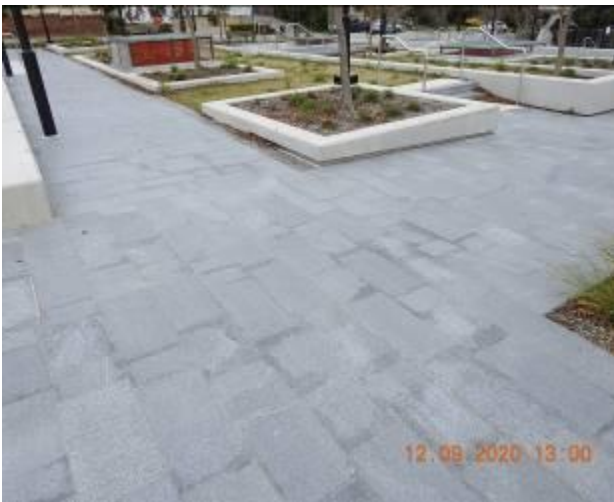
Figure 273 – General condition of footpath pavement

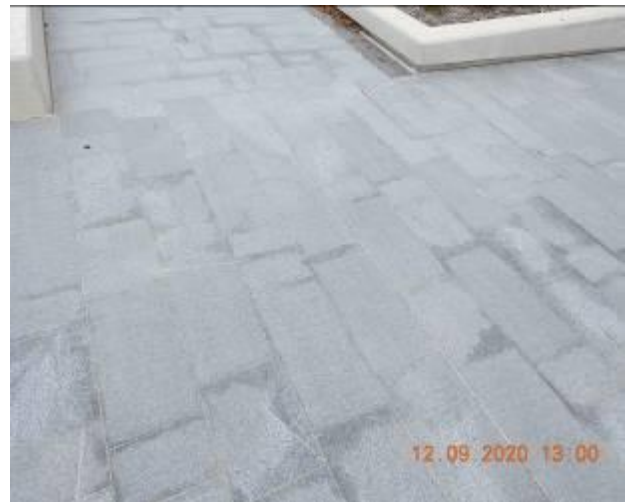
Figure 274 – Hairline cracking and efflorescence through footpath pavement

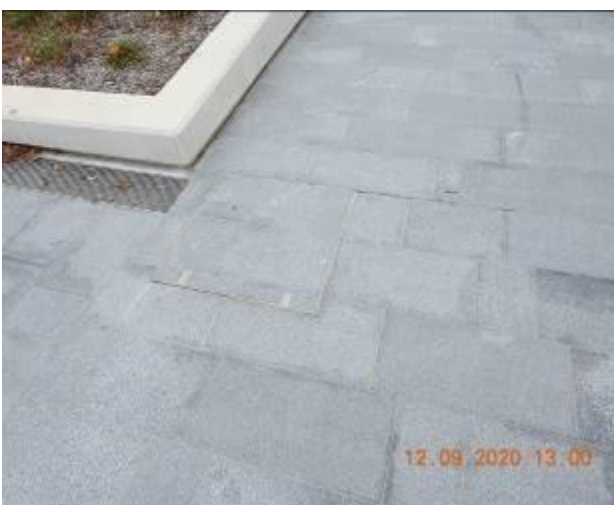
Figure 275 – Hairline cracking and efflorescence through footpath pavement

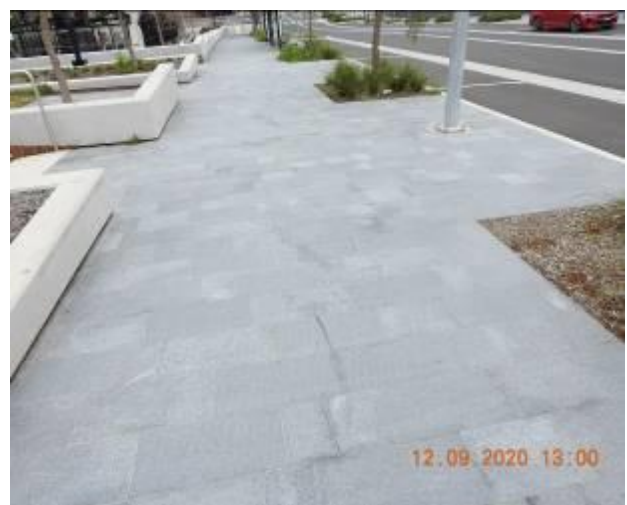
Figure 276 – General condition of footpath pavement

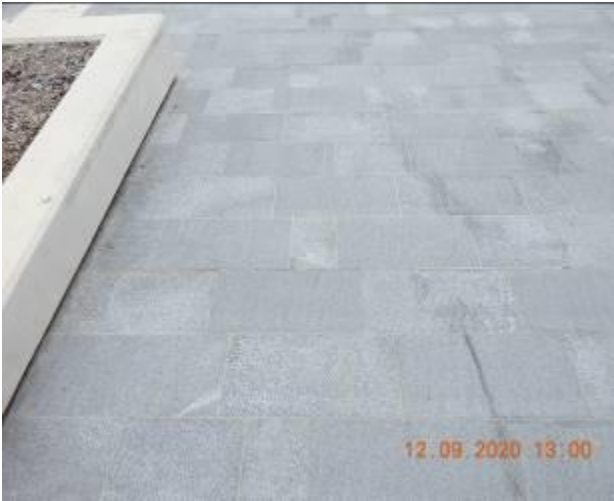
Figure 277 – Hairline cracking and efflorescence through footpath pavement

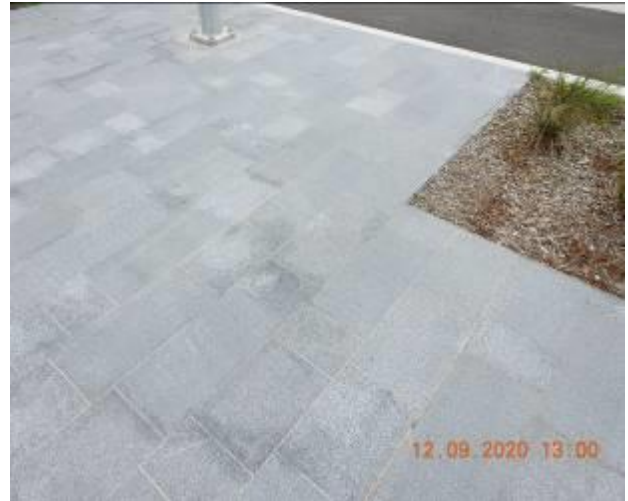
Figure 278 – Hairline cracking and efflorescence through footpath pavement

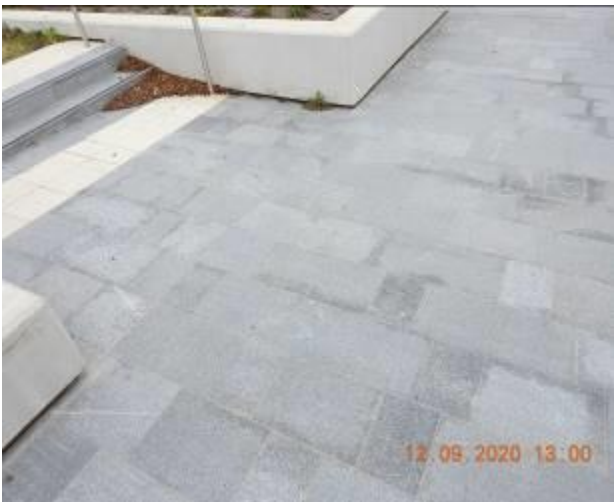
Figure 279 – Hairline cracking and efflorescence through footpath pavement

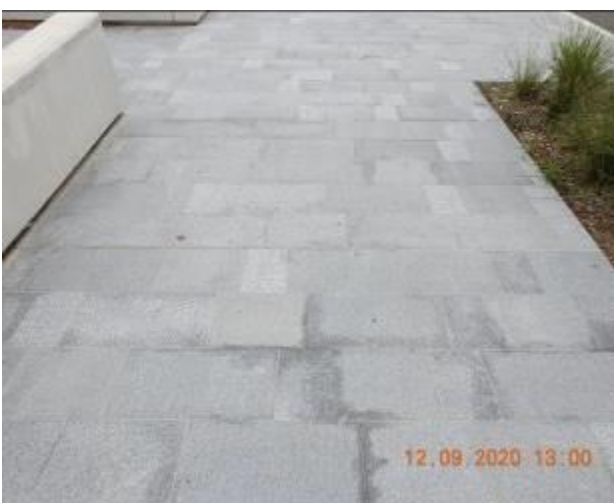
Figure 280 – Hairline cracking and efflorescence through footpath pavement

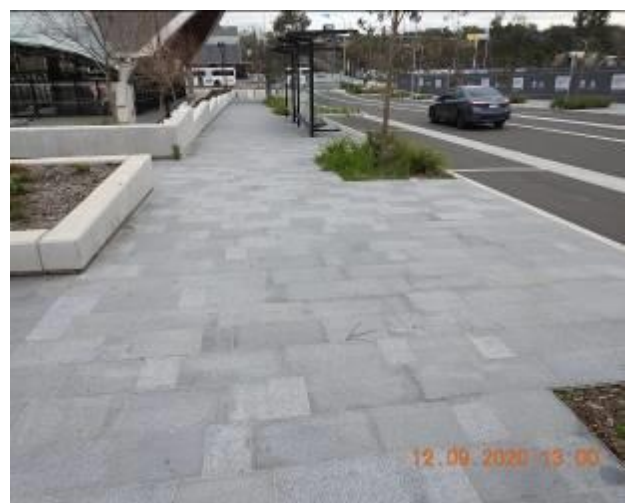
Figure 281 – Hairline cracking and efflorescence through footpath pavement

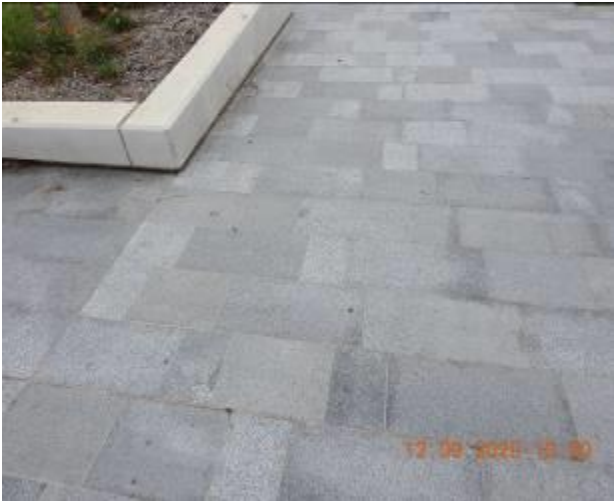
Figure 282 – General condition of footpath pavement
