**2 MANDALA PARADE, CASTLE HILL
(DORAN DRIVE PRECINCT)
PRE-DILAPIDATION REPORT
Of Sydney Metro and Hills Shire Council Assets
DEICORP PROJECTS SHOWGROUND
PTY LTD.**

Job No. 200124.3
07/07/2021

ACE Structural Services Pty Ltd

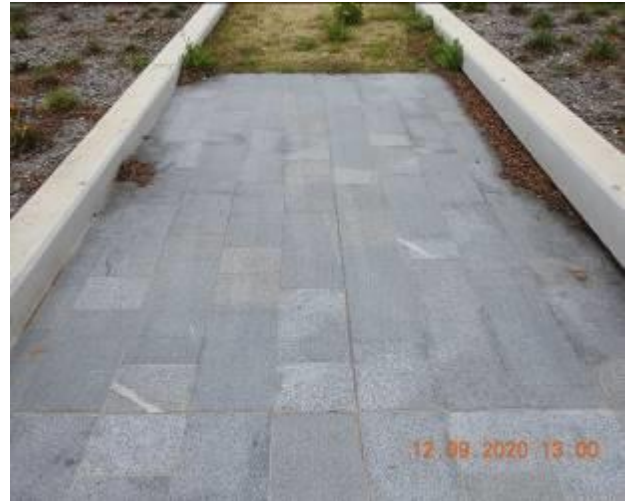
Figure 283 – Hairline cracking and efflorescence through footpath pavement

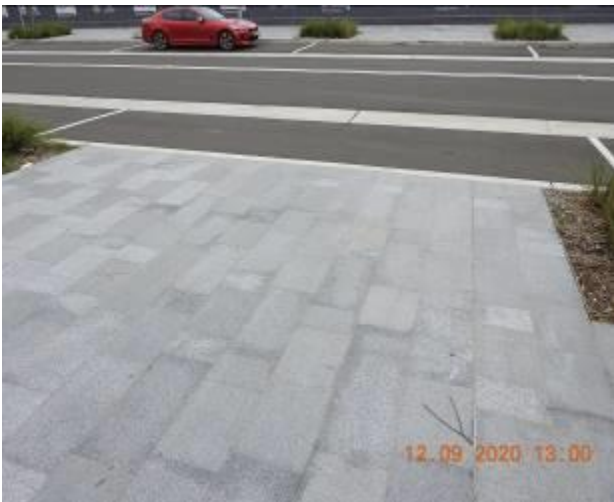
Figure 284 – Hairline cracking and efflorescence through footpath pavement

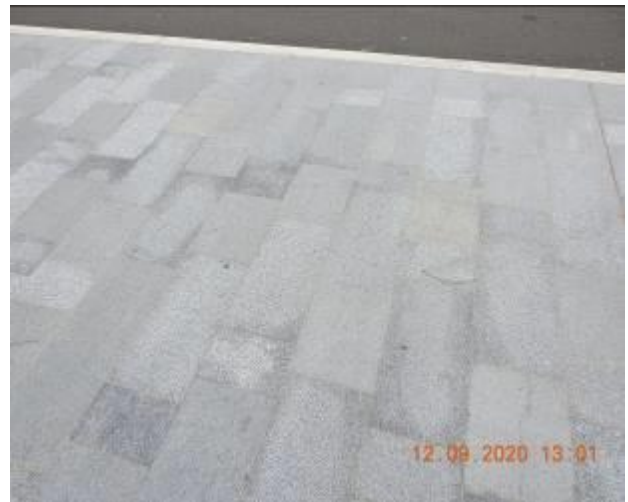
Figure 285 – Hairline cracking and efflorescence through footpath pavement

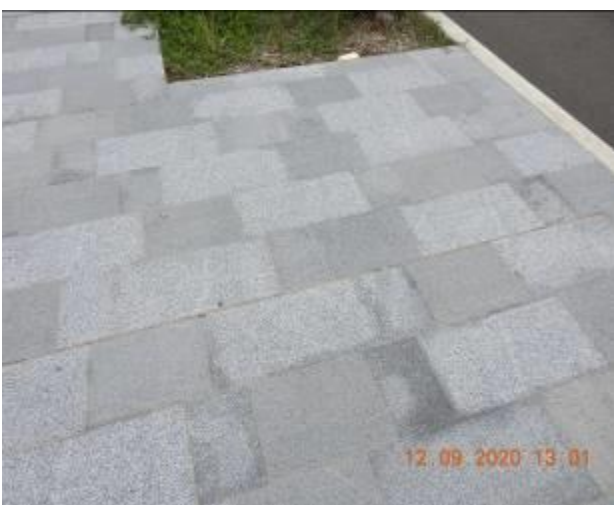
Figure 286 – Hairline cracking and efflorescence through footpath pavement

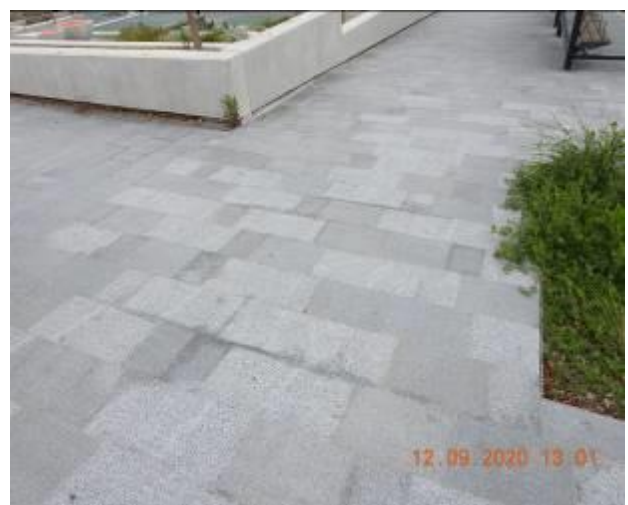
Figure 287 – Hairline cracking and efflorescence through footpath pavement

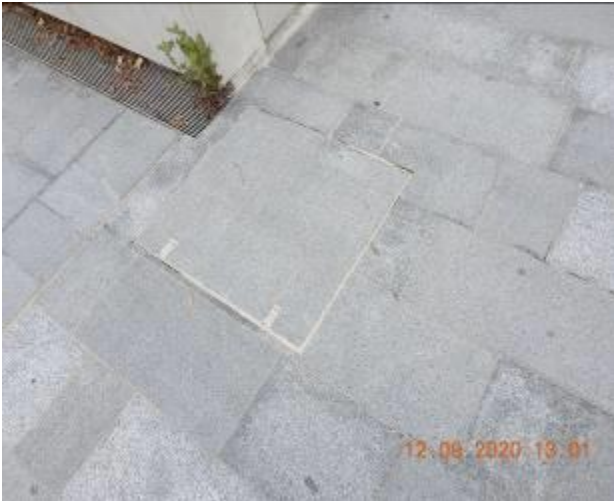
Figure 288 – Hairline cracking and efflorescence through footpath pavement

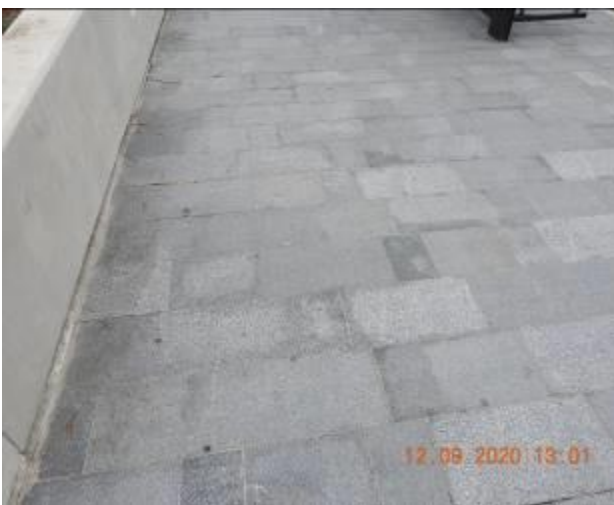
Figure 290 – General condition of footpath pavement

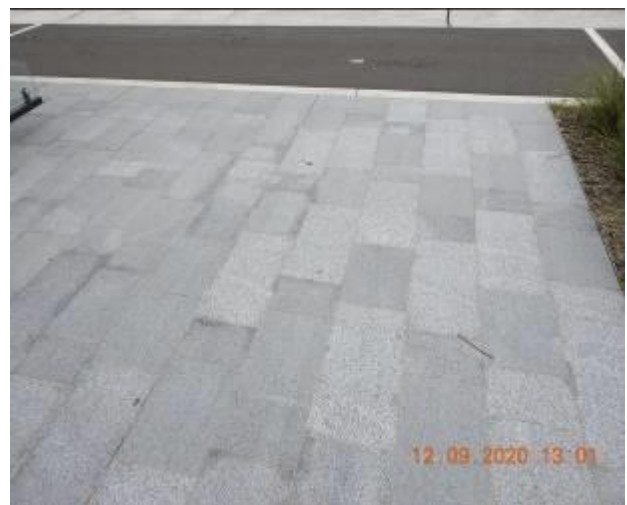
Figure 291 – Hairline cracking and efflorescence through footpath pavement

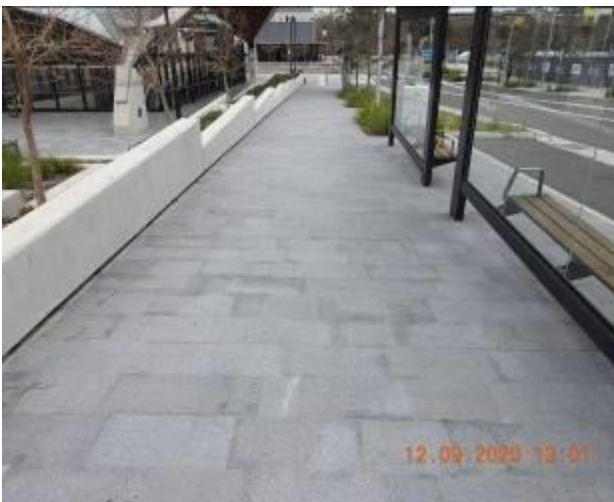
Figure 292 – Hairline cracking and efflorescence through footpath pavement

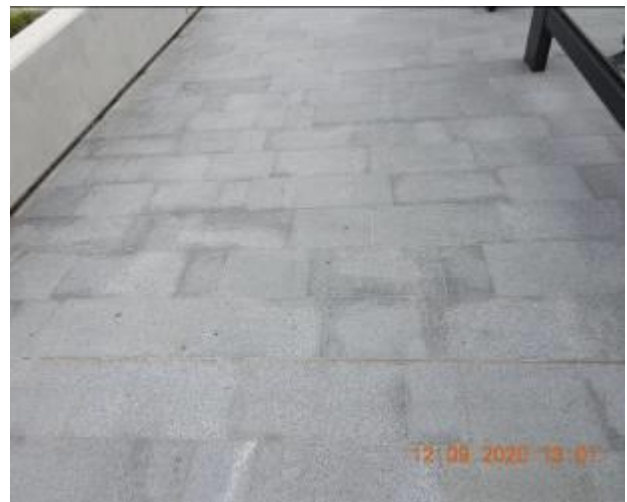
Figure 293 – General condition of footpath pavement

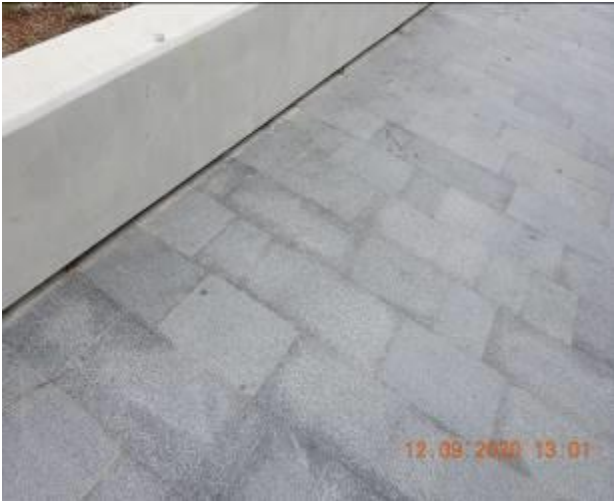
Figure 294 – Hairline cracking and efflorescence through footpath pavement

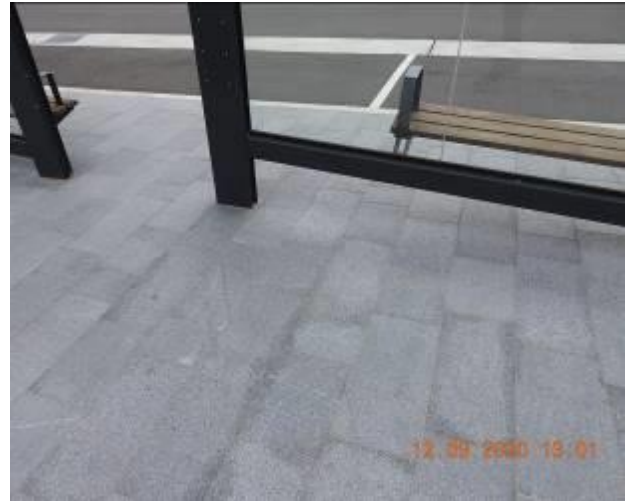
Figure 295 – Hairline cracking and efflorescence through footpath pavement

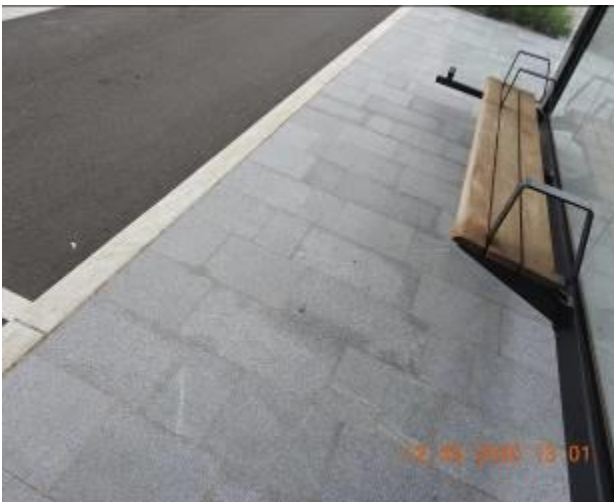
Figure 296 – Hairline cracking and efflorescence through footpath pavement

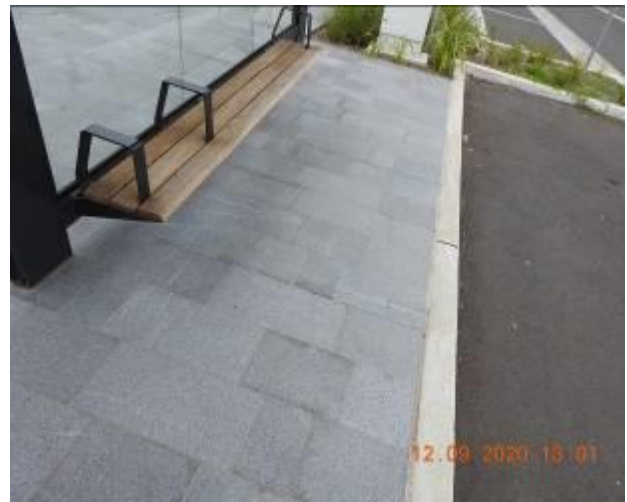
Figure 297 – Hairline cracking and efflorescence through footpath pavement

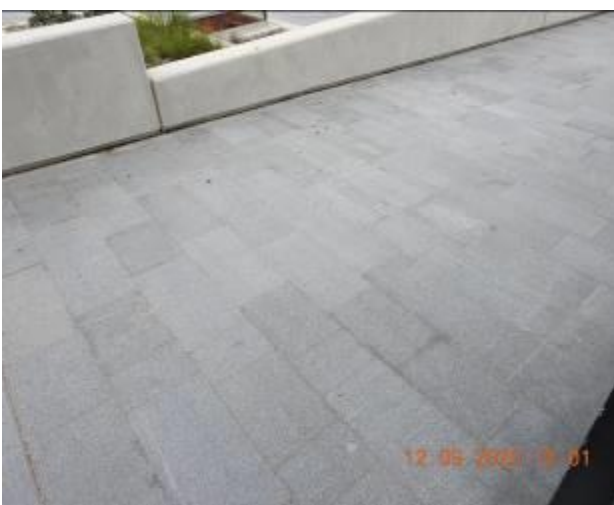
Figure 298 – Hairline cracking and efflorescence through footpath pavement

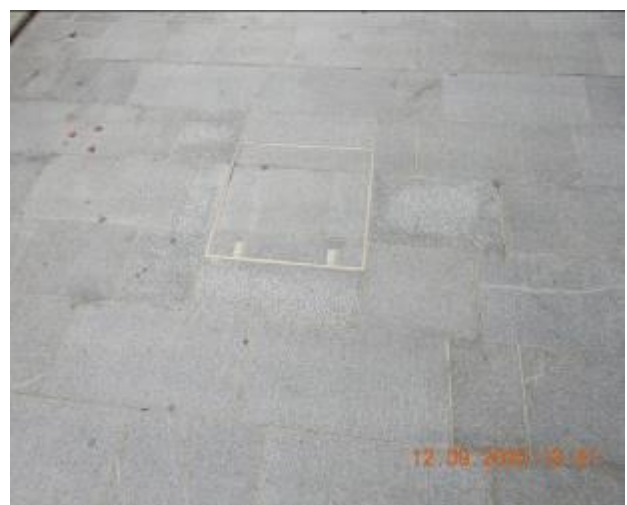
Figure 299 – Hairline cracking and efflorescence through footpath pavement

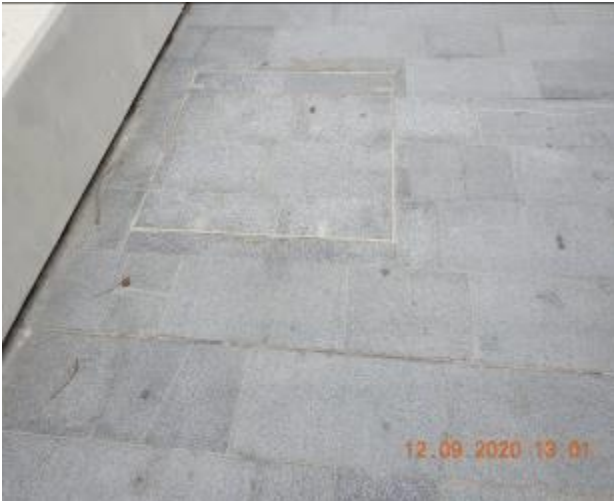
Figure 300 – General condition of service pit

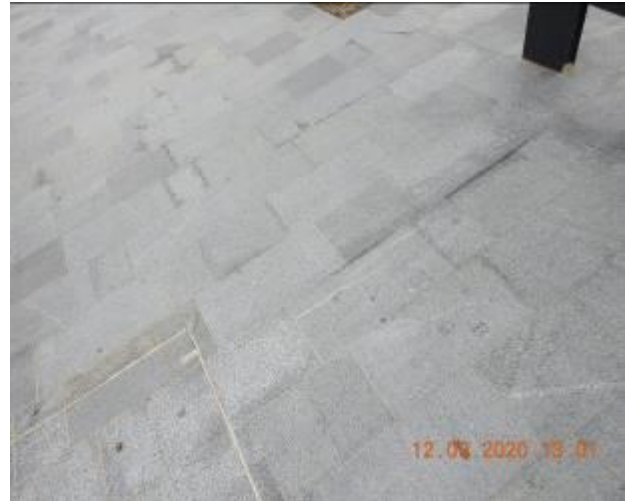
Figure 301 – General condition of service pit

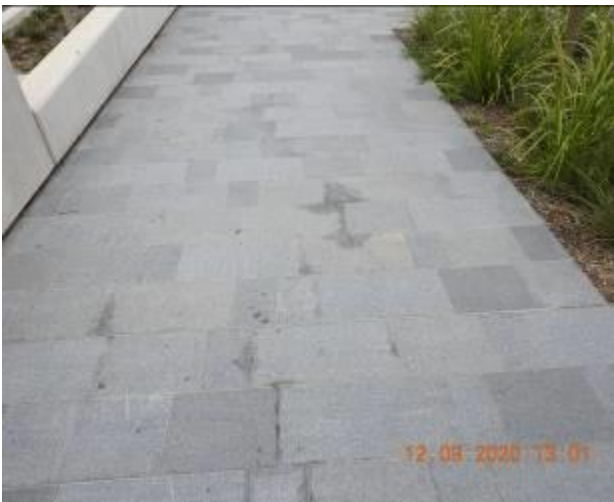
Figure 302 – Hairline cracking and efflorescence through footpath pavement

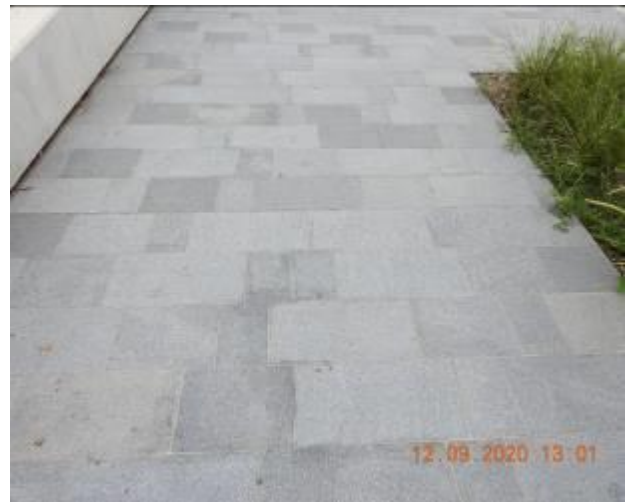
Figure 303 – Hairline cracking and efflorescence through footpath pavement

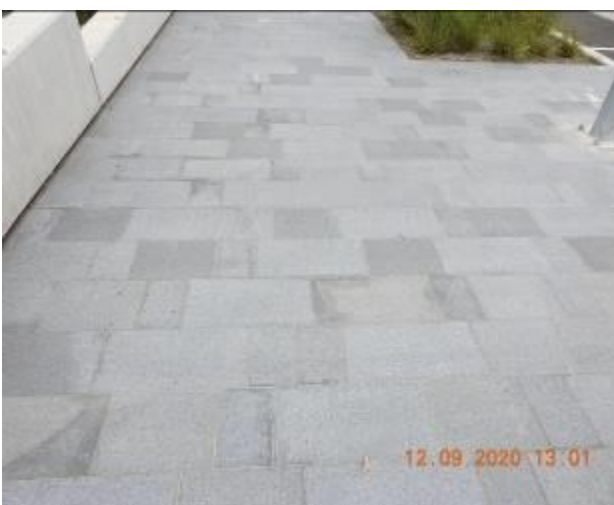
Figure 304 – Hairline cracking and efflorescence through footpath pavement

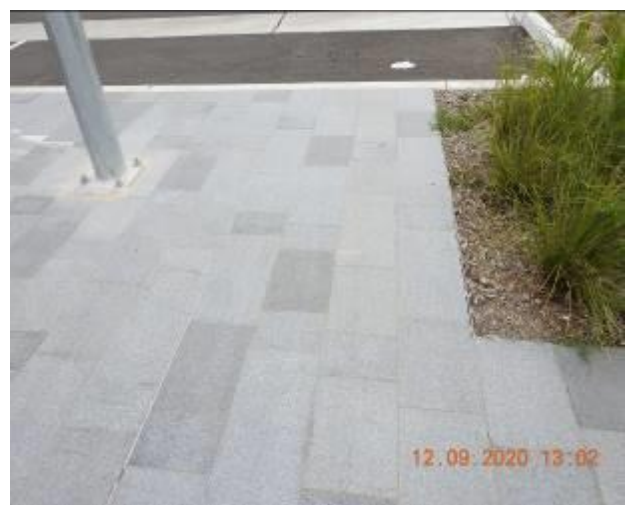
Figure 305 – Hairline cracking and efflorescence through footpath pavement

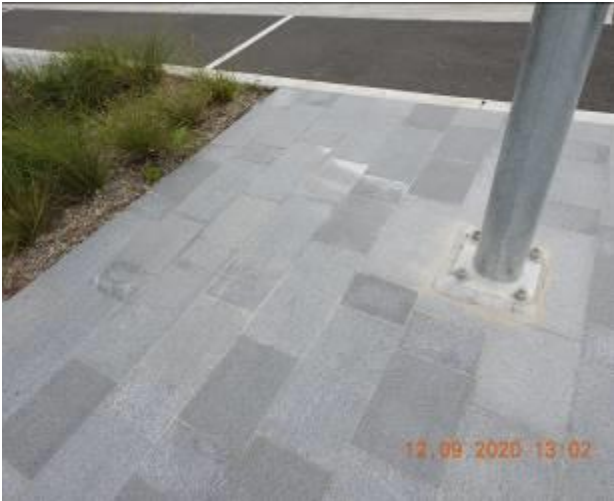
Figure 306 – Hairline cracking and efflorescence through footpath pavement

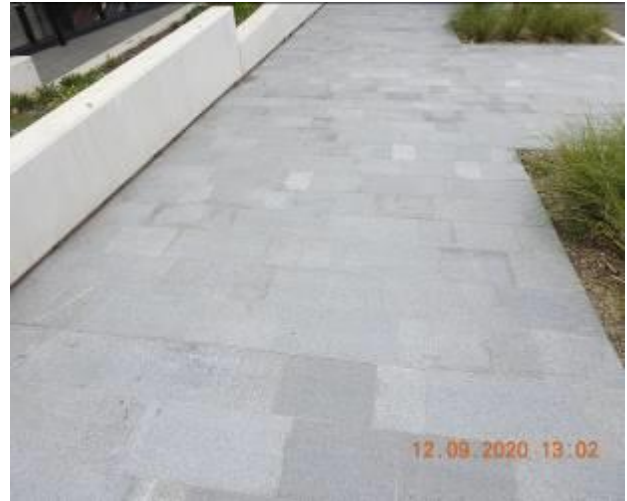
Figure 307 – Hairline cracking and efflorescence through footpath pavement

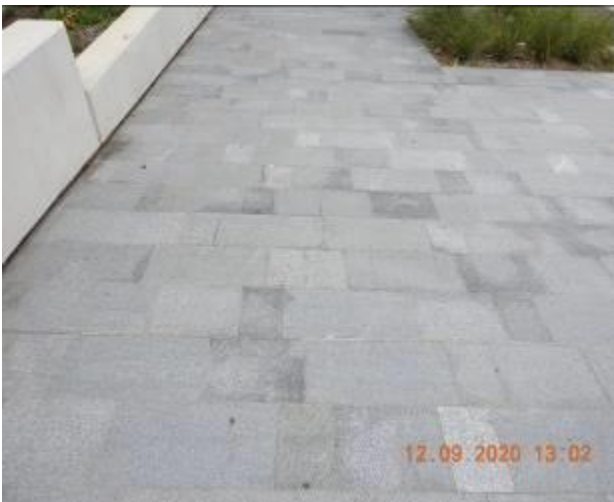
Figure 308 – Hairline cracking and efflorescence through footpath pavement

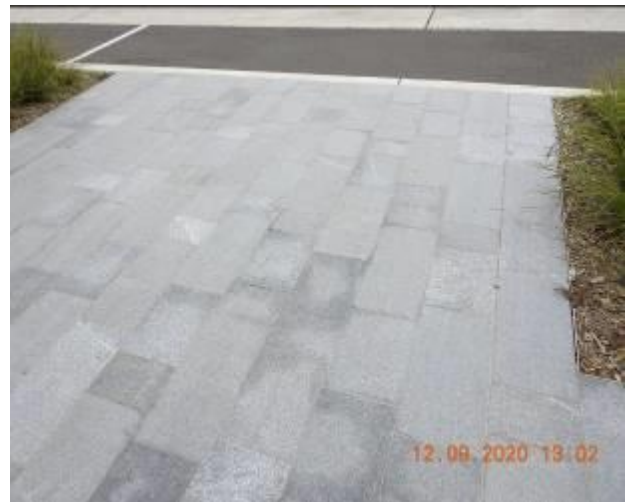
Figure 309 – Hairline cracking and efflorescence through footpath pavement

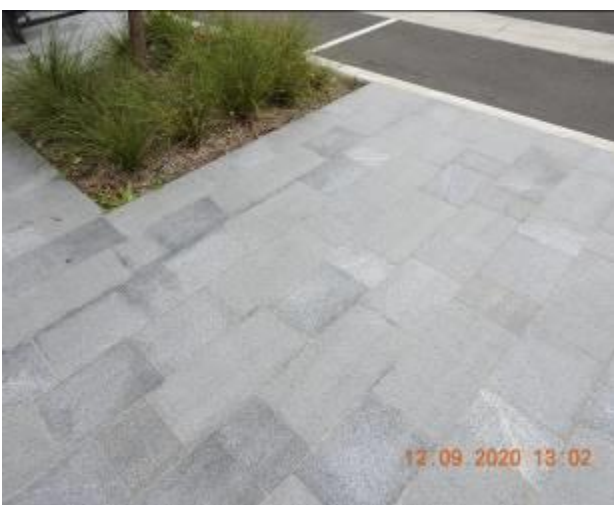
Figure 310 – Hairline cracking and efflorescence through footpath pavement

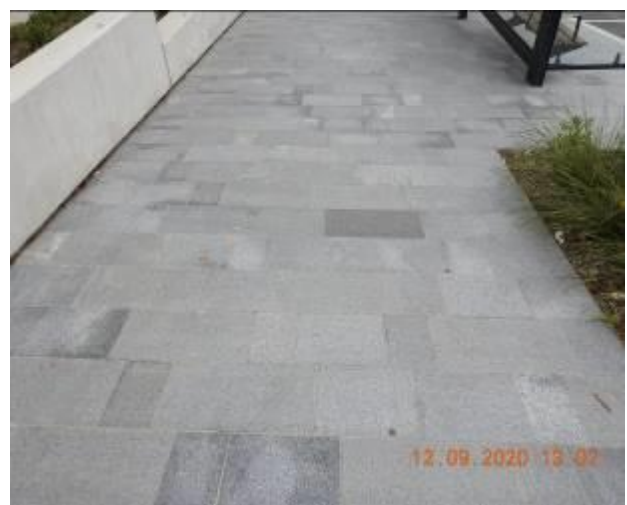
Figure 311 – Hairline cracking and efflorescence through footpath pavement

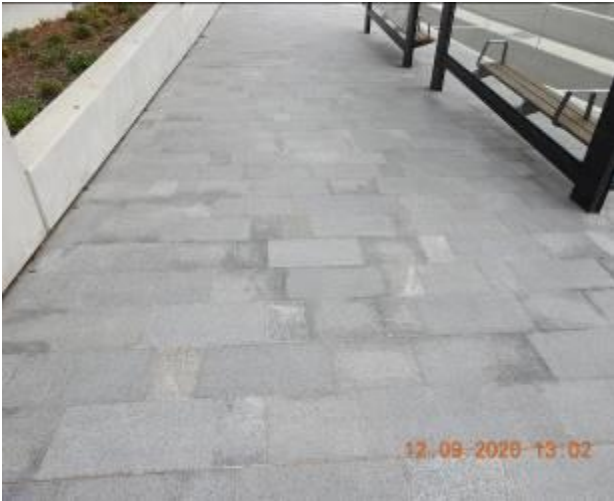
Figure 312 – Hairline cracking and efflorescence through footpath pavement

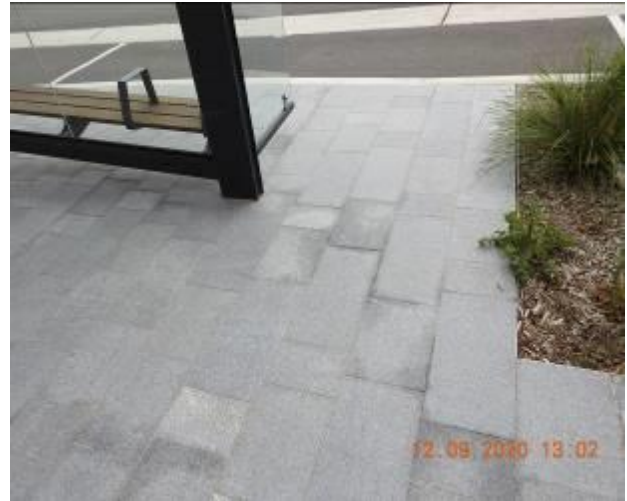
Figure 313 – Hairline cracking and efflorescence through footpath pavement

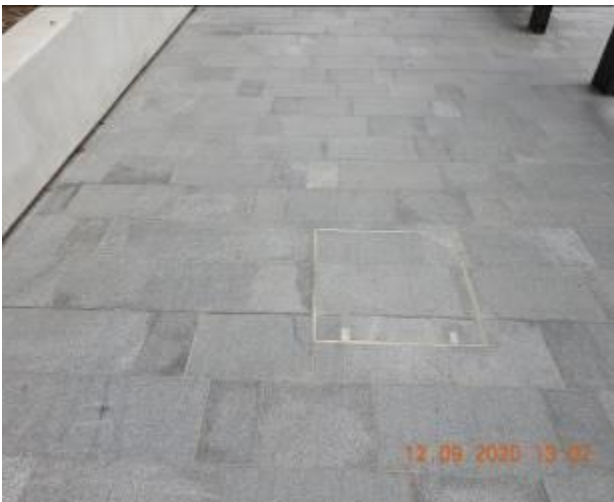
Figure 314 – Hairline cracking and efflorescence through footpath pavement

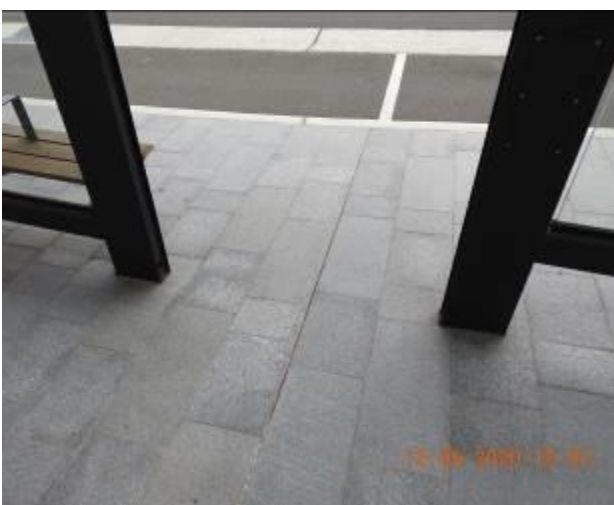
Figure 316 – Hairline cracking and efflorescence through footpath pavement

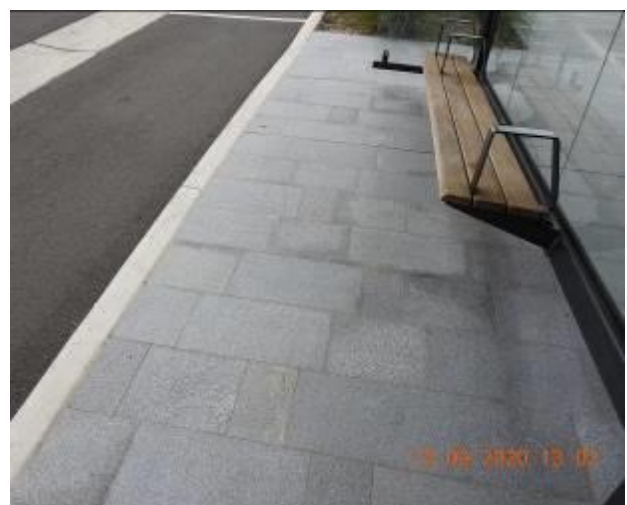
Figure 317 – Hairline cracking and efflorescence through footpath pavement

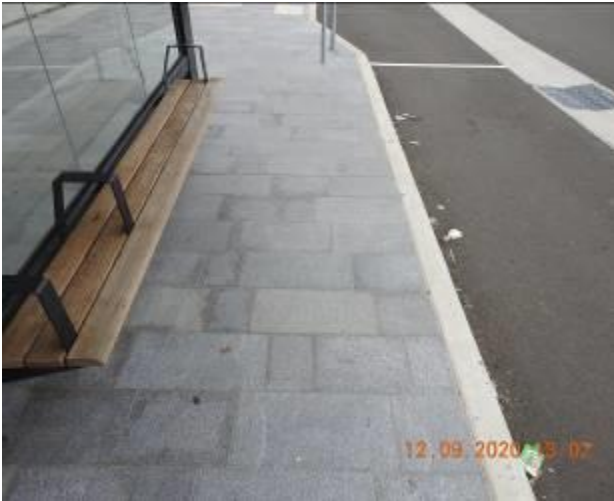
Figure 318 – Hairline cracking and efflorescence through footpath pavement

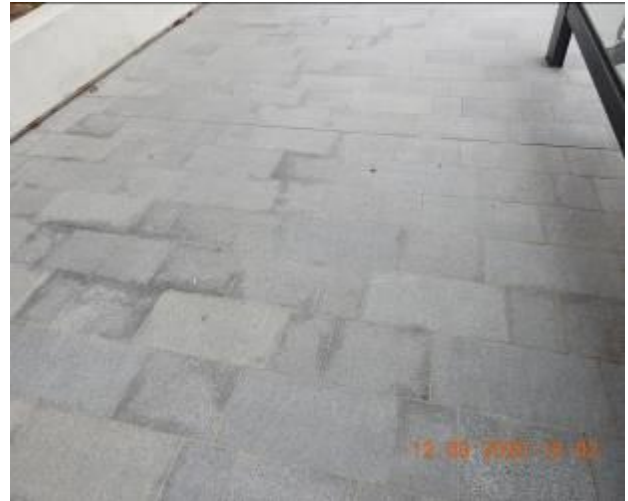
Figure 320 – Hairline cracking and efflorescence through footpath pavement

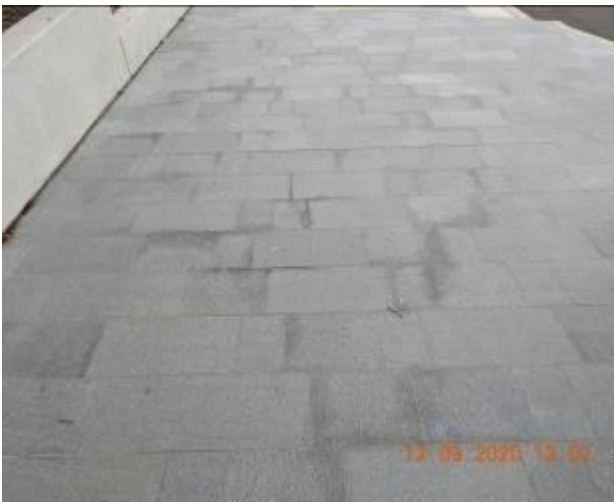
Figure 321 – Hairline cracking and efflorescence through footpath pavement

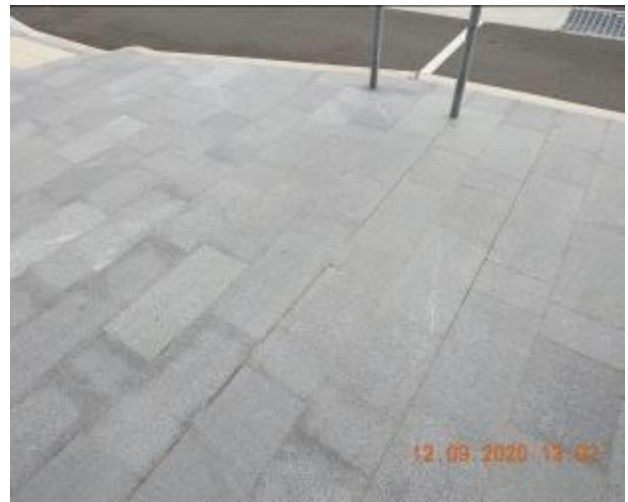
Figure 322 – Hairline cracking and efflorescence through footpath pavement

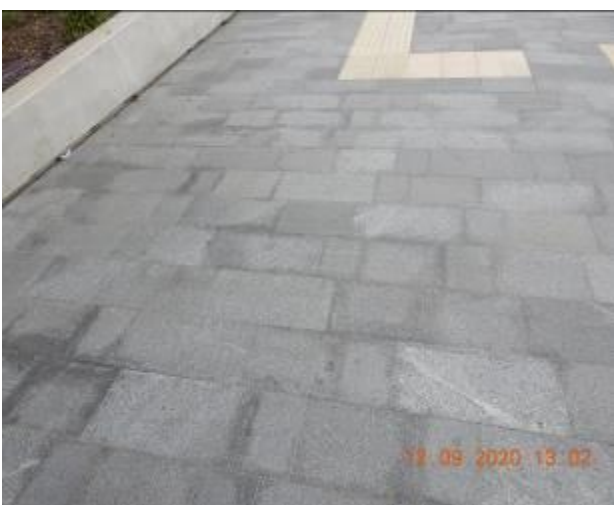
Figure 323 – Hairline cracking and efflorescence through footpath pavement

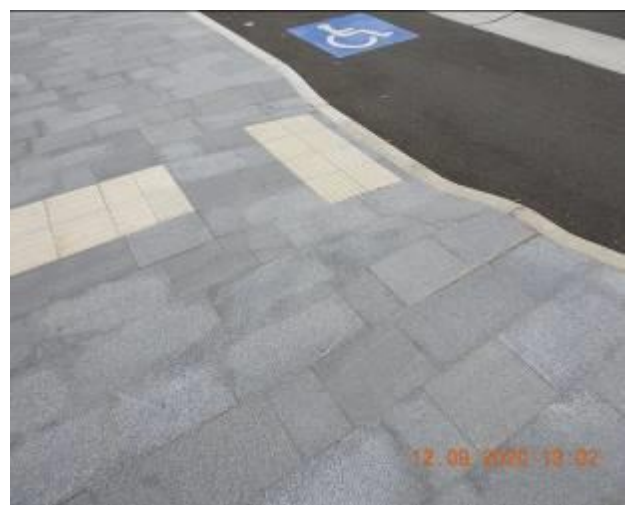
Figure 324 – Hairline cracking and efflorescence through footpath pavement

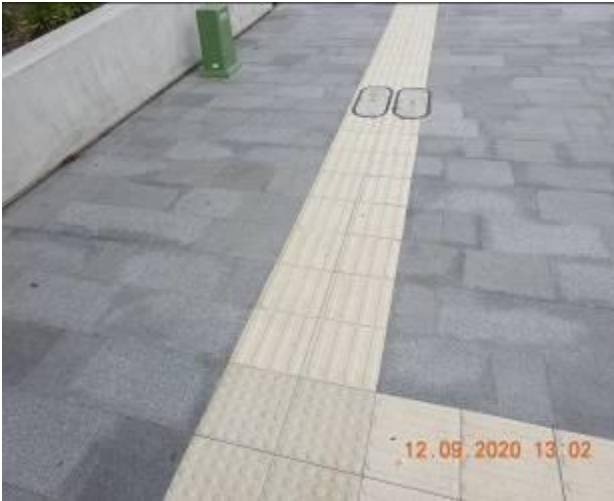
Figure 325 – Hairline cracking and efflorescence through footpath pavement

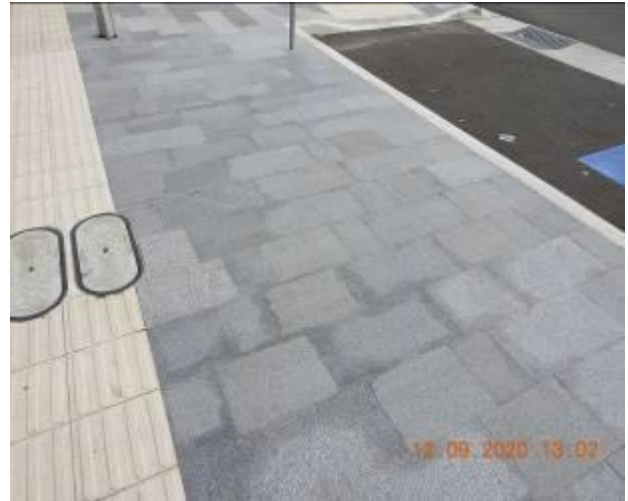
Figure 326 – Hairline cracking and efflorescence through footpath pavement

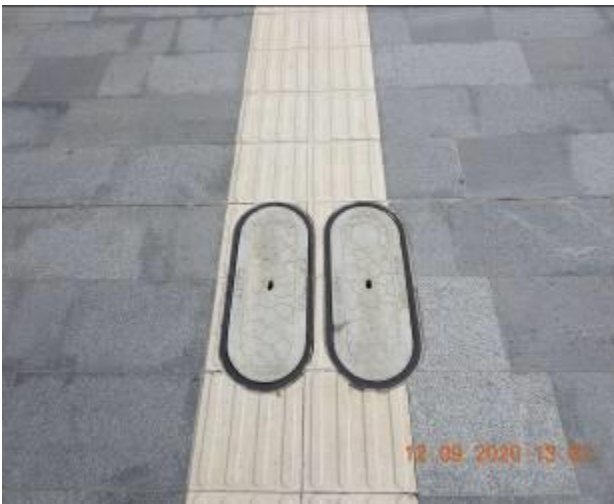
Figure 327 – General condition of service pit

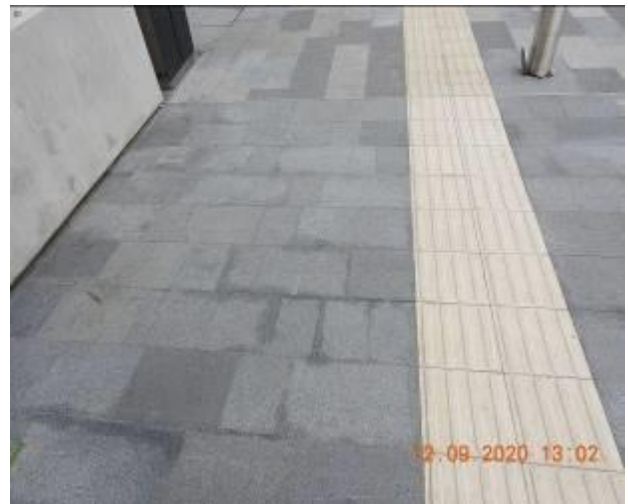
Figure 328 – General condition of footpath pavement

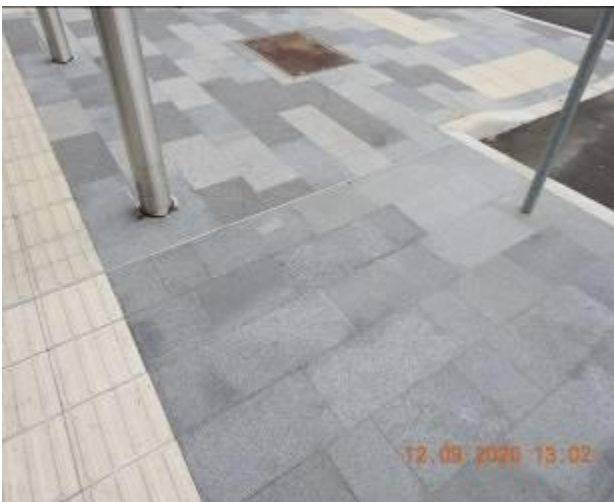
Figure 329 – Hairline cracking and efflorescence through footpath pavement

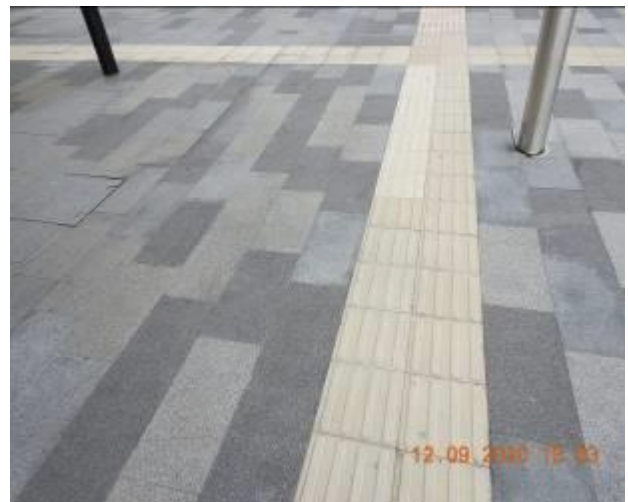
Figure 330 – General condition of footpath pavement

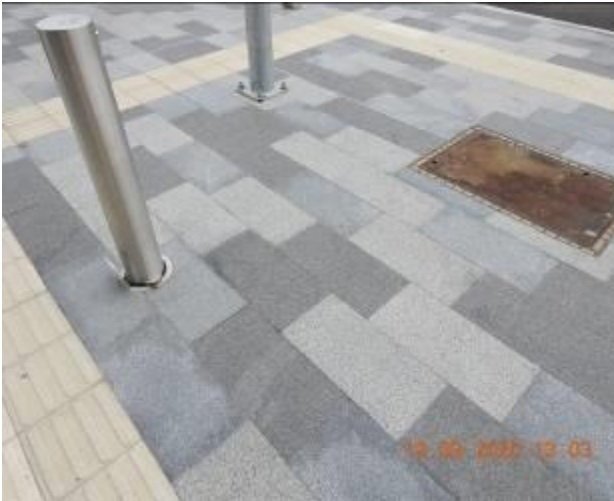
Figure 331 – Hairline cracking and efflorescence through footpath pavement

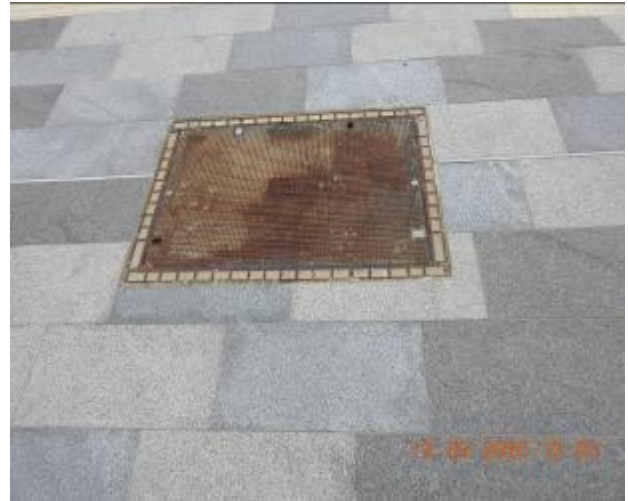
Figure 332 – General condition of service pit

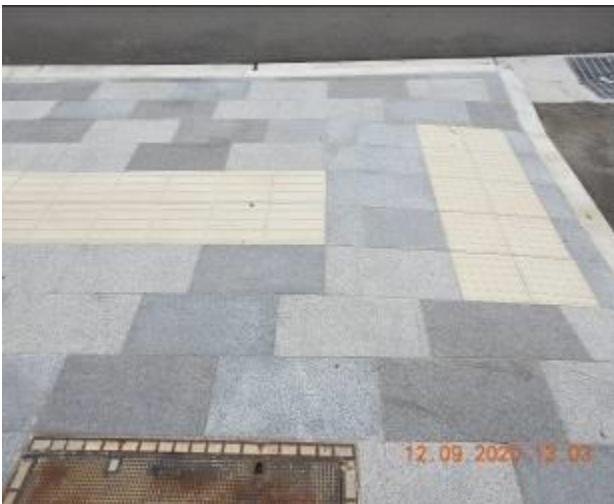
Figure 333 – General condition of footpath pavement

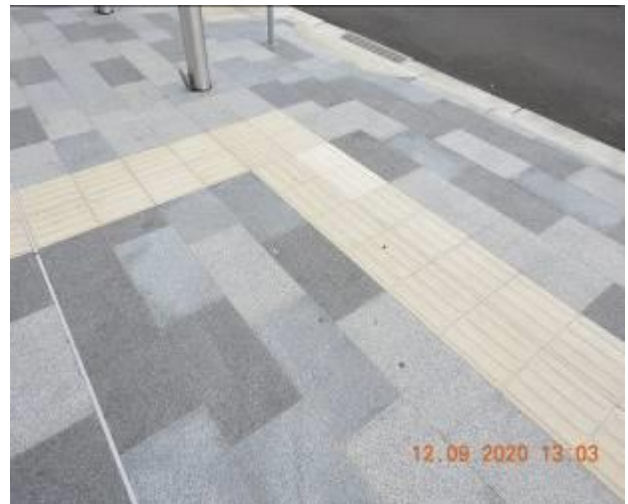
Figure 334 – Hairline cracking and efflorescence through footpath pavement

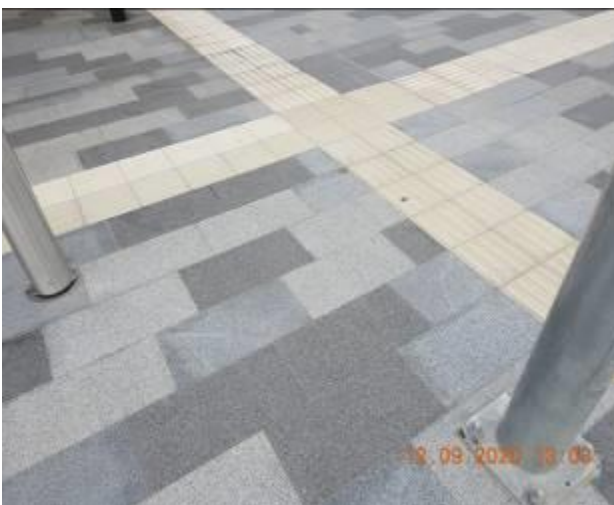
Figure 335 – Hairline cracking and efflorescence through footpath pavement

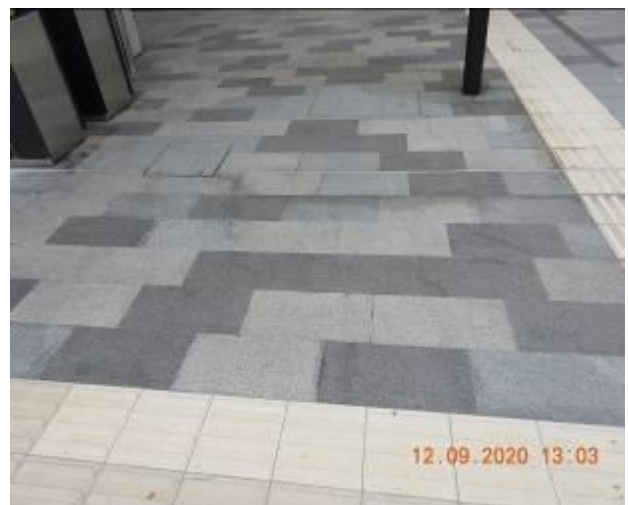
Figure 336 – Hairline cracking and efflorescence through footpath pavement

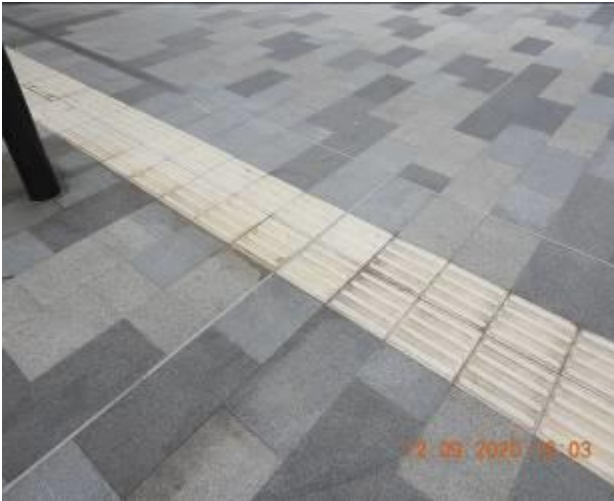
Figure 337 – Hairline cracking and efflorescence through footpath pavement

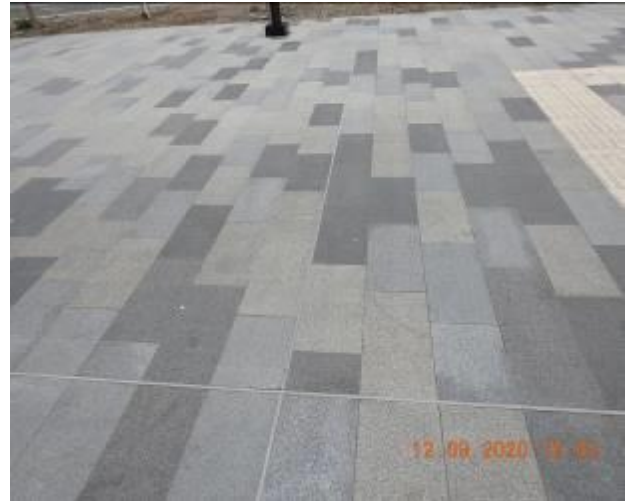
Figure 338 – Hairline cracking and efflorescence through footpath pavement

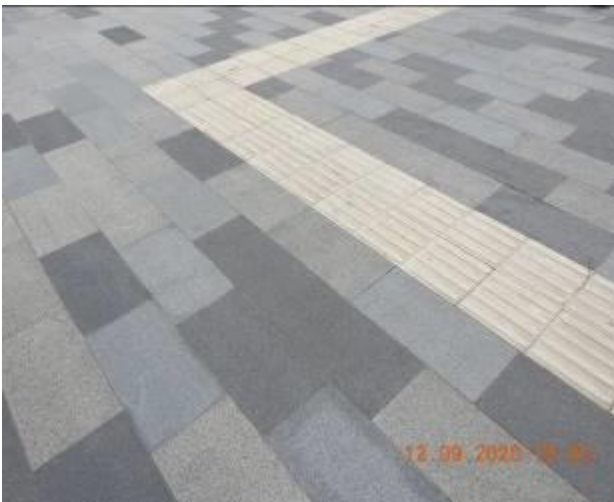
Figure 339 – General condition of footpath pavement

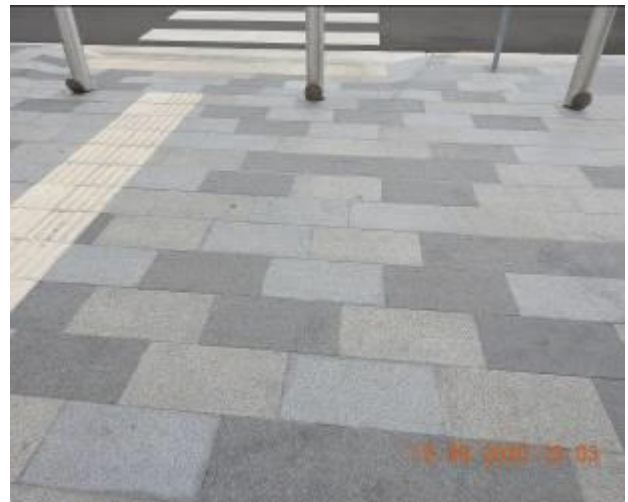
Figure 340 – General condition of footpath pavement

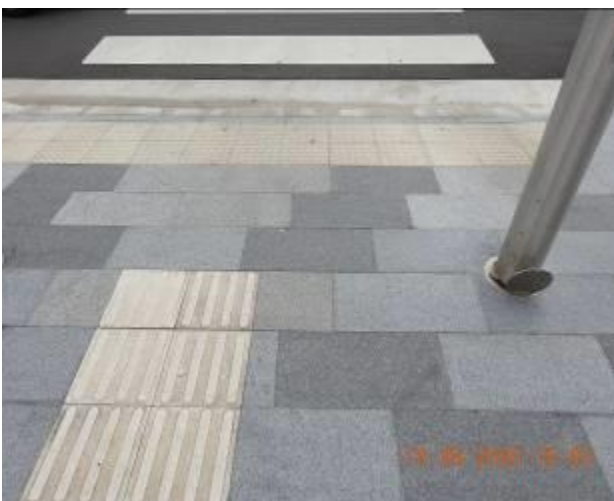
Figure 341 – General condition of footpath pavement

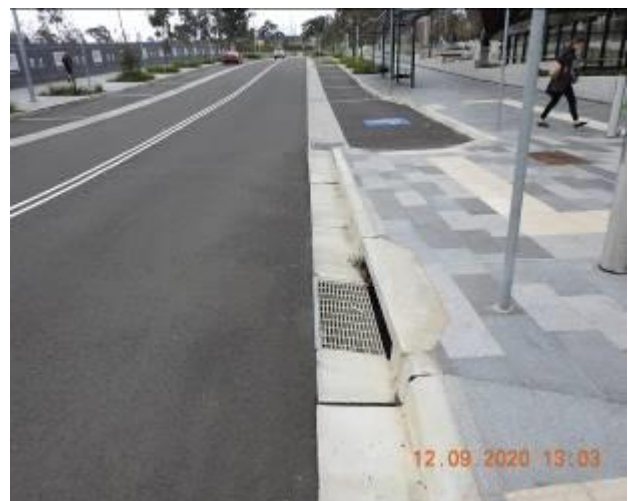
Figure 342 – General condition of kerb and gutter heading East

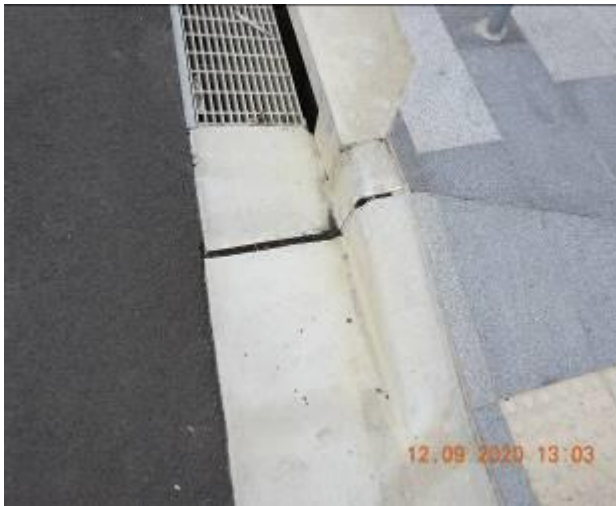
Figure 343 – Crack propagation and loss of material through kerb and gutter

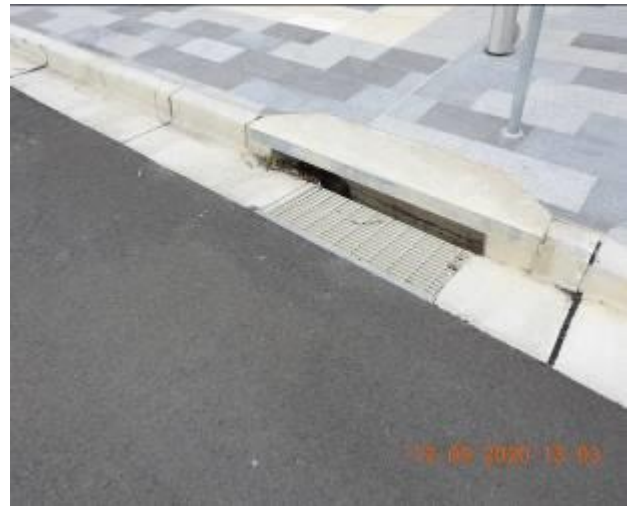
Figure 344 – General condition of kerb inlet pit and stormwater inlet pit

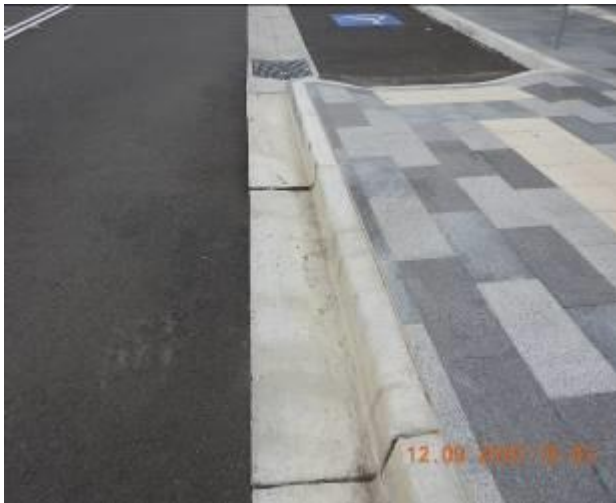
Figure 345 – General condition of kerb and gutter

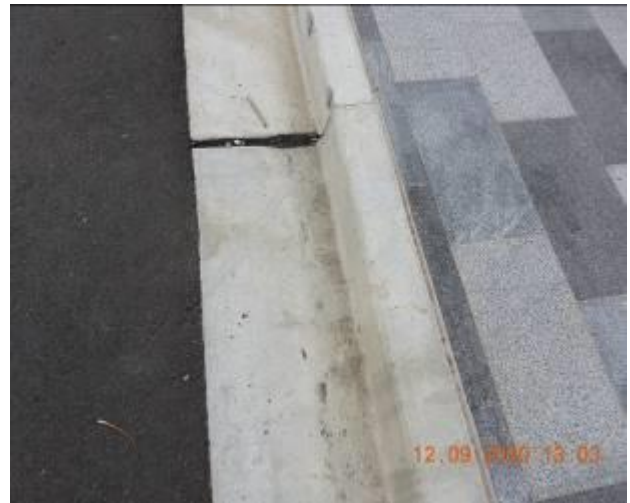
Figure 346 – Evidence of patchwork through gutter

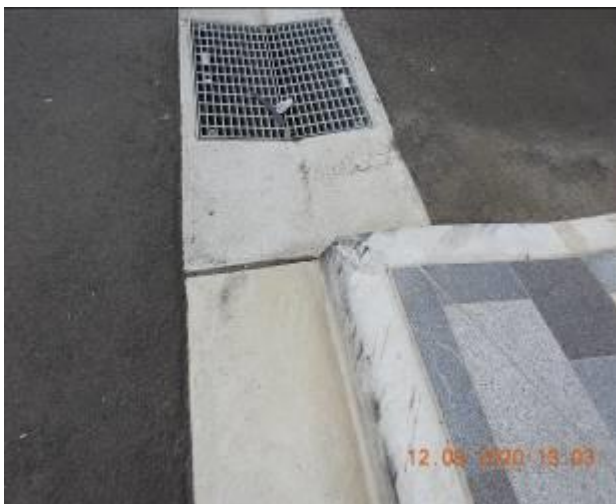
Figure 347 – Crack propagation through kerb

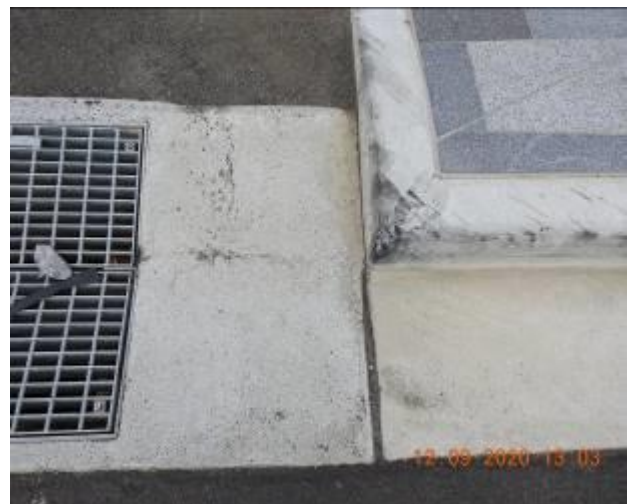
Figure 348 – Crack propagation through kerb

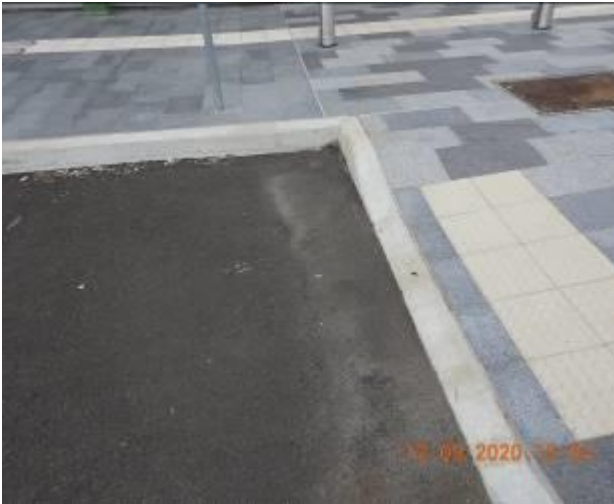
Figure 349 – General condition of layback

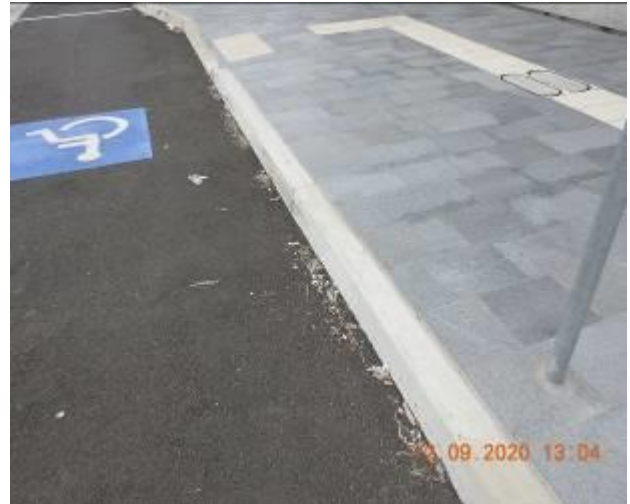
Figure 350 – General condition of kerb

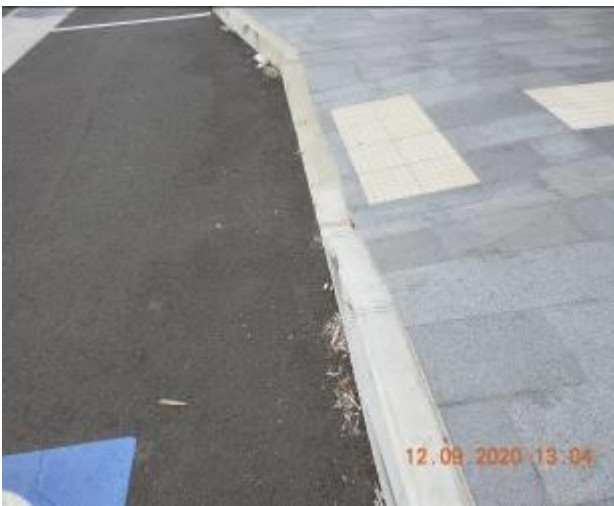
Figure 351 – General condition of kerb

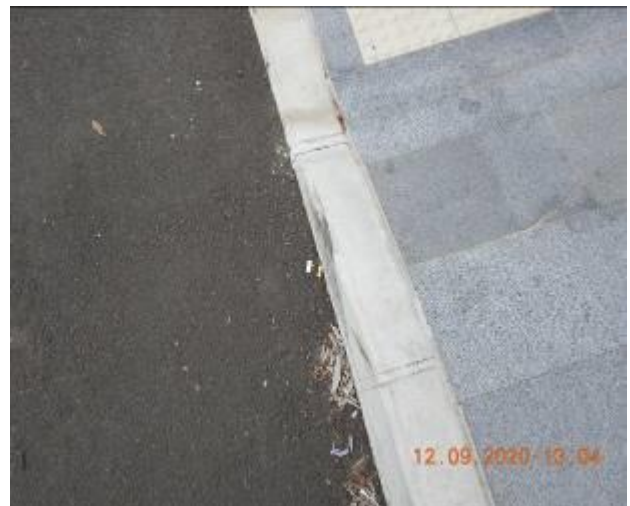
Figure 352 – Crack propagation through kerb

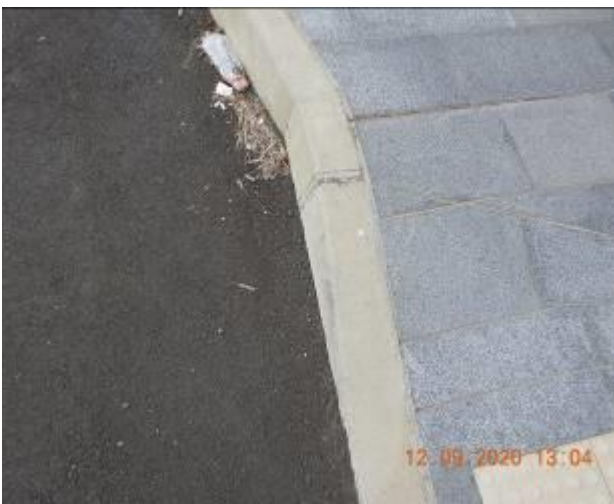
Figure 353 – Crack propagation through kerb

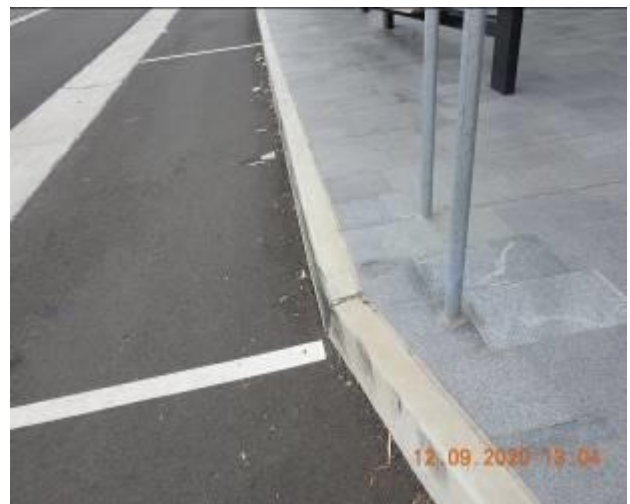
Figure 354 – General condition of kerb

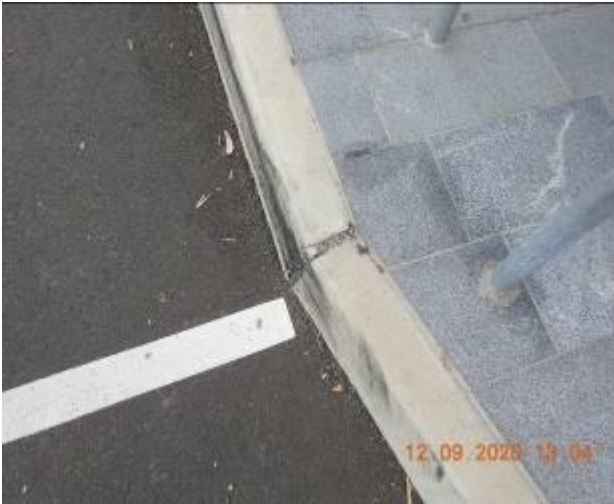
Figure 355 – Crack propagation and loss of material through kerb
