**2 MANDALA PARADE, CASTLE HILL
(DORAN DRIVE PRECINCT)
PRE-DILAPIDATION REPORT
Of Sydney Metro and Hills Shire Council Assets
DEICORP PROJECTS SHOWGROUND
PTY LTD.**

Job No. 200124.3
07/07/2021

ACE Structural Services Pty Ltd

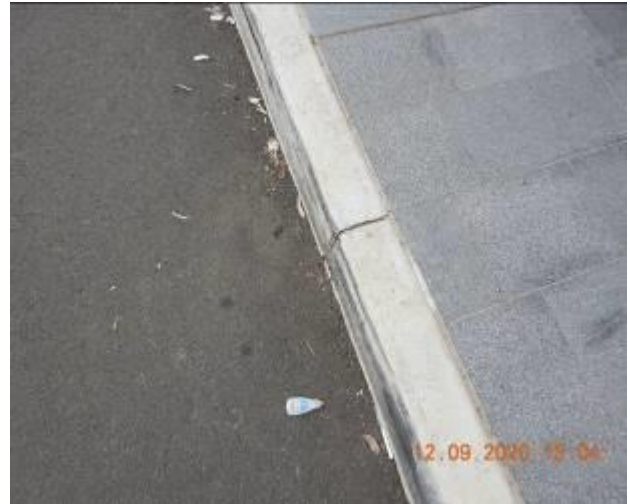
Figure 356 – Crack propagation through kerb

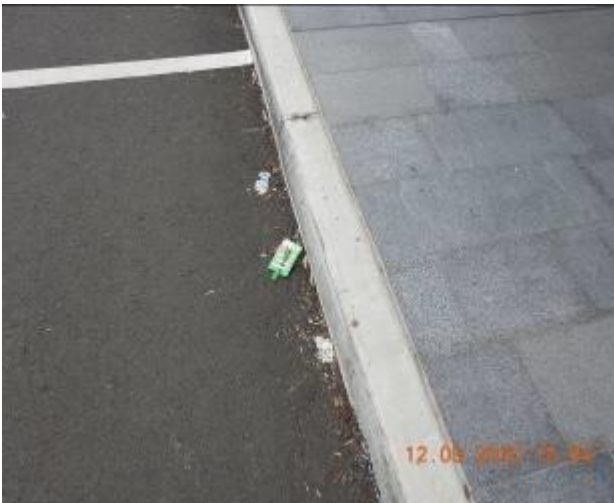
Figure 357 – Crack propagation and loss of material through kerb

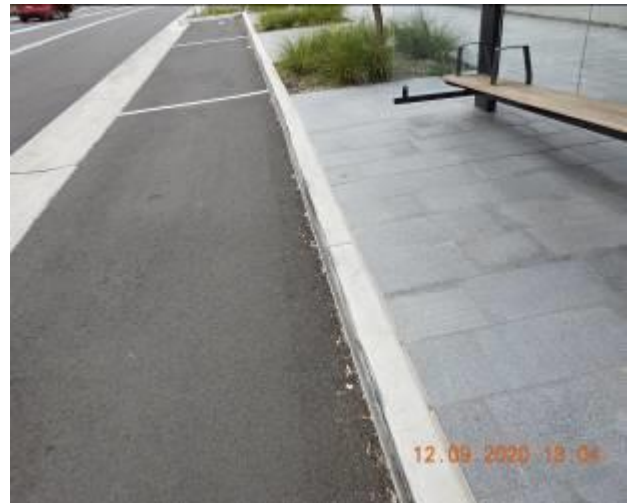
Figure 358 – General condition of kerb

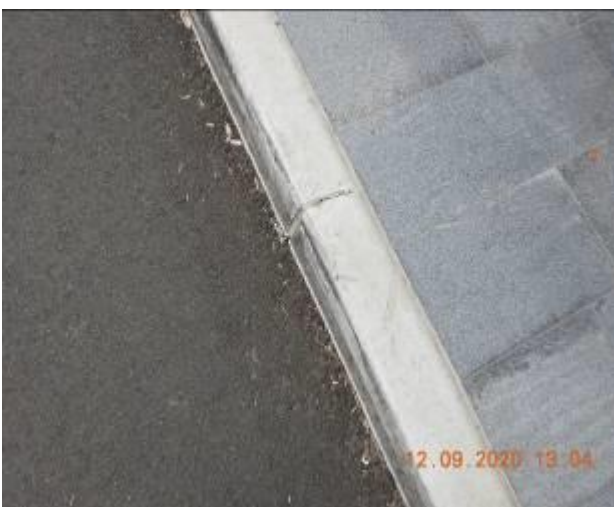
Figure 359 – Crack propagation and loss of material through kerb

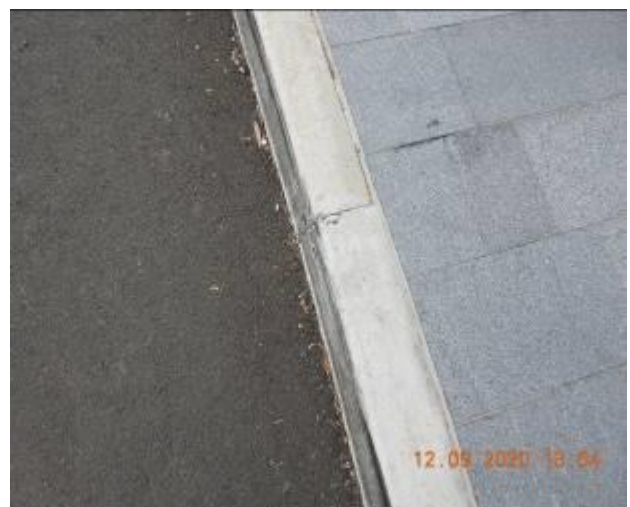
Figure 360 – Crack propagation through kerb

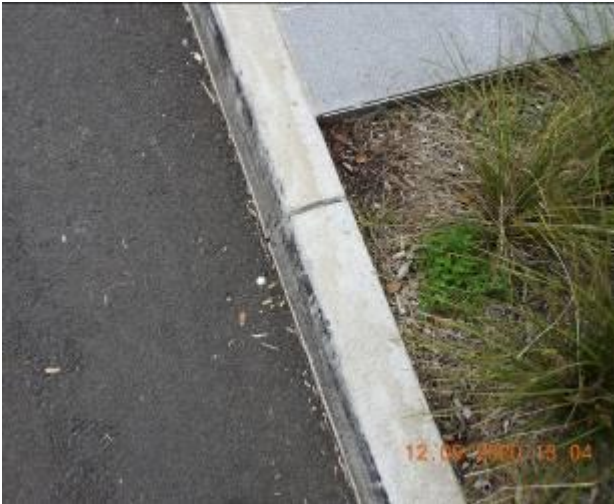
Figure 361 – Crack propagation through kerb

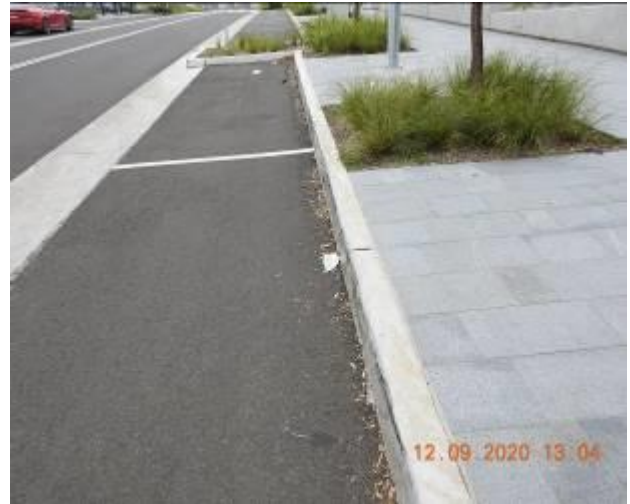
Figure 362 – General condition of kerb

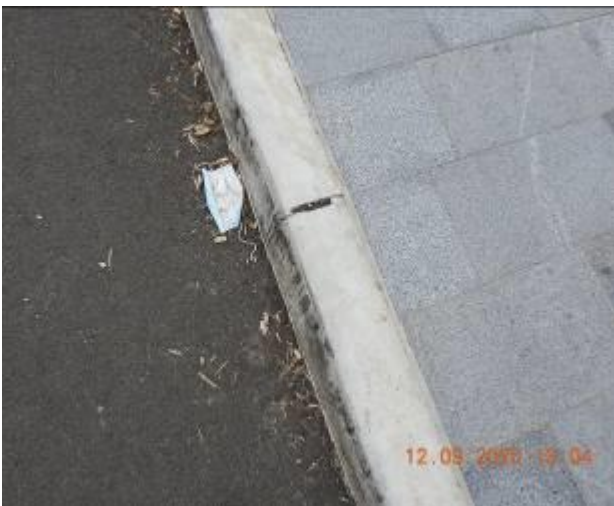
Figure 363 – Crack propagation and loss of material through kerb

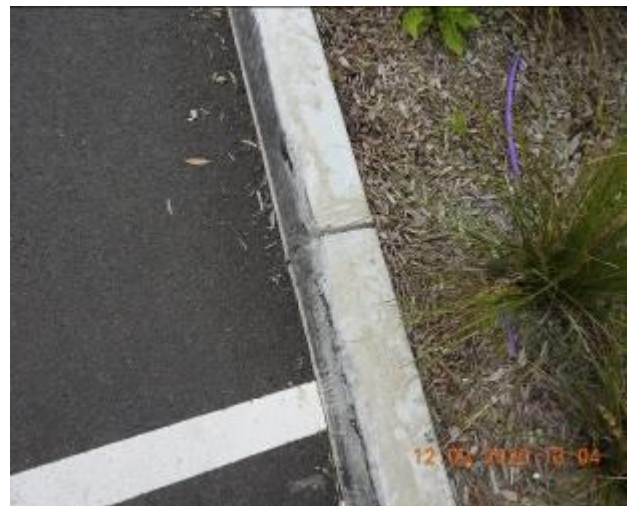
Figure 364 – Crack propagation through kerb

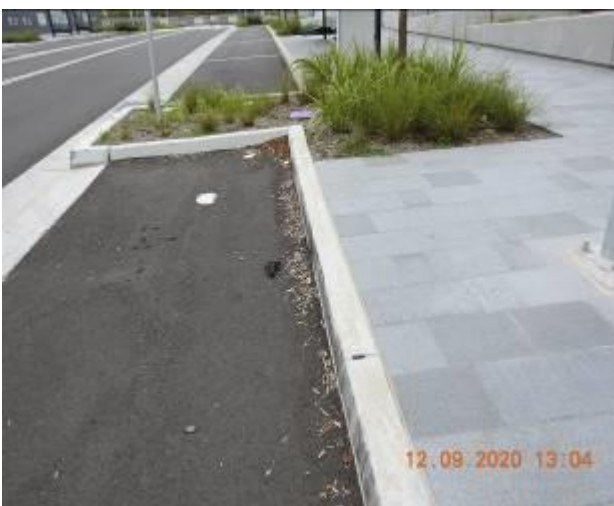
Figure 365 – General condition of kerb

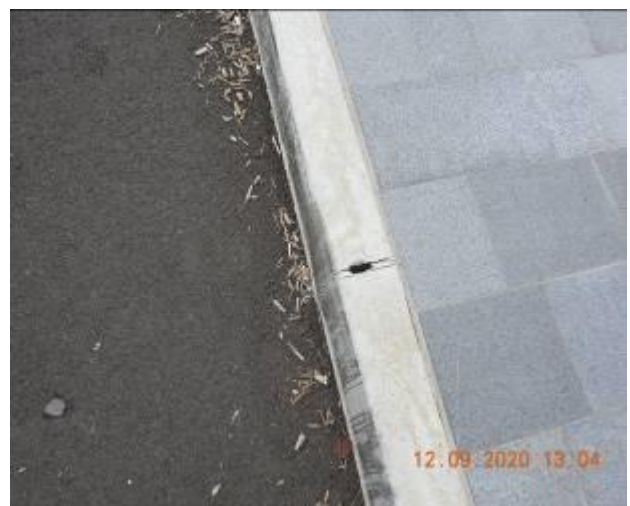
Figure 366 – Loss of material through kerb

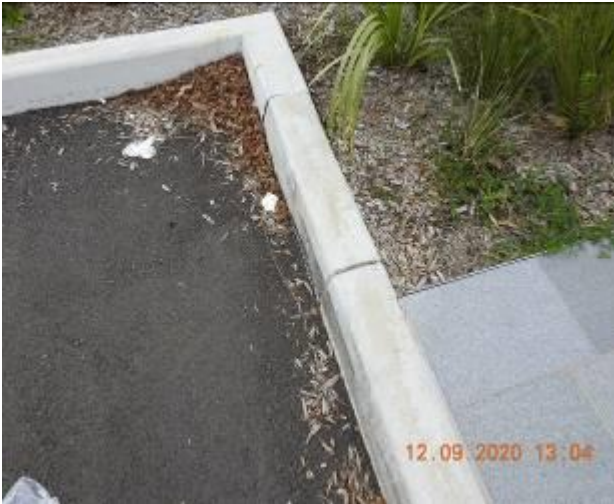
Figure 367 – Crack propagation through kerb

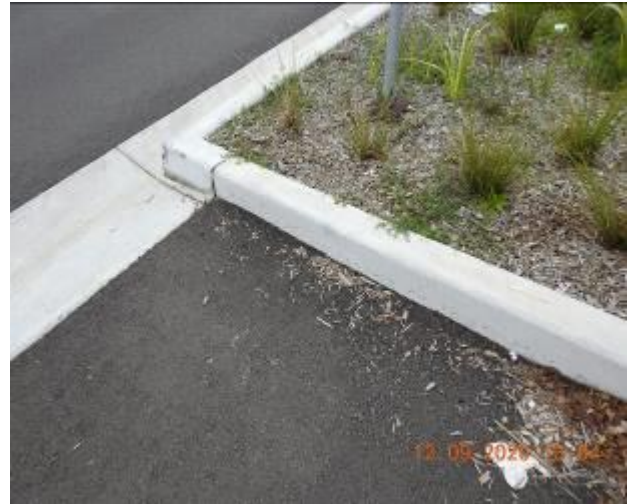
Figure 368 – General condition of kerb

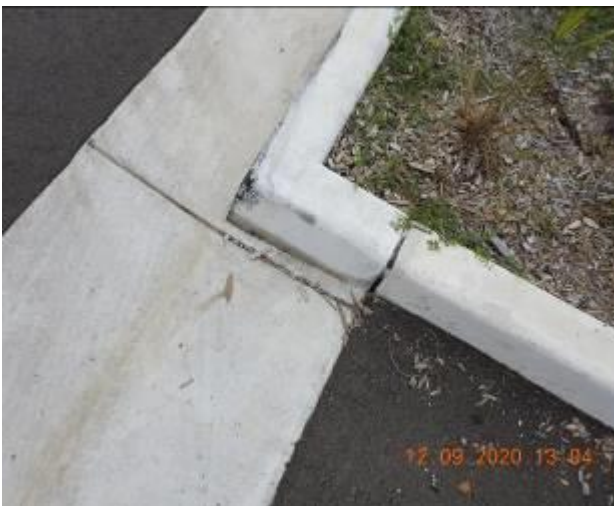
Figure 369 – Loss of material through kerb

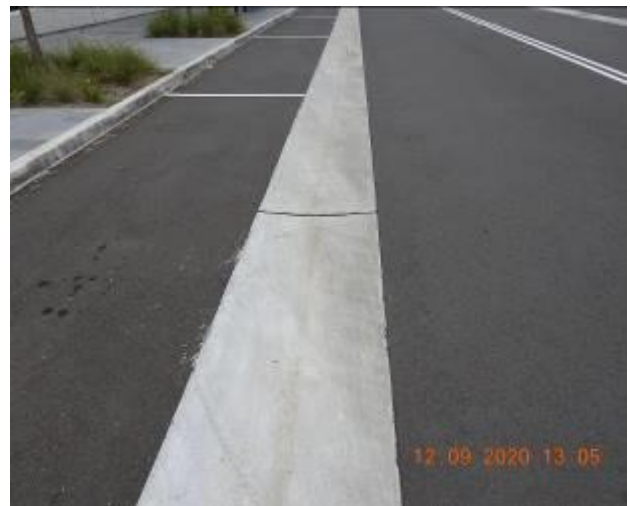
Figure 370 – General condition of gutter heading West

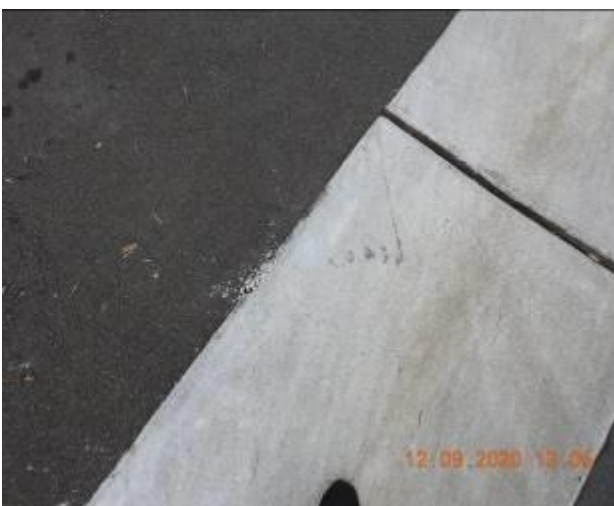
Figure 371 – Crack propagation and loss of material through gutter

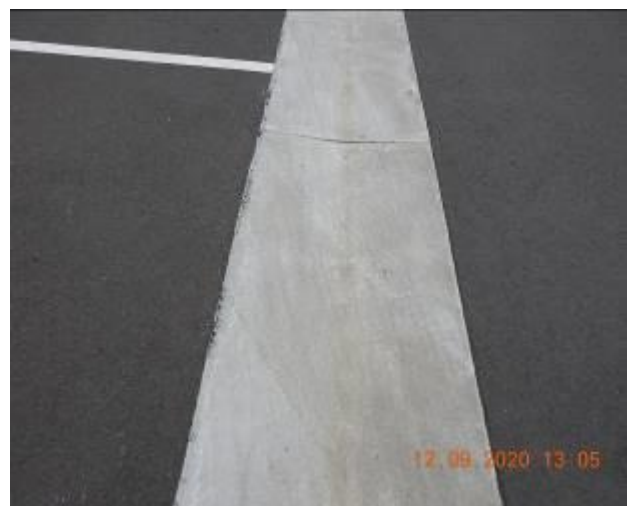
Figure 372 – Crack propagation through gutter

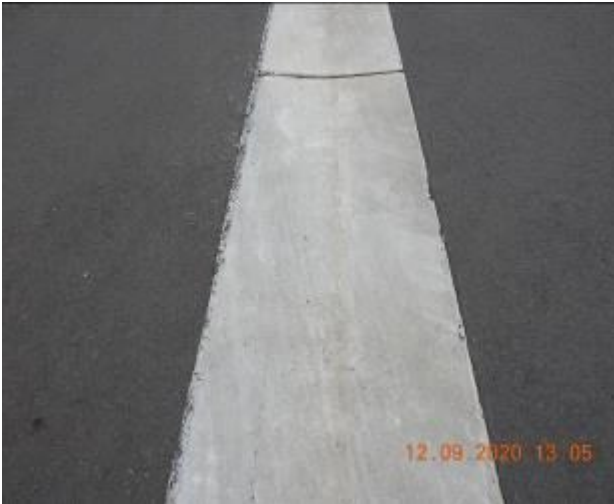
Figure 373 – Crack propagation through gutter

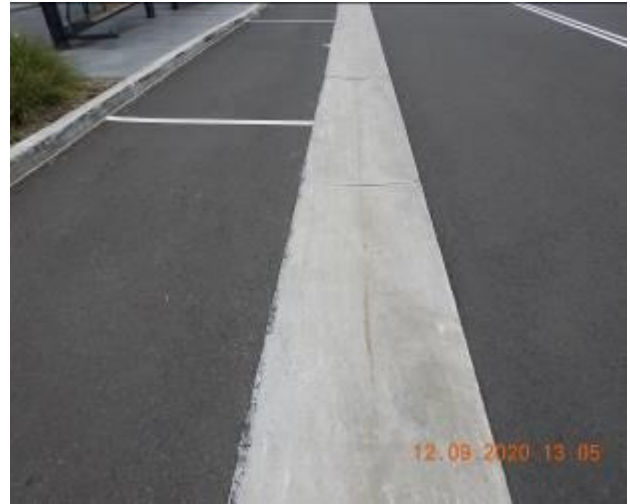
Figure 374 – Crack propagation through gutter

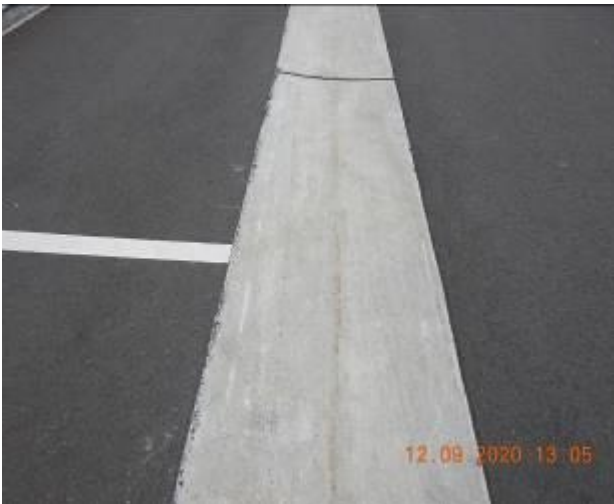
Figure 375 – Crack propagation through gutter

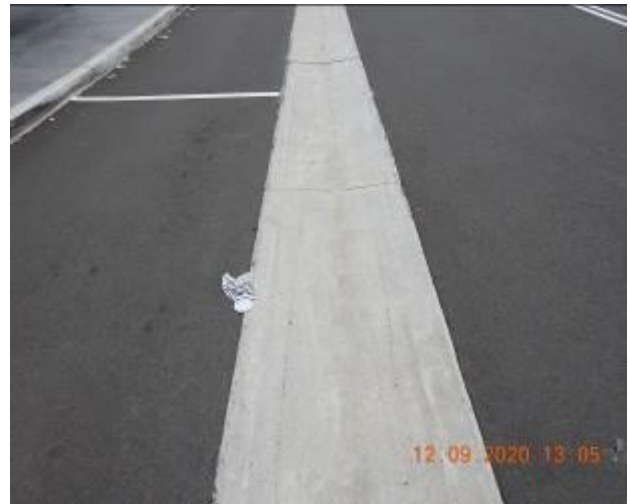
Figure 376 – General condition of gutter

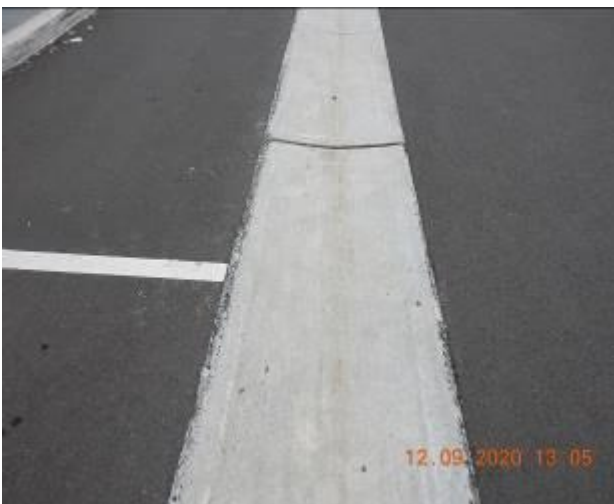
Figure 377 – Crack propagation and loss of material through gutter

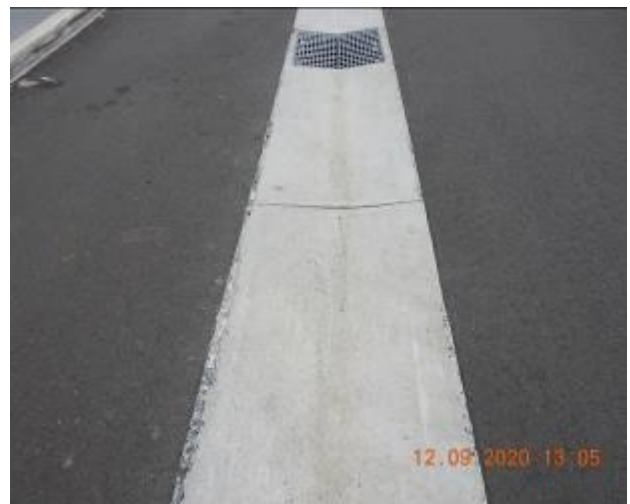
Figure 378 – Crack propagation and loss of material through gutter

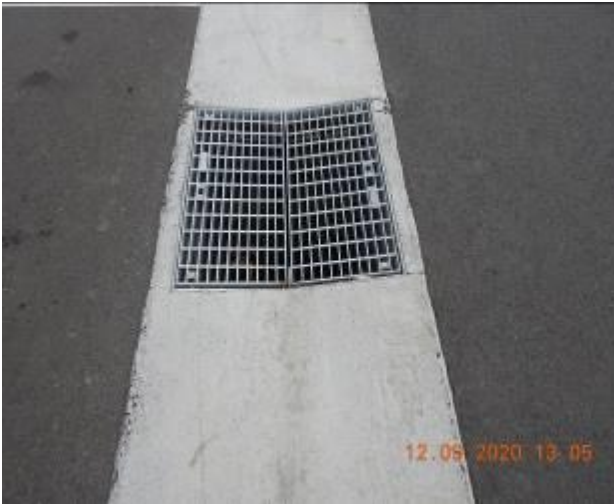
Figure 379 – Crack propagation and loss of material through gutter and general condition of stormwater inlet pit

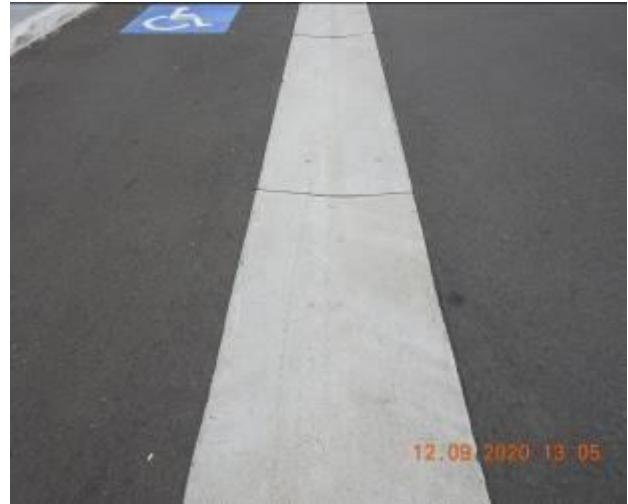
Figure 380 – General condition of gutter

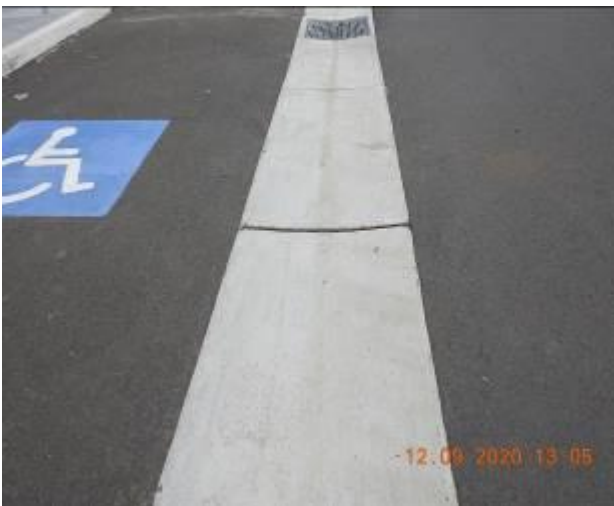
Figure 381 – General condition of gutter

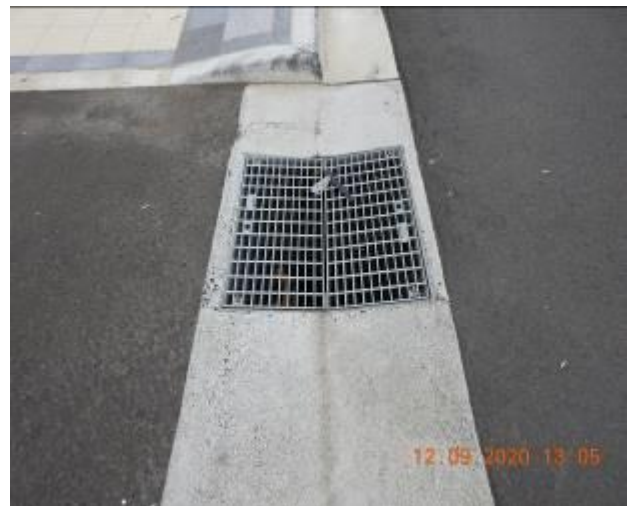
Figure 382 – General condition of stormwater inlet pit

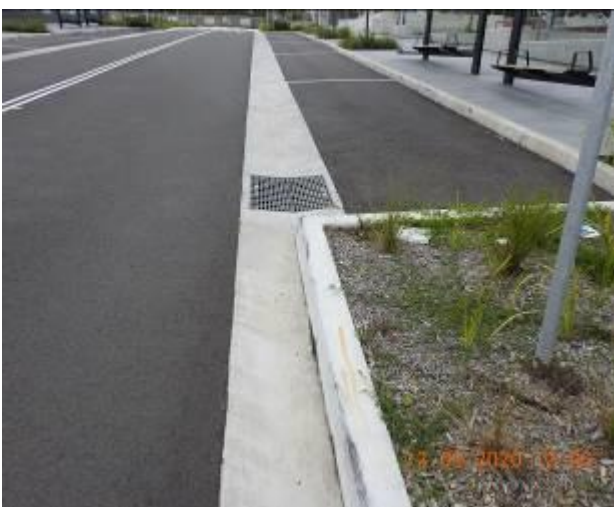
Figure 383 – General condition of kerb and gutter heading East

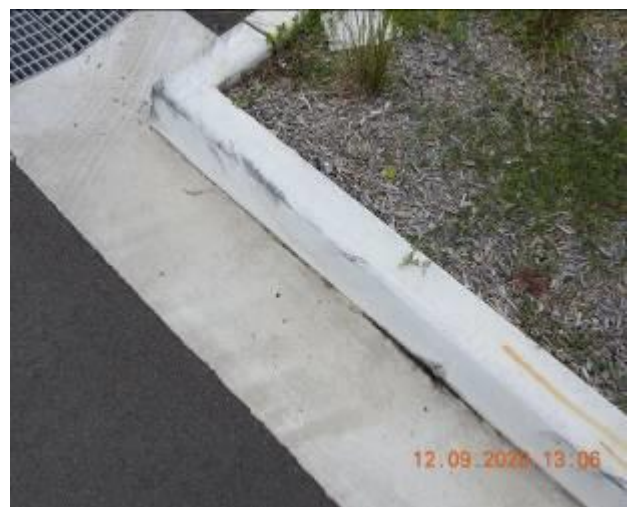
Figure 384 – Crack propagation through kerb

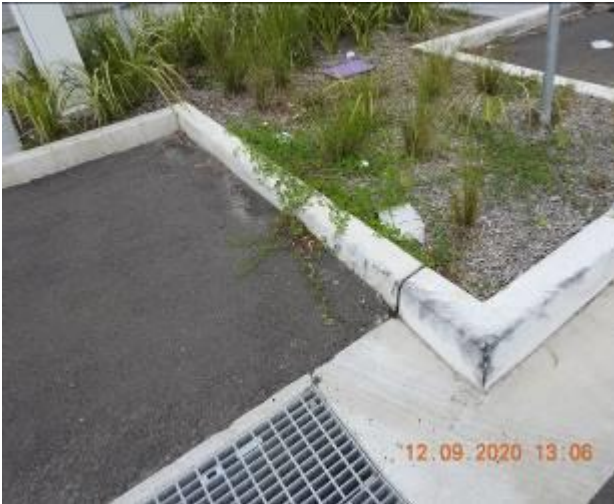
Figure 385 – Loss of material through kerb

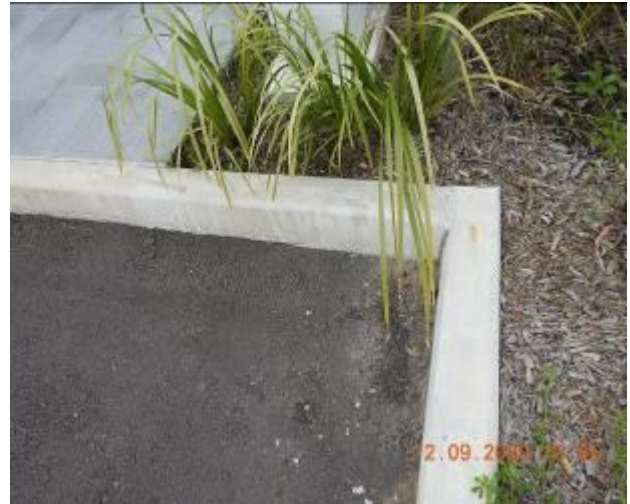
Figure 386 – General condition of kerb

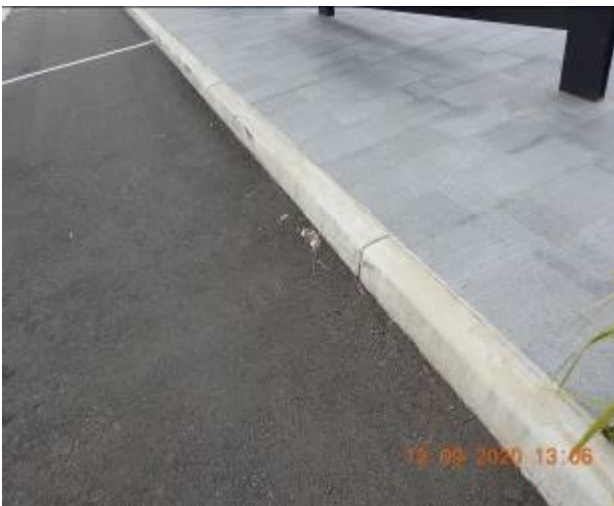
Figure 387 – Crack propagation through kerb

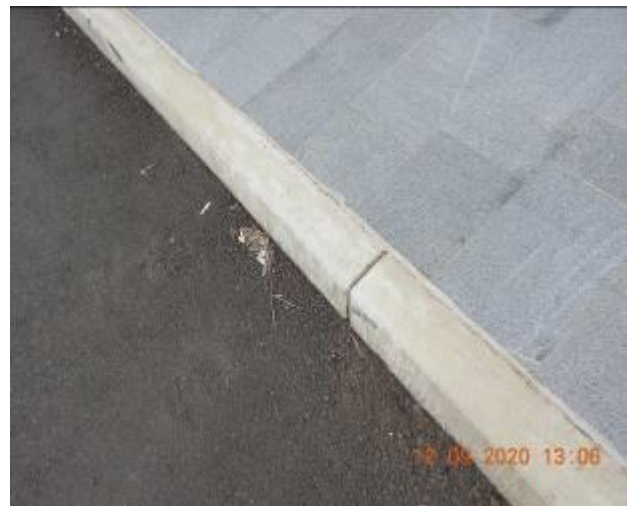
Figure 388 – Crack propagation through kerb

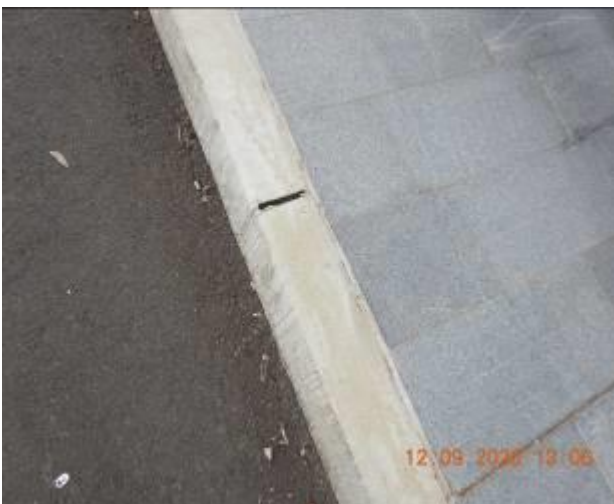
Figure 389 – Crack propagation and loss of material through kerb

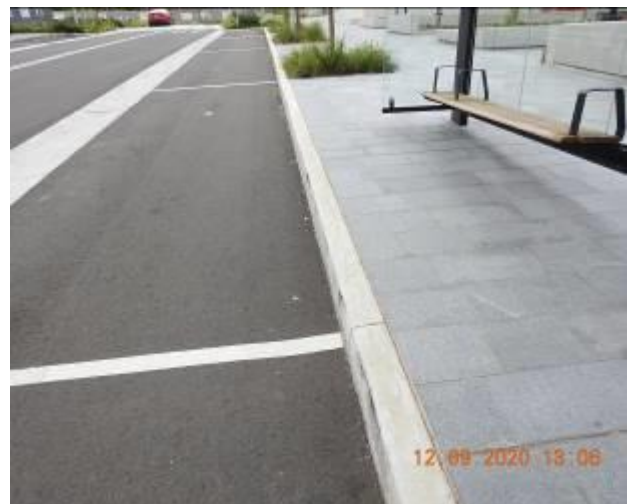
Figure 390 – General condition of kerb

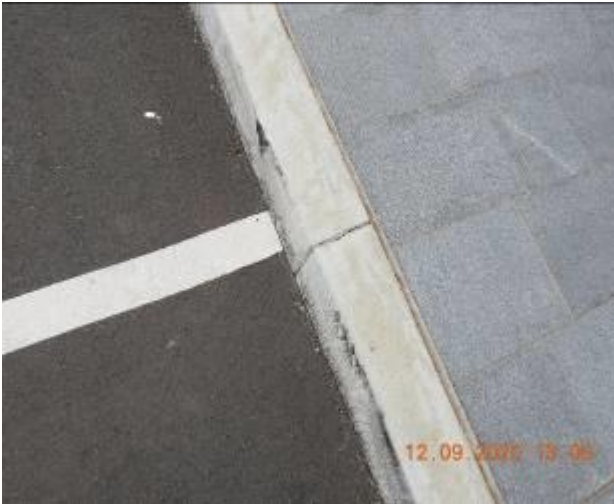
Figure 391 – Crack propagation through kerb

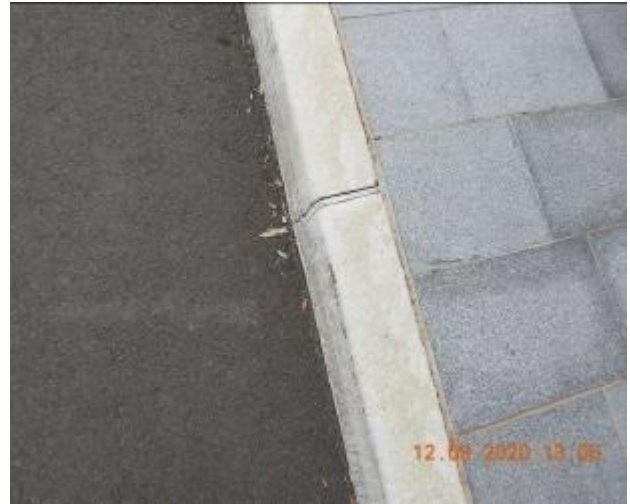
Figure 392 – Crack propagation through kerb

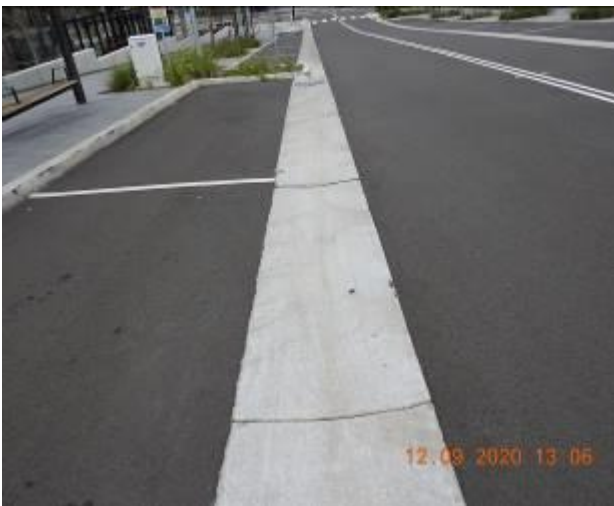
Figure 393 – General condition of gutter heading West

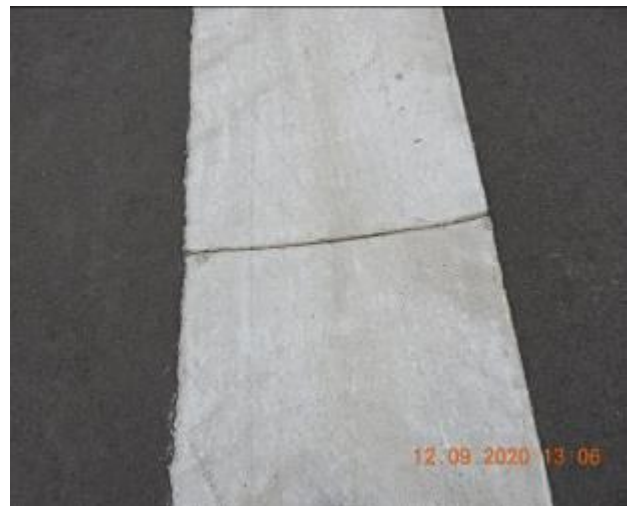
Figure 394 – Crack propagation through gutter

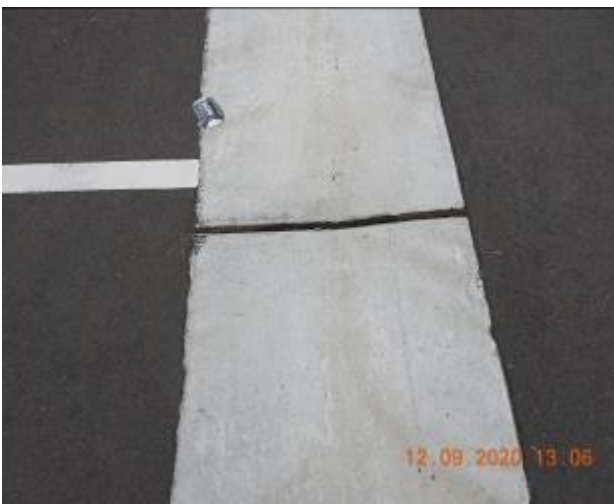
Figure 395 – General condition of gutter

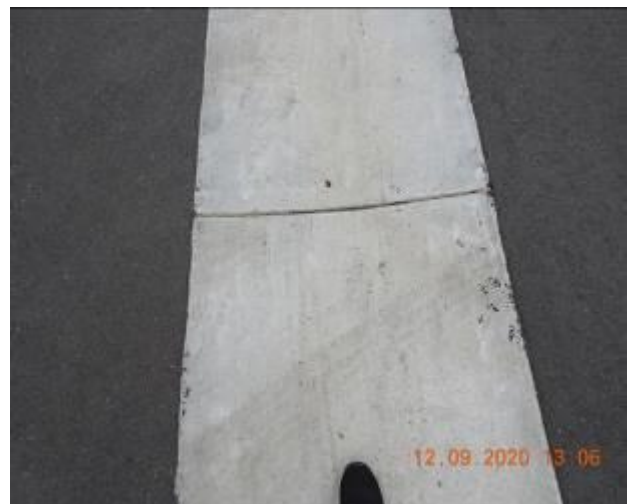
Figure 396 – Crack propagation through gutter

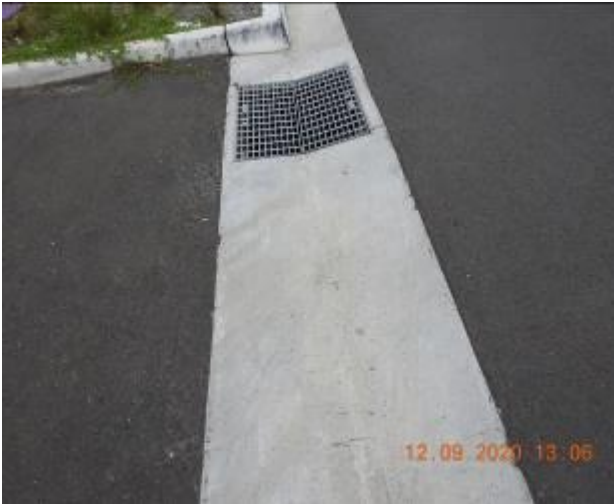
Figure 397 – General condition of gutter

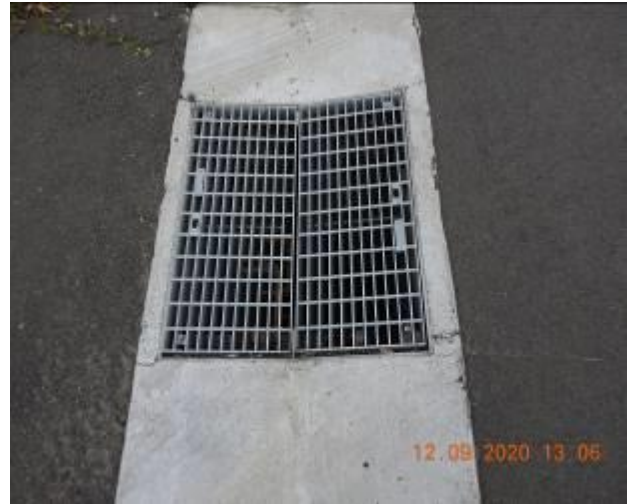
Figure 398 – Crack propagation through gutter and General condition of stormwater inlet pit

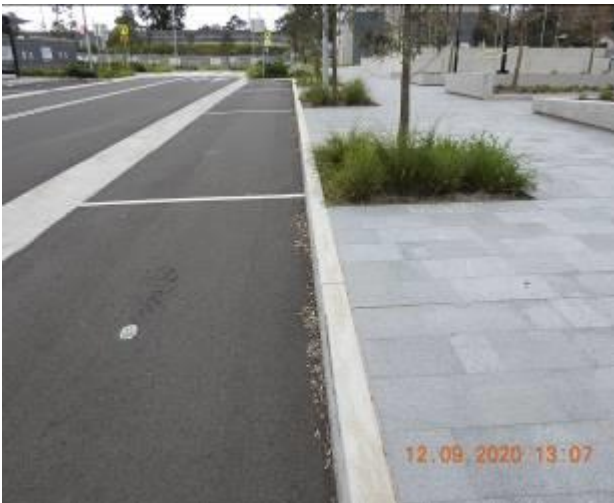
Figure 399 – General condition of kerb

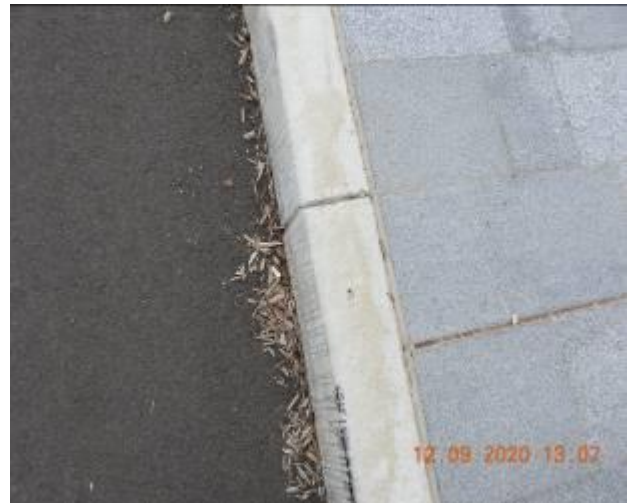
Figure 400 – Crack propagation through kerb

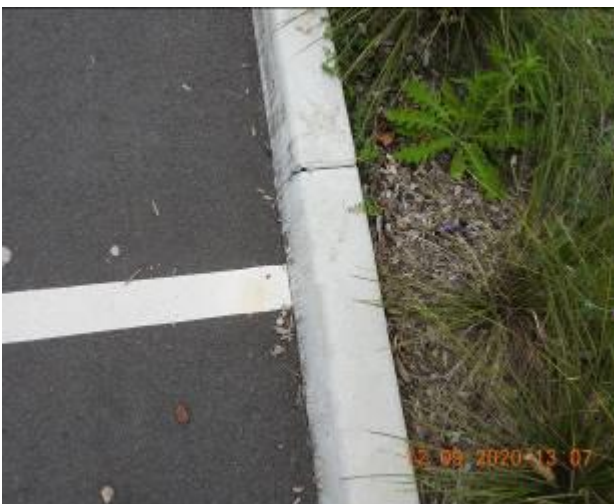
Figure 401 – Crack propagation through kerb

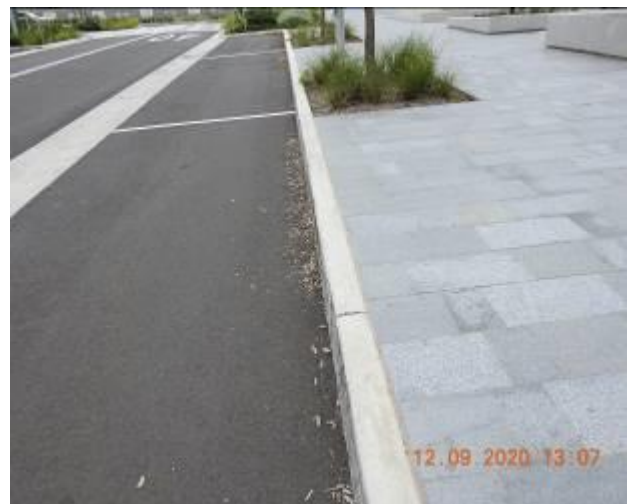
Figure 402 – General condition of kerb

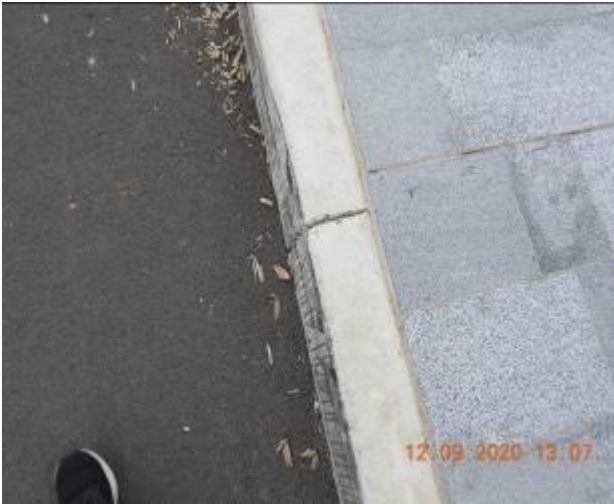
Figure 403 – Crack propagation through kerb

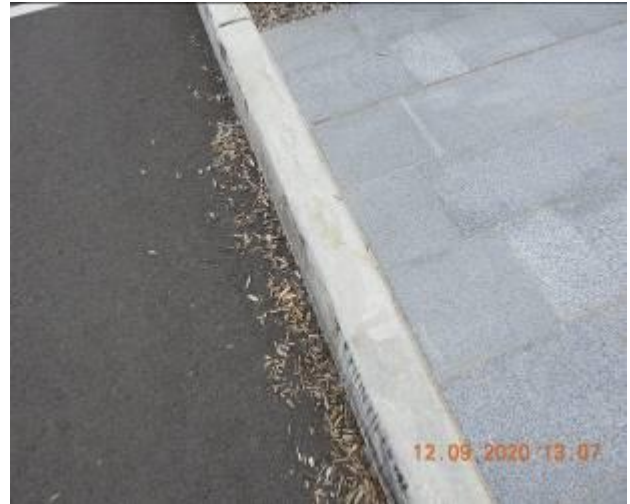
Figure 404 – General condition of kerb

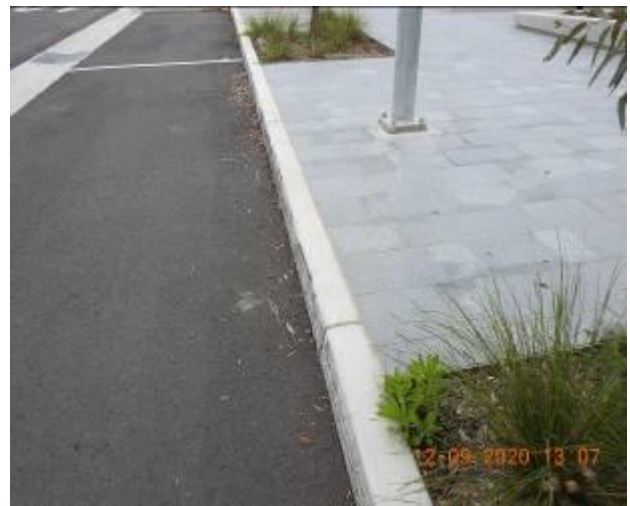
Figure 406 – General condition of kerb

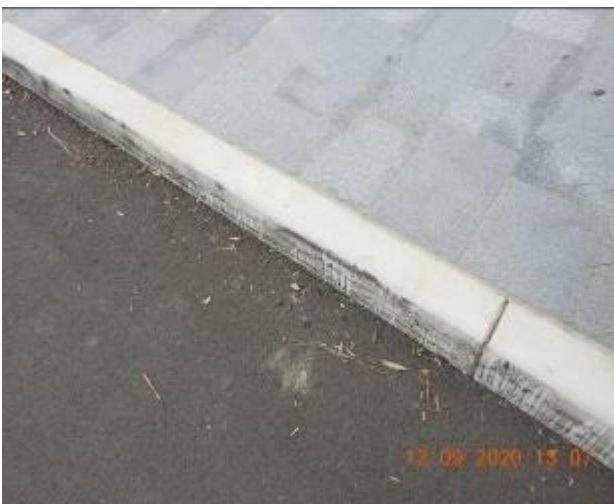
Figure 407 – Crack propagation through kerb

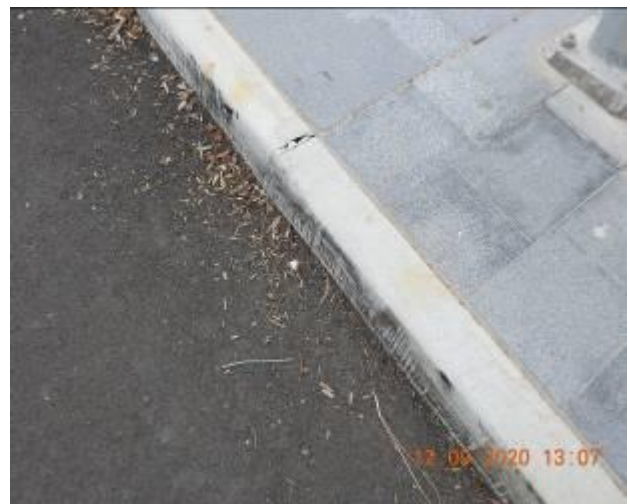
Figure 408 – Crack propagation and loss of material through kerb

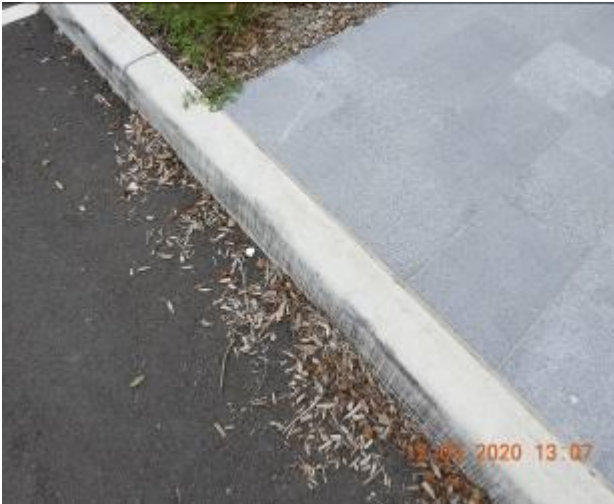
Figure 409 – General condition of kerb

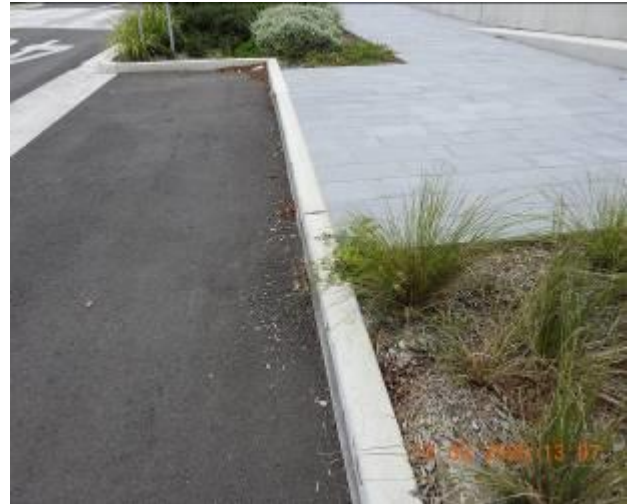
Figure 410 – General condition of kerb

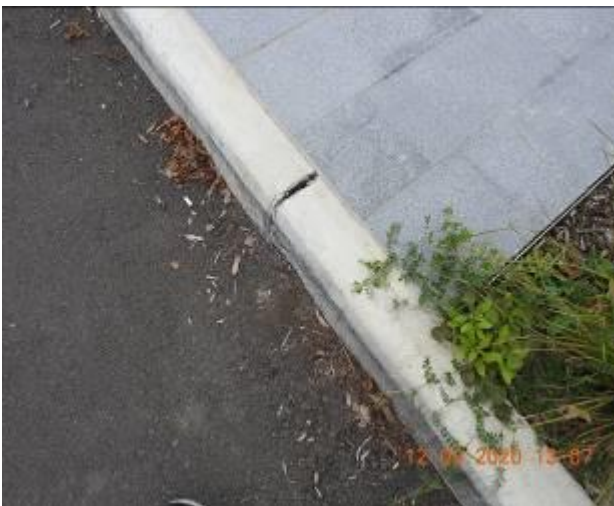
Figure 411 – Crack propagation and loss of material through kerb

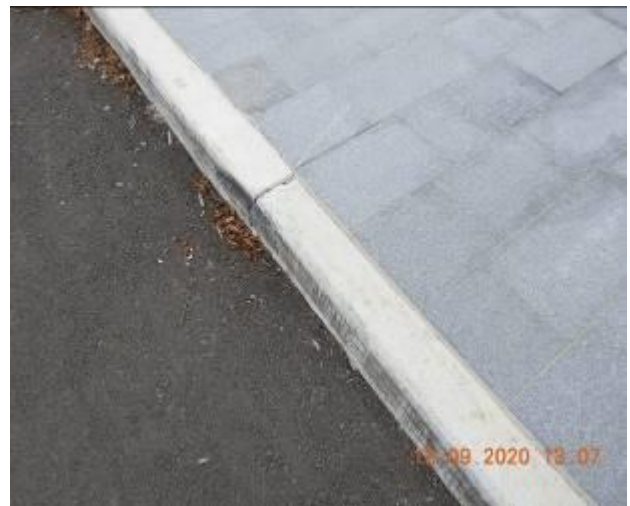
Figure 412 – General condition of kerb

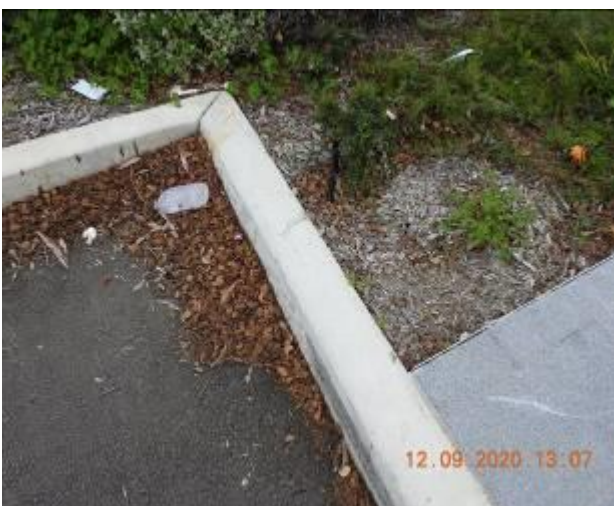
Figure 413 – General condition of kerb

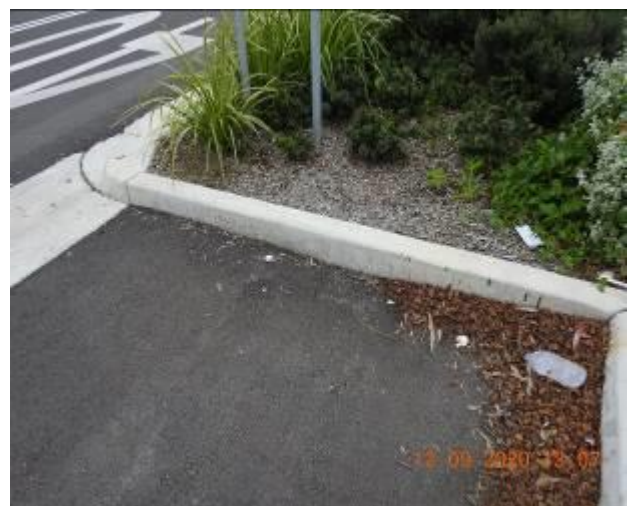
Figure 414 – General condition of kerb

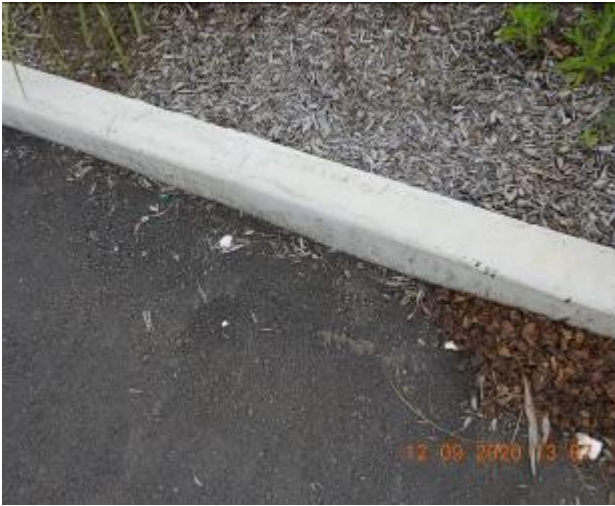
Figure 415 – Crack propagation through kerb

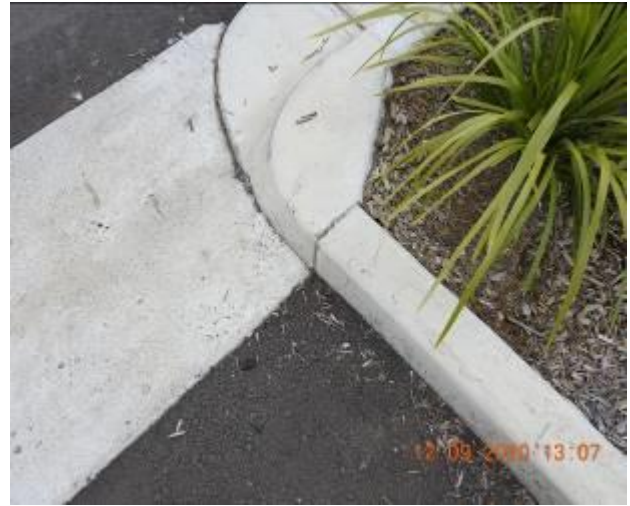
Figure 416 – Crack propagation through kerb

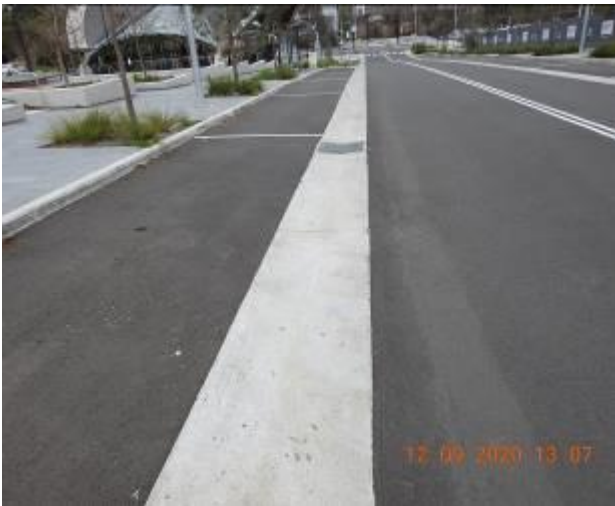
Figure 417 – General condition of gutter heading West

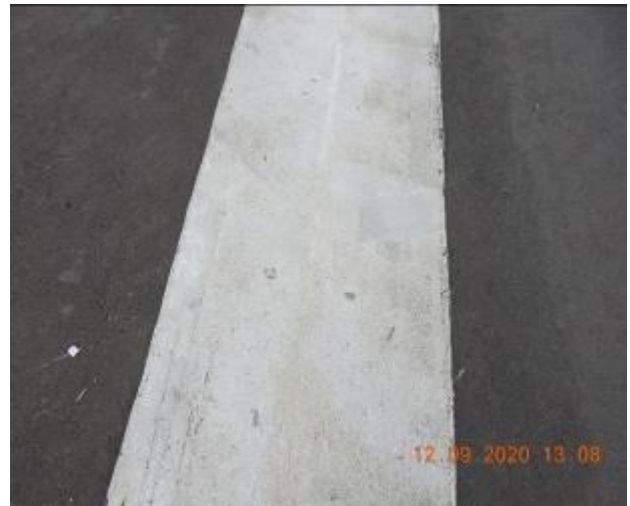
Figure 418 – Evidence of patchwork through gutter

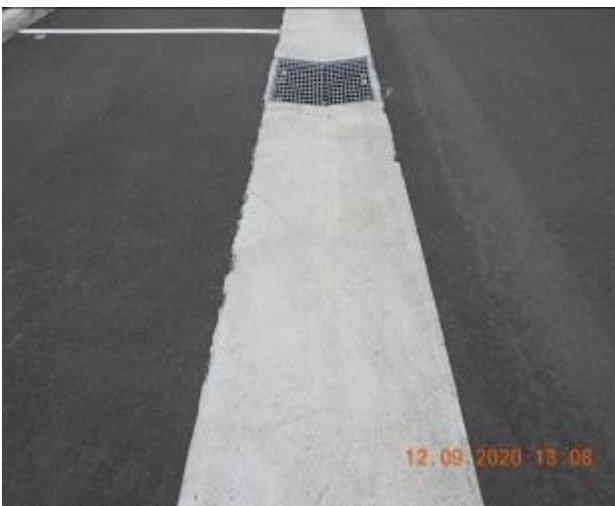
Figure 419 – General condition of gutter

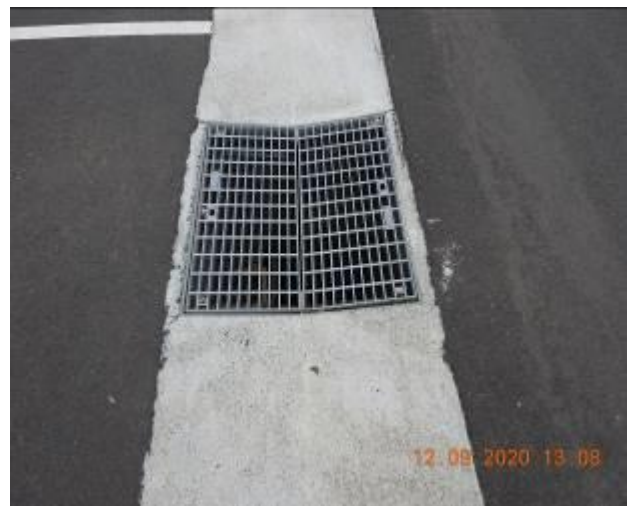
Figure 420 – General condition of stormwater inlet pit

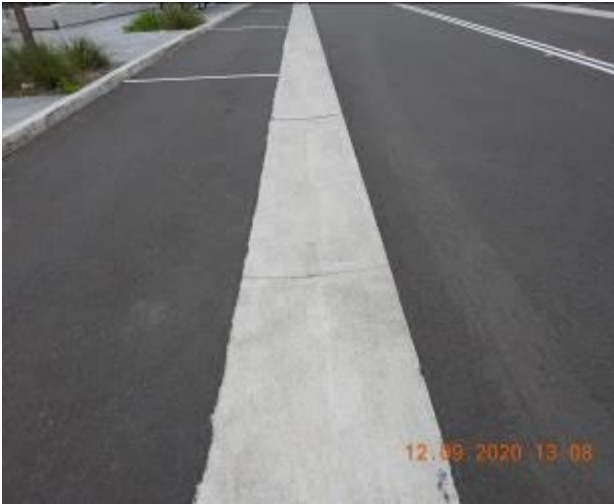
Figure 421 – General condition of gutter

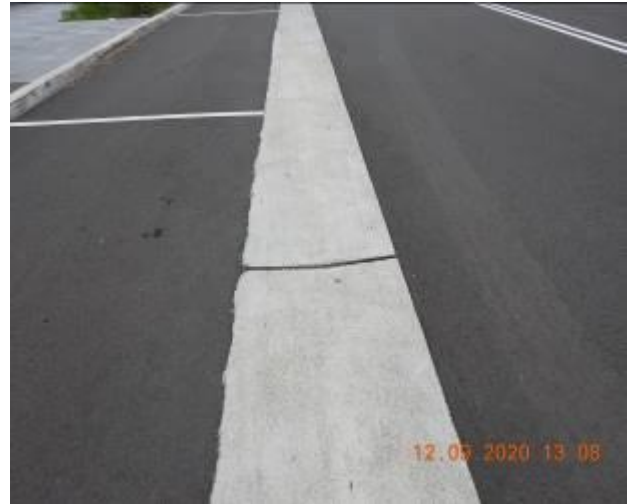
Figure 422 – General condition of gutter

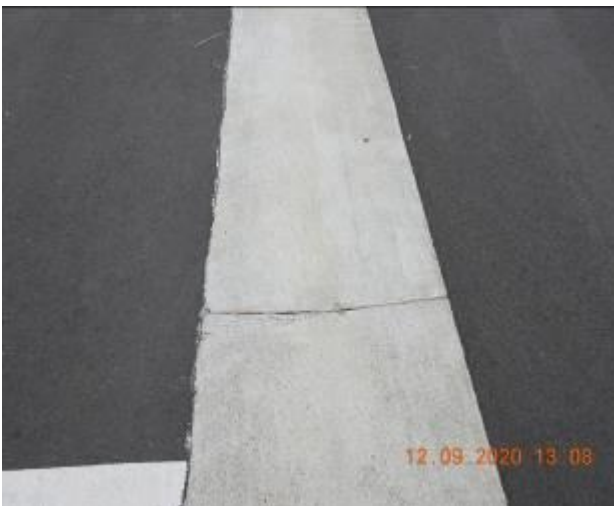
Figure 423 – Loss of material through gutter

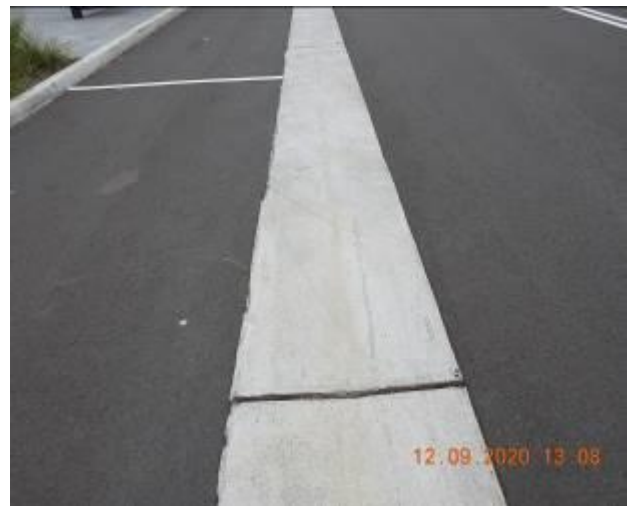
Figure 424 – General condition of gutter

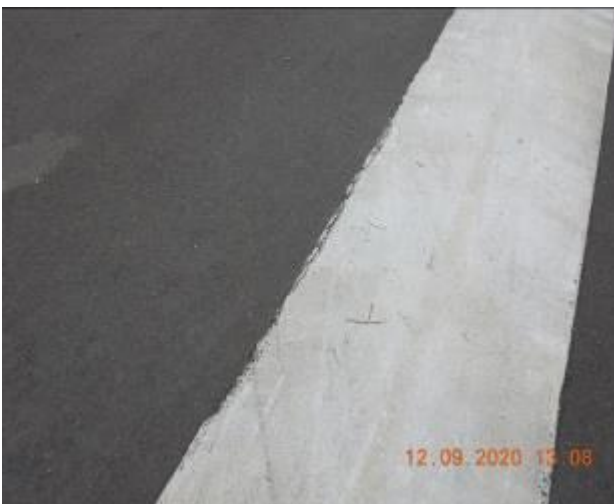
Figure 425 – Crack propagation and loss of material through gutter

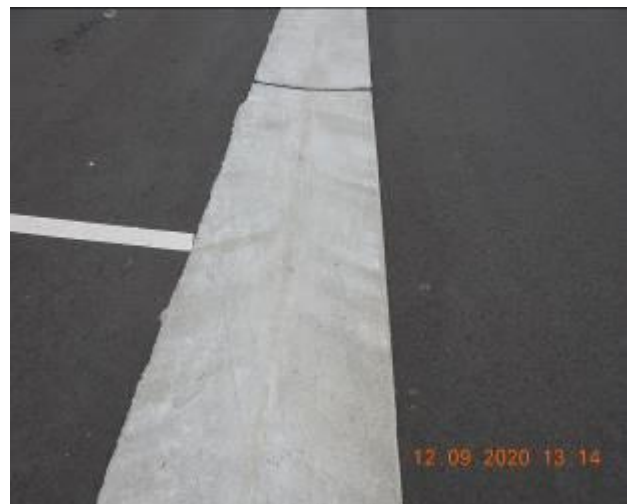
Figure 426 – General condition of gutter

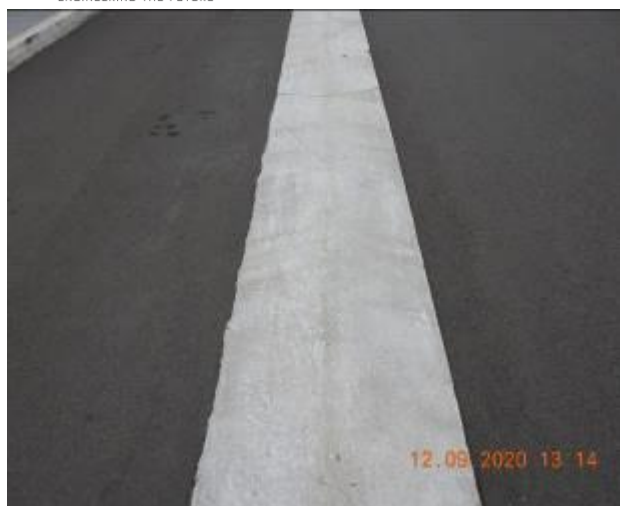
Figure 427 – General condition of gutter
