**2 MANDALA PARADE, CASTLE HILL
(DORAN DRIVE PRECINCT)
PRE-DILAPIDATION REPORT
Of Sydney Metro and Hills Shire Council Assets
DEICORP PROJECTS SHOWGROUND
PTY LTD.**

Job No. 200124.3
07/07/2021

ACE Structural Services Pty Ltd

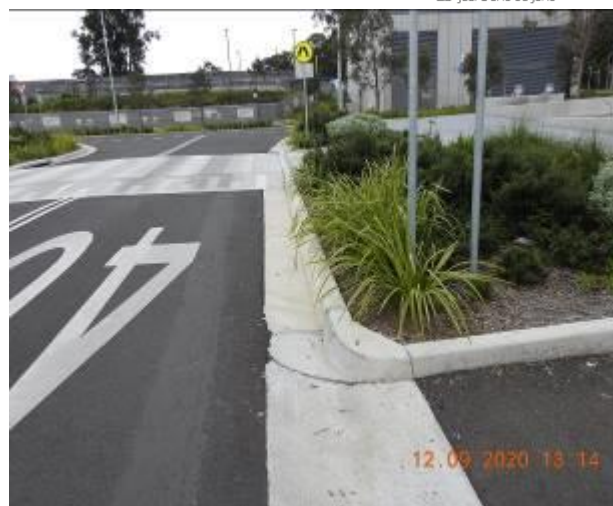
Figure 428 – General condition of kerb and gutter heading East

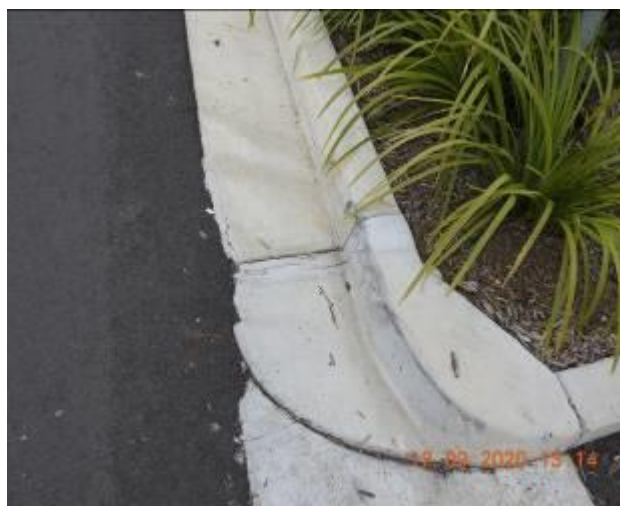
Figure 429 – Evidence of patchwork, crack propagation and loss of material through kerb and gutter

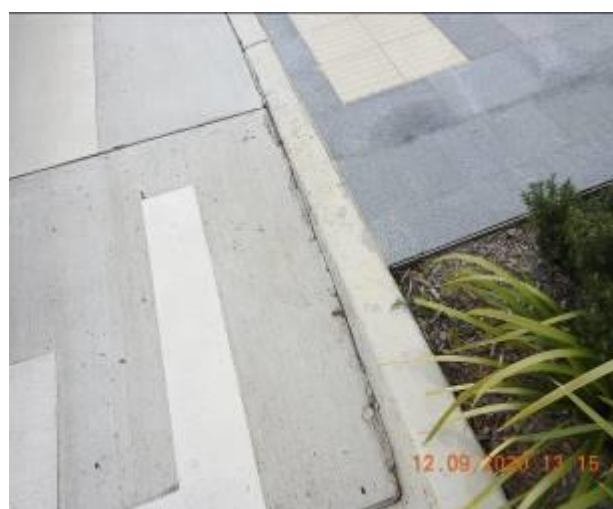
Figure 432 – Crack propagation and loss of material through layback

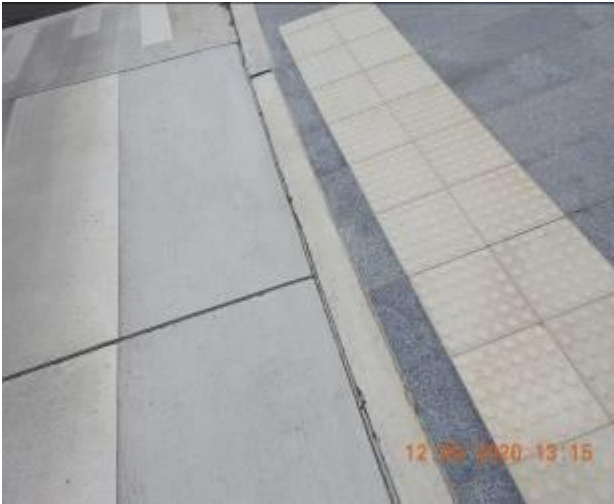
Figure 433 – Crack propagation and loss of material through layback

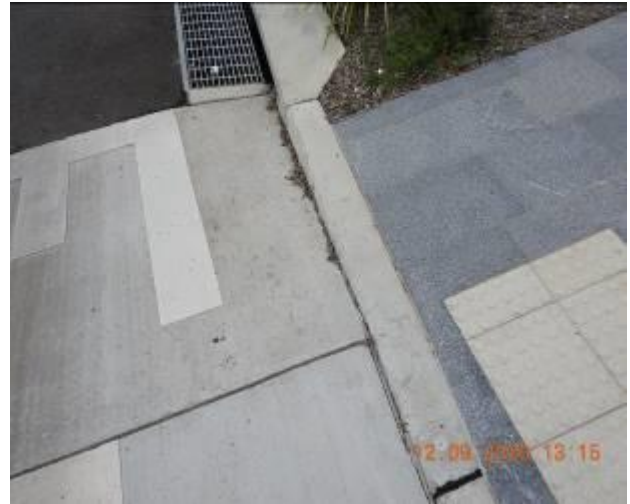
Figure 434 – Crack propagation and loss of material through layback

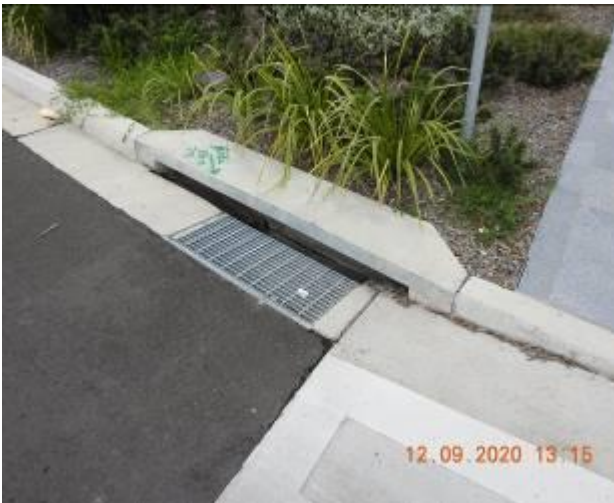
Figure 435 – General condition of kerb inlet pit and stormwater inlet pit

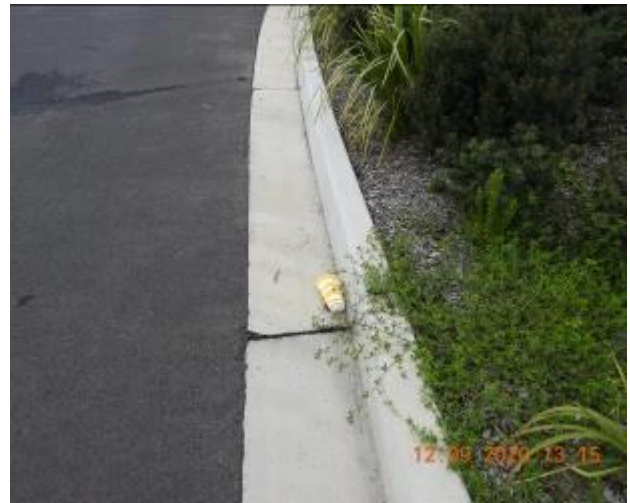
Figure 436 – General condition of kerb and gutter

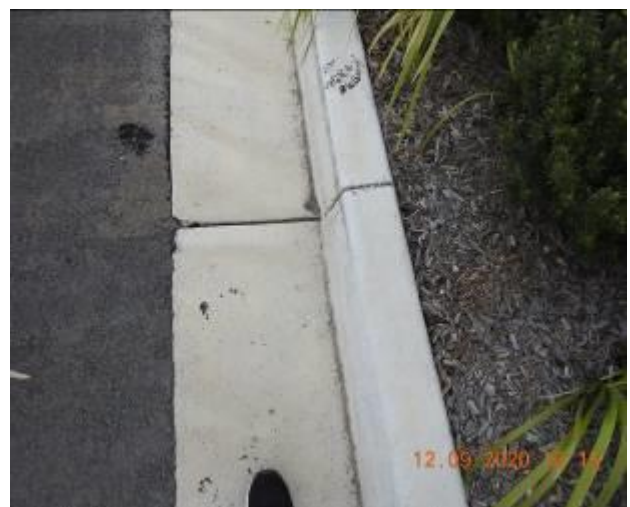
Figure 438 – Crack propagation and loss of material through kerb and gutter

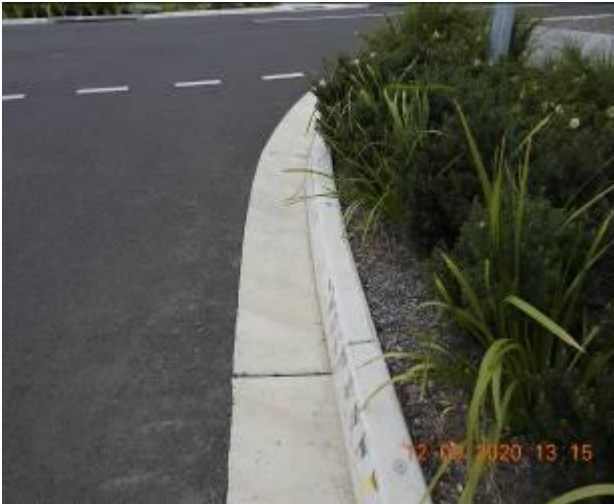
Figure 439 – General condition of kerb and gutter

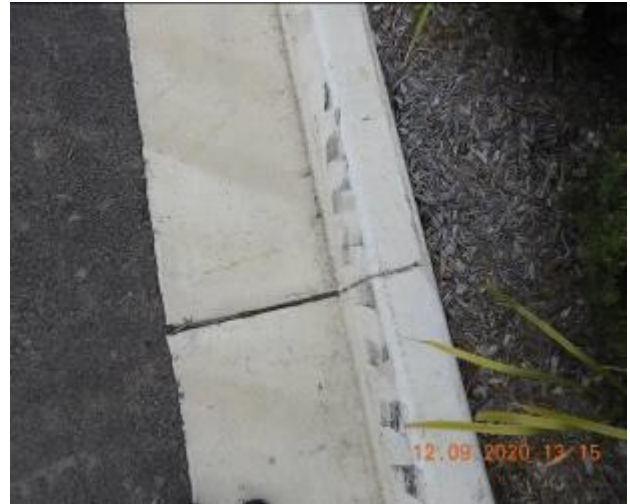
Figure 440 – Crack propagation through kerb

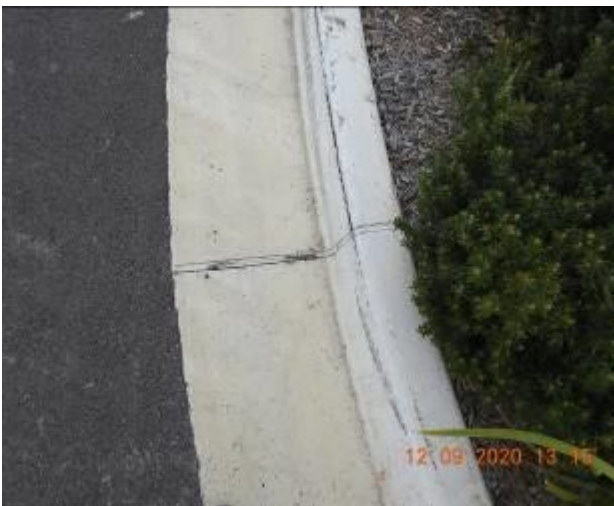
Figure 441 – Crack propagation through kerb and gutter

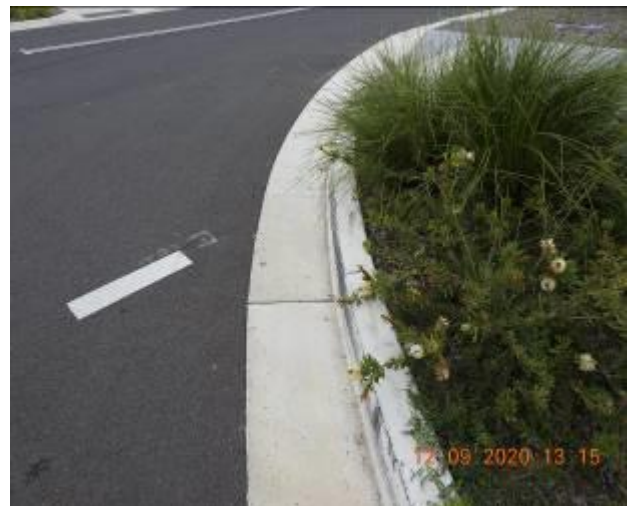
Figure 442 – General condition of kerb and gutter

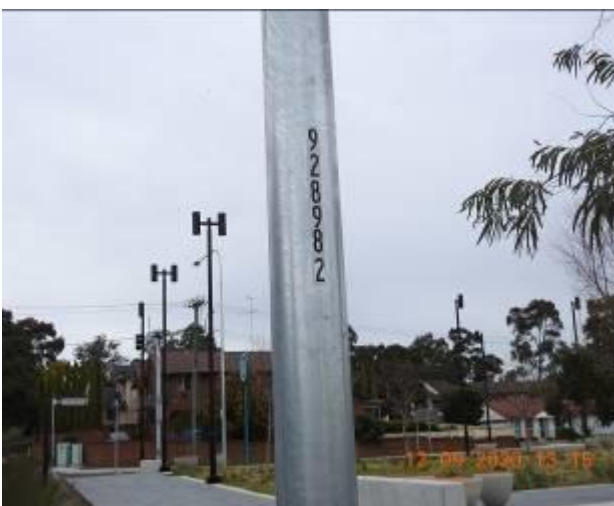
Figure 443 – General condition of lamp post identification No. 928982

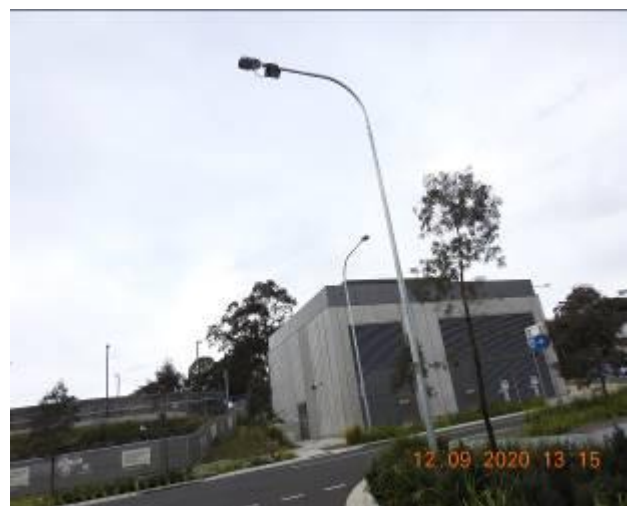
Figure 444 – General condition of lamp post identification No. 928982

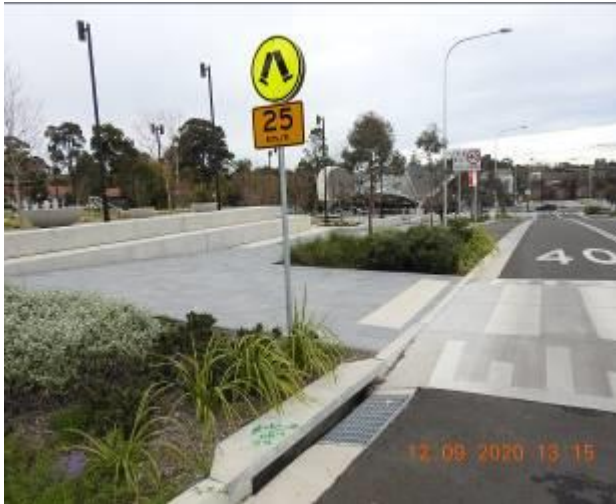
Figure 445 – General condition of street sign

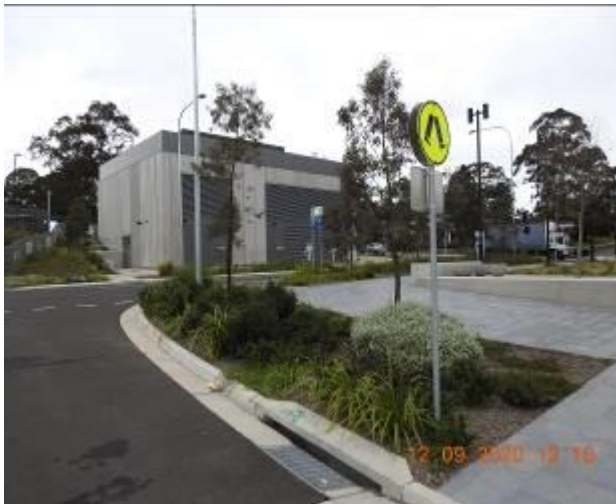
Figure 447 – General condition of street sign

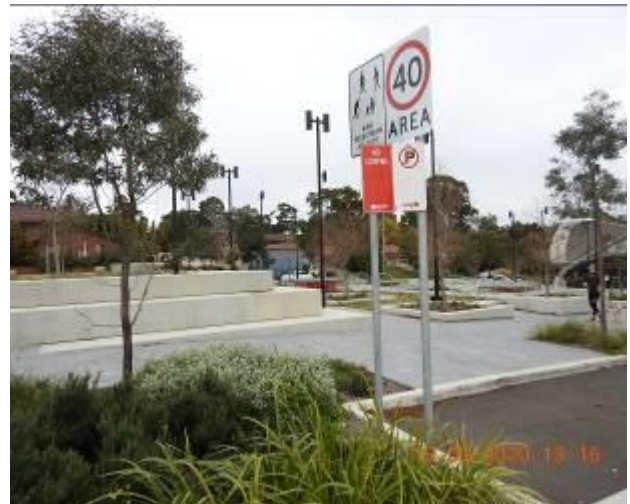
Figure 448 – General condition of street sign

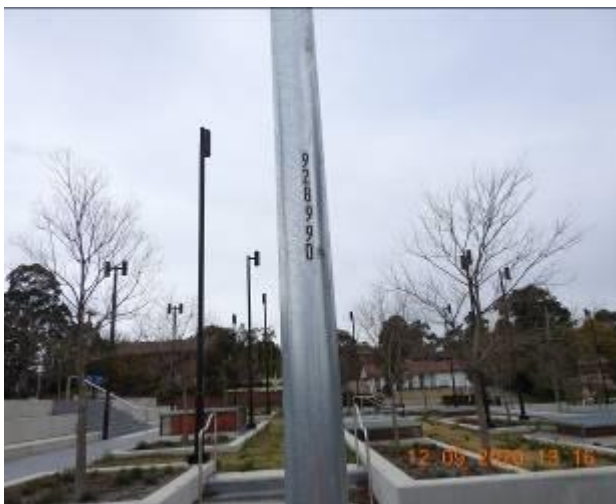
Figure 449 – General condition of lamp post identification No. 928990

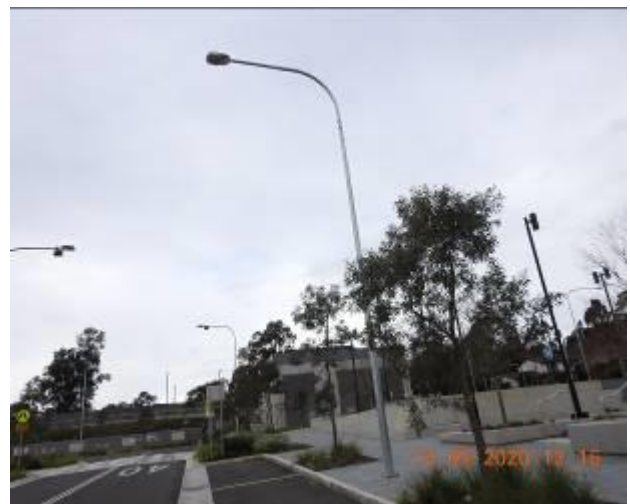
Figure 450 – General condition of lamp post identification No. 928990

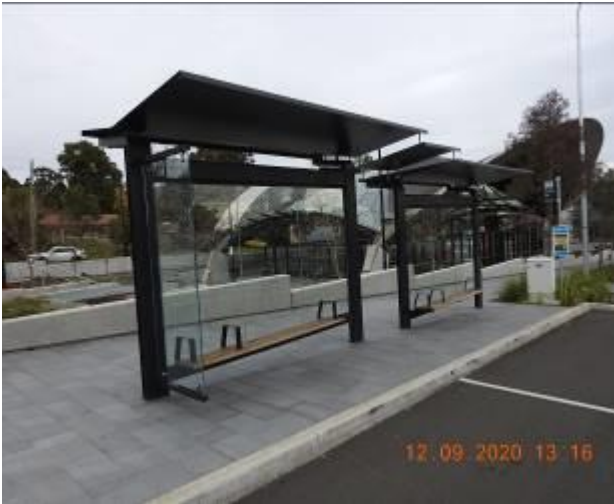
Figure 451 – General condition of bus shelter

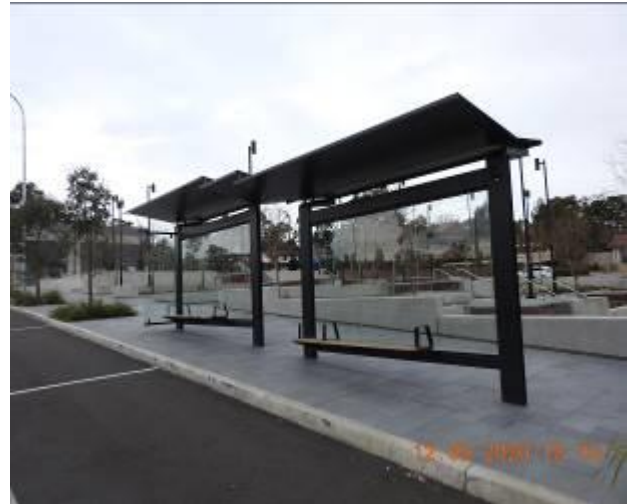
Figure 452 – General condition of bus shelter

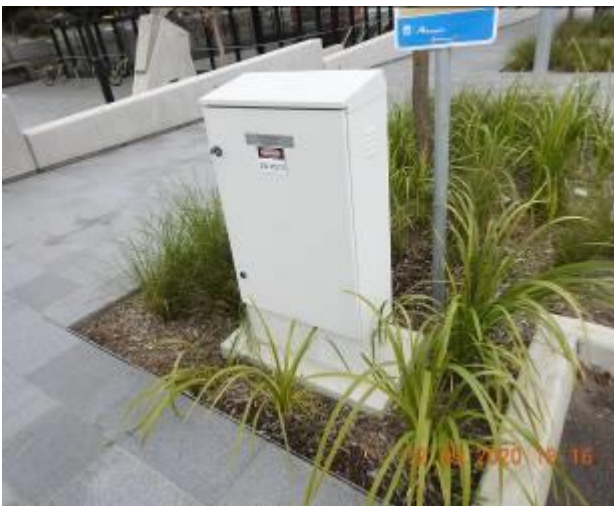
Figure 453 – General condition of electricity box

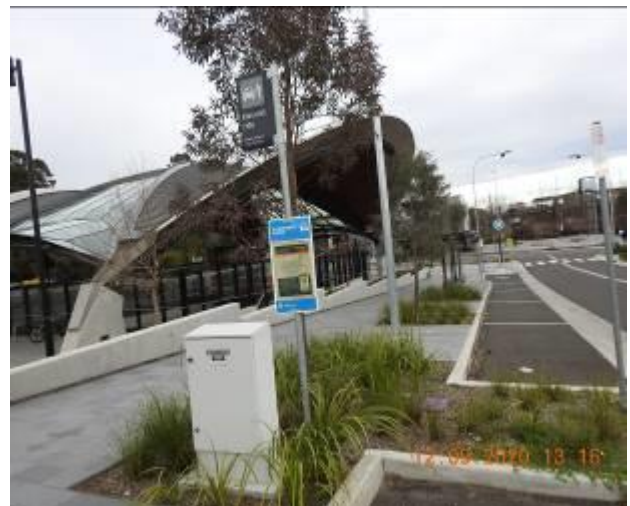
Figure 454 – General condition of street sign

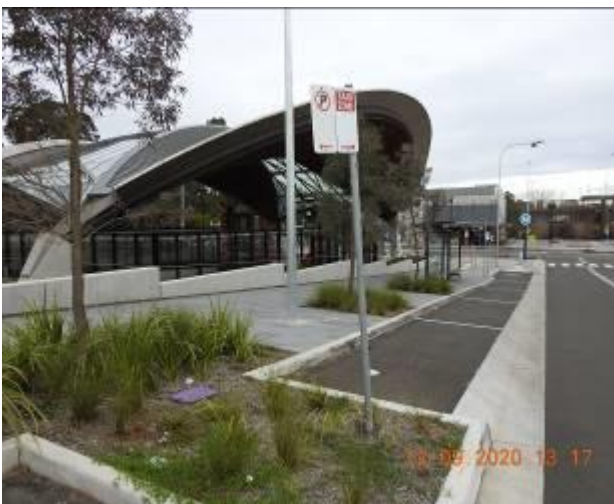
Figure 455 – General condition of street sign

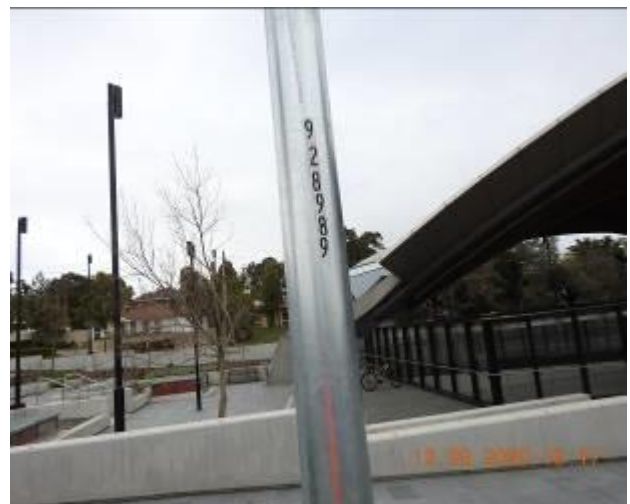
Figure 456 – General condition of lamp post identification No. 928989

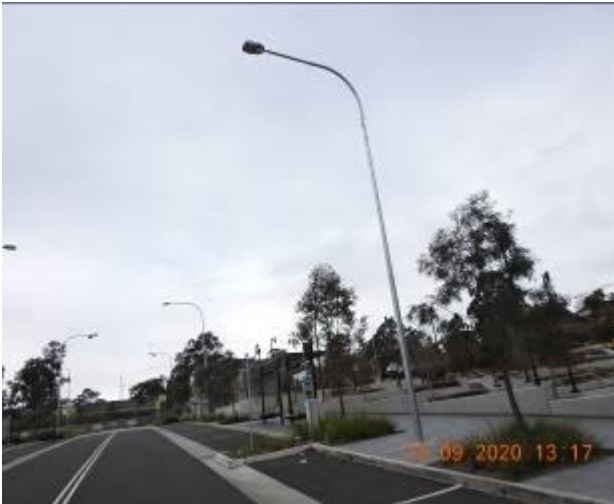
Figure 457 – General condition of lamp post identification No. 928989

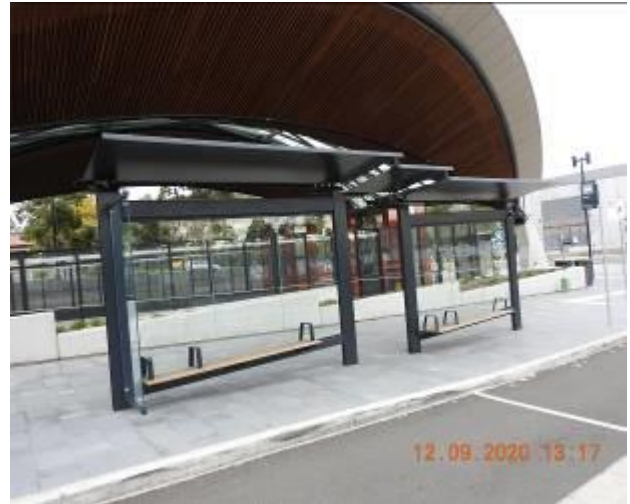
Figure 458 – General condition of bus shelter

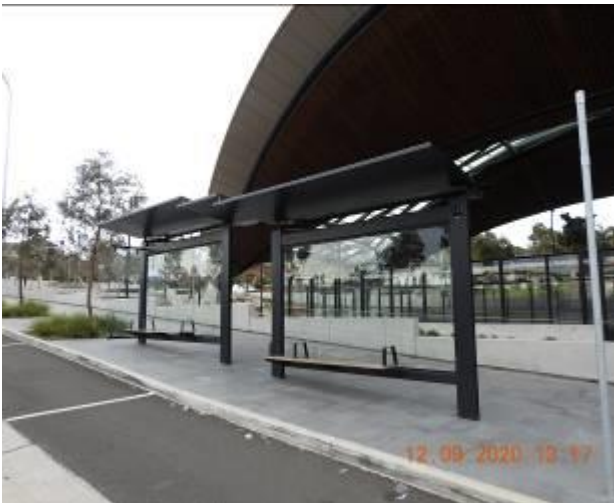
Figure 459 – General condition of bus shelter

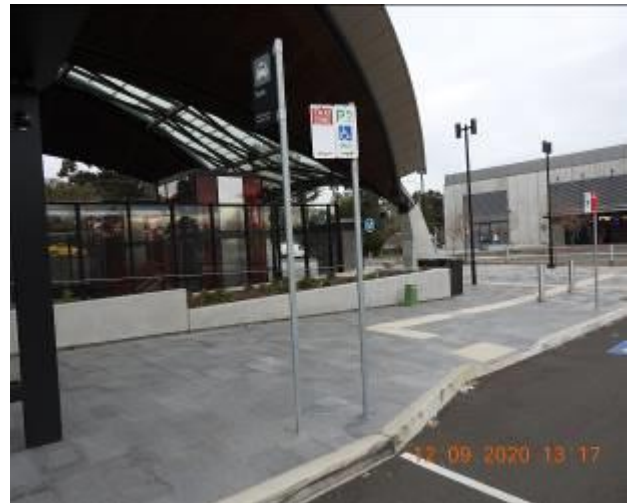
Figure 460 – General condition of street sign

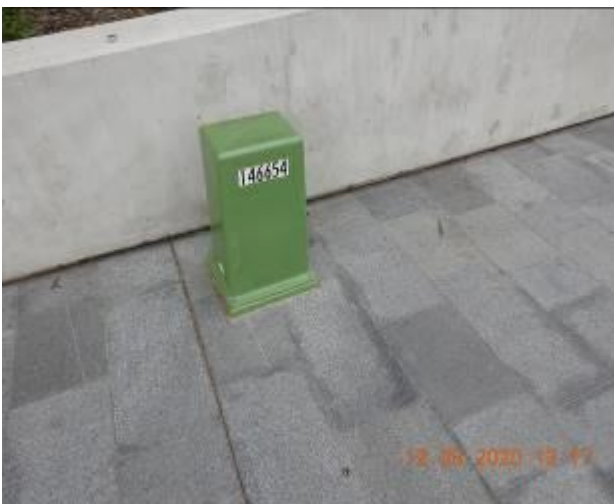
Figure 461 – General condition of electricity box identification No. 146654

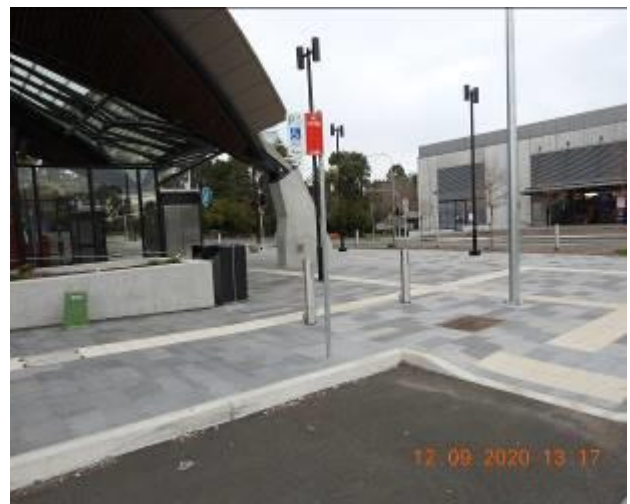
Figure 462 – General condition of street sign

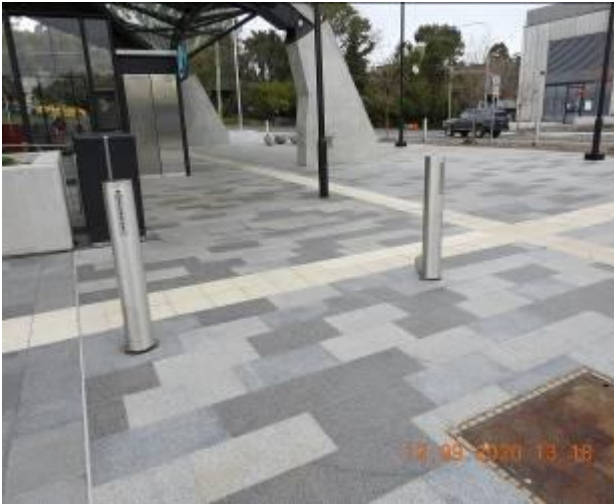
Figure 463 – General condition of pole along Mandala parade

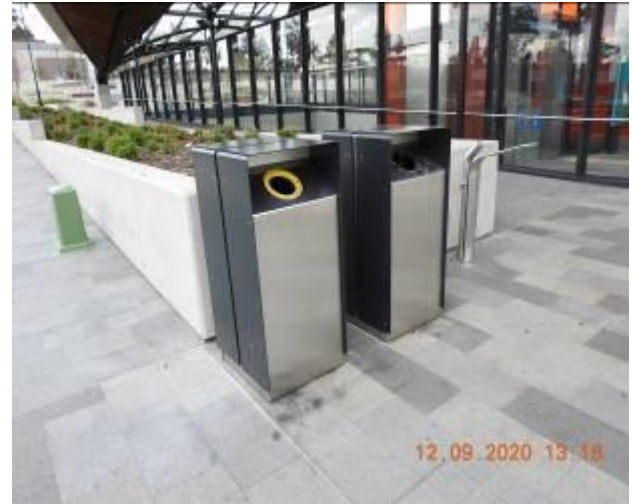
Figure 464 – General condition of public waste bin

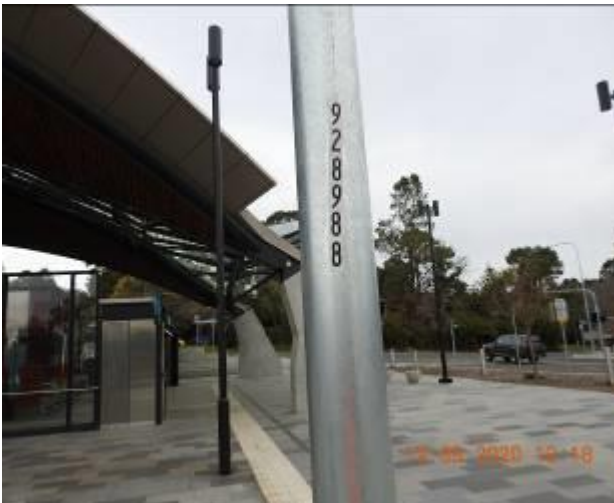
Figure 465 – General condition of lamp post identification No. 928988

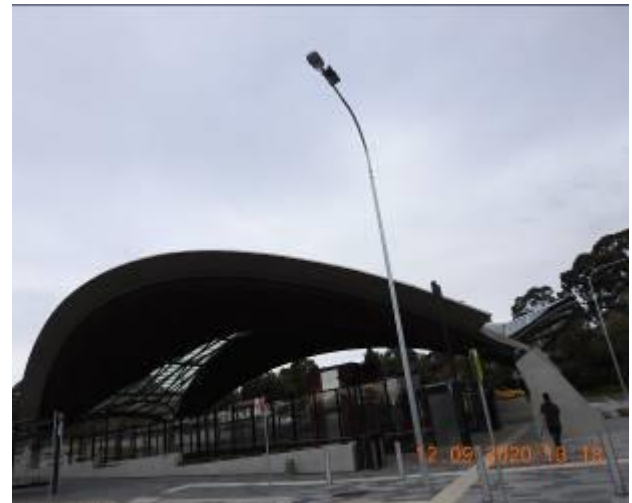
Figure 466 – General condition of lamp post identification No. 928988

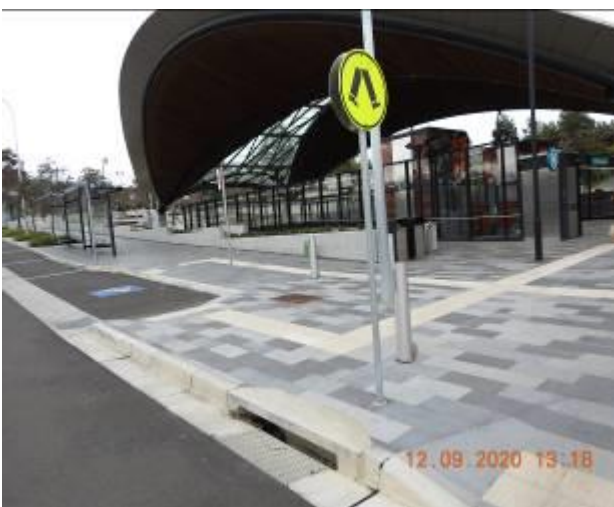
Figure 467 – General condition of street sign

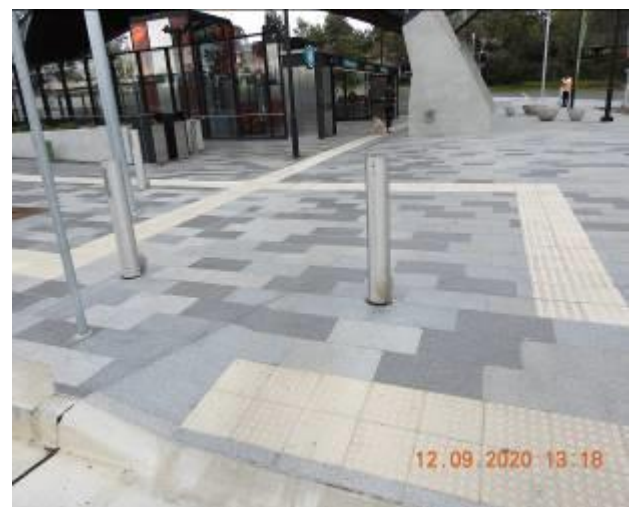
Figure 468 – General condition of safety bollards along Mandala parade

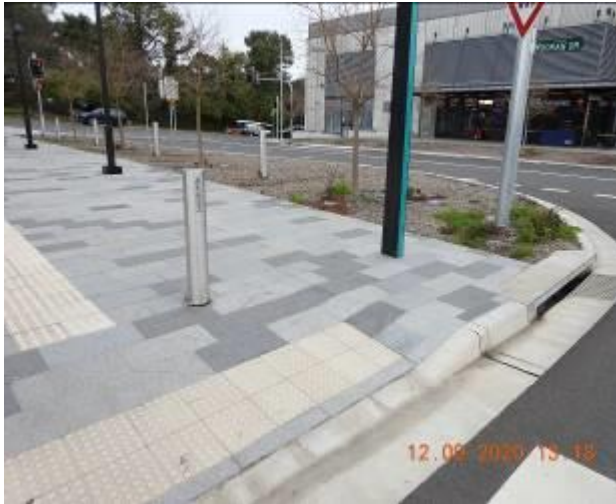
Figure 469 – General condition of safety bollards along Mandala parade

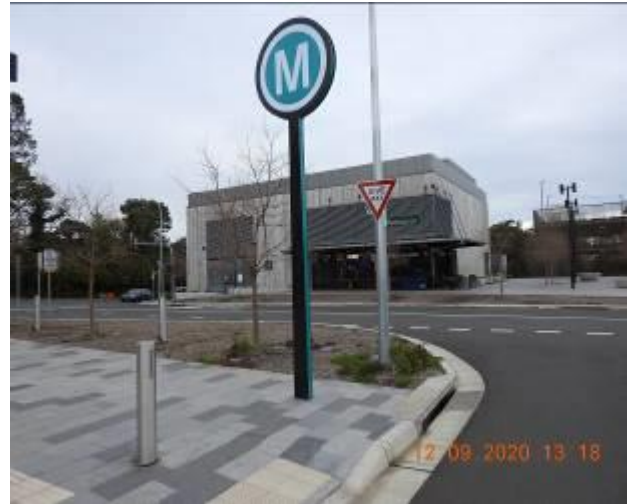
Figure 470 – General condition of street sign

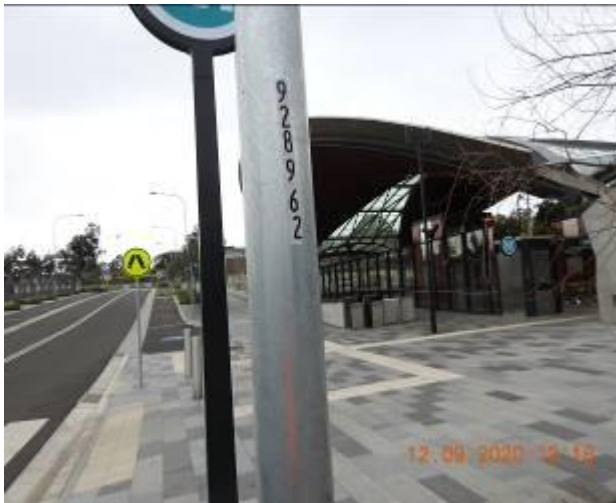
Figure 471 – General condition of lamp post identification No. 928962

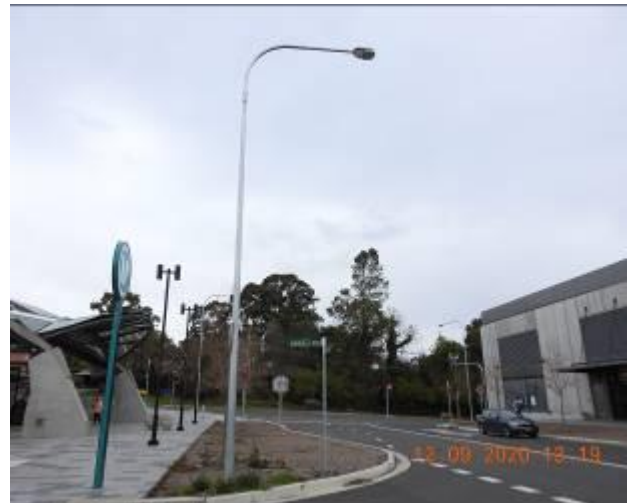
Figure 472 – General condition of lamp post identification No. 928962

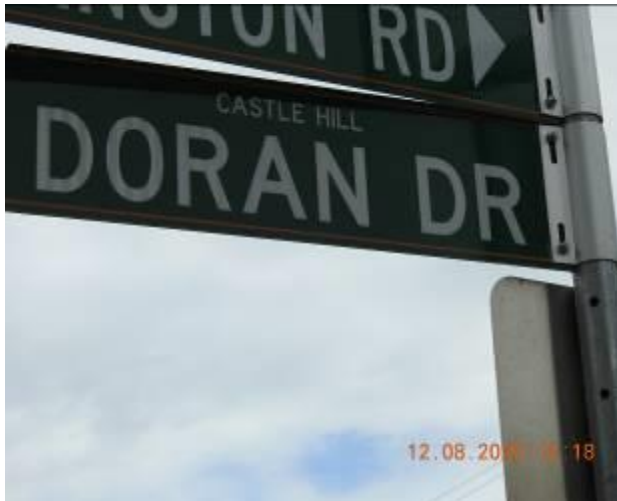
Figure 473 – The following images display the condition of Doran Drive Council Assets

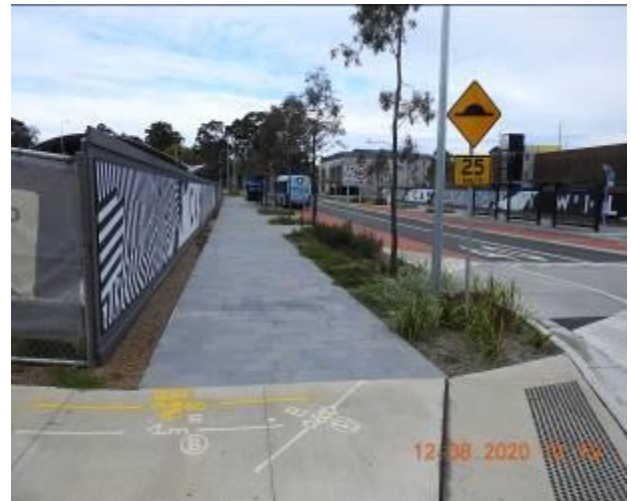
Figure 474 – General condition of footpath pavement heading South

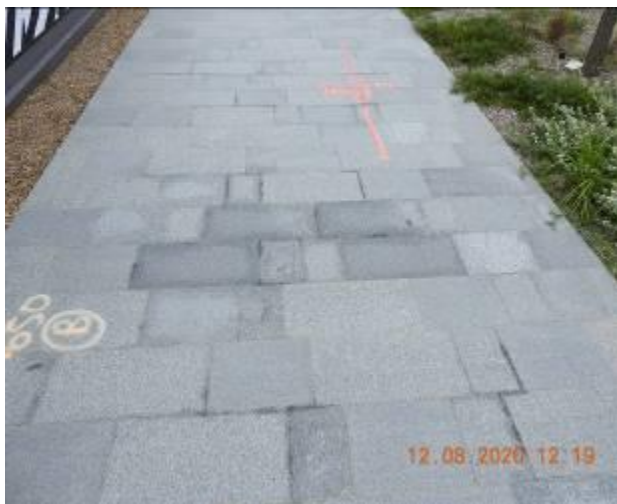
Figure 475 – Loss of material through footpath pavement

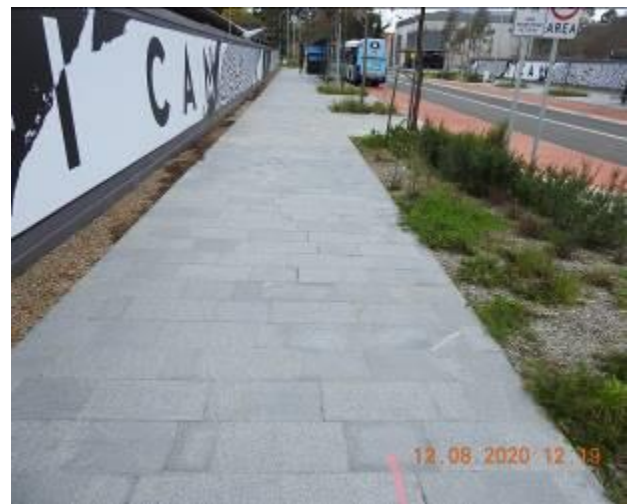
Figure 476 – General condition of footpath pavement

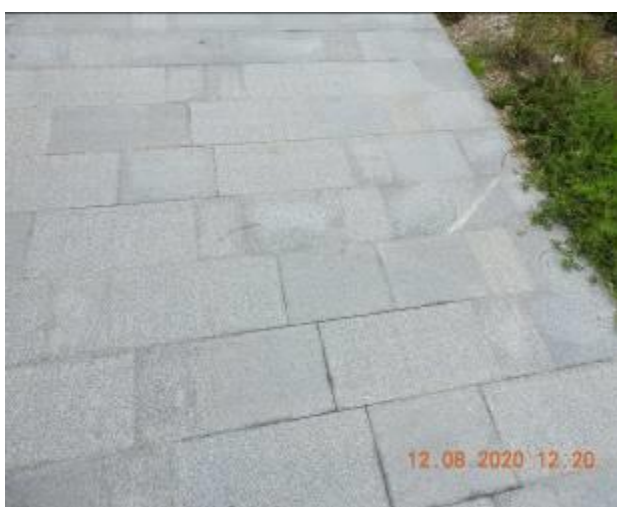
Figure 477 – Efflorescence, crack propagation and loss of material through footpath pavement

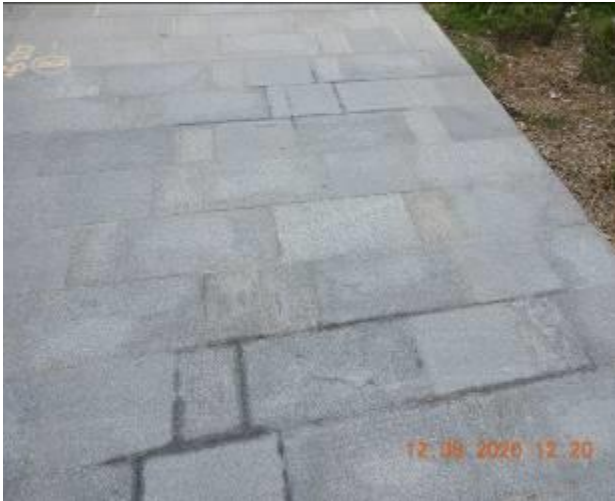
Figure 479 – Loss of material through footpath pavement

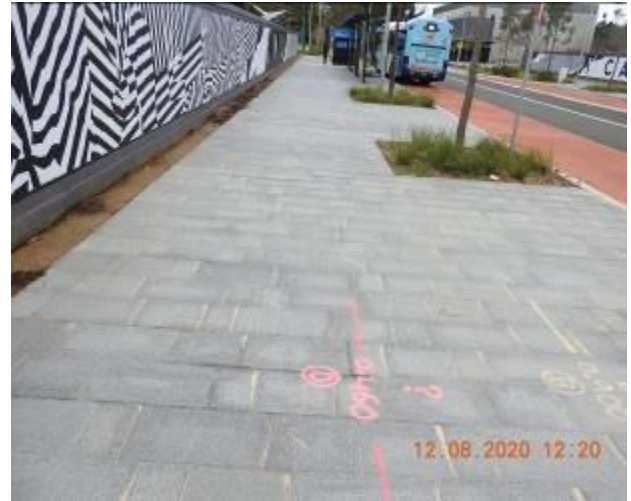
Figure 480 – General condition of footpath pavement

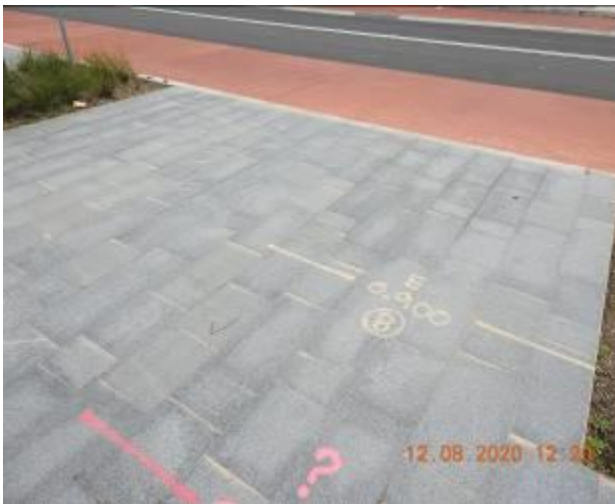
Figure 481 – General condition of footpath pavement

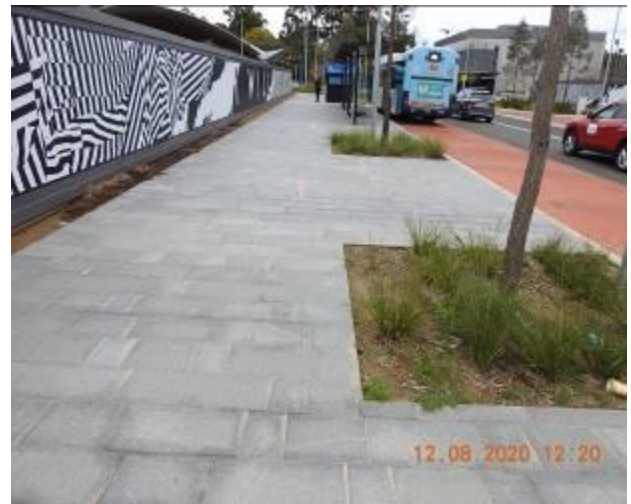
Figure 482 – Efflorescence, crack propagation and loss of material through footpath pavement

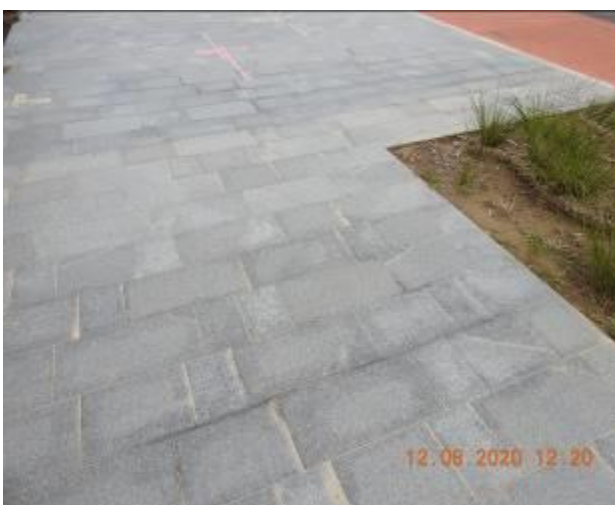
Figure 483 – Efflorescence and crack propagation through footpath pavement

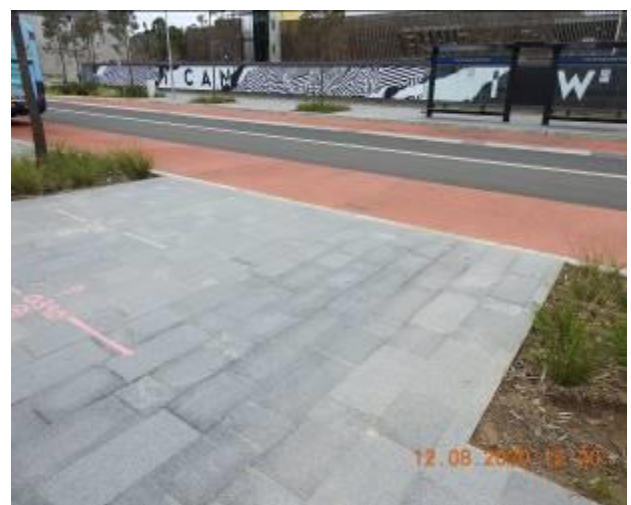
Figure 484 – General condition of footpath pavement

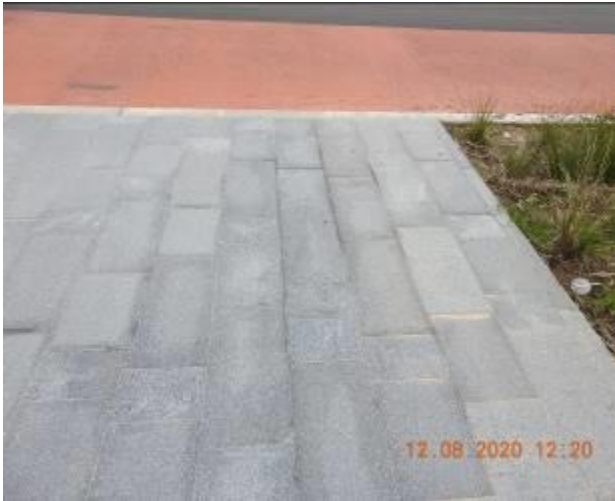
Figure 485 – Loss of material through footpath pavement

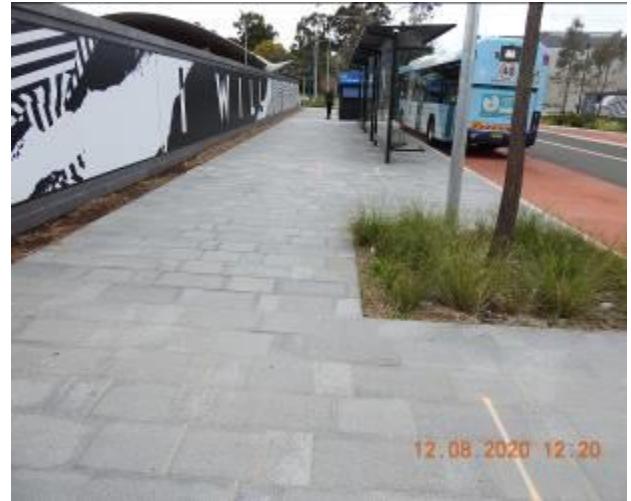
Figure 486 – Loss of material through footpath pavement

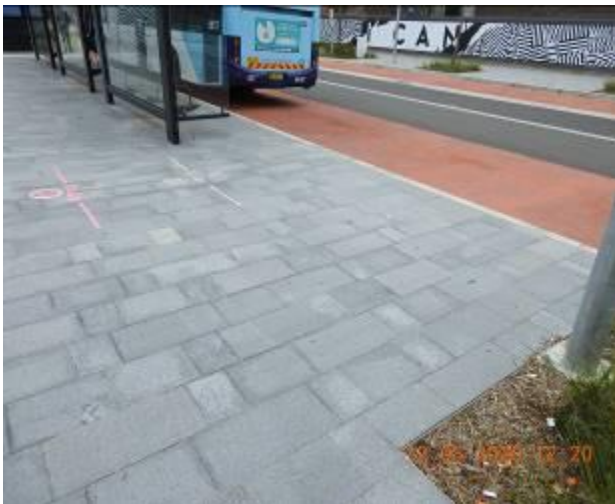
Figure 487 – Loss of material through footpath pavement

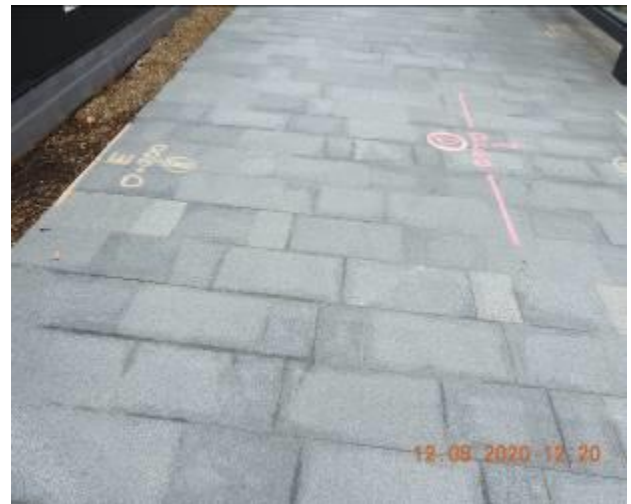
Figure 488 – Hairline crack propagation through footpath pavement

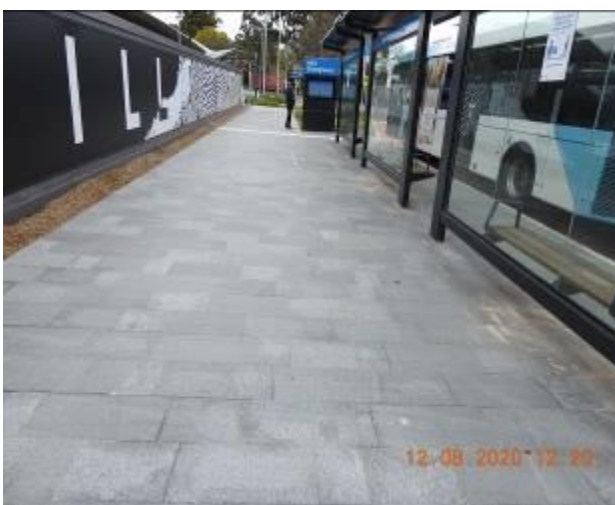
Figure 489 – General condition of footpath pavement

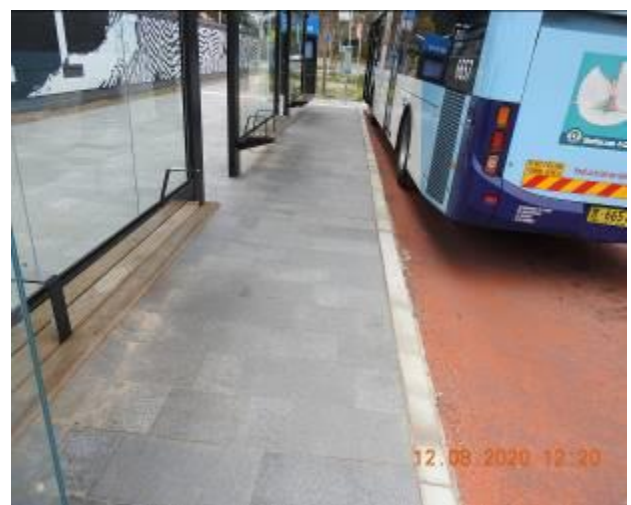
Figure 490 – General condition of footpath pavement

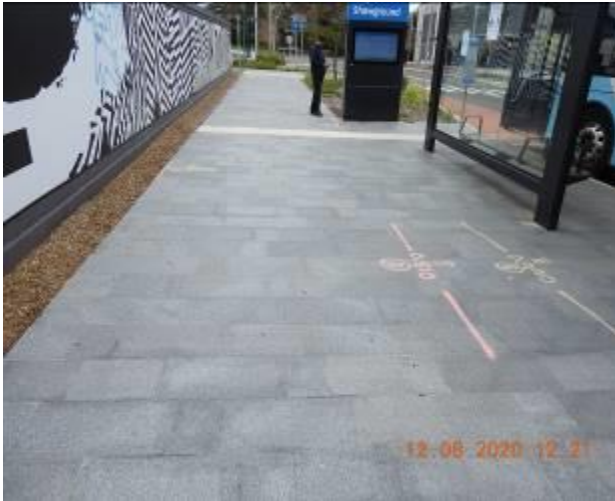
Figure 491 – General condition of footpath pavement

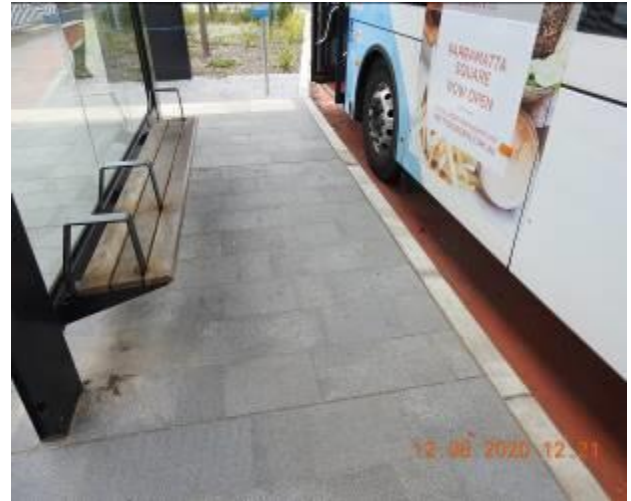
Figure 492 – General condition of footpath pavement

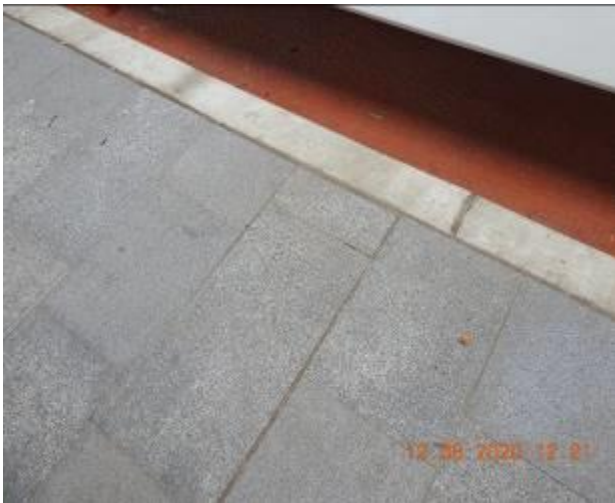
Figure 493 – Loss of material through footpath pavement

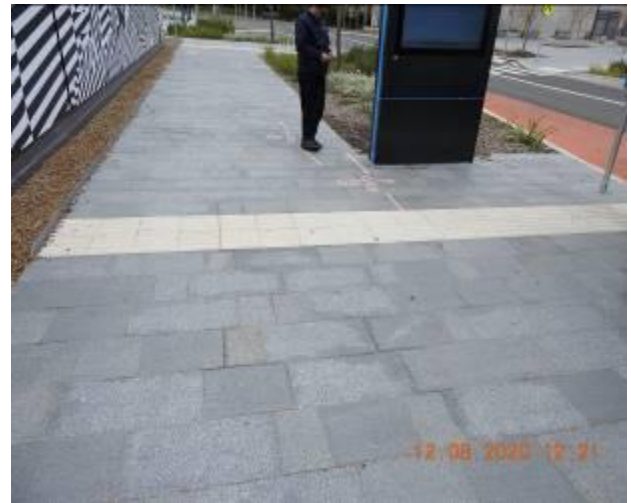
Figure 494 – Loss of material through footpath pavement

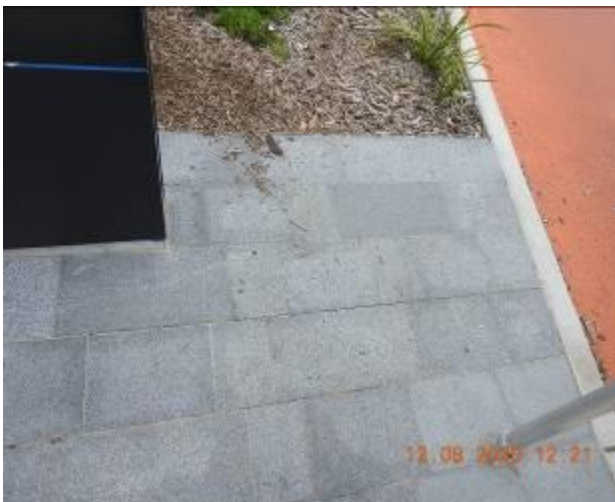
Figure 495 – Crack propagation and loss of material through footpath pavement

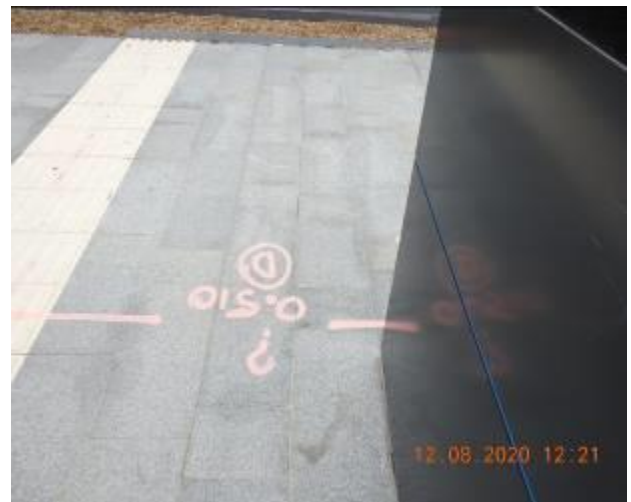
Figure 496 – Loss of material through footpath pavement

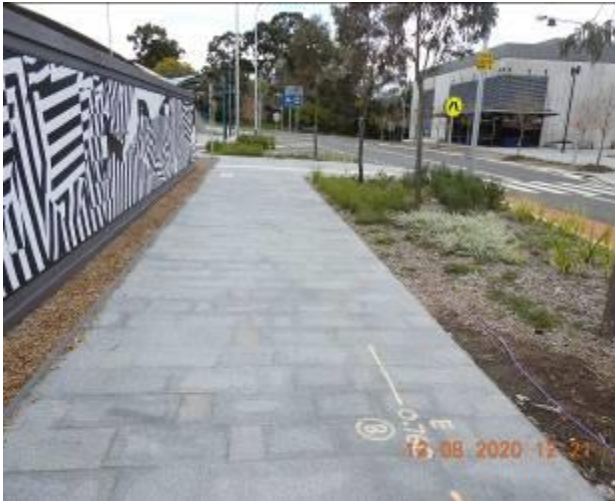
Figure 497 – General condition of footpath pavement

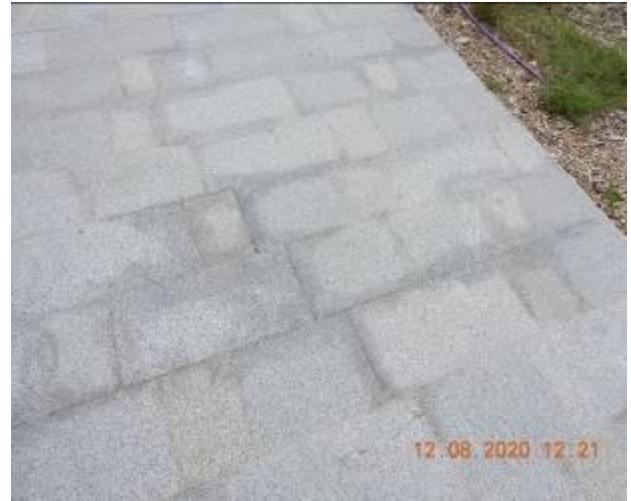
Figure 498 – Loss of material through footpath pavement

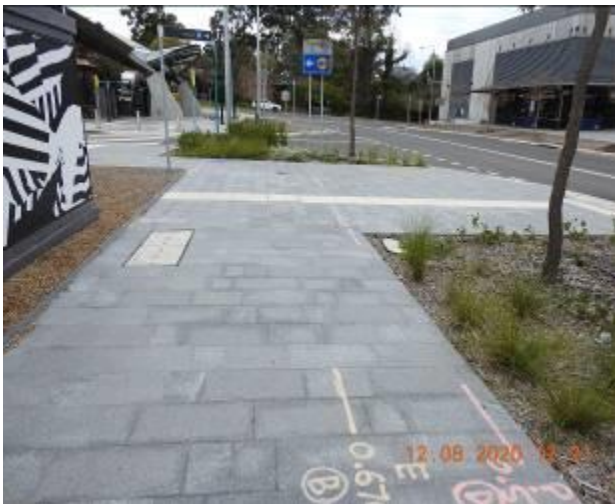
Figure 499 – General condition of footpath pavement

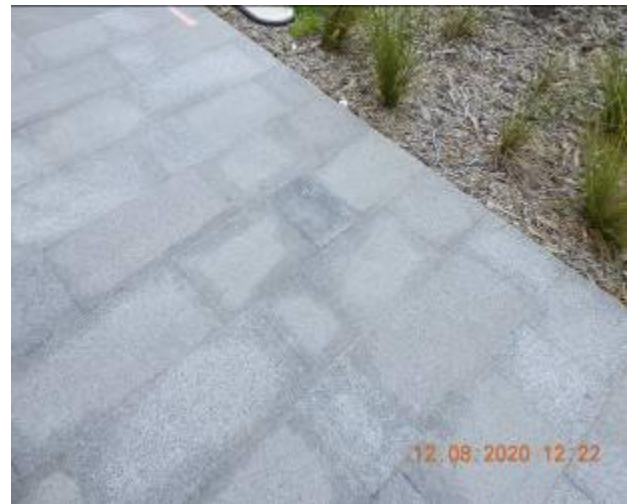
Figure 500 – Loss of material through footpath pavement

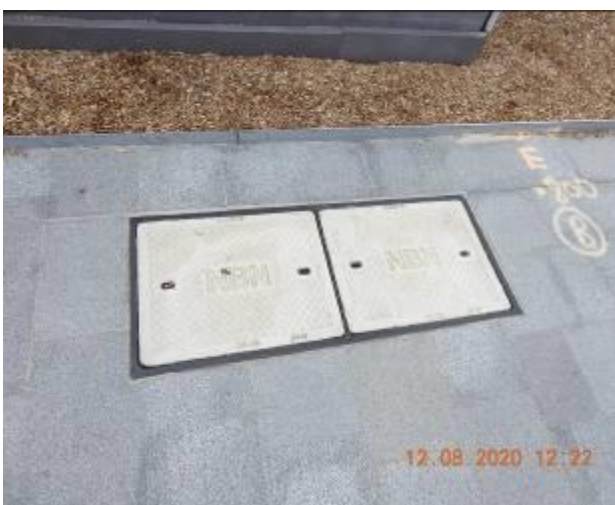
Figure 501 – General condition of service pit

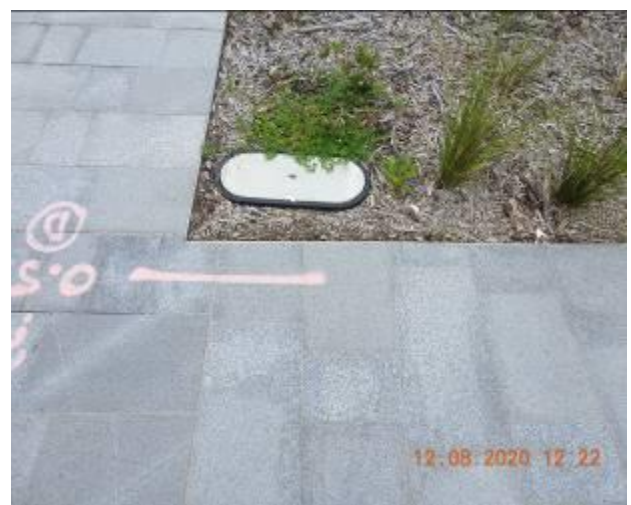
Figure 502 – Hairline crack propagation through footpath pavement/ General condition of service pit
