**2 MANDALA PARADE, CASTLE HILL
(DORAN DRIVE PRECINCT)
PRE-DILAPIDATION REPORT
Of Sydney Metro and Hills Shire Council Assets
DEICORP PROJECTS SHOWGROUND
PTY LTD.**

Job No. 200124.3
07/07/2021

ACE Structural Services Pty Ltd

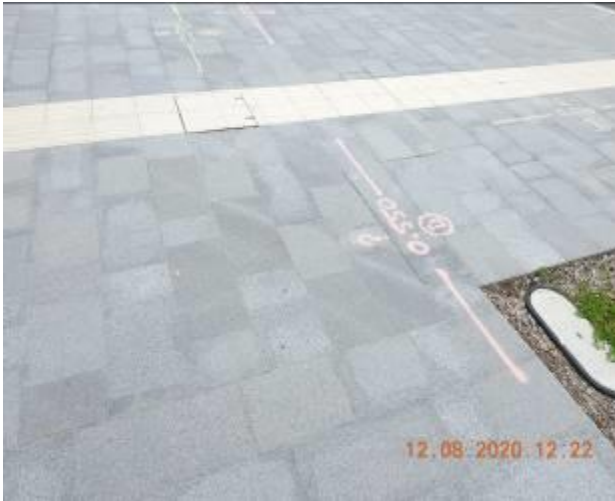
Figure 503 – Loss of material through footpath pavement

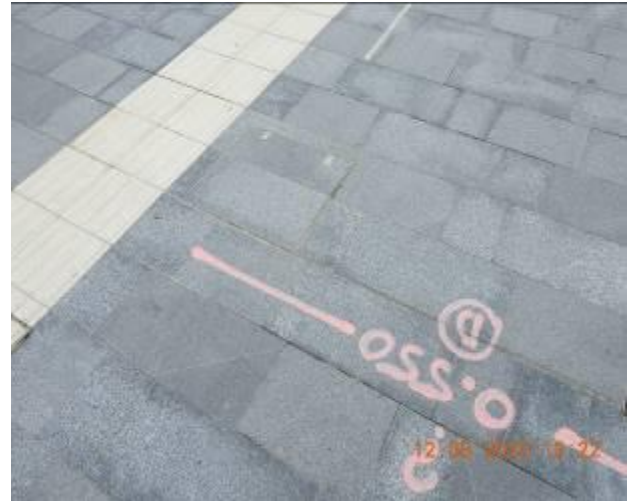
Figure 504 – General condition of service pit/ Loss of material through footpath pavement

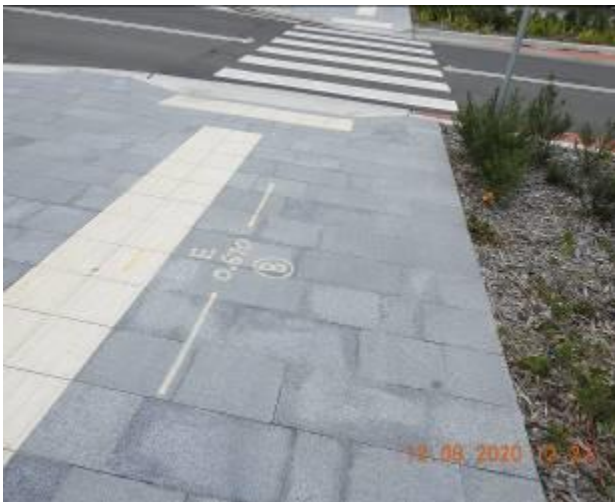
Figure 505 – Hairline crack propagation and loss of material through

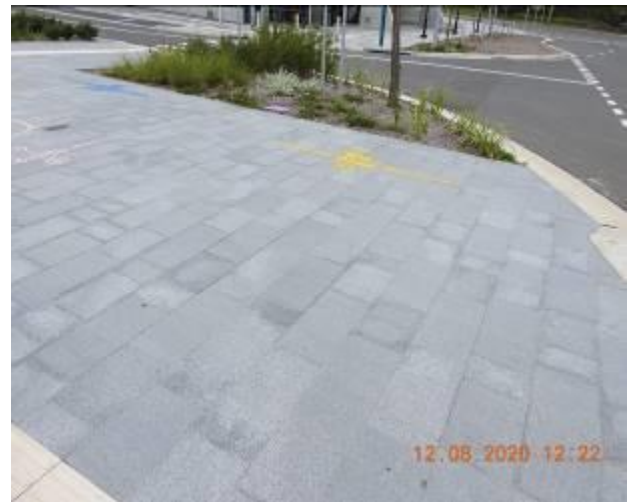
Figure 506 – Loss of material through footpath pavement

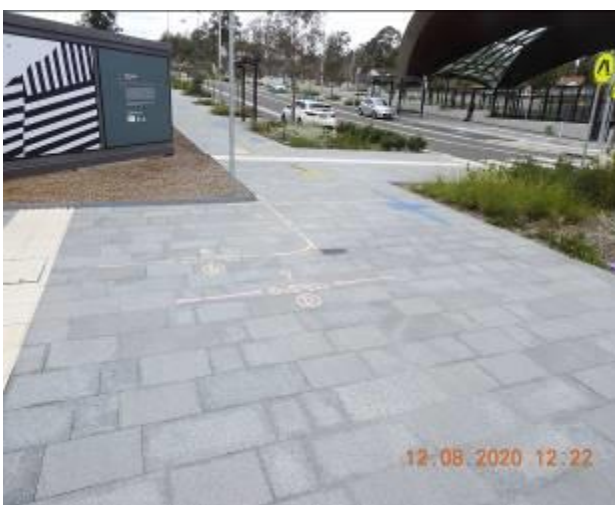
Figure 507 – Hairline crack propagation and loss of material through footpath pavement

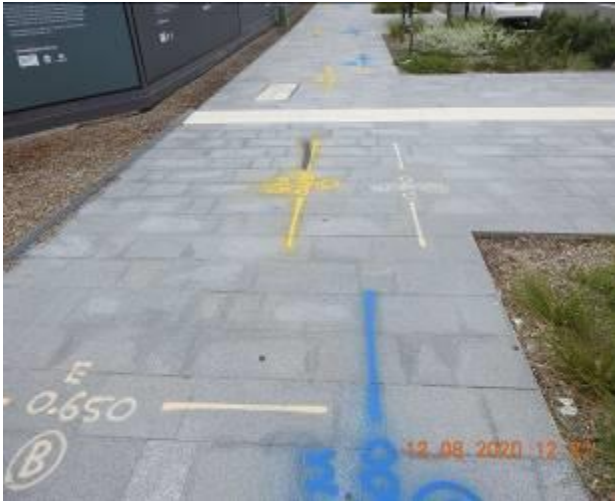
Figure 509 – Loss of material through footpath pavement

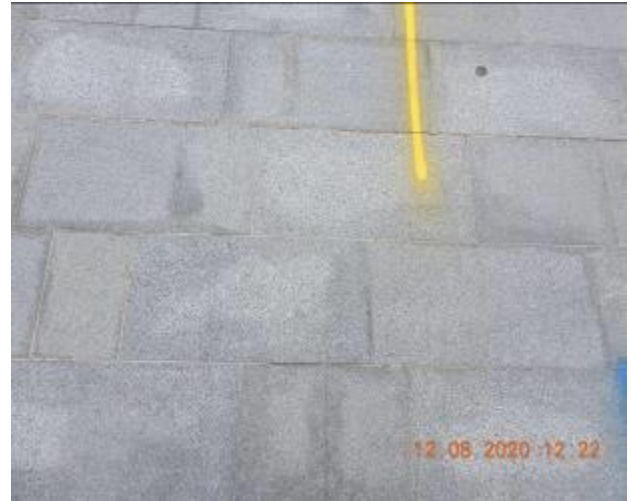
Figure 510 – Loss of material through footpath pavement

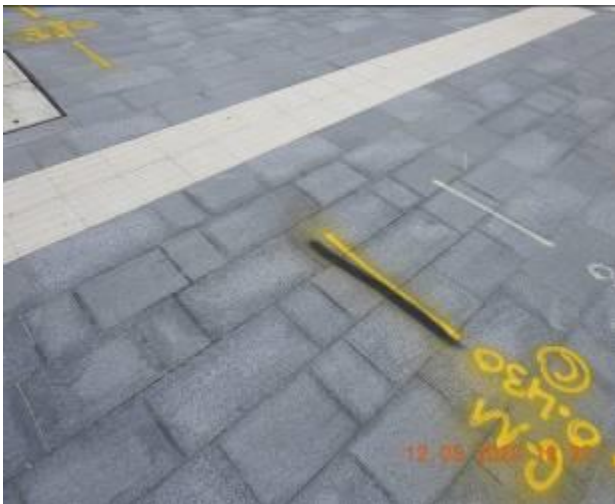
Figure 511 – Loss of material through footpath pavement

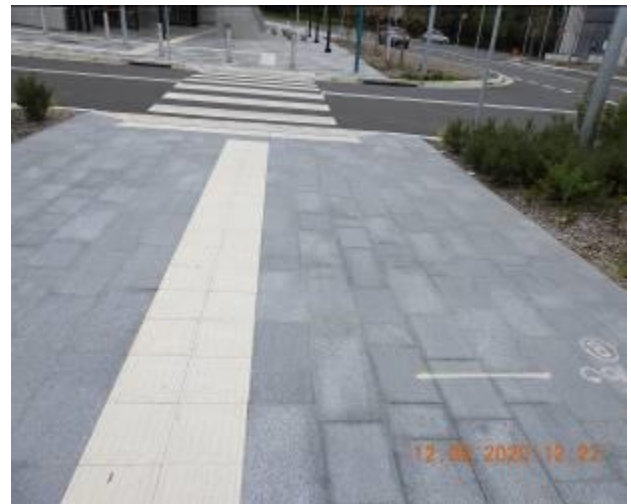
Figure 512 – Efflorescence and hairline crack propagation through footpath pavement

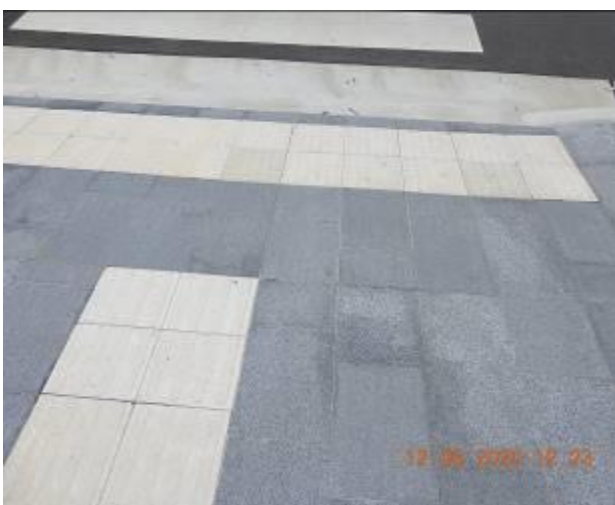
Figure 513 – Crack propagation and loss of material through footpath pavement

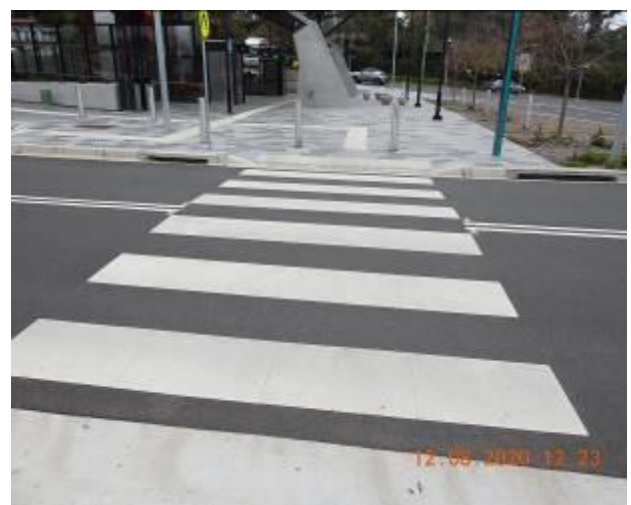
Figure 514 – General condition of road surface

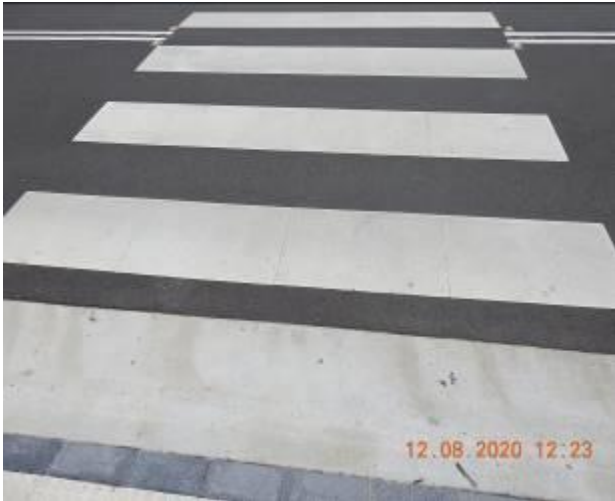
Figure 515 – Crack propagation and loss of material through road surface

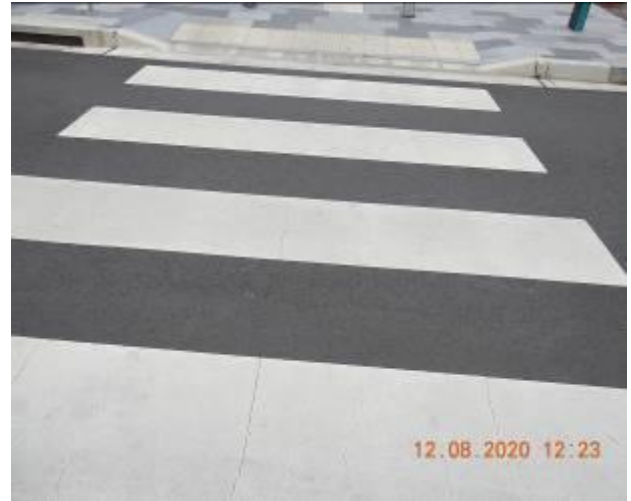
Figure 516 – Crack propagation and loss of material through road surface

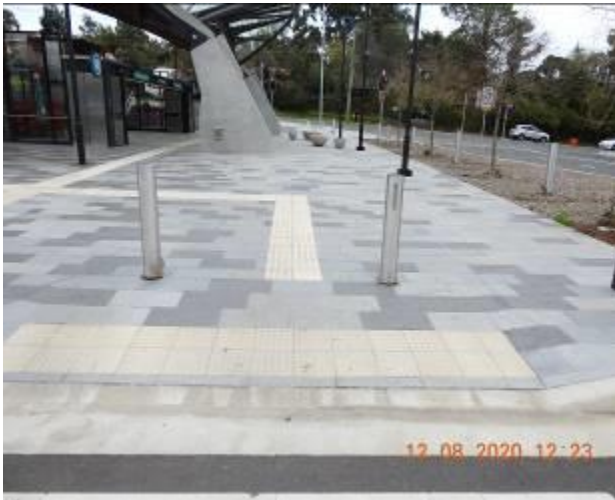
Figure 517 – Crack propagation and loss of material through footpath pavement

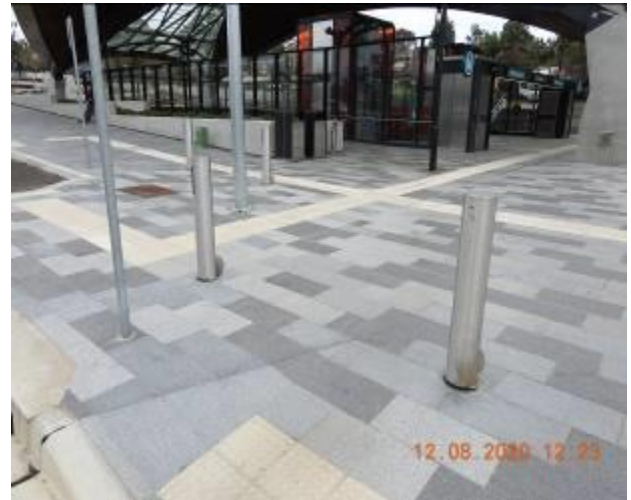
Figure 518 – Loss of material through footpath pavement

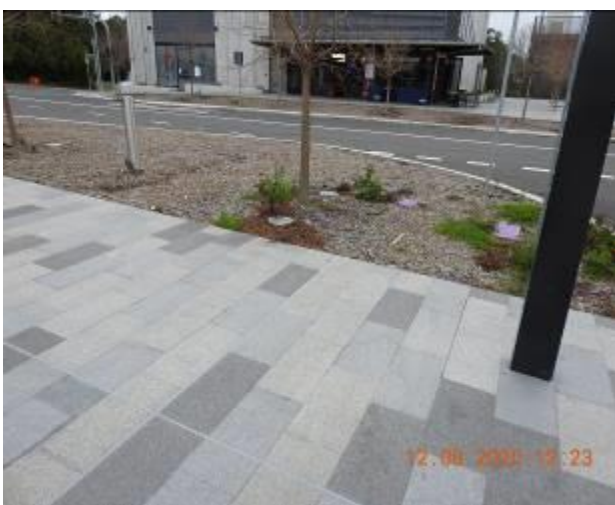
Figure 519 – Crack propagation and loss of material through footpath pavement

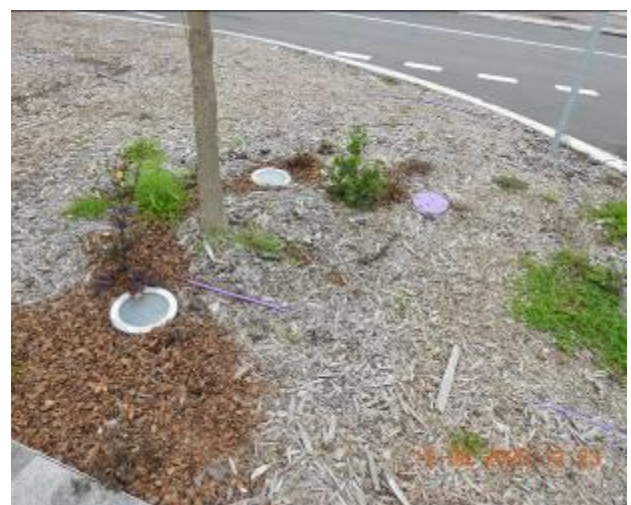
Figure 520 – General condition of service pit

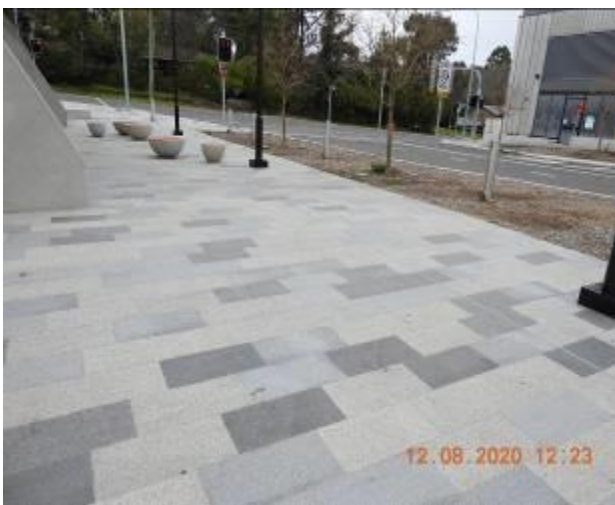
Figure 522 – General condition of footpath pavement

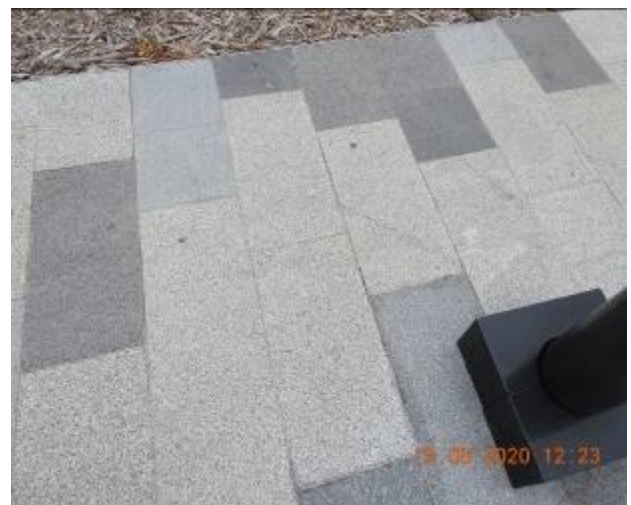
Figure 523 – General condition of footpath pavement

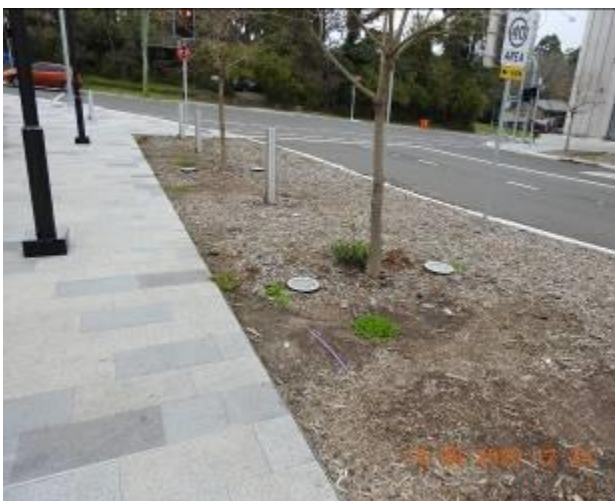
Figure 524 – Loss of material through footpath pavement

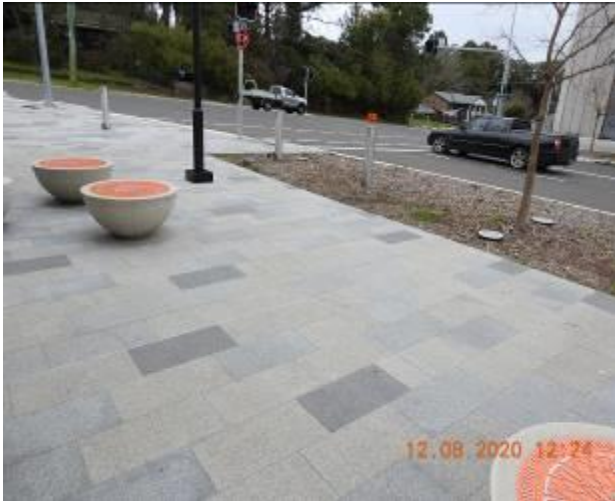
Figure 526 – General condition of footpath pavement

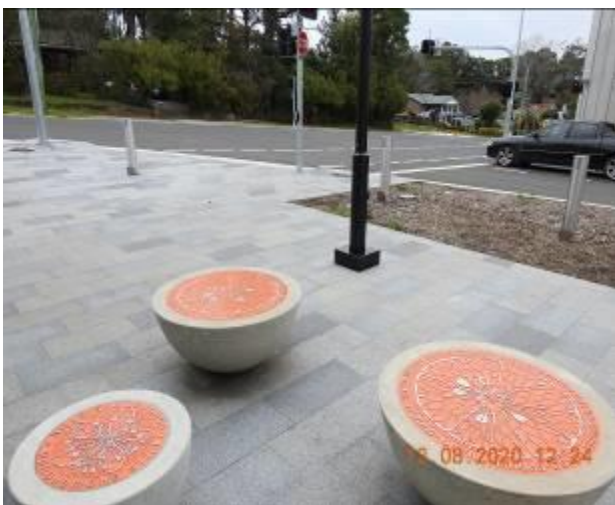
Figure 527 – General condition of footpath pavement

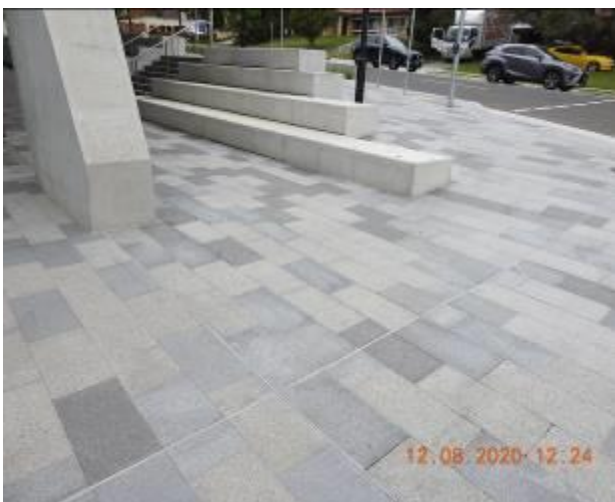
Figure 529 – General condition of footpath pavement

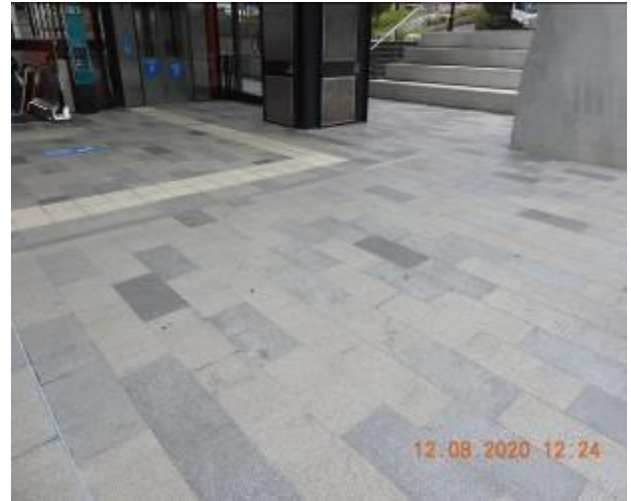
Figure 531 – Crack propagation and loss of material through footpath pavement

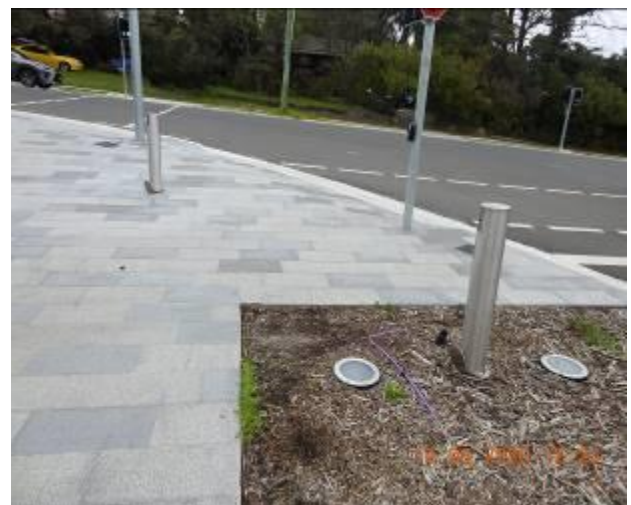
Figure 528 – General condition of footpath pavement

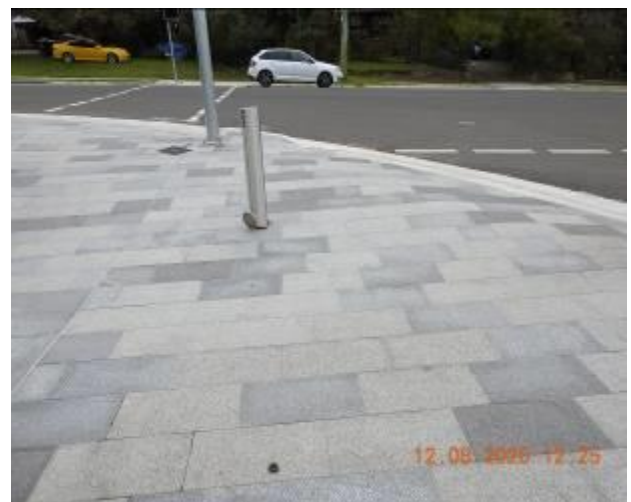
Figure 530 – General condition of footpath pavement

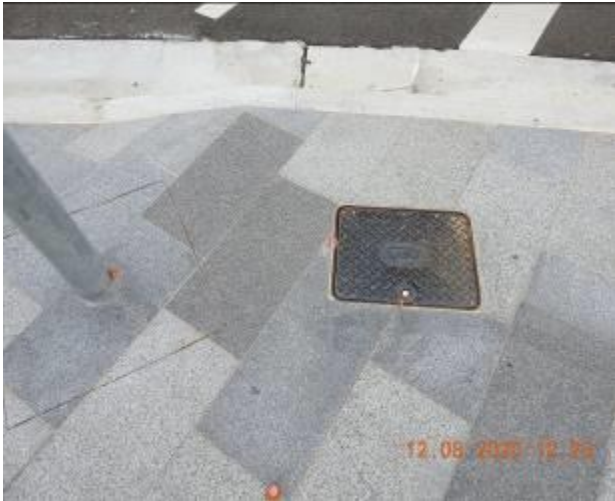
Figure 532 – Crack propagation and loss of material through footpath pavement

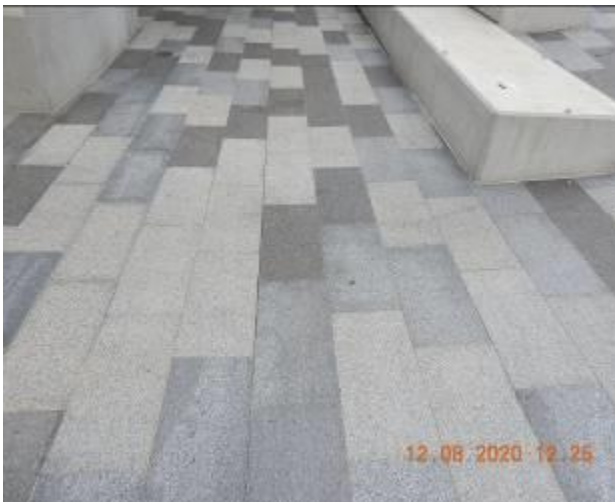
Figure 534 – Crack propagation and loss of material through footpath pavement

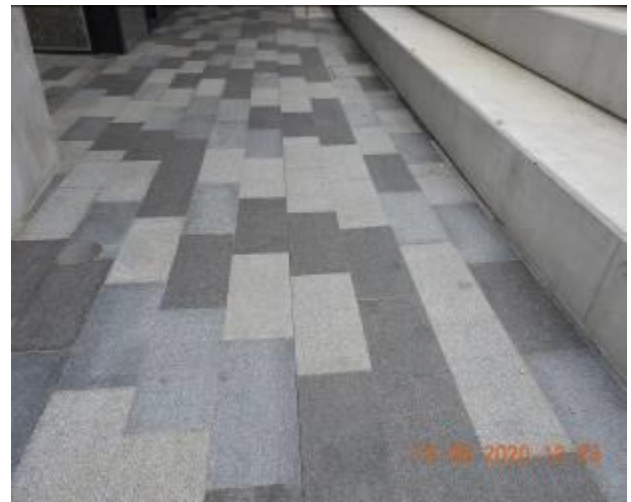
Figure 535 – Crack propagation and loss of material through footpath pavement

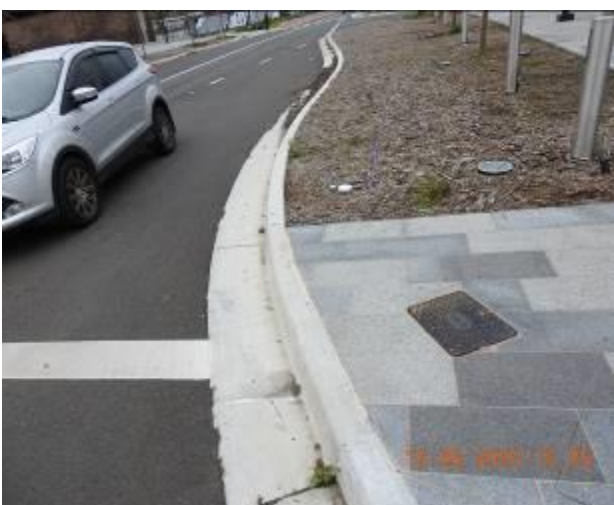
Figure 536 – Crack propagation and loss of material through footpath pavement

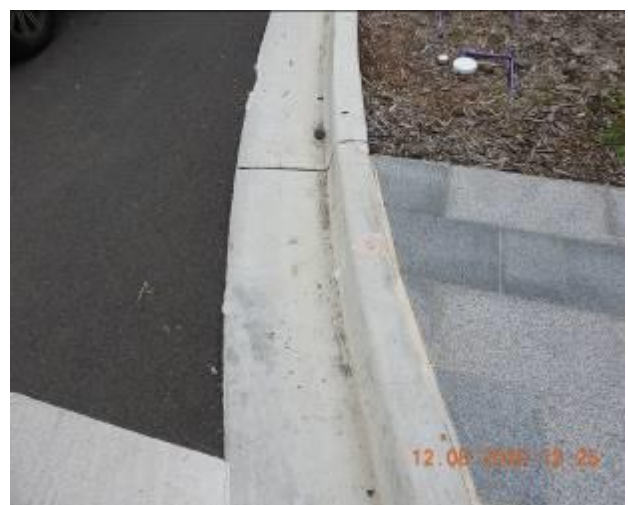
Figure 537 – General condition of kerb and gutter heading North

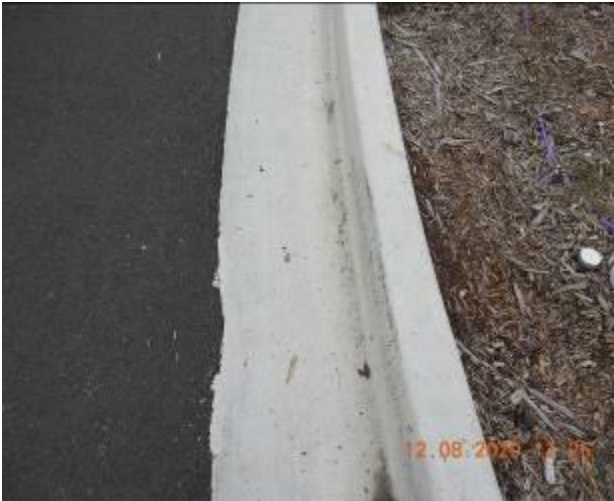
Figure 538 – Crack propagation and loss of material through kerb and gutter

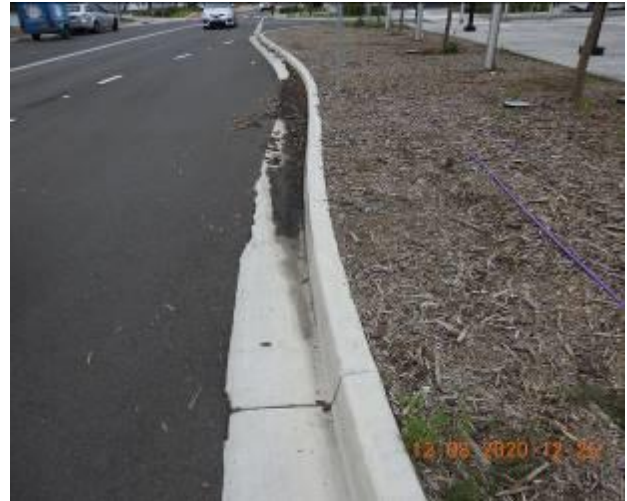
Figure 539 – Evidence of patchwork and hairline crack propagation through kerb and gutter

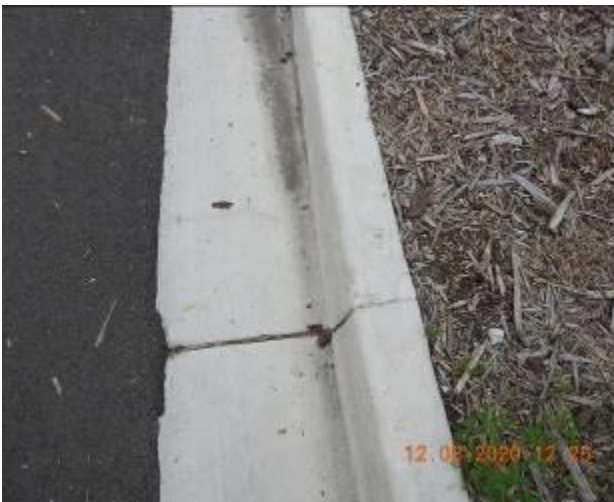
Figure 540 – General condition of kerb and gutter

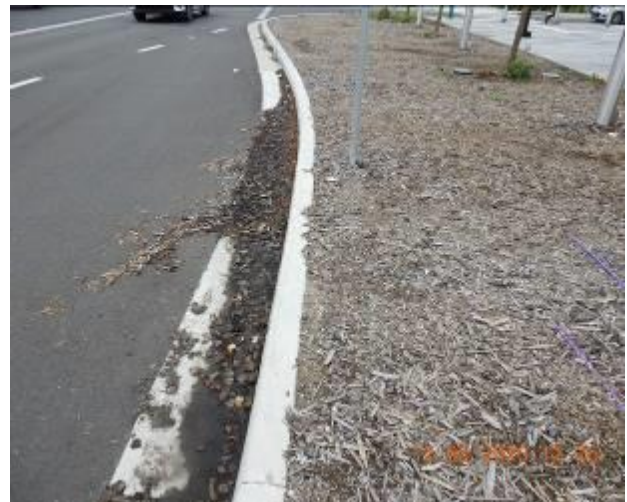
Figure 541 – Evidence of patchwork, crack propagation and loss of material through kerb and gutter

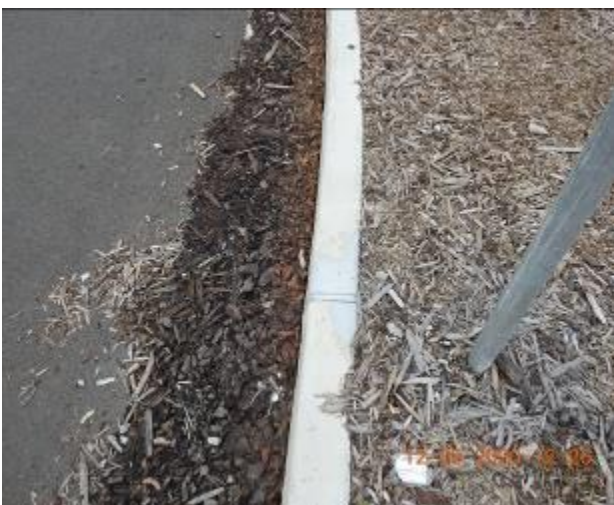
Figure 542 – General condition of kerb and gutter

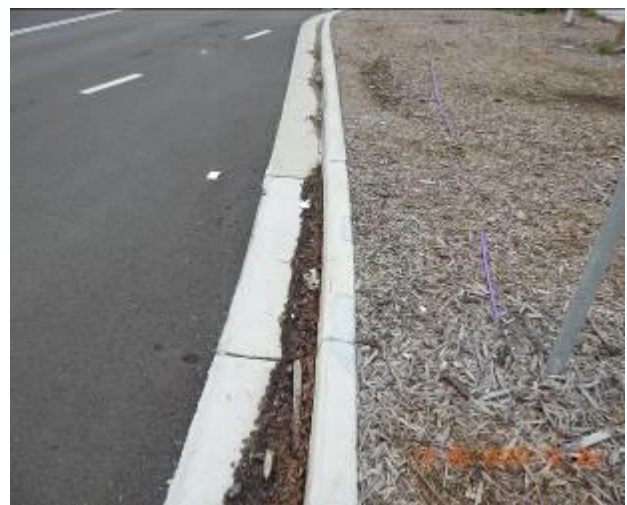
Figure 543 – Loss of material and crack propagation through kerb

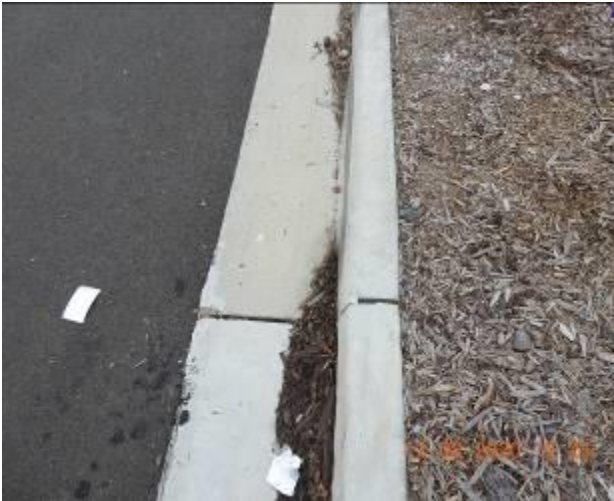
Figure 544 – Loss of material and loss of material through kerb and gutter

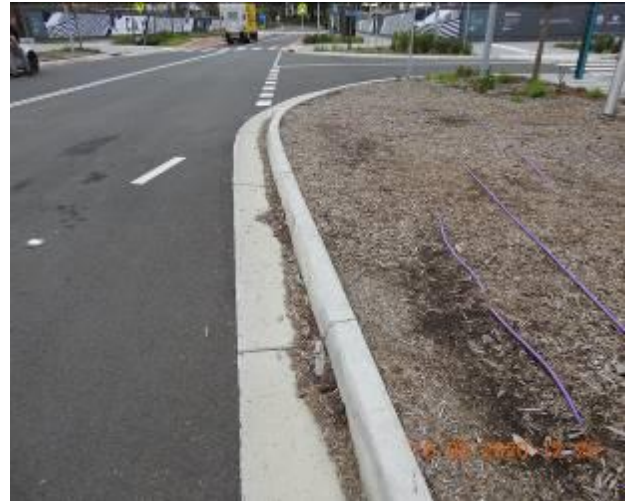
Figure 545 – Crack propagation and loss of material through kerb and gutter

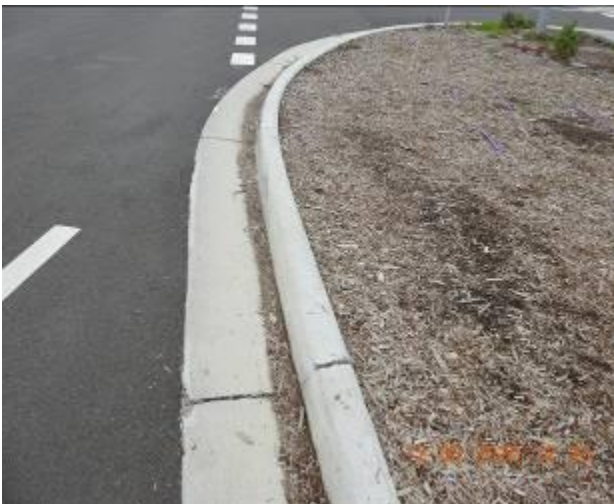
Figure 546 – General condition of kerb and gutter

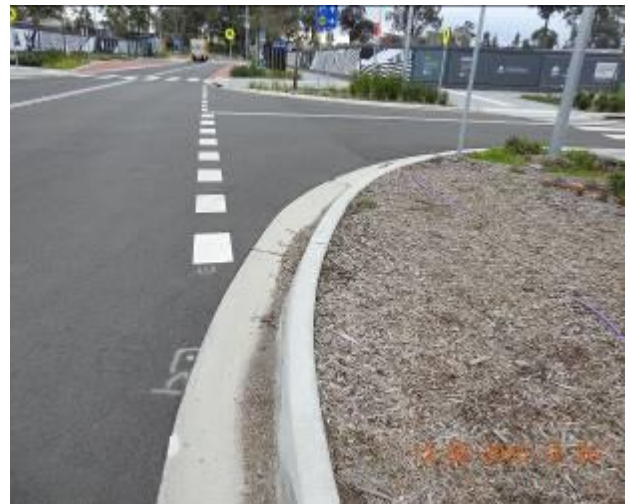
Figure 547 – Evidence of patchwork and loss of material through kerb and gutter

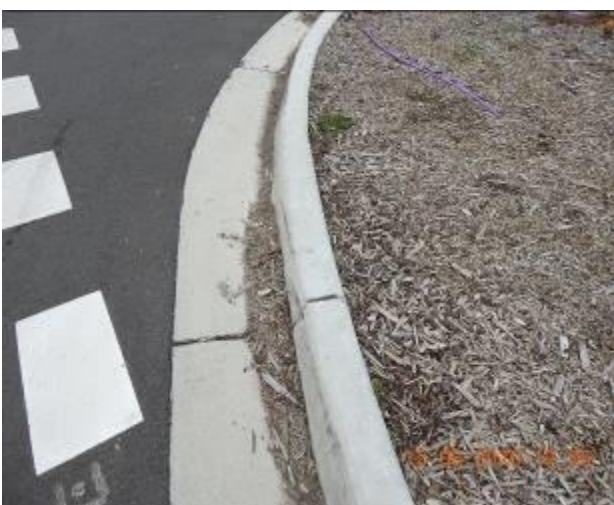
Figure 548 – Evidence of patchwork through gutter

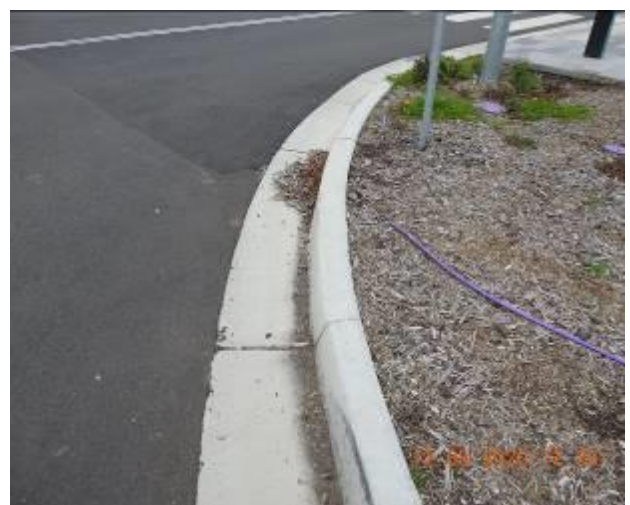
Figure 549 – Loss of material through kerb and gutter

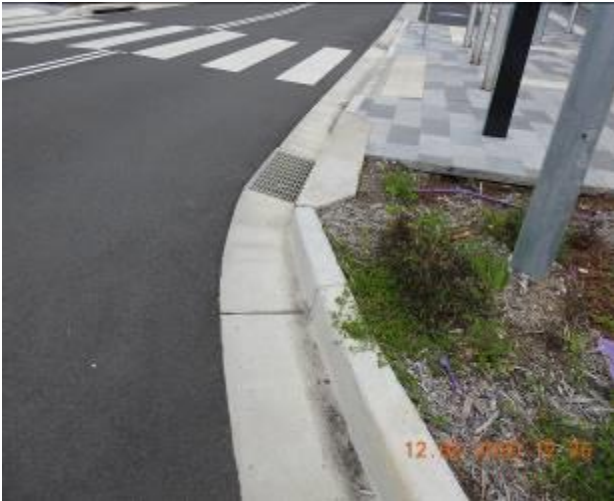
Figure 550 – General condition of kerb and gutter

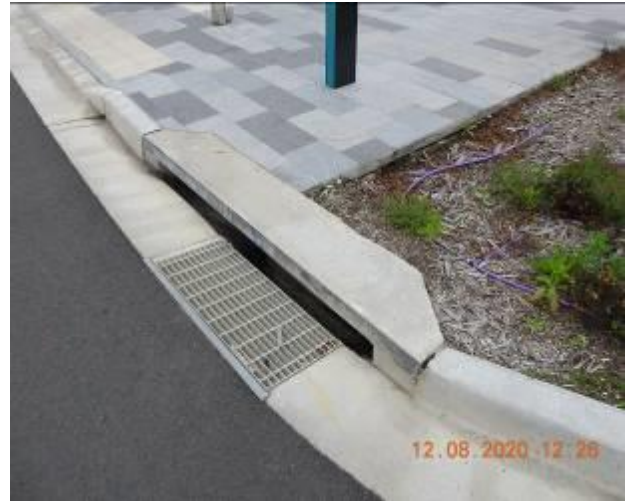
Figure 551 – General condition of kerb and gutter

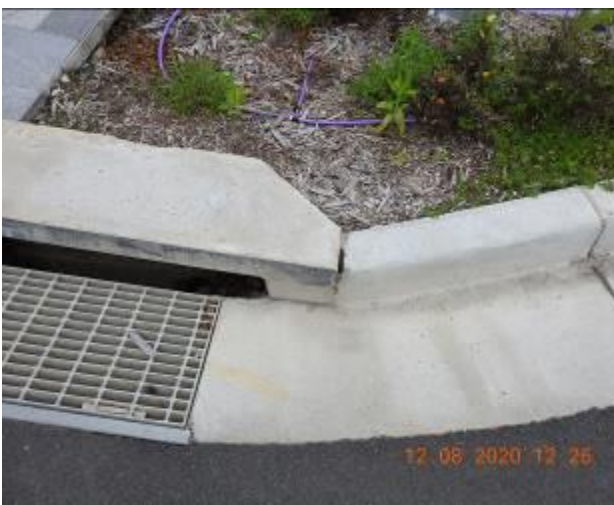
Figure 552 – General condition of stormwater inlet pit

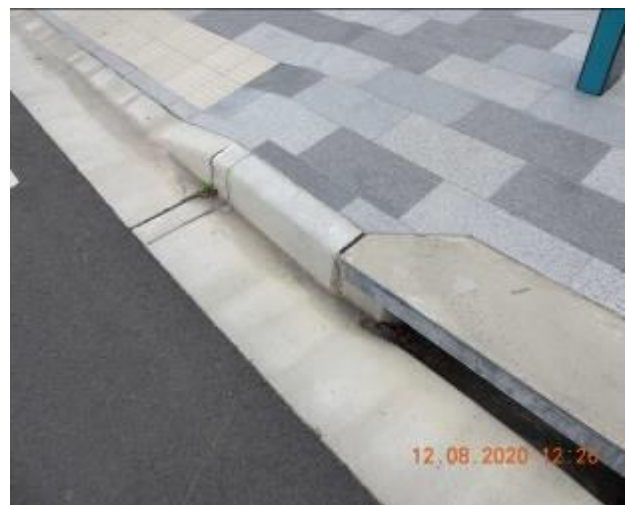
Figure 553 – Crack propagation and loss of material through kerb

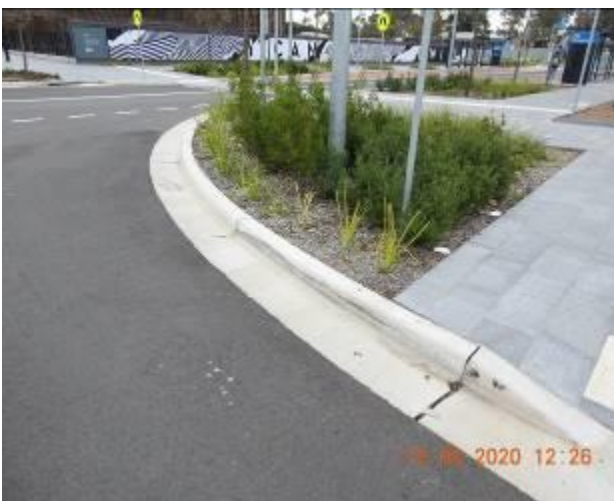
Figure 554 – Crack propagation and loss of material through kerb

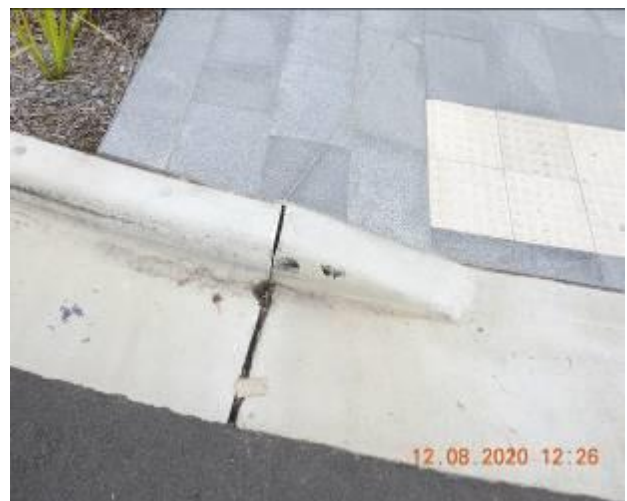
Figure 555 – General condition of kerb and gutter

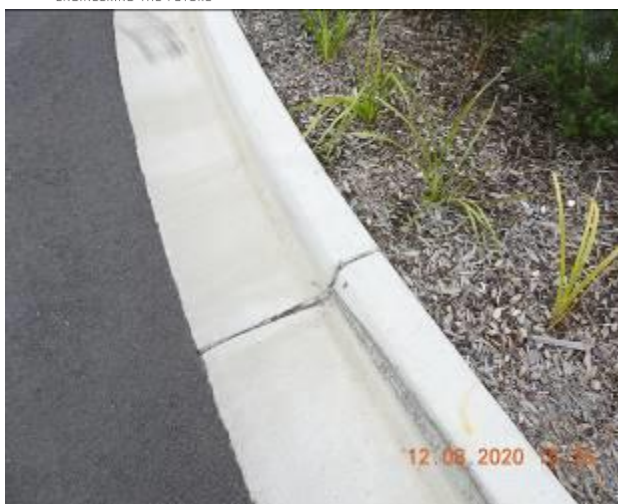
Figure 556 – Separation through kerb and gutter

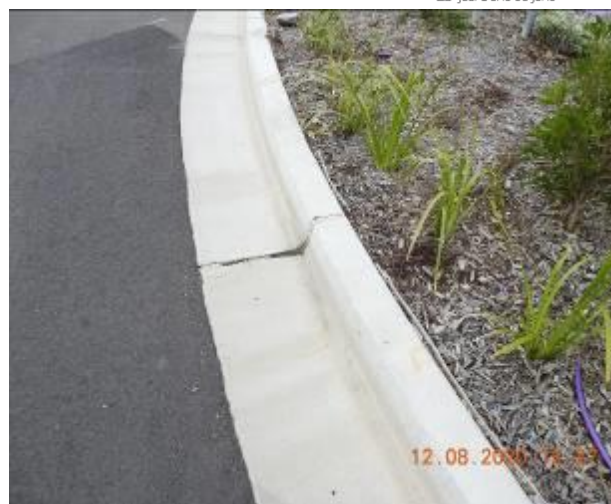
Figure 557 – Crack propagation and loss of material through kerb and gutter

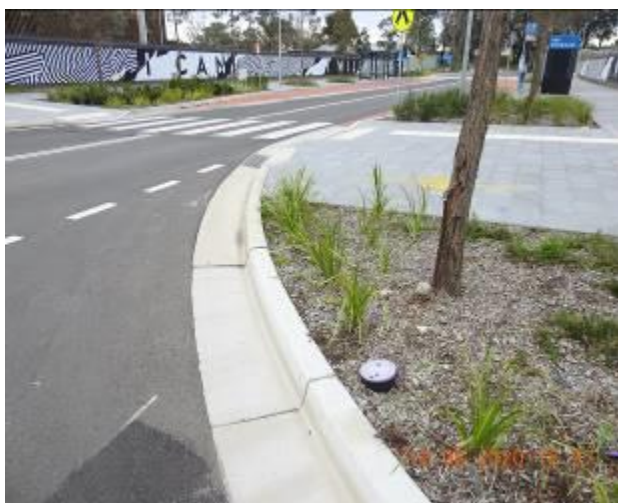
Figure 558 – Crack propagation and loss of material through kerb and gutter

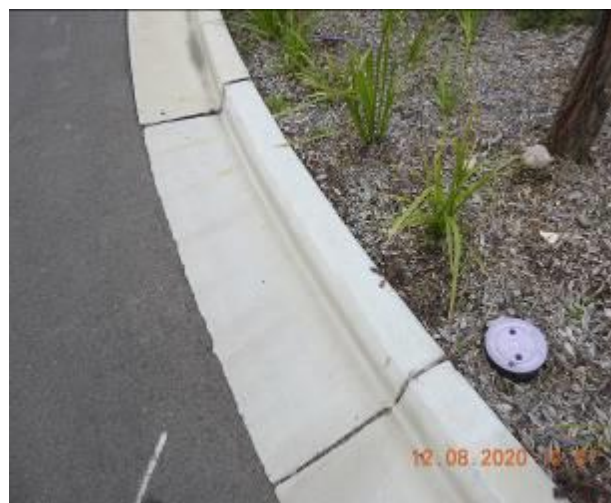
Figure 559 – General condition of kerb and gutter

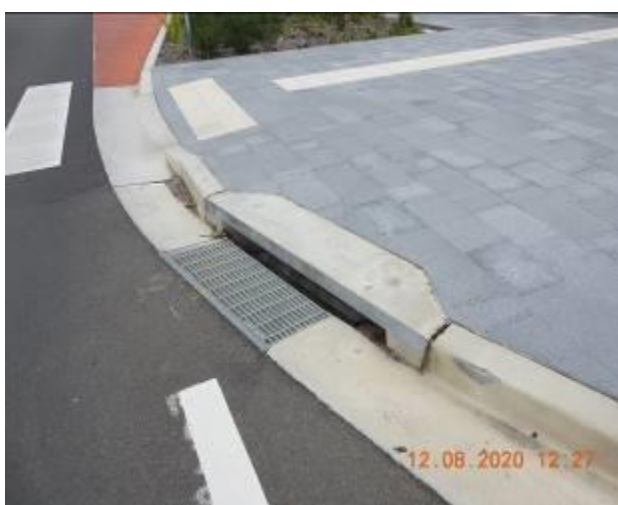
Figure 561 – General condition of stormwater inlet pit

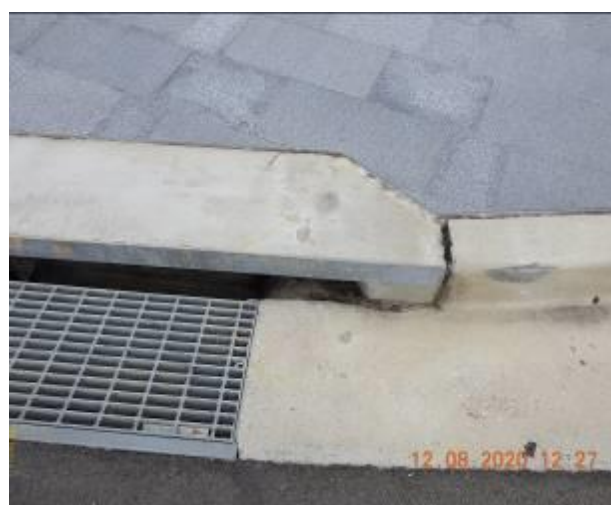
Figure 562 – Loss of material through kerb and gutter

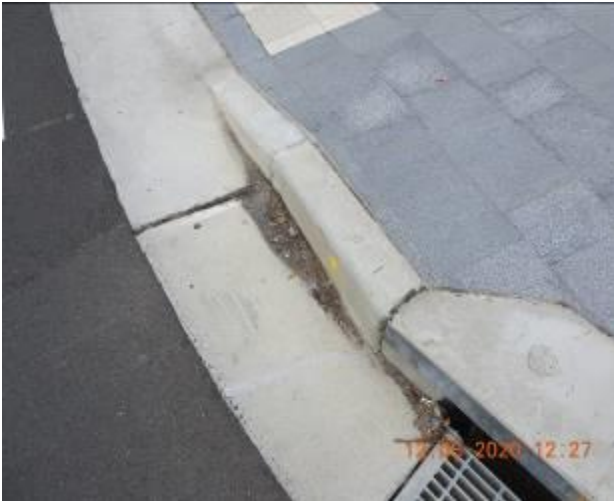
Figure 563 – Evidence of patchwork, crack propagation and loss of material through kerb and gutter

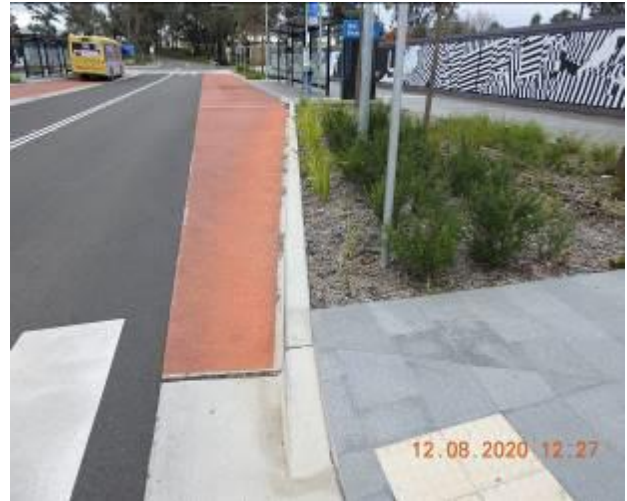
Figure 564 – General condition of kerb

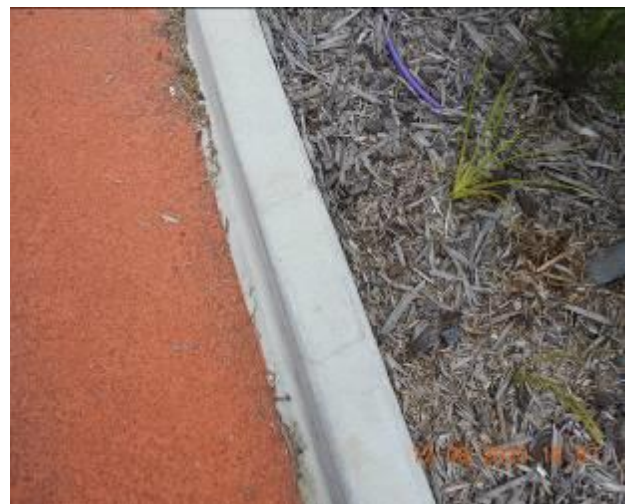
Figure 566 – Evidence of patchwork through kerb

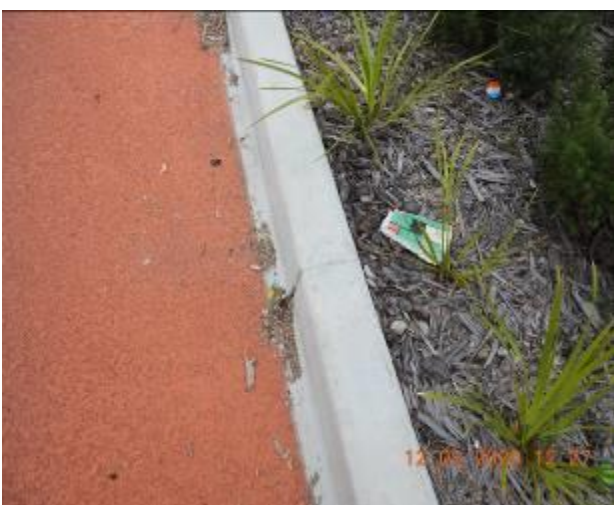
Figure 567 – Crack propagation through kerb

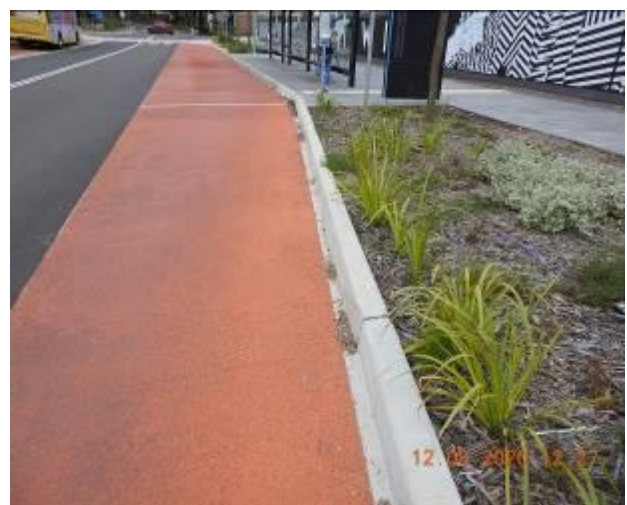
Figure 568 – General condition of kerb

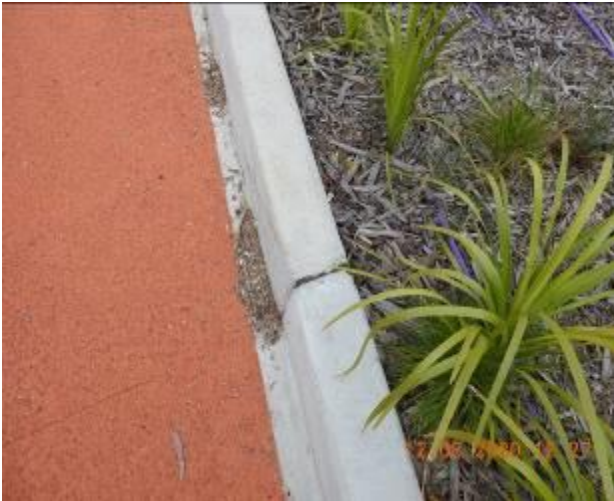
Figure 569 – Loss of material through kerb

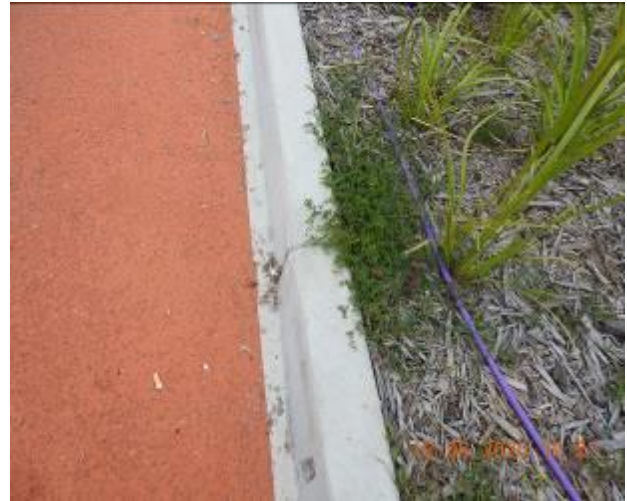
Figure 570 – Crack propagation and loss of material through kerb

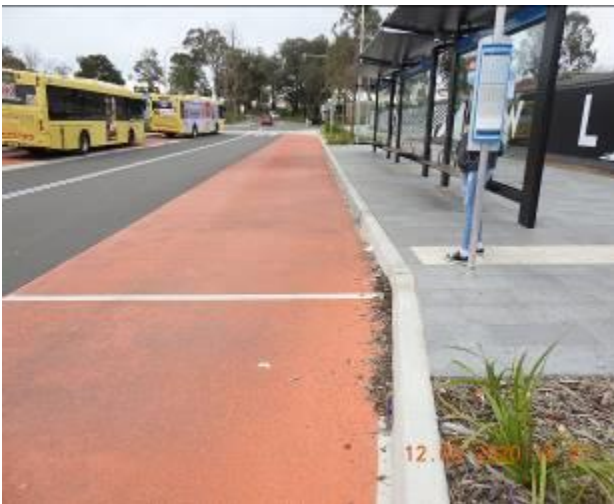
Figure 571 – General condition of kerb

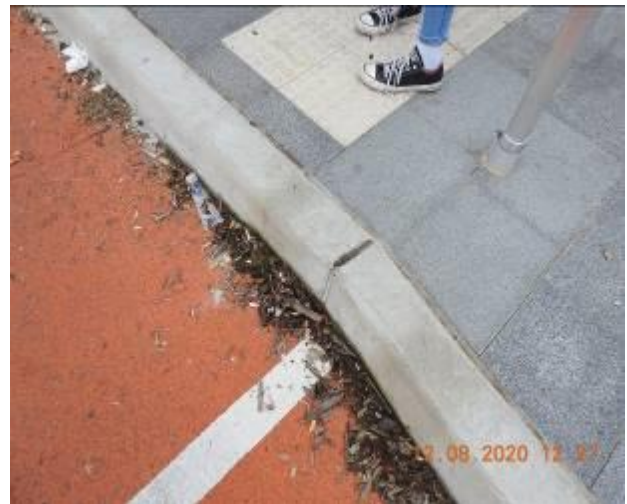
Figure 572 – Evidence of patchwork crack propagation and loss of material through kerb

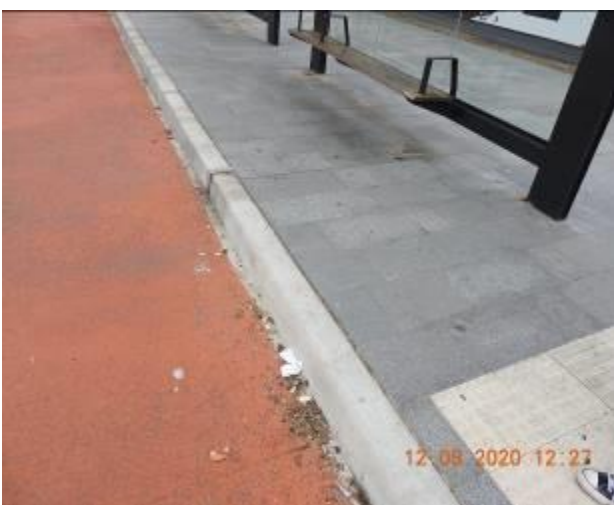
Figure 573 – Evidence of patchwork crack propagation and loss of material through kerb

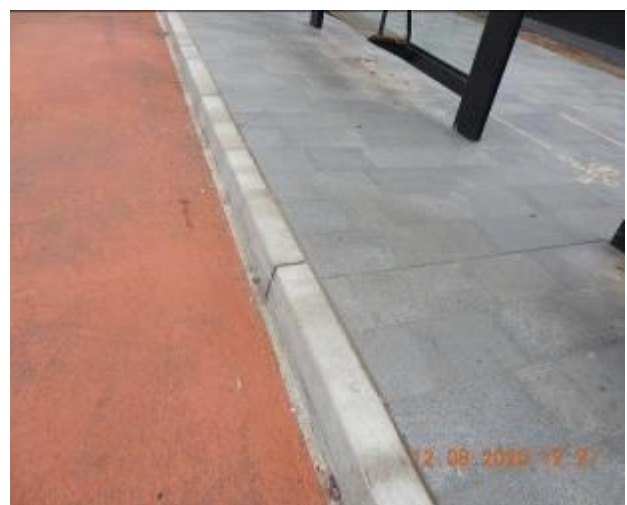
Figure 574 – Evidence of patchwork crack propagation and loss of material through kerb

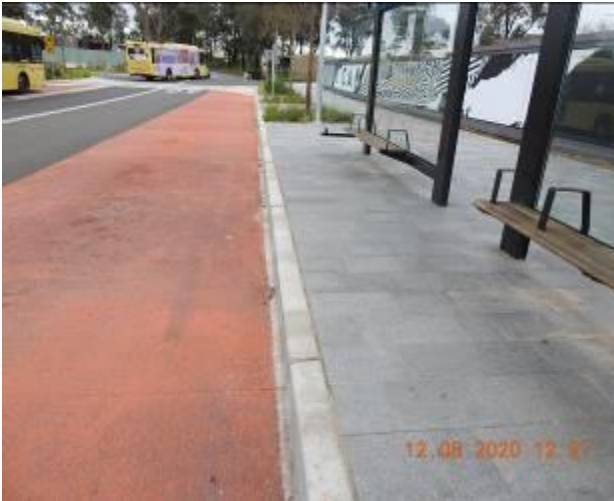
Figure 575 – General condition of kerb

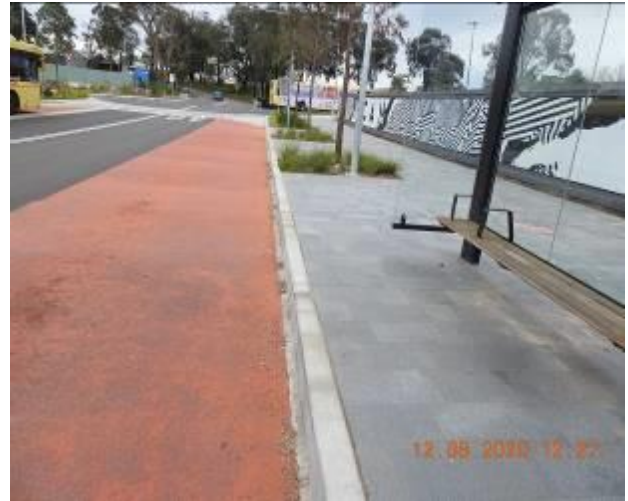
Figure 576 – General condition of kerb

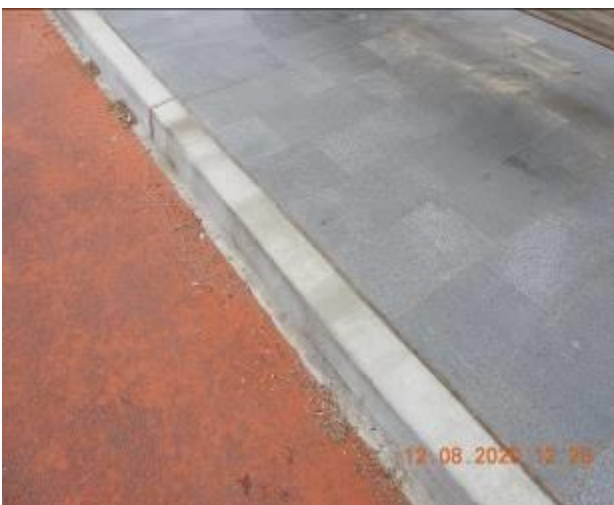
Figure 577 – Evidence of patchwork, crack propagation and loss of material through kerb

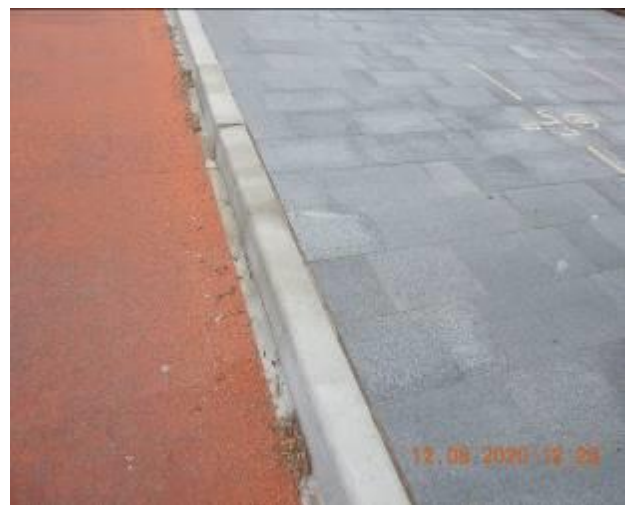
Figure 578 – Evidence of patchwork, crack propagation and loss of material through kerb
