**2 MANDALA PARADE, CASTLE HILL
(DORAN DRIVE PRECINCT)
PRE-DILAPIDATION REPORT
Of Sydney Metro and Hills Shire Council Assets
DEICORP PROJECTS SHOWGROUND
PTY LTD.**

Job No. 200124.3
07/07/2021

ACE Structural Services Pty Ltd

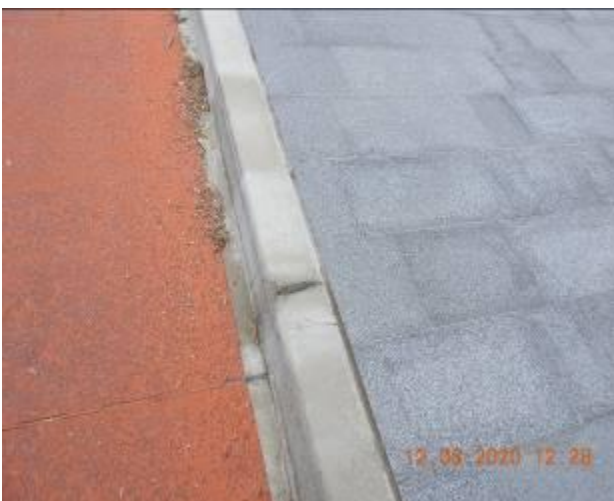
Figure 579 – Evidence of patchwork, hairline crack propagation and loss of material through kerb

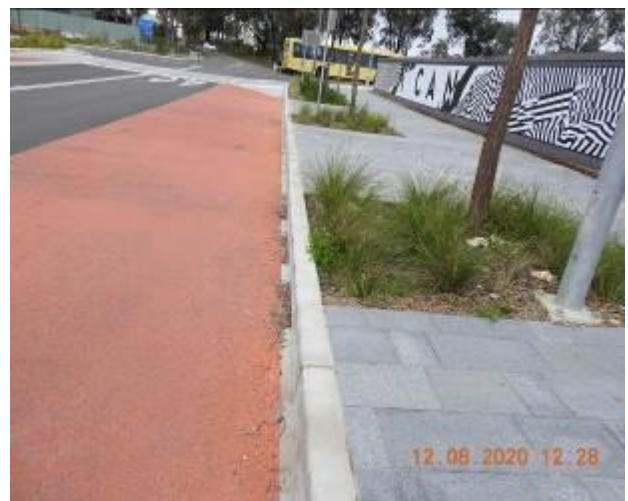
Figure 580 – General condition of kerb

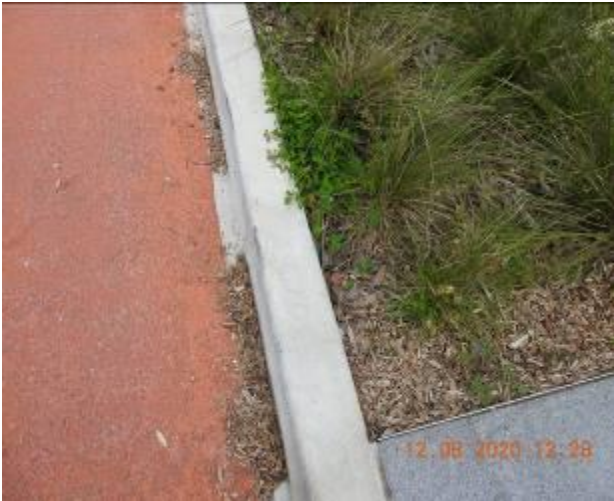
Figure 581 – Evidence of patchwork and hairline crack propagation through kerb

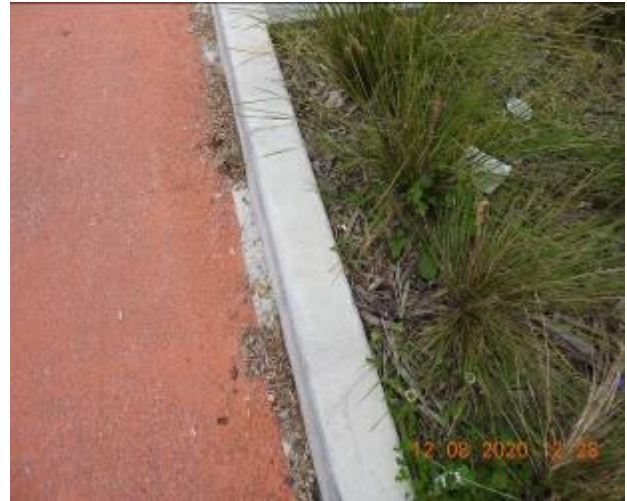
Figure 582 – Evidence of patchwork and hairline crack propagation through kerb

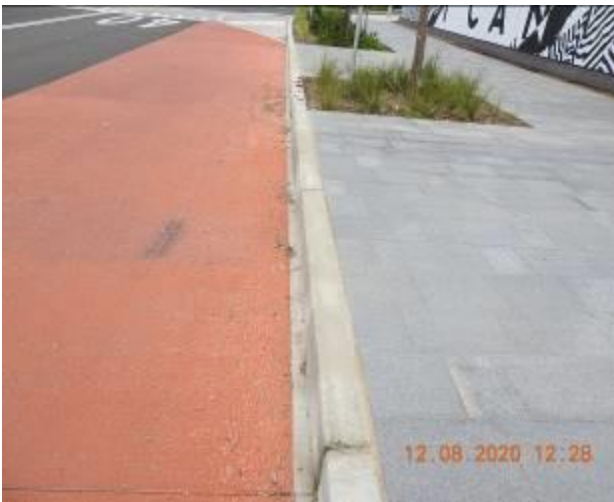
Figure 583 – Evidence of patchwork and hairline crack propagation through kerb

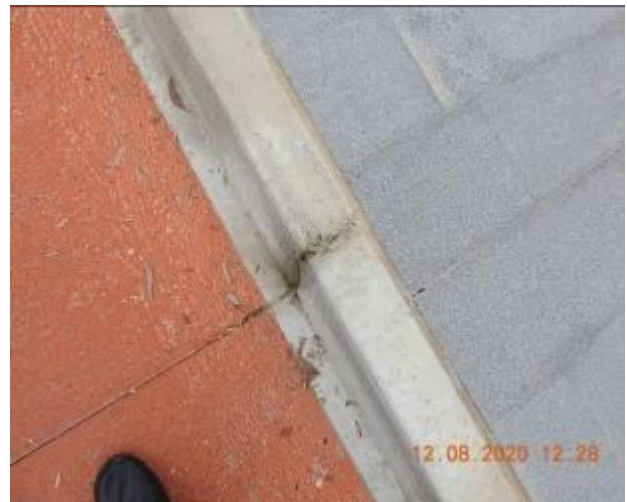
Figure 584 – Crack propagation and loss of material through kerb

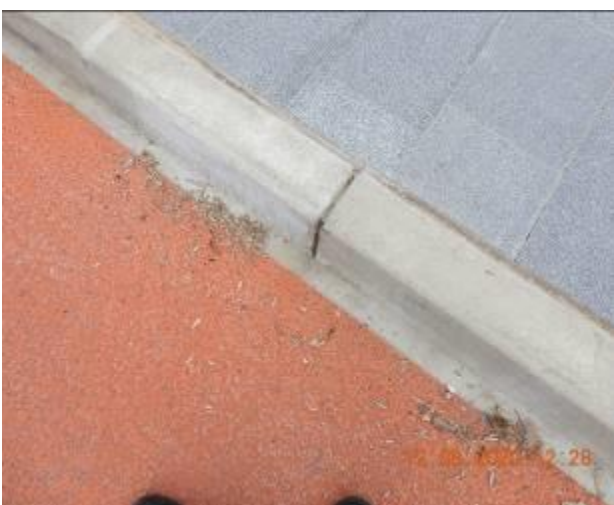
Figure 585 – Evidence of patchwork and loss of material through kerb

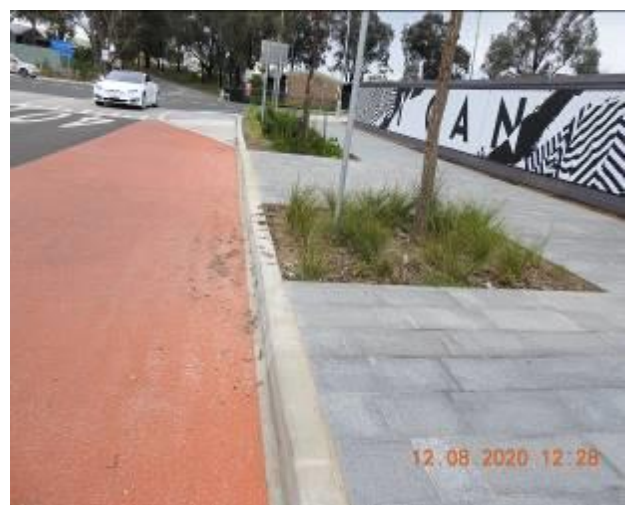
Figure 586 – General condition of kerb

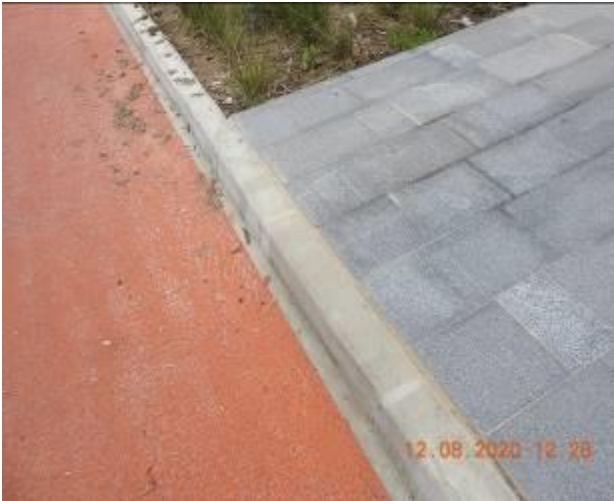
Figure 587 – Evidence of patchwork and hairline cracking through kerb

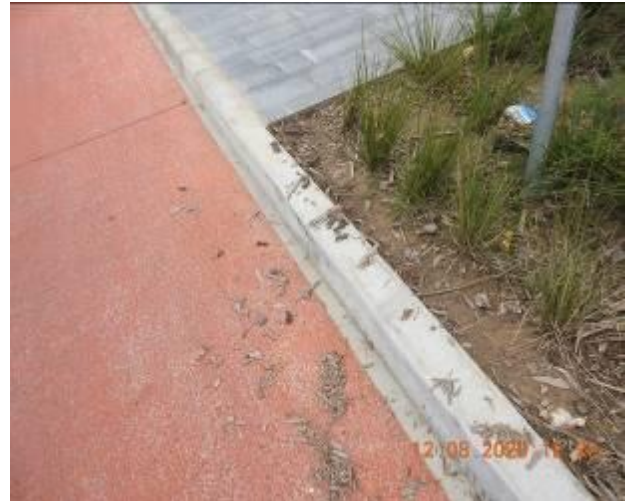
Figure 588 – Evidence of patchwork and hairline cracking through kerb

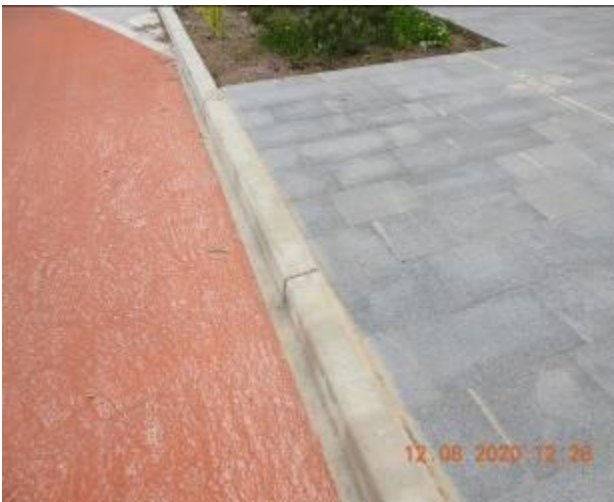
Figure 589 – Evidence of patchwork and hairline cracking through kerb

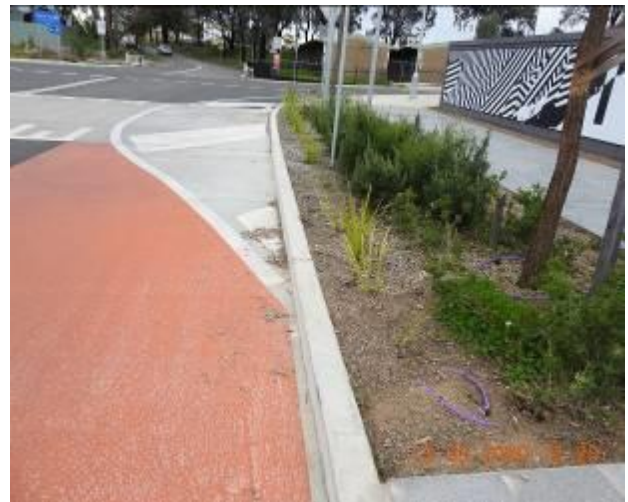
Figure 590 – General condition of kerb

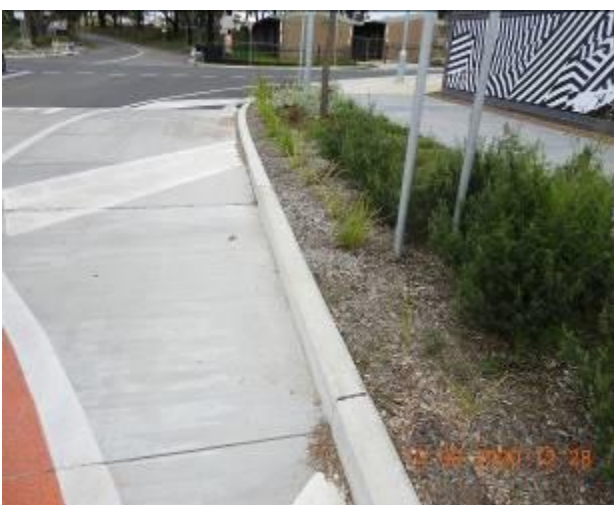
Figure 591 – General condition of kerb

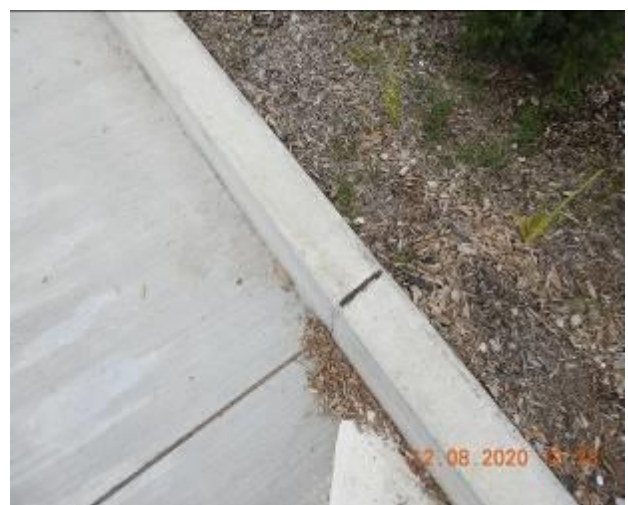
Figure 592 – Crack propagation and loss of material through kerb

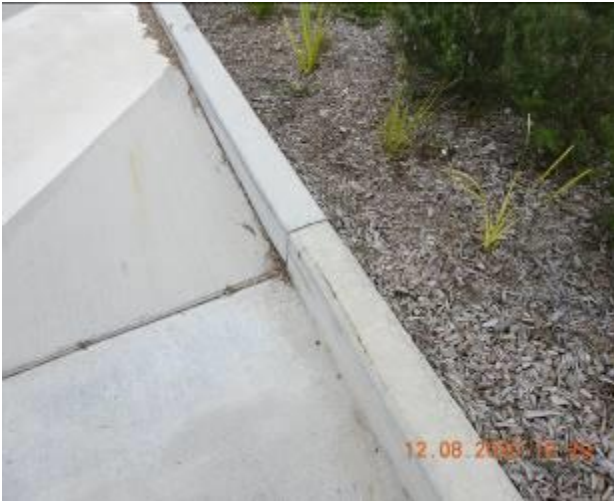
Figure 593 – Loss of material through kerb

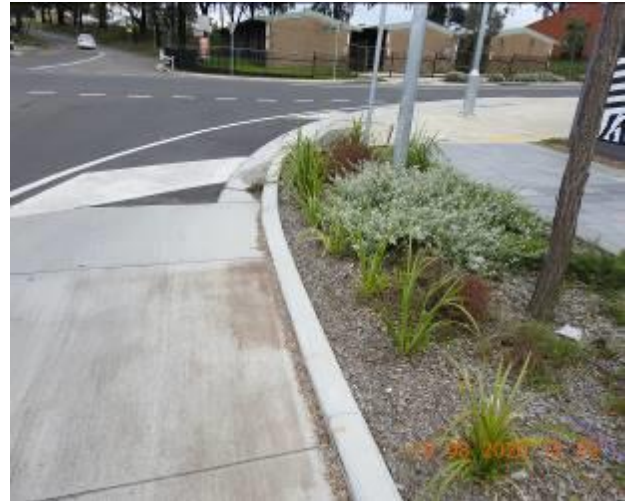
Figure 594 – General condition of kerb and gutter

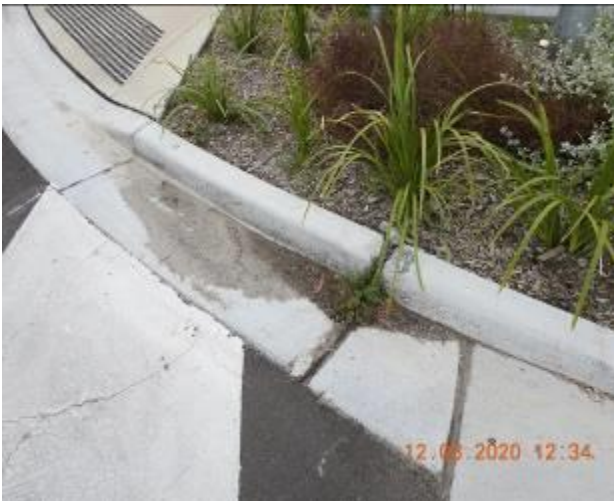
Figure 595 – Crack propagation and loss of material through kerb and gutter

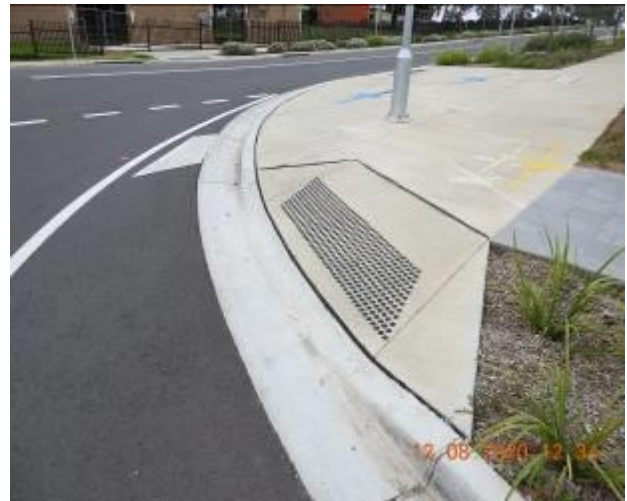
Figure 596 – Loss of material through layback

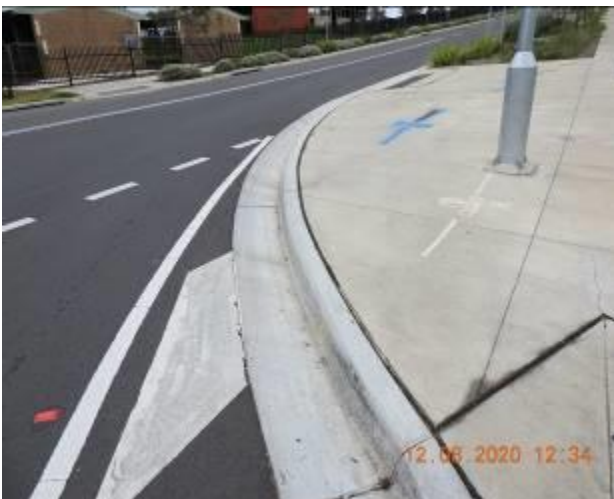
Figure 597 – Crack propagation and loss of material through kerb and gutter

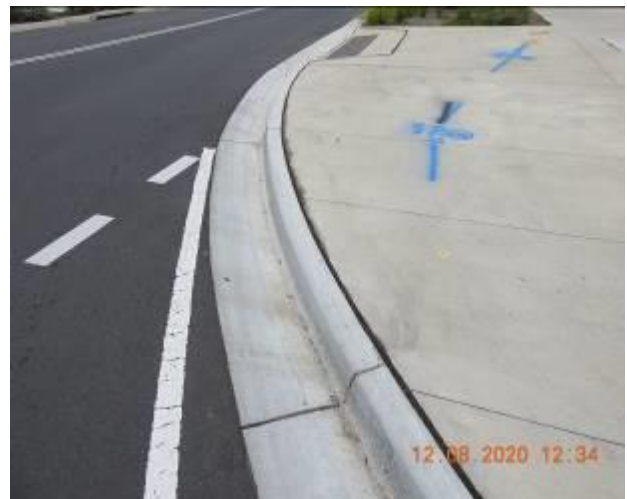
Figure 598 – Crack propagation and loss of material through kerb

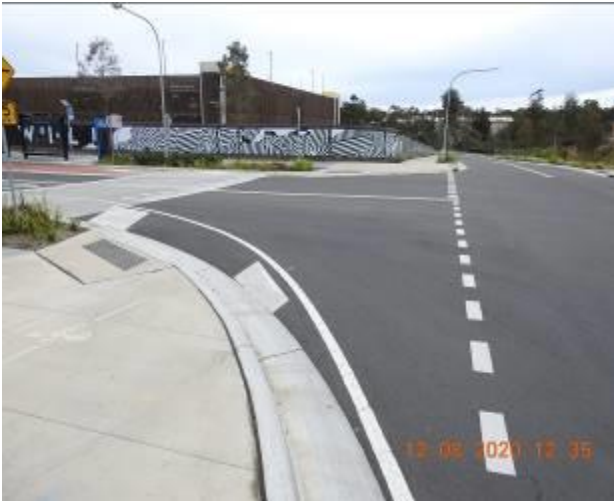
Figure 599 – General condition of road surface heading South

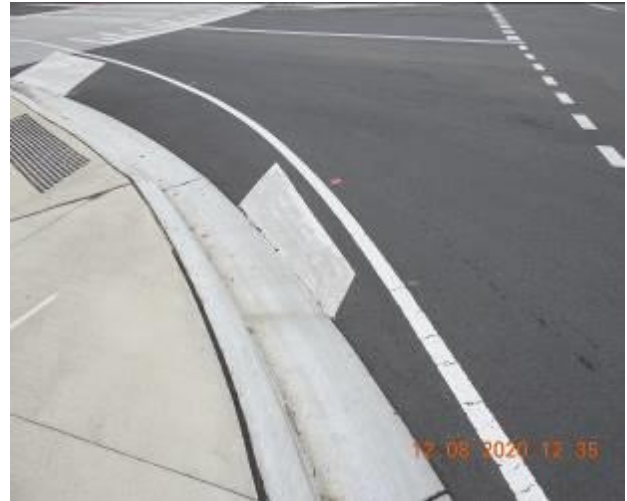
Figure 600 – Crack propagation and loss of material through road surface

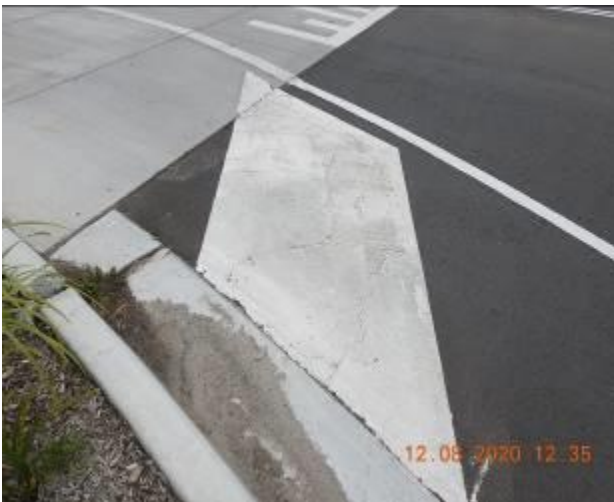
Figure 601 – Crack propagation and loss of material through road surface

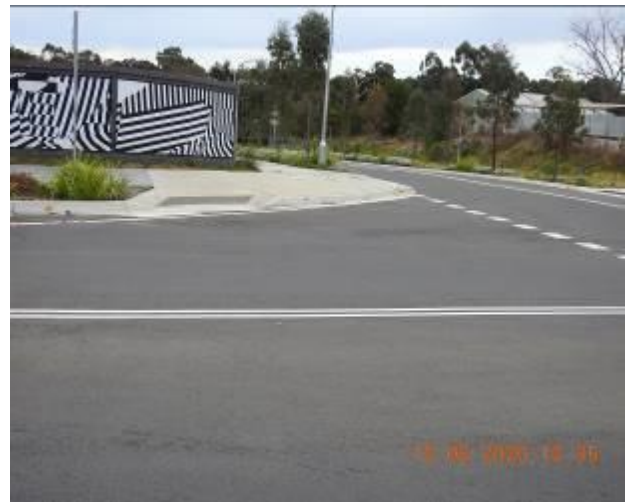
Figure 602 – General condition of road surface

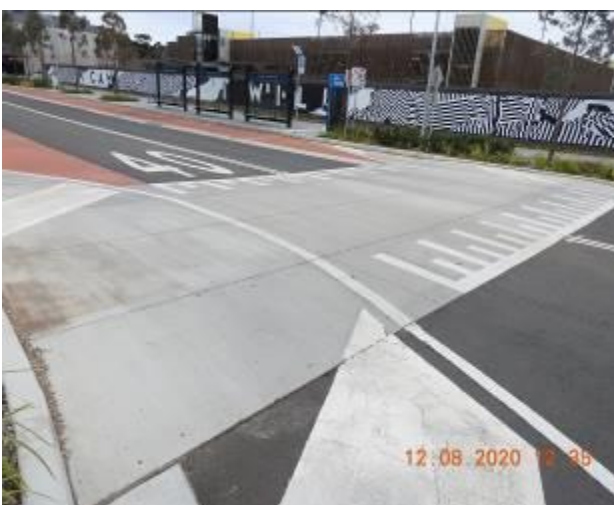
Figure 603 – Paint flaking crack propagation and loss of material through road surface ramp

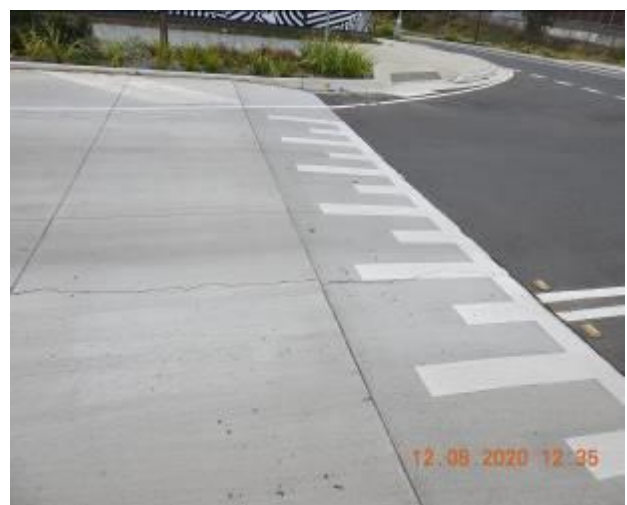
Figure 604 – Crack propagation and loss of material through road surface ramp

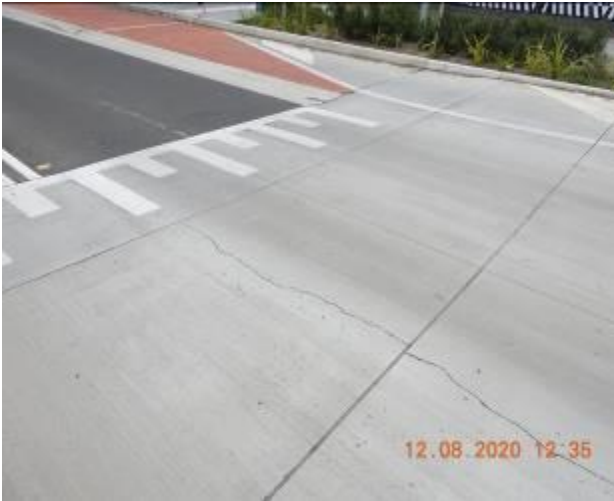
Figure 605 – Crack propagation and loss of material through road surface ramp

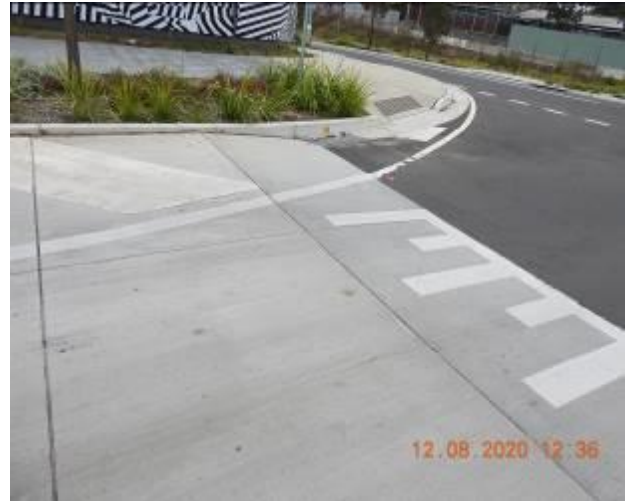
Figure 606 – Loss of material through road surface ramp

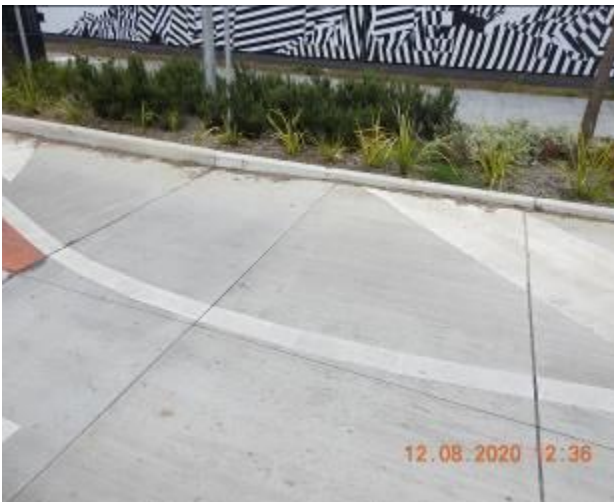
Figure 607 – Loss of material through road surface ramp

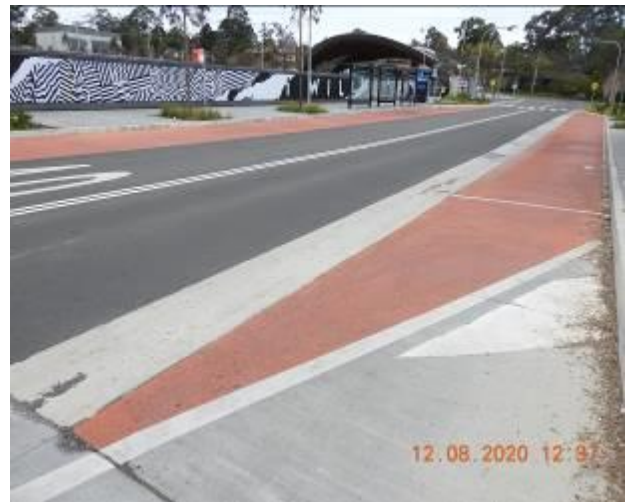
Figure 608 – General condition of road surface

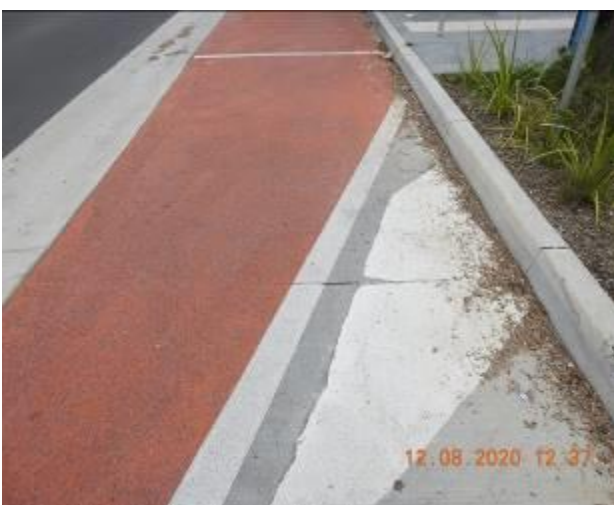
Figure 609 – Paint flaking and loss of material through road surface

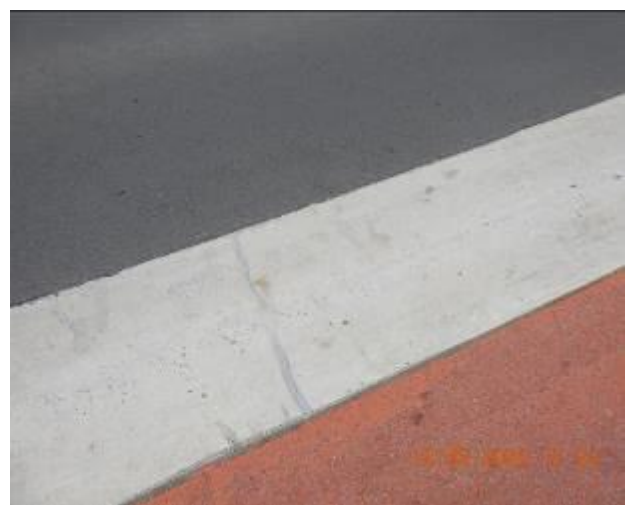
Figure 610 – Hairline crack propagation through and evidence of patchwork through road surface

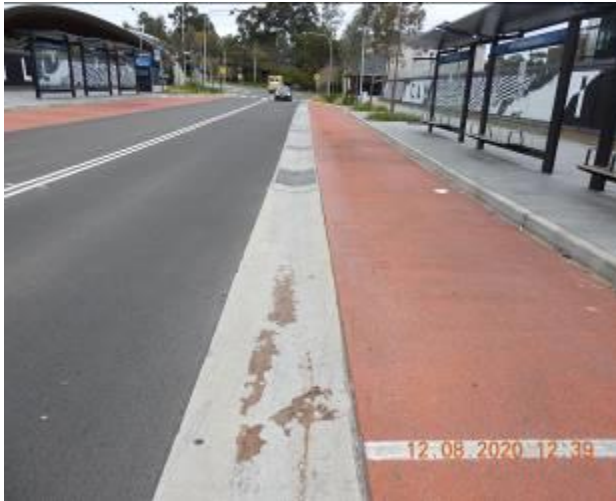
Figure 611 – General condition of road surface

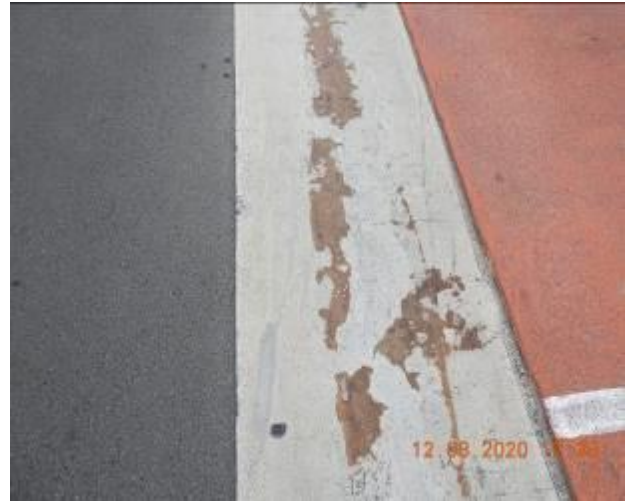
Figure 612 – Hairline crack propagation and evidence of patchwork through road surface

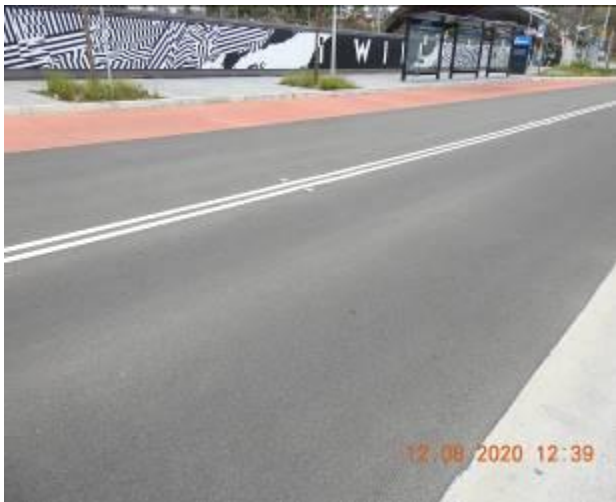
Figure 613 – General condition of road surface

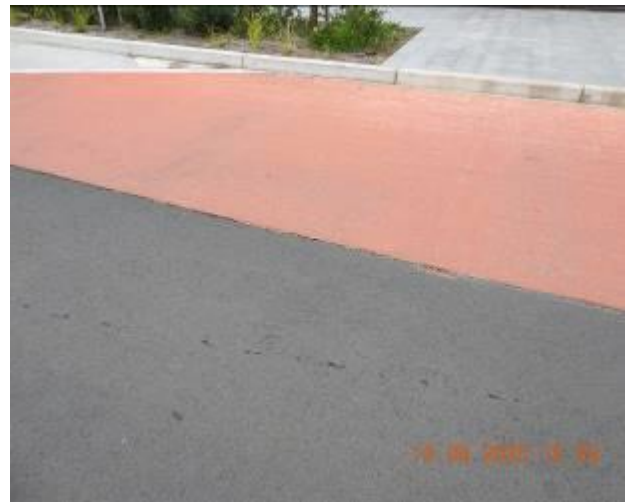
Figure 614 – Crack propagation and loss of material through road surface

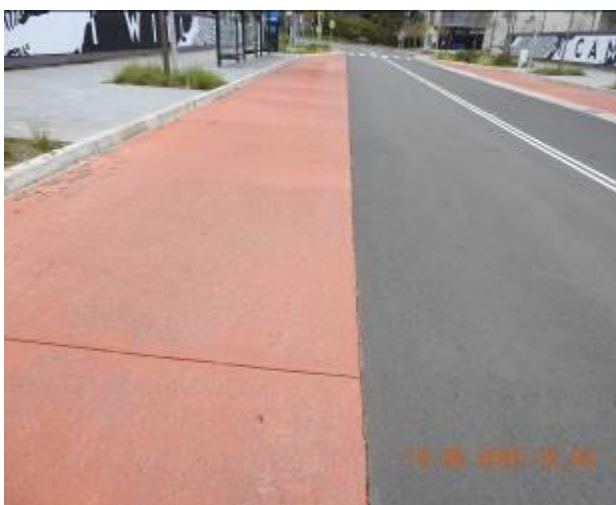
Figure 615 – Crack propagation and loss of material through road surface

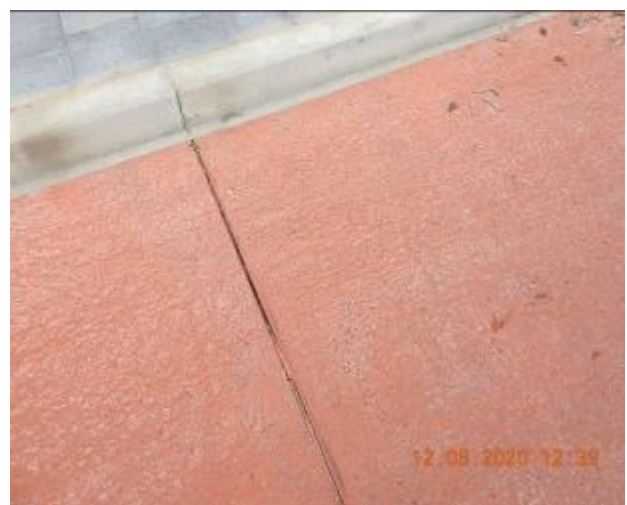
Figure 616 – Crack propagation and loss of material through road surface

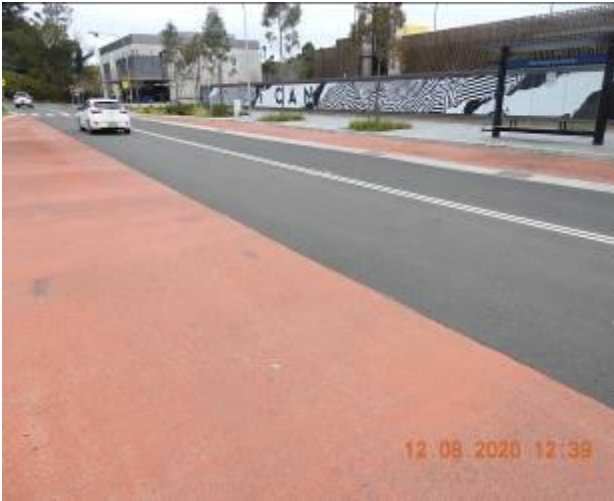
Figure 617 – General condition of road surface

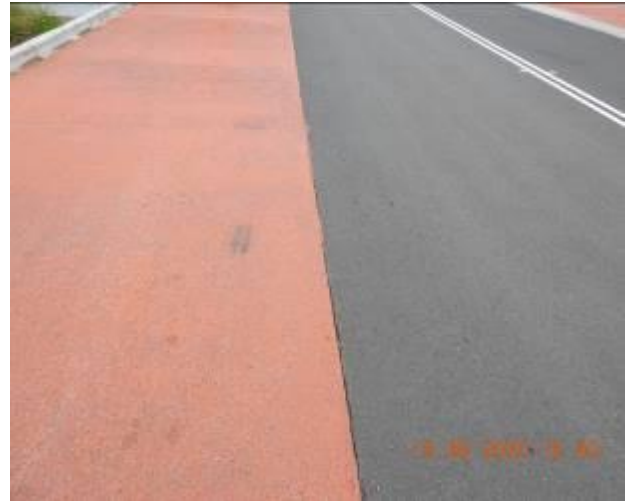
Figure 618 – Crack propagation and loss of material through road surface

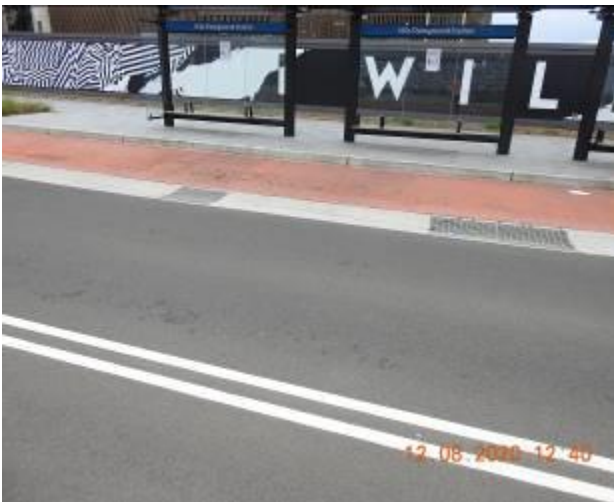
Figure 619 – General condition of road surface

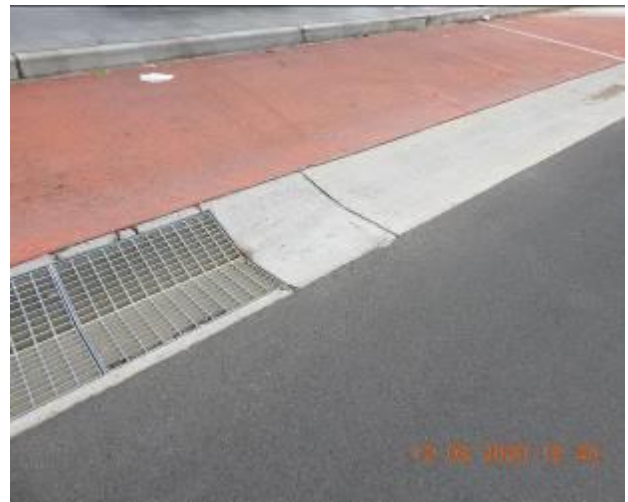
Figure 620 – Crack propagation and loss of material through road surface

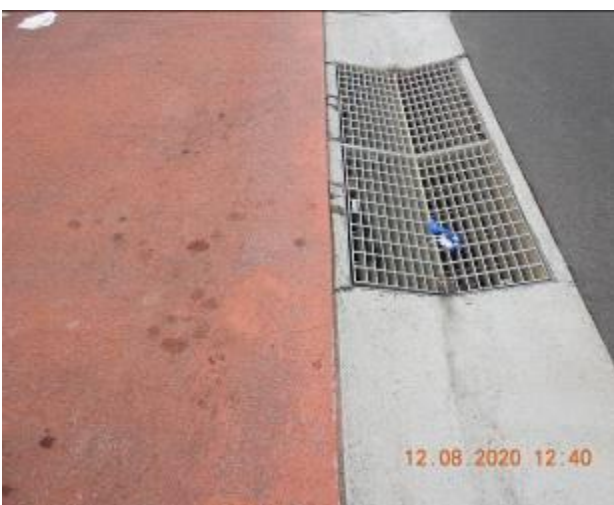
Figure 621 – Crack propagation and loss of material through road surface

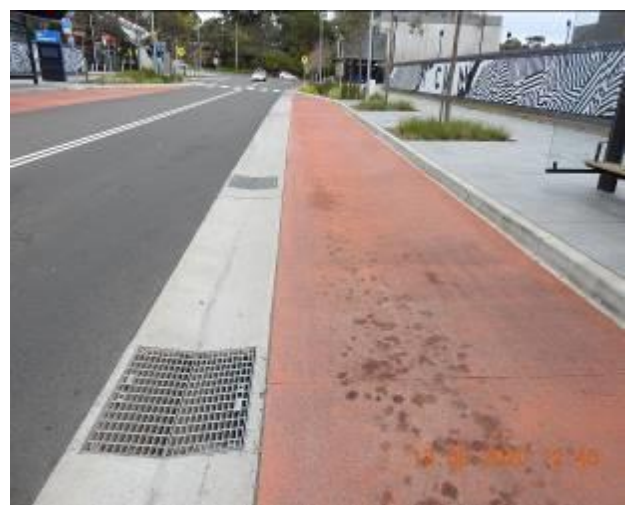
Figure 622 – Crack propagation and loss of material through road surface

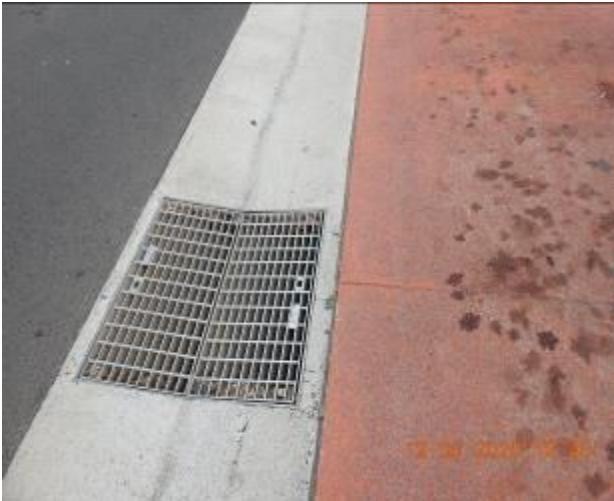
Figure 623 – Evidence of patchwork, crack propagation and loss of material through road surface

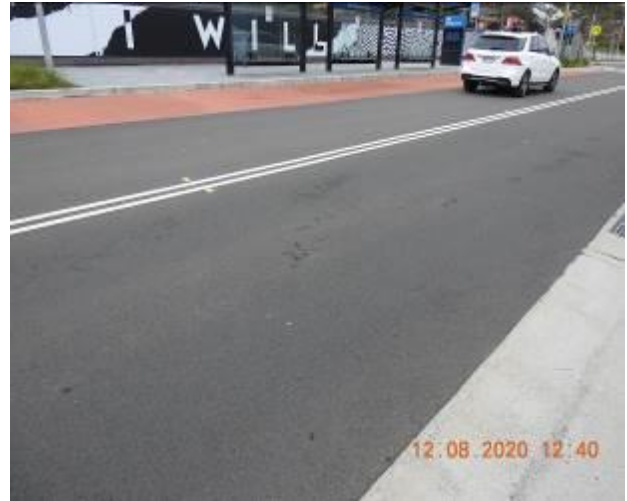
Figure 624 – General condition of road surface

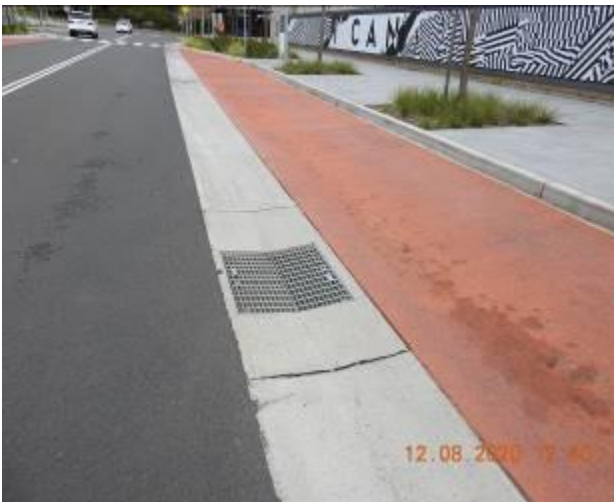
Figure 625 – Crack propagation and loss of material through road surface

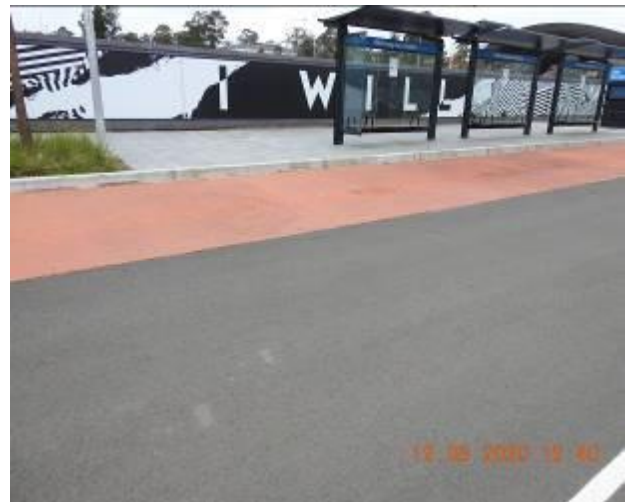
Figure 626 – General condition of road surface

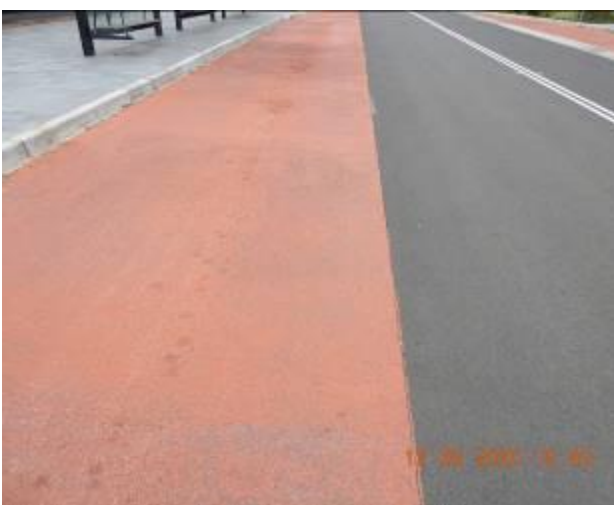
Figure 627 – Hairline crack propagation and loss of material through road surface

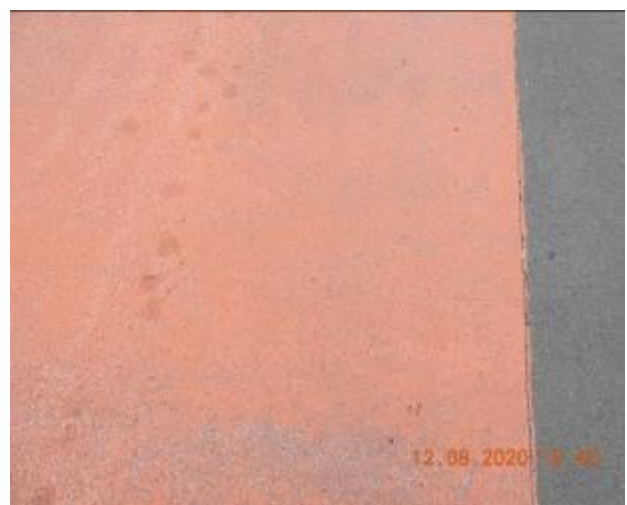
Figure 628 – Hairline crack propagation and loss of material through road surface

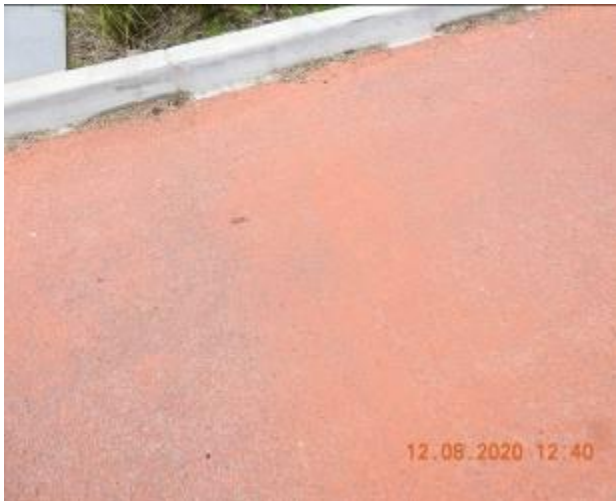
Figure 629 – Hairline crack propagation through road surface

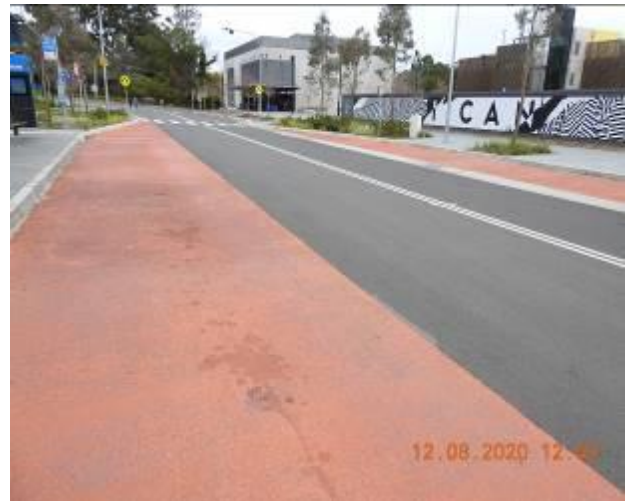
Figure 630 – General condition of road surface

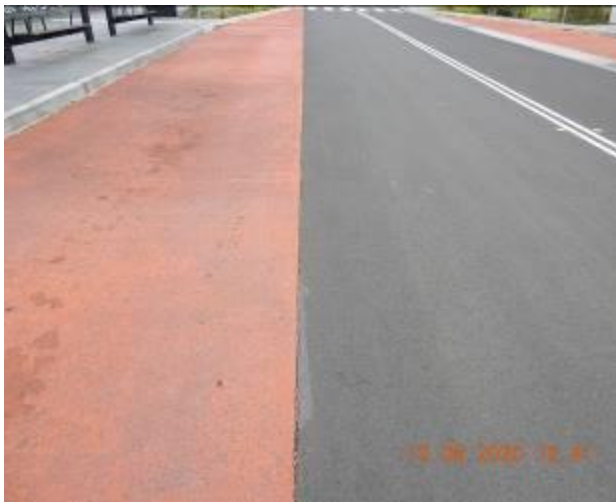
Figure 631 – Crack propagation and loss of material through road surface

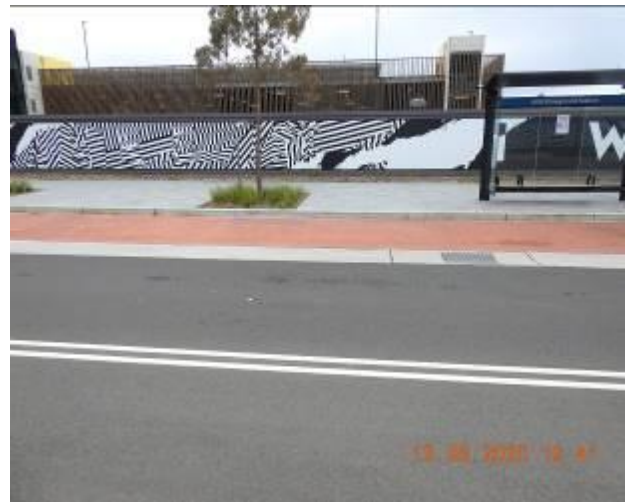
Figure 632 – General condition of road surface

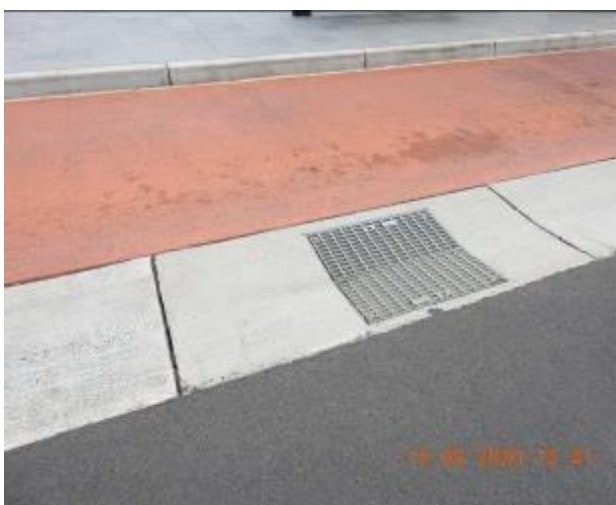
Figure 633 – Crack propagation and loss of material through road surface

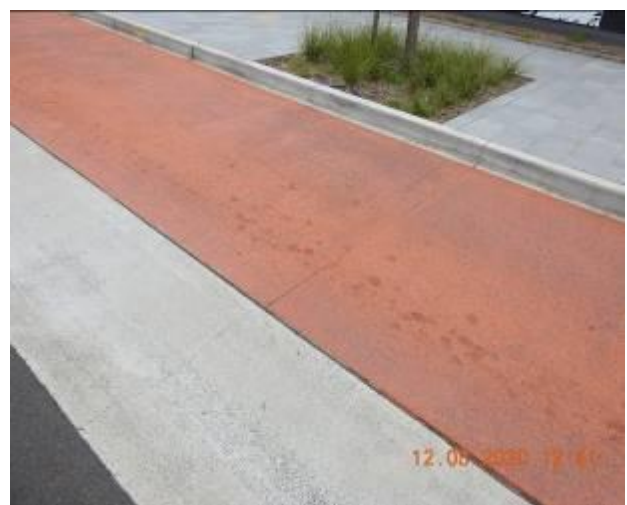
Figure 634 – Crack propagation and loss of material through road surface

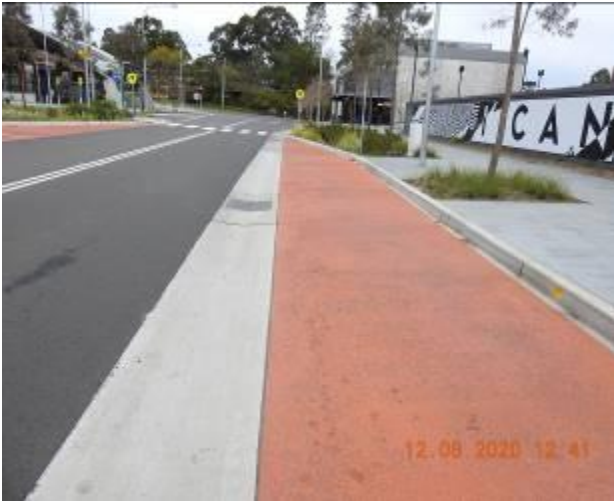
Figure 635 – Evidence of patchwork and loss of material through road surface

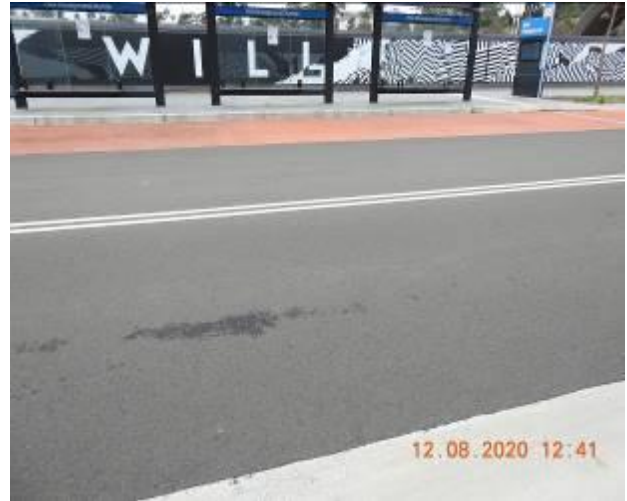
Figure 636 – Crack propagation and loss of material through road surface

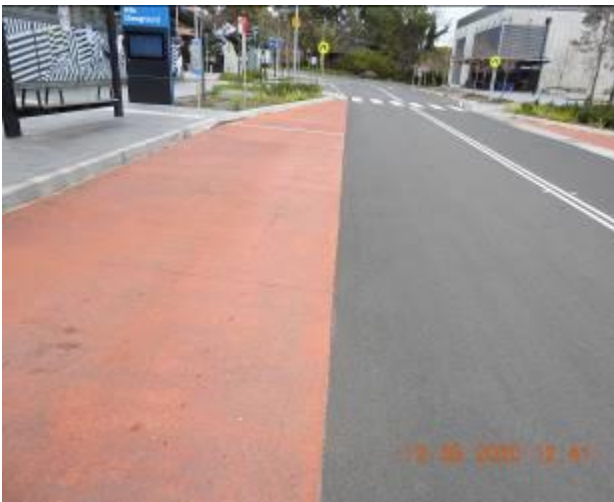
Figure 637 – General condition of road surface

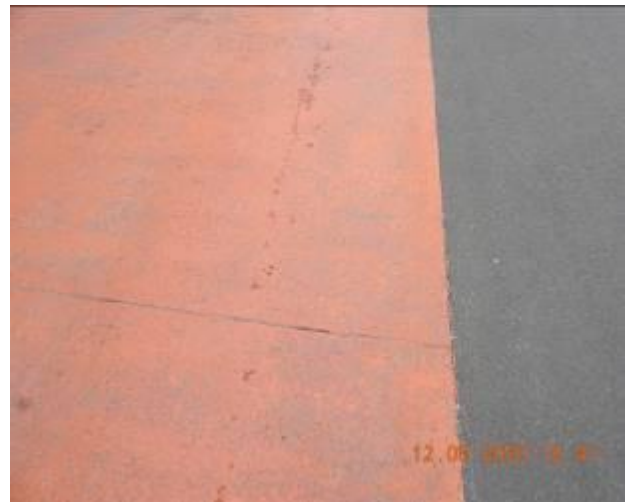
Figure 638 – Crack propagation and loss of material through road surface

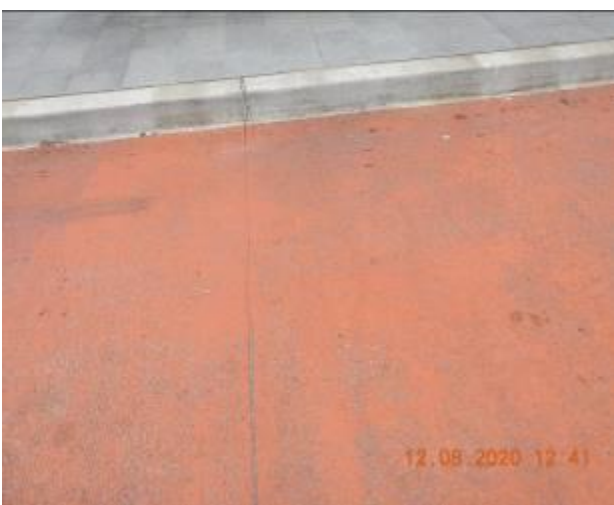
Figure 639 – Crack propagation and loss of material through road surface

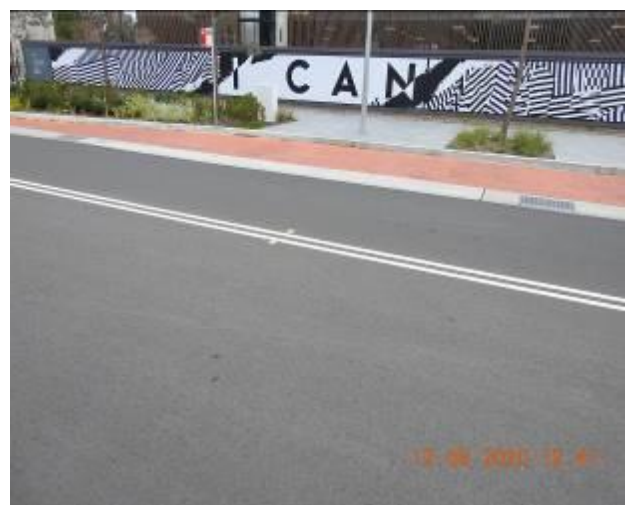
Figure 640 – General condition of road surface

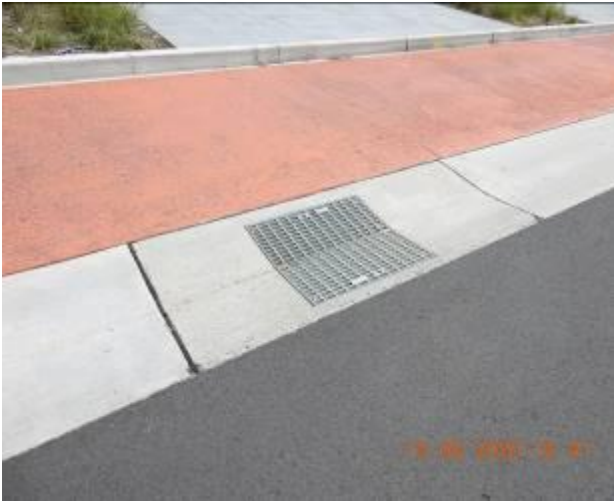
Figure 641 – Crack propagation and loss of material through road surface

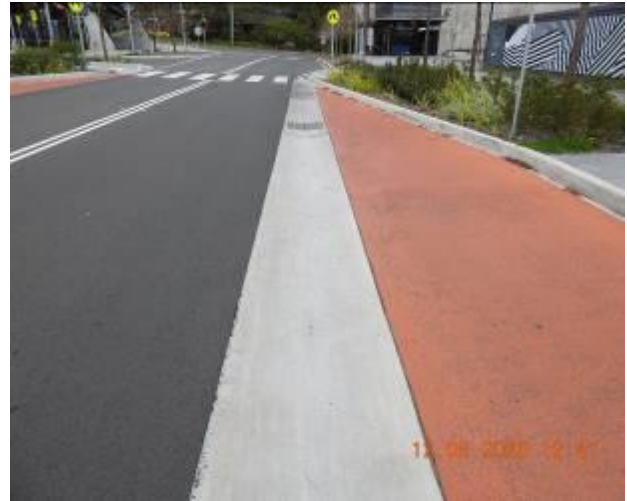
Figure 642 – Hairline crack propagation and loss of material through road surface

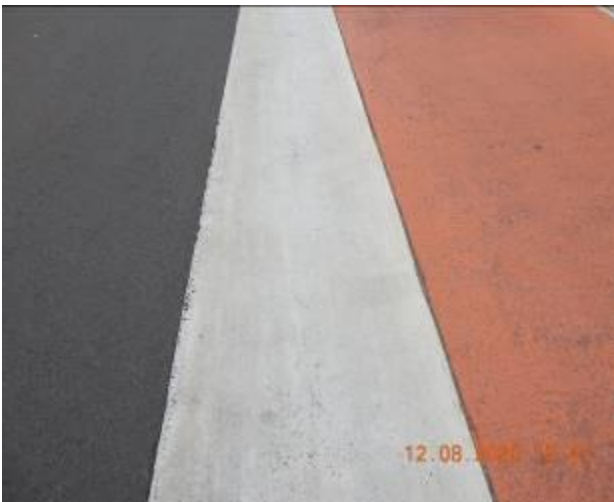
Figure 643 – Hairline crack propagation and loss of material through road surface

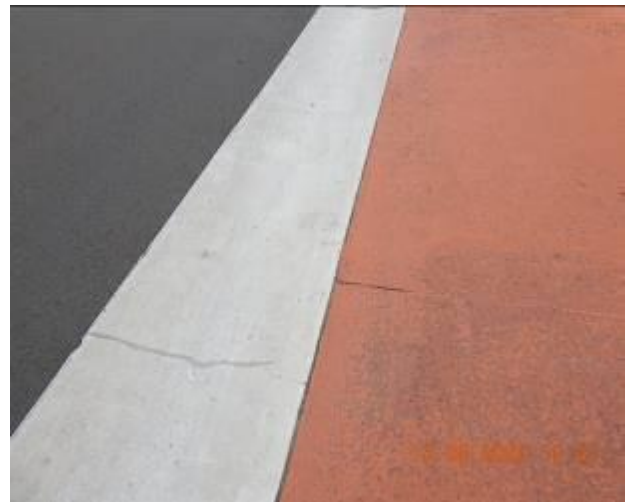
Figure 644 – Evidence of patchwork, hairline crack propagation and loss of material through road surface

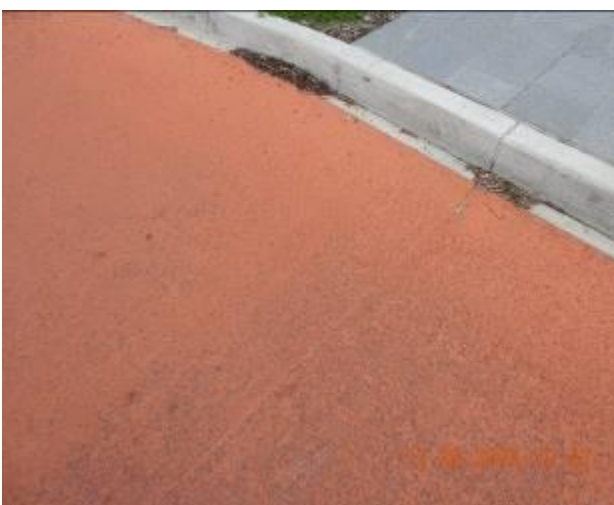
Figure 645 – Crack propagation and loss of material through road surface

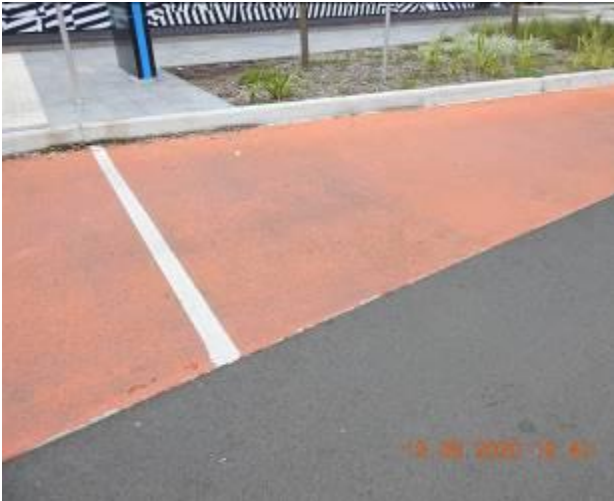
Figure 647 – Paint flaking and loss of material through road surface

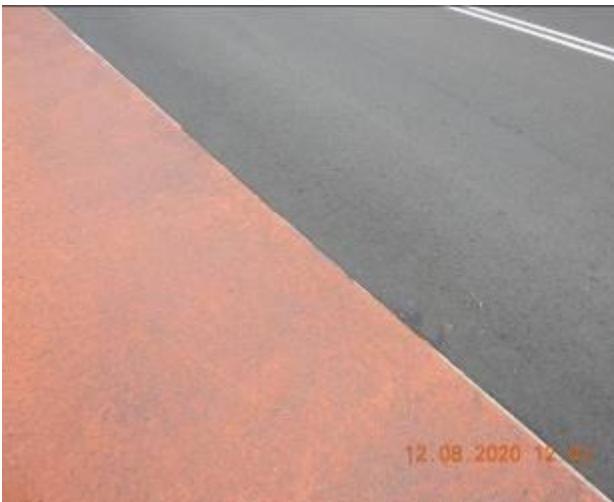
Figure 649 – Evidence of patchwork, crack propagation and loss of material through road surface

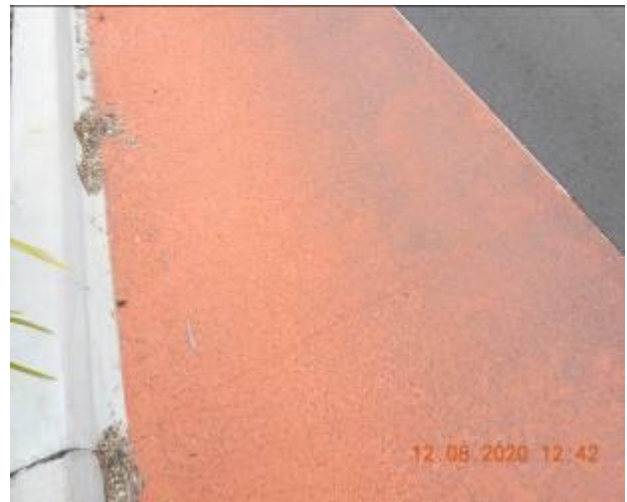
Figure 650 – Crack propagation and loss of material through road surface
