**2 MANDALA PARADE, CASTLE HILL
(DORAN DRIVE PRECINCT)
PRE-DILAPIDATION REPORT
Of Sydney Metro and Hills Shire Council Assets
DEICORP PROJECTS SHOWGROUND
PTY LTD.**

Job No. 200124.3
07/07/2021

ACE Structural Services Pty Ltd

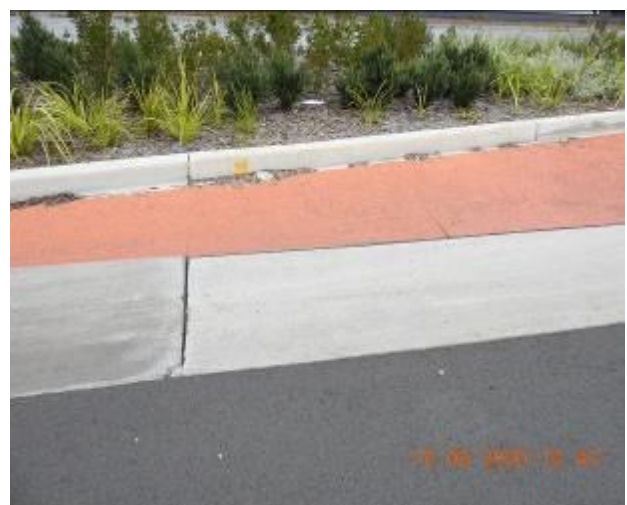
Figure 652 – Crack propagation and loss of material through road surface

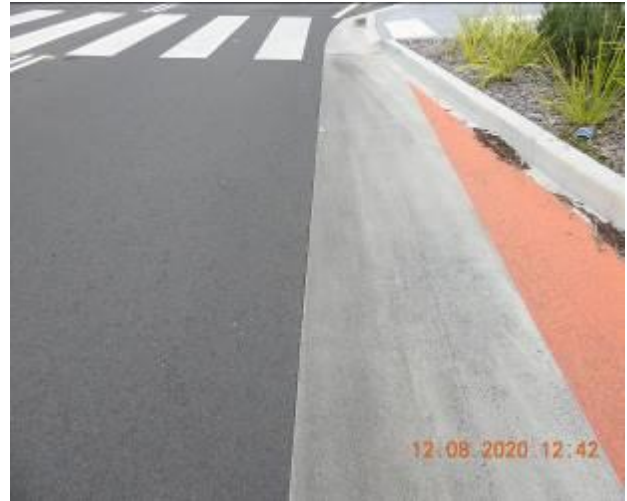
Figure 654 – Separation through road surface

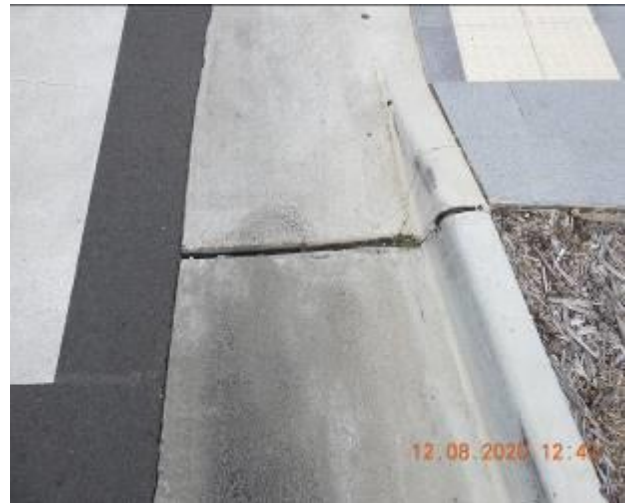
Figure 656 – Crack propagation and loss of material through gutter

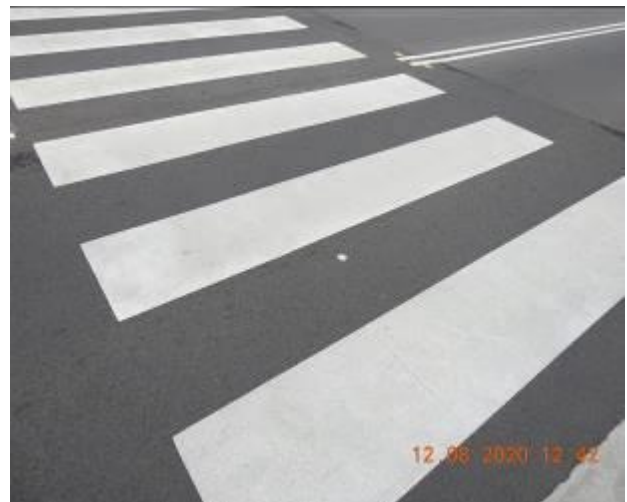
Figure 658 – Crack propagation and loss of material through road surface

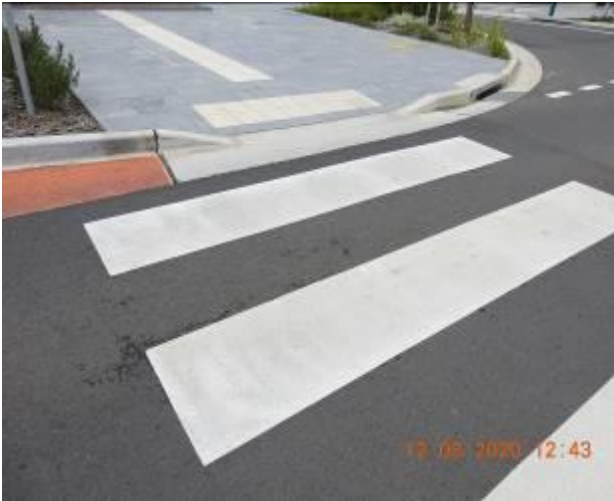
Figure 659 – Crack propagation and loss of material through road surface

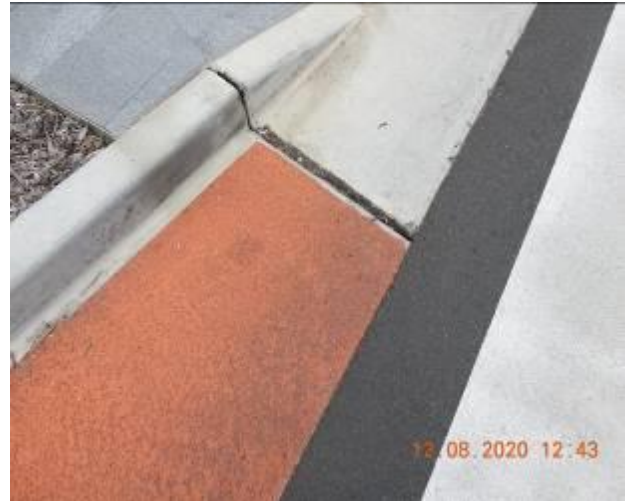
Figure 660 – Crack propagation and loss of material through road surface

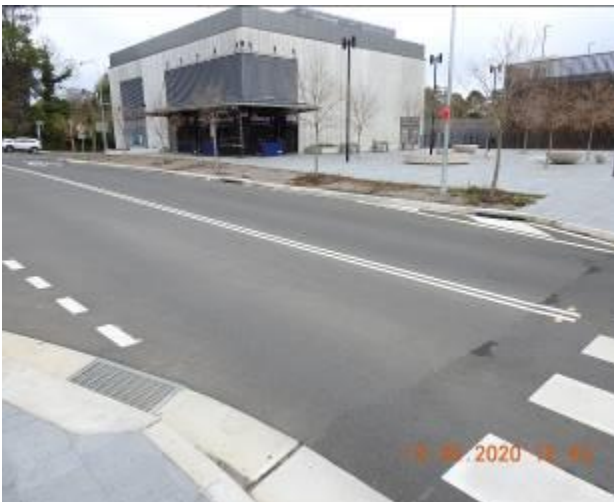
Figure 661 – Evidence of patchwork through road surface

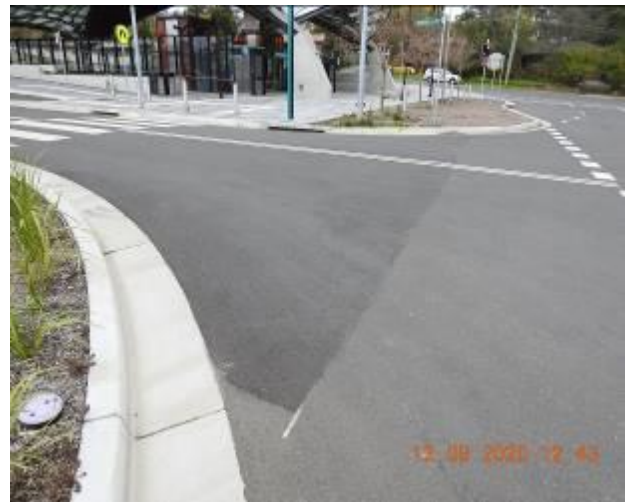
Figure 662 – Evidence of patchwork through road surface

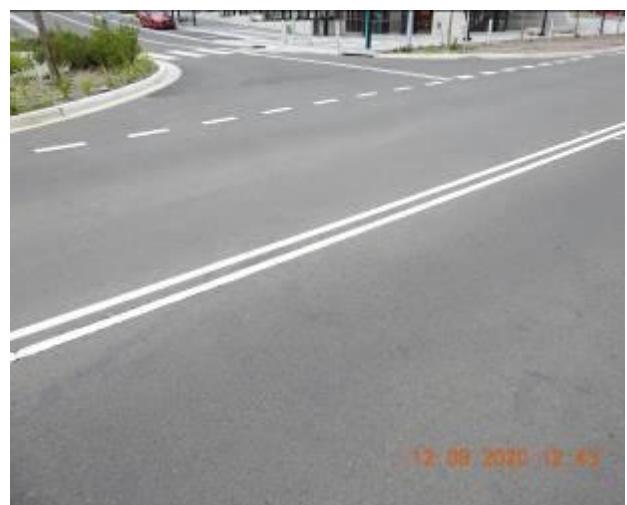
Figure 664 – Crack propagation and loss of material through road surface

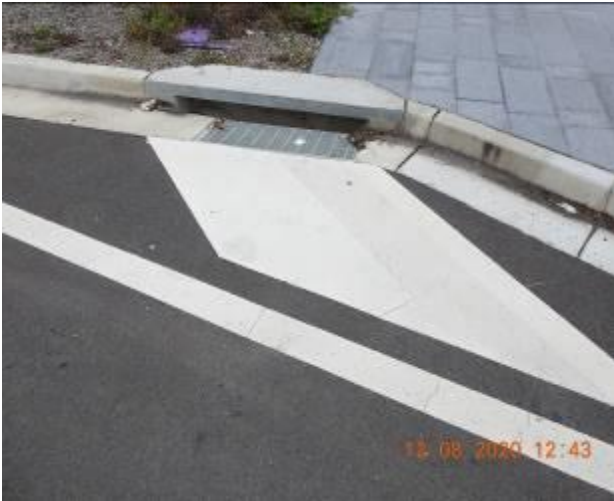
Figure 665 – Crack propagation and loss of material through road surface

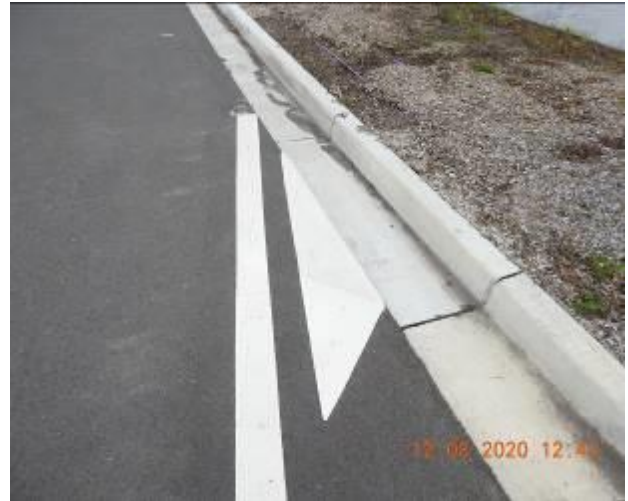
Figure 666 – Crack propagation and loss of material through road surface

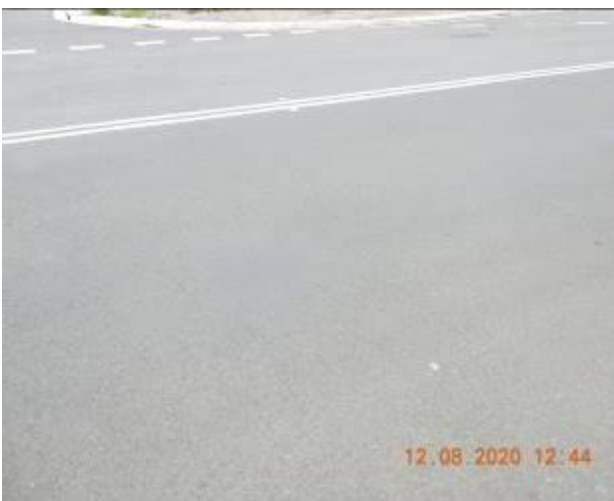
Figure 669 – Evidence of patchwork through road surface

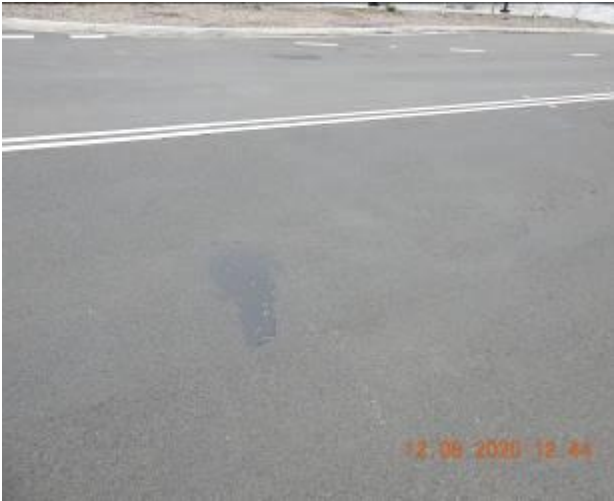
Figure 671 – Evidence of patchwork through road surface

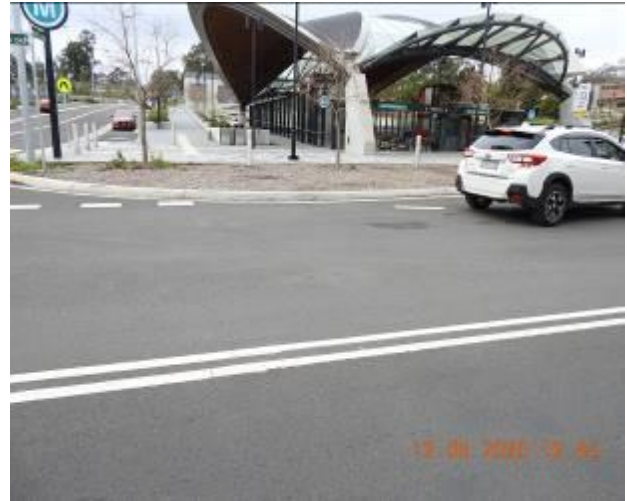
Figure 672 – Crack propagation and loss of material through road surface

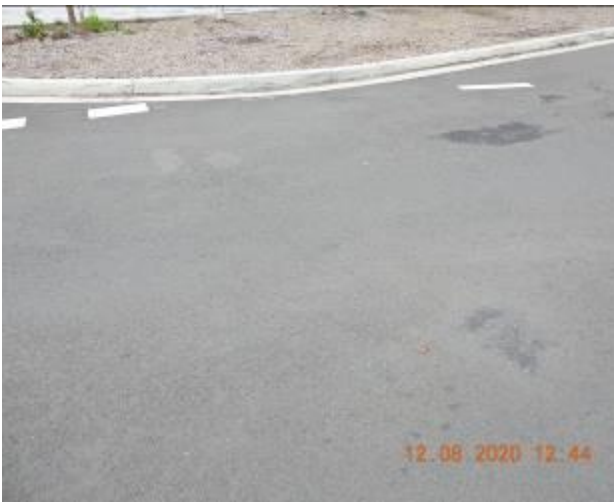
Figure 673 – Evidence of patchwork through road surface

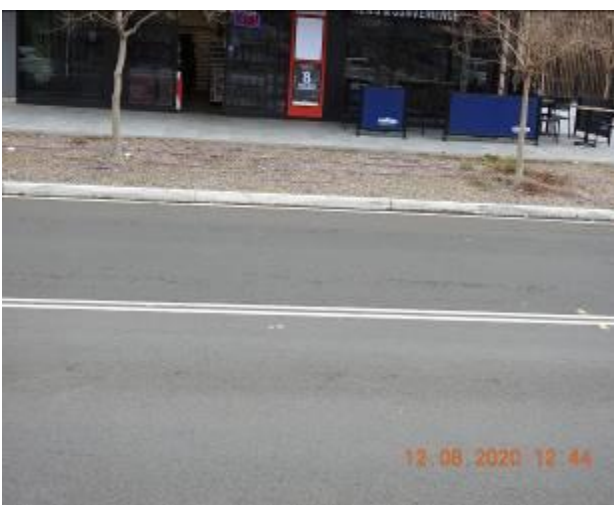
Figure 675 – Crack propagation and loss of material through road surface

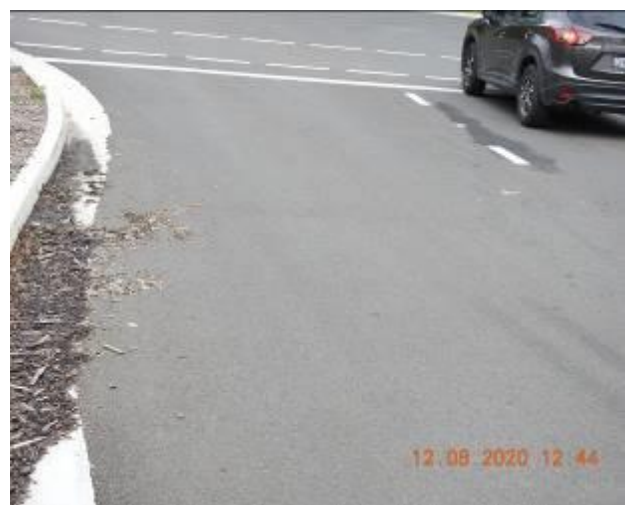
Figure 676 – Loss of material through road surface

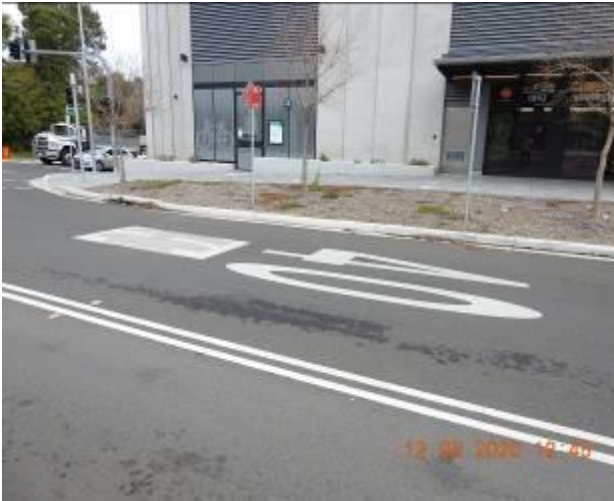
Figure 677 – Evidence of patchwork through road surface

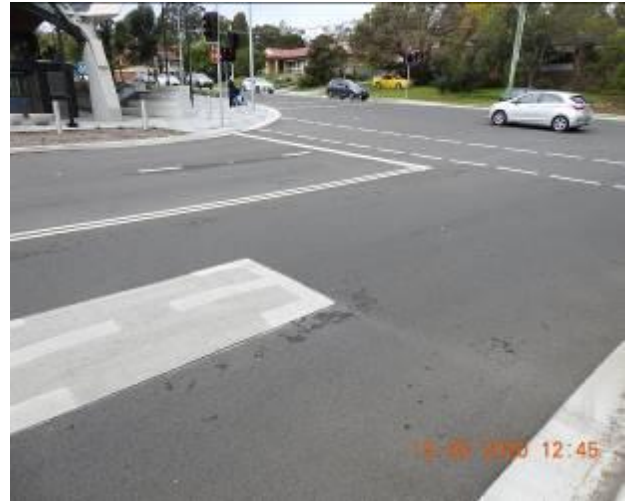
Figure 678 – Crack propagation and loss of material through road surface

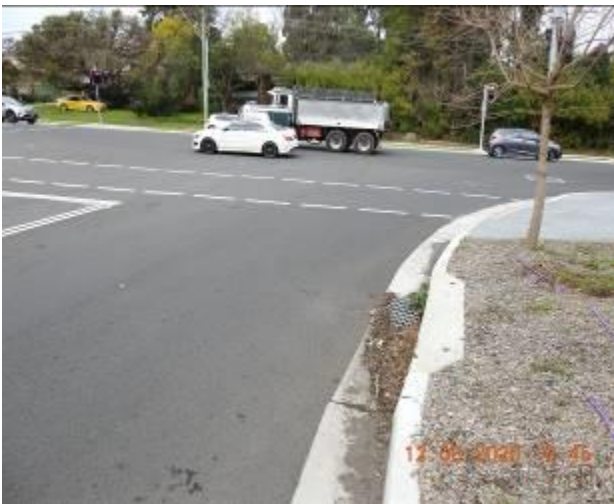
Figure 679 – Loss of material through road surface

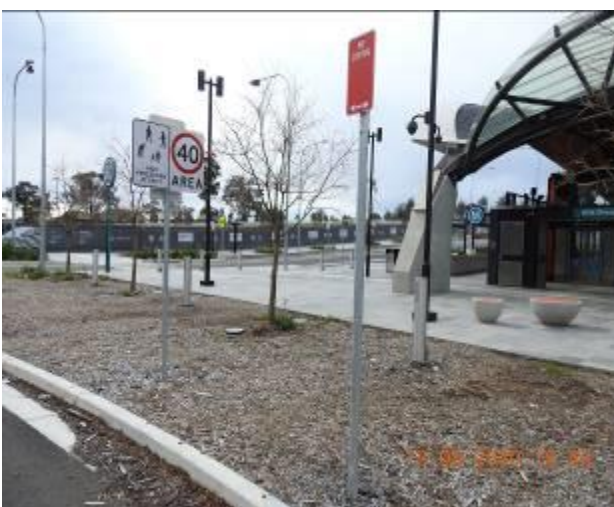
Figure 681 – General condition of street signs, plantations and safety bollards

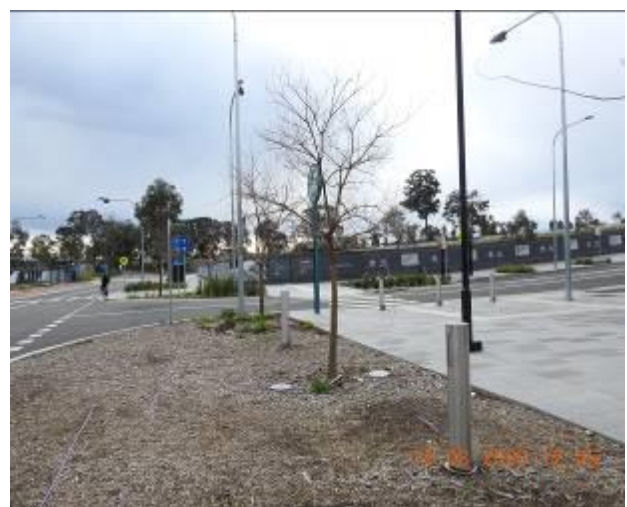
Figure 682 – General condition of plantations and safety bollards

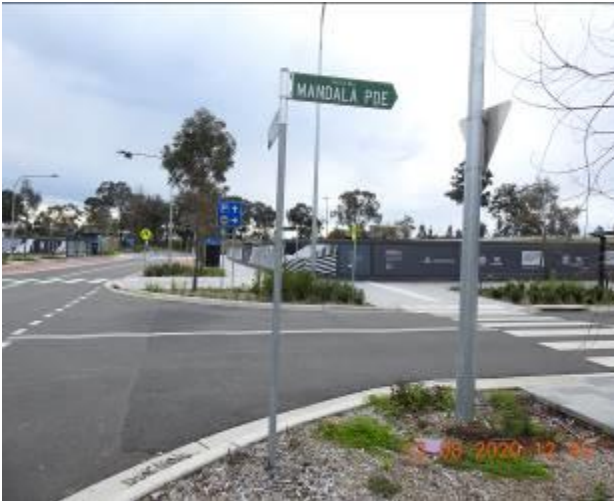
Figure 683 – General condition of street sign

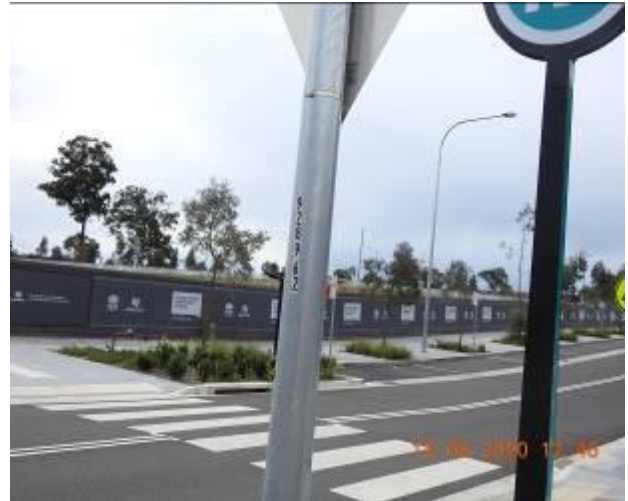
Figure 684 – General condition of lamp post
Identification No. 928962

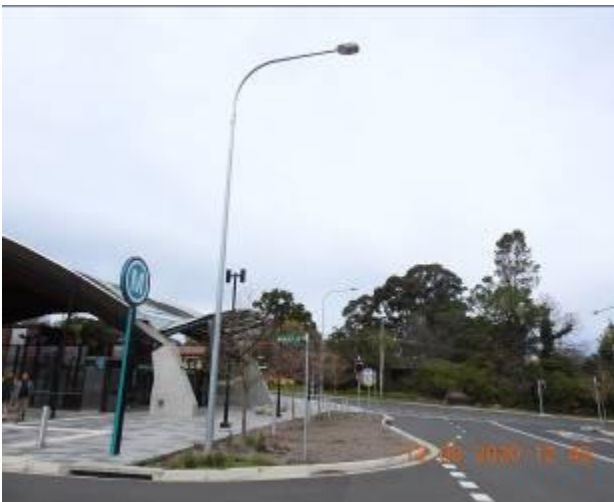
Figure 685 – General condition of lamp post
Identification No. 928962

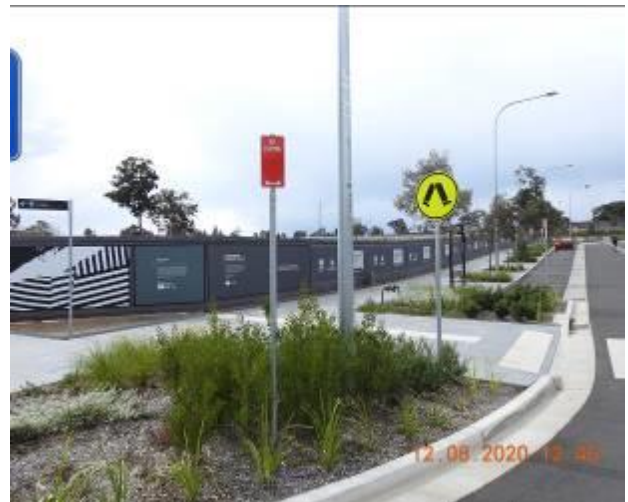
Figure 686 – General condition of street signs

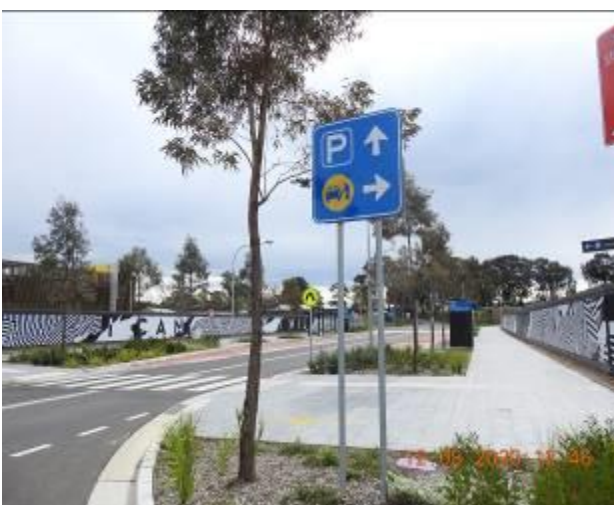
Figure 687 – General condition of street sign and
plantation

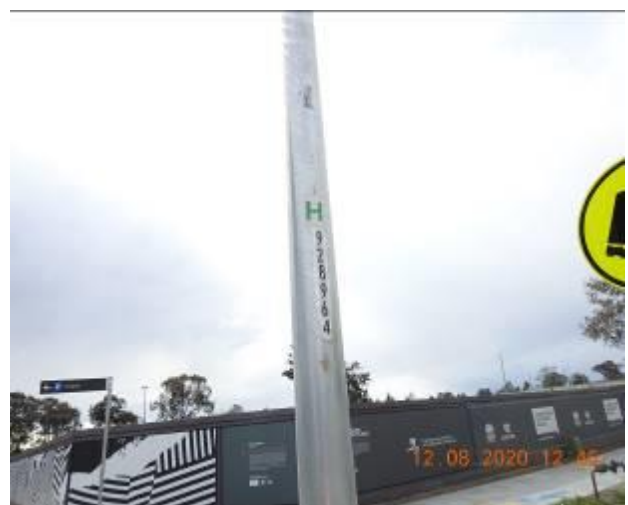
Figure 688 – General condition of lamp post
Identification No. 928964

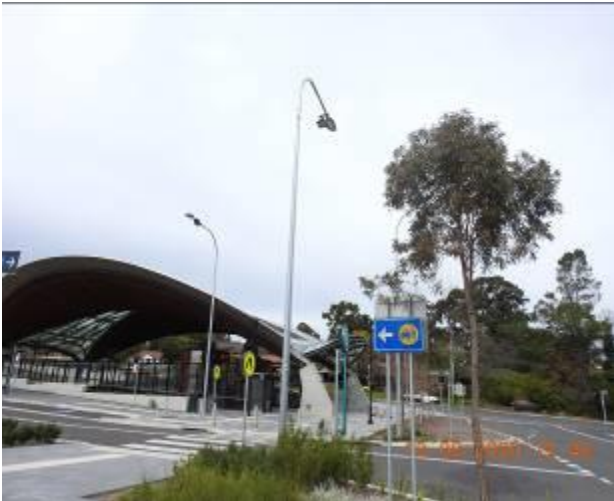
Figure 689 – General condition of lamp post
Identification No. 928964/General condition of street
sign

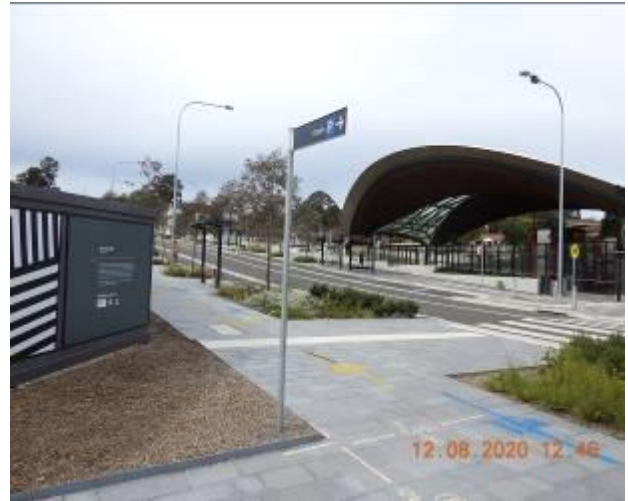
Figure 690 – General condition of street sign

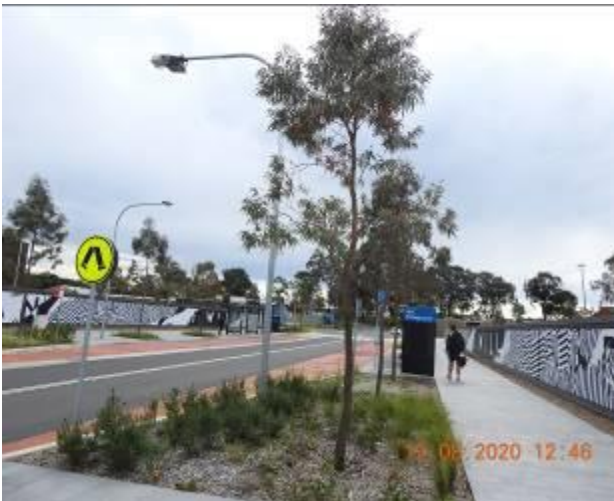
Figure 691 – General condition of plantation

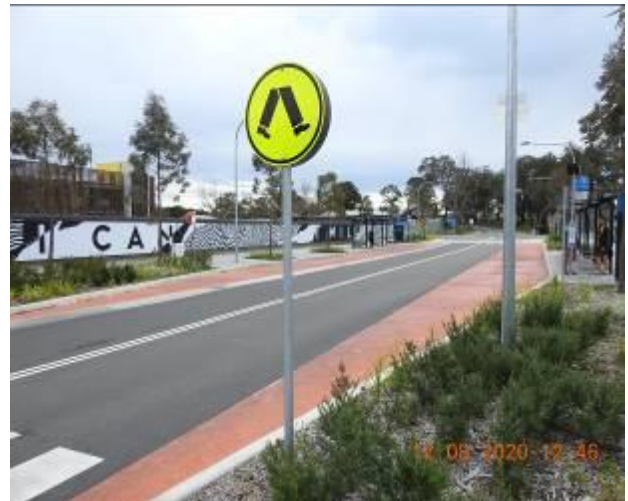
Figure 692 – General condition of street sign

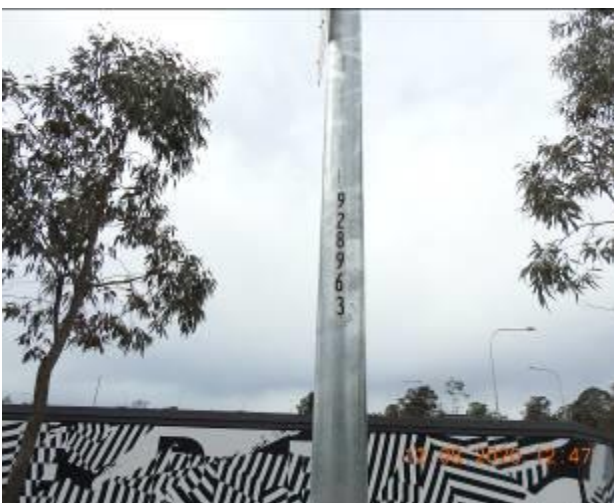
Figure 693 – General condition of lamp post
Identification No. 928963

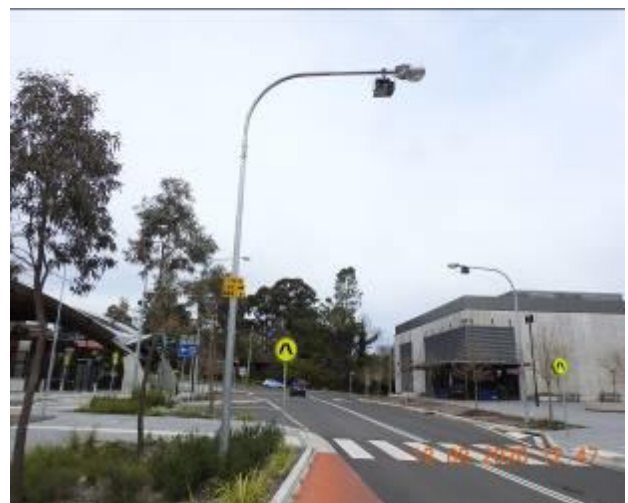
Figure 694 – General condition of lamp post
Identification No. 928963

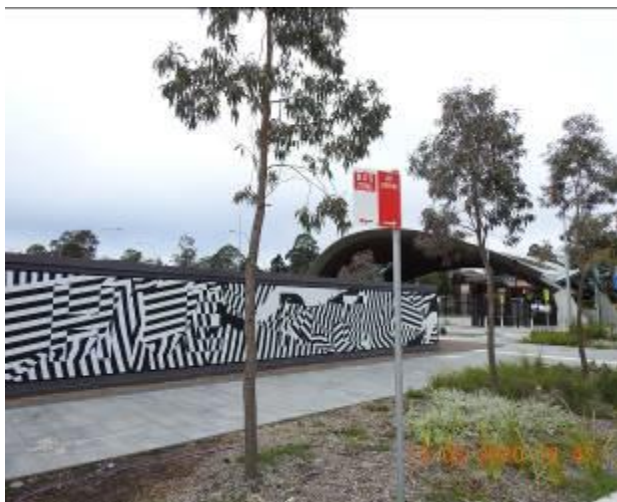
Figure 695 – General condition of street sign and plantation

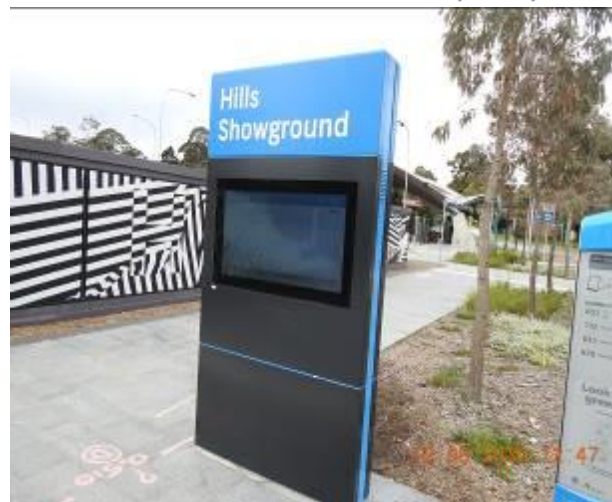
Figure 696 – General condition of street sign

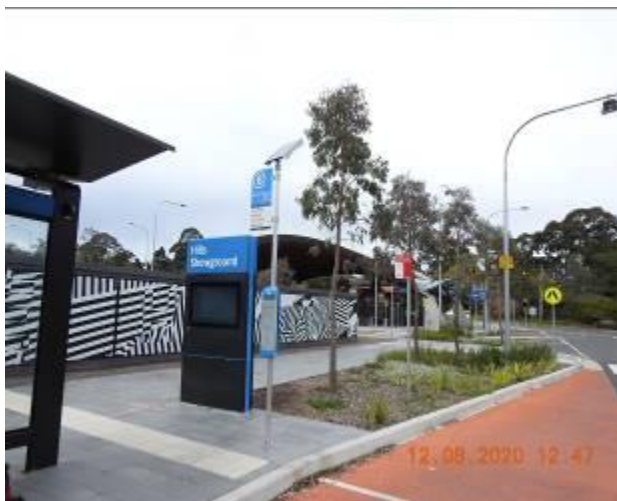
Figure 697 – General condition of street sign

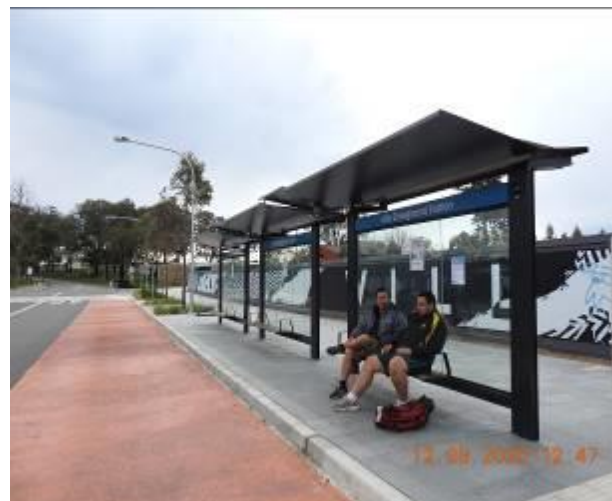
Figure 698 – General condition of bus public benches

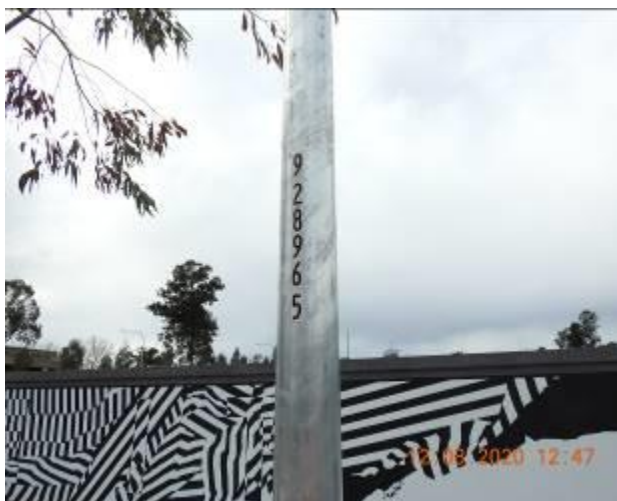
Figure 699 – General condition of lamp post
Identification No. 928965

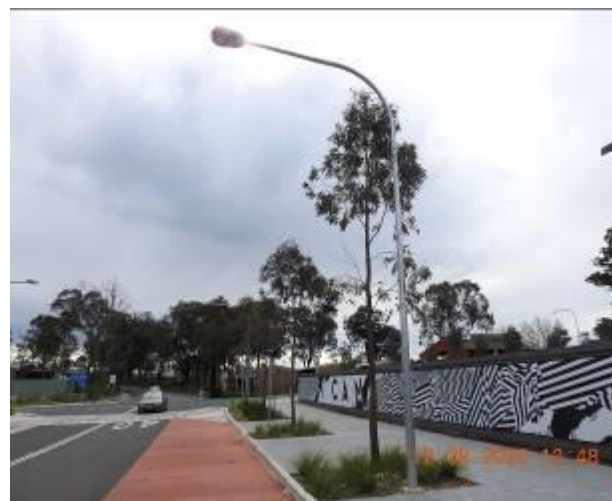
Figure 700 – General condition of lamp post
Identification No. 928965 and plantation

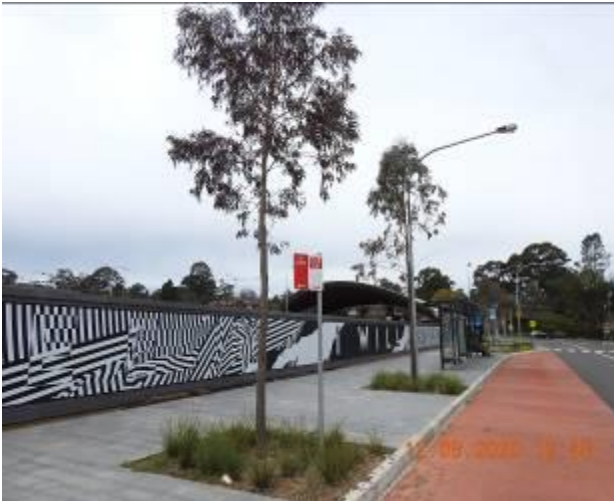
Figure 701 – General condition of street sign and plantation

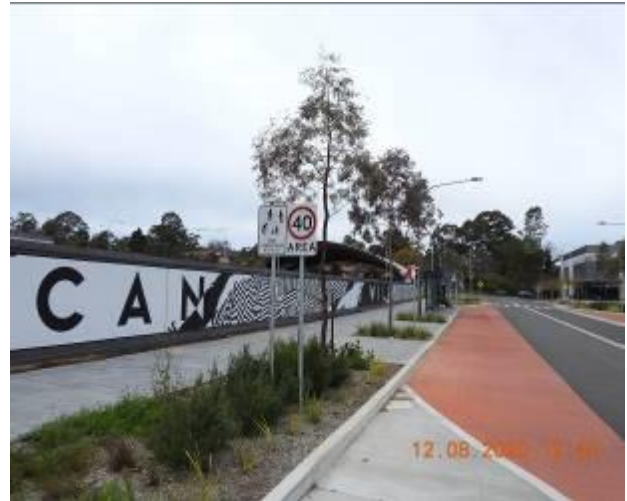
Figure 702 – General condition of street sign and plantation

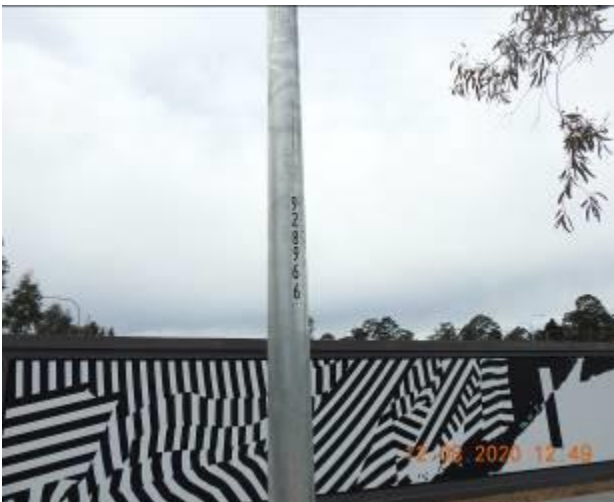
Figure 703 – General condition of lamp post
Identification No. 928966

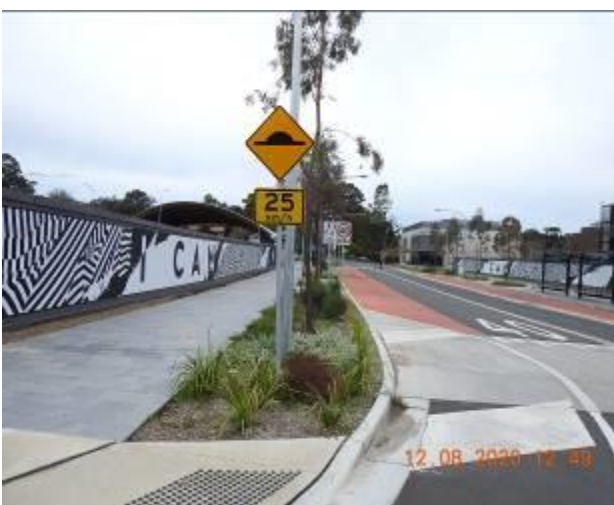
Figure 705 – General condition of street sign

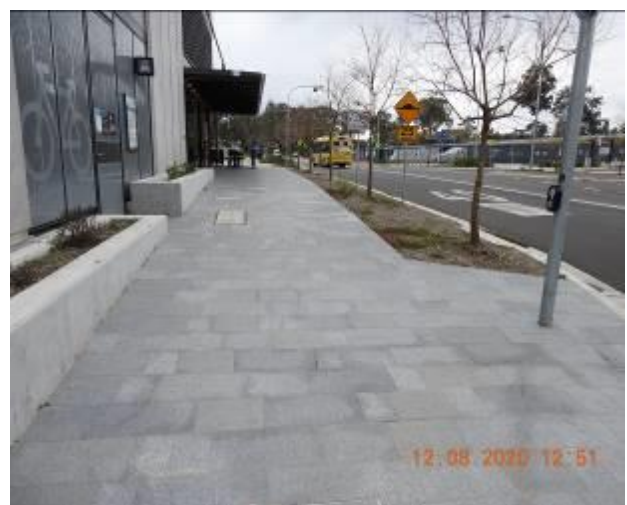
Figure 706 – General condition of footpath pavement
heading North

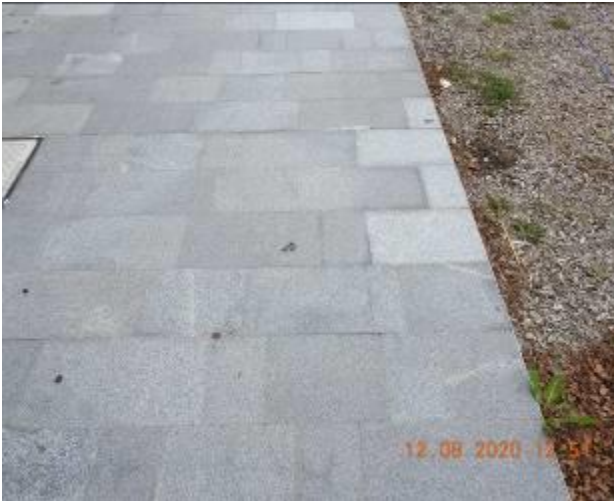
Figure 707 – Efflorescence, crack propagation and loss of material through footpath pavement

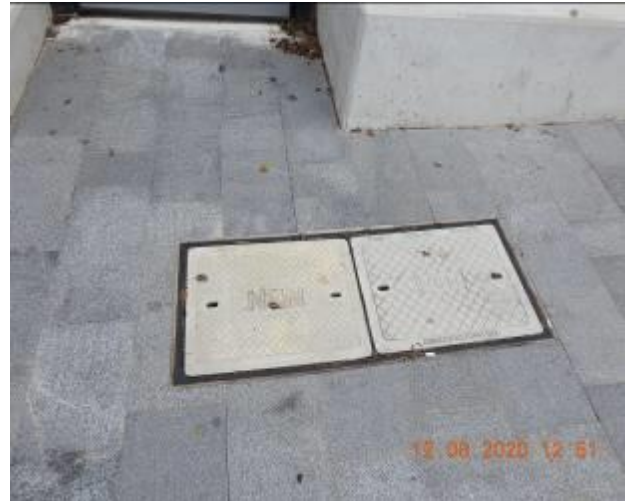
Figure 708 – General condition of service pit

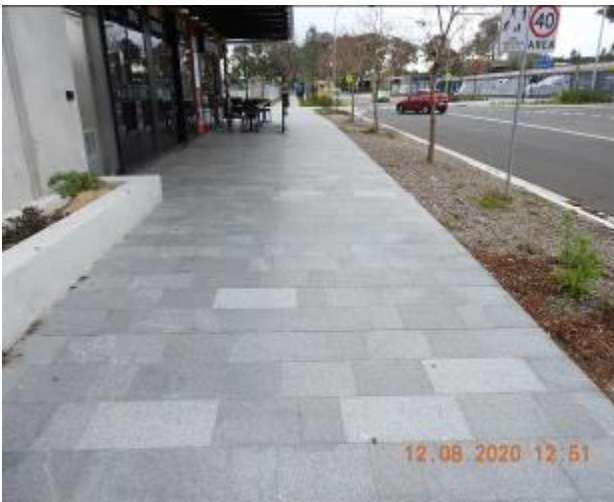
Figure 709 – Efflorescence, crack propagation and loss of material through footpath pavement

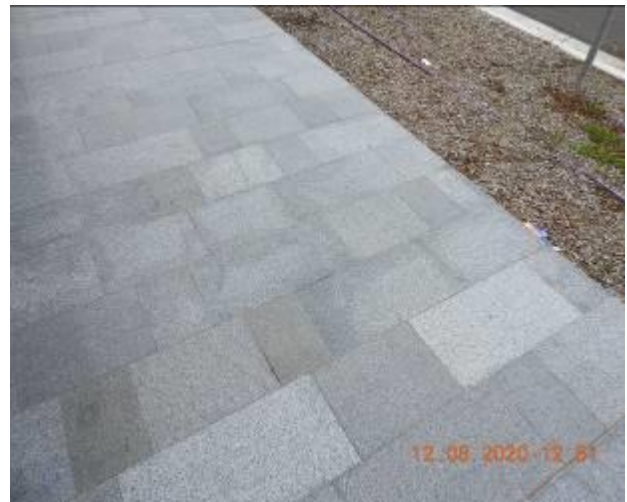
Figure 710 – Loss of material through footpath pavement

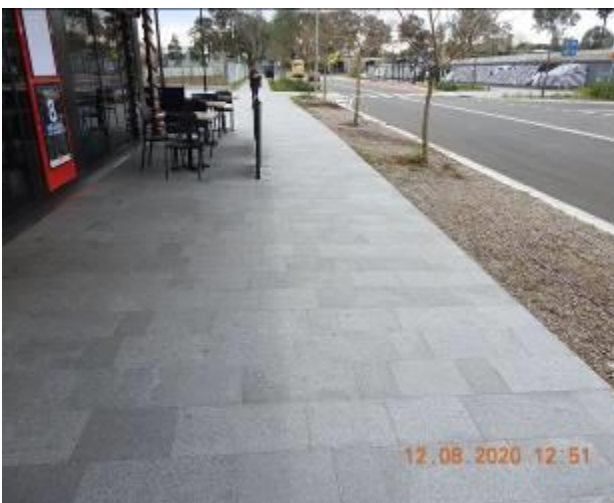
Figure 711 – General condition of footpath pavement

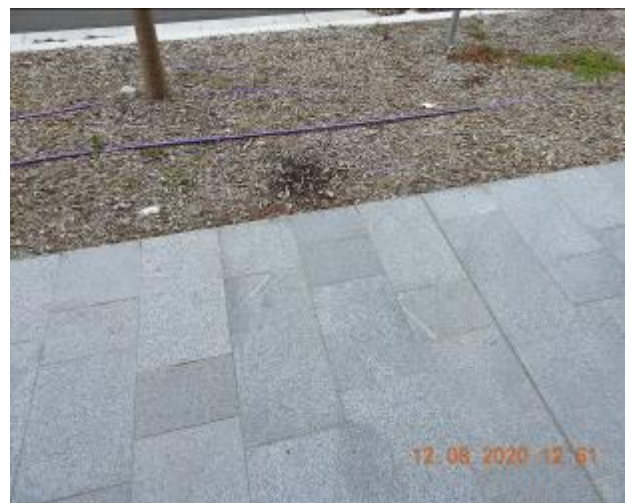
Figure 712 – Efflorescence, crack propagation and loss of material through footpath pavement

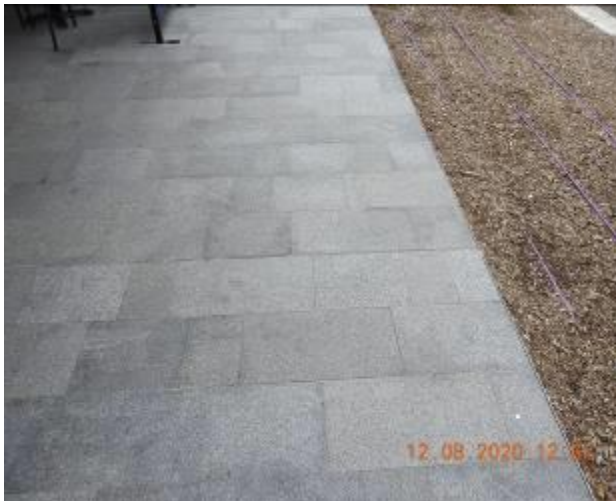
Figure 713 – Efflorescence, crack propagation and loss of material through footpath pavement

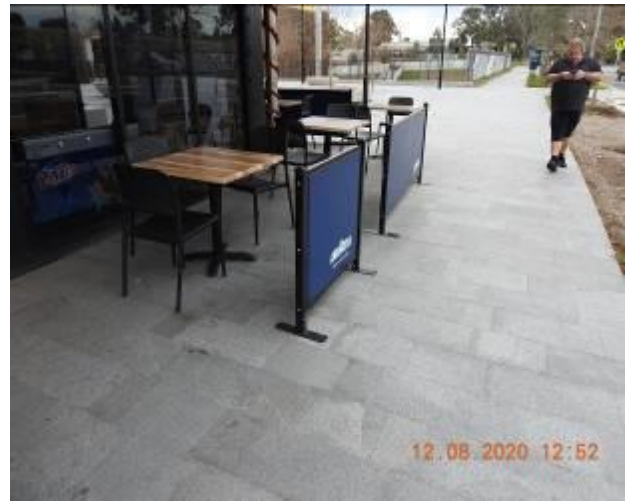
Figure 714 – Efflorescence and hairline crack propagation through footpath pavement

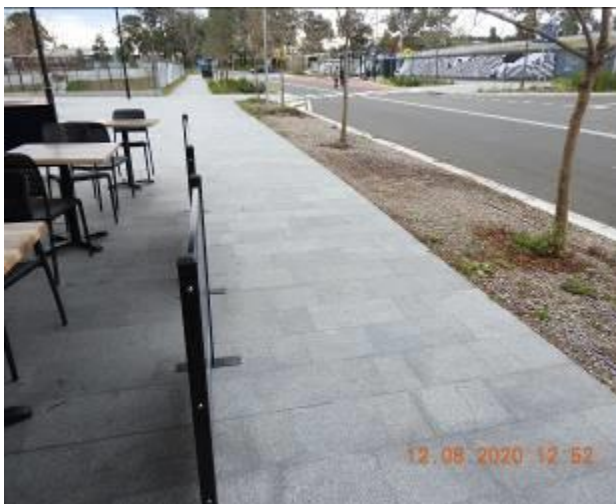
Figure 715 – General condition of footpath pavement

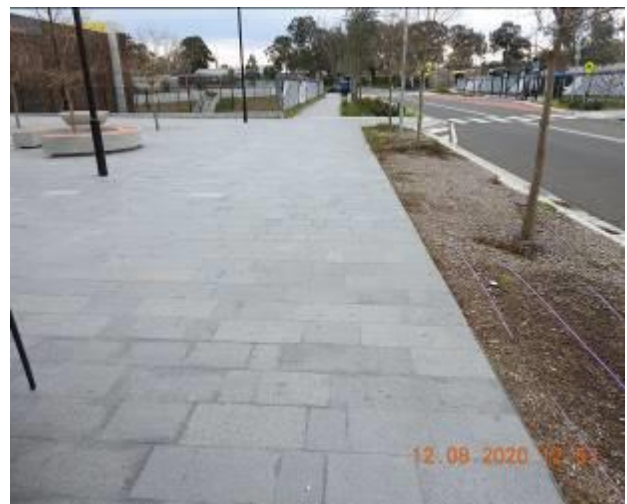
Figure 716 – General condition of footpath pavement

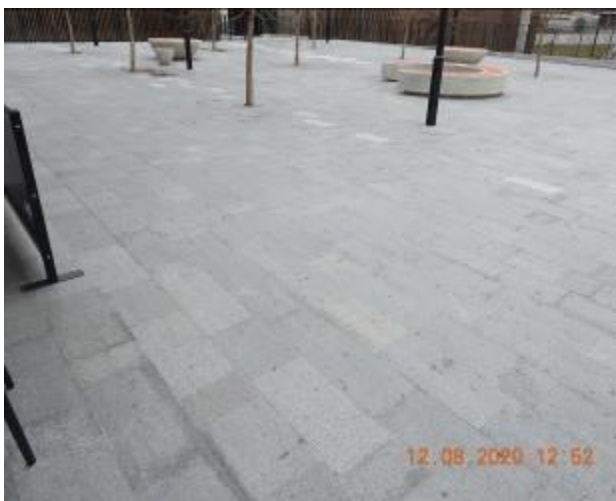
Figure 717 – Efflorescence, hairline crack propagation and loss of material through footpath pavement

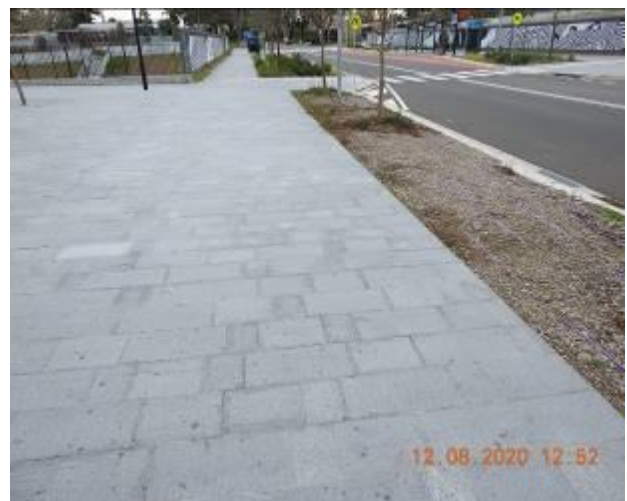
Figure 718 – Efflorescence, hairline crack propagation and loss of material through footpath pavement

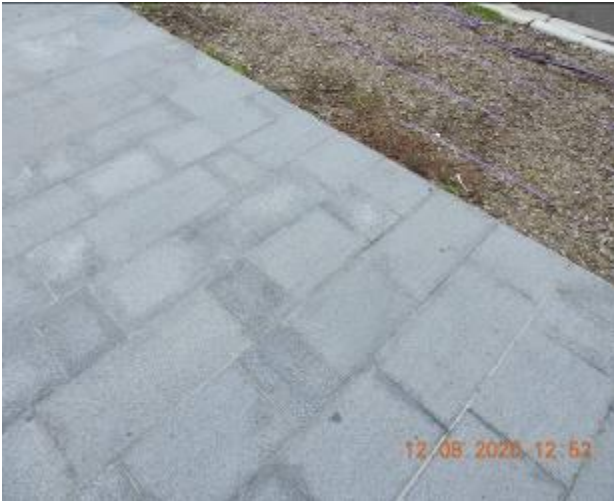
Figure 719 – Loss of material through footpath pavement

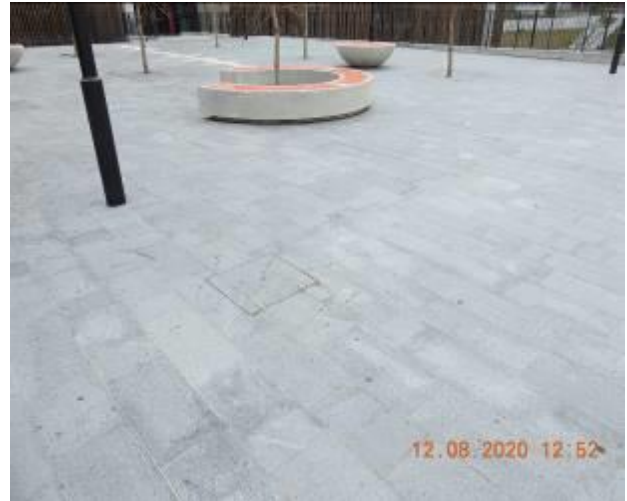
Figure 720 – Efflorescence, hairline crack propagation and loss of material through footpath pavement

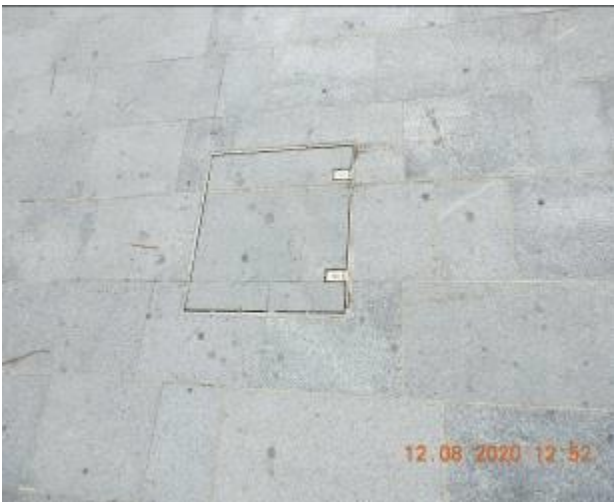
Figure 721 – Loss of material through service pit

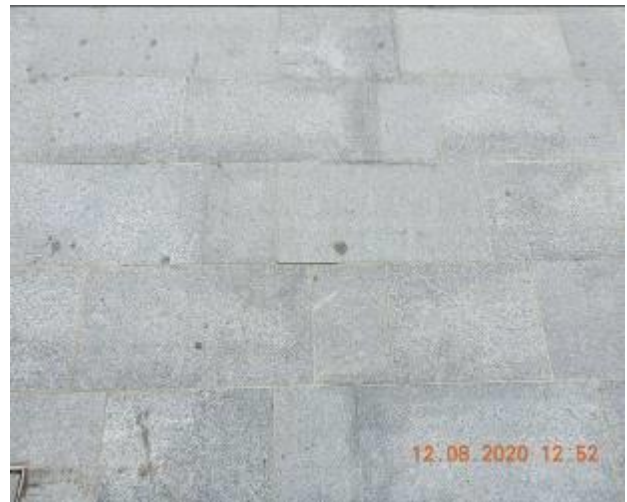
Figure 722 – Efflorescence, hairline crack propagation and loss of material through footpath pavement

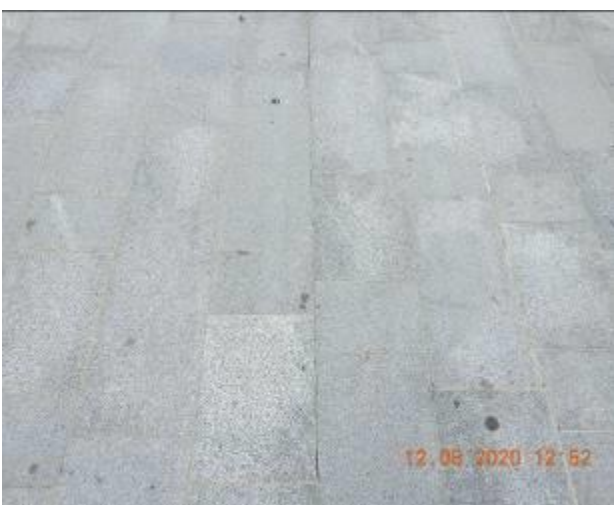
Figure 723 – Efflorescence, hairline crack propagation and loss of material through footpath pavement

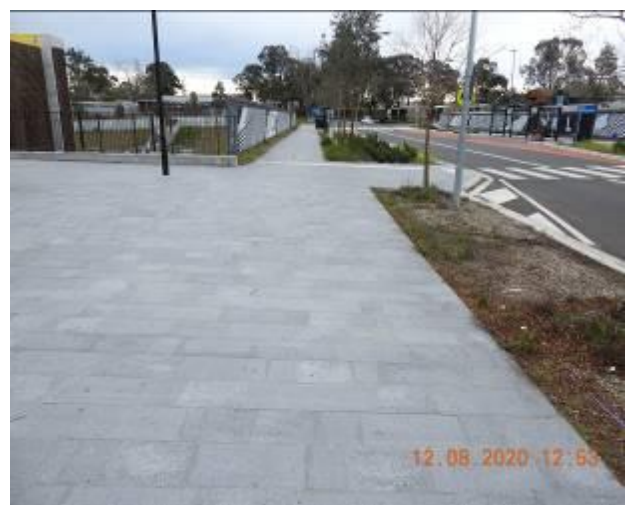
Figure 724 – General condition of footpath pavement

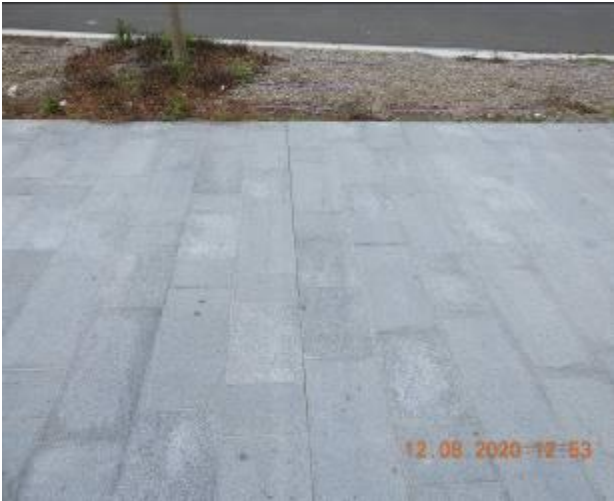
Figure 725 – Efflorescence, hairline crack propagation and loss of material through footpath pavement

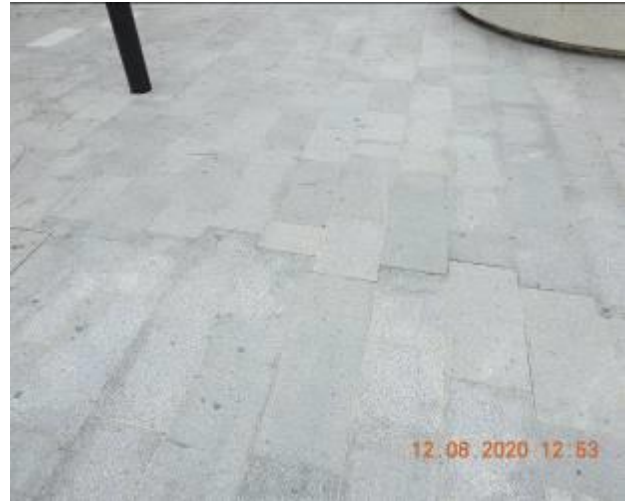
Figure 726 – Efflorescence, hairline crack propagation and loss of material through footpath pavement

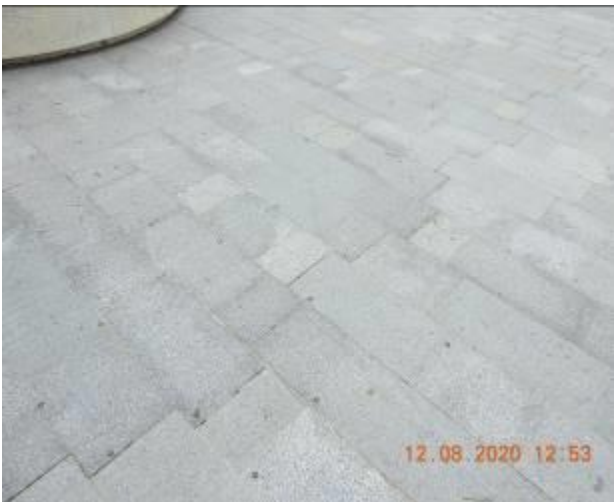
Figure 727 – Efflorescence, hairline crack propagation and loss of material through footpath pavement

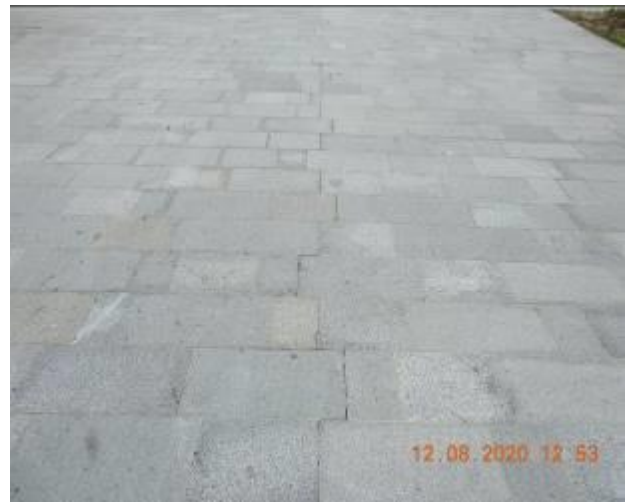
Figure 728 – Efflorescence, hairline crack propagation and loss of material through footpath pavement

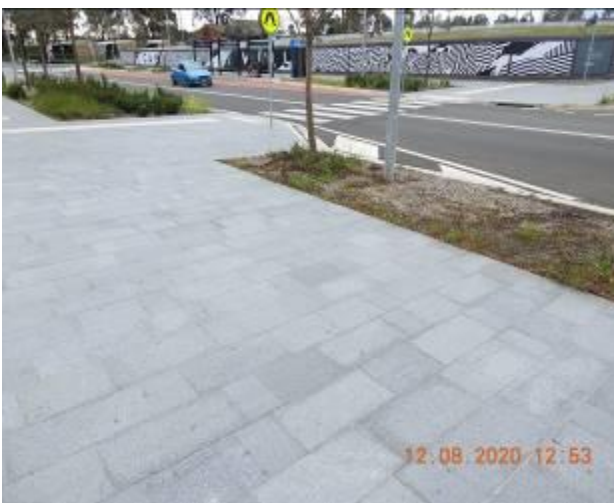
Figure 729 – Efflorescence, hairline crack propagation and loss of material through footpath pavement

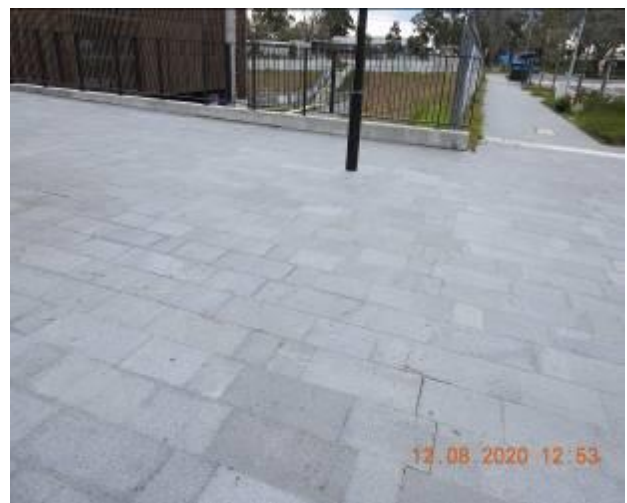
Figure 730 – Efflorescence, hairline crack propagation and loss of material through footpath pavement

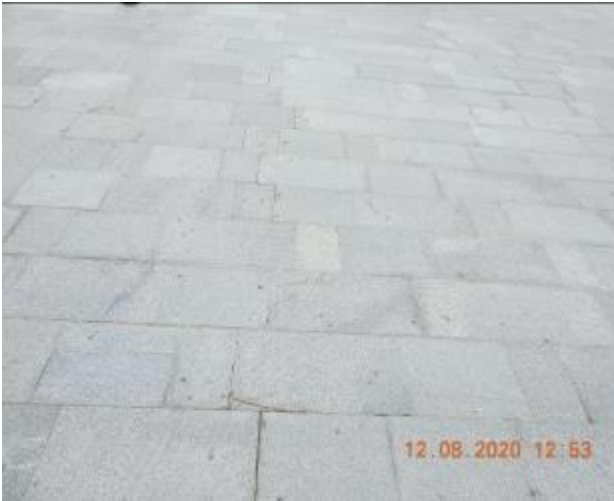
Figure 731 – Efflorescence, hairline crack propagation and loss of material through footpath pavement
