**2 MANDALA PARADE, CASTLE HILL
(DORAN DRIVE PRECINCT)
PRE-DILAPIDATION REPORT
Of Sydney Metro and Hills Shire Council Assets
DEICORP PROJECTS SHOWGROUND
PTY LTD.**

Job No. 200124.3
07/07/2021

ACE Structural Services Pty Ltd

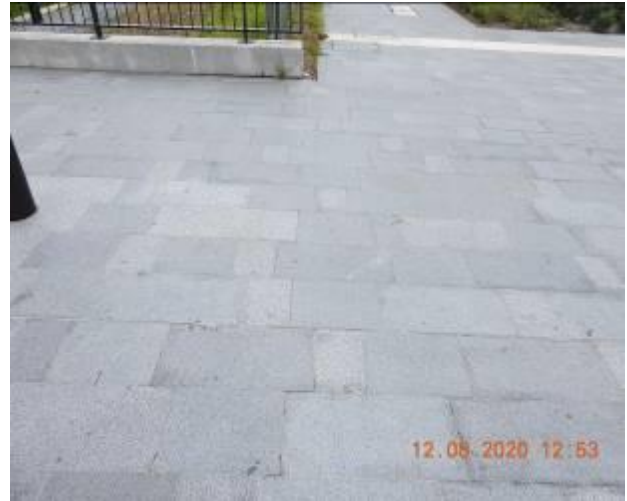
Figure 732 – Efflorescence, hairline crack propagation and loss of material through footpath pavement

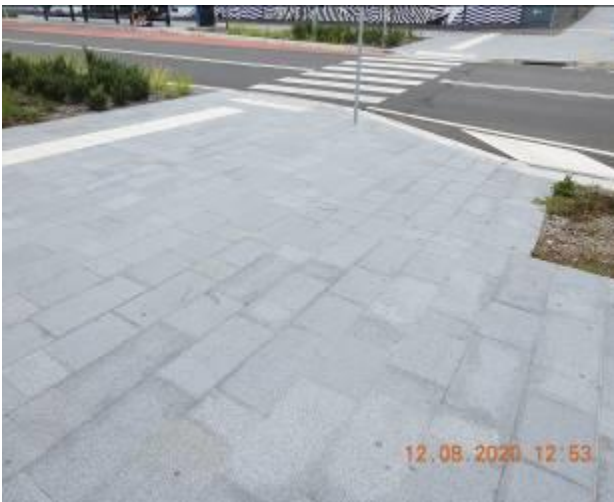
Figure 733 – General condition of footpath pavement

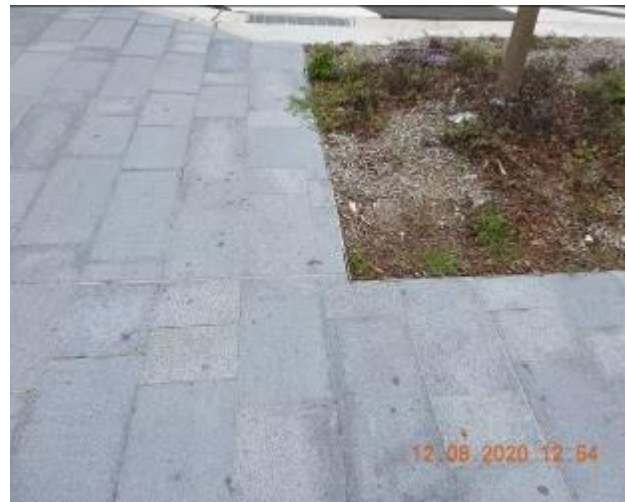
Figure 734 – Crack propagation and loss of material through footpath pavement

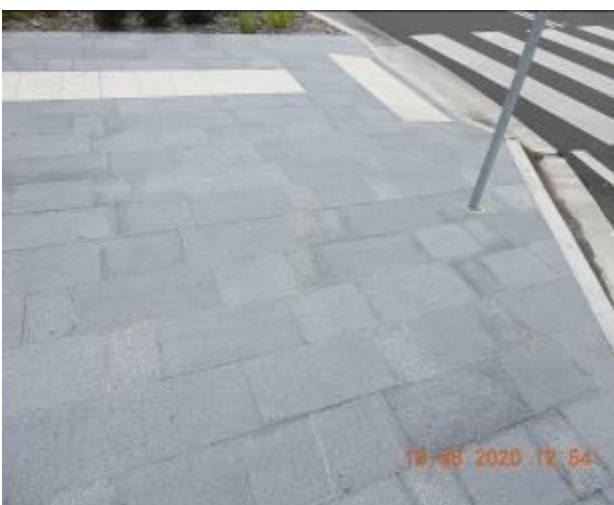
Figure 735 – Crack propagation and loss of material through footpath pavement

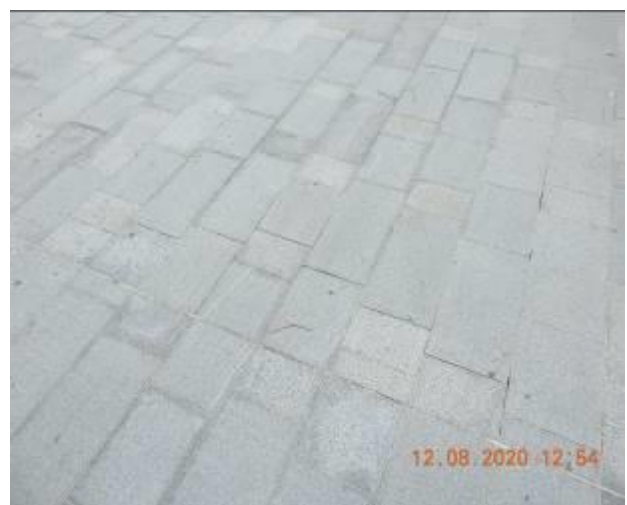
Figure 736 – Efflorescence, hairline crack propagation and loss of material through footpath pavement

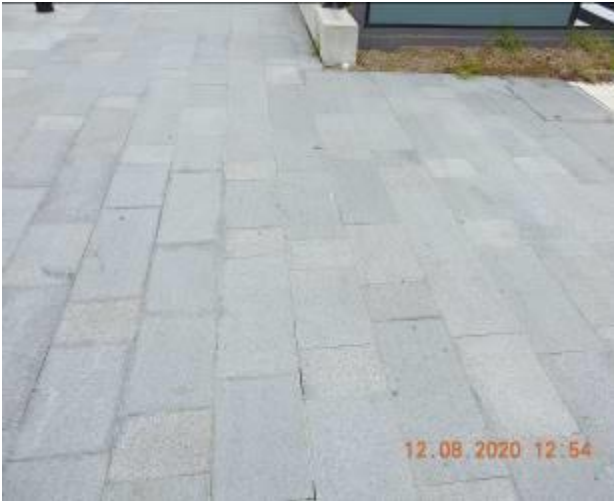
Figure 737 – Crack propagation and loss of material through footpath pavement

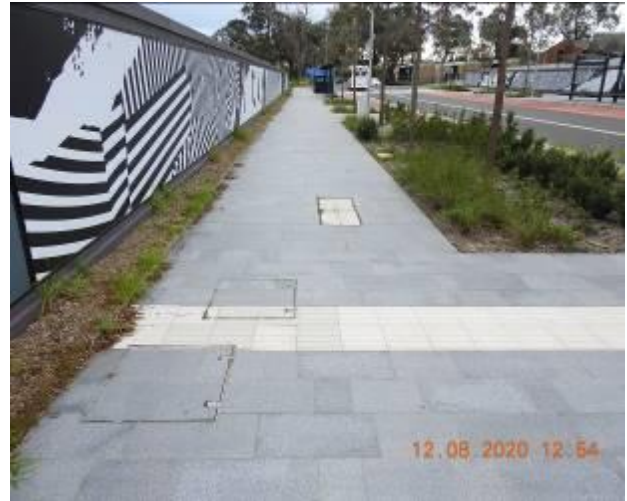
Figure 738 – General condition of footpath pavement

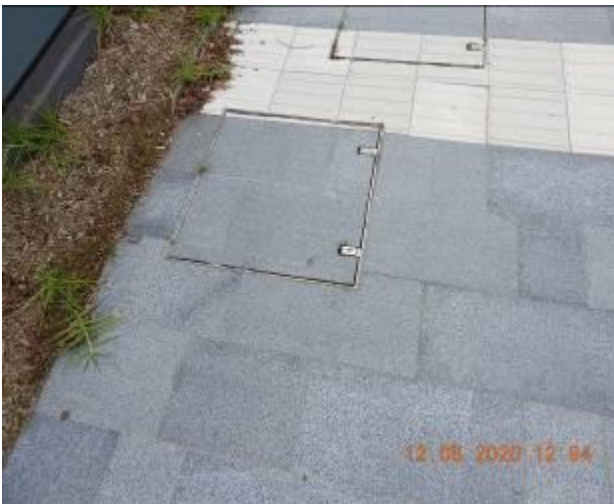
Figure 739 – Loss of material through service pit pavement

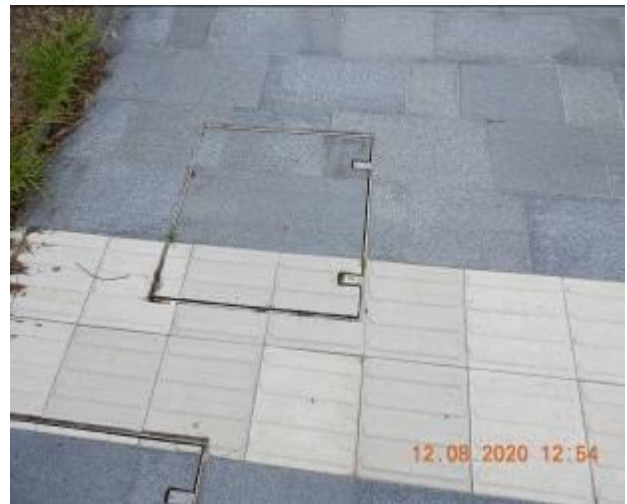
Figure 740 – Crack propagation and loss of material through service pit pavement

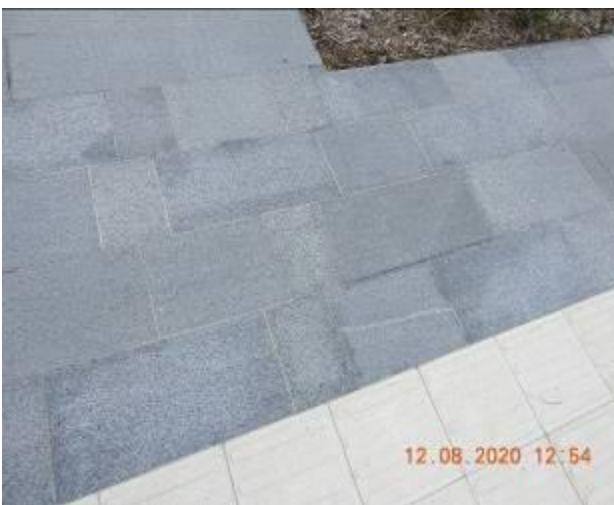
Figure 741 – Crack propagation and loss of material through footpath pavement

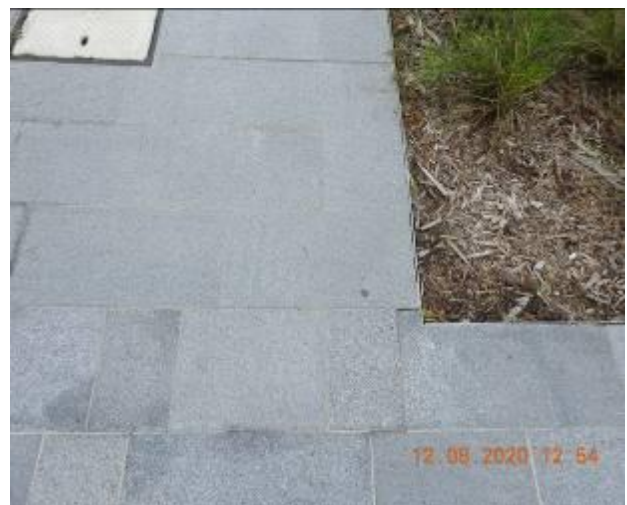
Figure 742 – Loss of material through footpath pavement

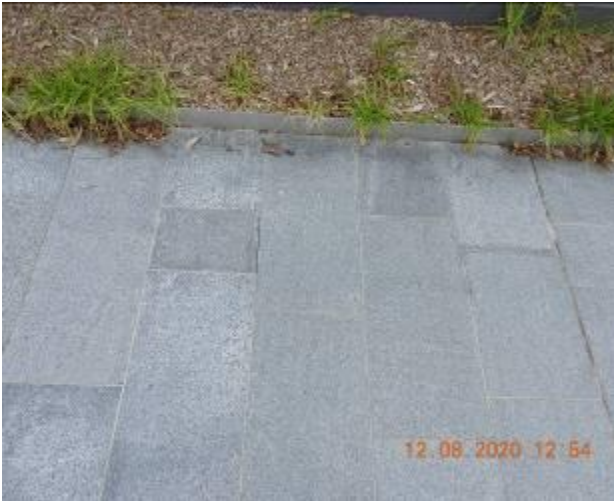
Figure 743 – Loss of material through footpath pavement

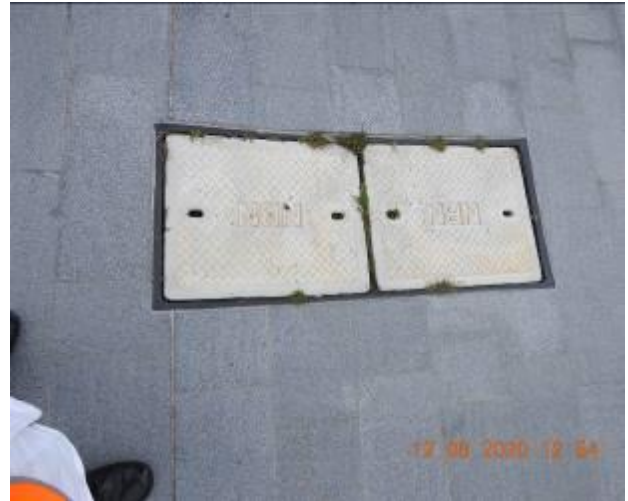
Figure 744 – General condition of service pit

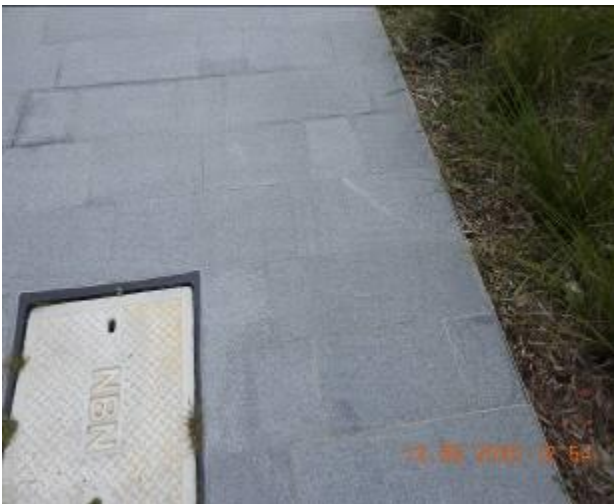
Figure 745 – Crack propagation and loss of material through footpath pavement

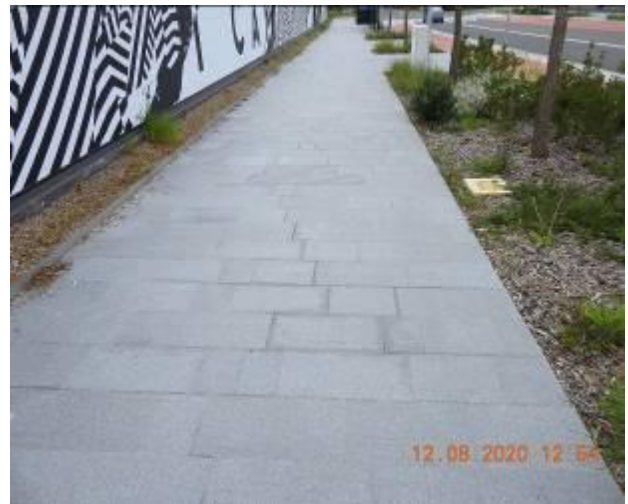
Figure 746 – General condition of footpath pavement

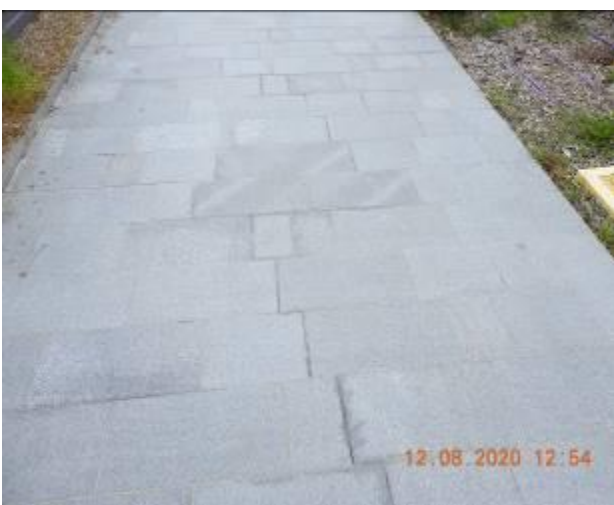
Figure 747 – Loss of material through footpath pavement

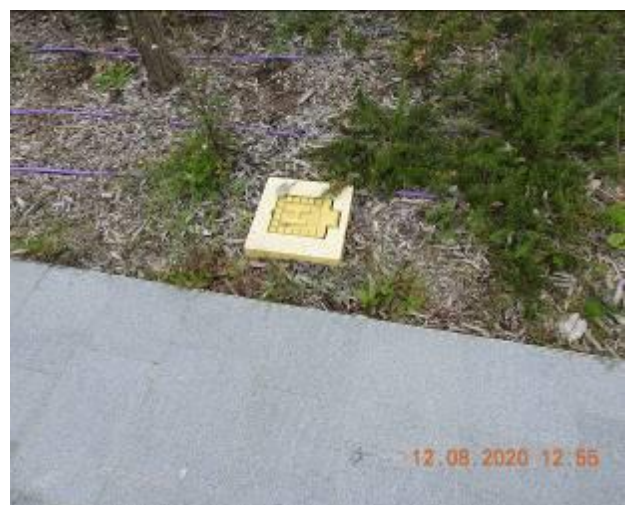
Figure 748 – General condition of service pit

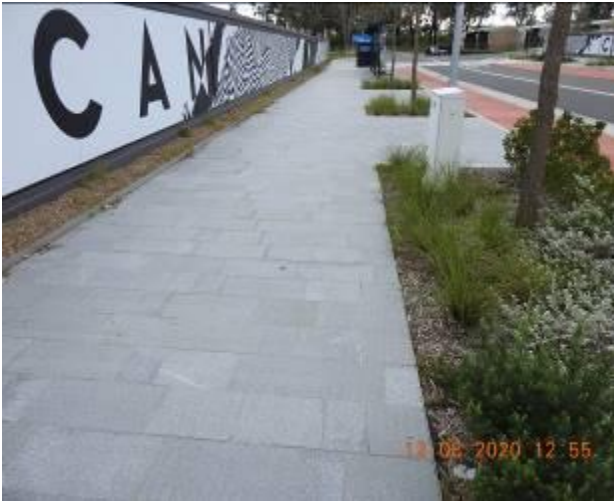
Figure 749 – General condition of footpath pavement

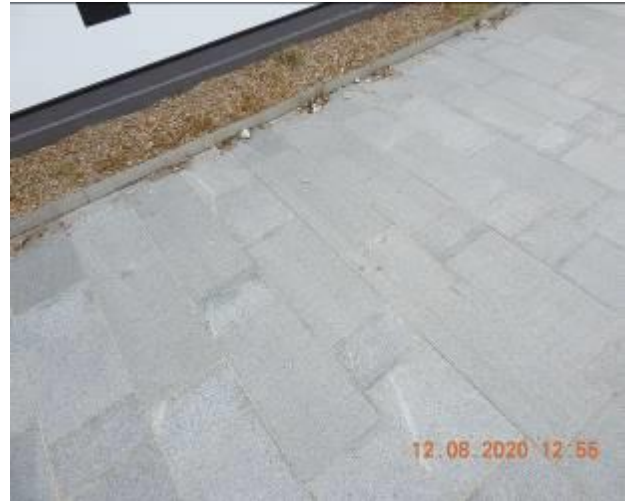
Figure 750 – Efflorescence, hairline crack propagation and loss of material through footpath pavement

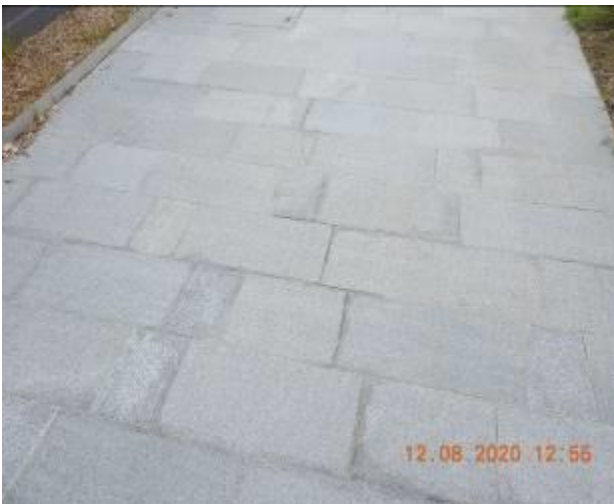
Figure 751 – Crack propagation and loss of material through footpath pavement

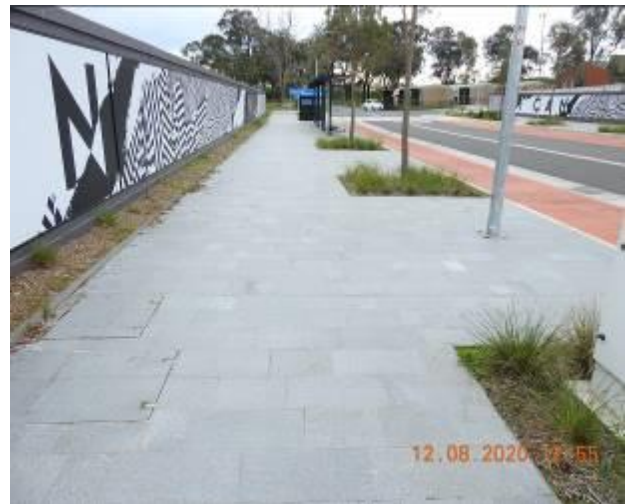
Figure 752 – General condition of footpath pavement

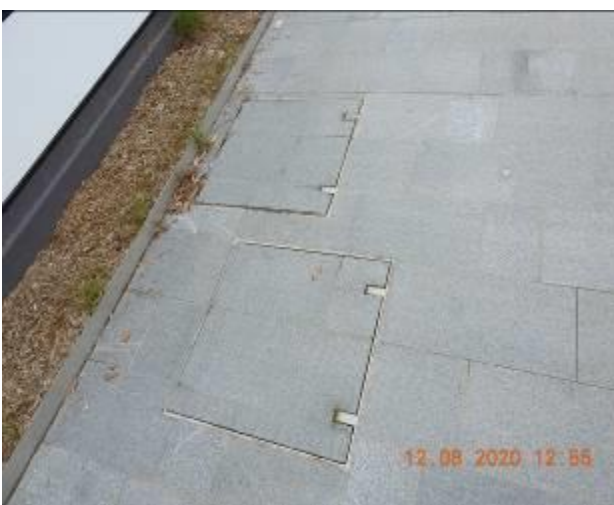
Figure 753 – Loss of material through service pit pavement

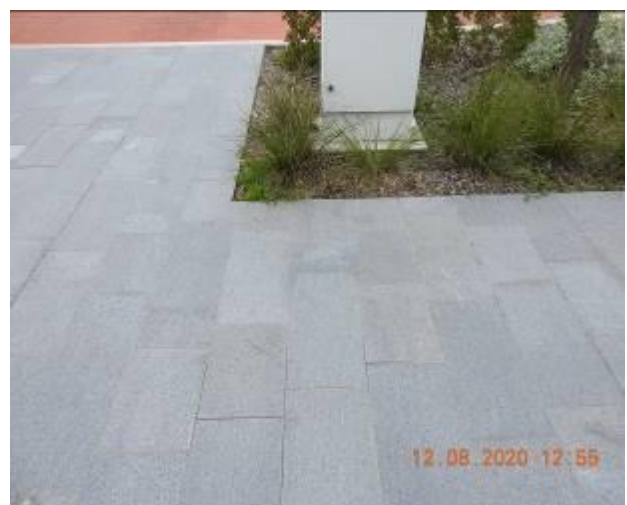
Figure 754 – Loss of material through footpath pavement

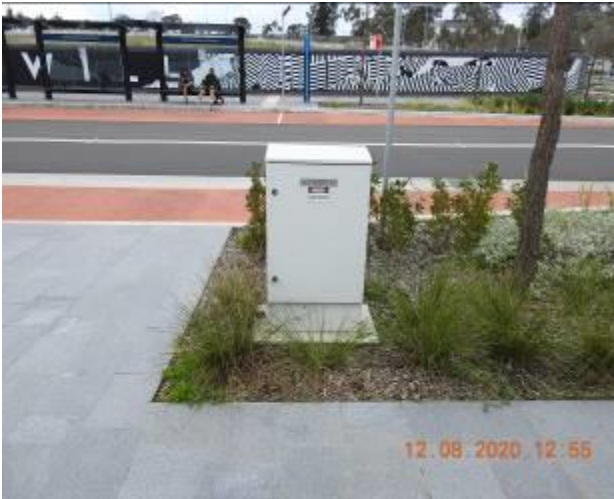
Figure 755 – General condition of communication box

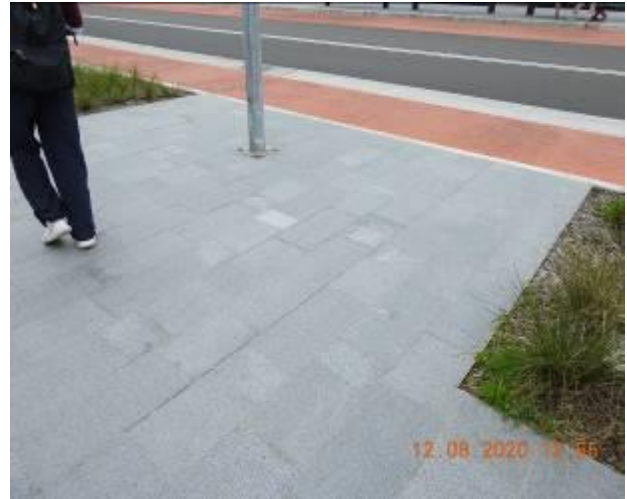
Figure 756 – Loss of material through footpath pavement

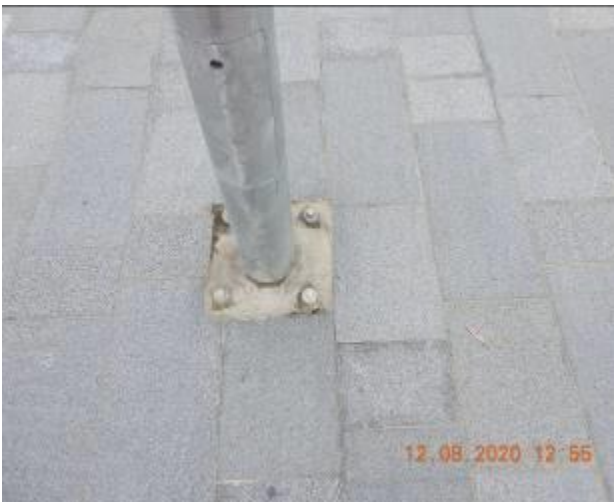
Figure 757 – Loss of material through lamp post foundation

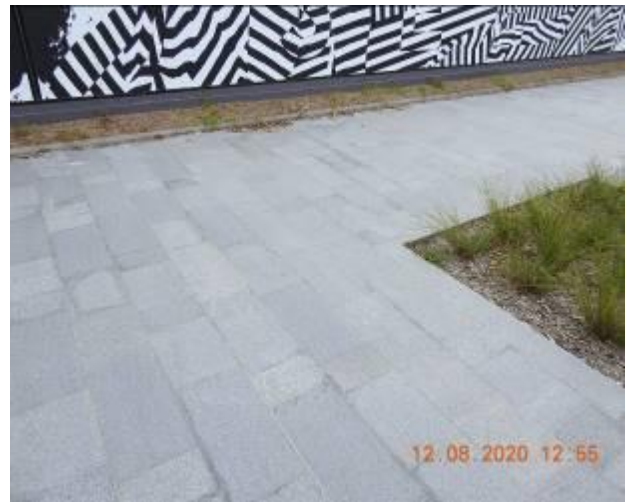
Figure 758 – Loss of material through footpath pavement

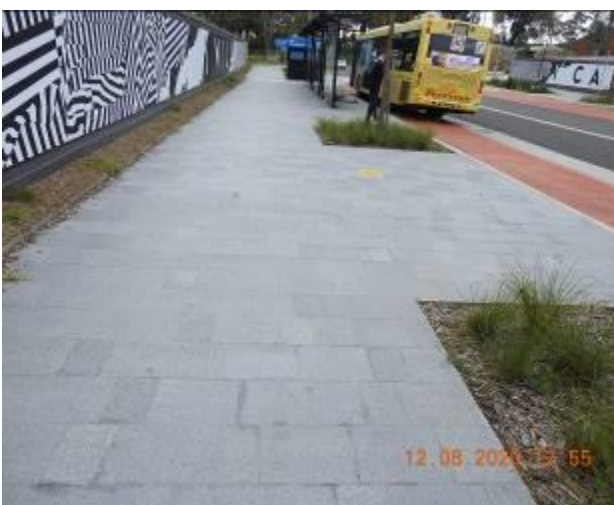
Figure 759 – Loss of material through footpath pavement

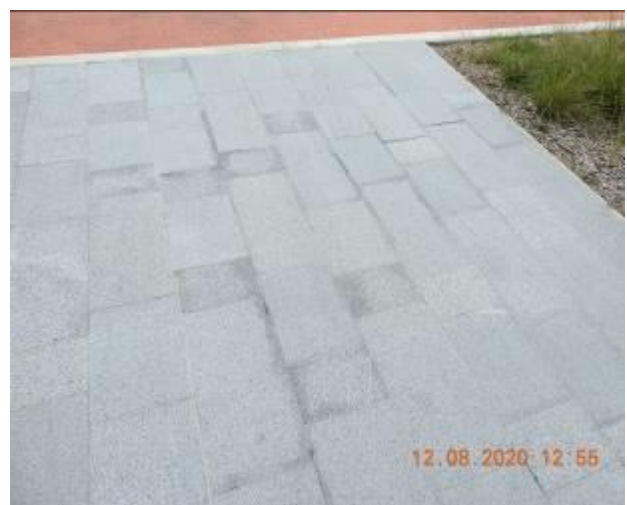
Figure 760 – Crack propagation and loss of material through footpath pavement

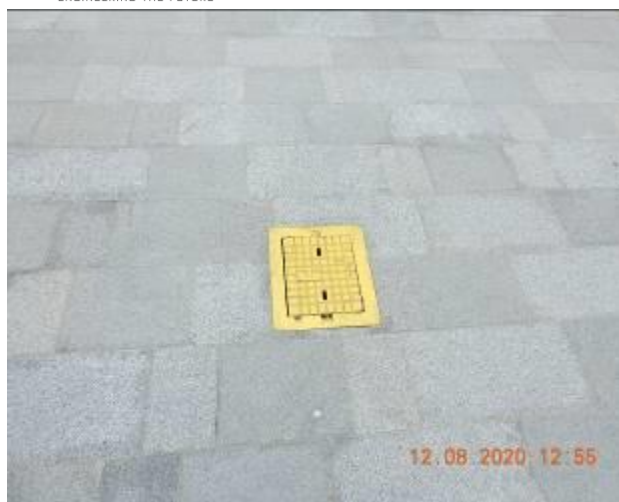
Figure 761 – General condition of service pit

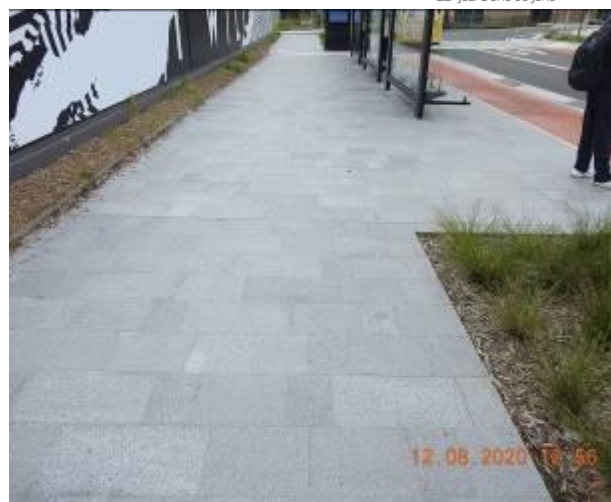
Figure 762 – Crack propagation through footpath pavement

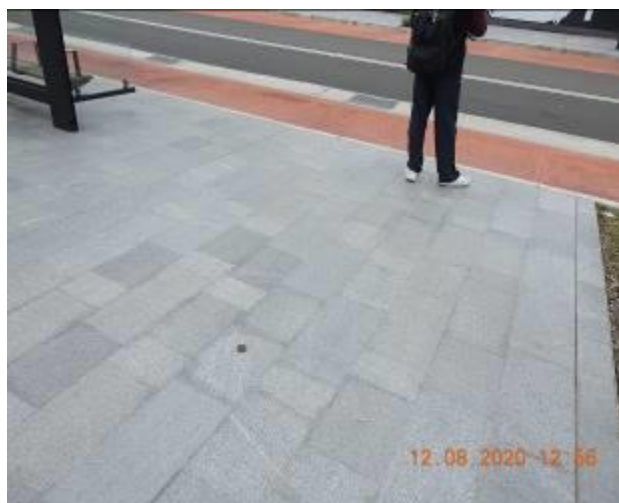
Figure 763 – Hairline crack propagation and loss of material through footpath pavement

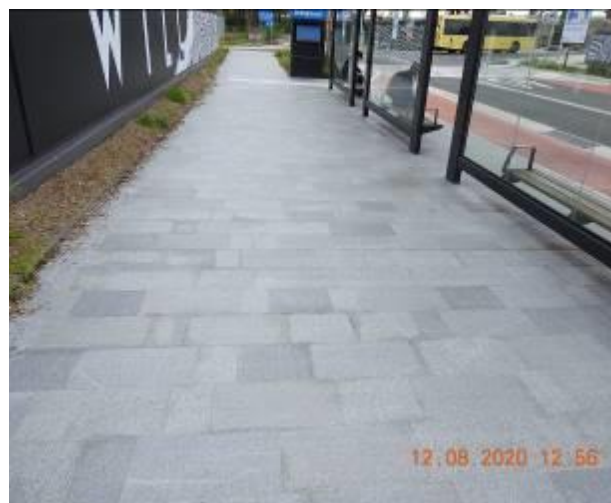
Figure 764 – Hairline crack propagation through footpath pavement

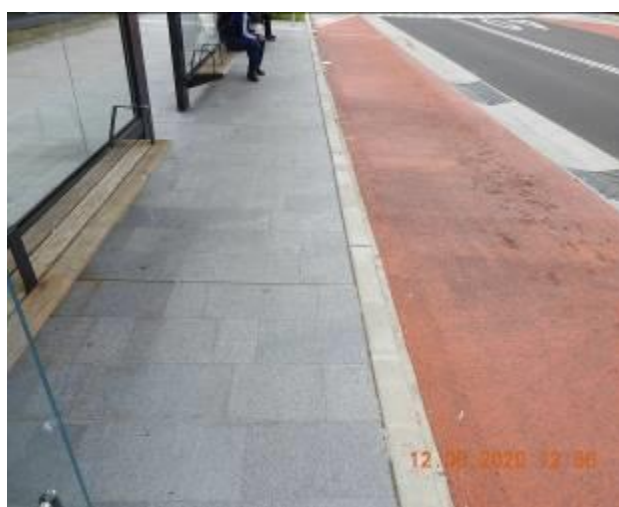
Figure 765 – Efflorescence and hairline crack propagation through footpath pavement

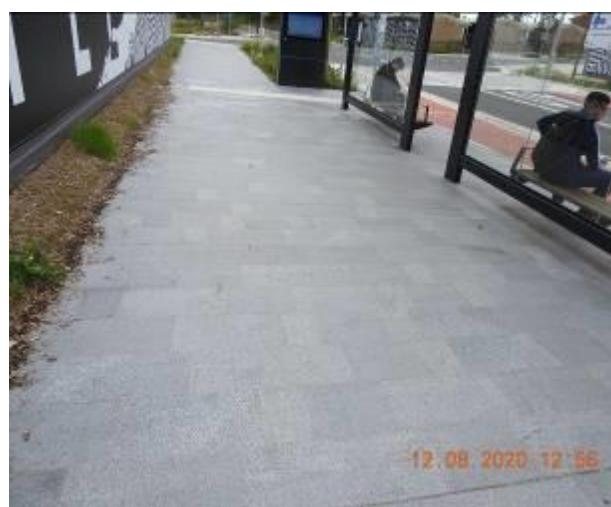
Figure 766 – General condition of footpath pavement

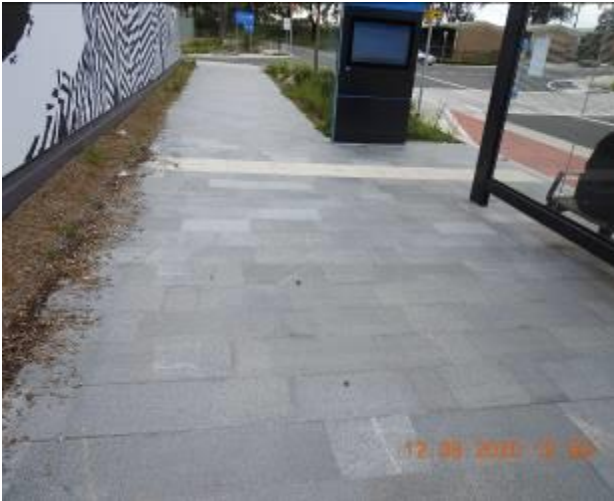
Figure 767 – Hairline crack propagation through footpath pavement

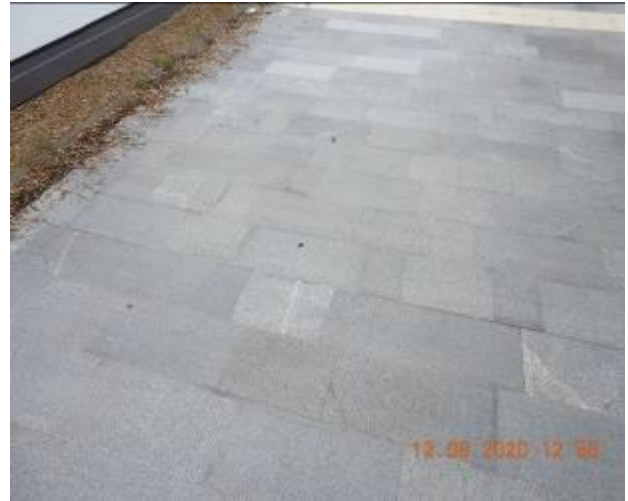
Figure 768 – Hairline crack propagation through footpath pavement

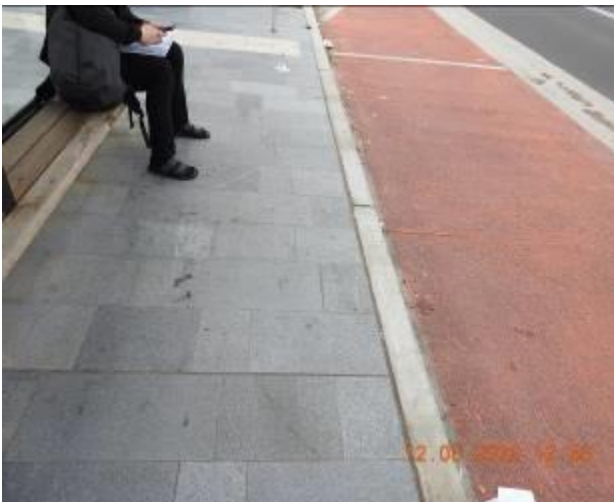
Figure 769 – Hairline crack propagation through footpath pavement

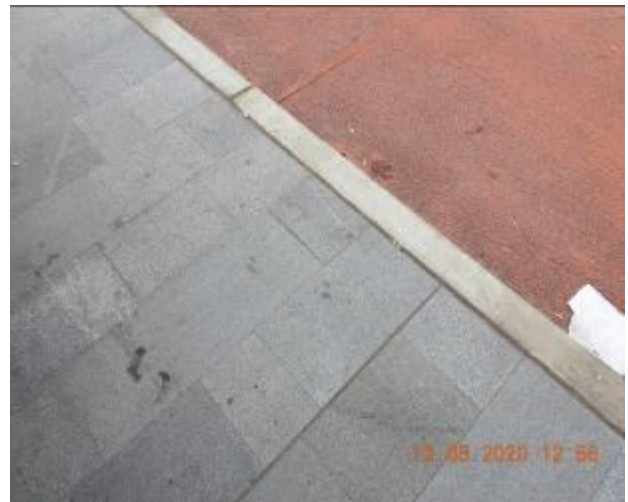
Figure 770 – Hairline crack propagation through footpath pavement

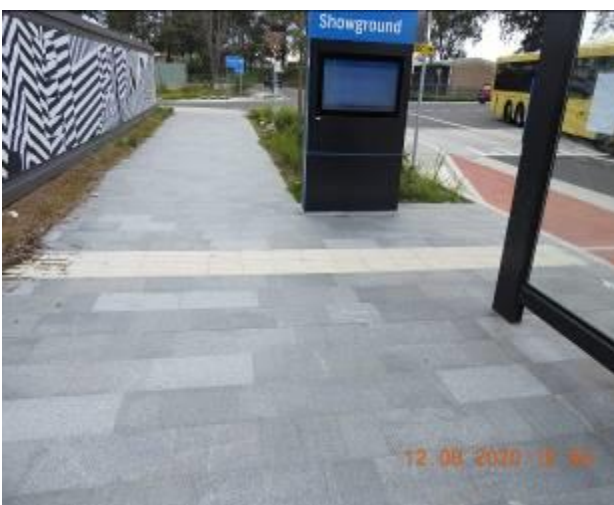
Figure 771 – Hairline crack propagation through footpath pavement

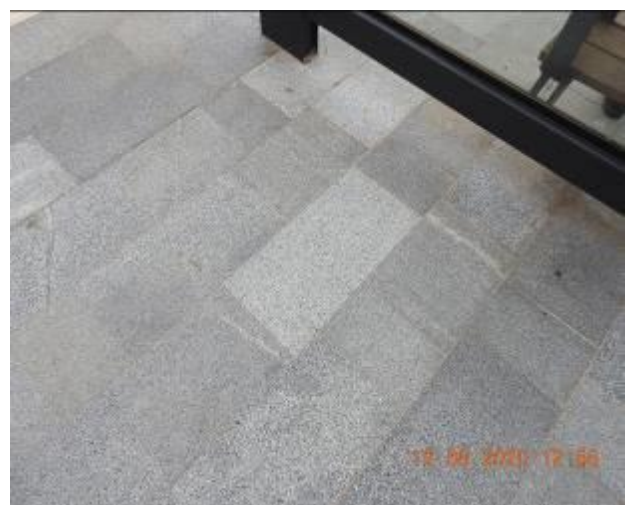
Figure 772 – Hairline crack propagation through footpath pavement

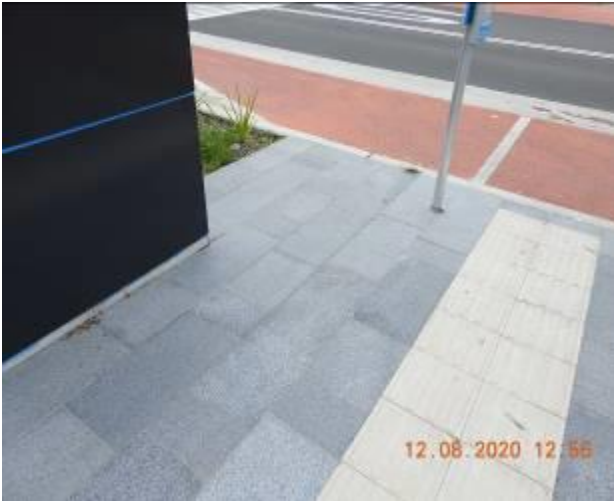
Figure 773 – Hairline crack propagation and loss of material through footpath pavement

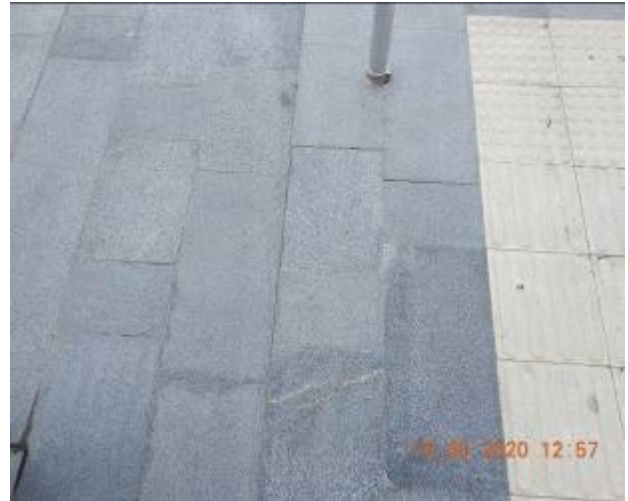
Figure 774 – Hairline crack propagation and loss of material through footpath pavement

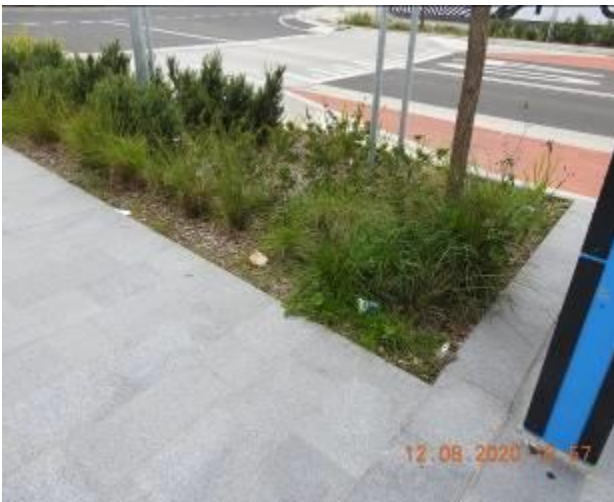
Figure 775 – General condition of nature stripes

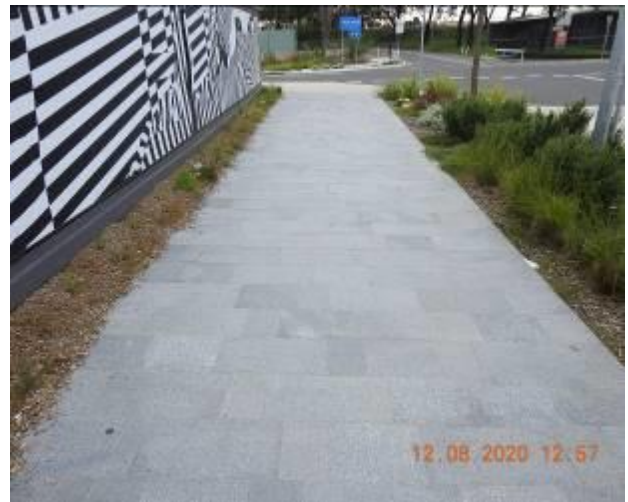
Figure 776 – General condition of footpath pavement

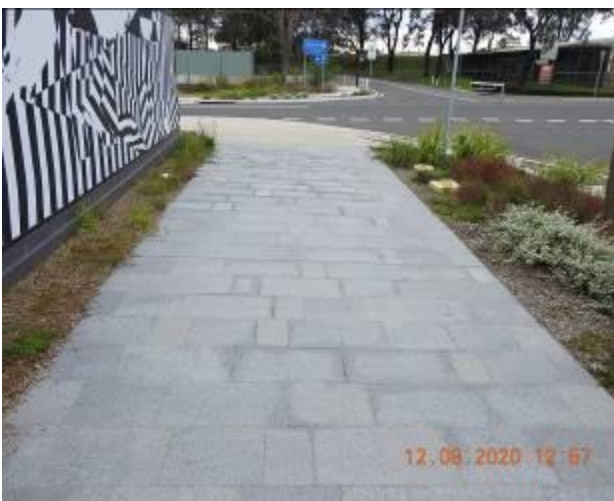
Figure 777 – Loss of material through footpath pavement

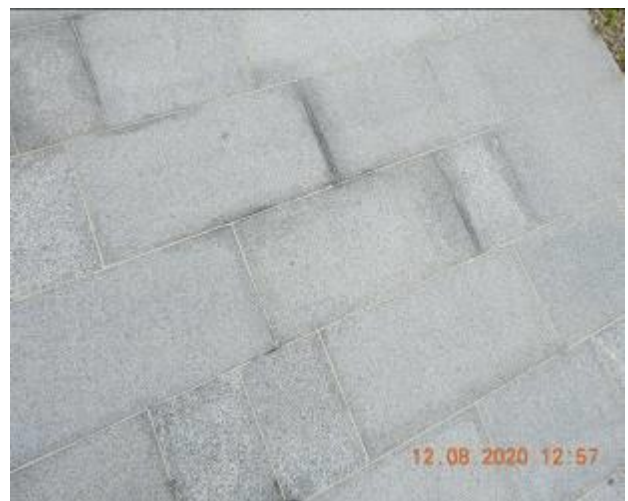
Figure 778 – Loss of material through footpath pavement

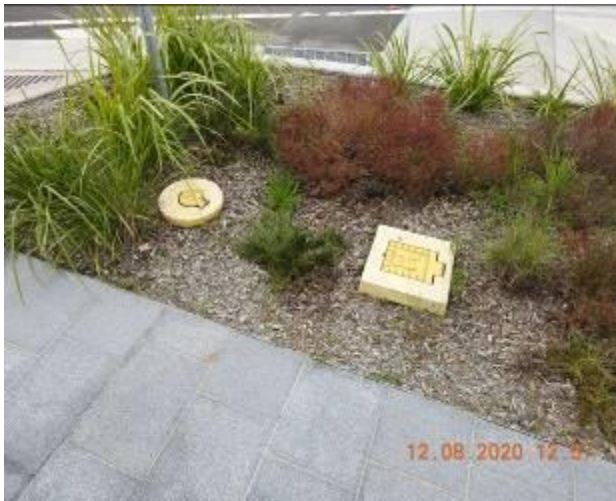
Figure 779 – General condition of service pit

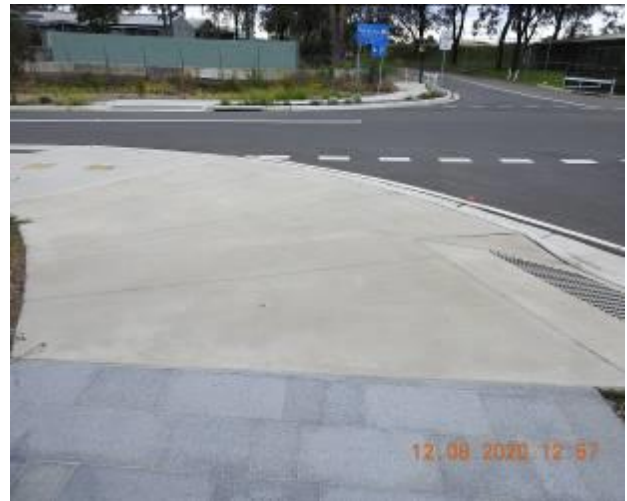
Figure 780 – General condition of footpath pavement

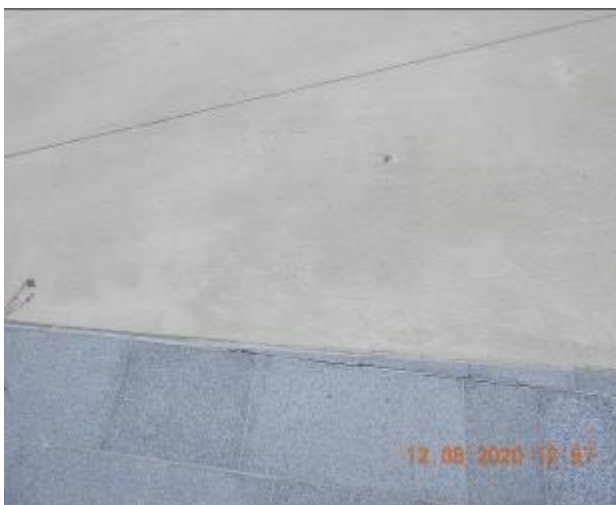
Figure 781 – Crack propagation and loss of material through footpath pavement

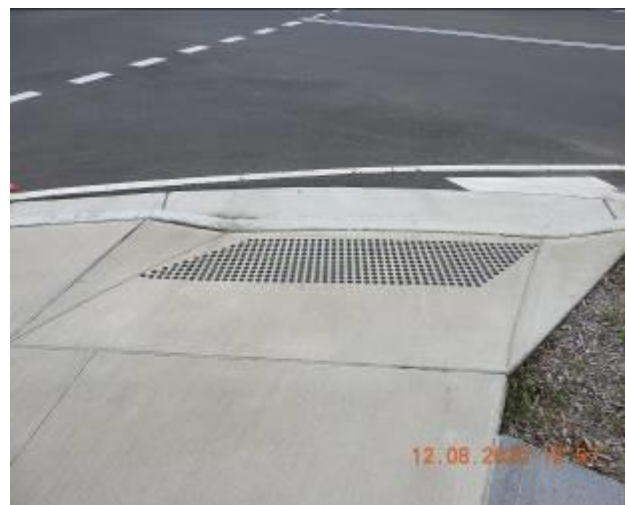
Figure 782 – Crack propagation and loss of material through footpath pavement

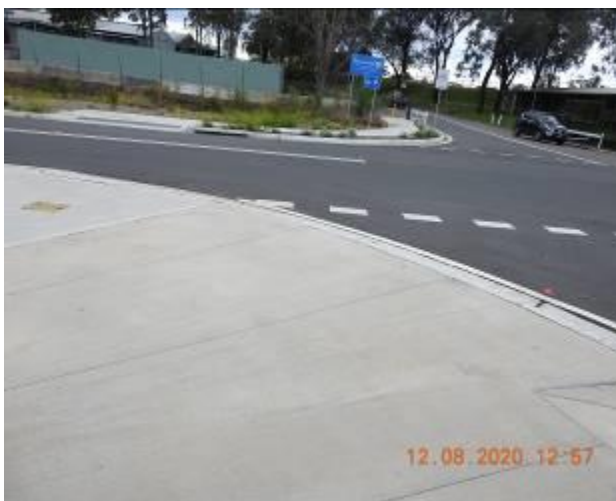
Figure 783 – General condition of footpath pavement

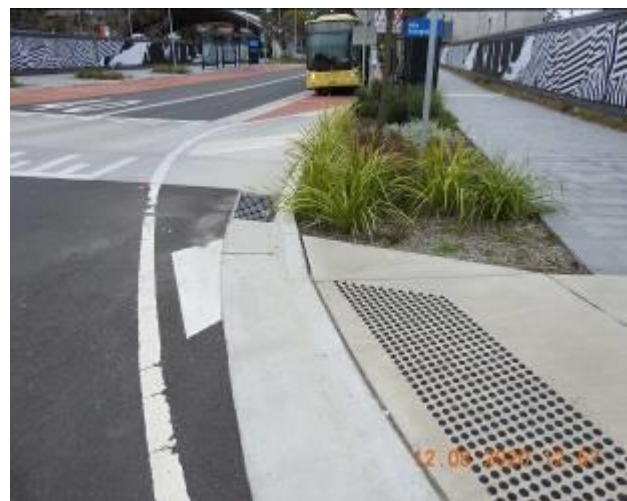
Figure 784 –General condition of kerb and gutter heading South

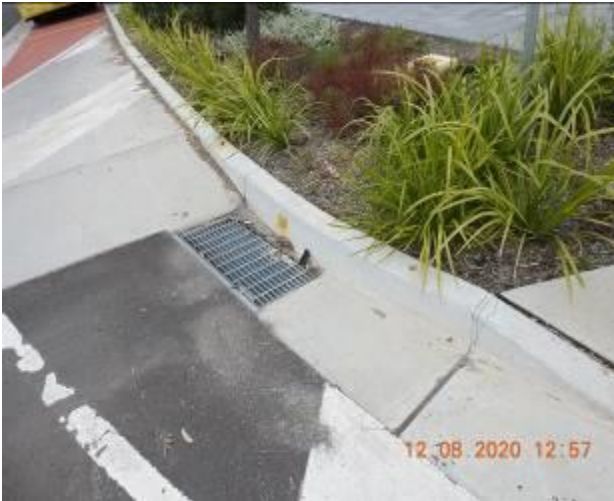
Figure 785 – General condition of stormwater inlet pit

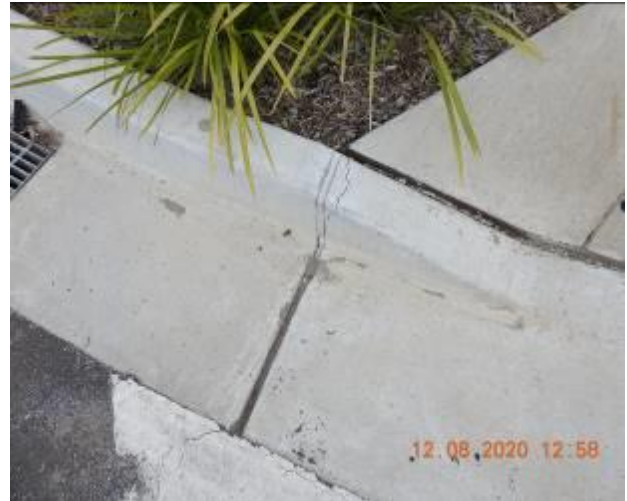
Figure 786 – Crack propagation and loss of material through kerb and gutter

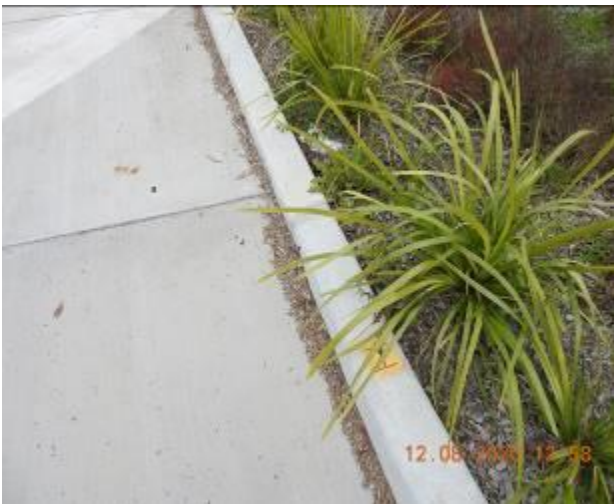
Figure 787 – Evidence of patchwork crack propagation and loss of material through kerb

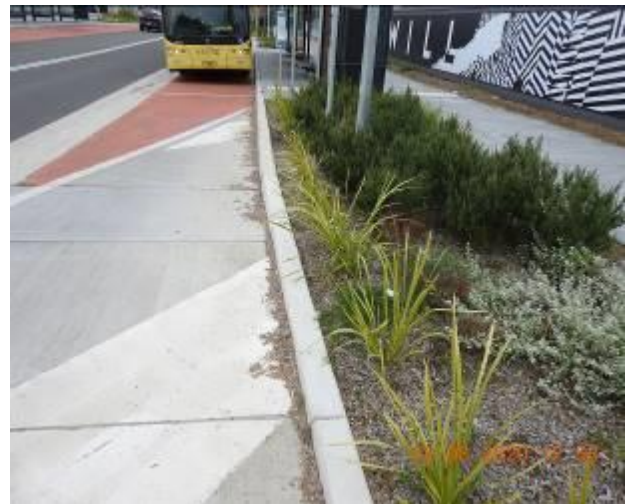
Figure 788 – General condition of kerb

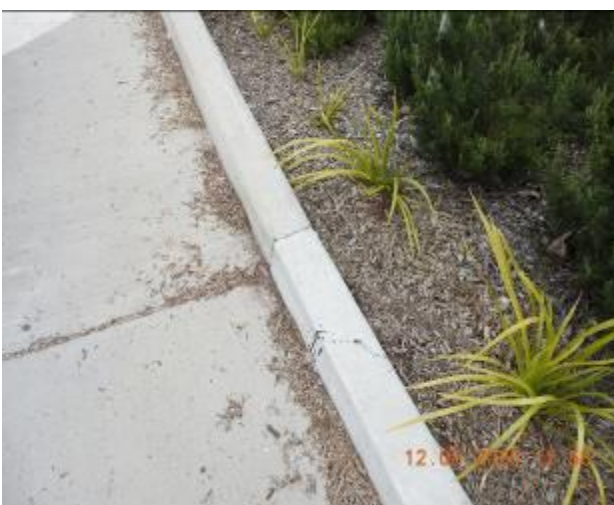
Figure 789 – Loss of material through kerb

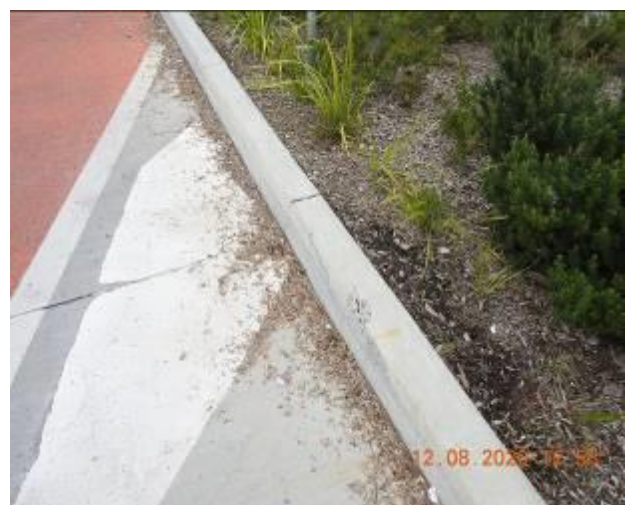
Figure 790 – Crack propagation and loss of material through kerb

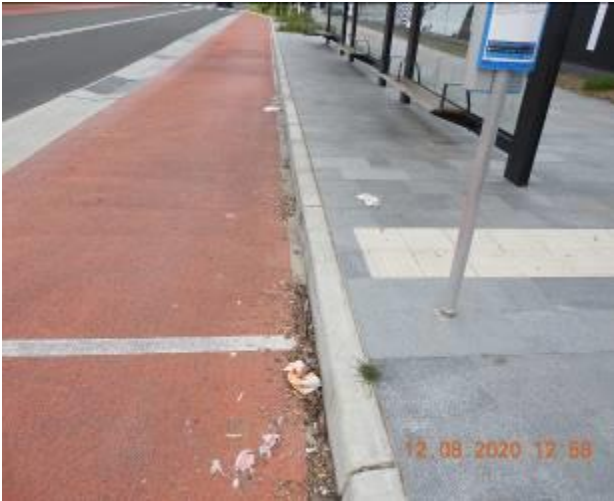
Figure 791 – General condition of kerb

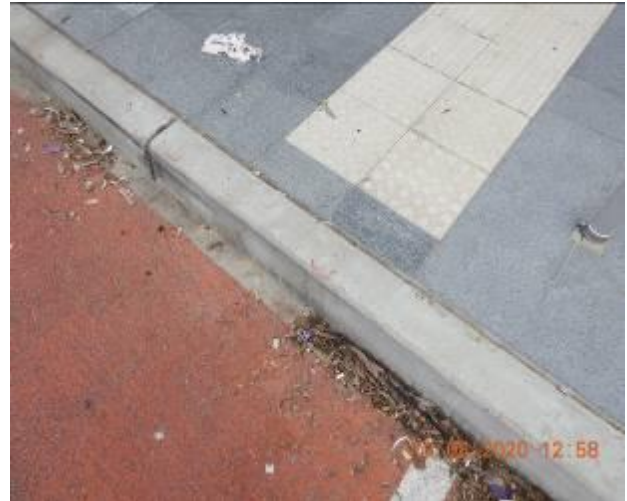
Figure 792 – Evidence of patchwork, crack propagation and loss of material through kerb

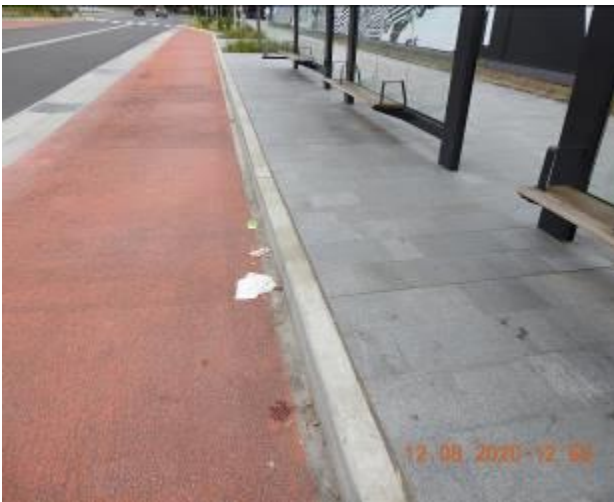
Figure 793 – General condition of kerb and gutter

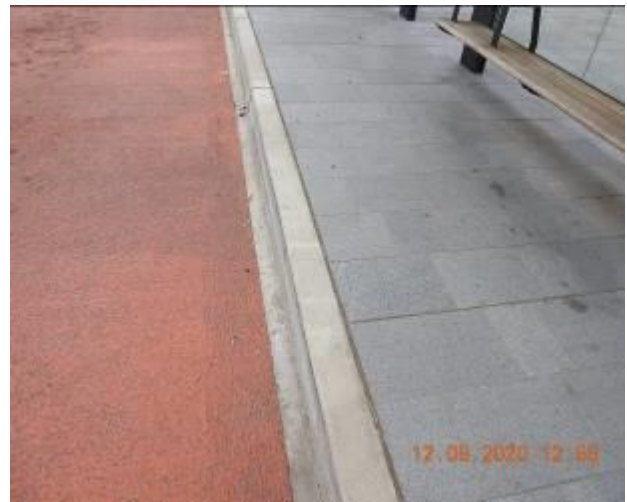
Figure 794 – Hairline crack propagation and evidence of patchwork through kerb

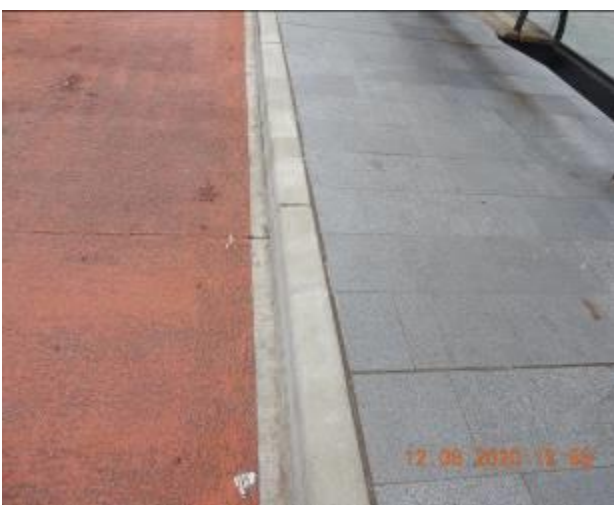
Figure 795 – Hairline crack propagation and evidence of patchwork through kerb

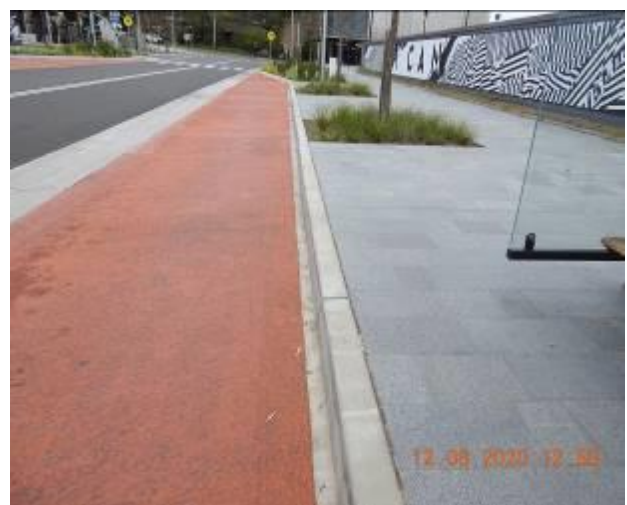
Figure 796 – General condition of kerb

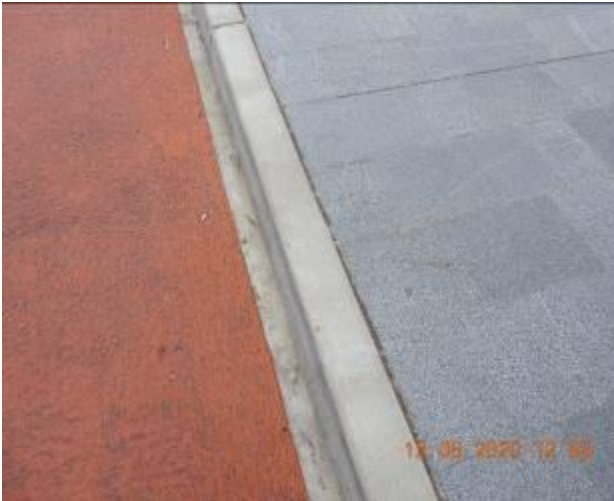
Figure 797 – Hairline crack propagation and evidence of patchwork through kerb

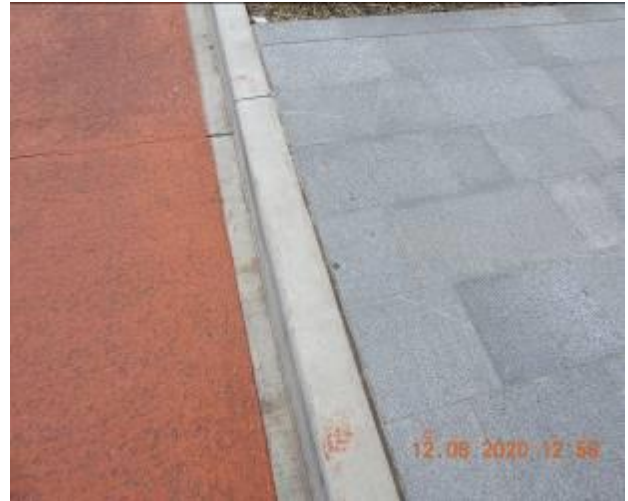
Figure 798 – Hairline crack propagation and evidence of patchwork through kerb

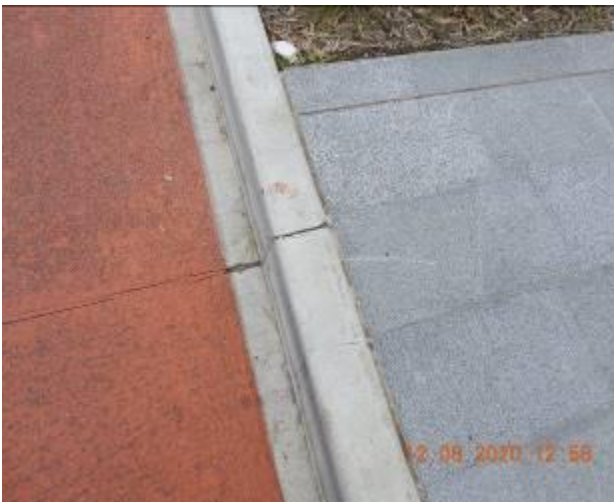
Figure 799 – Evidence of patchwork, crack propagation and loss of material through kerb

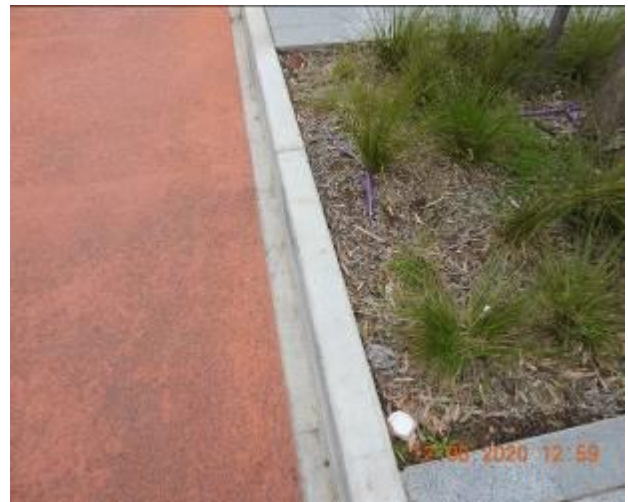
Figure 800 – Crack propagation and evidence of patchwork through kerb

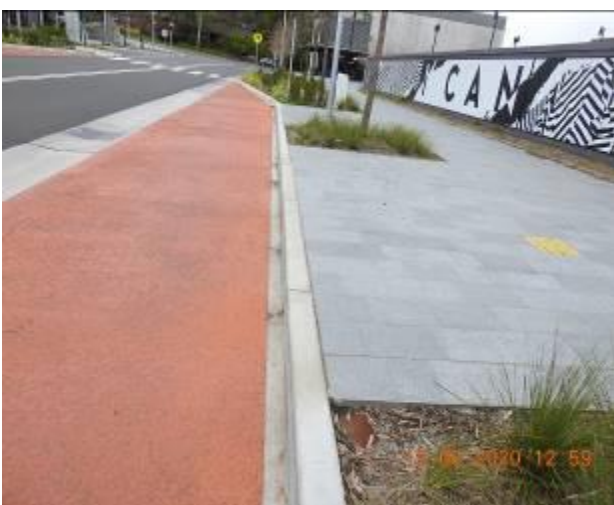
Figure 801 – General condition of kerb
