**2 MANDALA PARADE, CASTLE HILL
(DORAN DRIVE PRECINCT)
PRE-DILAPIDATION REPORT
Of Sydney Metro and Hills Shire Council Assets
DEICORP PROJECTS SHOWGROUND
PTY LTD.**

Job No. 200124.3
07/07/2021

ACE Structural Services Pty Ltd

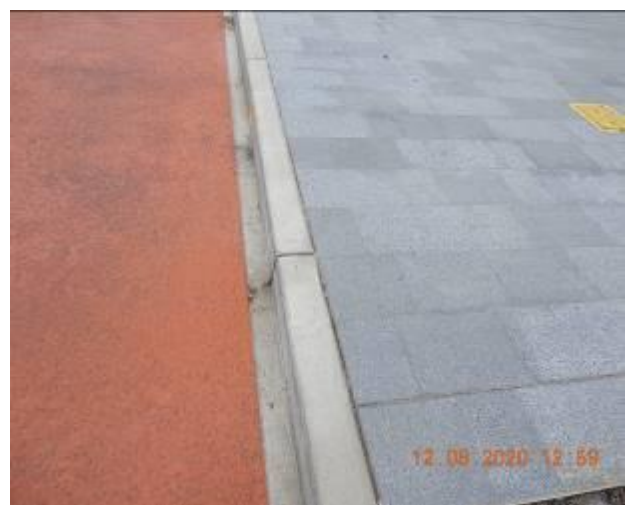
Figure 802 – Hairline crack propagation and evidence of patchwork through kerb

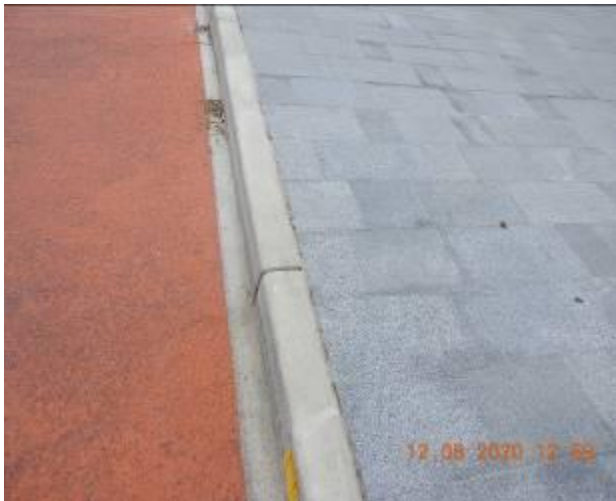
Figure 803 – Evidence of patchwork, hairline crack propagation and loss of material through kerb

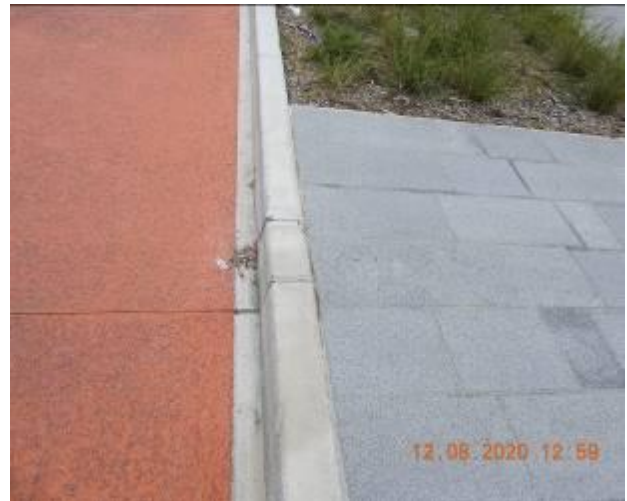
Figure 804 – Crack propagation and loss of material through kerb

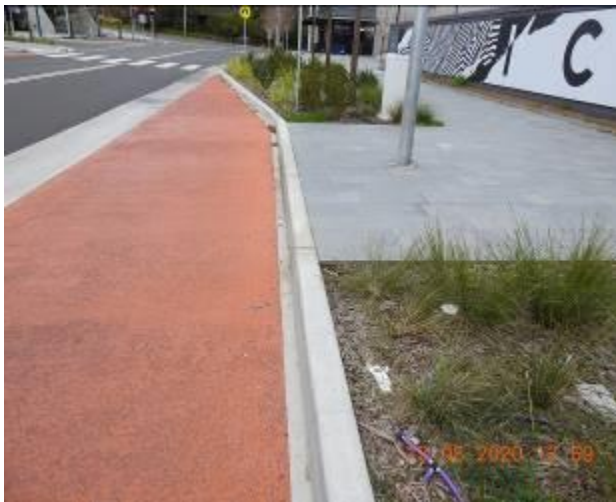
Figure 805 – General condition of kerb

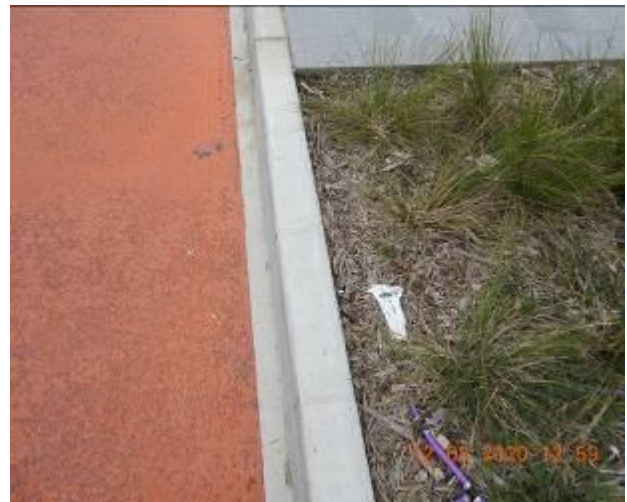
Figure 806 – Hairline crack propagation and evidence of patchwork through kerb

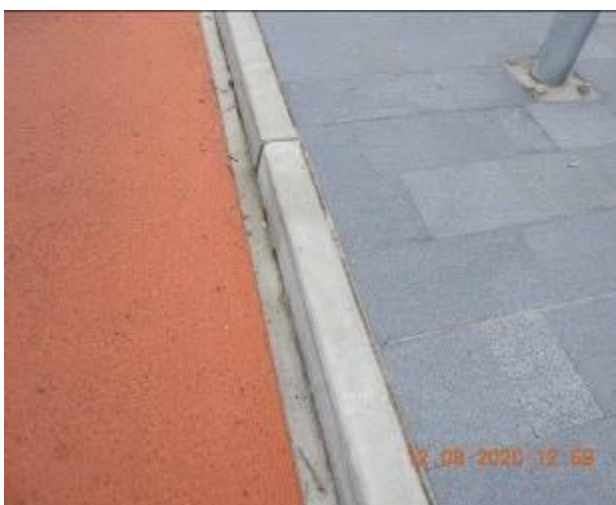
Figure 807 – Hairline crack propagation and evidence of patchwork through kerb

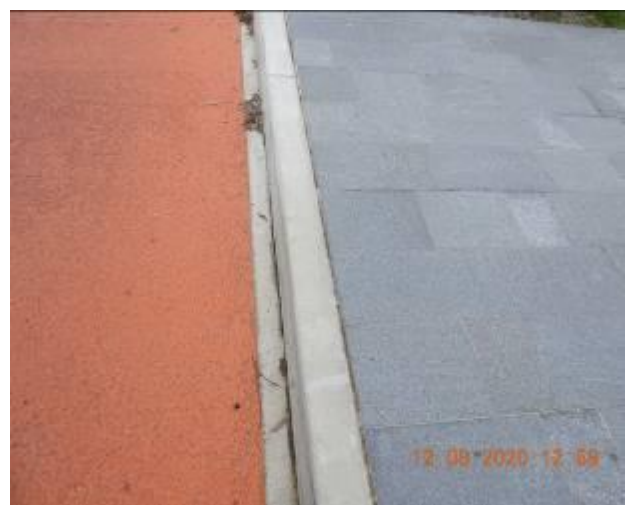
Figure 808 – Hairline crack propagation and evidence of patchwork through kerb

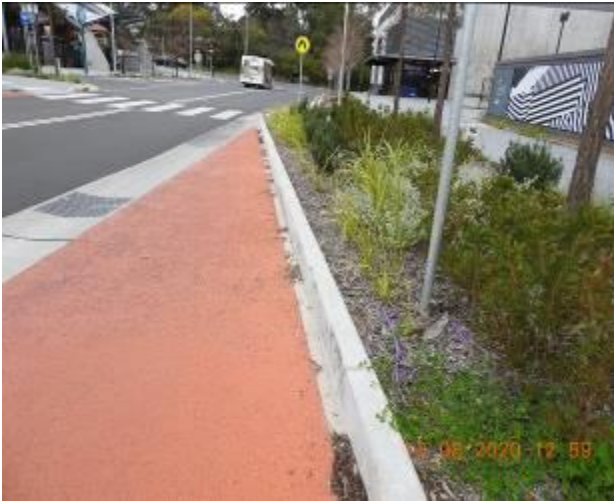
Figure 809 – General condition of kerb

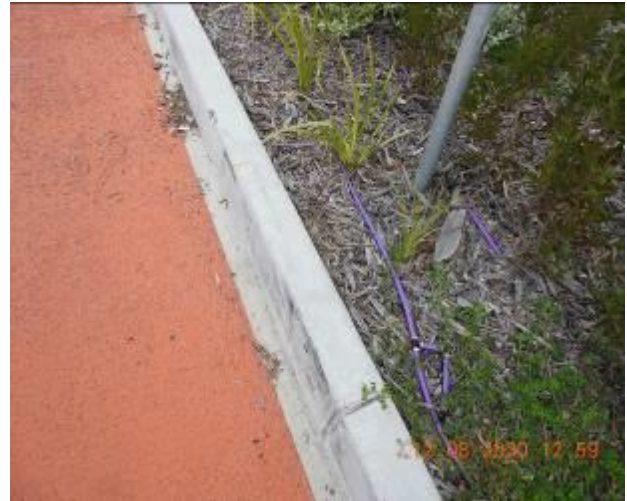
Figure 810 – Evidence of patchwork, crack propagation and loss of material through kerb

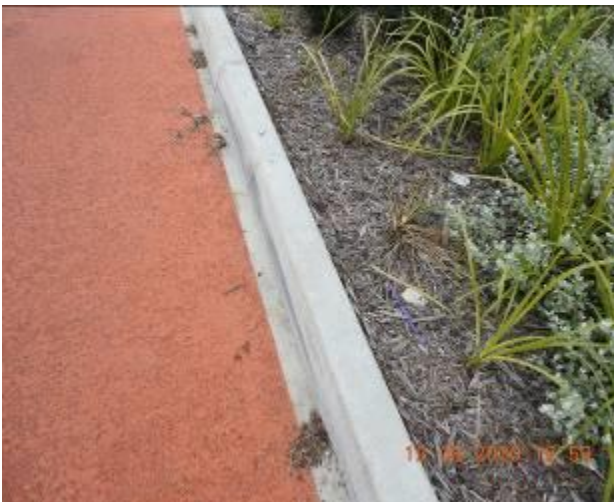
Figure 811 – Hairline crack propagation and evidence of patchwork through kerb

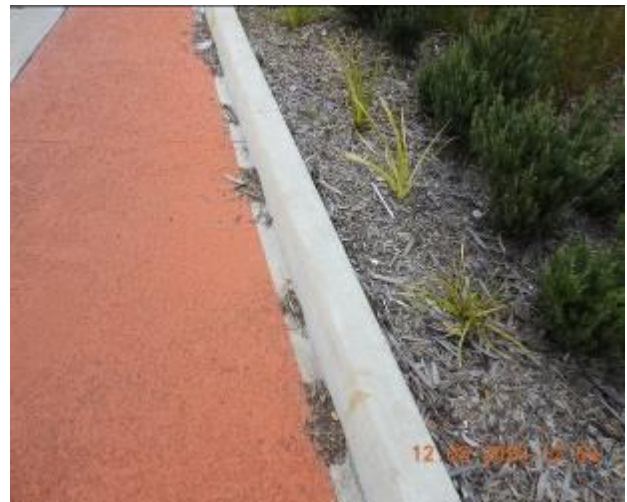
Figure 812 – Hairline crack propagation through kerb

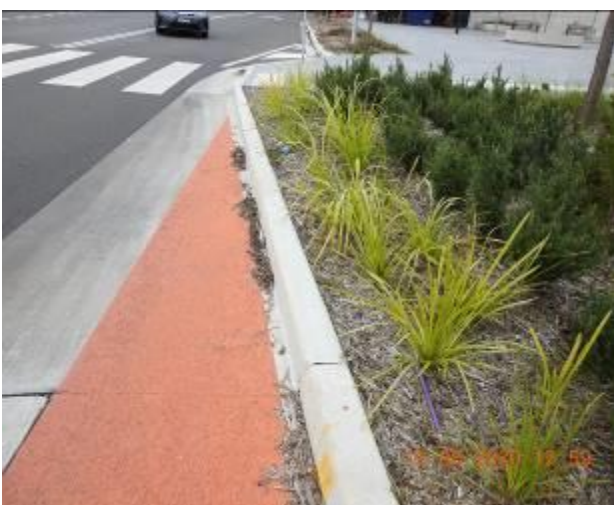
Figure 813 – General condition of kerb and gutter

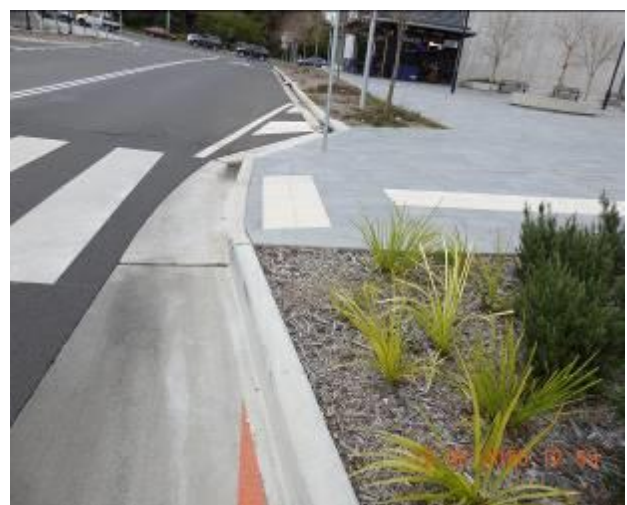
Figure 814 – General condition of kerb and gutter

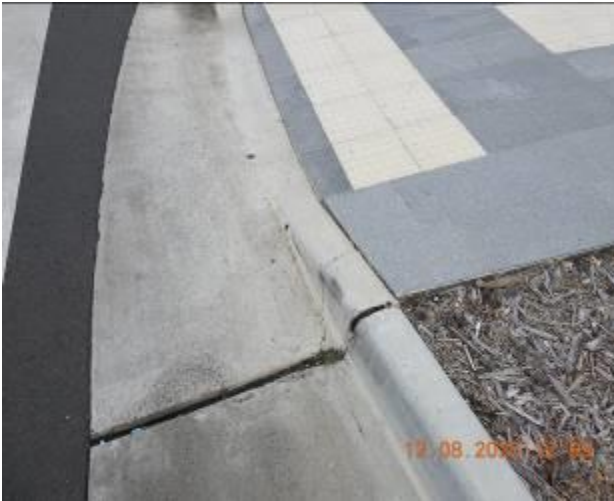
Figure 815 – Crack propagation and loss of material through kerb and gutter

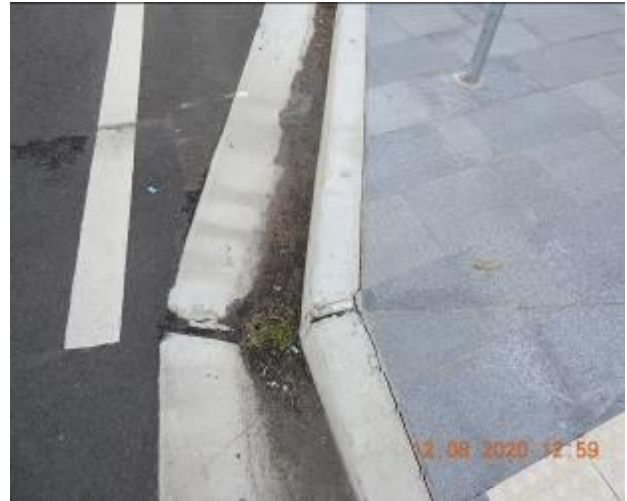
Figure 816 – Crack propagation and loss of material through kerb and gutter

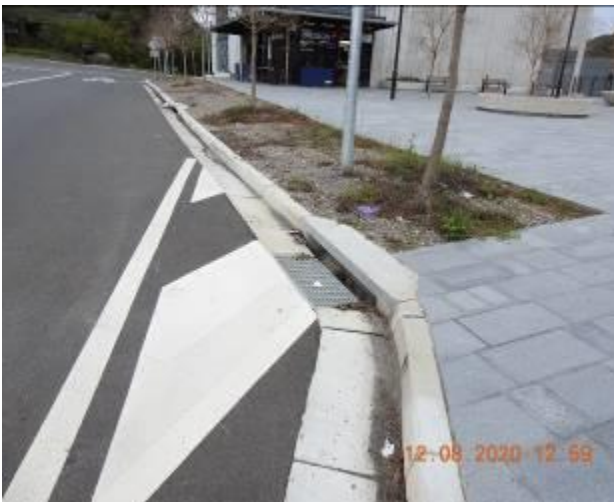
Figure 817 – General condition of kerb and gutter

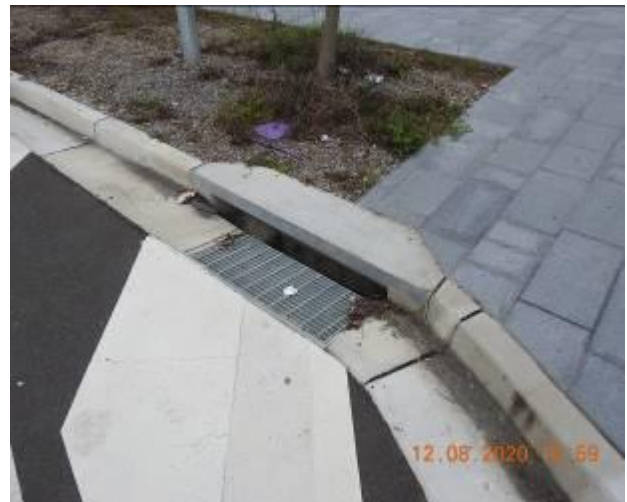
Figure 818 – General condition of stormwater inlet pit

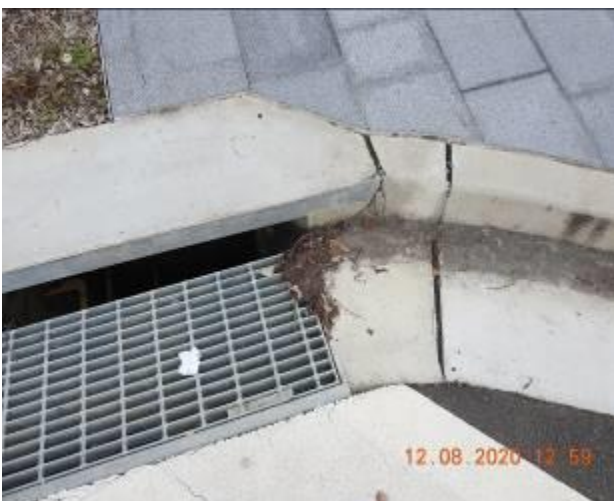
Figure 819 – Crack propagation and loss of material through kerb and gutter

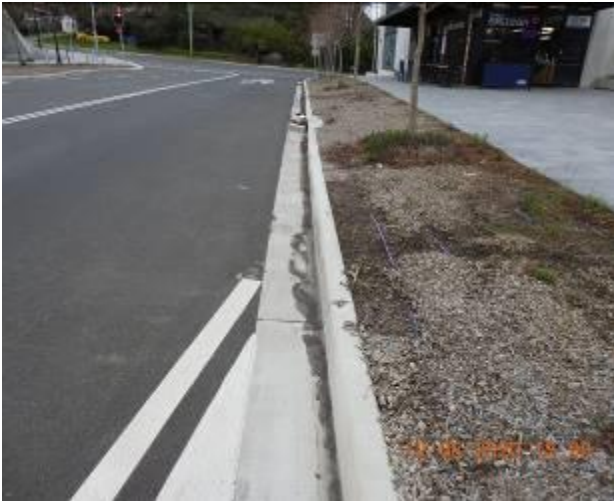
Figure 821 – General condition of kerb and gutter

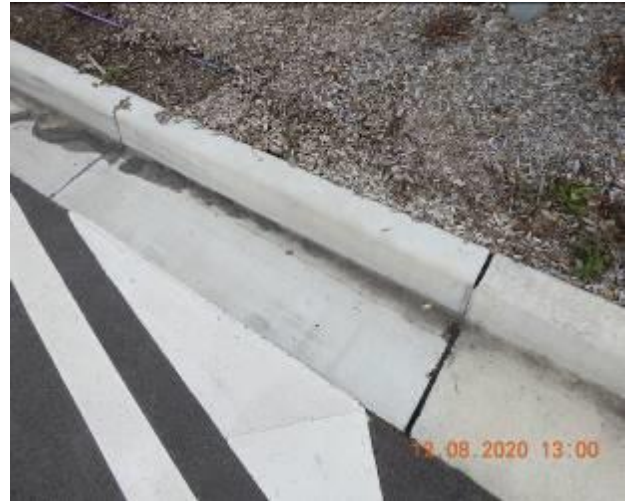
Figure 822 – Loss of material through kerb

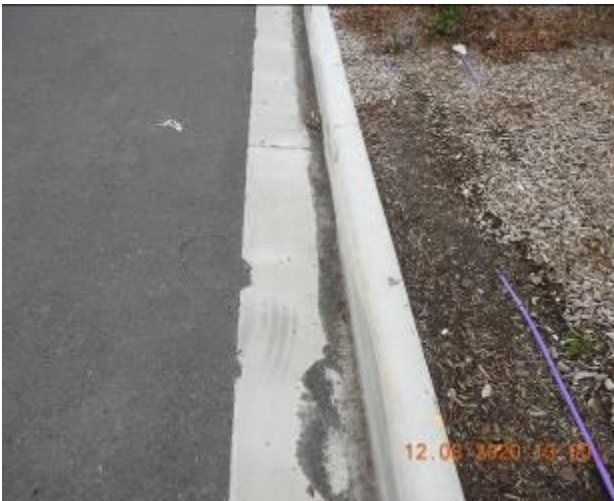
Figure 823 – Loss of material through gutter

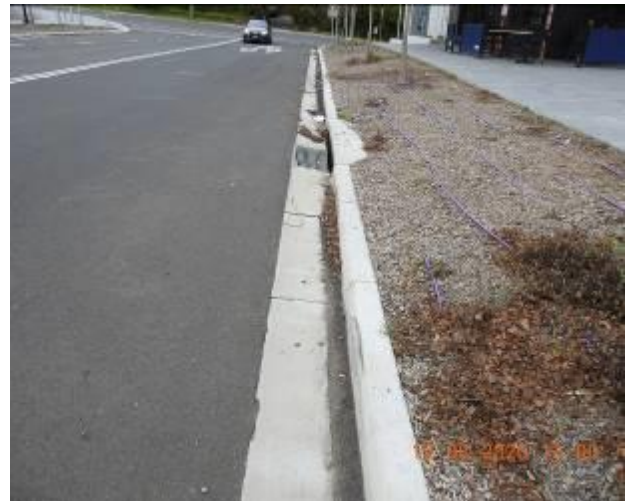
Figure 824 – General condition of kerb and gutter

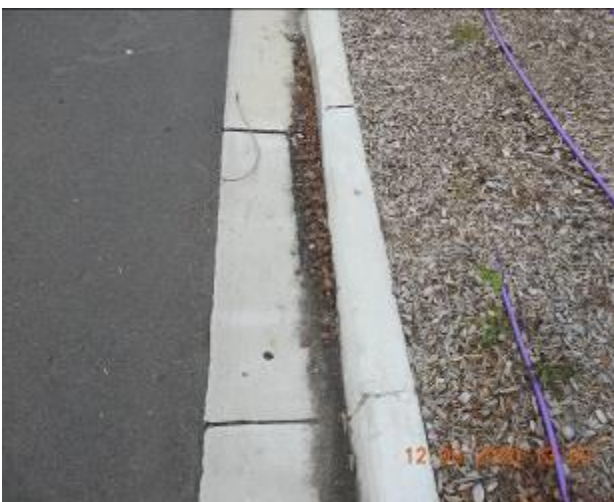
Figure 825 – Crack propagation and loss of material through kerb and gutter

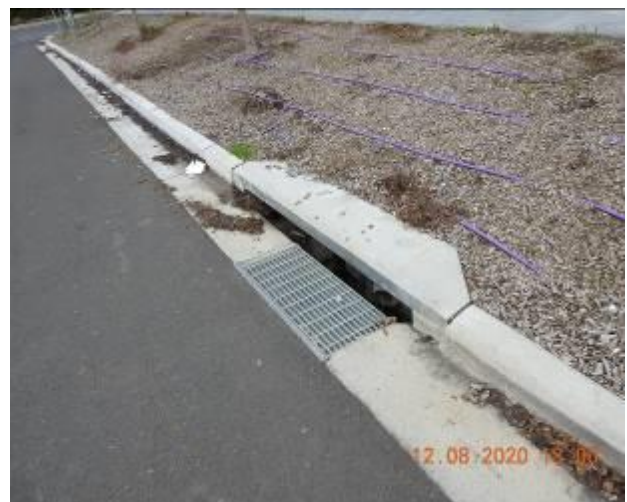
Figure 826 – General condition of stormwater inlet pit

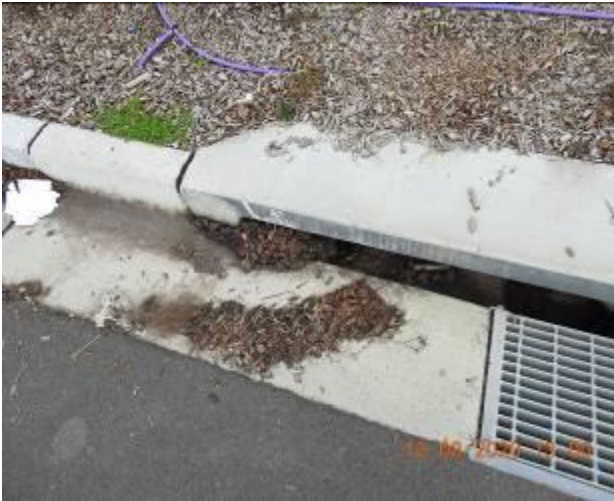
Figure 827 – Loss of material through kerb

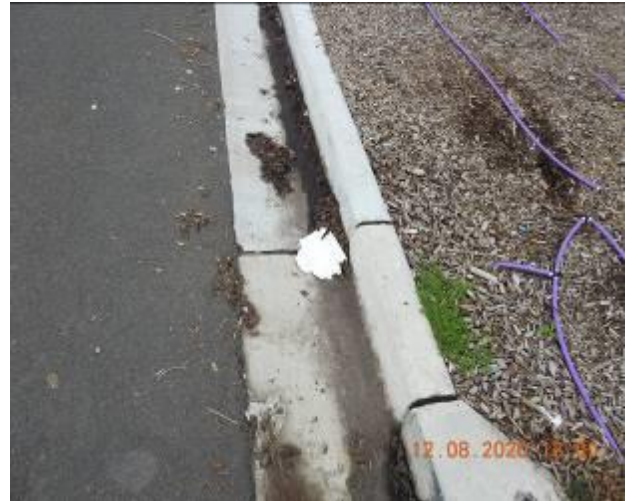
Figure 828 – Loss of material through kerb and gutter

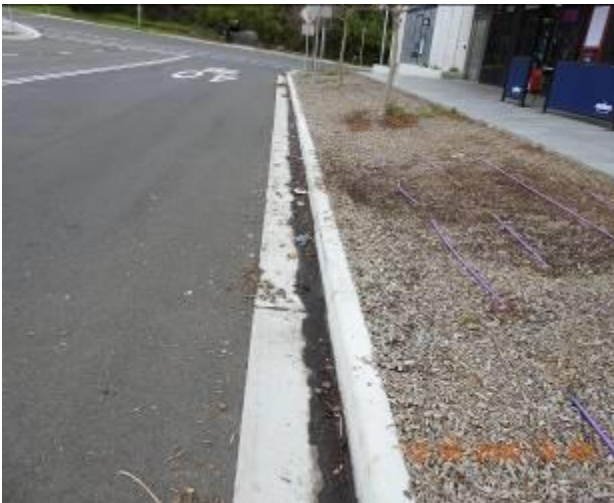
Figure 829 – General condition of kerb and gutter

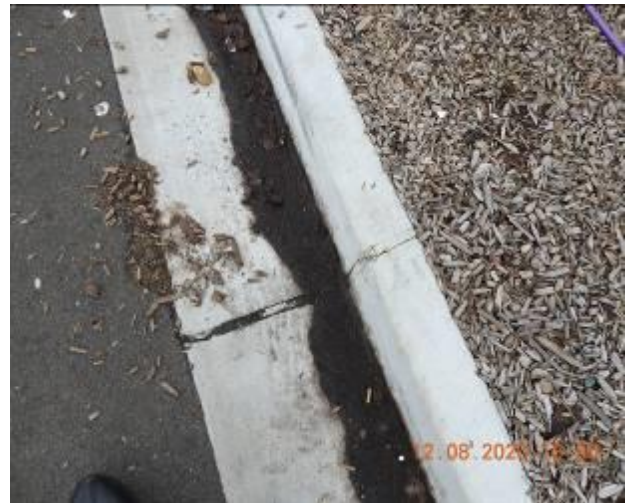
Figure 830 – Crack propagation and loss of material through kerb and gutter

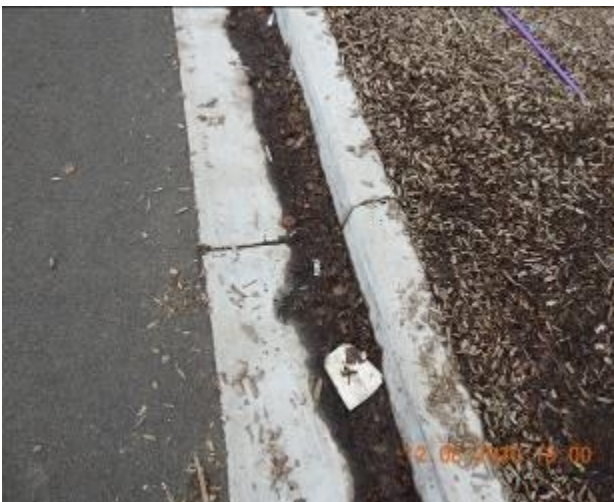
Figure 831 – Crack propagation and loss of material through kerb and gutter

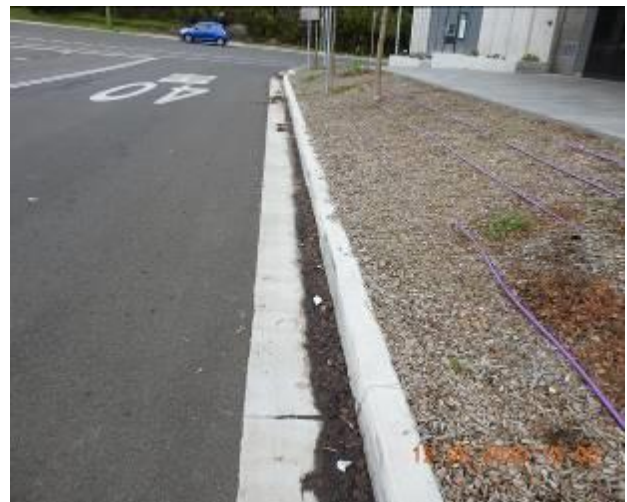
Figure 832 – General condition of kerb and gutter

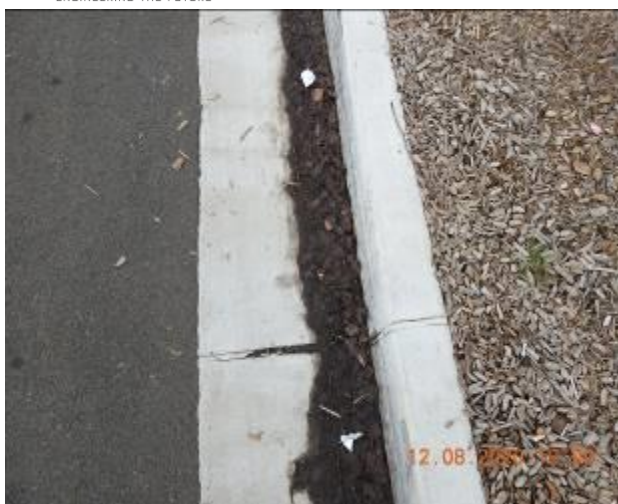
Figure 833 – Crack propagation and loss of material through kerb and gutter

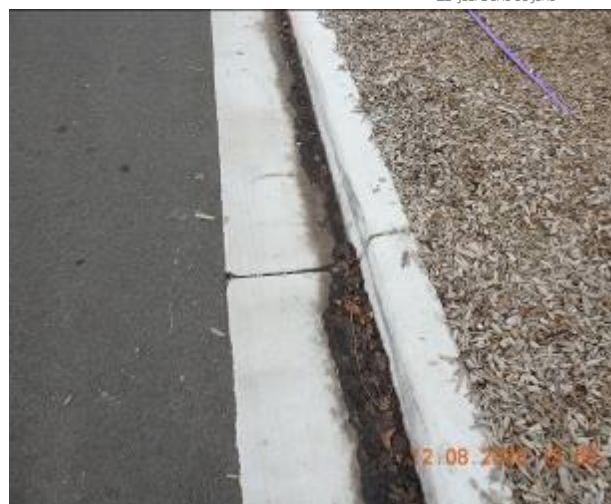
Figure 834 – Loss of material through kerb and gutter

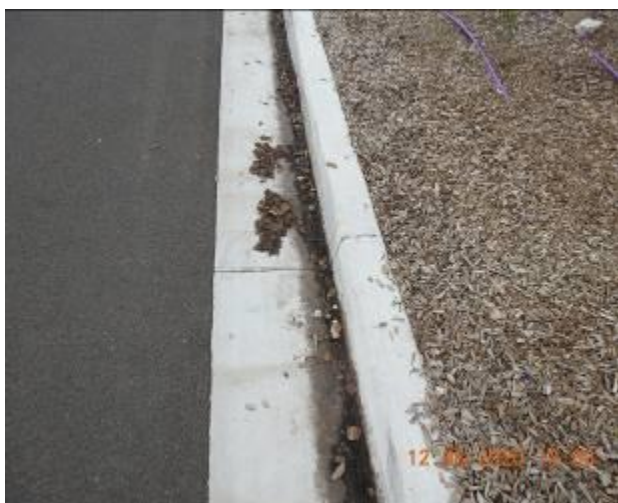
Figure 835 – Crack propagation and loss of material through kerb and gutter

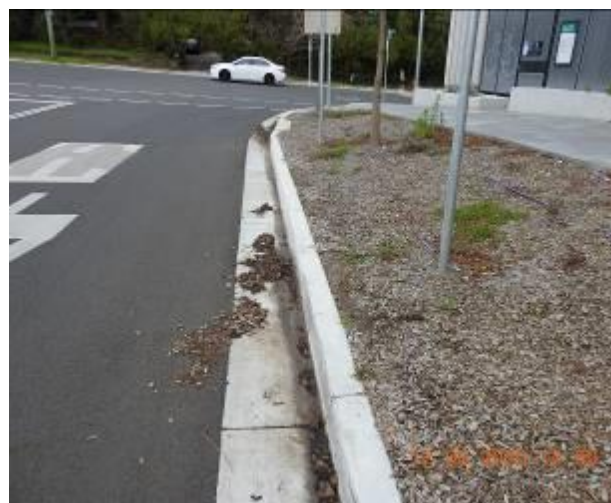
Figure 836 – General condition of kerb and gutter

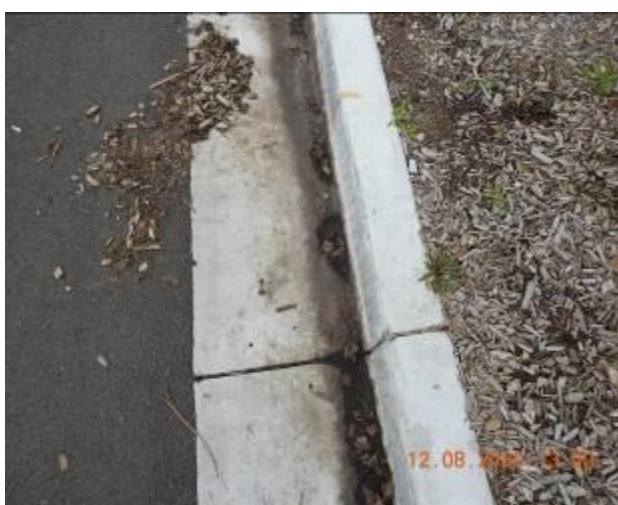
Figure 837 – Crack propagation and loss of material through kerb and gutter

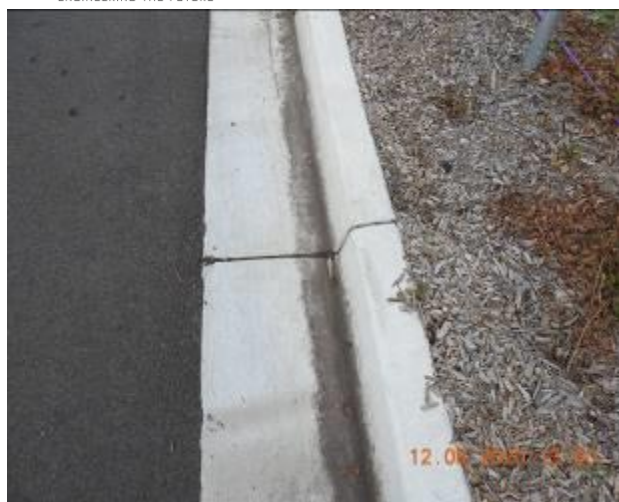
Figure 839 – Crack propagation and loss of material through kerb and gutter

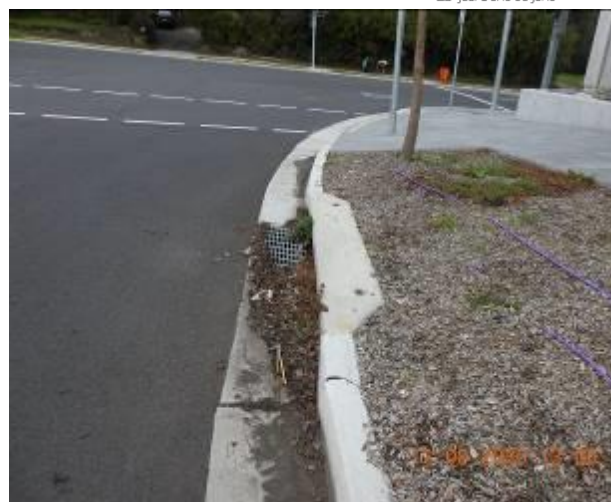
Figure 840 – General condition of kerb and gutter

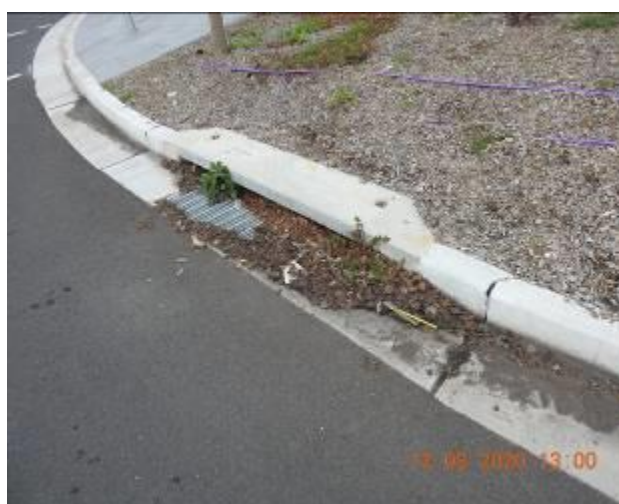
Figure 841 – General condition of stormwater inlet pit

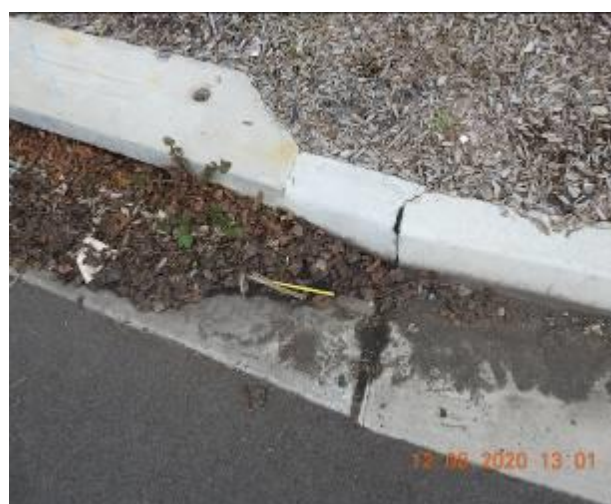
Figure 842 – Crack propagation and loss of material through kerb and gutter

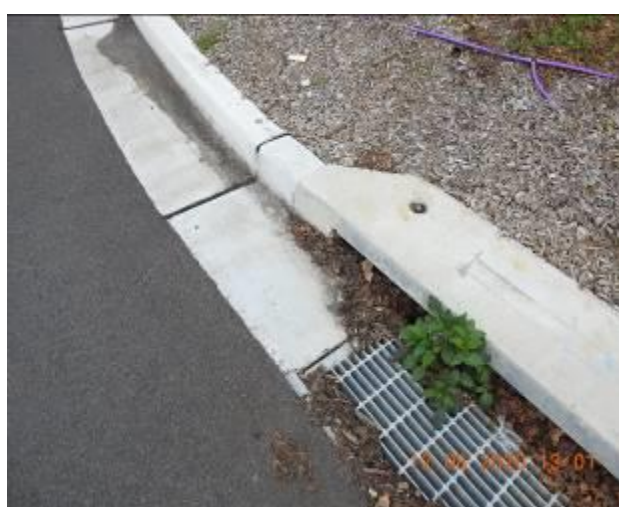
Figure 843 – Loss of material through gutter

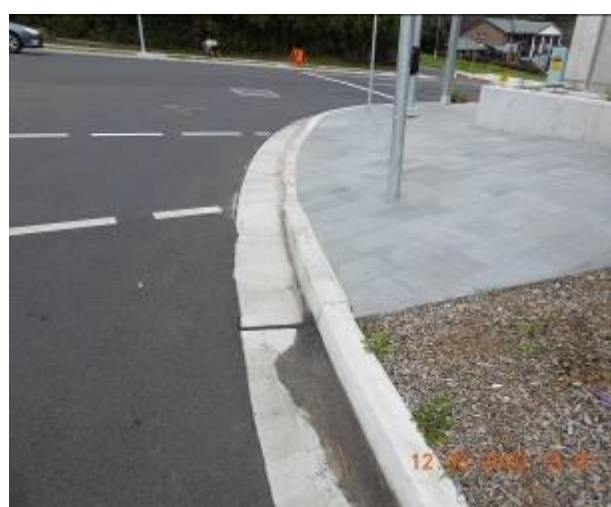
Figure 844 – General condition of kerb and gutter

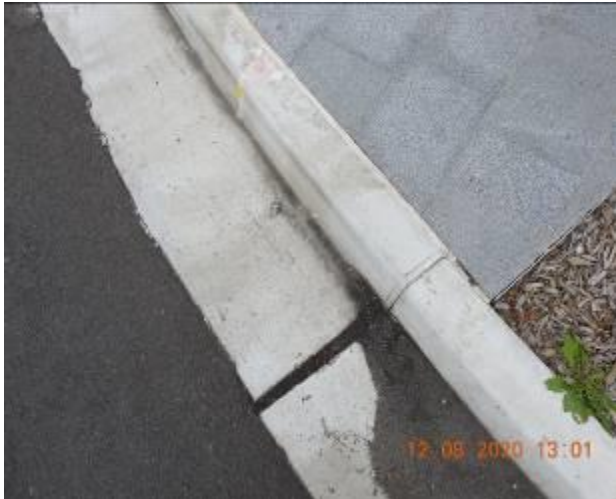
Figure 845 – Crack propagation and loss of material through kerb

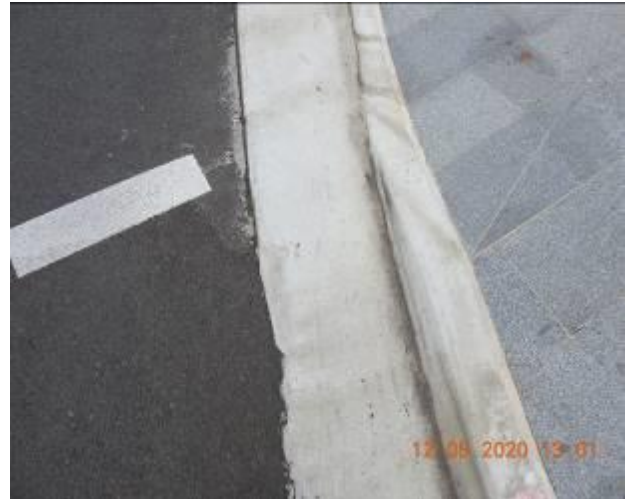
Figure 846 – Evidence of patchwork and loss of material through gutter

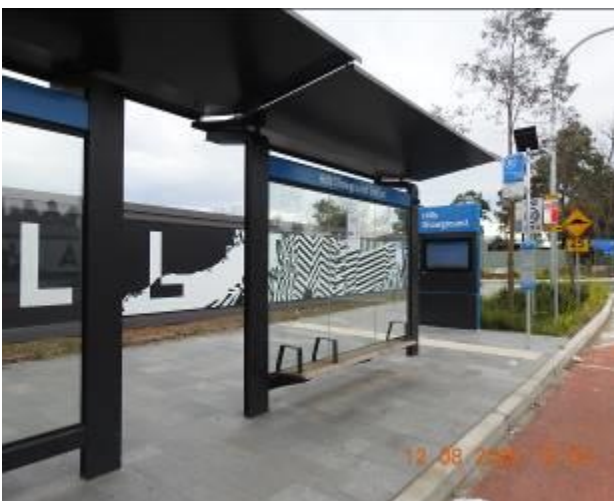
Figure 867 – General condition of bus shelter

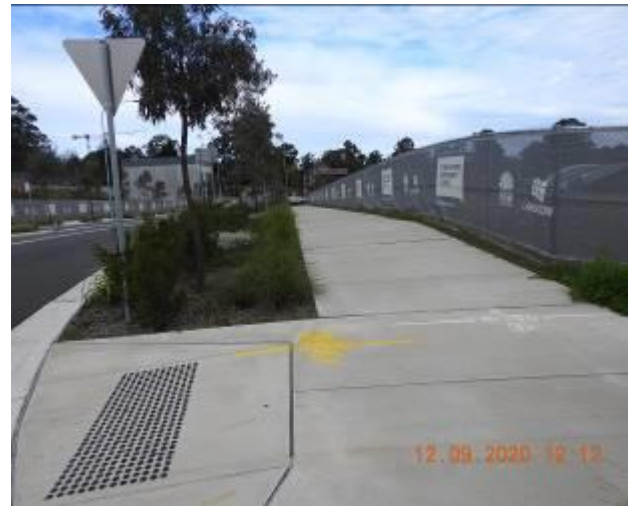
Figure 877 – General condition of footpath pavement heading South

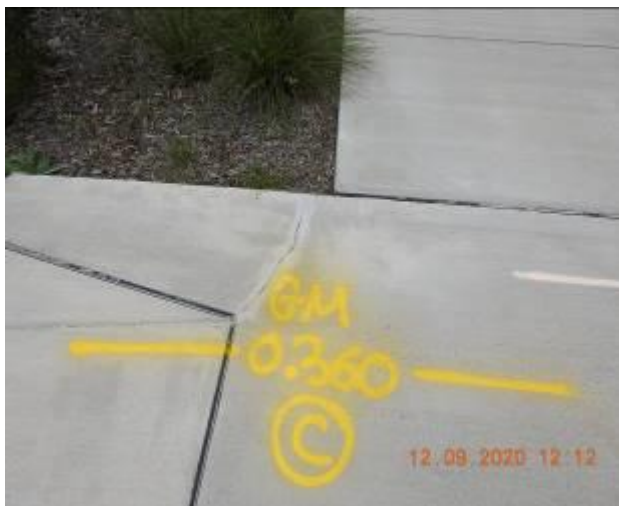
Figure 878 – Crack propagation and loss of material through footpath pavement

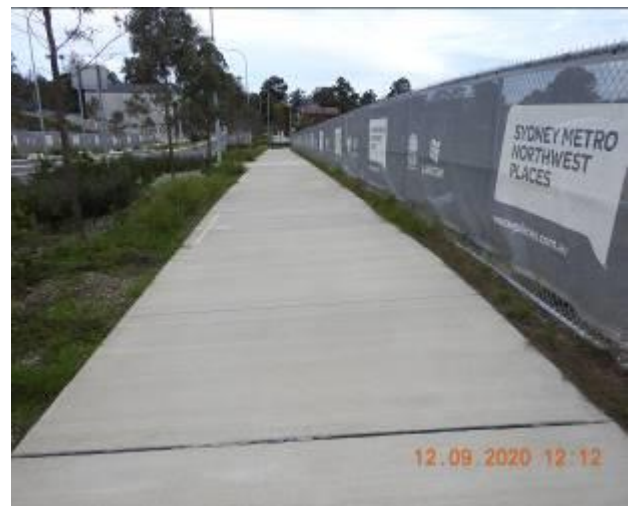
Figure 879 – General condition of footpath pavement

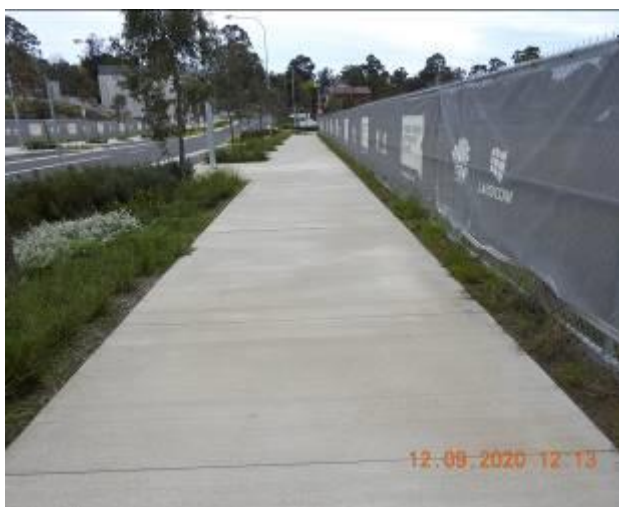
Figure 880 – General condition of footpath pavement

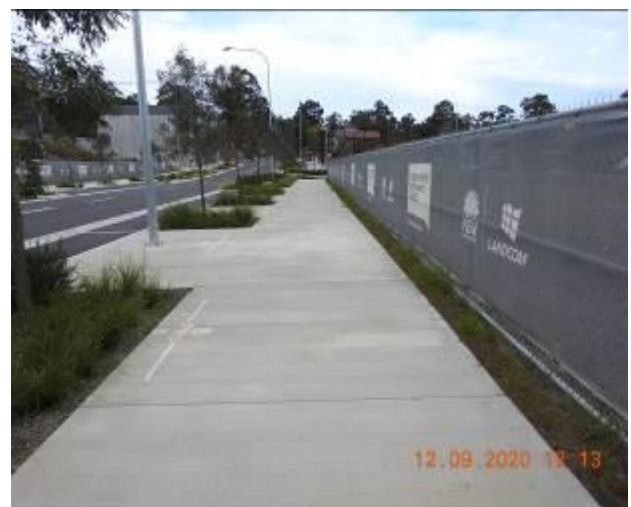
Figure 881 – General condition of footpath pavement

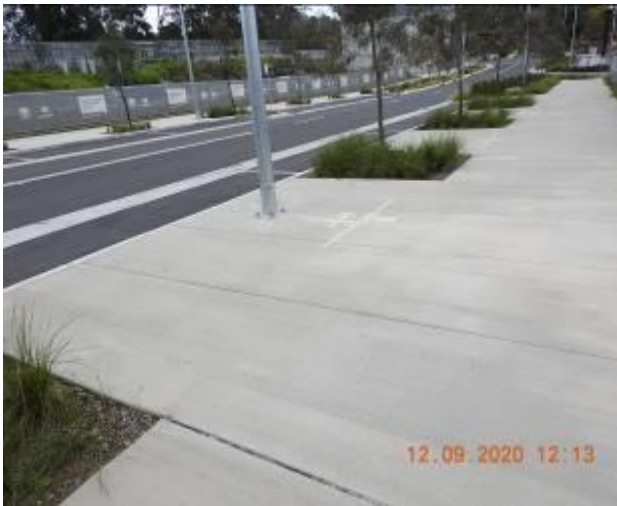
Figure 882 – General condition of footpath pavement

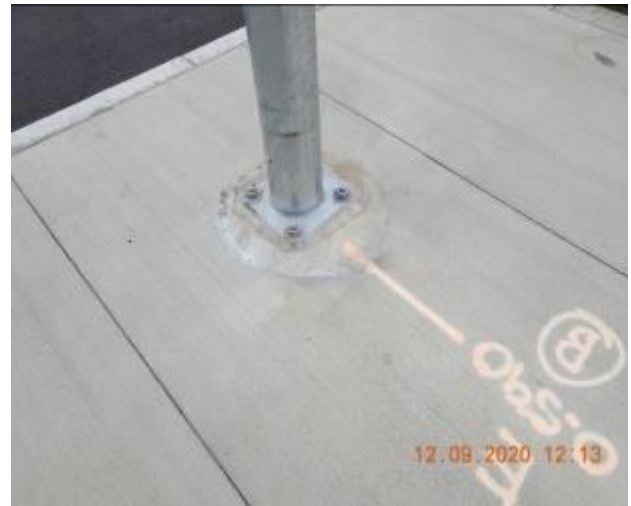
Figure 883 – Crack propagation through footpath pavement

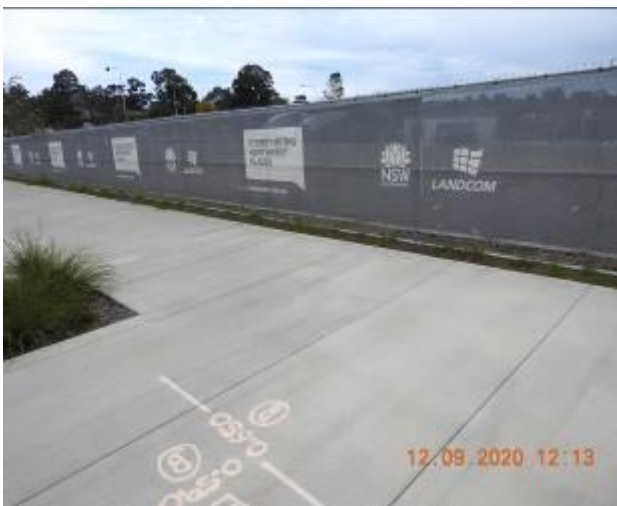
Figure 884 – General condition of footpath pavement

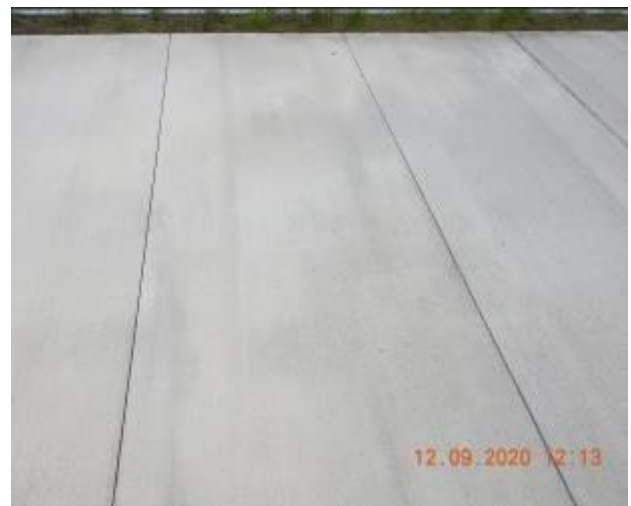
Figure 885 – Crack propagation and loss of material through footpath pavement

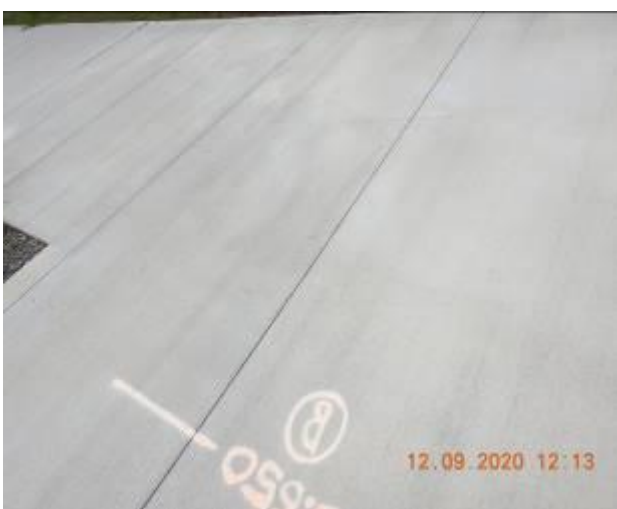
Figure 886 – Crack propagation and loss of material through footpath pavement

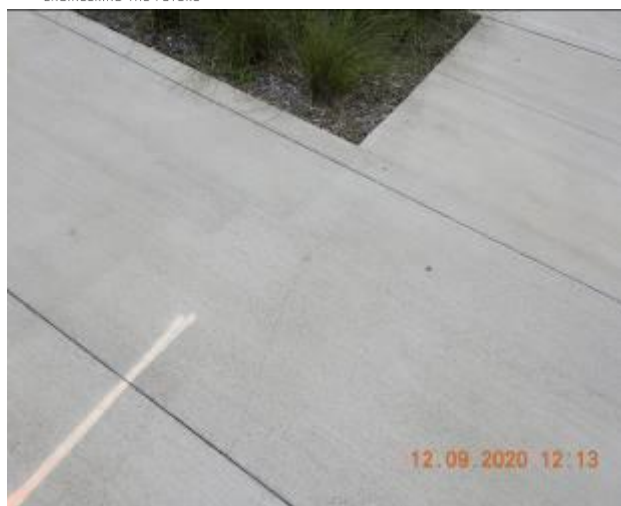
Figure 888 – Crack propagation through footpath pavement

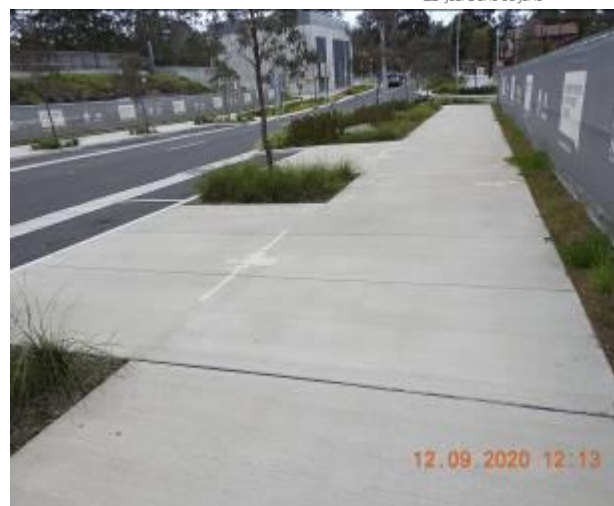
Figure 889 – General condition of footpath pavement

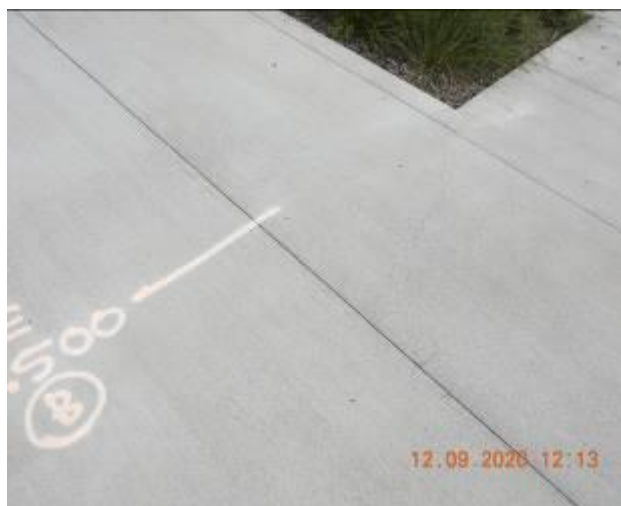
Figure 890 – Crack propagation through footpath pavement

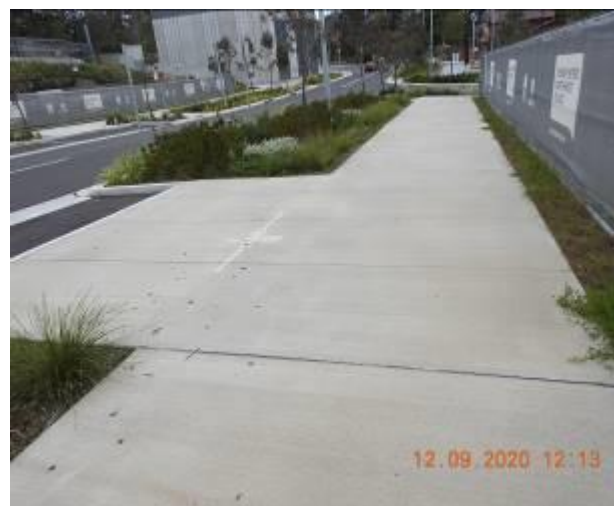
Figure 891 – General condition of footpath pavement

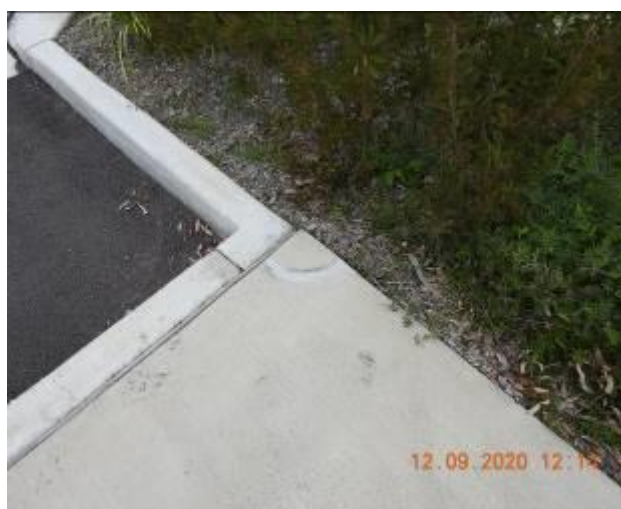
Figure 892 – Hairline Crack propagation and evidence of patchwork through footpath pavement

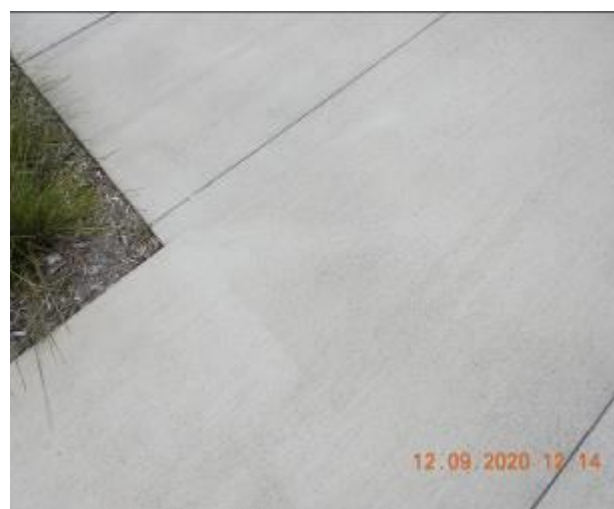
Figure 893 – Crack propagation through footpath pavement

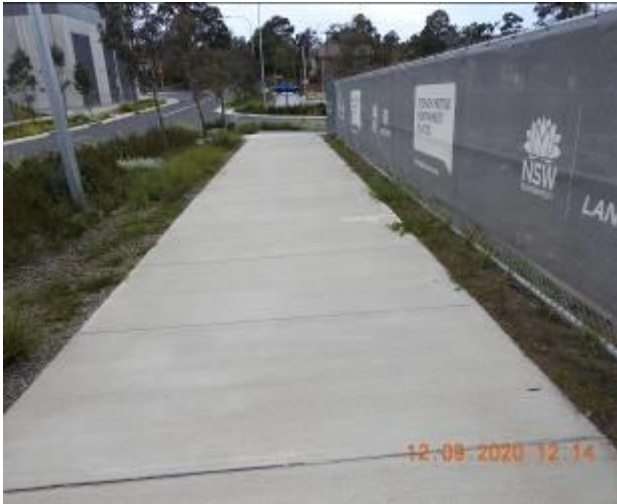
Figure 894 – General condition of footpath pavement

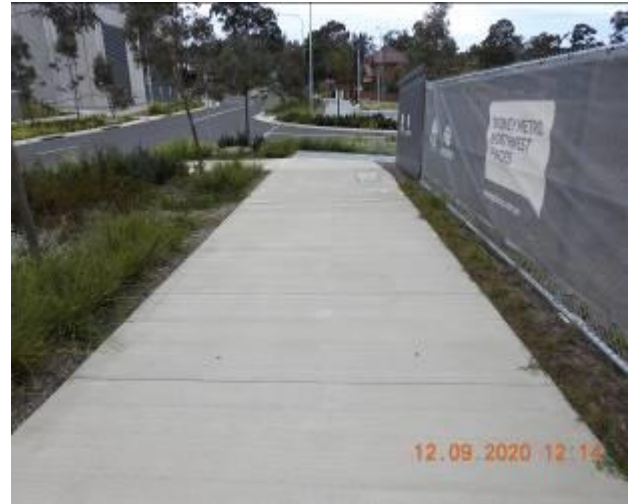
Figure 895 – General condition of footpath pavement

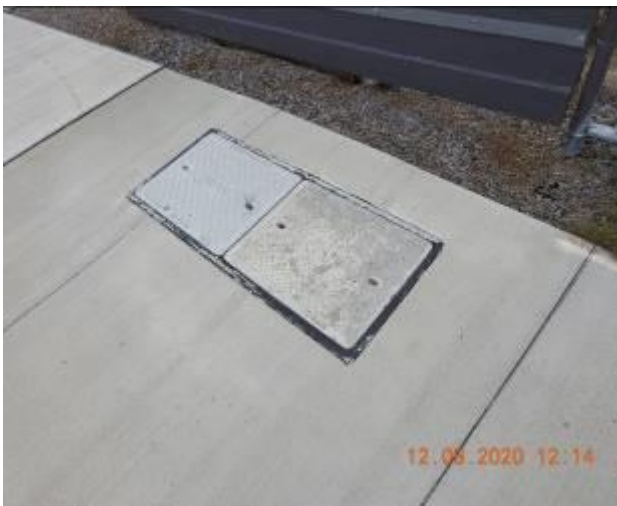
Figure 896 – Loss of material through service pit pavement

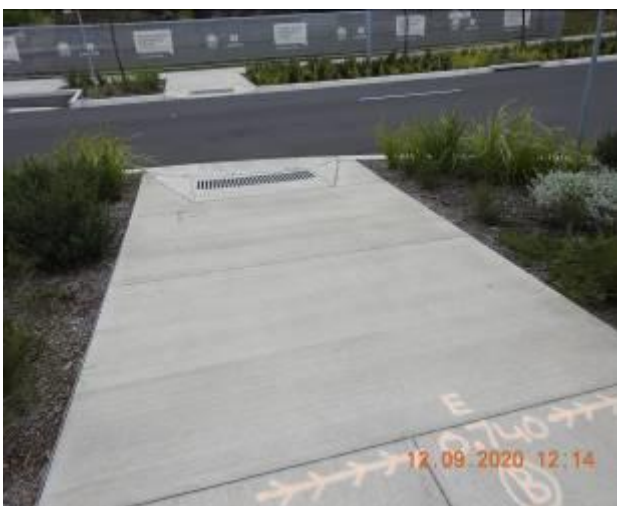
Figure 898 – General condition of footpath pavement

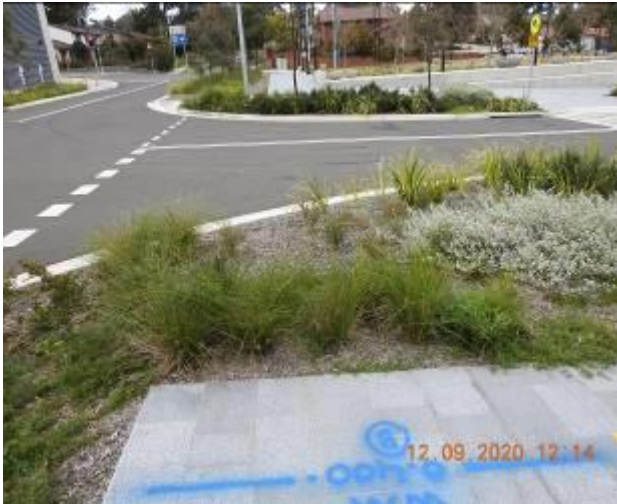
Figure 900 – General condition of footpath pavement

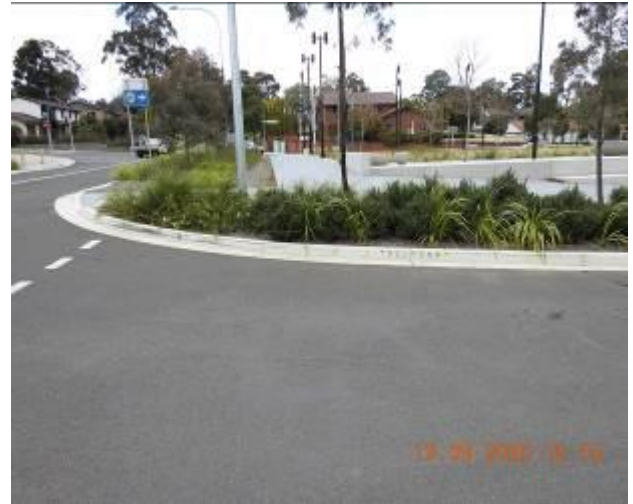
Figure 901 – General condition of footpath pavement

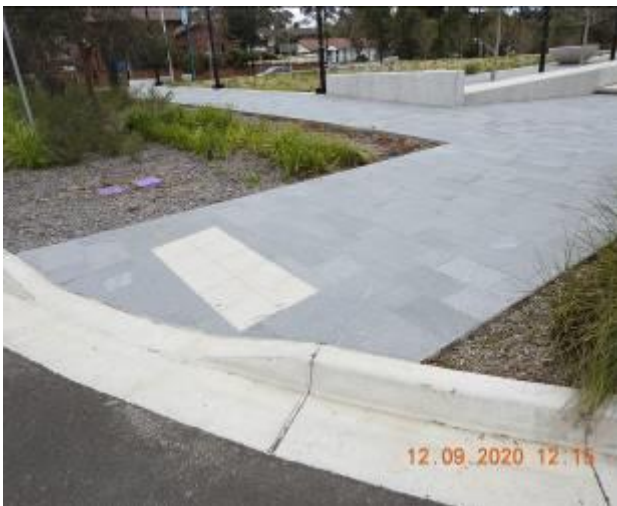
Figure 902 – General condition of footpath pavement

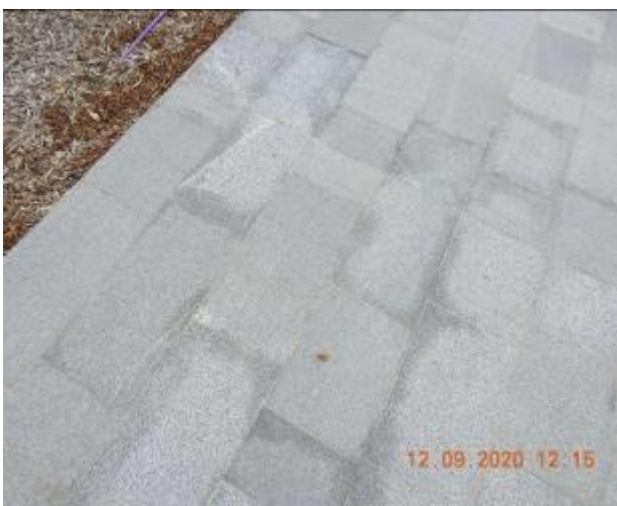
Figure 904 – Loss of material through footpath pavement

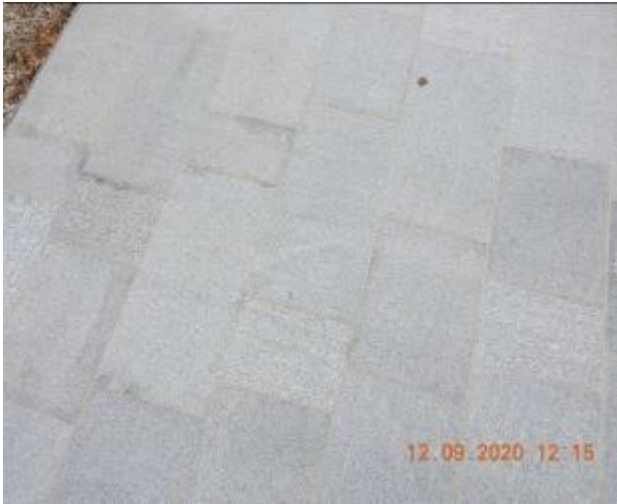
Figure 906 – Crack propagation and loss of material through footpath pavement

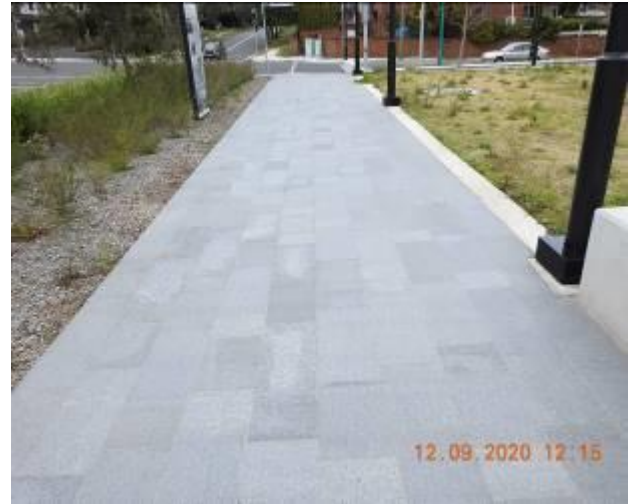
Figure 907 – General condition of footpath pavement
