**2 MANDALA PARADE, CASTLE HILL
(DORAN DRIVE PRECINCT)
PRE-DILAPIDATION REPORT
Of Sydney Metro and Hills Shire Council Assets
DEICORP PROJECTS SHOWGROUND
PTY LTD.**

Job No. 200124.3
07/07/2021

ACE Structural Services Pty Ltd

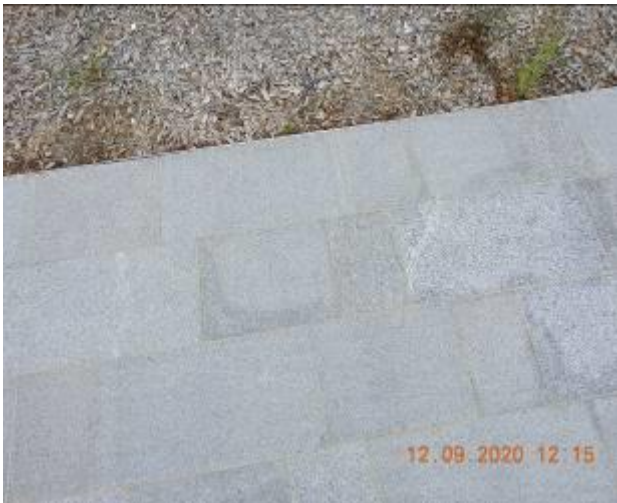
Figure 908 – Crack propagation and loss of material through footpath pavement

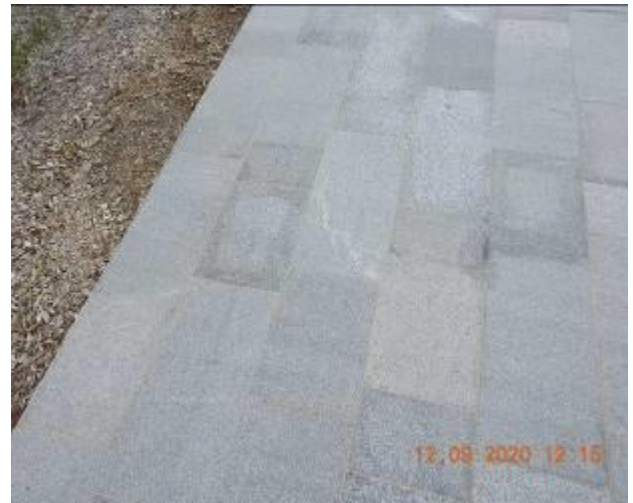
Figure 909 – Crack propagation and loss of material through footpath pavement

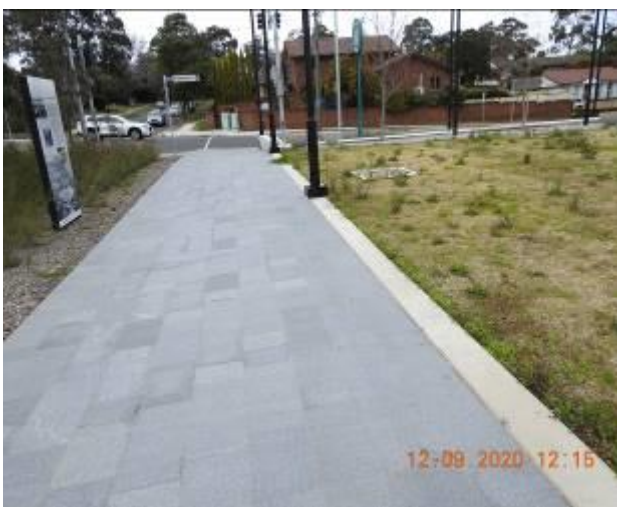
Figure 910 – General condition of footpath pavement

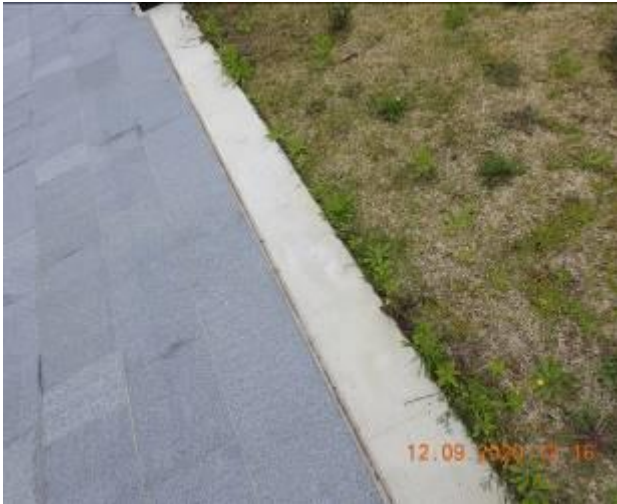
Figure 912 – Crack propagation through footpath pavement

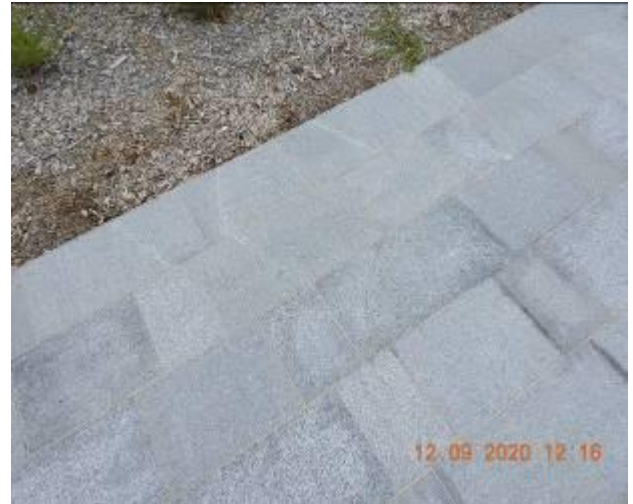
Figure 913 – Hairline crack propagation through footpath pavement

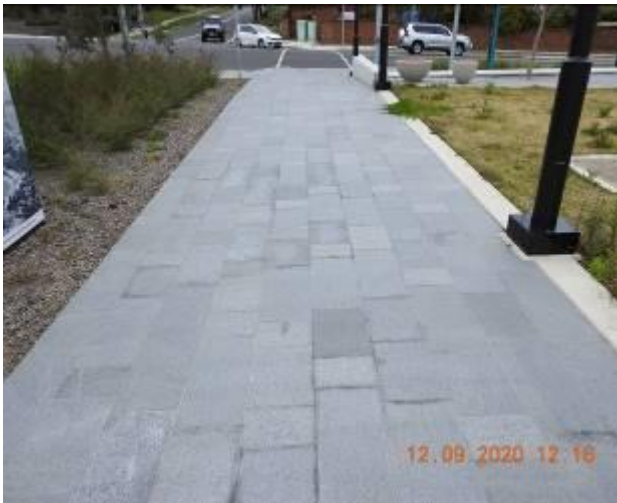
Figure 914 – Loss of material through footpath pavement

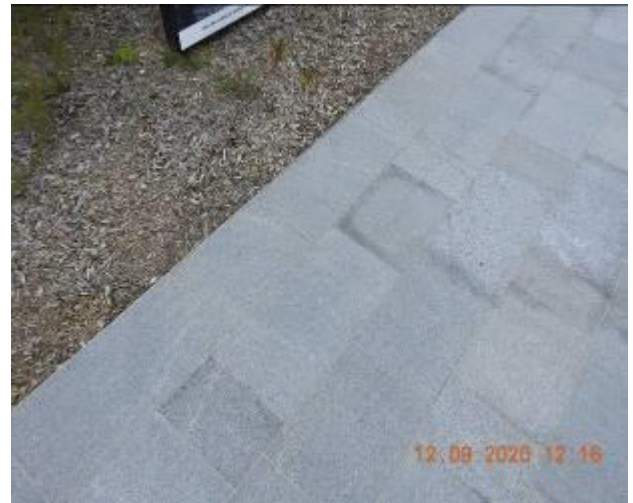
Figure 915 – Hairline crack propagation through footpath pavement

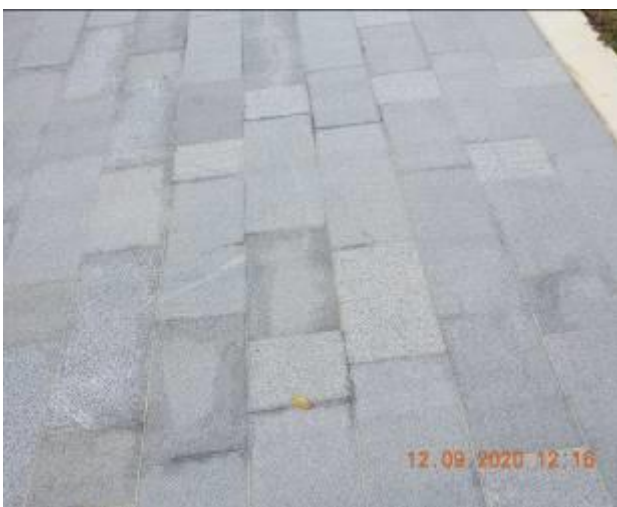
Figure 916 – Crack propagation and loss of material through footpath pavement

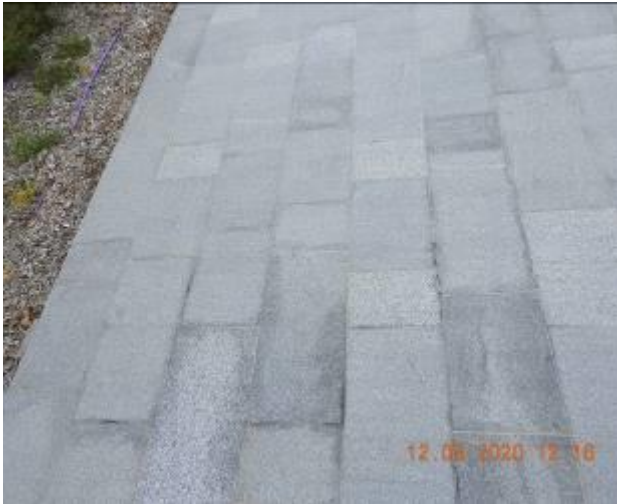
Figure 918 – Crack propagation and loss of material through footpath pavement

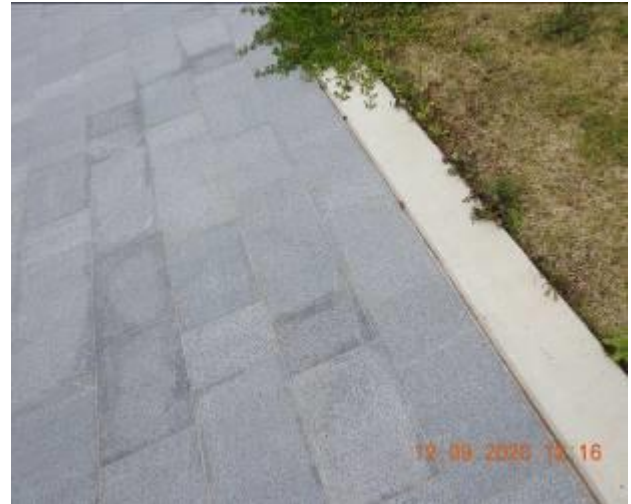
Figure 919 – Crack propagation through footpath pavement

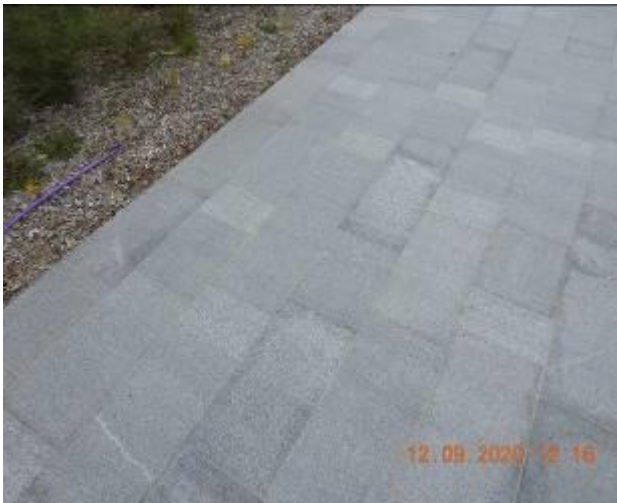
Figure 920 – Hairline crack propagation through footpath pavement

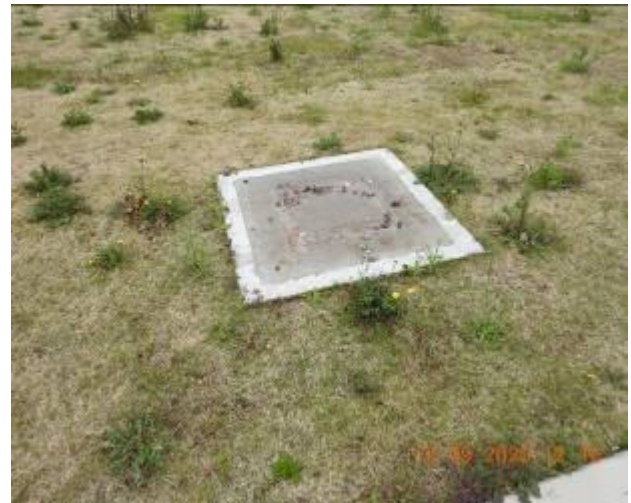
Figure 921 – Crack propagation and loss of material through service pit pavement

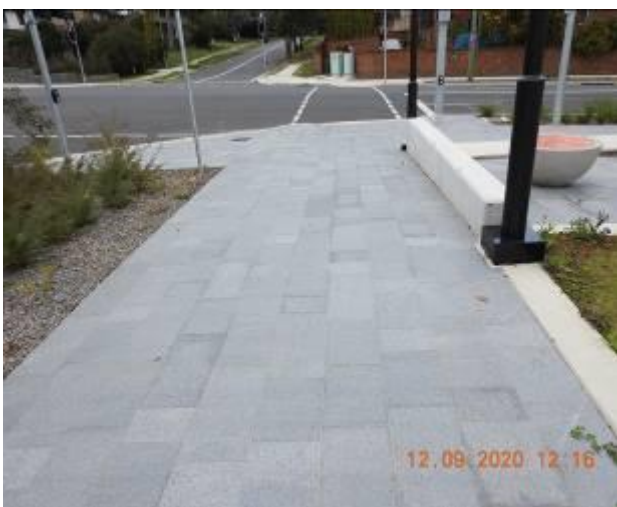
Figure 922 – General condition of footpath pavement

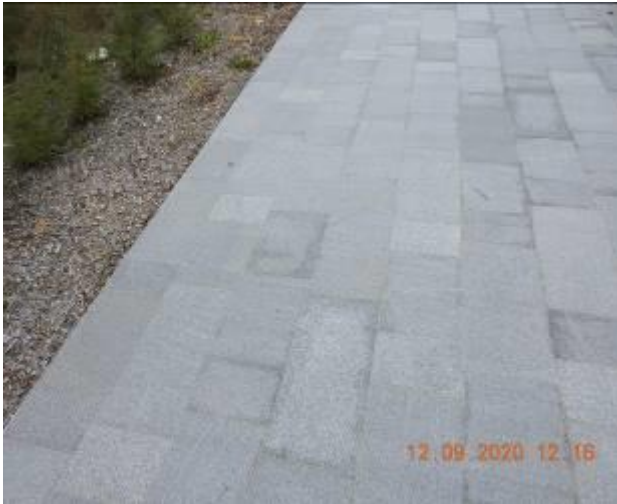
Figure 924 – Hairline crack propagation through footpath pavement

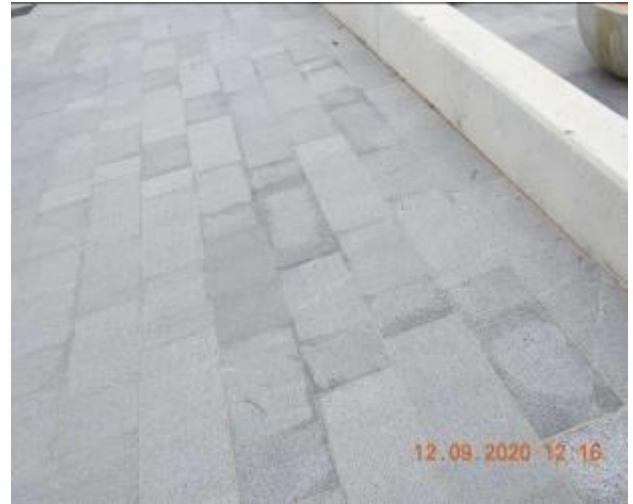
Figure 925 – Hairline crack propagation through footpath pavement

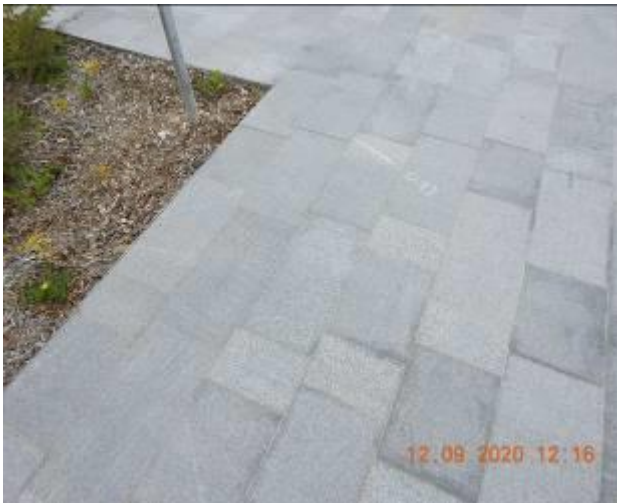
Figure 926 – Hairline crack propagation through footpath pavement

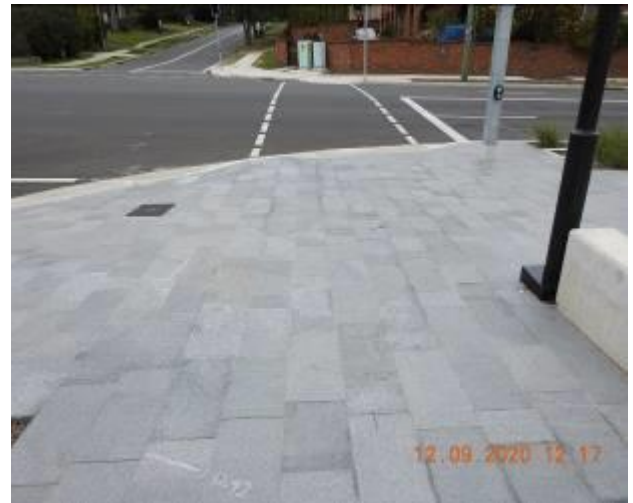
Figure 927 – Hairline crack propagation through footpath pavement

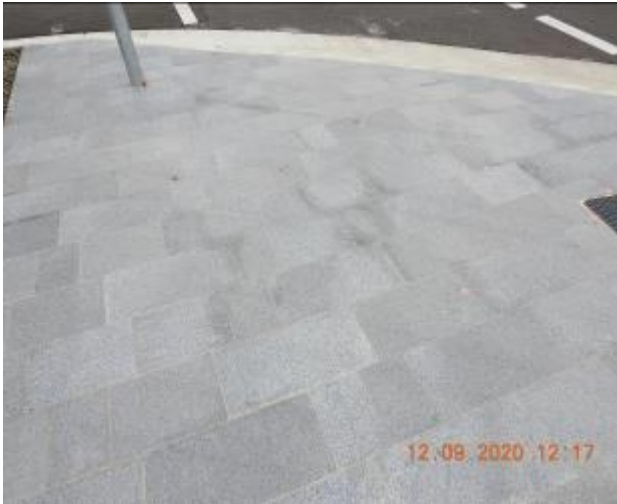
Figure 929 – Crack propagation and loss of material through footpath pavement

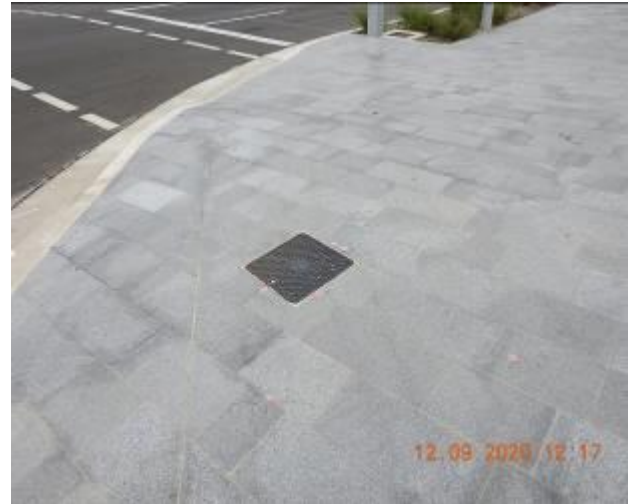
Figure 930 – Hairline crack propagation through footpath pavement

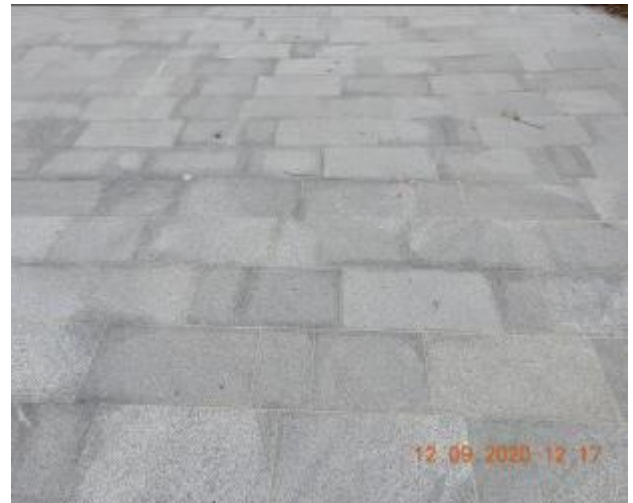
Figure 932 – Hairline crack propagation through footpath pavement

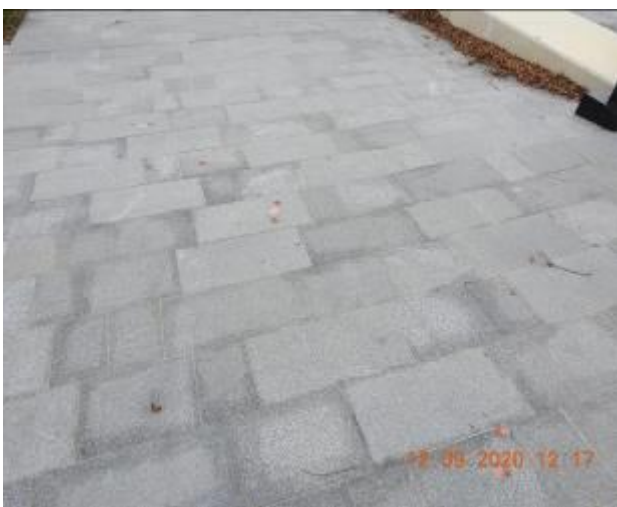
Figure 933 – Hairline crack propagation through footpath pavement

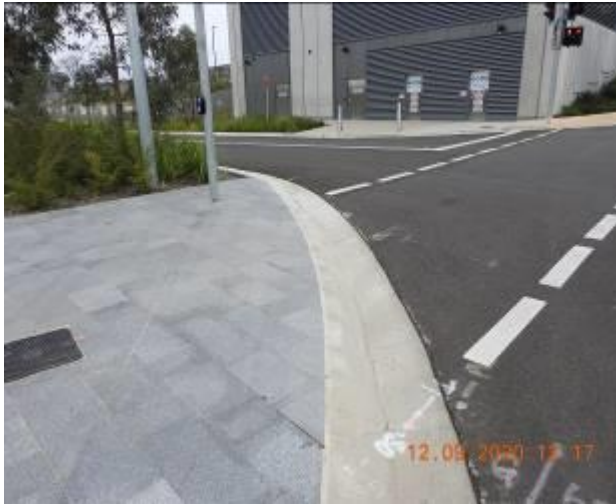
Figure 935 – Hairline crack propagation through footpath pavement

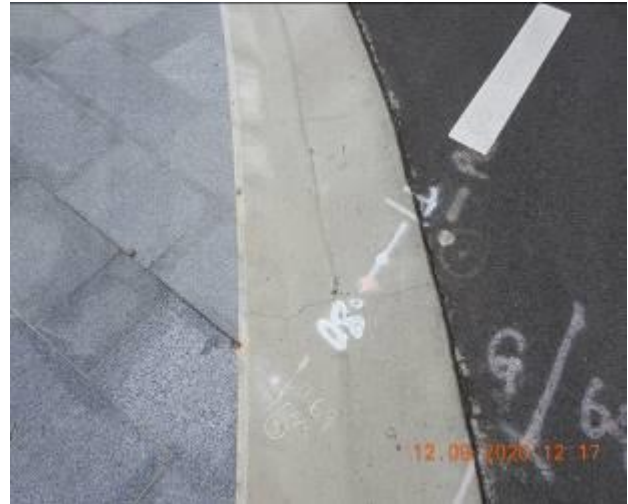
Figure 936 – General condition of layback and gutter heading North

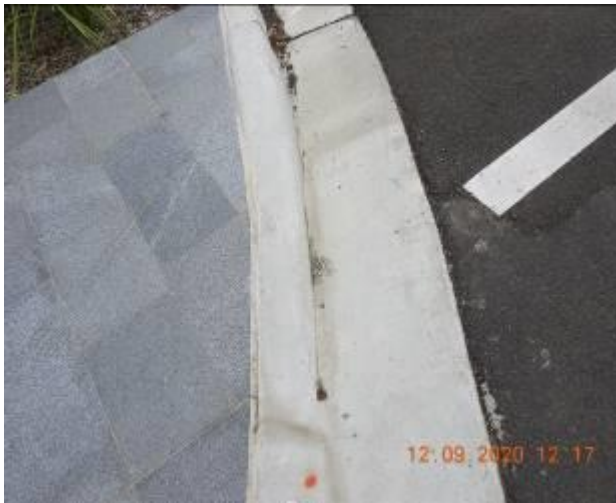
Figure 937 – Crack propagation and loss of material through layback and gutter

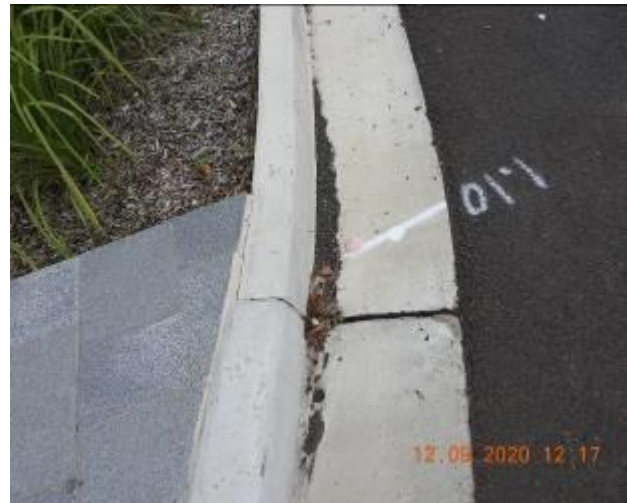
Figure 938 – Crack propagation and loss of material through layback and gutter

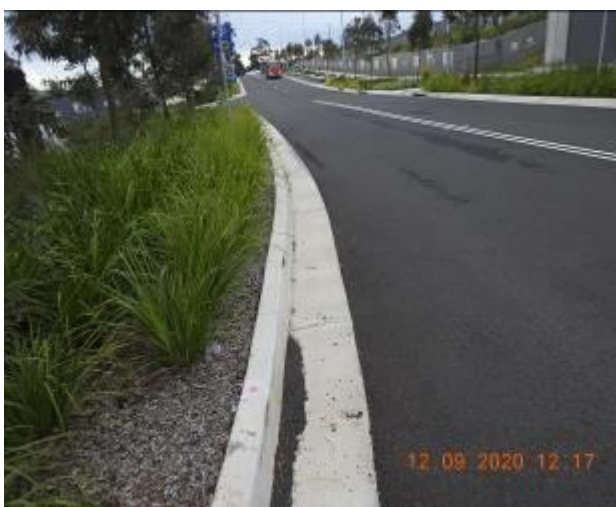
Figure 939 – Evidence of patchwork, crack propagation and loss of material through kerb and gutter

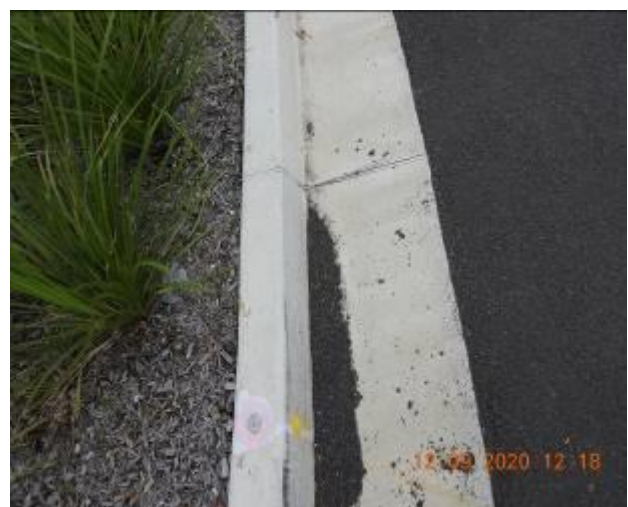
Figure 940 – General condition of kerb and gutter

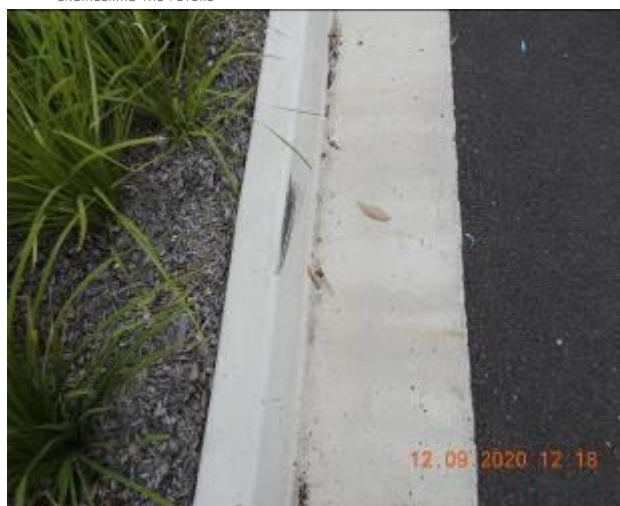
Figure 941 – Crack propagation and loss of material through kerb and gutter

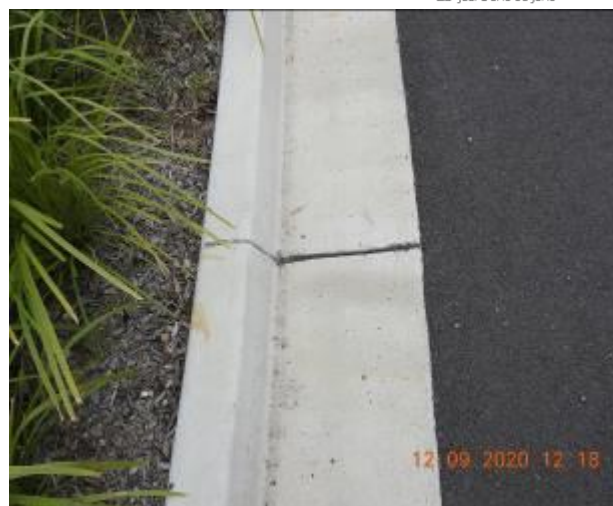
Figure 942 – Hairline crack propagation through kerb

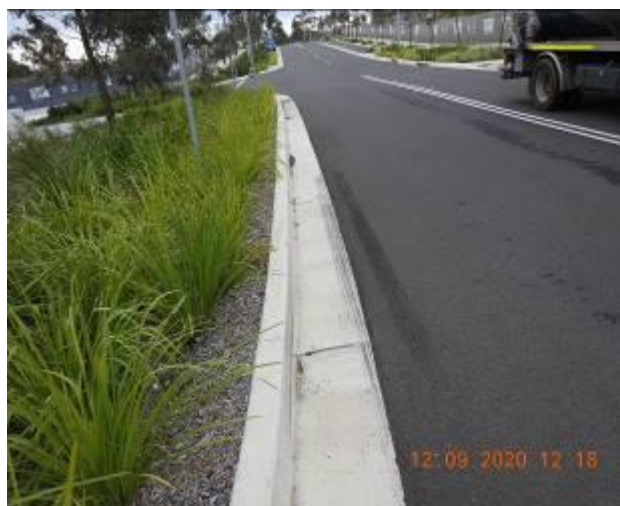
Figure 943 – Crack propagation and loss of material through kerb and gutter

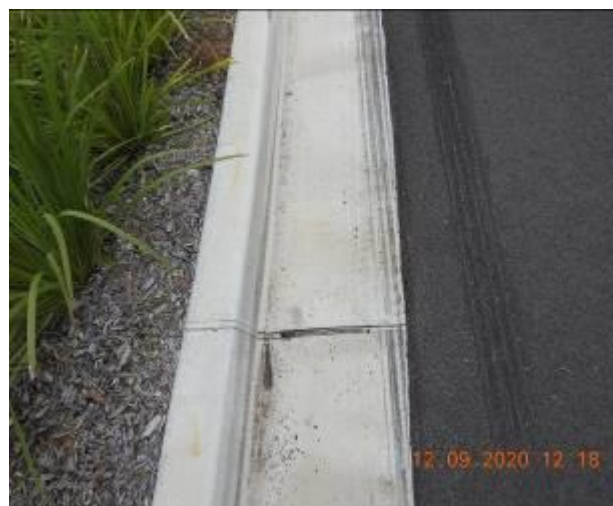
Figure 944 – General condition of kerb and gutter

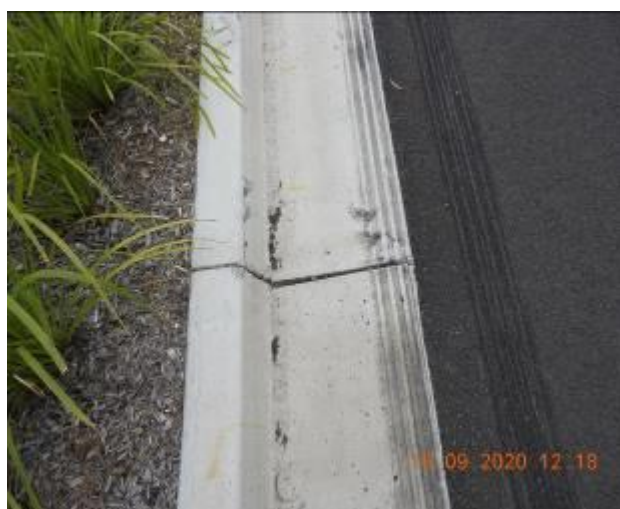
Figure 945 – Crack propagation and loss of material through kerb and gutter

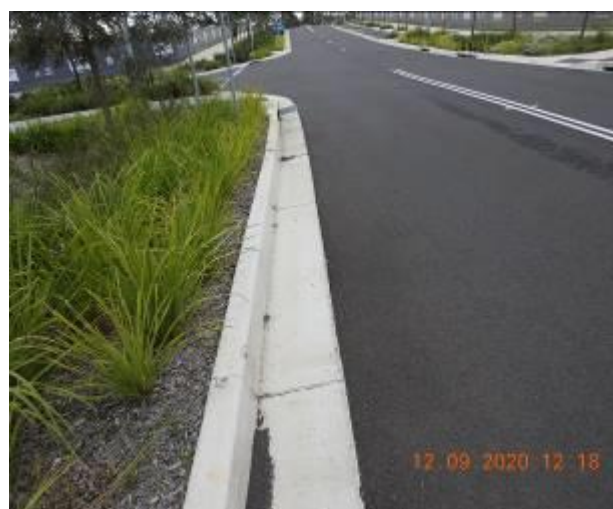
Figure 946 – Crack propagation and loss of material through kerb and gutter

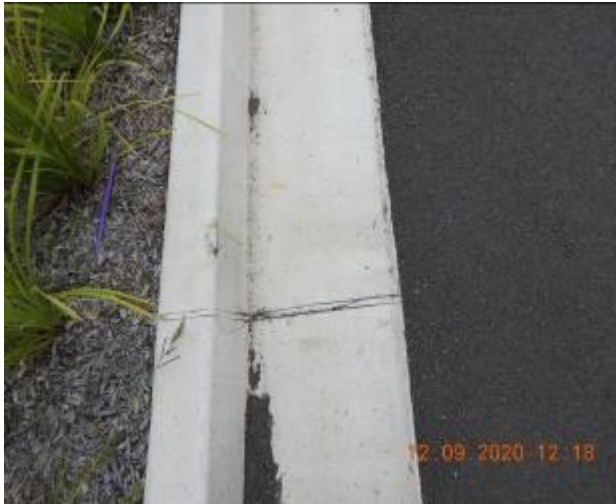
Figure 947 – General condition of kerb and gutter

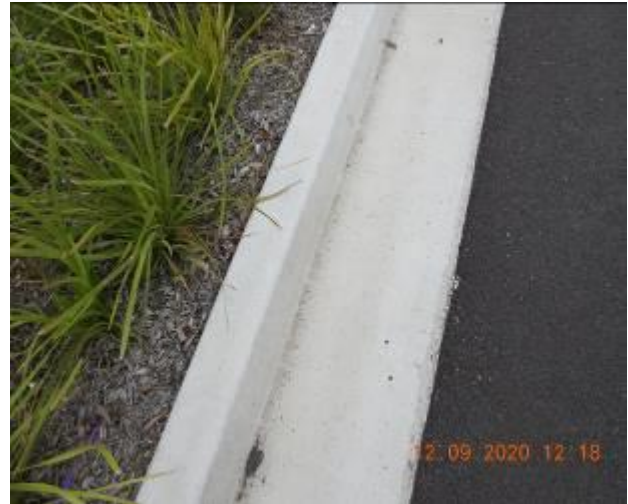
Figure 948 – Crack propagation and loss of material through kerb and gutter

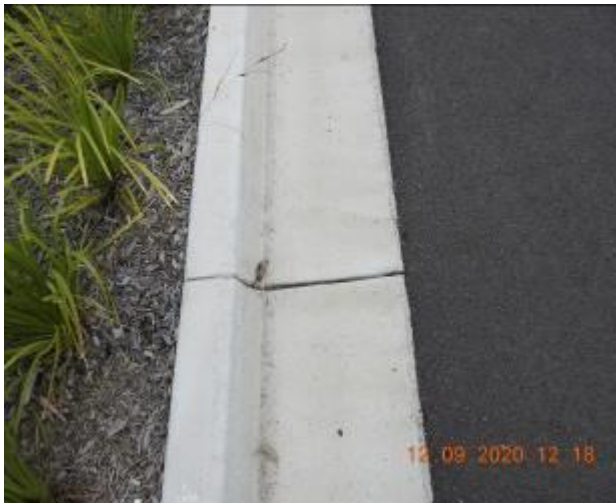
Figure 949 – Hairline Crack propagation through kerb and gutter

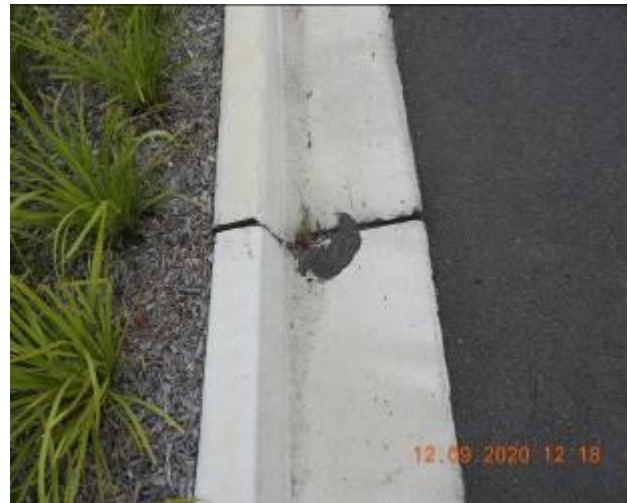
Figure 950 – Crack propagation and loss of material through kerb

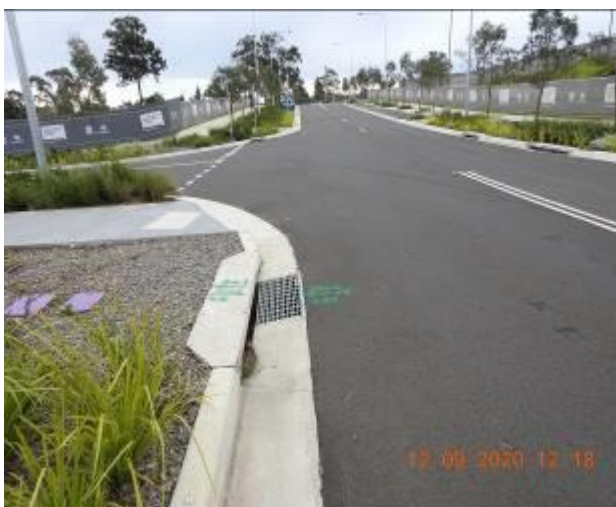
Figure 951 – Crack propagation and loss of material through kerb

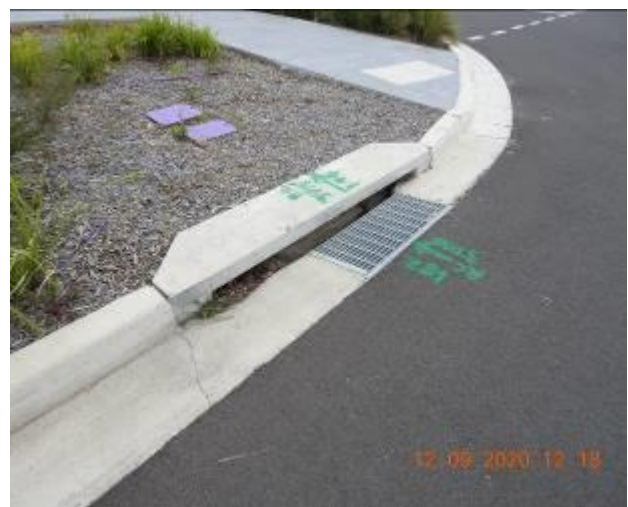
Figure 952 – General condition of kerb and gutter

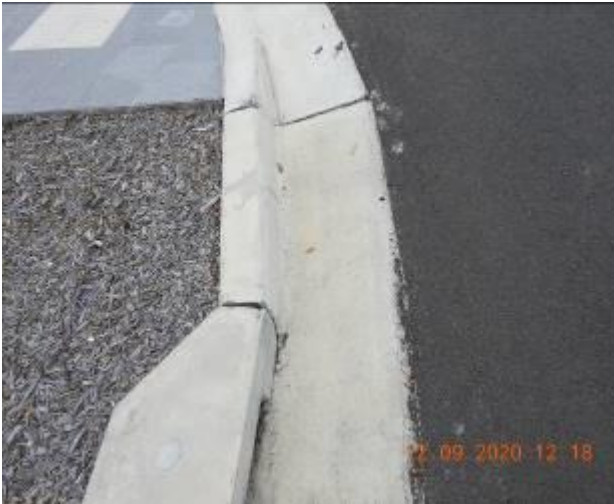
Figure 953 – General condition of stormwater inlet pit/Crack propagation and loss of material through kerb and gutter

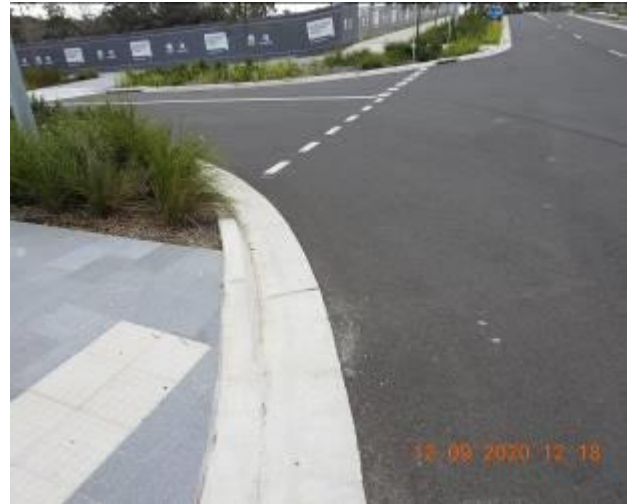
Figure 954 – Crack propagation and loss of material through kerb

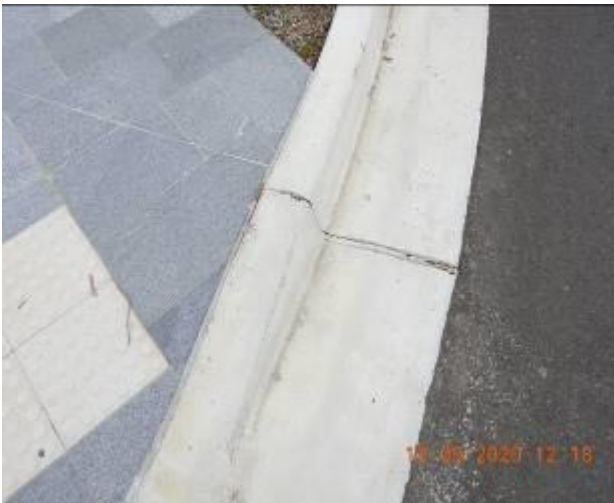
Figure 955 – General condition of layback and gutter

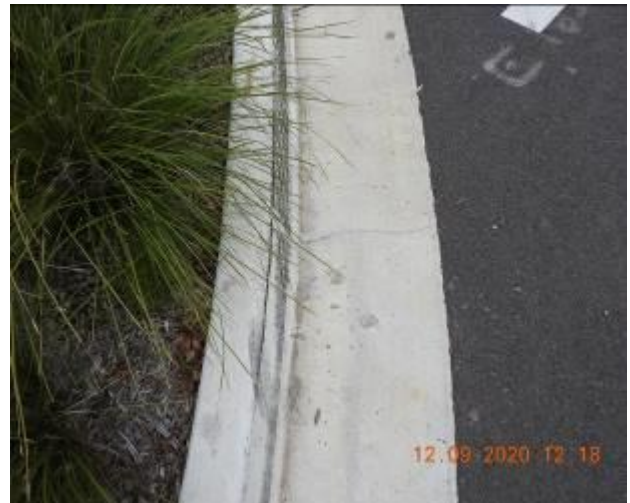
Figure 956 – Crack propagation and loss of material through kerb and gutter

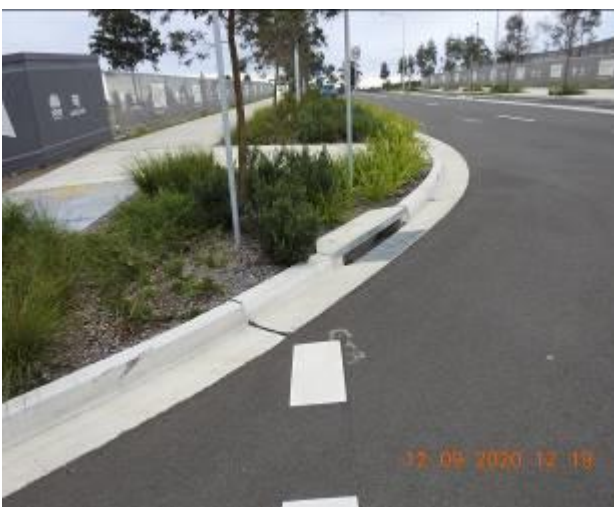
Figure 957 – Crack propagation and loss of material through kerb and gutter

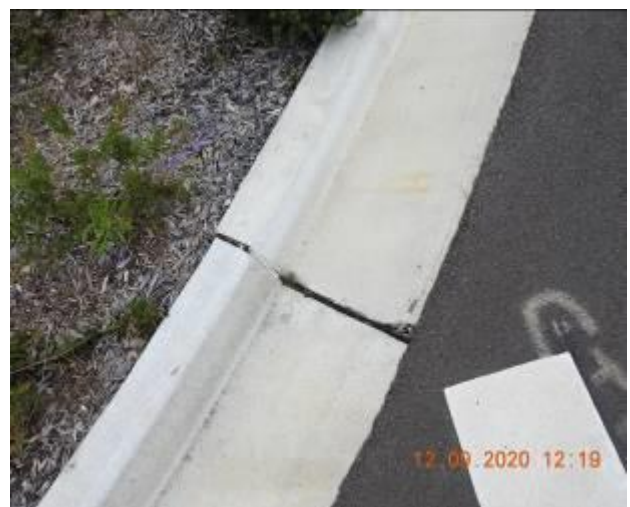
Figure 958 – General condition of kerb and gutter

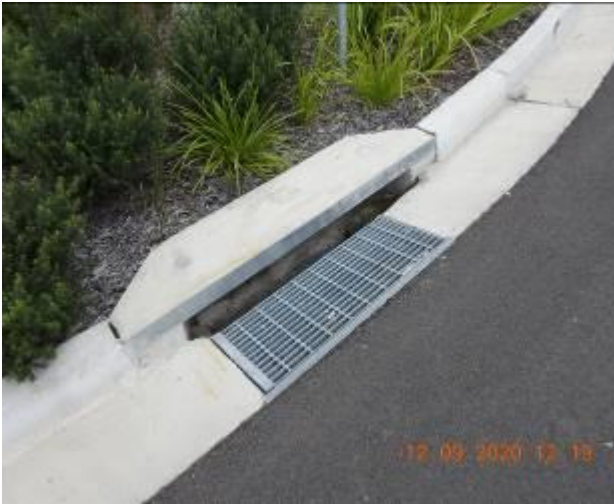
Figure 959 – Crack propagation and loss of material through kerb and gutter

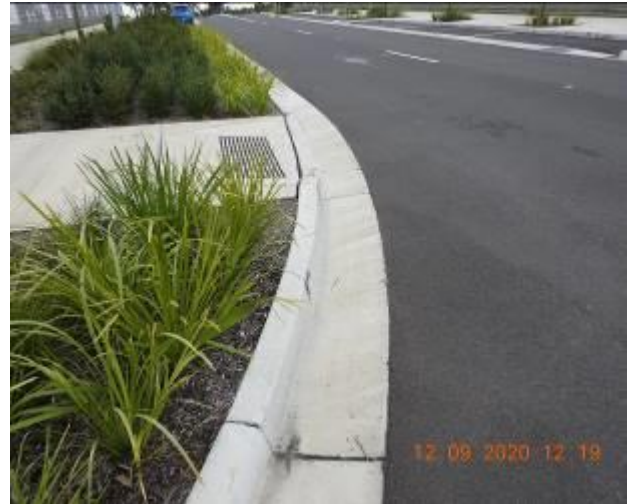
Figure 960 – General condition of stormwater inlet pit/Loss of material through kerb

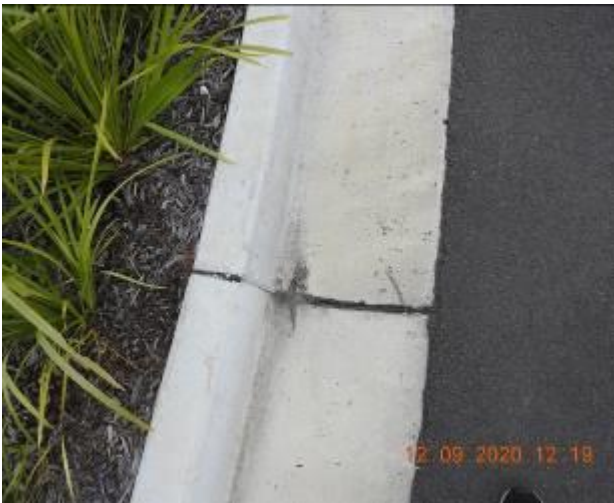
Figure 961 – General condition of kerb and gutter

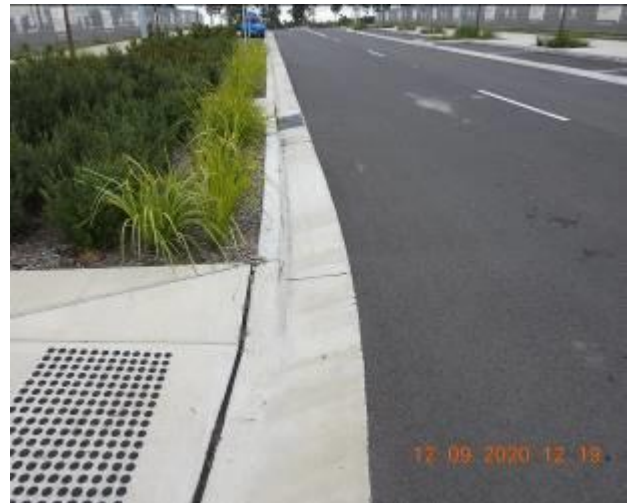
Figure 962 – Crack propagation and loss of material through kerb and gutter

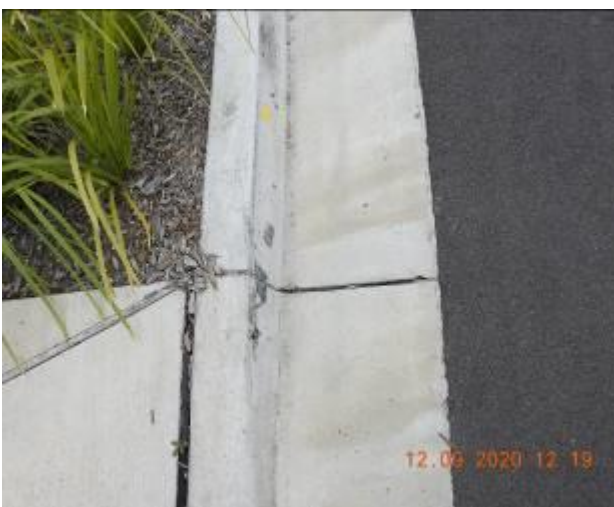
Figure 963 – General condition of kerb and gutter

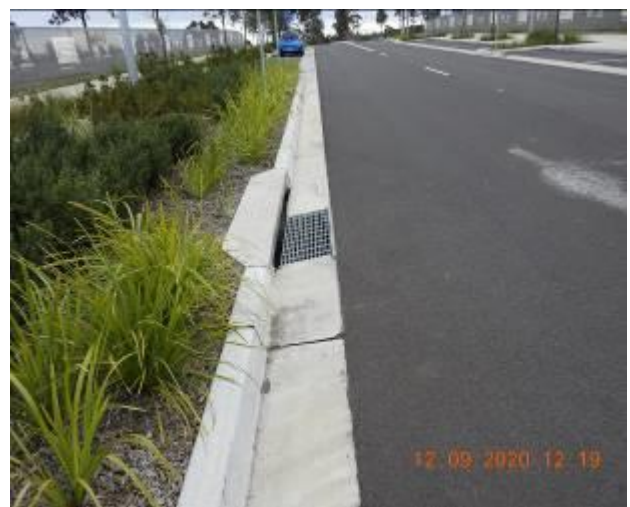
Figure 964 – Crack propagation and loss of material through kerb and gutter

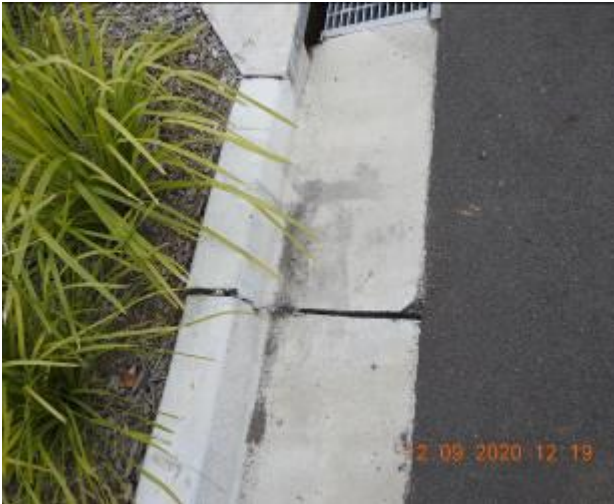
Figure 965 – General condition of kerb and gutter

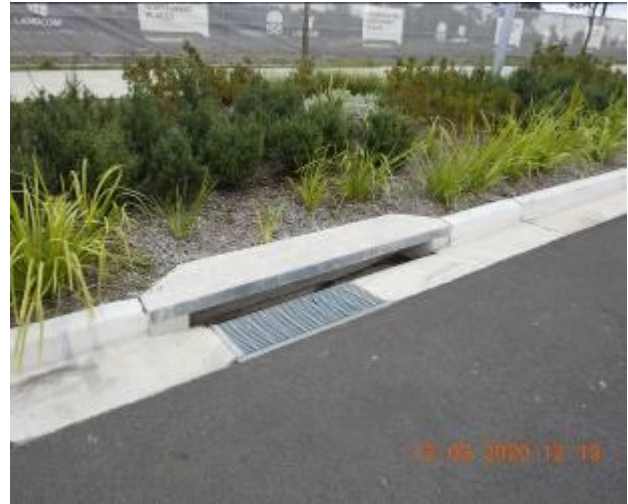
Figure 966 – Crack propagation and loss of material through kerb and gutter

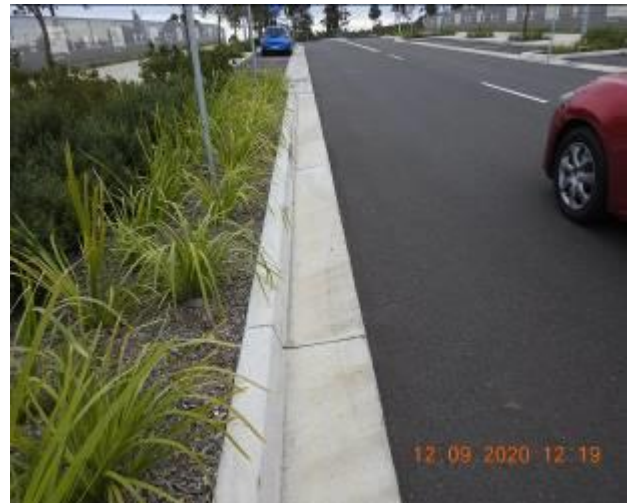
Figure 968 – Loss of material through kerb

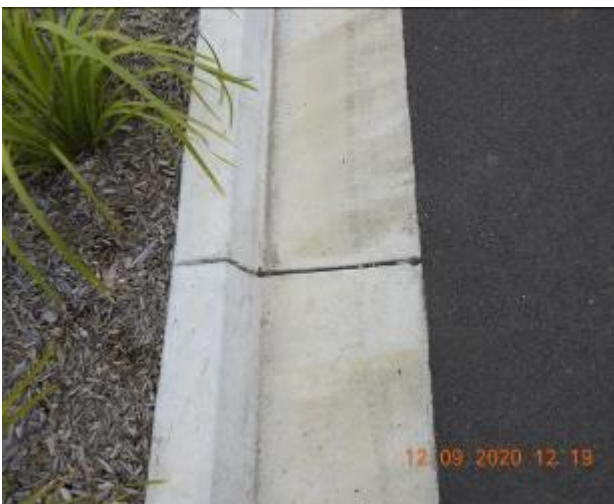
Figure 969 – General condition of kerb and gutter

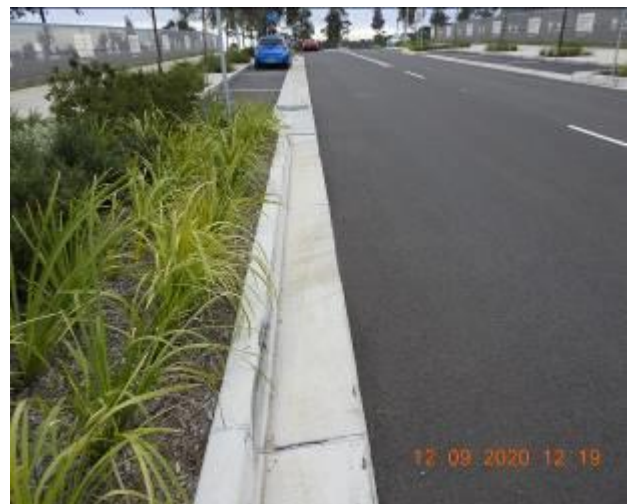
Figure 970 – Crack propagation and loss of material through kerb and gutter

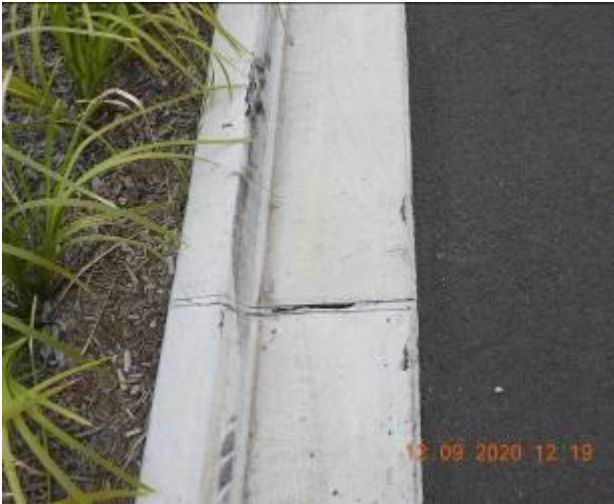
Figure 971 – General condition of kerb and gutter

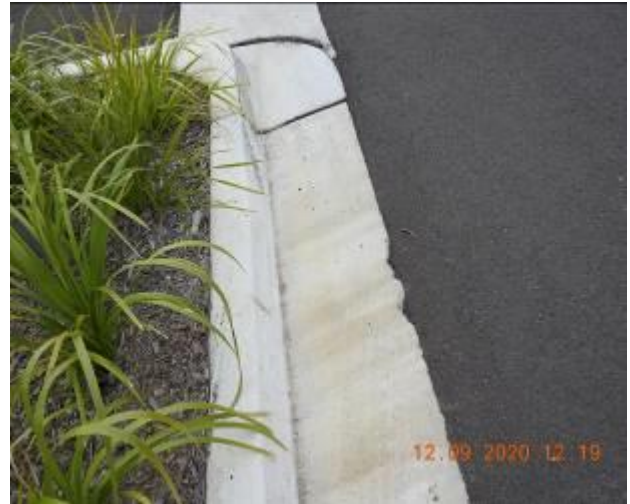
Figure 972 – Crack propagation and loss of material through kerb and gutter

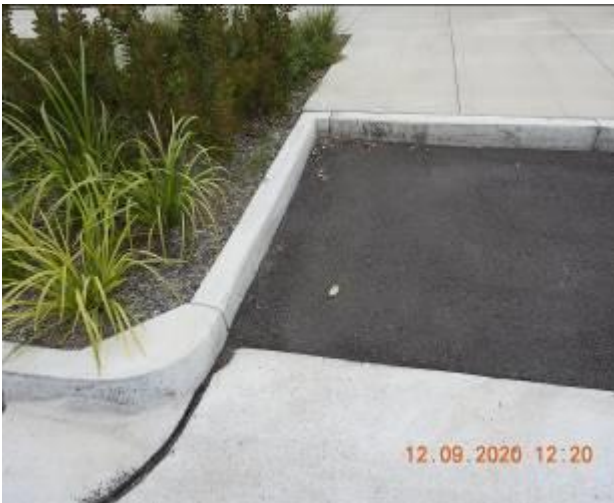
Figure 973 – Loss of material through gutter

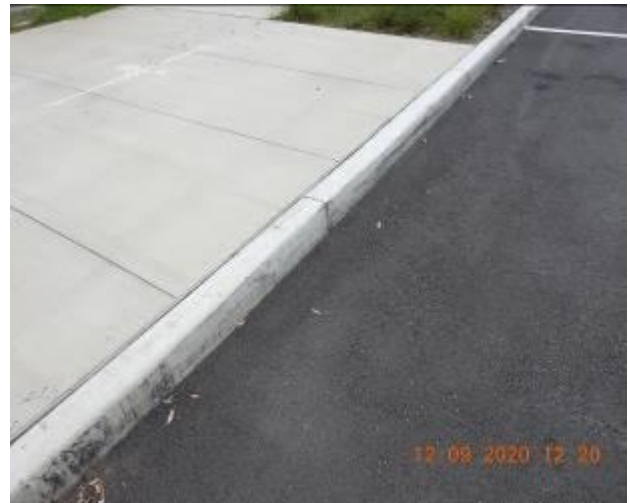
Figure 974 – General condition of kerb

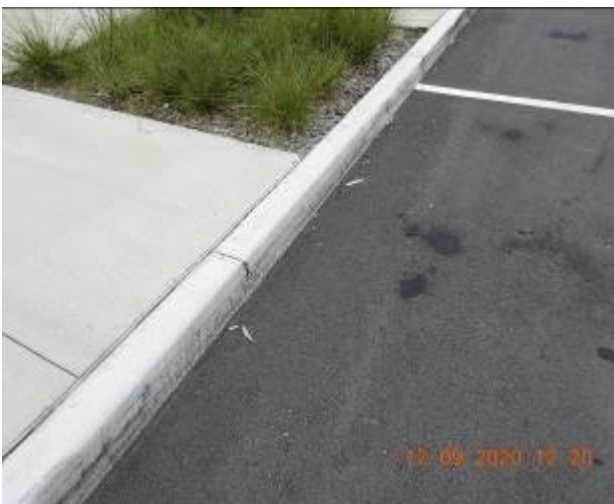
Figure 975 – General condition of kerb

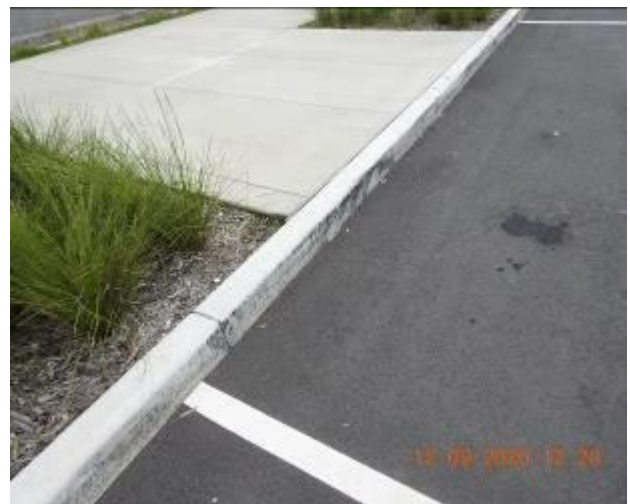
Figure 976 – Loss of material through kerb

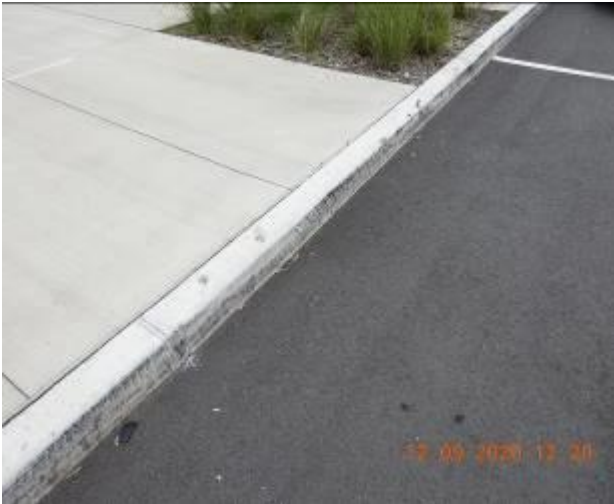
Figure 977 – General condition of kerb

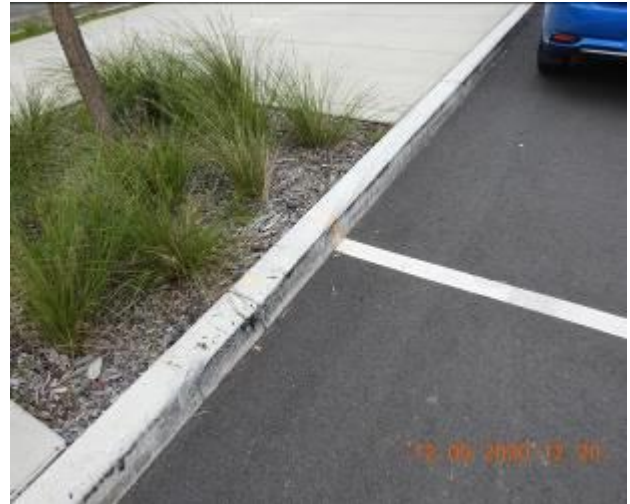
Figure 978 – Loss of material through kerb

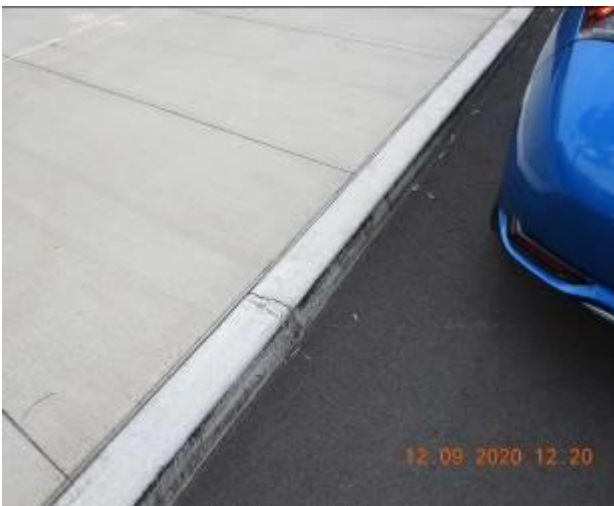
Figure 979 – General condition of kerb

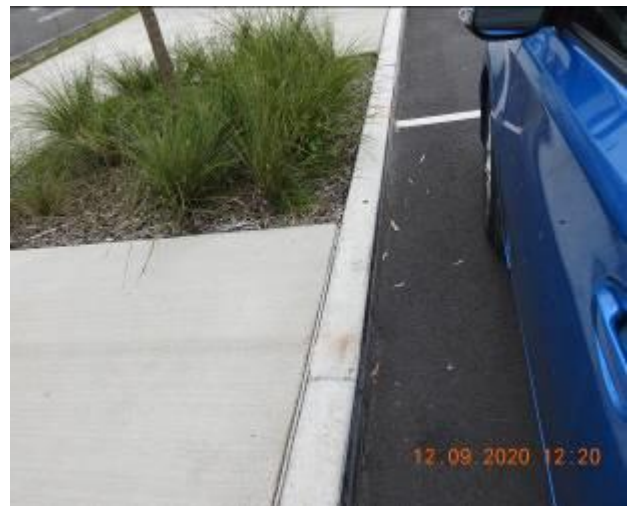
Figure 980 – Crack propagation and loss of material through kerb

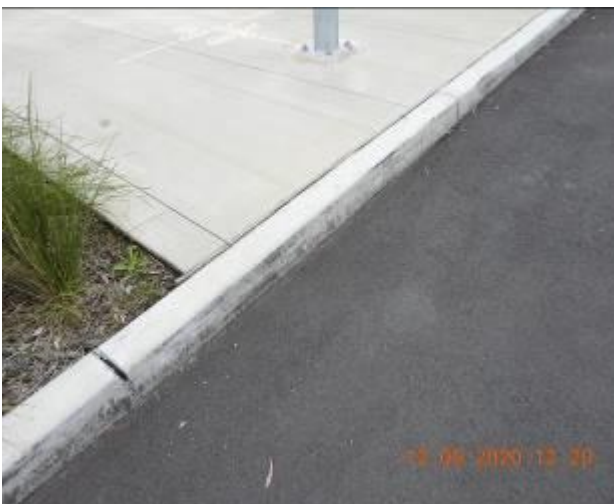
Figure 981 – Evidence of patchwork and Loss of material through kerb

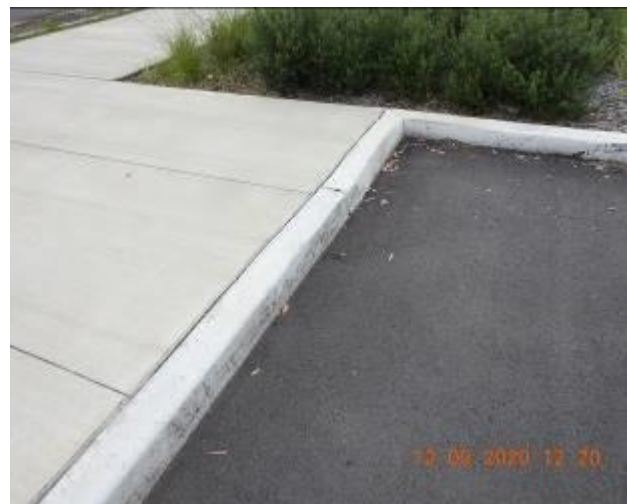
Figure 982 – Loss of material through kerb

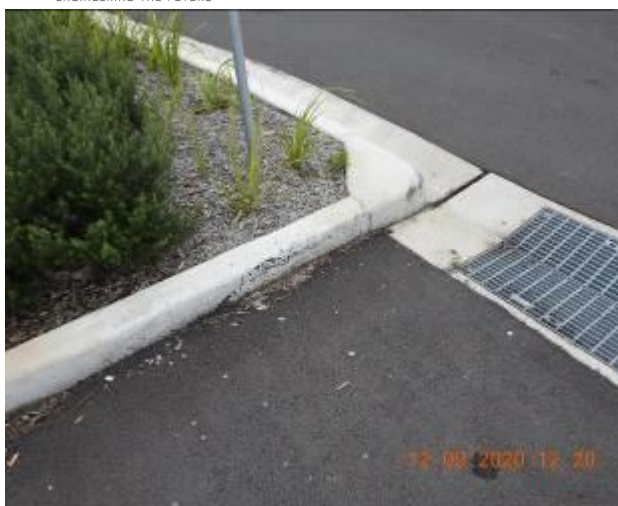
Figure 983 – General condition of kerb

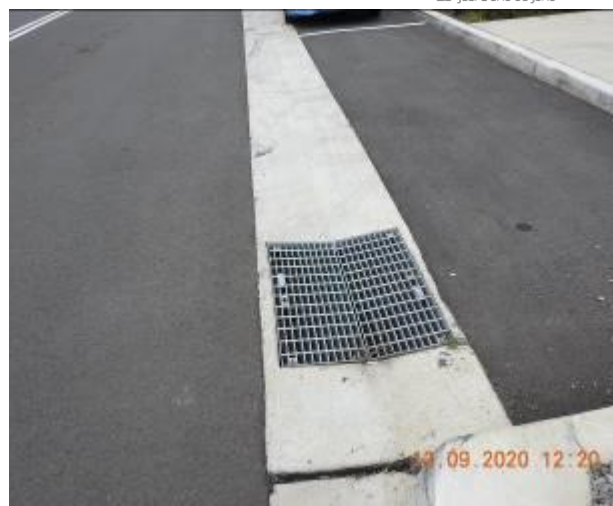
Figure 984 – General condition of kerb
